**Centennial Campus Project, The University of Hong Kong  
Heritage Impact Assessment Report**

**Workmen's Quarters, Senior Staff Quarters and Treatment Works  
Building of the Former Elliot Pumping Station and Fliters  
in Pokfulam**

**The University of Hong Kong**

**March, 2012**

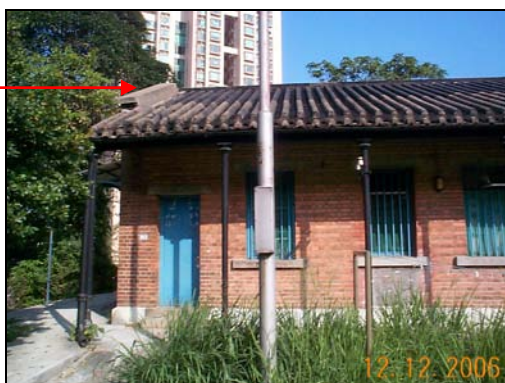
Granite coping on top of west gable wall

- From the condition survey, there are leakages on the roof.
- The “double layer pan and double layer roll” (雙筒雙瓦) Chinese tile roof shall be replaced with similar construction.
- The granite coping on top of both side of gable wall shall be preserved (not to be taken down) and protected during replacement of the roof tiling.
- The granite coping shall be cleaned, and the defective pointing to be removed and the joint re-point with 1:3 lime sand mortar.

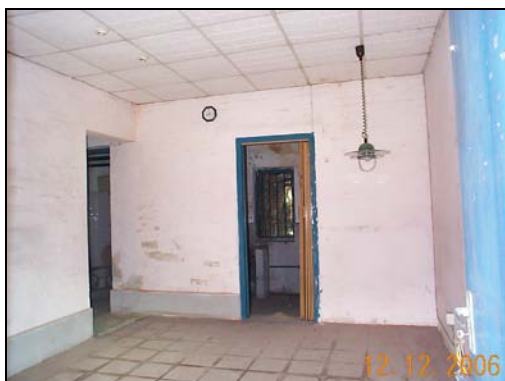
Suspended false ceiling at the east end room

- The soffit of the roof is covered either by timber panels fixed at the soffit of the tiling or suspended false ceiling, and after taking down part of the covering it is found that the timber roof members have been infested by termite.
- The timber roof structure including the timber roof trusses, purlins and battens shall be replaced, if found to be defective. Such replacement work may have difficult in satisfying the statutory requirements, early consultation with Building Authority is recommended. (Paragraph 1.4 in the *Practical Guidebook*).
- The replacement shall follow the existing construction, i.e. the size, spacing, and details of the joints, etc.

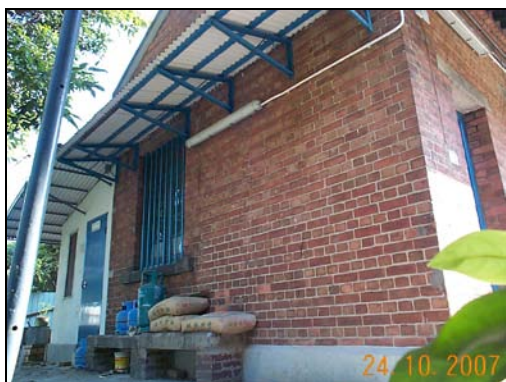
Later added canopy at west elevation

- Canopies have been added surrounding the building except at the verandah (façade), these later added canopies shall be carefully removed without creating additional damages to the red facing brickwork.
- The holes shall be carefully fill up with repair mortar. The repair mortar is recommended to be 1:3 lime / red brick fines mortar, and mock ups shall be prepared before the final decision for the mix and the type of red brick fines and other aggregates for the repair mortar.
- After the removal of the canopies, it may be necessary to added eaves gutter to the rear pitch of the roof. The size, shape and material of the eaves gutter and rainwater downpipe shall follow the existing at the verandah.

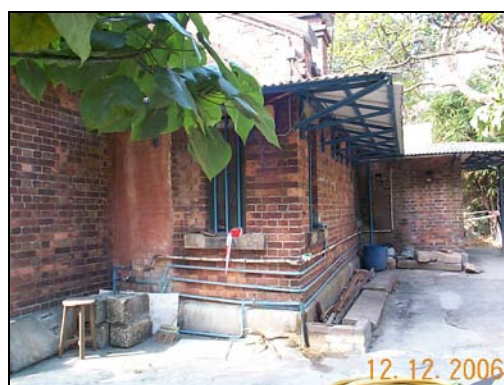
Later added canopy at rear elevation,  
east side

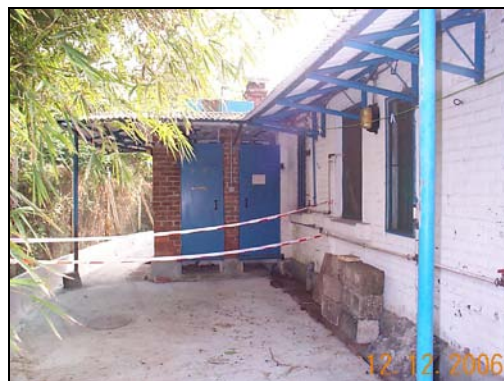
- Part of the red facing brickwall at the rear (west side) has been painted white. The white paint shall be removed and the damaged bricks and pointing (if any) to be restored.

West part of rear elevation painted white,  
view from west side

- It is recommended that a close examination be carried to the red facing bricks including the previous repair works to identify the damaged / deteriorated bricks to be repair and the inappropriate/detrimental previous repair work to be removed.
- The method of repair the red facing brick is to be determined after the close examination, different repair approaches may be necessary for different extent of repair work and the availability of matching red facing bricks.
- The defective pointing shall be removed and the joints re-pointed with 1 : 3 lime sand mortar.

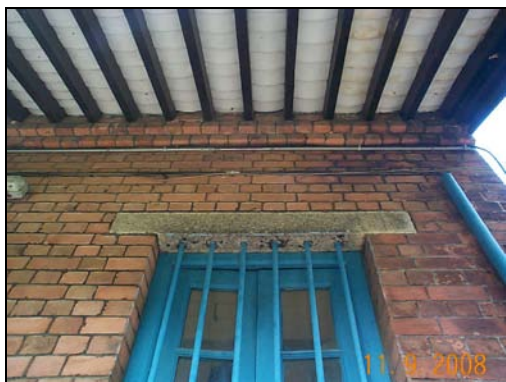
The red facing brickwork cornice

- The timbers battens are supported by the timber purlin on the open side and the red facing brickwork cornice on the wall side. Care shall be taken when taking down and installation of new battens in order to minimize any damages to the brick cornice.

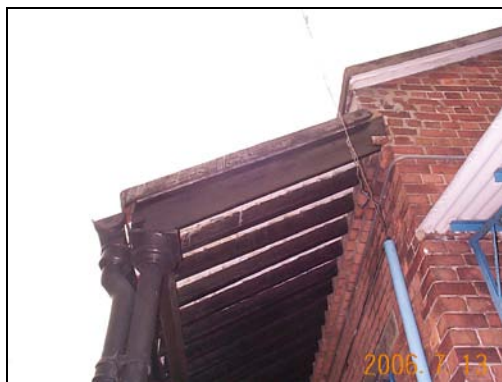
The timbers battens are supported by the timber purlin on the open side and the red facing brickwork cornice on the wall side

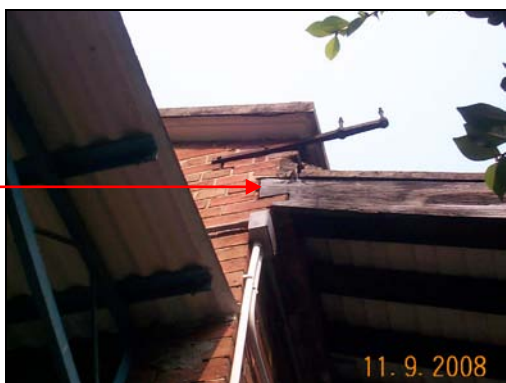
The batten at the west end

- The upper end of the batten at both end are “tongued” into the red facing brickwork and this details shall be recorded and replicated (not to be changed) in the replacement.

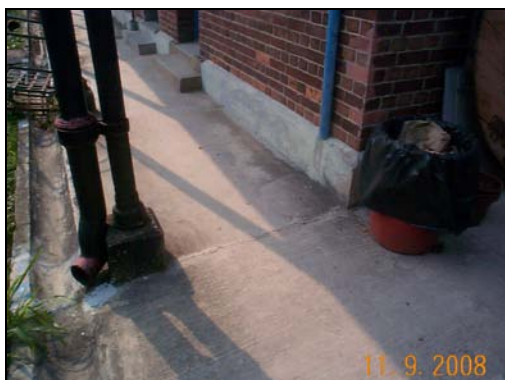
Cast iron pillar (lower part) and  
rainwater downpipe

- The paint on the cast iron pillars shall be removed, and the pillars properly primed and re-painted.
- The granite pillar base shall be cleaned and it is not necessary to repair the minor damages and irregularities, i.e. wear and tear, and chipped corners.

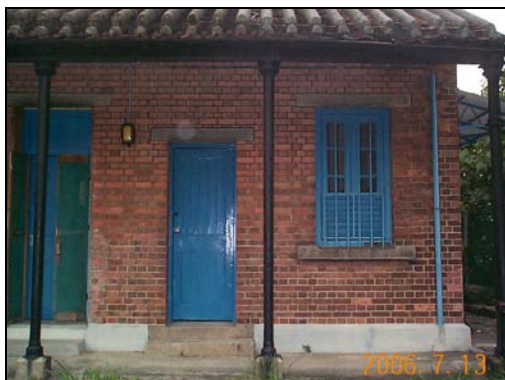
Door at façade east part to be taken as prototype door

- From site inspection, the condition of the doors and frames are in a very poor condition and beyond repair, they are to be replaced.
- Care shall be taken when taking down the door frame and installation of new door frame in order to avoid any damages to the brick door jambs.
- The doors at the central part and west part of the façade have been replaced. The door at the east part of the façade may be the original door, thus it is recommended to take this door as the prototype (size, detailing and construction) for replication.
- The colour of the door can be changed.
- The ironmongeries, e.g. pull handle, shall match the style of the building.

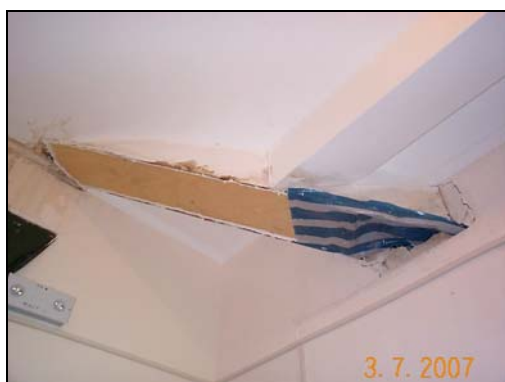
- From the condition survey, there is severe leakage on the roof.
- The “double layer pan and double layer roll” (雙筒雙瓦) Chinese tile roof shall be replaced with similar construction.
- The features at the end of the hip ridges, i.e. the “ox horn” end, shall be preserved during the re-roofing work, and if it is not possible to preserve the “ox horn”, they should be re-constructed with similar construction.

Roof water leakage at the ceiling of the corridor at first floor

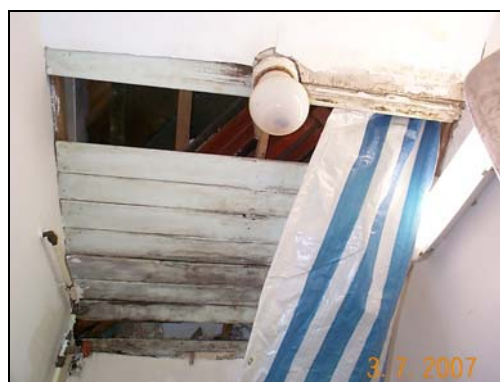
Roof water leakage at the ceiling of the toilet at first floor

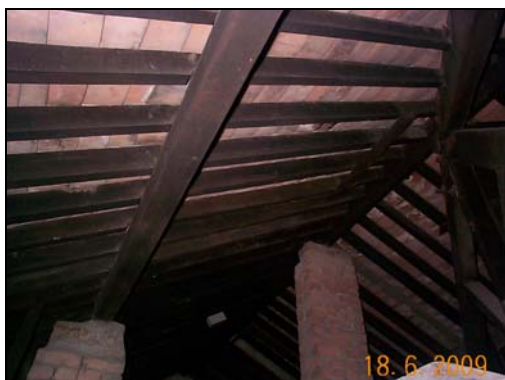
Soffit of the roof from the access panel at the false ceiling of the 1/f verandah – the main part

- The soffit of the roof is covered by suspended false ceiling, and on accessing to the attic part from the access panel at the verandah, it is found that the timber roof members have been infested by termite, and steel members have been added to reinforce one of the hip purlin.
- The timber roof structure including the timber roof truss, purlins, battens, eaves board and eaves soffit boards shall be replaced, if found to be defective. Such replacement work may have difficulty in satisfying the statutory requirements, early consultation with Building Authority is recommended. (Paragraph 1.4 in the *Practical Guidebook*).
- Based on conservation approach, the replacement shall follow the existing construction, i.e. the size, spacing, and details of the joints, etc.

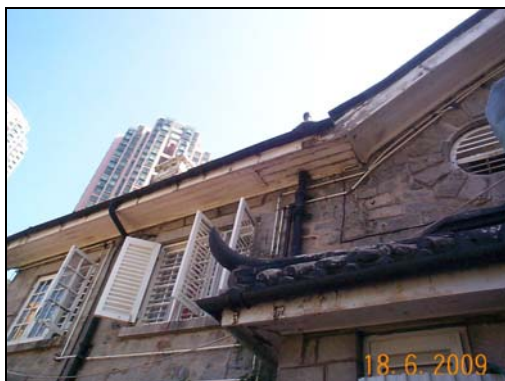
The soffit panel of the projecting roof eaves and fascia board at facade

- The roof eave is projected above 500 mm beyond the external wall and the soffit is covered with timber panel.
- From visual inspection, the panel and side fascia board are defective and may have been infested by termite.
- The panel and fascia board shall be replaced with similar construction.
- It is recommended to keep the white colour, unless a more appropriate colour to match the external appearance of the building is identified.

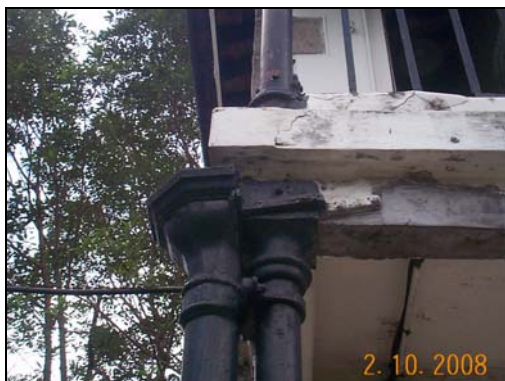
Hopper installed at floor drain outlet

- The eaves gutter including the brackets shall be repair, and to be replaced if beyond repair.
- The paint on the rainwater downpipes and brackets shall be removed, and these components properly primed and re-painted.
- The rainwater hoppers which are not properly fixed, shall be taken down and properly fix with appropriate brackets and fixing details.

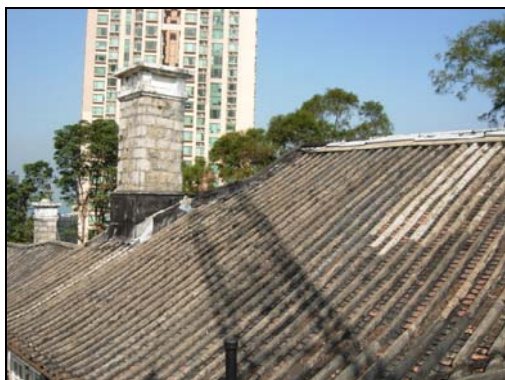
Two chimney stacks

- The granite chimney stacks shall be cleaned.
- The defective pointing shall be removed and the joints re-pointed with 1 : 3 lime sand mortar.
- Copper wire mesh shall be added at the internal side of the chimney stack to prevent birds building nest inside the chimney.

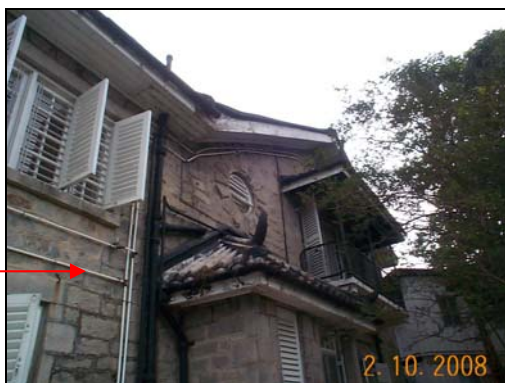
Water pipes fixed on the facade

- All conduits, light fittings and water pipes fixed on the wall shall be carefully removed without creating additional damages to the granite blocks.
- The holes shall be carefully fill up with repair mortar. The repair mortar is recommended to be 1:3 lime / granite fines mortar, and mock ups shall be prepared before the final decision for the mix and other aggregates of the repair mortar.

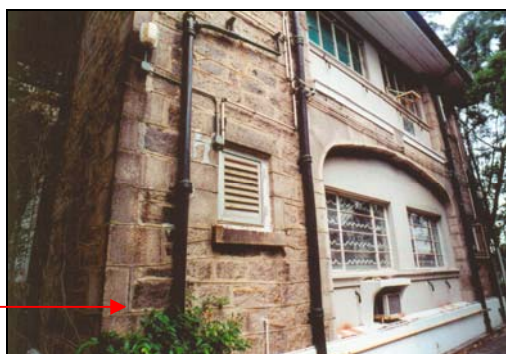
The verandah at both floors have been blocked up and the space converted to a room

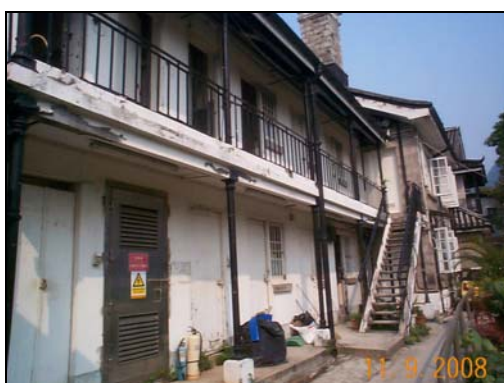
The metal balustrade

- The paint on the metal balustrade shall be removed, and the members handrail, vertical and horizontal railing properly primed and re-painted.
- Although this balustrade cannot satisfy the statutory requirements, e.g. height, spacing between vertical railing and lateral load capacity, it should not be replaced.
- A new set of balustrade is recommended to be added at the internal side of the balustrade.

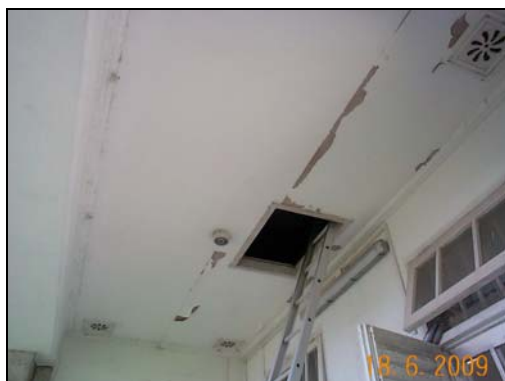
The timber false ceiling at first floor verandah

- The soffit of the roof is covered by suspended timber false ceiling, and on accessing to the attic part from the access panel it is found that the timber false ceiling have been infested by termite, the timber false ceiling shall be replaced with similar construction.
- The pattern grille at the four corners shall be preserved if possible, if they are beyond repair, they shall be re-constructed.
- It is recommended to keep the white colour, unless a more appropriate colour to match the external appearance of the building is identified.

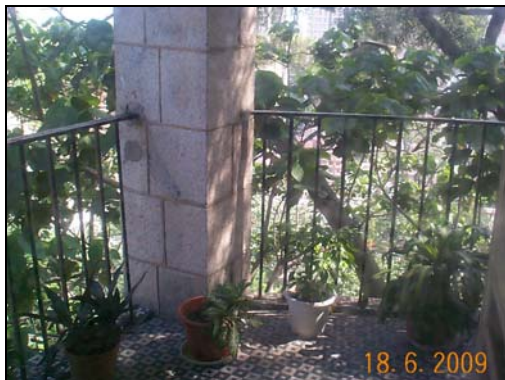
The granite pillar

- Clean the granite block pillar and corbels.
- The defective pointing shall be removed and the joints re-pointed with 1 : 3 lime sand mortar.

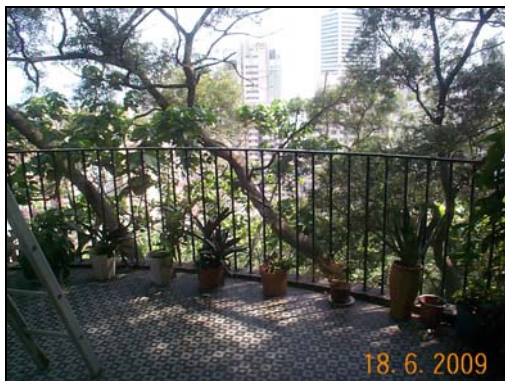
- The existing balustrade is not the original balustrade, because the pocket for the fish-tail of the original handrail of the balustrade is still visible.
- This balustrade cannot satisfy the statutory requirements for protective barrier, e.g. lateral load capacity. They shall be replaced with design to match the architectural style of the building. The replacement may have difficulty in satisfying the statutory requirements, early consultation with Building Authority is recommended. (Paragraph 1.4 in the *Practical Guidebook*).
- Any damages to the granite work should be filled with repair mortar as recommended in the repair of the granite external wall.

The balustrade

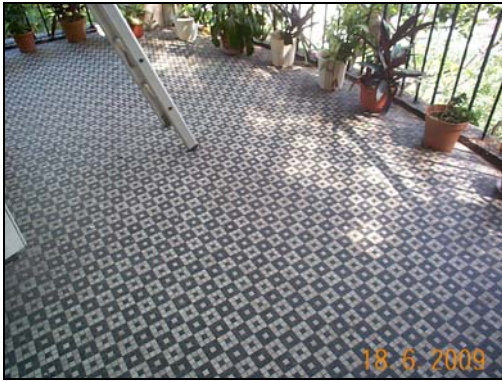
The pattern mosaic floor finishes

- The pattern mosaic floor finishes should not be the original floor finishes, because this type of ceramic mosaic should not be available after Second World War.
- They shall be preserved and the defective parts shall be repair.

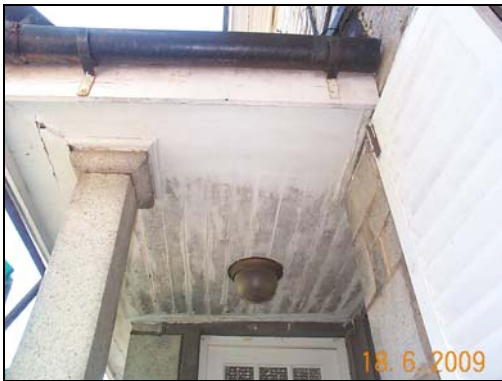
The timber false ceiling at ground floor entrance porch

- The soffit of the roof is covered by suspended timber false ceiling, and may have been infested by termite as in other timber building components.
- If it has been infested, the timber false ceiling shall be replaced with similar construction.
- The pattern grille at the four corners shall be preserved if possible, if they are beyond repair, they shall be re-constructed.
- It is recommended to keep the white colour, unless a more appropriate colour to match the external appearance of the building is identified.

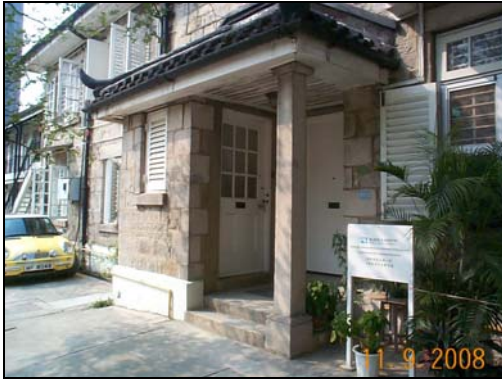
The granite pillar at ground floor entrance porch

- The granite pillar with base and capital shall be cleaned.
- The defective pointing shall be removed and the joints re-pointed with 1 : 3 lime sand mortar.

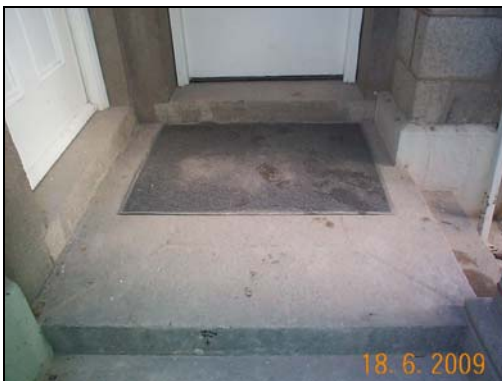
The granite floor paving at ground floor entrance

- The granite floor paving shall be cleaned.
- The defective pointing shall be removed and the joints re-pointed with 1 : 3 lime sand mortar.
- The floor mat well at both the exterior and the interior shall be preserved.

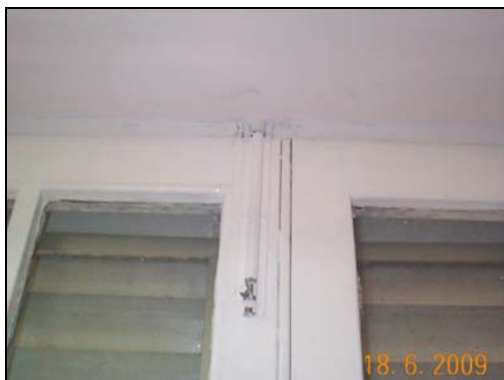
Vertical top bolt to French window at first floor balcony

- The later replacement ironmongeries which are not compatible with those used in the period when the building was constructed shall be replaced with compatible ones.
- The ironmongeries can be replaced with brass ironmongeries.

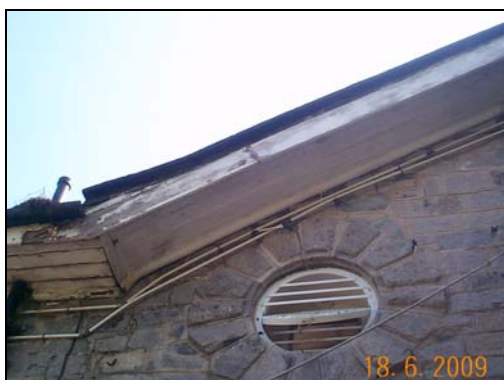
External view of window

- From site inspection, the painting to the window and frame is very thick, it is recommended to remove the paint to examine the condition of the window.
- The defective part of the window and frame shall be repair.
- The centre-pivoted mechanism shall be touched up for easy opening and closing of the window.
- It is recommended to keep the white colour, unless a more appropriate colour to match the external appearance of the building is identified.
- The mosquito screen and the three horizontal security bars shall be removed.
- Glazing panel can be added at the rear side of the window of necessary.
- The brass window stay shall be preserved and polished.
