Revitalisation Scheme – Conversion of Lui Seng Chun into Hong Kong Baptist University Chinese Medicine and Healthcare Centre

**HERITAGE IMPACT ASSESSMENT
CONSERVATION MANAGEMENT PLAN**

April 2010

Heritage Consultant: AGC Design Ltd.

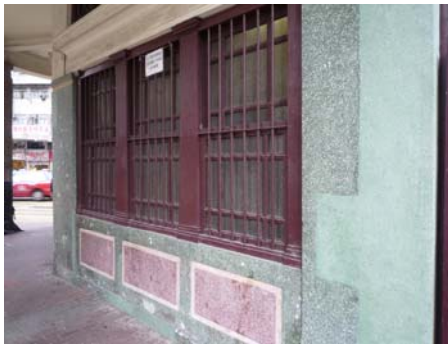
<p>(Ref: No. 1.4)</p>	High

<p>(Ref: No. 1.3)</p>	Exceptional
1.4	<p>Shanghai plastered coloured walls with plastered cornice and moldings at G/F</p> <p>The shanghai rendering have been badly repaired in different colour</p>

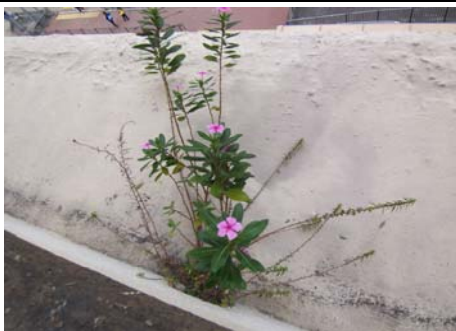
</div> <p>(Ref: No. 1.8a)</p> <div data-bbox="604 595 1062 936">

<p>1.8</p>	<p>Drain points at parapet wall at 3/F and Roof</p> <p>Vegetation is found at certain location of the drain points</p>	<div data-bbox="604 192 1062 521">

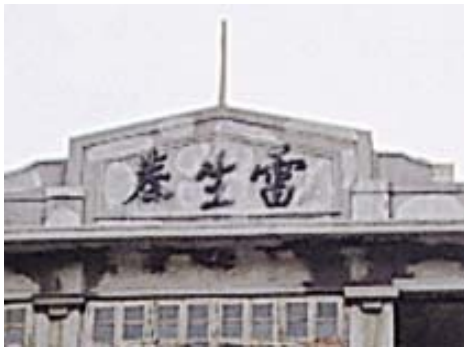
<p>(Ref: No. 4.4a)</p>

<p>(Ref: No. 4.3)</p>	High
4.4	Flag posts R.C. flag poles (2 nos.) above of each of the stone plaques at roof level but found missing on site.

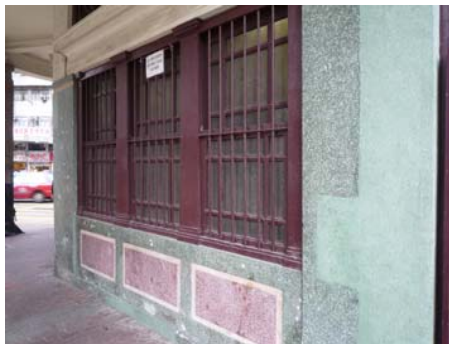
<p>(Ref: No. 1.3)</p>	Exceptional	<ul style="list-style-type: none"> - Preserve in-situ - Repair and clean, brush off & remove stains from the surface of stone - Keep the granite unpainted - The painted commercial letterings to be remained to reflect the past commercial activities of the building 	Low
1.4	<p>Shanghai plastered coloured walls with plastered cornice and moldings at G/F</p> <p>The shanghai rendering have been badly repaired in different colour</p>

<p>(Ref: No. 1.4)</p>	High	<ul style="list-style-type: none"> - Preserve in-situ - Carefully removed and replaced areas of Shanghai rendering have been badly repaired in the past by material of the correct colour 	Moderate
