SIGNIFICANCE

4.1 Assessment criteria for cultural significance

CONDITION

5.7 The Buildings: Condition

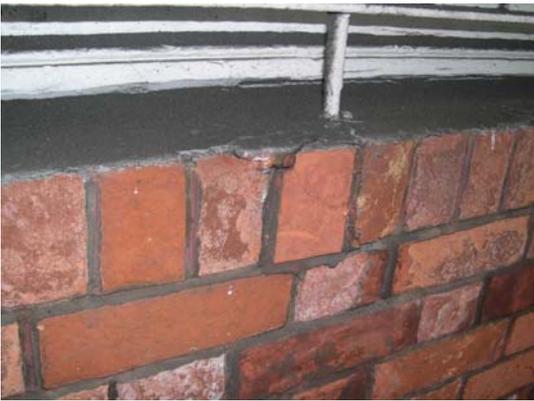
Cracked brickwork possibly due to corrosion of steel.
18.

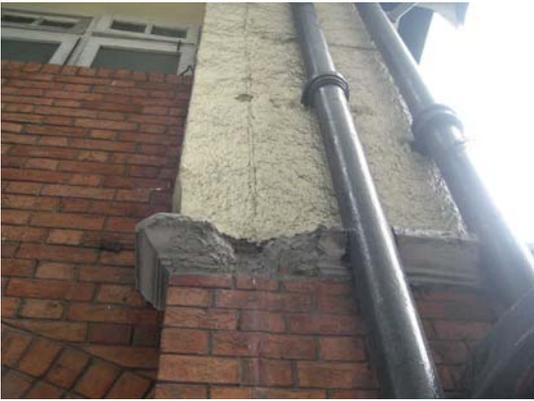
Molding broken.
19.

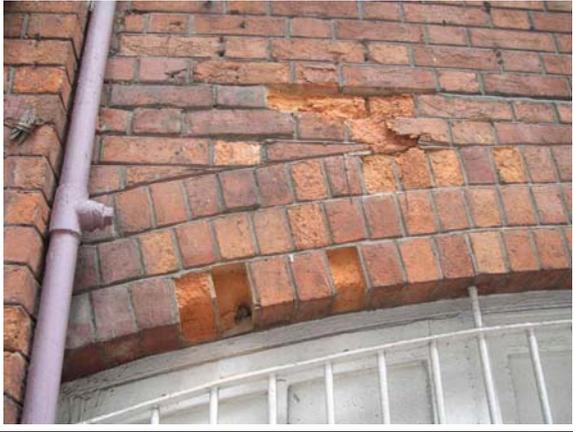
Degraded bricks.
21.

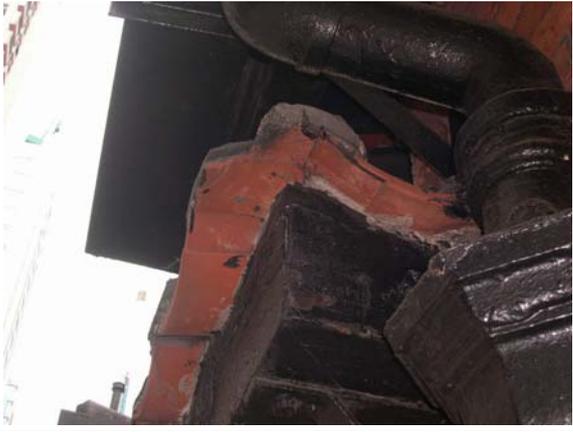
Broken roof tiles.
22.

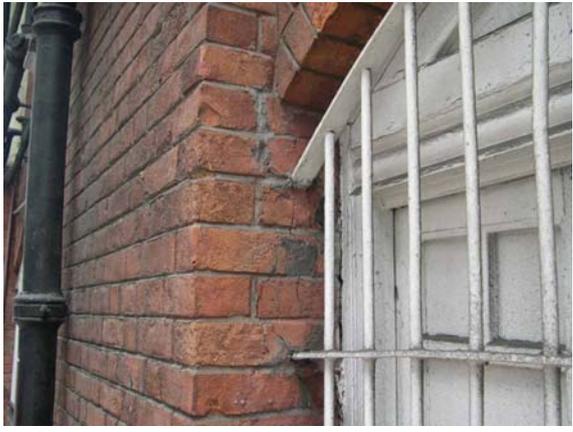
Hairline cracks on brick under arch opening.
23.

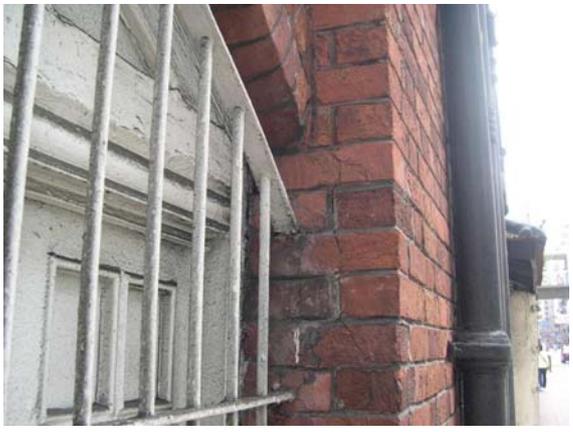
Hairline cracks on brick under arch opening.

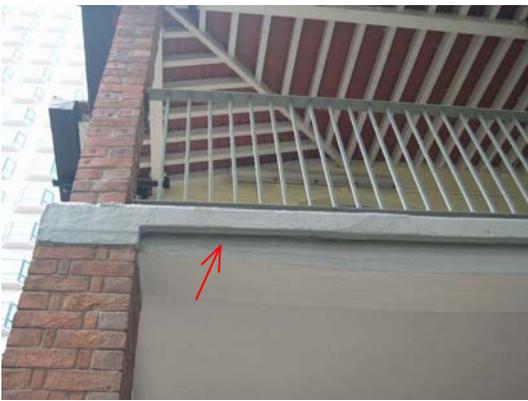
1. Hairline crack was found at the beam supporting the verandah.
2. The corroded metal railings in the brick column had caused the brick to split.
3. Hairline cracks were also found at the brickwork next to the G/F windows.
4. Damp patches were found on the wall at toilets.

Hairline crack to the side of the verandah beam.
66.

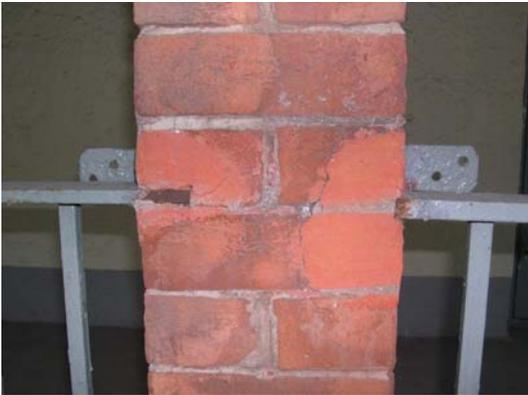
Corroded metal railing in the brick column causes splits in the brickwork.
67.

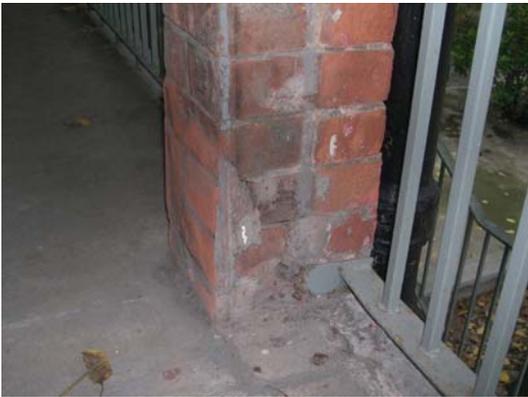
Brickwork at the column base was broken.

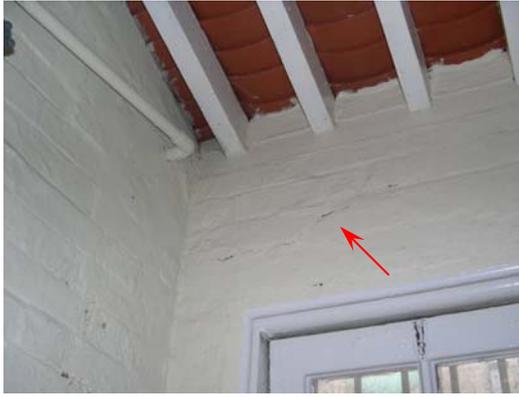
Hairline cracks above window.
89.

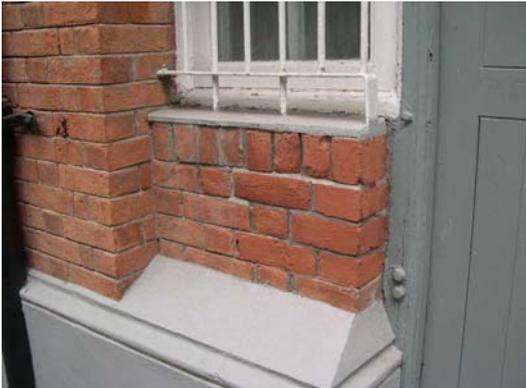
<p>The new door opening and infill panel with repaired brick surfacing. Hairline crack steps down from left to right at the edge of the repair.</p>
102.

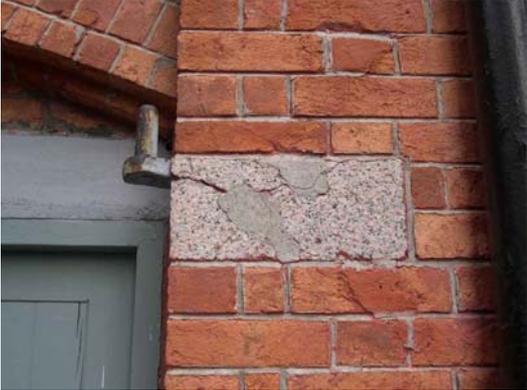
6. The granite pintles exhibited cracks consistent with minor corrosion of the pintles.
7. A split at one of the battens was found at the enclosed verandah.

The pintle blocks; the pintle would have been leaded in position, cracking consistent with corrosion.
109.

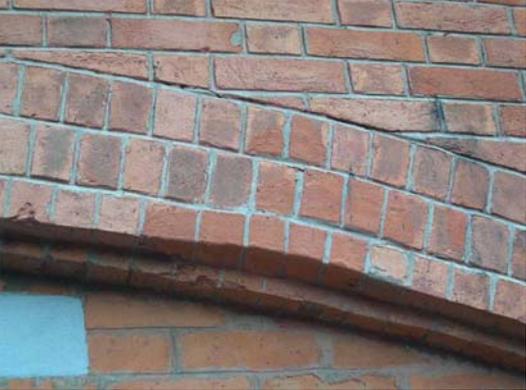
Areas of repair to the bricks and arches done in sand cement.
113.

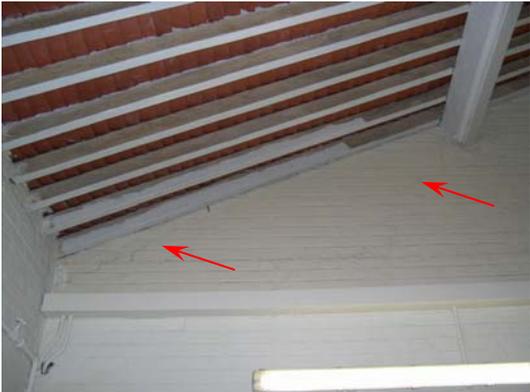
Hairline cracks at the brickwork indicating minor lateral movement.

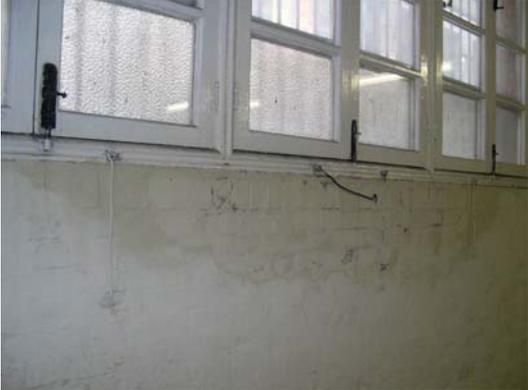
Water stain on wall under the windows indicates water seepage from the window cills.
121.

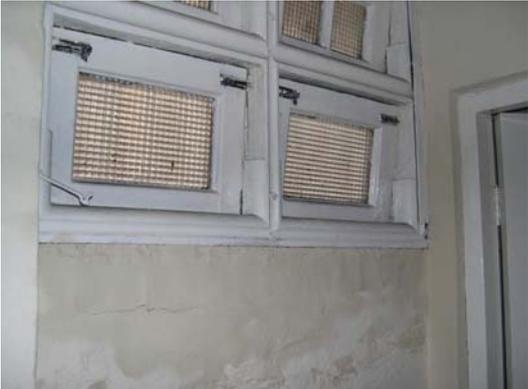
Water stain on wall under the windows indicates water seepage from the window cills.
122.

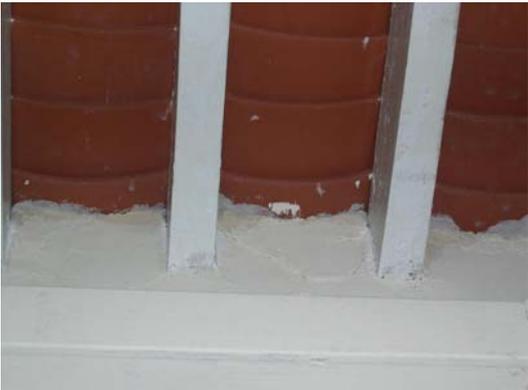
The infilling of the eaves inhibiting air circulation..
123.

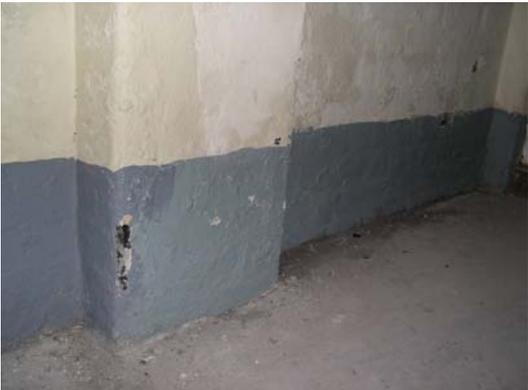
Water stain and dampness at the wall bases.

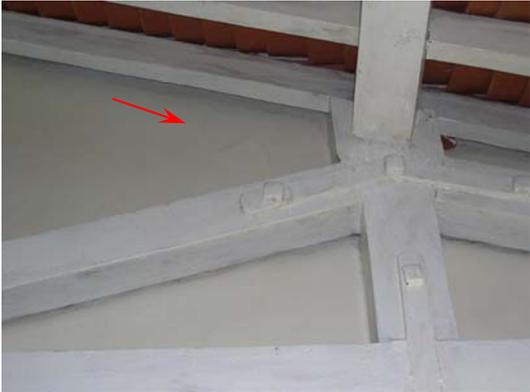
<p>A close-up photograph of a white-painted wall and a wooden beam. A thin, hairline crack is visible in the white paint, indicated by a red arrow pointing to it.</p>	Hairline crack at the wall.

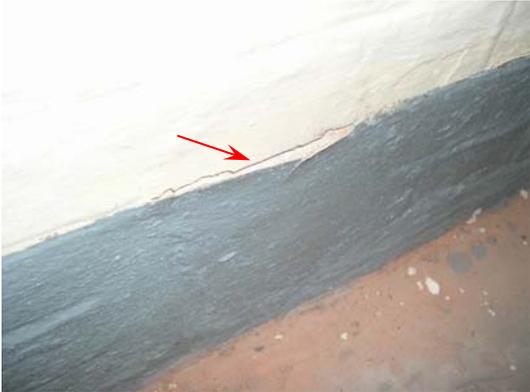
<p>A close-up photograph showing the base of a wall where the paint is peeling off. The peeling paint is dark and flaking, revealing the underlying surface. A red arrow points to the area of peeling.</p>	Paint to the wall bases peeling off.

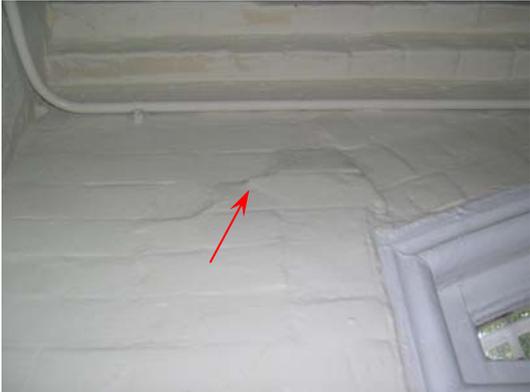
<p>A photograph of a window corner showing significant damage to the brickwork. The bricks are cracked and crumbling, with a red arrow pointing to the most damaged area.</p>	Cracked and defective brickwork at the window corner

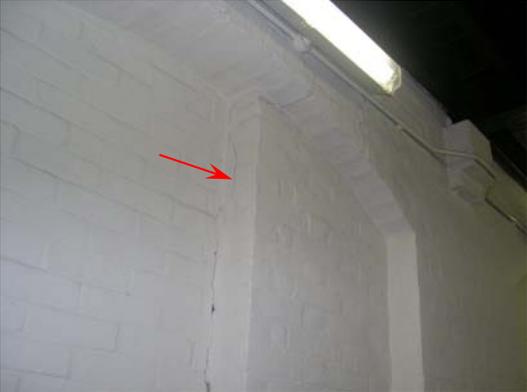
Hairline crack on wall, from arch down to the bottom.

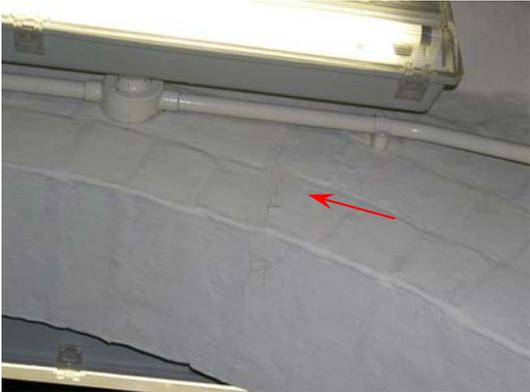
Hairline cracks on the arch.
133.

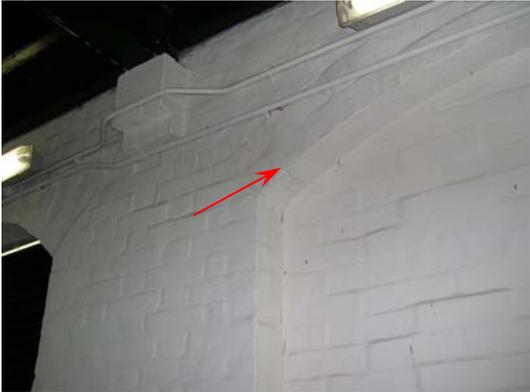
Hairline cracks on the arch.
134.

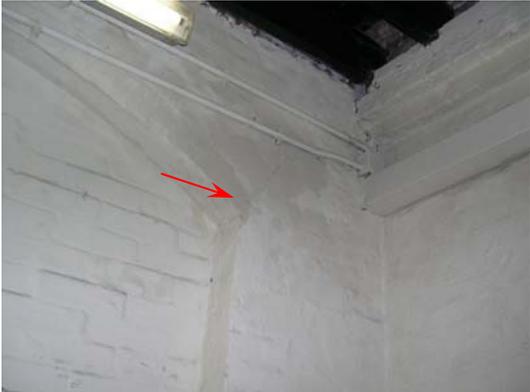
Hairline cracks and water stain on the arch.
135.

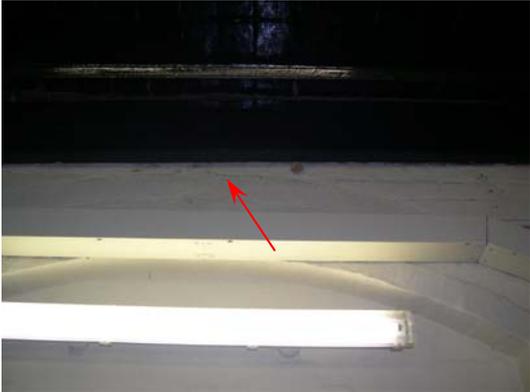
Hairline crack above the arch

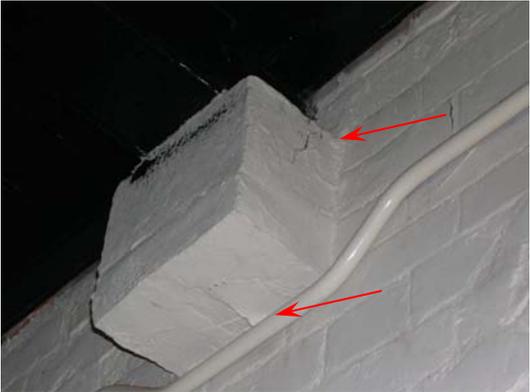
2. There was a hairline crack to a granite corbel supporting one of the beams that requires further investigation.
3. Other hairline cracking was noted to the floor finishes, the tiles at the verandah, the 1/F moldings to the ceiling and various arch openings.

Hairline crack to the corbel. Further investigation is recommended.
137.

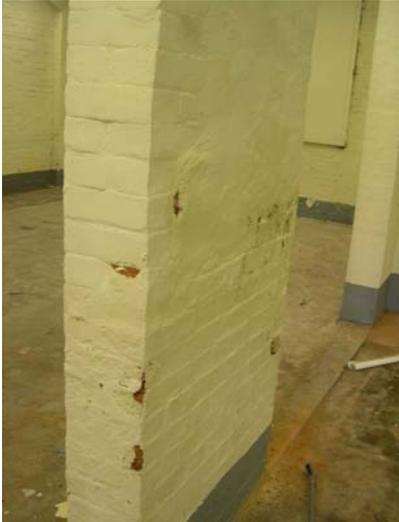
Degraded brickwork becomes powdery. Recommended to remove the paint on brickwork to review condition.
138.

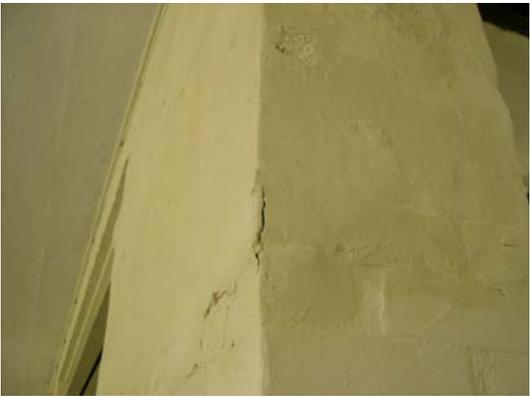
Degraded brickwork at the column. Suggested to remove paint on brickwork to review condition.
139.

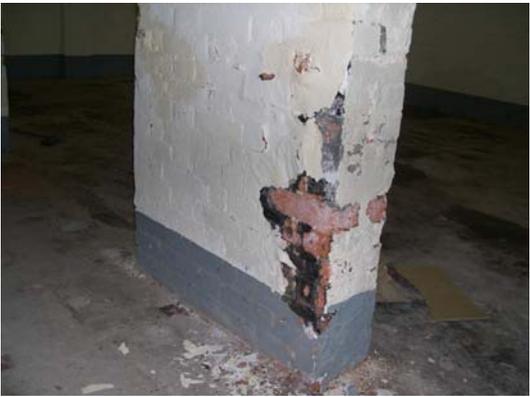
Degraded bricks, water stain and dampness on the brickwork.

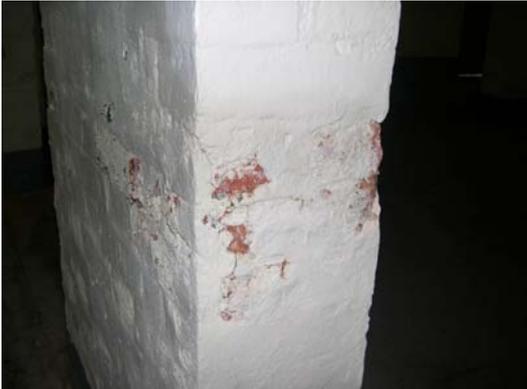
Water stain on brickwork, surface of the brickwork powdery.
141.

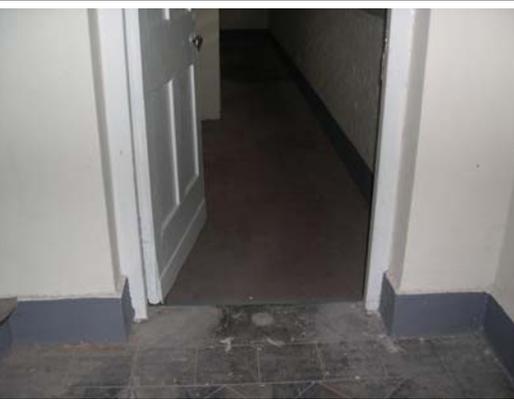
Change in floor level between the room at the base of the stairs and the area beneath the verandah.
147.

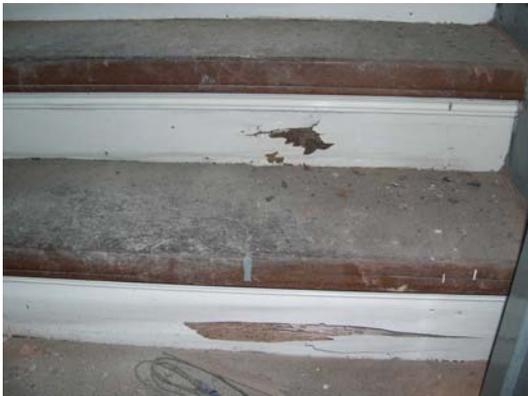
8. There was an area of rotten timber noted at the base of the timber staircase.
9. Signs of previous repair to the external brick wall and the cracking on the hard landscaping indicated the building may have been subject to differential settlement over the years.

Rotten timber at the bottom 2 steps.
154.

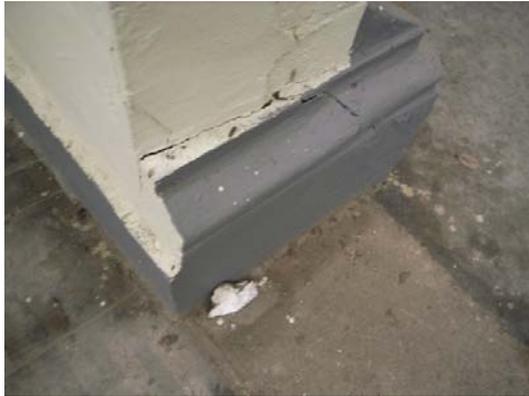
Cracking to the plinth at the column base.

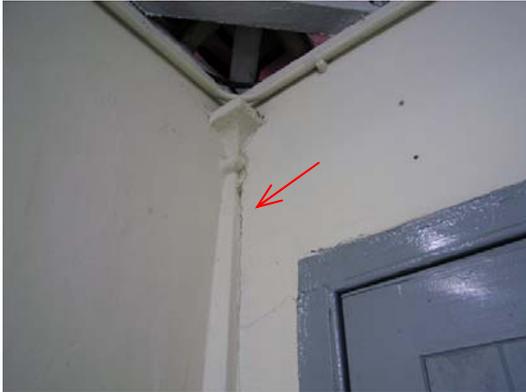
Hairline crack at the junction between wall and column.
161.

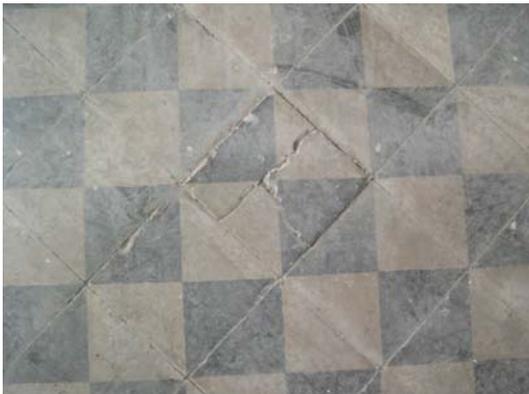
Broken floor tiles at the verandah.
166.

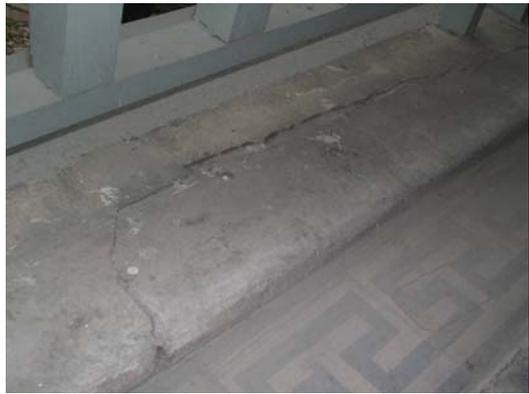
Hairline crack to the cement sand flooring of the verandah.

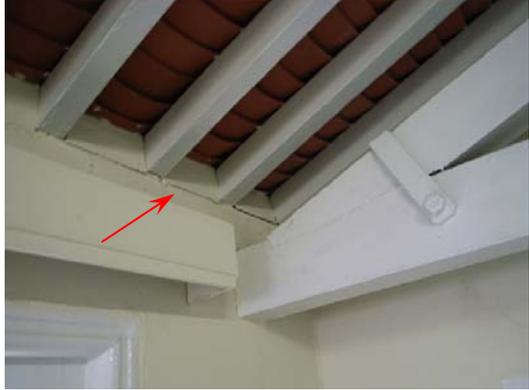
Hairline crack to the eave.
182.

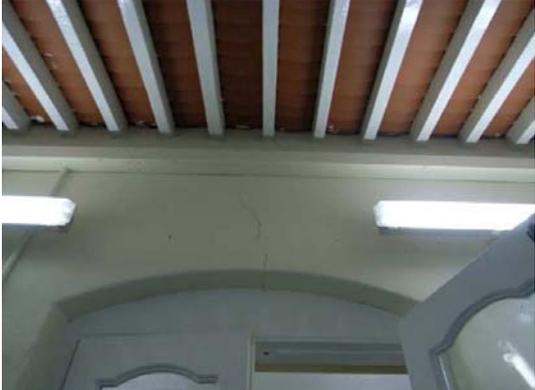
Hairline crack to the arch opening.
184.
