CONSULTANCY STUDY ON THE PRESERVATION OF ANCIENT ROCK CARVINGS OF HONG KONG

12-18 January 2010

Richard A. Engelhardt, UNESCO Senior Advisor for Culture
Consultant

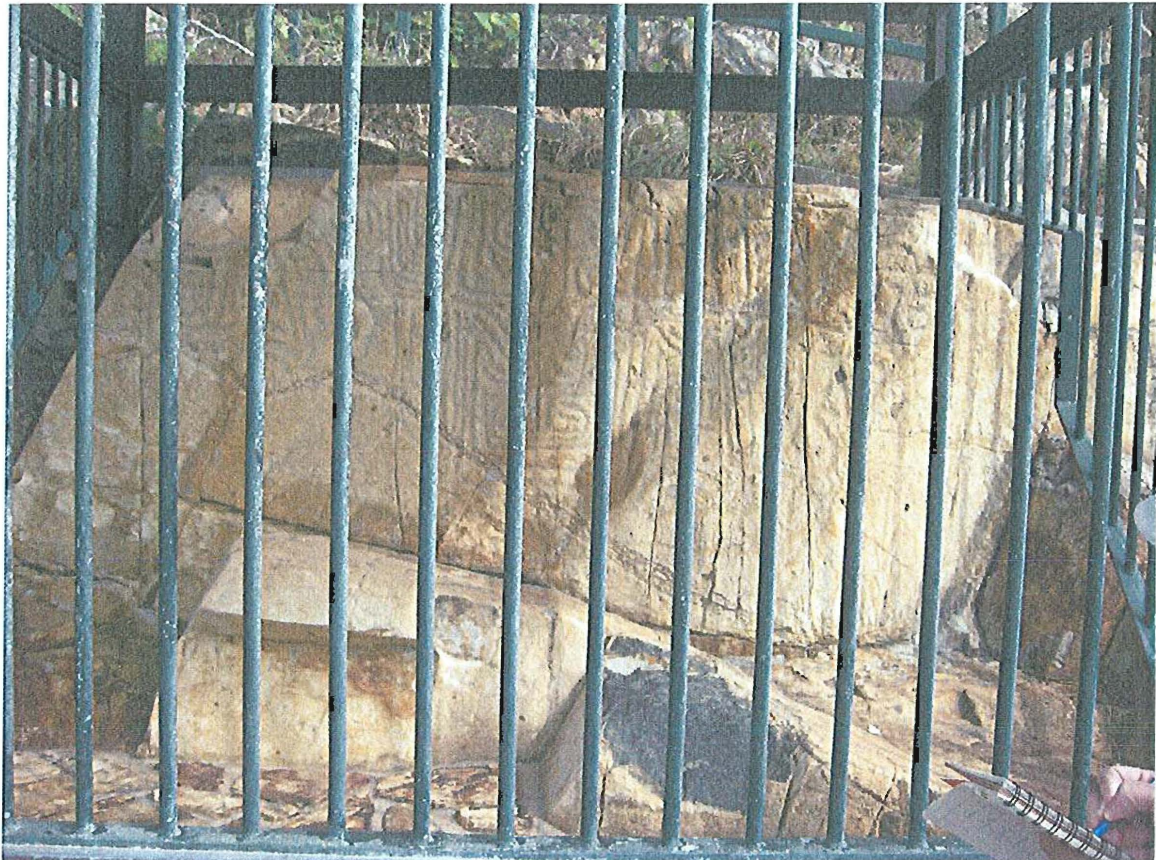
Photo 1: Existing protective shelter; cracks/fissures in rock bedding

Note: Cracks in the bedding of the rock which allow water to migrate through the rock to the surface of the caving

Note: Prison-like structure of the shelter does not enhance the value of the carving as an important resource

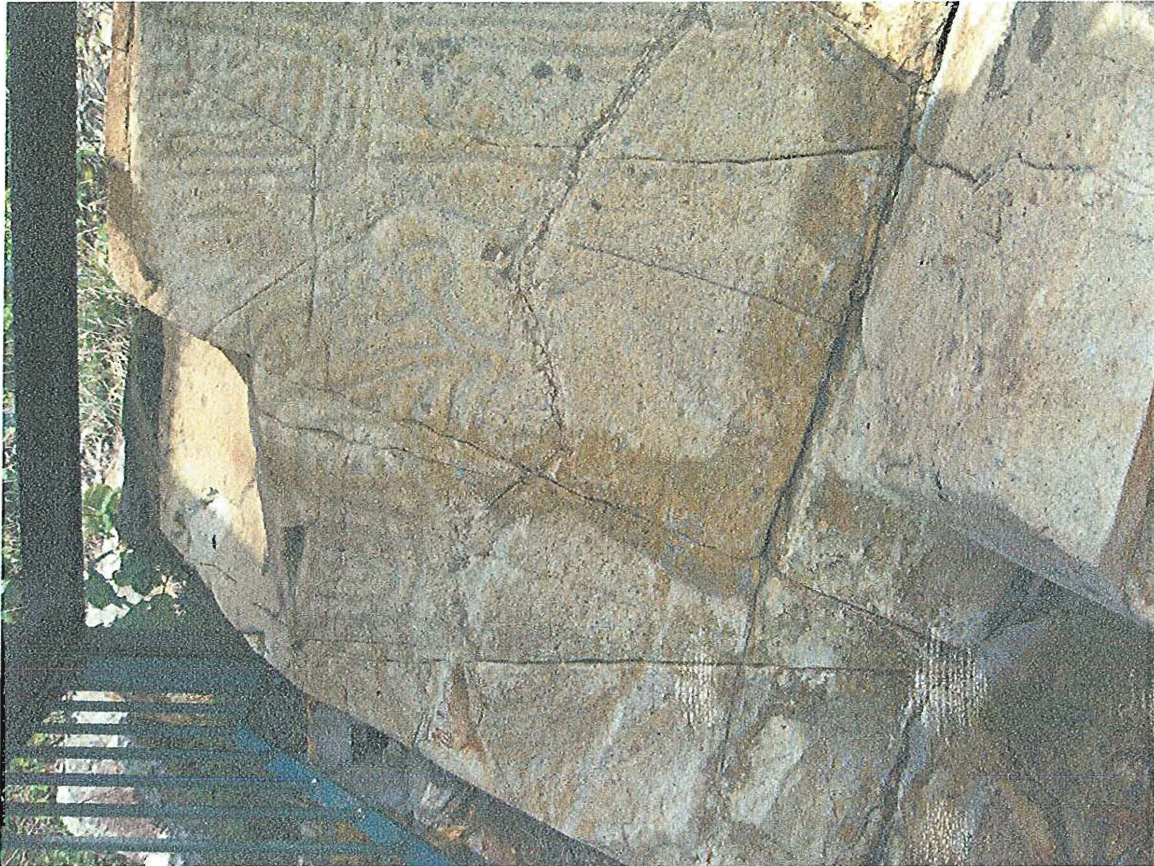
Photo 2: Moist surface due to migration of water from within the rock onto the surface of the carving

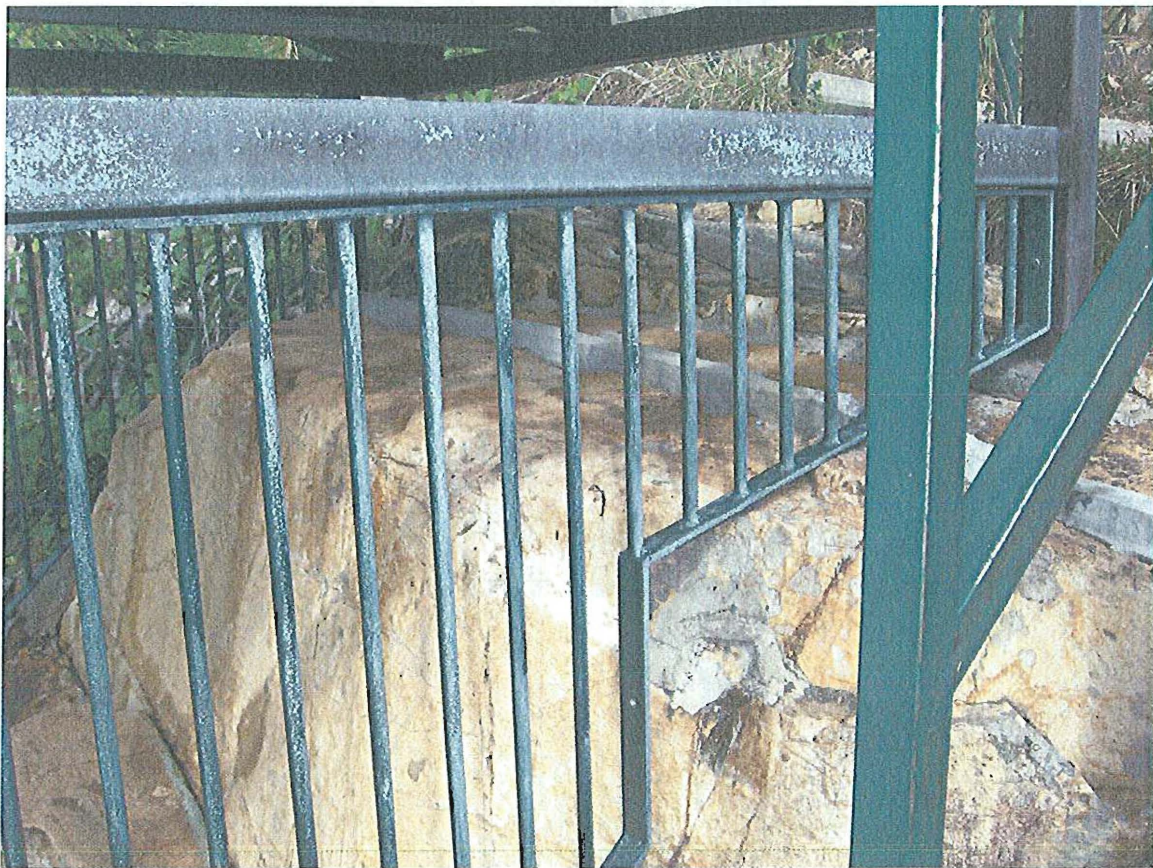
Photo 3: Problems with existing shelter

Note: Concrete from the construction of this and/or previous shelters was contaminated the rock so near to the carving as to make leaching of cement onto the carving almost inevitable

Note: Concrete dam above the carving is too near the edge of the rock to be effective in preventing water from seeping down into cracks/fissures in the rock. The dam is also a potential source of cement contamination.

Shelter. It is recommended that in the construction of new shelters, which are required at all sites, no concrete is used in any location where there would be any danger of dissolved concrete coating the rock surface. Nor should untreated iron be used. Consideration should be given to the use of stainless steel, tempered, shatter-proof glass, wood and stone in the construction of the new shelters. The final choice of materials is a matter for the architecture specialists to decide.

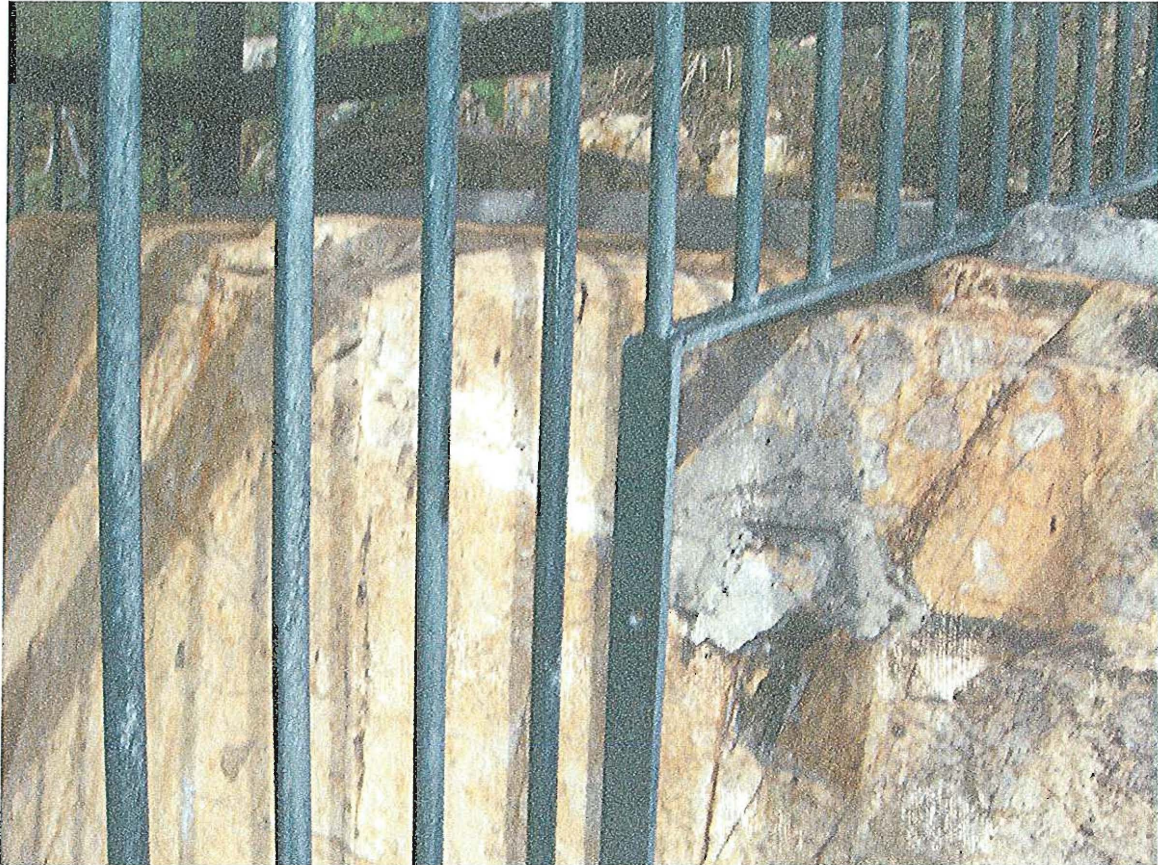
- The only ascertained risk affecting Big Wave Bay is the possibility of cement leaching onto the surface of the carving.
- A possible risk is from mechanical damage from small wind-borne rocks hitting the carved surface and pitting the cortex of the rock.
- Another possible risk comes from the mechanical action of infiltrated water.

Photo 4: Close up of cement contamination from construction of shelter

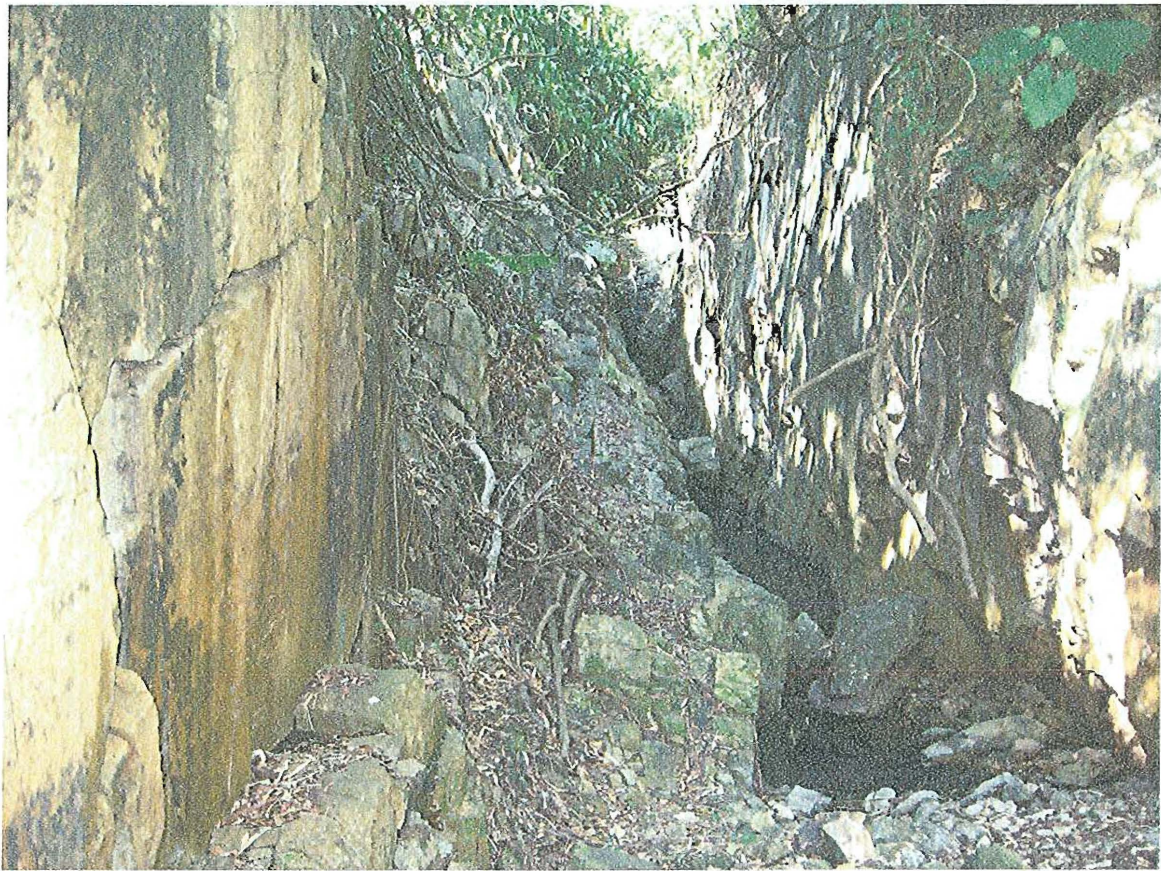
The most potentially harmful practice affecting the site is caused by careless housekeeping. The contractee responsible for maintaining the site, attended to the site just prior to the visit by the consultant. Branch overhanging the site were cut and thrown down the rock face to lie at the foot of the carving. This practice is unsightly, and may scratch the surface of the carving. Housekeeping at the site needs to be better supervised.

Photo 1: Refuse from cleaning deposited at foot of carving

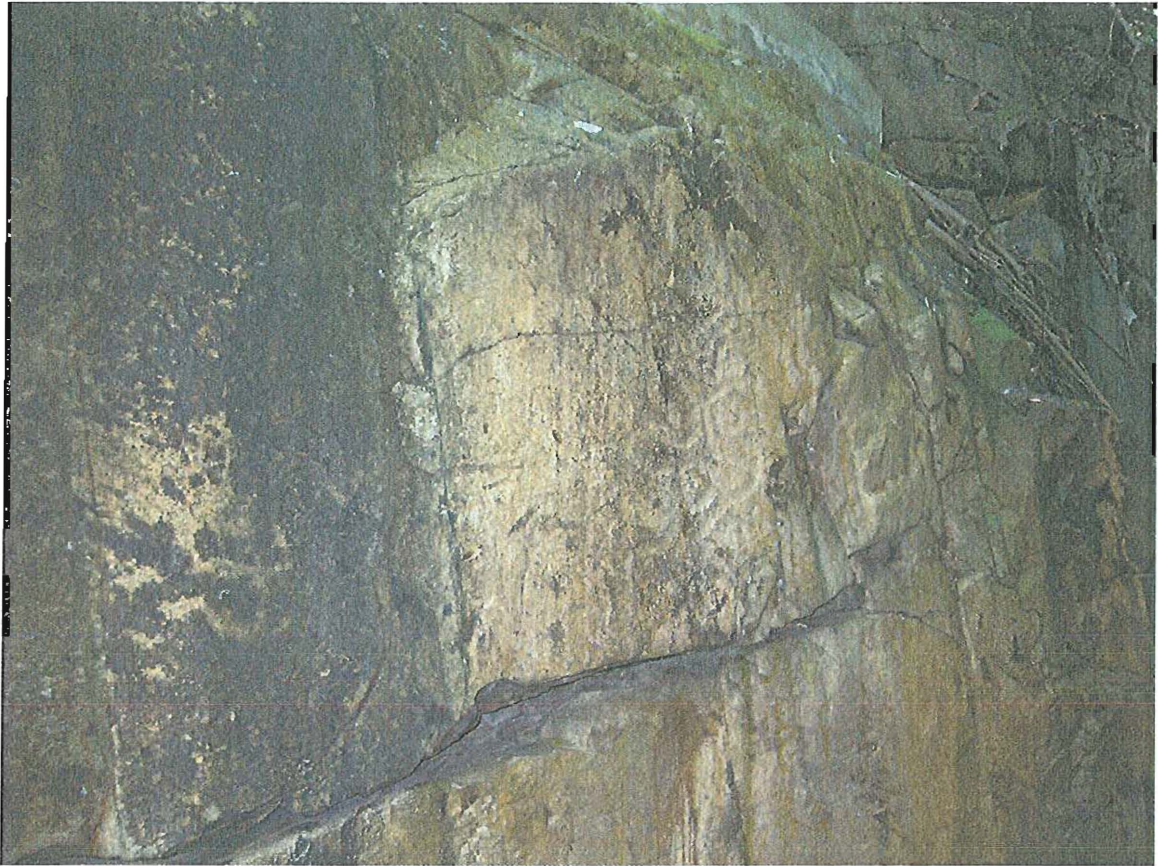
Photo 2: Surface cleaned of bio-contamination

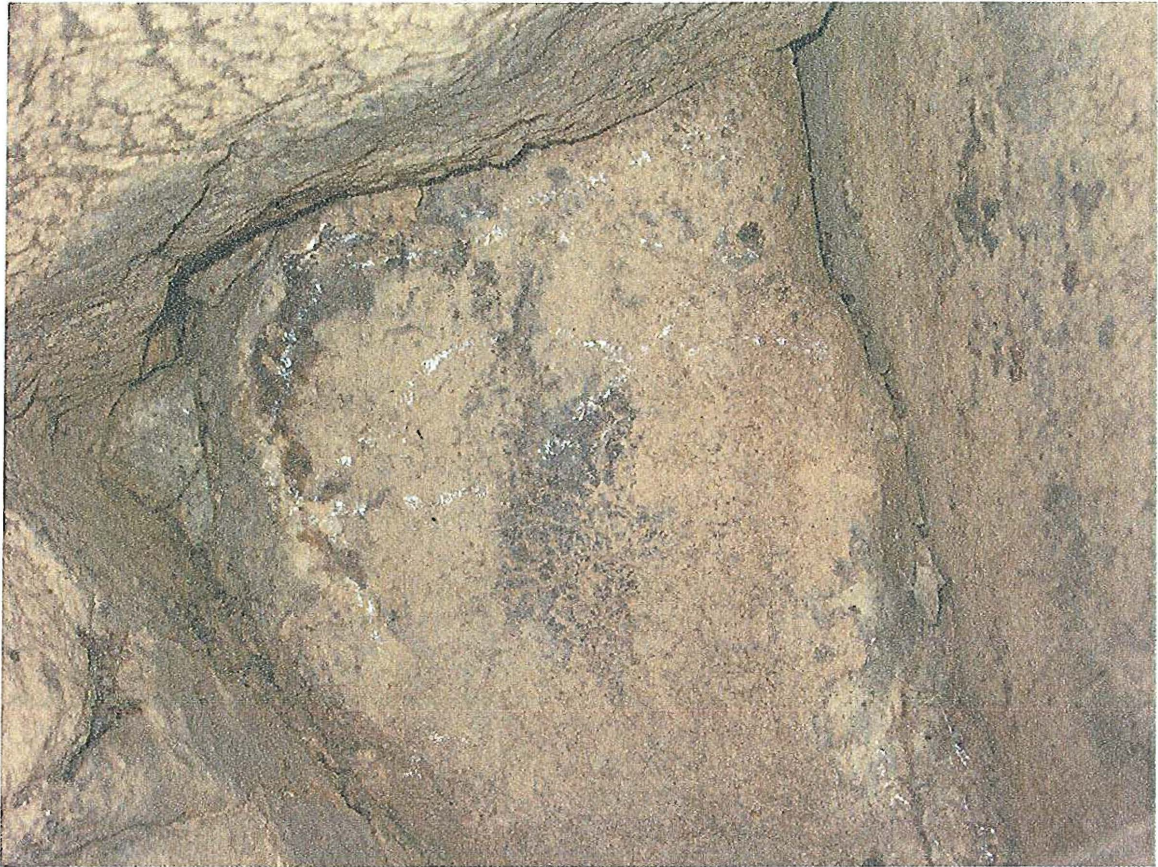
There is some evidence of recurrence of biological growth which needs to be monitored. The presence of insects nesting in a crevice of the rock is evidence that biological growth may be more advanced than was observed by the consultant who visited the site in the dry season.

Photo 3: Evidence of insect presence, indicative of fungal contamination

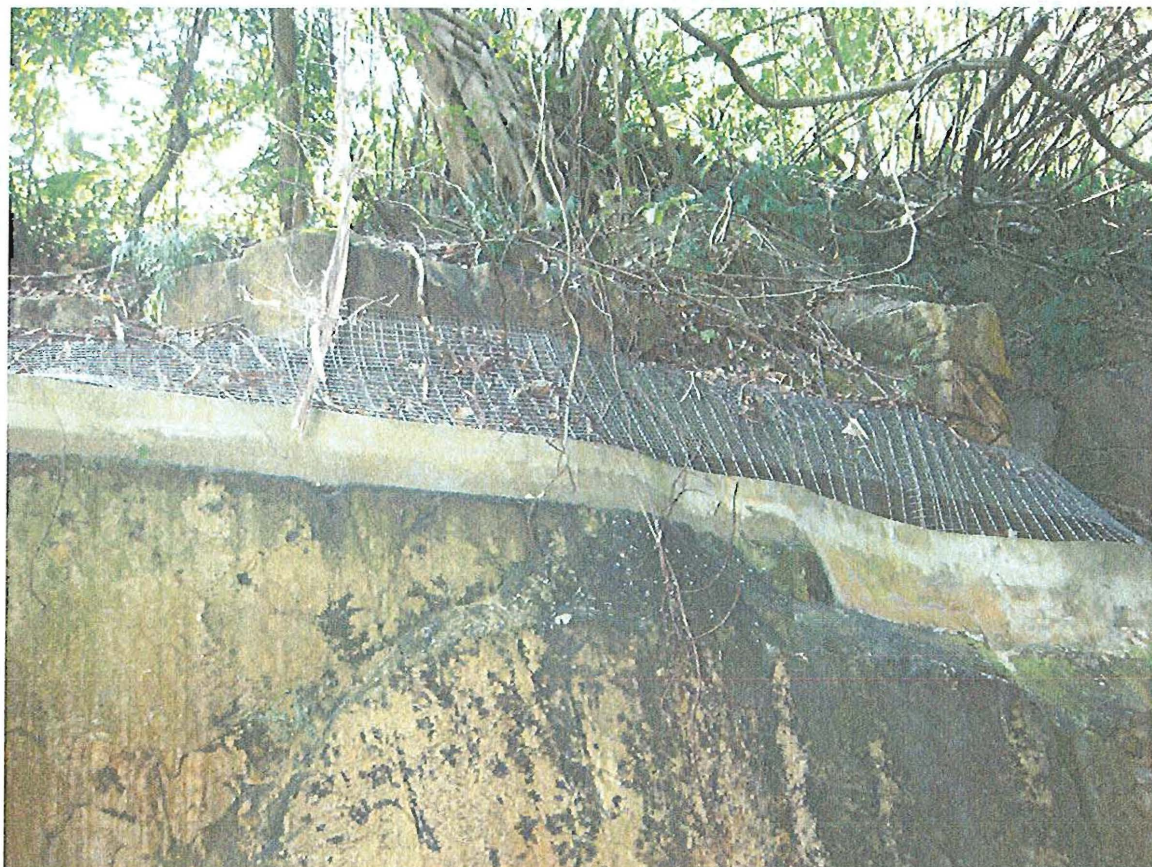
Photo 4: Concrete dam directly above carving

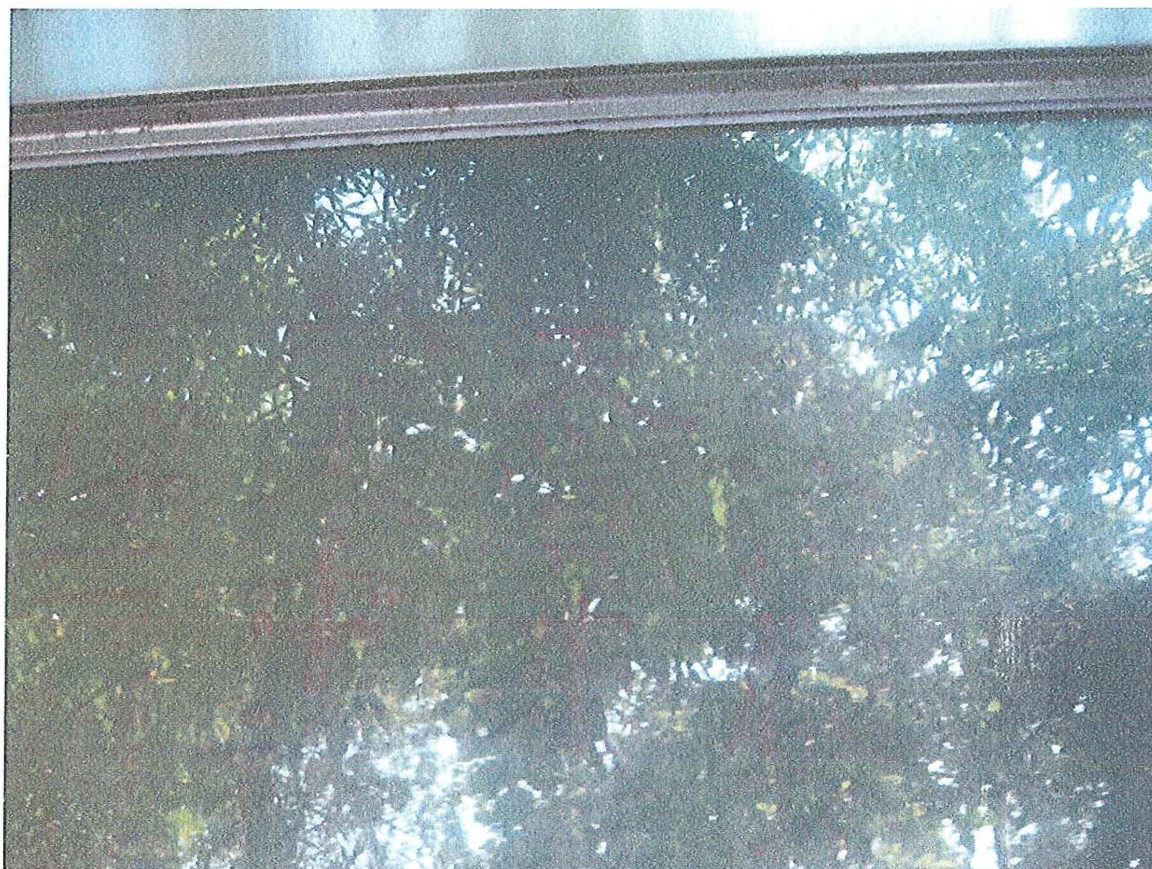
Photo 1: The protective screen

Note: That the screen makes it very difficult to read the inscription. It also traps condensation behind the screen, keeping the surface of the inscription moist and warm – an environment conducive to bio-growth

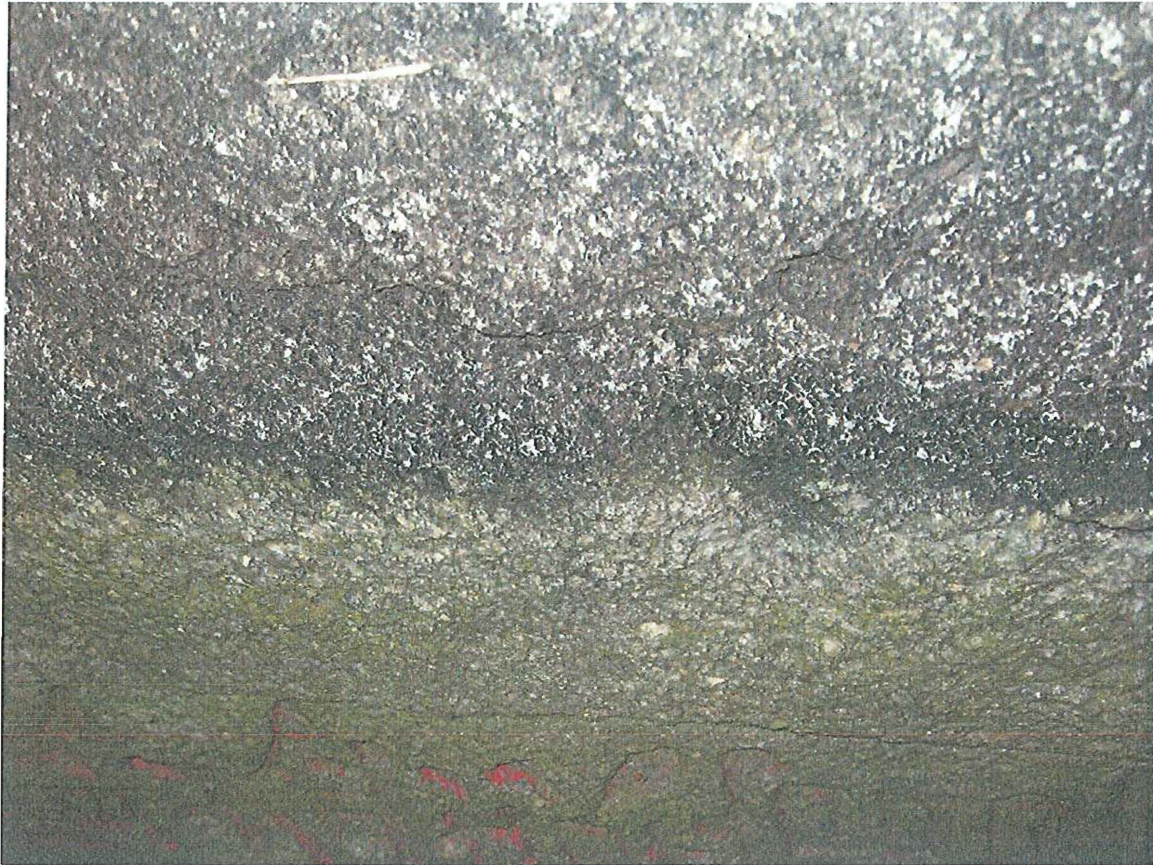
Photo 1: Interface between cleaned and uncleaned surface

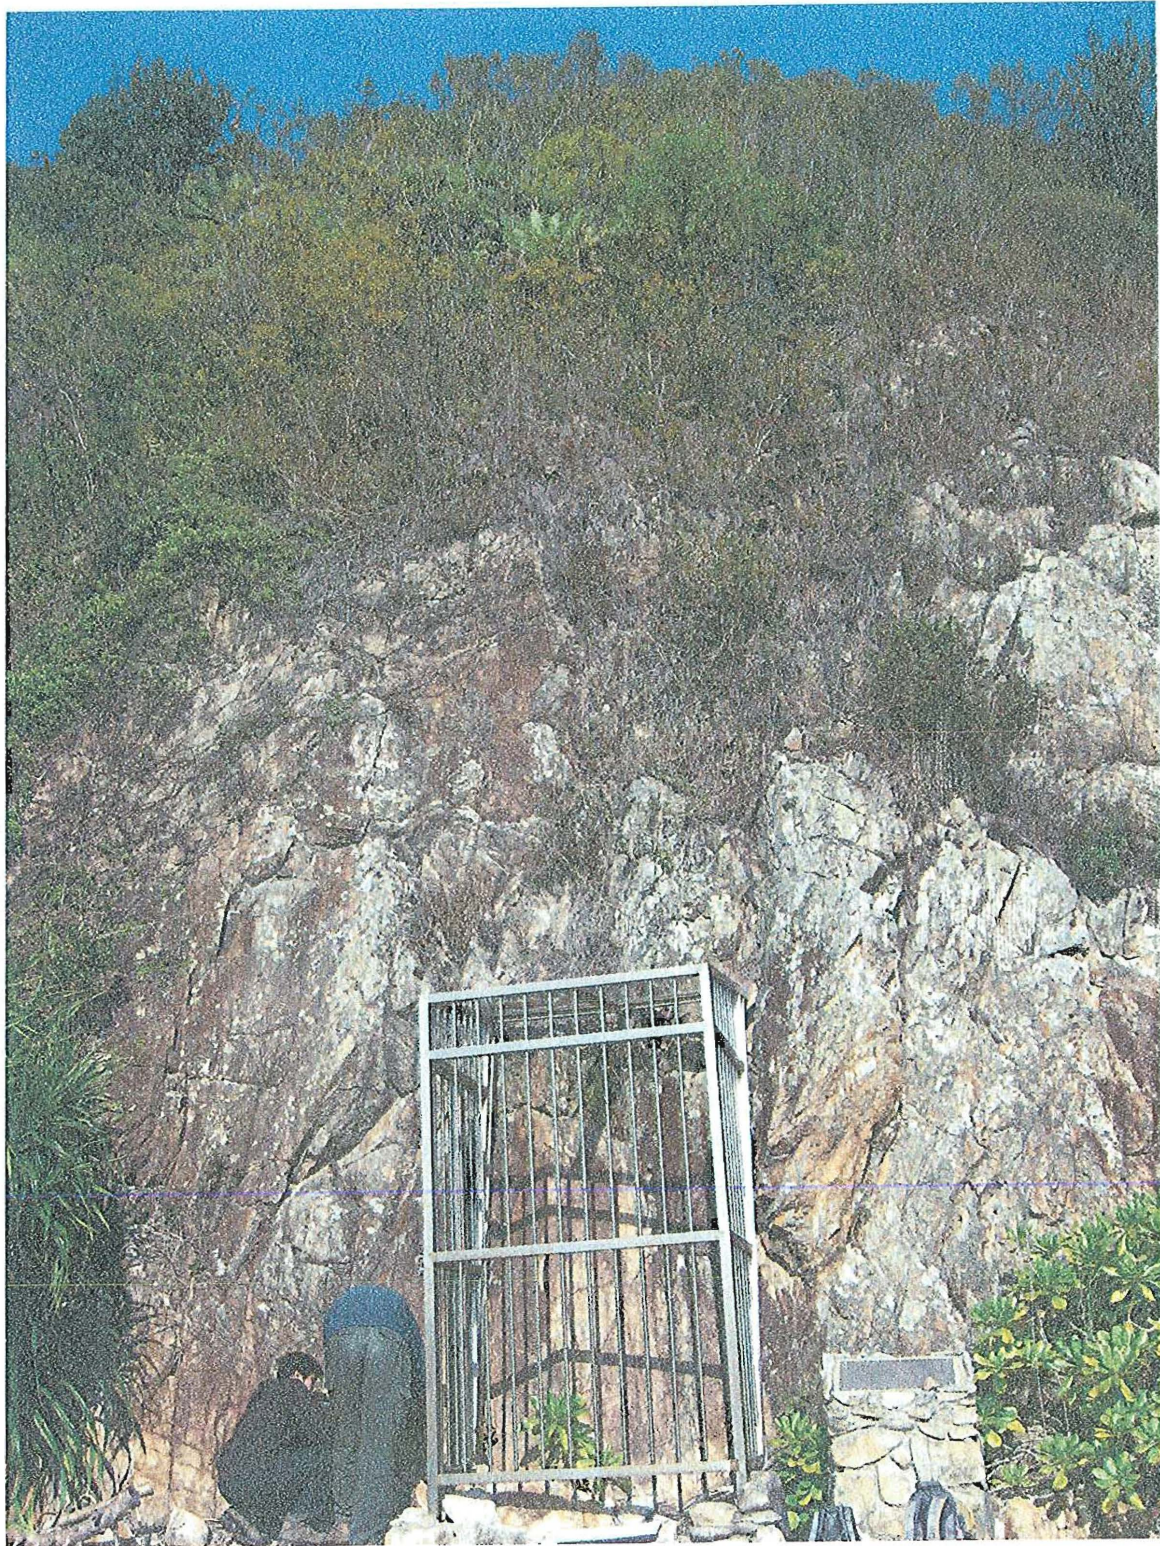
Photo 1: Cliff with loose rocks above the carving

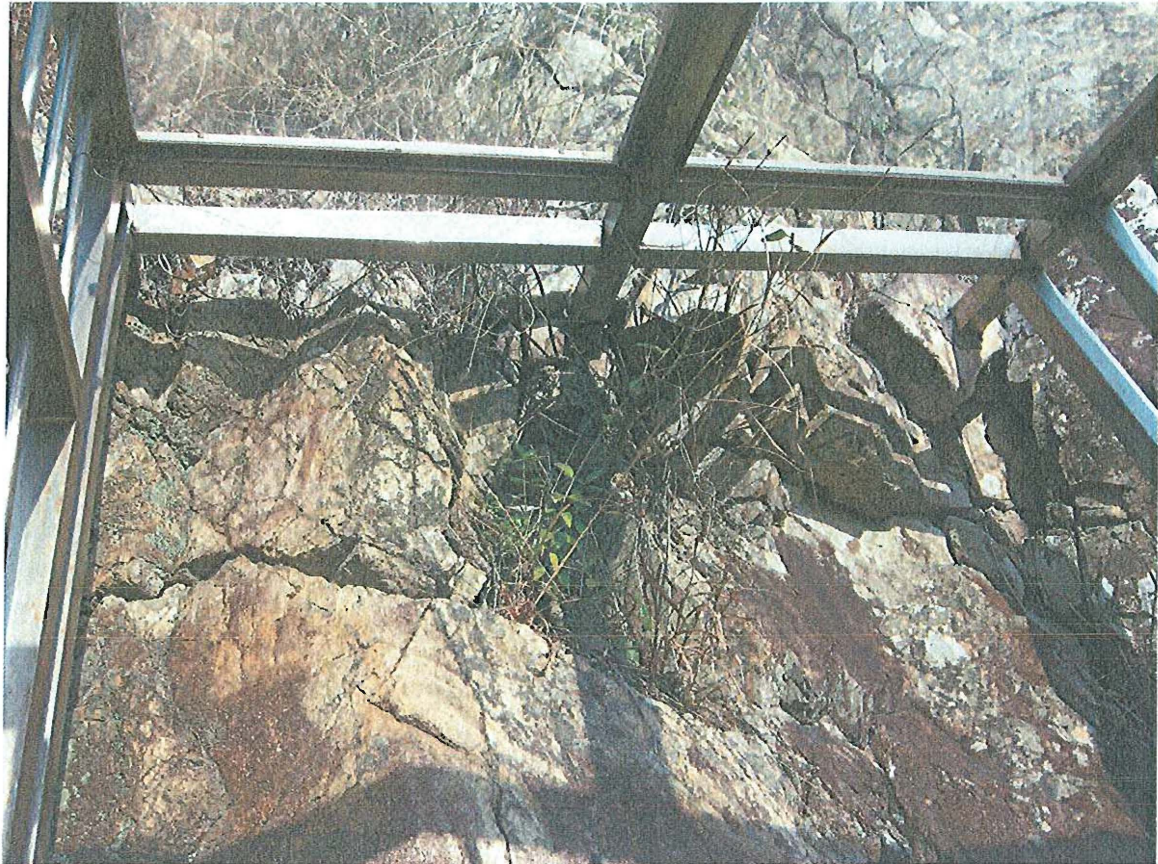
Photo 2: Close of protective structure interface with rock surface

Note: Poor construction of the structure damages the rock

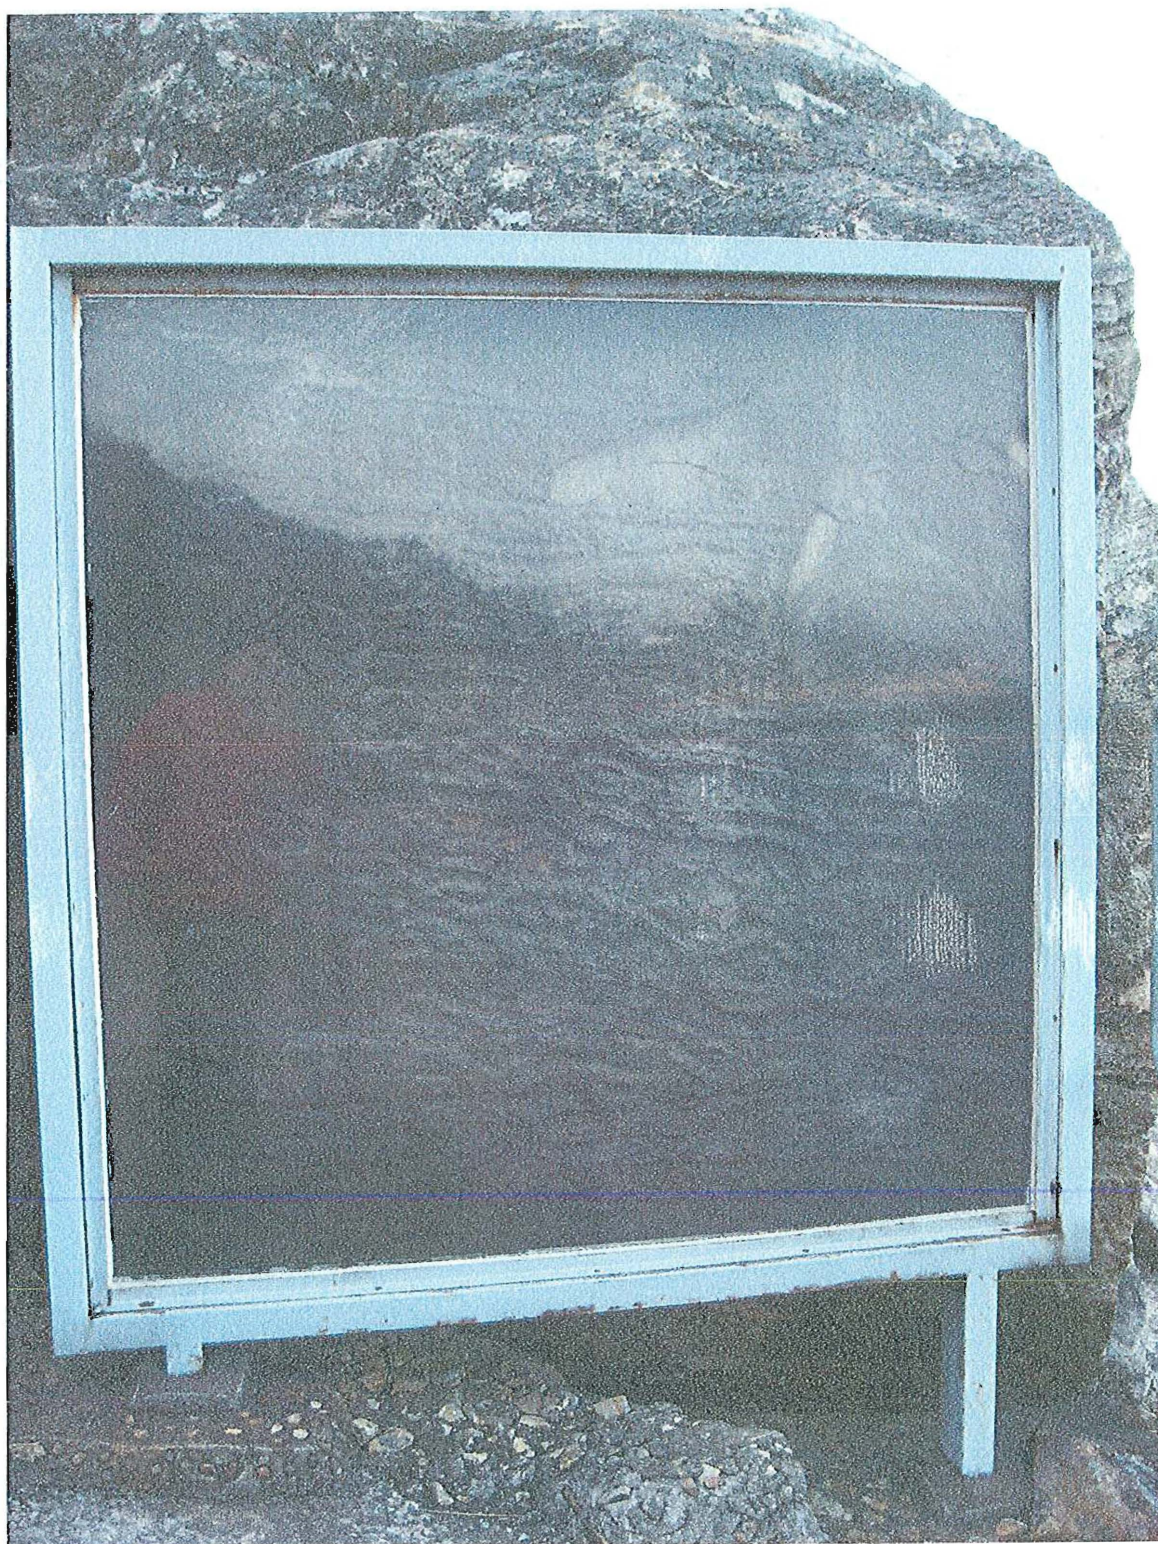
Photo 1: Protective screen

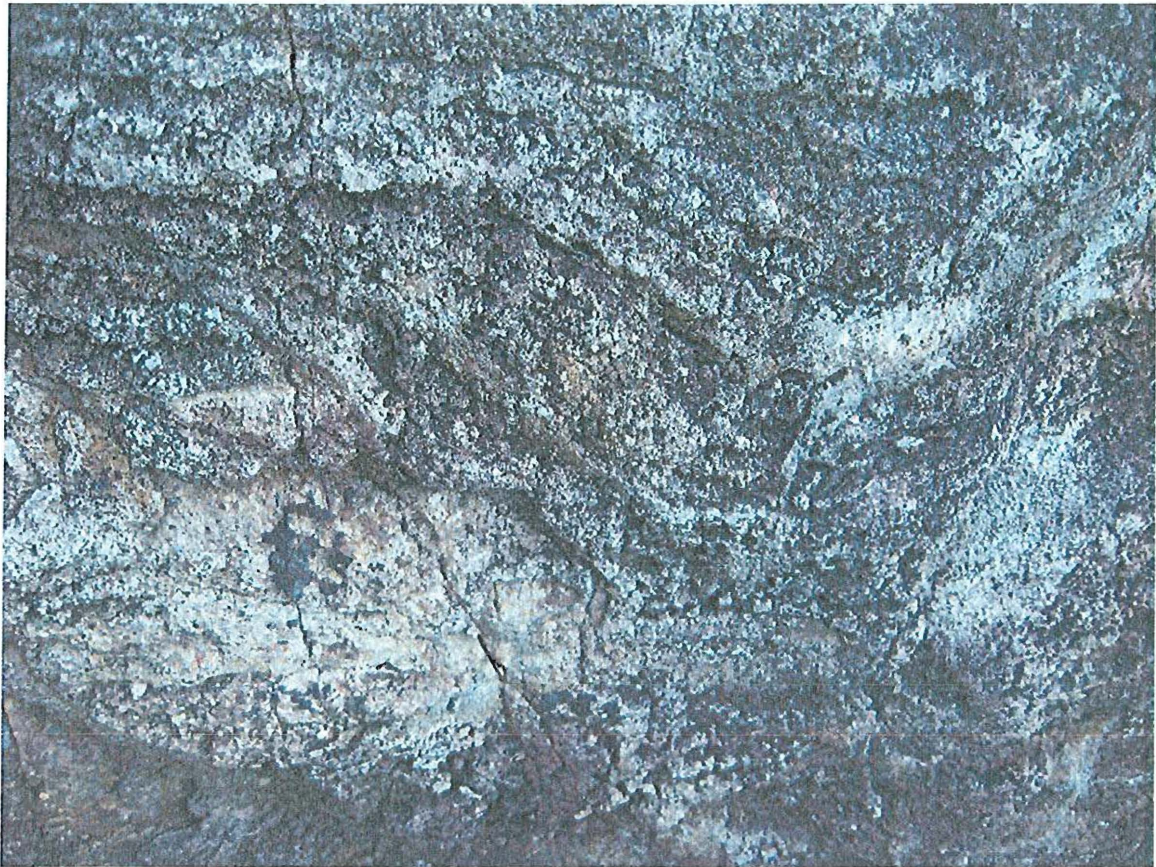
Photo 2: Close up of results of wind erosion

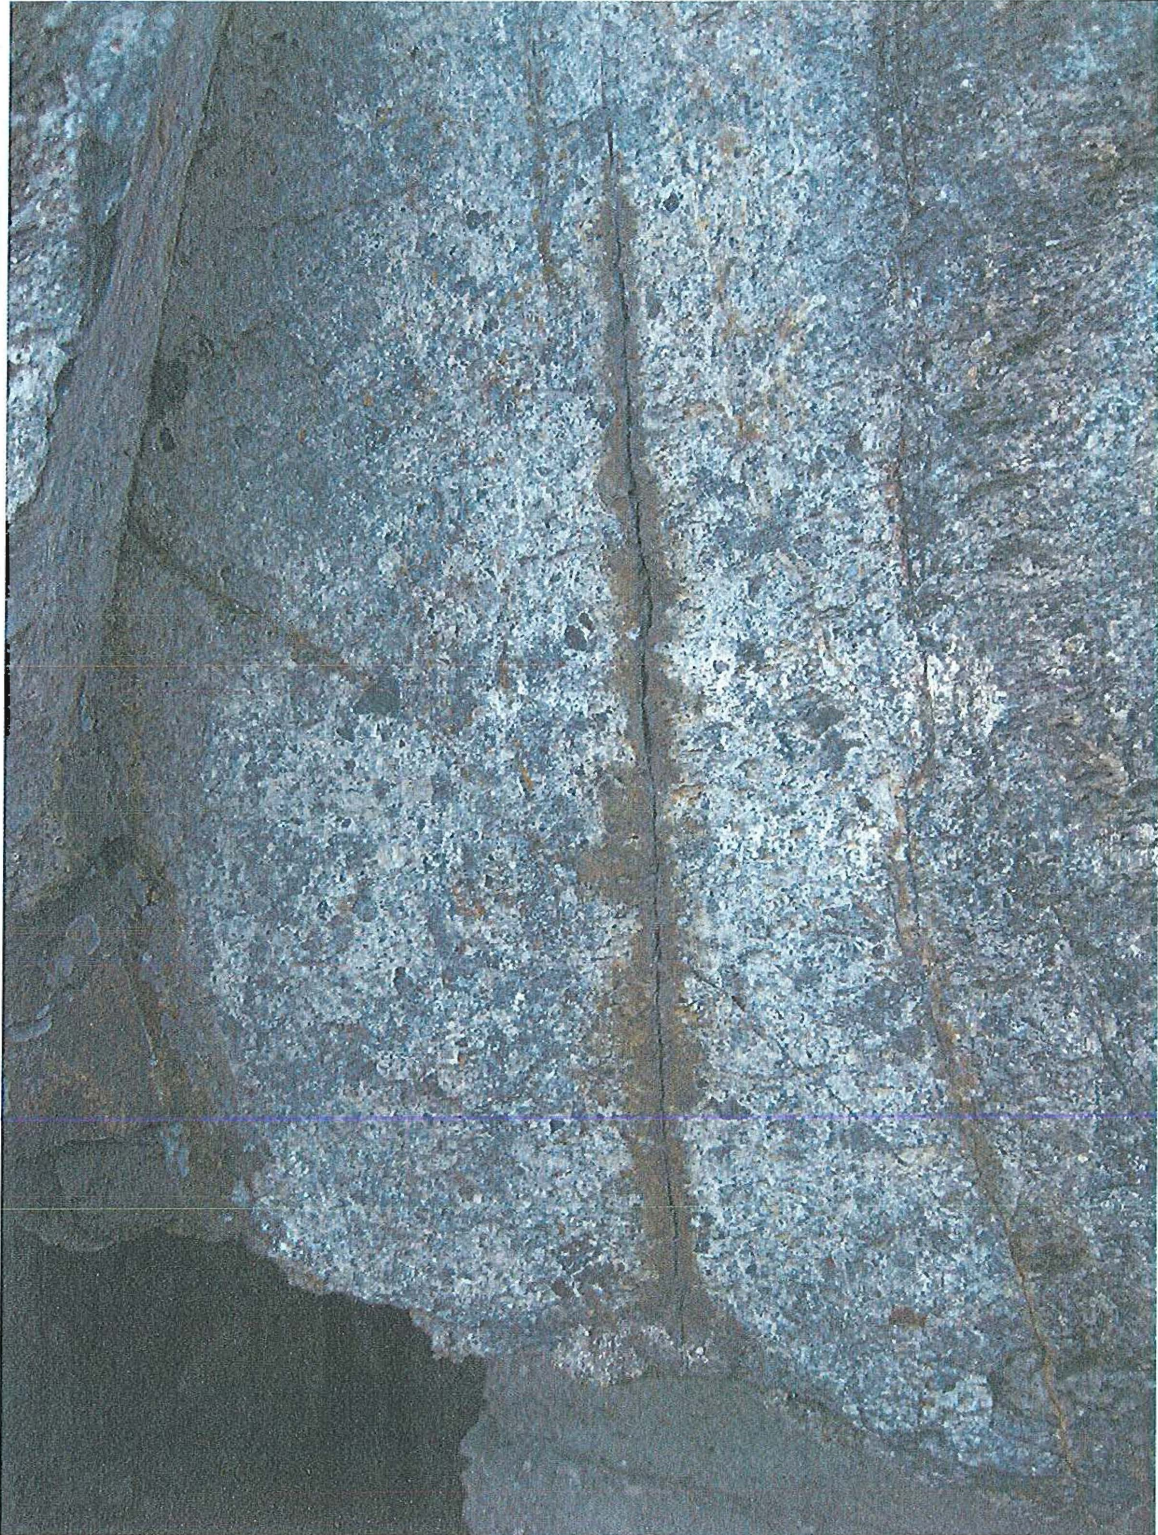
Photo 1: Cracks in bedding of the rock through which water migrates to surface, deposits dissolved mineral stain on surface, and creates a moist environment conducive to the growth of micro-organisms

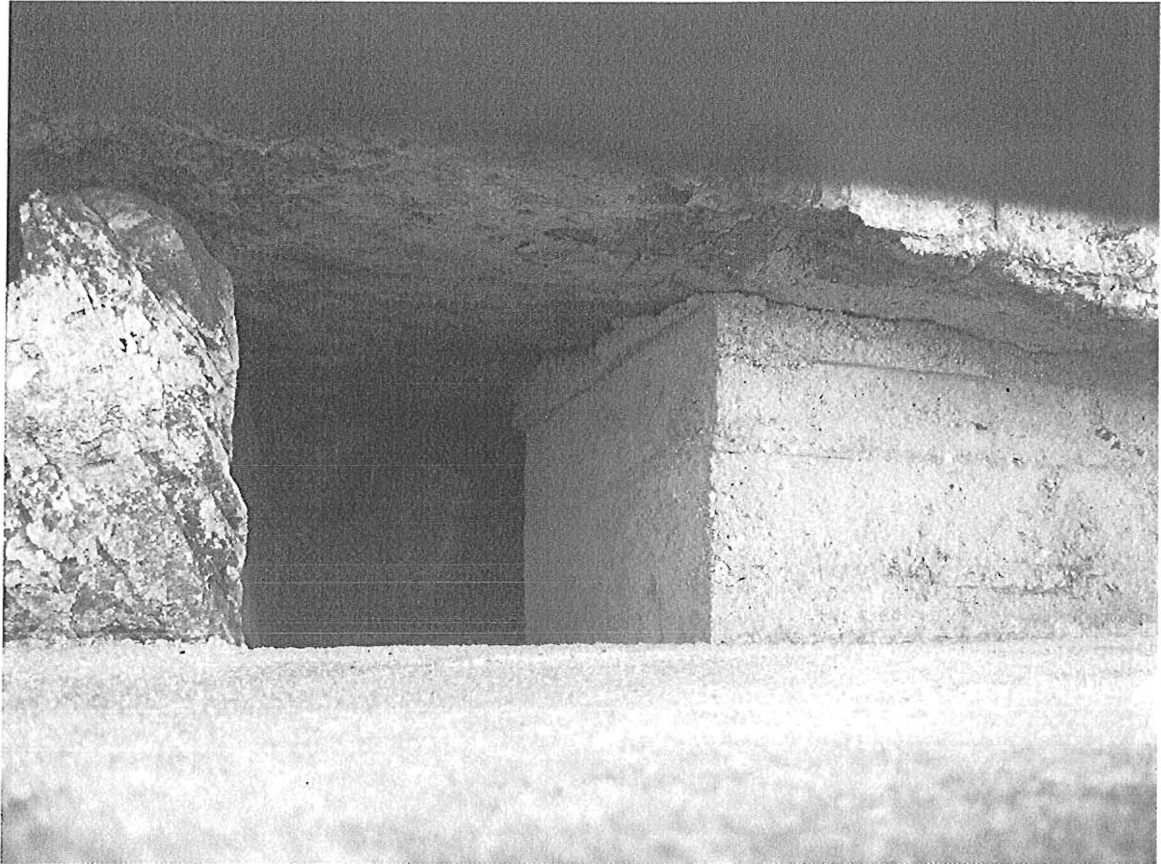
Photo 2: The concrete plinth underpinning the boulder on which the Tung Lung carving is located. The failure of this concrete plinth is a long-term risk for the safeguarding of the site.

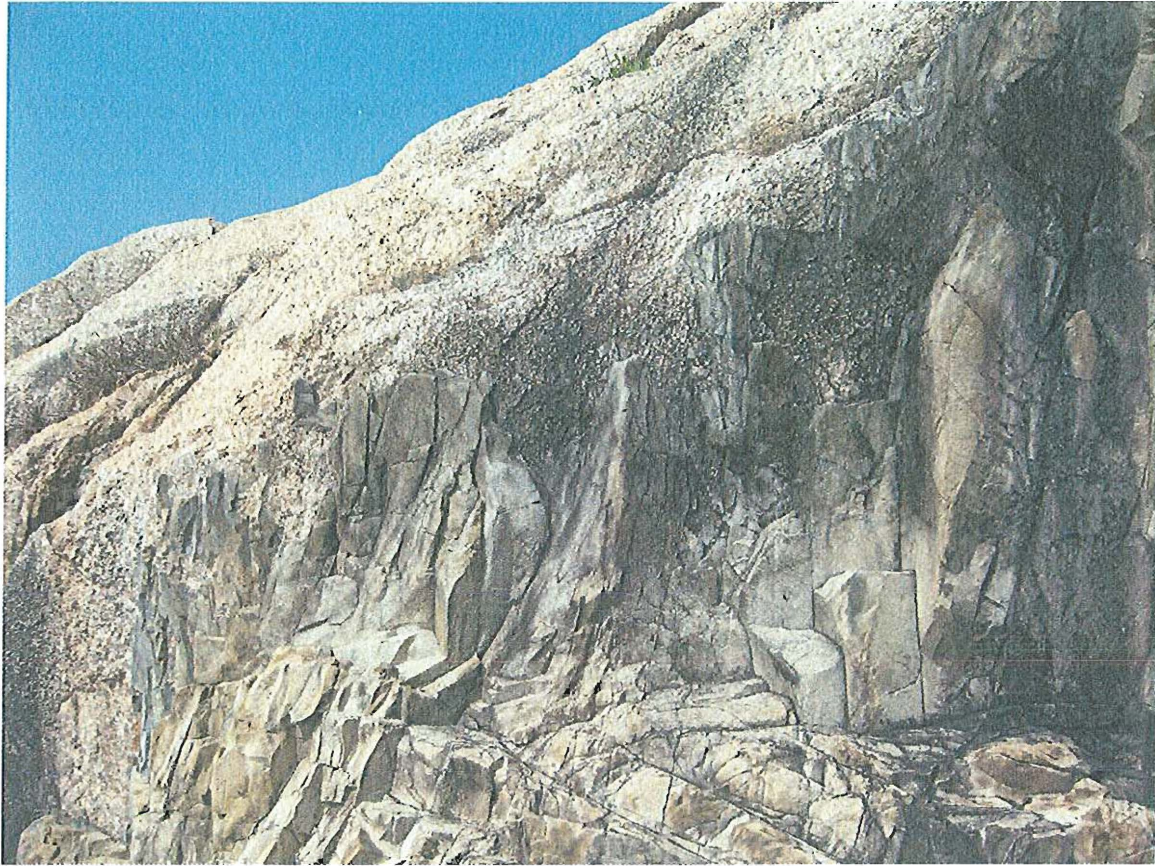
Photo 1: Rock bedding showing cracks through which infiltrated water migrates to surface of carvings

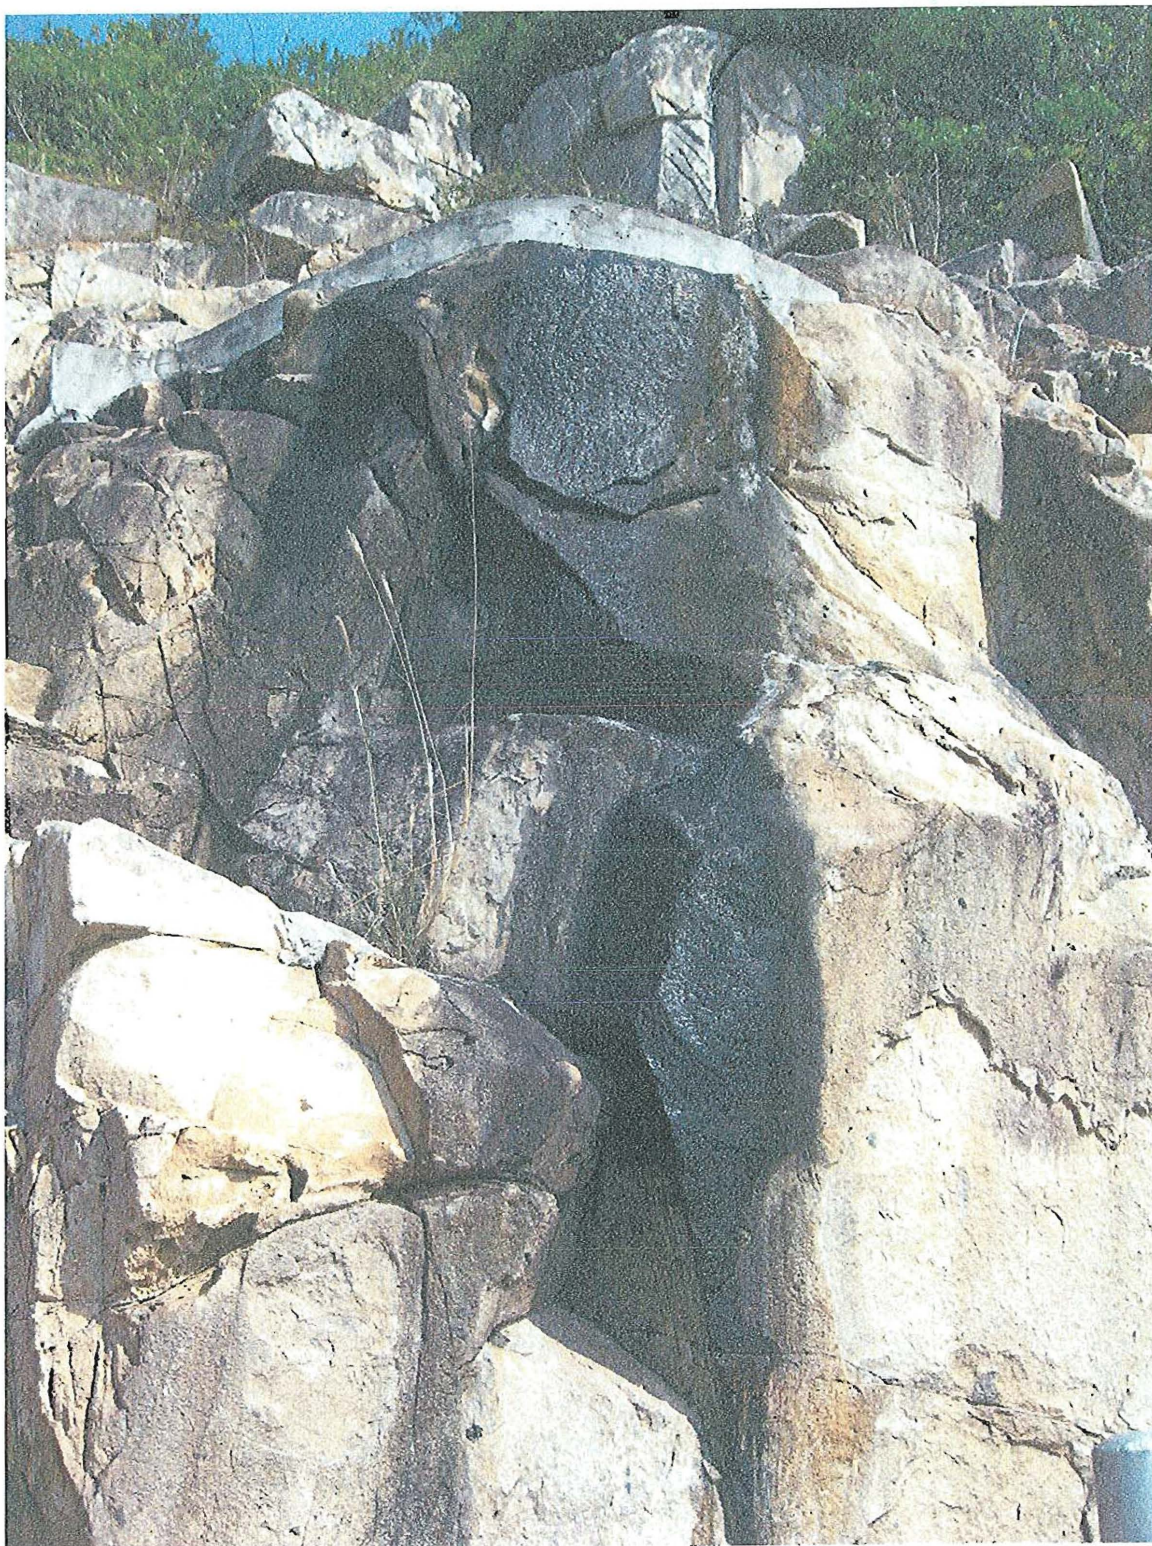
Photo 2: Spalling (cracking off) of carved surface, due to action of infiltrated water

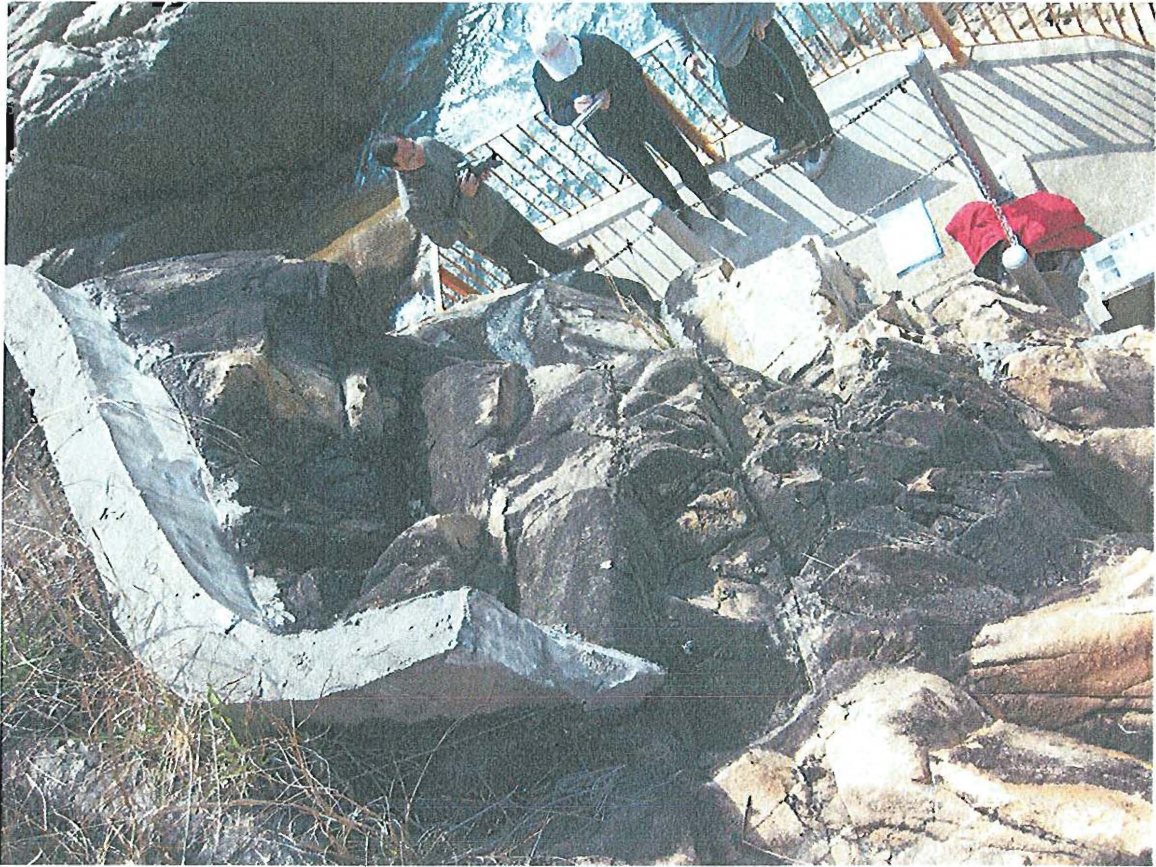
Photo 3: Concrete dam above carvings
