CONSULTANCY STUDY ON THE PRESERVATION OF ANCIENT ROCK CARVINGS OF HONG KONG

12-18 January 2010

Richard A. Engelhardt, UNESCO Senior Advisor for Culture
Consultant

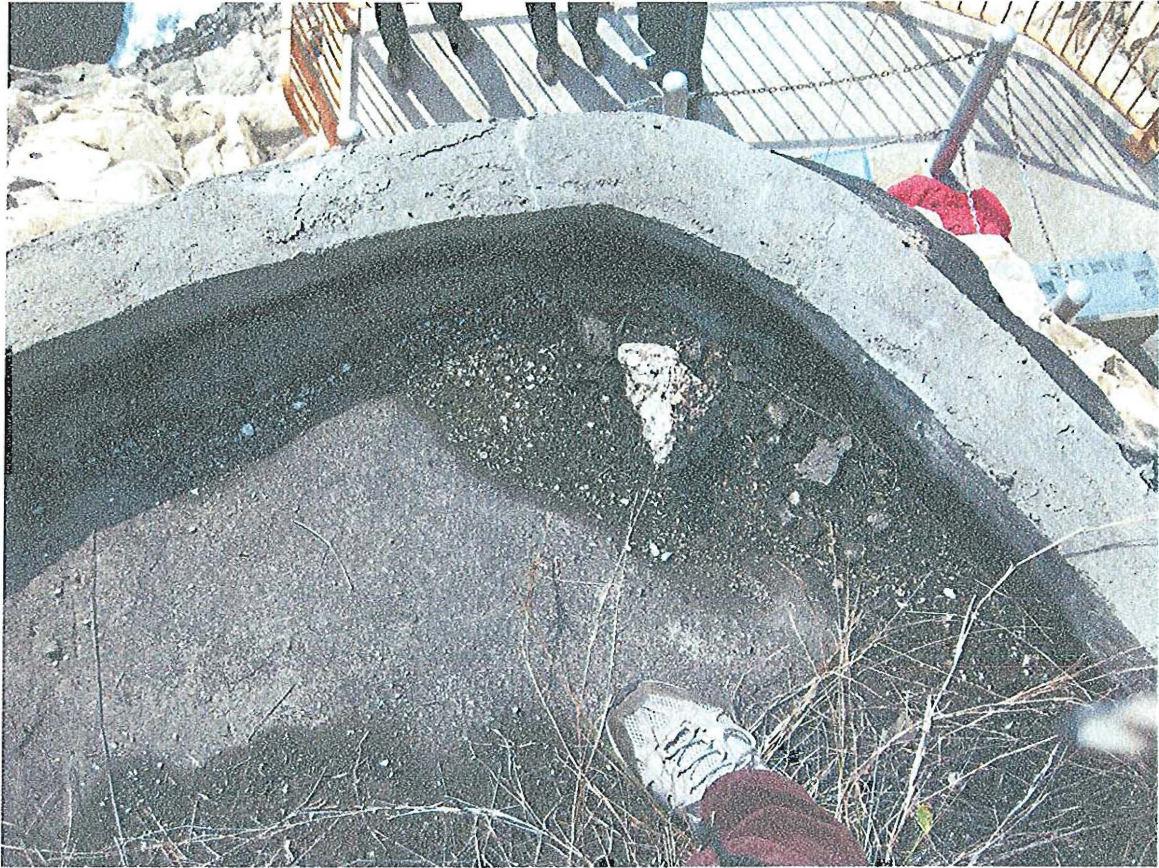
Photo 4: Concrete dam acting to trap water on top of rock which promotes the infiltration of surface water into the crack in the rock

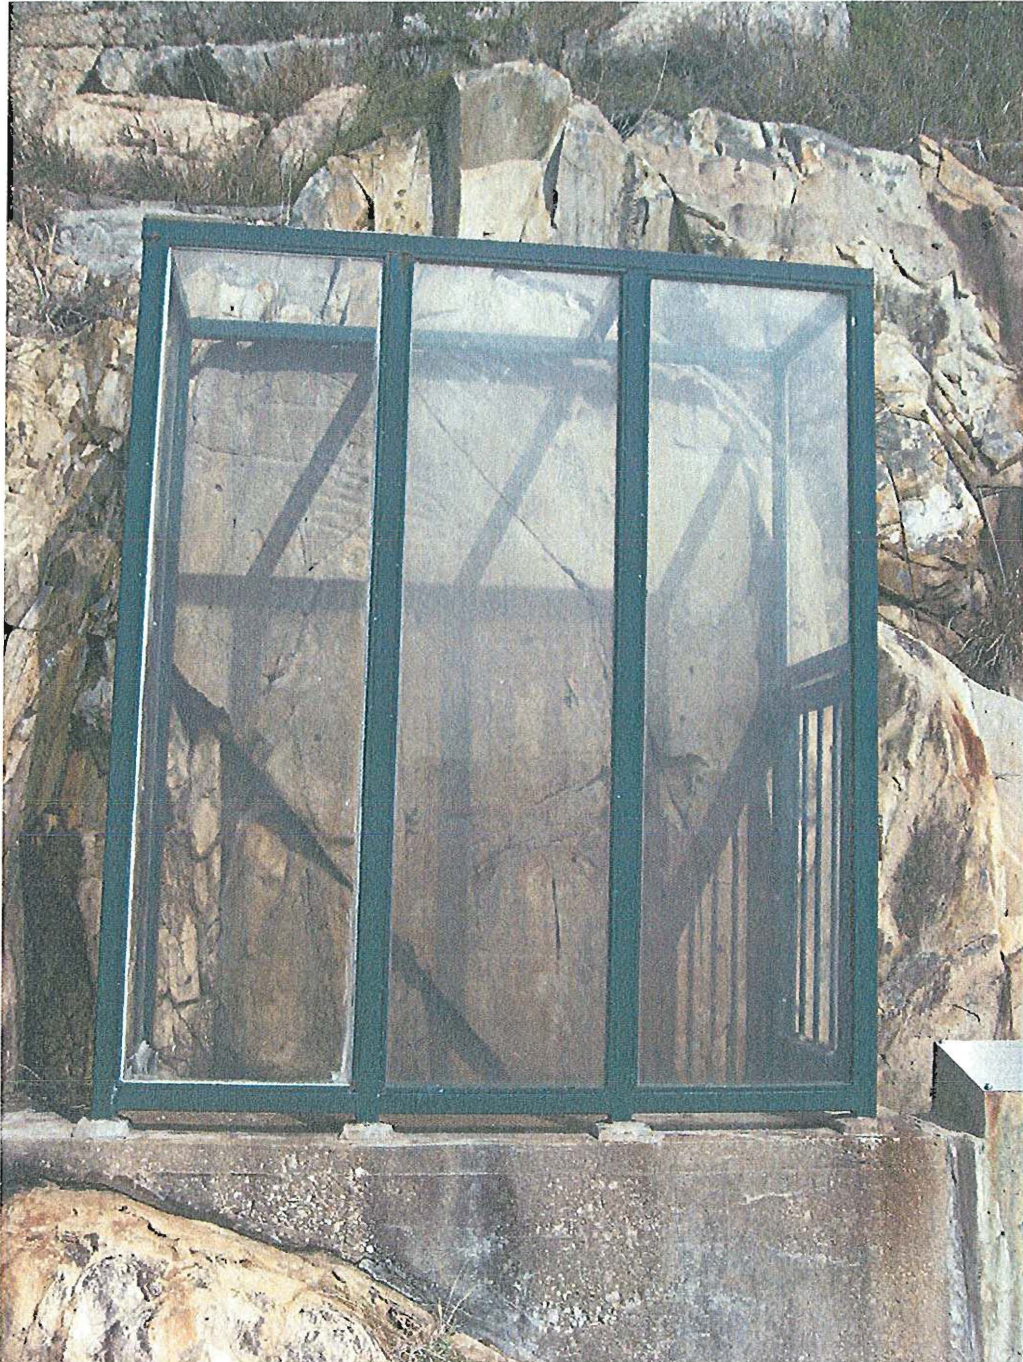
Photo 5: Protective shelter

Note: Shelter does not protect from wind, as shelter has been damaged by typhoons

Note: Shelter detracts from the visitor experience of the site

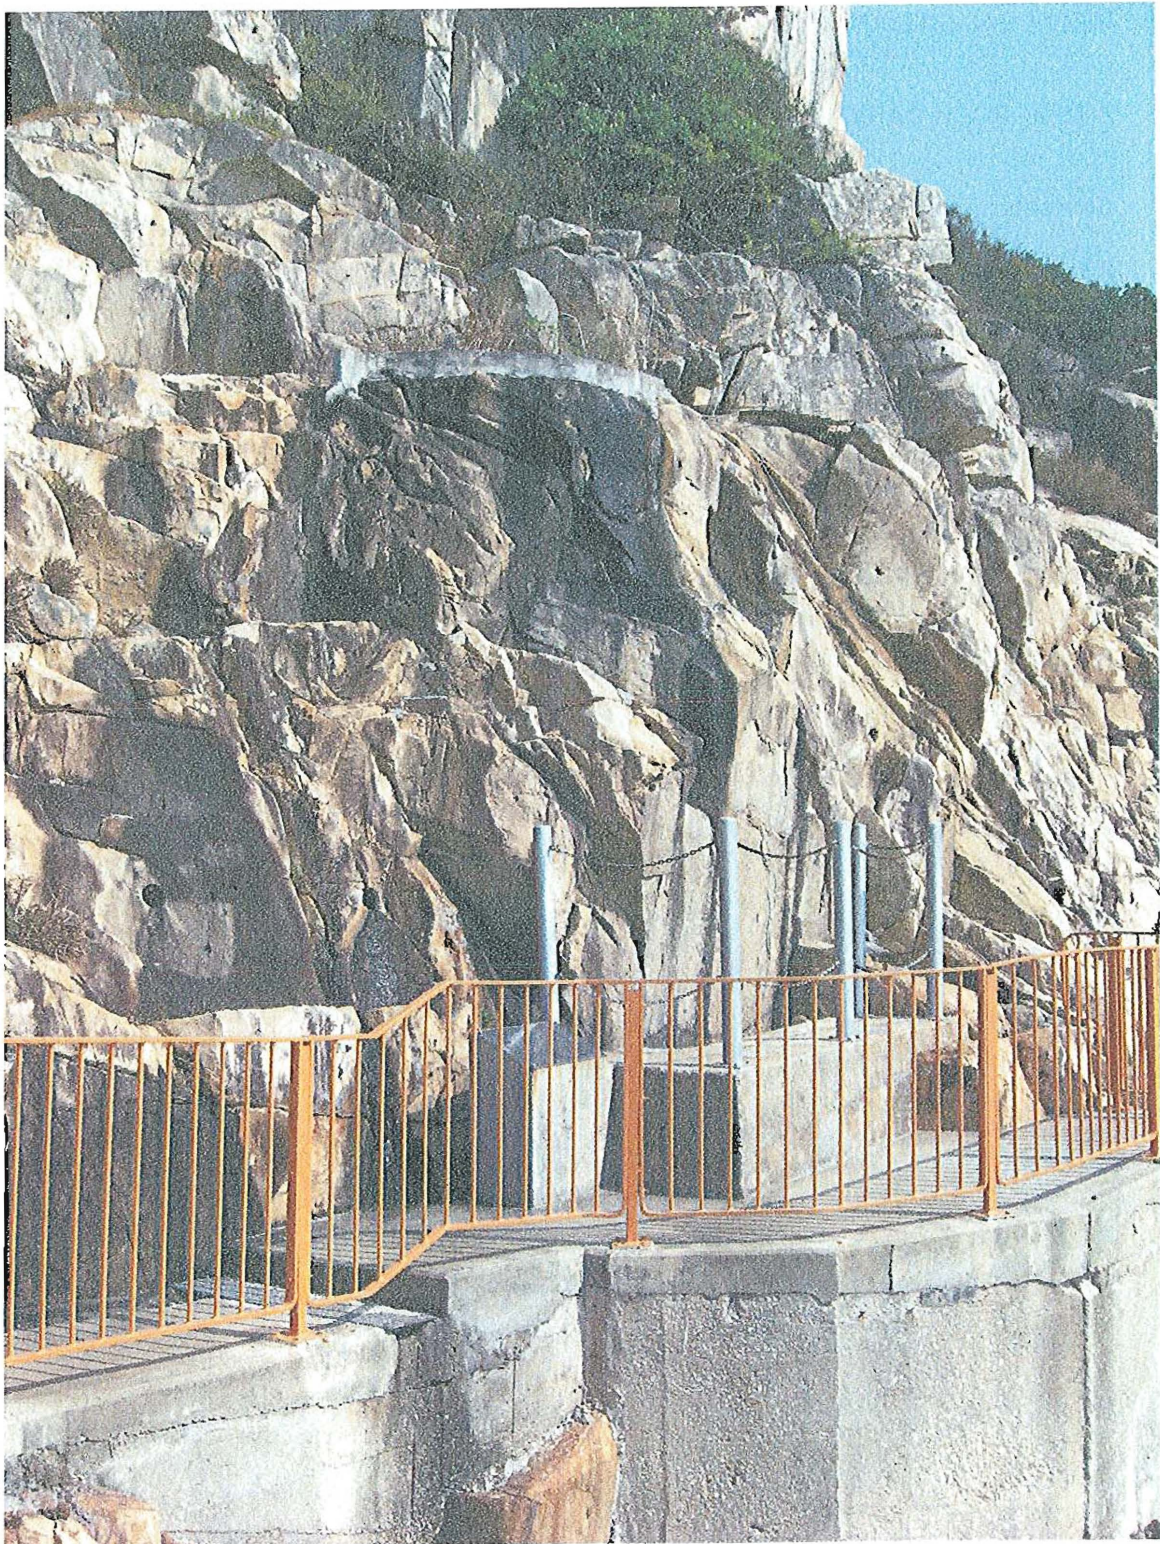
Photo 6: Walkway brings visitors too close to the carvings

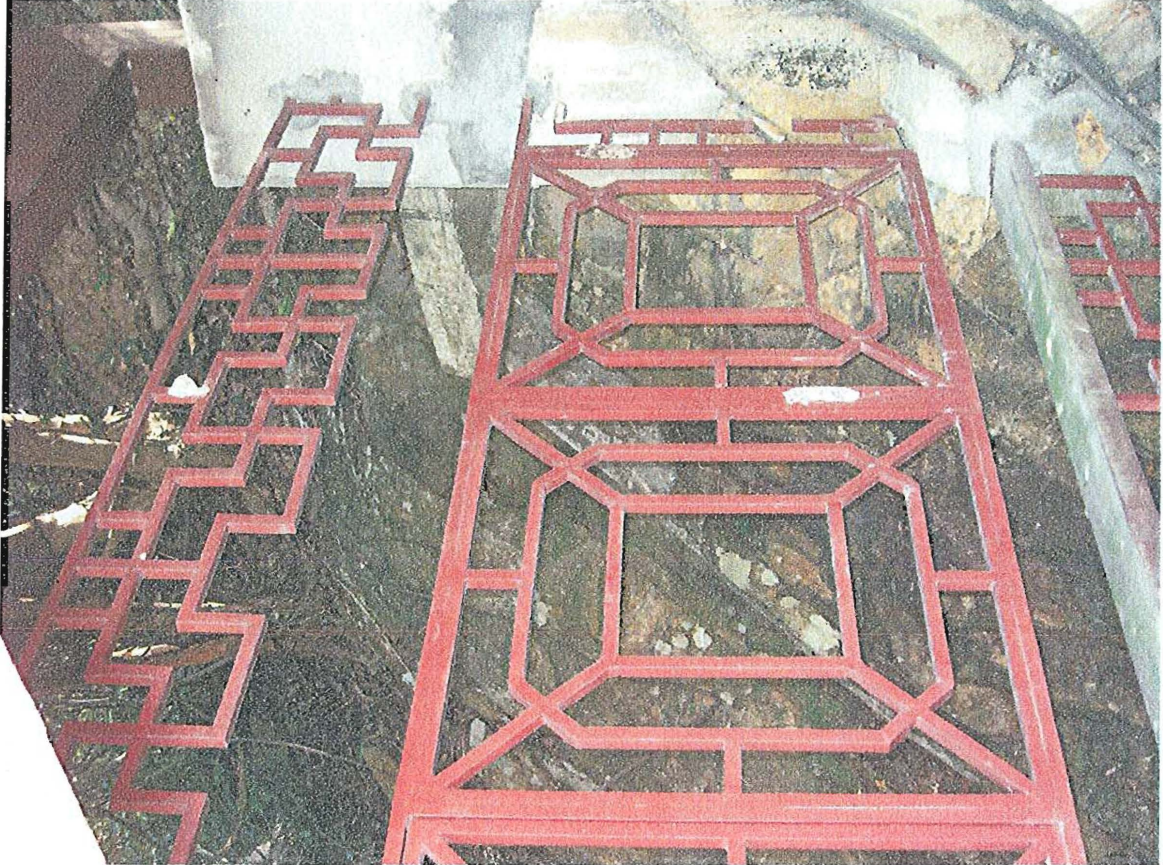
Photo 1: Showing how the nearness of the shelter to the carving diminishes the value of the carving in the eye of the public

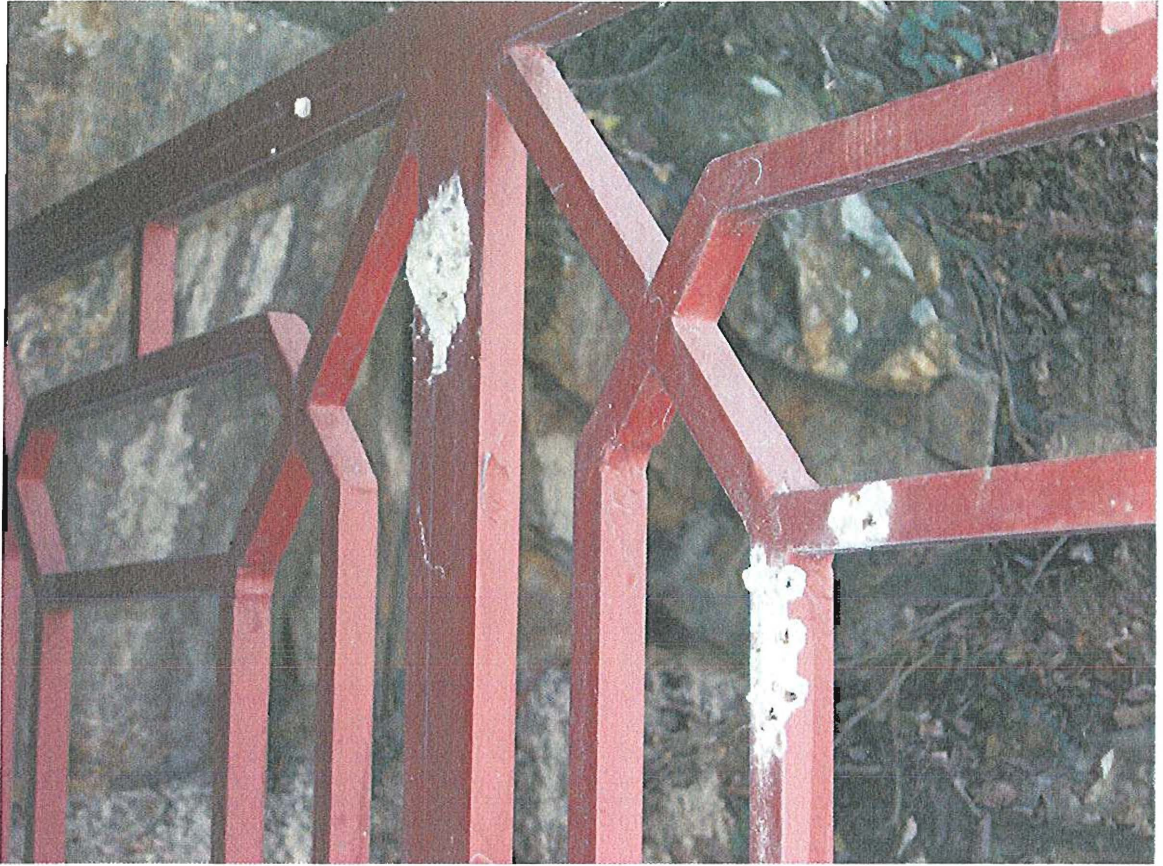
Photo 2: Showing insect infestation
