Study project on the preservation of nine rock art carvings in Hong Kong

Consultancy Agreement Report

Valérie Magar

Rome, 10 July 2010

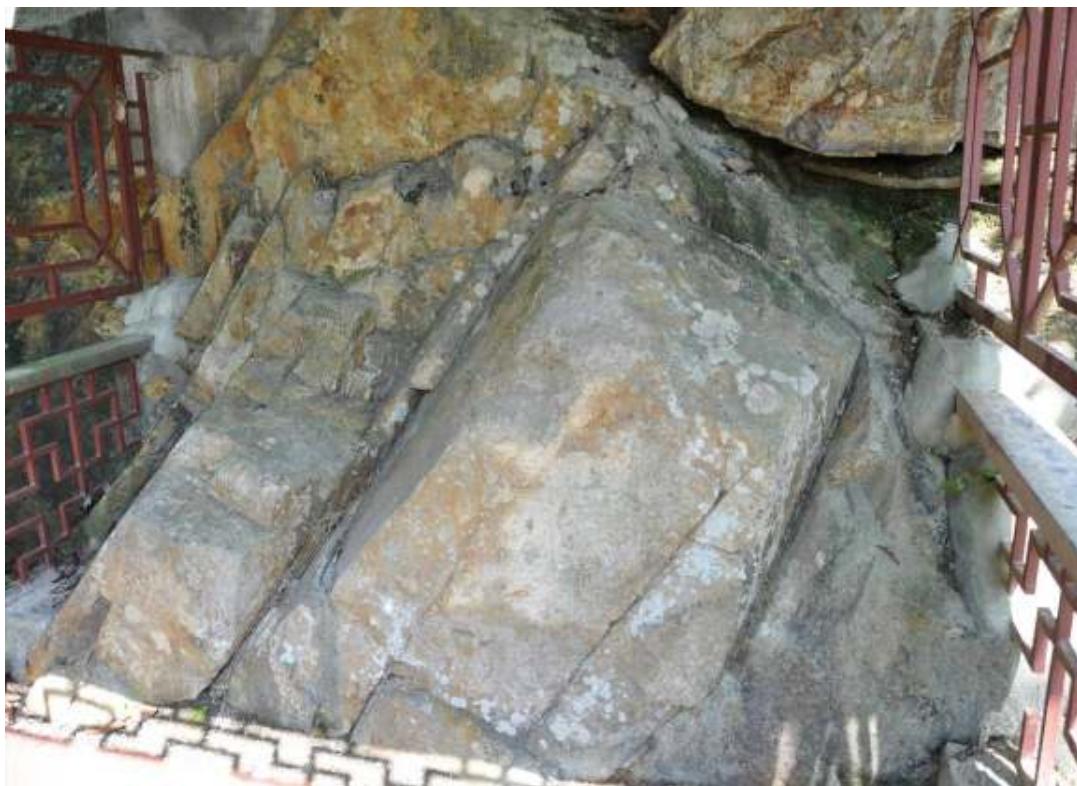
Figure 3. Engravings at Shek Pik

Two specific engraved areas can be found on the surface. They depict concentric squares and circles, believed to date from the Bronze Age, ca. 3,000 years ago (Preliminary information sheets). The engravings were not very easy to be fully perceived, although it is possible that visibility may vary during the day, according to the angle of incidence of light.

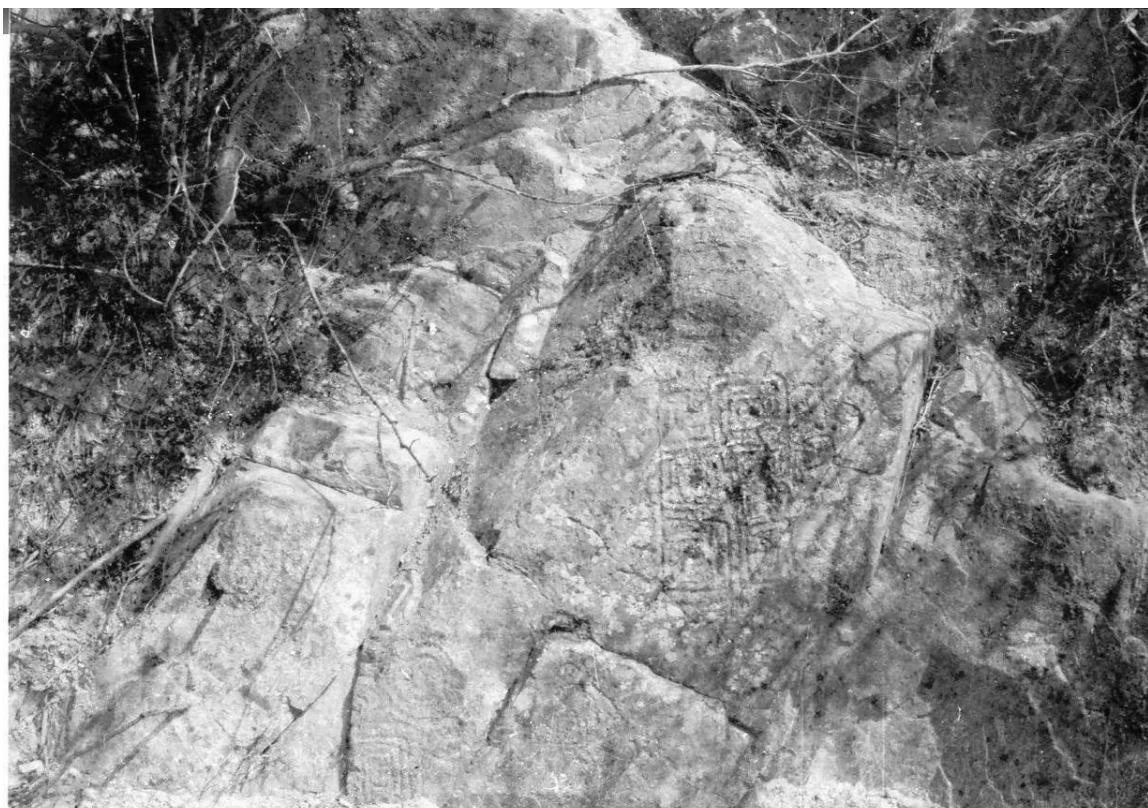
Earlier images of the site dating from 1977 revealed the presence of a third engraved area between the two visible ones, now no longer visible as it was reburied. The area where the outcrop is found was levelled and backfilled at some point between 1977 and 1986.

Figure 4. Ancient image of Shek Pik, dating from 1977 (courtesy Government of the Hong Kong Special Administrative Region)

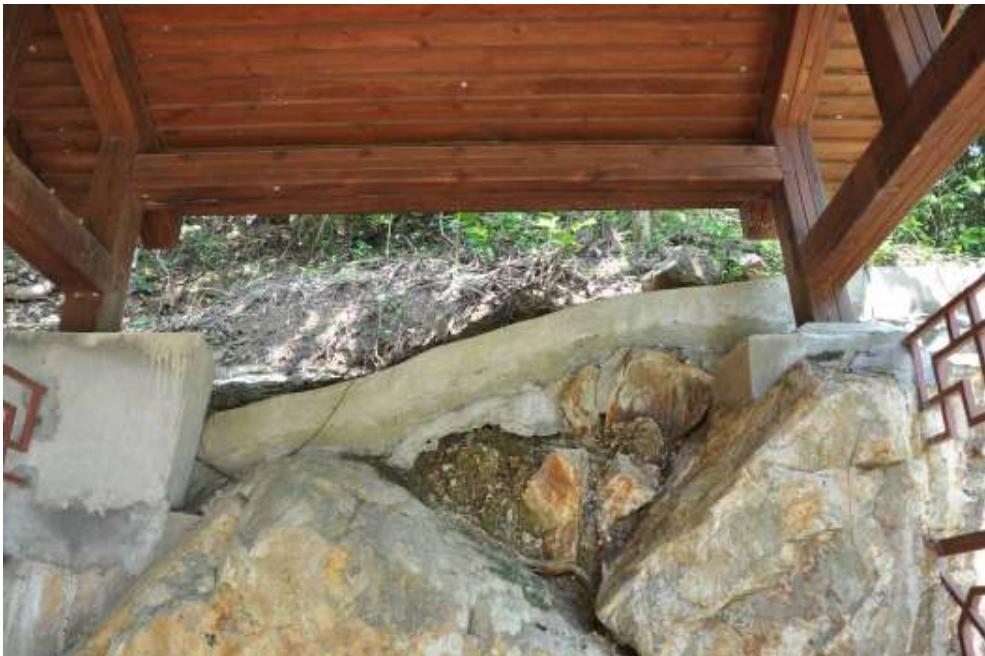
A long cement barrier was placed in 1985 above the outcrop, with the aim of channelling the water coming from the terrain above the site. The water is directed towards the northern side, taking advantage of the shape of the outcrop. However, the slope at the ground level seems to go towards the shelter, and the soil level is lower under the shelter. Possible water accumulation inside the shelter should be monitored in the future.

Figure 6. Cement channel on top of the shelter

A possible solution would be to change the channel for a new one. Cement is not an adequate material for a series of reasons. On one hand, it is a material which releases soluble or partially soluble salts (essentially sulphates) which can be harmful to the rock (causing whitish veils which can obscure a surface, or favouring exfoliation and disintegration of the rock through the wetting and drying of the soluble salts). Cement is also inadequate as it will never form a perfect bond with the rock: they have different physical reactions to changes in temperature and humidity, and there are therefore often hairline cracks (or larger visible ones) between cement and stones, allowing for water to penetrate and seep. A new channel could be built using smaller stones from the locality, with a lime-based mortar (using preferably a natural hydraulic lime). On the channel side, the barrier could be covered with a layer of clay (such as bentonite). The clay layer will swell in the presence of humidity, creating a water-proof barrier. This has been successfully used in various heritage sites, including for example the Domus Aura in Rome (GIAVARINI, 2001: 217-228).

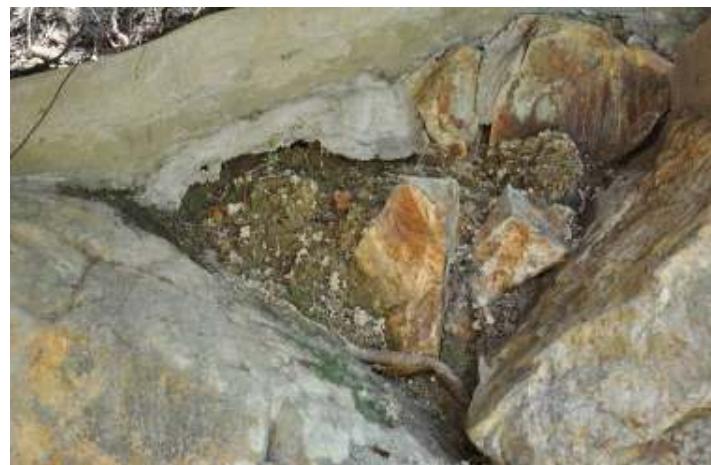
A more problematic aspect of the cement barrier is its poor attachment to the underlying rock and soil: water is very likely seeping towards the outcrop. There seems to be a repair on the cement barrier where it joins with the soil, in which more cement was added to try to ensure a better sealing (see figure 9 below). This should be another element to consider for monitoring.

Figure 9. Detail of the lower part of the cement barrier. Note the space existing between the underlying soil and the cement. There are also visible cracks between the cement and the rock (upper right side)

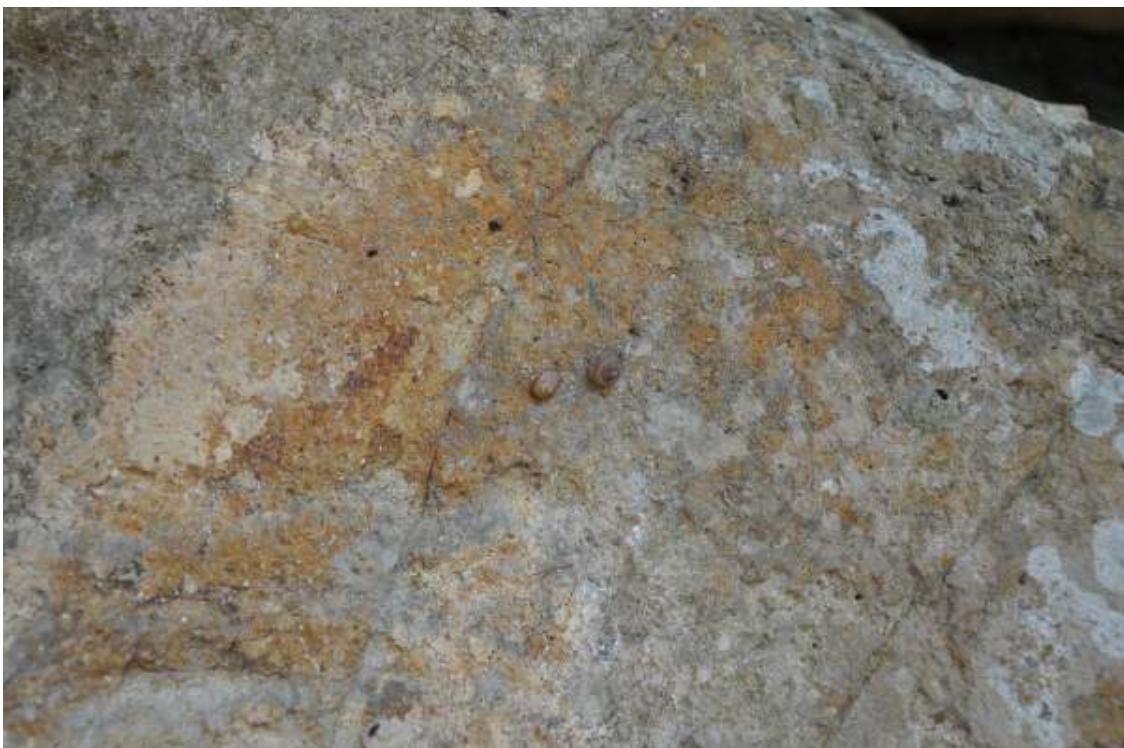
At the moment of the visit, the overall condition of the rock seemed stable. There is only a small area on the larger engraving, with little areas of possible flaking, which will need to be monitored in the future.

Figure 10. Detail of the large engraving at Shek Pik, with possible areas of flaking, to be monitored

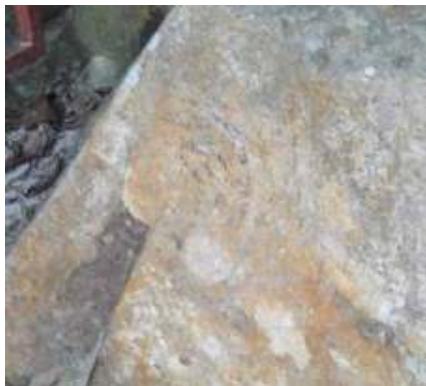
In the area of the small engraving (on the left of the outcrop), there is a presence of a discontinuous black accretion (it could be manganese oxide), essentially found on the areas surrounding the engraved lines. The older images of the site do not offer enough detail to allow for a comparison and defining whether this black material was already present.

Although it does not seem to pose any threat to the site, it would be important to monitor the evolution of this material. If significant changes were detected over time, further chemical analyses would be recommended to understand the nature of the process, and its possible implications for the engravings.

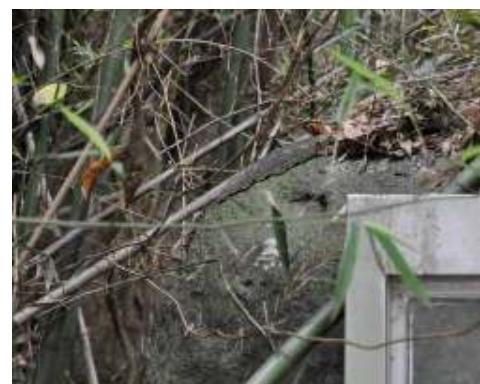
A cement barrier was built on top of the boulder to divert water from the engraved area (no date provided, but it is present on images dating from 1982). As in the case of Shek Pik, a poor bond is clearly visible between the rock surface and the cement, and the barrier is likely to allow water seepage at its base.

Figure 15. Detail of the cement barrier in the upper part of the boulder, with a visible separation.

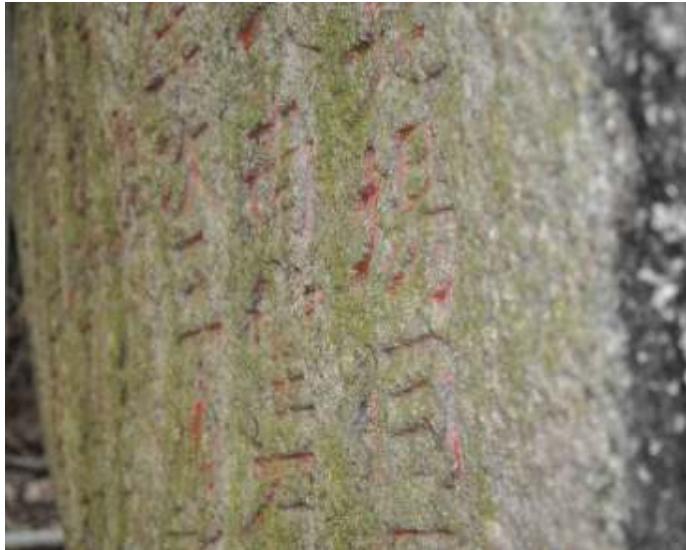
There is however new bio-growth on the inscription area, creating green vertical lines.

Figure 16. Detail of the growth of microorganism in vertical lines, according to water run-off patterns on the rock surface.

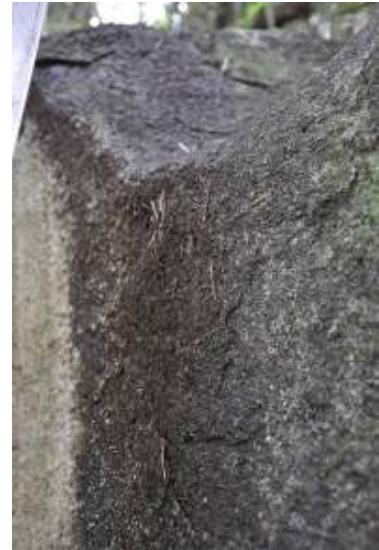
Figure 17. Detail of organic matter accumulation in the vicinity of the inscription area.

The condition of the rock surface seems stable, although there are areas of potential which may be at future risk of spalling. These are clearly visible on Figure 17. A close monitoring of the surface would be desirable to identify any evolution of the surface and, if required, proceed to a conservation treatment to stabilize it.

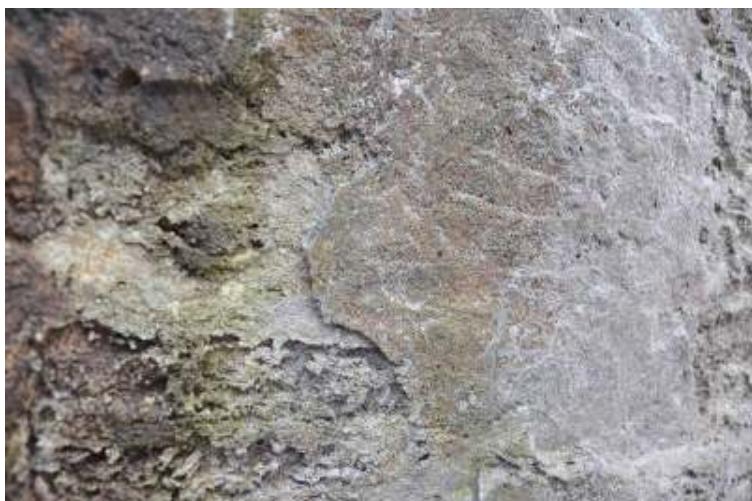
The aspect of the surface, with some smooth and hard surfaces next to badly weathered ones could suggest a phenomenon that can be found in tuffs exposed to humidity, called case-hardening. The mechanism essentially implies a migration of silica towards the surface of rock, where water evaporates), forming a hard layer at the surface. This process, over time, weakens the inner part of the rock by progressively reducing the silica content. When the inner part becomes too weak, the outer silica crust falls.

Figure 26. Detail of the surface of the rock in the vicinity of the engravings

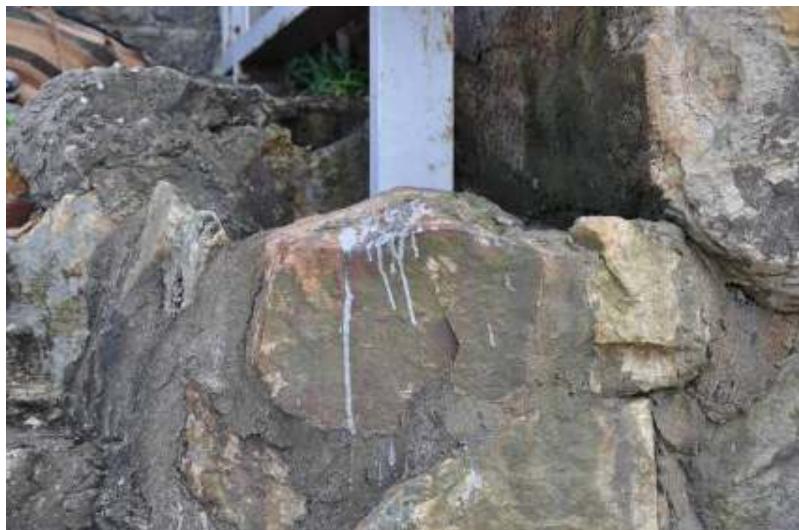
While the site is very clean, there are a few areas where improvements could be made. There are various areas with paint drops under the fences and railing at the site. Although the engraved panel is not damaged by this, it is important to remove those stains (and prevent new ones from happening in the future), to ensure the site looks perfectly looked after. This has proved to be an encouragement for respect to the site from visitors.

Figure 28. Detail of paint drippings from the structure for the panel

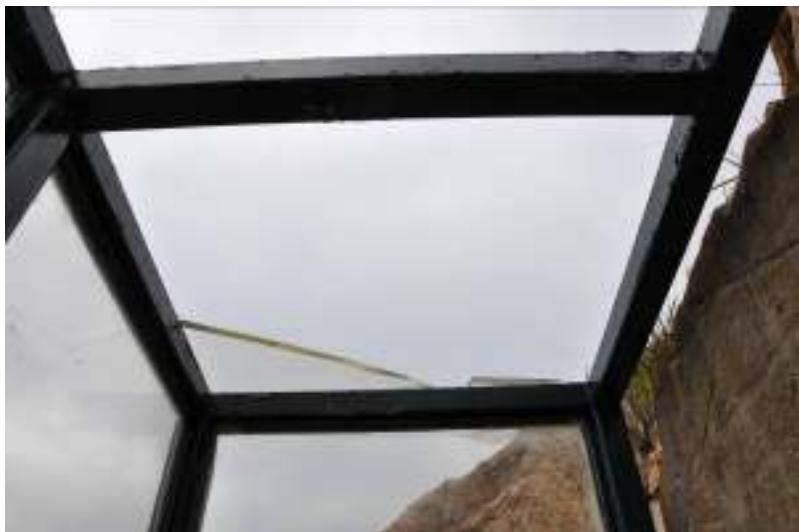
Figure 32. Detail of the upper broken glass

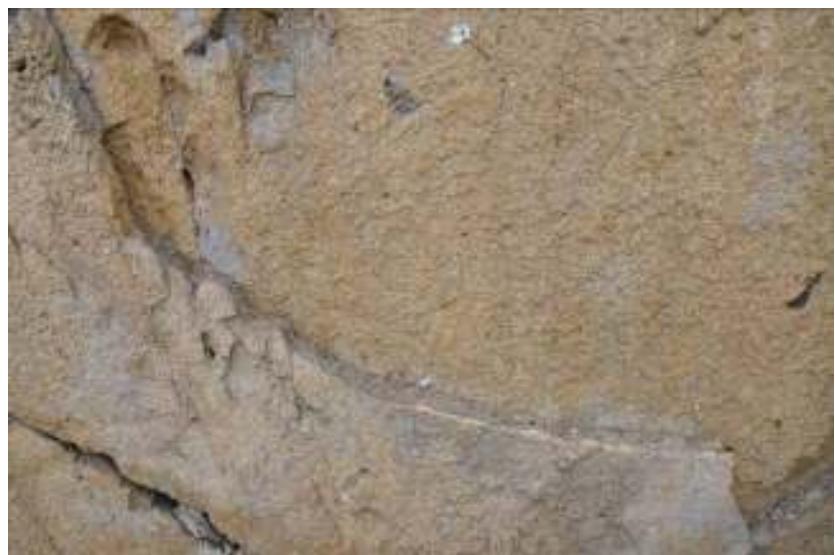
Figure 34. Detail of infills

Evidence of some of these treatments is still visible at the site. There is also evidence of infills, which were placed on the edges of a large spalling area (the infills could have been done with a mortar mixed with a coarse sand) (see Figure 34). The infills were not done along all the edge, but rather only on the horizontal ones. Where the edge becomes vertical, no infills were detected.

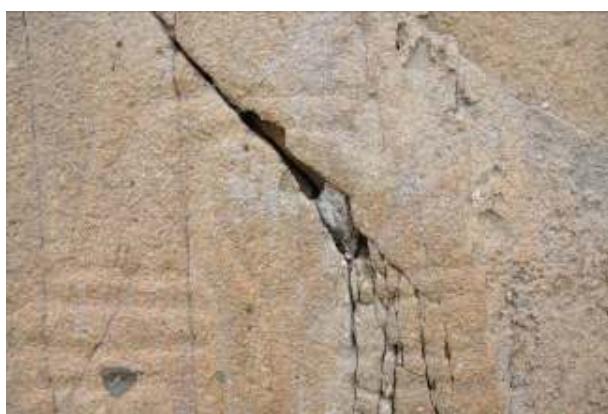
There are plant roots (apparently dead) on some of the cracks in the central part of the panel, as well as in the lower area, which should be monitored.

Figure 35. Detail of an apparently dry root inside a crack

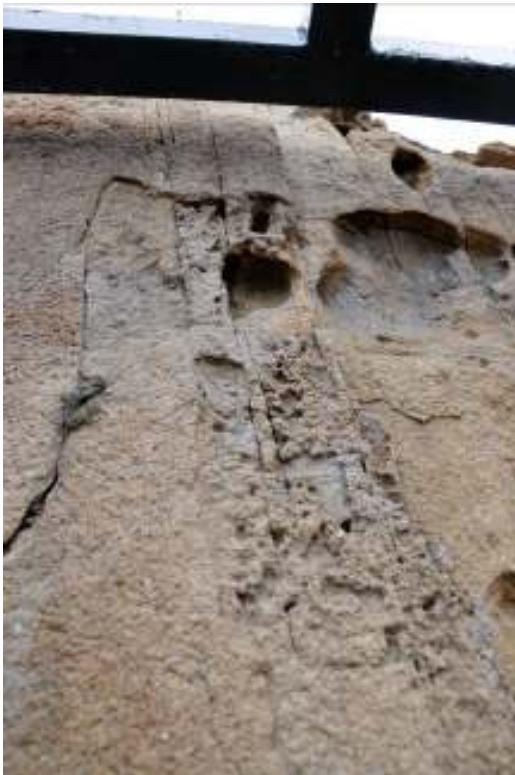
Alveolar decay patterns are visible in various parts of the panel, but they seem to be stable at the moment. There is only one unstable fragment in lower right side, next to the metal structure (see Figure 36).

Figure 36. Alveolar decay

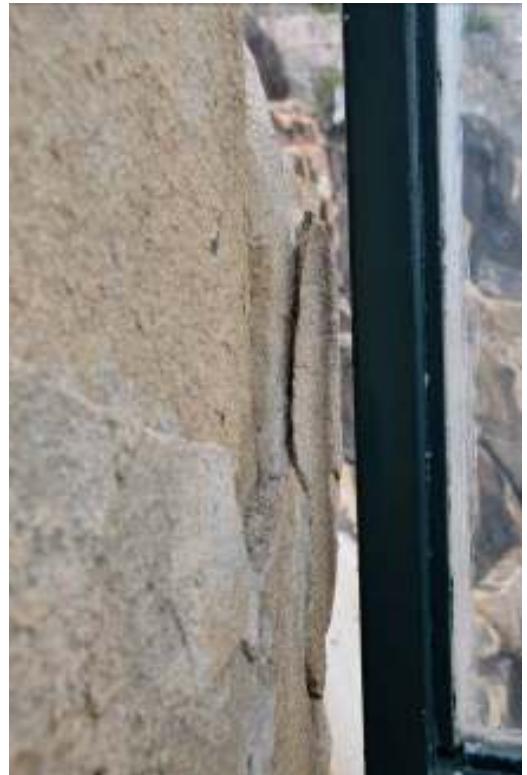
Figure 37. Unstable and partially detached fragment

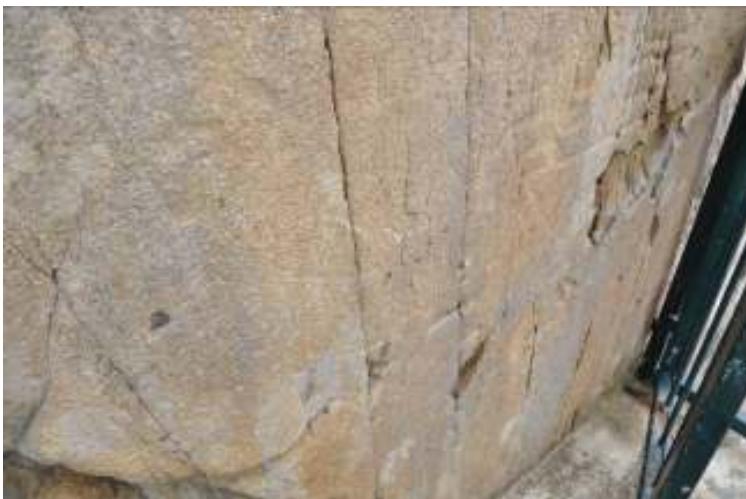
There is a visible scratch in the central part of the panel, which may have been caused when the protective cages were damaged by a recent typhoon.

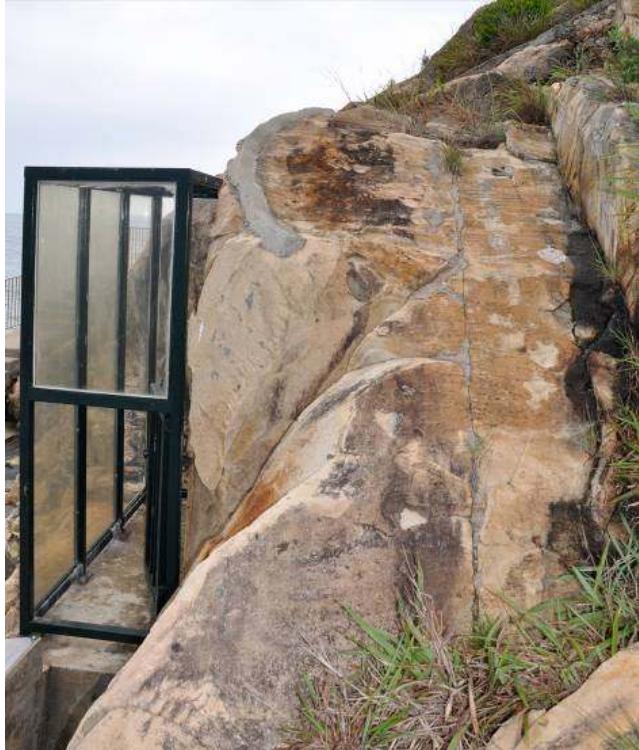
On top of the engraved area, a cement barrier was applied in the past. The same situation as at other sites, this is not really useful, as there is a poor connection between the cement and the granite surface. Water could seep under the cement barrier, however in this case it may not be so because of the angle of the surface in that area, which would tend to take water away from the vertical surface. On this horizontal landing (where the cement barrier was placed), the area has a series of cracks, which were infilled in the past with a coarse grained mortar (likely cement-based). The infill is not preventing water infiltration along those cracks, as there is again a poor bonding between the mortar and the granite, and there are still visible gaps. Furthermore, the infills were only applied on the larger openings, but not along the entire cracks.

Figure 39. View of the cement barrier placed above group 1. Note also the grey coloured infills placed on some of the cracks.

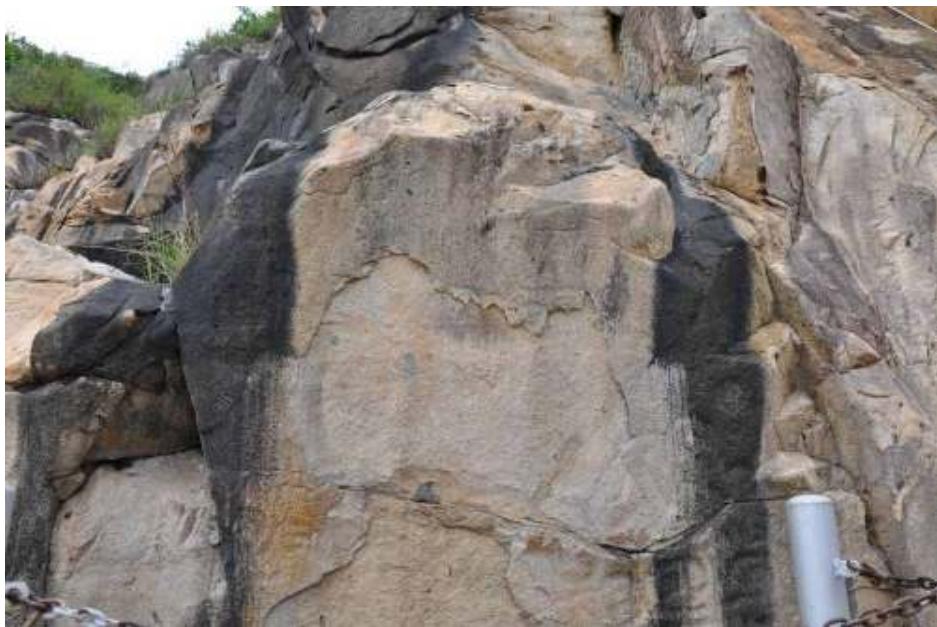
The central part of the panel has a broad spalling area, which likely led to the loss of a large part of the engravings.

Figure 43. General view of group 2

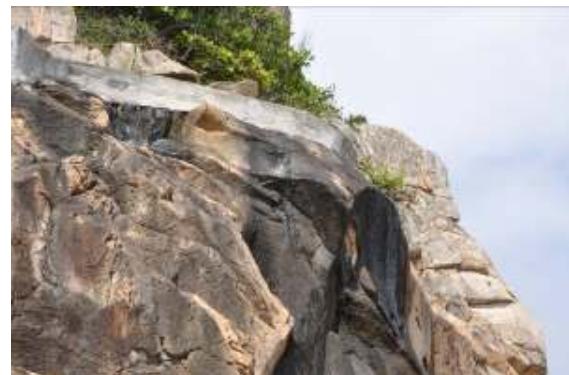
Figure 48. Detail of water seeping under the barrier

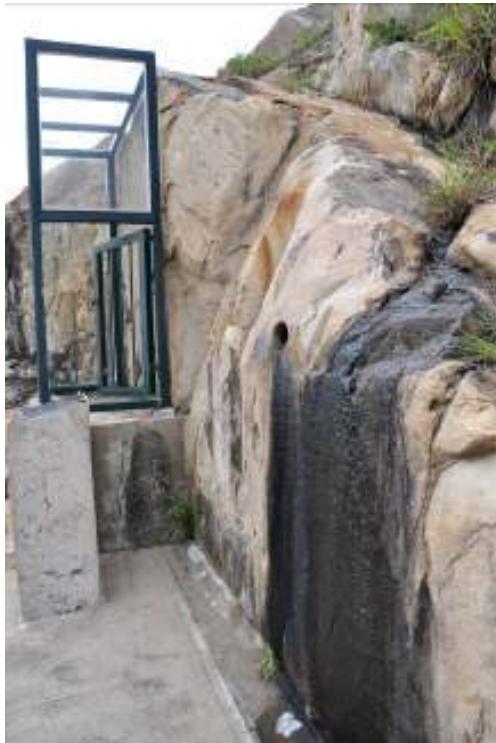
The area located between the two groups of engravings seems to have a different structure in the granite. There are visible marks and evidence of water seeping from cracks and joints of the rock.

Figure 49. Detail of water seeping in the area between the two engraved groups

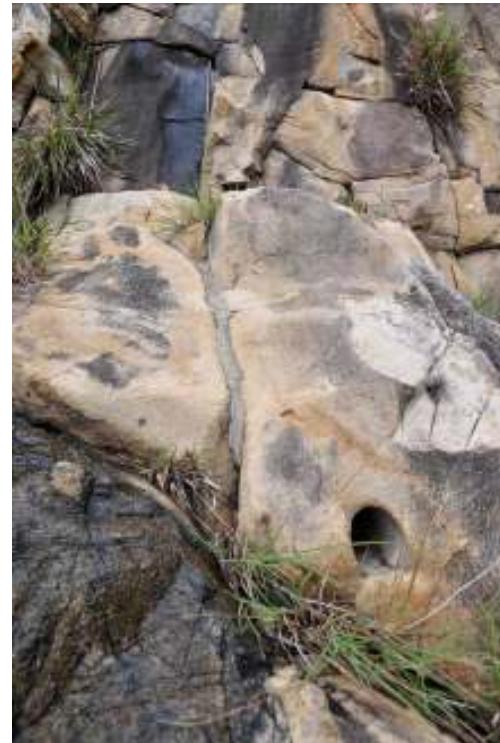
Figure 50. Detail of the drilled holes and the infills on the cracks

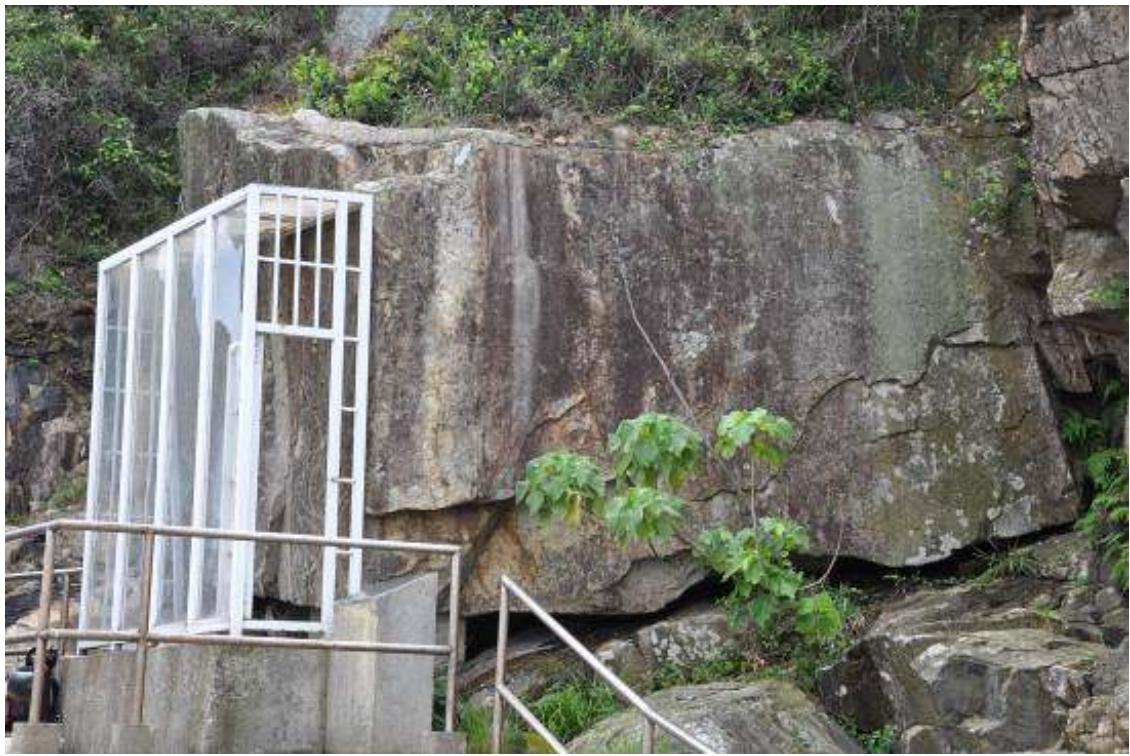
Figure 62. View of the block from the lateral side. Note the large overhang underneath it.

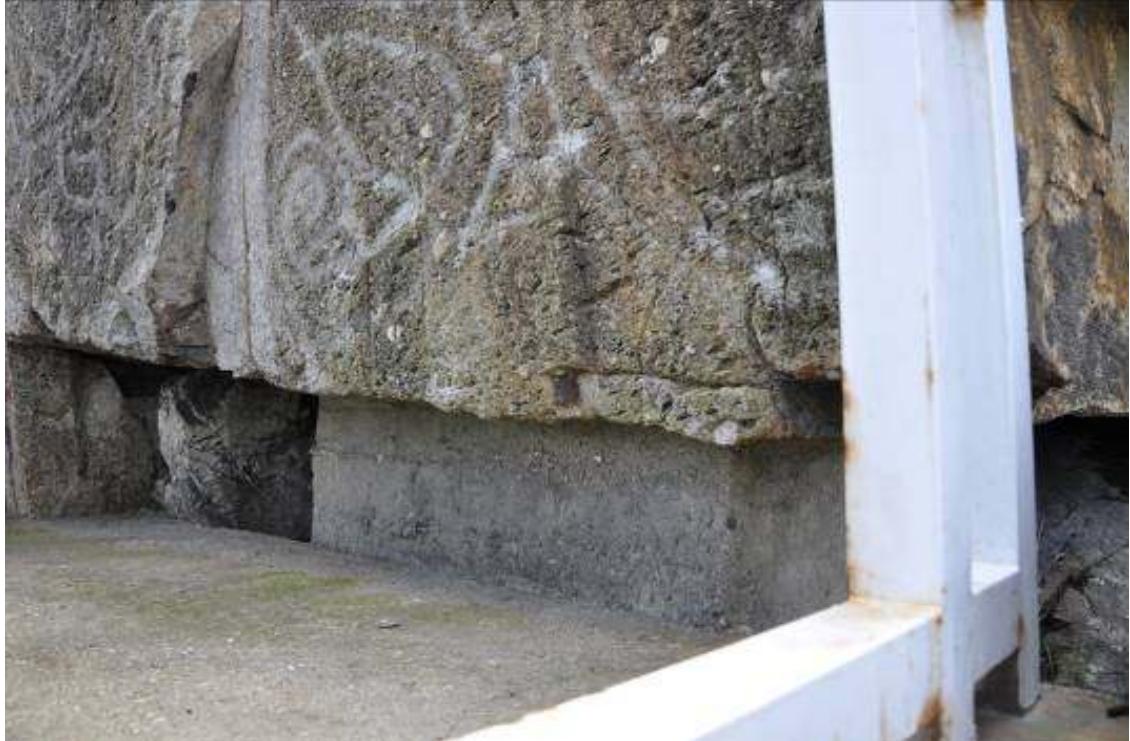
Figure 63. Detail of the cement pillars placed under the overhang

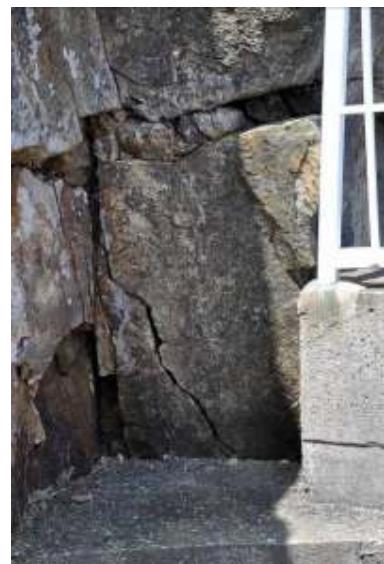
Figure 64. Detail of a crack at the base of the rock, on the left hand side.

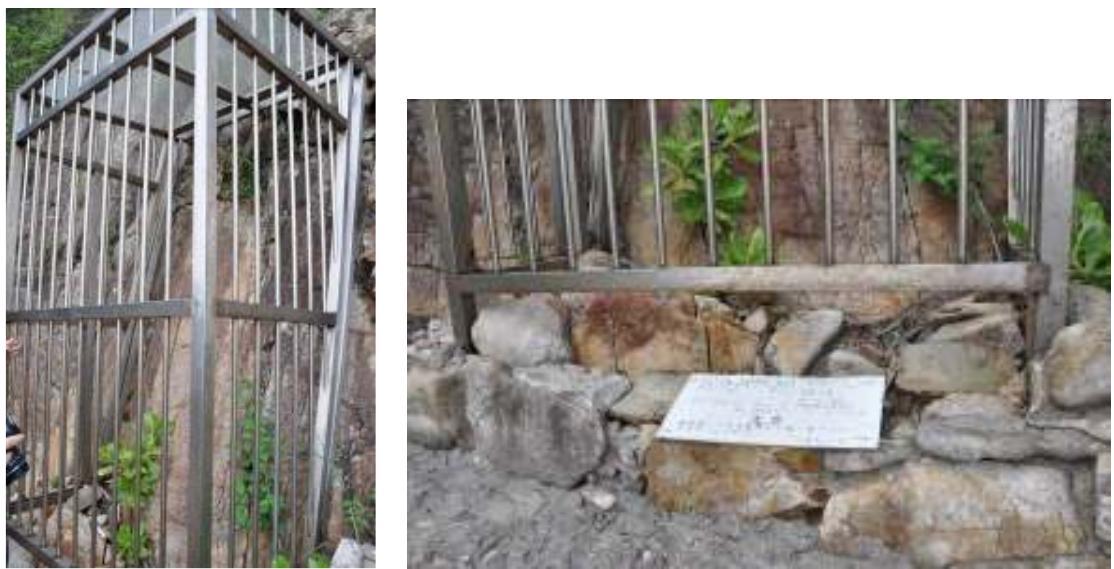
Figure 69 and 70. Views of the protective cage at the site. Note the large gap on the right image

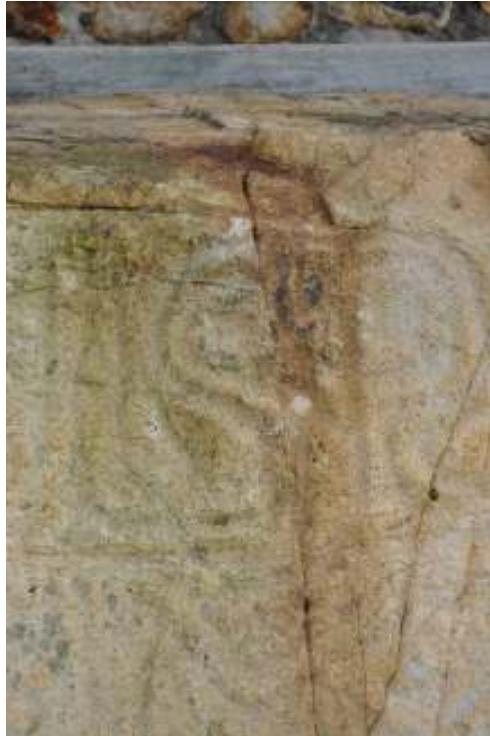
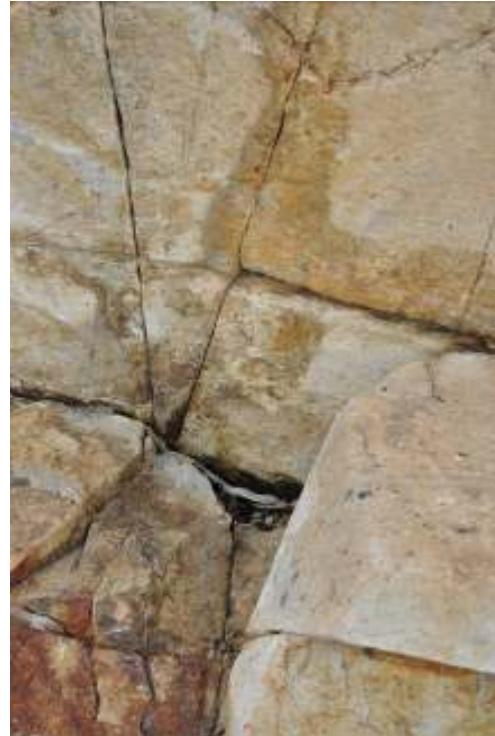
Figures 87 and 88. Detail of microorganisms of the surface of the engravings (left) and of roots on some of the cracks (right)

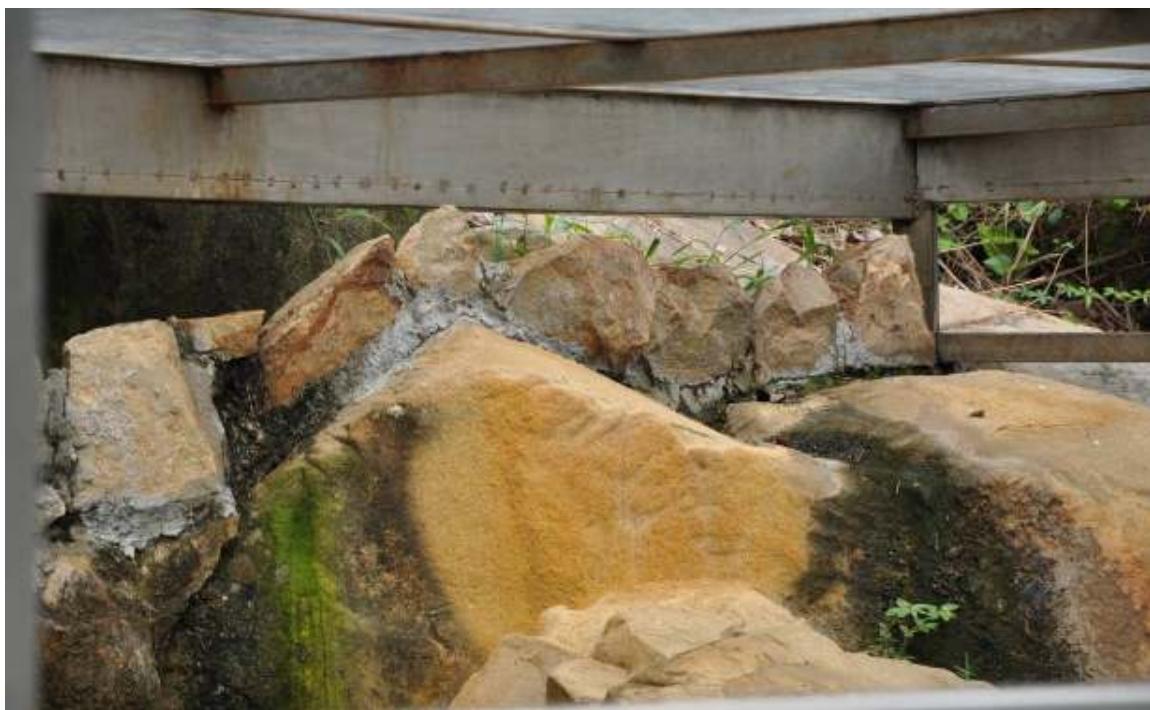
Figure 101. Detail of the actively decaying area, above the engravings. Note the evident presence of humidity on both sides, and the presence of a barrier built with cement on top of it.

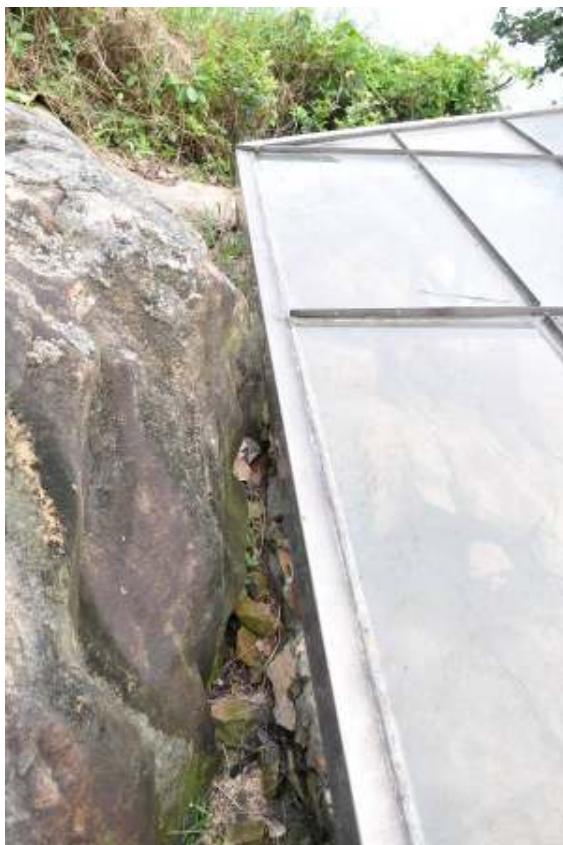
Figure 102. Detail of the area where water should be channelled away from the engravings, filled with soil and leaves, and visibly very damp
