Condition Survey of Nine Rock Carvings

A study of the condition, management and treatments of nine sites within the Hong Kong autonomous boundaries.

Prepared for the
Leisure and Cultural Services Department

December 2009

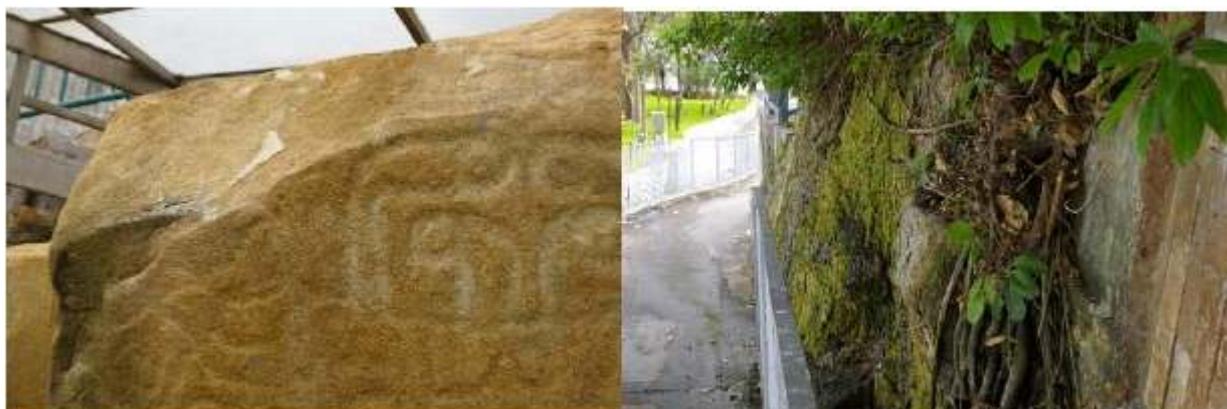
Figure 2 Cheung Chau – There is slight evidence of biological growth inside the structure (left) but nothing like that growing outside the enclosure where water supply is ideal for growth and full shading from the sun.

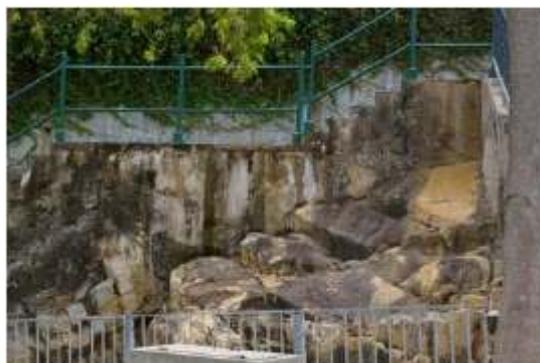
Figure 6 Concrete steps at Cheung Chau with evidence of white salt and black enhanced biological growth due to the concrete.

It has also been pointed out in earlier sections that Portland cement concrete releases large amounts of soluble and semi soluble salts that can be very damaging to any rock they flow over. While there is little evidence of this practice continuing in recent years it is recommended that all future management aims to reduce and remove concrete from the sites.

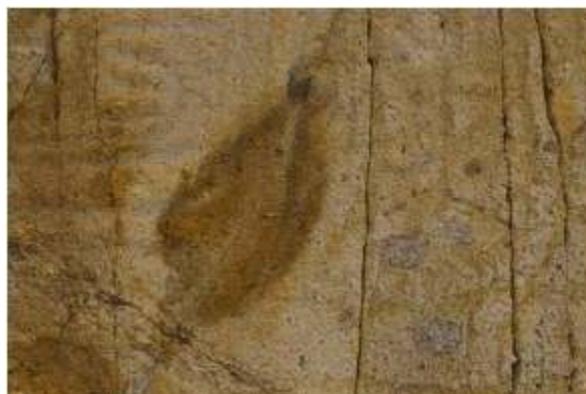
Moisture survey No measurements taken but there would normally be some surface wash, which has now been diverted. Seepage is a greater threat and wet patches, one of which is seen at right associated with fine fissures in the rock, are evident in lower areas. If these areas are found to have higher moisture levels then the water diversion system needs to be modified to prevent such infiltration. This may not be readily rectified as the seepage may come from much further into the hill slope above. There are no signs of erosion associated with this apparent seepage and more often the seepage waters have become enriched with consolidating minerals and can remain more durable than their surroundings.

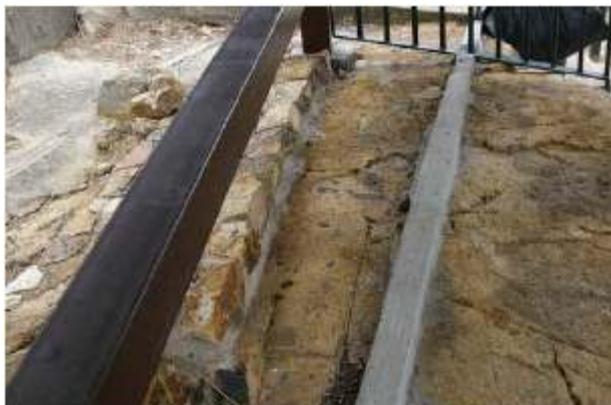
This site has received the same degree of heavy infrastructure as most other sites. Access path, steps and roof fixing points are all in Portland cement material. The appearance is one of heaviness and the potential impact from concrete above the engravings is high. It has been recommended throughout this report that there needs to be a move away from concrete towards more light weight access. Equally the use of Portland cement for building water diversion dams and other features above the engravings should be avoided. Dams can be constructed from siliceous grout materials as described within this report.

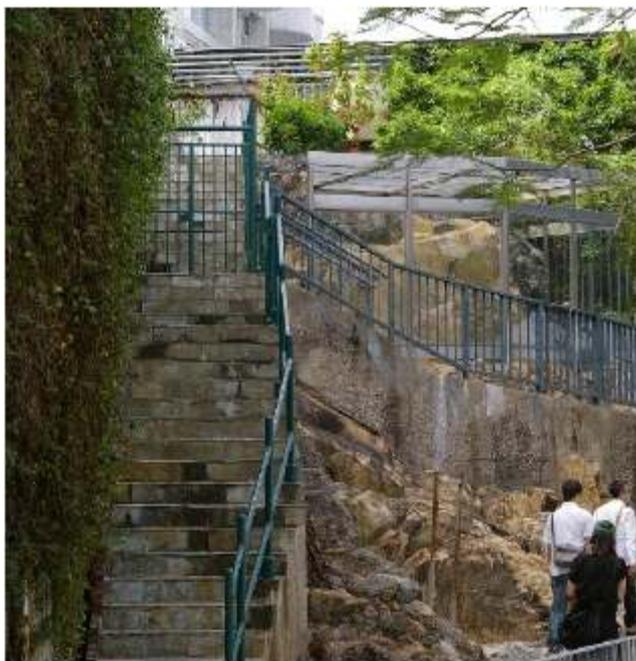
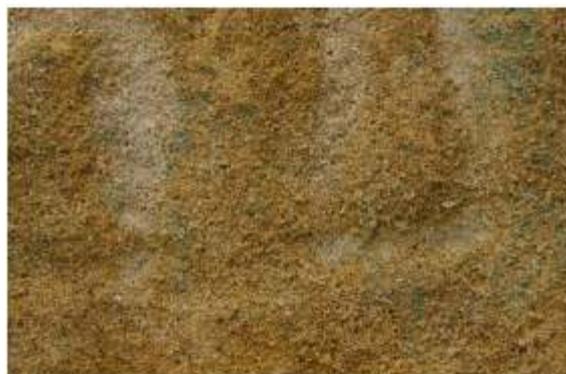
Human impact Green paint applied to east panel. This is not highlighting as it covers the channels and background outer surface equally. Portland cement has been used abundantly to cap several of the blocks. It is doubtful that this material is providing any benefit to stability and should all be removed. This material appears to predate the glass enclosure and is friable and broken. It has very poor adhesion to the rock which is caused by the fact that salts released by such cement cause disruption to rocks. This usually results in a

separation between the two surfaces as seen here.

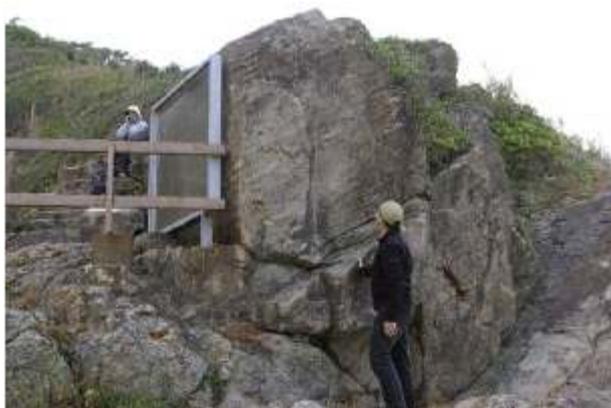
The access path, viewing area and protective screen all throw up issues in relation to visitor experience at this site. The first point to make is that this site has been considered to be ambiguous in its origins. Some believe it to be natural while others are clear that it represents defined motifs. This writer is in no position to contribute to this issue. While the motifs may be indistinct it is very clear that the site does not present a rich cultural experience. The markings are not clear and this is made even more difficult by the highly reflective screen. The screen has been placed there for two reasons. The first is to prevent damage and the second to reduce salt spray and resultant damage. Given that the site is Rhyolite and already treated with siloxane there is little extra benefit achieved through a protective screen. Protection from the public is necessary but at this site, as at Kau Sai Chau, it is questionable whether presentation to the public is necessary. The current viewing platform is ill equipped to take more than 3-4 people and in itself quite precariously positioned. Access to the site is gained through Portland cement steps and further concrete has been used to support the viewing platform. This massive installation provides minimal visitor experience and it is proposed that this site be reduced to a recorded site with no infrastructure. It is recommended that the track be terminated at the point where it branches down to the pathway used by fishermen gaining access to nearby shoreline rock platforms. Visits to the site can be achieved from this location and the removal of all infrastructure will still permit viewing at a greater distance from the rock. If necessary, determined by the Office's legal responsibilities to protect visitors to their sites, it would be possible to construct a light weight platform in the rock ledges below the site at the level where Hong stands in the adjacent photo.

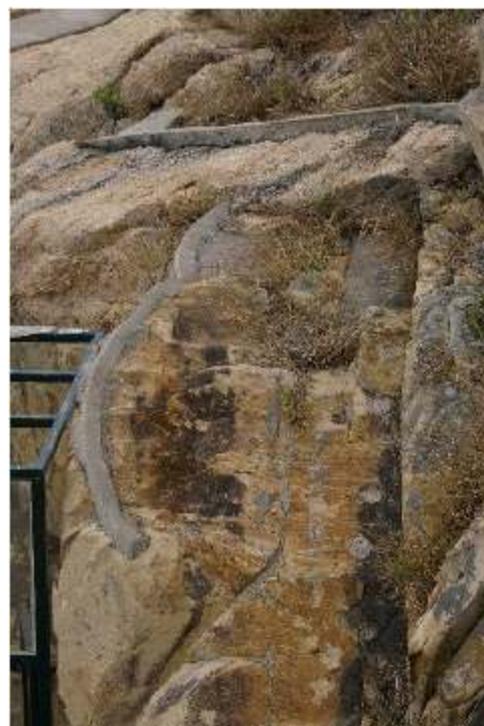
Water wash damage Water washing into the carved surface has the potential to cause delaminations by entering into the upper opening of several detachments. A very large one of these is found in the upper right corner. This detachment has been capped but the filling has cracked away ensuring that water can enter. Water into these upper openings will lead to dissolution and detachment in several areas. This is quite a different mechanism to that referred to somewhat dismissively in relation to the core drilled drainage pipes. The pipes are drawing water from deep within the rock whereas these delaminations and associated water infiltration are surface phenomena.

Rock stability Through water entry described above there are several detaching areas that could further deteriorate and detach completely in time. One of these is quite large and while it has been capped with a Portland cement based grout this is not a satisfactory material and there is already a separation along one edge. The detachment is 250 mm across and possibly as far down the surface. This detachment requires additional attachment support to remain intact. This area does not contain engraved surfaces but should be retained as part of the significant surface.

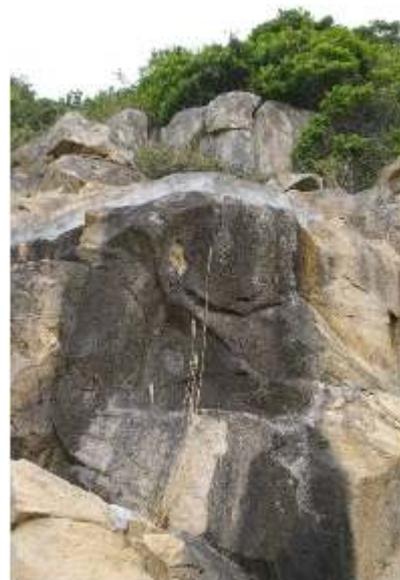
significant impact is through the promotion of biological growth and this is quite pronounced through the engraved panels (adjacent photograph). Whether this has become significantly enhanced as a result of the salt wash is not certain but this can be determined from early photographs predating the dam walls. The SE exposure is not conducive to high biological growth. What is also clear from surveying the right hand panel is that there is no distinction between the previously caged sections and those that have always been exposed. There has been some comment about the dangers of creating biologically conducive conditions within enclosures such as the left hand panel. At Po Toi there is absolutely no evidence of this and no justification in pursuing this view.

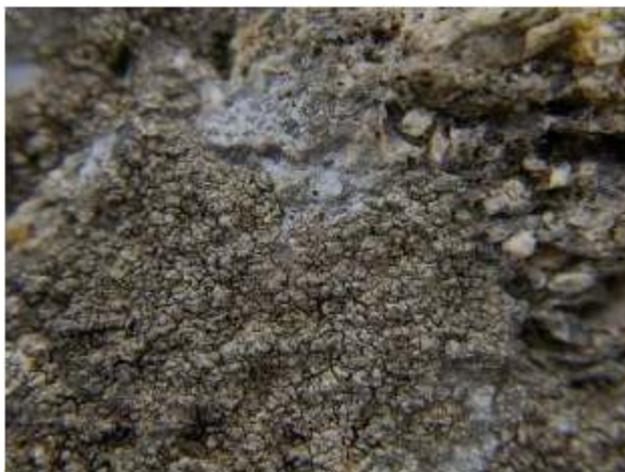
Surface alterations Cultural surface has an orange patination. Engraved channels uniquely contain a thick grey crust. Microscope study suggests crustose lichen that may have been encouraged by calcium sulphate chalking. Layer may also contain calcium oxalate as evolutionary final stage. The adjacent photograph shows the crustose lichen appearance in the lower section with a lighter grey chalking or similar evident just above it.

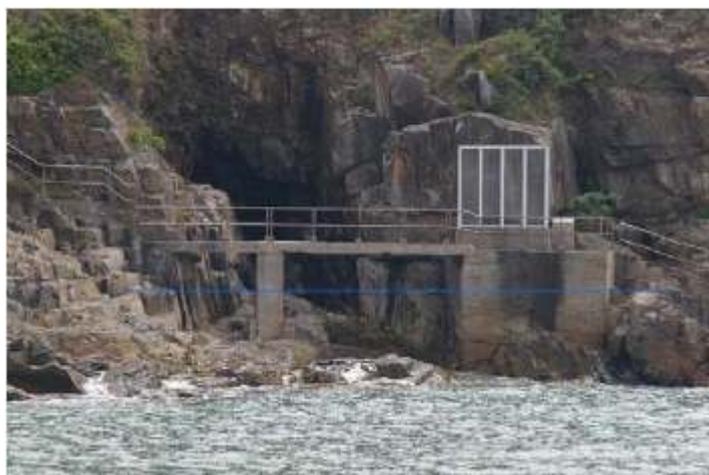
The infrastructure at this site overwhelms the site and its setting. It is recommended that the presentation of this site be reviewed and that this be used as the first site, or perhaps after Po Toi, to implement low impact and low visibility infrastructure. It has been argued that the screen provides some but not substantial protection from the elements and that there are better ways of separating the panels from visitors. In fact this is the perfect site to create separation due to the severe drop between the panel and surrounding rocks.

The adjacent photograph presents the site as it stands. A blue line indicates how the viewing level could be separated by lowering it by a metre and separating the platform from the rock by at least 1.5 metres. Ideally this could be more but is limited by the need to secure the platform to rock ledges below. By lowering and moving the viewing area away from the rock face the severe drop between will prevent touching and visitors cannot approach from below due to the height and angularity of the natural rock. Under this recommendation the screen should be removed and all the concrete steps going further to the right.
