Revitalisation of the Rear Portion of the Cattle Depot at To Kwa Wan, Kowloon, Hong Kong

HERITAGE IMPACT ASSESSMENT CONSERVATION MANAGEMENT PLAN

Applicant: Architectural Services Department

Heritage Consultant: AGC Design Ltd.

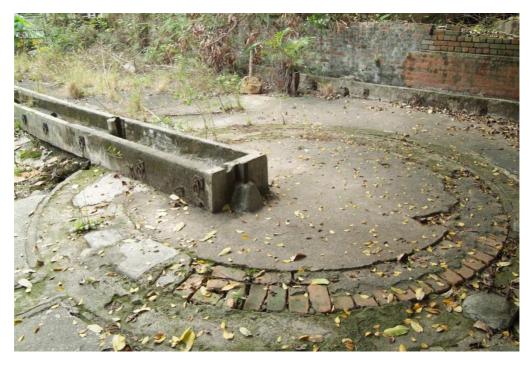
Fig.46 Current Condition of water pond in water pond zone Source: photo by the author

The traces of the water pond still exist which is covered by concrete and feeding trough channel.

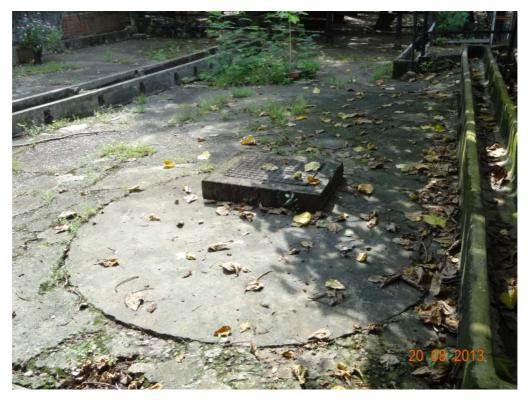
Fig.47 Current Condition of the well in water pond zone

The traces of the well still exit which is covered up by concrete and a manhole is constructed on top of the well.

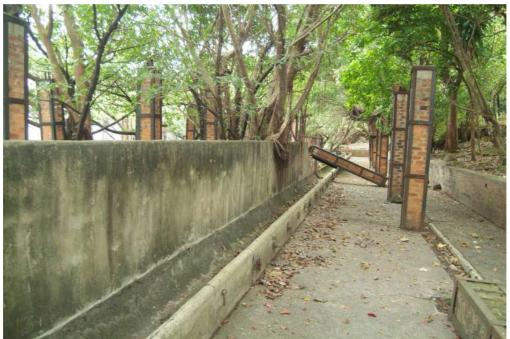
Fig.64 Current condition of PB 632

Collapsed columns and mature trees are found in the shed area. Feeding troughs and the associated low wall are in relatively good condition.

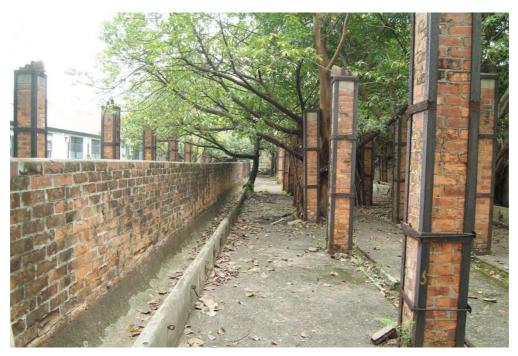
Fig.65 Current condition of PB 631

Roofs no longer exist. Partial remains of the timber truss are found on the top of the red brick columns. Trees grew in the shed area over the past decades during the abandoned period of time. Feeding troughs and the associated low wall are in relatively good condition.

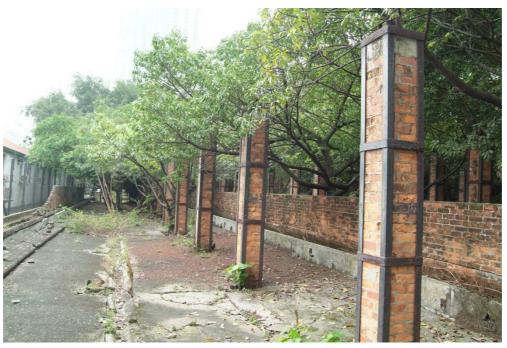
Fig.66 Current condition of PB 630 & PB 631

Half of the PB630 is within the project site. The only artifact remains on site is the feeding trough. No more columns are found on site except the marks of the column base. Part of the associated low wall on the feeding trough has collapsed.

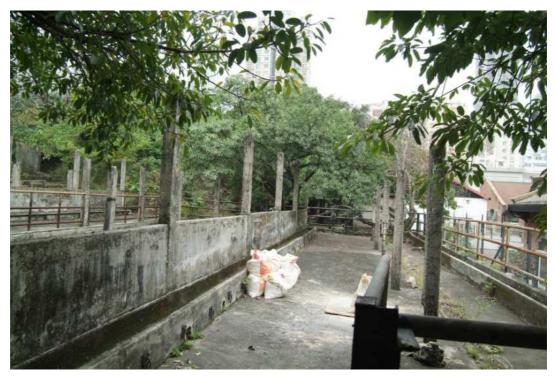
Fig.68 Current condition of PB 623

The project site is unoccupied at the moment. For the sheds PB 623 to PB 628 in the Concrete Column Zone, spalling and rusted reinforcement are noted at many of the columns. Most of the feeding troughs are in good condition.

Part of PB623 will be converted into a rain shelter. The feeding troughs at PB624 to PB626 will be removed to form a landscaped open space. Part of the feeding troughs of PB627 and PB628 will be removed to provide room for the necessary circulation space and seating-shelters. The free standing concrete columns with low cultural value are in poor condition and have to be removed for safety reason.
