# **Archaeological Watching Brief for South Island Line (East) for MTR Corporation Ltd.**

**Final Watching Brief Report**

**ARCHAEOLOGICAL ASSESSMENTS LTD.  
September 2013**

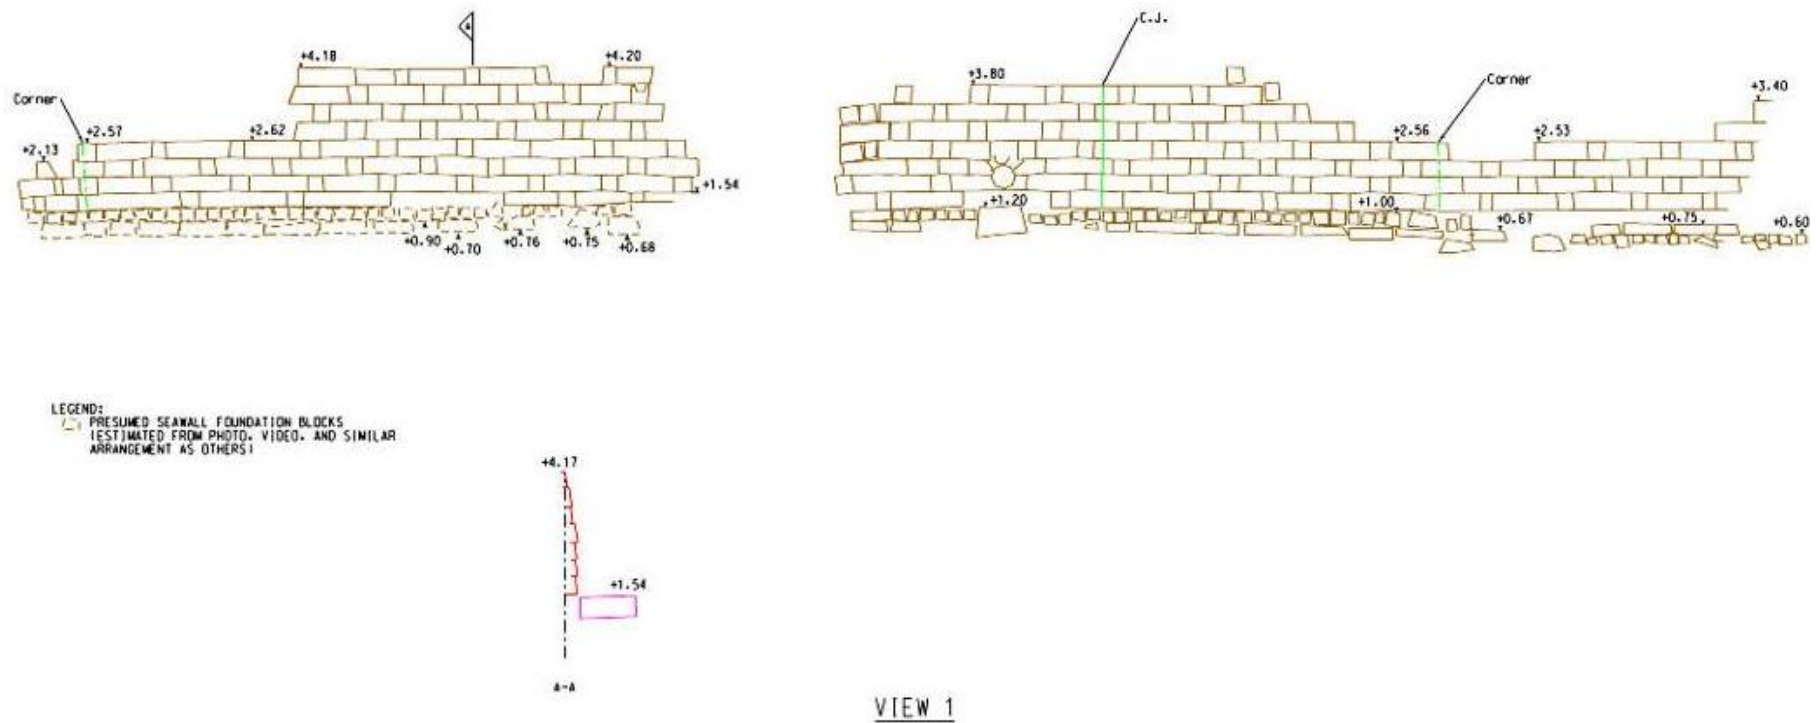
The seawall foundation (FIGURE 13) was minimal and consisted mainly of three and in parts of only 2 rows (PLATE 12). A *pierre perdue* foundation had been expected following late 19<sup>th</sup> century public seawall foundation designs, however, the seawall foundation recovered in front of the military area was laid onto stable well weathered rock deposits. The condition of the seawall foundation was found heavily deteriorated: the blocks underneath the drain were replaced by concrete and a large natural rock (PLATE 8, top right) and a section near the western off-set had been damaged by former Admiralty Station Entrance 'E' (PLATE 13). The excavation of the foundation under the current works permanent slab proved very dangerous as the exposed cuts were deep and unstable (PLATE 12g). The foundations were recorded and surveyed as far as possible and removal of blocks was video-ed.

Figure 13 Surveyors drawing of the North facing elevation of seawall fragment and foundation. (901\_C\_ADM\_SUR\_C80\_004C); green line is location of cross section shown below.

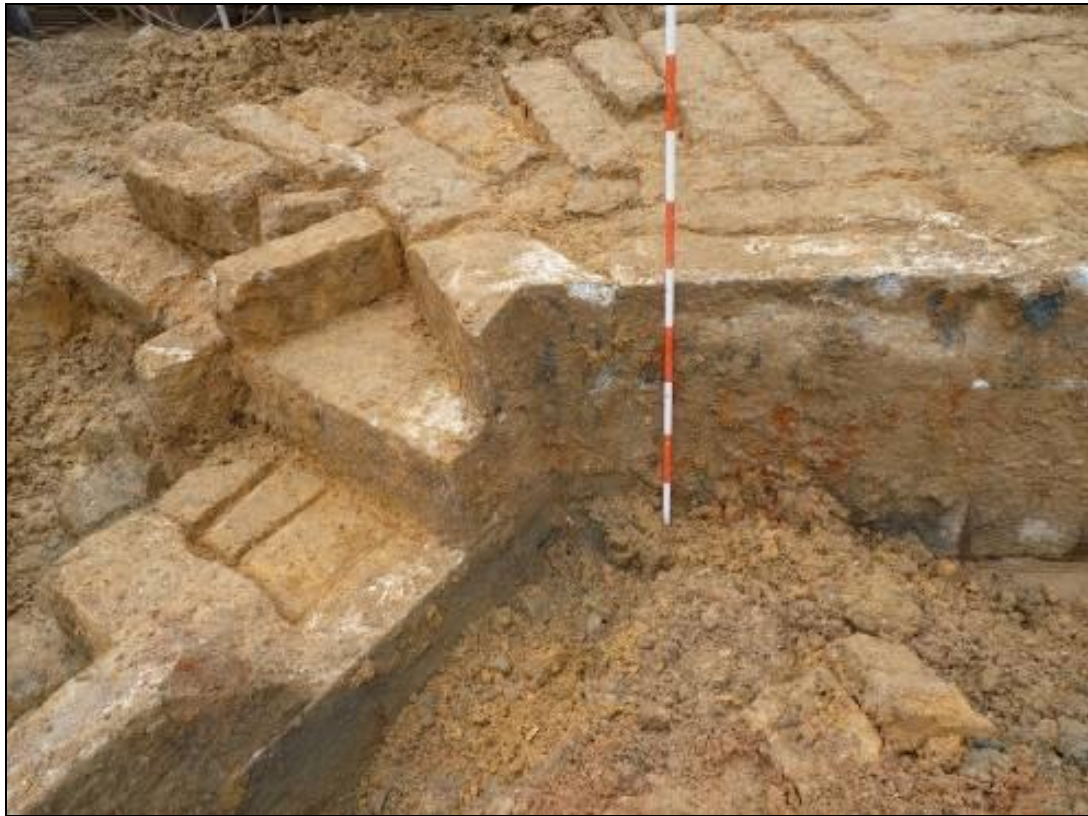
Plate 6a View of the seawall fragment: bend at eastern end

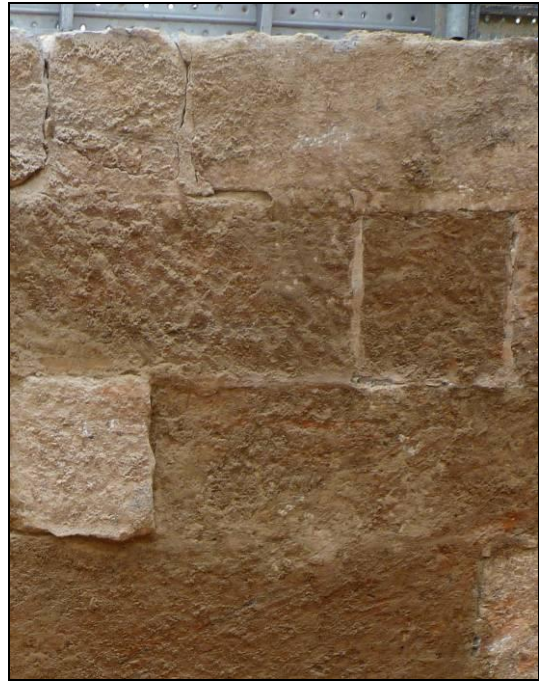
Plate 7 Sealing of cracks between dressed granite façade blocks

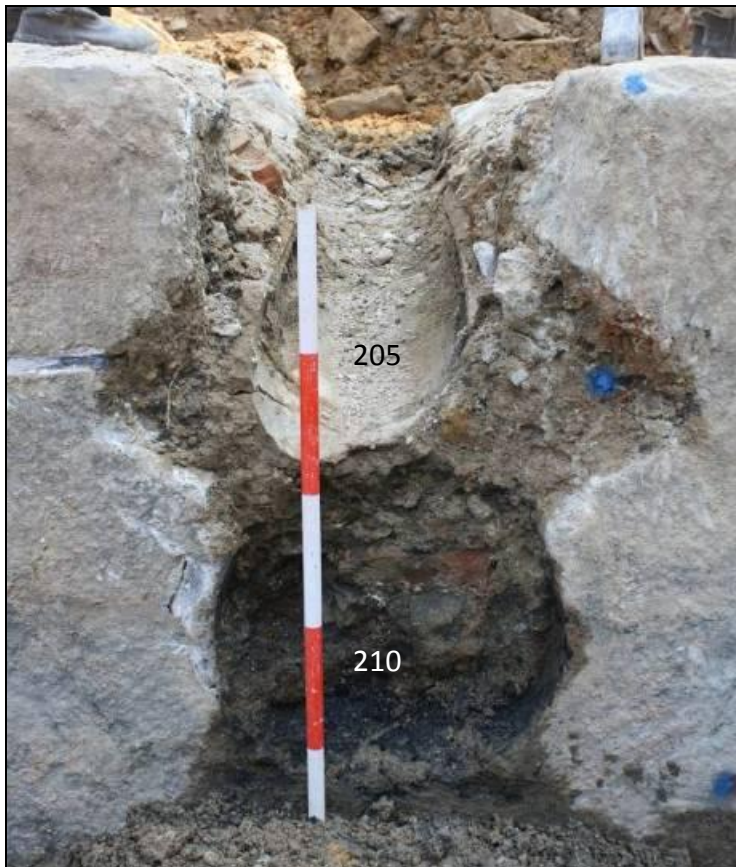
- A stone drain later set into concrete (PLATE 8) was located within row '2-3'. A circle had been cut out in four stone blocks and later set in concrete. The top of the stone circle had been broken to allow a ceramic pipe (PLATE 8 and 9c-d) later addition in row '4'. No archaeological materials were collected from the inside of the pipes. At the same location on top of the seawall fragment crushed fragments of another ceramic pipe were also recorded (PLATE 9a-b).

Plate 8a Stone drain, context 210 with later addition ceramic drain, context 205 recorded around row '2-3'

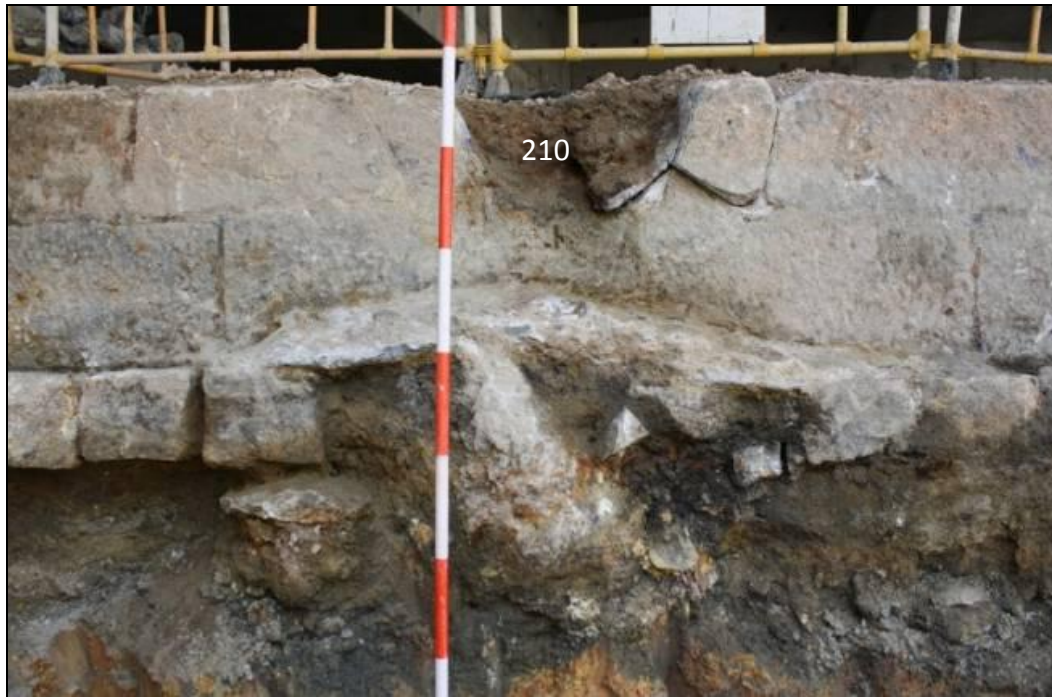
Plate 8b Bottom of stone drain with replaced concrete foundation and natural stone

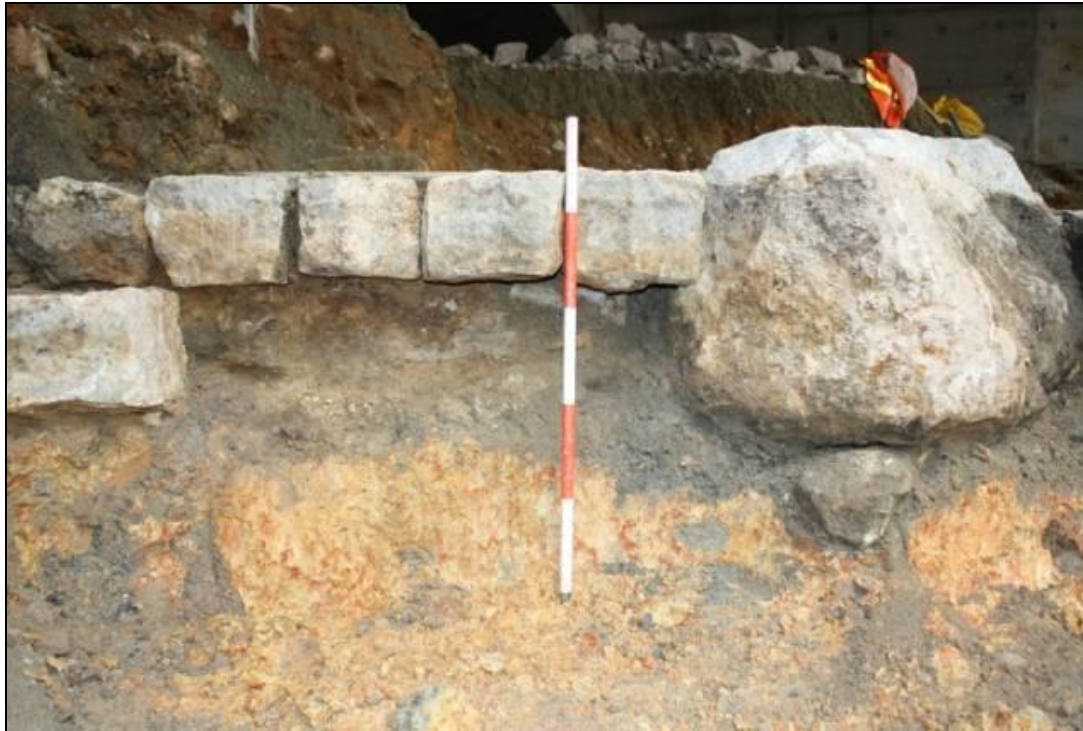
Plate 12d Seawall foundation: missing foundation blocks near and under stone drain, context 210

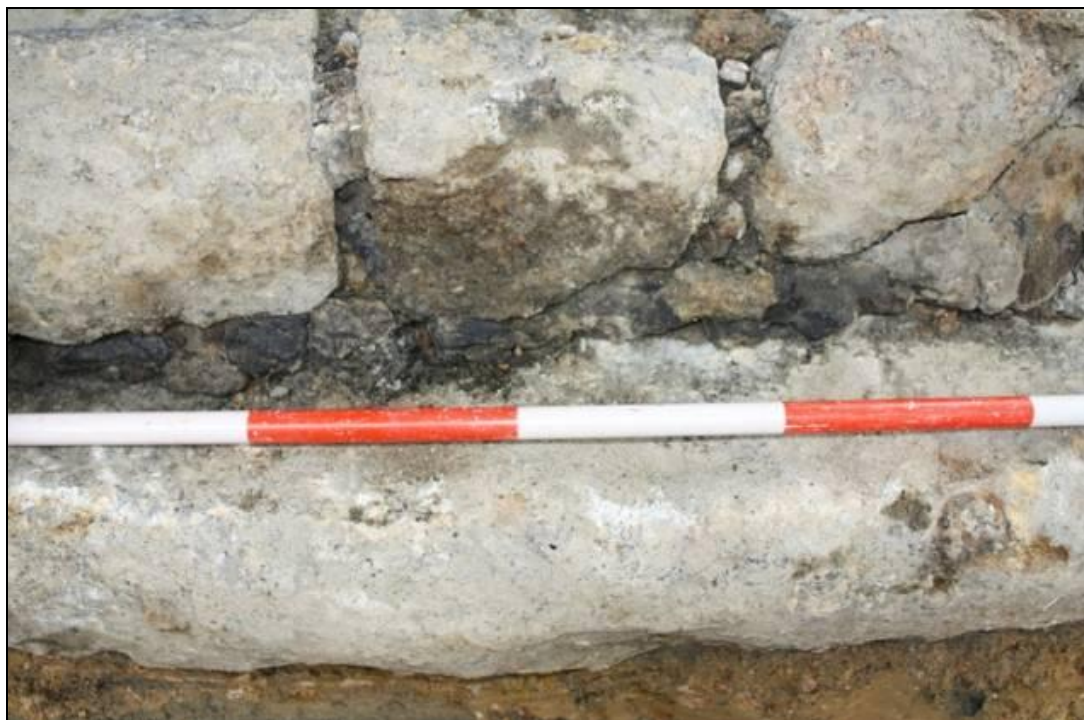
Plate 12i Seawall foundation: deteriorated grouting used at foundation

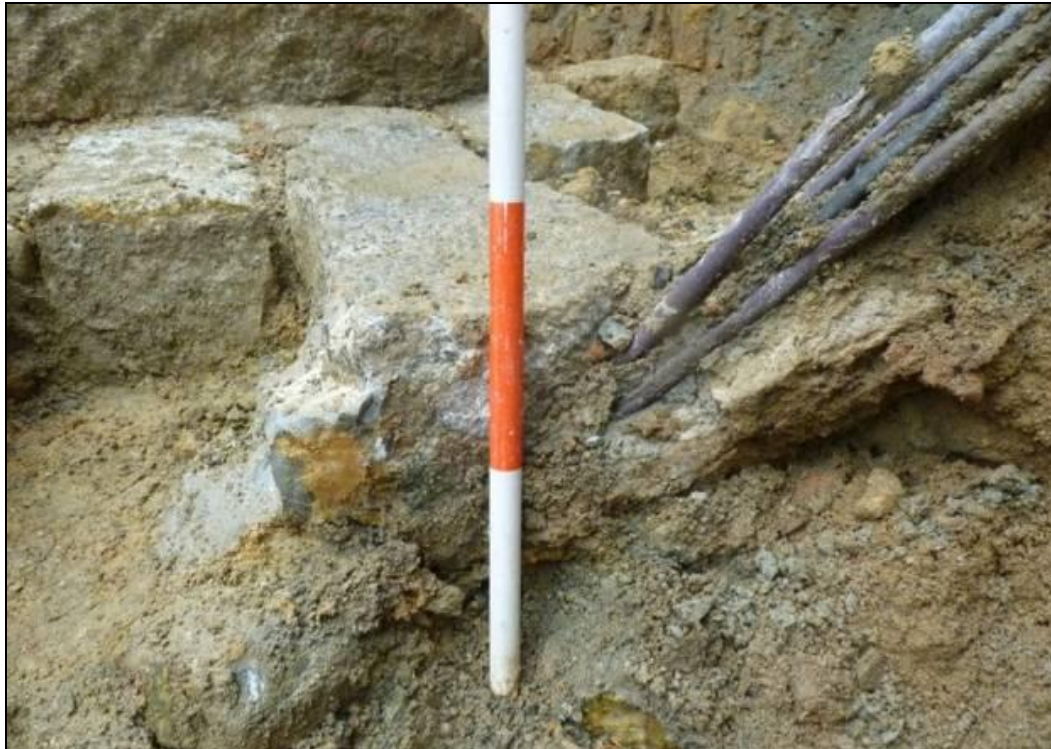
Plate 13a      Damaged seawall foundation: metal brace and sheet piling associated with former Admiralty Station Entrance 'E' which disturbed the foundation at the western end

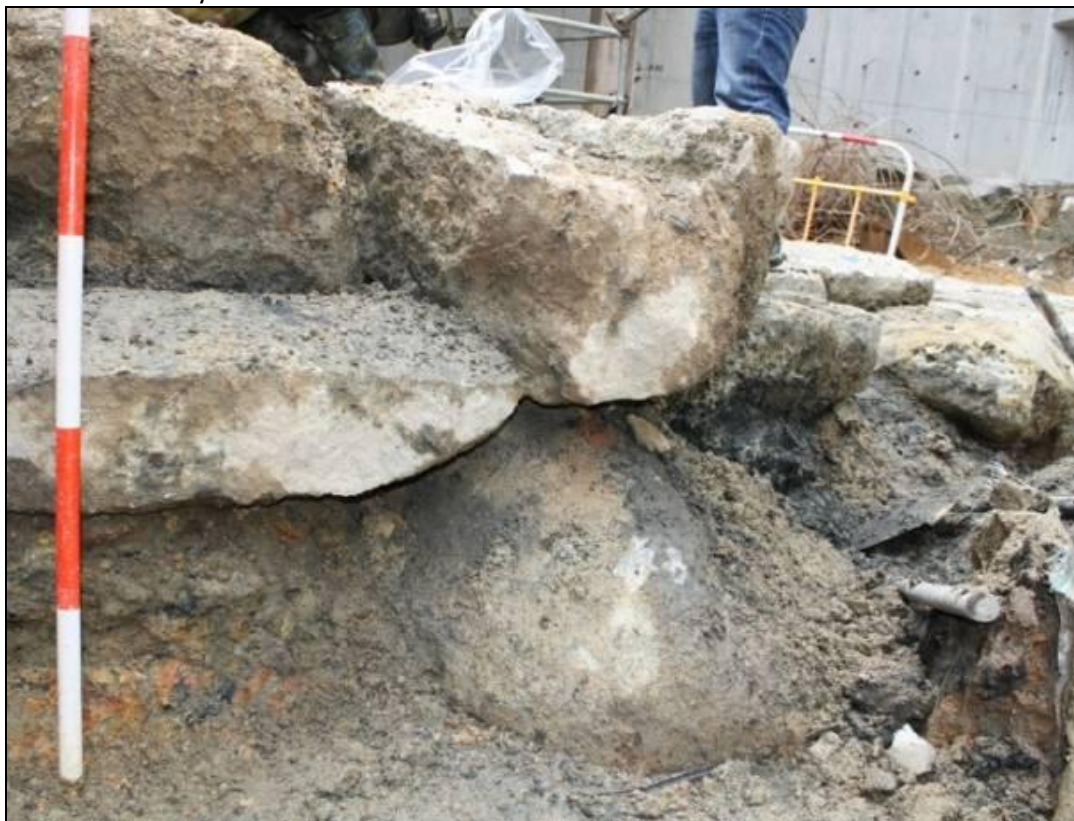
Plate 13b      Damaged seawall foundation: disturbance near the divergence at western end, note rubbish and large natural rock at point of turning

Destruction around the alignment deviation caused by the former Admiralty Station Entrance "E" had not affected the seawall but did affect the foundation. Blocks were missing and a natural rock found on the outside was on top of plastic (PLATE 13b).

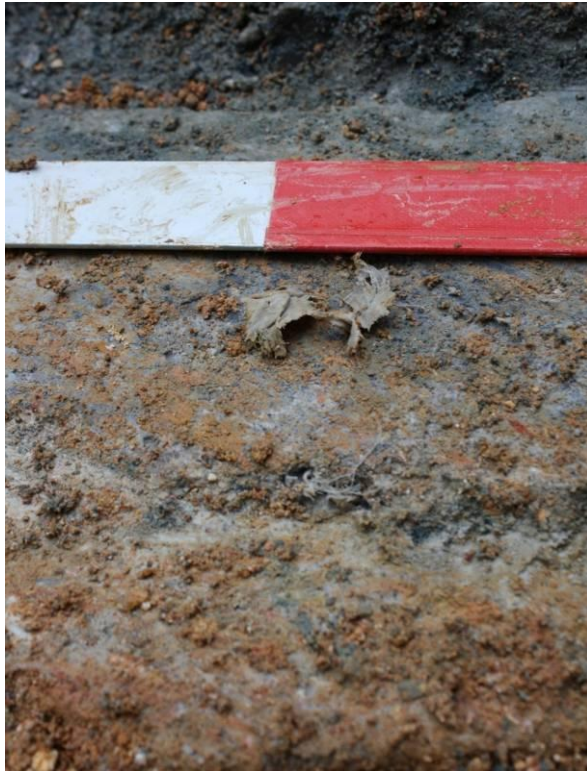
Some textile noted within the concrete infill

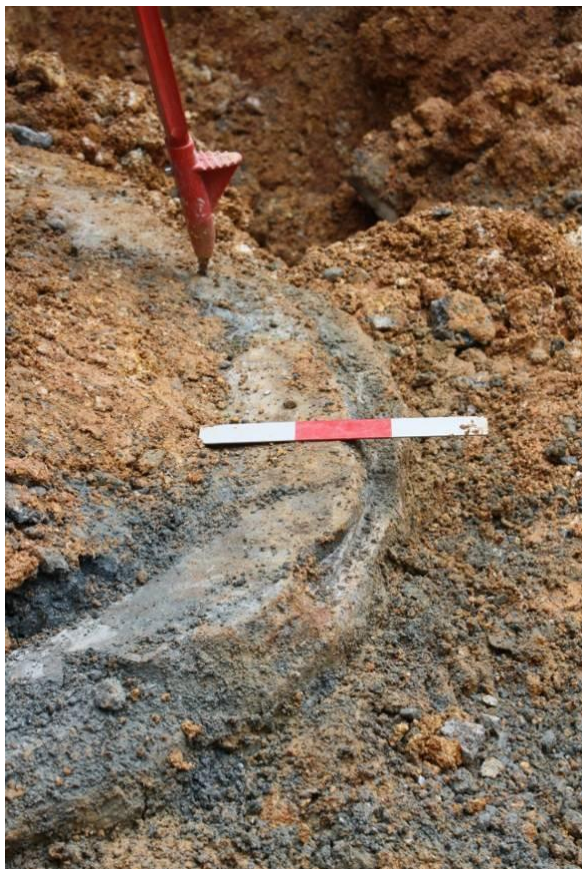
Edges noted within the concrete infill near the bottom of the 'plug'

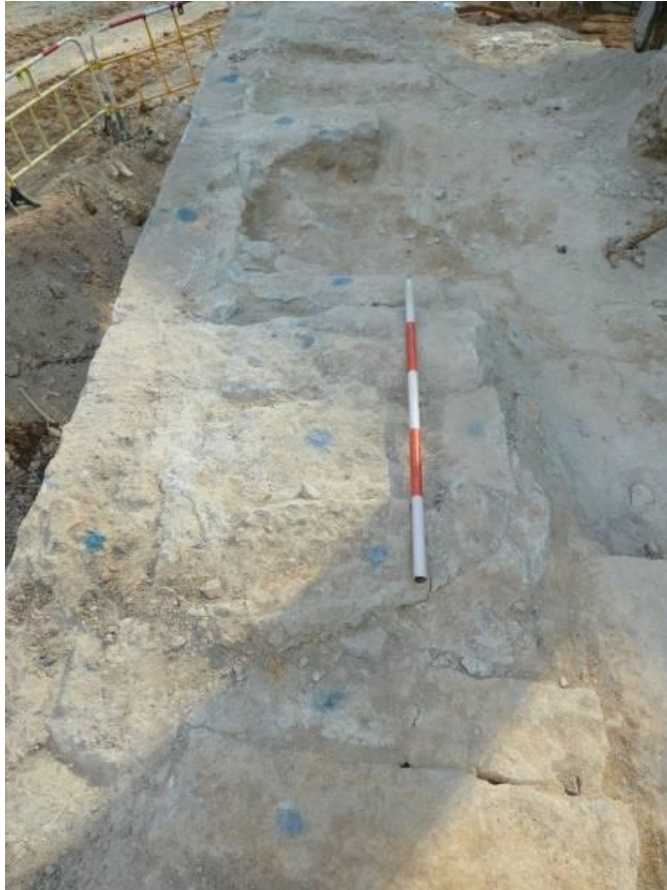
Area of concrete on top of surviving seawall fragment

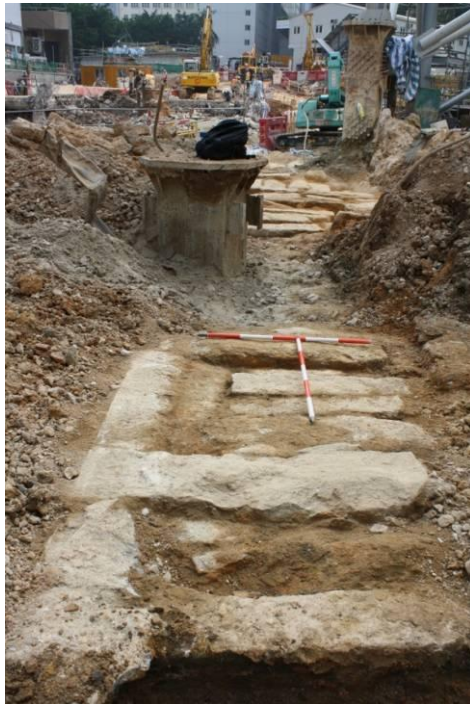
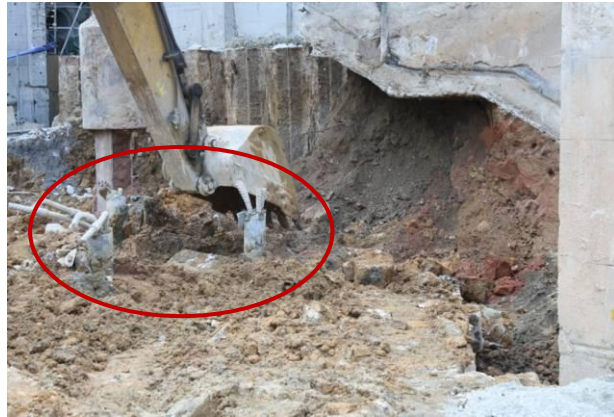
In addition to some smaller impacts which damaged the various part of the surviving seawall, a plunge column sunk as part of the current project dissected the wall fragment in two (see below left, plunge column in front of photo on left), another recently built plunge column damaged the rear of the wall (see same photo below left, plunge column in background of the photo on right), and thick rebar foundations part of the MTR Entrance 'E' (see below bottom right) affected the rear of the wall at its western end.

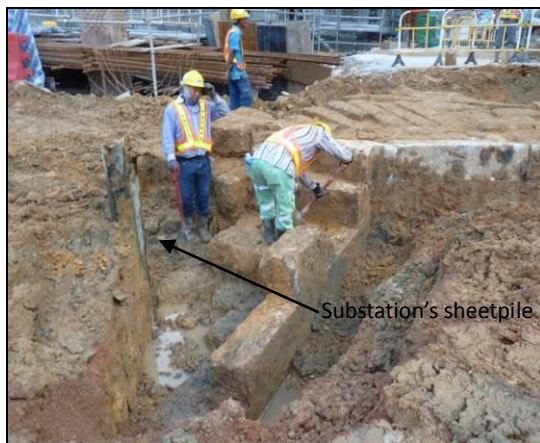
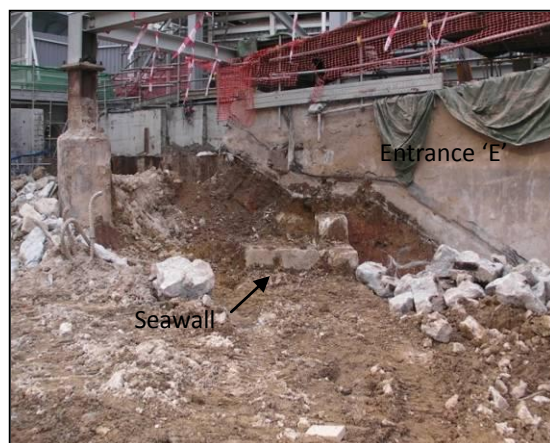
The damage to the seawall on the east was by the electric substation (see below left) and the former Admiralty Station Entrance 'E' truncated the western end (see below right).
