Antiquities and Monuments Office

Study on Old Trails in Hong Kong - Final Study Report

February 2014

Study on Old Trails in Hong Kong: *Final Study Report*

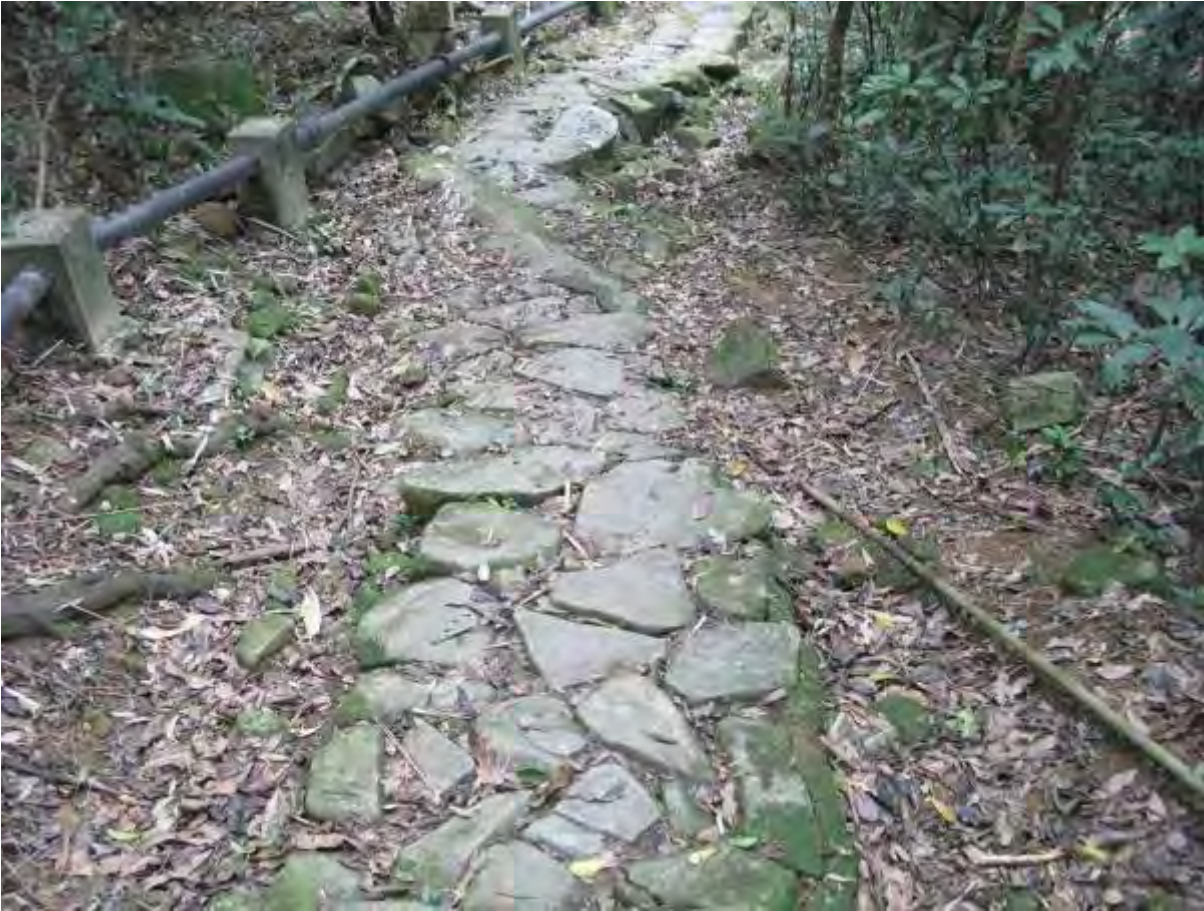
Photo Reference No.	Photographic Records
5

<p data-bbox="862 1193 1514 1230">Boulder section with intrusion of modern utilities.</p>

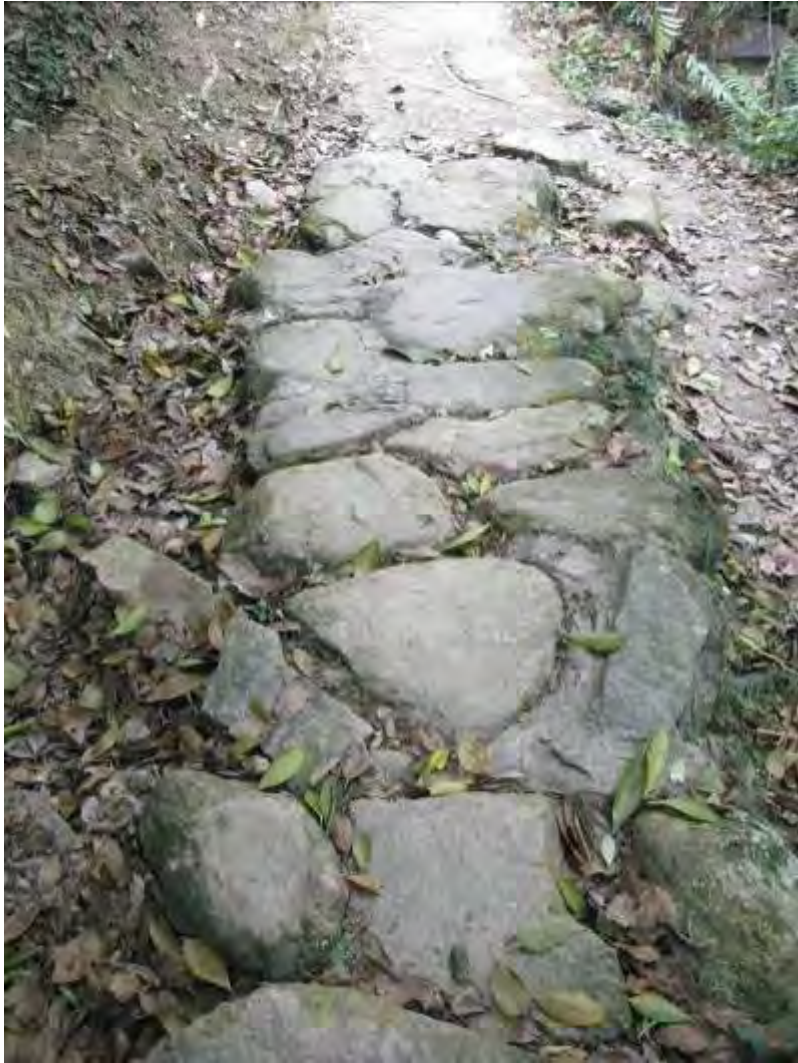
<p>Boulder steps with missing section. (View B to A)</p>

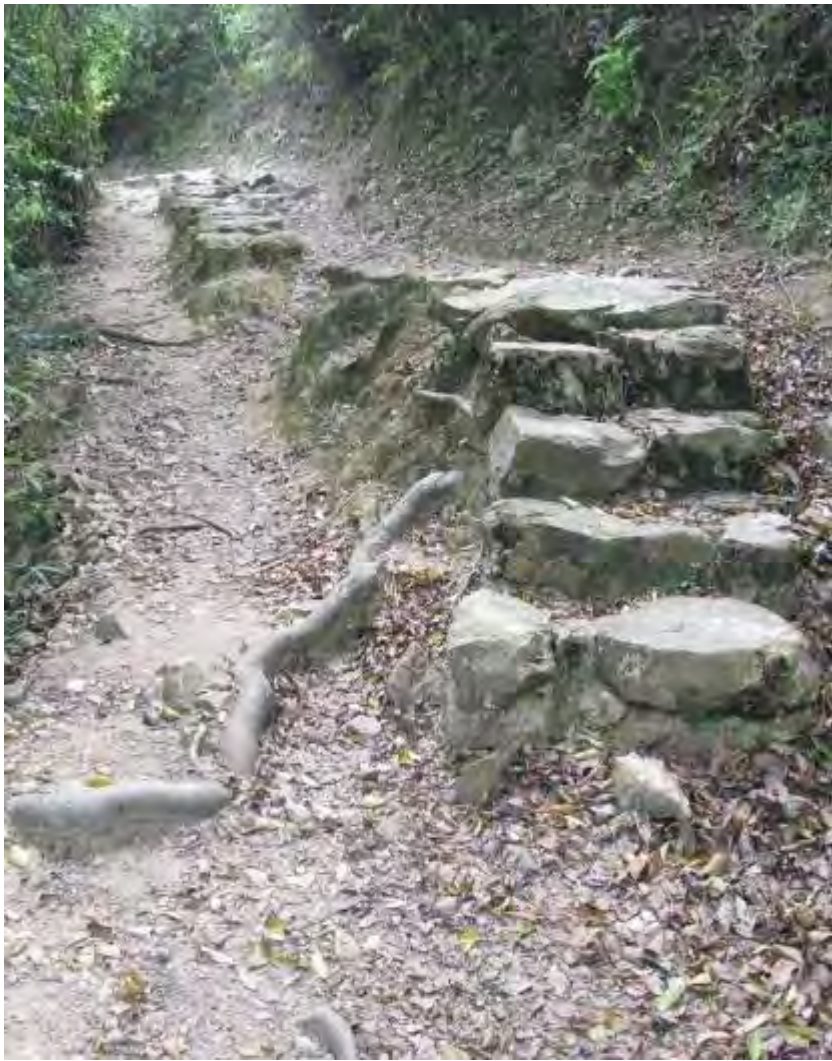
<p>Another example of mud path parallel with boulder section with missing boulders. (View A to B)</p>	16

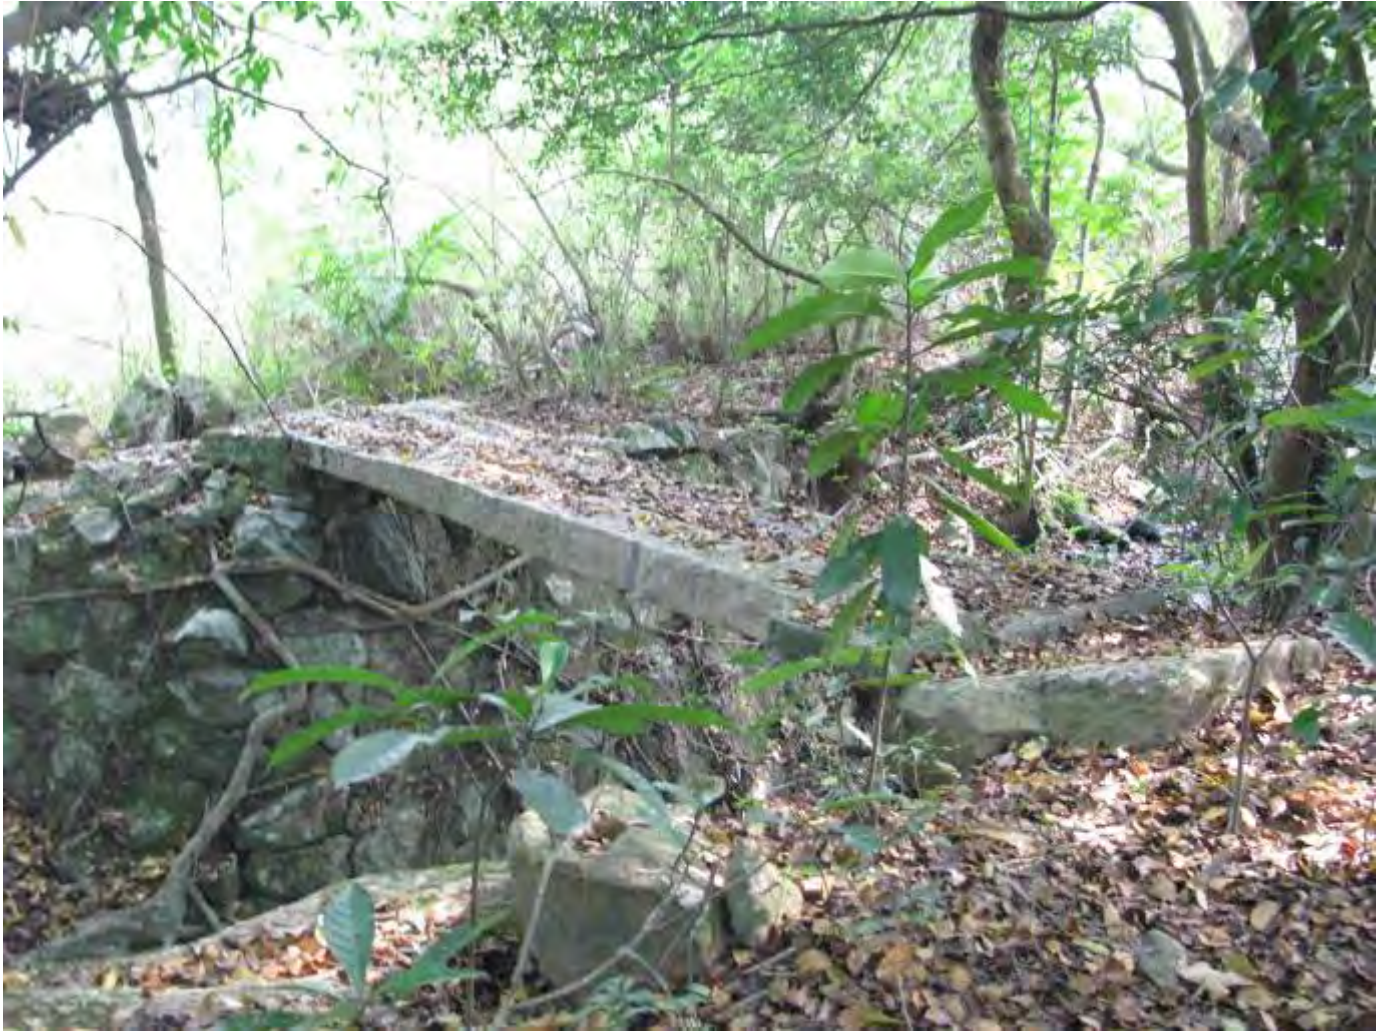
Photo Reference No.	Photographic Records
F6

<p data-bbox="293 1305 2101 1380">A granite slab bridge crossing a stream. No trace of boulder footpath can be found in this area due to abandonment of the fields and thick vegetation within the field. (View north to south)</p>

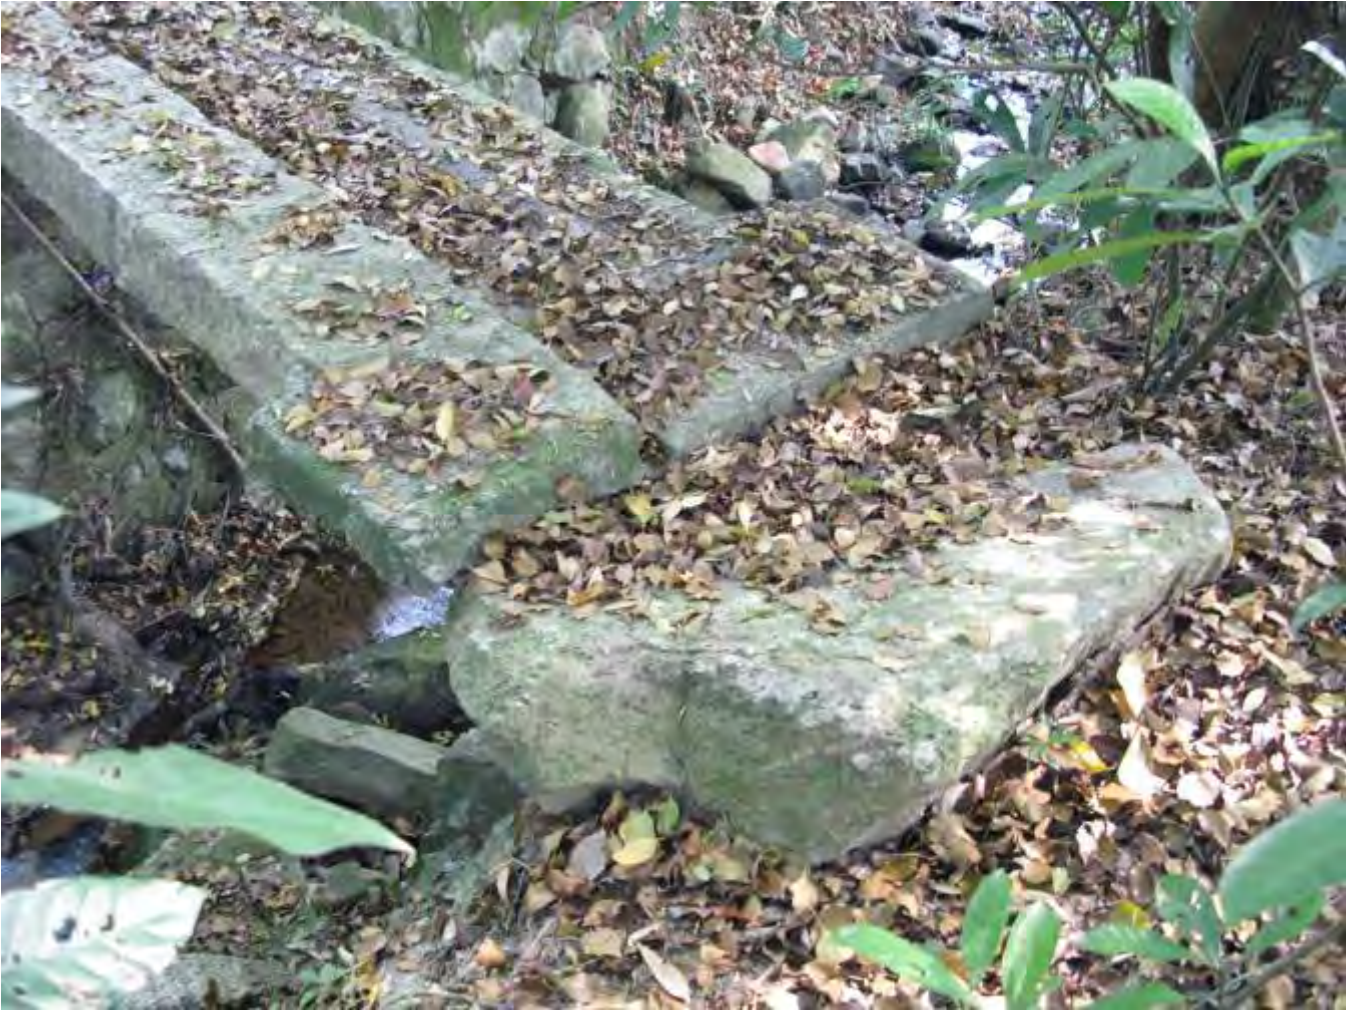
Photo Reference No.	Photographic Records
F6

<p data-bbox="808 1286 1583 1321">Close-up of west end of the bridge - appears to be unstable.</p>

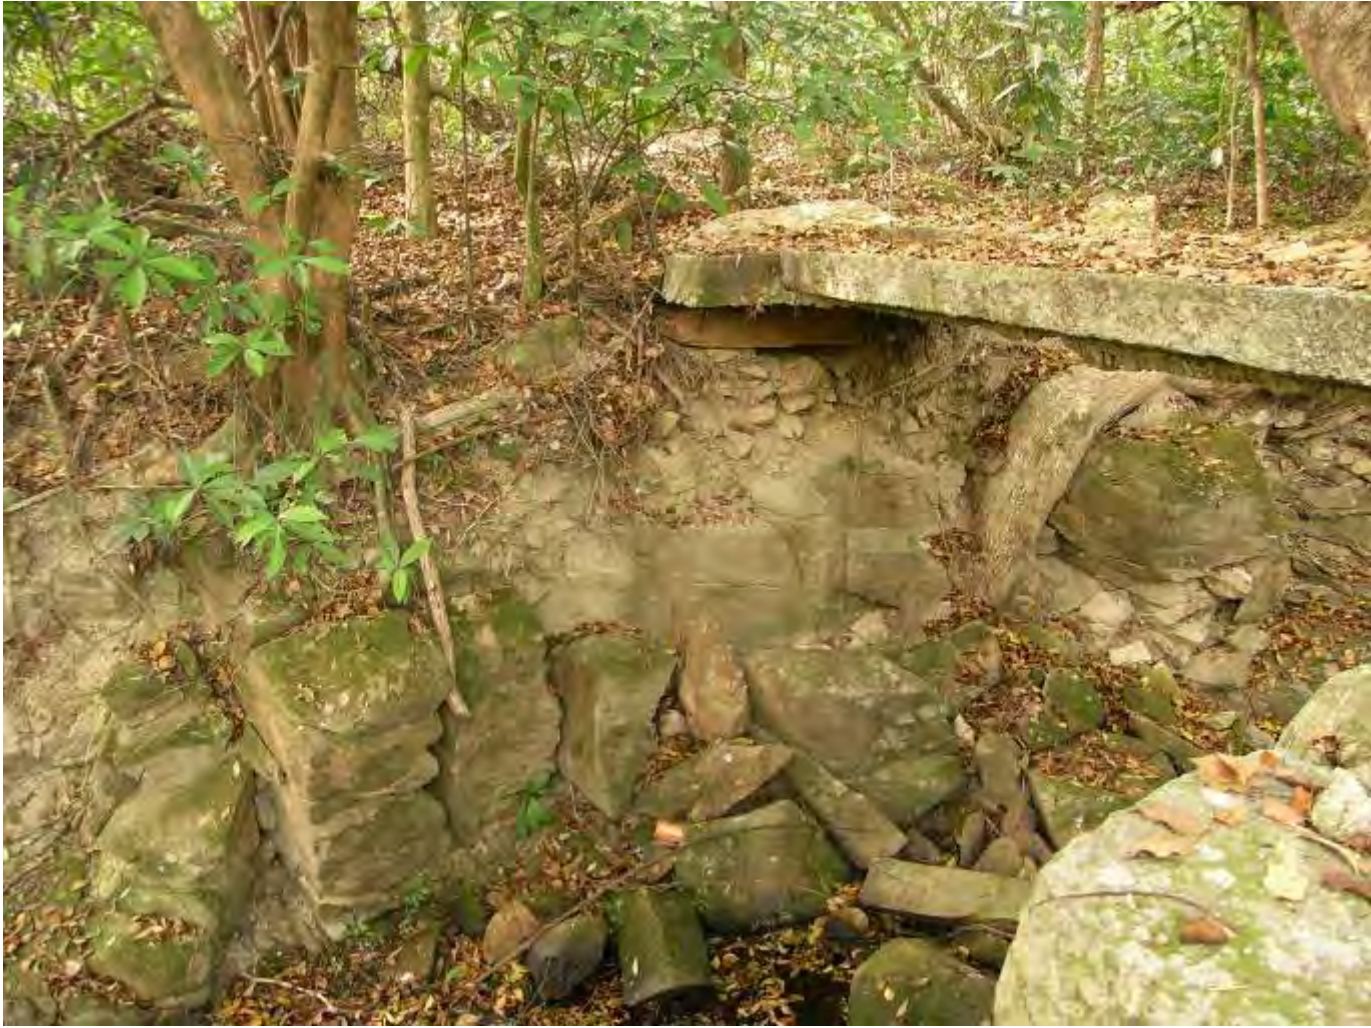
Photo Reference No.	Photographic Records
F6

<p data-bbox="392 1300 2002 1337">West end of the bridge. Note the foundation was built less organized comparing with the east end. (View south to north)</p>

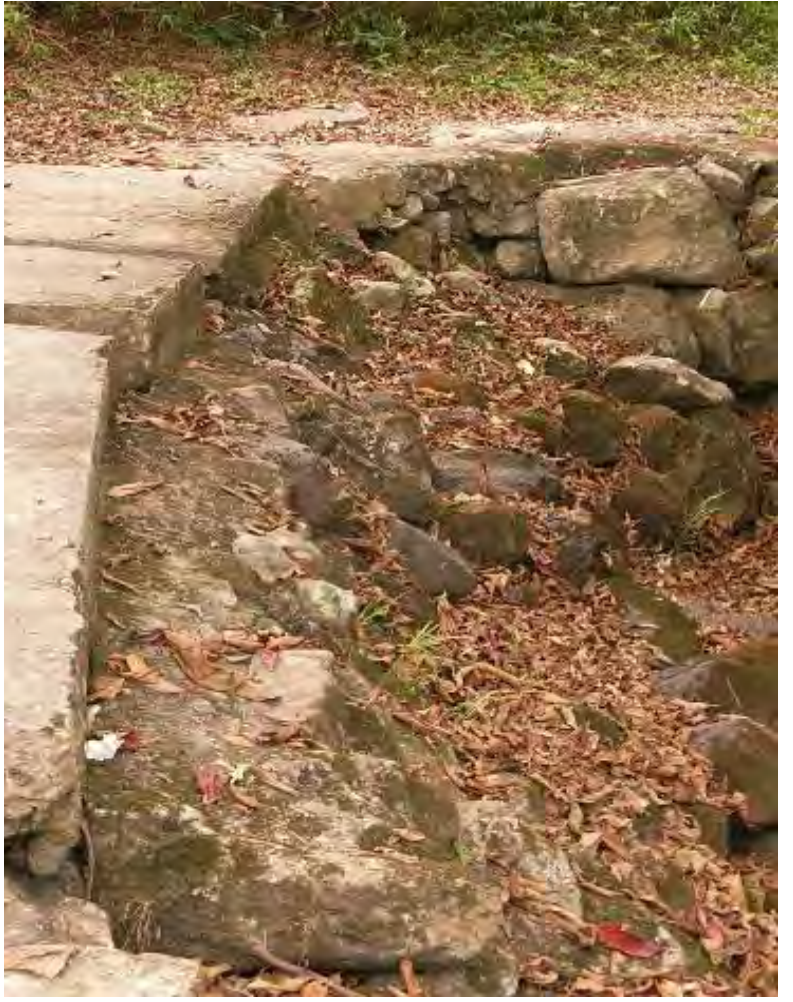
<p>Concrete covering boulders. (View C to B)</p>

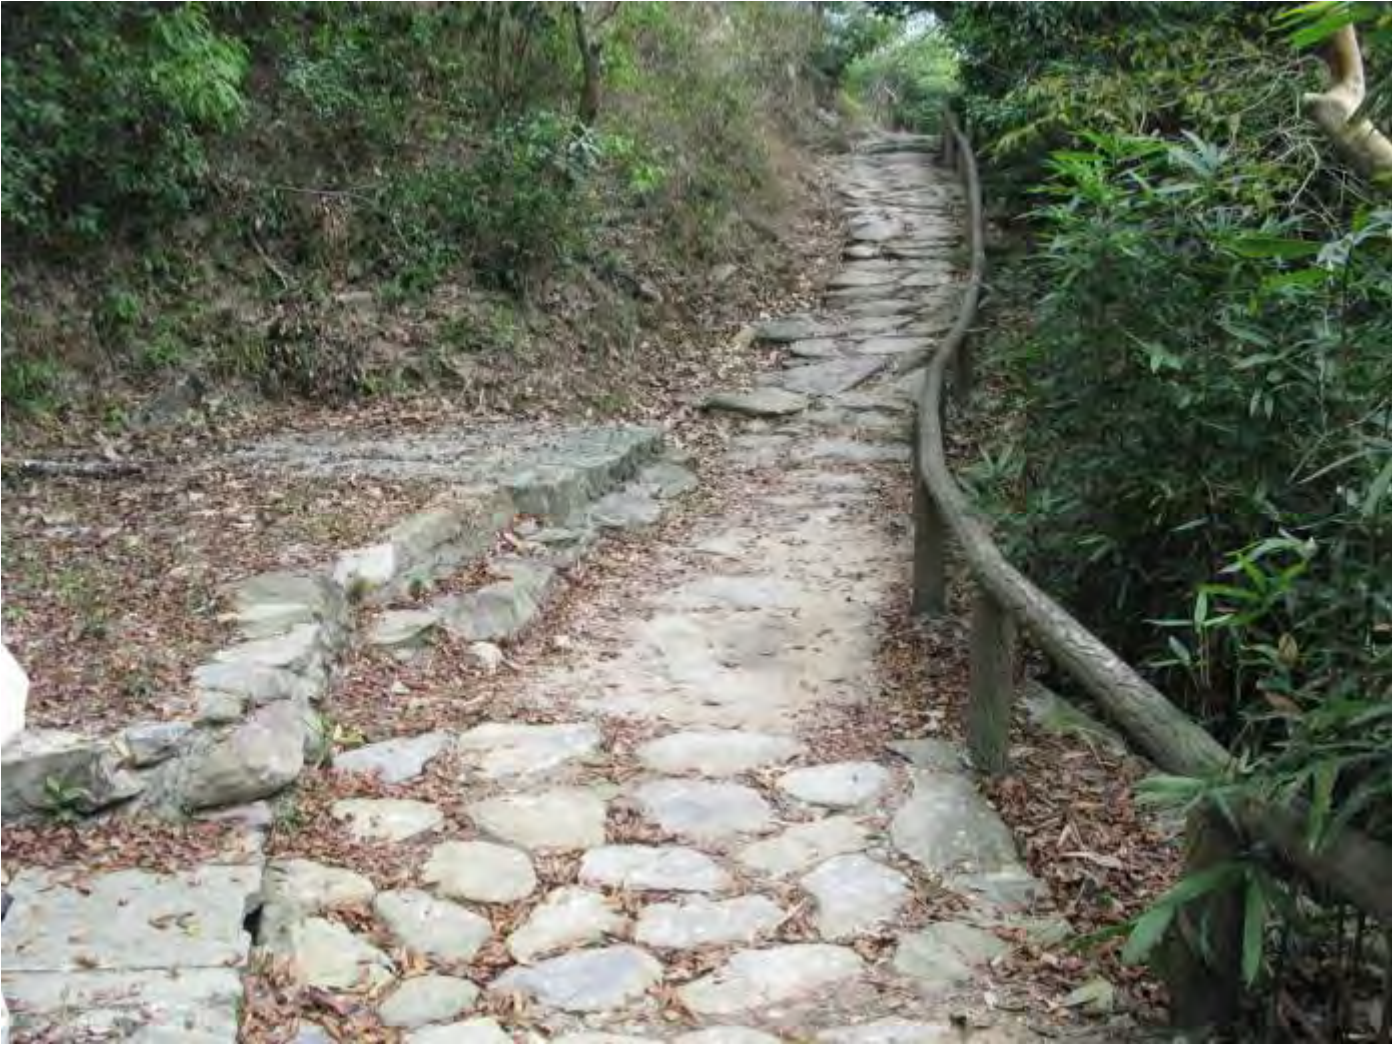
Photo Reference No.	Photographic Records
7

<p data-bbox="792 1321 1581 1358">Section reworked with missing boulders. (View from A to B)</p>

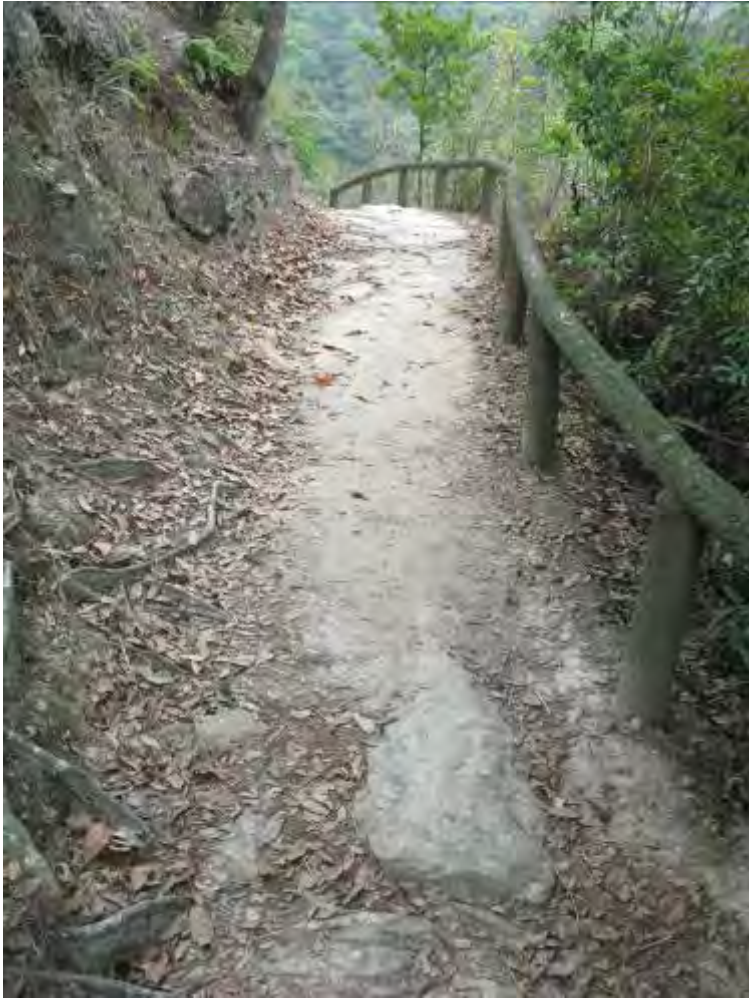
<p>Boulder section with missing boulders. (View from A to B)</p>	10

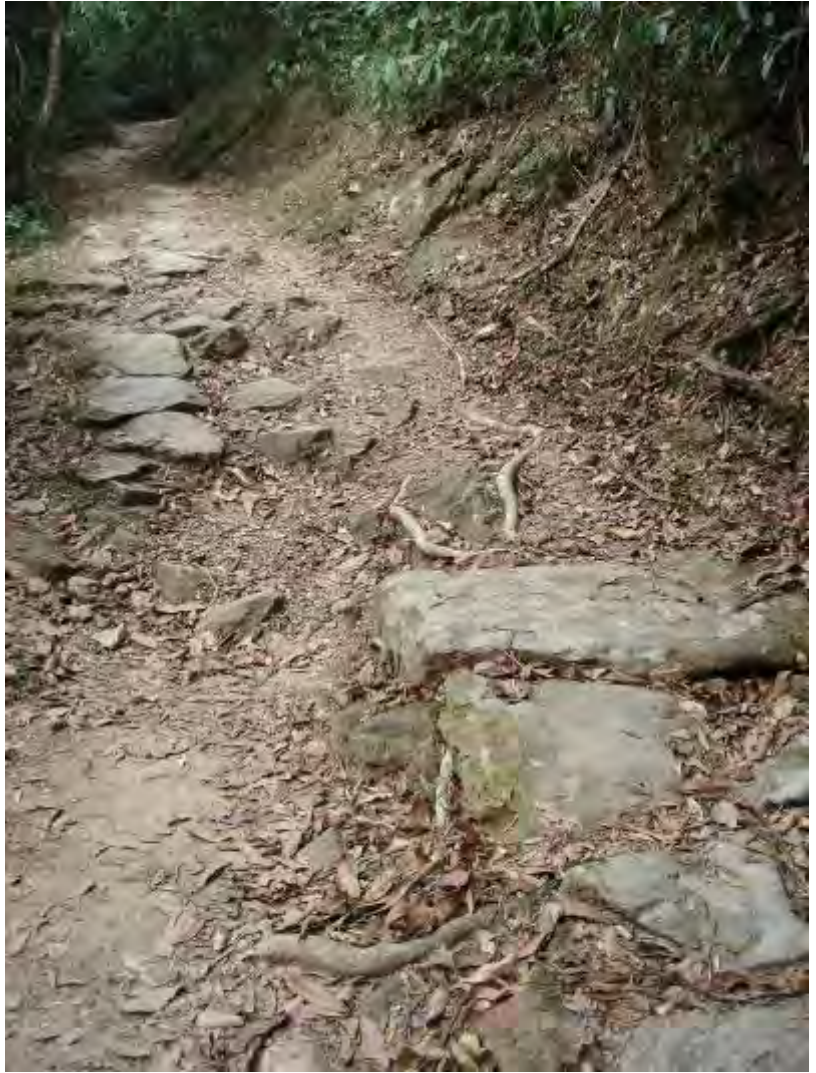
<p>Boulder section with missing boulders. (View D to C)</p>

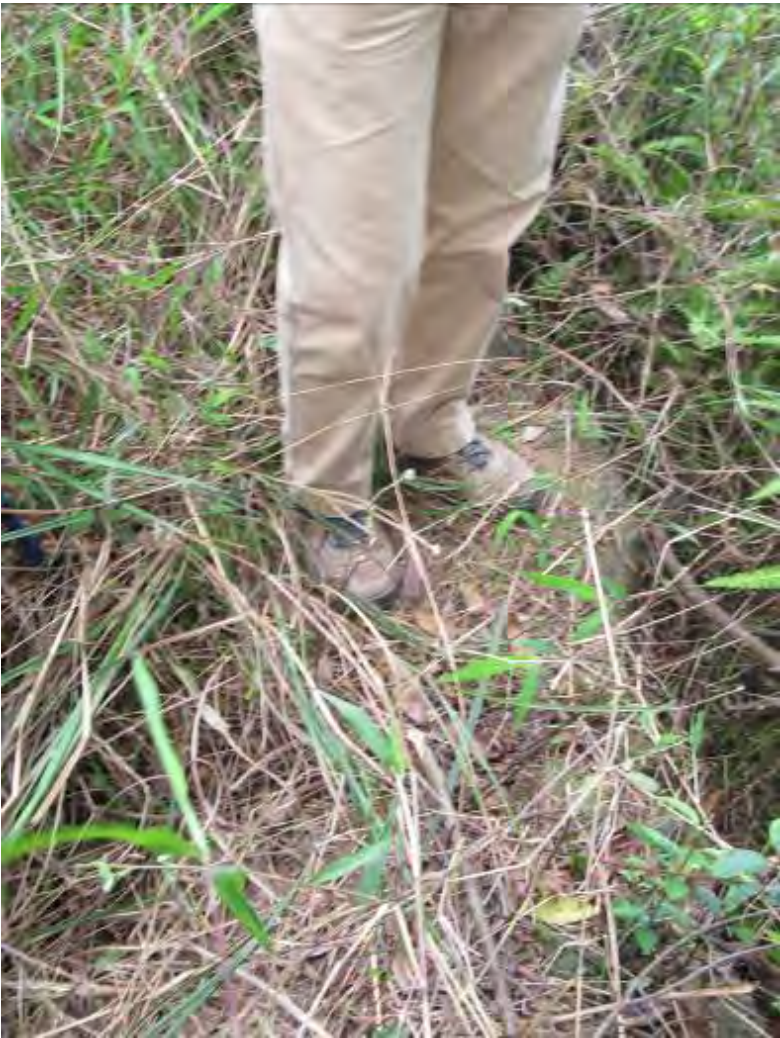
<p>Trace of boulders has been found under thick vegetation. It is not clear enough to identify it as start point of the Trackway. (View south to north)</p>

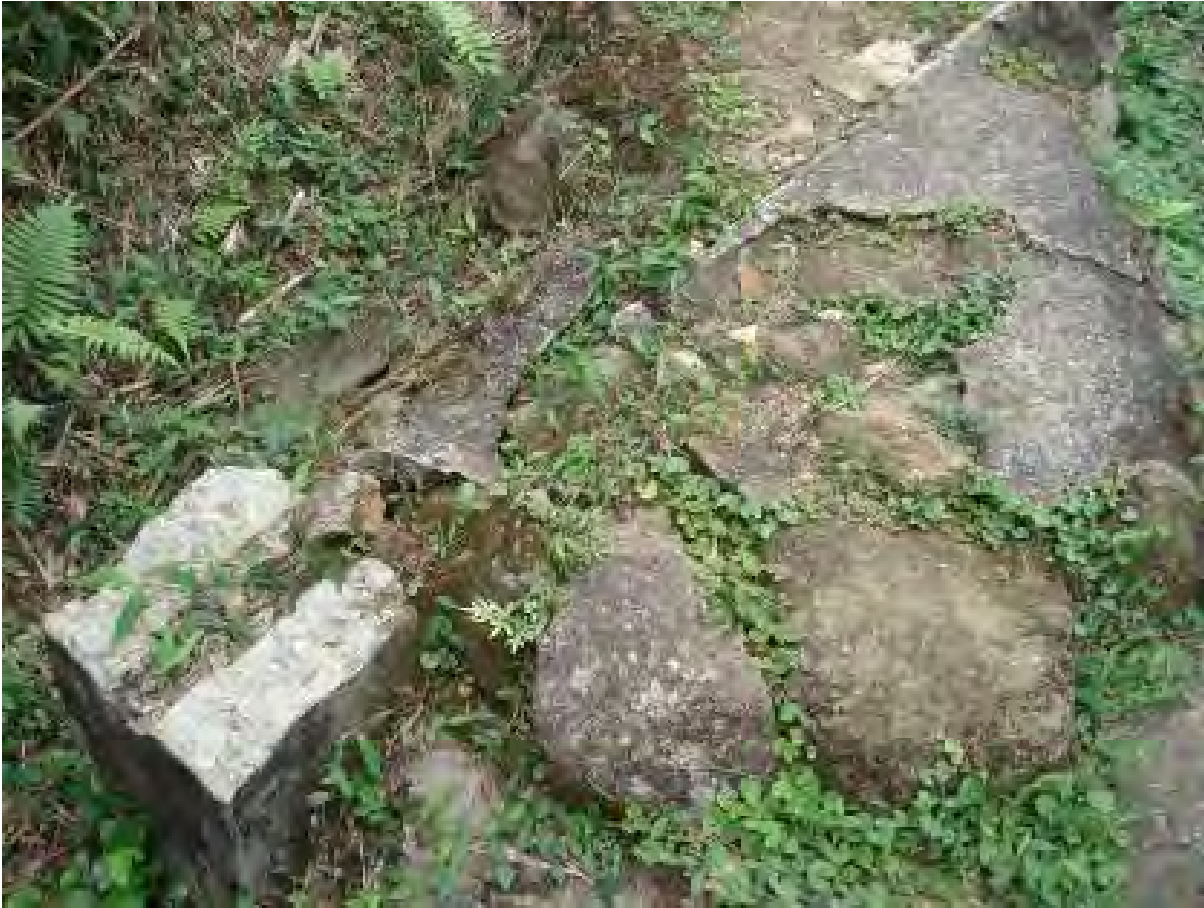
Photo Reference No.	Photographic Records
12

<p data-bbox="293 1249 2085 1326">A modern drain pipe was found at the left hand side of the boulder boulders. Modern materials such as concrete were also observed on or around the boulders. (View A to B)</p>

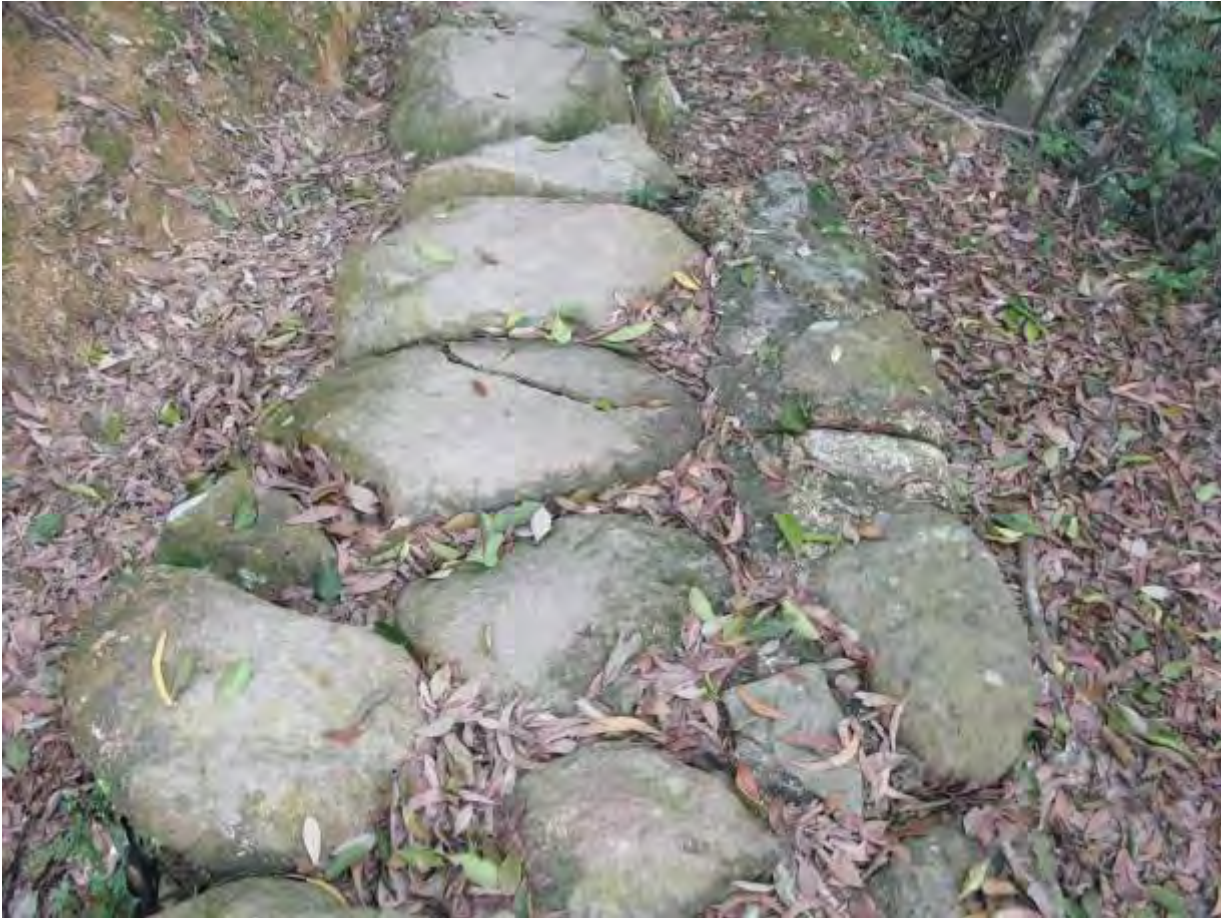
Photo Reference No.	Photographic Records
5

<p data-bbox="869 1214 1536 1249">Boulder section repaired by concrete. (View A to B)</p>

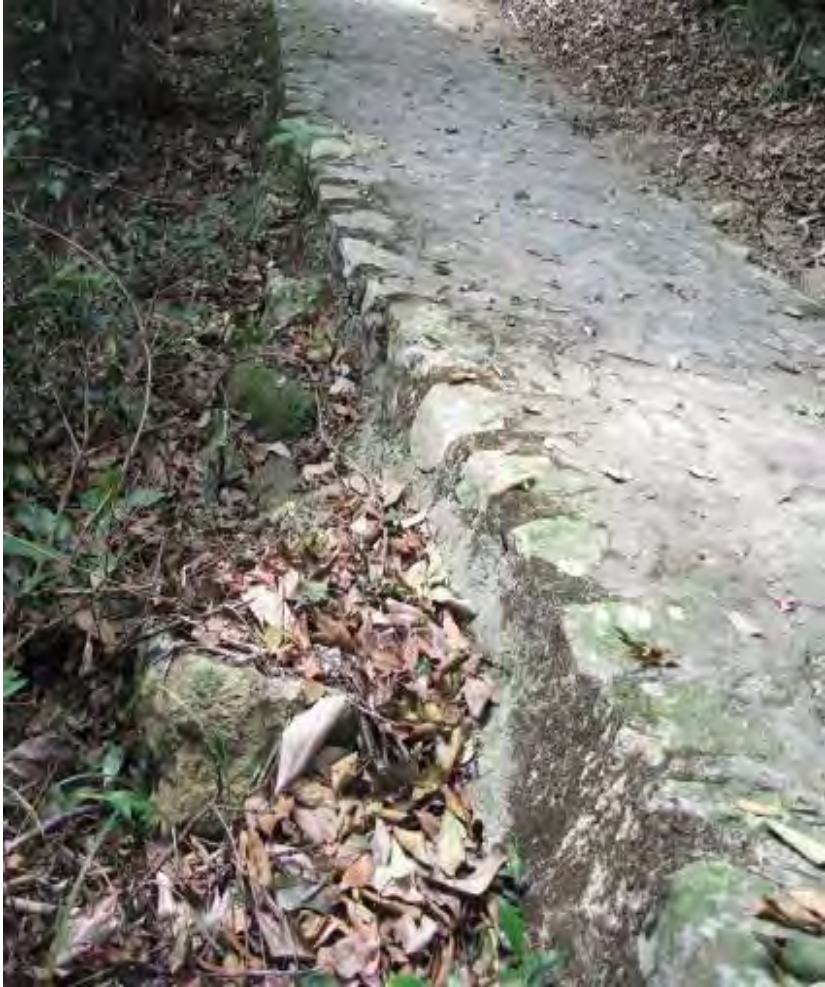
<p>Boulder of old footpath possible covered by concrete in a later period. (View A to B)</p>

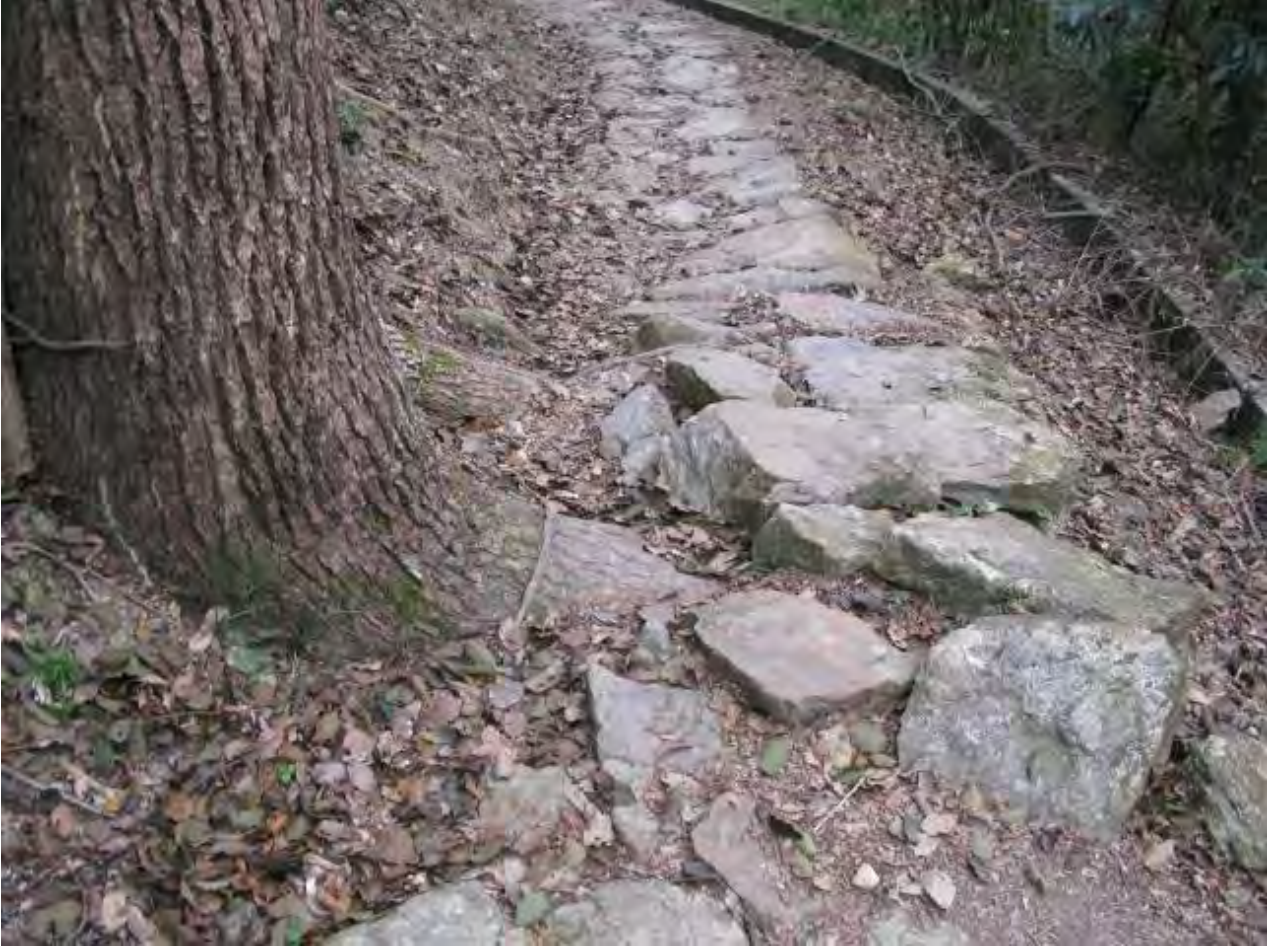
Photo Reference No.	Photographic Records
8

<p data-bbox="651 1337 1736 1374">A large tree root was observed emerging beneath the boulder section. (View B to A)</p>

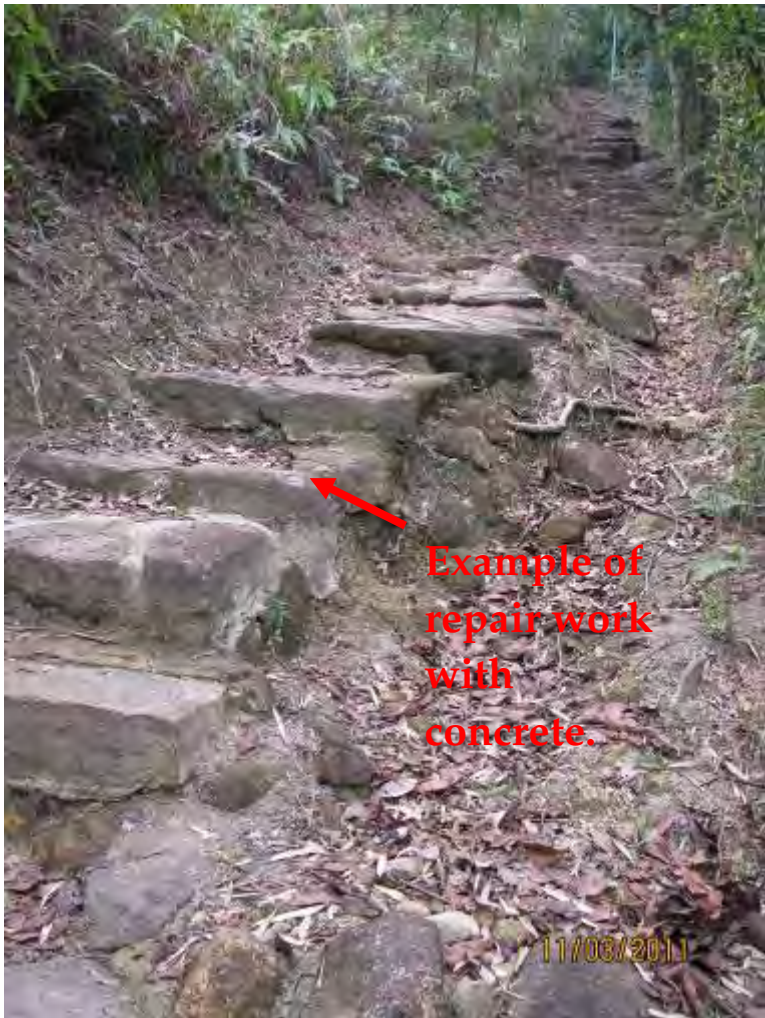
<p>Boulder section with signs of repair with in-filled concrete. (View A to B)</p>

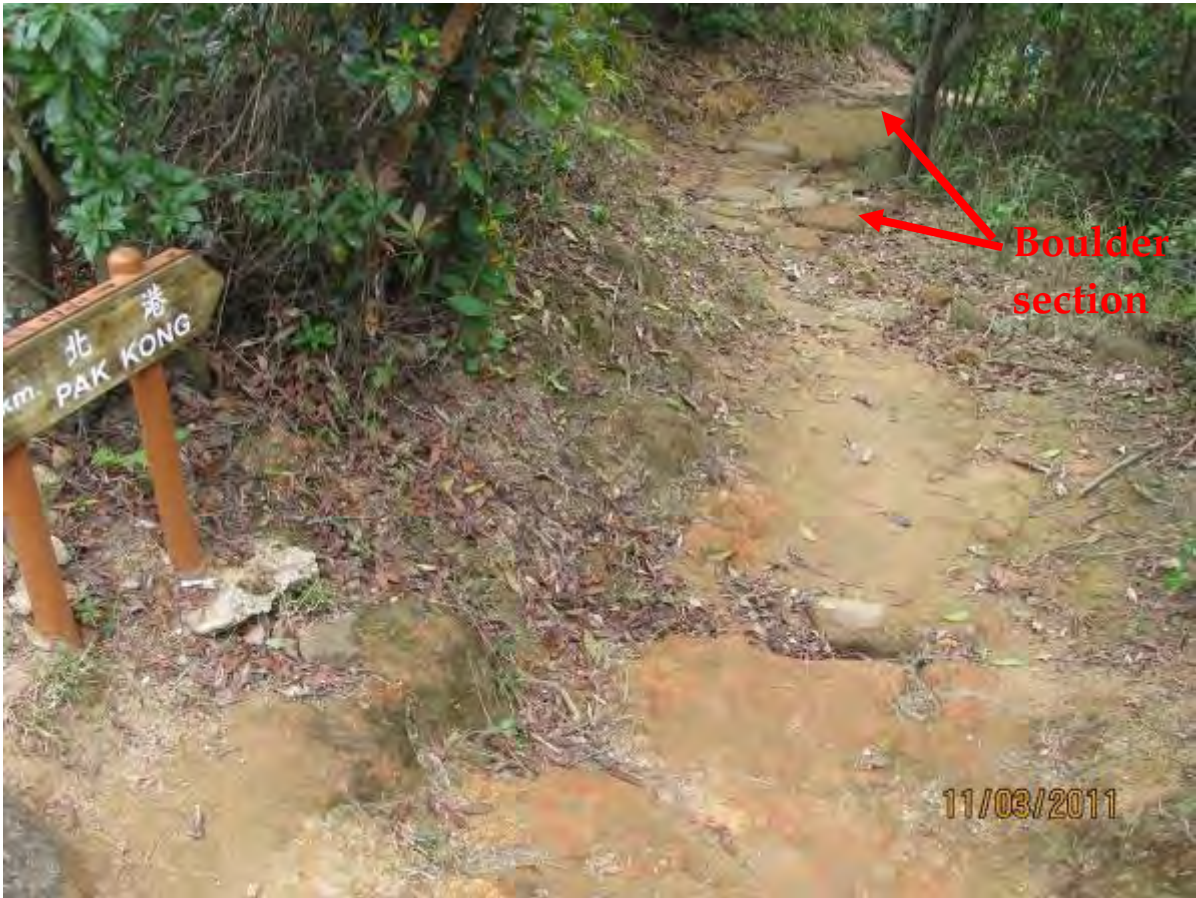
Photo Reference No.	Photographic Records
6

<p data-bbox="846 1217 1534 1252">Boulder section with missing boulders. (View B to A)</p>

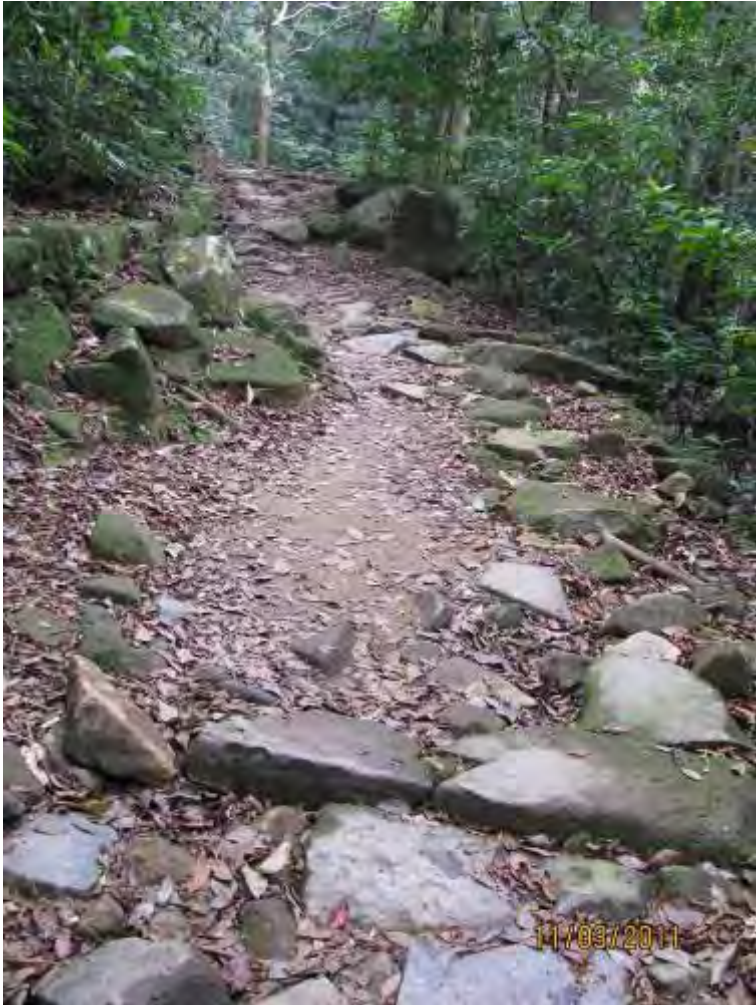
<p>Boulder section with missing boulders. (View A to B)</p>		(Blank)

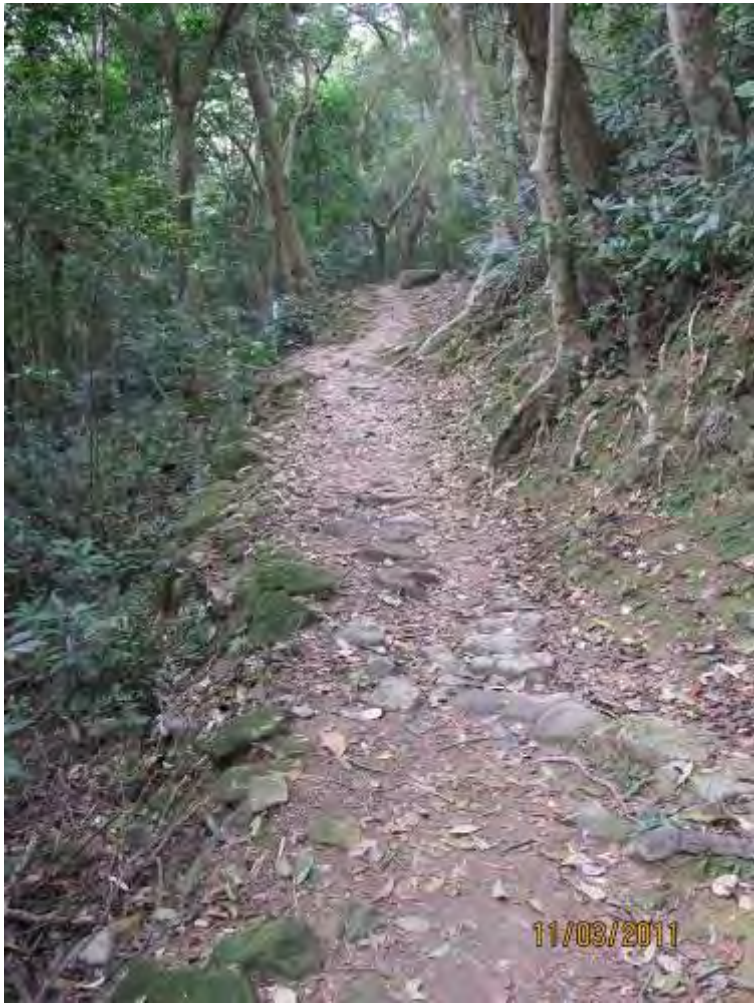
<p>Boulder section with missing boulders. (View B to A)</p>	19

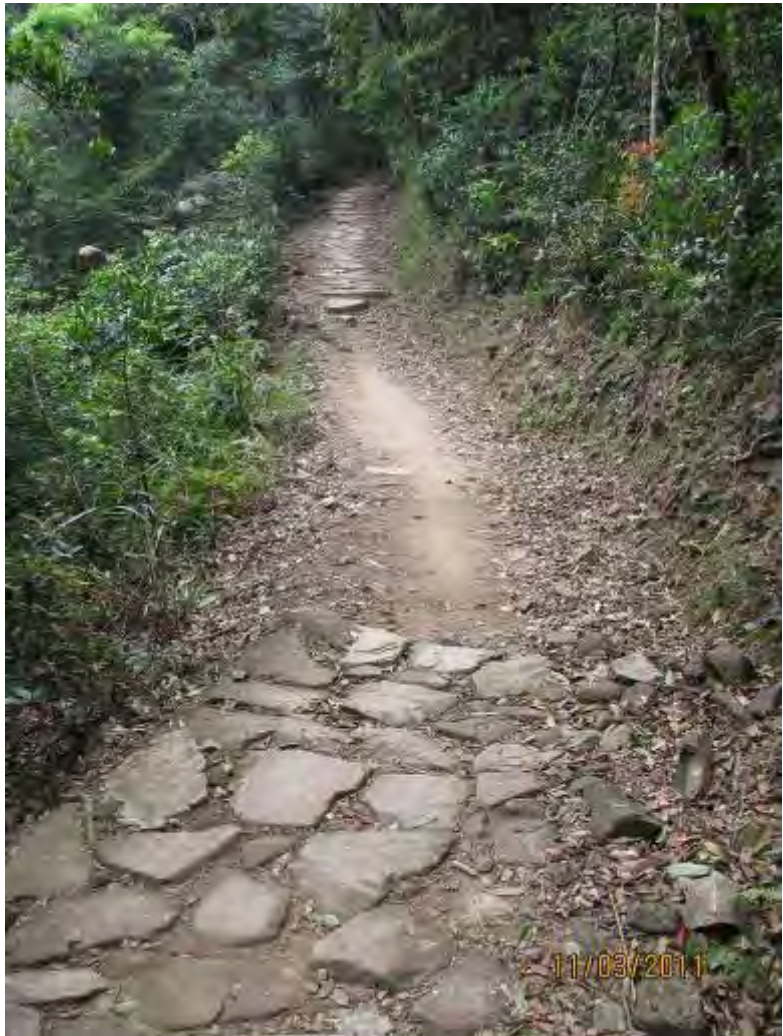
<p>Boulder section with missing boulders. (View B to A)</p>

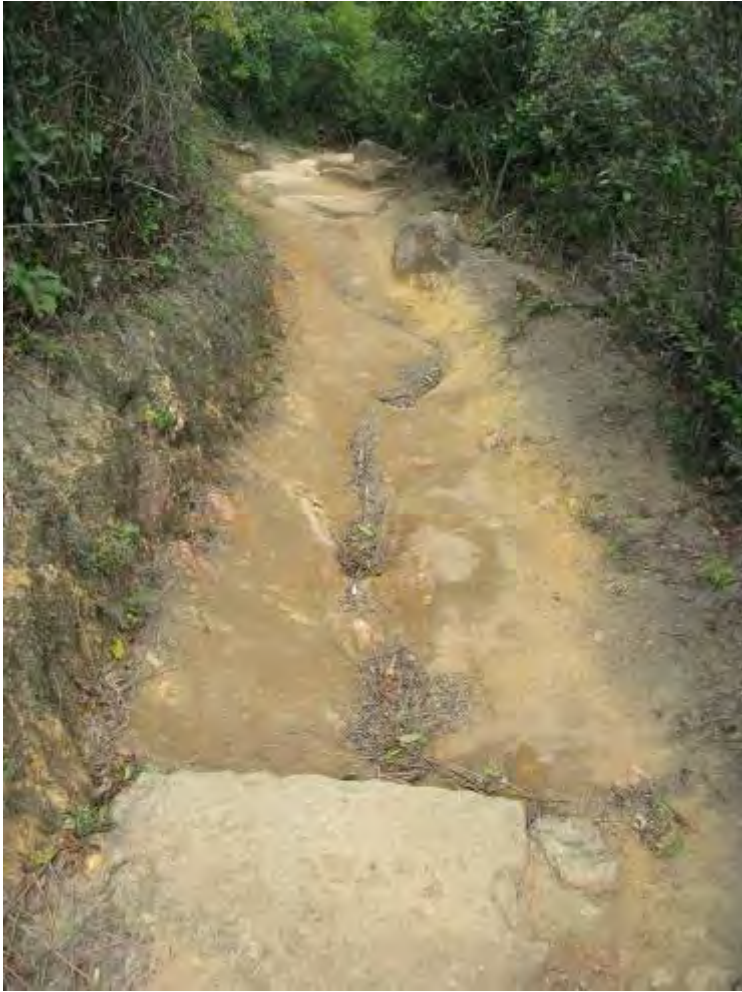
<p>Boulder section with occasional missing boulders. (View A to B)</p>	3

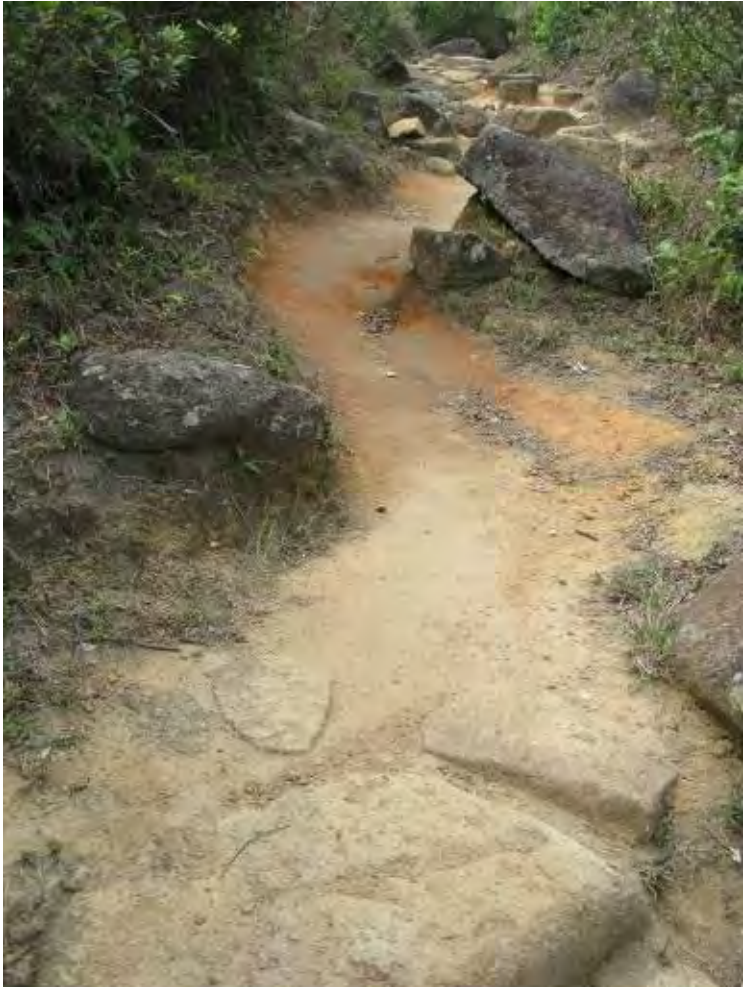
<p>Boulder section with occasional missing boulders. (View A to B)</p>

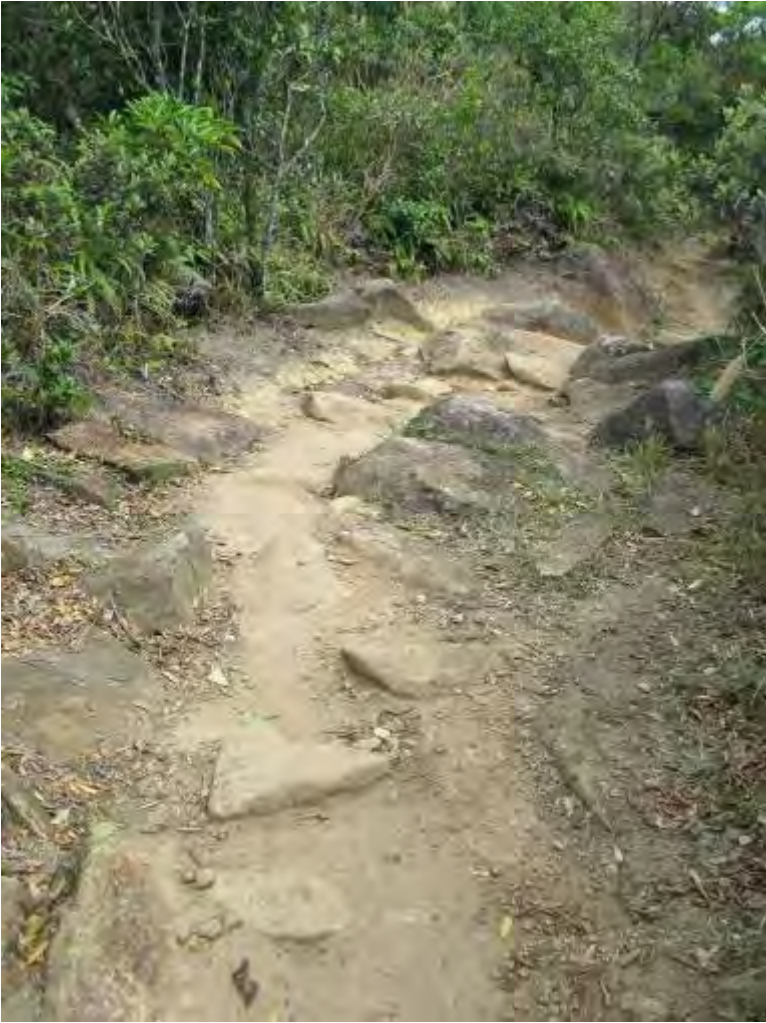
<p>Boulder section with occasional missing boulders. (View A to B)</p>	5	  <p>Boulder section with occasional missing boulders. (View A to B)</p>
