Antiquities and Monuments Office

Study on Old Trails in Hong Kong - Final Study Report

February 2014

Study on Old Trails in Hong Kong: *Final Study Report*

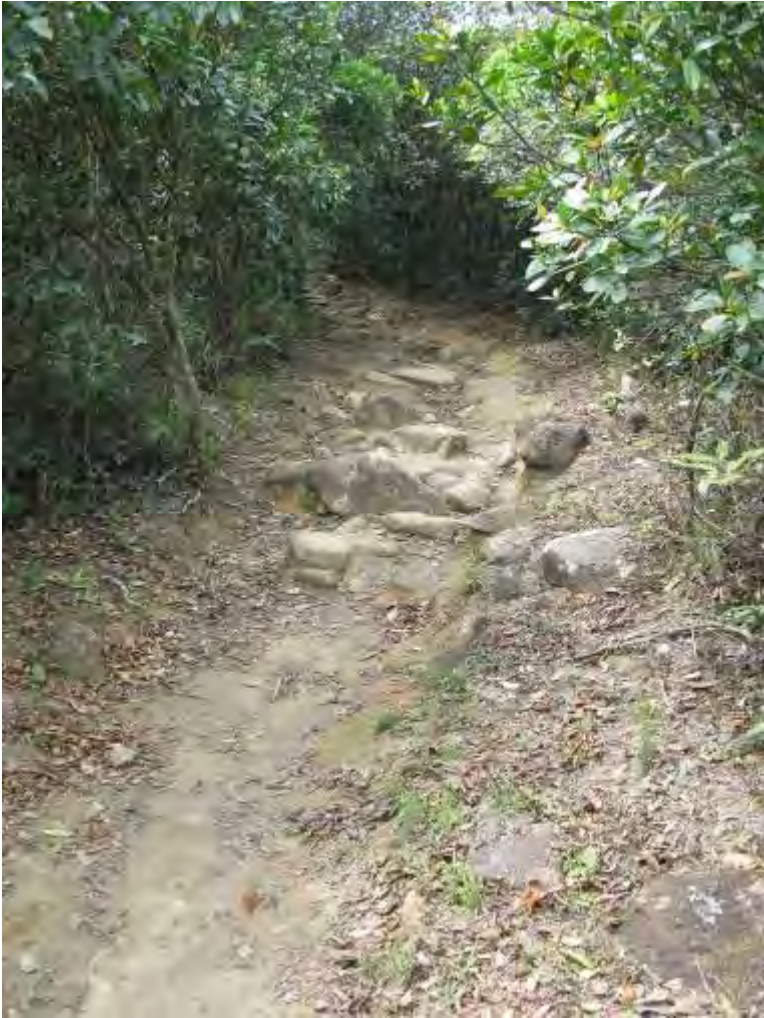
<p>Boulder section with occasional missing boulders. (View A to B)</p>	F1

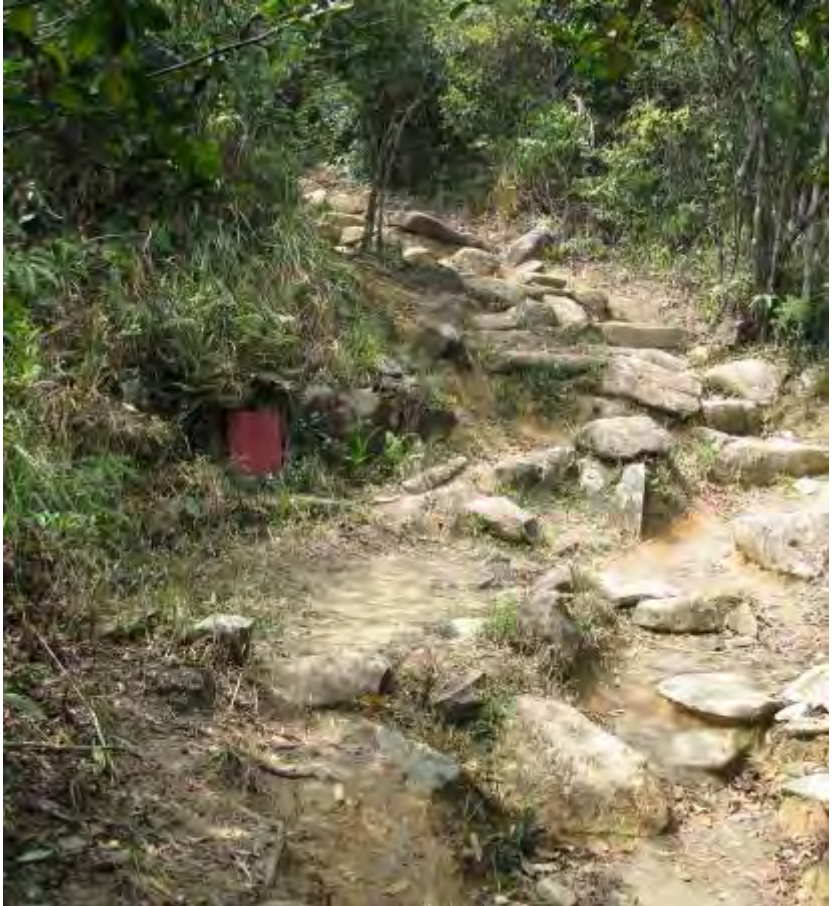
<p>A grave by the steep uphill old footpath. Large stones with flat surfaces have been arranged as steps but many have fallen due to erosion.</p>

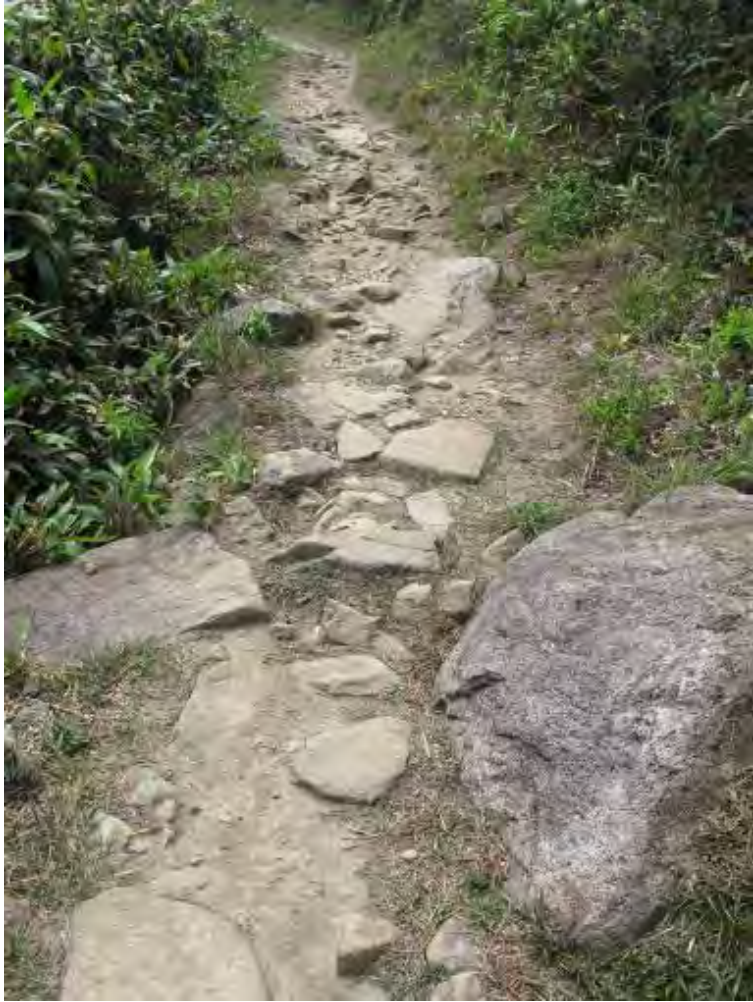
<p>A section of the boulder section eroded. (View B to E)</p>

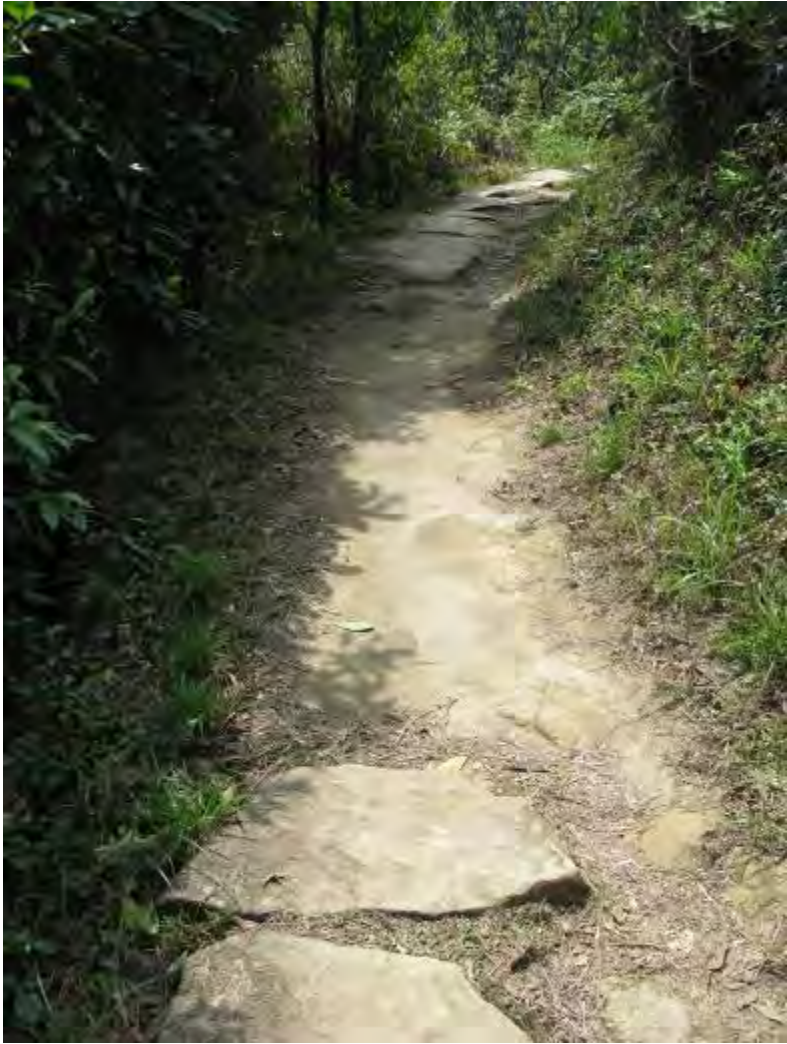
<p>Boulder section with missing boulders. (View B to E)</p>

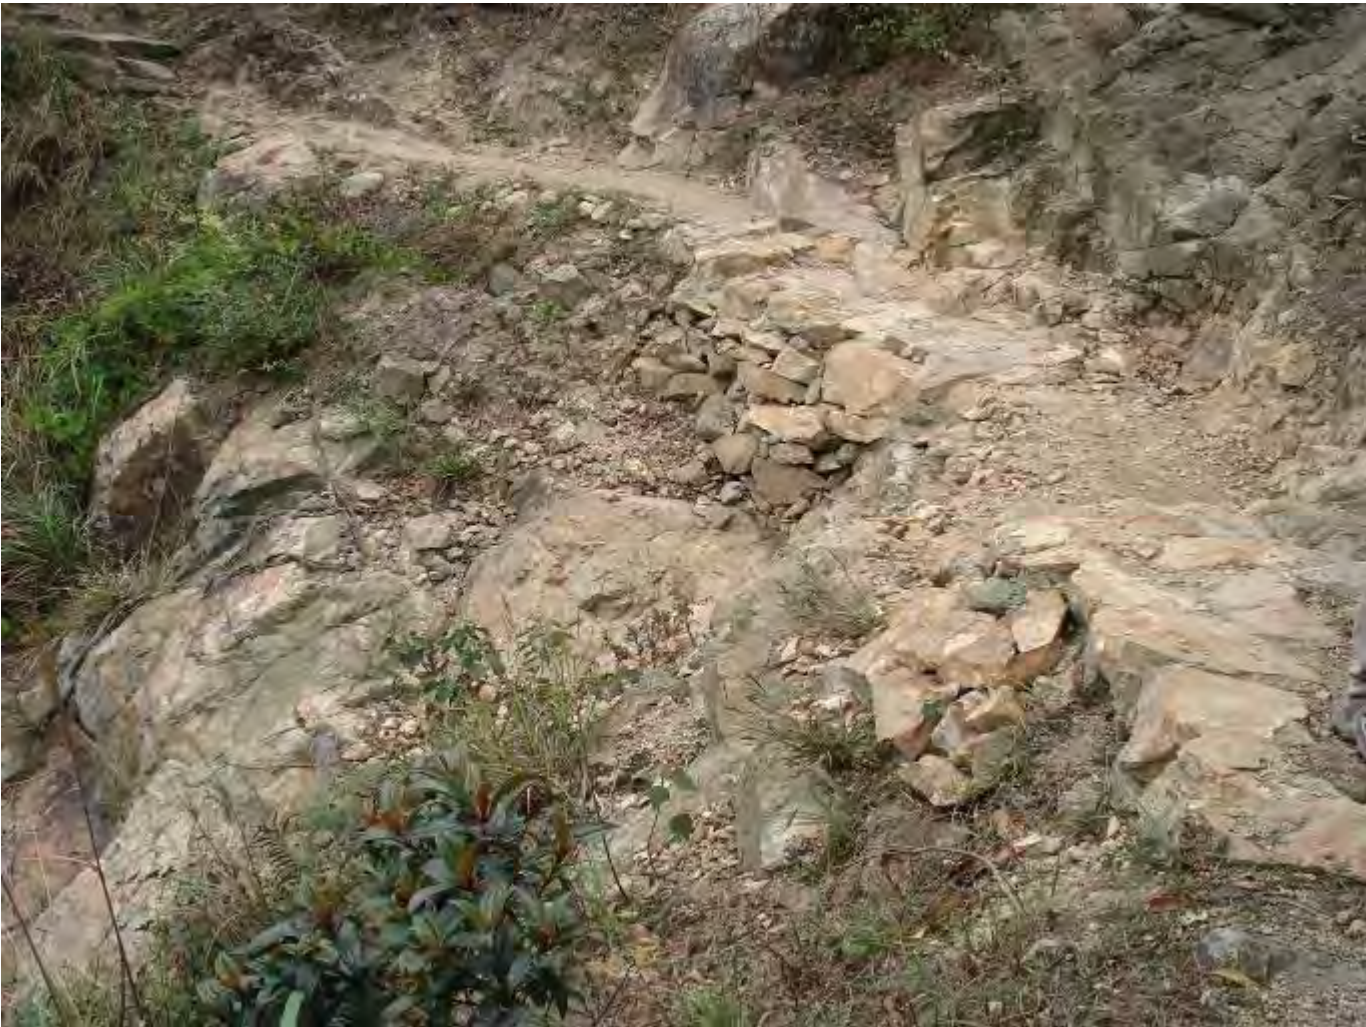
<p data-bbox="286 1299 2092 1334">Location of previous landslide from the opposite angle; The later-added concrete can be seen clearly in between the boulders. (View B to A)</p>
