Heritage Impact Assessment for Conversion of
the Former Clubhouse of Royal Hong Kong Yacht Club
at 12 Oil Street, North Point
into a Community and Public Art Centre - Artspace @ Oil Street

Volume II - Heritage Impact Assessment
September 2011

**HERITAGE IMPACT ASSESSMENT
FOR THE FORMER CLUBHOUSE OF ROYAL HONG KONG YACHT
CLUB AT 12, OIL STREET, NORTH POINT, INTO A COMMUNITY
AND PUBLIC ART CENTRE – ARTSPACE @ OIL STREET
VOL. II – HERITAGE IMPACT ASSESSMENT**

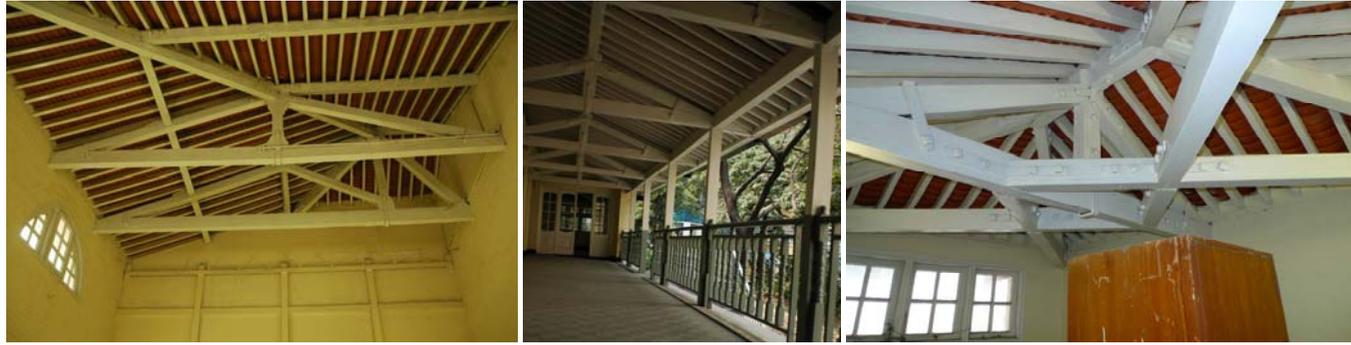
<div style="border: 1px solid red; padding: 5px; display: inline-block;"> <p>Timber columns and timber roof structures supporting the roofs</p> </div>

⁸ According to the structural appraisal and loading assessment, it is advised by Structural Engineer that the existing roof timber trusses, masonry walls and foundations are all structurally adequate and the corresponding wind load. Structural strengthening works are not required.

C Fire resisting construction to the elements of construction (Cont'd)						
Item	Assessment items / Proposed Works	Fabric affected	Level of Significance	Reasons for changes/ Deficiency	Mitigation measures	Overall Adverse Impact Level
C-02	<p>Timber structure – roof truss and columns supporting the roof</p> <p>Application of fire retardant paint to existing roof structures and columns and the roof structures will be exposed.</p> <ul style="list-style-type: none"> • Main Building • Annex A • Annex B 	Timber roof truss and columns	High	<ul style="list-style-type: none"> • Existing element of construction are not fire rated • Upgrading the fire safety for new uses 	<ul style="list-style-type: none"> • Expose the existing timber structures as far as practicable, which form significant architectural character of the interior space. • Investigate fire engineering approach and other compensatory measures if possible, such as installation of fire services installation like fast response sprinkler head, etc. • Carry out survey to investigate the structural condition of existing structure, and repair if necessary⁸. • Carry out mock up to ensure the compatibility of the proposed fire retardant paint with other anti-termite or protective treatment of timber. 	Low

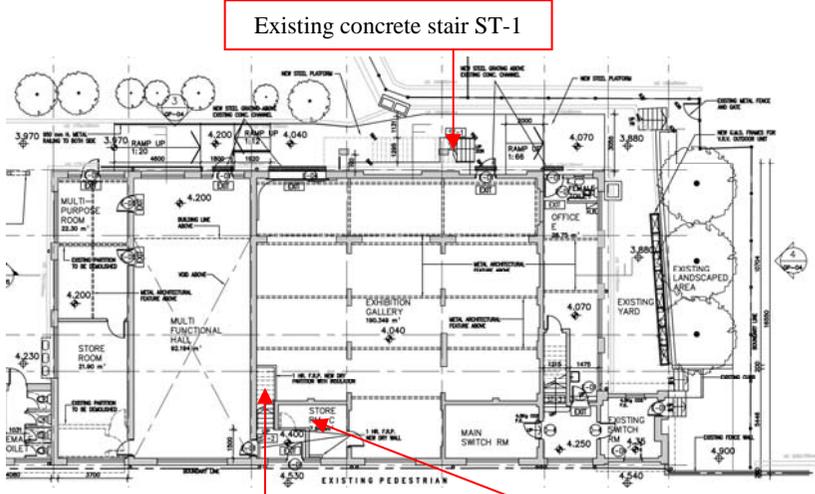
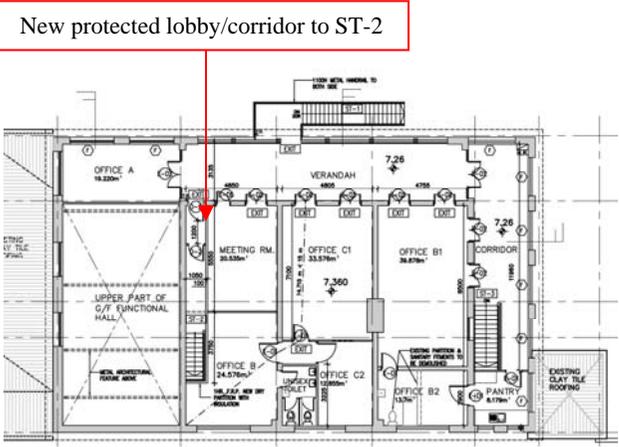
D-01

Existing timber stair ST-2

These internal windows and door on G/F of ST-2 are later alteration and addition which can be removed or blocked up

External windows shall be kept intact as far as practicable.

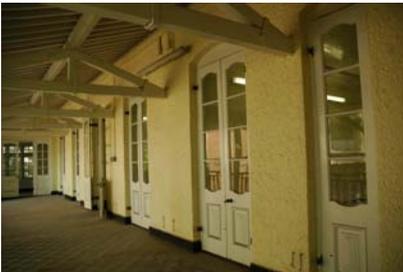
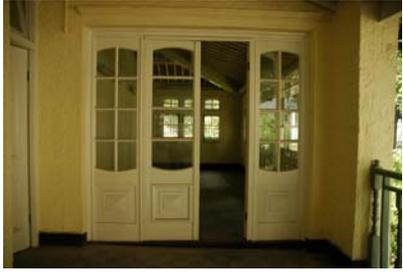
<p>Existing doors along verandah</p>

High	Existing doors are not fire-rated	<ul style="list-style-type: none"> • Existing doors along verandah shall be preserved as far as practicable. Total replacement of verandah doors would affect the elevation. • Subject to the approval of the fire engineering study for the means of escape strategy, i.e. the route of fire escape and the provision of necessary compensatory measures such as installation of fast response sprinkler along verandah shall be considered in order to minimize the impact on existing windows/doors along verandah. 	Low

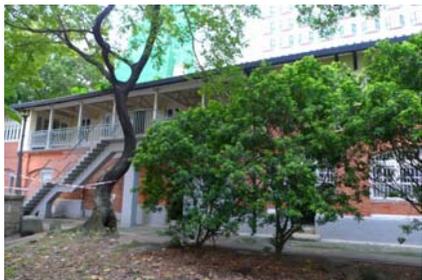
Existing metal balustrades	Neutral	Existing balustrades do not comply with the design requirements, which is without the 150mm solid base and lower than the required 1100mm safety height	<ul style="list-style-type: none"> The design and construction of the replaced metal balustrades, can be of the same appearance of existing, or it shall be discernible from the original historic fabric. They shall be understated in character to minimize the visual impact without overruling the elevation of the historic buildings. 	Low

E Others upgrading works for statutory requirements (Cont'd)						
Item	Assessment items / Proposed Works	Fabric affected	Level of Significance	Reasons for changes/ Deficiency	Mitigation measures	Overall Adverse Impact Level
Main Building						
E-03	<p>Replacement of existing metal balustrades of the concrete stair and the verandah</p> <p>Existing metal balustrades will be replaced by new metal balustrades</p>

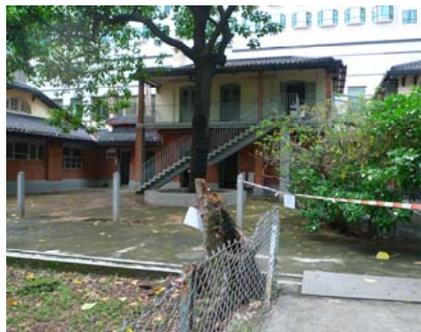
Existing metal balustrades	Neutral	Existing balustrades do not comply with the design requirements, which is without the 150mm solid base and lower than the required 1100mm safety height	<ul style="list-style-type: none"> The design and construction of the replaced metal balustrades, can be of the same appearance of existing, or it shall be discernible from the original historic fabric. They shall be understated in character to minimize the visual impact without overruling the elevation of the historic buildings. The construction and installation of the replaced balustrades shall minimize the damage to existing brick columns. The existing floor without authentic floor tiles finishes shall be made good after the replacement. 	Low

E Others upgrading works for statutory requirements (Cont'd)						
Item	Assessment items / Proposed Works	Fabric affected	Level of Significance	Reasons for changes/ Deficiency	Mitigation measures	Overall Adverse Impact Level
Annex A						
E-04	<p>Replacement of existing metal balustrades at Annex A</p> <p>Existing metal balustrades will be replaced by new metal balustrades</p>

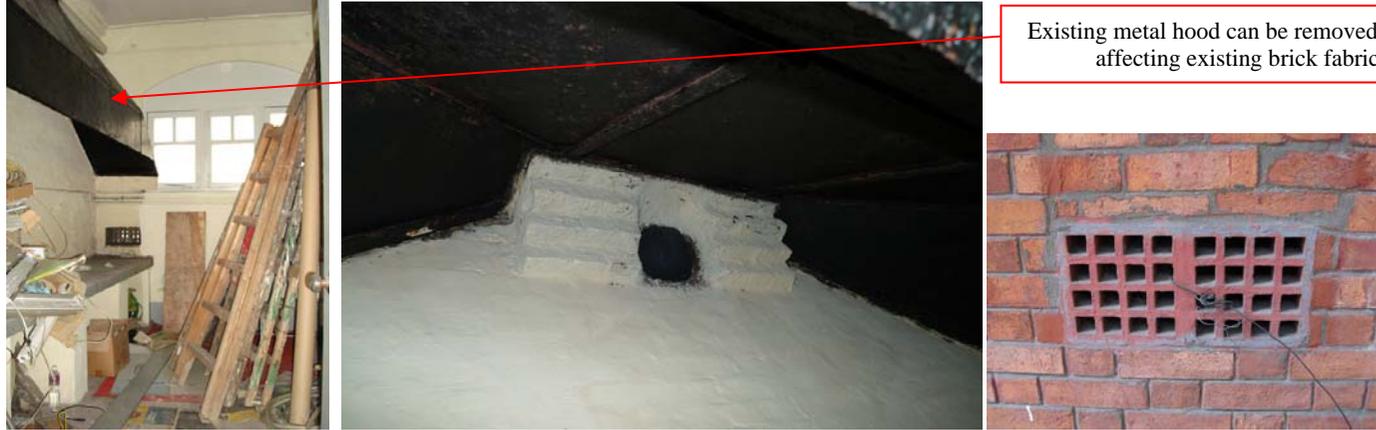
<div data-bbox="1288 703 1767 778" style="border: 1px solid red; padding: 5px; display: inline-block;">Existing metal hood can be removed without affecting existing brick fabrics</div>

F Others alteration and addition works for new uses (Cont'd)						
Item	Assessment items / Proposed Works	Fabric affected	Level of Significance	Reasons for changes	Mitigation measures	Overall Adverse Impact Level
F-03	Convert the existing kitchen to toilet	Existing metal hood, kitchen bench, and sink will be removed	Low	Upgrading toilet provision of new uses for open to public	<ul style="list-style-type: none"> Detail photographic and cartographic survey on existing setting of the kitchen prior to the commencement of any works. The metal hood and the kitchen benches shall be removed without damaging adjoining brickworks. Existing smoke flue with brick corbelling shall be remained intact. Existing ventilation brick on external walls shall be remained intact for interpretation of original use of this room as kitchen. 	Low

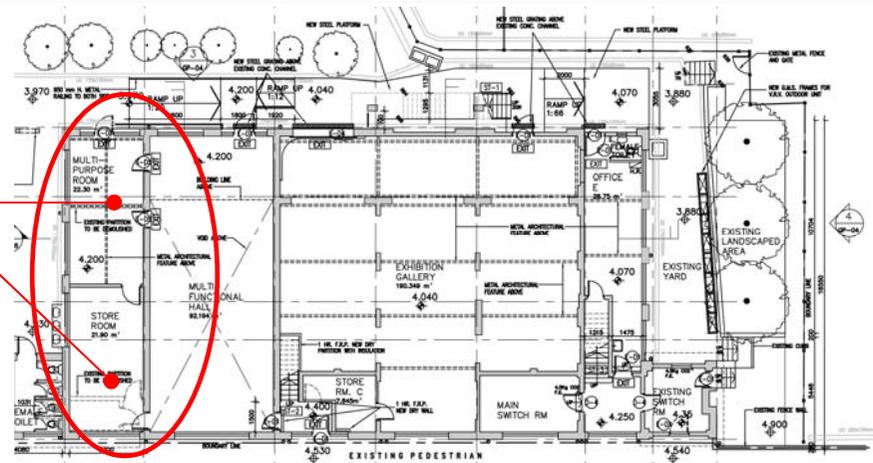
Existing internal partition walls in the toilet and rooms to be removed

F Others alteration and addition works for new uses (Cont'd)						
Item	Assessment items / Proposed Works	Fabric affected	Level of Significance	Reasons for changes	Mitigation measures	Overall Adverse Impact Level
F-07	Remove existing internal wall partition to enlarge the room on G/F of the Main Building	Existing internal walls inside the rooms and the toilet	Low	For new uses	<ul style="list-style-type: none"> Existing wall partition are later alteration and addition that the proposed removal of the wall partition to enlarge the room is acceptable. Existing timber roof structure shall not be affected during the removal of existing wall partitions. 	Low

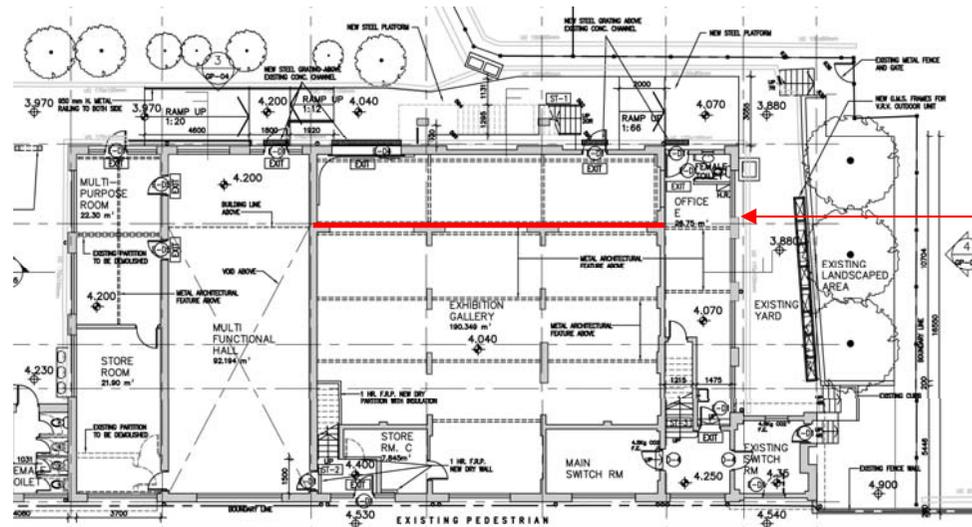
Strengthening of Steel Beam under the verandah

2.	Steel beams underneath 1/F verandah (3 nos.) (for Main Building)	Structurally inadequate	Structural strengthening works are required by welding new steel plate underneath the existing twin steel beams up to the edge of the brick corbel.

3 bays of existing steel beams required strengthening works

G Structural strengthening works						
Item	Assessment items / Proposed Works	Fabric affected	Level of Significance	Reasons for changes	Mitigation measures	Overall Adverse Impact Level
All historic buildings						
G-01	Limit 1/F for storage with design imposed load not exceeding 5KPa No strengthening work is required	Timber floor structure	High	To minimize strengthening works	<ul style="list-style-type: none"> Heavy equipment, heavy exhibits or other items with design imposed load exceeding 5 KPa shall not be placed at 1/F store room. Special training and briefing shall be provided to the frontline management staff to pay special attention to avoid unregulated loading. 	Low
Main Building						
G-02	Strengthen the existing 3 bays steel beams underneath 1/F verandah of the Main Building (along the edge between the concrete slab and the timber floor structure of the Exhibition Gallery)	Steel beams	High	Structurally inadequate	<ul style="list-style-type: none"> The strengthening to the existing 3 bays steel beams of the timber floors shall not damage the adjoining brick structures. This can be achieved by welding additional steel plates underneath the existing beams in lieu of replacing or removing them. The strengthening steel plates shall not cover the brand name of the existing steel "GLENARNOCK STEEL" which signified the steel beams were supplied from UK. 	Low
