CONSERVATION MANAGEMENT PLAN AND HERITAGE IMPACT ASSESSMENT

24 FEBRUARY 2015

RENOVATION WORKS FOR THE WEST WING OF THE FORMER CENTRAL
GOVERNMENT OFFICES - 8AB114

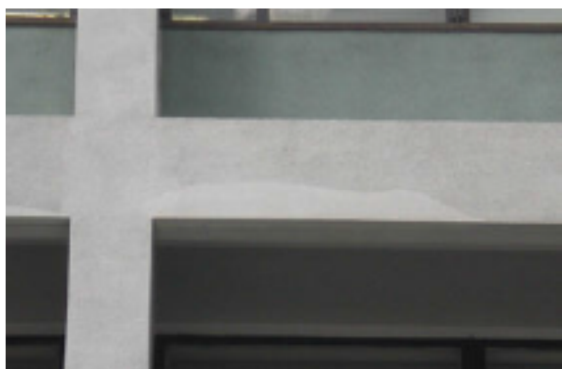
Although not particularly noticeable, there is evidence of a number of recent concrete repairs having been carried out to the concrete frame, particularly the north side. These are probably as a result of corrosion of reinforcement bars which have expanded and blown the face off the concrete. A number of arrises over windows also show signs of previous repair.

Fig.28: Concrete repairs to arrises

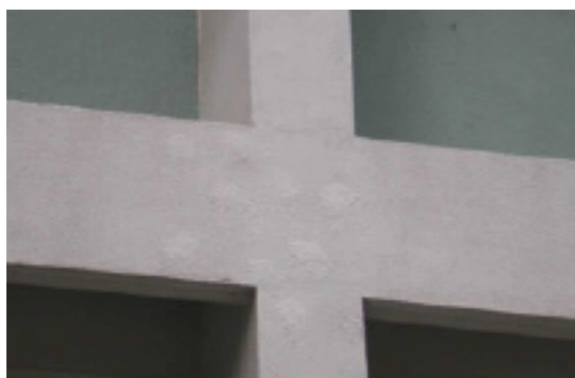
Fig.29: Concrete repairs on the West Wing

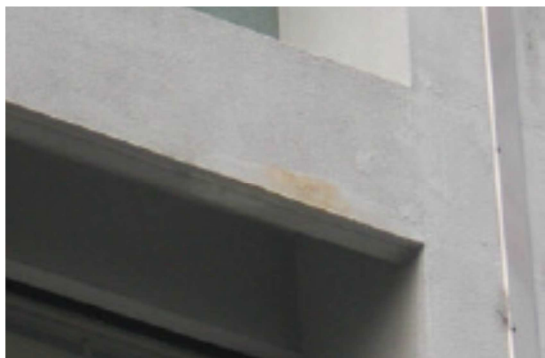
The design of the exposed frame, with deep horizontal ledges, means that the elevation is subject to staining to the front faces from water run-off. This is once again apparent despite the recent redecoration.

Fig.30: Staining on the West Wing

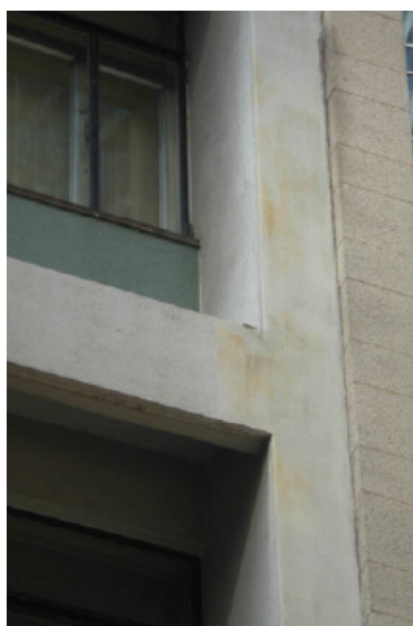
Fig.31: Staining on the West Wing

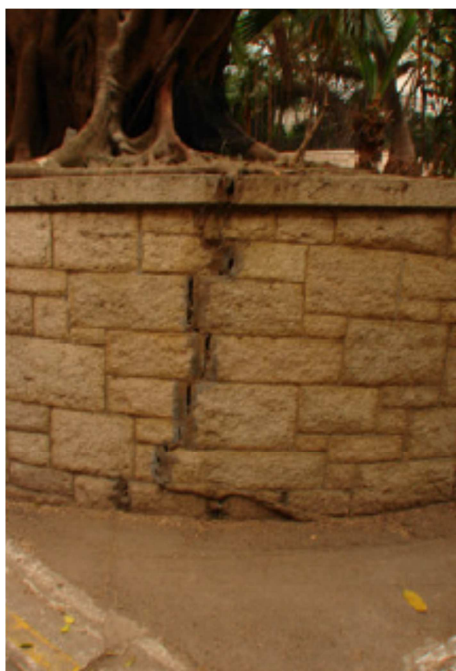
Fig.32: A large crack in a retaining wall of a shrub bed

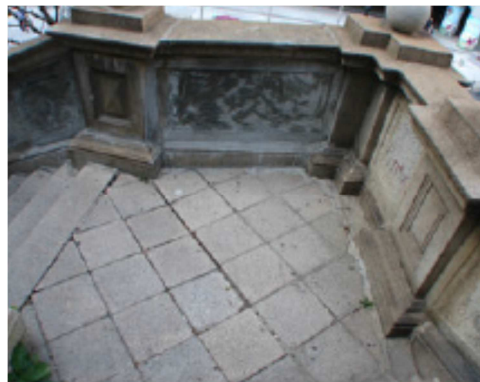
Fig.35: Concrete repairs and gaps in the paving of the Battery Path steps adjacent to the French Mission Building
