Archaeological Watching Brief for MTRC West Island Line

Final Watching Brief Report

**ARCHAEOLOGICAL ASSESSMENTS LTD.
September 2013**

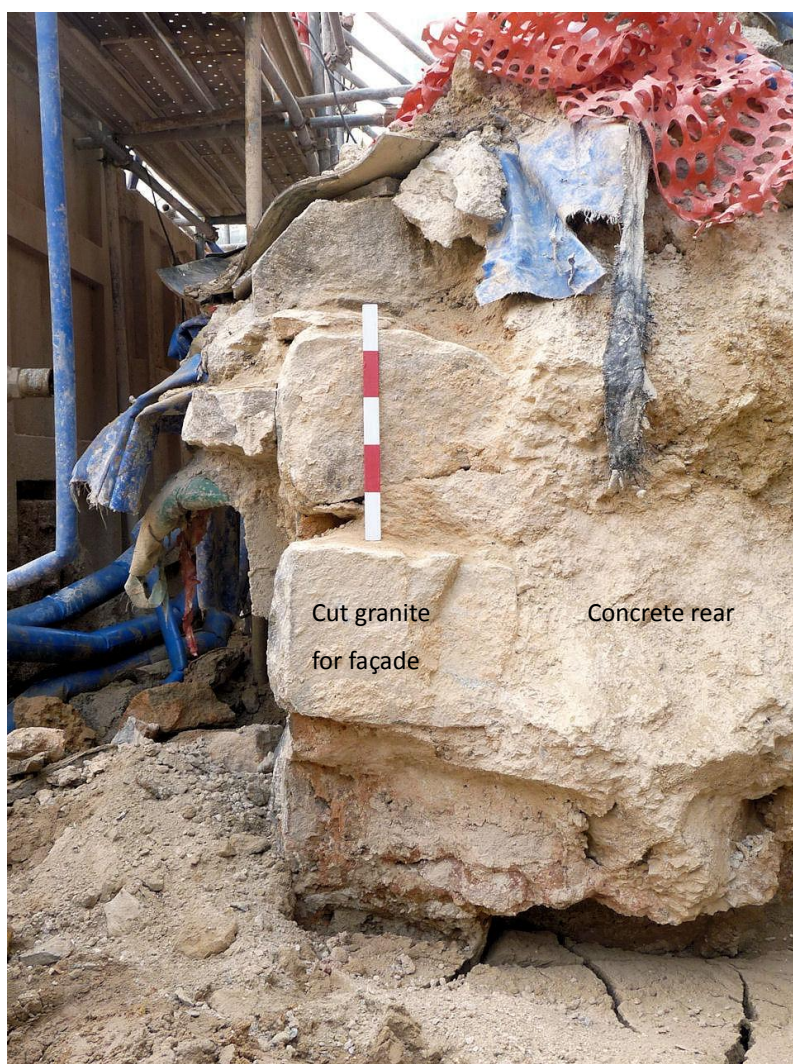
Plate 11.B.2 Photograph showing the section of the southern retaining wall, which shows the concrete backing and cut granite front wall.

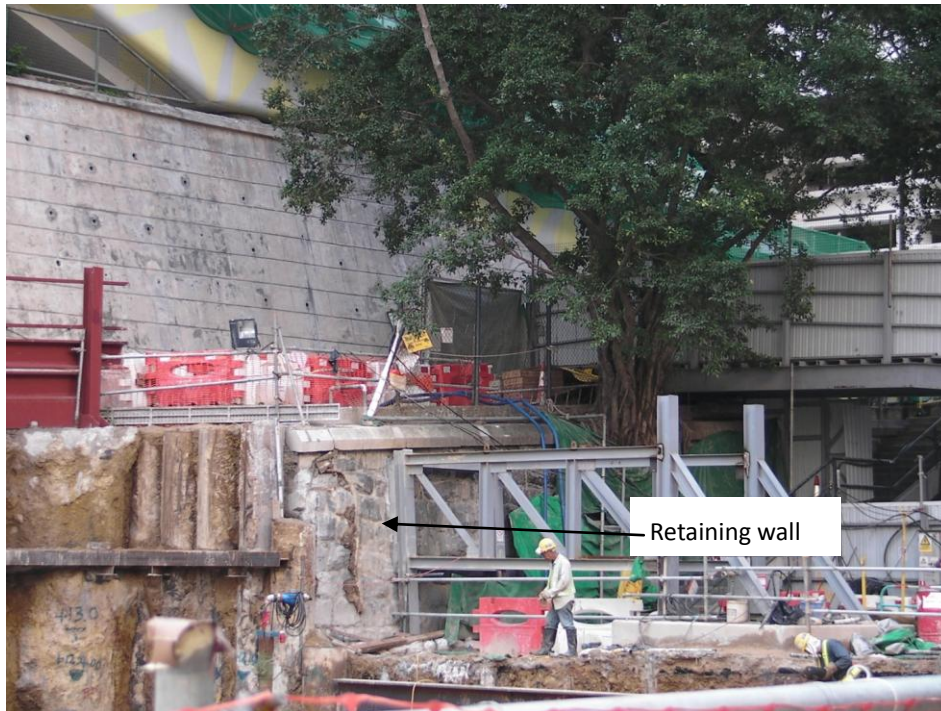
Plate 11.B.3 Photograph showing the retaining wall in the Southwest corner of the works area. The portion will be preserved.

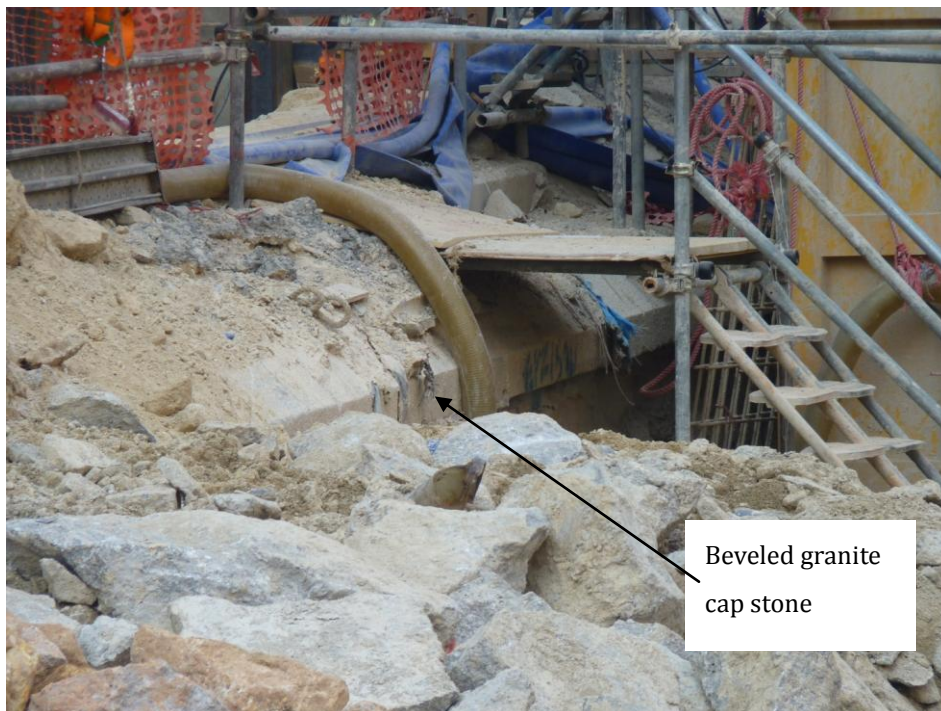
Plate 11.B.4 Photograph showing the top of the retaining wall; notice the beveled granite cap stone.

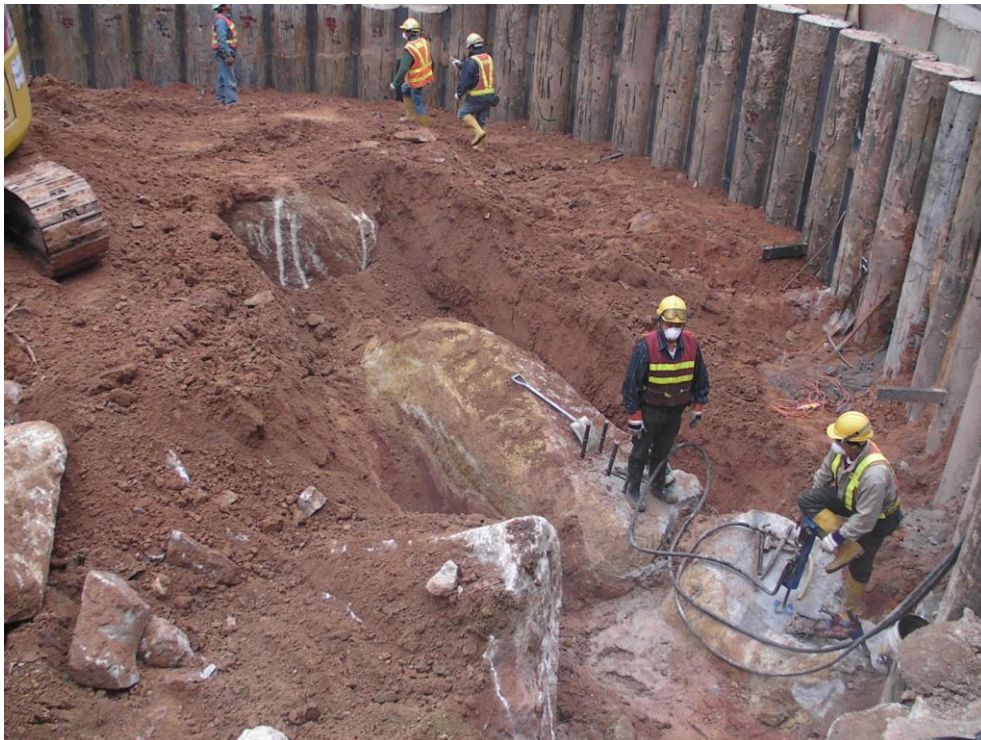
Shaft excavations both at the eastern (Plates 11.B.7-11.B.8) and western end (Plates 11.B.9) of the site confirmed that a thin layer of artificial fill overlays CDG colluviums under the modern surface. No archaeological materials were noted. Within the eastern shaft more construction debris was noted than in the western shaft this is due to the residential back which occupied the eastern part of the site prior to the construction of the fly-over.

Plate 11.B.8 Rock debris within the eastern shaft at a depth of approx. 2m below the surface.

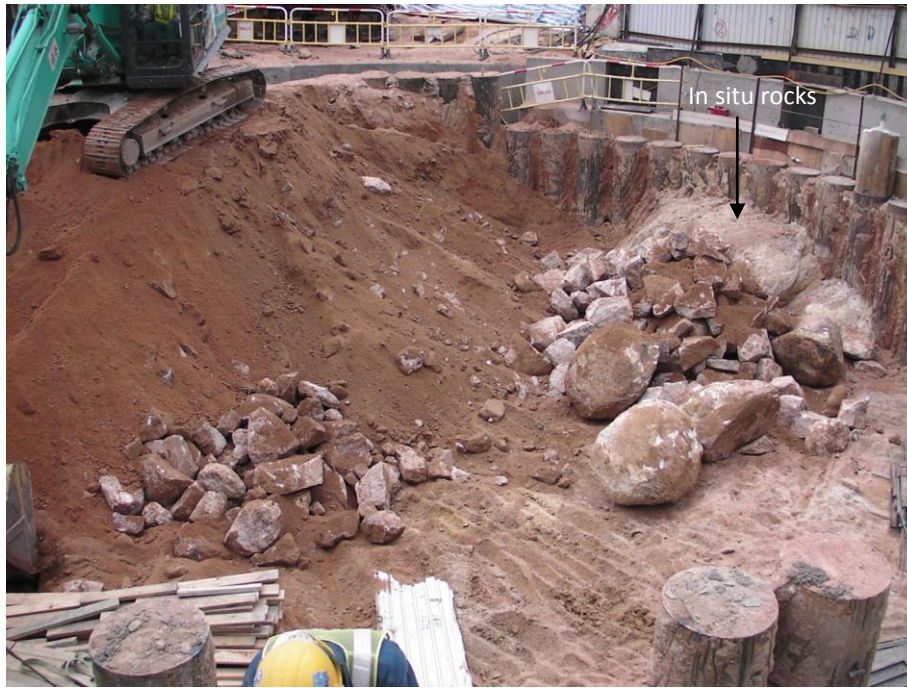
Plate 11.B.9 Photo showing ongoing excavations at the western shaft; note the large rocks appearing to the centre right of the photo at shallow depths

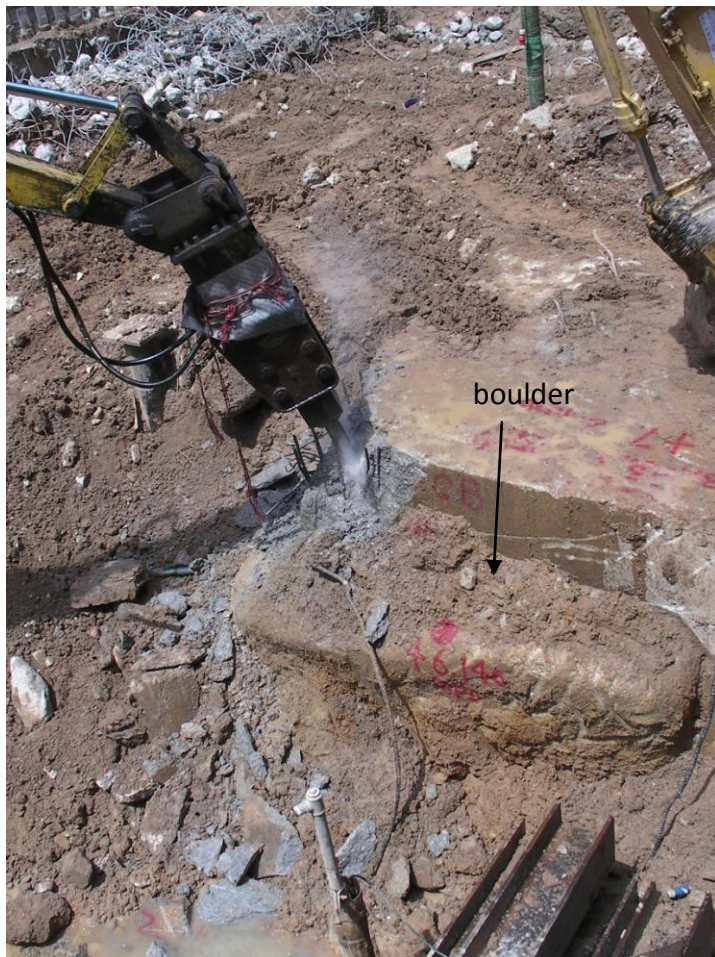
Plate 11.B.12 Photograph which shows the large boulder in the northwest of the works site

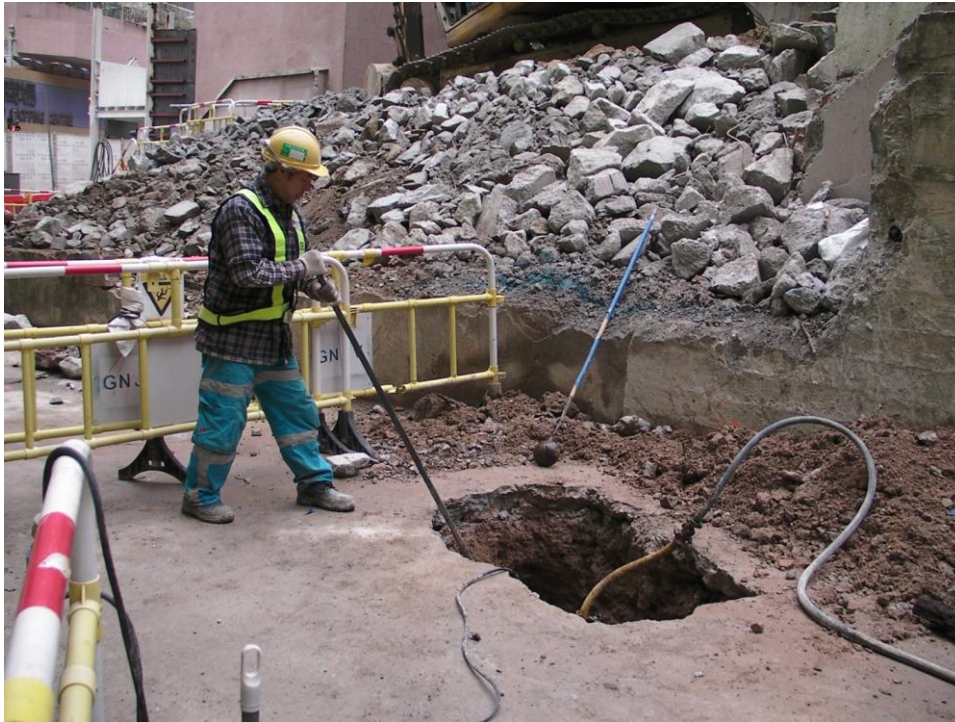
Plate 11.B.13 Photograph showing one of the pits excavated to locate the utilities and a general view north-northeast of the site with the demolition of the public toilets and creation of the artificial ramp needed for piling works

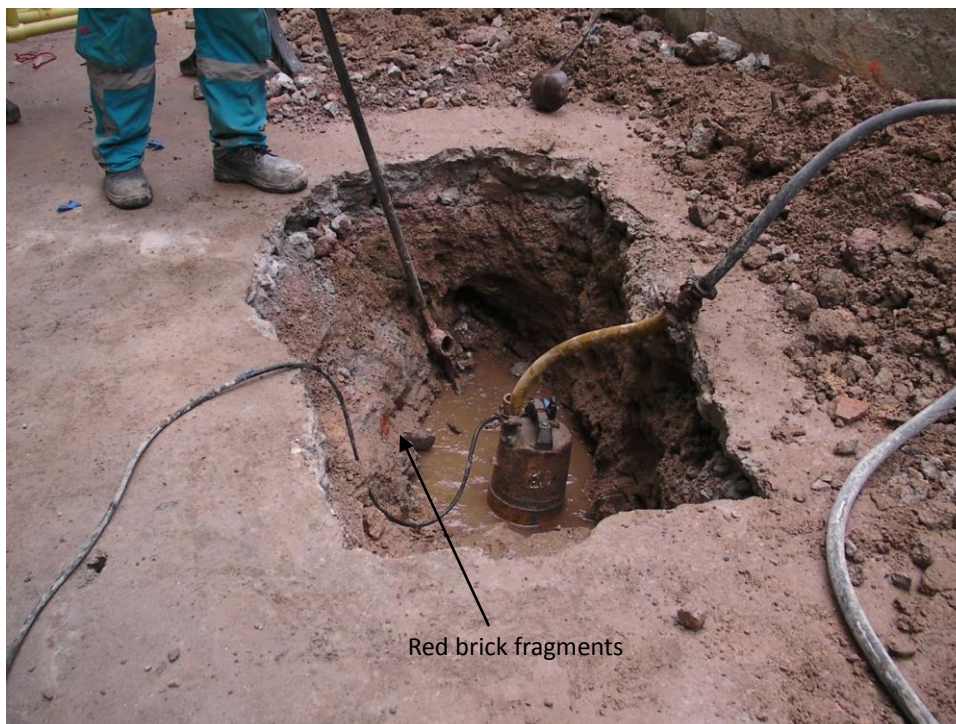
The initial site inspection showed that an artificial ramp was being constructed following the slope of the existing hill to enable piling. A few shallow test pit excavations had been conducted along the west of the site to locate existing utilities (Plate 11.B.13). Despite the fact that these were excavated in the dry season the pits showed water seepage, suggesting the drainage of the area must have significantly changed. The stratigraphy showed red and blue brick fragments along some ceramic pipe fragments: modern mixed with the old, but no material of archaeological interest was noted (Plate 11.B.14).

Plate 11.B.14 Photograph showing a view of the utility pit with some red brick visible in the western section and water seepage

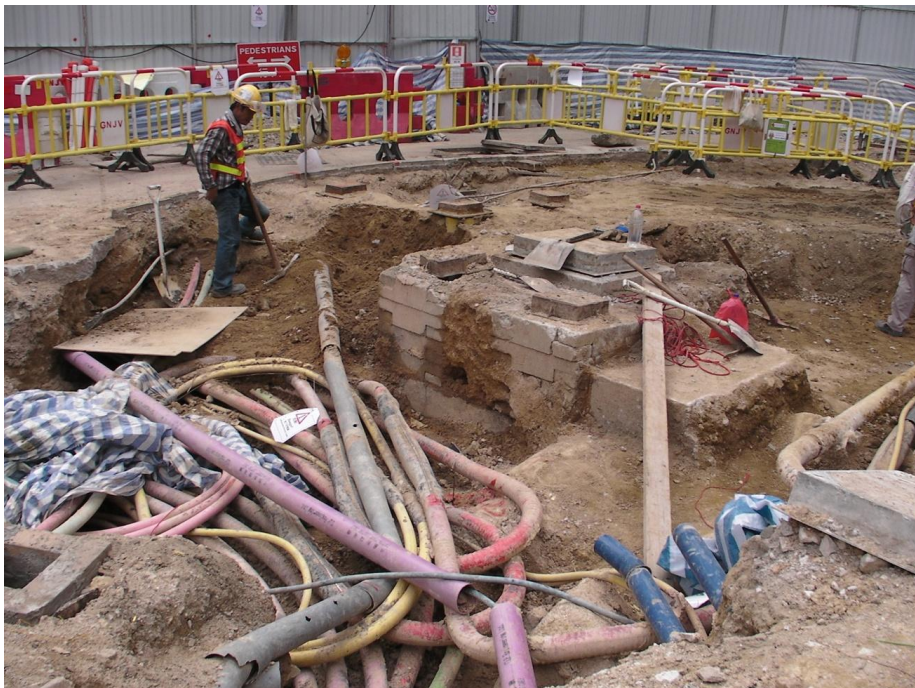
Plate 11.B.16 Photograph showing the works area at site inspection stage; view of the northern part of the site looking east.

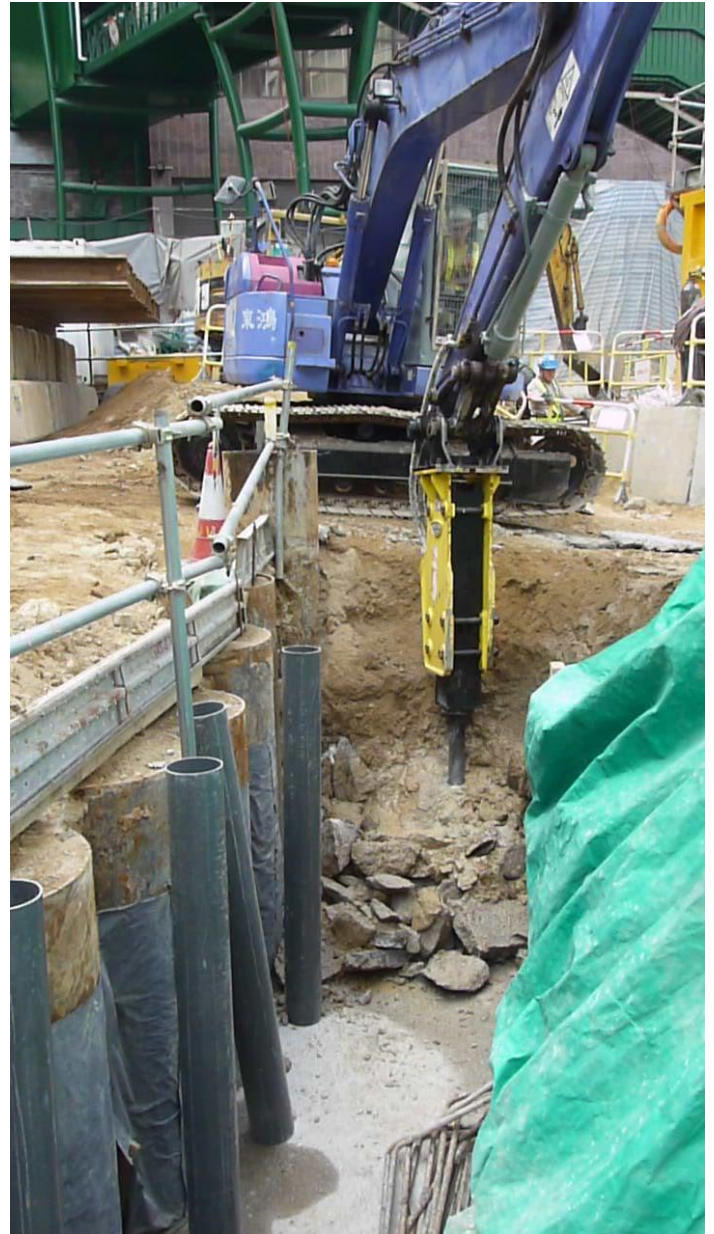
Plate 11.B.18 Photograph showing the drilling of a debris flow boulder to the southwest of the shaft

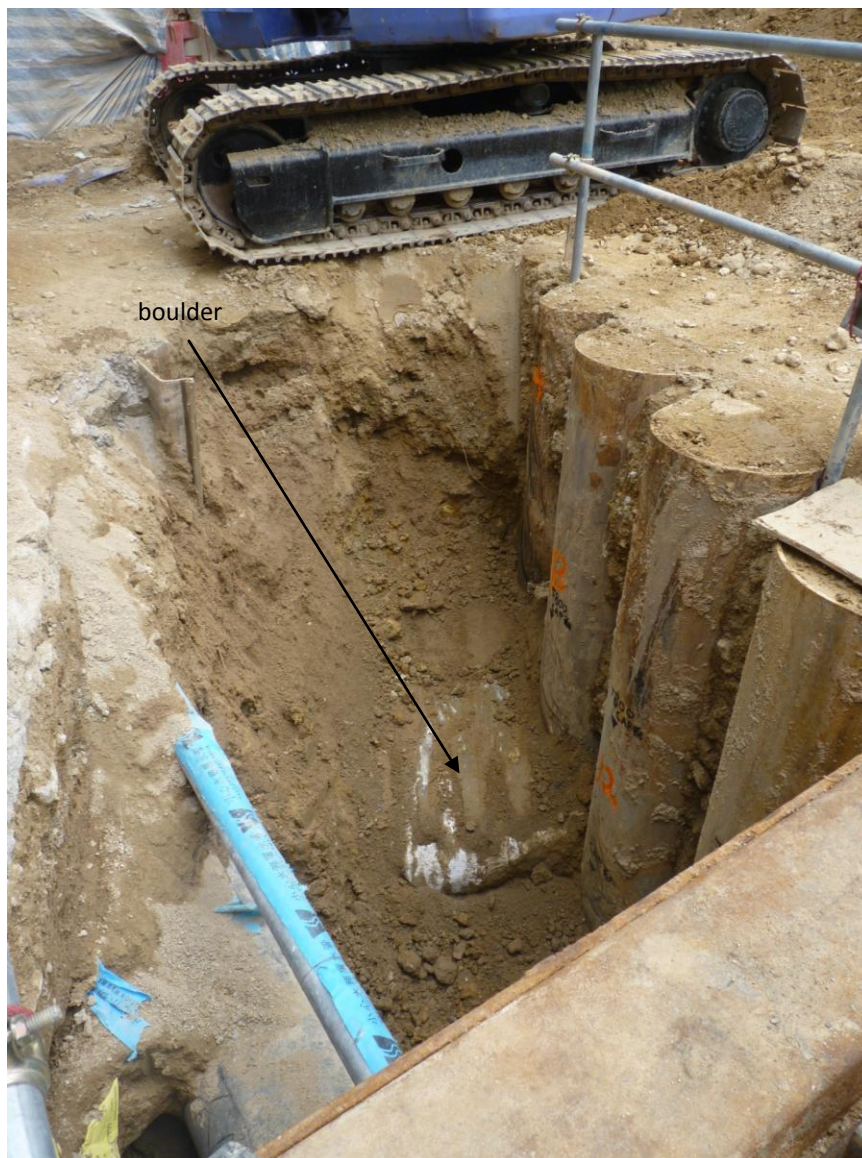
Plate 11.B.19 Photograph showing boulders appearing around 1m below surface set in sterile soils

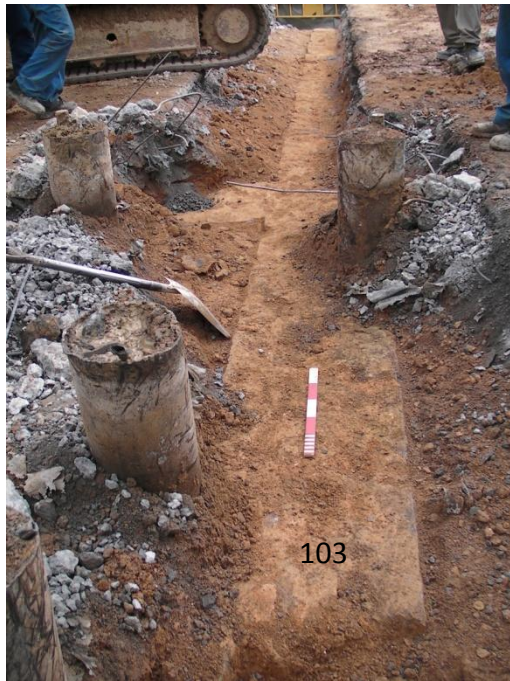
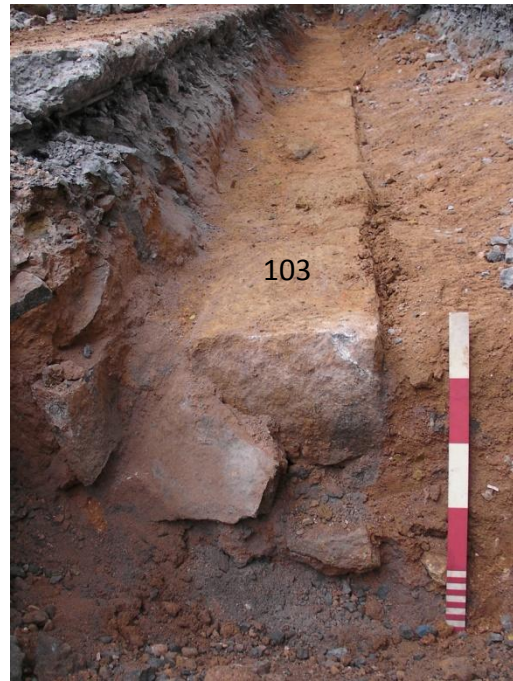
In the Northeast corner of the noise enclosure monitoring indicated below modern surface and a sequence of CDG (coarse decomposing granite) fill, a wall foundation of granite blocks [**WF103**] (Plate 11.B.20a and b). The foundation trench for the wall [**104**] cut into pre-existing CDG fill [**105**] and had an east-west orientation. Apart from three undiagnostic red tile fragments (probably 20th-century in date) (Plate 11.B.21) within the foundation cut no other dateable material was noticed. The continuation of wall foundation [**WF103**] was noted in the Northwest corner of Site M (703) and it extended for some 11m west of where it was first discovered. During removal of hardcore layer [**102**], which sealed the wall foundation [**WF103**], a base sherd dated late 19th-century to 20th-century provincial porcelain (Plate 11.B.22) was recovered.

Plate 11.B.20a Granite block wall foundation 103; view looking west

Plate 11.B.20b Photograph showing the granite wall west facing section

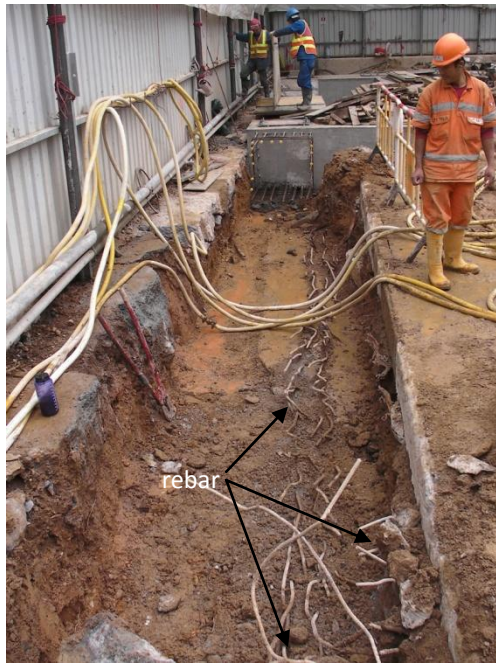
In the northern end of the trench for TB4, the presence of deep rebar foundations was noted (Plate 11.B.23). The latter foundations were associated with the basketball court fencing and perimeter drains and extended south along the western side of the site and were still present in the base of excavation at formation level. The depth of disturbance evidenced in TB4 suggested that there would be little chance of archaeological remains surviving along the western edge of the site in TB4 and TB6.

Plate 11.B.23 Photograph showing a view of TB4 trench looking north; note the rebar foundations

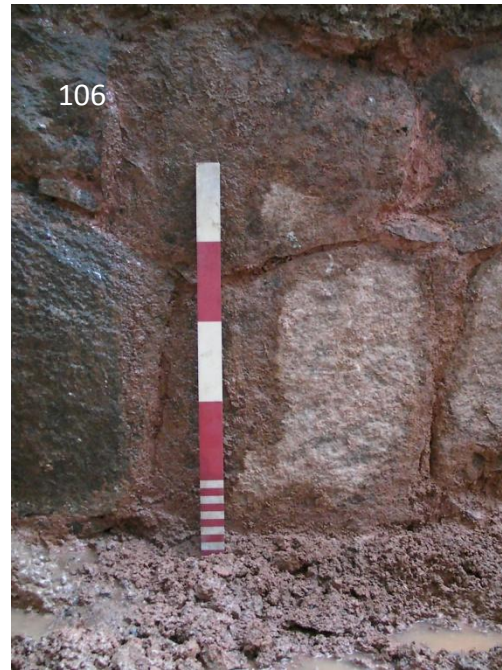
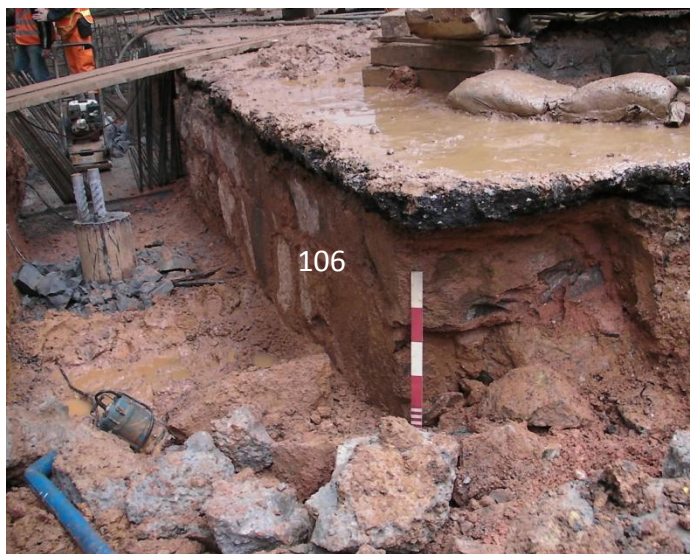
In MTB1 a substantial and well-made wall foundation (**WF106**) was noted under the west facing section of the trench. **WF106** extended some 6.5m N-S and was 0.65m high at the limit of excavation by 0.63m thick (Plates 11.B.24 and 11.B.25) , like all granite wall foundations at Site M, WF106 was only partially exposed in plan and almost certainly did not survive to its original height. Neither finished ends nor abutments with other wall foundations were visible in the contractor's foundation cuts - so WF106 can be considered to be a substantial fragment of a longer and taller wall/foundation. Moreover, only the mortar/gravel bedding trench and two courses of granite blocks survived in vertical section and, as shown by the uneven and unfinished upper surface of similar wall foundation **WF103**, which was exposed nearby, one or more courses must have been removed when the site was levelled-up for later development.

Plate 11.B.24 Photograph showing west facing elevation of granite wall foundation 106

Plate 11.B.25 Photograph showing a view of granite wall foundation 106 looking to the northeast

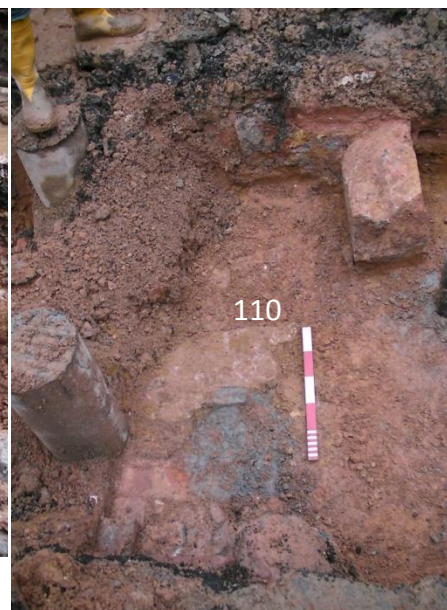
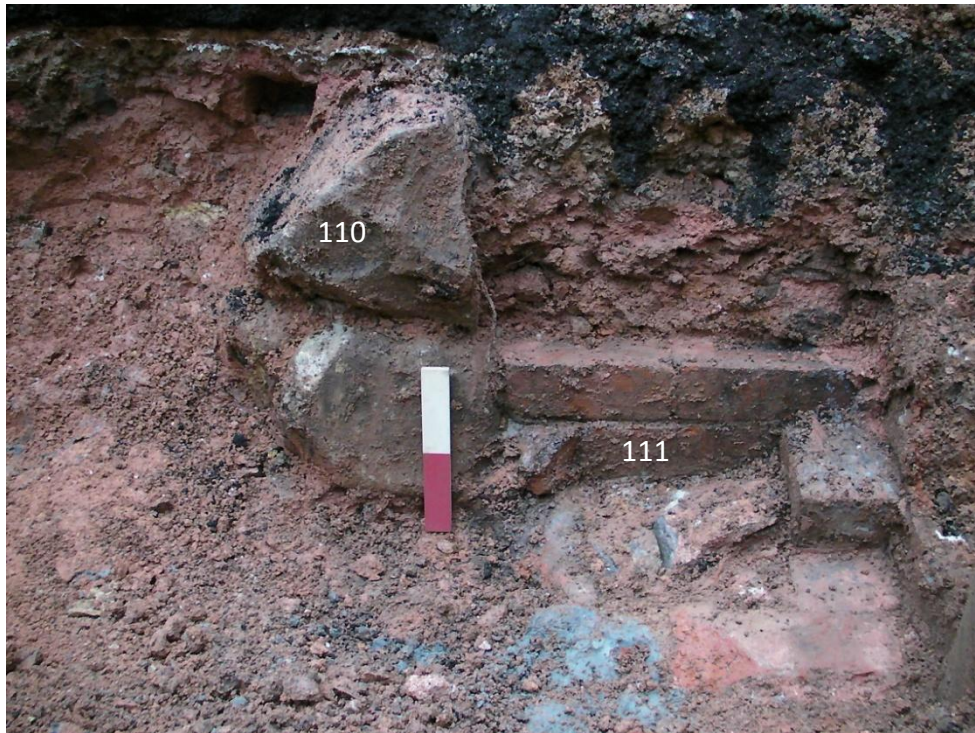
Another N-S orientated wall foundation (**WF110**, Plate 11.B.26) was observed near **CAP 5** in association with a brick foundation (**BF111**, Plate 11.B.27), which appeared to be in alignment with **WF106/108** (Figure 11.B.5). Under the stone and brick foundations a mortar gravel bedding foundation was recorded (**MG115**). It is assumed that wall fragments 106, 108 and 110 and its mortar/gravel bedding 115 are parts of the same wall.

Plate 11.B.26 Photograph showing the wall foundation 110; view looking north

Plate 11.B.27 Photograph showing brick foundation 111 and wall foundation 110; view looking south

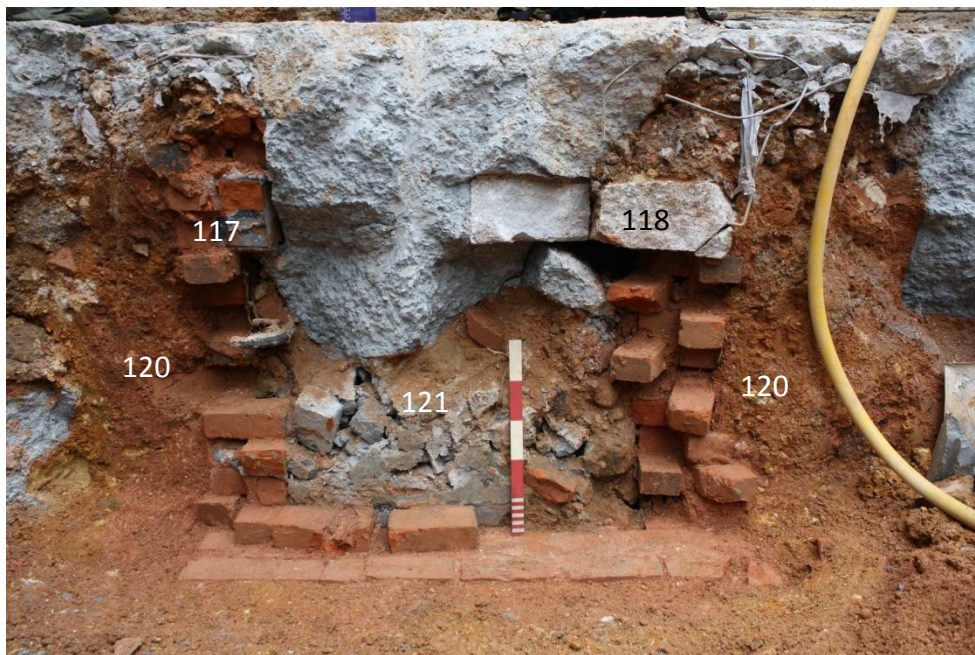
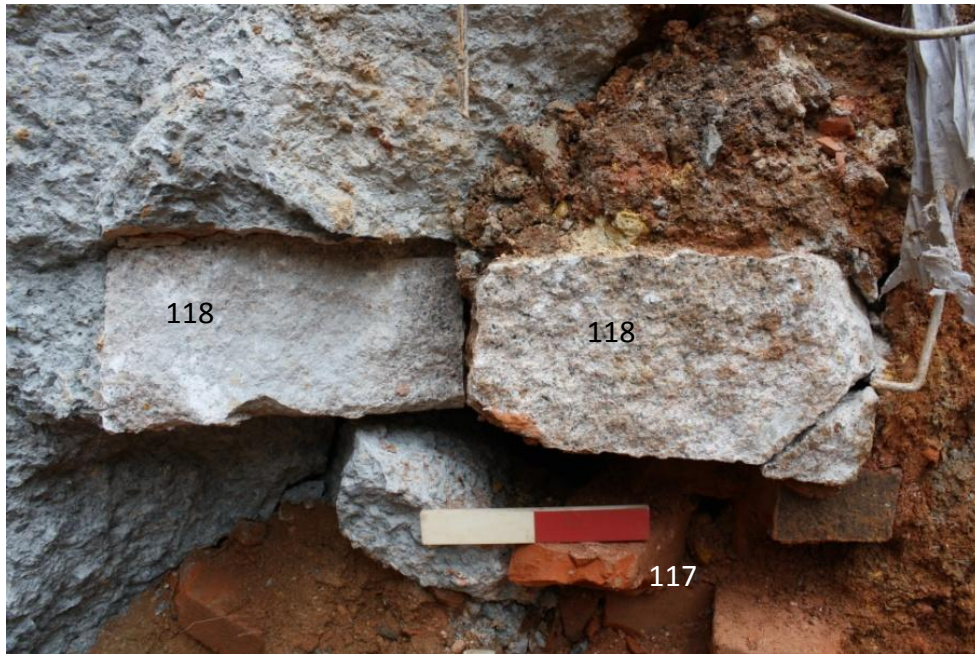
Remains of a brick structure (**BS117**) were identified in the south-east corner of the site near the junction of **CAP 8 and TB7** (Plate 11.B.28). On top of the bricks a couple a granite blocks were recorded (**118**); the purpose of these two blocks or their relationship to the brick structure is unknown (Plates 11.B.28 and 11.B.29). The remains are interpreted as a brick manhole; it is not clear however, if the structure is contemporary with the other wall and brick foundations found at the site.

Plate 11. B.28 Photograph showing brick structure 117; view of north facing section. Note also the two granite blocks on top of the structure (118)

Plate 11.B.29 Photograph showing the 118 granite blocks lying above the brick structure (117).

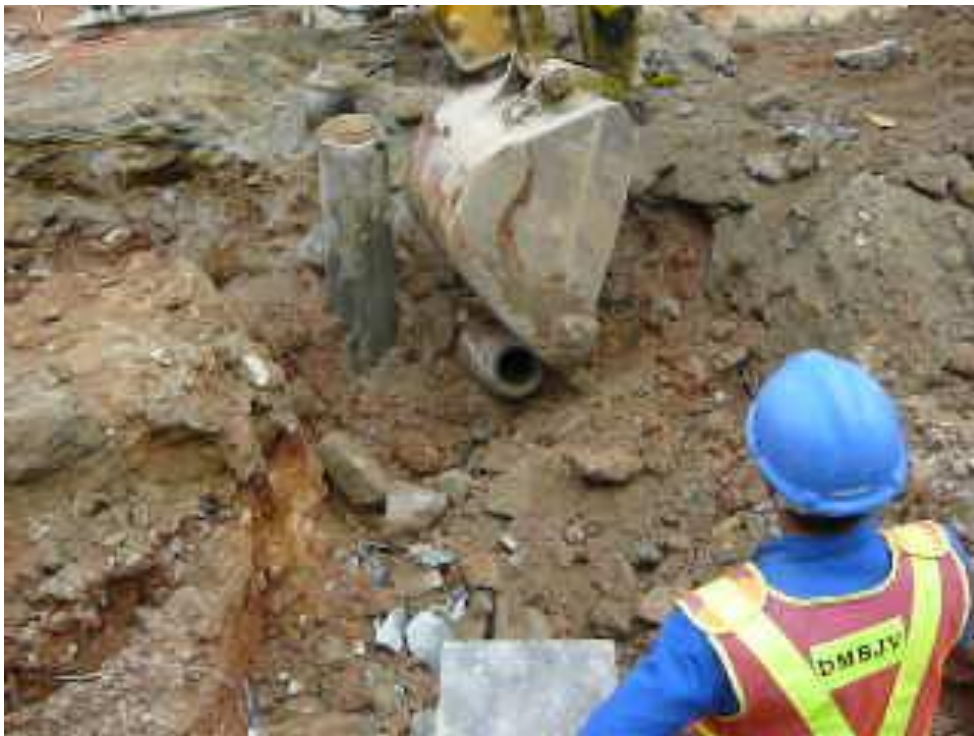
The groundworks for **CAP 7**, the western half of **TB8 and MTB3**, as well as the completed foundation trench for **TB6** evidenced **significant modern disturbance**: from drainage pipes in the case of **TB8 and CAP 7** (Plate 11.B.30), and from rebar foundations in the case of **TB6 and MTB3** (Plate 11.B.31).

Plate 11.B.30 Photograph showing modern pipe disturbance at CAP 7, noise enclosure; view looking east.

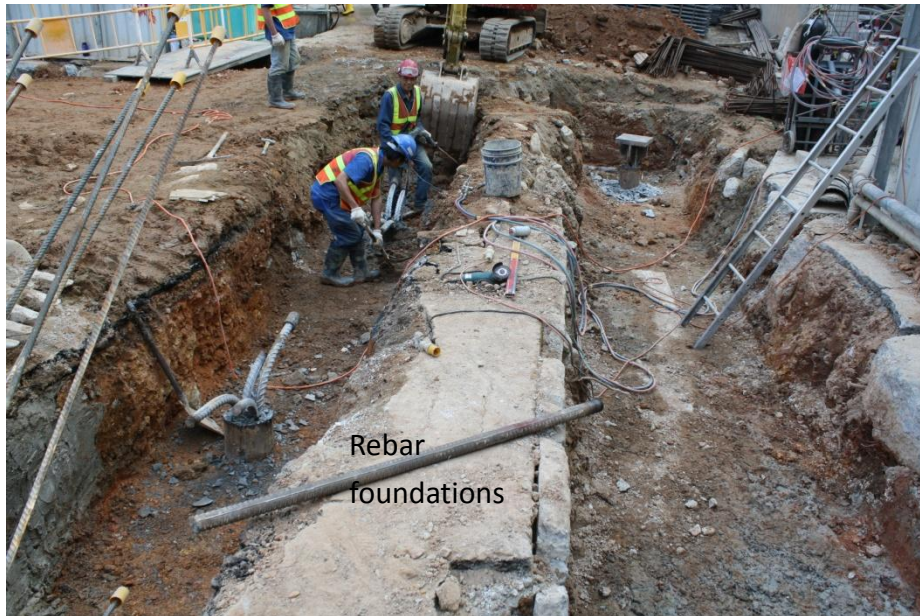
Plate 11.B.31 Photograph showing rebar foundations at TB6 and MTB3; view looking north.

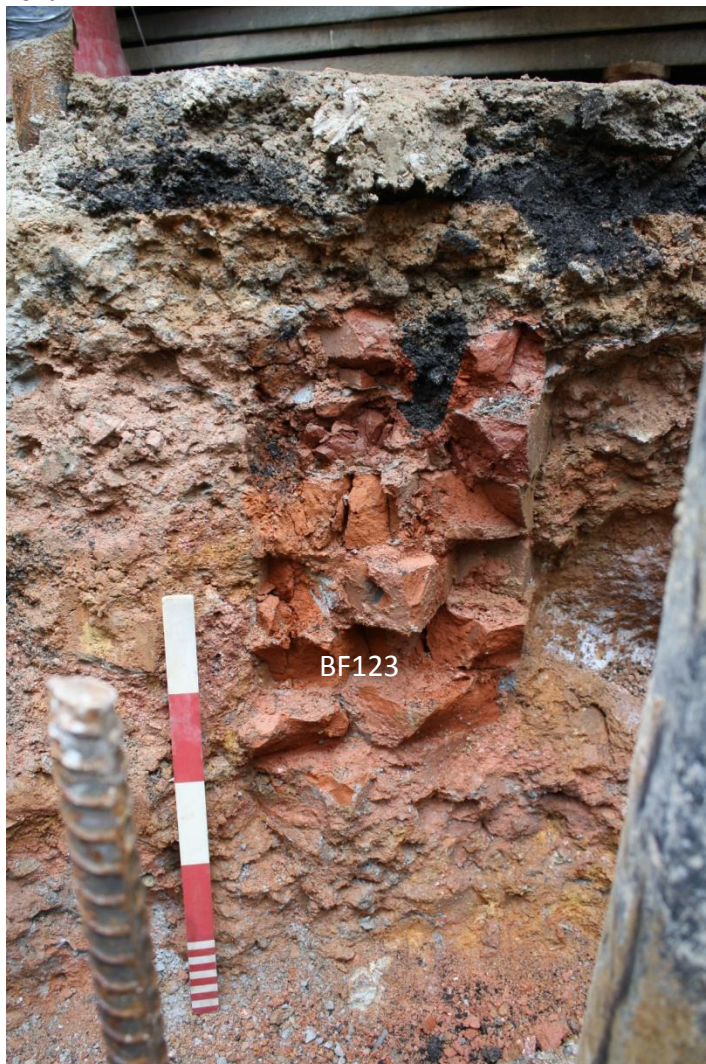
Eastern side of shaft ring-beam groundworks in the site, three sets of structural remains were noted: two E-W orientated brick foundations, one red (**BF123**, Plate 11.B.32) and one grey brick (**BF124**, Plate 11.B.33), and an N-S orientated granite wall foundation (**WF125**, Plate 11.B.34). **WF125** has a mortar/gravel bed (**130**) underneath the granite blocks.

Plate 11.B.32 Photograph showing BF123; view of west facing section

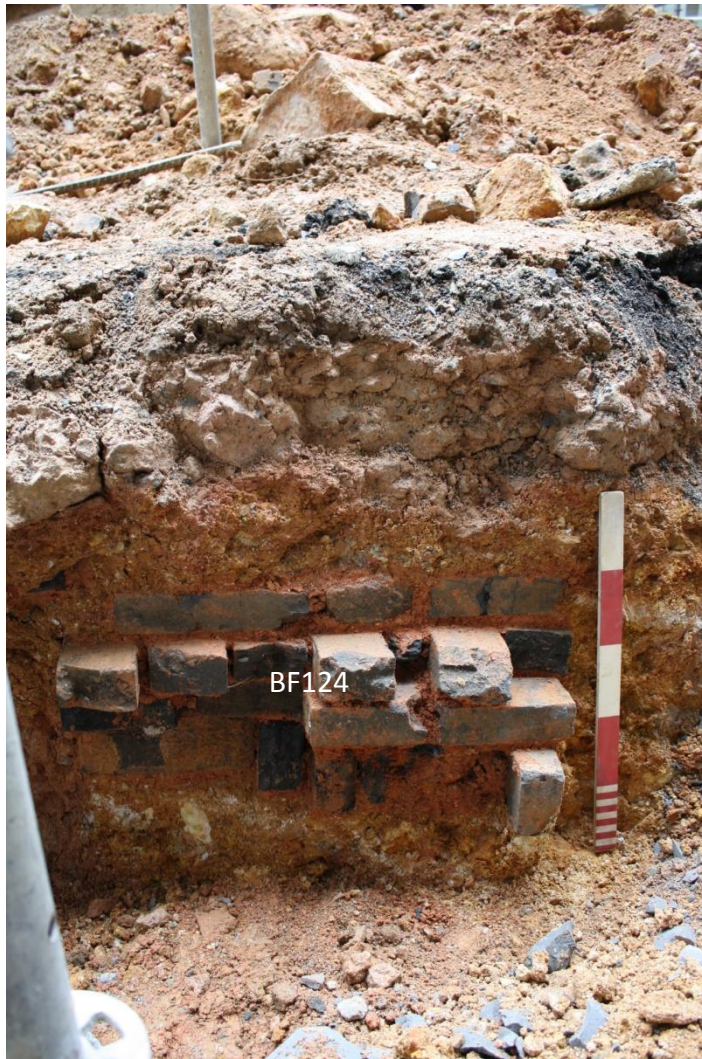
Plate 11.B.33 Photograph showing BF124; view of east facing section

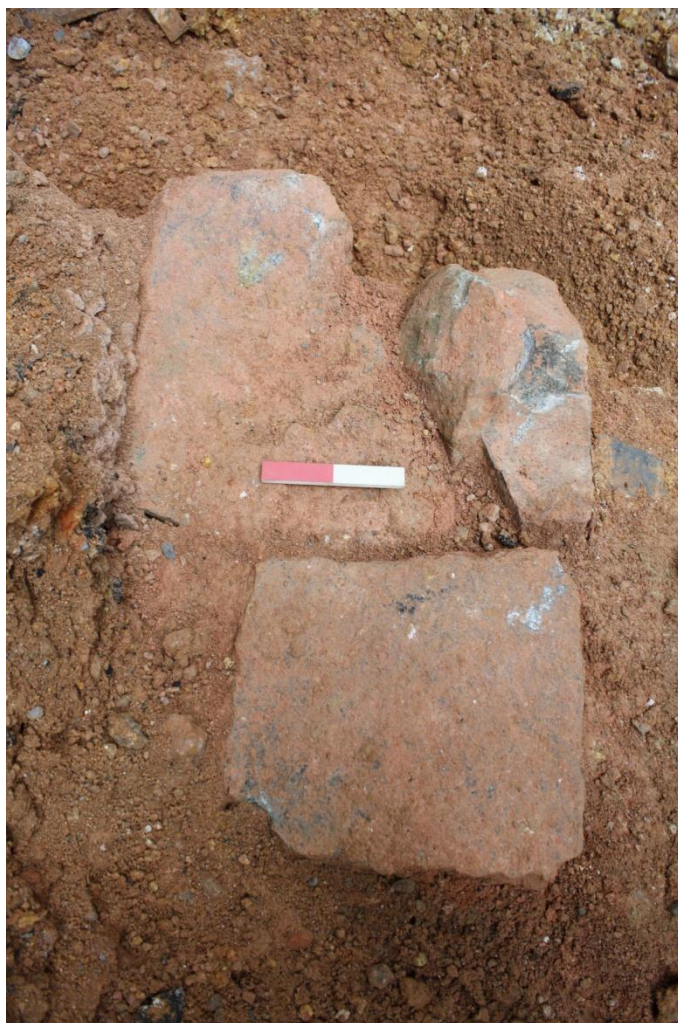
A further fragmentary wall foundation (**WF134**, Plates 11.B.35 and 11.B.36) was identified in the Northeast quadrant of the shaft footprint. **WF134** was constructed in a manner similar to previous granite foundations on site, having a mortar/gravel hardcore bed upon which the granite block foundation had then been built. The remains of **WF134** had an upper surface level of 37.98m PD – approximately 0.15m below the modern basketball court surface, whilst the base level of the foundation trench cut was at 37.30m PD.

Plate 11.B.36 Photograph of WF 134 in detail; view of plan looking south

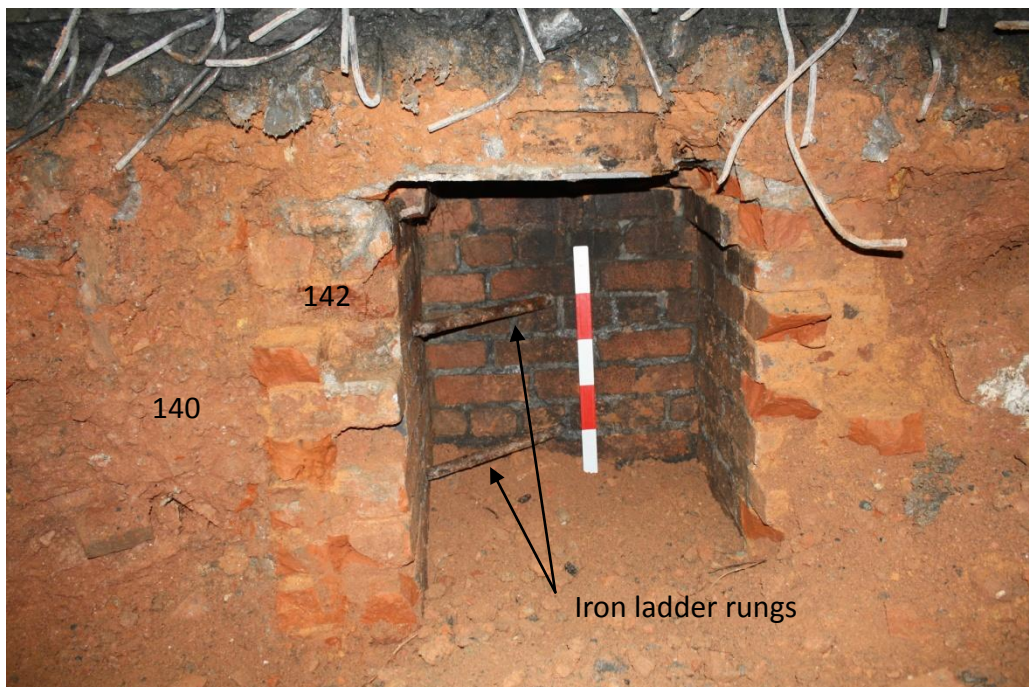
Plate 11.B.38 Photograph of Manhole 142; view looking west; note the iron ladder rungs

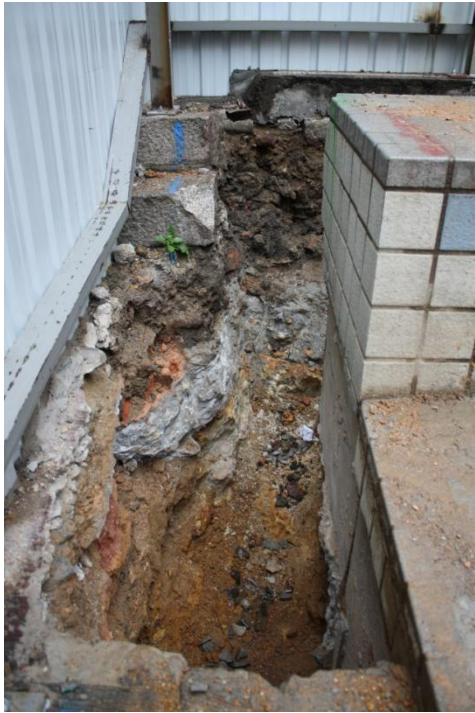
Plate 11.B.43 Photograph of Site M2 showing a deep sequence of rubble fill; view looking south

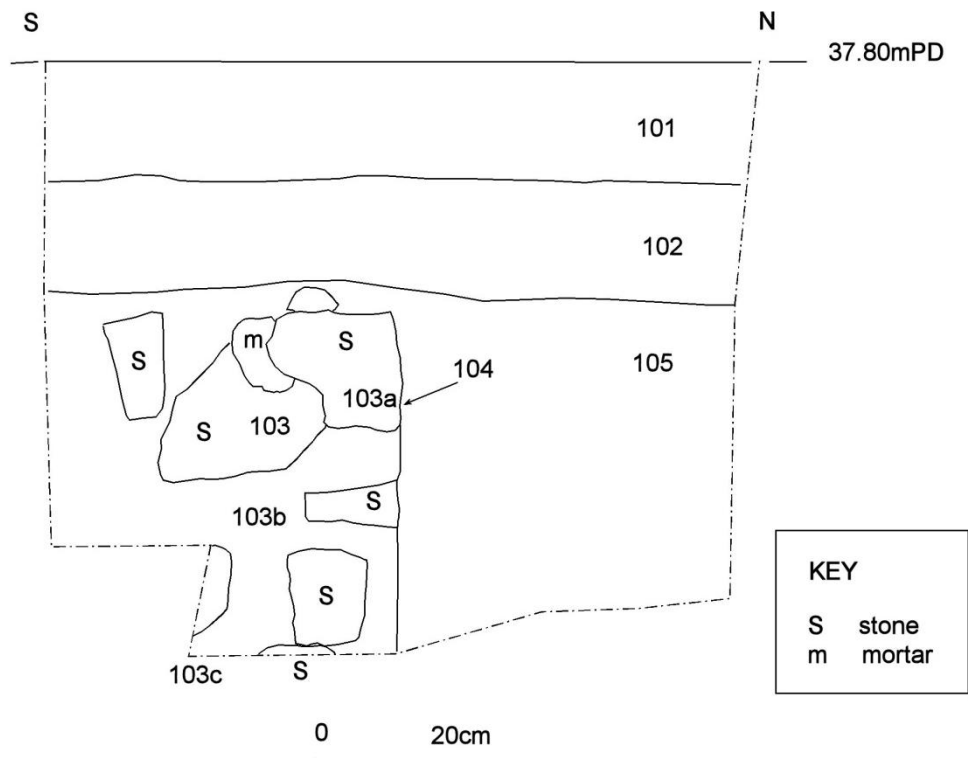
Drawing 1 East facing section of wall foundation 103 and its associated cut 104

In the **Northeast corner** of the noise enclosure monitoring indicated below modern surface and a sequence of CDG fill, a wall foundation [WF103] constructed with granite blocks (Drawing 1 and 2). The red bricks measured ca. 0.18 by 0.23 by 0.27m and 0.08 by 0.10 by 0.10m in size. White mortar was noticed in patches but there was no evidence that the foundation had been fully mortared.

The foundation trench for the wall [104] cut into pre-existing CDG fill [105] and had an east-west orientation. Apart from three undiagnostic red tile fragments (probably 20th-century in date) (Plate 11.B.21) within the foundation cut no other dateable material was noticed.

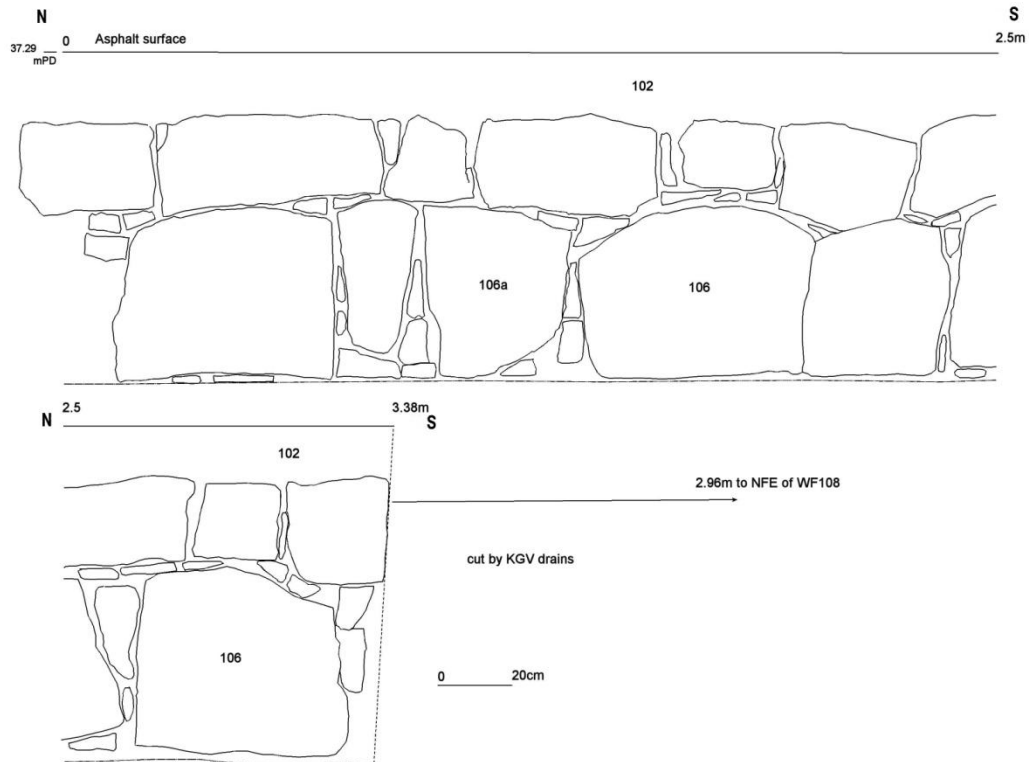
Drawing 3 Drawing shows 3 metres section of granite wall foundation 106 and which continued for approximately another 3m metres

WF106 extended some 6.5m N-S and was 0.65m high at the limit of excavation by 0.63m thick. In **CAP 3** the wall foundation had been cut by a substantial E-W orientated modern drain, but the remains of a further length of wall were visible 2.96m south of **WF106**, in the north facing section of the trench (**WF108**).

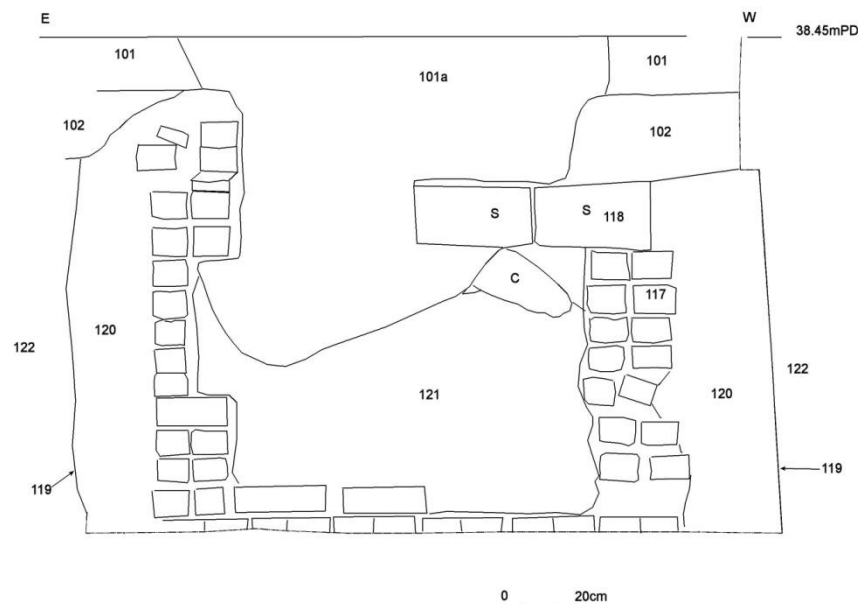
Drawing 8 Drawing showing the manhole 117 and it associated contexts, showing north facing section

Remains of a brick structure [**BS117**] were identified in the south-east corner of the site near the junction of **CAP 8 and TB7**. The brick structure appears isolated and is a manhole. The chamber measured: 1.42m (E-W) by 0.27m (N-S) and at the end of excavation has a height of 1.04m on its east side and 0.88m on its west side. The red bricks measured 21 to 22cm in length, 10cm wide and 7cm thick. The structure had been back filled with rubble and capped with concrete.

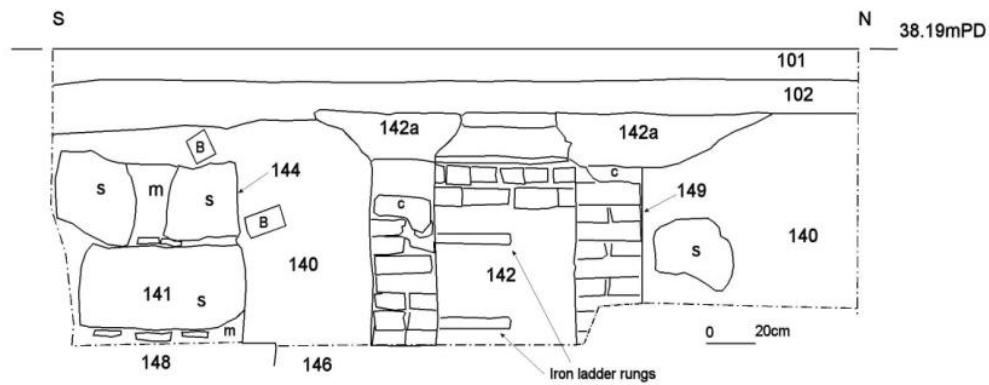
Drawing 13 Drawing showing east facing section of WF141 and more recent manhole MH142 and their respective associated contexts

The remains of a granite wall foundation and brick manhole [**WF141** and **MH142**] were first unearthed in the **Northwest corner** of the spoil basin area. The two lengths of granite wall foundation [**WF141**] were uncovered – one E-W orientated foundation at the western edge of the spoil basin and another 5m-long E-W orientated example, appeared to be the continuation of the one found the previous day. Few artefacts were found in the CDG fill (**140**) surrounding the structures (Plate 12.A.1); the finds consist of Qing to early modern materials. **MH142** is a more recent manhole structure.

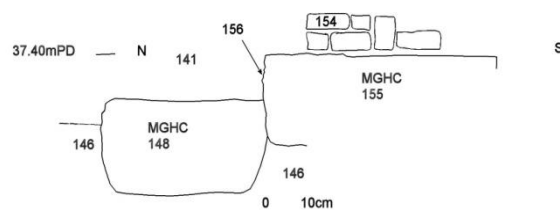
Drawing 17 Drawing of west facing elevation showing BF154 and gravel/mortar foundation beds 155 and 148

On further excavation, it was clear that all granite blocks of the wall foundations had been removed by the contractor and all that survived was the mortar/gravel levelling foundations. The mortar/gravel-filled bedding trenches of four lengths of wall foundation were thus identified: E-W orientated **MG148** (under **WF141**), E-W orientated **MG159**, both parallel with and south of **MG148**, and N-S orientated cross-walls **MG155** and **MG157**. The latter two were added later than the E-W oriented walls **MG148** and **MG159**. **MG155** had some fragmentary remains of a red brick foundation **BF154**.
