Revitalising Historic Buildings Through Partnership Scheme – Batch I Projects

Adaptive Re-use of Mei Ho House as City Hostel

Hong Kong Youth Hostels Association

March, 2010

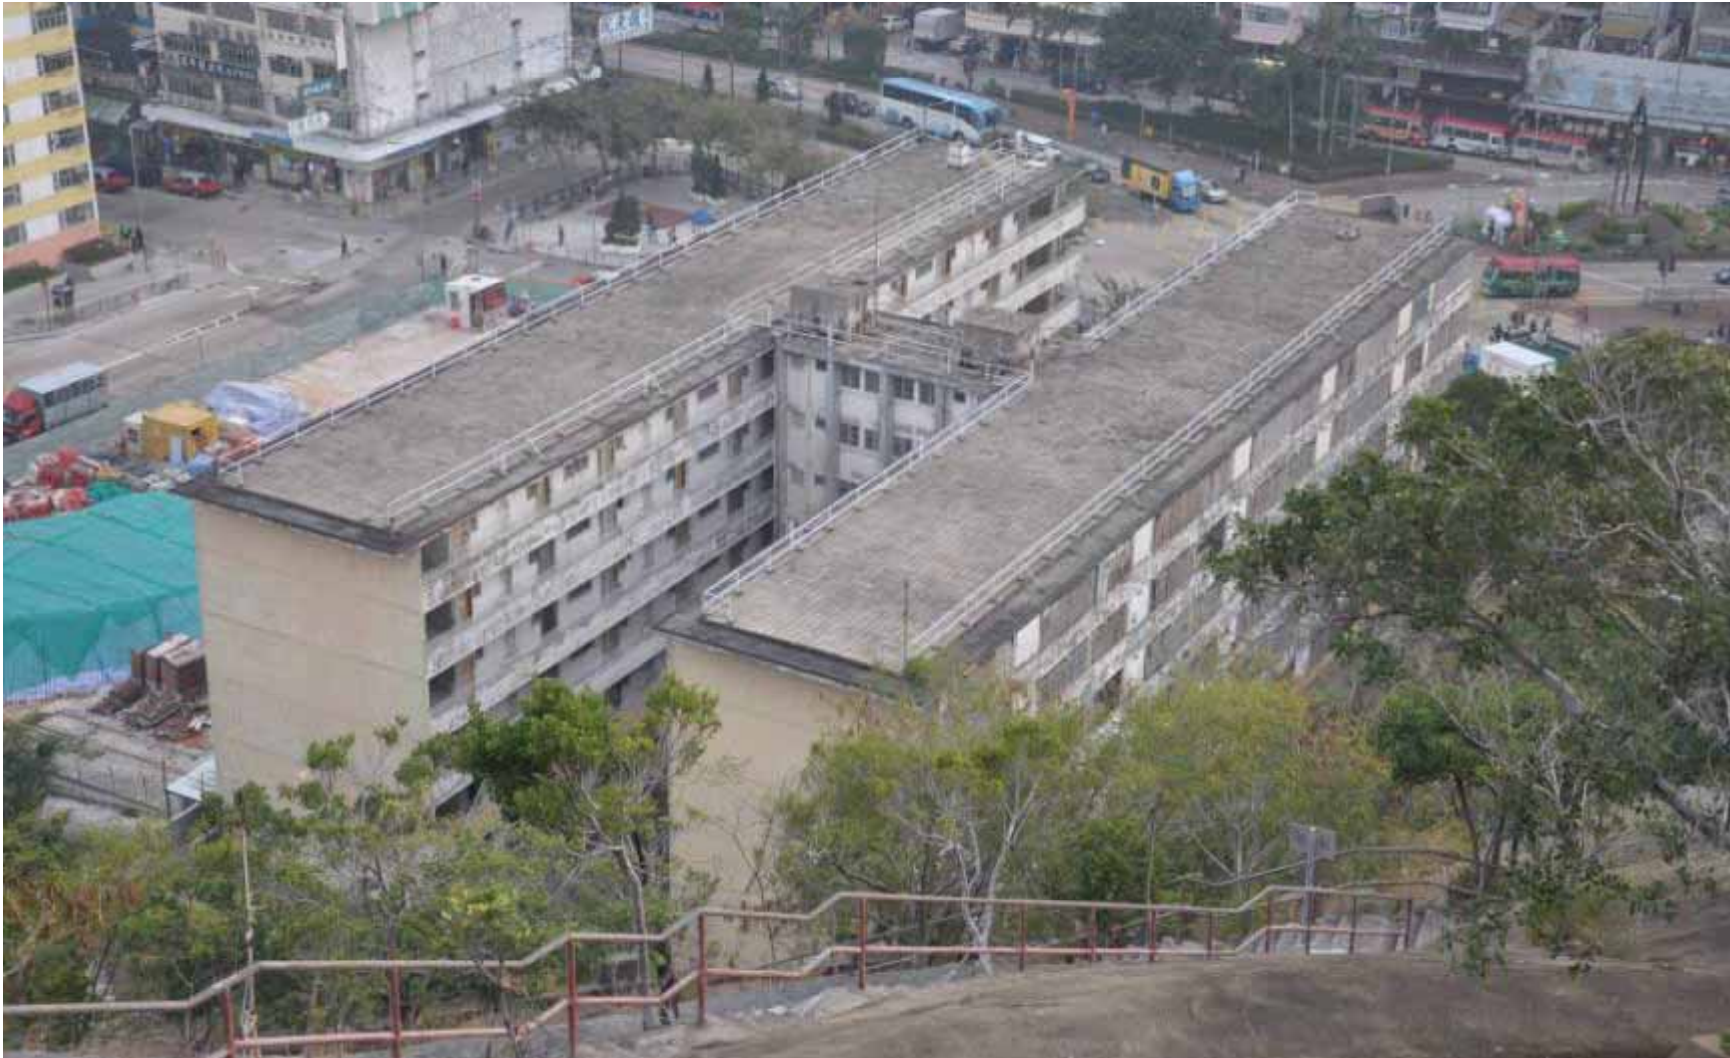
Character defining element – the H-shaped plan

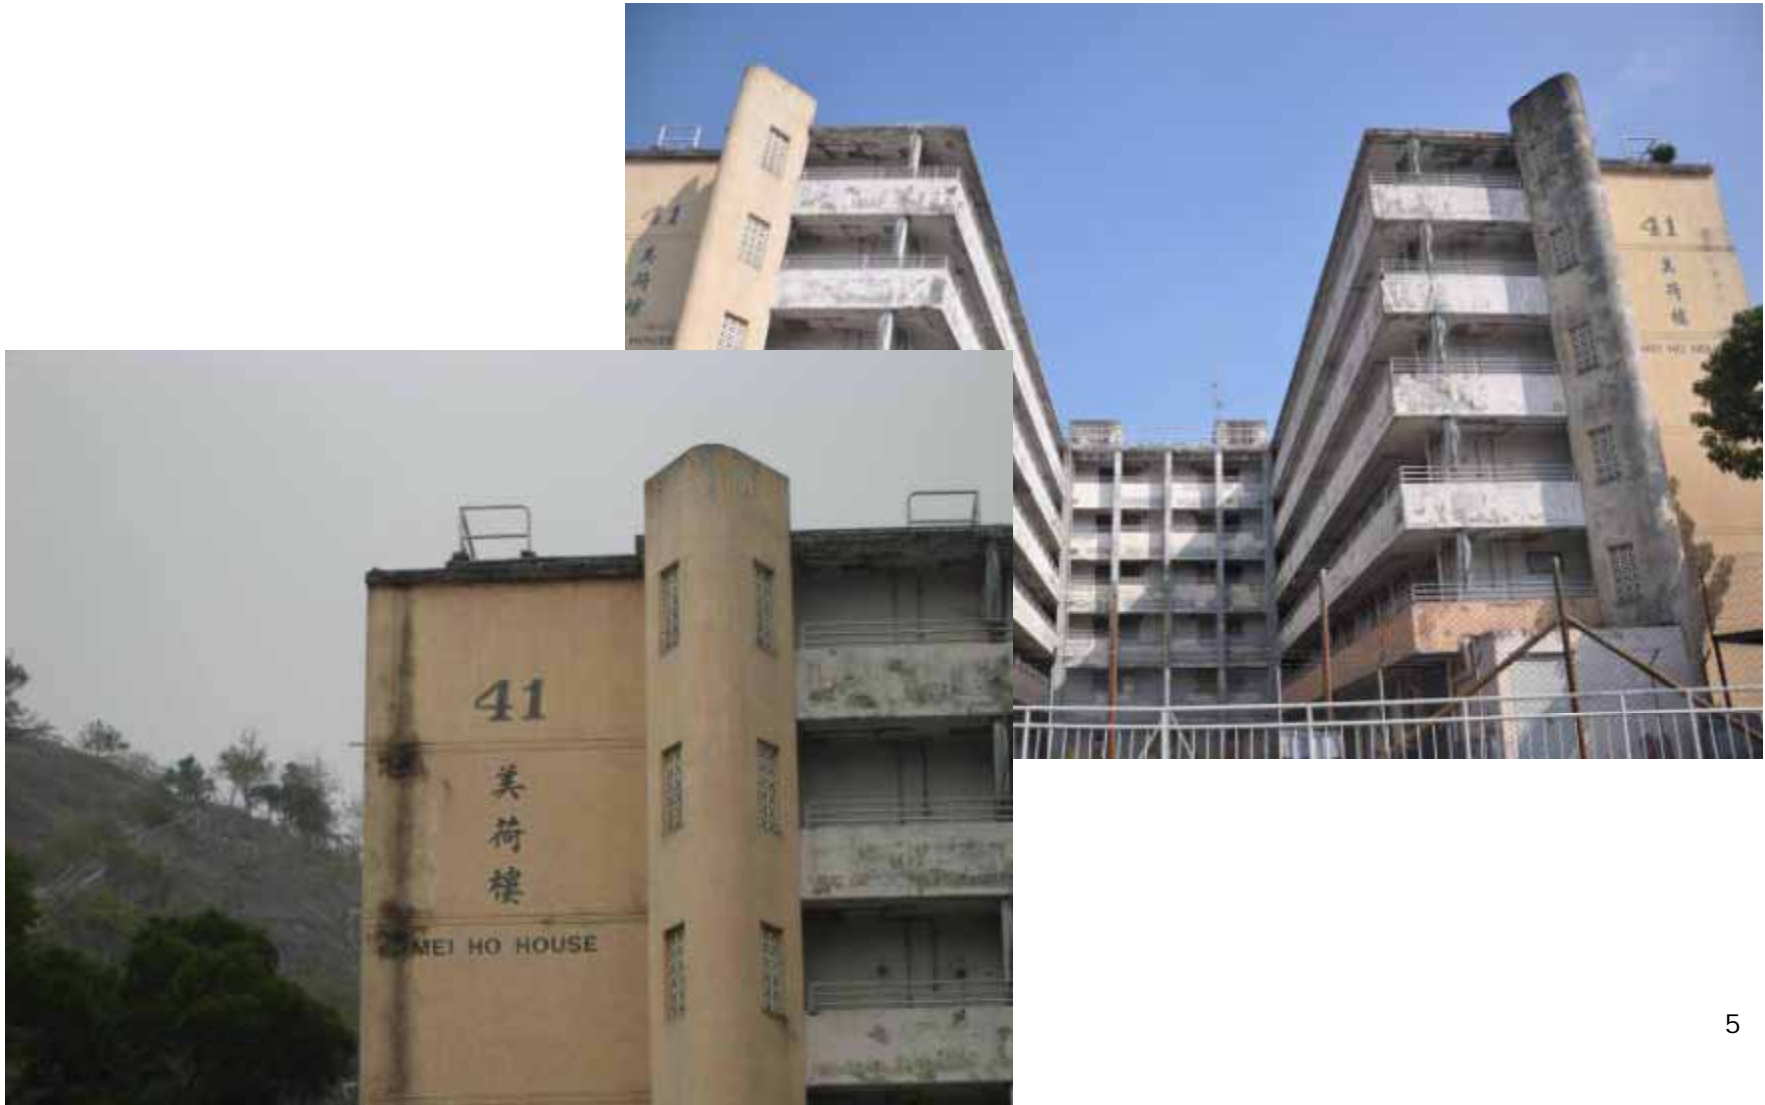
Character defining element – the “Mei Ho House” signage

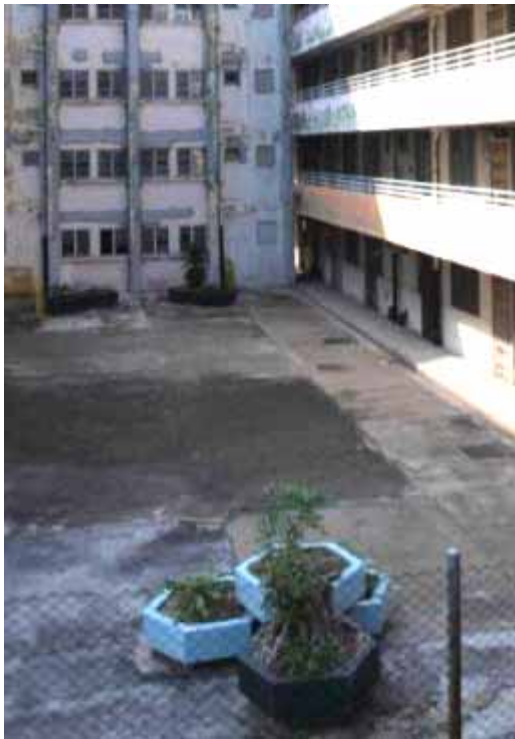
Rear Courtyard

Character defining element – mature tree at rear of the courtyard

- The existing tree had been destroyed during a typhoon in 2009. Another tree at site entrance would be transplanted to the rear courtyard.

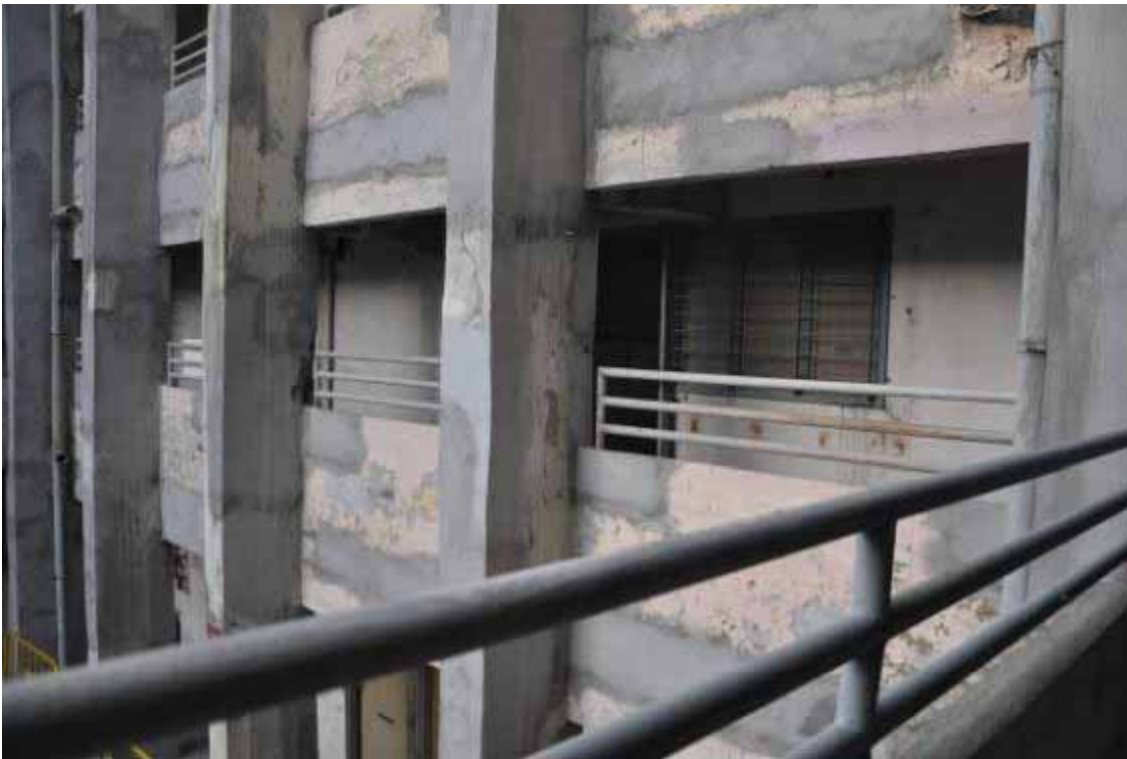
□ Condition of the central block

□ From the structural investigation commissioned by A.S.D. It is reported in 2008. It depicted that –

- Of the five columns at each side of the central connecting block, differential settlement is noted for the one located at the centre
- The two nos. of water tanks at roof are in a poor condition and their water-tightness is in doubt
- High carbonation depth and some chloride contaminated concrete are found

- The central block was needed to be re-constructed to cater for the new passenger lift and disabled and fireman lift. The area in front of the new lifts should be slightly enlarged to cater for visitors waiting and proper circulation. As such, the foot-print is slightly enlarged to accommodate the additional lifts and ancillary facilities for hostel development.

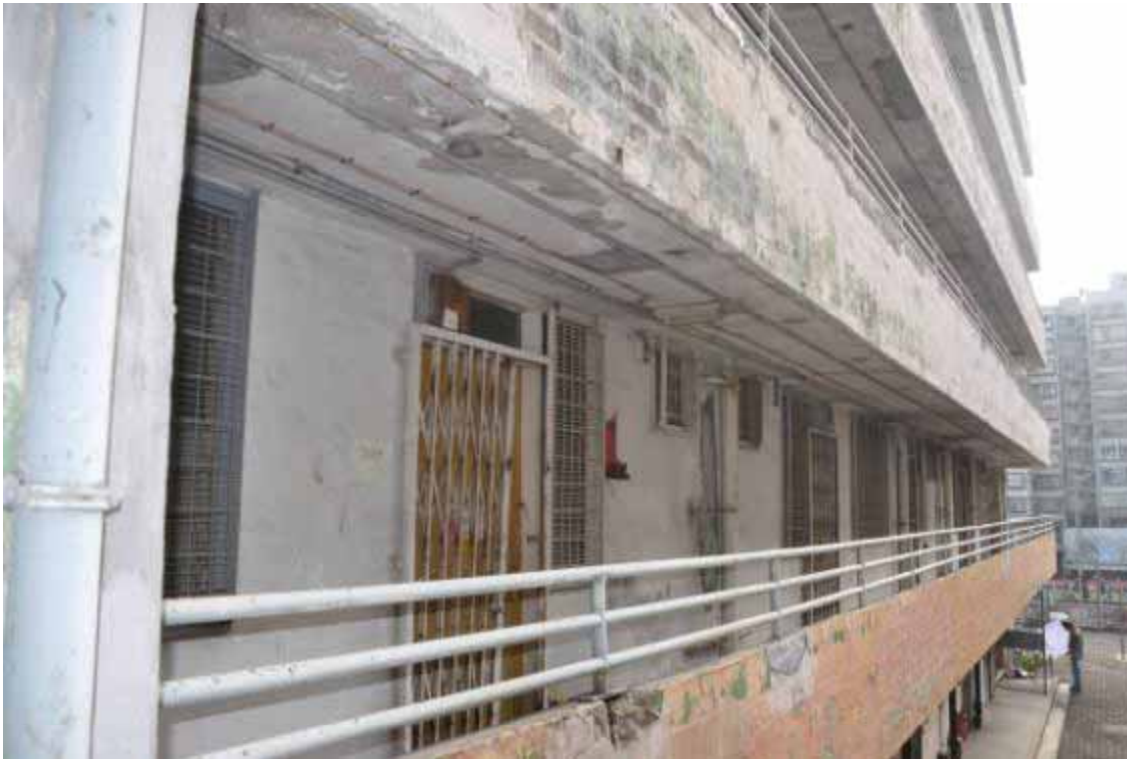
- The open access balcony –

- From the structural investigation commissioned by A.S.D. in 2008. It depicted that –
 - original design live load of the public corridors at each floor was 2.9 kPa,
 - now it could only take 2.0 kPa, and
 - the loading requirements for corridor in the Buildings Ordinance is 3.0 kpa.
- The brick parapet wall could not satisfy the statutory requirements on lateral impacted load.

- Replacement of the top surface concrete of the slab by high-performance concrete – may not be able to achieve the required loading.
- Addition of steel beams at the soffit of the slab – headroom reduced (existing headroom about 2.4 m. (8 feet)) and strengthening elements behind the existing brick parapet wall further reduced the statutorily required width of the means of escape.
- In conclusion, re-construction is needed.

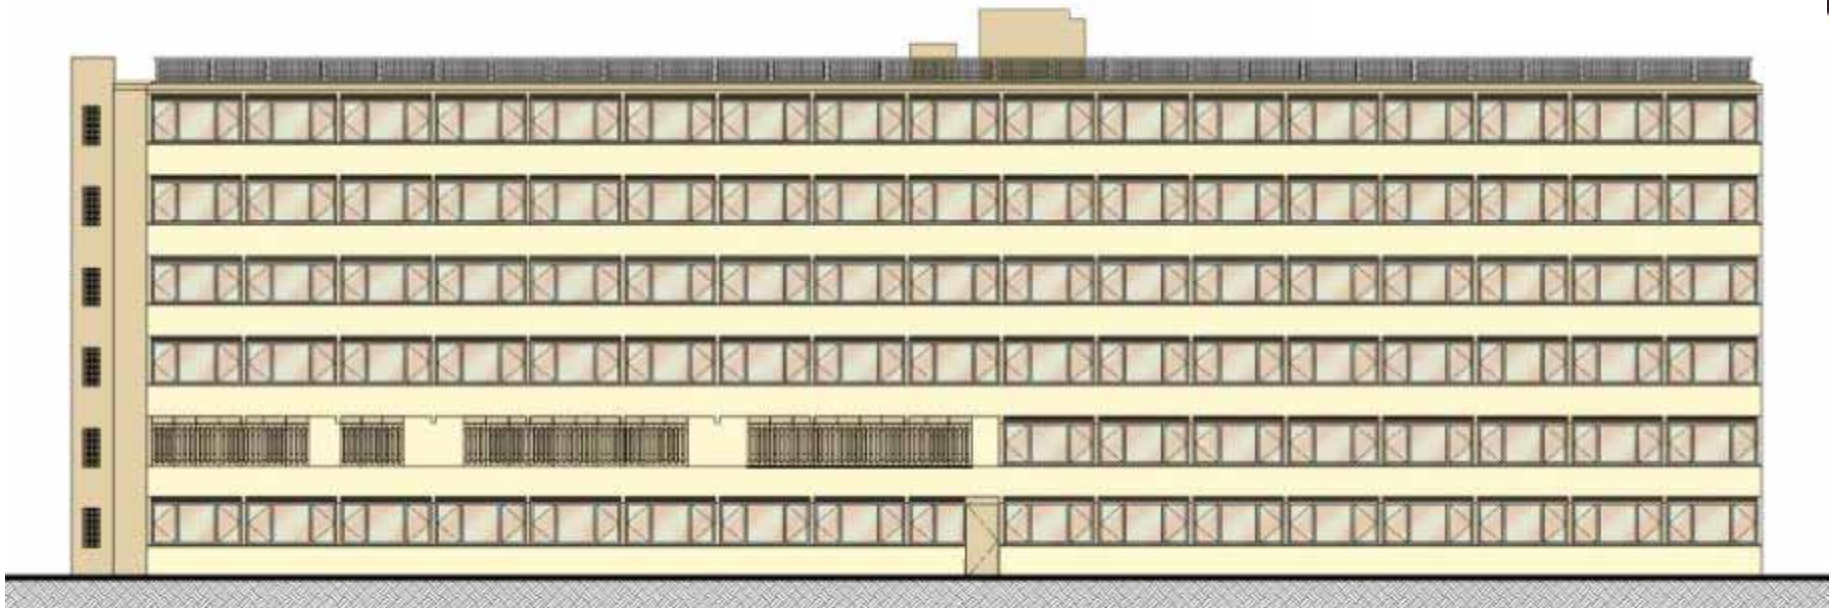
SOUTH-EAST ELEVATION

The twin bed room

- ❑ The size of the twin bed room is about 25 sq.m. (250 sq.ft.).
- ❑ So all internal space including the balcony has to be fully utilized.

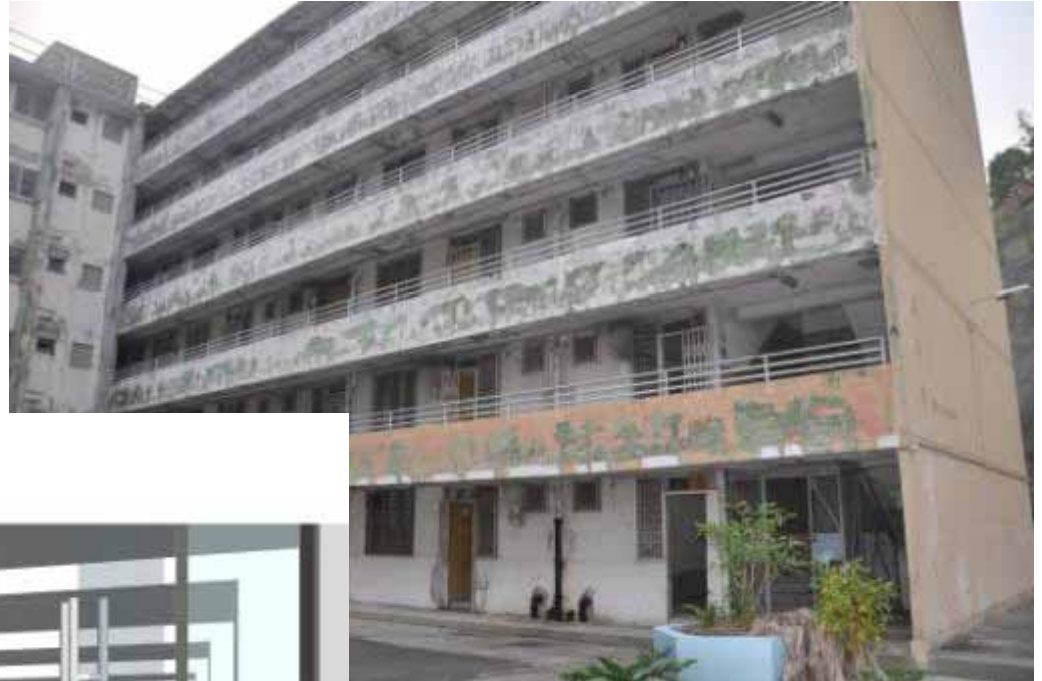
The common room (café) at G/F – integrating interior with the courtyard

- ❑ A proper hostel cannot be operated without a proper multi-purpose function room – addition of a function room is needed.

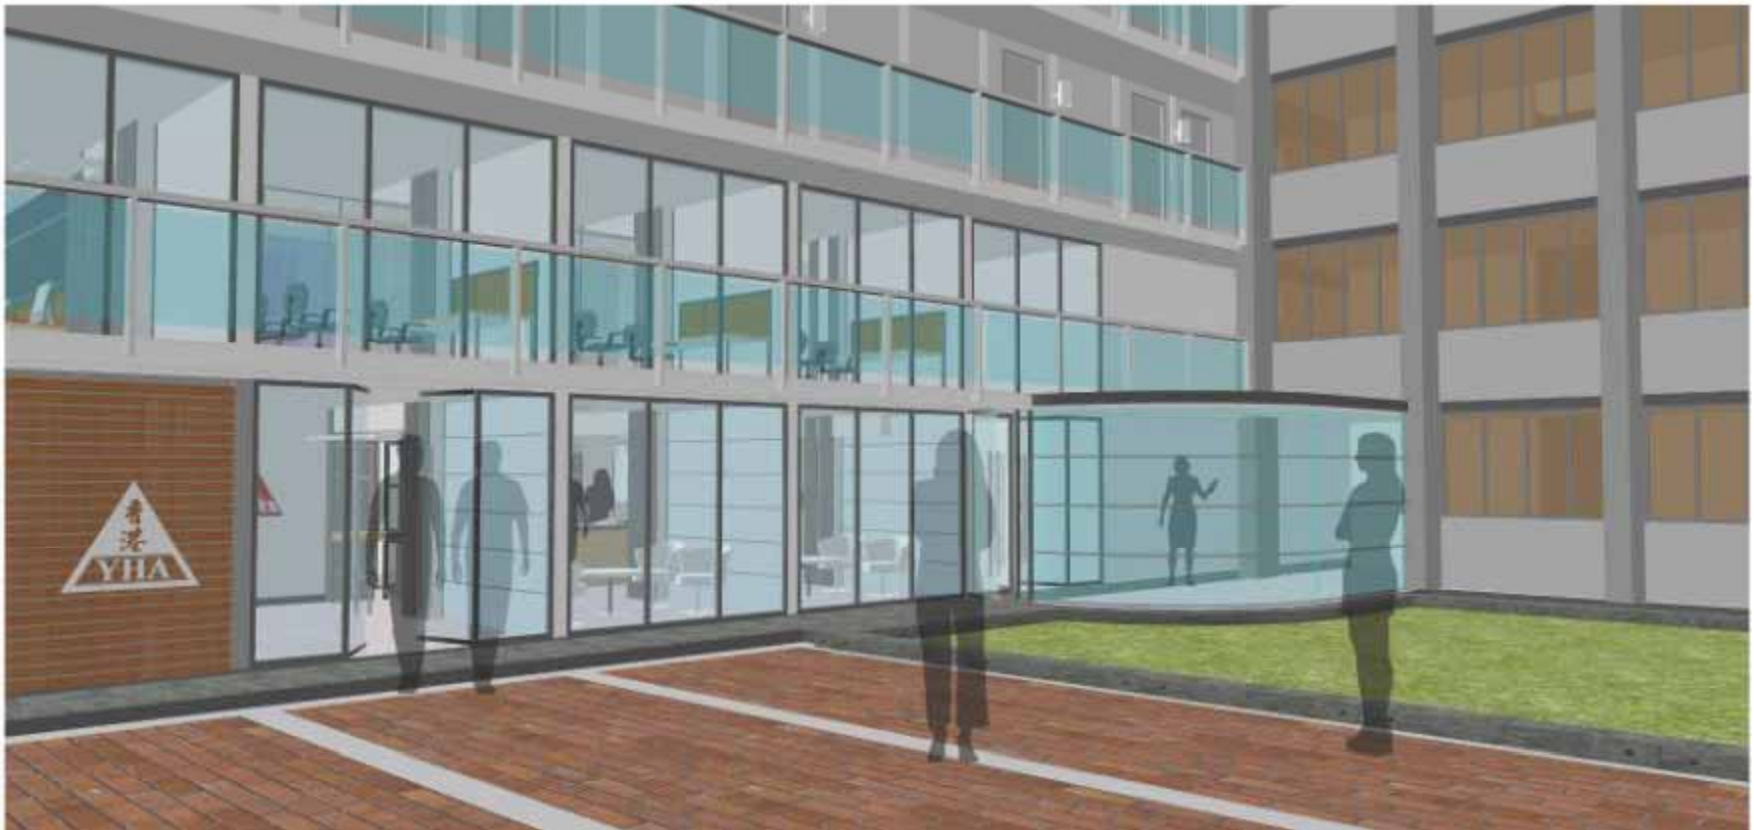
ENTRANCE (FRONT COURTYARD) AT G/F

A weather-proof passage from reception to the lift

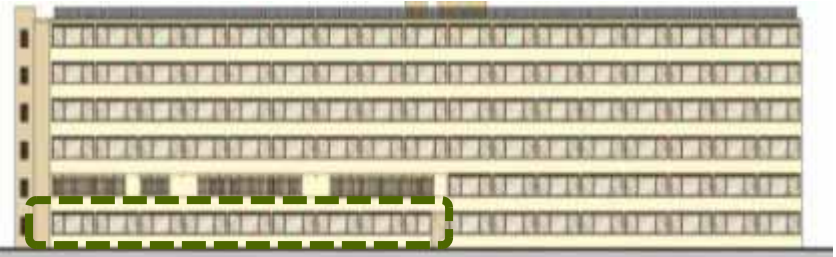
G/F Mei Ho House Museum

Museum Layout Plan

FLOOR FINISH:
EXHIBITION AREA - HEAVY-DUTY CARPET TILE
COLLECTIONS STORES - VINYL FLOOR TILE

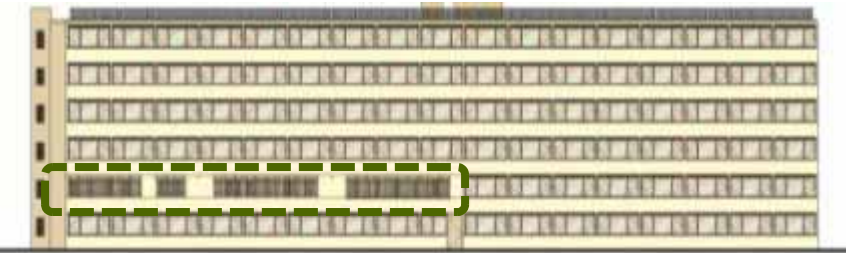
1/F Mei Ho House Museum

Museum Layout Plan

ADDITIONAL B.S. PROVISIONS SHOULD BE AVOIDED ON THE CEILING OF FAMILY FLATS & SHOPS. EXISTING POWER POINTS & LIGHT SWITCHES SHALL BE RETAINED & MADE GOOD FOR PERIOD LAMPS INSTALL BY EXHIBIT FABRICATOR.

FLOOR FINISH:
 50s FAMILIES & SHOPS - CONCRETE
 70s FAMILIES - OLD FASHIONED VINYL FLOOR TILE
 BALCONY & 70s KITCHEN - RETAIN / CONCRETE
 STORES - VINYL FLOOR TILE
 OTHER EXHIBITION AREAS SHALL BE HEAVY-DUTY CARPET TILE
