Provision of Architectural Designs of
Protection and Visitor Facilities for
Rock Carvings and Inscription in Hong Kong

FINAL REPORT

15th March 2012

THE UNIVERSITY OF HONG KONG 香港大學
faculty of architecture 建築學院
Community Project Workshop 社區項目工作坊

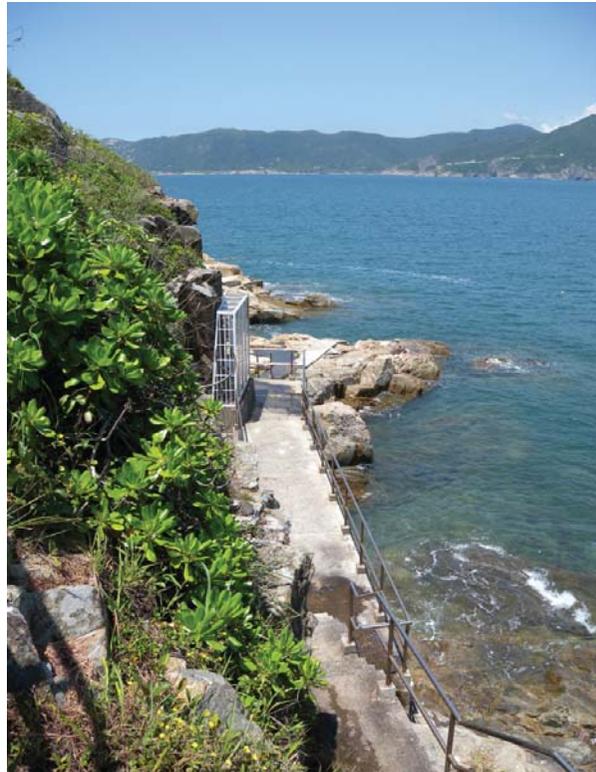
- Stainless steel shelter with Perspex covers
- Concrete viewing platform and footbridge
- Concrete water diversion dam
- Concrete platform for the shelter

- Natural setting being ignored
- Opening at the sides allow the carvings to be touched
- Deleterious effects of concrete on the rock

Present condition of existing facilities

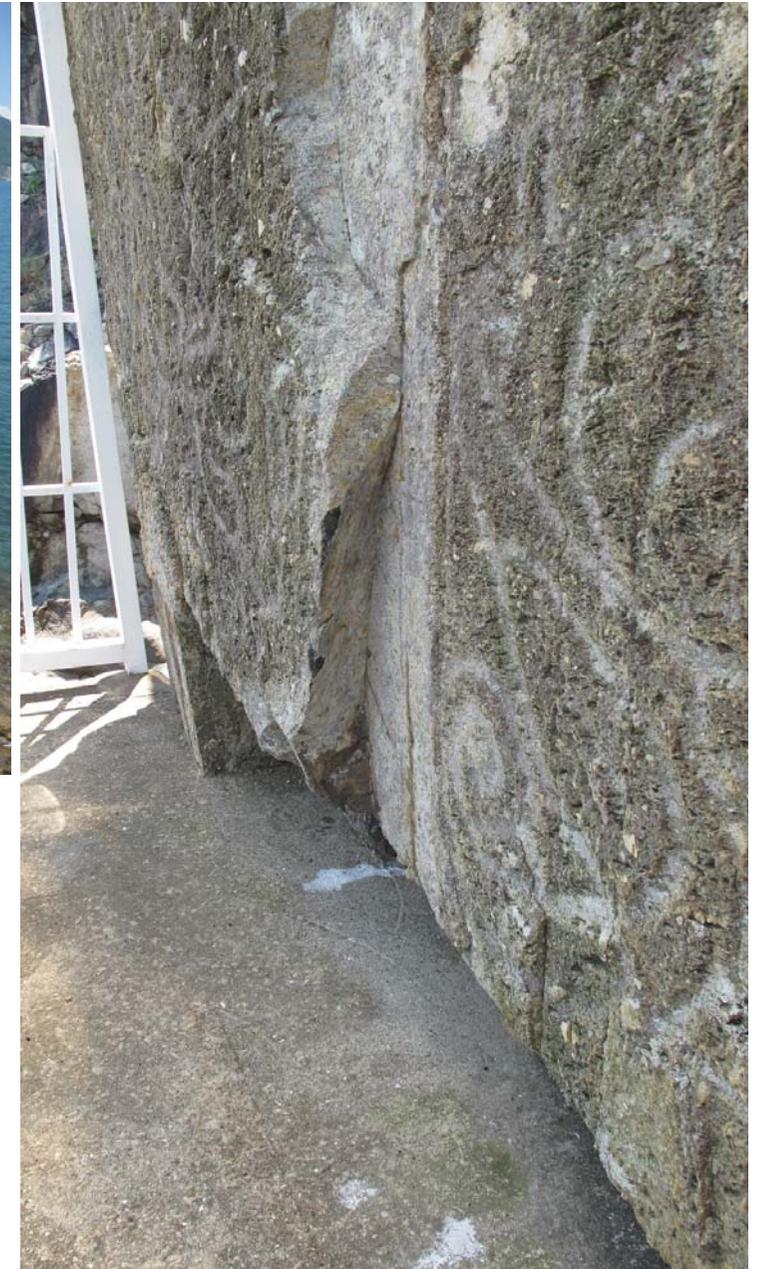
The engraved design at Tung Lung Chau is the largest and most impressive in Hong Kong, with a height of 180cm and a width at base of 240cm. It was executed on a large boulder that stands out somewhat from the other coastal rocks and is only 4 to 5m above sea level.

As at Po Toi, a fracture divides the motifs of this carving. On the right, there seems to be a highly ornate bird although only the head and possibly feet are distinguishable from the swirls and elaboration; to the left there is a conglomerate of figures with several 'eyes' and other non-distinct units. The carving is also similar to the Po Toi group in setting – on a remote rocky coast distant from any possible settlement. Tung Lung Island itself has no known prehistoric sites.

Current appearance of the carving

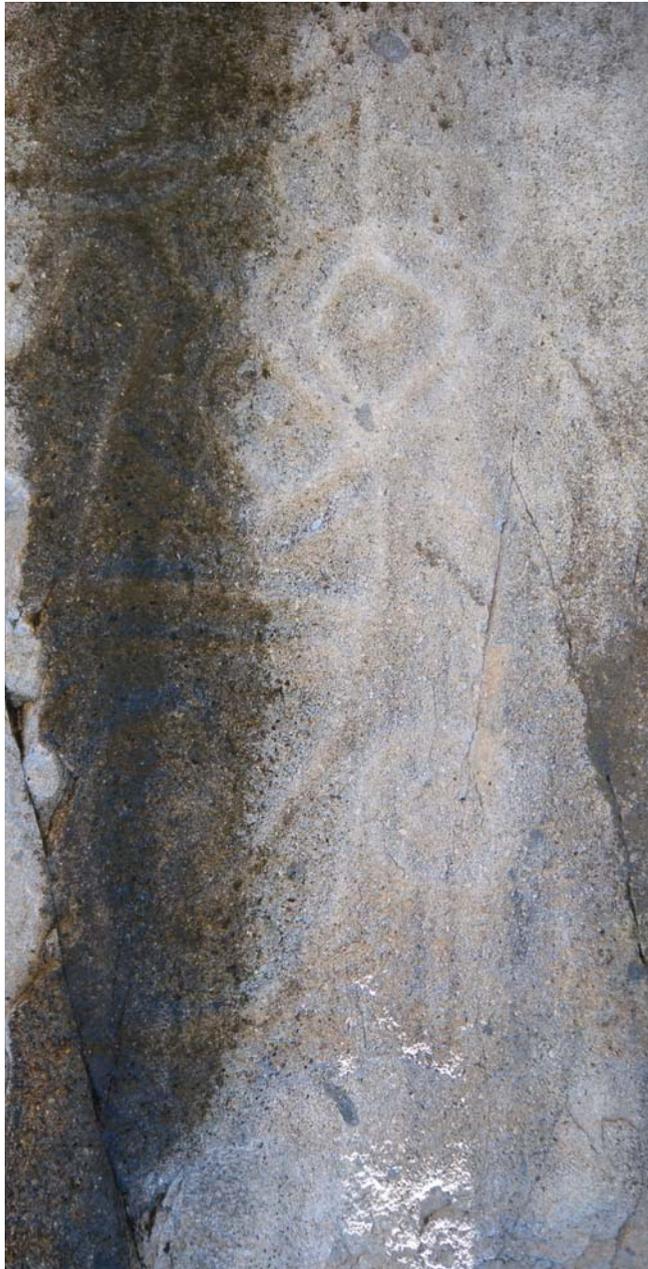
Current appearance of the carving

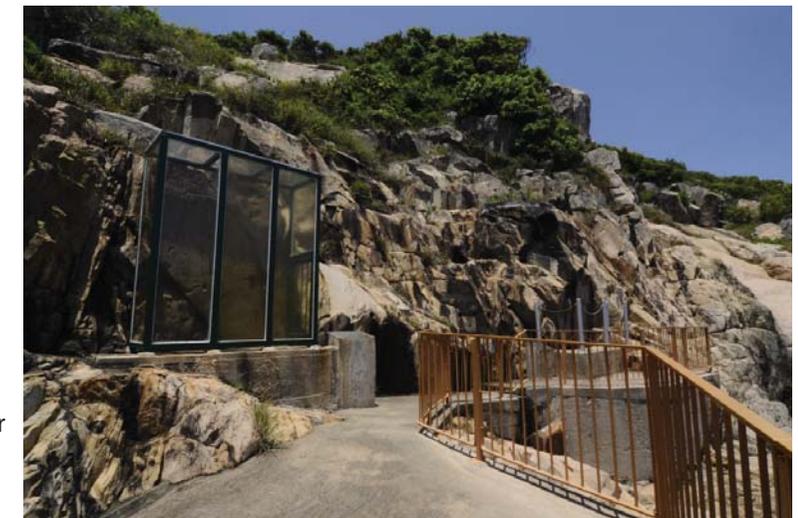
- Iron frame protective shelter with Perspex covers for the carving
- Concrete platform for the shelter
- Concrete barriers for the carving
- Viewing platform

- Concrete platform for the rock carving
- Chains barrier for carving
- Concrete water diversion dam for the carving

- Temporarily stabilized
- Natural process of spalling off from the rock surface in thin layers
- Failure of the water diversion dam
- Shelter damaged after recent typhoon
- Concrete platform/concrete block
- Archaeological and natural setting altered
- The Perspex case may create micro-climate
- Insufficient ventilation
- Growth of micro-organisms

Present condition of existing facilities

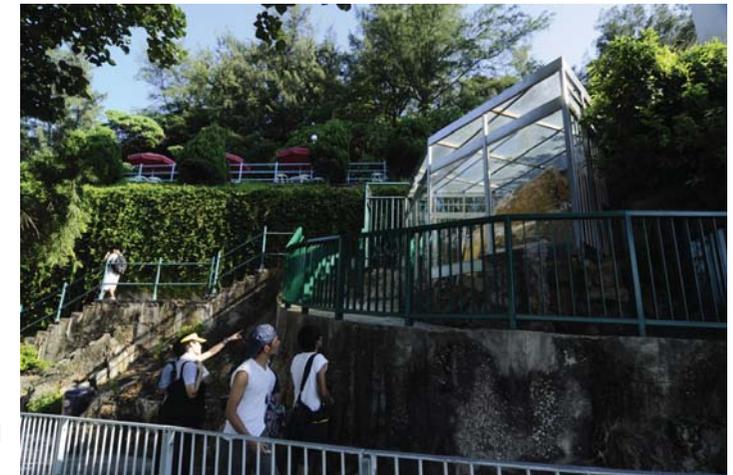
- Concrete water diversion dam
- Stainless steel frame with glass panels

- One large rock face is experiencing degradation
- Water dripping from the roof
- Wind focused by the openings
- Condition of the rock outcrop is not very stable.
- The enclosure of the rock carving has space at the top large enough for a person to climb through and gain access to the carvings

Present condition of existing facilities

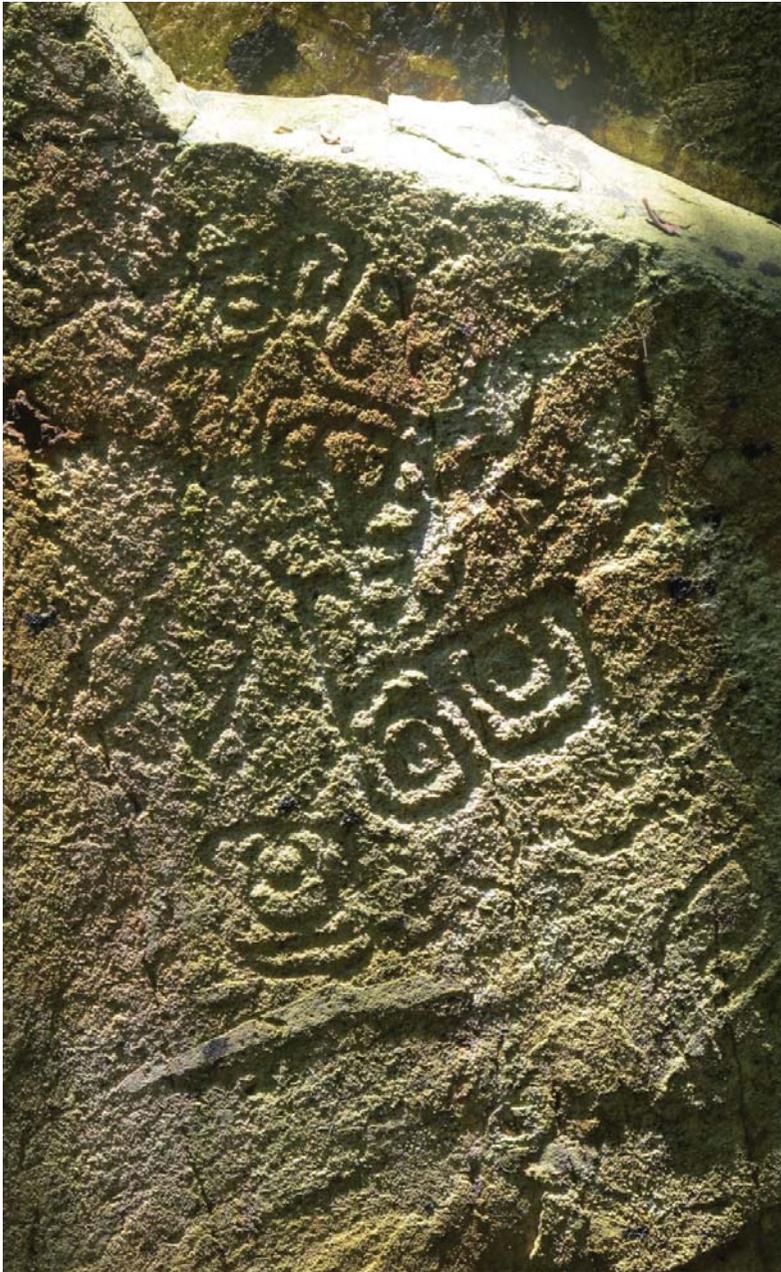
Current appearance of the carving

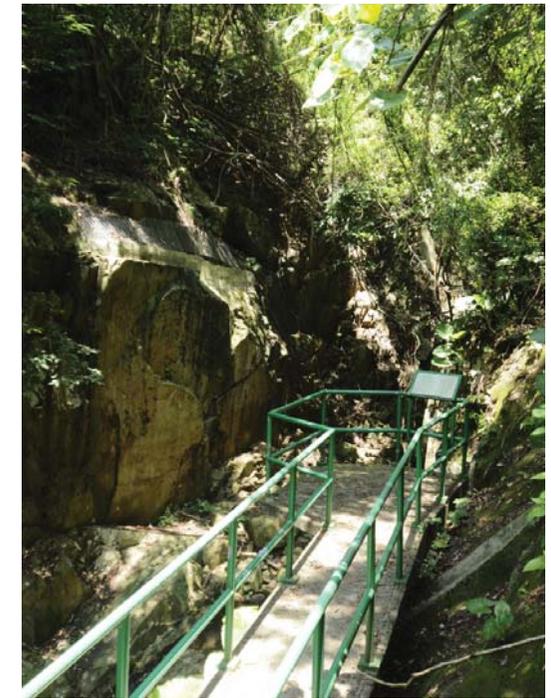
- Stable
- Ineffectual concrete dam directly above the rock face as illustrated by the drip lines below it
- Presence of insects
- There are remnants of squatter huts and chunam on the slope above

Present condition of existing facilities

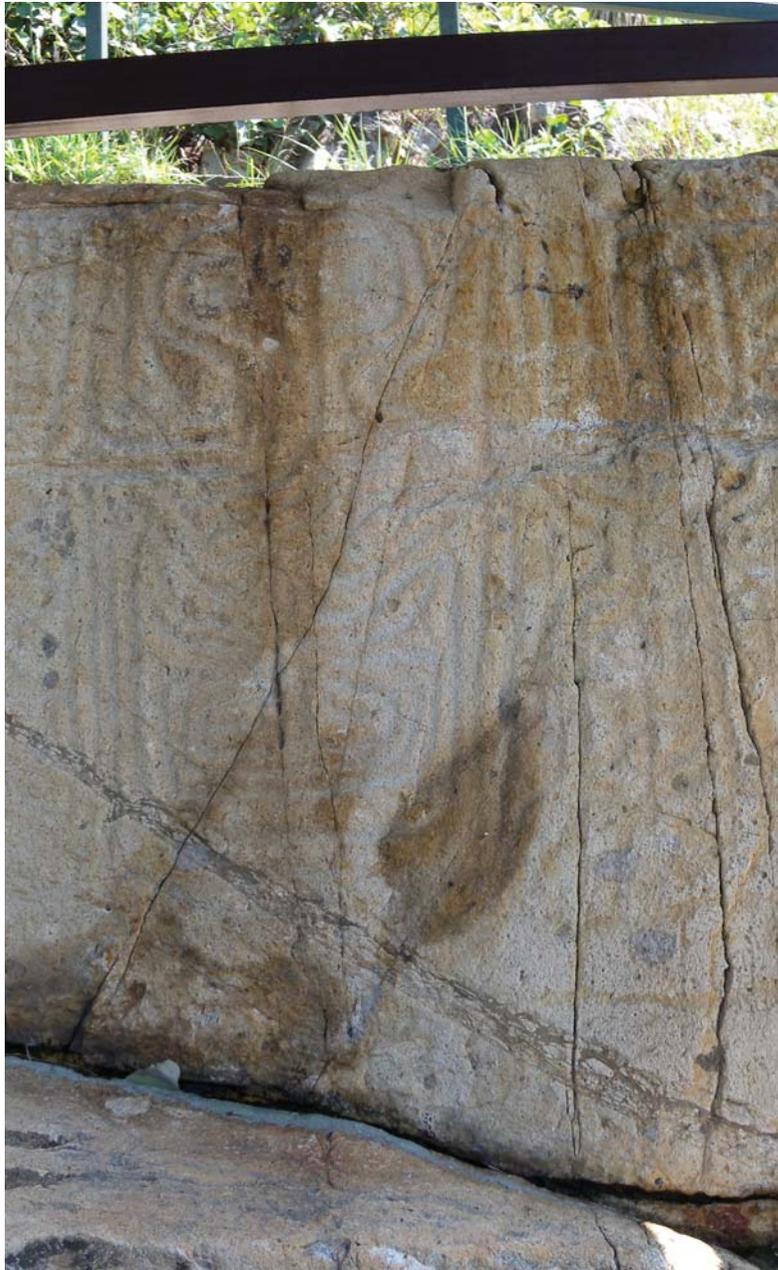
Current appearance of the carving

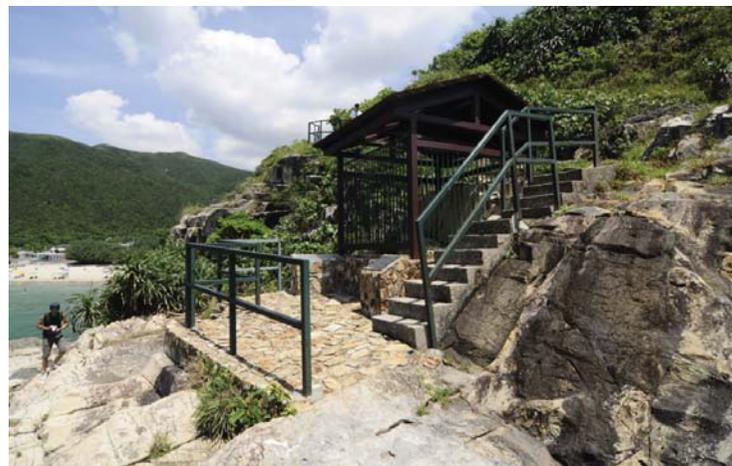
- Carving condition is stable
- No evidence of biological growth
- Most easily accessible rock among all hence more vulnerable to vandalism
- Failure of concrete dam above the rock (trapping instead of diverting water)

Present condition of existing facilities

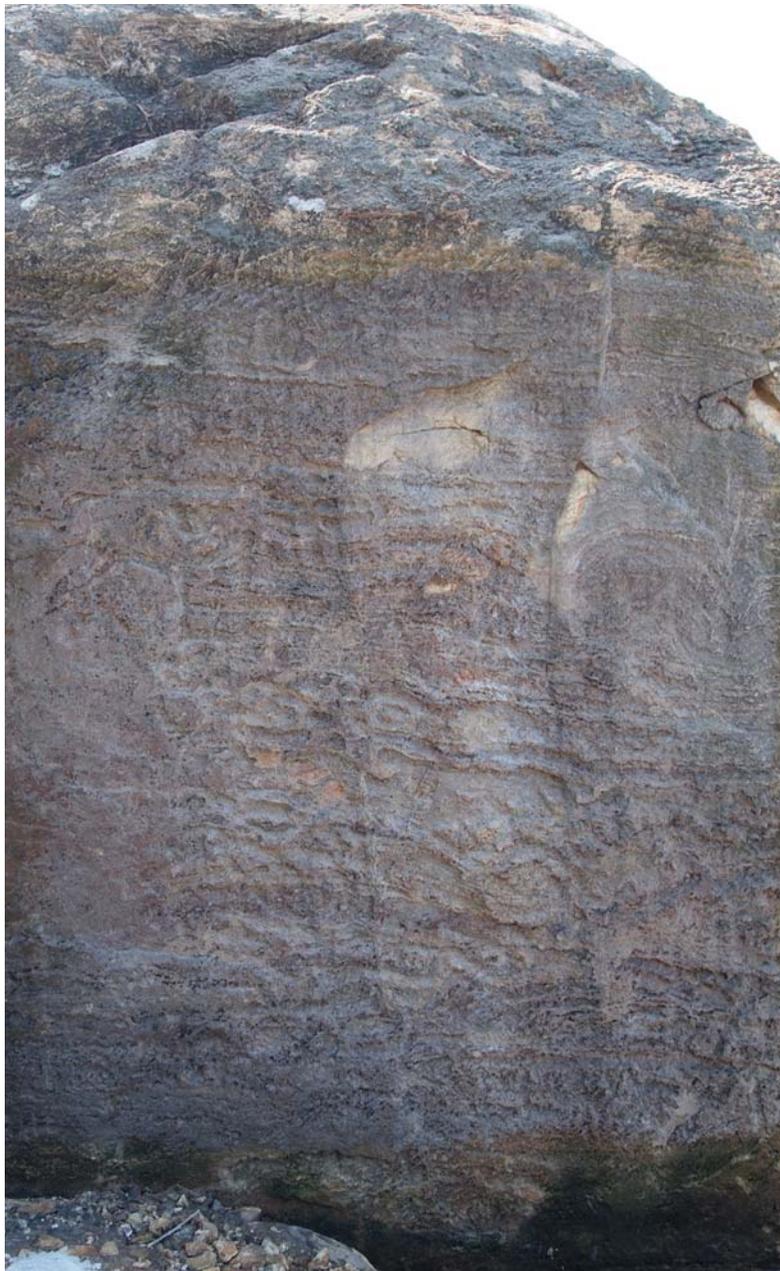
The engraving is located on the vertical face of a rocky area, in very close proximity with the sea. The site is facing east, from where the wind was blowing during our visit. There has always been a debate whether it is an engraving or shapes created by natural erosion of the rock surface.

Current appearance of the carving

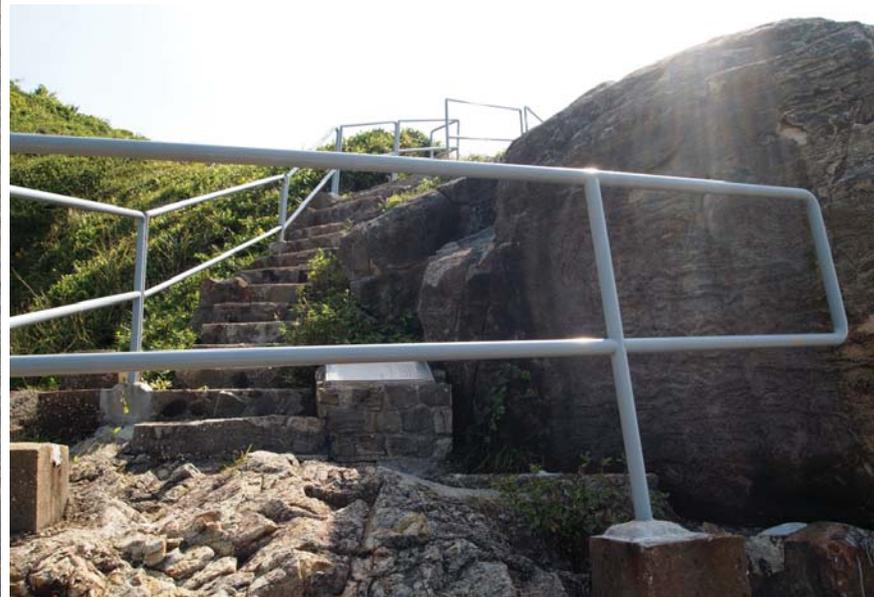
Present condition of existing facilities

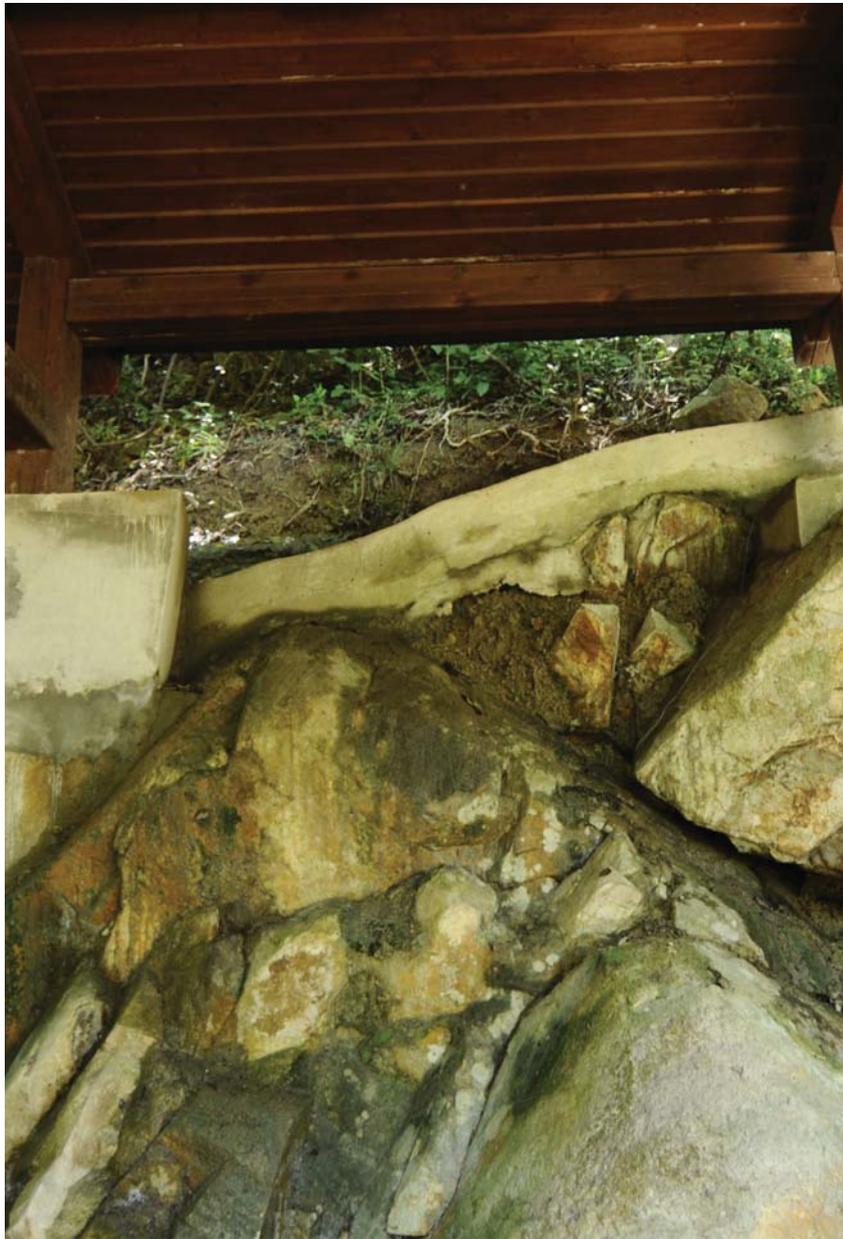
Current appearance of the carving

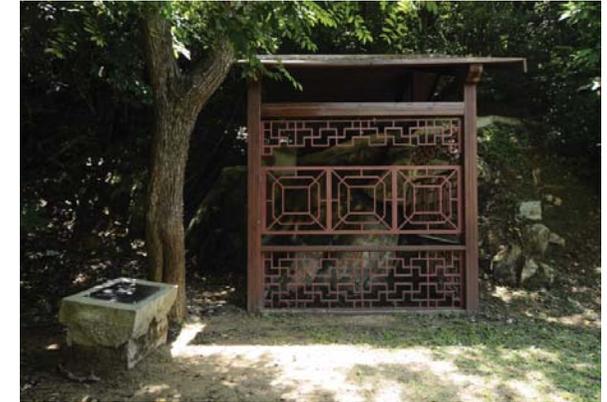
- Potential hazards, mostly created by human intervention
- Pavilion allows air flows, but still alters the natural condition
- Blocking of UV leads the to growth of micro-organisms that may cause damage
- The amount of lichen and other growths on the rock seems to be more than in the 1970s
- Concrete poses a great hazard to the rock

Present condition of existing facilities

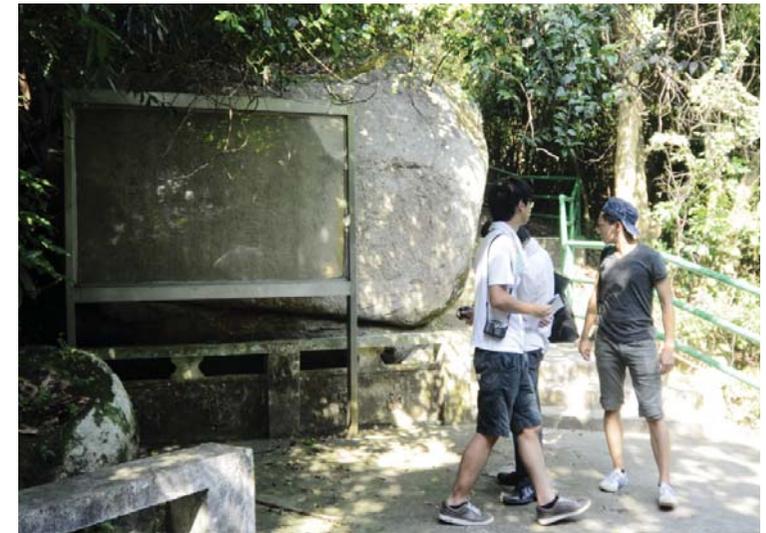
- Perspex protective screen with stainless steel frame

- Stable condition
- Perspex screen does not provide adequate protection, as much of the inscription can be touched from under the screen
- The outer edges should have been blocked with some kind of chainlink or grill

Present condition of existing facilities

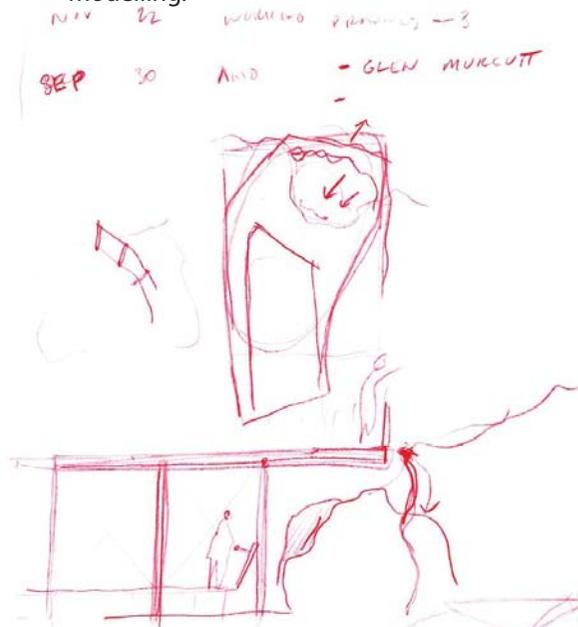
Top: sketch describing relationship of footpath and rock
Bottom: sketch section of rock and visitor and facility

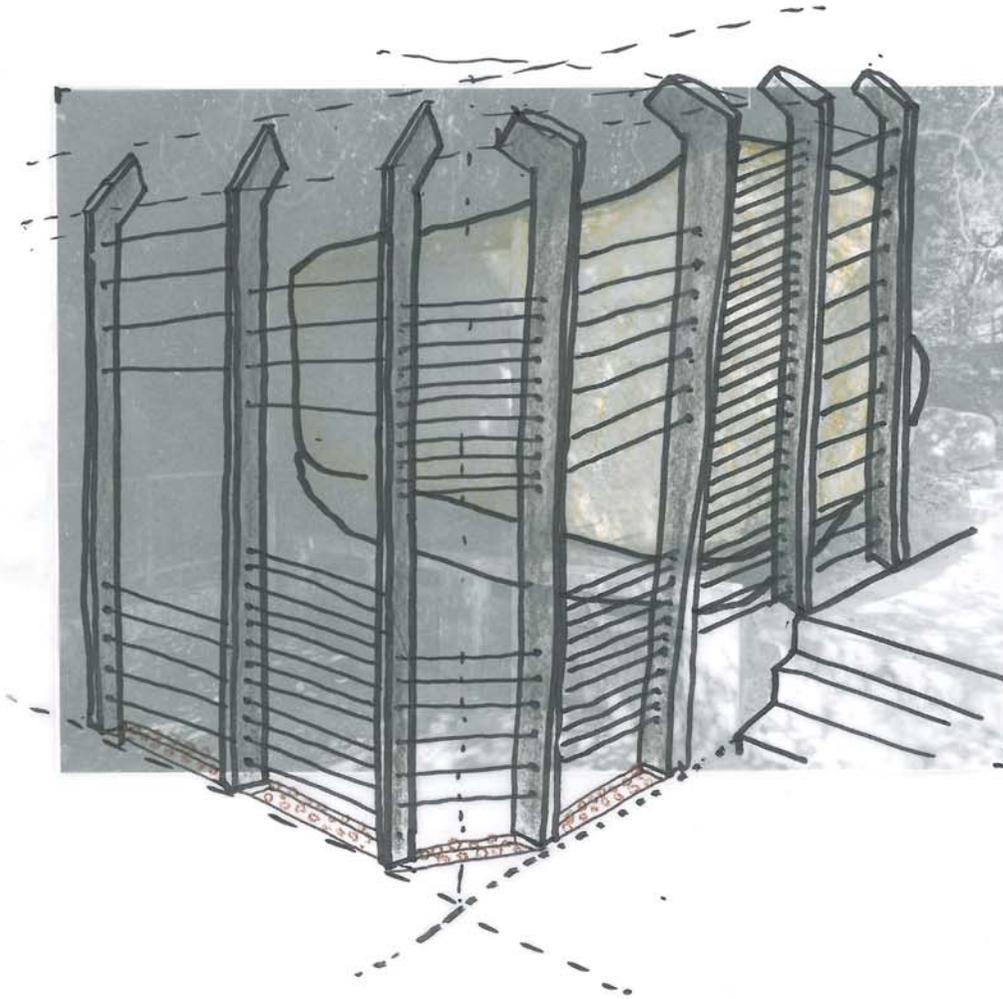
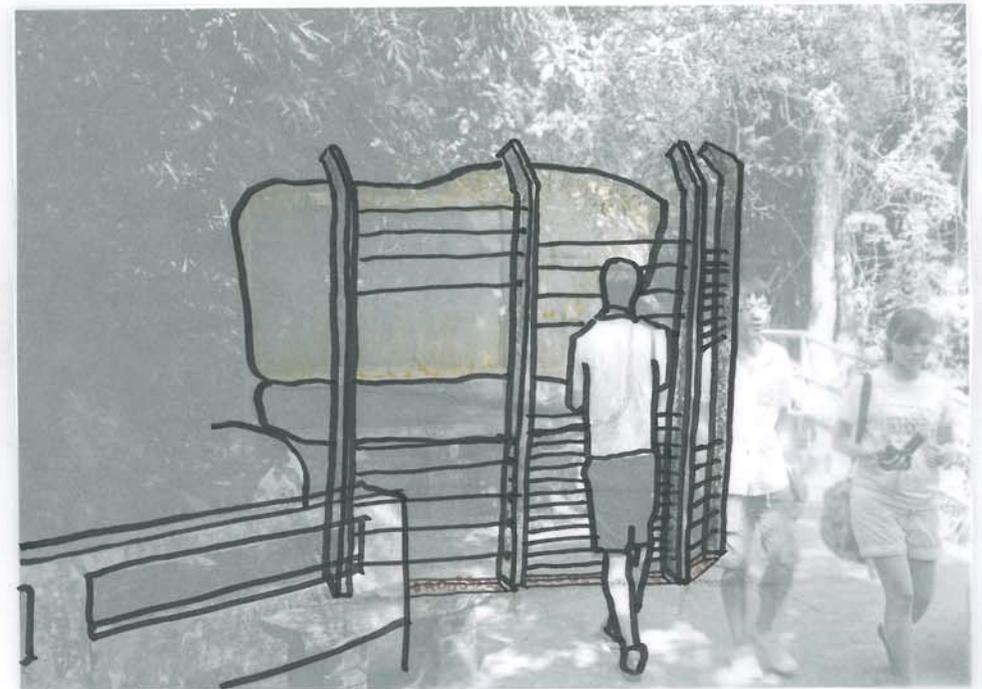
Sketches of stainless steel barrier with wire cables for Joss House Bay

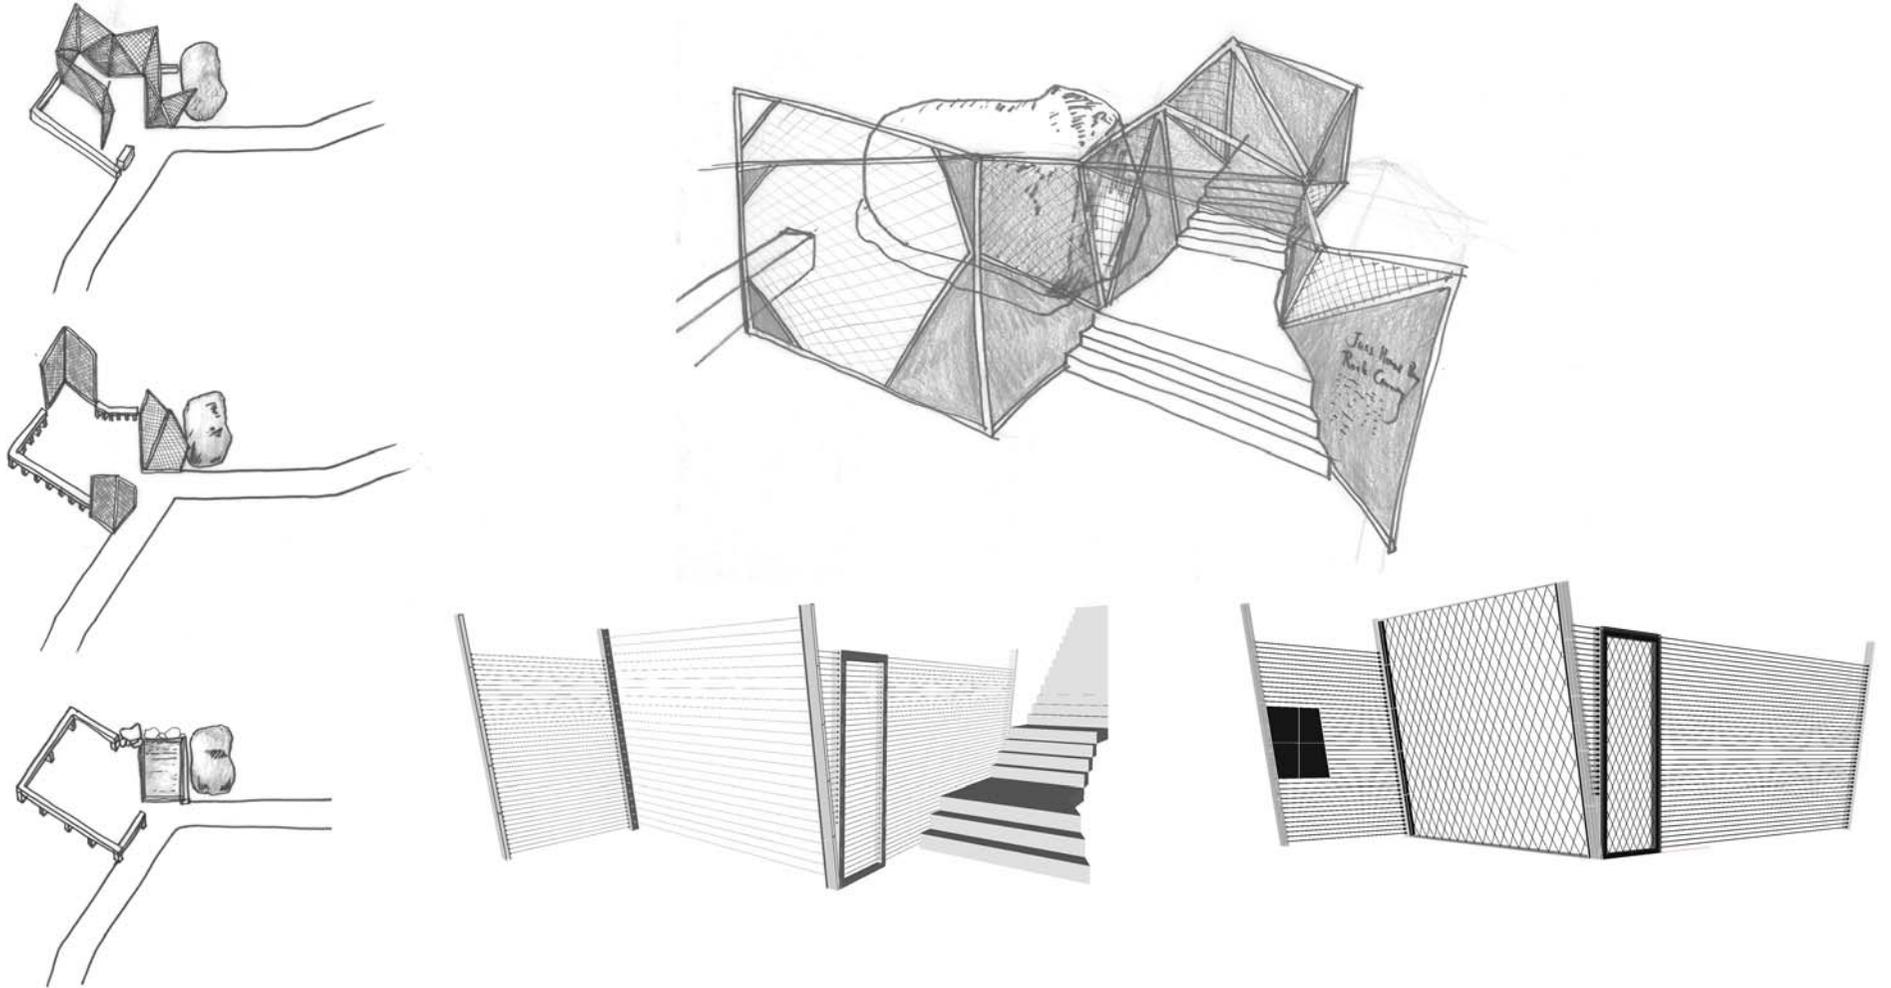
Sketches of stainless barrier with wire cables or mesh for Joss House Bay

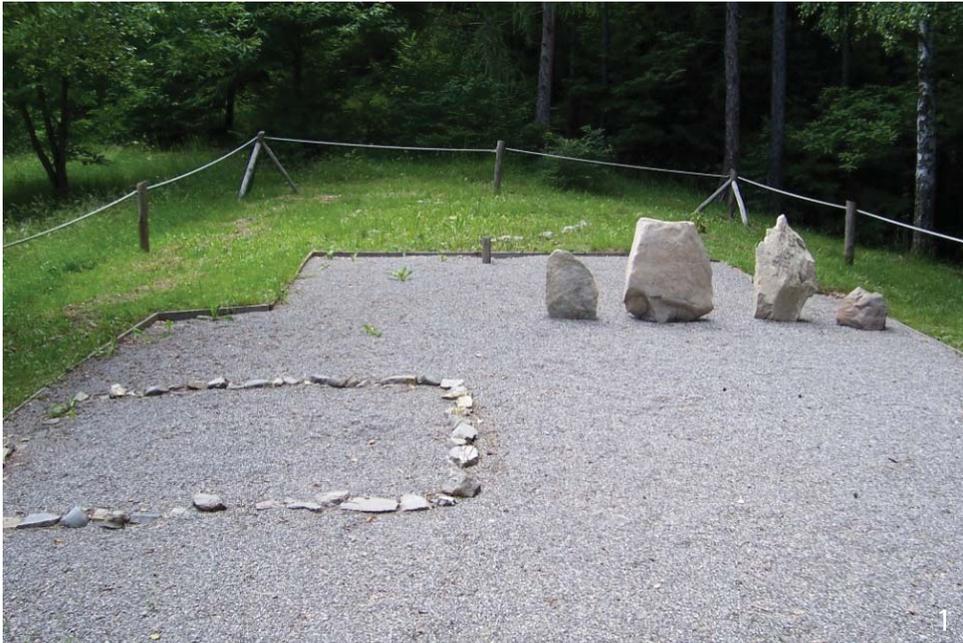
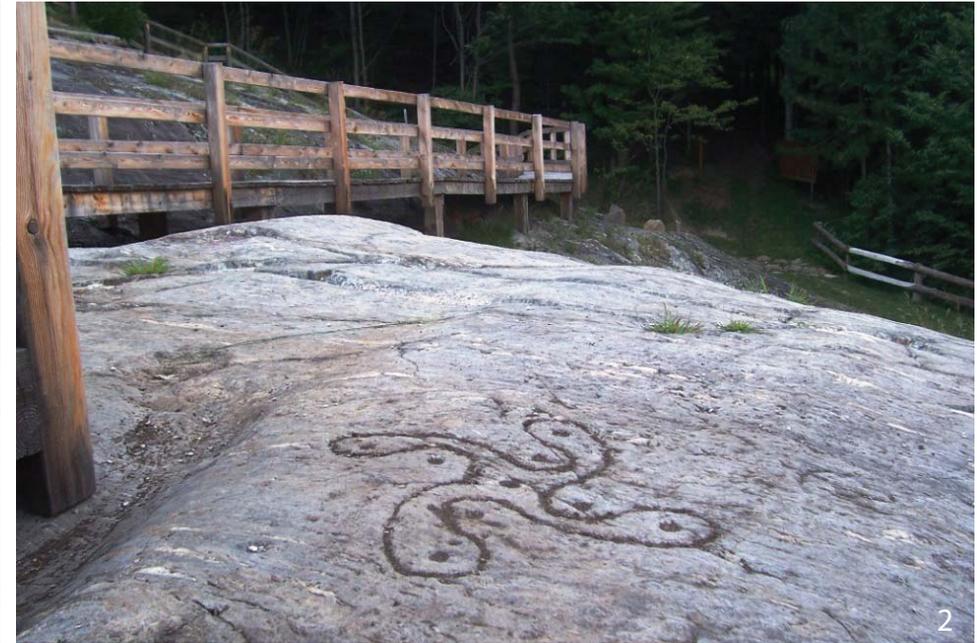
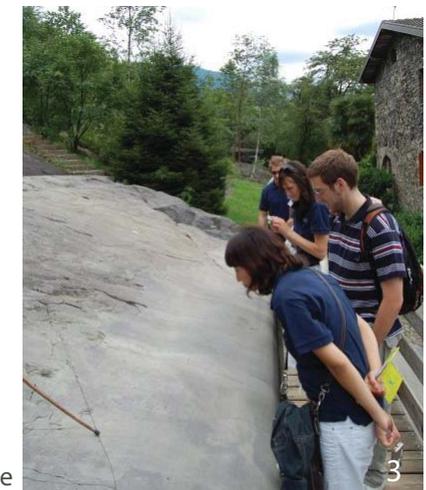
Case Study 1_Rock drawings in Valcamonica, Italy Psychological barrier

No massive visitor facilities are installed on site so to minimize intervention to the original setting. Visitors are guided to various prehistoric stones by wooden footbridges. There are simple, low fences around some of the rocks, functioning as psychological barriers than physical ones.

1. Simple barrier surrounding rock art in Valcamonica
2. Wooden walkway in Valcamonica
3. Visitors appreciating the rock drawings at short distance

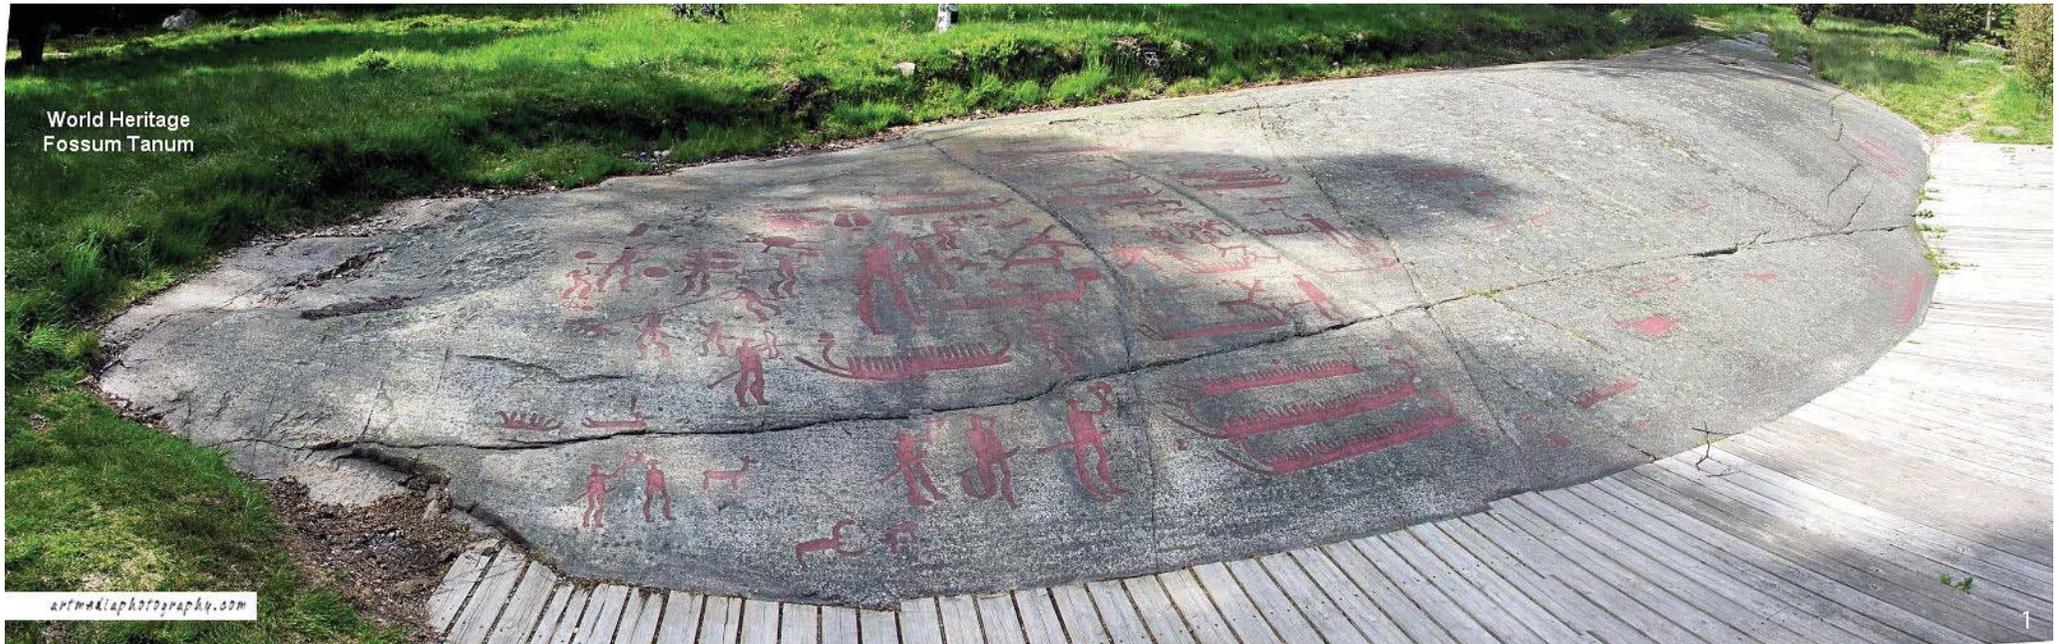
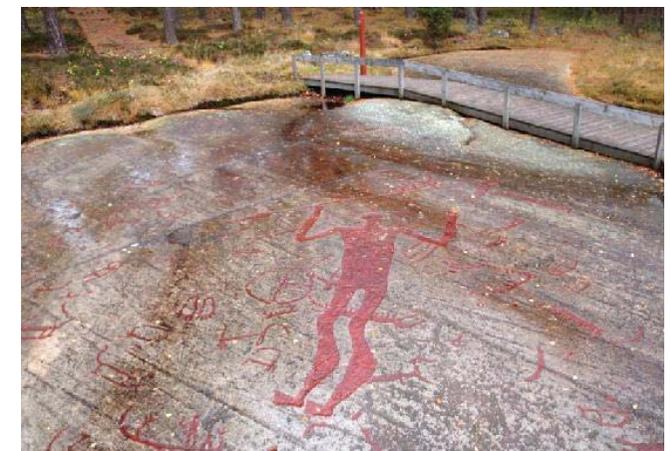
Case Study 3_Rock carvings in Tanum, Sweden No physical barrier

Similar to the previous two examples, the carvings are connected and accessed by wooden walkways. This approach provides good visibility of the rocks.

1-2. Wooden walkways in Tanum

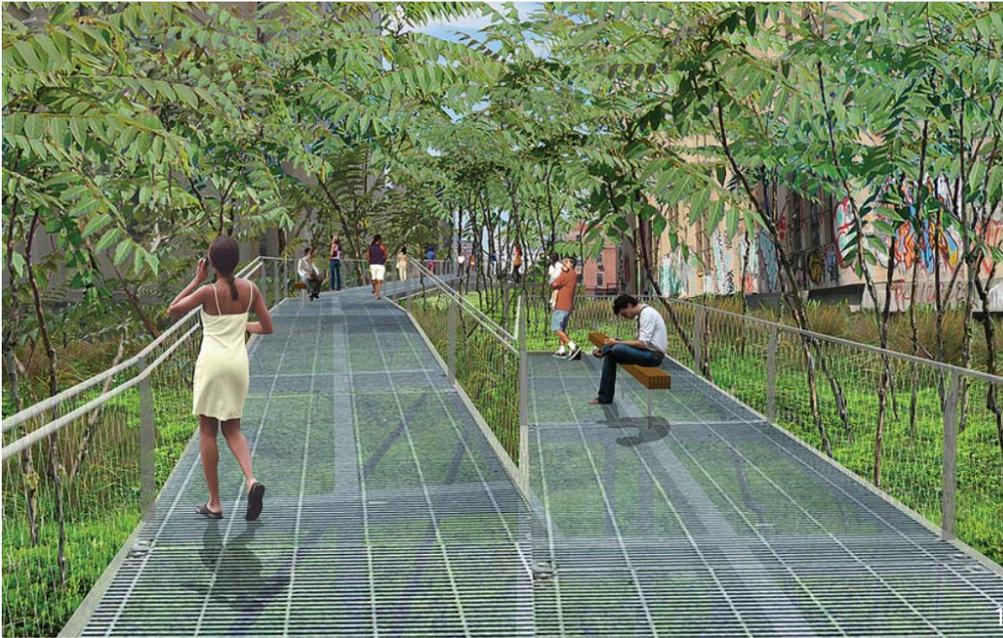
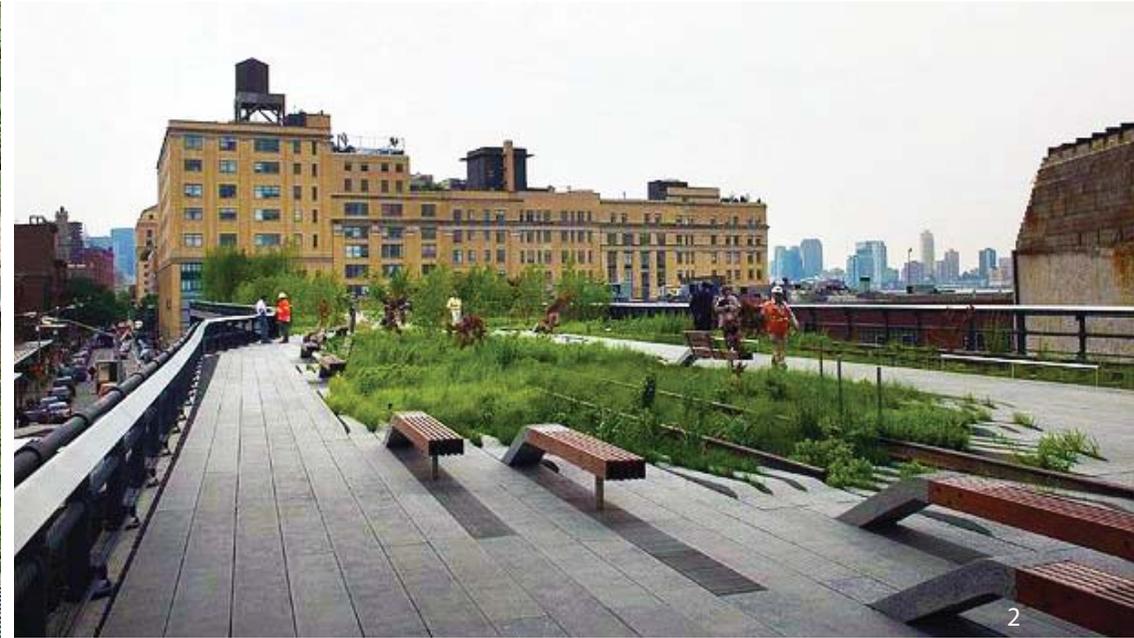
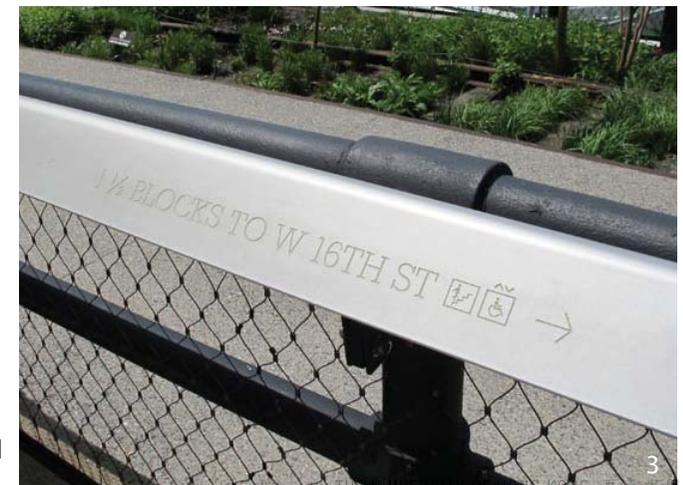
Case Study 4_The High Line, New York City

The park has used wire mesh and other transparent materials for its railings and decking. Seating, signage and other visitor facilities are well integrated into the design. The High Line is a very successful redevelopment scheme and has helped revitalizing the community. It has also demonstrated the way to minimize site intervention and integrate a design with the existing environment by using light and transparent materials.

1. Transporent materials used for railing and footpath
2. Environment and visitor facilites are well-integrated
3. Direction sign incorporated into railing

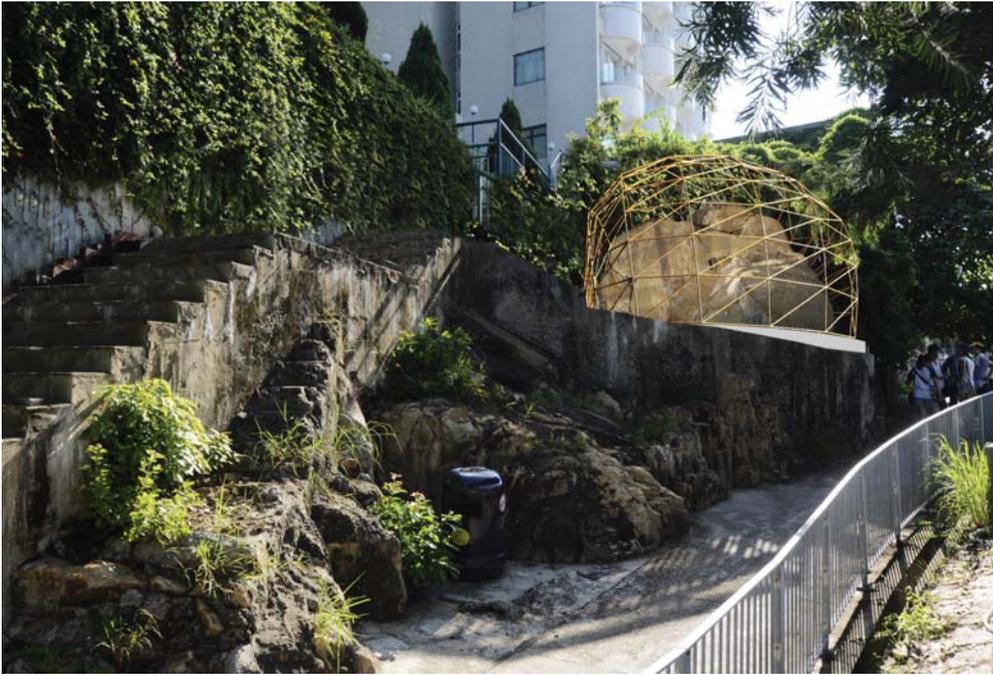
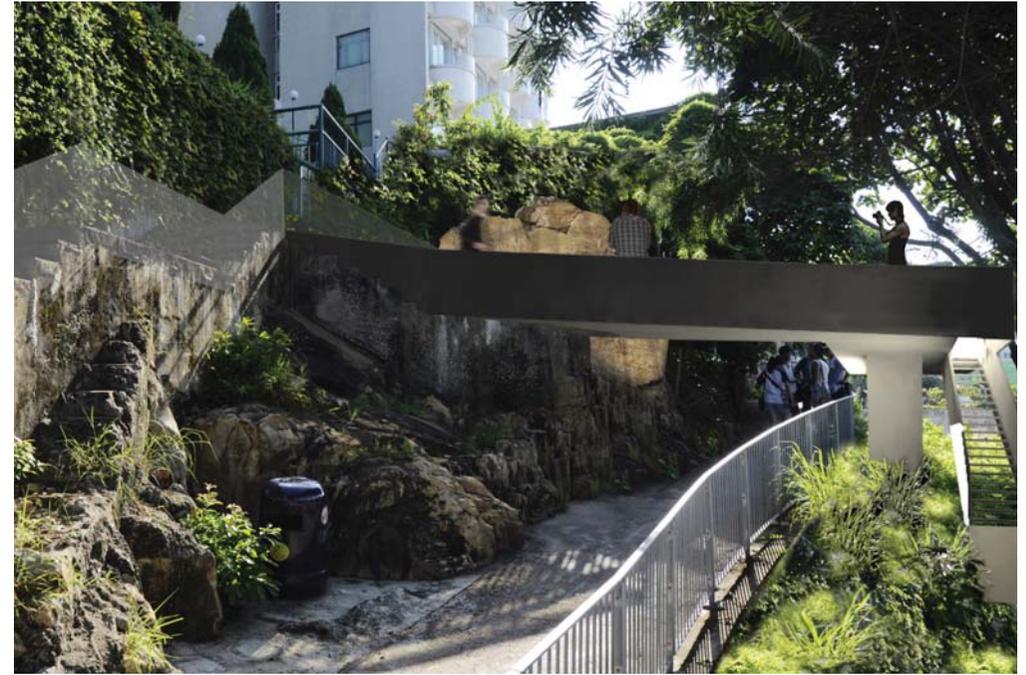
Previous Design Site 3_Cheung Chau Option 1: Weaved shelter

Pro:
- Allows ample air flow and will not create micro-climate

Con:
- The form is visually attractive but may not fit the natural environment

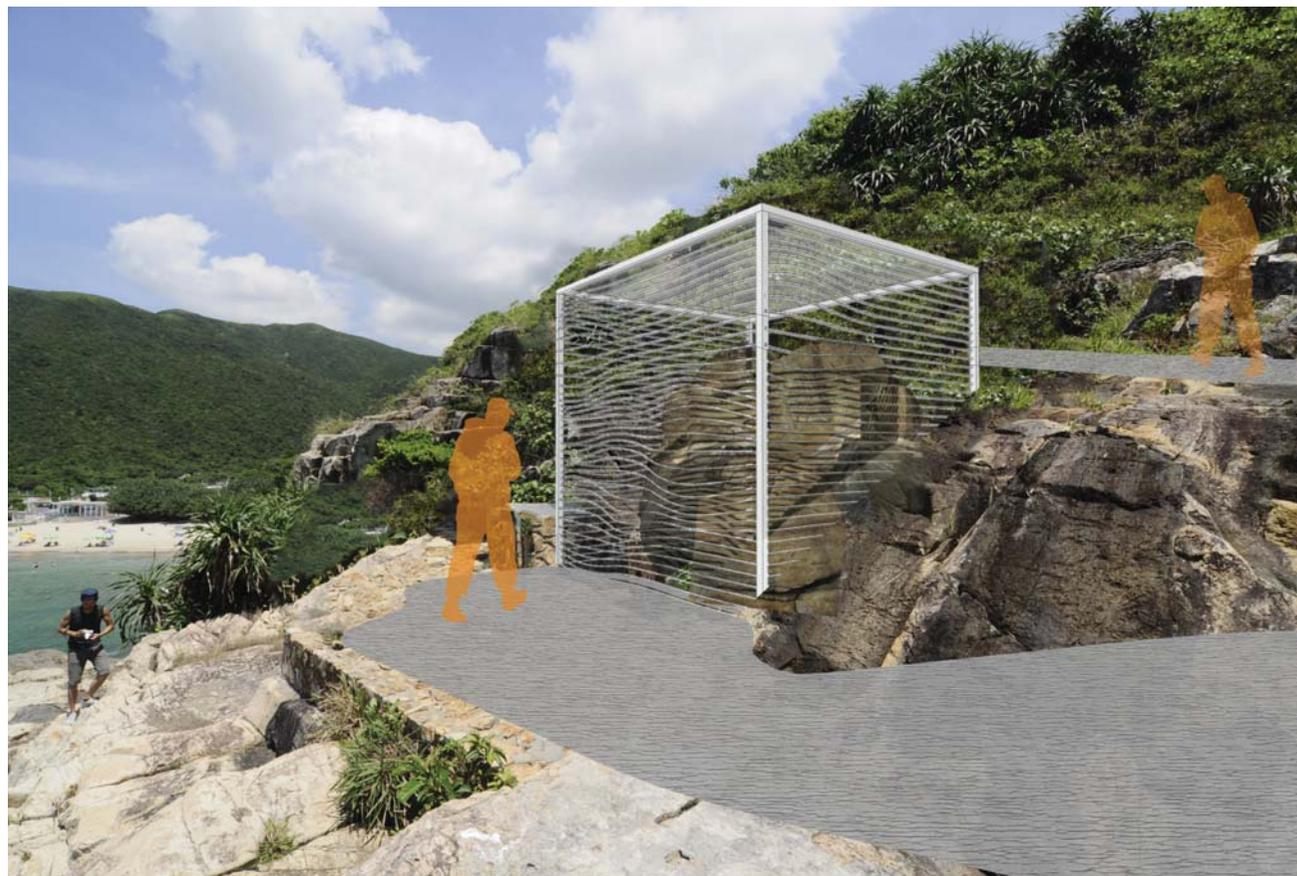
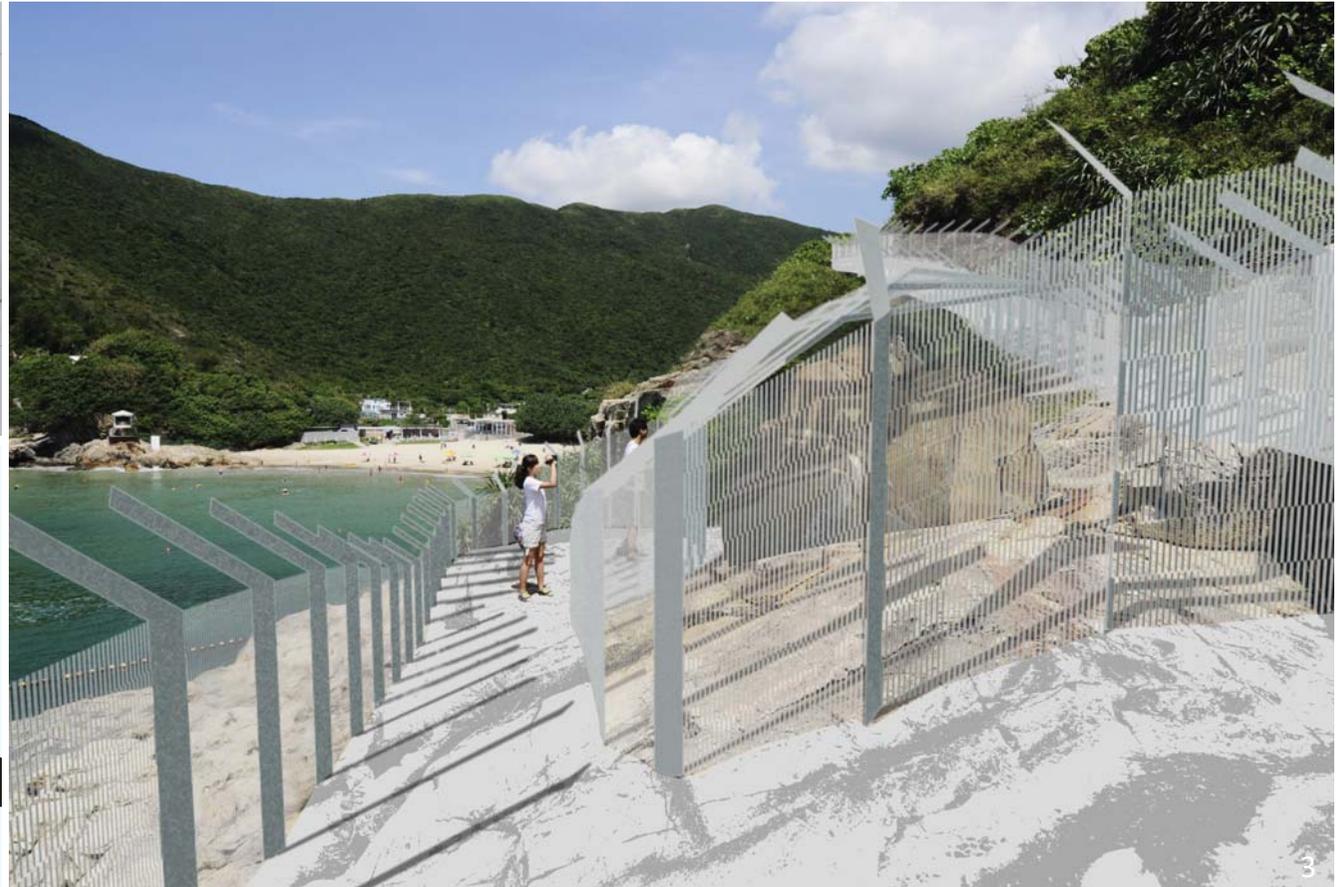
Previous Design Site 5_Big Wave Bay Option 2: Integrated railing and shelter

1. Plan showing diverted path and how the railing transforms and arches over to become a shelter for the rock
2. Elevation of railing/shelter
3. Wire mesh is used for the railing for its transparent and lightweight appearance
