Provision of Architectural Designs of
Protection and Visitor Facilities for
Rock Carvings and Inscription in Hong Kong

FINAL REPORT

15th March 2012

THE UNIVERSITY OF HONG KONG 香港大學
faculty of architecture 建築學院
Community Project Workshop 社區項目工作坊

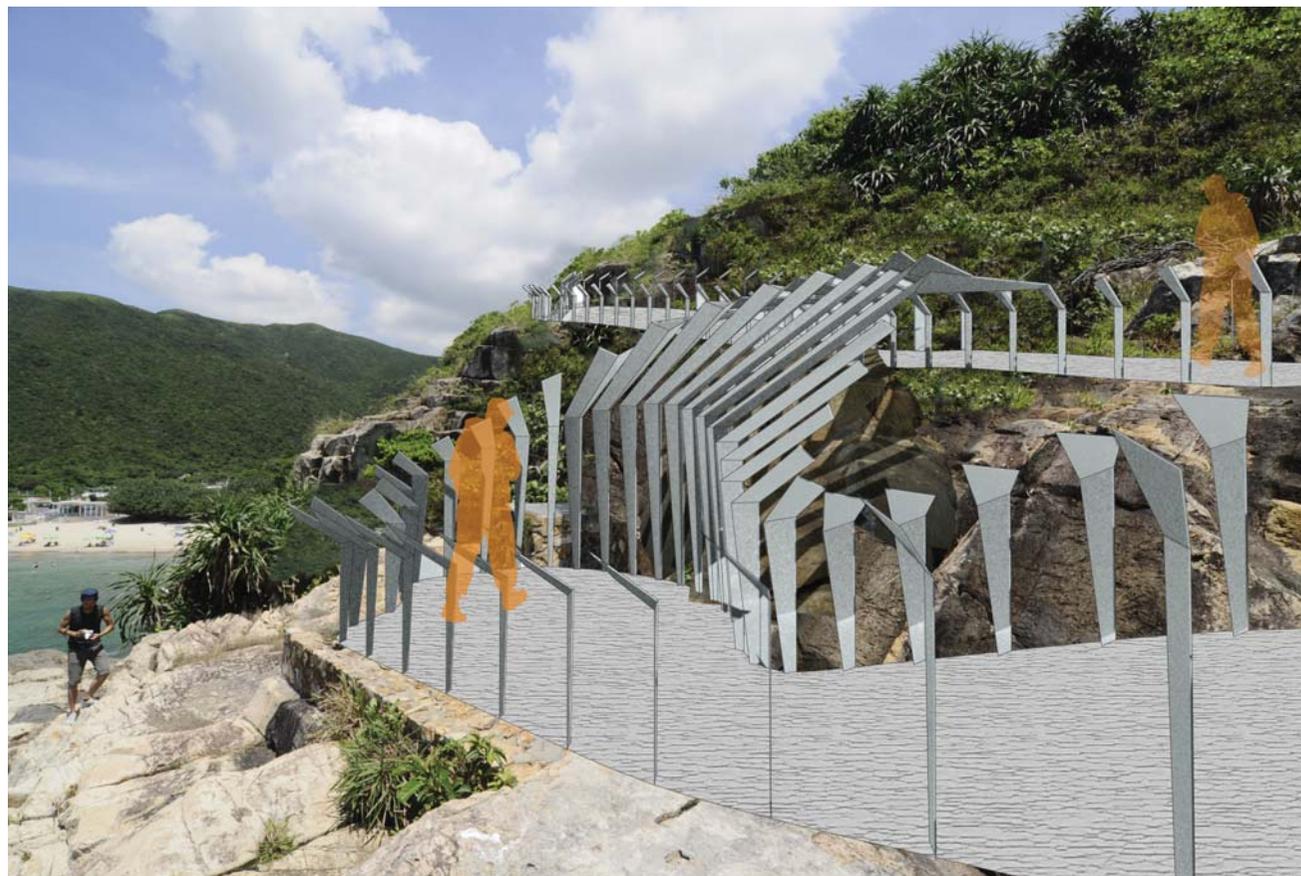
Site 5_Big Wave Bay

Option 3: Railing, shading and gutters integrated unit

Pros:

- Allows ample air flow and will not create micro-climate
- Railing transforms to double as rain shelter for the rock

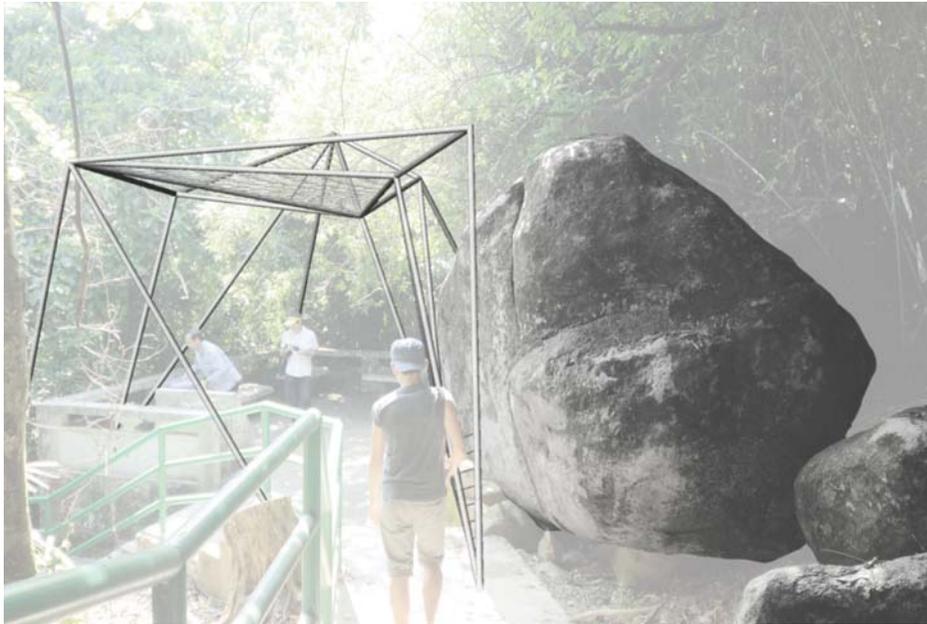
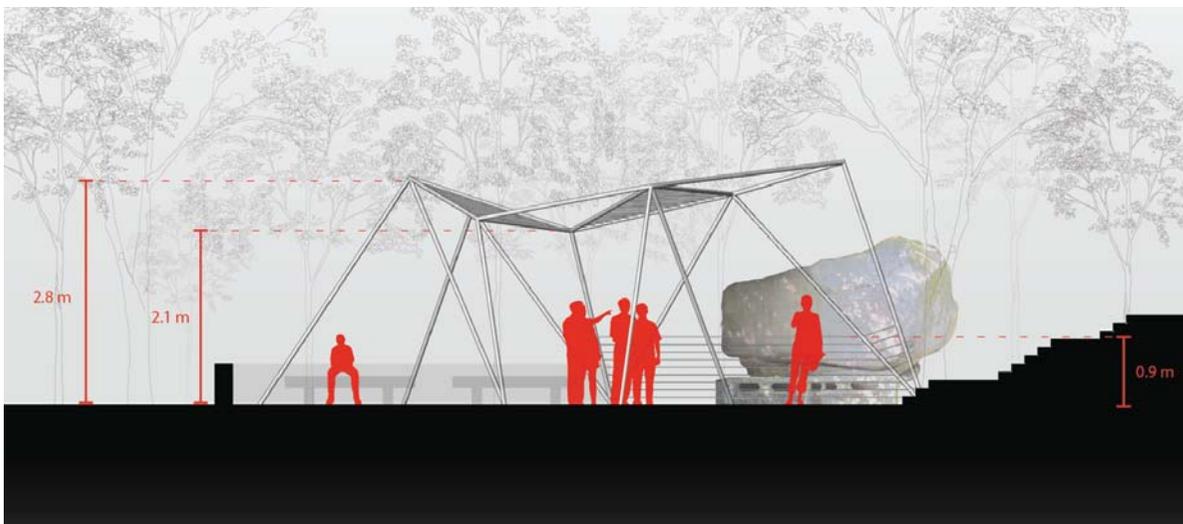
Site 8_Joss House Bay

Faceted shelter with low cable barrier

Shelter in combination with steel cables as barrier

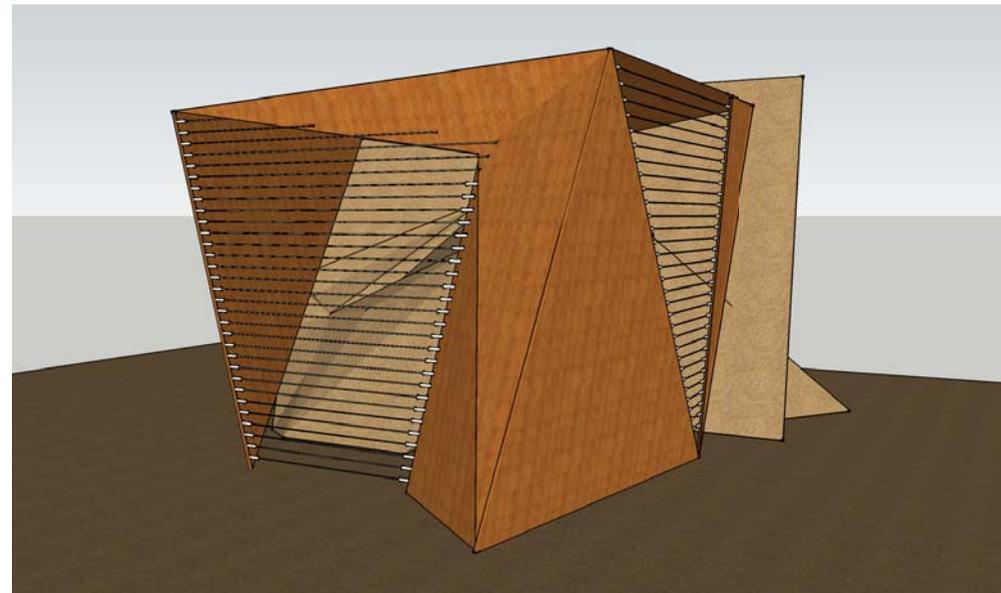
Option 2: Wooden panel modular system

Wooden panels with steel cables

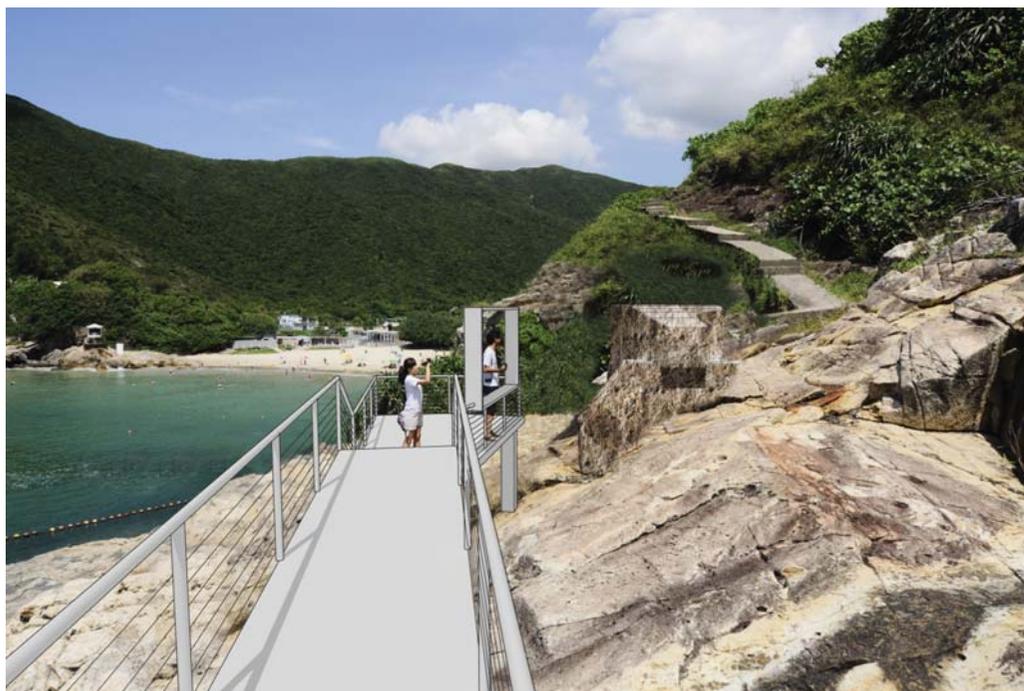
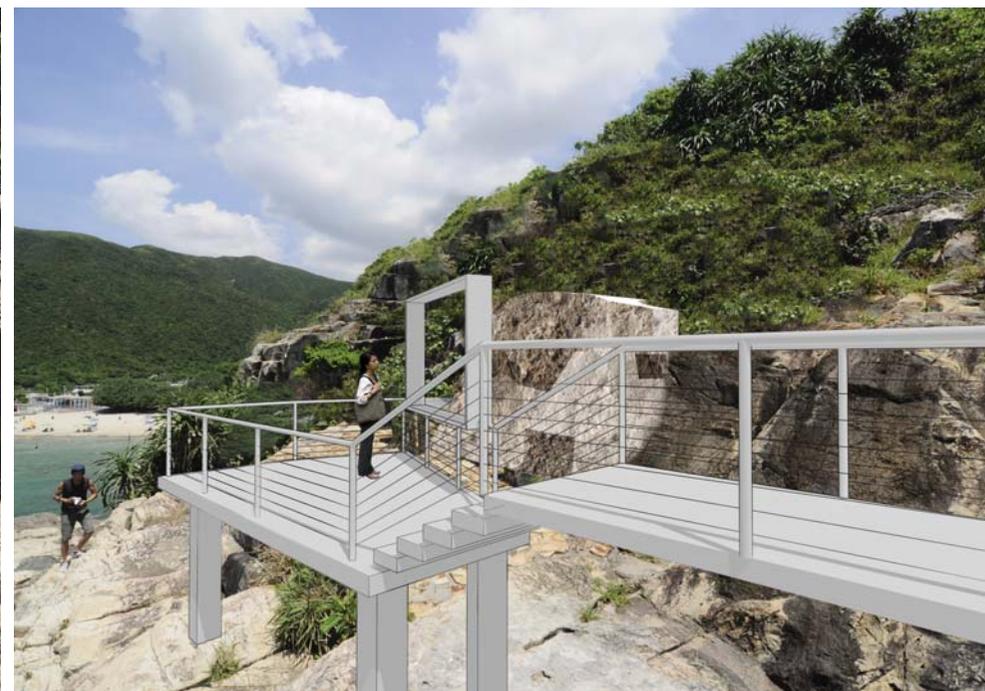
Option 1: Stainless steel
Site 5_Big Wave Bay

Stainless steel railing with cables and 'picture frame'

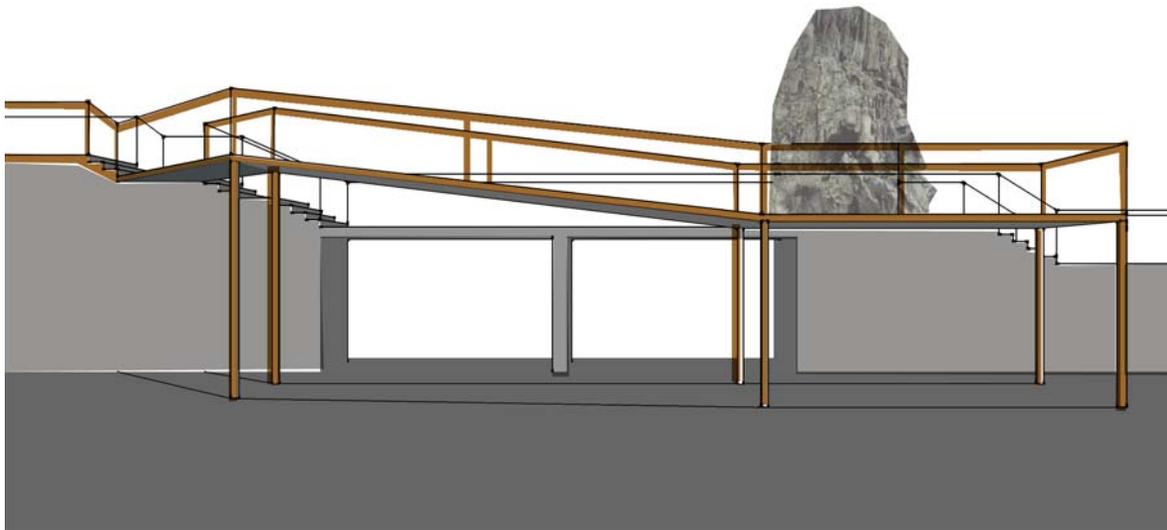
Option 2: Wood-plastic Site 1_Tung Lung Chau

Wooden viewing deck as a more organic option to stainless steel

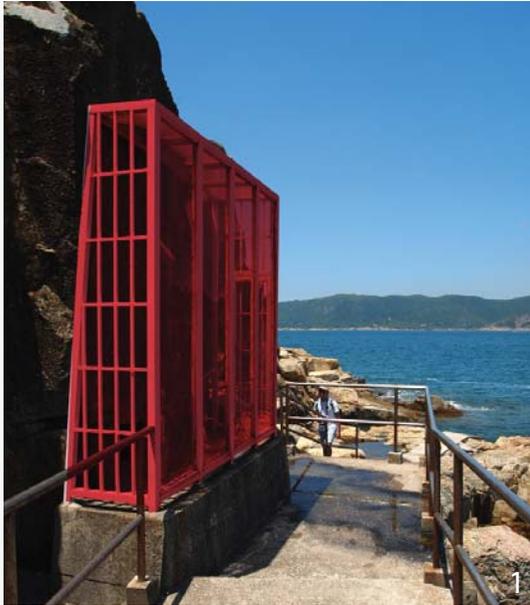
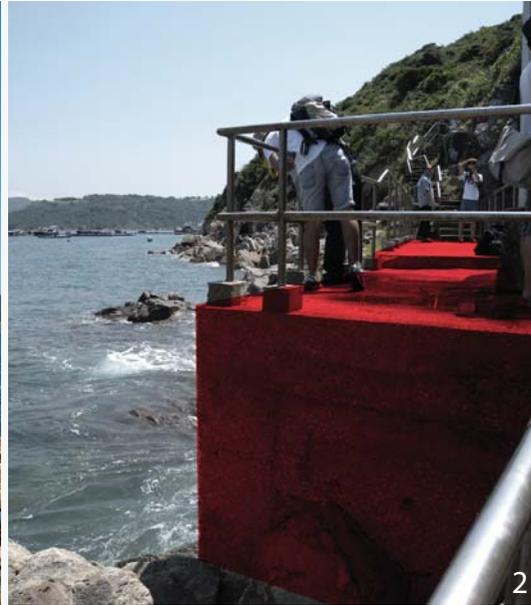
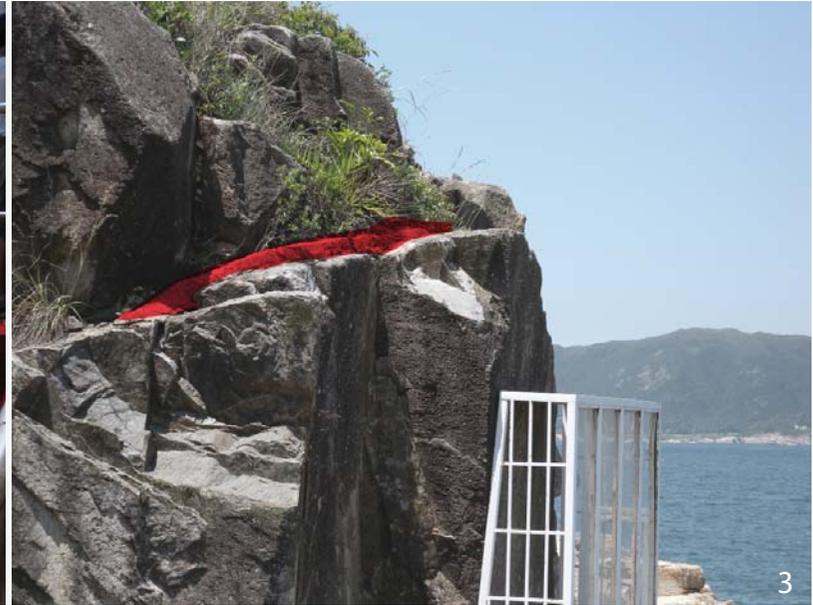
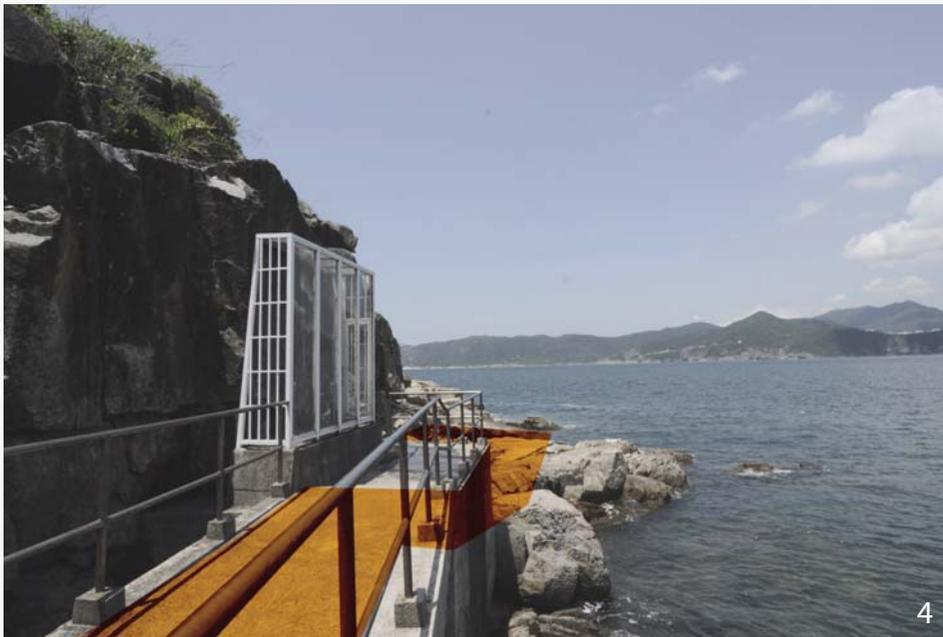
1. Existing Perspex covers can create undesirable micro-climate and impair visibility
2. Part of the existing concrete platform will be demolished
3. Existing cement water diversion dam to be removed since it is not effective and soluble salts from the cement can damage the rock carving
4. By redirecting the footpath, visitors will be kept at a safe distance from the rock without compromising its visibility.

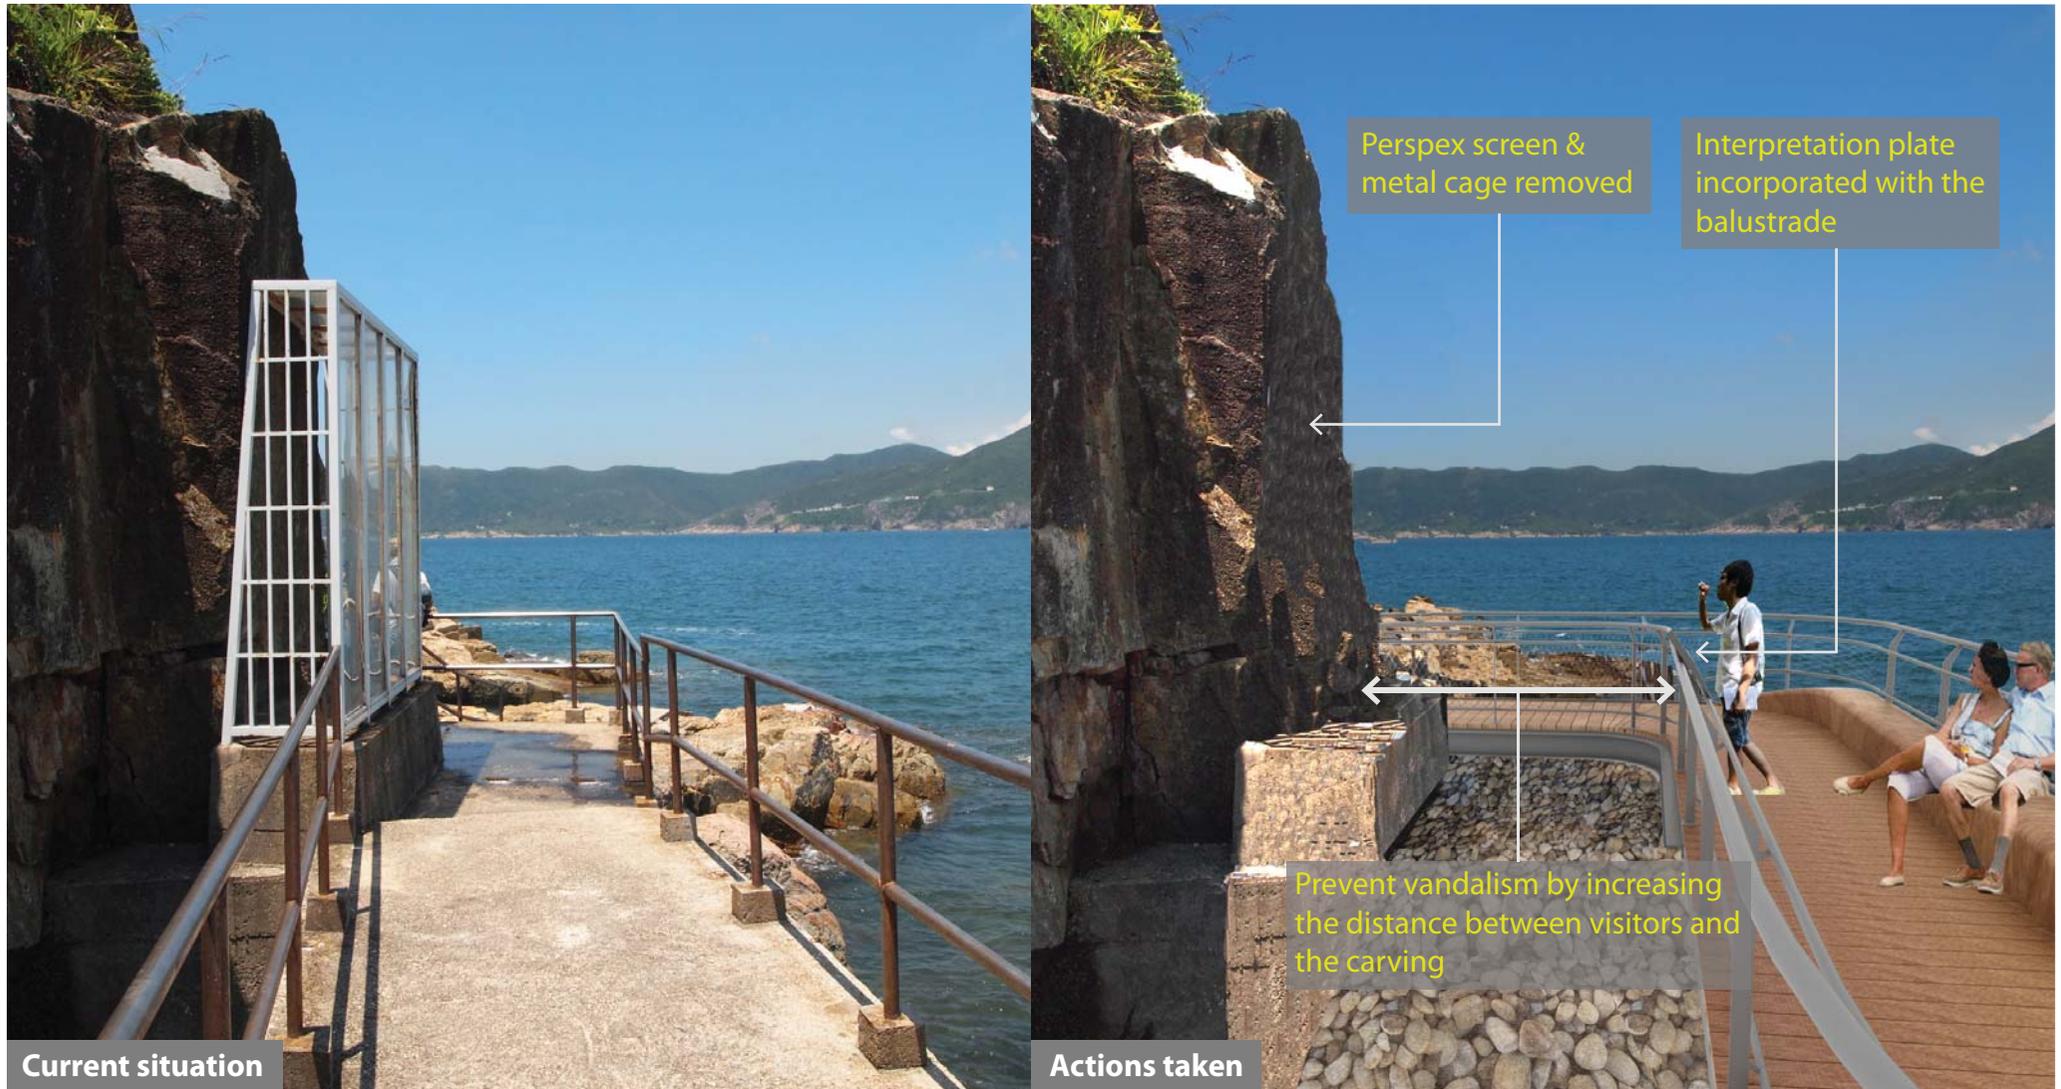
Design approach 1 for Site 1_Tung Lung Chau

Controlled pathway

Actions taken in the design

Current situation

Actions taken

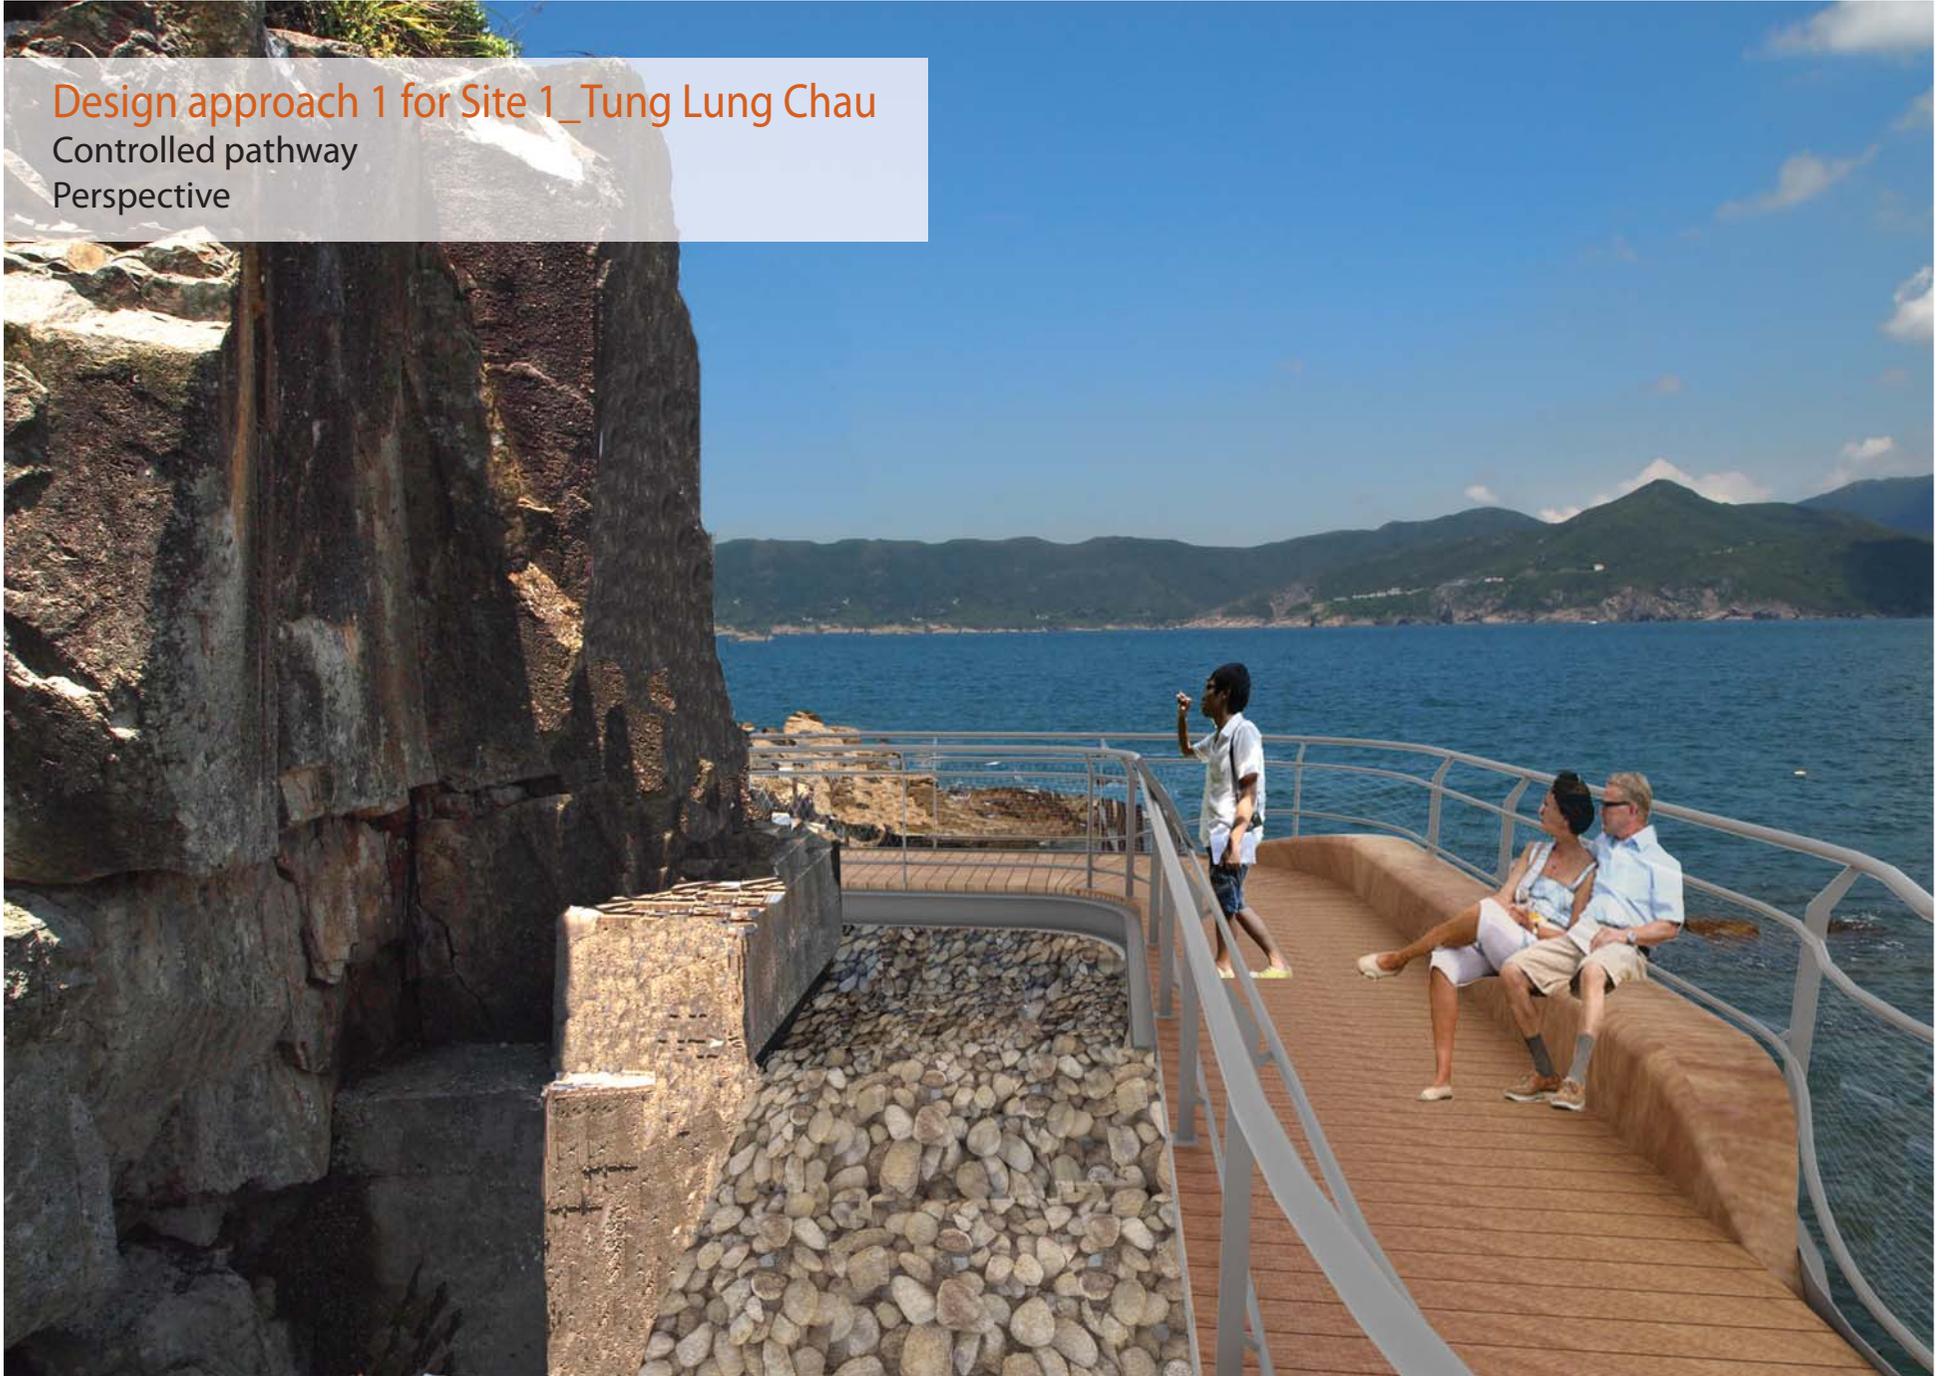
Design approach 1 for Site 1_Tung Lung Chau

Controlled pathway
Perspective

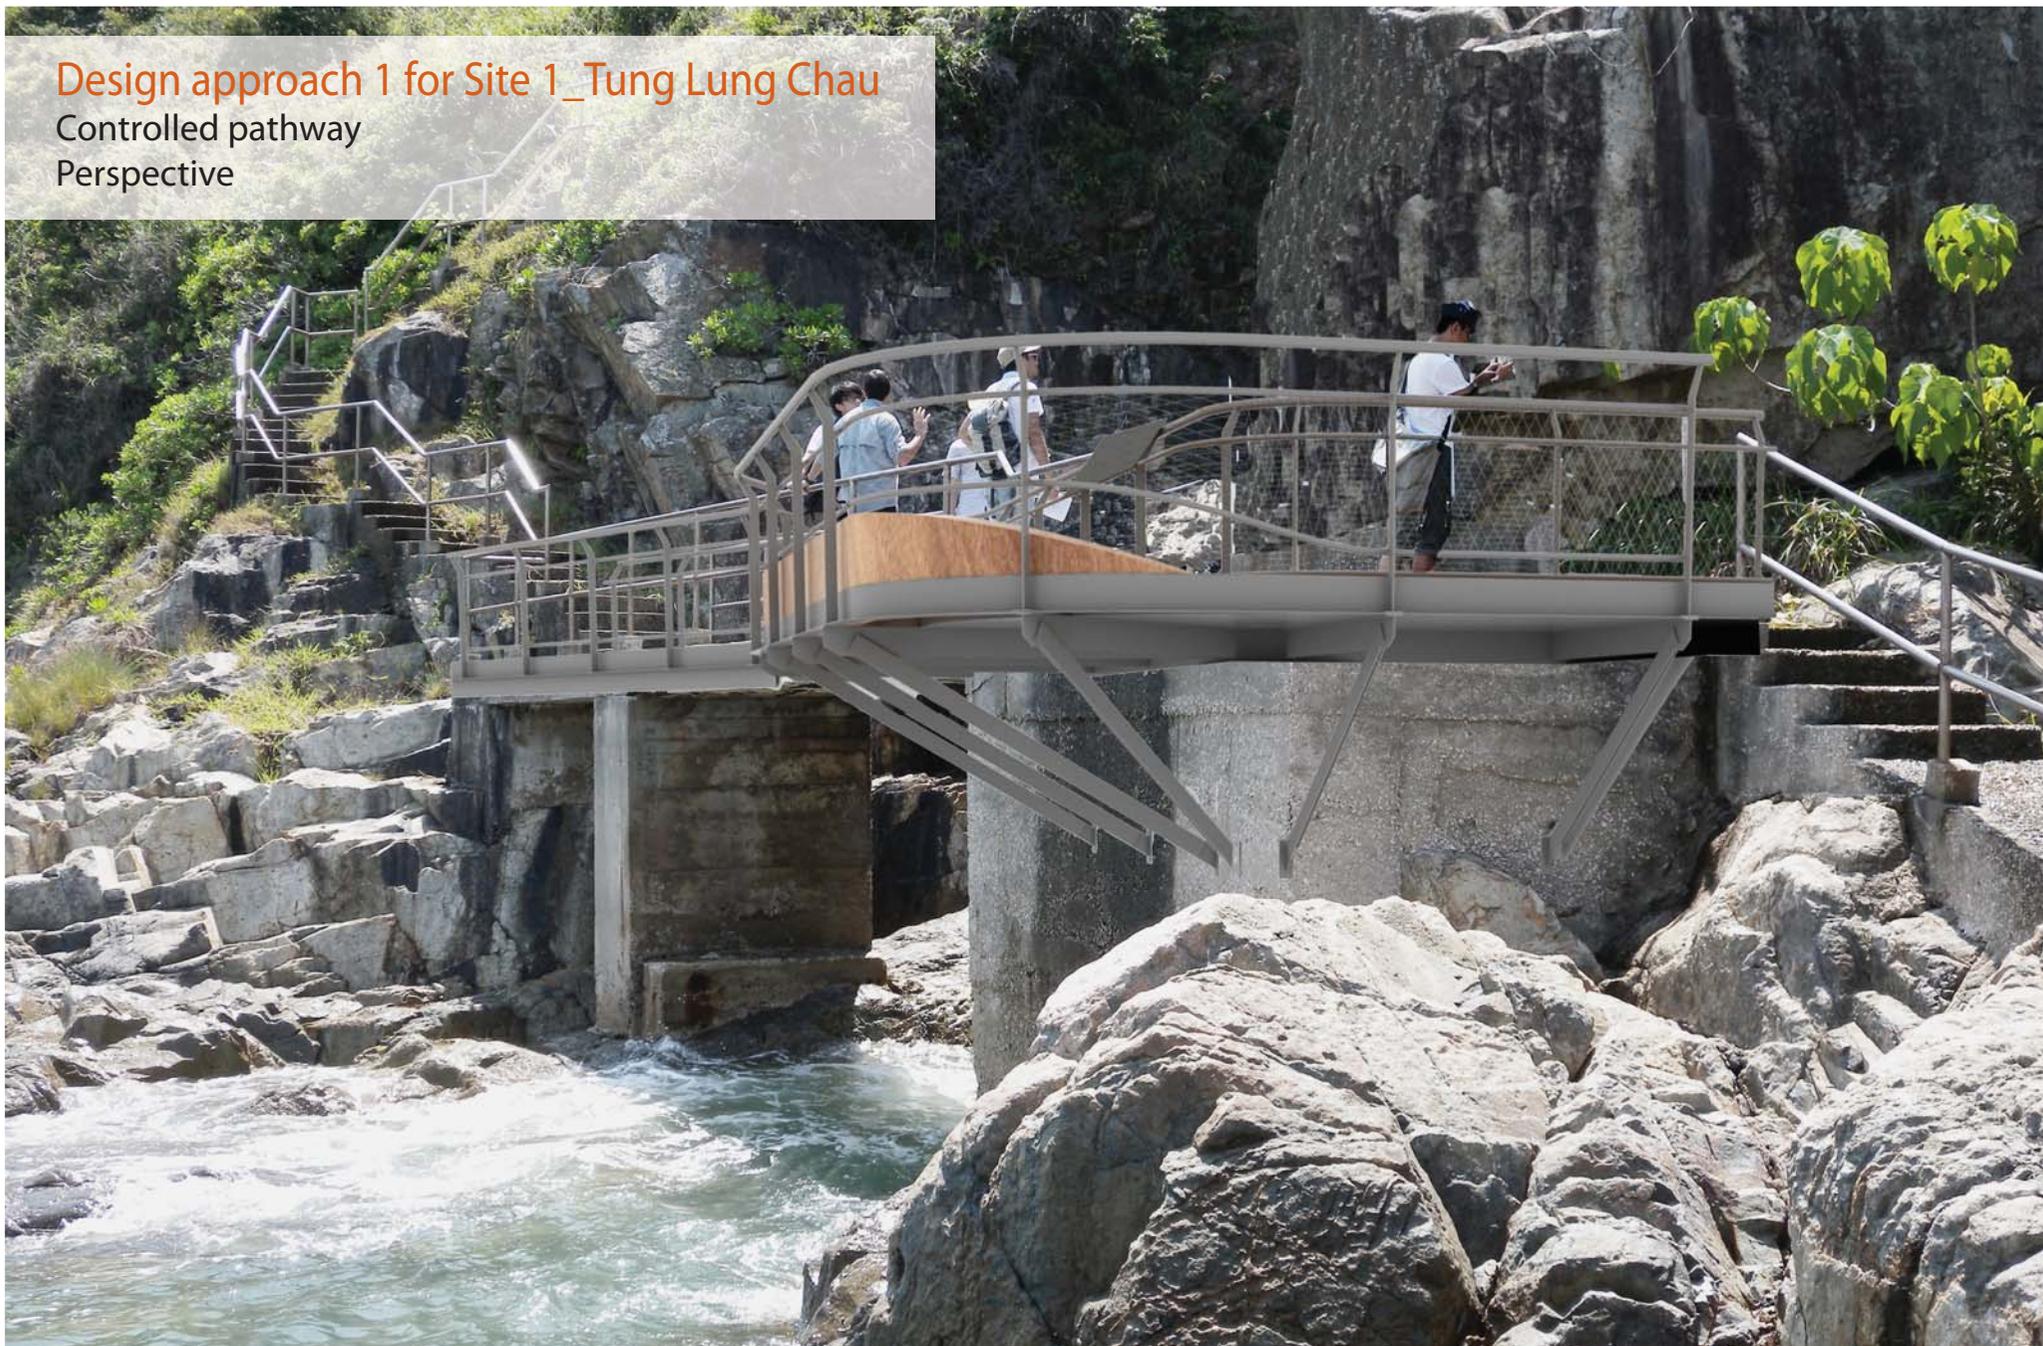
Design approach 1 for Site 1_Tung Lung Chau

Controlled pathway
Perspective

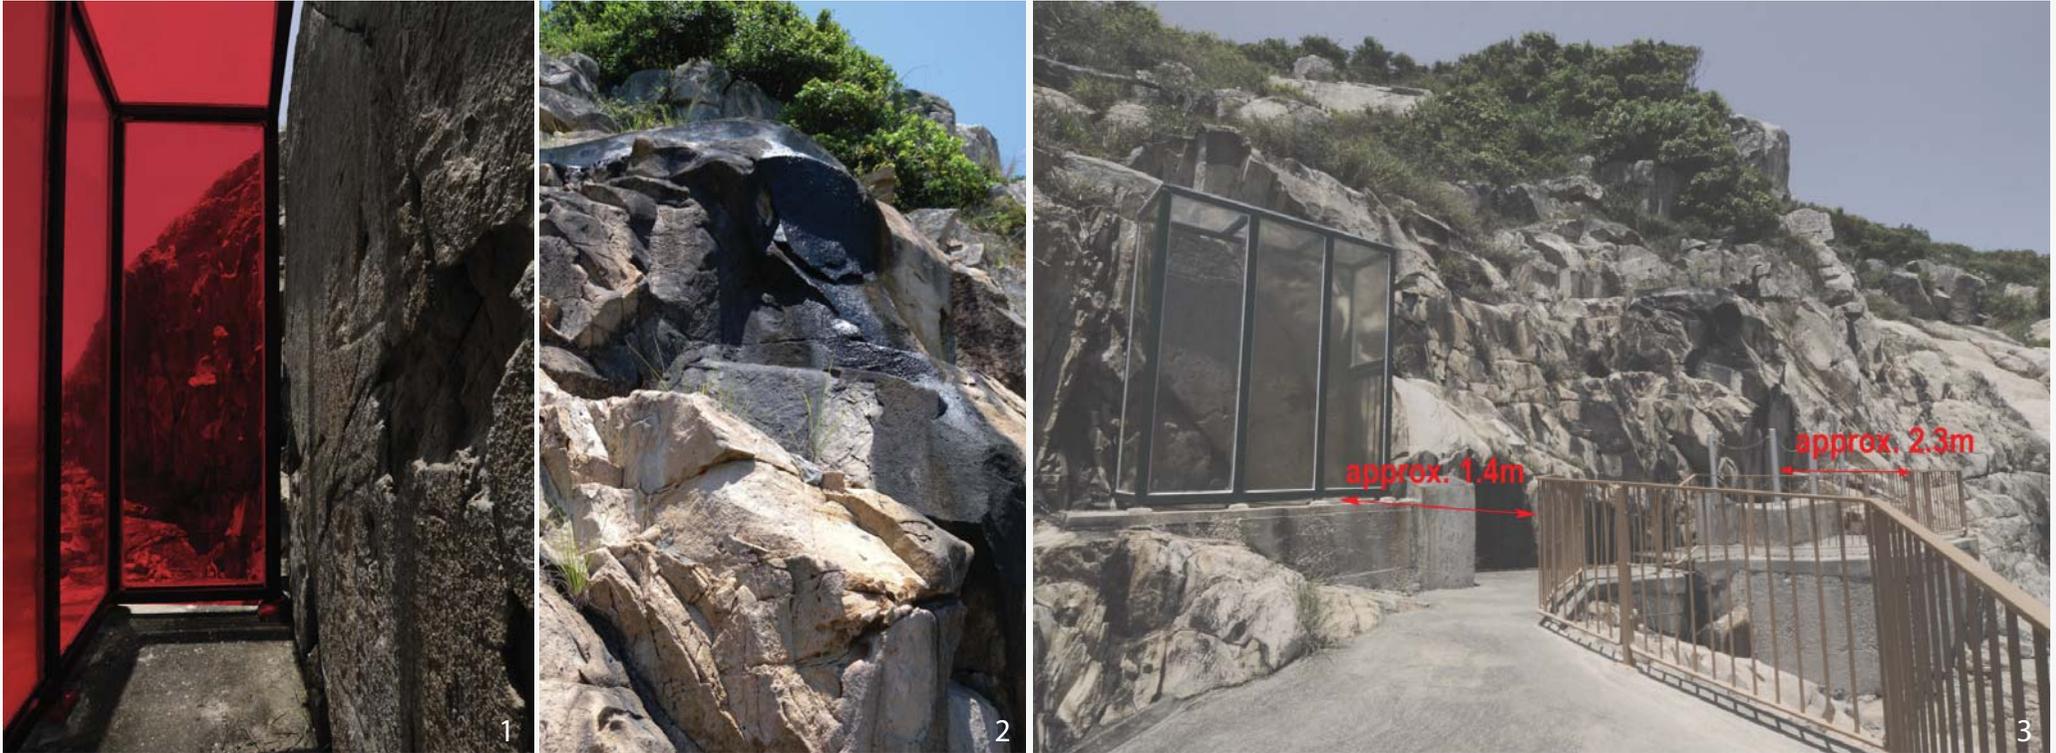
1. Current Perspex cover has lowered visibility and can create micro-climate which is undesirable in terms of conservation in the long term.
2. The walkway will be redirected so that tourists will not get too near to the rock, thus preventing vandalism.

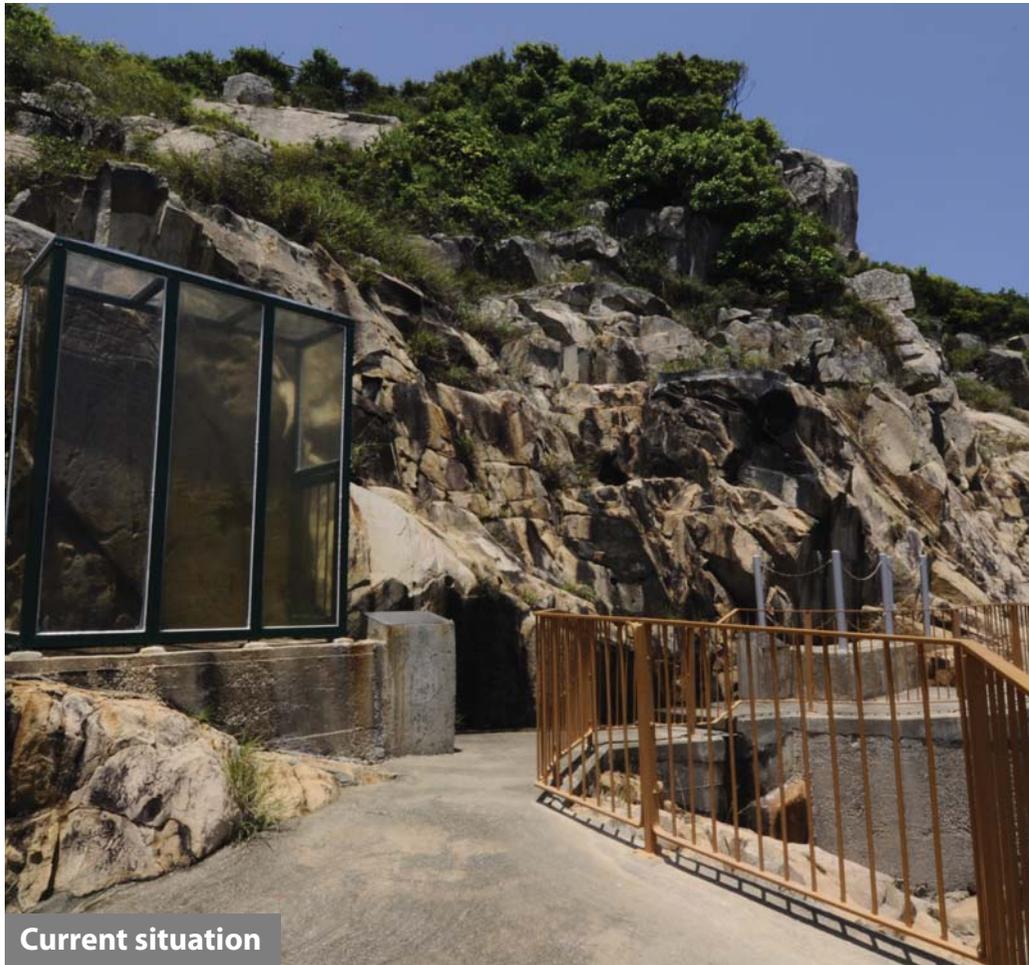
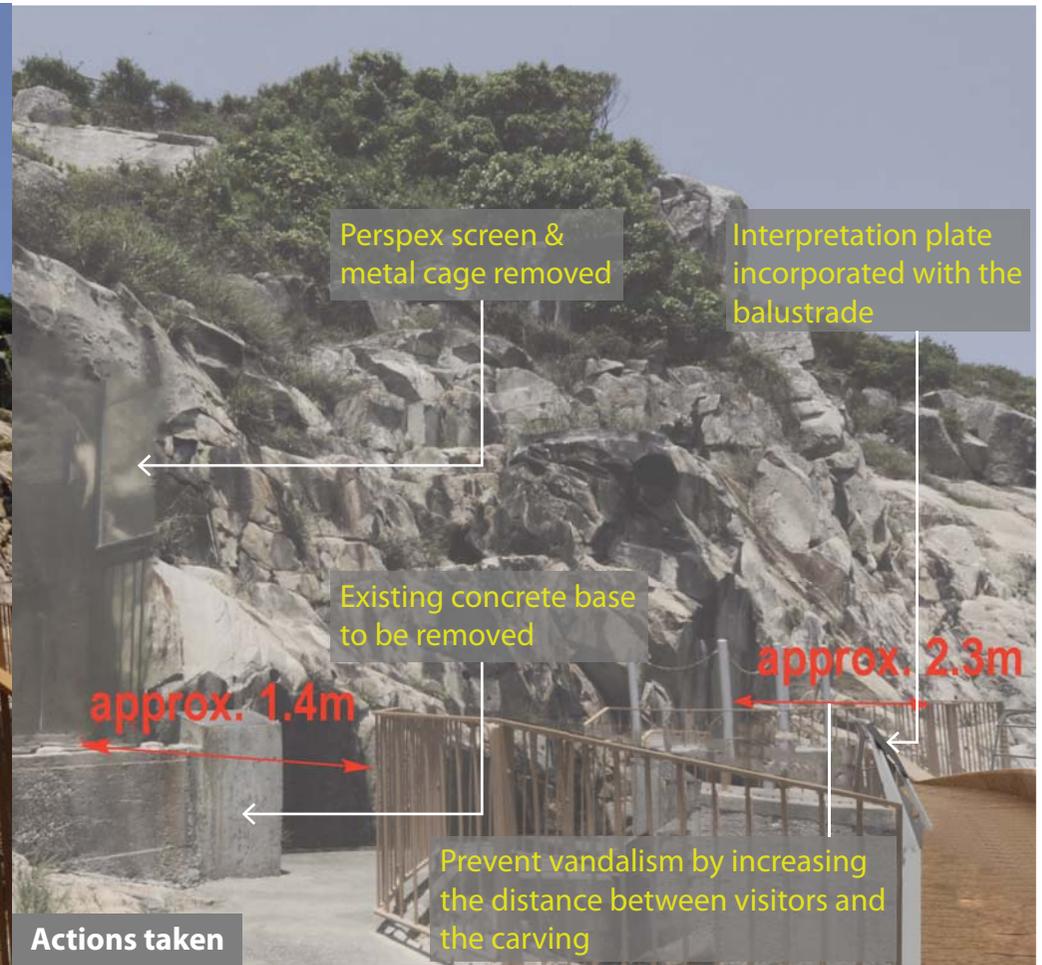
Design approach 1 for Site 2_Po Toi Island Controlled pathway

Controlled pathway

Actions taken in the design

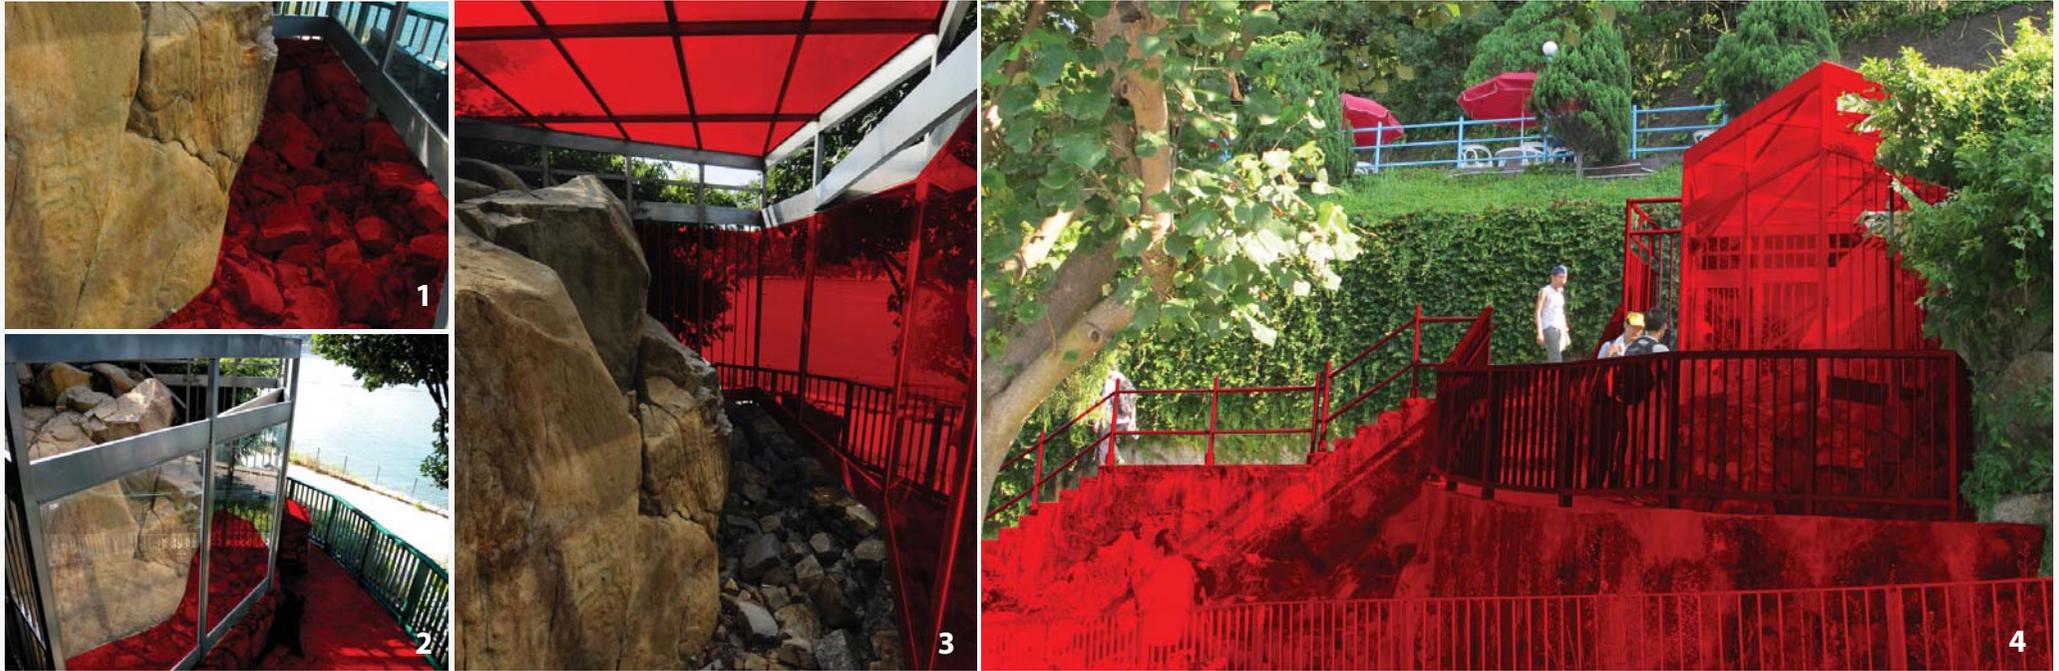
- 1 & 2. Existing stone rubbles look too artificial and do not match with the natural environment. They are affecting the authenticity of rock carving and alter beyond recognition the natural setting which is of archaeological significance.
- 3. The shelter and glass screen adversely create a micro-climate at the rock carving.
- 4. Too many concrete facilities affect the rock carving and alter the natural setting which is of archaeological significance.

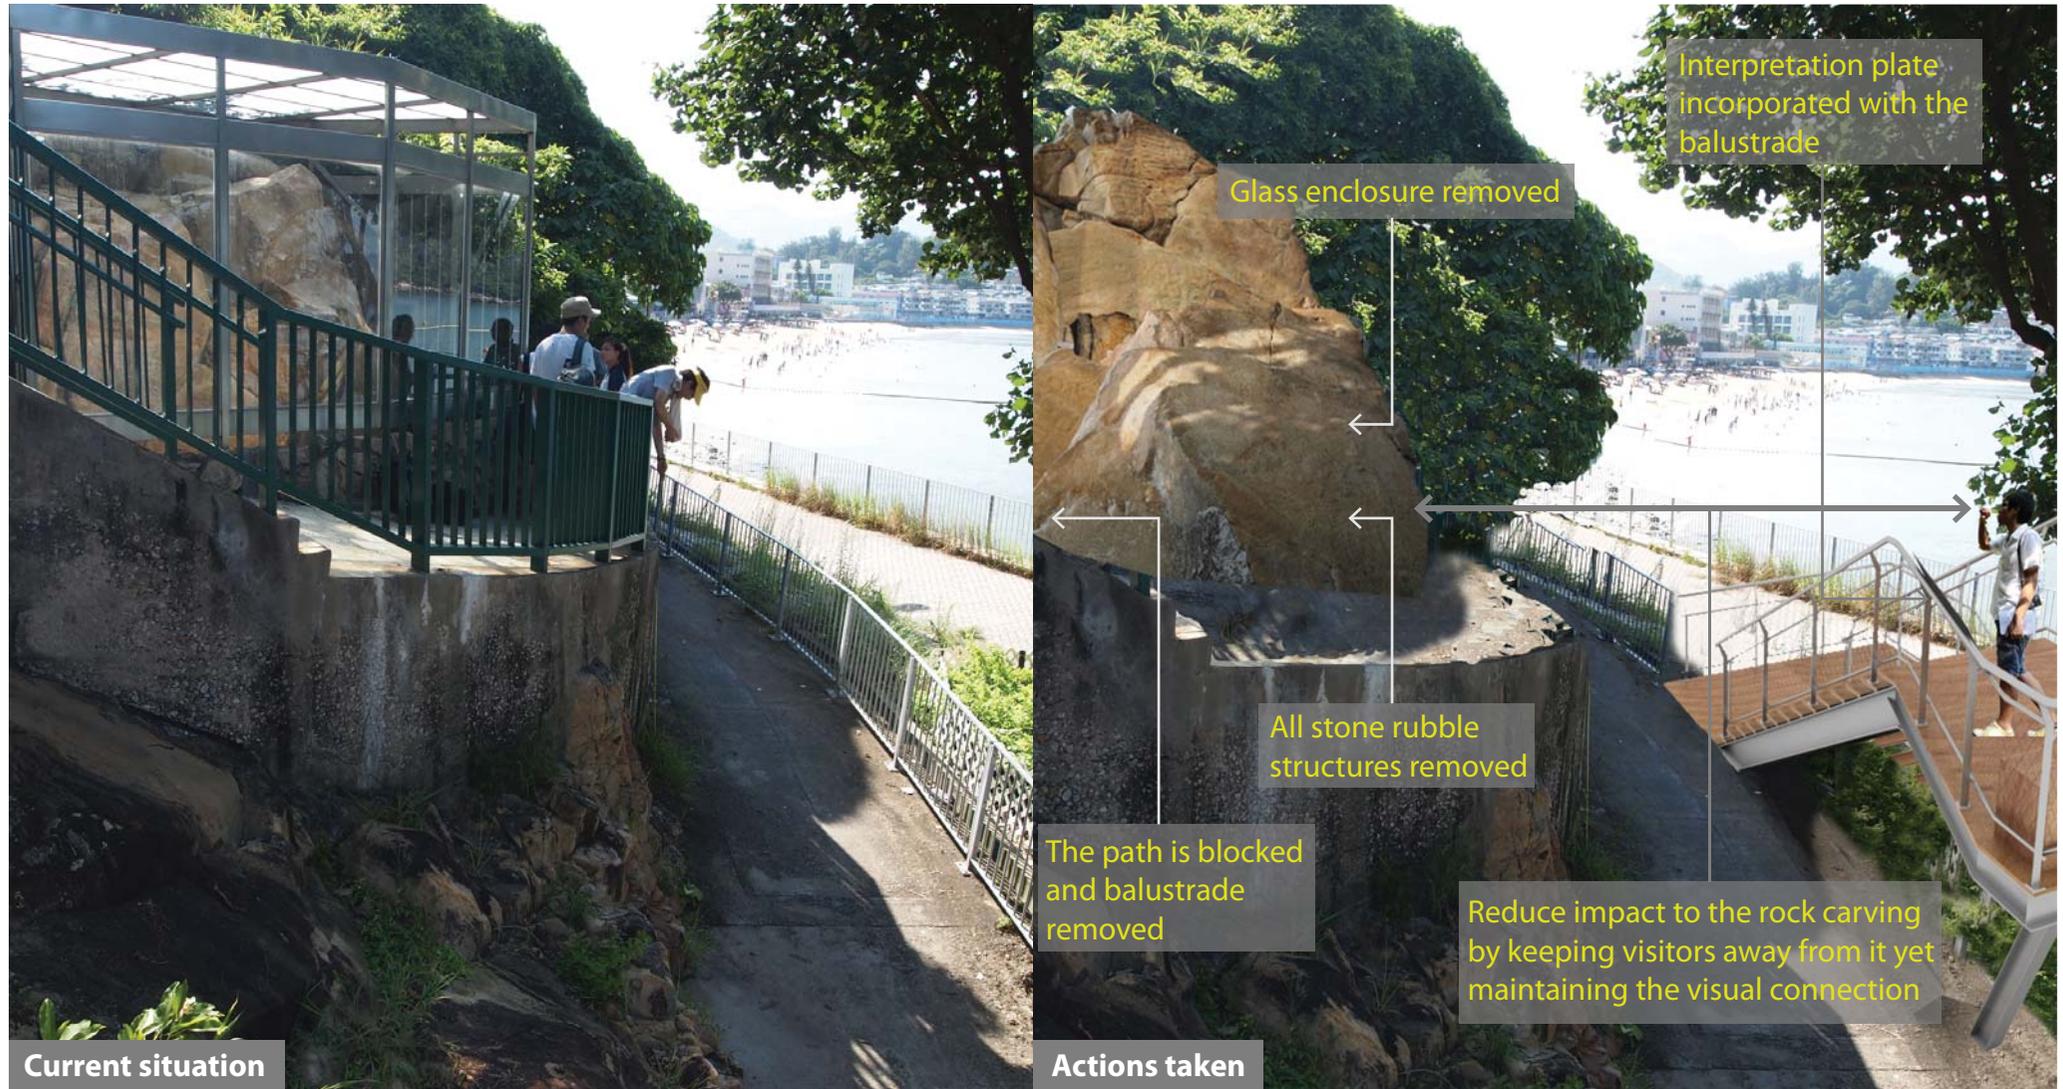
Design approach 1 for Site 3_Cheung Chau Controlled pathway (viewing platform)

Controlled pathway (viewing platform)

Actions taken in the design
