Provision of Architectural Designs of
Protection and Visitor Facilities for
Rock Carvings and Inscription in Hong Kong

FINAL REPORT

15th March 2012

THE UNIVERSITY OF HONG KONG 香港大學
faculty of architecture 建築學院
Community Project Workshop 社區項目工作坊

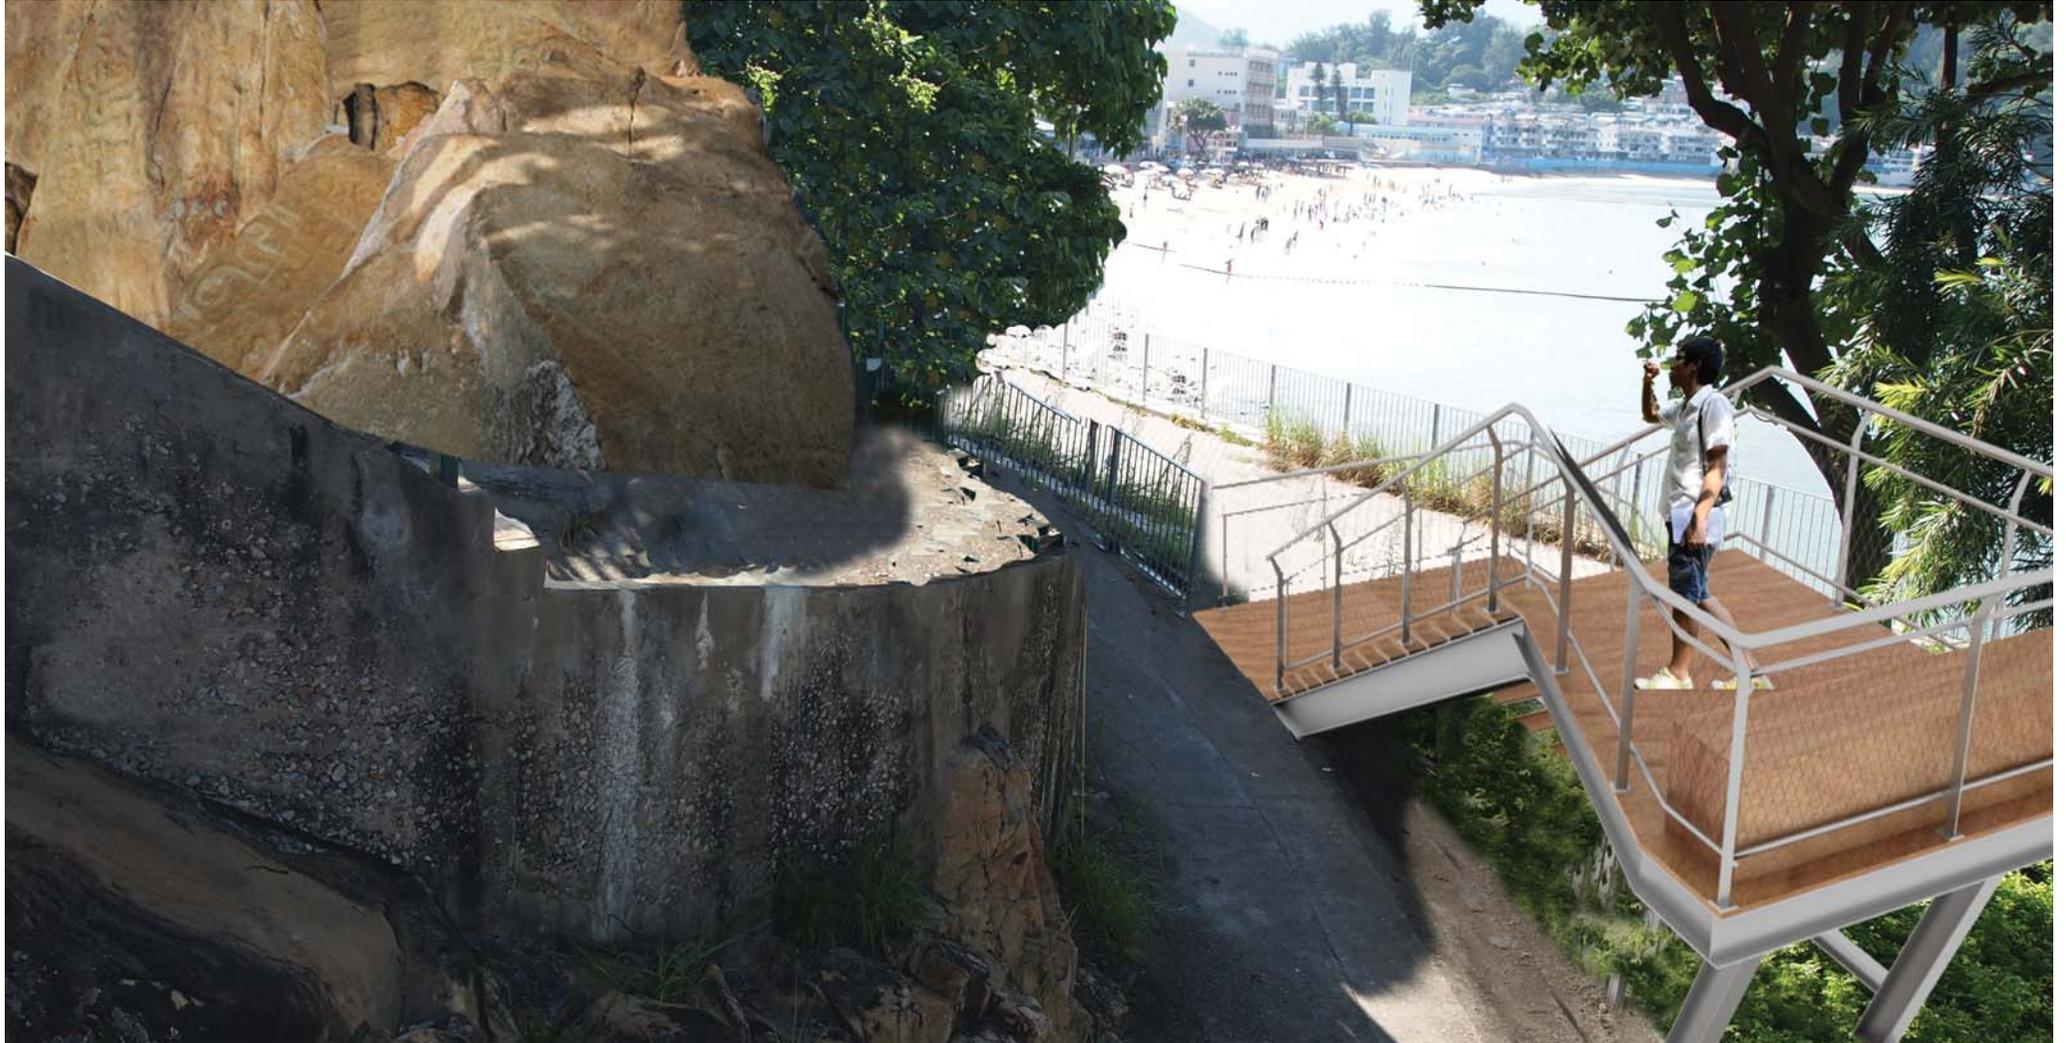
Design approach 1 for Site 3_Cheung Chau

Controlled pathway (viewing platform)

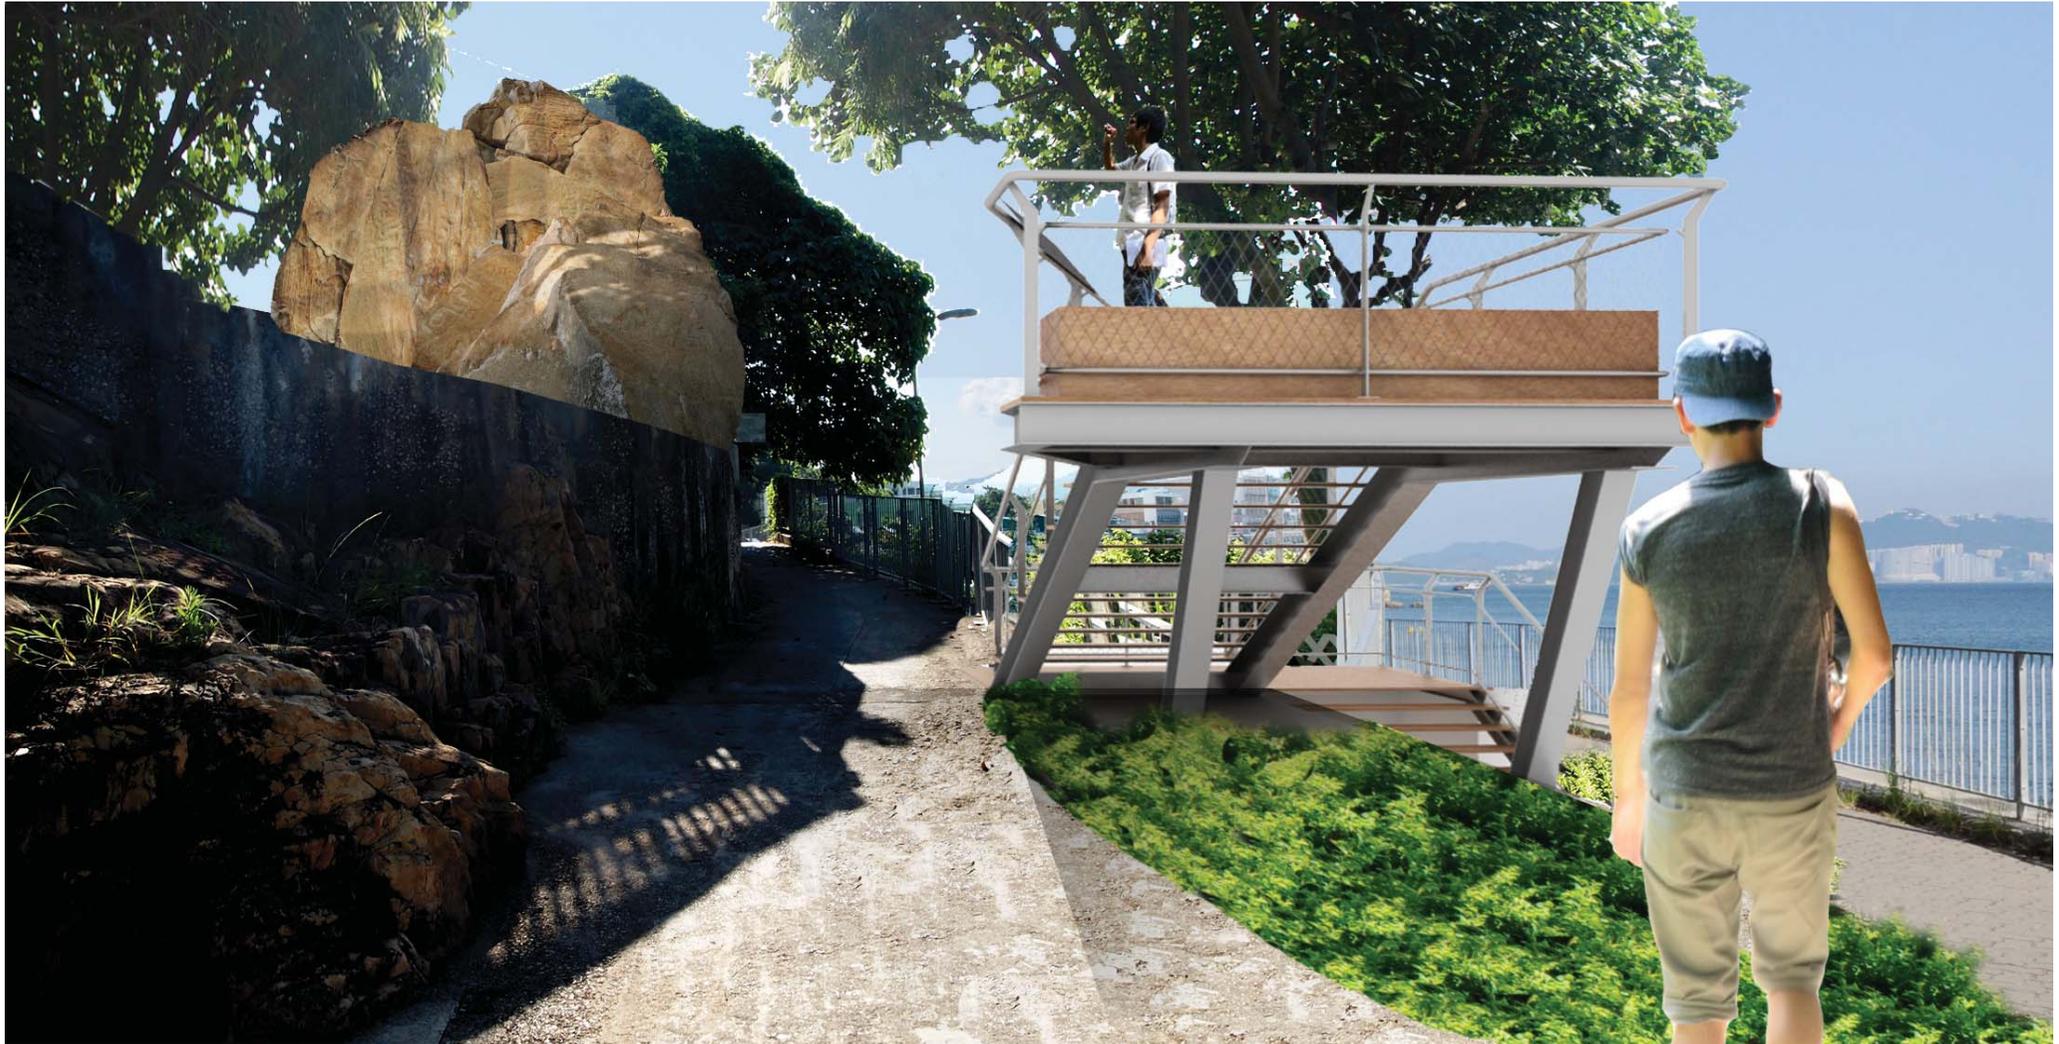
Design approach 1 for Site 3_Cheung Chau Controlled pathway (viewing platform)

*Disable access will be incorporated in the final design.

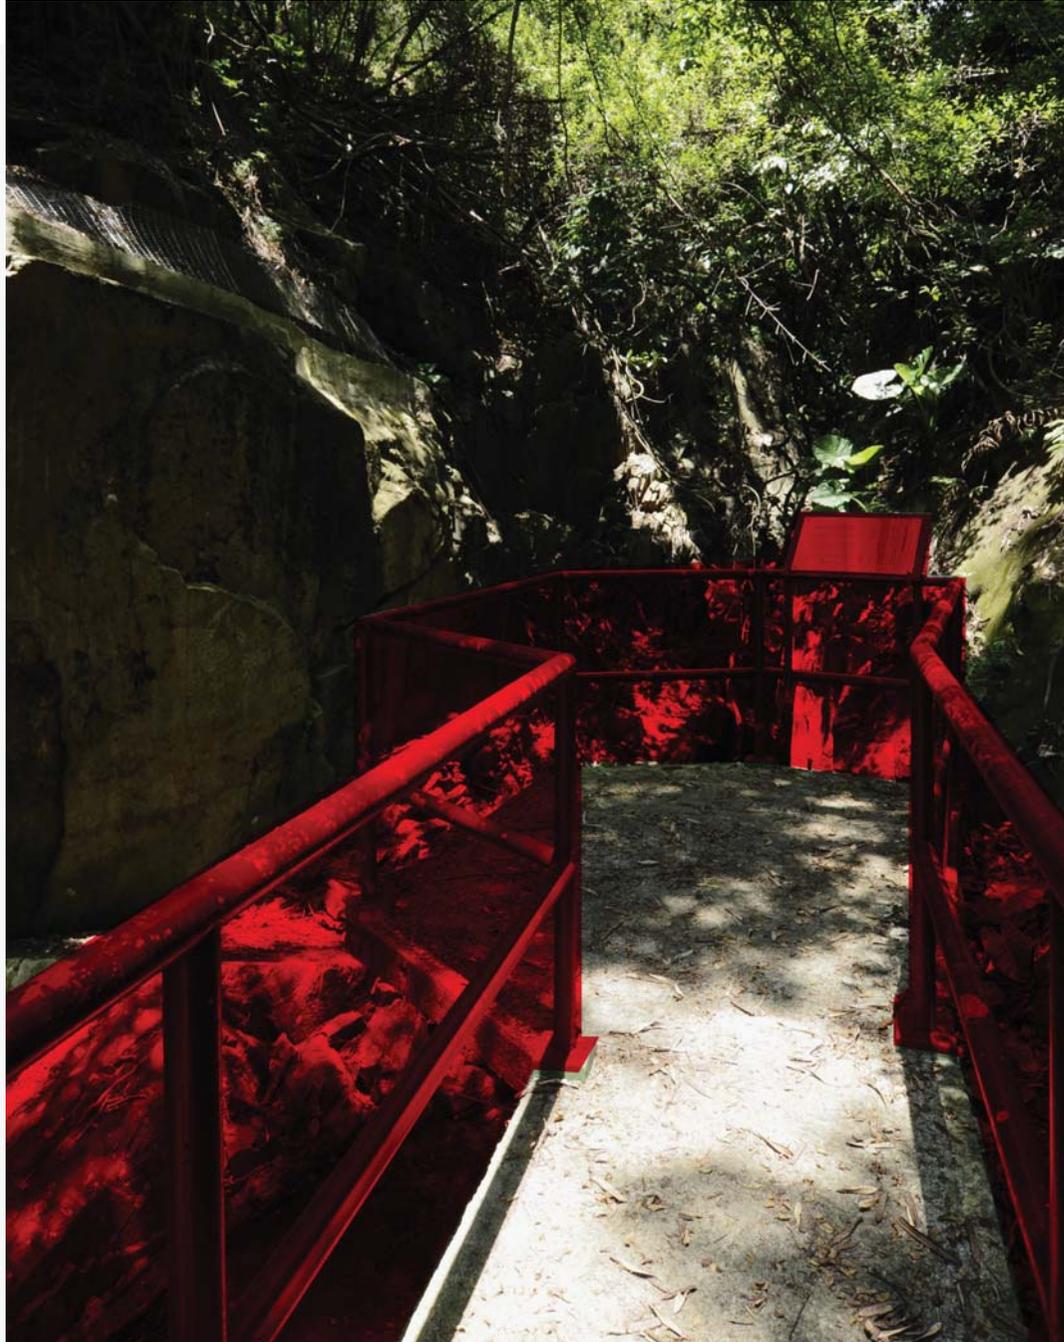
The current level of protection is not sufficient since visitors can get through the railing and reach the carving easily. The balustrade is to be redesigned and incorporate with the new interpretation plate.

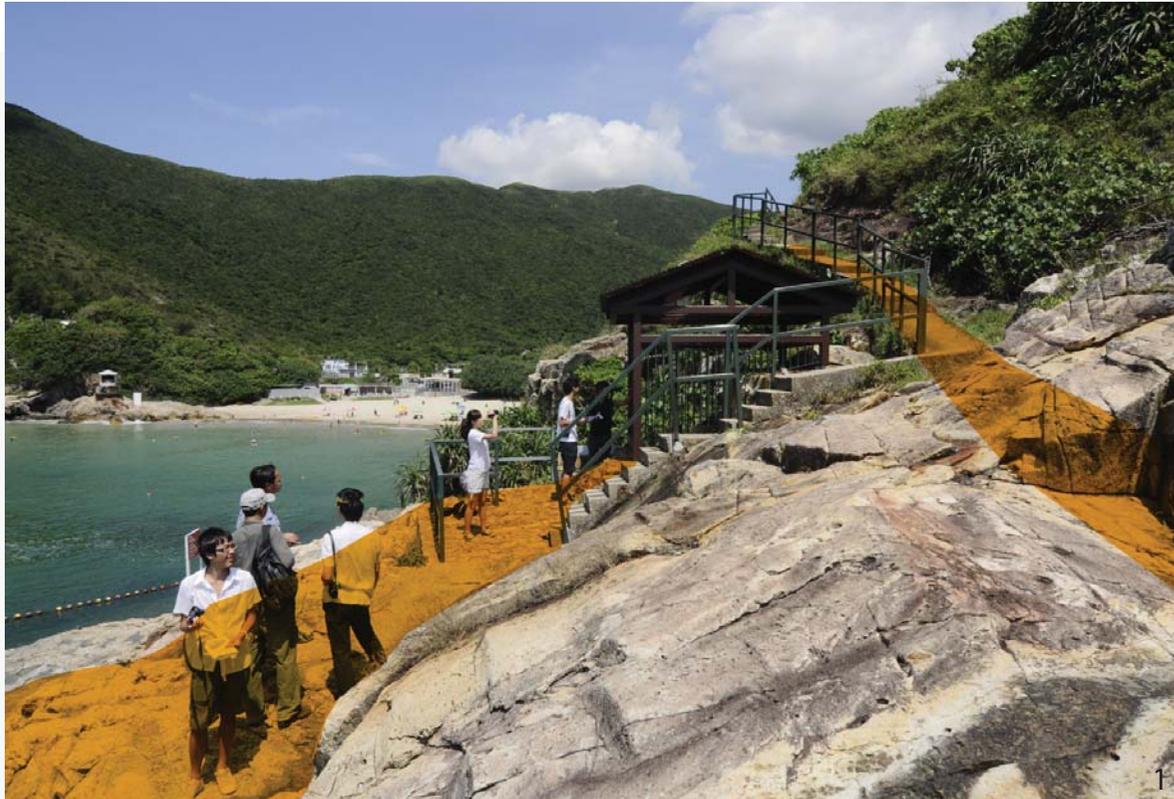
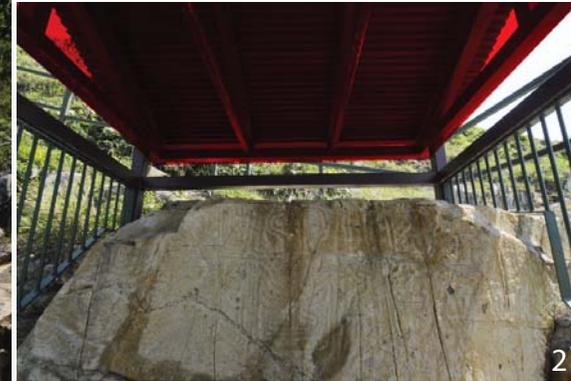
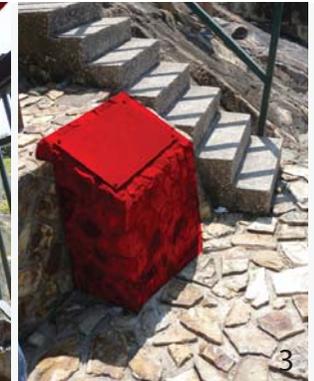
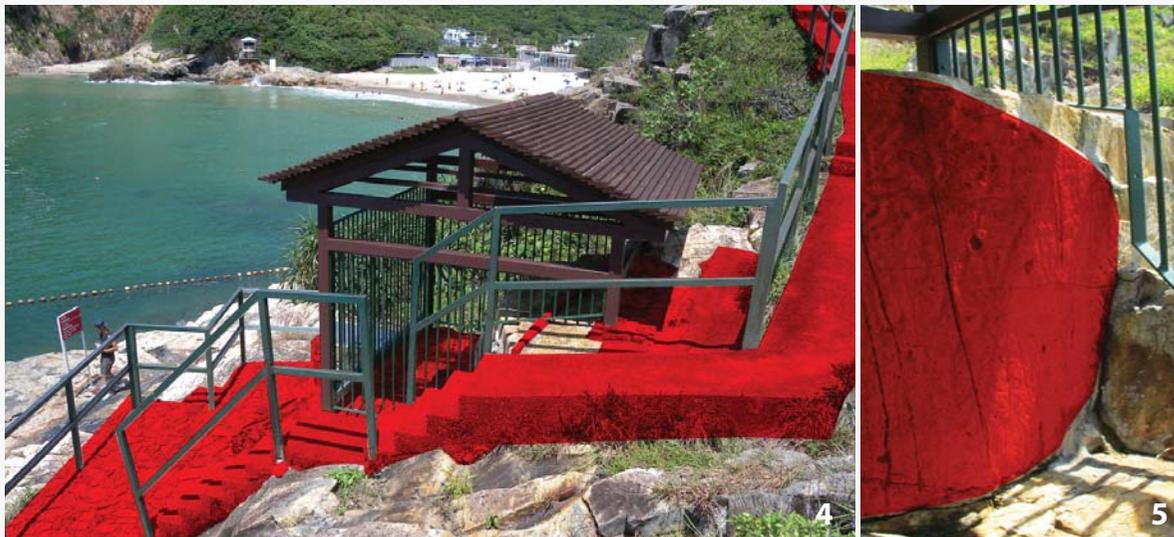
1. We propose redirecting the route and building a wooden footbridge which connects to the existing footpath.

2. The roof of the pavilion creates a micro-climate underneath, thus affecting the condition of the rock carving

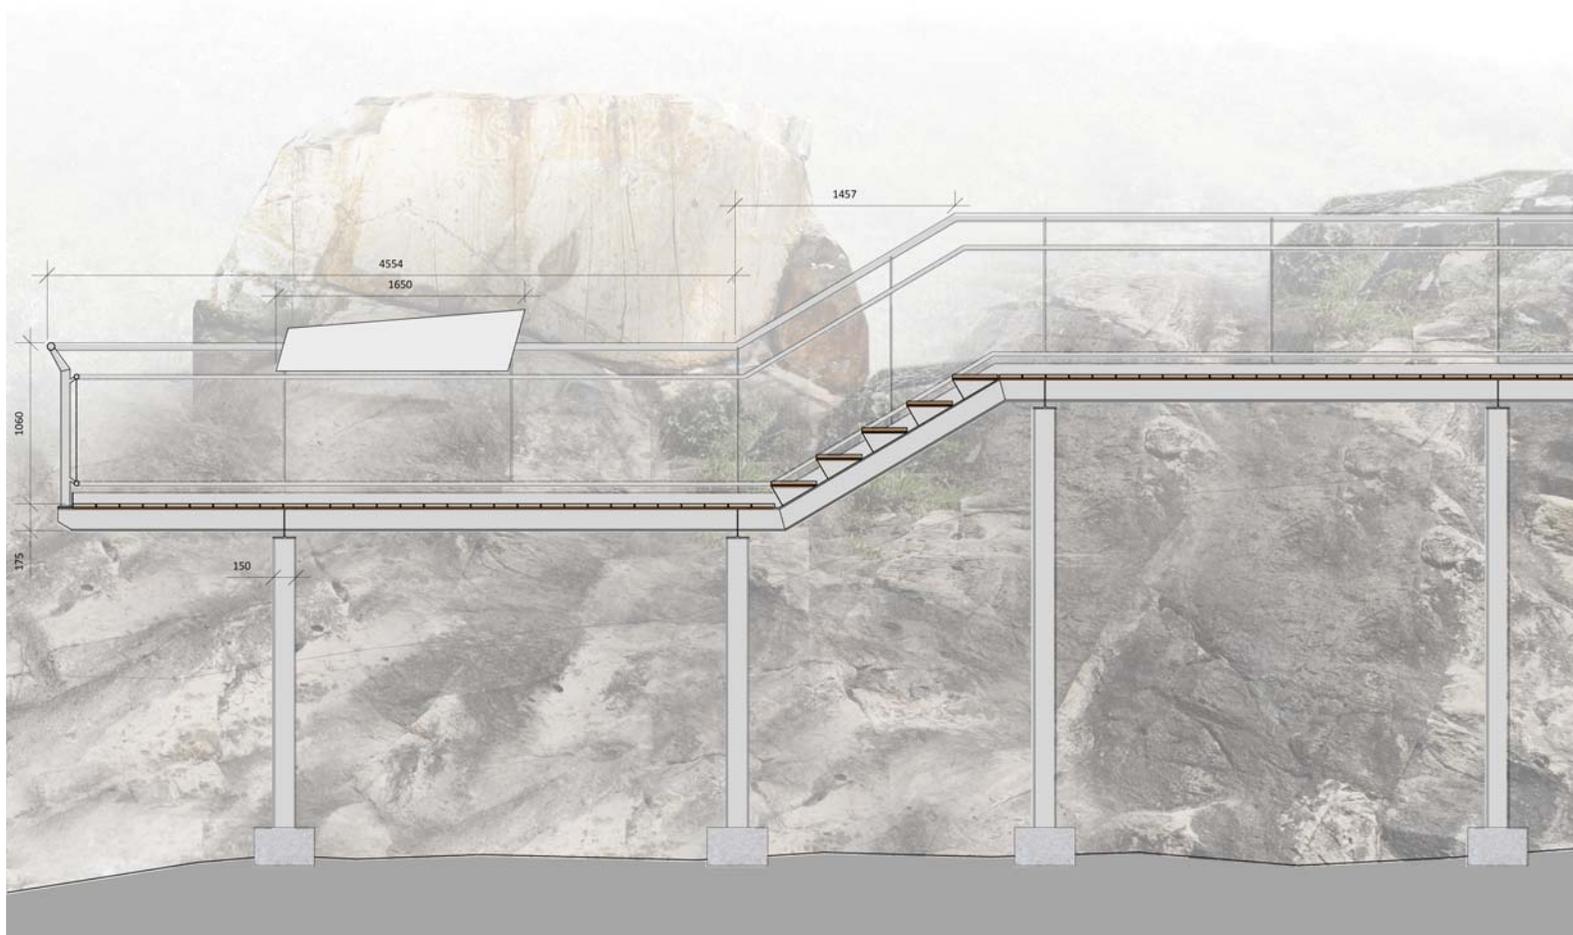
Design approach 1 for Site 5_Big Wave Bay

Controlled pathway
Section AA' 1:50

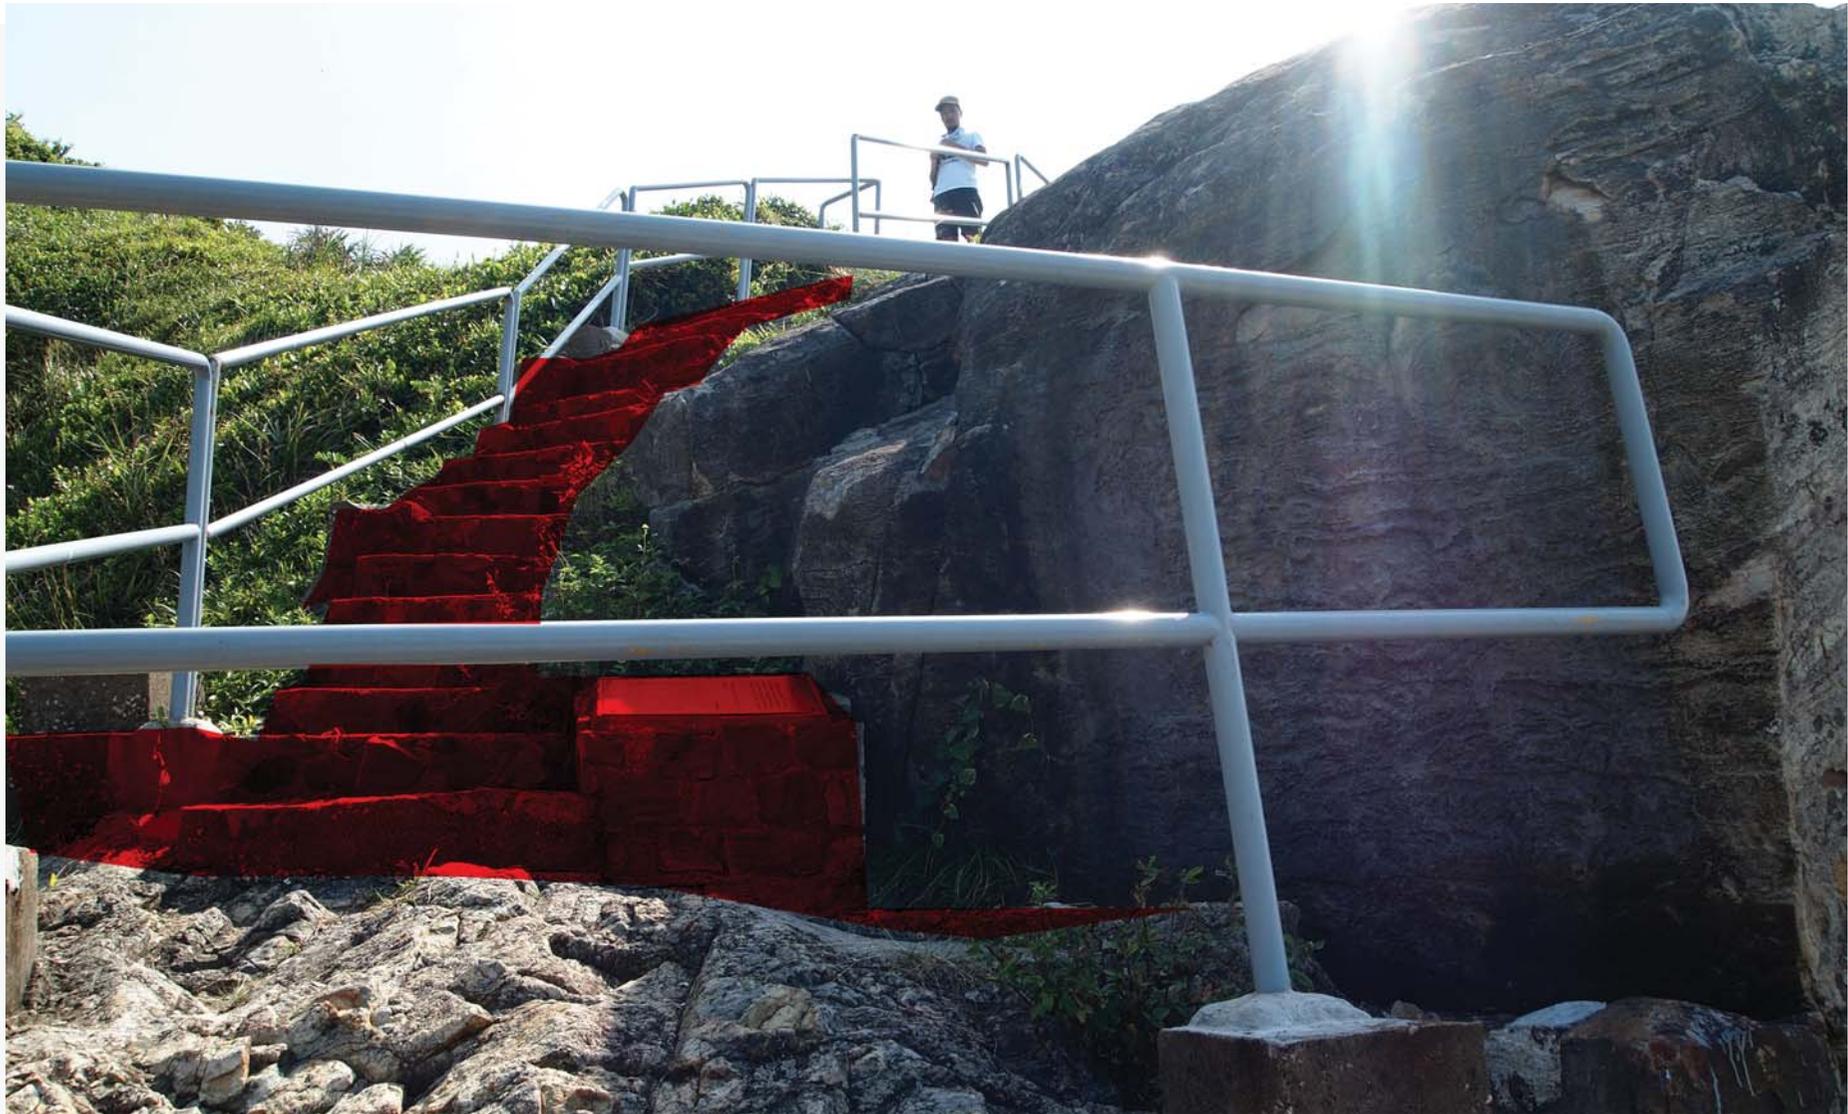
The concrete steps will be removed to reduce accessibility of the site so that the rock can be protected away from tourists. A new interpretation plate will be installed.

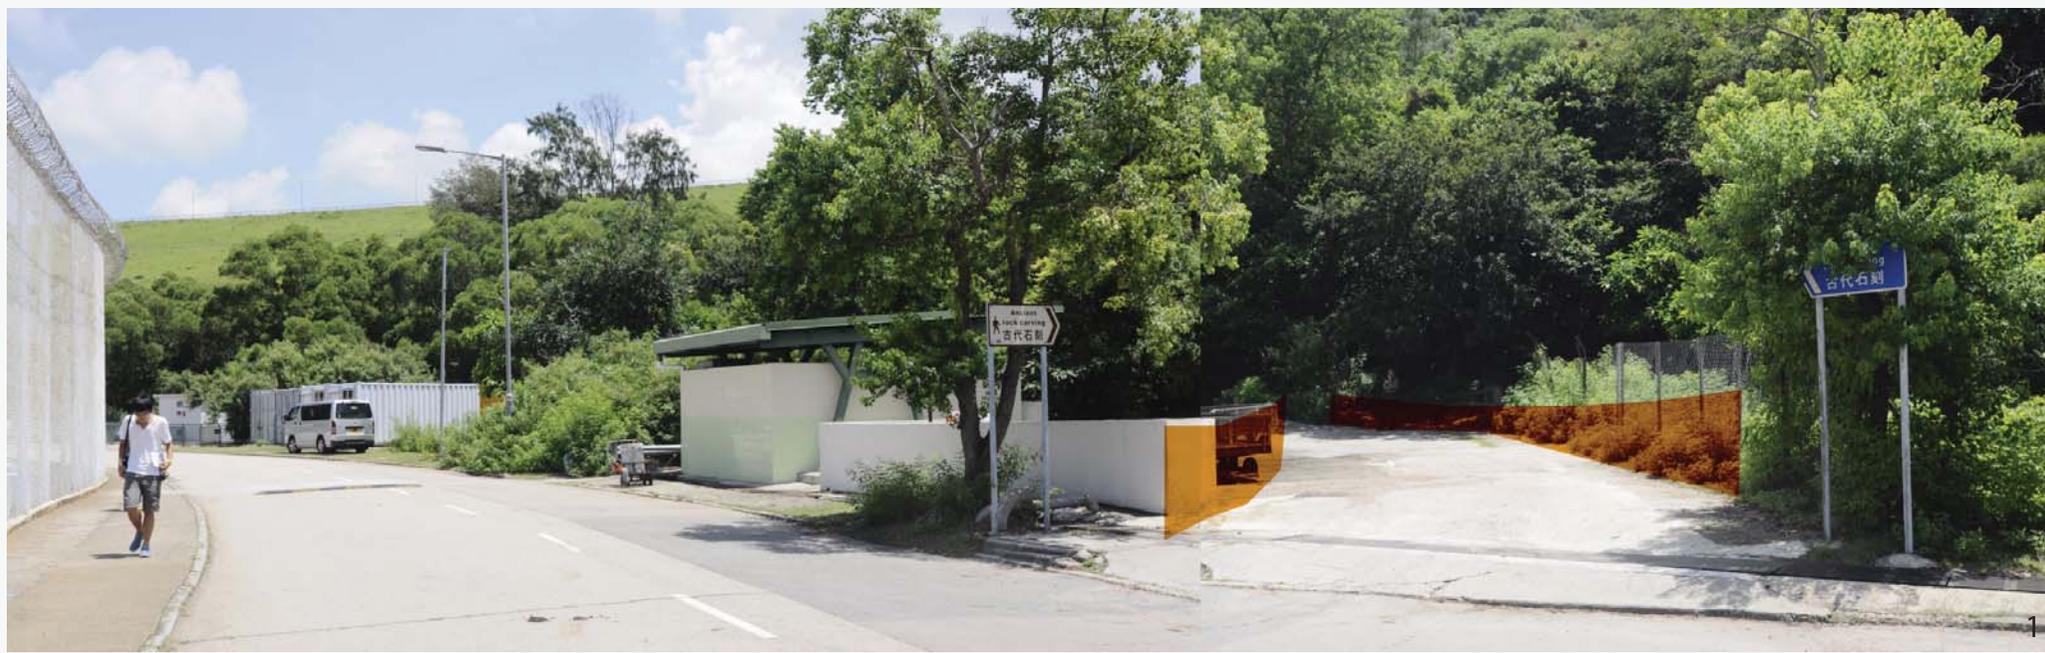
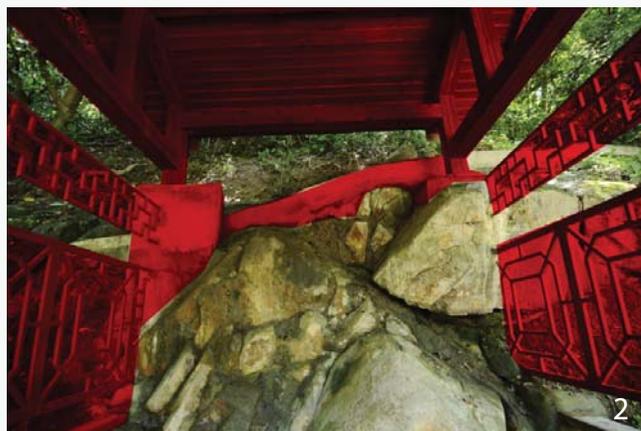
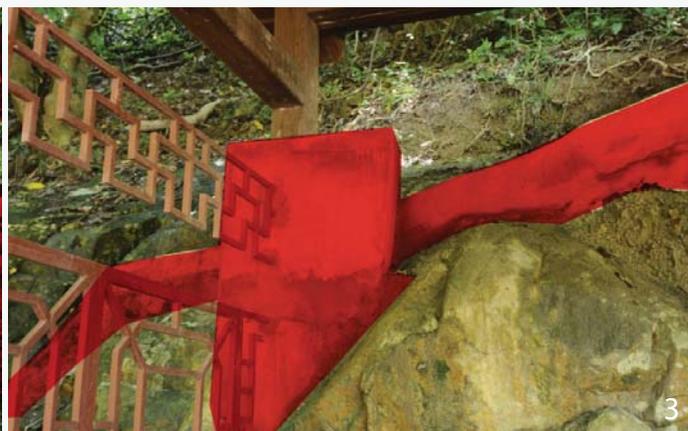
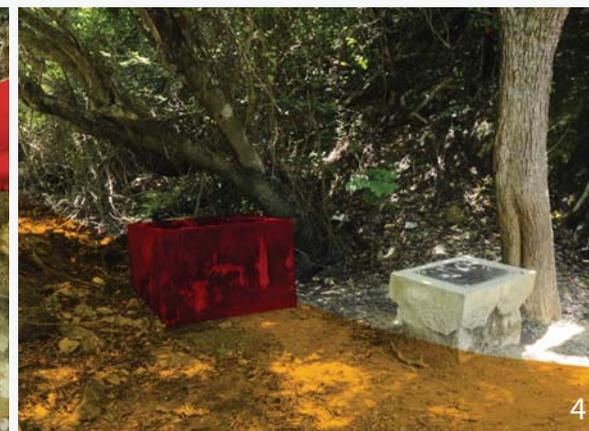
1. We suggest putting up low fences outside the refuse collection point so that visitors can enjoy a more pleasant walk to the site.
- 2 & 3. Shelter to be removed to allow air flow and avoid micro-climate. The concrete water diversion dams need to be replaced to prevent water seeping into the rock.
4. The unused well is to be removed.

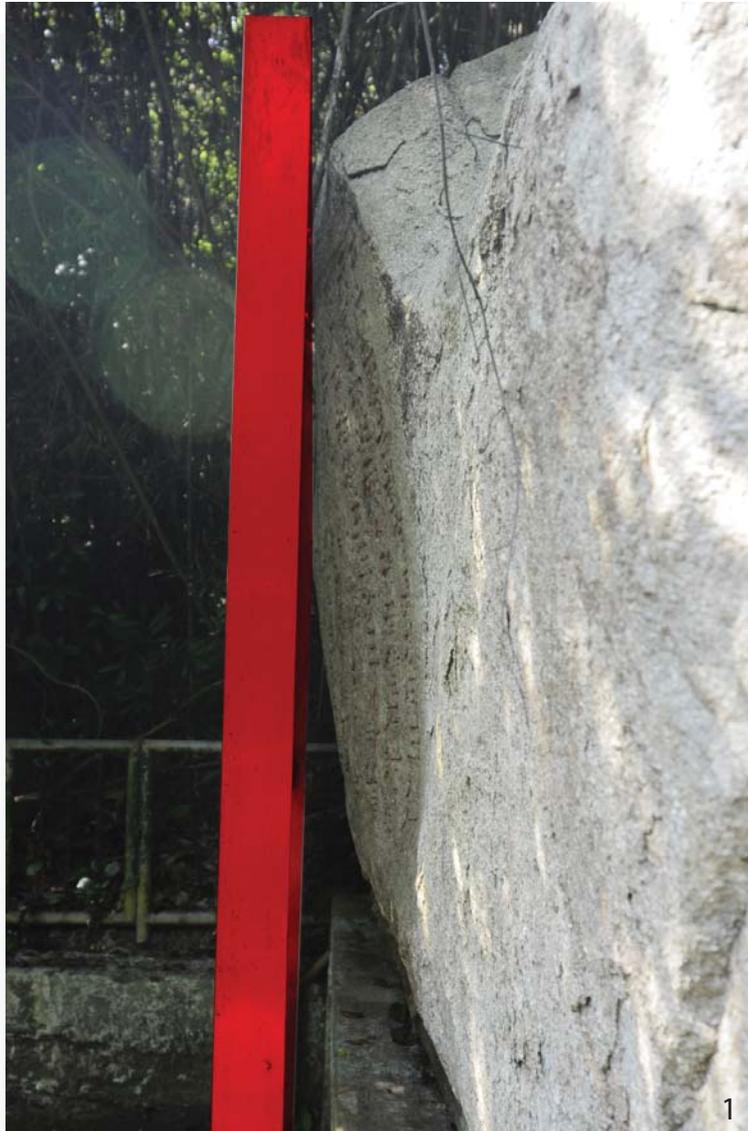
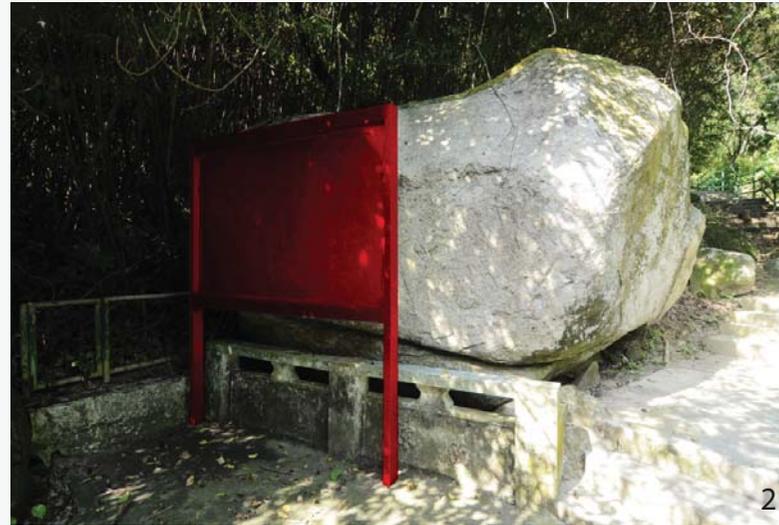
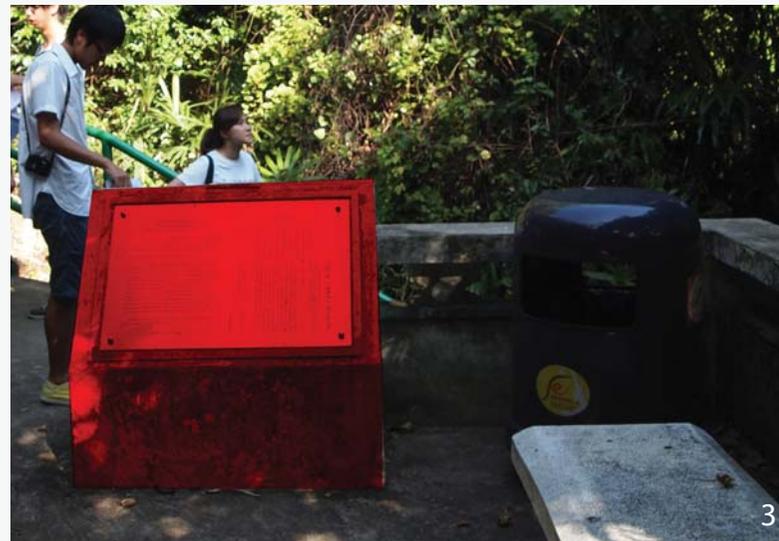
Site 8 Joss House Bay

Design approach 2 - physical barrier

- To be removed
- Proposed structure

Suggested actions in the Rock Carvings Consultancy Study	Purpose	Suggested architectural approach by CPW
Physical measure	<ul style="list-style-type: none"> To remove Perspex screen 	<ul style="list-style-type: none"> To increase visibility 	<p>Being the only readable rock inscription, it is most prone to vandalism. We propose erecting a physical barrier as the area has constraints for extensions or construction of alternative pathway.</p> <p>Interpretation plate is to be incorporated with the barrier structure.</p>
Interpretation plate	<ul style="list-style-type: none"> To be incorporated with the balustrade 	<ul style="list-style-type: none"> To provide more background information of the rock To educate visitors to protect the cultural heritage of Hong Kong. 	
Chemical & geographic conditions	<ul style="list-style-type: none"> To remove existing concrete plinth 	<ul style="list-style-type: none"> To reveal the original setting To avoid soluble salt from concrete and protect the rock in the long term

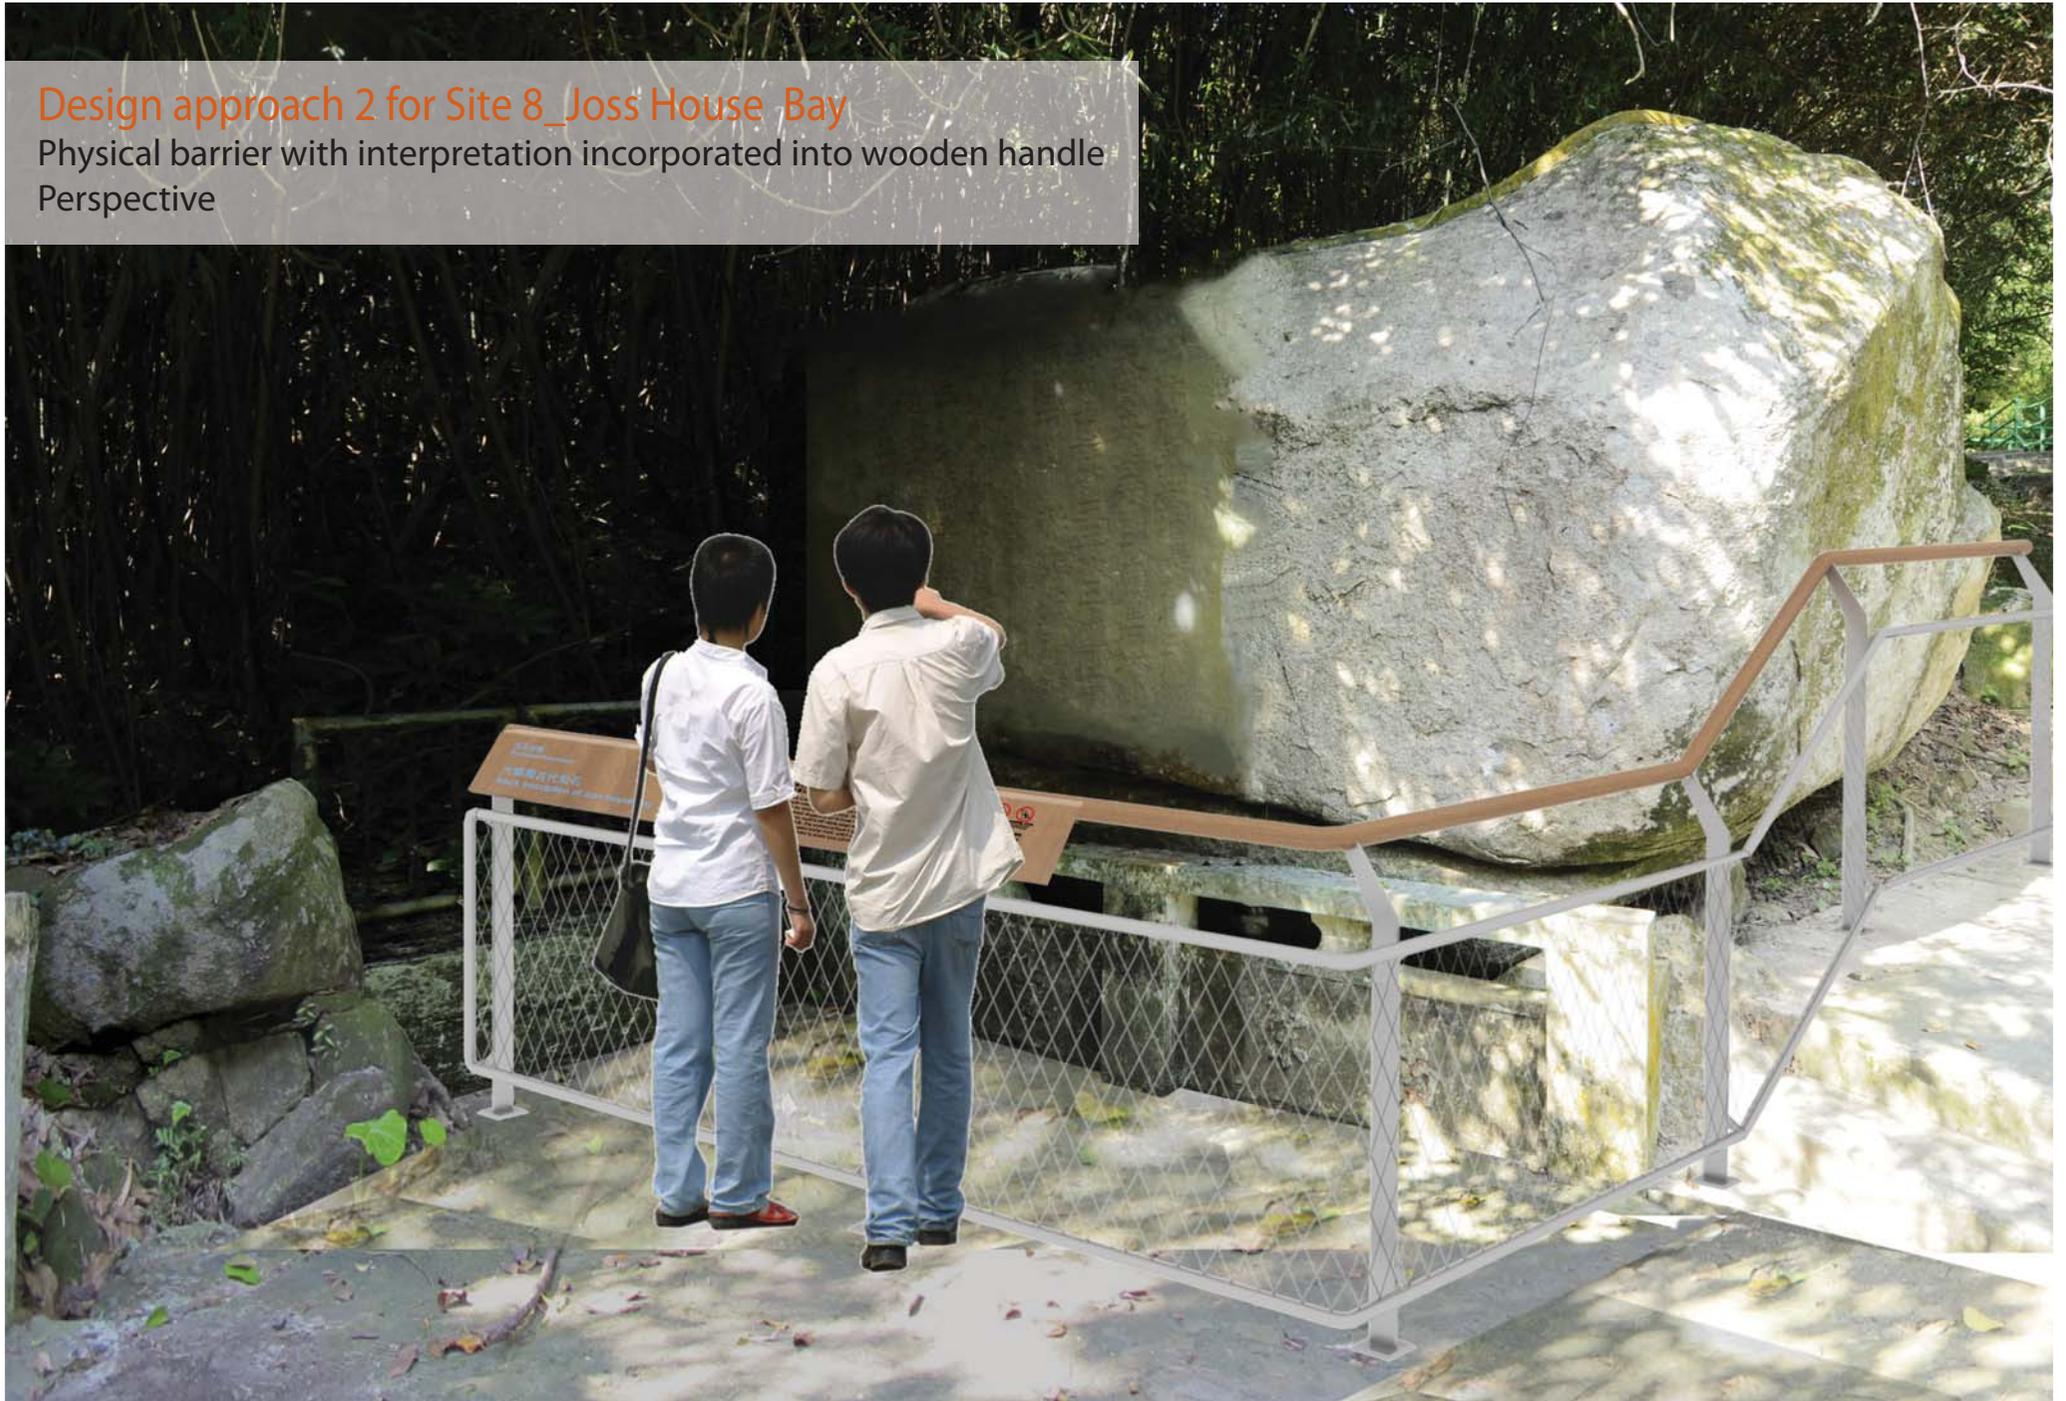
Physical barrier with interpretation incorporated into wooden handle
Perspective

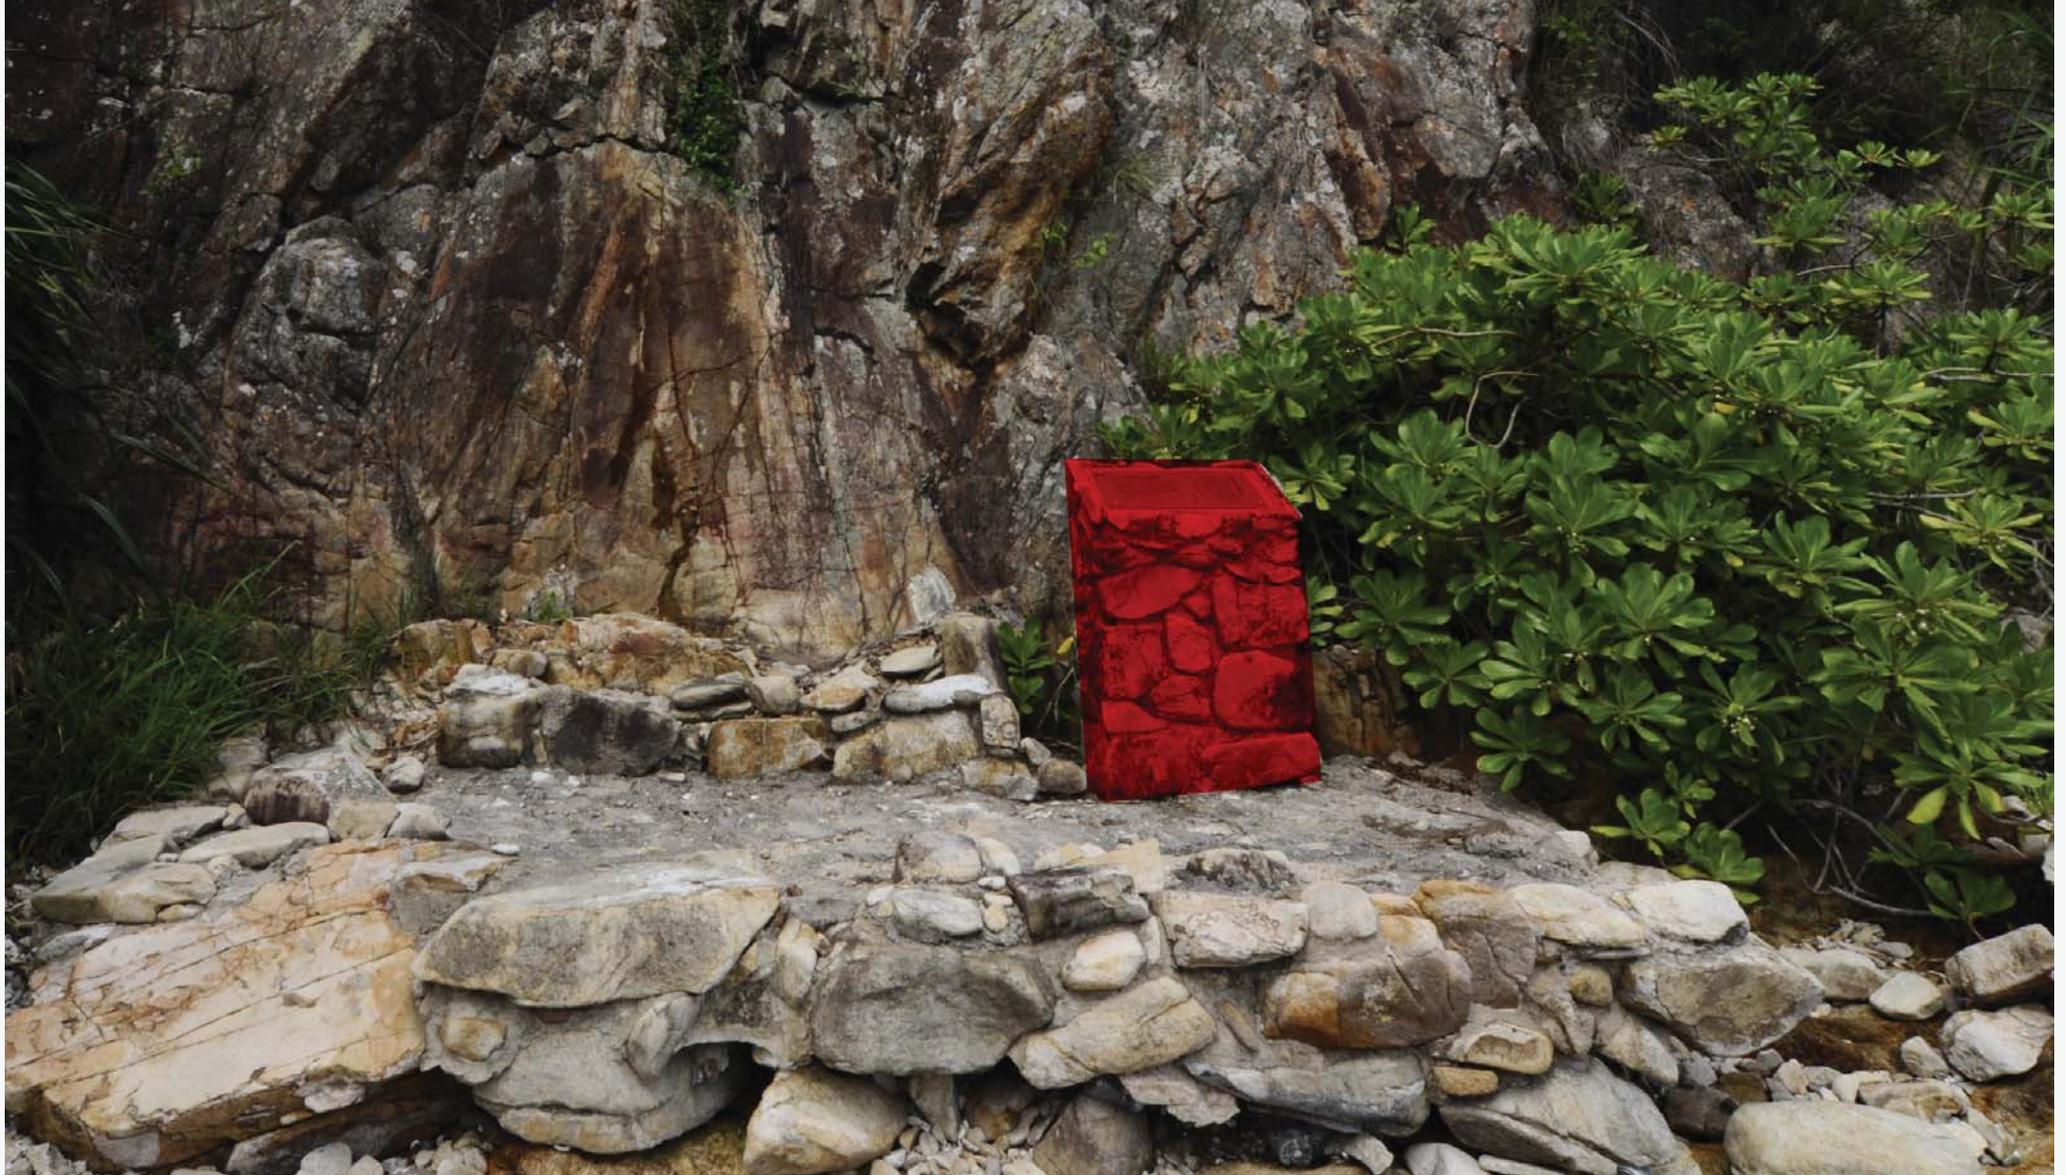
■ To be removed

Suggested actions in the Rock Carvings Consultancy Study	Purpose	Suggested architectural approach by CPW
Physical measure	<ul style="list-style-type: none"> To stabilize rocks above the carving To remove all existing structures 	<ul style="list-style-type: none"> To increase visibility To prevent formation of micro-climate 	<p>Only a standalone interpretation plate is to be installed.</p> <p>*It is agreed among the experts that the site should not be developed into a popular tourist destination so to ensure minimum disturbance to the carving and the environment. It has also been strongly recommended that the site is to have minimal infrastructure.</p>
Interpretation plate	<ul style="list-style-type: none"> To be incorporated with the balustrade 	<ul style="list-style-type: none"> To provide more background information of the rock To educate visitors to protect the cultural heritage of Hong Kong.

Chemical & geographic conditions	<ul style="list-style-type: none"> To remove existing concrete base 	<ul style="list-style-type: none"> To reveal the original setting To avoid soluble salt from concrete and salt deposition in the long term 	
Maintenance	<ul style="list-style-type: none"> Periodical maintenance is essential 	<ul style="list-style-type: none"> To ensure the rock carving is in the equilibrium condition. 	
Other remarks	3D laser scanning is essential for further detailed design as well as actual construction.
