Provision of Architectural Designs of
Protection and Visitor Facilities for
Rock Carvings and Inscription in Hong Kong

FINAL REPORT

15th March 2012

THE UNIVERSITY OF HONG KONG 香港大學
faculty of architecture 建築學院
Community Project Workshop 社區項目工作坊

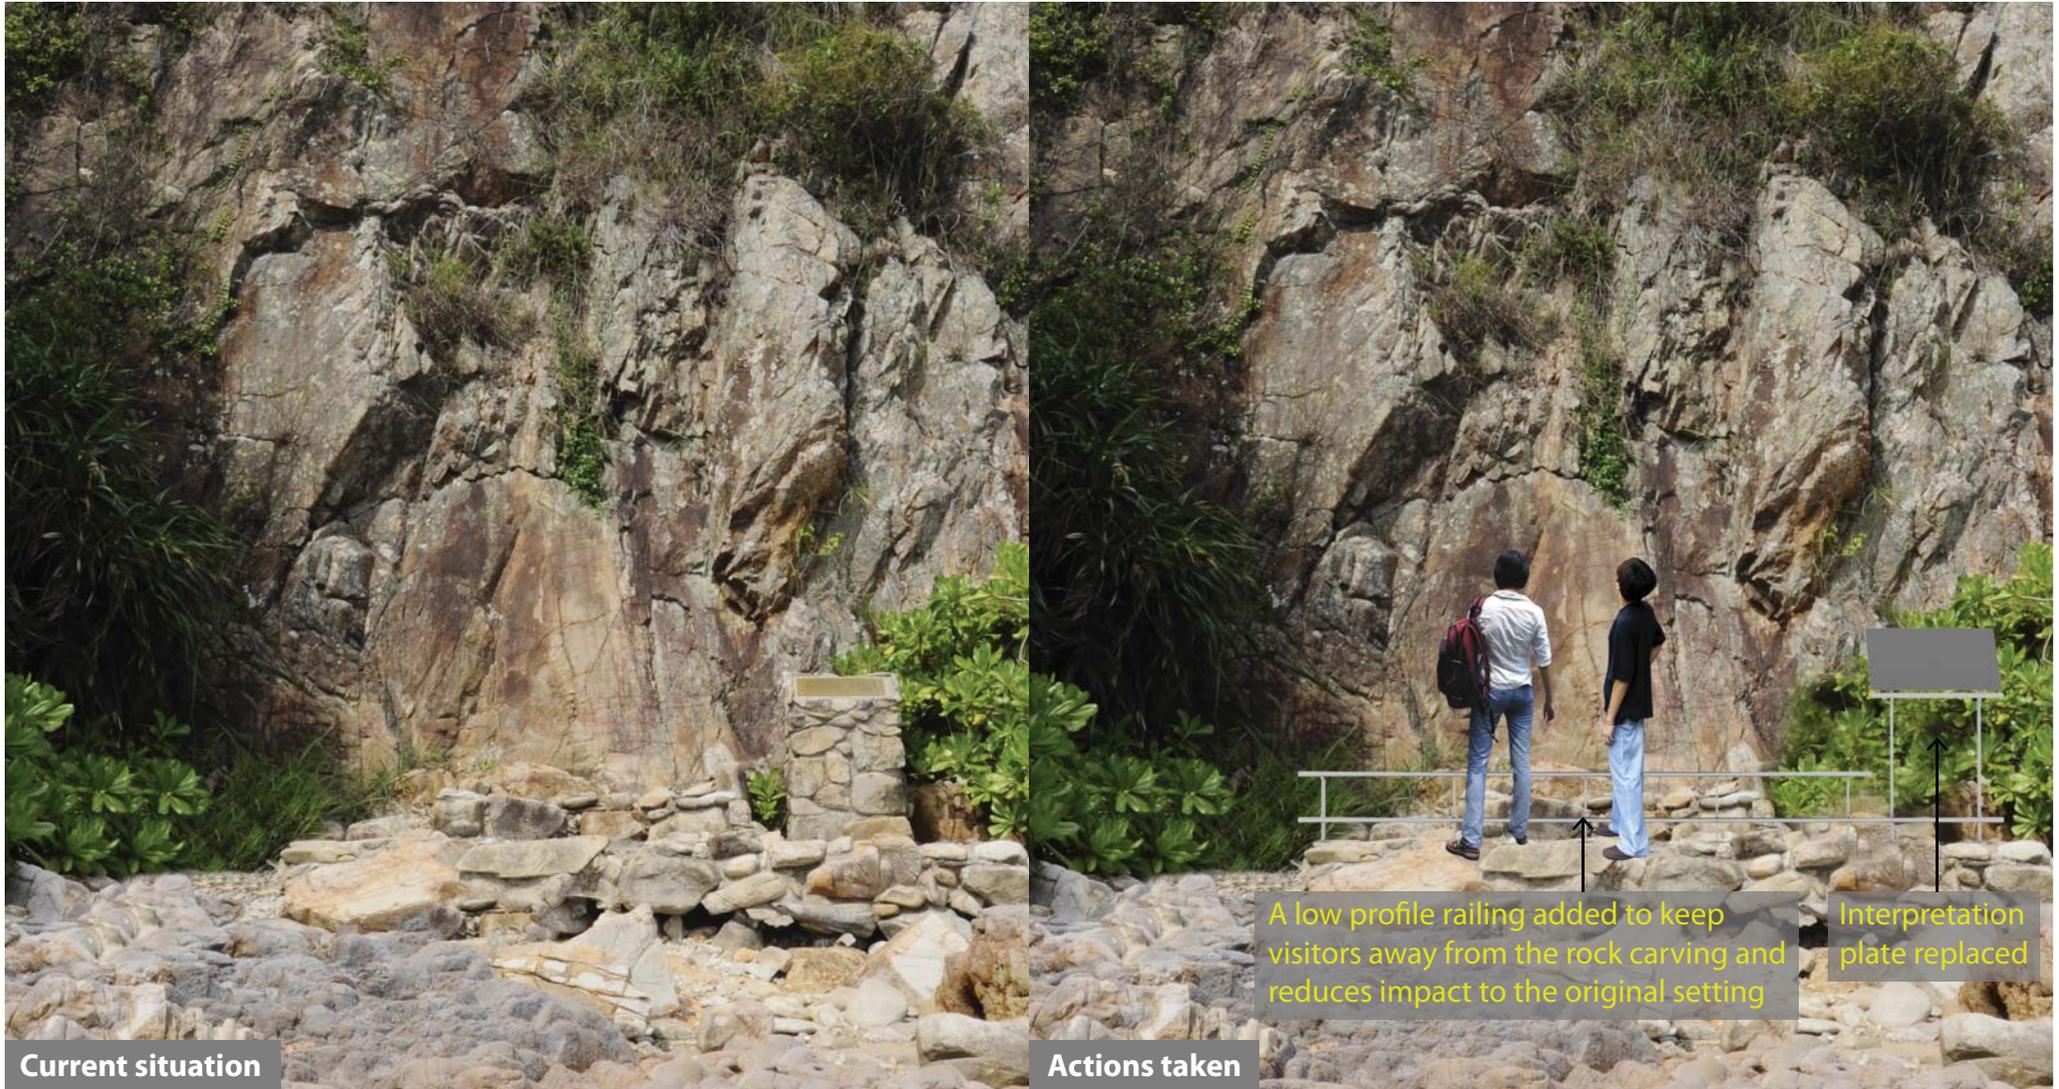
Interpretative panel as psychological barrier

Actions taken in the design

Current situation

Actions taken

Interpretation plate replaced

The site is not frequently visited by tourists. Only the interpretation plate is to be replaced.

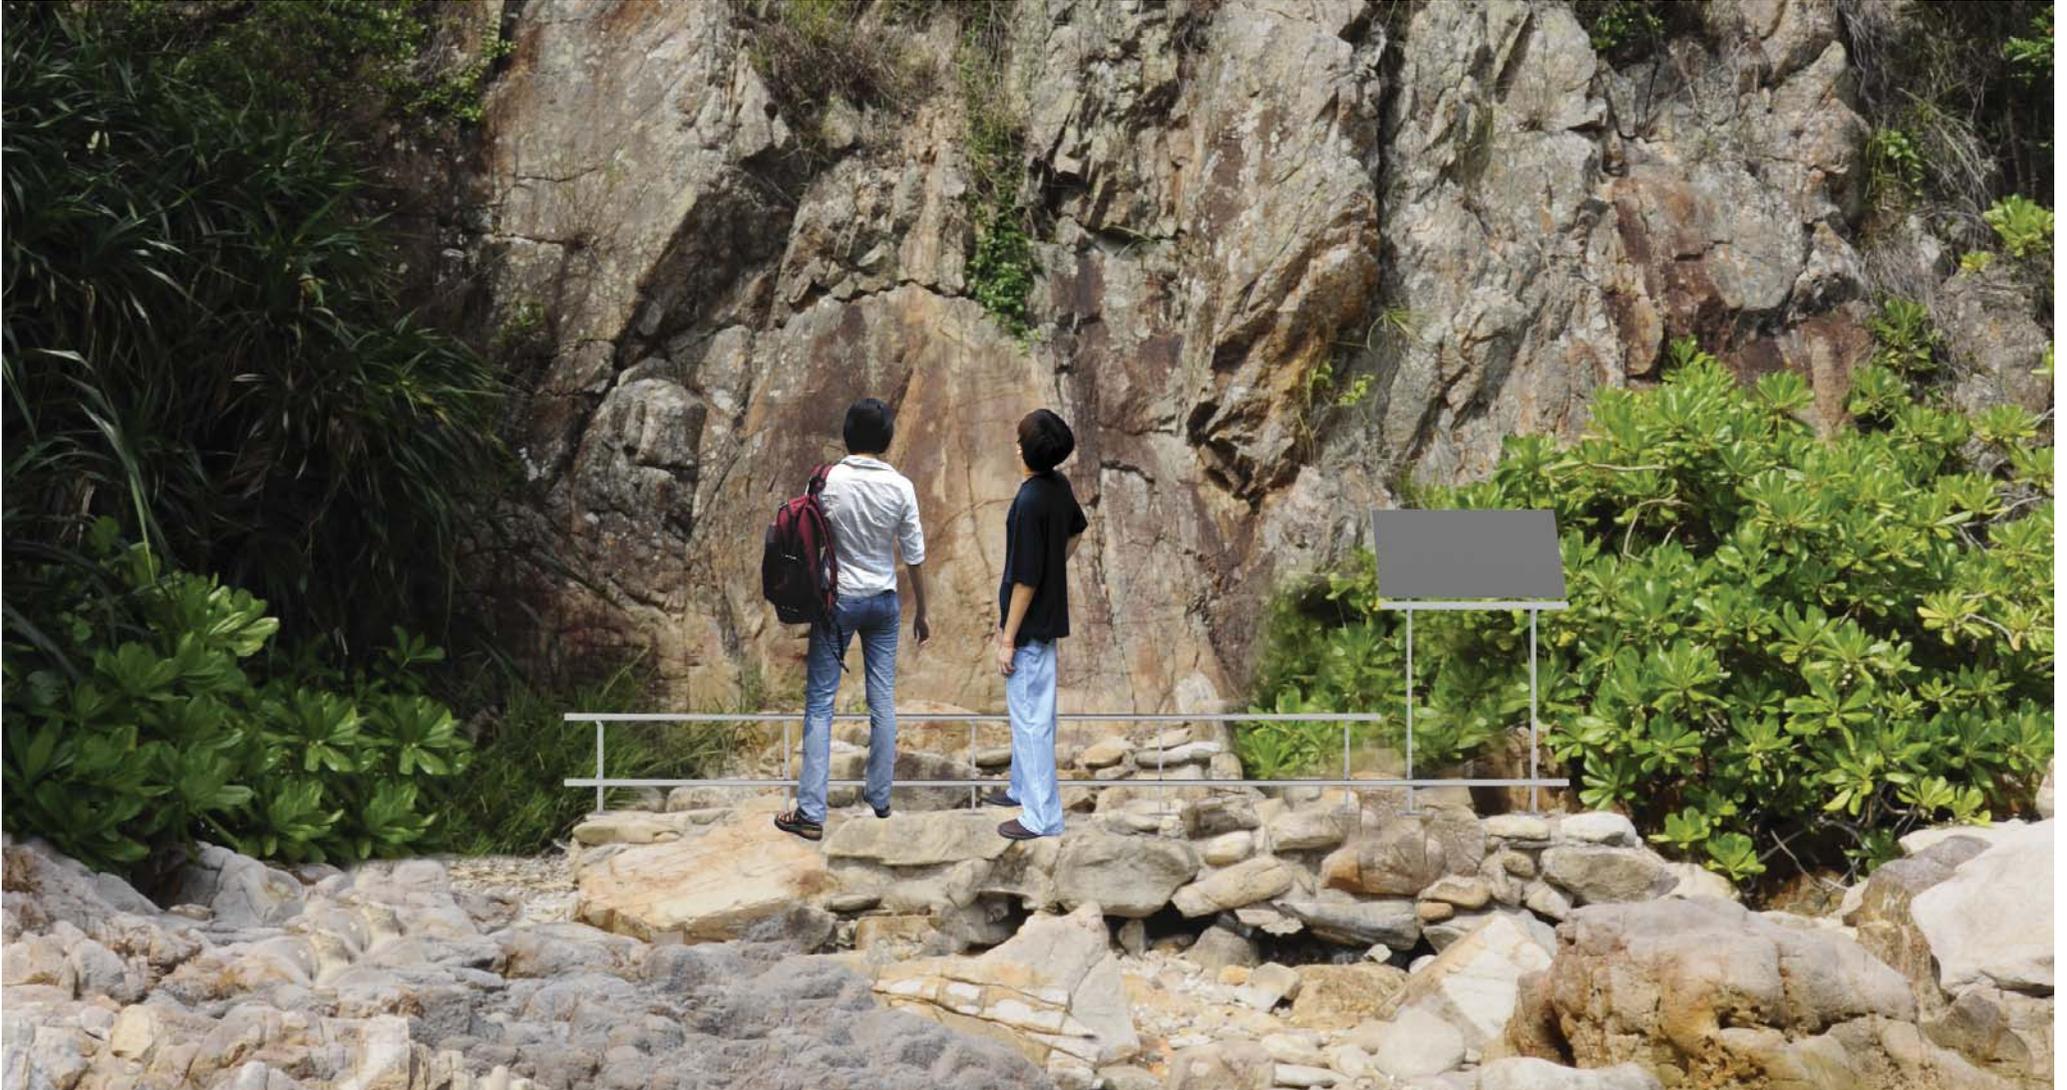
Interpretative panel as psychological barrier

Perspective

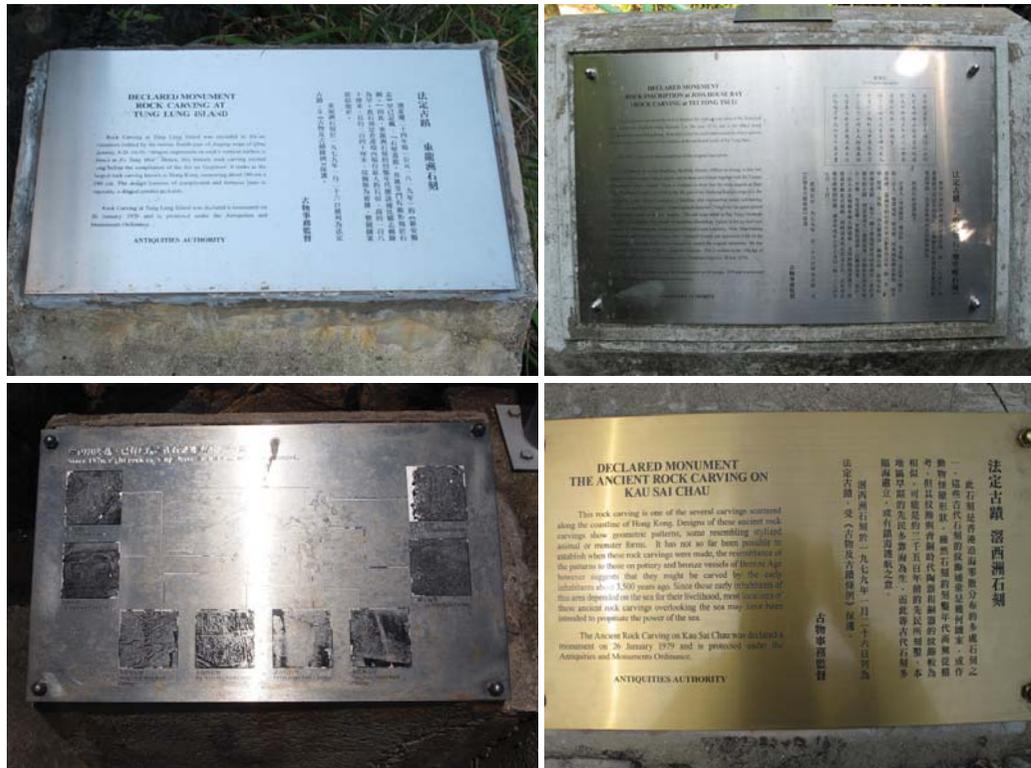
Existing interpretation plates for the carvings

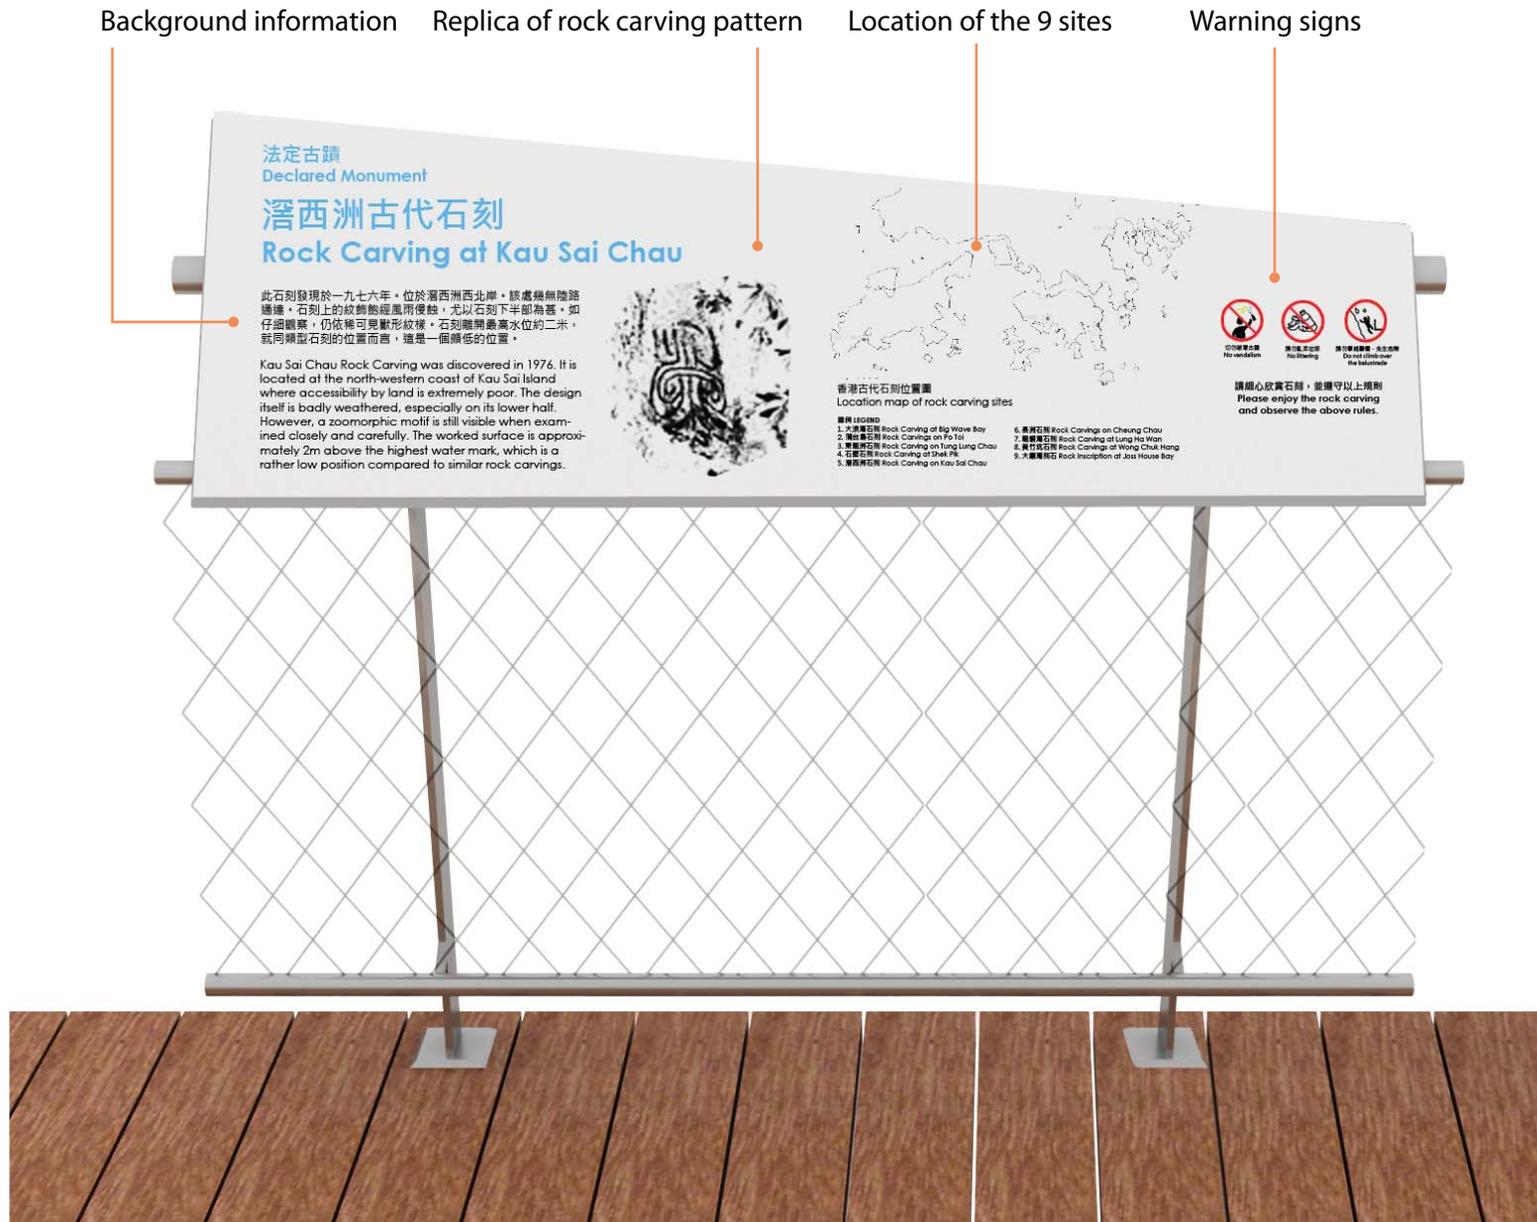
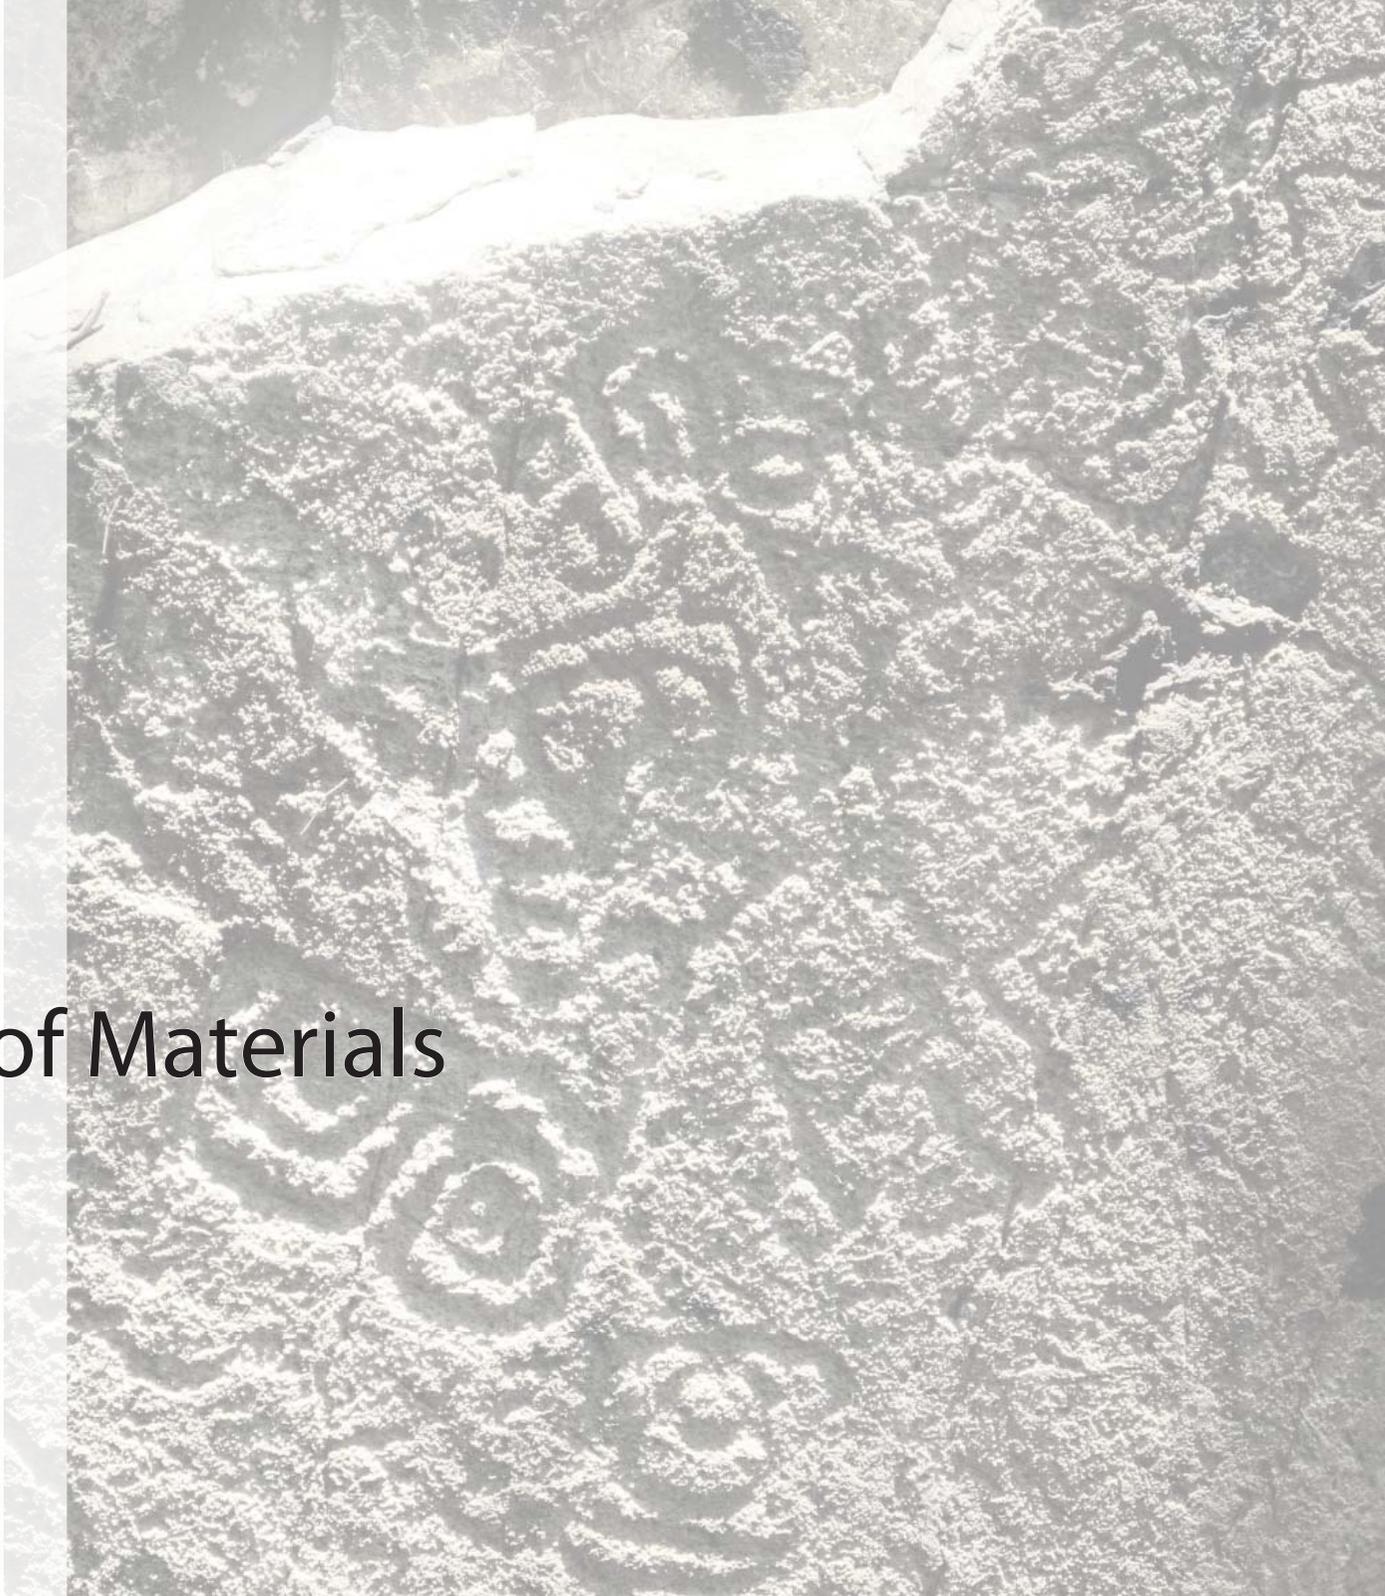
Interpretation plate design

The interpretation plate is a very important part of the protection measure for the rock carving not only because it helps educating the visitors about the historical value of the rock, but it can also convey the warning message in a more gentle and visually pleasing way.

The design approaches for the 9 sites may vary depending on specific site condition, but all interpretive facilities shall be united under one consistent design language.

Warning signs should be included to warn against undesirable behaviours such as littering and vandalism.

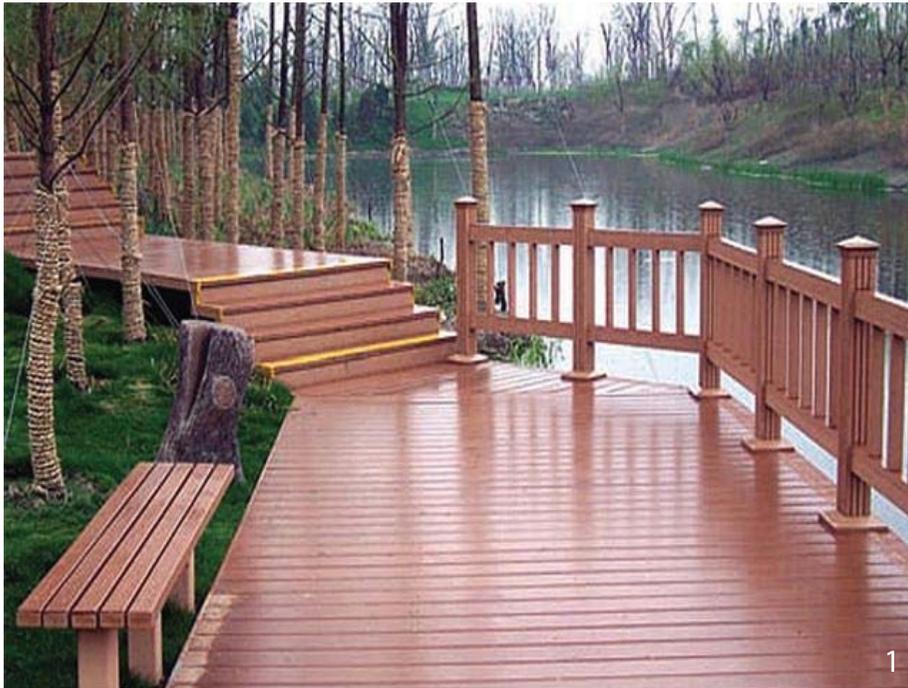
1

Wood-plastic is made from a composite of wood fibre and plastic. Wood-plastic is lightweight and resistant to corrosion. Unlike timber, it does not rot and is not affected by insects. As it is a relatively new material, durability is yet to be proved, but warranty period can vary from 5 to 30 years depending on the manufacturer. It is fairly strong with high resistance to impact but is not a structural material. It can deform slightly in extremely hot weather but is more stable than timber. General applications include outdoor deck, cladding, railing etc.

Wood-plastic composite comes in hollow or solid forms and in different colours. It can be moulded with or without simulated grain details. No surface treatment like varnishing, sanding etc. is needed. It is therefore a low-maintenance material that allows flexibility in design. The only concern from the experts is that it might appear bulky.

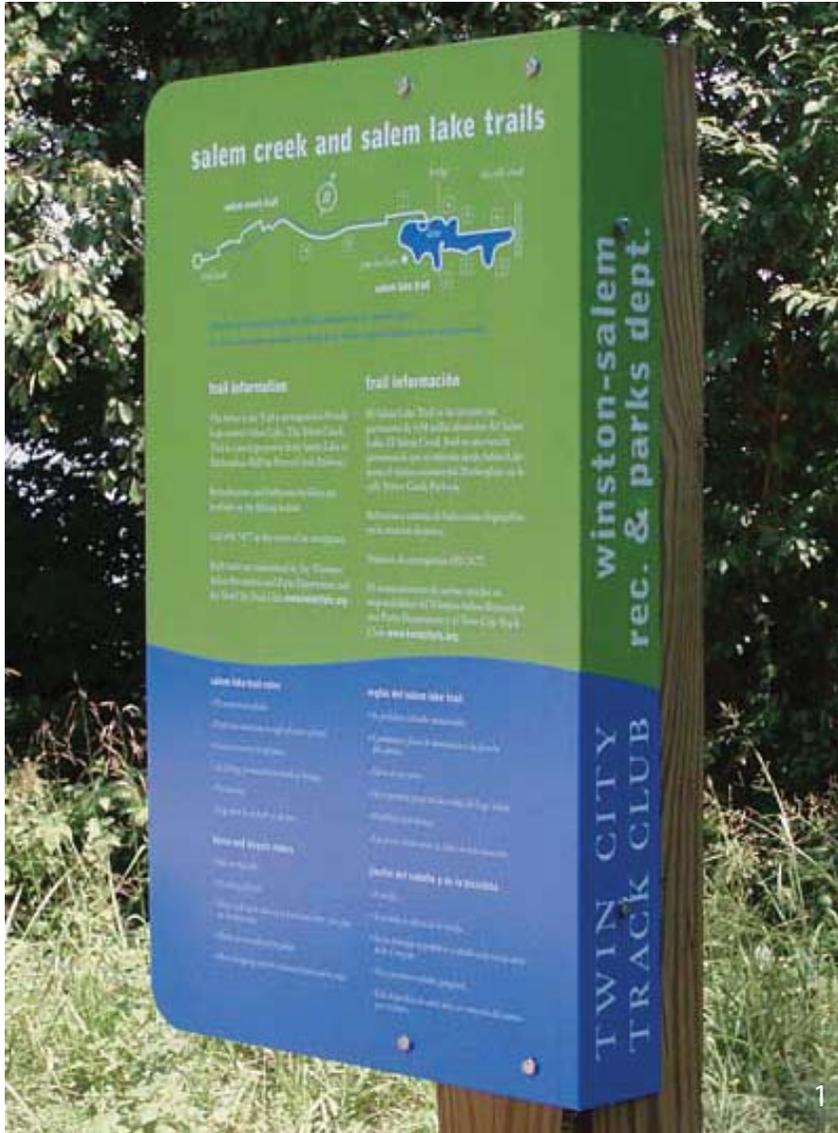
1. Wood-plastic decking, railing and seating
2. Wood-plastic composite members
3. Park signage in wood-plastic
4. Wood-plastic riverside footpath

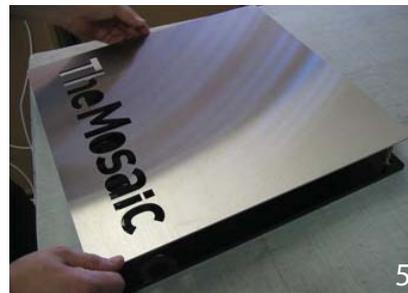
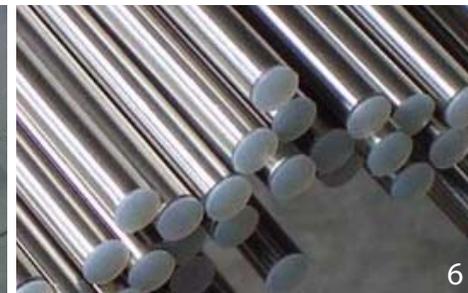
Stainless Steel 316L

Stainless steel 316L is the low carbon version (0.03% carbon maximum) of stainless steel 316. The low carbon content makes it easier to weld. 316L is known as the ‘marine grade’ stainless steel. It is extremely resistant to water, heat and corrosion but can exhibit slight surface corrosion if the surface has not been polished after welding or grinding. It is highly durable and strong as a structural material, and the surface corrosion aforementioned does not affect its structural integrity or its lifetime. Regular maintenance is required every 6 to 12 months in coastal and rural areas to maintain the appearance.

316L comes in various finishing options and forms including angles, sheets, hollow sections, wire mesh etc. The material’s neutral look goes well with many different types of materials and is therefore very versatile. It can withstand harsh climates and chloride environments, and is often used in marines. We suggest the material to be used for structural frames, walkway structures and interpretive facilities.

1. Stainless steel signage along Salem Creek, North Carolina
- 2-4. Various stainless steel finishes
5. Die-cut stainless steel
6. Stainless steel tubes

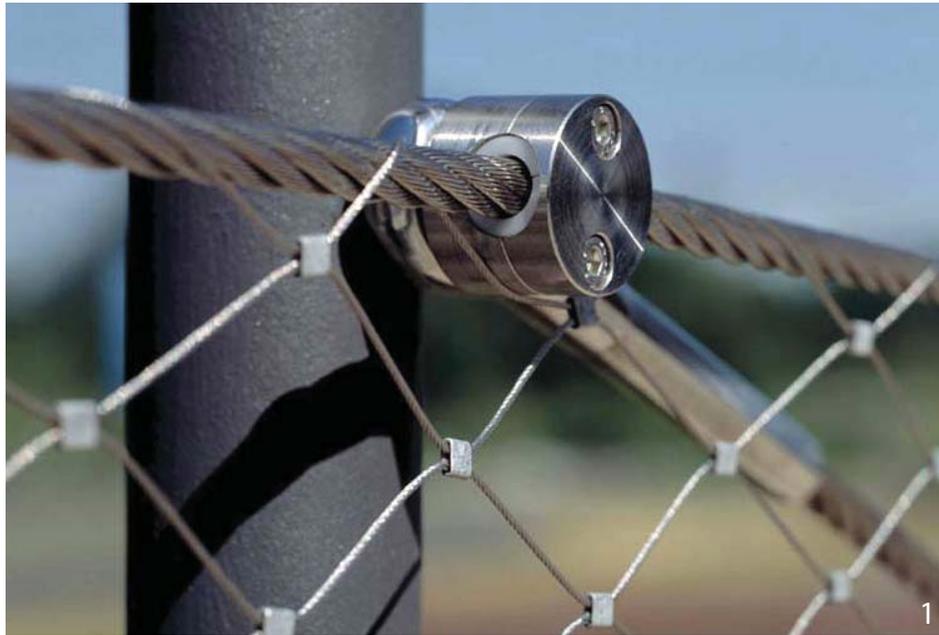
Mesh (X-Tend, Stainless Steel 316)

X-Tend is a wire mesh made from grade 316 stainless steel cables. It is corrosion-resistant, has a high load capacity & long spans. The mesh can be bent into various shapes and can even be used as a 3D structural element. The flexible diamond pattern is climb resistant and prevents a secure foothold. Diamond sizes and cable diameters can be customized (diamond size: 20mm to 200mm, cable diameters: 1.0mm to 4.0mm).

1. Mesh detail
2. Mesh used for outdoor pathway in Landesgartenschau, Germany

Company	Item	Description	Quantity	Unit rate	Amount (HKD)
Widevelop	X-Tend wire mesh	Product: X-Tend Safety Net Material: Stainless Steel 316 Model: 80/2	85m ²	1,280.00/m ² less 20% = 1,024.00/m ² * *Discount is valid for the above quantity only. Fixing kit and installation at extra cost	87,040.00

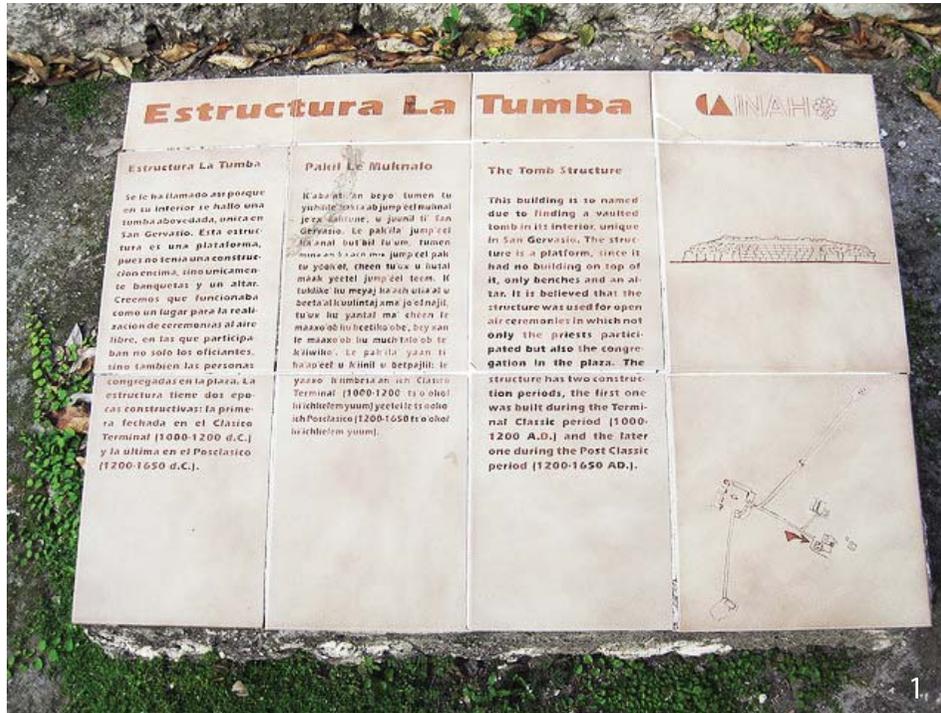
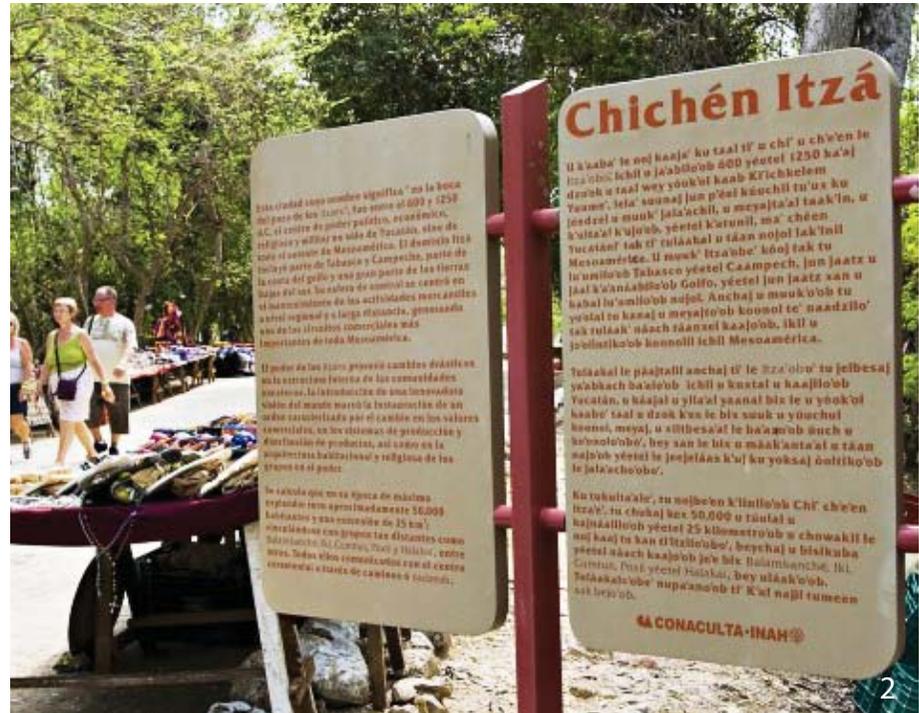
Ceramic Tile

Ceramic tiles are highly resistant to water due to its density. Tiles can be glazed, matte or unglazed. Water absorption rate of glazed tiles is as low as below 0.5 percent. Glazed tiles are stain-resistant and extremely durable (can last up to 50 years).
