附錄 A 圖

附錄 B 照片

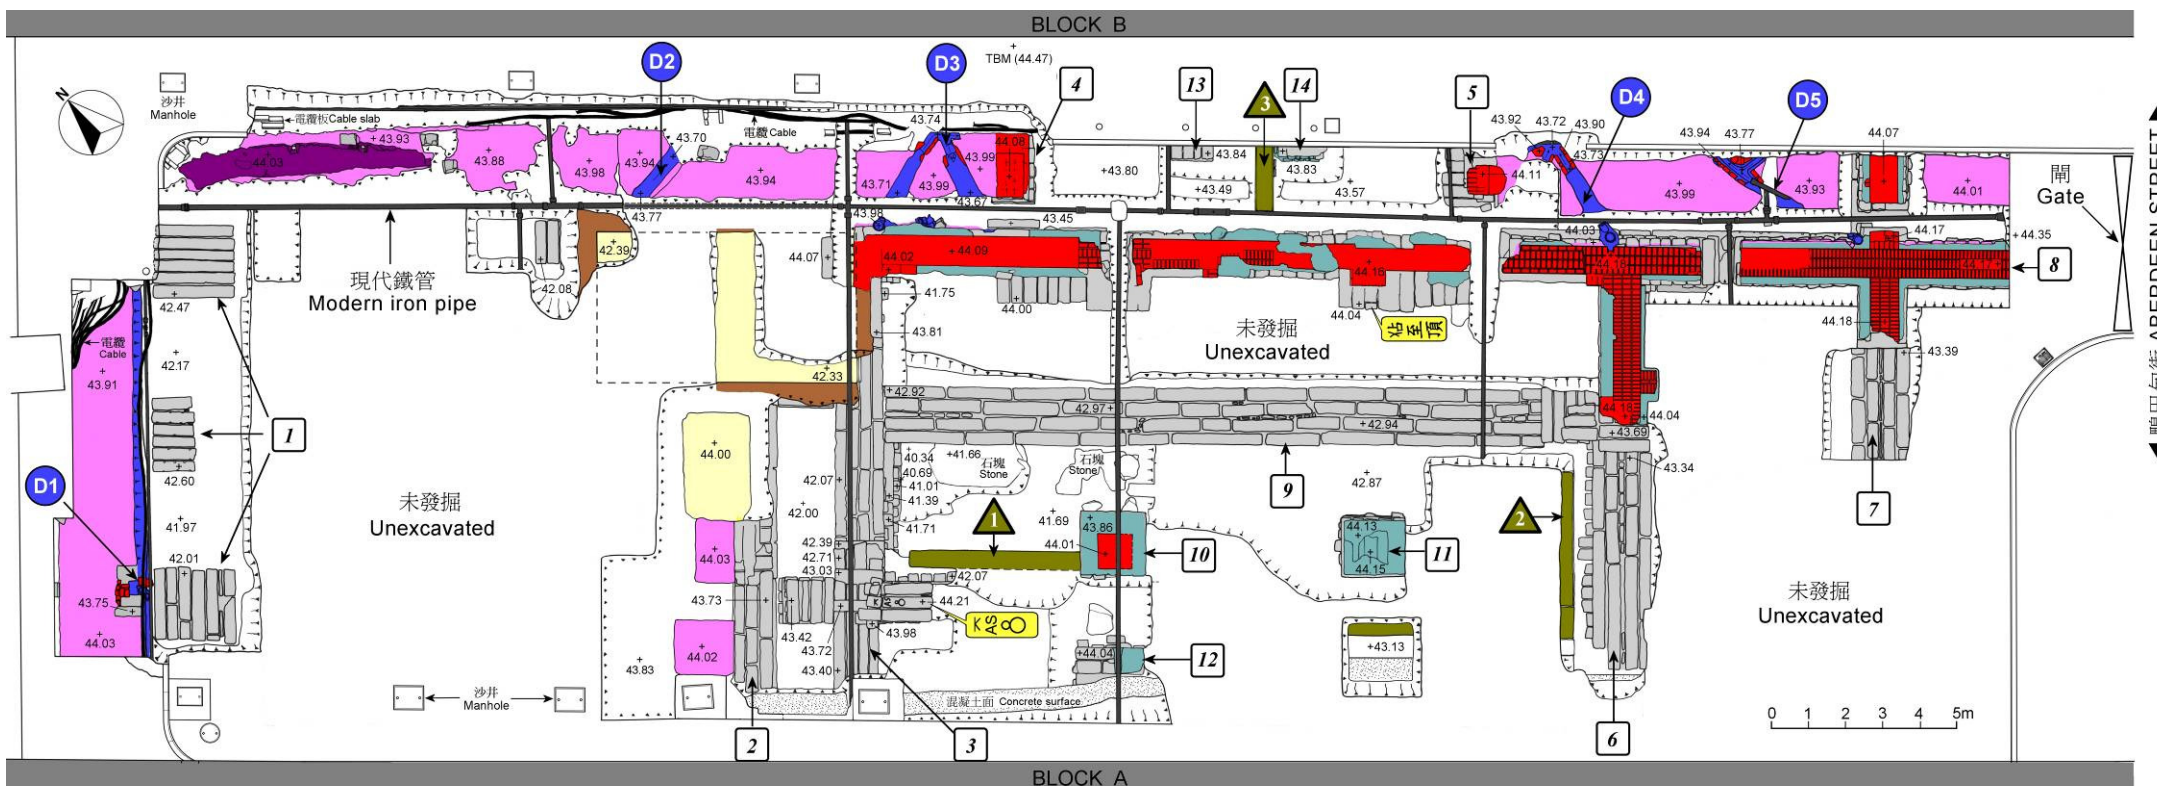
圖例 LEGEND:

圖 13 停車場範圍發現的主要遺跡

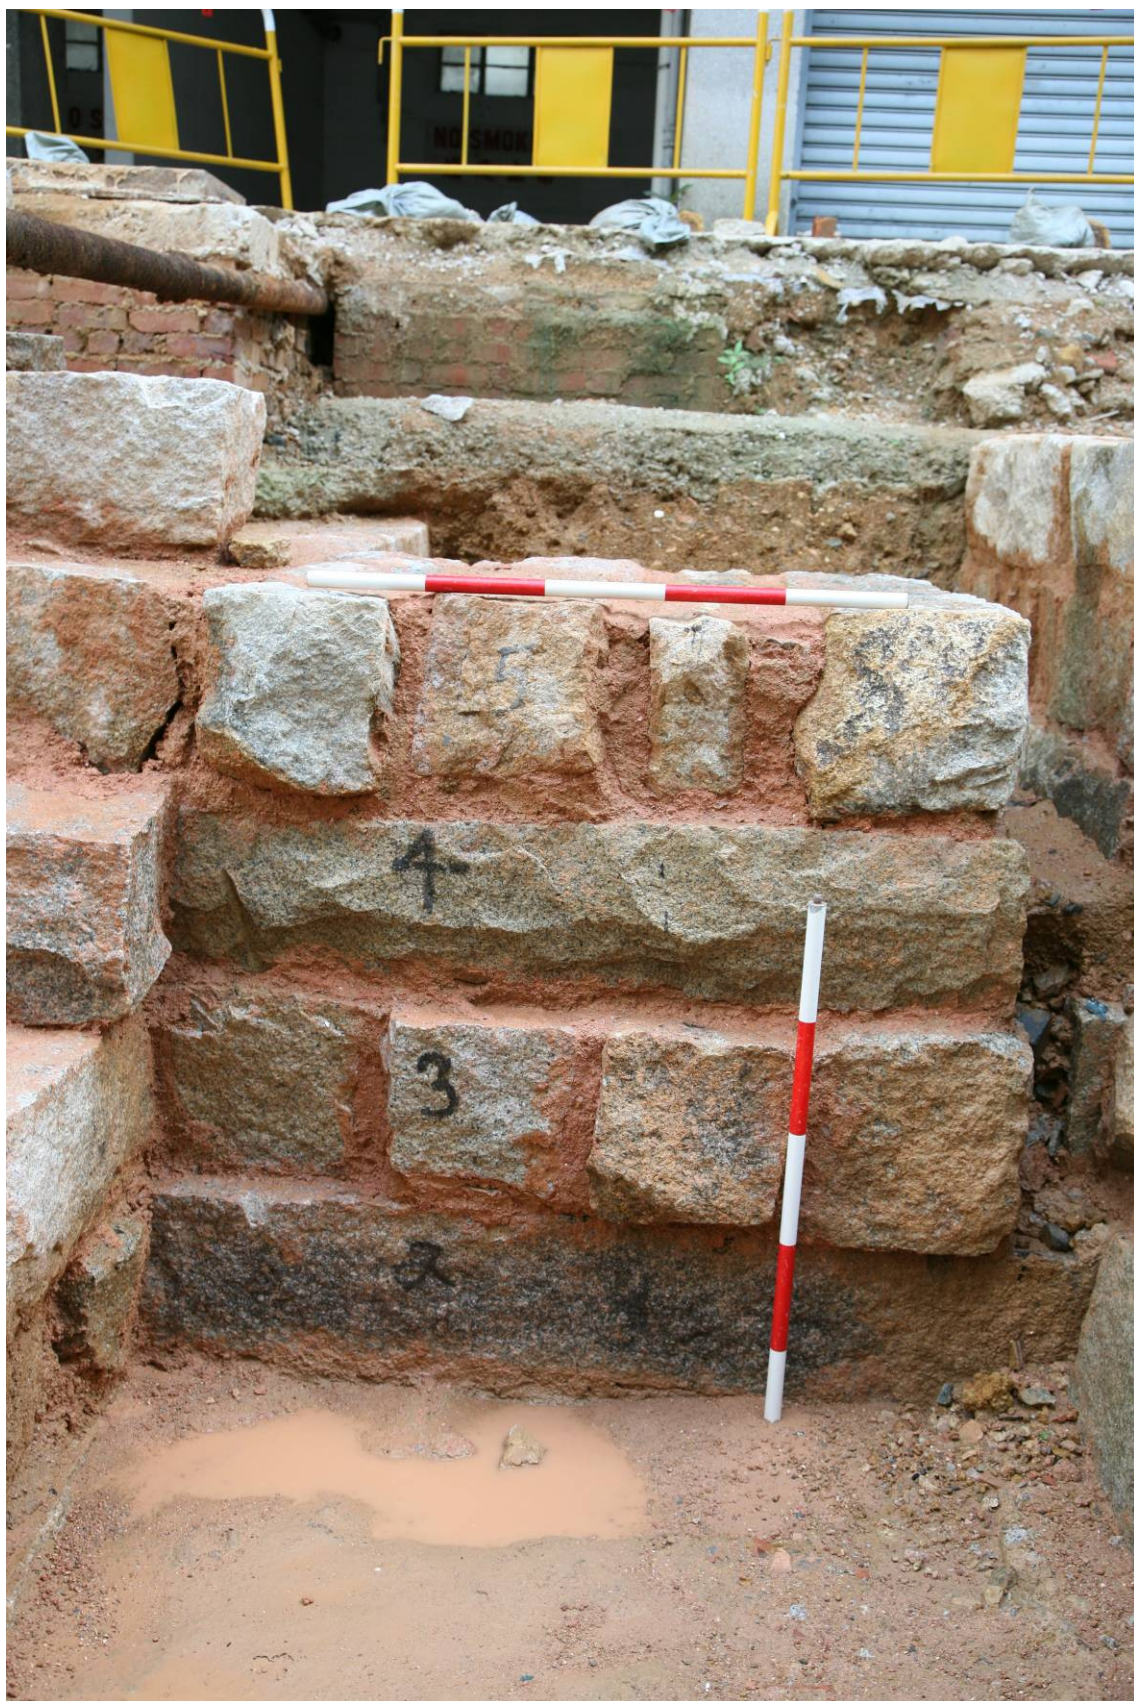
1. 牆基(3)南部的“2”,“3”,“4”及“5”墨跡 (自北向南)

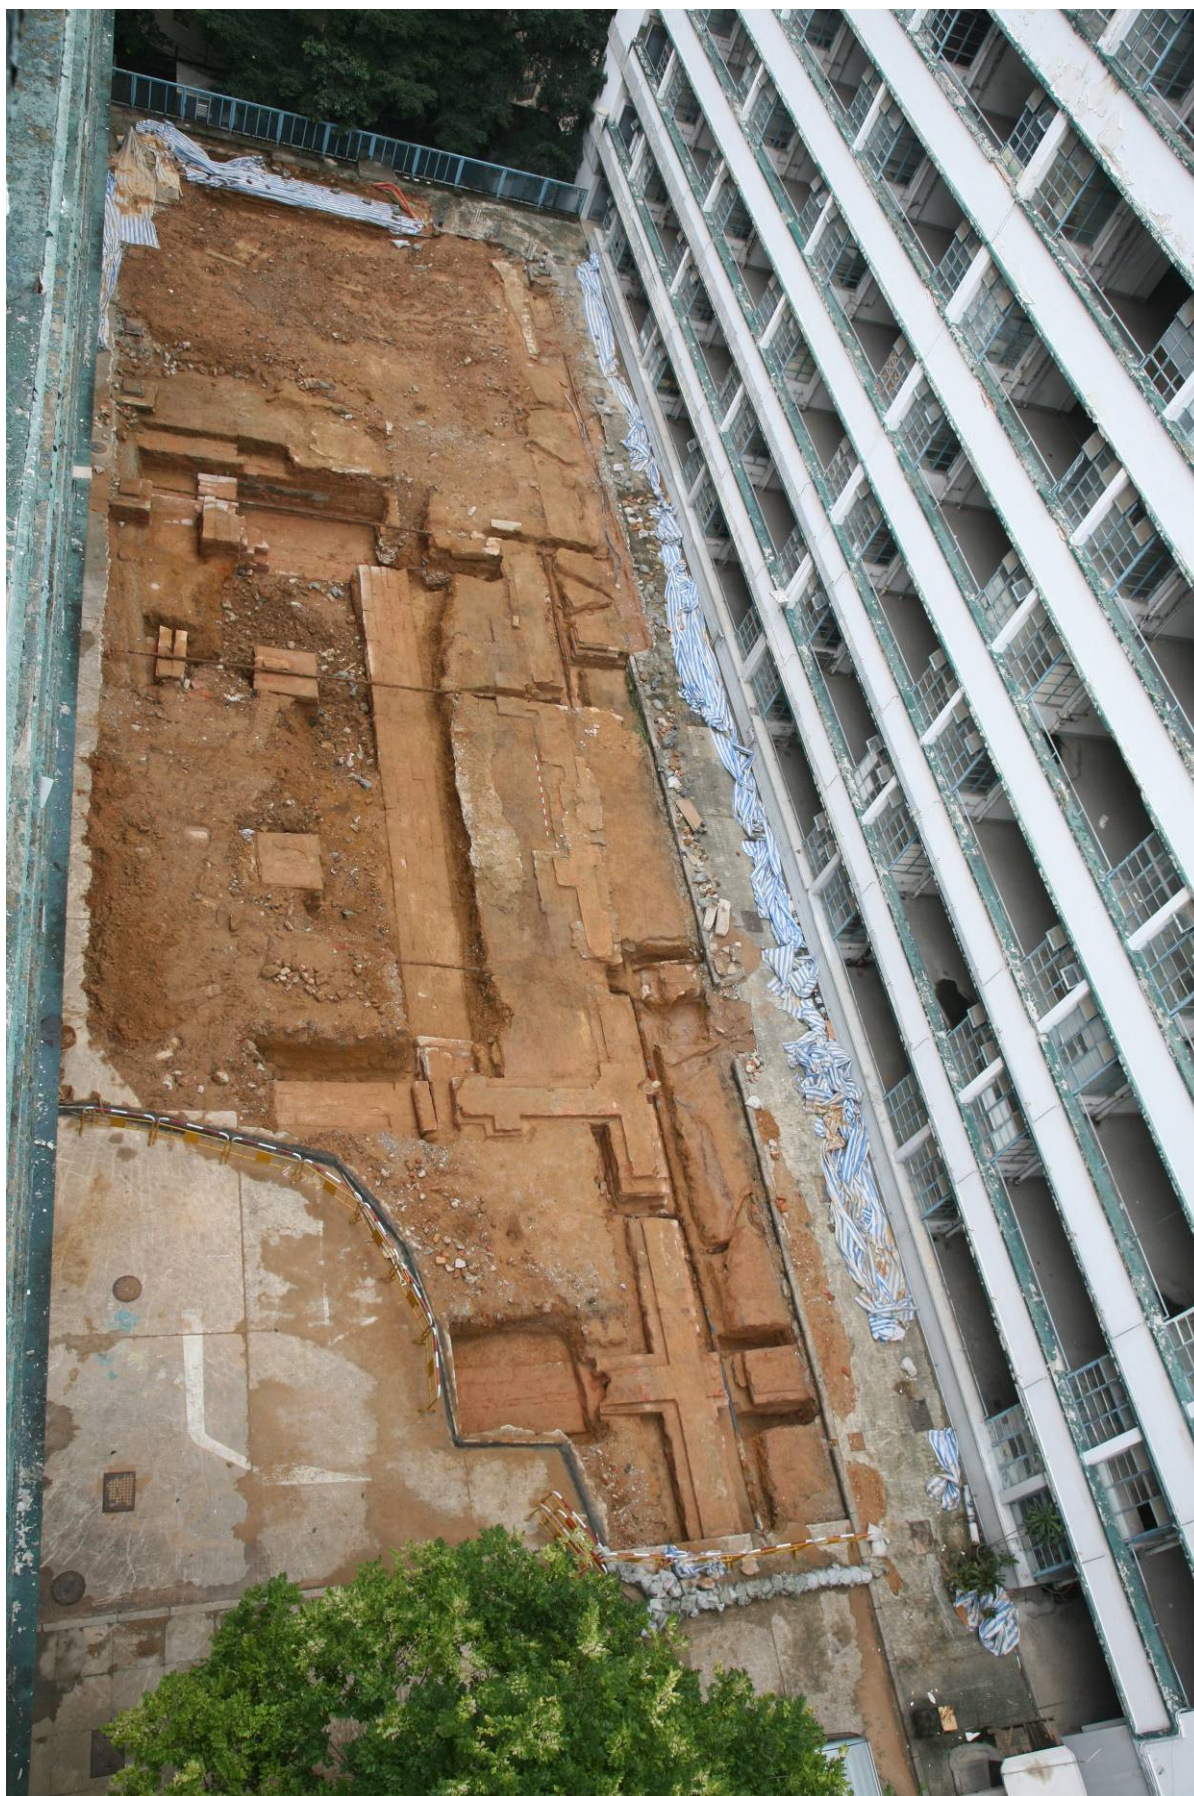
1. 2007 年 7 月下旬在停車場範圍的發掘情況 (自東向西)

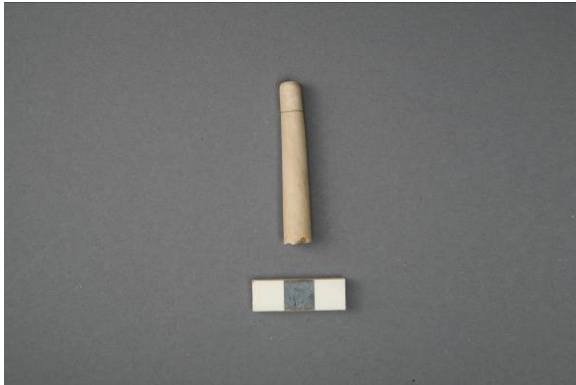
重要器物 SF29 瓷管 SF29: Ceramic pipe

Colour and Description	Light yellow with incised line on one end	Dimension	L:5.2cm T:0.8cm
Remarks	Broken
