**Heritage Impact Assessment
for
Revitalizing Historic Buildings through Partnership Scheme**

**Conversion of
Fong Yuen Study Hall
into a
Tourism & Chinese Cultural Centre cum Ma Wan Residents Museum**

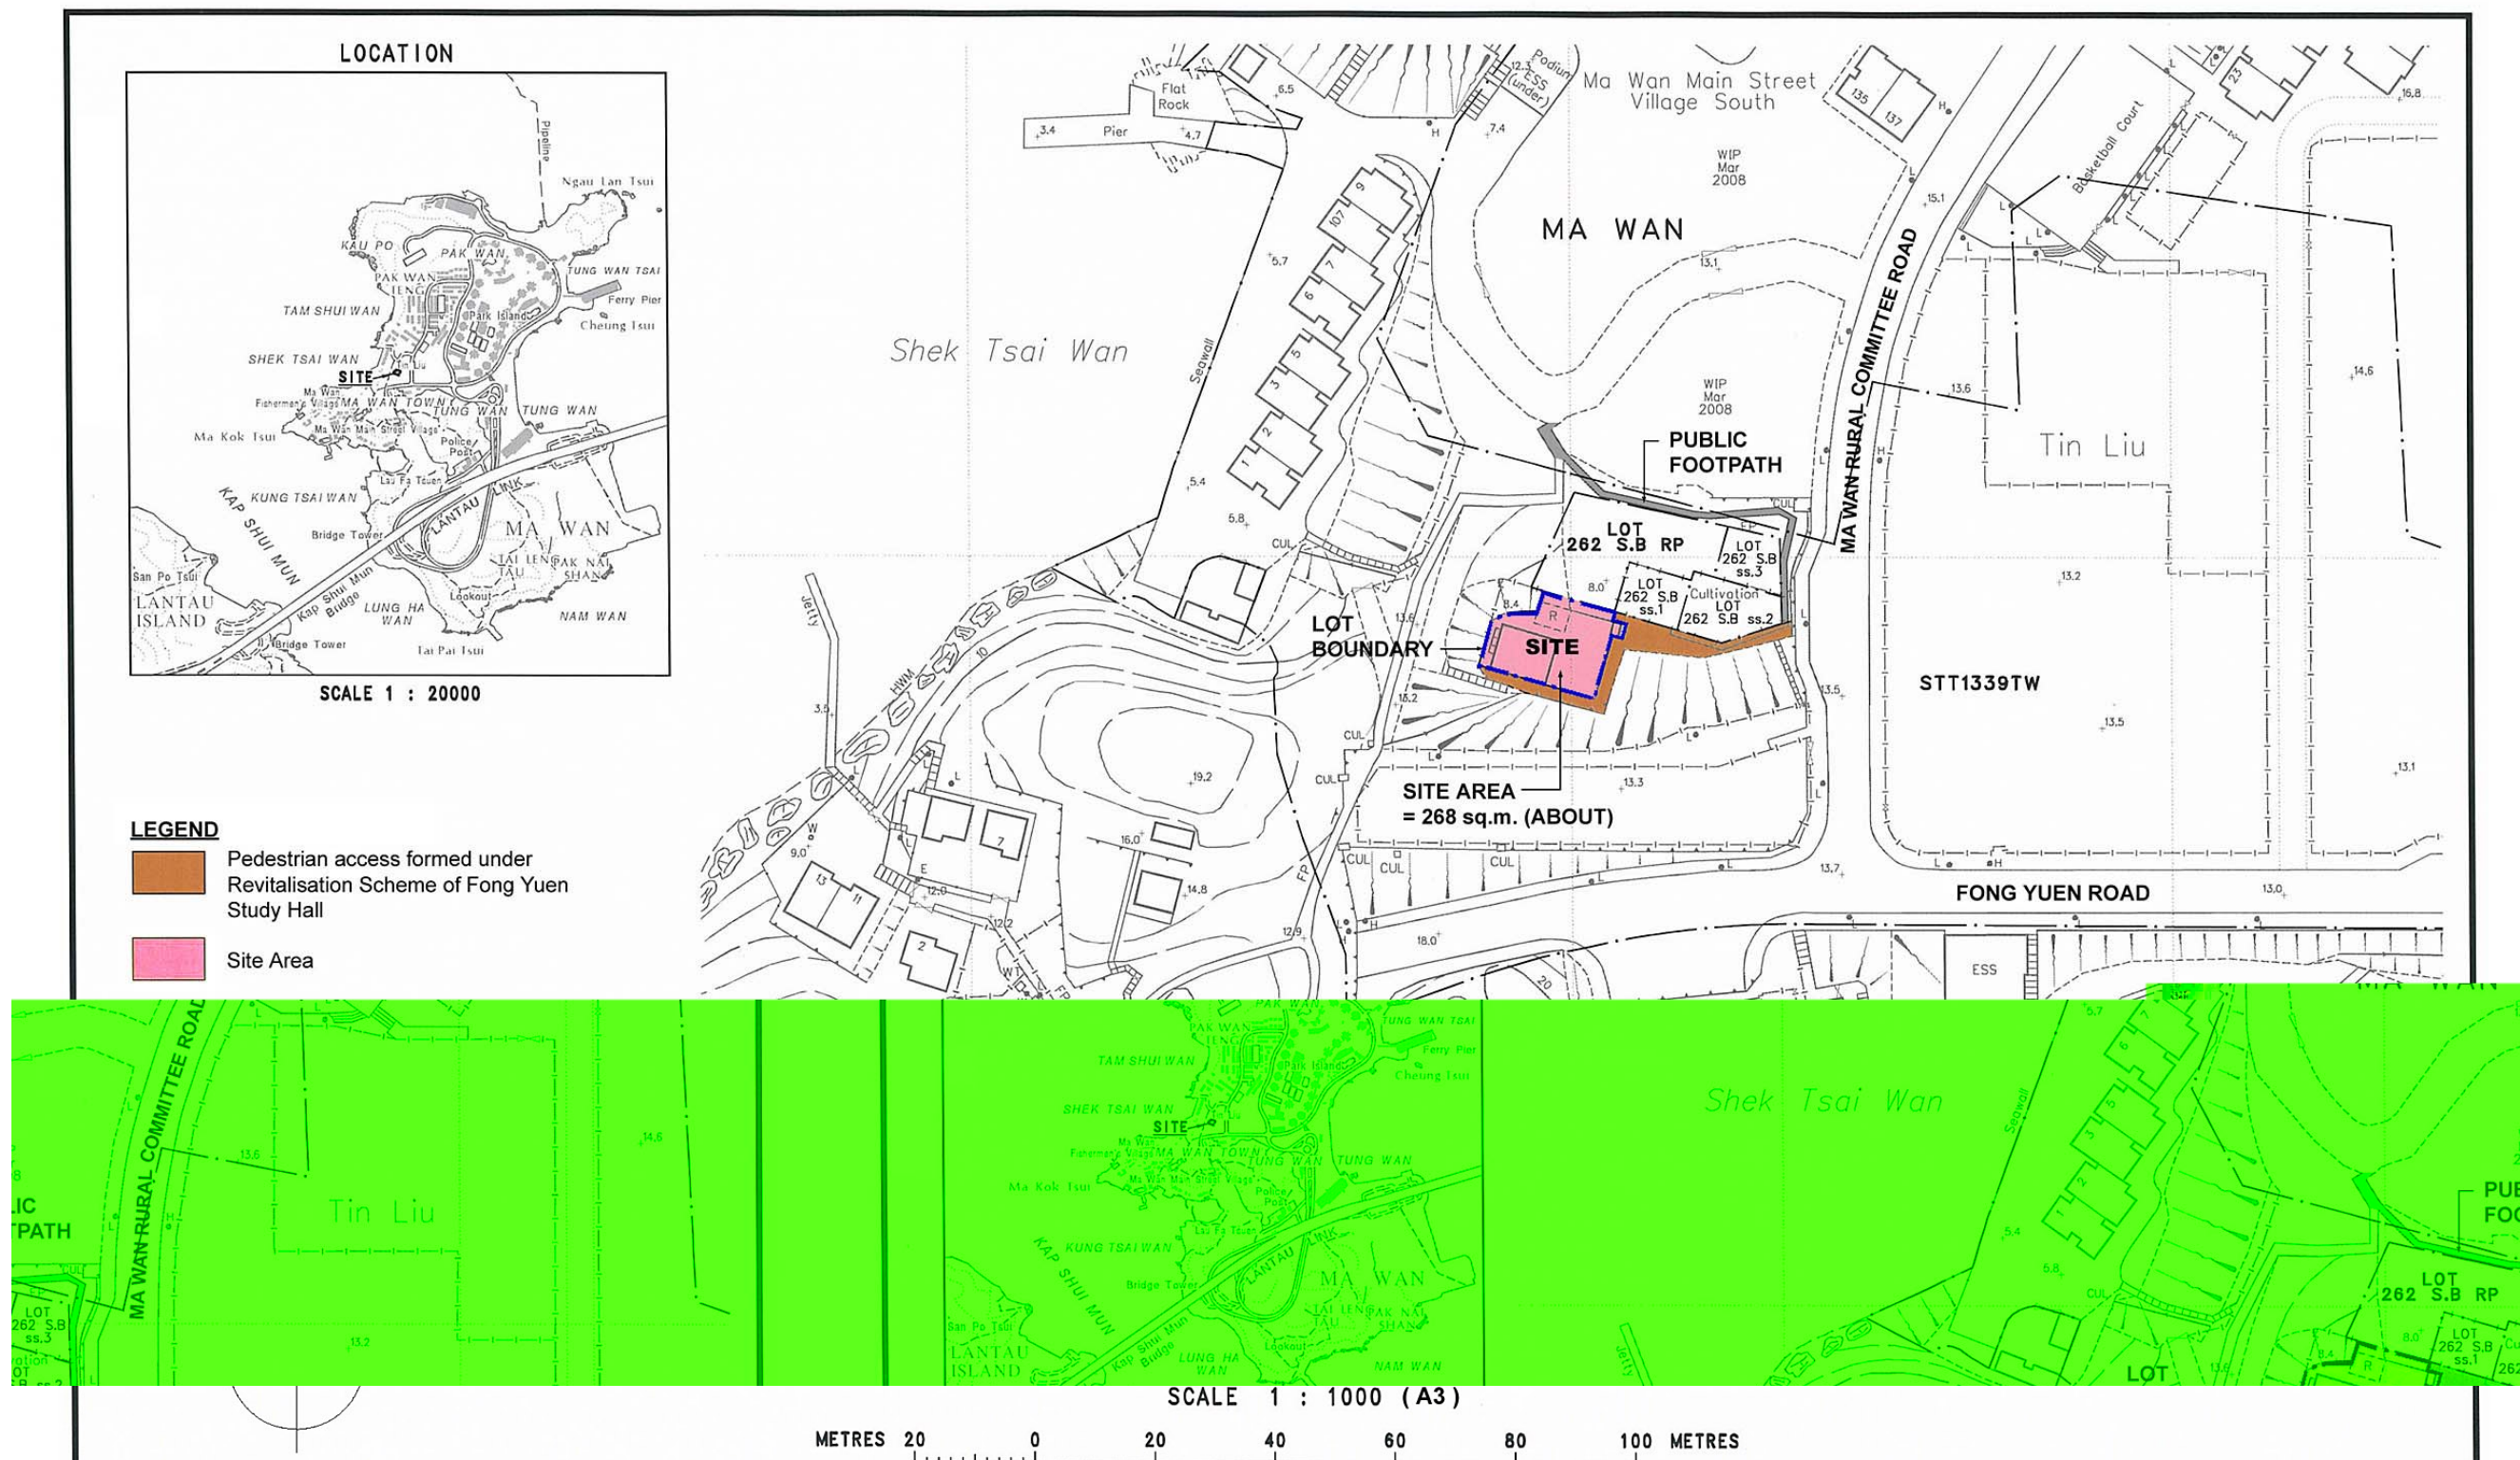
The layout of the interior is as follows:

Location	Function	remarks
Fong Yuen Study Hall		
Ground Floor	Exhibition rooms	Display artifacts, old photos and textual information, etc.
First Floor	Learning Centre Tourist Centre	Organization and registry for eco-tours Operate thematic course on Chinese culture and art
Forecourt	Performance space Retail space	Demonstrate fishermen's skill for daily living, such as sailing, making salty fish, knolling, net knitting, etc. Selling locally made dry sea food, meal and souvenir
New toilet block		
Ground floor	Male Lavatory Female Lavatory / Disable lavatory	Provide proper and adequate sanitary fitments
Upper floor	F.S. Pump room / F.S. water tank

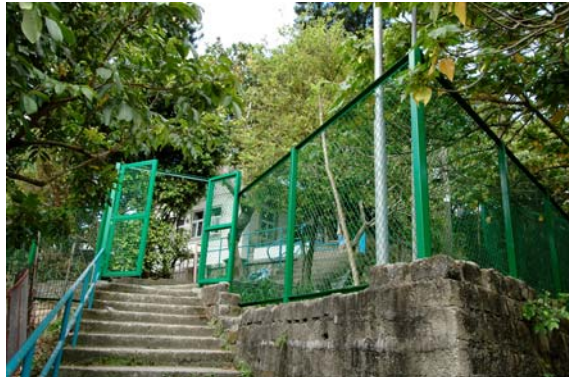
9	Replace the existing fencing around the building premises with new fencing for better security	existing fencing	neutral	<p><u>Mitigation Measures</u></p> <ul style="list-style-type: none"> - Such improvement works is acceptable providing the new fencing is independent structure and will not disturb the historic building fabrics. - The design of the new fencing should be discernible from the original historic fabric and be understated in character. Thus it will not induce any serious visual impact to the historic buildings. - a sample is shown as follows:

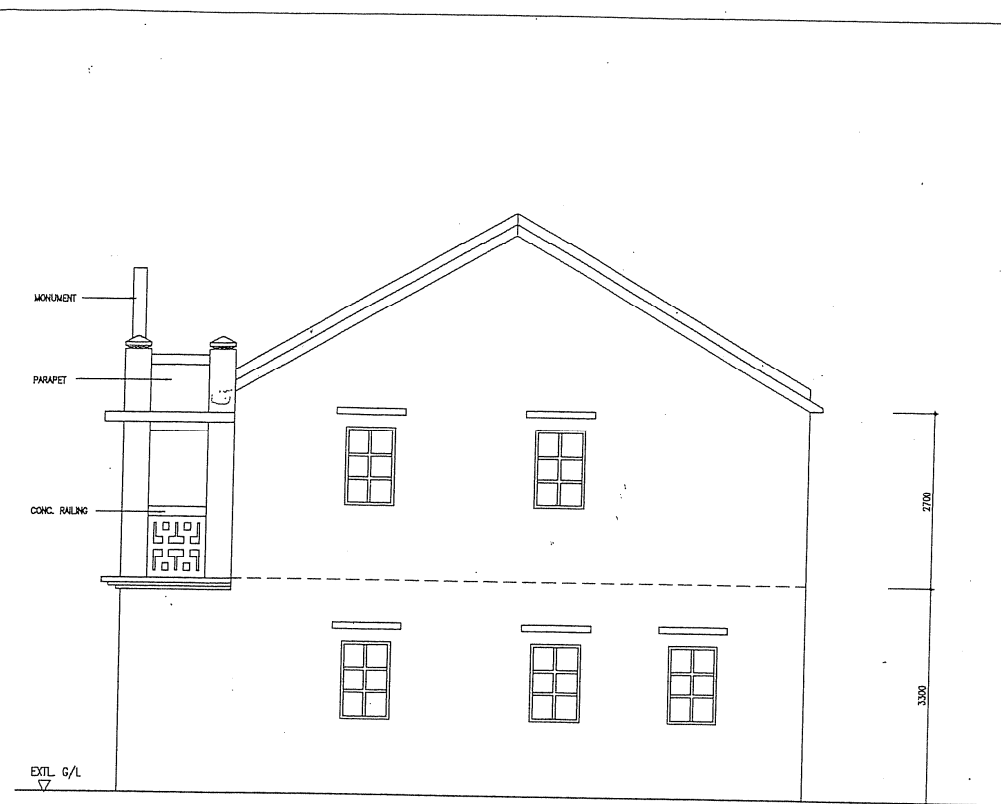
SIDE ELEVATION

Drawings showing the original timber roof structure
