HERITAGE IMPACT ASSESSMENT FOR

REPROVISIONING OF HARCOURT ROAD
FRESH WATER PUMPING STATION

Client:
Water Supplies Department

February 2014

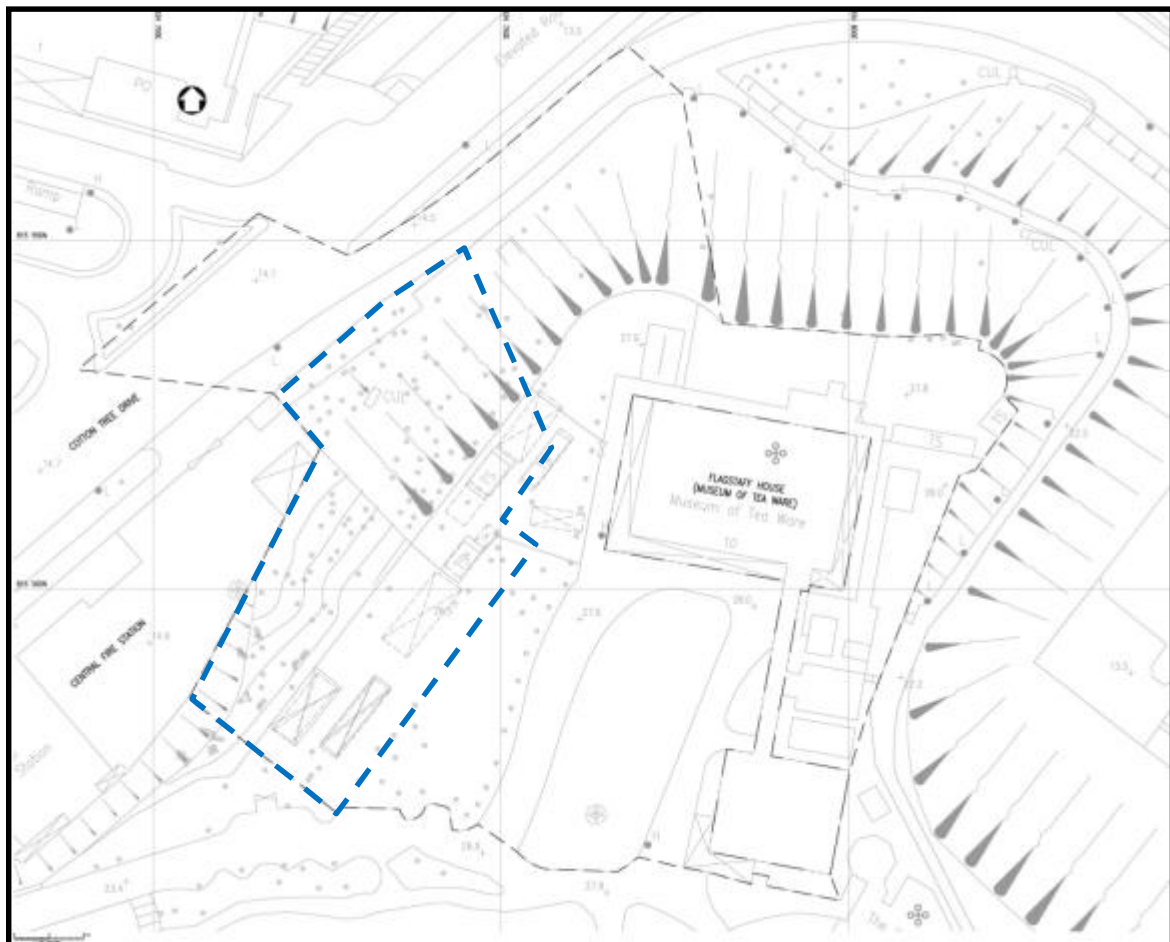
Figure 2: Site for proposed Cotton Tree Drive FWPS and Study Area for HIA
Source: provided by WSD, modified by author

The existing site for the Harcourt Road Fresh Water Pumping Station (HRFWPS) is located at the harbourfront area adjacent to the Hong Kong Academy for Performing Arts (see Figure 1). The site has been identified as a potential site for other land uses in the Victoria Harbourfront developments according to “Urban Design Study for the New Central Harbourfront” completed by Planning Department in 2011. The objective of the Project “Reprovisioning of Harcourt Road Fresh Water Pumping Station” is to relocate the existing HRFWPS to a site adjacent to the Central Fire Station at Cotton Tree Drive (see Figure 1 for the location of the proposed Cotton Tree Drive Fresh Water Pumping Station). The Project comprises construction of the proposed Cotton Tree Drive Fresh Water Pumping Station (FWPS) within an existing slope of Hong Kong Park adjacent to the Central Fire Station and Flagstaff House, together with the supply and installation of associated mechanical and electrical equipment for the Cotton Tree Drive FWPS; demolition of the existing HRFWPS upon commissioning of the Cotton Tree Drive FWPS, laying of fresh water mains along Queensway, Hennessy Road and the slip road of Cotton Tree Drive and associated architectural, drainage, geotechnical and landscaping works. The boundary of the Site for the proposed Cotton Tree Drive FWPS is shown as a blue dotted line in Figure 2.

The proposed site recommended for relocating HRFWPS as shown in Figure 2 (area coloured blue) and Figure 4 (area coloured orange) is considered ideal in fulfilling the above constraints because the site is currently a slope which forms part of the outside perimeter of the Hong Kong Park and is not accessible to the public. Also the new pumping station will not affect any current public uses within the Hong Kong Park during both construction and operation stages and will not reduce the overall amenity areas available to the public in Hong Kong Park.

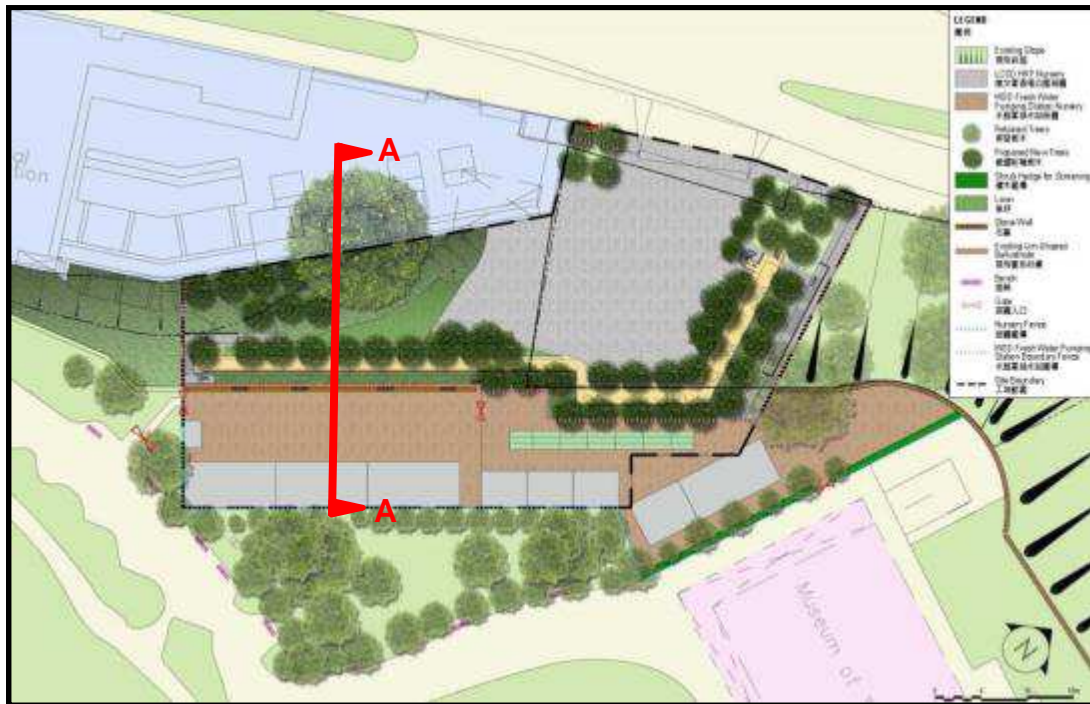
Figure 7: Proposed landscape plan
Source: provided by URBIS

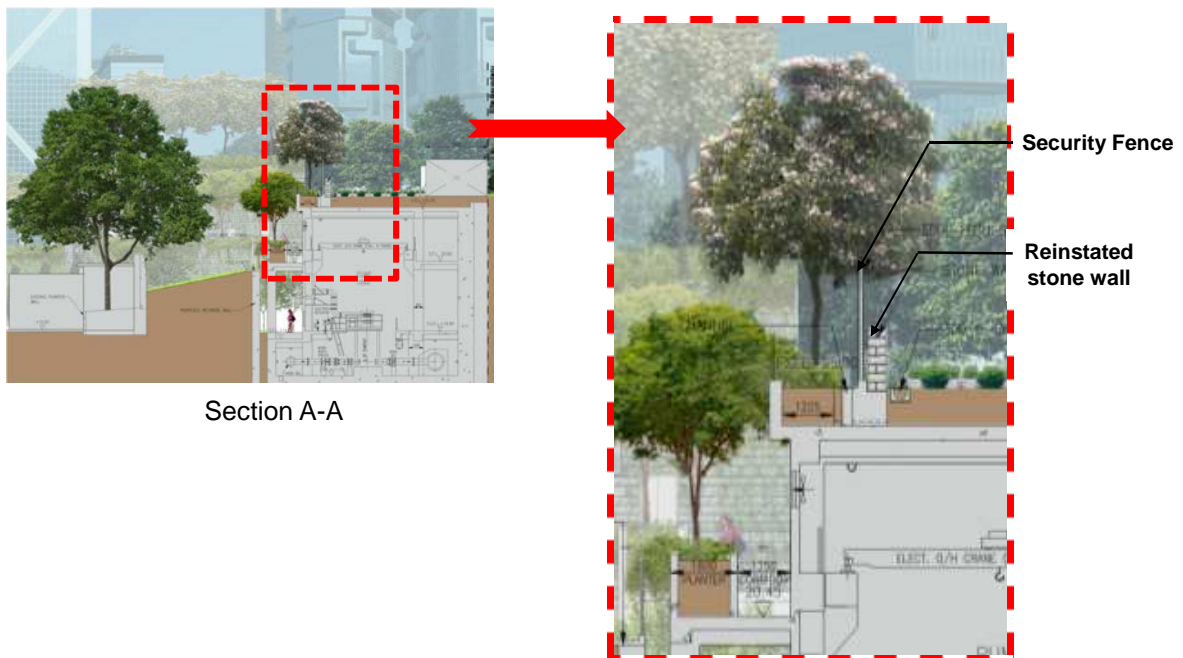
Figure 8: Section of the landscape design scheme
Source: provided by URBIS

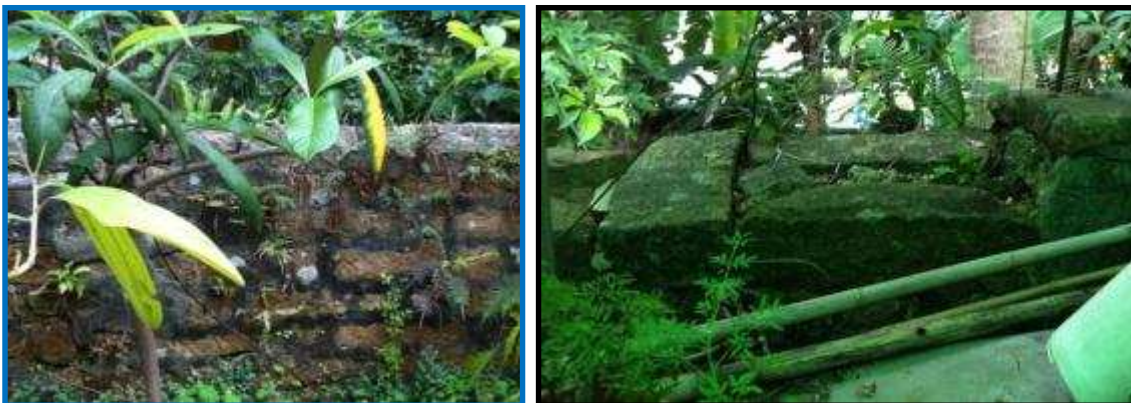
Figure 18: Photo of existing stone wall within the Site of FWPS and a close-up of the damaged capping stone
Source: photo by the author

wall and was a part of the Victoria Barracks (see Figure 18). From the article by Clive Lucas in 1981, the encircling stone wall has been there since at least 1889. With reference to the photo in the 1860s (see Figure 14), there was a stone boundary wall along the crest of the slopes. The wall was much longer than the existing one. It had the same height throughout its length, but the existing wall has sections with different heights. It is lower in height especially at the junction with the balustrade and the stone wall outside the Site (see Appendix I). Thus, it is assumed that the upper part of the stone wall might be damaged over the years and was subsequently repaired, resulting in a lower height of the wall.

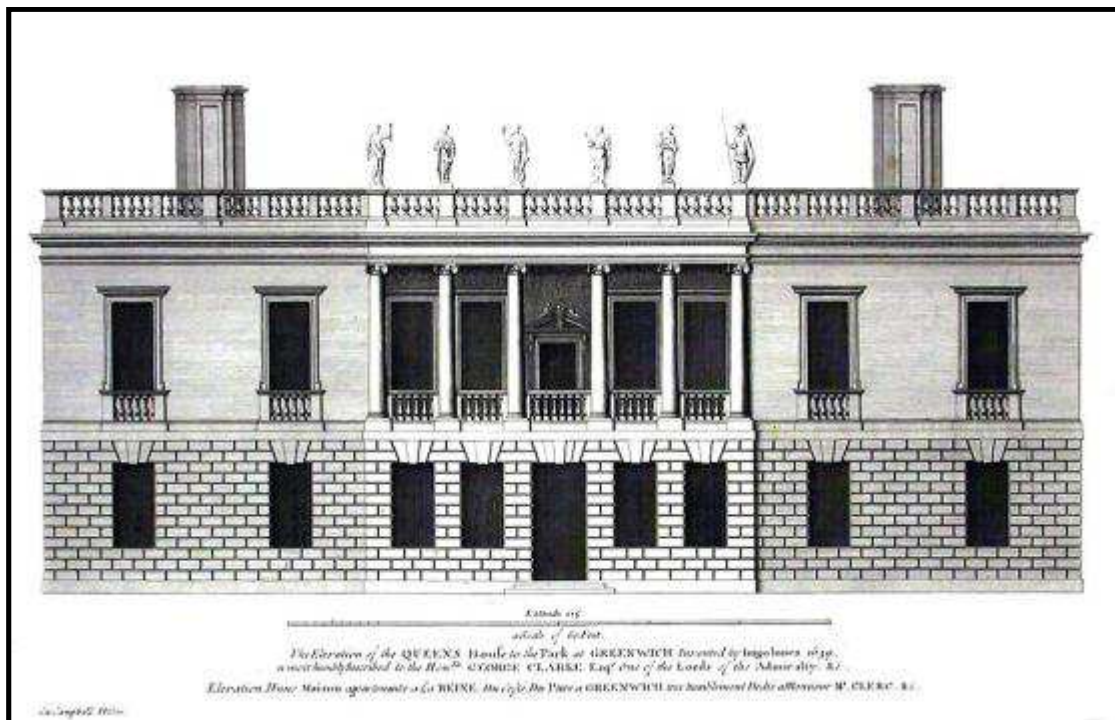
Figure 37: Elevation drawing of Queen's House

Flagstaff House has a two-storey main block connected to a single-storey service block by a covered walkway. There are different opinions on who was the designer of the building. According to the original plan drawn in 1844 (see Figure 35), the name of Edward Aldrich, the first Commander Royal Engineer in Hong Kong, was found. Like other colonial building design in the region at that period, it was common that the design was modified from the architectural pattern books. It was similar to the Indigo Jones' elevation drawing of Queen's House at Greenwich, London (see Figure 36 and Figure 37).

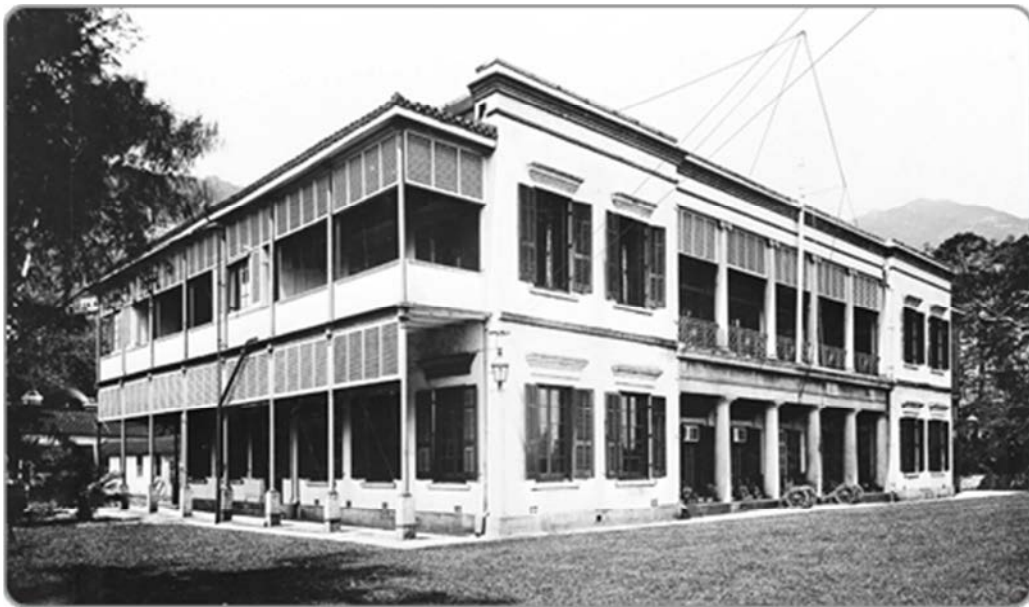
Figure 40: 1890 photo with cast-iron posts clearly seen

From the painting in the 1860s (see Figure 39), the balconies were supported by cast iron posts. The posts can be more clearly seen from photos in the 1890s (see Figure 40). Before 1897, it had been rebuilt as two-storey iron structure incorporating bathrooms. The cast iron posts were replaced by concrete columns in the 1930s (see Figure 41). The main door was shifted one bay to the west and a porch was added. These were restored as far as possible to its original mid-nineteenth-century appearance in the construction work of the Tea Ware museum in 1982 (see Figure 42). Up to present moment, there is no change in the appearance of Flagstaff House (see Figures 43 to 45). The building is the oldest surviving domestic building in colonial style in Hong Kong, representing the early period of Hong Kong city. Although the building was restored in 1982, the authenticity is largely retained and the building elements reflecting the character of the monument are considered to have a high level of architectural significance.

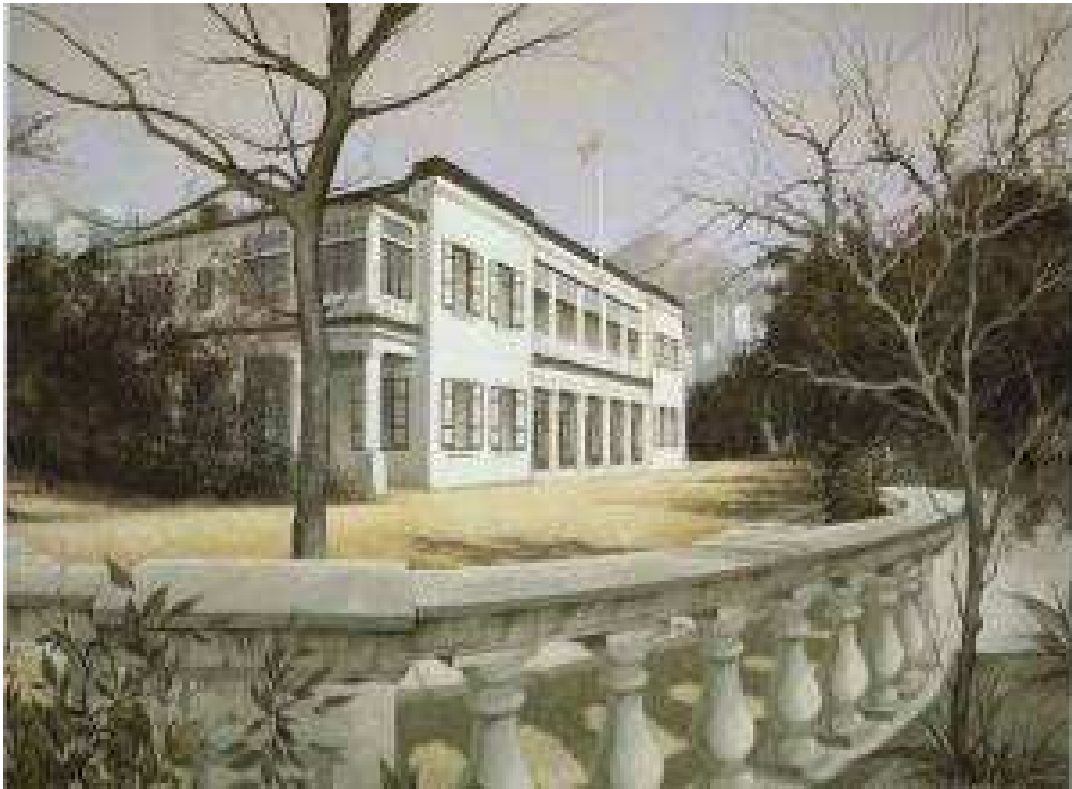
Figure 41: 1930s drawing after cast-iron posts were renewed to concrete
Source: <http://hkas.org.uk/membership-offers>

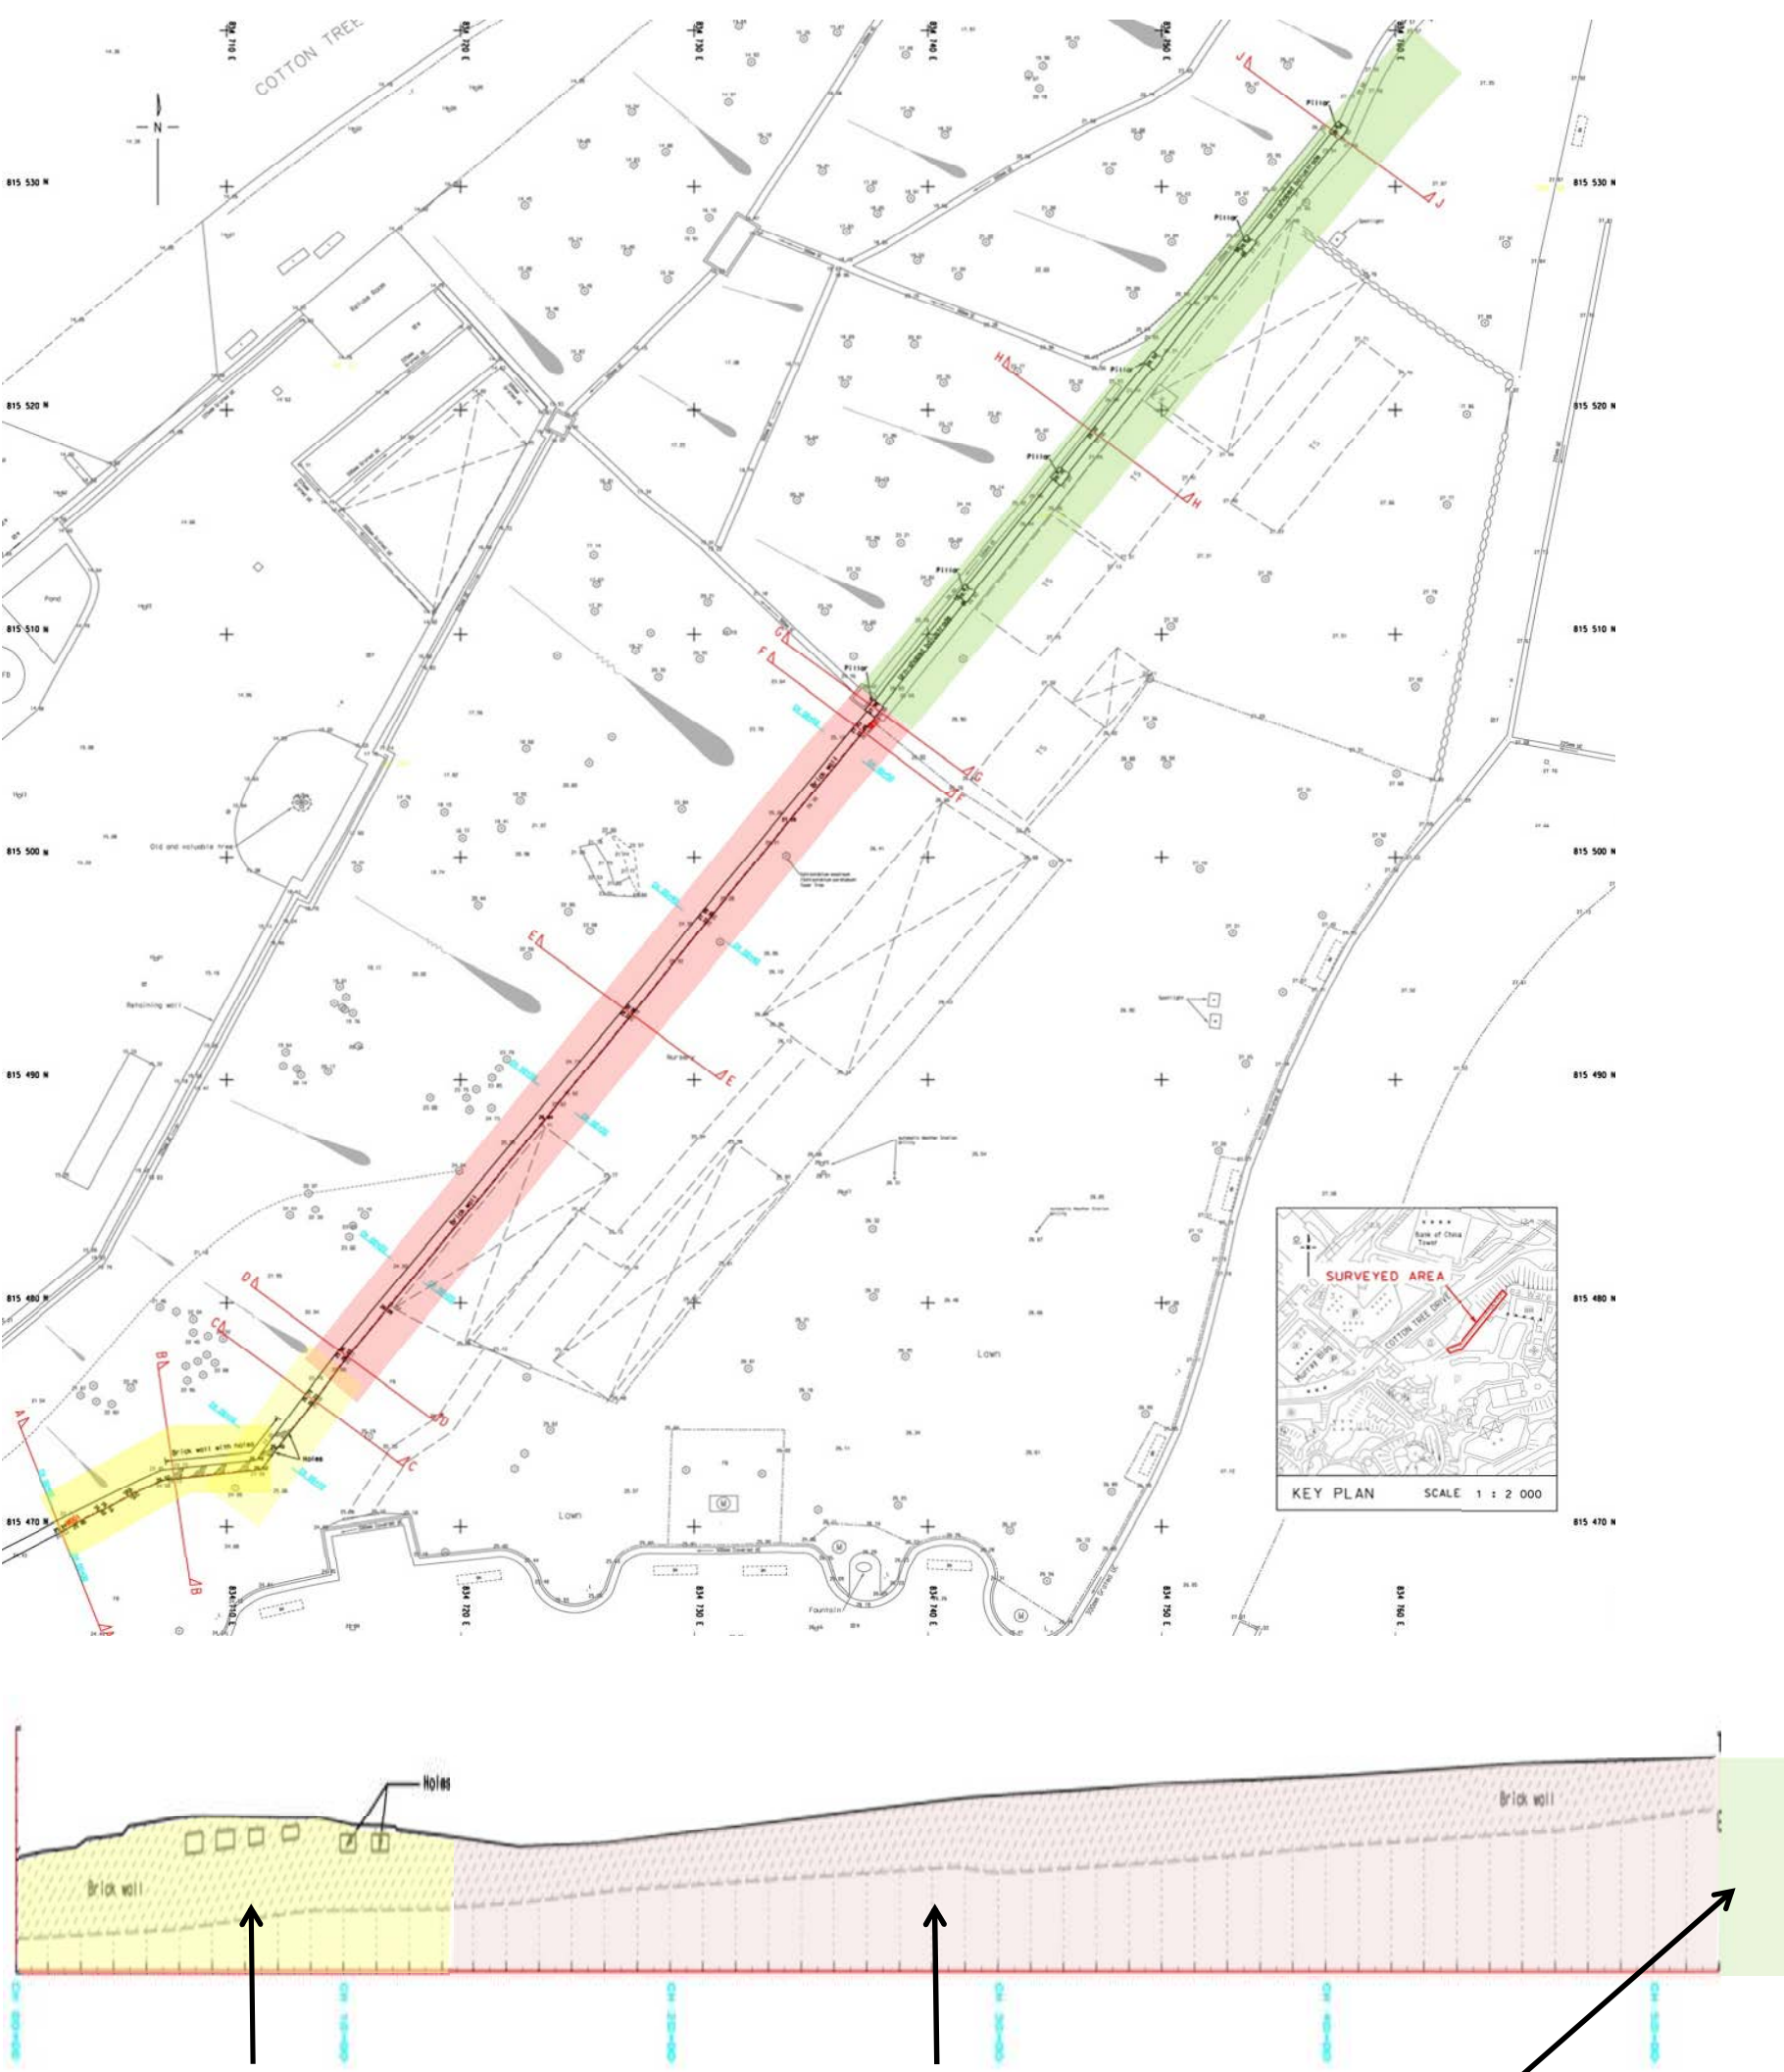
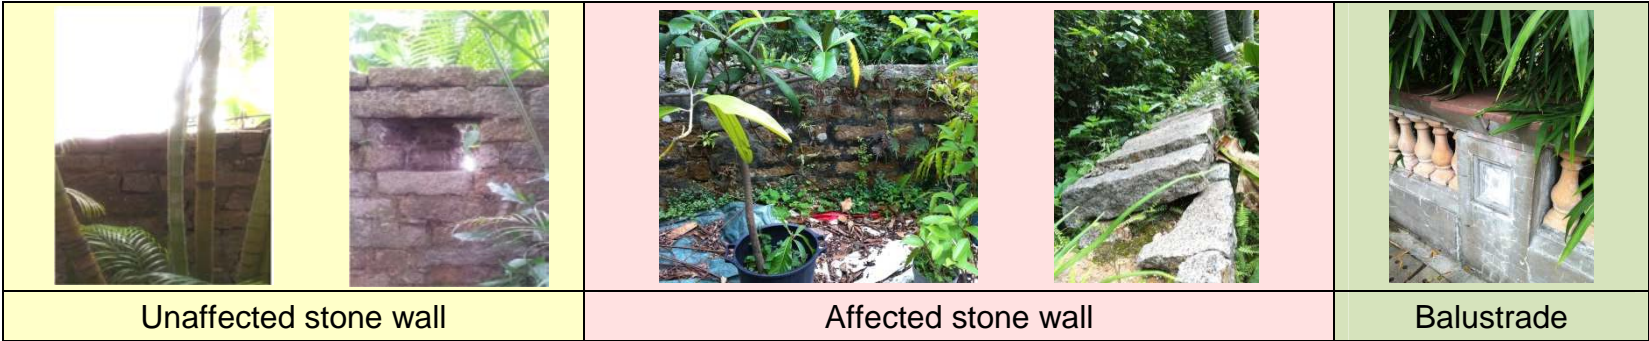
• Figure A1

APPENDIX I – Topographic survey drawing of affected stone wall

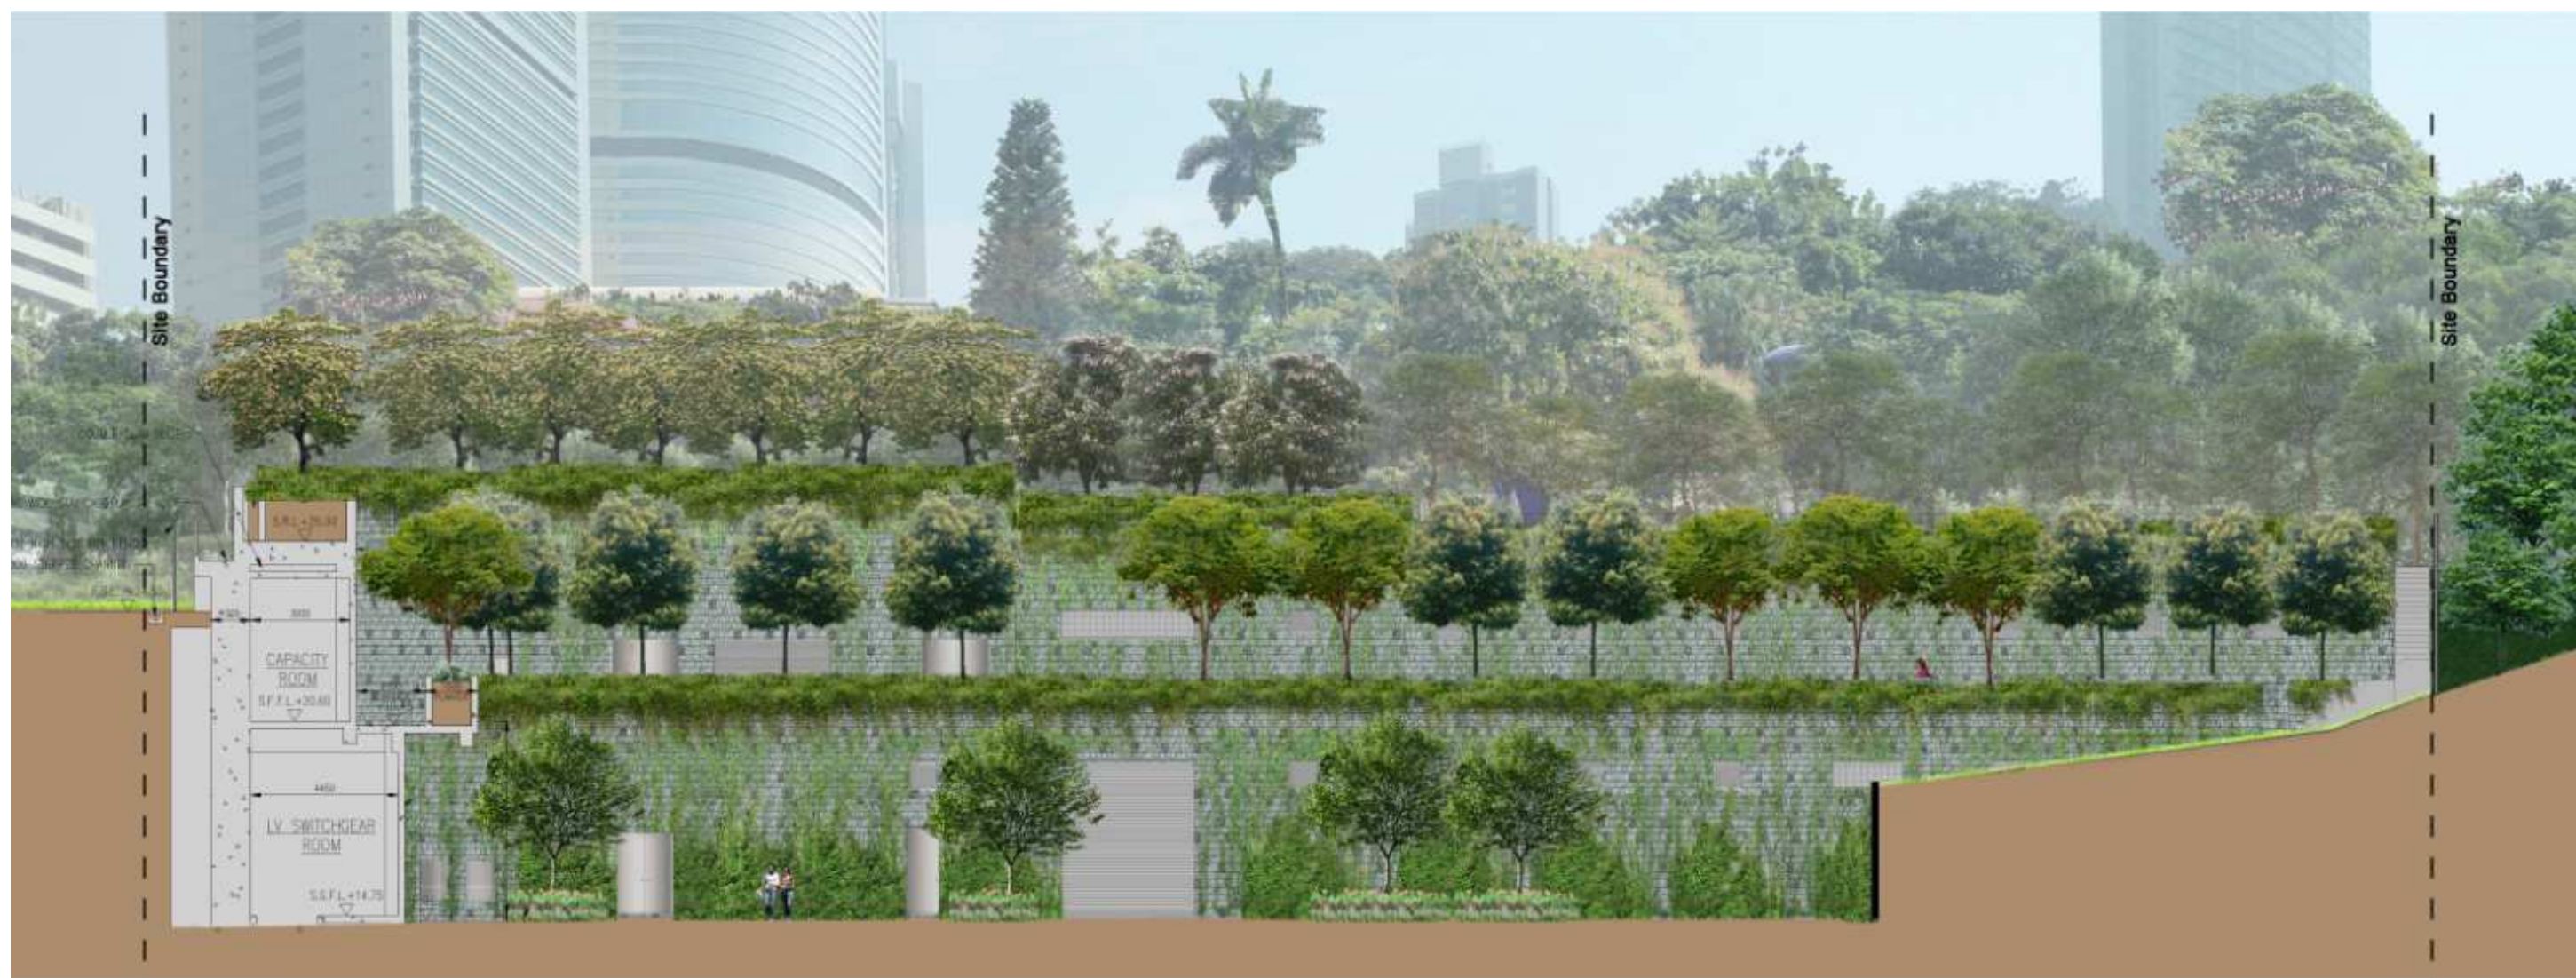
Figure A2.3: Proposed Elevation A
Source: provided by URBIS

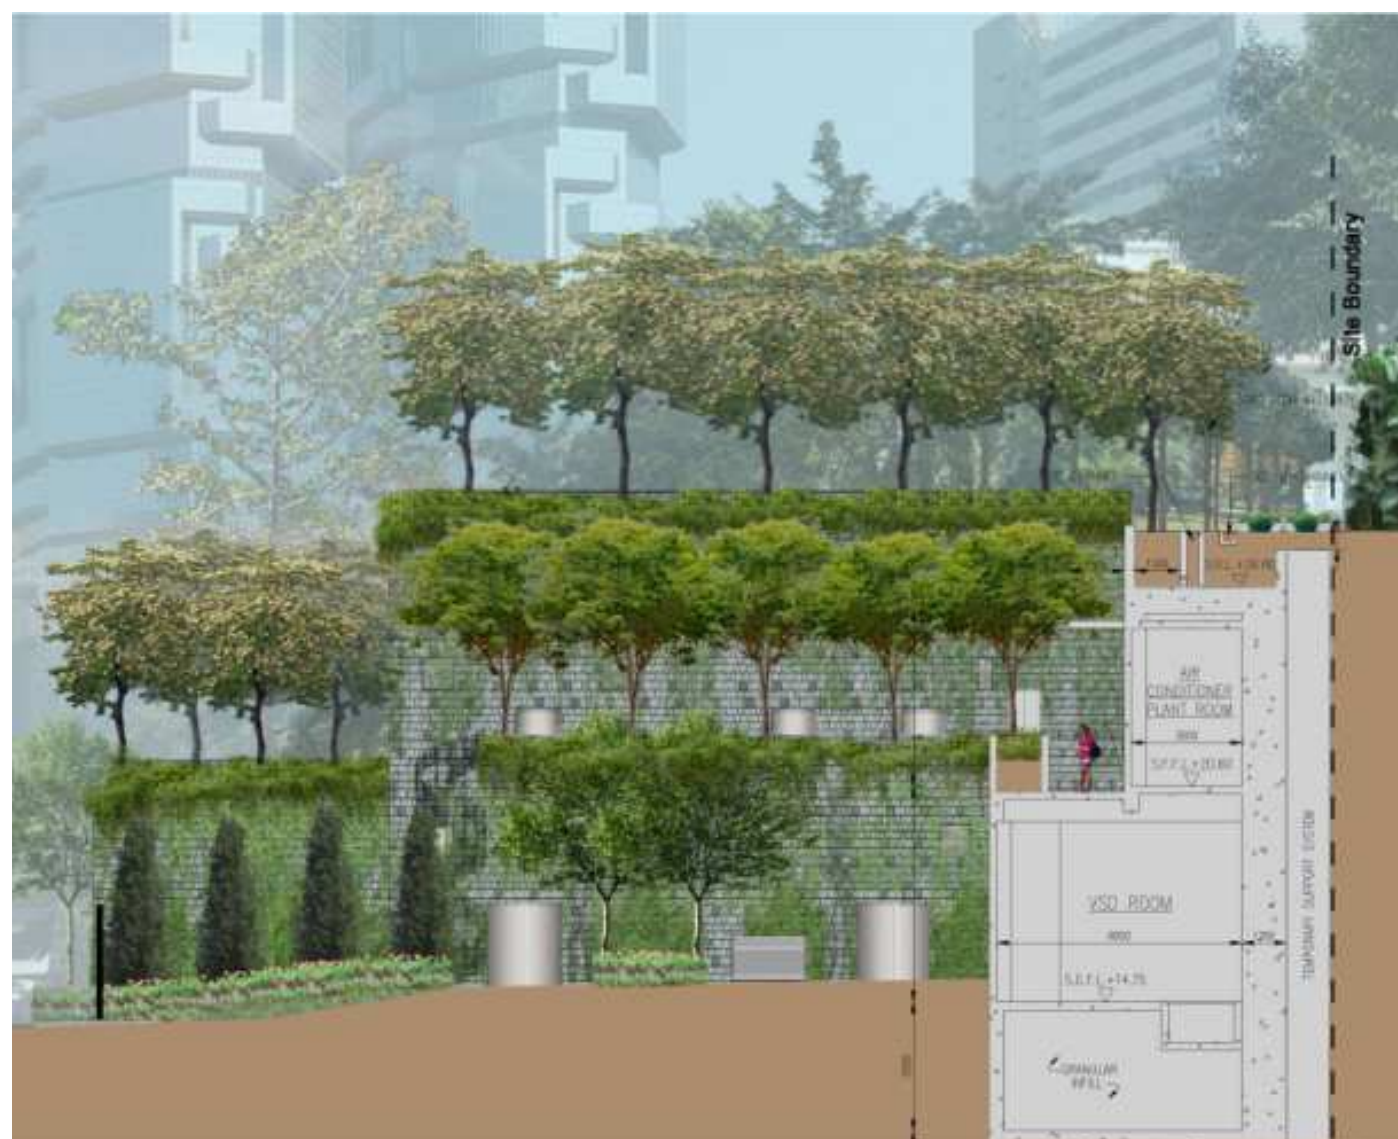
Figure A2.4: Proposed Section B
Source: provided by URBIS

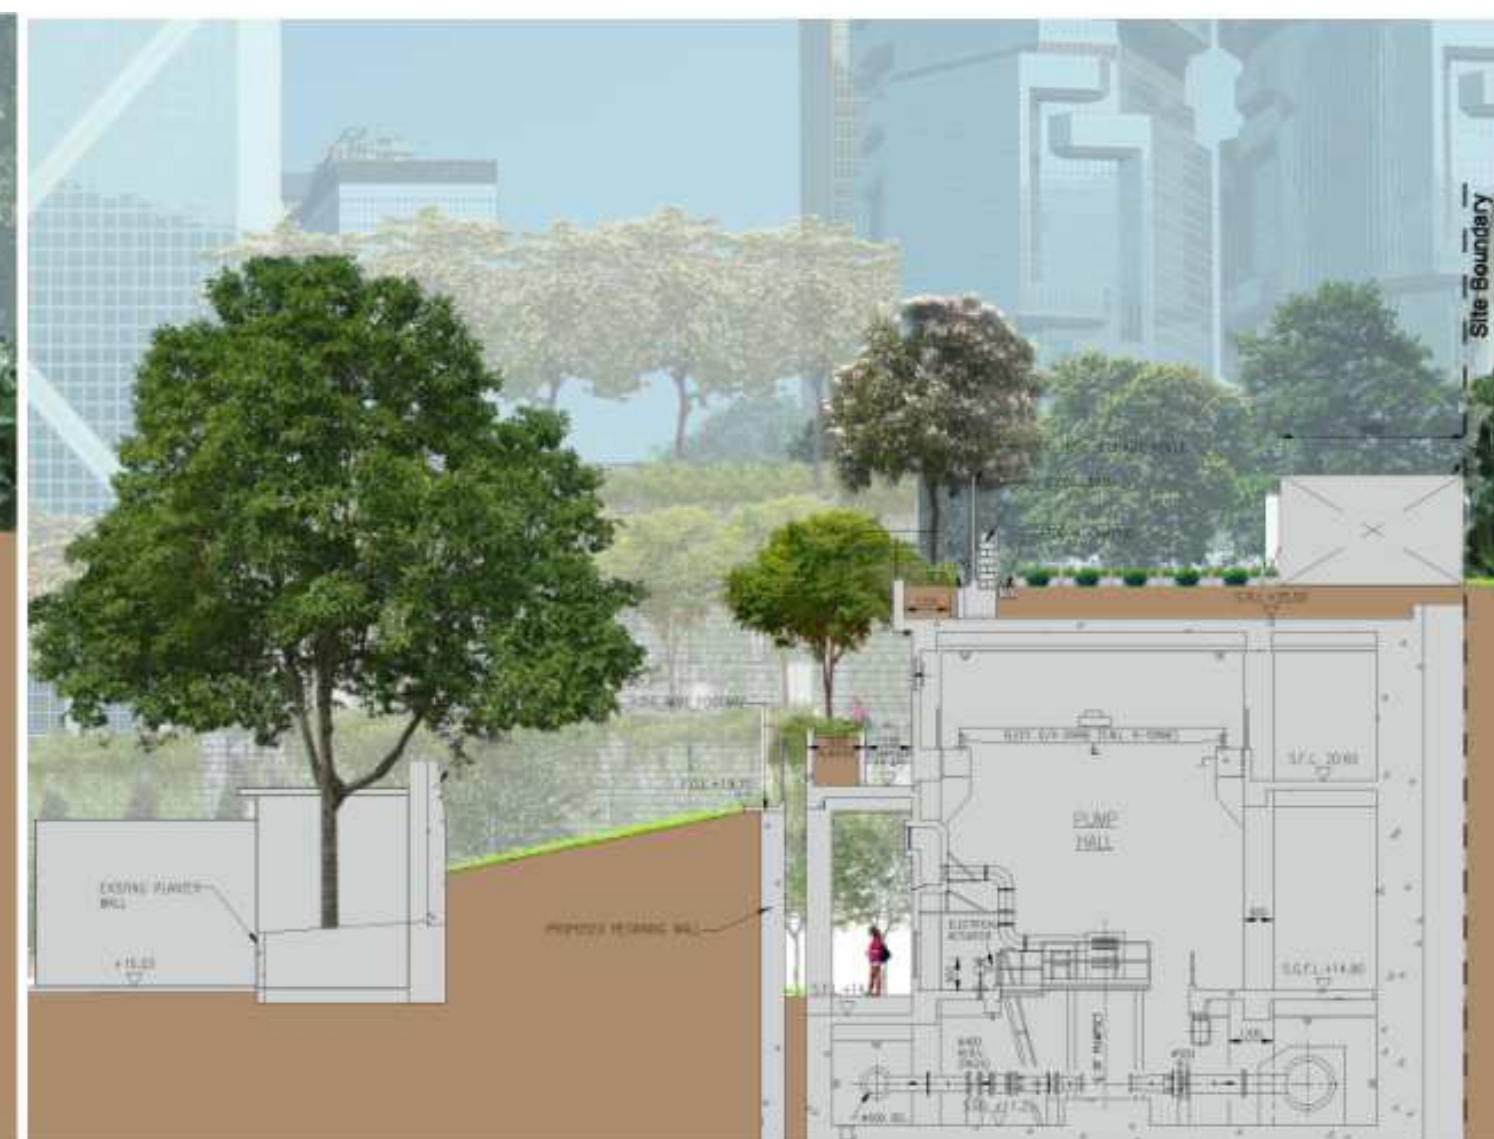
Figure A2.5: Proposed Section D
Source: provided by URBIS

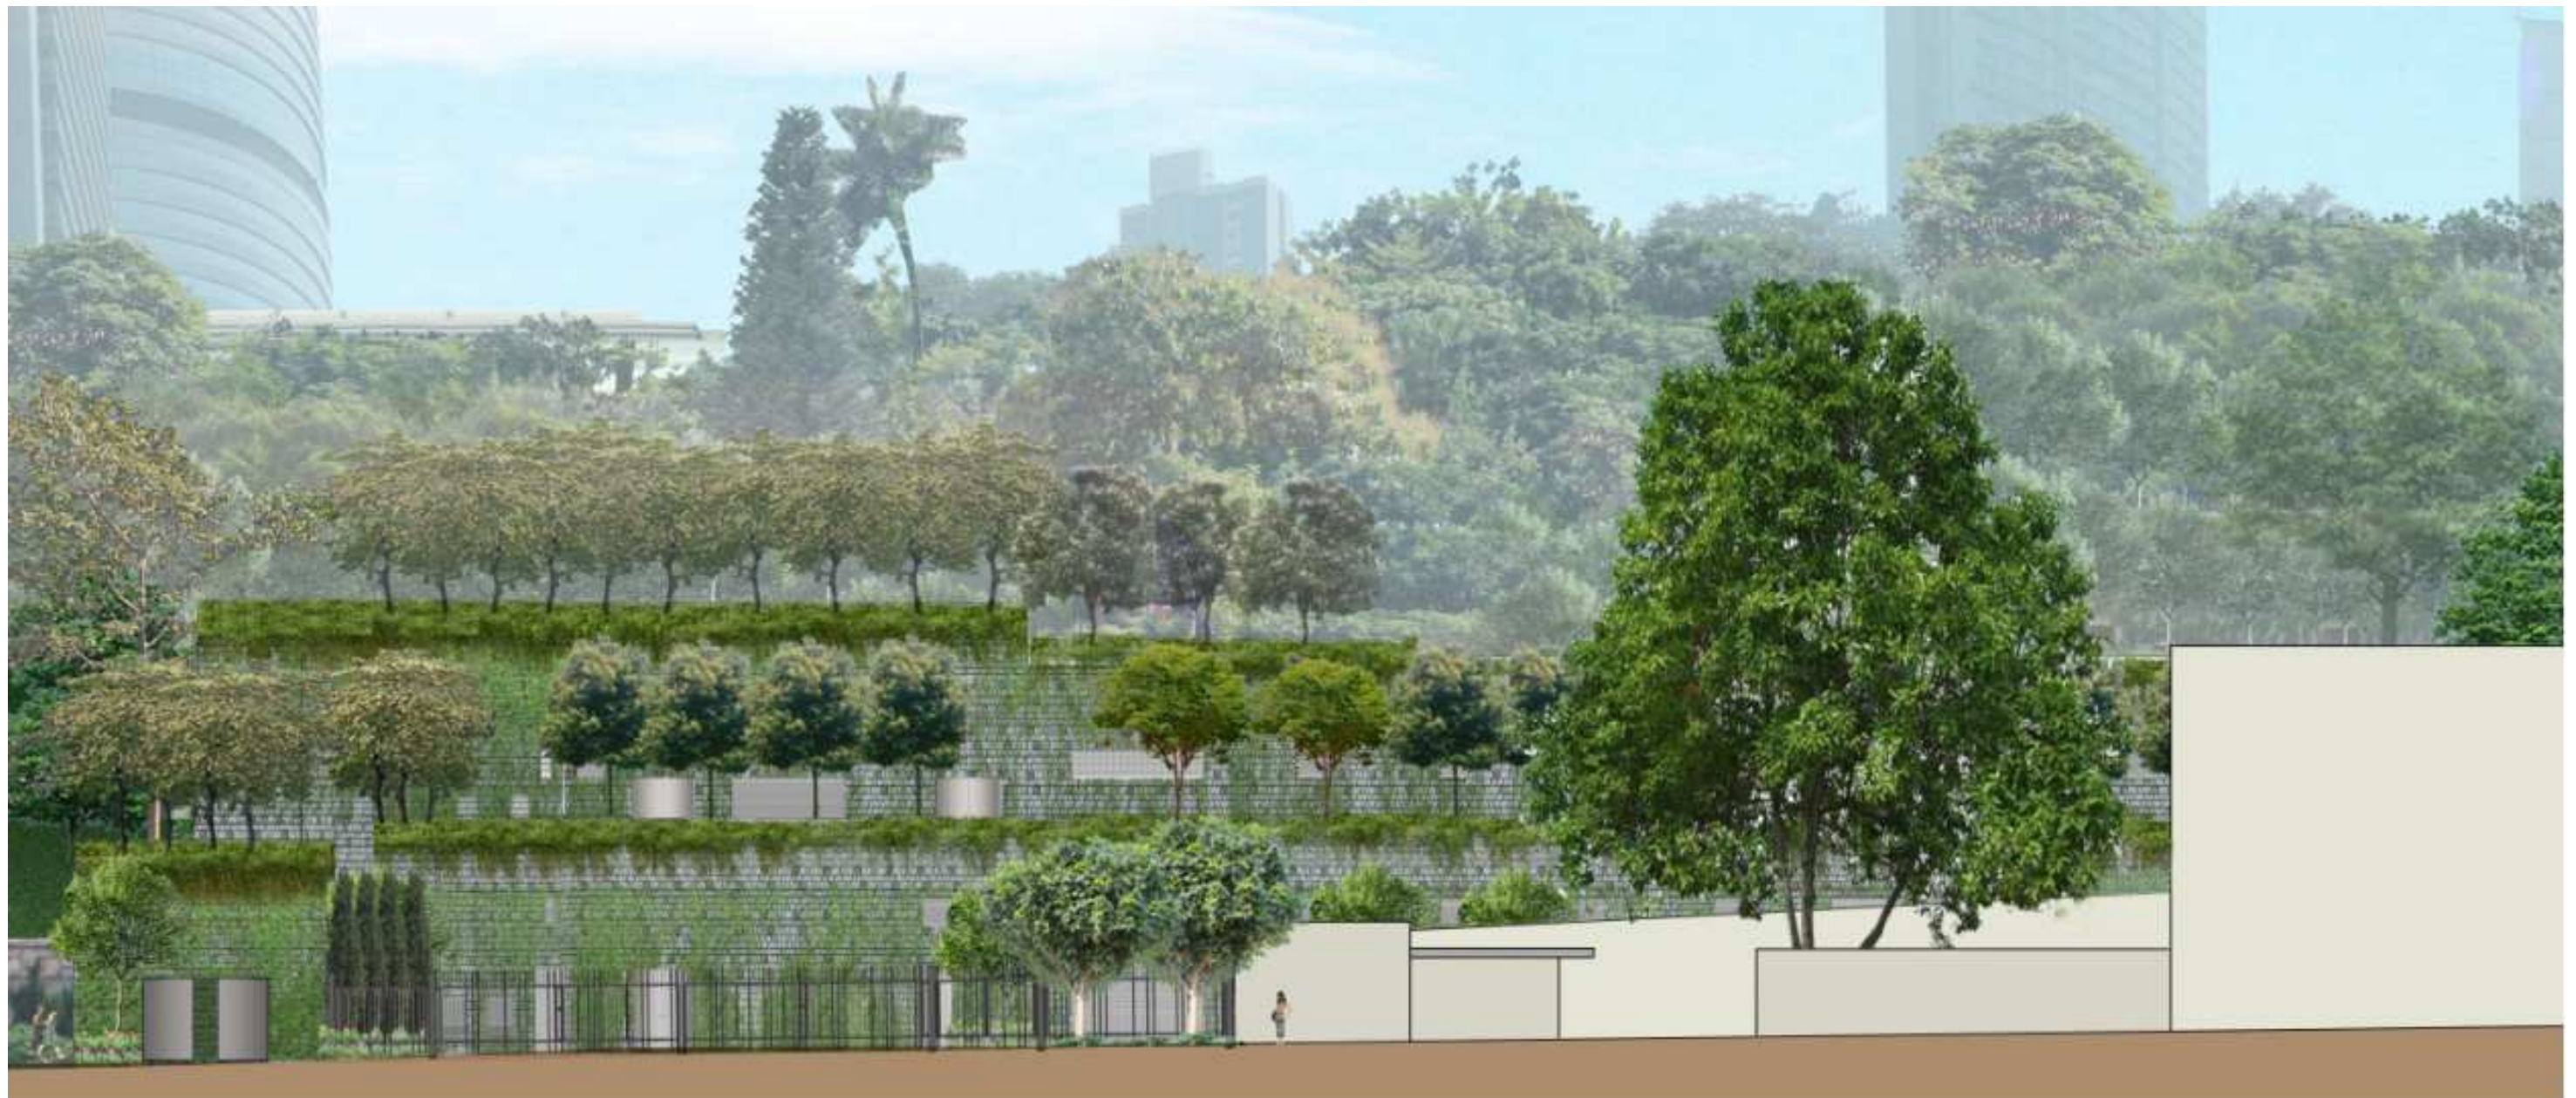
Figure A2.6: Proposed Elevation C
