Heritage Impact Assessment Report

Development of the International Culinary College
At Pok Fu Lam, Hong Kong

Prepared for
Vocational Training Council

By
China Point Consultants Limited

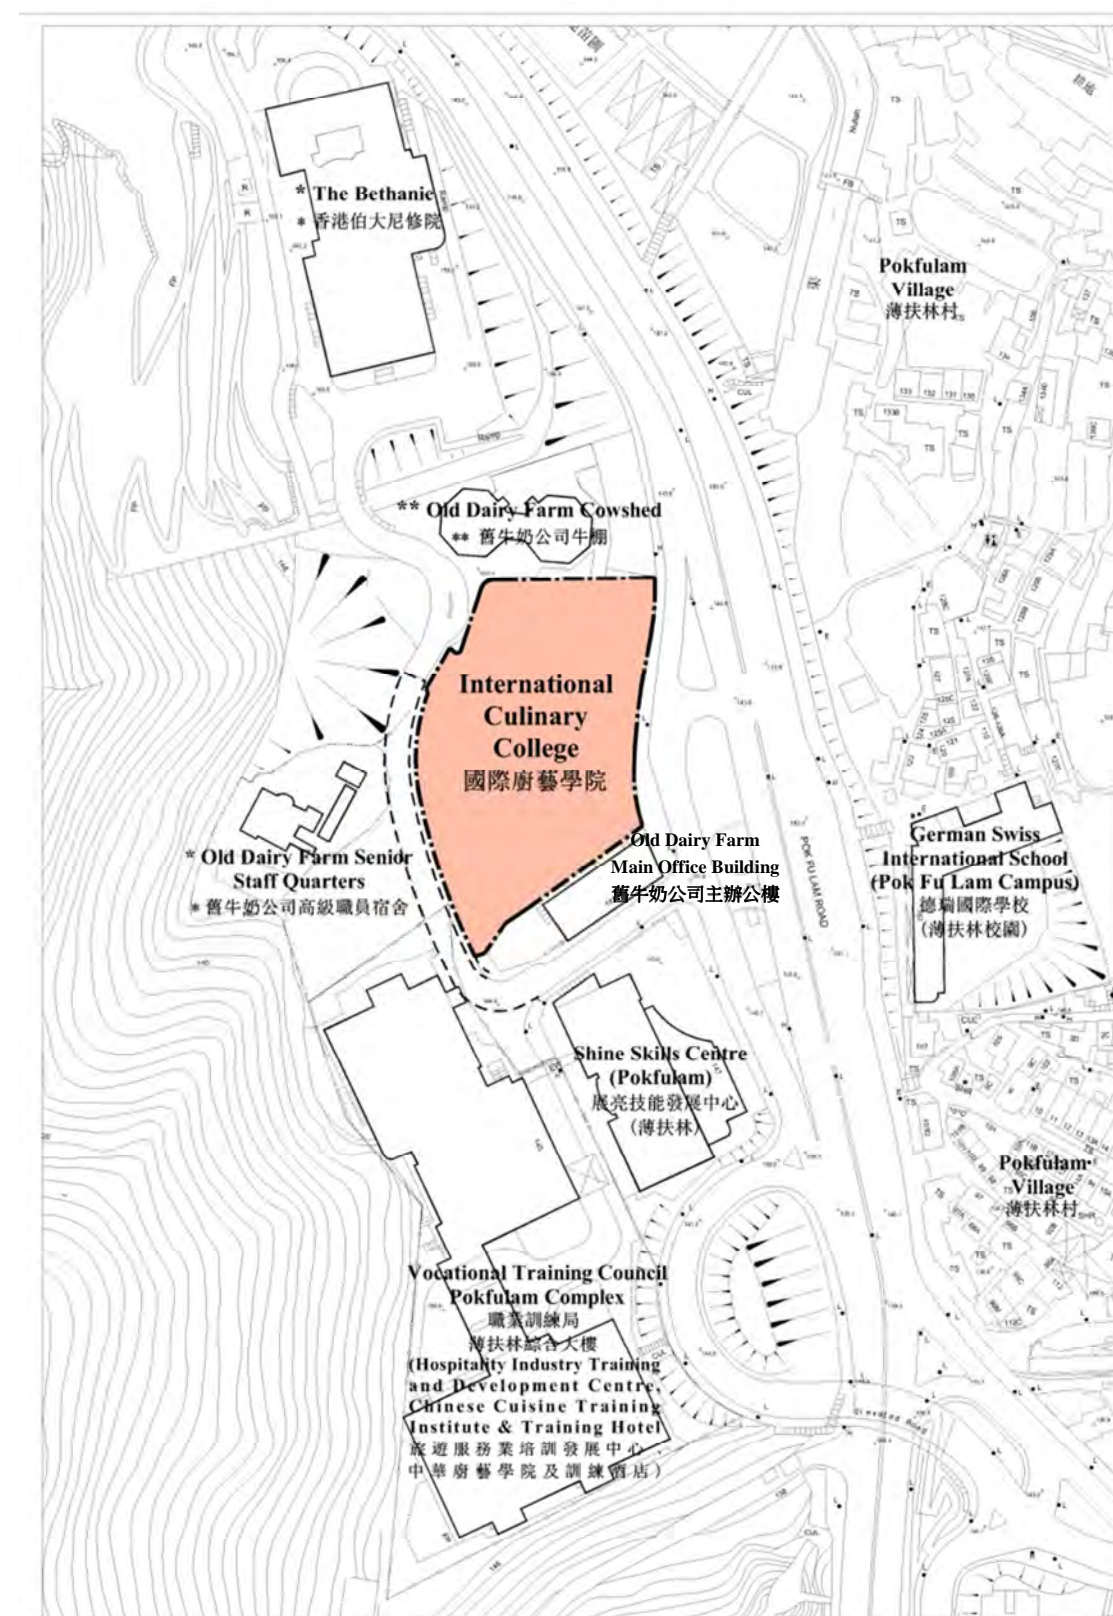
Fig.1 Proposed site boundary of ICC shaded in pink.

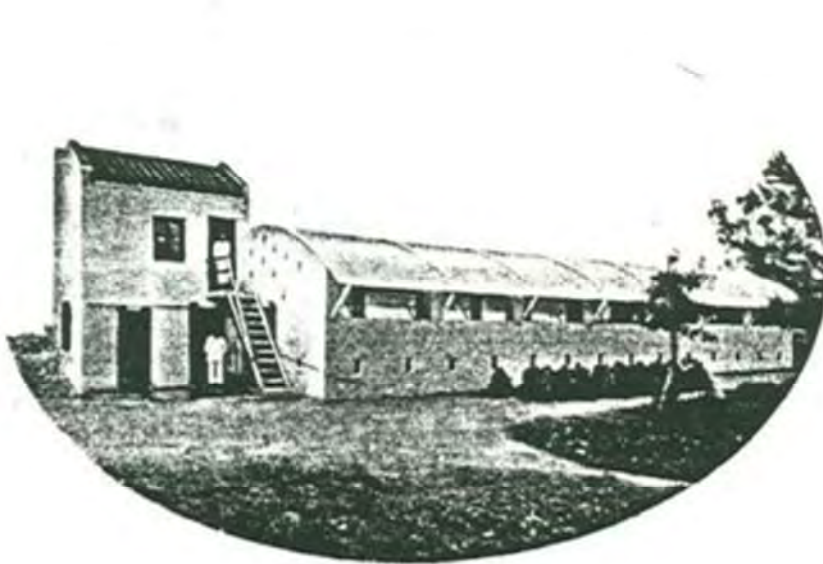
Cowshed, with attendants' quarters attached to it.
(Source: The Dairy Farm, Ice and Cold Storage Co. Ltd. Hong Kong, 1919, p.40)

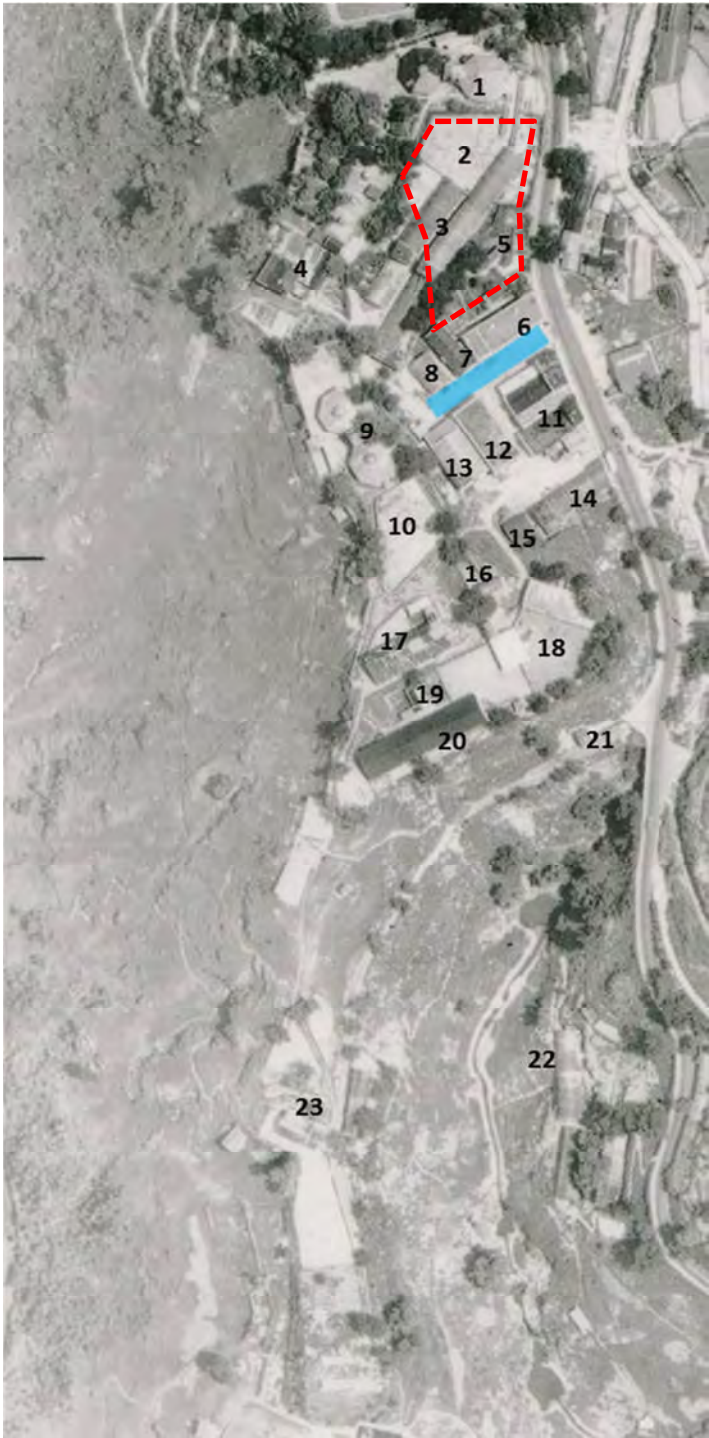
Item	Building/Structure
1	Octagonal cowsheds
2	Paddock
3	Poultry batteries
4	Senior Staff Quarters, i.e. <i>Braemar</i>
5	Quarters
6	Main Office
7	Office
8	Carpenter shop
9	Octagonal cowsheds
10	Paddock
11	Dairy/ Refrigeration plant
12	Bran store
13	Straw store
14	Boiler house
15	Blacksmith's shop/ Workshop
16	Boiler house
17	Piggery
18	Cowshed
19	Tank
20	Quarters
21	Quarters
22	Quarters
23	Piggeries

Fig.11 Blow up of 1949 aerial photo. Item 1, 4 and 6 are the only buildings of the Mains that still remain today. Blue indicates the entrance access road to the Mains. Dotted line roughly refers to the proposed project site. (Source: Survey and Mapping Office, 1949, Ref.no.: 6093; edited by Hebi Chan)

The Mains was in a stepping terrain separating into various levels. Two octagonal cowsheds (the cowsheds that remain today) were housed at the highest point of the Mains. Immediate below were the paddock and poultry batteries, which the paddock was connected with the cowsheds by a ramp. Slightly downhill were

the offices and carpenter shop. Across the entrance access road were the Dairy and other cowshed, piggery and quarters, at the location of today's VTC Pokfulam Complex. To the west of the poultry batteries were the Senior Staff Quarters *Braemar*. Some other structures were located at the lower part of the slope. See [Fig.10](#)

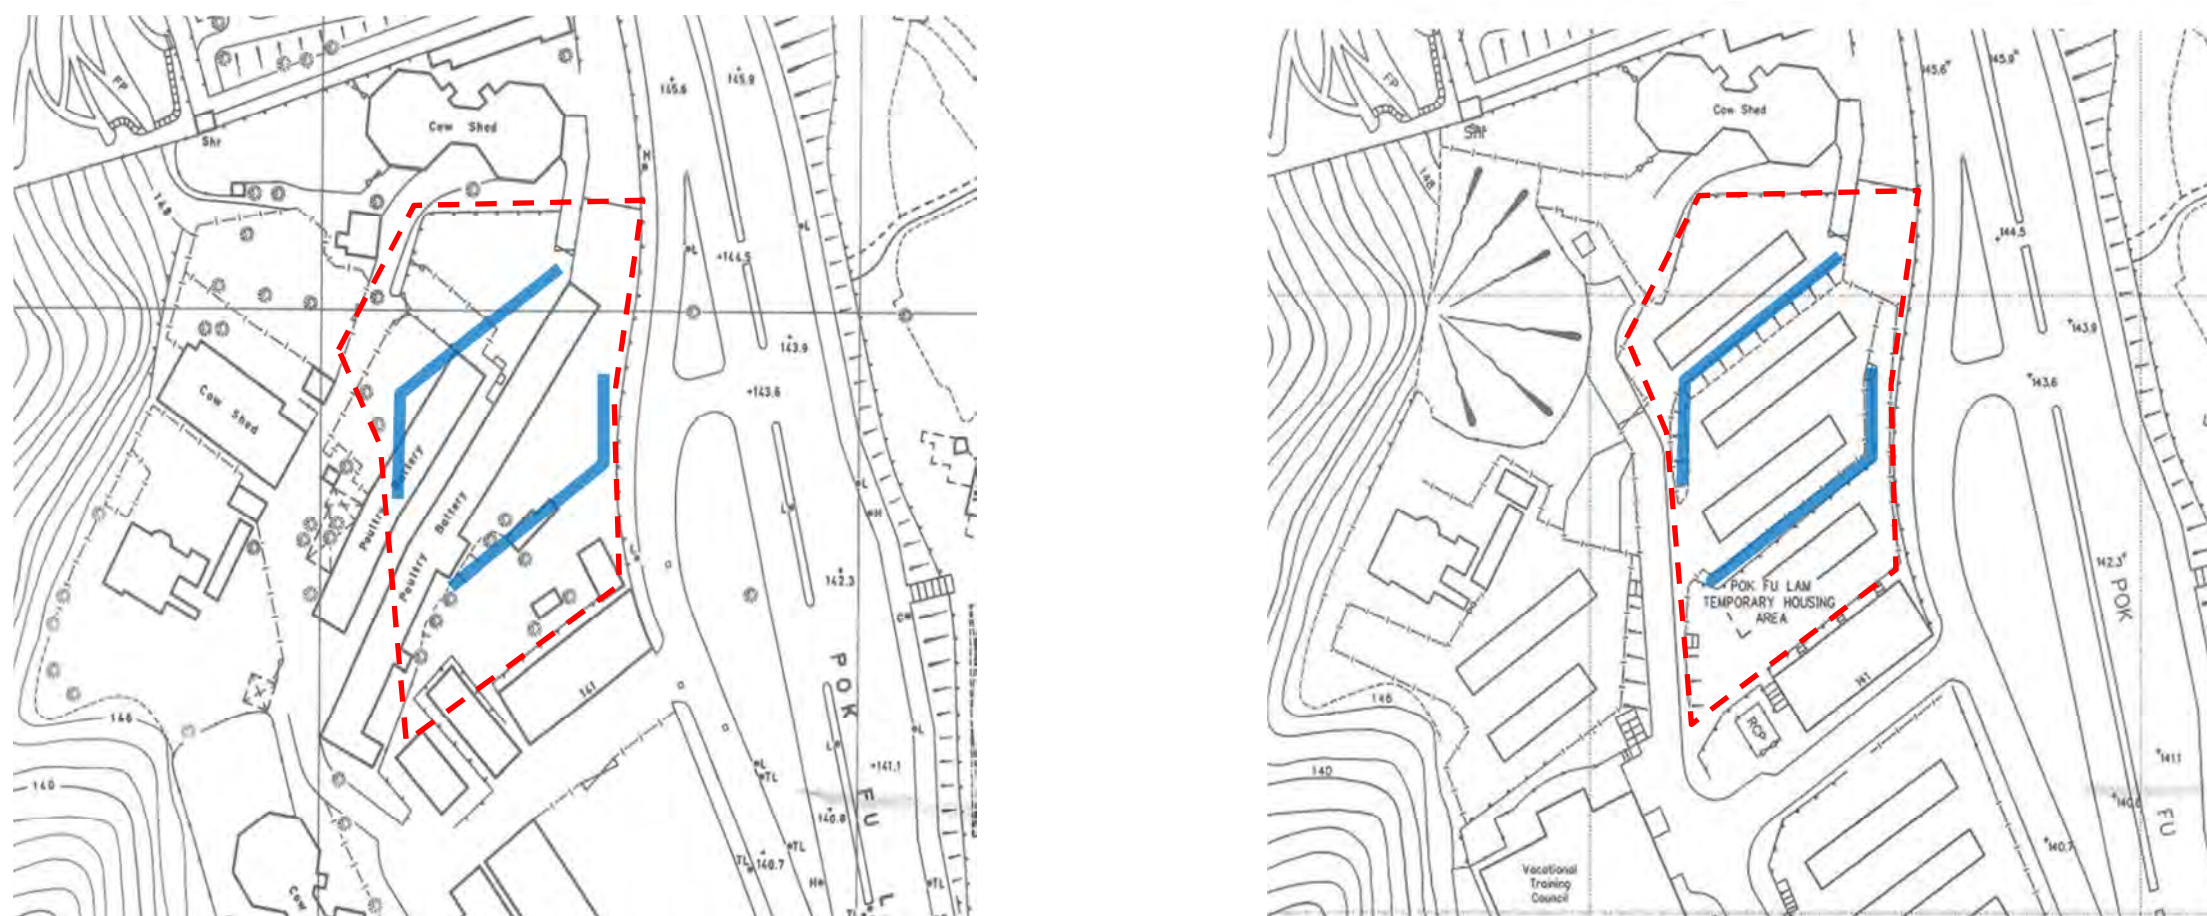
Fig.12 Comparing the layout of the Site in 1983 (left) to 1993 (right). Shade in blue refers to the distinct strata created during the construction of temporary housings in late 1980s, which were not existed in 1983. Dotted line refers to proposed project site. (Source: Survey and Mapping Office, 1983, Ref. no.: 11-SW-17C (Left); Survey and Mapping Office, 1993, Ref. no.: 11-SW-17C (Right); edited by Hebi Chan)

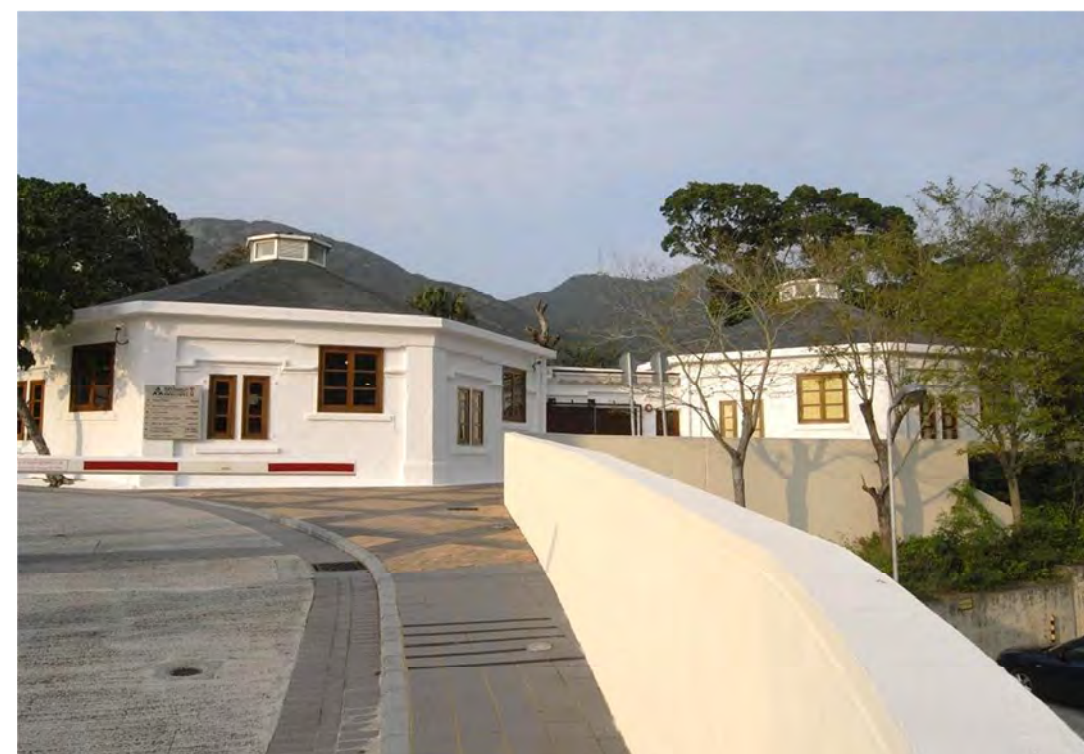
View of existing octagonal Cowsheds. (Source: China Point)

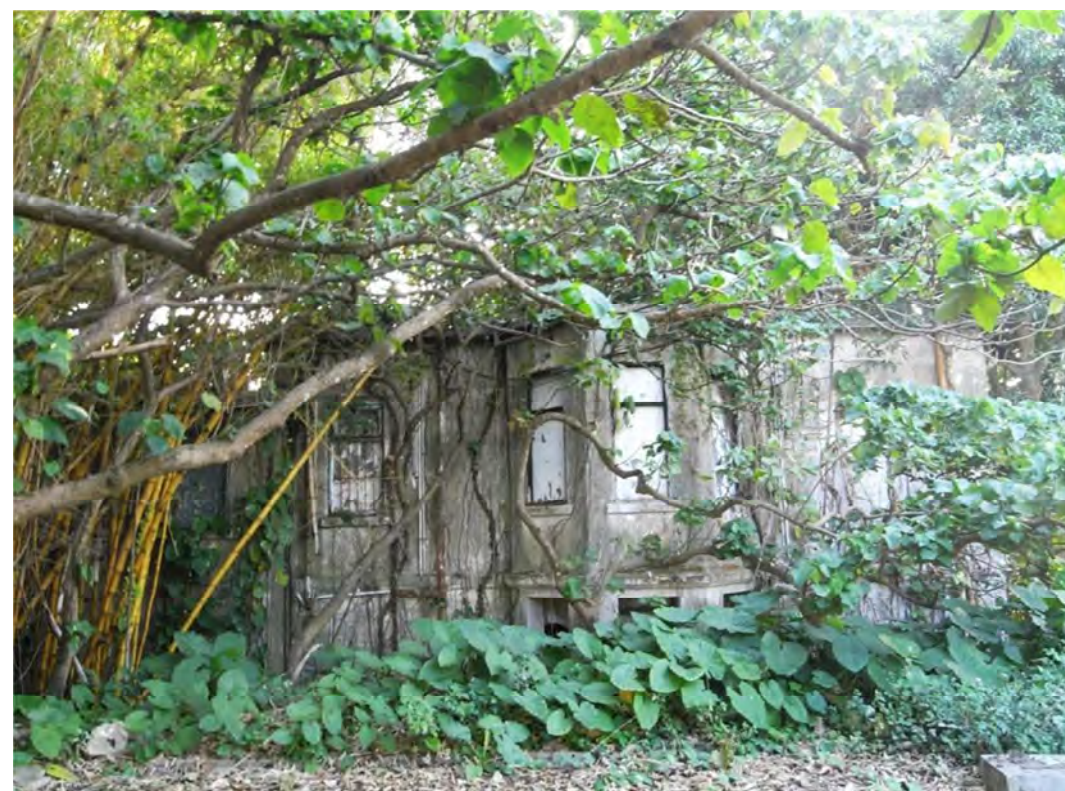
View of existing Old Dairy Farm Senior Office Quarters *Braemar*.
(Source: China Point)

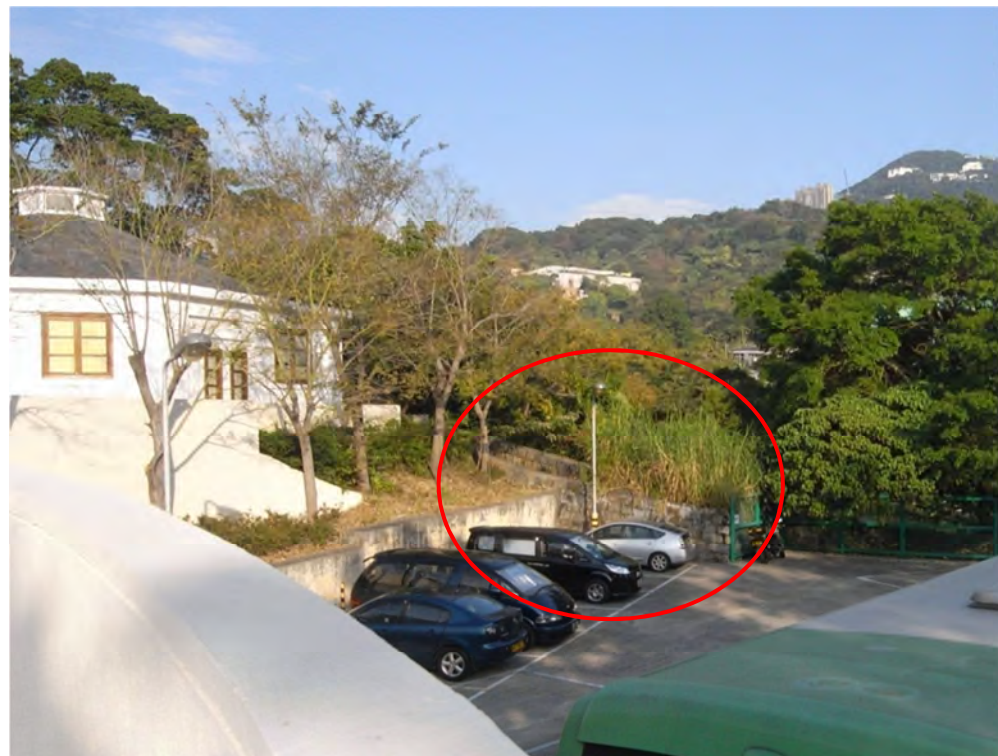
Part of the original ramp leading from the paddock to the octagonal Cowsheds is still remains on site. (Source: China Point)

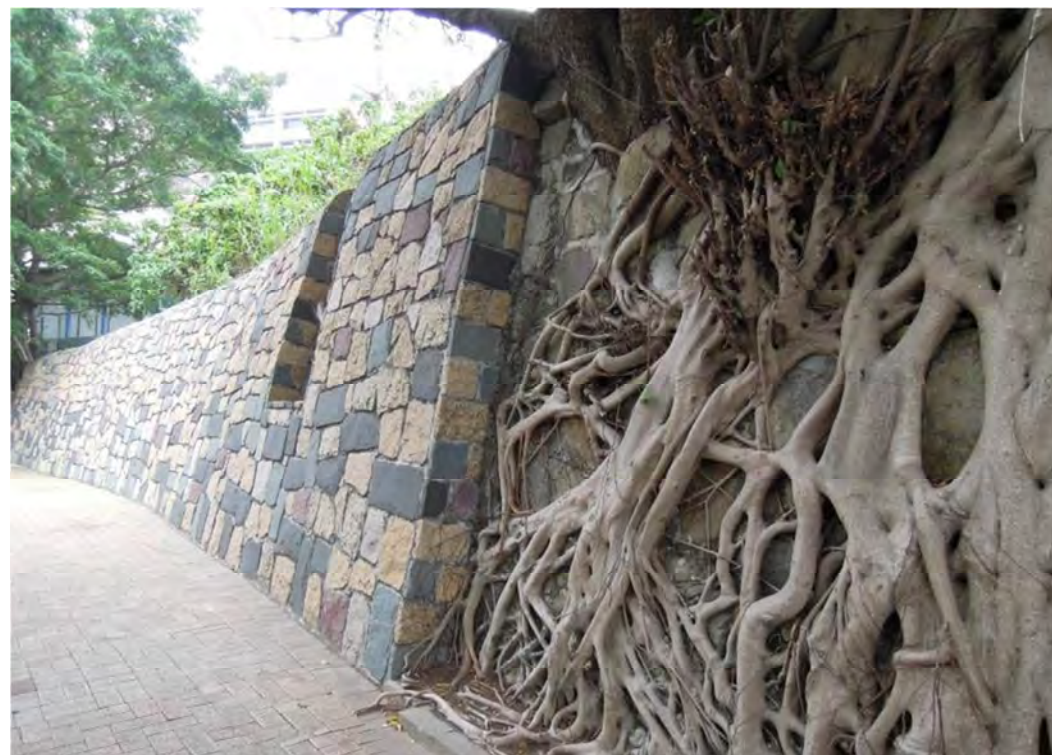
The retaining wall along the Pok Fu Lam Road leading from the Main Office Building to the *Bethanie* is believed to be the original boundary wall of the Mains of Old Dairy Farm, while it has been reinforced and covered up by a “new wall”.
(Source: China Point)

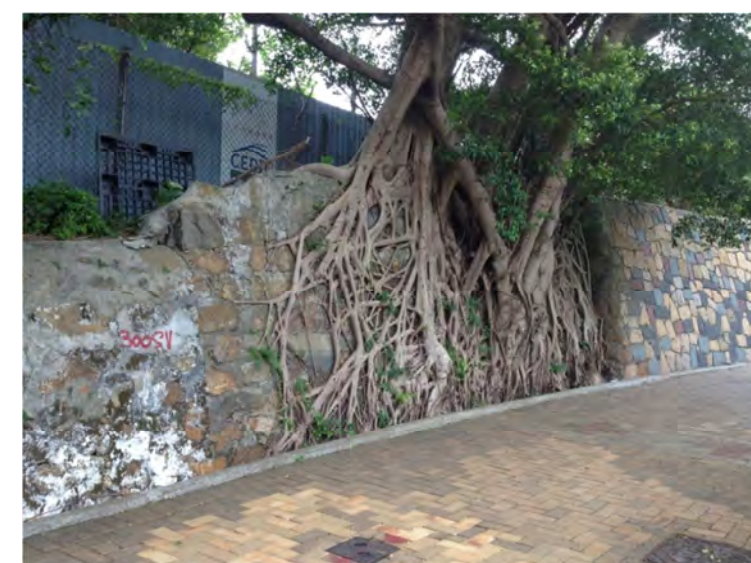
Retaining wall screening off the Site (Source: China Point)

The Site sits behind the retaining wall along Pok Fu Lam Road where mature trees screen off most part of the Site. The Old Dairy Farm Cowshed, Senior Staff Quarters and the *Bethanie* are visually blocked by the retaining walls and trees when viewed from Pok Fu Lam Road.

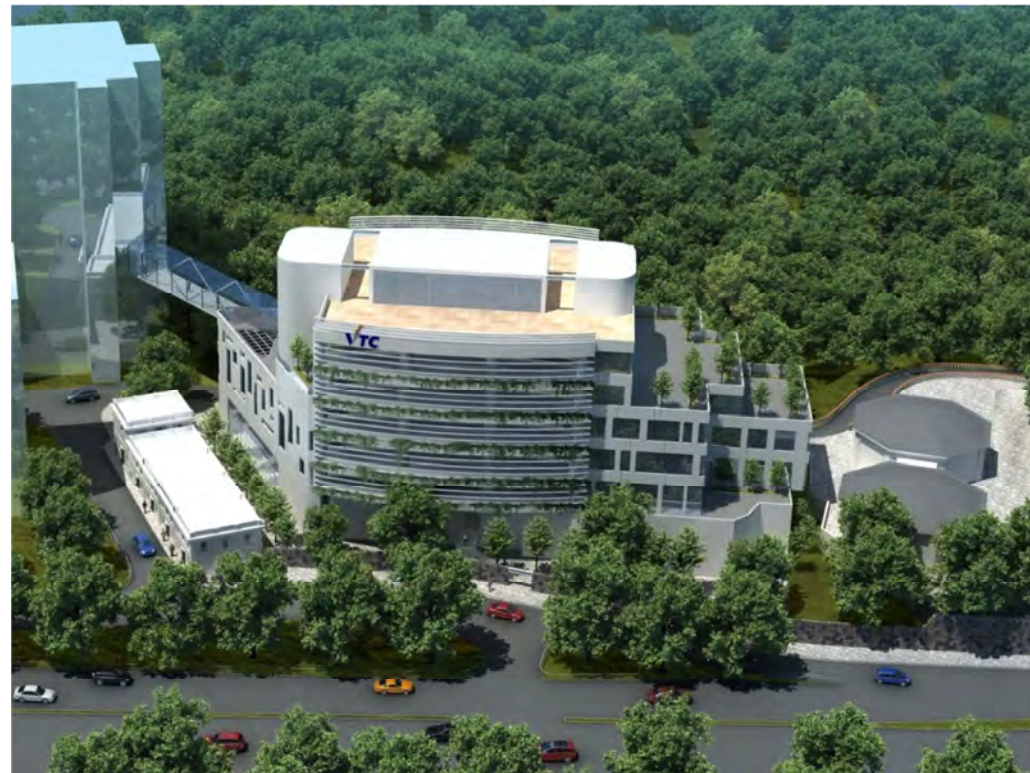
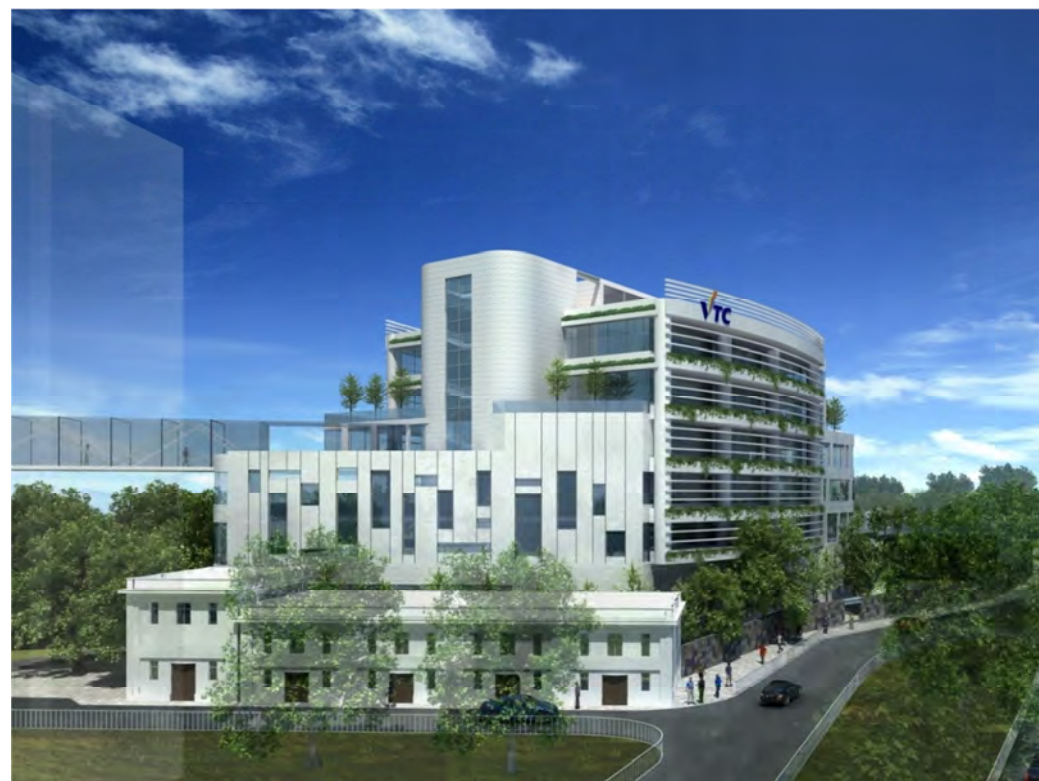
Fig. 15a (top) & 15b (bottom) Preliminary design of ICC as proposed in TFS

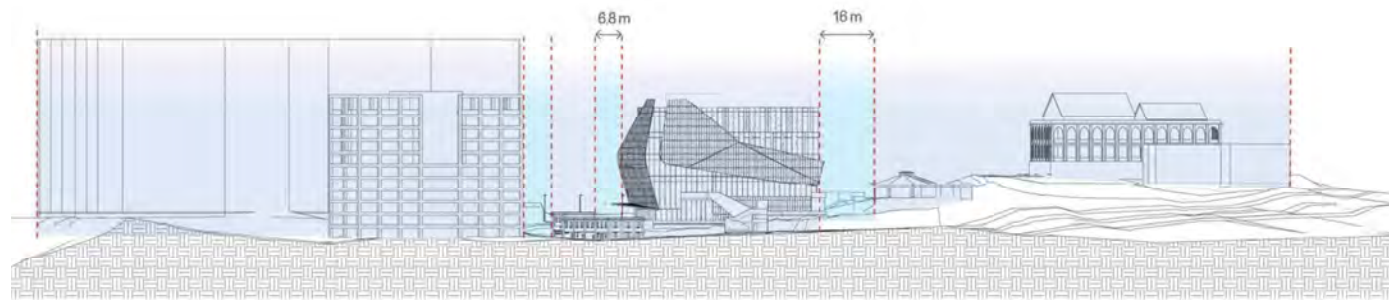
(2) **Set-back Analysis**- to maintain a buffer zone between the new development and the adjoining cowshed and Dairy Farm office building to keep a visual corridor and ventilation breath-way

To allow more separation from the surrounding historic buildings, ICC was designed to set-back 6.8m and 16m from the Old Dairy Farm Main Office and Cowshed respectively.

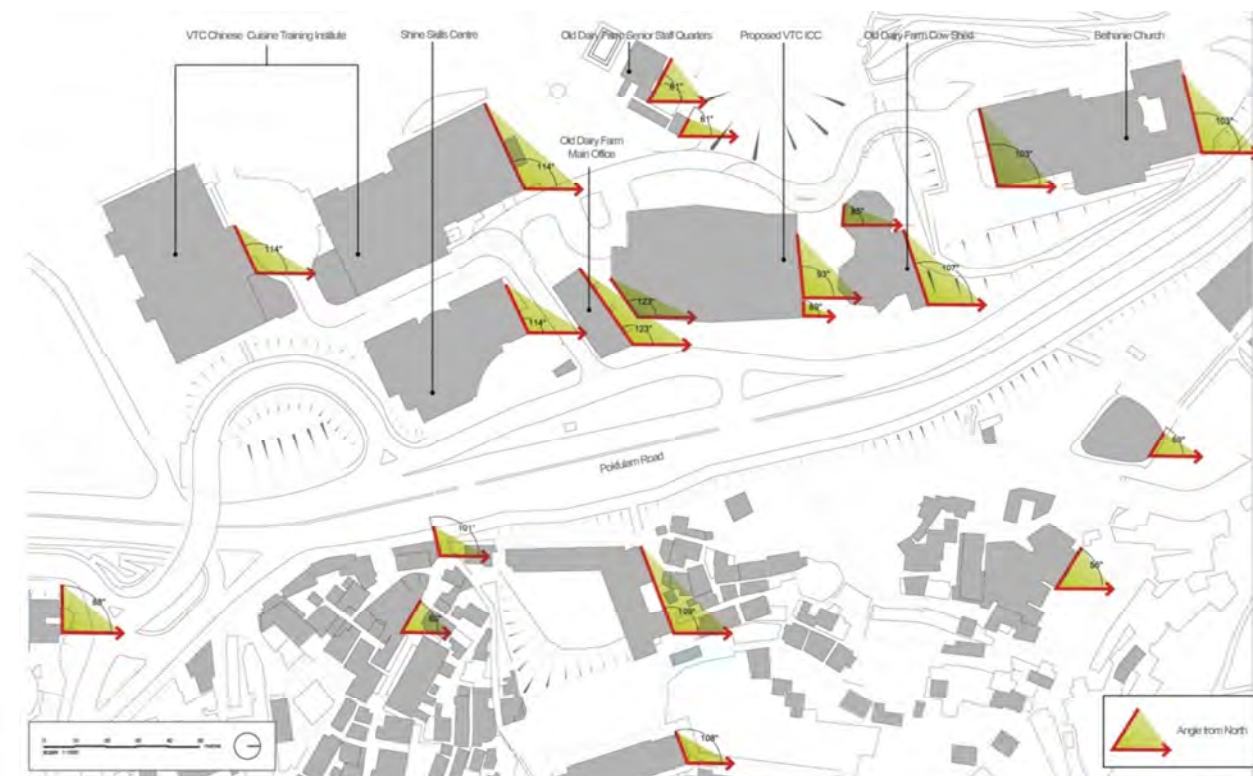
(4) **Townscape Analysis** - to manipulate the orientation of the proposed ICC to fit into the existing building fabrics and texture

To fit into the existing townscape, the ICC façade at different orientations are carefully studied and

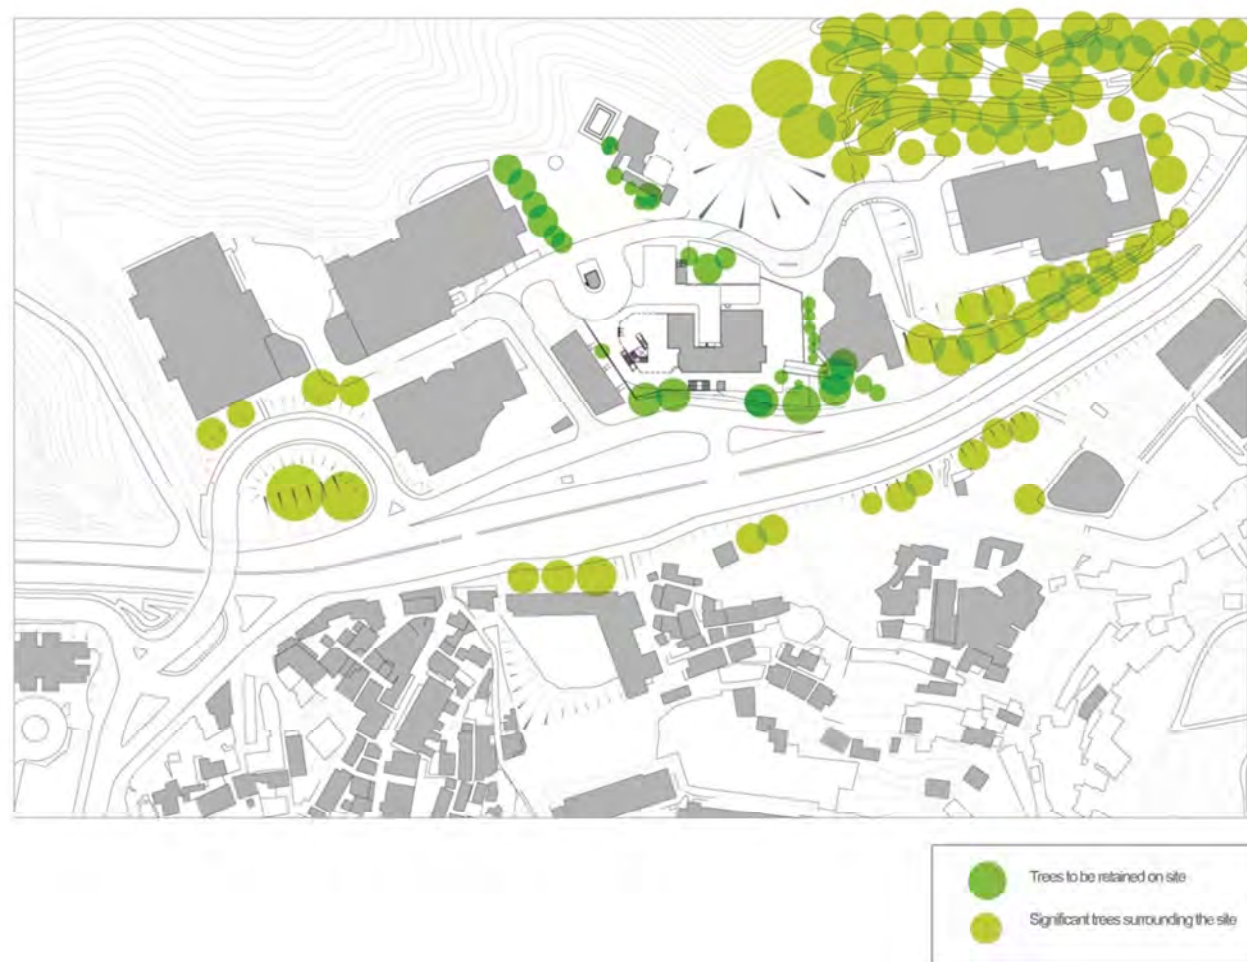
(5) Landscape Study - to retain mature trees in the Site and incorporate them into landscape design

Mature trees within and near the Site are mapped by the Landscape Architect. These trees will be retained and incorporated into landscape design and maintain the green curtain at the retaining wall along Pokfulam Road.

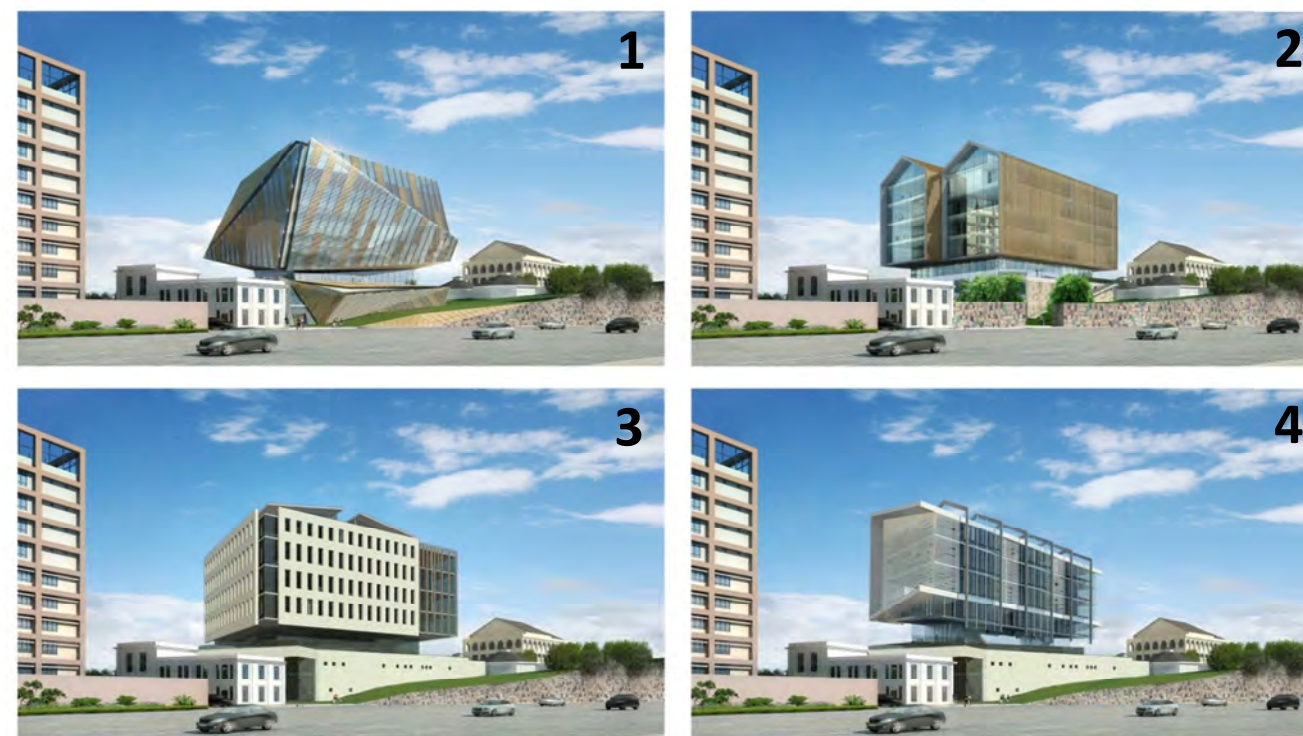
Option 1: An iconic design approach – a distinct personality

Option 2: An imitation approach that borrowed bungalow shape and roof form from the *Bethanie*

Based on the previous studies which suggested parameters on mass, height and set-back, four design approaches had been developed with exploration on the built form, façade, material and landscape.

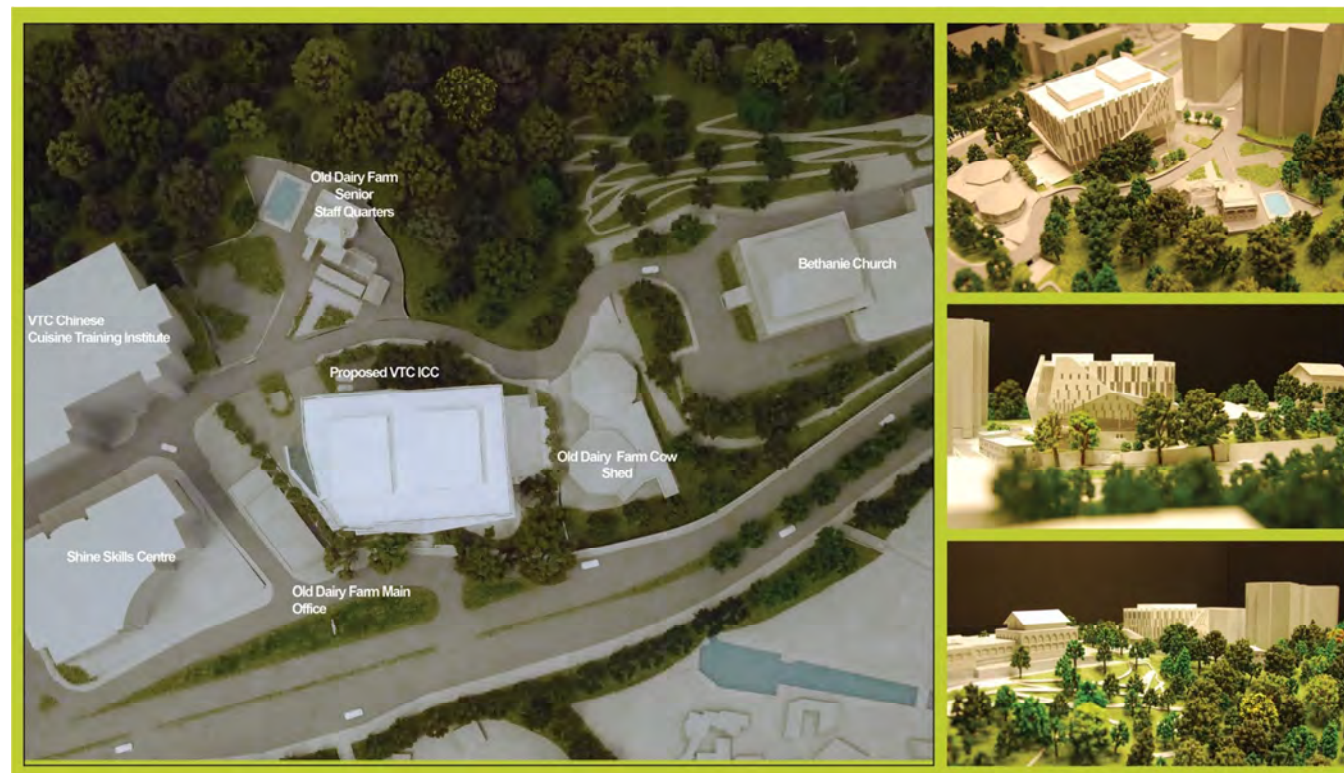
Fig.17 Different angles of a physical ICC study model showing the overall massing and alignment in response to the nearby historic buildings

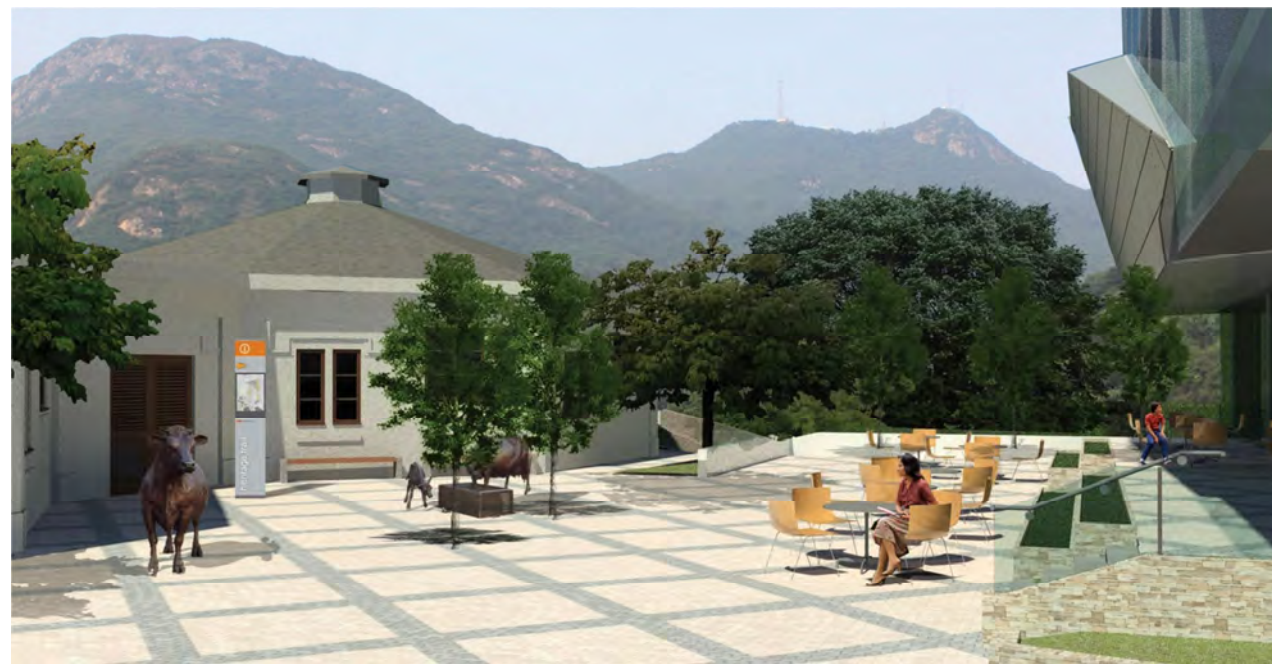
Fig.21 Proposed communal plaza leveled with the Old Dairy Farm Cowshed (Northern façade)

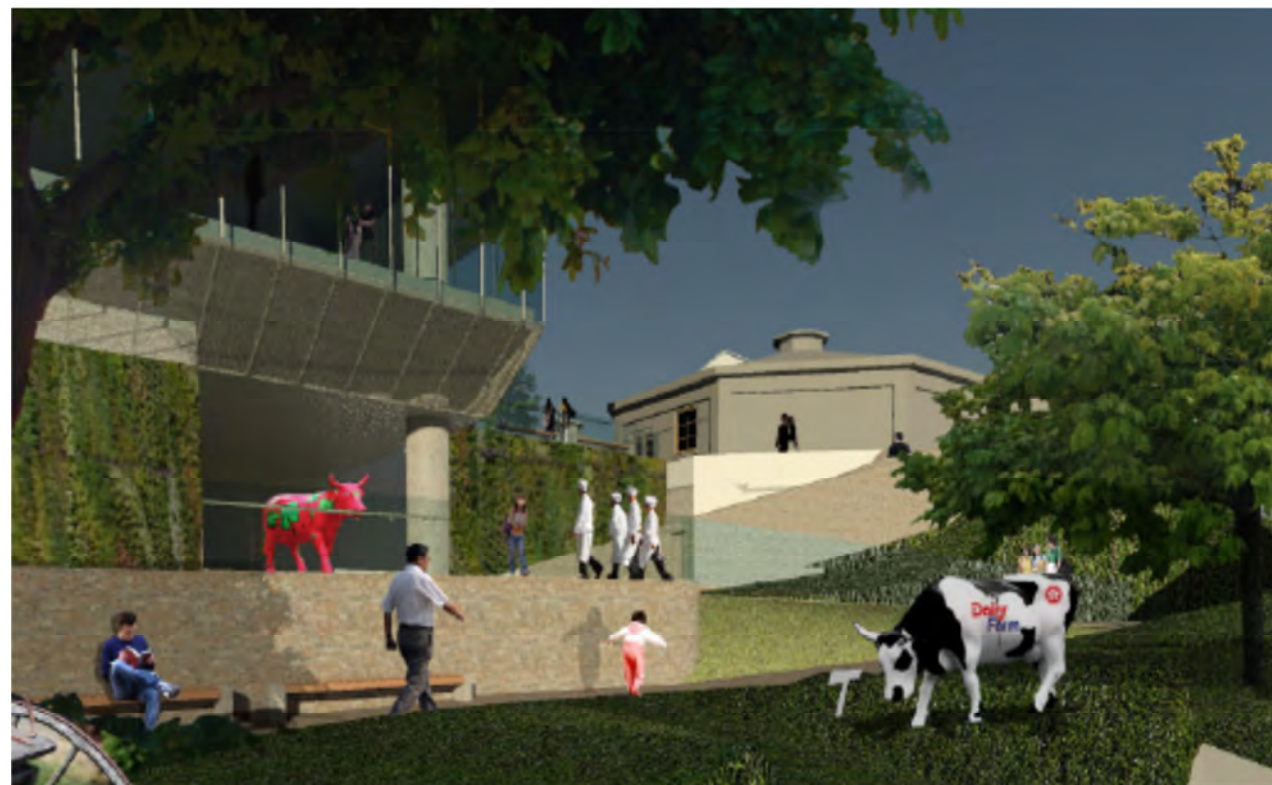
Fig.22 Various vertical greening and landscaping ideas are incorporated (Eastern façade)

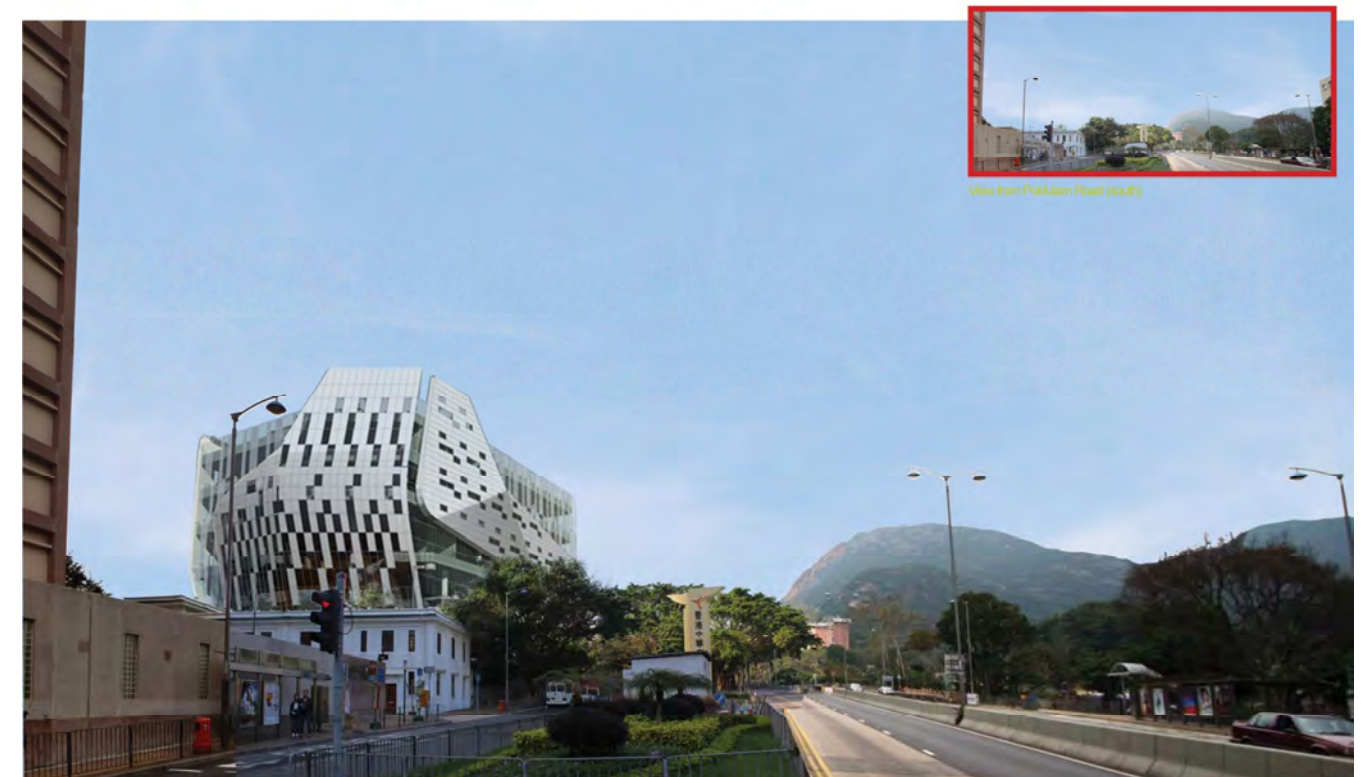
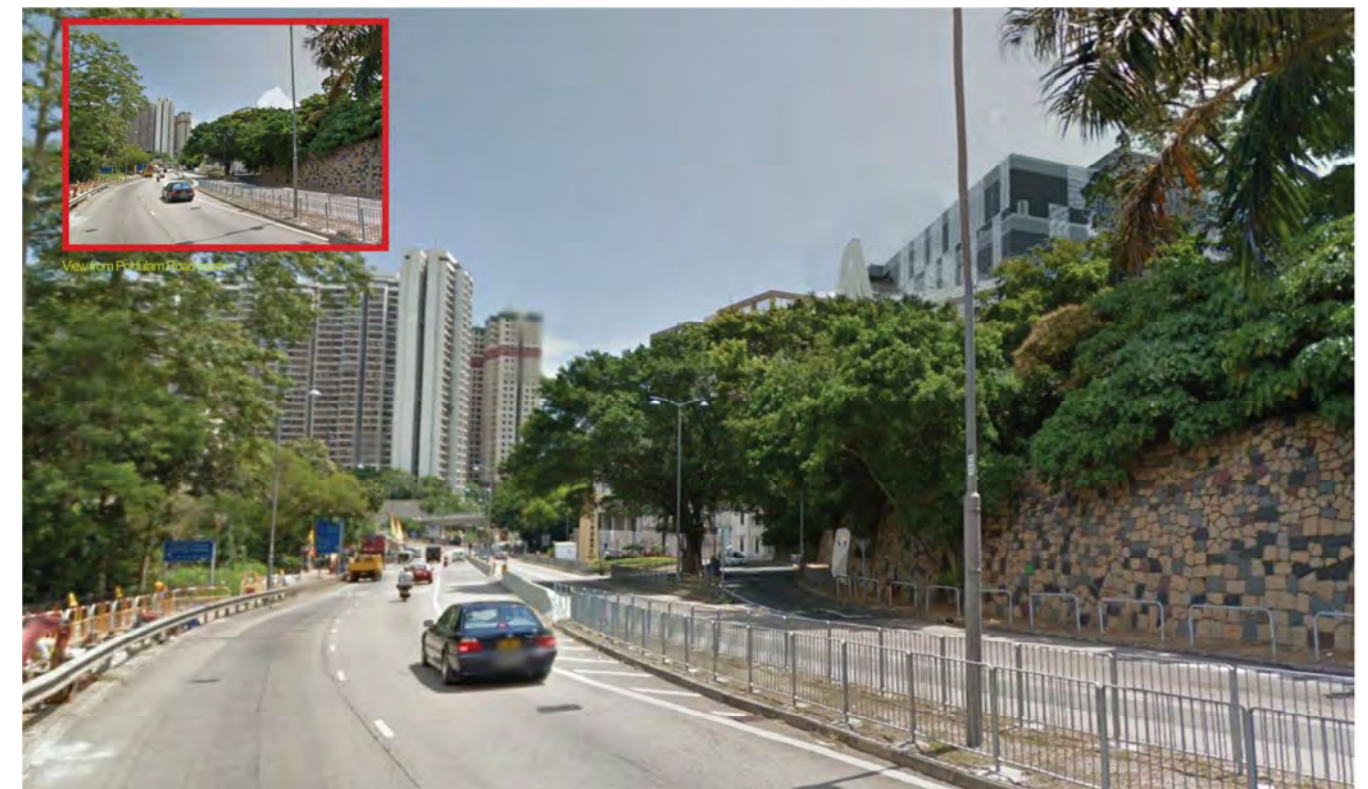
Fig.23a (top) & 23b (bottom) Vista study along Pok Fu Lam Road

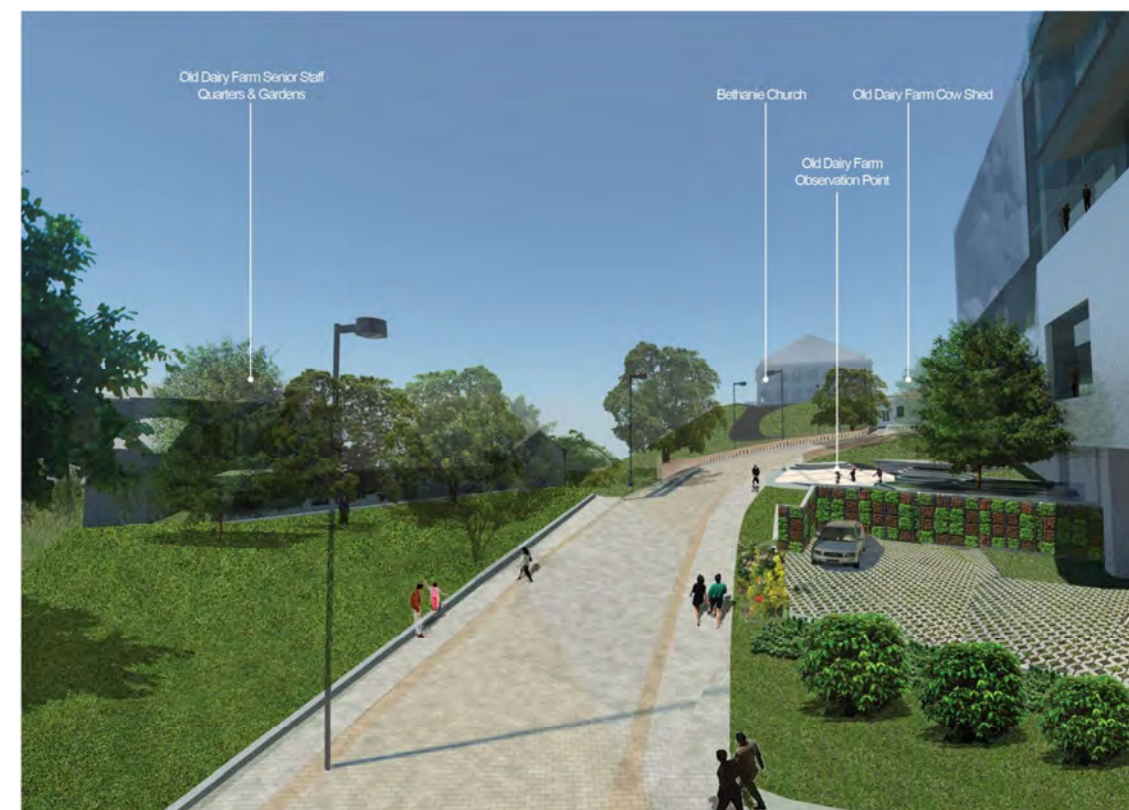
Fig.24 Proposed “Heritage Spine” concept that re-connects the nearby historic buildings and beyond

The design of proposed ICC takes the opportunity to bring enhancement and re-create the missing link between the identified heritage resources. A concept of ‘**Heritage Spine**’ was developed to re-connect the historic building cluster, and to provide breathing space to the development. This spine is not limited to the Site of ICC but extends upward to the *Bethanie* and its gardens and further northbound towards the Old Douglas Castle and other declared monuments and graded historic structures at Pokfulam reservoir. It also extends southward to Pok Fu Lam Village and other heritage resources as recorded via the Cultural Mapping exercise (see [Section 3.1.5](#) & [Appendix 7.2](#)).
