Heritage Impact Assessment Report

Development of the International Culinary College
At Pok Fu Lam, Hong Kong

Prepared for
Vocational Training Council

By
China Point Consultants Limited

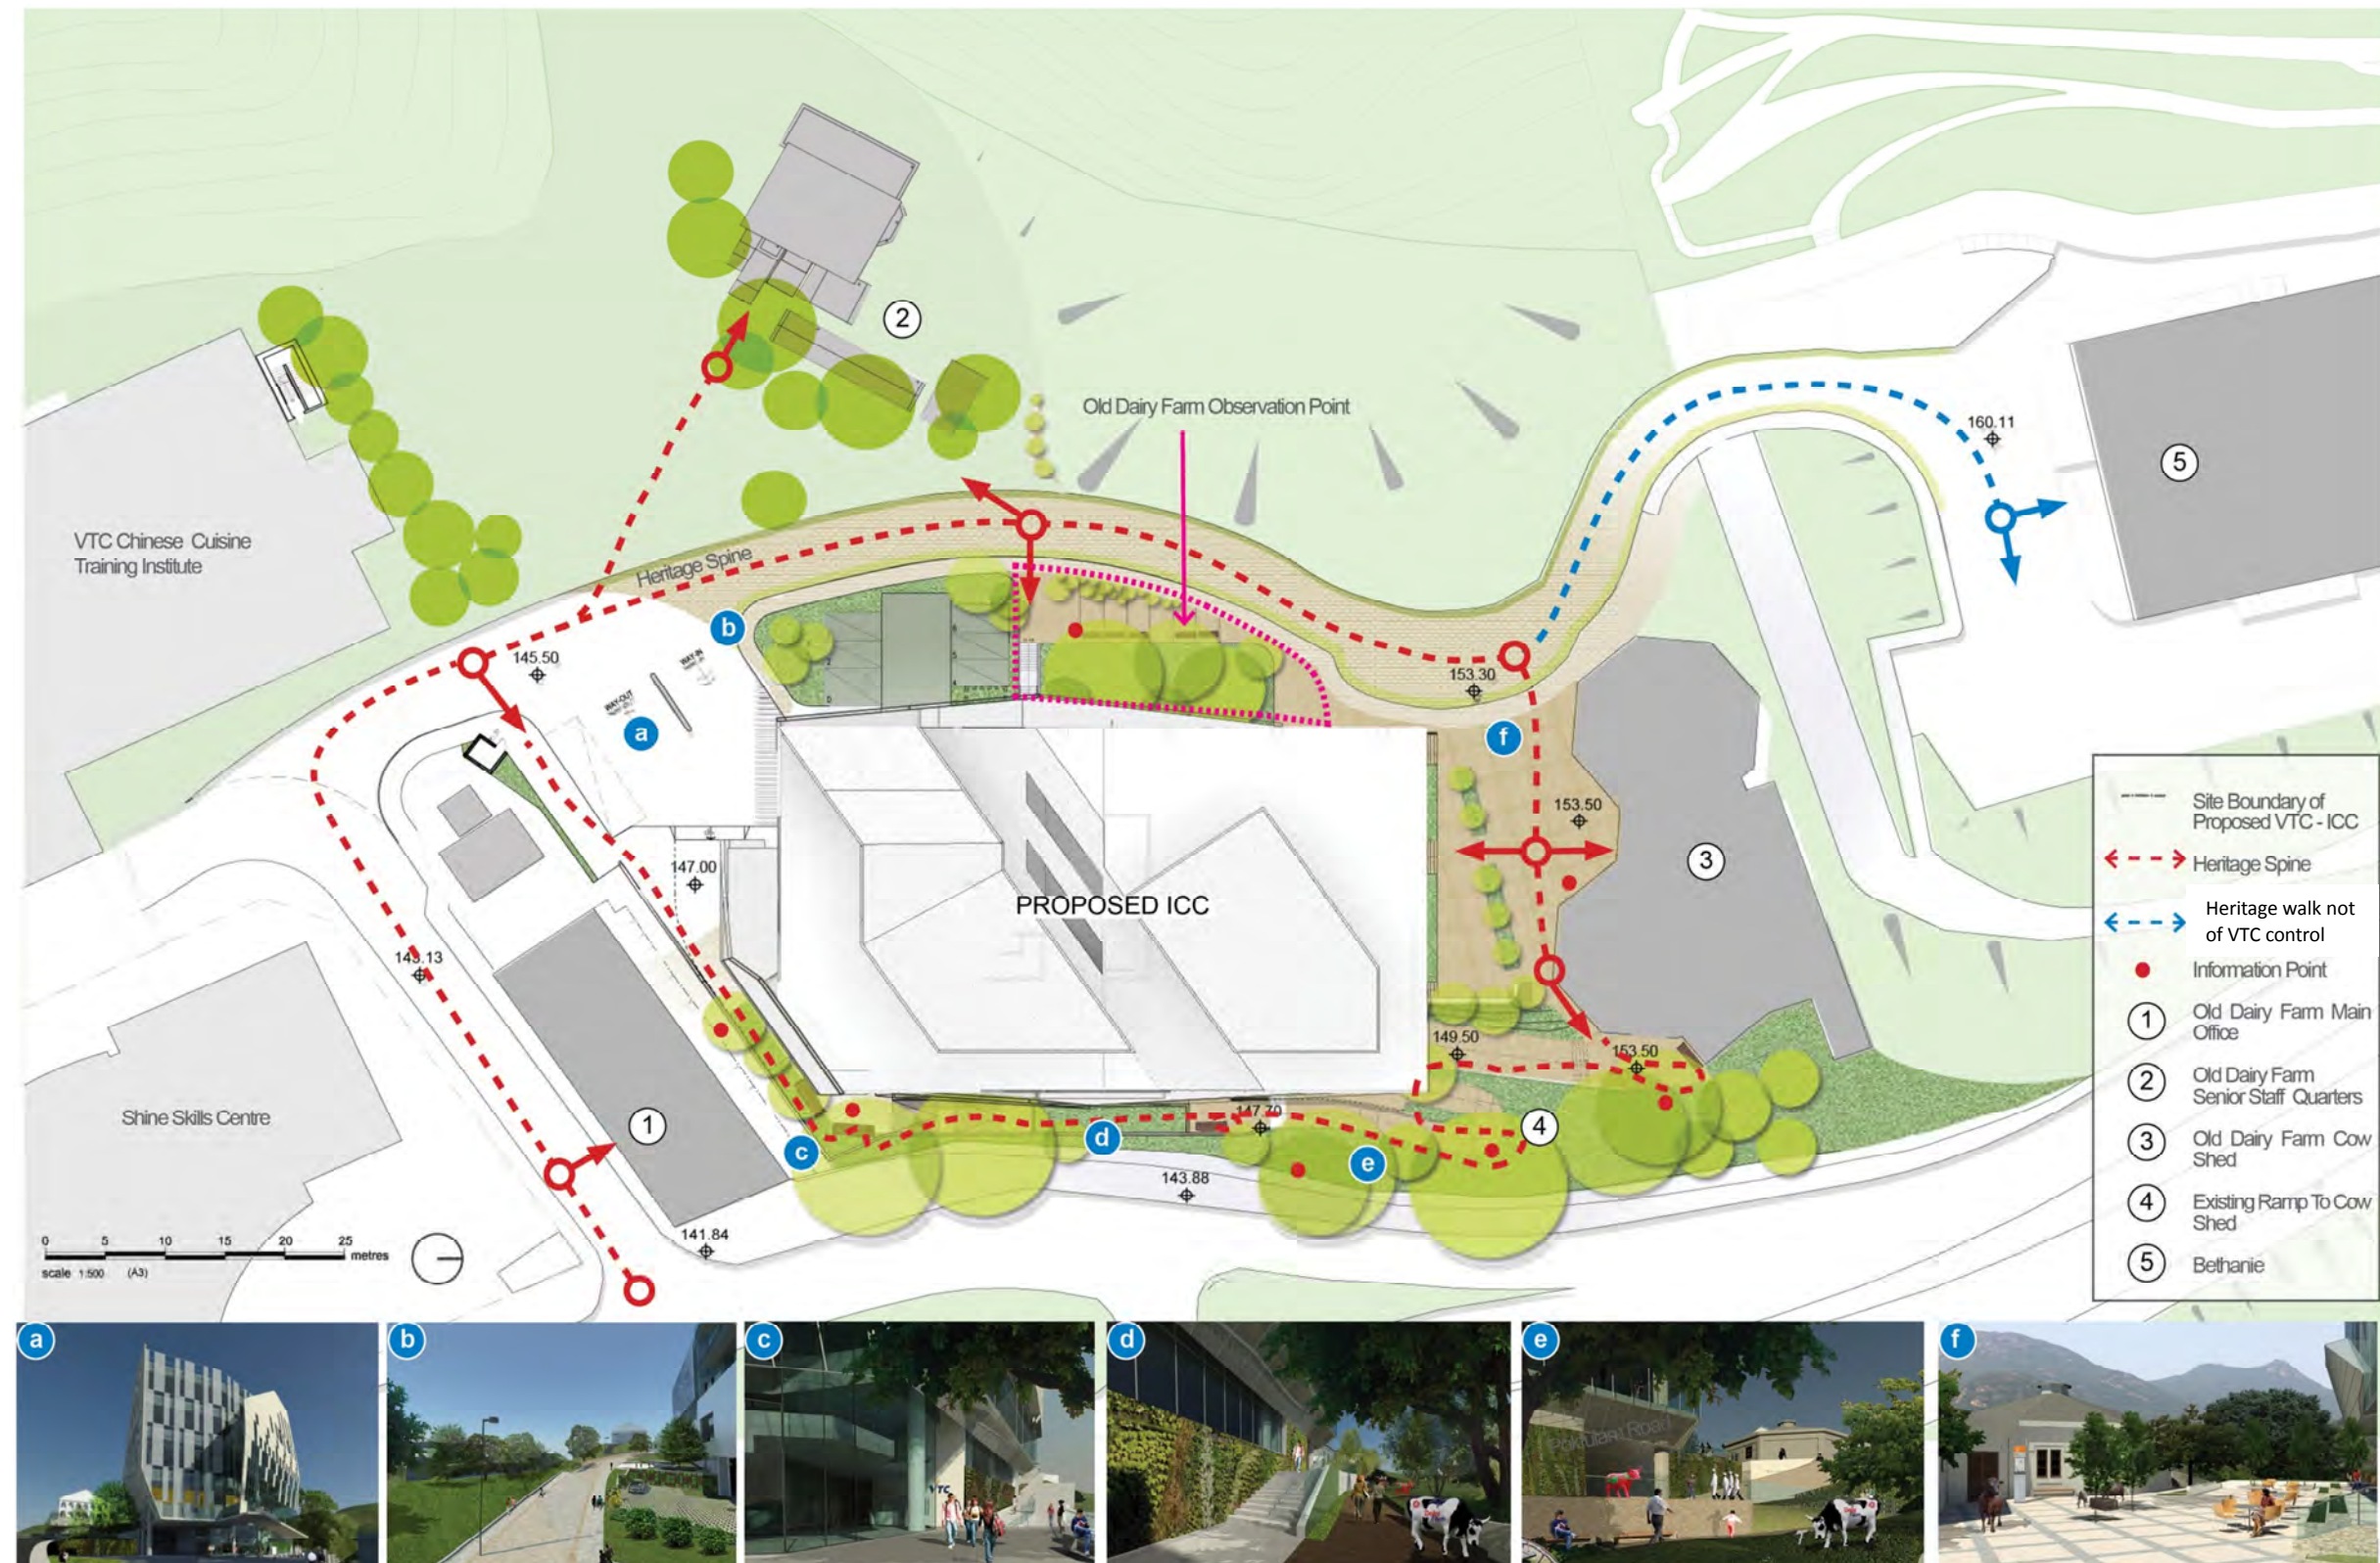
Fig.26 Site plan of ICC showing the Heritage Spine (light brown area), the heritage walk and the 'Old Dairy Farm Observation Point' (in red dotted line) at the western orientation.
The whole ground plane will become a landscaped Interpretation Area for Old Dairy Farm, the *Bethanie* and other cultural resources located beyond.

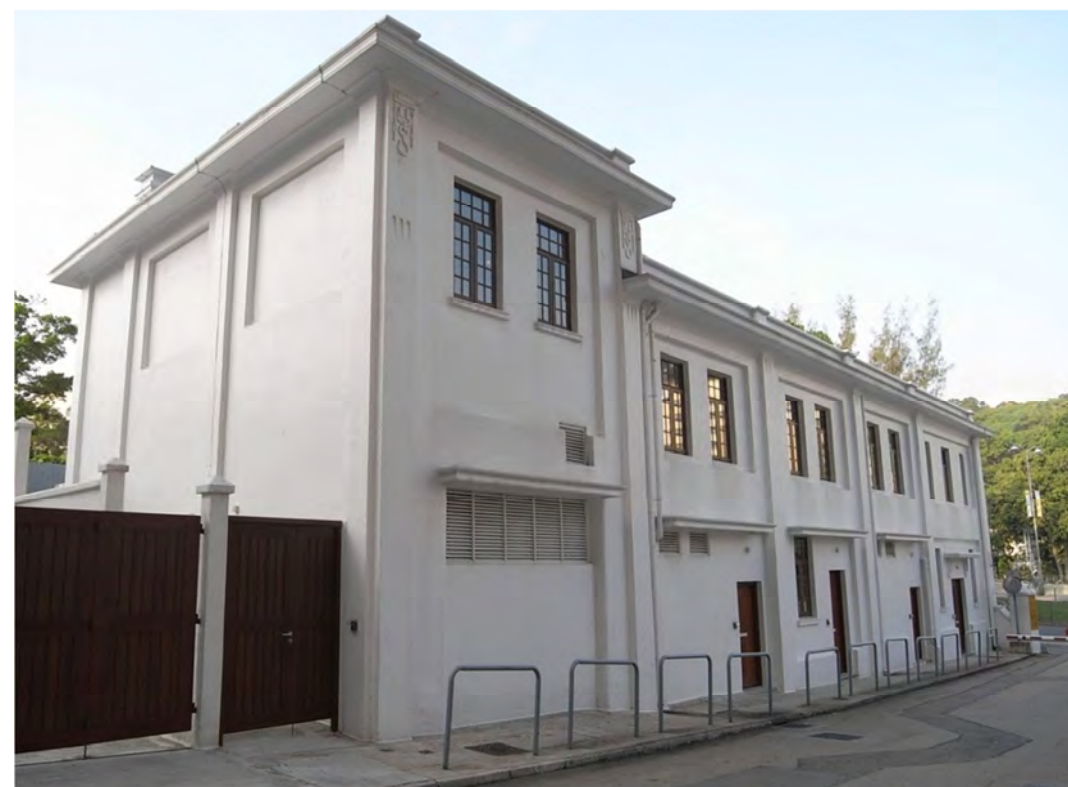
(Source: China Point)

The Main Office is a two storeys building divided into 5 bays which the rear bay stands slightly higher than the rest of the building. It is built in an architectural style popular in the 1920s and 1930s. A simple projecting cornice runs around the building at parapet level and vertical emphasis is provided by flat piers or pilasters between the bays. The fenestration on the east and south elevations consists of metal windows set into blank window recesses with projecting shaped canopies for weather protection. Ornamentation is confined to applique art deco motifs at the top of pilasters and each side of the canopy over the main entrance. The applique motif at the top of the two pilasters at the end of the building is a device featuring a hook, pulley and chains possibly denoting use as a repair workshop. The rear elevation consists of irregular arrangement of windows, doors and flights of steps to the first floor offices. Numerous alterations seem to have been carried out. Internally the building is divided by cross walls into large featureless utilitarian rooms. It is a building of the Old Dairy Farm now rare in Hong Kong. It is of built heritage value and remains fairly authentic in its external appearance.

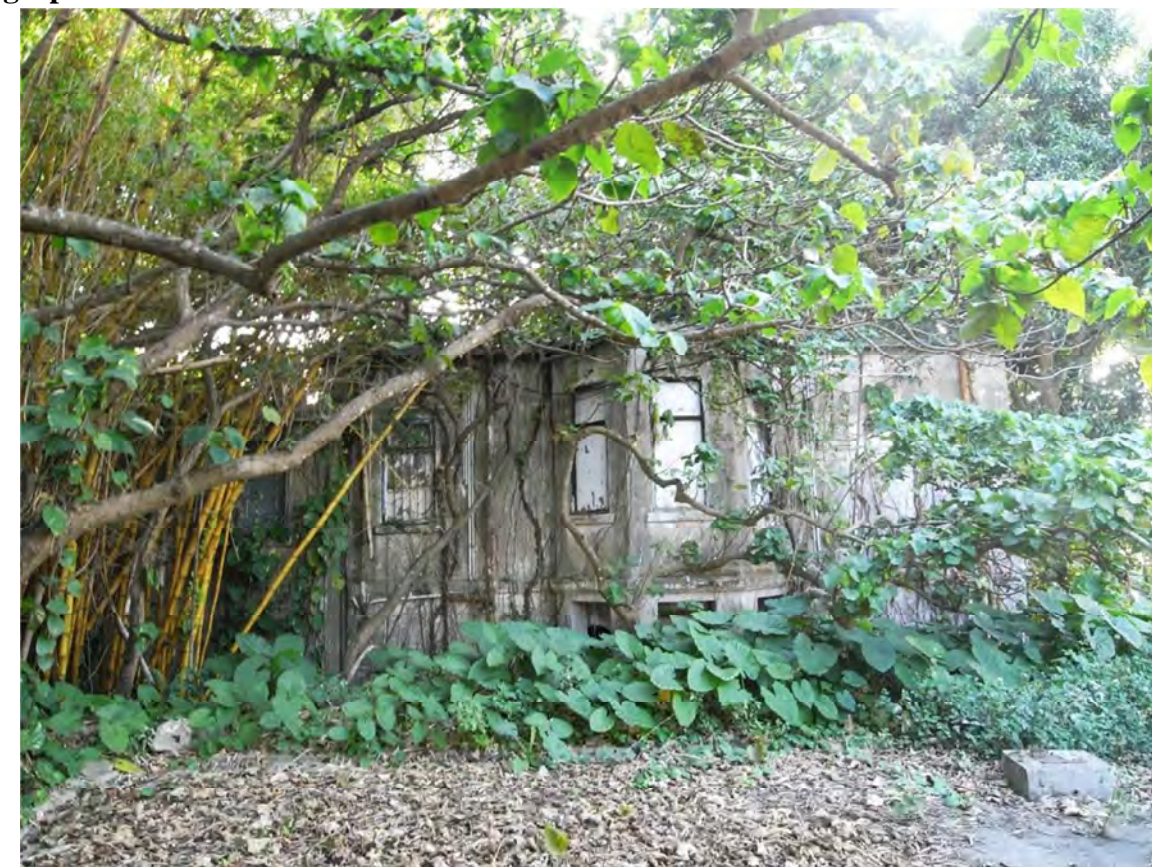
The Senior Staff Quarters is a two storeys building. The lower or ground floor storey, which corresponds to a basement, has thick granite block walls pierced at regular intervals by circular bull's eye windows for ventilation. These granite walls act as a plinth to support the principal storey at first floor level which has simple classical architectural features. Each elevation is different but the main features are a bay window on the north-east side. The main features of the interior, which has suffered from vandalism and decay, are period fireplaces in the main rooms, panelled doors, and heavily moulded architraves to windows and door frames. There are two outbuildings comprising a single storey building probably used as servants' quarters and a garage block in simple classical architectural style. Both outbuildings have double-roll Chinese tile pitched roofs. It is a building of the Old Dairy Farm now rare in Hong Kong. It is of considerable built heritage value and it remains fairly authentic.

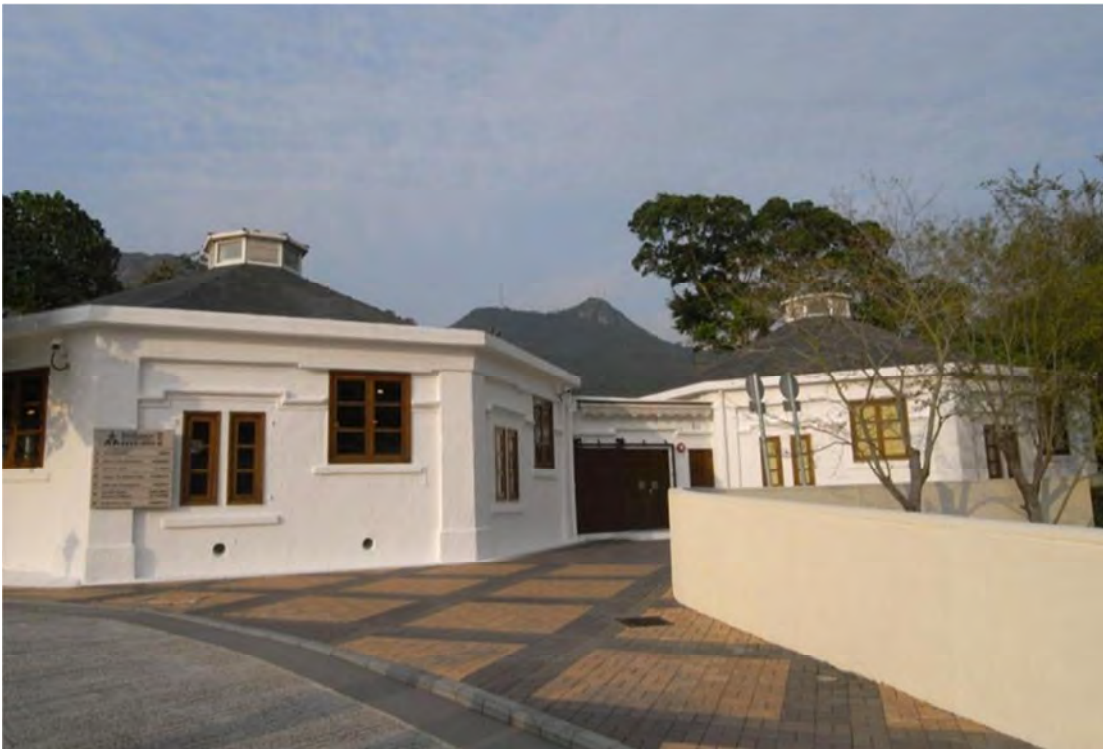
(Source: China Point)

The cowshed is built of grey-green brick walls stuccoed externally and plastered internally, with sloping reinforced concrete roofs. An octagonal ventilation turret is situated at the apex of each roof. Externally the cowshed has a simple classical architectural appearance. The reason for the irregular arrangement of the windows is not known, but it does appear to be the original design, or else a very early alteration. Internally, the side-by-side stall partitions are formed in concrete. Originally the dado, or lower part of the walls, was left as bare cement render to facilitate washing down, but the upper part of the walls and sloping soffits were lime-washed. Window openings are fitted with iron ventilation grilles and closed by external wooden shutters. Floors are of concrete with raised platforms to the stalls with herring-bone drainage grooves. There is a central service passage with wash-down channels on either side.

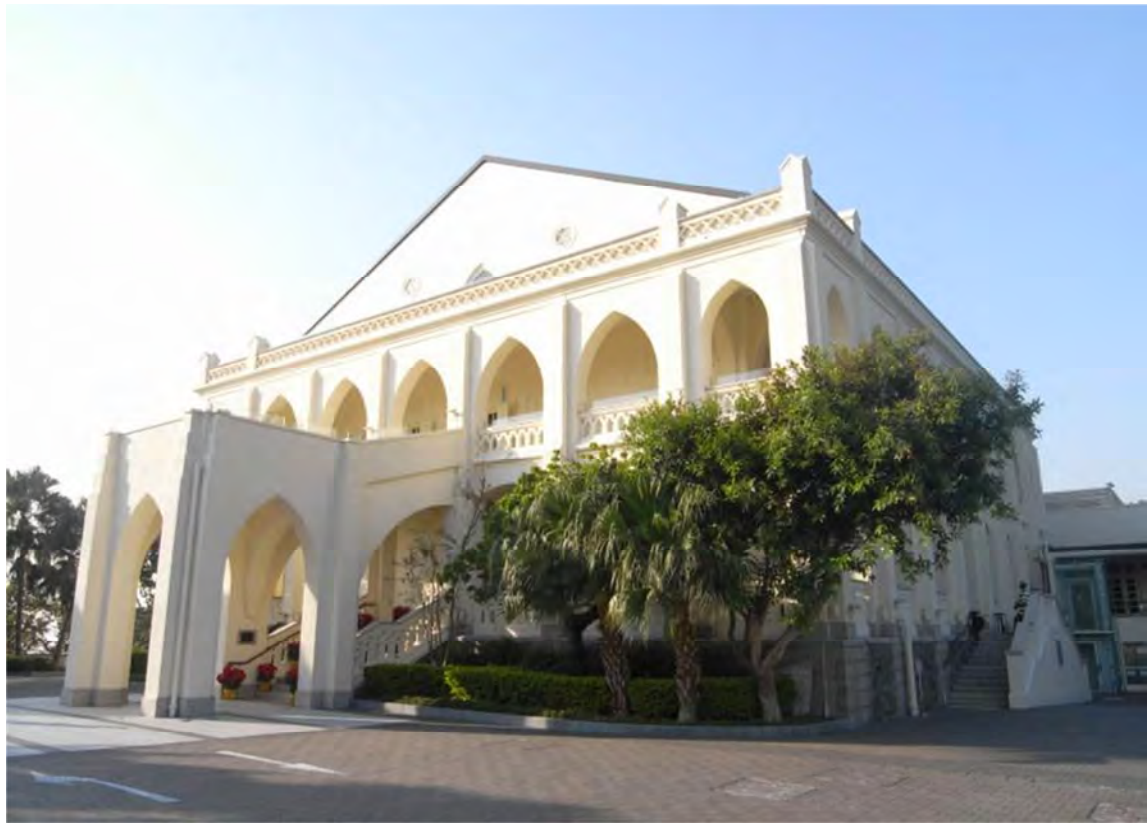
(Source: China Point)

The building consists of three parts: the Chapel, the Sanatorium and the Service Wing. The predominant architectural style is Neo-Gothic featuring pointed lancet windows, pointed arched colonnades to verandahs, flying buttresses, pinnacles, crockets and trefoil ornamentation to parapets. An extension on the east side is of Bauhaus style with typical 1930s architectural features. Internally the Chapel is the most striking with a ribbed and vaulted dome supported on slender Gothic style columns. As a rare building type in the area it has obvious built heritage value and local interest. *Bethanie* remains fairly authentic, despite the additions and alterations it has undergone during the change-of-use process to enable its present use as the second campus of the APA. The additional flat roof built in the 1960s has been removed to reveal the original pitched roof design, which was rebuilt with glazed tiles and gable walls. To comply with the current safety standards and building requirements while preserving the heritage features of *Bethanie*, some decorative features such as fireplaces have been kept and restored; but some have been removed or salvaged for reuse and display purpose.

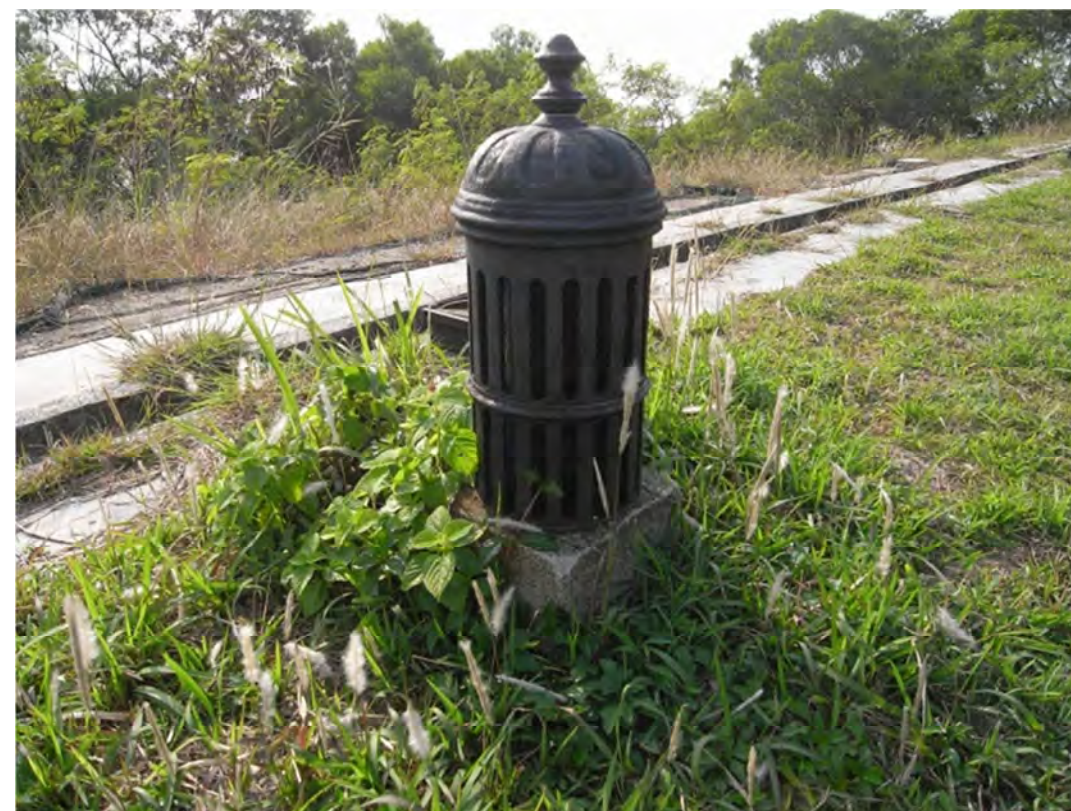
(Source: China Point)

The Air Vents at the Service Reservoir (covered) consist of twelve cast iron ventilators situated on top of the small covered reservoir which is situated on a hilltop at the west end of the main reservoir and reached by a flight of steps behind the Management Office. The ventilators are a standard design seen on other reservoirs and simply consist of an iron pipe with slots in the side and a domed top. Their purpose is to release compressed air and vapours from the covered reservoir below. As Pok Fu Lam Reservoir is the oldest reservoir in Hong Kong, the engineering structures have built heritage value as well as being rare examples of Victorian civil engineering. There have been obvious alterations to some of the structures, but their basic authenticity remains.

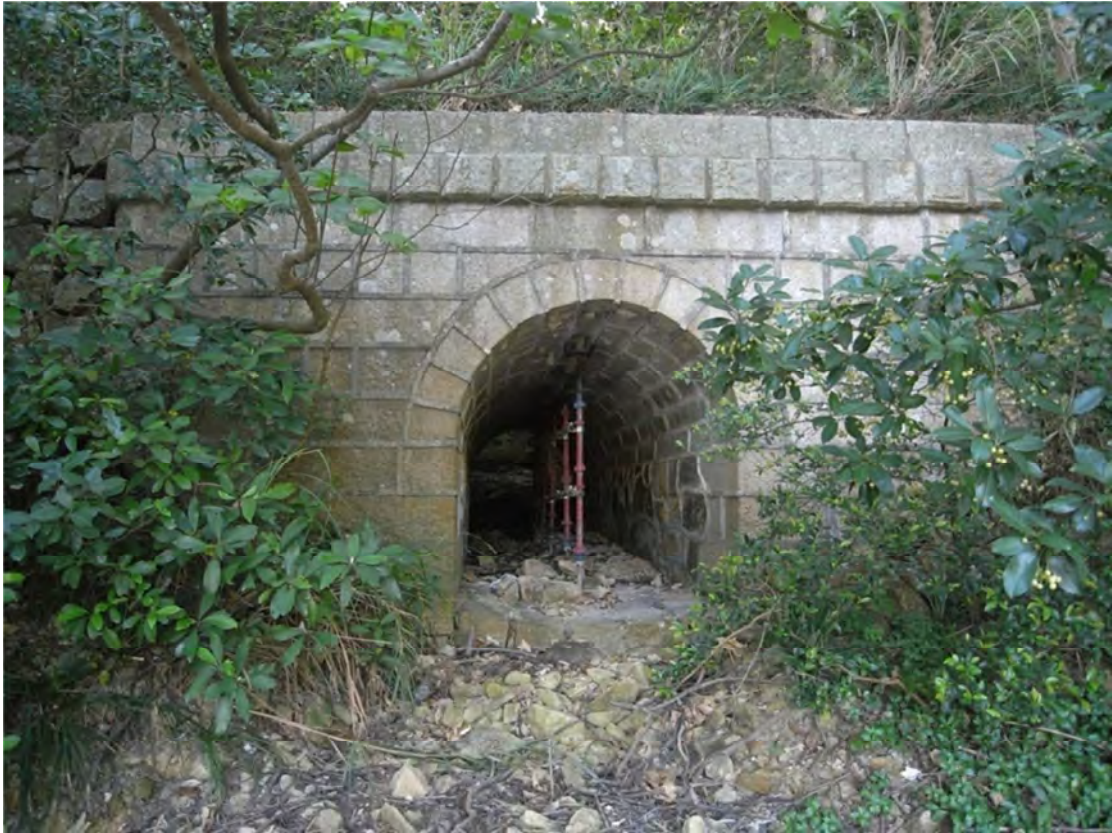
(Source: China Point)

The four Masonry Bridges are situated at the east end of the Reservoir and along the Pok Fu Lam Reservoir Road along the north side of the Reservoir. The bridges span the mouths of four feeder streams which run off the hillsides. The four bridges are constructed of granite with semi-circular or segmental arches. Two of the smaller bridges have granite copings with the ends of the stones neatly finished with chamfered margins and reticulated or vermiculated surfaces in Italianate Renaissance style. The two larger stone bridges have mass concrete copings and splayed concrete abutments, sometimes known as wings. As Pok Fu Lam Reservoir is the oldest reservoir in Hong Kong, the engineering structures have built heritage value as well as being rare examples of Victorian civil engineering. There have been obvious alterations to some of the structures, but their basic authenticity remains.

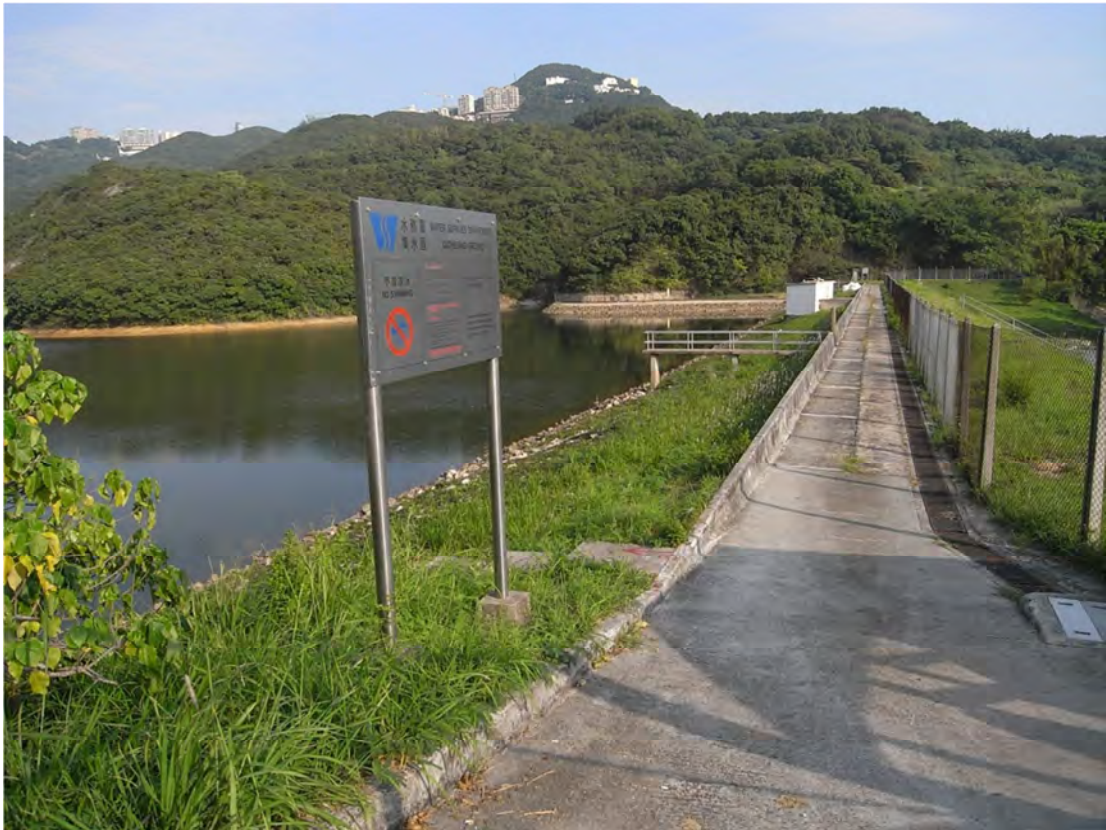
(Source: China Point)

The Dam Embankment is an earth embankment with a puddled clay core surfaced with rip-rap (civil engineering mixture of small stones and sand). Grass and vegetation grow on the embankment which has a fenced concrete road running along it. As Pok Fu Lam Reservoir is the oldest reservoir in Hong Kong, the engineering structures have built heritage value as well as being rare examples of Victorian civil engineering. There have been obvious alterations to some of the structures, but their basic authenticity remains.

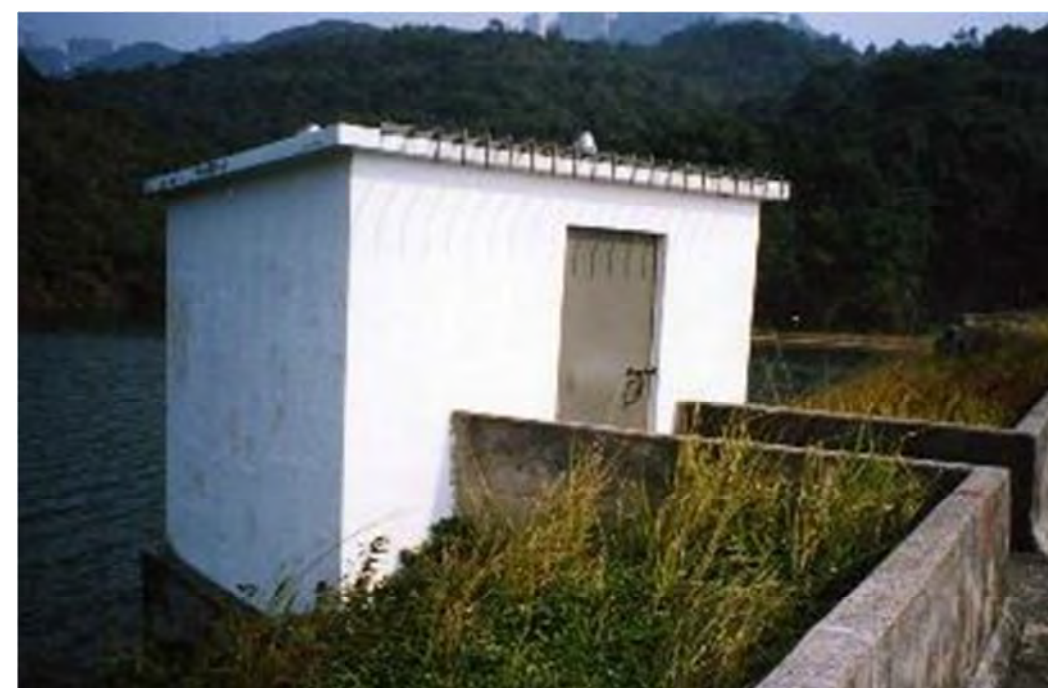
(Source: The Geographical Information System on Hong Kong Heritage)

Features along the dam include a small railed jetty giving access to a water level gauge, a small pump house, a Box Culvert and an overflow spillweir with coursed granite side walls. As Pok Fu Lam Reservoir is the oldest reservoir in Hong Kong, the engineering structures have built heritage value as well as being rare examples of Victorian civil engineering. There have been obvious alterations to some of the structures, but their basic authenticity remains.

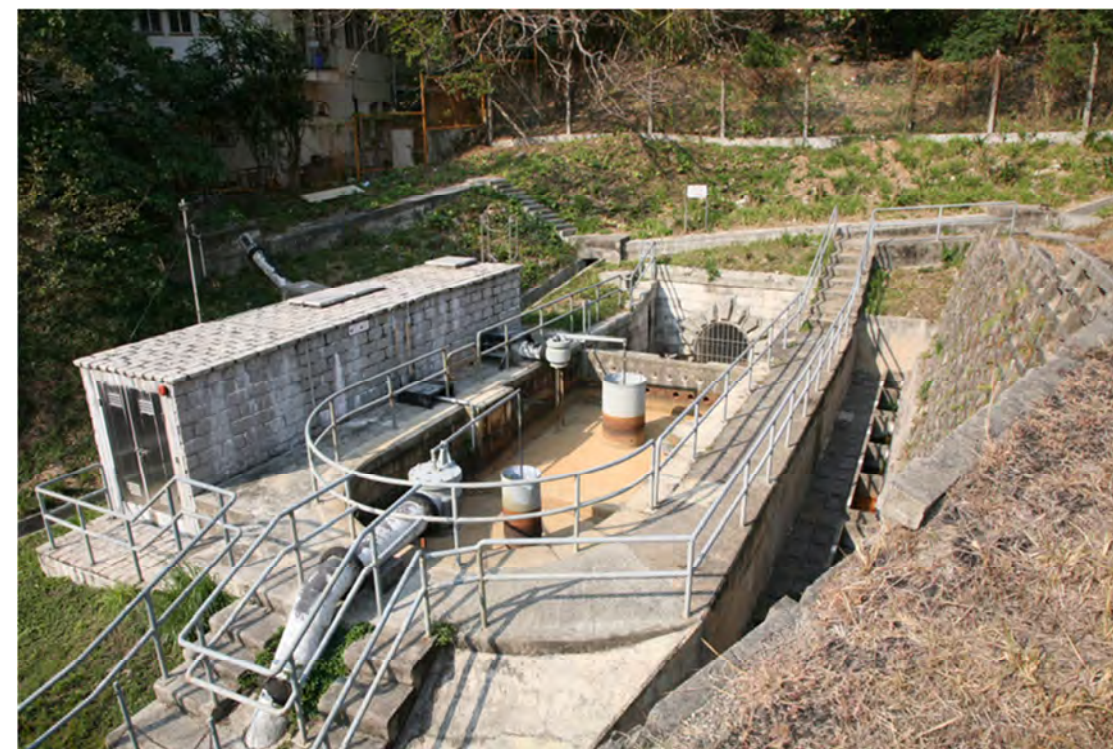
Photographic Record:

Ref. No.: BH14		
Name: Pok Fu Lam Reservoir Gauge Basin		
Location: Pok Fu Lam Reservoir Road, Pok Fu Lam, Hong Kong		
AMO Accorded Grading: Declared monument		
AMO Building Types: Waterworks		
Completion Date: 1871		
Ownership: Government		
Current User: Water Services Department		
Current Use: Gauge basin		
General Condition:		
Building Materials:		
Roof: N/A	Wall: N/A	Ex. Finishes: Granite block
Historical Appraisal: <p>Pok Fu Lam Reservoir is the oldest reservoir in Hong Kong. The construction of the Reservoir commenced in 1860 and was completed in 1871. The storage capacity of the Reservoir was limited when first built, while it was enlarged several times in later years. Prior to the erection of Tai Tam Reservoir, Pok Fu Lam Reservoir was the only reservoir providing fresh water to the Central and Western districts. The Gauge Basin, situated below the embankment, was used to monitor the flow and depth of water. Its site was the original site of the Reservoir built in 1863? to collect water from upper stream. The site was then converted to the Gauge Basin in the 1890s. The Gauge Basin, together with other Reservoir's structures, illustrated the development of water supply in Hong Kong.</p>

The Gauge Basin are situated below the dam. The structure is an elongated pit with coursed granite walls, a semi-circular end and a tunnel inlet at the other end with rock-faced rusticated voussoirs in the Italianate Renaissance style. The structure also features perforated and stepped concrete walls across the pit, tubular steel guard rails, and raised rectangular tanks with coursed granite walls. As Pok Fu Lam Reservoir is the oldest reservoir in Hong Kong, the engineering structures have built heritage value as well as being rare examples of Victorian civil engineering. There have been obvious alterations to some of the structures, but their basic authenticity remains.

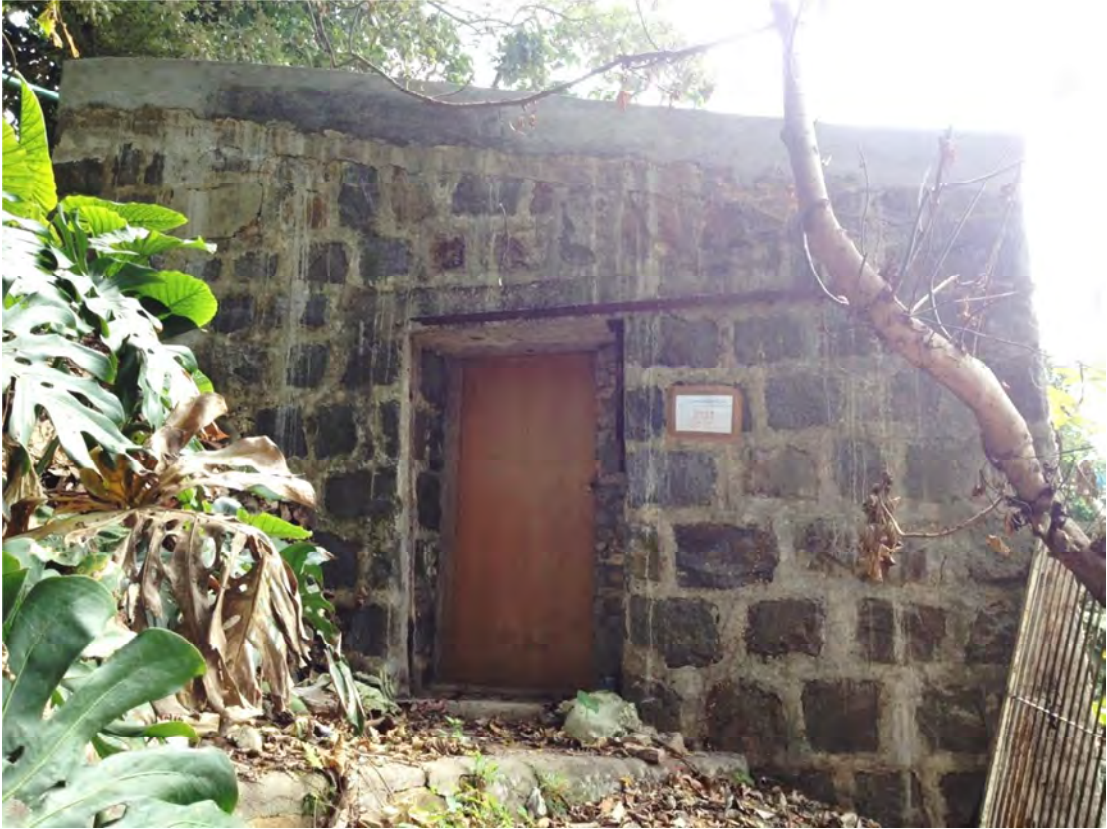
Photographic Record:

Ref. No.: DF1		
Name: Old Dairy Farm Manure Pit		
Location: Within Pok Fu Lam village		
AMO Accorded Grading: Nil		
AMO Building Types: Nil		
Completion Date: (Cannot be ascertained)		
Ownership: Private		
Current User: Private storage use		
Current Use: Store room		
General Condition: Fair with roof reconstructed		
Building Materials:		
Roof: Concrete	Wall: Granite blocks	Ex. Finishes: Fairface
Historical Appraisal: Dairy Farm was started to establish in Pok Fu Lam since 1986 to provide hygienic fresh milk to Hong Kong community. It has numerous farms, cowsheds and associated facilities spanning over the whole Pok Fu Lam. One of the major facilities of Dairy Farm was the manure pits. They were attached to every farm for the collection and storage of manure. It is believed that most of the manure pits have been demolished after the removal of Dairy Farm, while the one located at the north of Pok Fu Lam Village is the only remain of such that found to be intact. The Manure Pit, together with other Dairy Farm’s remains, serve as a reminder of the existence of Dairy Farm in Pok Fu Lam.

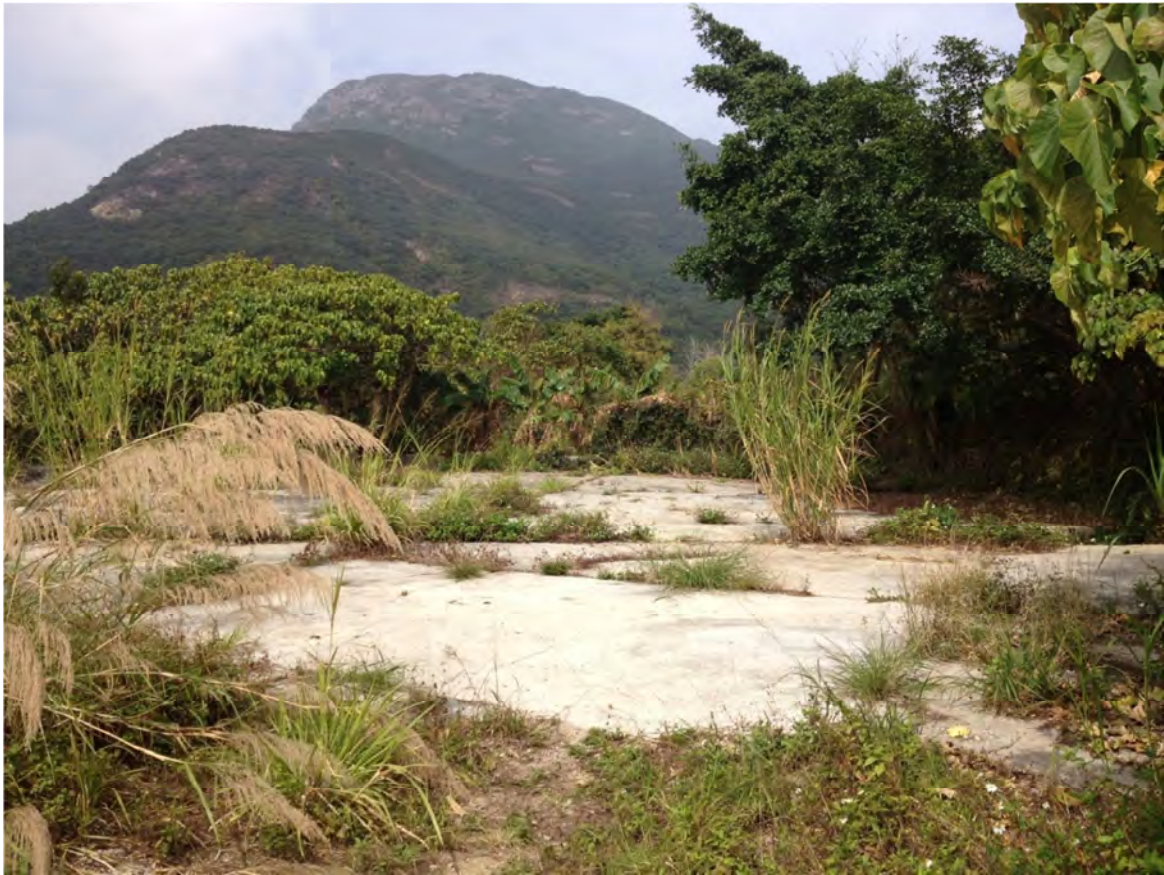
Photographic Record:

Ref. No.: DF2/3		
Name: Old Dairy Farm Paddock (Partial)		
Location: Mid level hill side of old Dairy Farm		
AMO Accorded Grading: Nil		
AMO Building Types: Nil		
Completion Date: Cannot be ascertained		
Ownership: Under the land ownership		
Current User: Nil		
Current Use: Open space		
General Condition: Poor with lack of maintenance. Wild vegetation blocks the remaining edge trimming blocks of the paddocks		
Building Materials:		
Roof: Nil	Wall: Nil	Ex. Finishes: Nil
Historical Appraisal: Dairy Farm was started to establish in Pok Fu Lam since 1986 to provide hygienic fresh milk to Hong Kong community. It has numerous farms, cowsheds and associated facilities spanning over the whole Pok Fu Lam. All the cowsheds were associated with paddocks to create some area for the cattle to do roam around, and also to protect them from injury such as snakebite or breaking of legs. Although most of the paddocks have been removed, some paddocks which located away from residential development area partially remained. The Paddocks, together with other Dairy Farm’s remains, serve as a reminder of the existence of Dairy Farm in Pok Fu Lam.

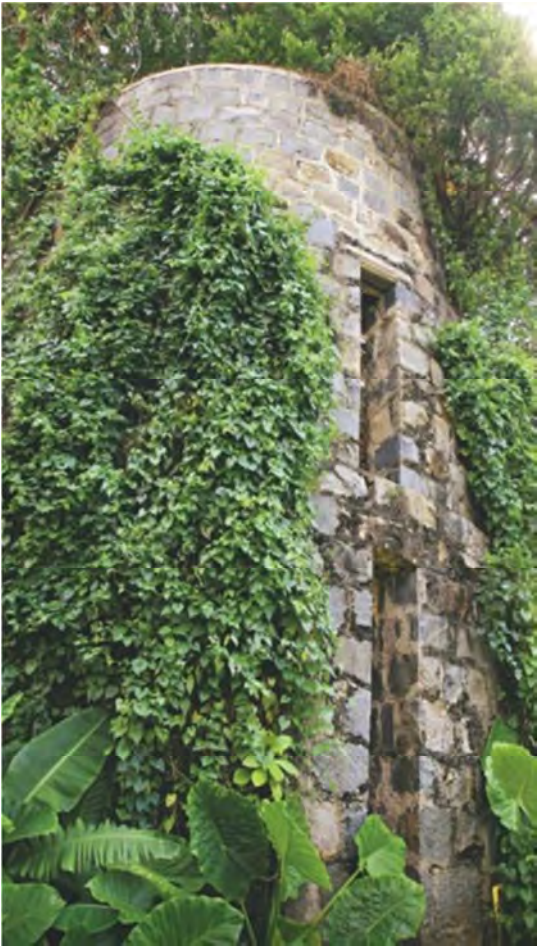
Photographic Record:

Ref. No.: DF4		
Name: Old Dairy Farm Silo		
Location: Mid level hill side of old Dairy Farm		
AMO Accorded Grading: Nil		
AMO Building Types: Industrial		
Completion Date: Cannot be ascertained		
Ownership: Private		
Current User: Private use		
Current Use: Vacant		
General Condition: Poor, with lack of maintenance. Wild vegetation blocks the access and external walls of silo		
Building Materials:		
Roof: Concrete	Wall: Granite Blocks	Ex. Finishes: Fairface
Historical Appraisal: Dairy Farm was started to establish in Pok Fu Lam since 1986 to provide hygienic fresh milk to Hong Kong community. It has numerous farms, cowsheds and associated facilities spanning over the whole Pok Fu Lam. Silos were built to convert surplus green fodder in summer into silage that to be used during winter months. They scattered over the farms at convenient centers, each had accommodation of about 100 tons silage. There were six silos built on farm at the time of 1919. It is believed that only the one located at the back of Dairy Farm Dormitories remained intact today. The Silo, together with other Dairy Farm’s remains, serve as a reminder of the existence of Dairy Farm in Pok Fu Lam.

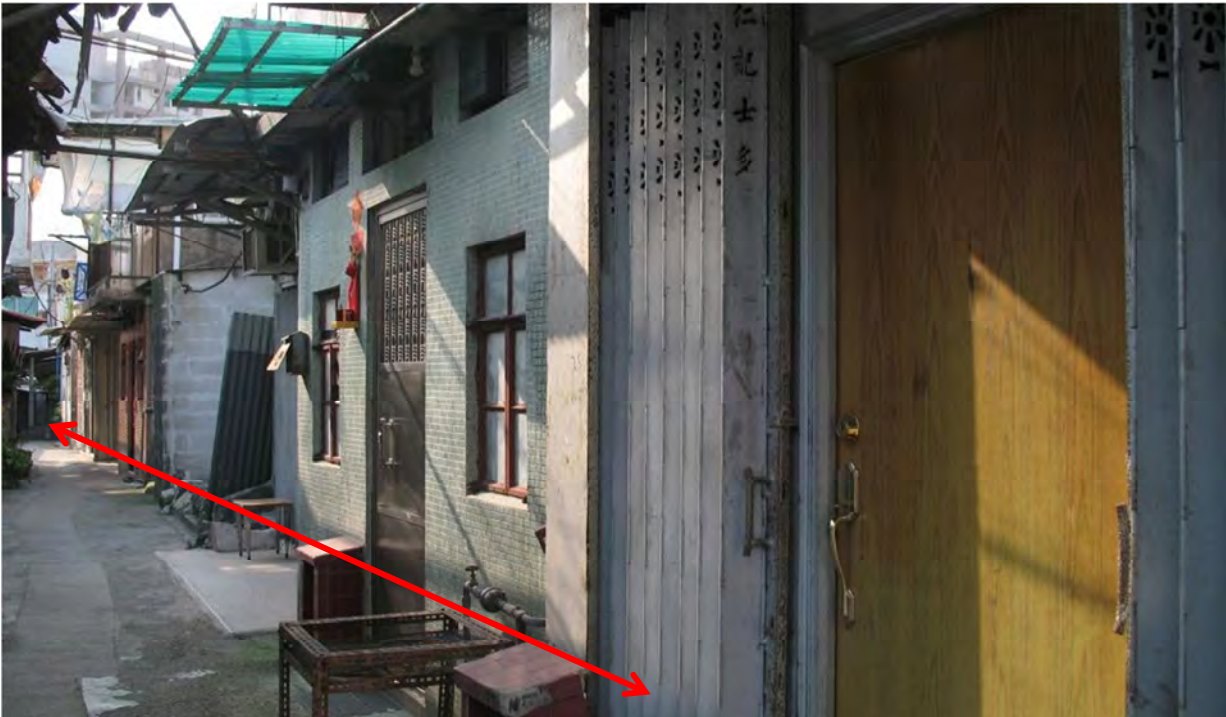
Photographic Record:

Ref. No.: OH1		
Name: No. 10 to No. 25, Pok Fu Lam Village		
Location: No. 10 to No. 25, Pok Fu Lam Village, Pok Fu Lam, Hong Kong		
AMO Accorded Grading: Nil		
AMO Building Types: Residence		
Completion Date: Circa 1870s		
Ownership: Private		
Current User: Local villagers		
Current Use: Residence		
General Condition: Fair with severe alterations		
Building Materials:		
Roof: Various materials	Wall: Bricks & concrete (mixed use)	Ex. Finishes: Various materials including mosaic tiles, render with paint
Historical Appraisal: Pok Fu Lam Village is in the southwest of Hong Kong Island. It has a history of more than 200 years. The villagers engaged in farming or worked in the nearby Dairy Farm in early years to maintain a rather sustainable community. Many houses in the Pok Fu Lam Village have been undergone reconstruction or renovation. The location of No. 10 to 25 is believed to be the earliest settlement of the Village, which housed around 20 families at first. The setting and houses arrangement is more or less retained while the buildings have been substantially altered. This row of houses reminds people of the settlement of Pok Fu Lam Village and helps to illustrate the evolution of village live.

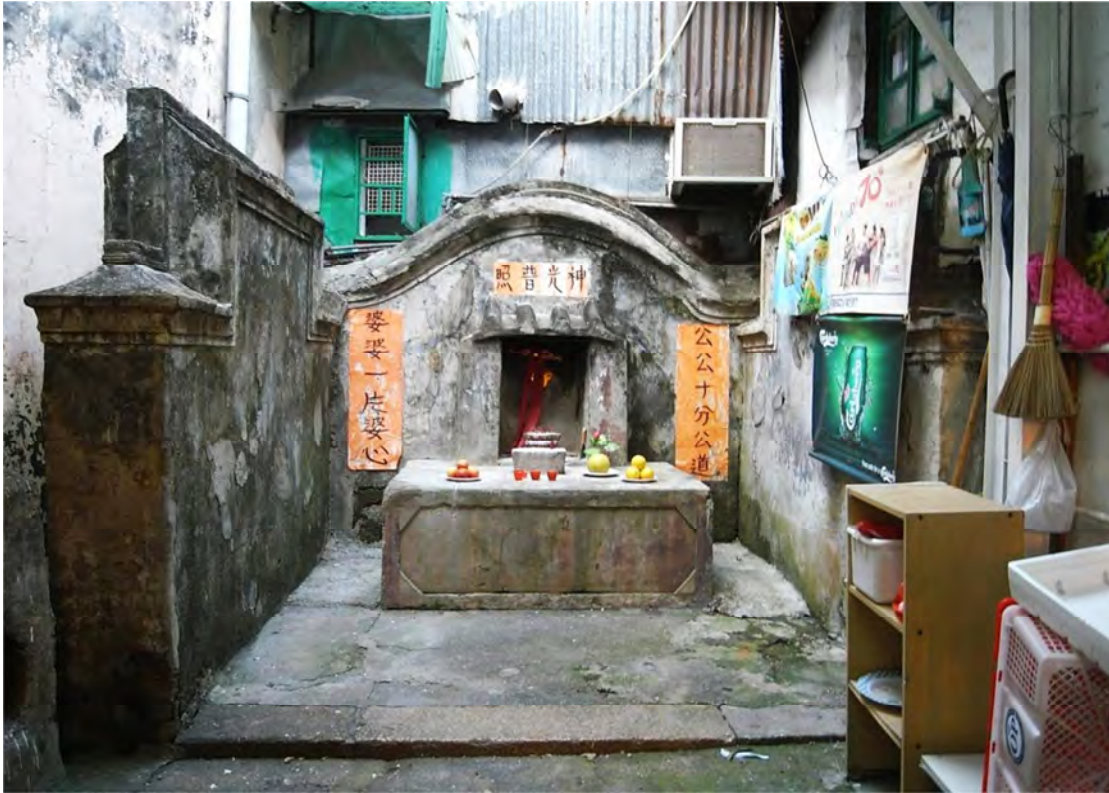
Photographic Record:

Ref. No.: OH2		
Name: God of Earth Shrine, Pok Fu Lam Village		
Location: God of Earth, Pok Fu Lam Village, Pok Fu Lam, Hong Kong		
AMO Accorded Grading: Nil		
AMO Building Types: Shrine		
Completion Date: Circa 1870s		
Ownership: Pokfulam village		
Current User: Community of Pokfulam village		
Current Use: Shrine		
General Condition: Good with some mould is found on wall of shrine		
Building Materials:		
Roof: Nil	Wall: Bricks	Ex. Finishes: Plaster rendering
Historical Appraisal: Pok Fu Lam Village is in the southwest of Hong Kong Island. It has a history of more than 200 years. The villagers engaged in farming or worked in the nearby Dairy Farm in early years to maintain a rather sustainable community. There are a total of four God of Earth Shrine in the village; the one located at the village entrance is the largest one. It is the tradition of the Chinese to worship God of Earth to pray for safety and luck. It is believed that this God of Earth Shrine is the earliest established shrine of such in Pok Fu Lam, which built by the founder of Pok Fu Lam Village. The worshipping of God of Earth Shrine is part of village’s culture and also a representation of local cultural heritage.

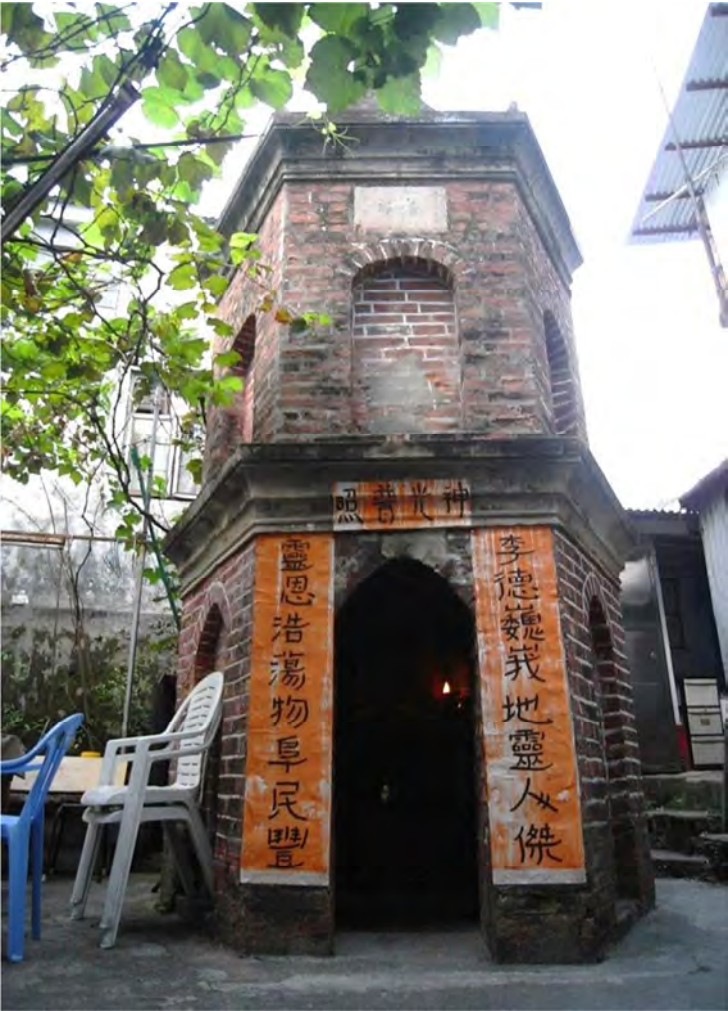
Photographic Record:

Ref. No.: OH3		
Name: Li Ling Shin Che Pagoda, Pok Fu Lam Village		
Location: Li Ling Shin Che Pagoda, Pok Fu Lam Village, Pok Fu Lam, Hong Kong		
AMO Accorded Grading: Nil		
AMO Building Types: Pagoda (religious)		
Completion Date: 1916		
Ownership: Pokfulam village		
Current User: Community of Pokfulam village		
Current Use: Religious and ceremonial use		
General Condition: Good with some mould is found on wall of shrine		
Building Materials:		
Roof: Concrete	Wall: Grey bricks	Ex. Finishes: Fairface brick
Historical Appraisal: Pok Fu Lam Village is in the southwest of Hong Kong Island. It has a history of more than 200 years. The villagers engaged in farming or worked in the nearby Dairy Farm in early years to maintain a rather sustainable community. A pagoda, which called Li Ling Shin Che Pagoda, is situated in the Pok Fu Lam Village. It was built in 1916, when a fairy Li Ling Shin Che helped to expel evils away from the Village. The Pagoda was then built by the villagers as an offer to fairy. The villagers used to have rituals on Li Ling Shin Che Festival (every 15 th April of the Chinese calendar) and special seasons. The worshipping of God of Earth Shrine is part of village’s culture and also a representation of local cultural heritage.
