Heritage Impact Assessment

Adaptive Reuse of Block M at Kowloon Hospital No.147A Argyle Street, Mong Kok, Kowloon

Contract No. 8110001199

Type: Second Draft Submission of HIA

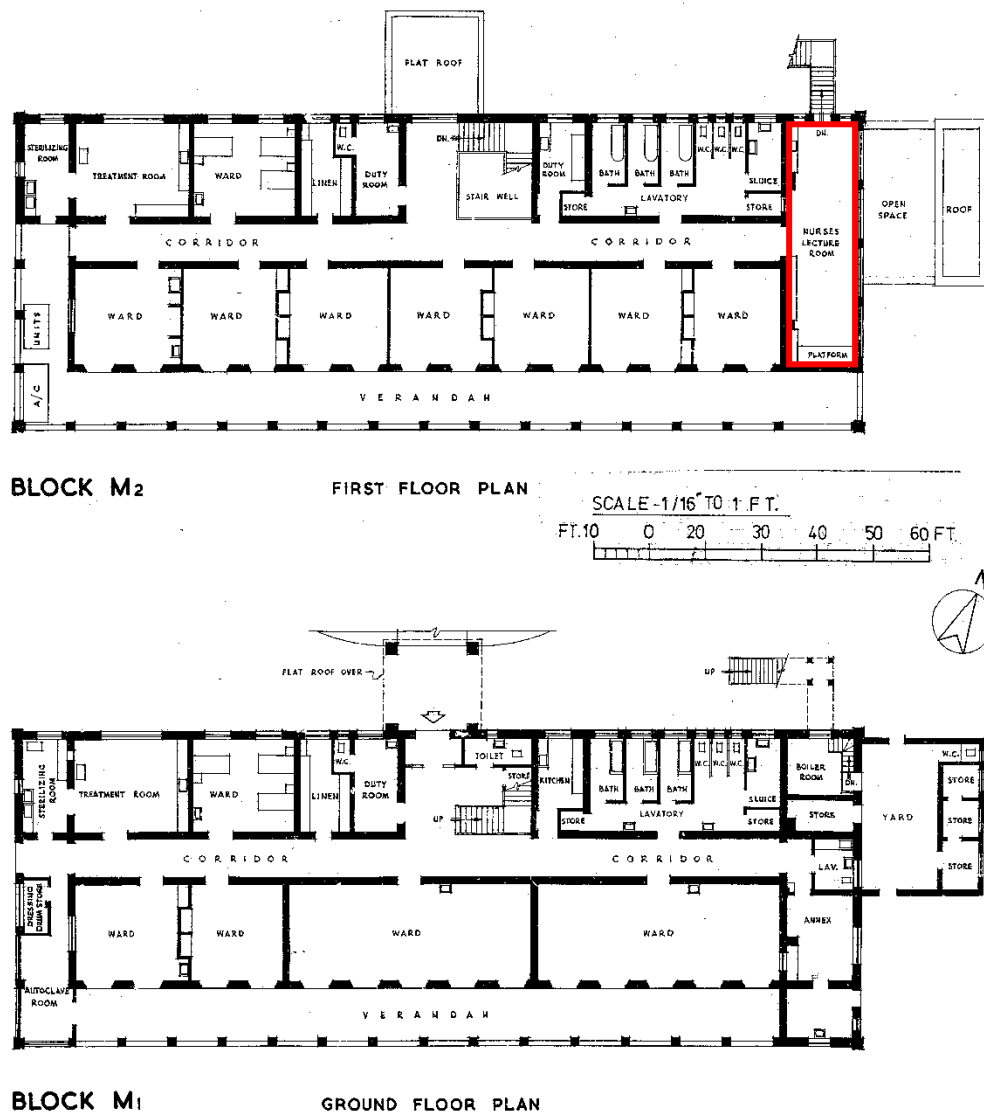
7658

Fig.7 Record Plan after 1964/5 rehabilitation. Room outlined in red was the Nurses Lecture Room. (Source: Hospital Authority, 1965)

With reference to the record plan of Block M after 1964/65 rehabilitation, the ground floor and the first floor of Block M was further divided into M1 & M2 respectively. Although the actual use of Block M after 1964 could not be ascertained, some space at the first floor had once used as ‘Nurses Lecture Room’.

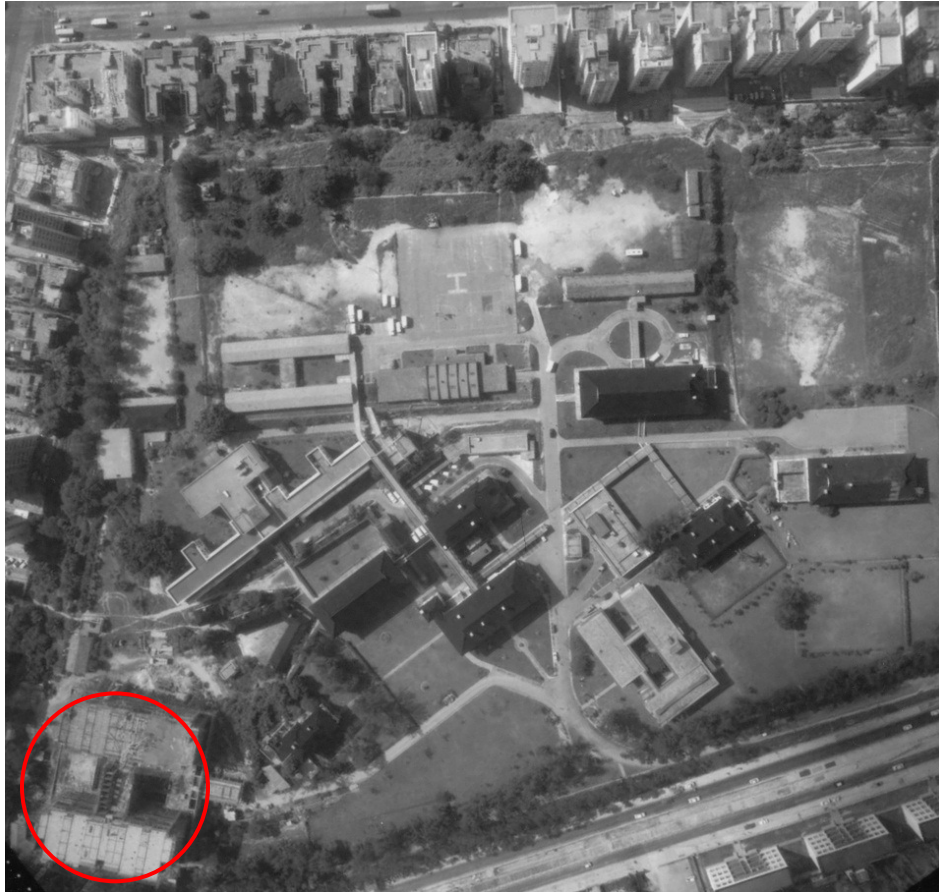
Fig.8 1969 aerial photo shows the construction of West Wing in progress. The building is relatively high comparing to the old hospital blocks. (Source: Survey and Mapping Office, 1969)

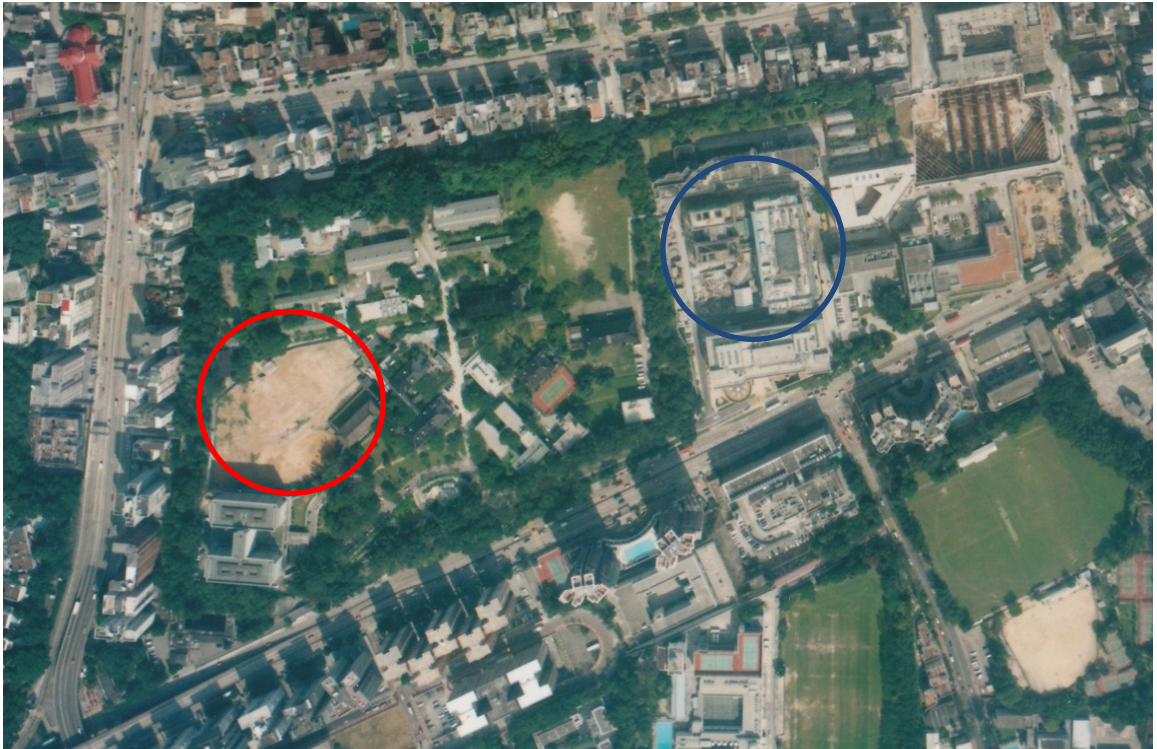
Fig.9 1998 aerial photo shows the Rehabilitation Building in completion stage (in blue circle) and the foundation of Main Building (in red circle). (Source: Survey and Mapping Office, 1998)

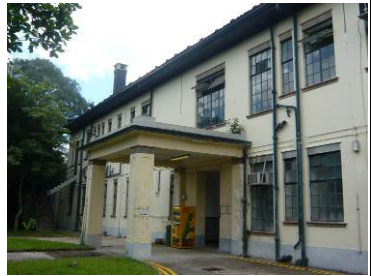
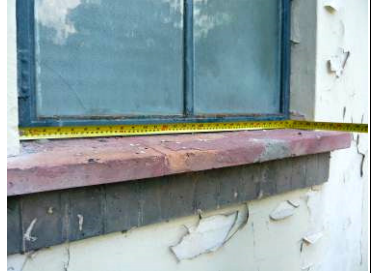
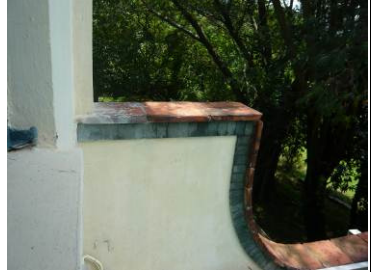
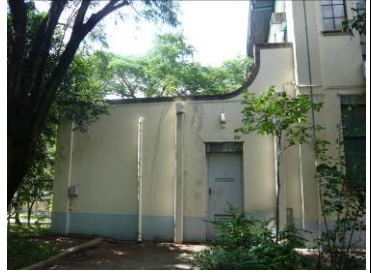
Significant Features	Levels of Significance	Photos
EXTERIOR		
North Elevation (facing Block N)		
<ul style="list-style-type: none"> ■ “Cow’s horn” curling ends to the ridge and corners of hipped and pitched roof ■ Entrance porch with square-section columns and flat cover with flat projecting eaves ■ Red tiled sill to window openings ■ Grey gauged brick and red brick trimming at window and door openings ■ Grey gauged brick trimming and red tile coping at curved parapet wall at the East end 	Exceptional

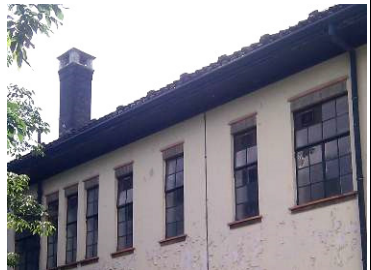
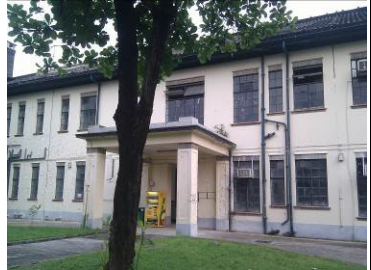
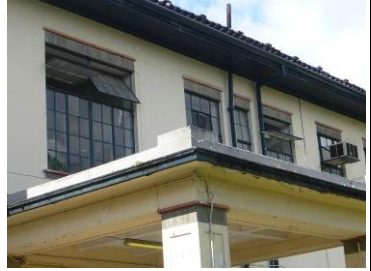
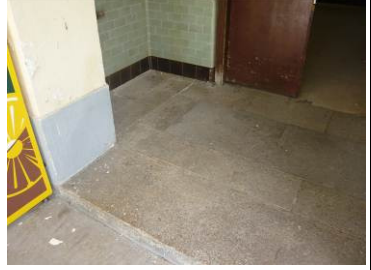
Significant Features	Levels of Significance	Photos
EXTERIOR (cont.)		
North Elevation (facing Block N) (cont.)		
<ul style="list-style-type: none"> Chimney Chinese tiled hipped and pitched roof with projecting eaves supported by ornamental brackets Rendered and painted external walls painted in cream colour with grey skirting Arrangement of window openings (rectangular) Steel framed windows painted in dark green and divided into small glazing squares Granite slab pavement at entrance porch 	High

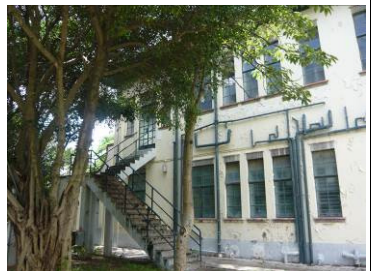
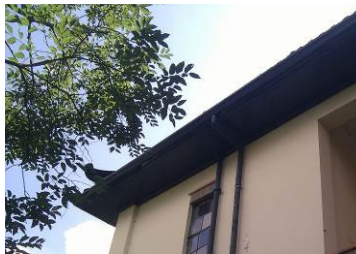
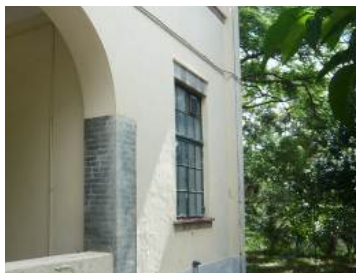
Significant Features	Levels of Significance	Photos
EXTERIOR (cont.)		
South Elevation		
<ul style="list-style-type: none"> ■ “Cow’s horn” curling ends to the ridge and corners of hipped and pitched roof ■ Open colonnaded and arcaded verandahs on the G/F and the 1/F ■ Arches with grey gauged brickwork column shaft and granite base at the verandah on the G/F ■ Granite threshold stone at the verandah on the G/F ■ Grey gauged brick and red Canton tile trimming at parapet wall of 1/F verandah ■ Red tile sill at window openings ■ Grey gauged brick and red tile trimming at window openings 	Exceptional

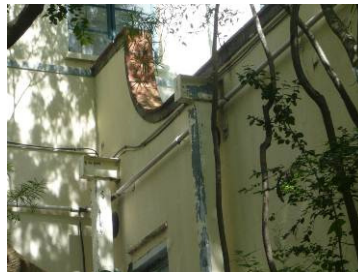
Significant Features	Levels of Significance	Photos
EXTERIOR (cont.)		
South Elevation (cont.)		
<ul style="list-style-type: none"> ■ Grey gauged brick trimming and red Canton tile trimming at parapet wall and door opening at East end 	Exceptional

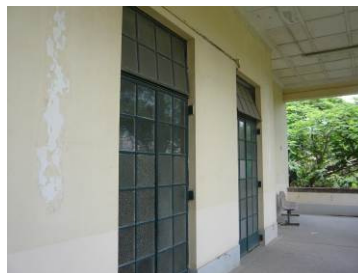
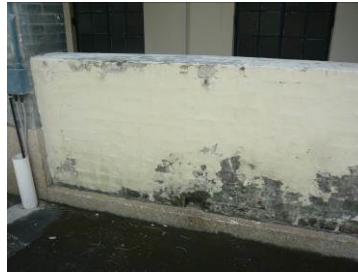
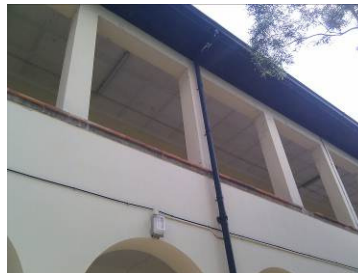
<ul style="list-style-type: none"> ■ Chimney ■ Chinese tiled hipped and pitched roof with projecting eaves supported by ornamental brackets ■ Rendered and painted external walls in cream colour with grey skirting ■ Arrangement of window and door openings ■ Steel framed glass window and doors painted in dark green and divided into small glazing squares ■ Use of obscured and patterned glass at lower portion of glass doors ■ Use of transparent glass at upper portion of windows ■ Painted and plastered brick parapet wall at G/F verandah 	High

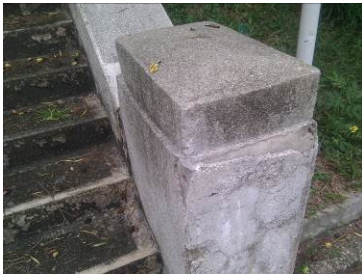
Significant Features	Levels of Significance	Photos
EXTERIOR (cont.)		
South Elevation (cont.)		
<ul style="list-style-type: none"> External staircase with Shanghai plaster parapet wall 	High

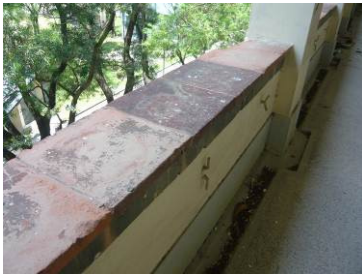
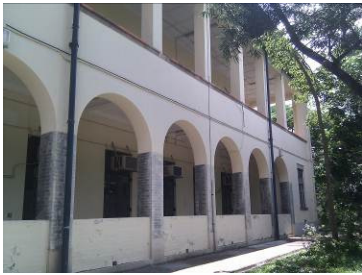
<ul style="list-style-type: none"> Metal hooks for securing stings of blinds at parapet wall of 1/F verandah Gutters drained by exposed cast iron rainwater downpipes 	Moderate

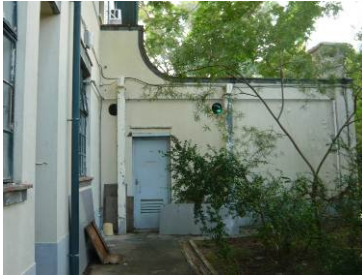
<ul style="list-style-type: none"> Steel columns acting as structural reinforcement 	Intrusive

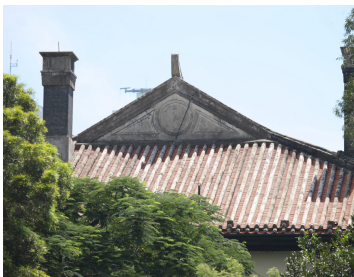
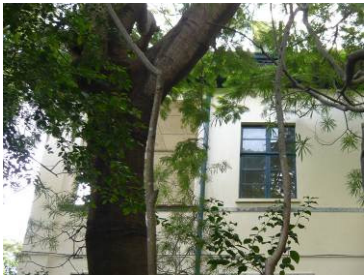
Significant Features	Levels of Significance	Photos
EXTERIOR		
East Elevation		
<ul style="list-style-type: none"> ■ “Cow’s horn” curling ends to the ridge and corners of hipped and pitched roof ■ Circle motif at the triangular vertical surface ■ Red brick sill to window openings ■ Grey gauged brick and red tile trimming at window openings ■ Open colonnaded and arcaded verandahs on the 1/F 	Exceptional

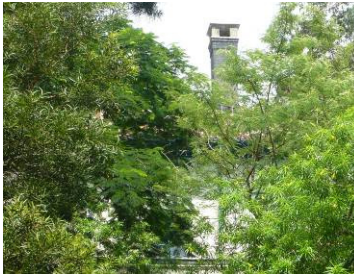
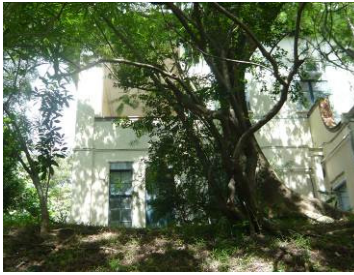
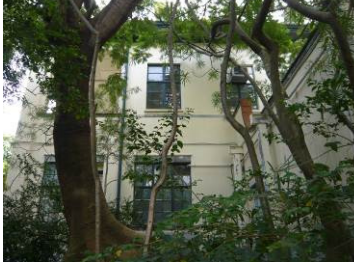
<ul style="list-style-type: none"> ■ Chinese tiled hipped and pitched roof with projecting eaves supported by ornamental brackets ■ Chimney ■ Rendered and painted external walls in cream colour with grey skirting ■ Arrangement of window openings ■ Steel framed windows (rectangular) painted in dark green and divided into small glazing squares ■ Use of obscured and patterned glass at lower portion of windows ■ Use of transparent glass at upper portion of windows 	High

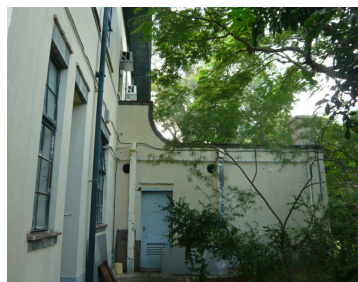
Significant Features	Levels of Significance	Photos
EXTERIOR (cont.)		
East Elevation (cont.)		
<ul style="list-style-type: none"> Gutters drained by exposed cast iron rainwater downpipes 	Moderate

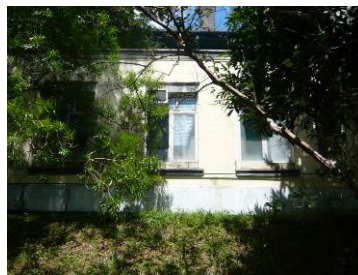
<ul style="list-style-type: none"> Aluminium windows at the East end on the G/F, installed when the portion was used as overnight room. 	Low

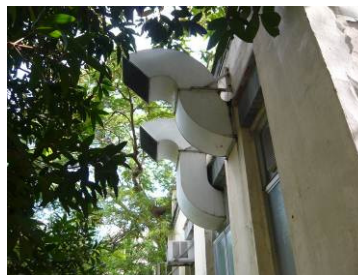
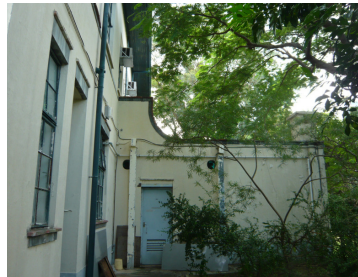
<ul style="list-style-type: none"> Exhaust duct hoods Reinforcement steel I-beams Steel columns acting as structural reinforcement 	Intrusive

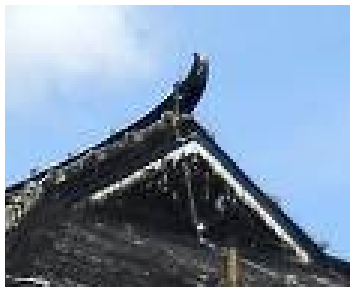
Significant Features	Levels of Significance	Photos
EXTERIOR (cont.)		
West Elevation		
<ul style="list-style-type: none"> ■ “Cow’s horn” curling ends to the ridge and corners of hipped and pitched roof ■ Circle motif at the triangular vertical surface of roof ■ Red tile sill to window openings ■ Grey gauged brick and red tile trimming at window openings 	Exceptional

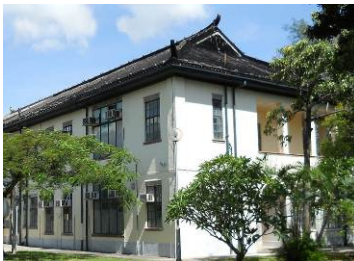
<ul style="list-style-type: none"> ■ Chinese tiled hipped and pitched roof with projecting eaves supported by ornamental brackets 	High

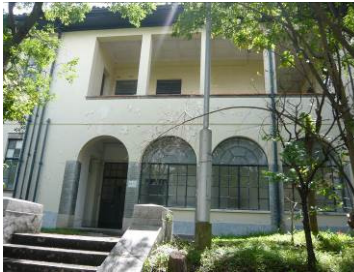
<ul style="list-style-type: none"> ■ Open colonnaded and arcaded verandahs on the 1/F ■ Arches with grey gauged brickwork column shaft and granite base at the verandah on the G/F ■ Arrangement of archway and window openings ■ Rendered and painted external walls in cream colour with grey skirting

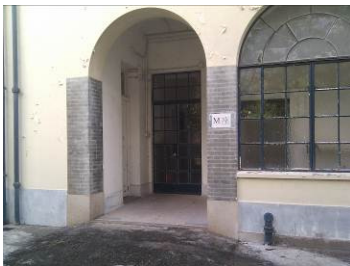
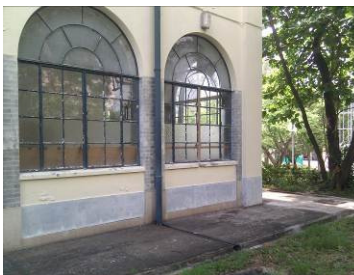
<ul style="list-style-type: none"> ■ Steel framed windows (rectangular and arched windows) painted in dark green and divided into small glazing squares ■ Use of obscured and patterned glass at lower portion of windows ■ Use of transparent glass at upper portion of windows

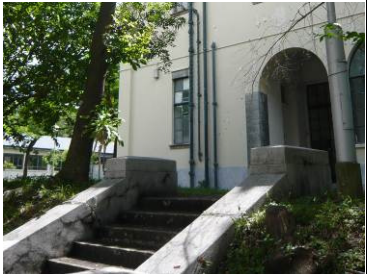
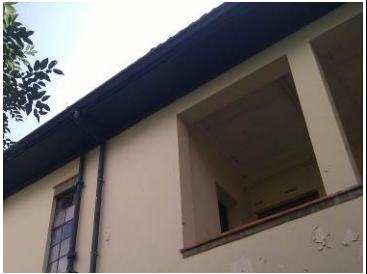
Significant Features	Levels of Significance	Photos
EXTERIOR (cont.)		
West Elevation (cont.)		
<ul style="list-style-type: none"> External staircase with Shanghai plaster parapet wall White timber false ceiling in grid at verandah on 1/F

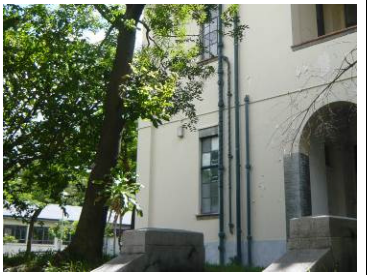
<ul style="list-style-type: none"> Gutters drained by exposed cast iron rainwater downpipes 	Moderate

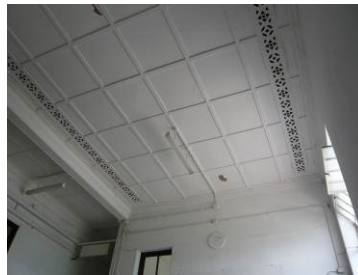
Significant Features	Levels of Significance	Photos
INTERIOR		
Ceiling, Entrance Lobby, Grand Staircase and Corridor		
<ul style="list-style-type: none"> White painted false ceiling in grid with ventilation holes above grand staircase and all of the rooms on the 1/F 	Exceptional

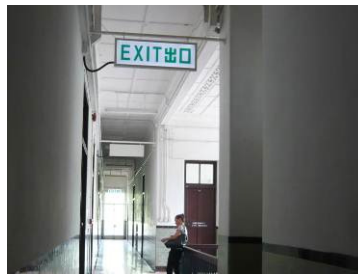
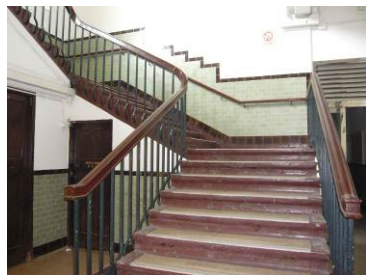
<ul style="list-style-type: none"> Timber false ceiling painted in white on the 1/F Decorative plastered moulding at edges of timber false ceiling on the 1/F Curved corned ceiling on the G/F Grand staircase with metal railing and timber coping, and circular timber railing. 	High

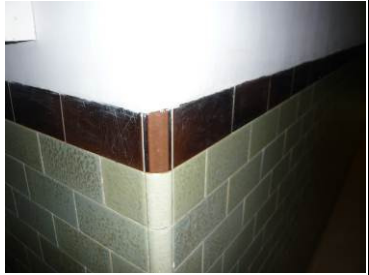
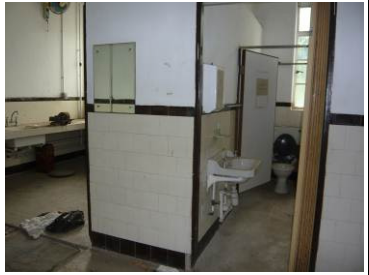
Significant Features	Levels of Significance	Photos
INTERIOR (cont.)		
Wall Finishes		
<ul style="list-style-type: none"> Ceramic wall tiles of brown and tinted green colours in public area, and of ivory and black colours in wet zones 	High

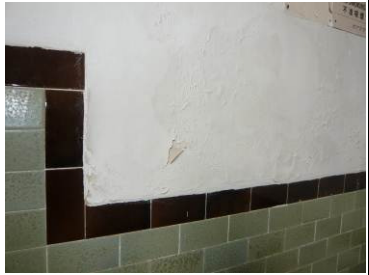
<ul style="list-style-type: none"> Emulsion paint in white 	Moderate

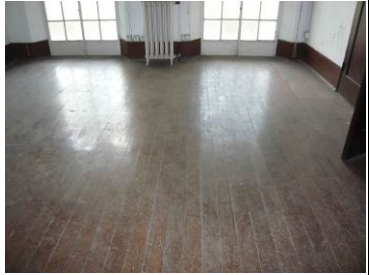
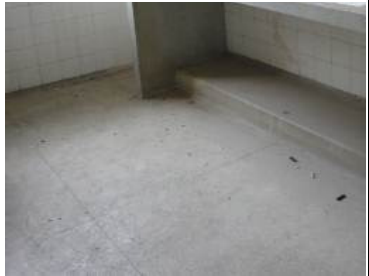
Floor Finishes		
<ul style="list-style-type: none"> Old timber flooring in ward zones with plaster skirting painted in dark brown Terrazzo flooring in wet zones and public area 	High

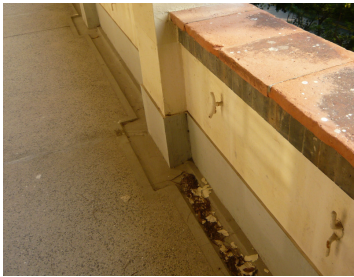
Significant Features	Levels of Significance	Photos
INTERIOR (cont.)		
Floor Finishes (cont.)		
<ul style="list-style-type: none"> ■ Granolithic floor finish at verandahs 	High

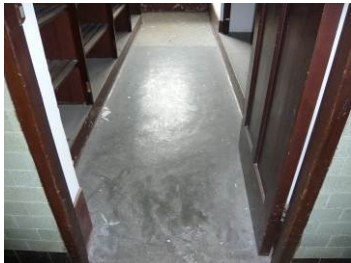
<ul style="list-style-type: none"> ■ Cement sand flooring in the interior 	Moderate

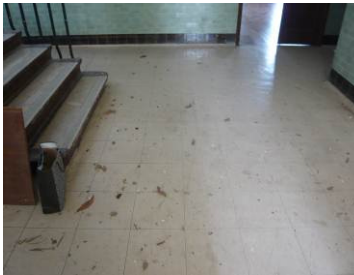
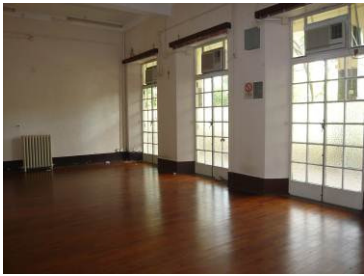
<ul style="list-style-type: none"> ■ Vinyl flooring in tiles or roll form ■ New timber flooring 	Low

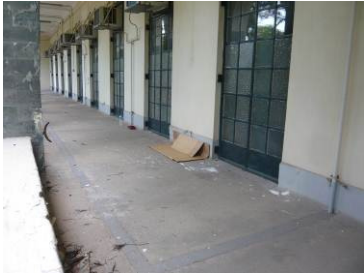
<ul style="list-style-type: none"> ■ Tiles to pave the intervened floor for condensate pipes at verandahs 	Intrusive

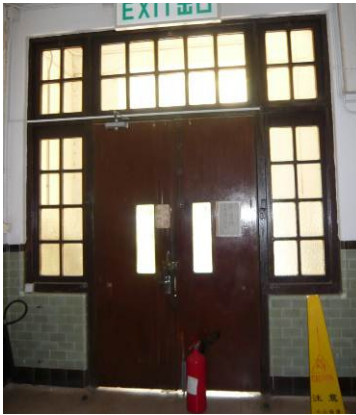
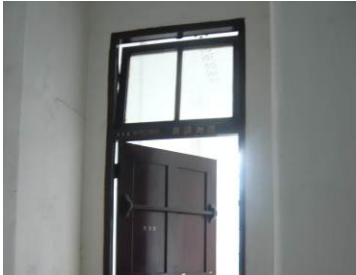
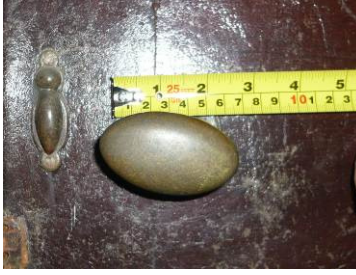
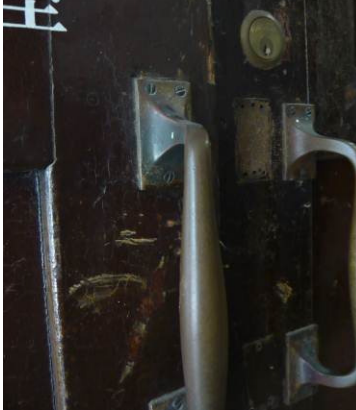
Significant Features	Levels of Significance	Photos
INTERIOR (cont.)		
DOOR		
<ul style="list-style-type: none"> ■ Timber doors painted in brown (except modern ones e.g. main entrance doors) and associate windows and accessories ■ Fanlights (pivoted ventilation glass panels or fixed timber framed glass panel) above door openings ■ Ironmongery of doors (except modern ones) 	High

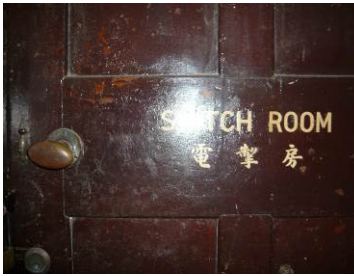
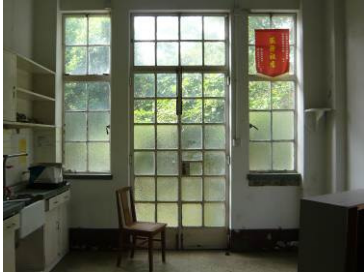
Significant Features	Levels of Significance	Photos
INTERIOR (cont.)		
Doors (cont.)		
<ul style="list-style-type: none"> ■ Lettering (in Chinese and in English) painted on timber doors indicating the room nos. and past functions ■ Steel frames of glass doors painted in white ■ Use of clear glass at upper, and patterned and obscured glass and lower portion 	High

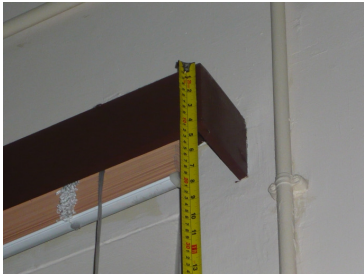
<ul style="list-style-type: none"> ■ Curtain pelmet 	Moderate

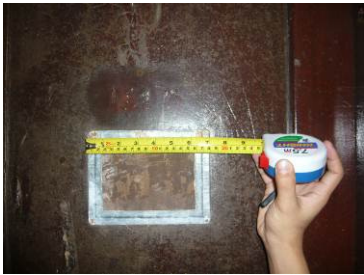
<ul style="list-style-type: none"> ■ Name card slot 	Low

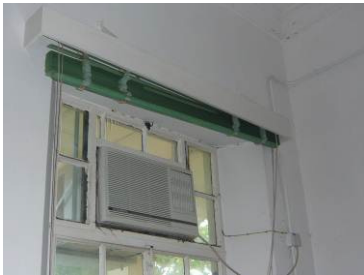
<ul style="list-style-type: none"> ■ Air-conditioners 	Intrusive

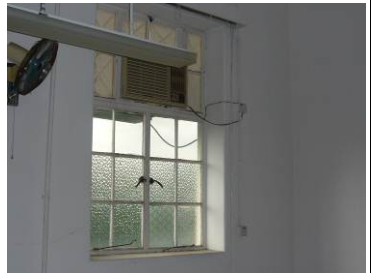
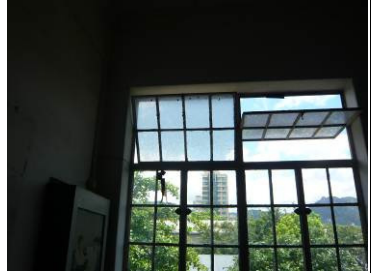
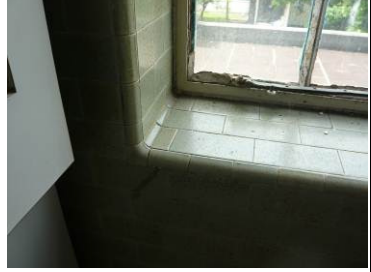
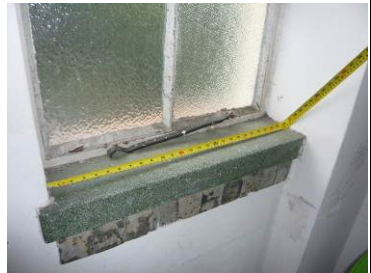
Significant Features	Levels of Significance	Photos
INTERIOR (cont.)		
Windows		
<ul style="list-style-type: none"> Steel frames of glass doors painted in white Use of clear glass at upper, and patterned and obscured glass and lower portion Side hung and pivoted windows Ironmongery (except modern ones) Curved edges of wall openings for windows Green terrazzo window sill with grey brick trimming 	High

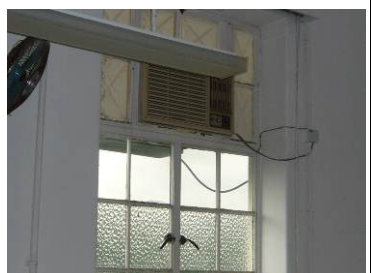
<ul style="list-style-type: none"> Air-conditioners 	Intrusive

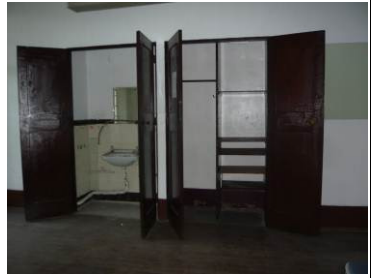
Significant Features	Levels of Significance	Photos
INTERIOR (cont.)		
Others		
<ul style="list-style-type: none"> Wardrobe and wash basin cupboards 	High

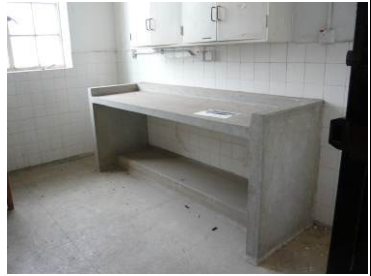
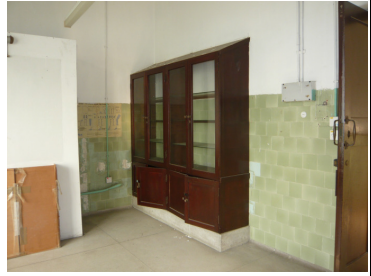
<ul style="list-style-type: none"> Terrazzo working bench at Room 113 Cupboards at Room 108, former delivery room on the 1/F 	Moderate

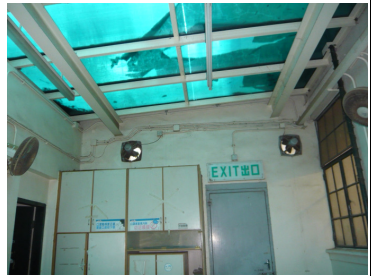
<ul style="list-style-type: none"> Skylight covering the original yard at East end 	Intrusive

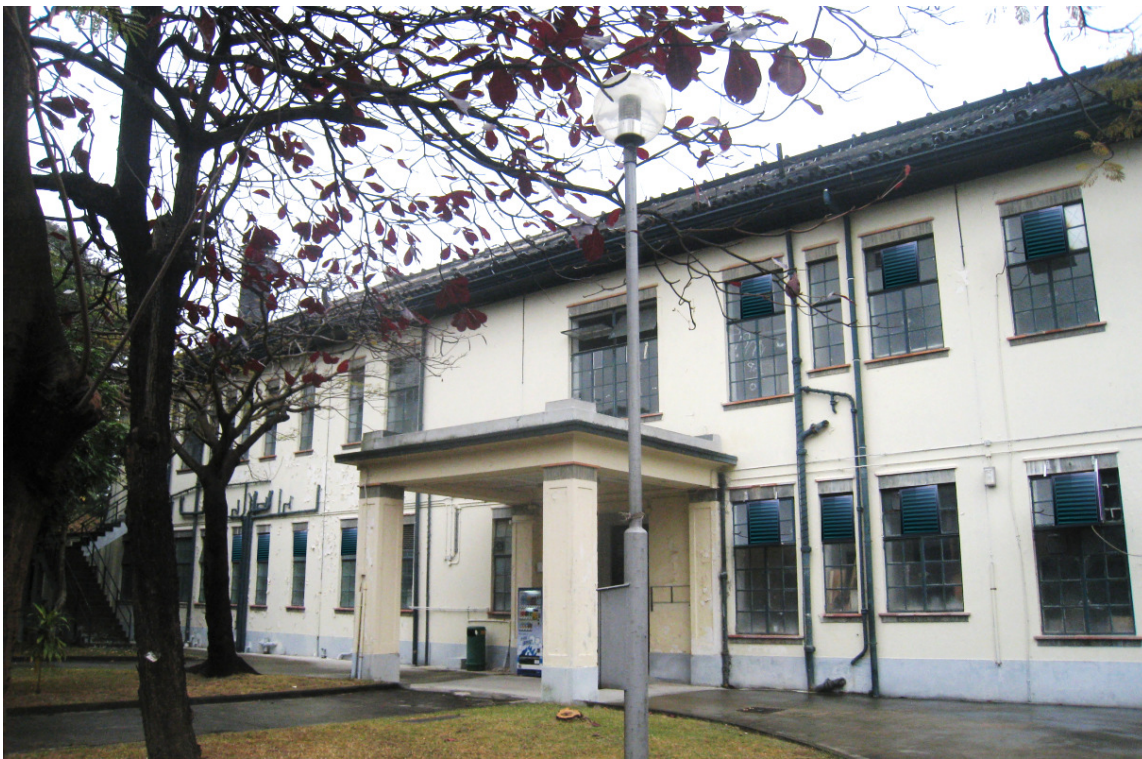
PERSPECTIVE 1
Artist impression of the restored façade
with new louvres for the new air-conditioning system

<u>New MVAC system</u> A new VRV system coupled with outdoor units would be installed to replace existing window type AC units and exhaust fans. (Please refer DWG-03, and PERSPECTIVE 1)	To enhance the performance of air-conditioning system and reduce energy consumption	<ul style="list-style-type: none"> ■ Windows and doors would retrieve its original appearance with A/C and exhaust fans removed ■ New outdoor units would be placed at the open area to the east end, and the reinstated open yard at the east end ■ New openings would be made at existing internal walls for the penetration of new MVAC ducts ■ New louvres at external walls for fresh air intake 	<ul style="list-style-type: none"> ■ New MVAC ducts to go through new openings of partitioning walls that are at a level higher than fanlights of doors, and covered by new false ceiling ■ New false ceiling would be installed to hide new MVAC ducts ■ Provide visual barrier to cover the outdoor units at the east end when space allows 	Beneficial	-

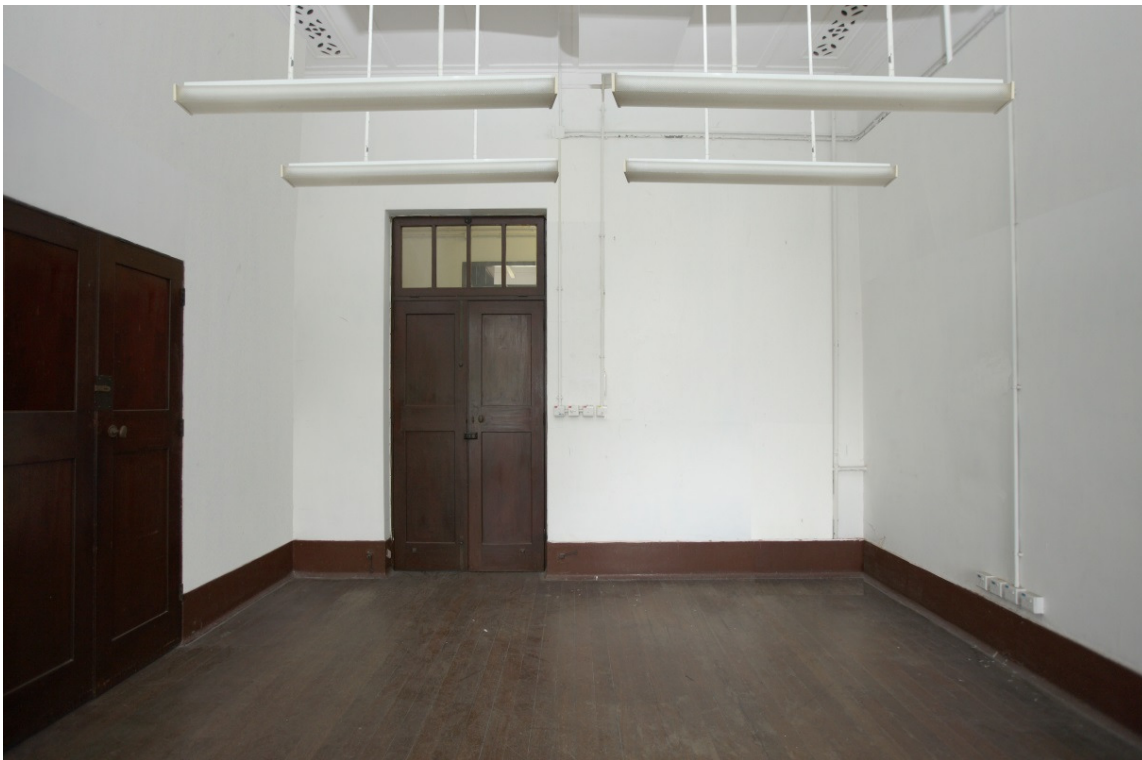
PERSPECTIVE 2
Artist impression of the preserved delivery room on
the G/F

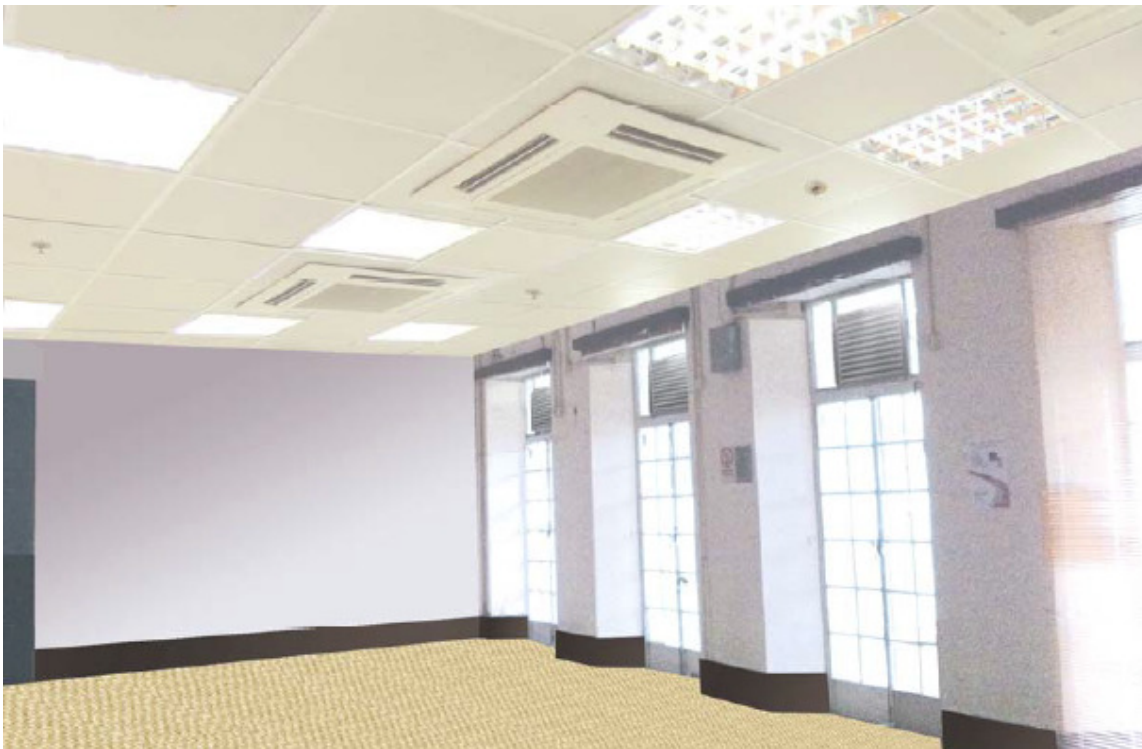
PERSPECTIVE 4
Artist impression of one the training rooms on the
G/F with the new false ceiling maintaining at 3.4m
from the floor level

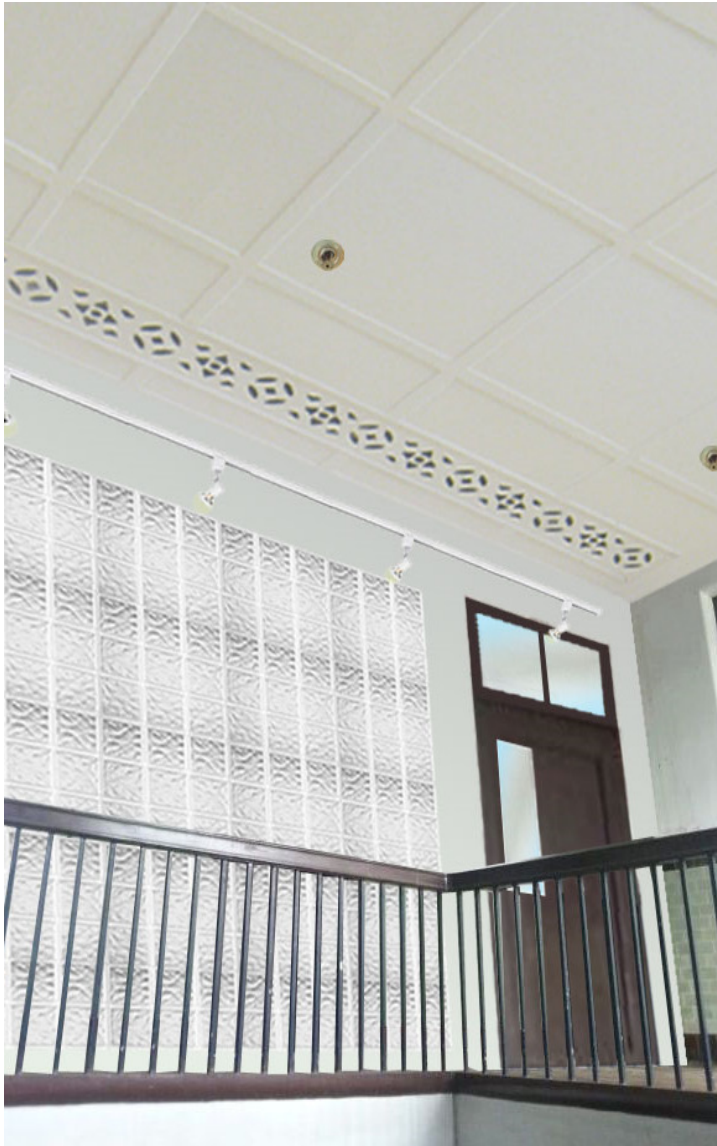
PERSPECTIVE 5
Artist impression of the new fire rated glass block
wall at the 1/F landing of the grand staircase
