## Heritage Impact Assessment

in respect of the Block 3 at Old Lei Yue Mun Barracks

Architectural Services Department

**September 2016**

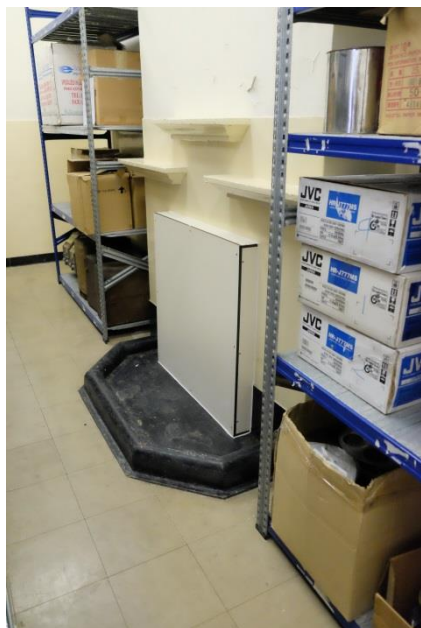
Fireplace on 1/F before it is opened up

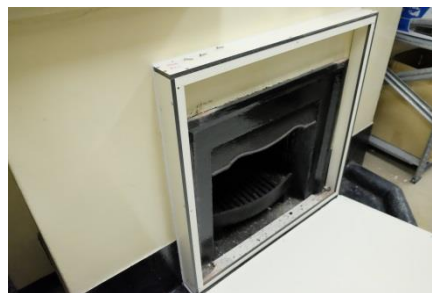
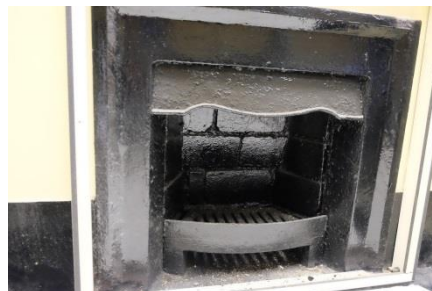
Fireplace on 1/F after it is opened up

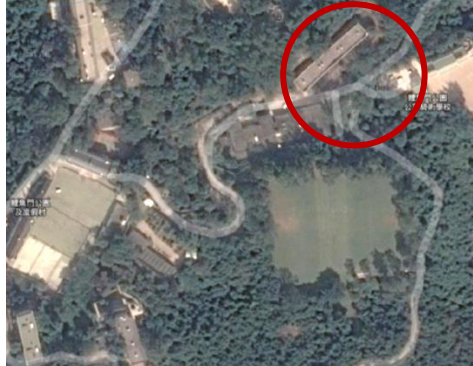
No.	CDE	Level of Significance	Photo	Location
E-01	<p>Long rectangular layout of the block</p> <ul style="list-style-type: none"> <li>- The long rectangular layout is typical for barrack block arrangement</li> <li>- Simple and clarified rectangular building form.</li> </ul>	<p>High</p> <ul style="list-style-type: none"> <li>- It is an example of typical military barrack blocks</li> <li>- Simple and clarified rectangular building form</li> <li>- Typical international modern style</li> </ul>

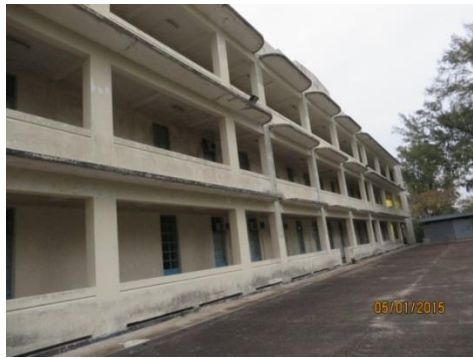
<p>Site Plan</p>
E-02	<p>The Symmetrical elevation of the block</p>	<p>High</p> <ul style="list-style-type: none"> <li>- Prominent feature contributing to the original configuration of the typical International Modern style</li> </ul>

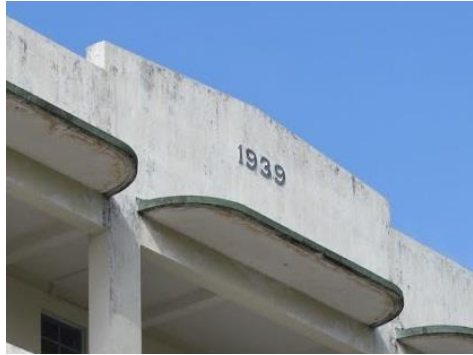
No.	CDE	Level of Significance	Photo	Location
E-03	Stepped “ziggurat” shaped parapet wall on the crown of the front façade with the lettering of the construction year “1939”	High <ul style="list-style-type: none"> <li>- The shaped characters recording the year of the construction of the block</li> </ul>

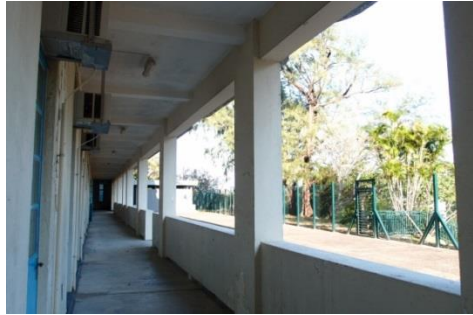
No.	CDE	Level of Significance	Photo	Location
E-05	<p>Concrete verandahs along the front and rear elevations</p> <ul style="list-style-type: none"> <li>- The verandahs were designed to act as weather protective shelters. The Royal Engineers adopted the standard designs to suit the diverse climatic regions of individual colonies and this has become an early form of what is now termed “environmental design”</li> <li>- Functional and pragmatic approach to avoid direct sunlight on the walls</li> </ul>	<p>High</p> <ul style="list-style-type: none"> <li>- Major contributor to the original spatial configuration of military barracks</li> <li>- Feature having regard both to the internal occupation and to the local and climatic conditions</li> <li>- Functional and pragmatic approach to avoid direct sunlight on the walls</li> </ul>

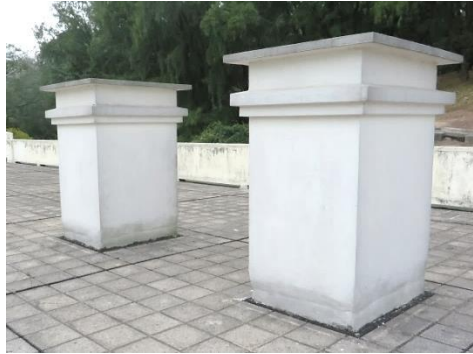
<p>First Floor Plan</p>
E-06	<p>Original brick built Chimney stacks on the roof</p>	<p>High</p> <ul style="list-style-type: none"> <li>- Evidence of the original daily living requirements of military barracks</li> <li>- Feature having regard both to the internal occupation and to the local and climatic conditions</li> </ul>

- Addition of lift shafts on the roof top.
- Preserve and repair all existing chimneys and cat ladder access on the roof top.

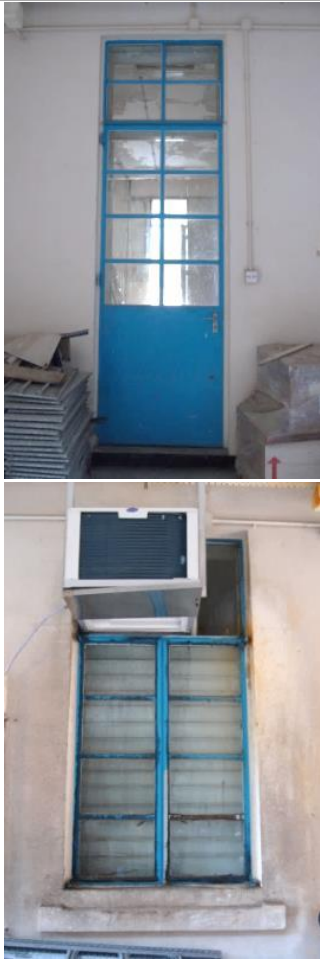
No.	CDE	Level of Significance	Photo	Location
E-07	<p>Metal door and window and their grid-like openings on the facade</p> <ul style="list-style-type: none"><li>- The door and window openings on both front and rear facades forming a uniform grid like pattern.</li><li>- According to the record plan and ironmongery schedule from ArchSD, the current doors and windows were later altered in 1972.</li></ul>	<p>High</p> <ul style="list-style-type: none"><li>- Major contributor to the original room arrangement and architectural style of the block</li></ul>

\* Replacer all windows and doors to match with existing

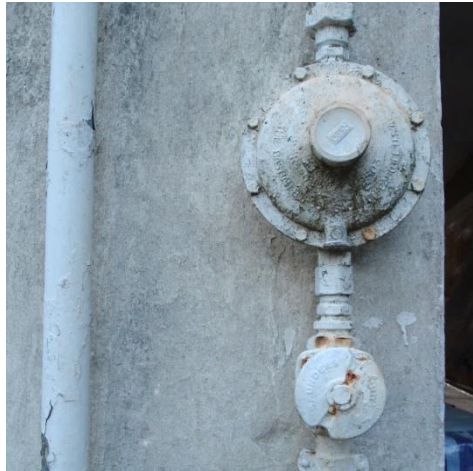
<p>Cut Sheet of the 2503 Series regulator</p>

No.	CDE	Level of Significance	Photo	Location
E-08	<p>Gas regulator</p> <ul style="list-style-type: none"> <li>- An obsolete 2503 Series LP-Gas regulator manufactured by the Bastian-Blessing Company of Chicago, IL USA in 1960s to deliver liquid petroleum gas to the heaters on first floor, which were installed when the block being used as the interim accommodation for the 5th Battalion in 1981.</li> </ul>	<p>Moderate</p> <ul style="list-style-type: none"> <li>- Evidence of the later alteration to the block and the use of LP-Gas in the past</li> </ul>

Building facade	Low	Nil	<ul style="list-style-type: none"> <li>- Make good and keep the gas regulators which have fallen out of use at their original locations for demonstrating the building service equipment in the past.</li> <li>-</li> </ul>

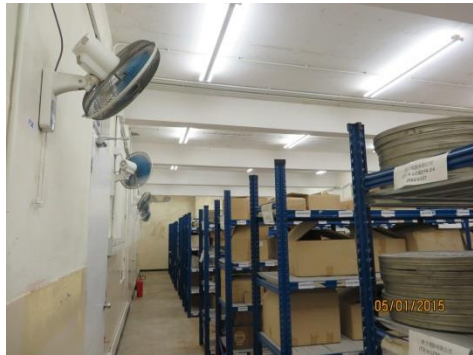
<p>First Floor Plan</p>
I-02	<p>Internal layout</p> <ul style="list-style-type: none"> <li>- The original record plan could not be found but the internal layout has been altered many times according to the record drawings found on 1972 and 1981.</li> </ul>	<p>Low</p> <ul style="list-style-type: none"> <li>- Evidence of the later alteration and change of use of the building</li> <li>- Visual expression of structure</li> </ul>

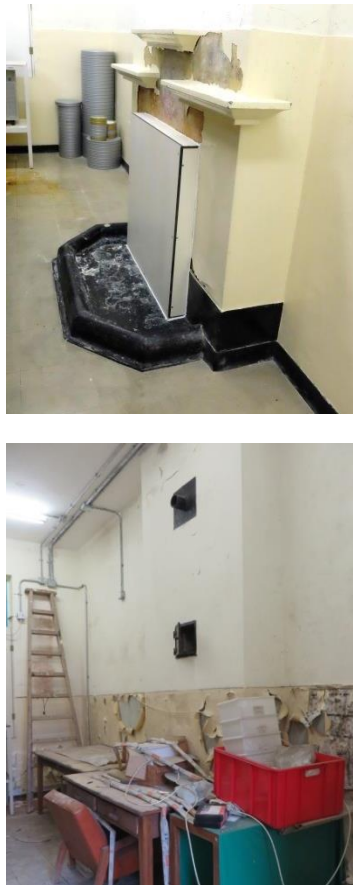
<p>First Floor Plan (Chimney at Room 107)</p>

No.	CDE	Level of Significance	Photo	Location Plan
I-03	<p>Fireplaces and chimney stacks</p> <ul style="list-style-type: none"> <li>- Edwardian fireplaces with chamfered hearth and round curb reflecting the influence of Art Deco aesthetics. Such type of fireplaces use coal as the source of fuel in the 1900s, as coal was considerably less expensive<sup>6</sup> than other available alternatives such as electrical or gas heating.</li> <li>- No fireplace was found in Rm108 on first floor. Instead there are two holes (one with cast iron door) on the wall of the chimney possibly for connection to a kitchen stove for cooking, oven and warmth.</li> <li>- Fireplaces on first floor and one fireplace on ground floor (room G03) are covered up by plywood.</li> </ul>	High

Fireplace hearths could be found on ground floor and second floor plan indicating the existence of fireplaces in the past. No fireplace was left in the current second floor. Only 1 no. on ground floor and 8 nos. on the first floor still remain. It is believed that some fireplaces were removed or blocked during the alteration works in 1978.

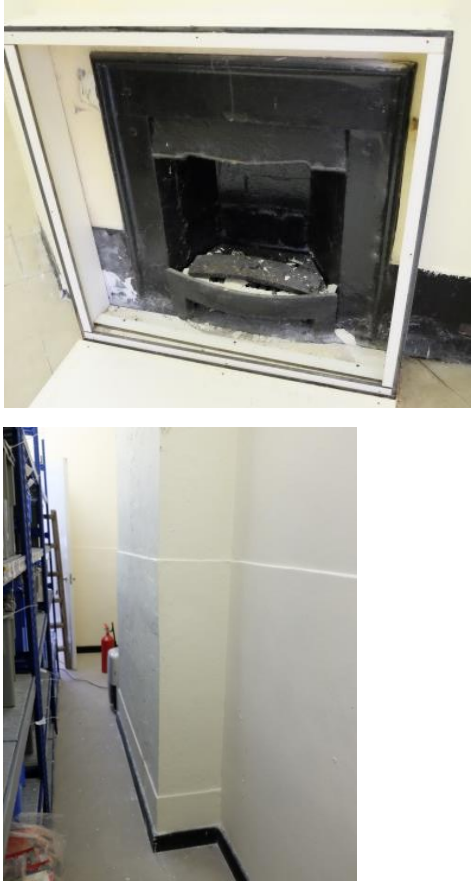
<p>Chimney at Room 215</p></div>

No.	CDE	Level of Significance	Photo	Location Plan
	<p>The rest of the fireplaces on ground floor and second floor were blocked. Further investigate is needed to be carried out by carefully opening up the wall.</p>

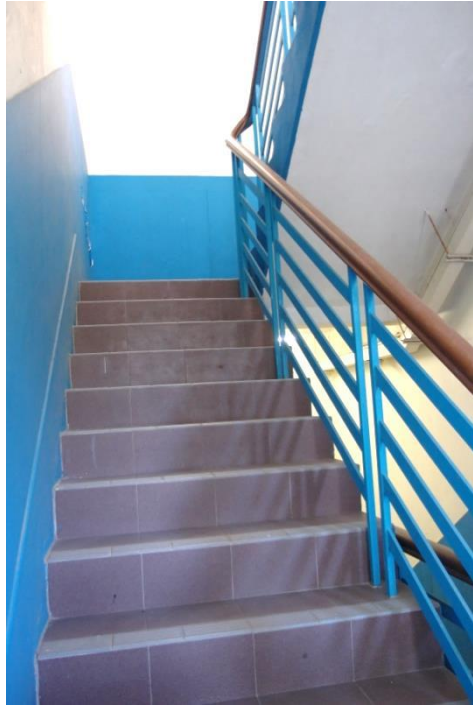
<p>Western Staircase</p>

No.	CDE	Level of Significance	Photo	Location Plan
I-04	<p>Staircases and handrails</p> <ul style="list-style-type: none"> <li>- The current staircases at both ends of the block are finished with ceramic tiles paved in the past decades. According to a record plan from ArchSD, the staircases were paved with terrazzo in 1972. Handrails are also believed to have been altered in the past.</li> </ul>	<p>Moderate</p> <ul style="list-style-type: none"> <li>- Features reflecting the functional design of the block</li> </ul>

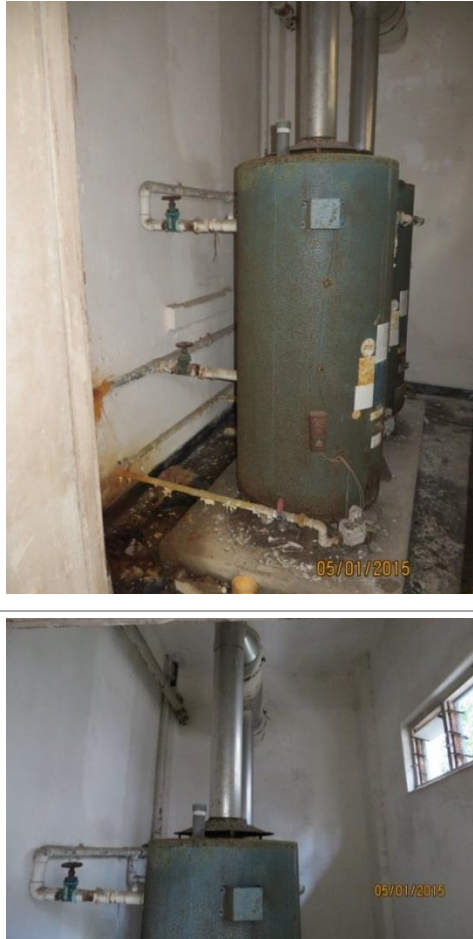
No.	CDE	Level of Significance	Photo	Location Plan
I-05	<p>Water Heaters</p> <ul style="list-style-type: none"> <li>- Added in 1981 for providing hot water to the ablutions (showers and toilets) at the two ends of the block.</li> </ul>	<p>Low</p> <ul style="list-style-type: none"> <li>- Feature reflecting the later alteration to the block for improving the living condition</li> </ul>

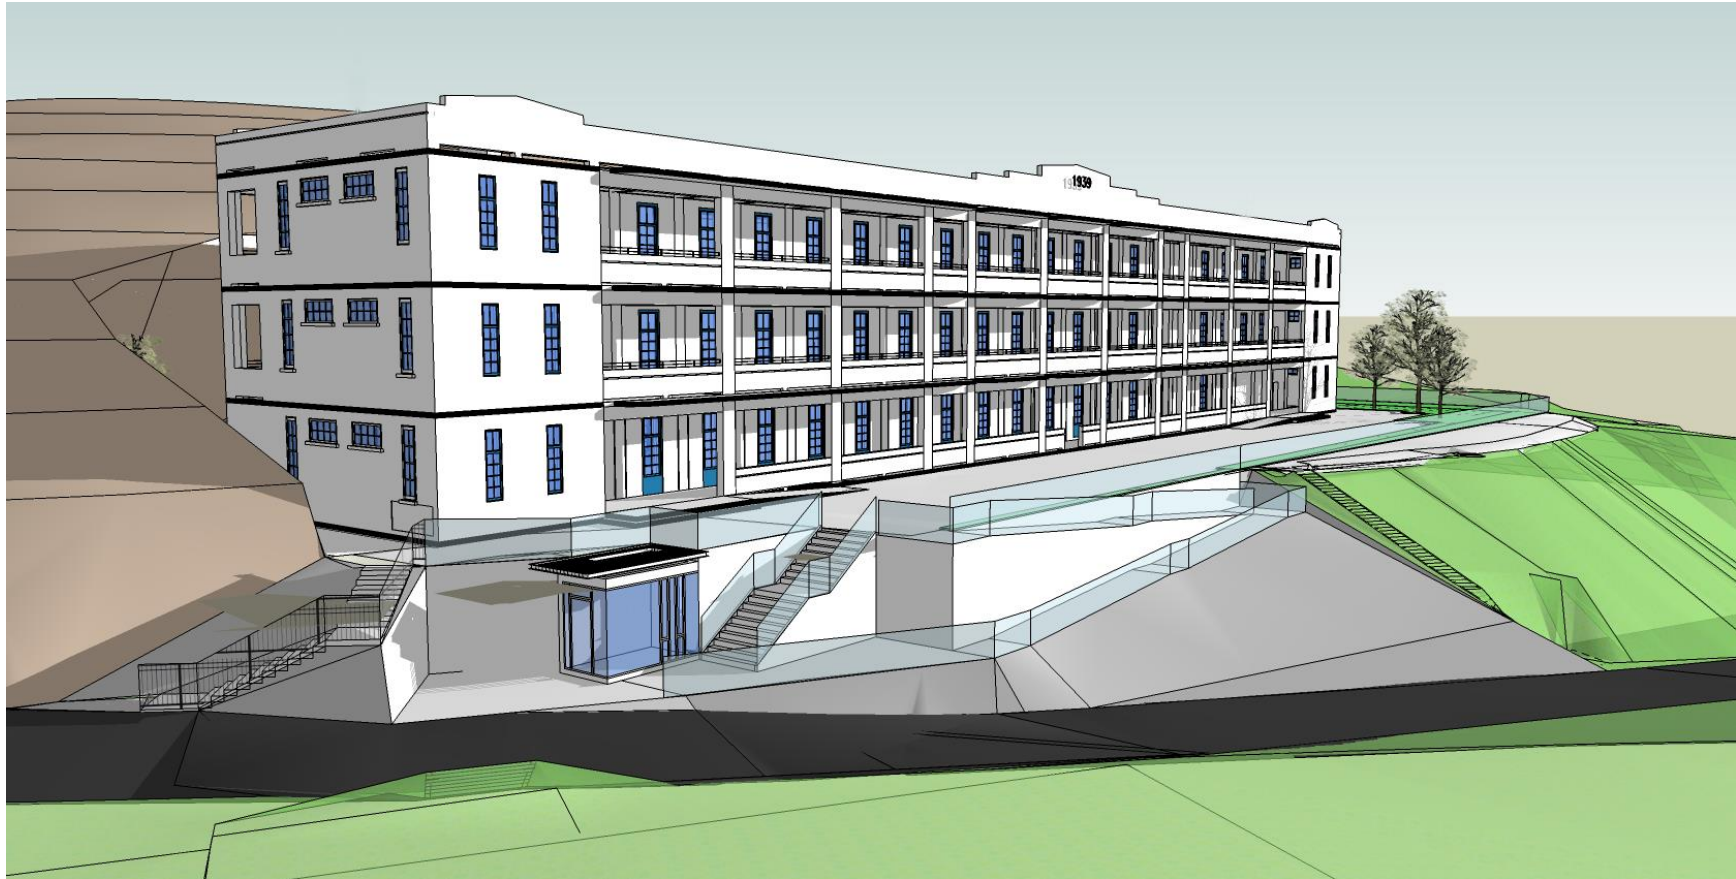
Fig. 38 *Proposed Perspective 2*

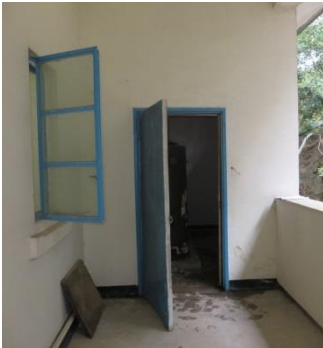
No.	Assessment Items	Reasons for Changes	Affected CDEs / Fabric	Level of Significance	Impact Level after Mitigation Measures	Treatment / Mitigation Measures
C-06	<p>Demolish the boiler room and reveal the verandah on 1/F</p>

<p>The boilers are no longer suitable for future use Preserve the original feature for future interpretation</p>	Rear facade	Moderate	Beneficial	<ul style="list-style-type: none"> <li>- Recording and documenting, with photos and record drawing, the existing layout, finishes and details</li> </ul>
C-07	<p>Make good and keep the gas regulators in North East and South West facades</p>

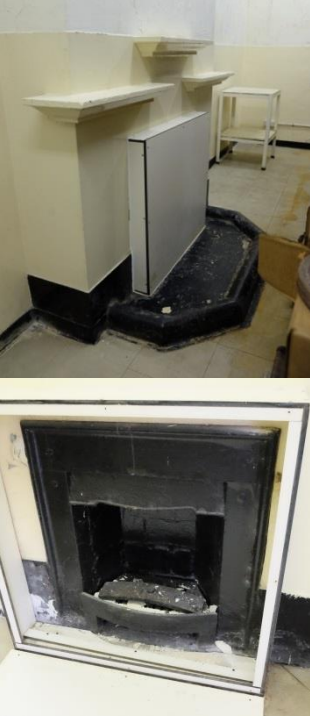
No.	Assessment Items	Reasons for Changes	Affected CDEs / Fabric	Level of Significance	Impact Level after Mitigation Measures	Treatment / Mitigation Measures
D-04	<p>Retain and restore existing fireplaces <i>in-situ</i>.</p>

To reveal the fireplaces	Fireplaces	Moderate	Beneficial impact	<ul style="list-style-type: none"> <li>- The reinstatement is considered beneficial and acceptable provided that the works are carried out by experienced workmen under the guidance of conservationists.</li> <li>- Although most fireplaces on ground floor and second floor have already been removed (except one blocked by timber board in G03), open up inspection is recommended to verify if there was any proof that fireplaces that had actually been installed.</li> <li>- The investigation should be carried out by removing existing paint with hand-held tools or suitable stripper with due care.</li> <li>- Recording and documenting, with photos and record drawing, for any findings. Replicate of new fireplaces is not recommended.</li> </ul>
