Heritage Impact Assessment for Revitalization of the Old Tai Po Police Station, Tai Po into Green Hub

November 2011

CONSULTANCY FOR HERITAGE IMPACT ASSESSMENT FOR REVITALIZATION OF OLD TAI PO POLICE STATION, TAI PO INTO GREEN HUB

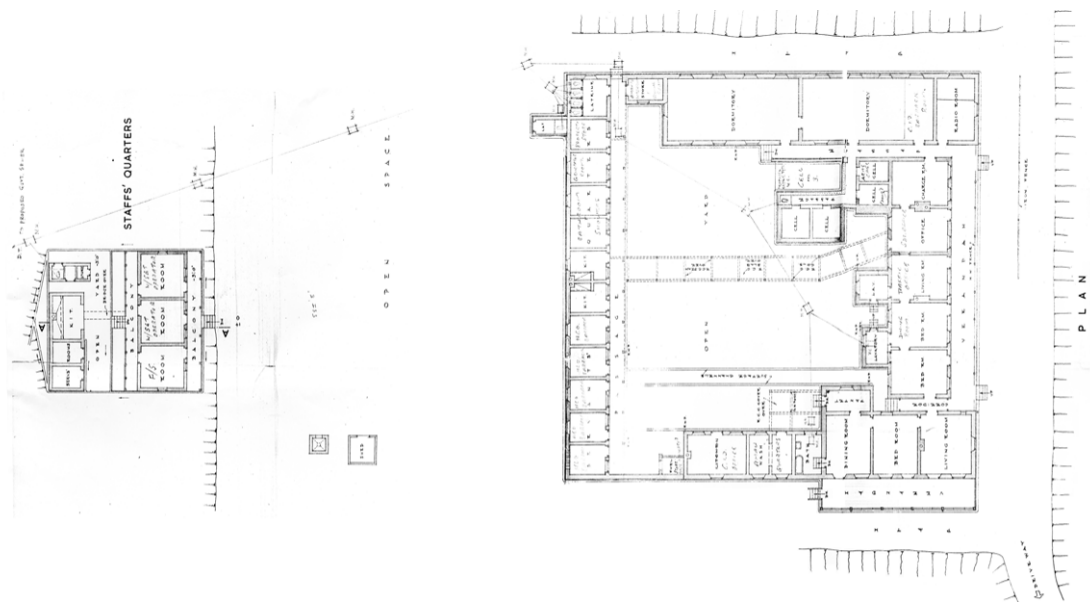
Fig. 38. Old architectural drawings of Old Tai Po Police Station in 1958.
(courtesy of Public Record Office, Ref. No. HKRS478-2-51.)

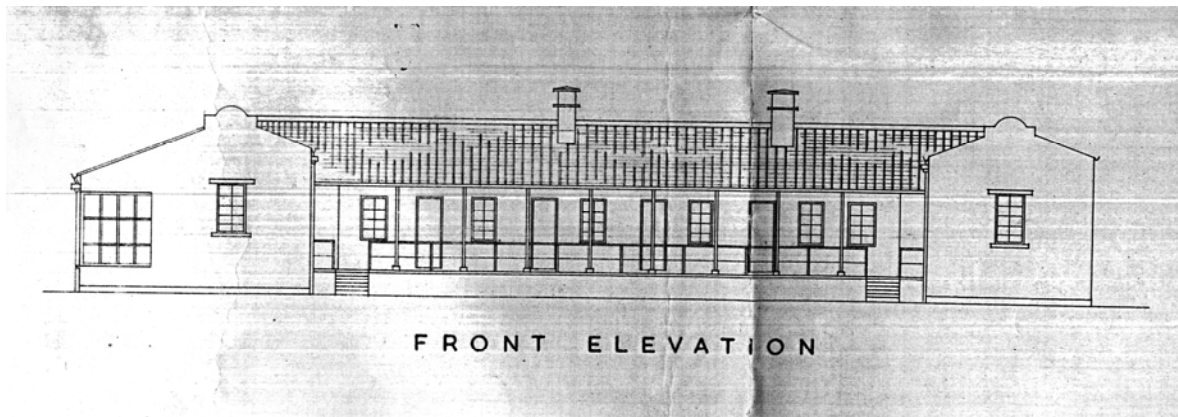
Fig. 39. Front elevation of Main Building on drawings dated to 1958.

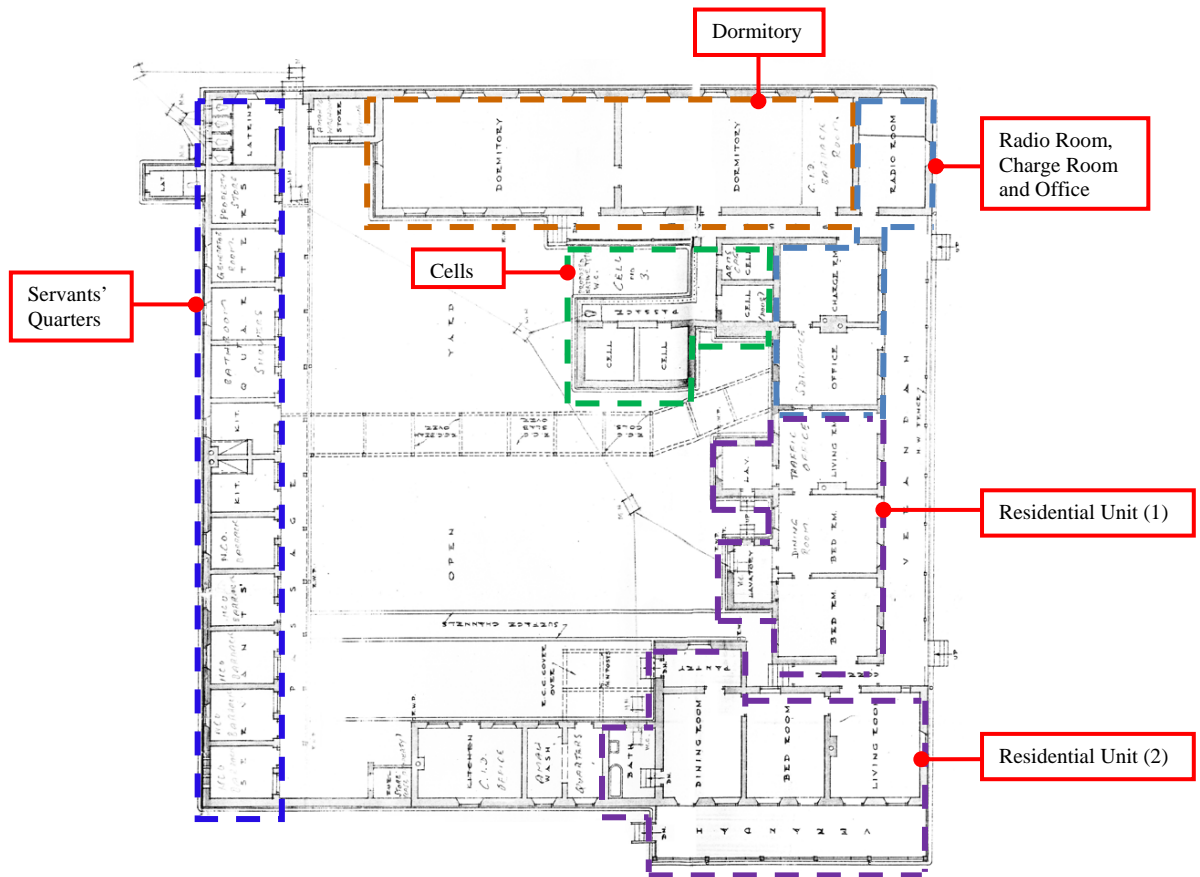
Fig. 41. Spatial layout of the Main Building in 1958.

West wing	Small rooms of similar size for servants' quarters, kitchen and latrine	Partitioning of a few rooms is altered. A corridor is created connecting to the Canteen Block.
Structure at the rear of west wing	a small room as latrine	Replaced by later built structures for storage
Internal courtyard	Remained open	Occupied by later added structures

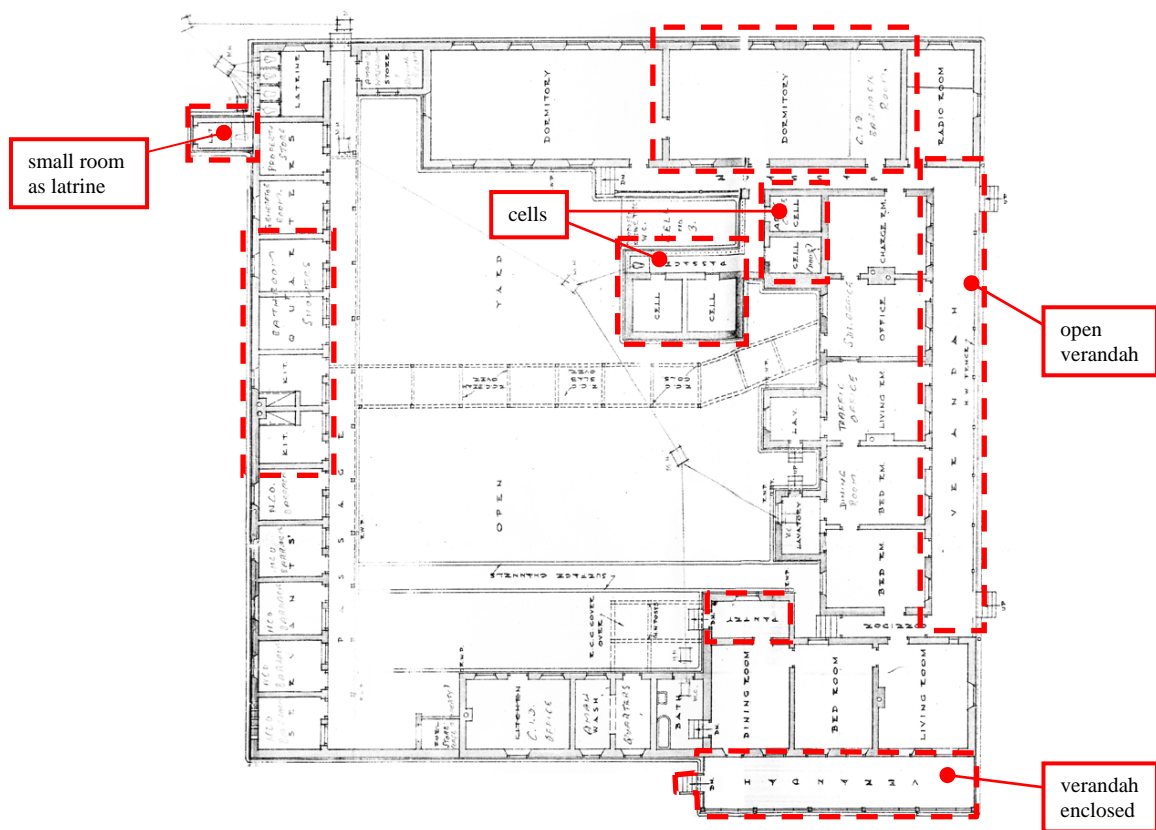
Fig. 42. Ground floor plan of Main Building in 1958.

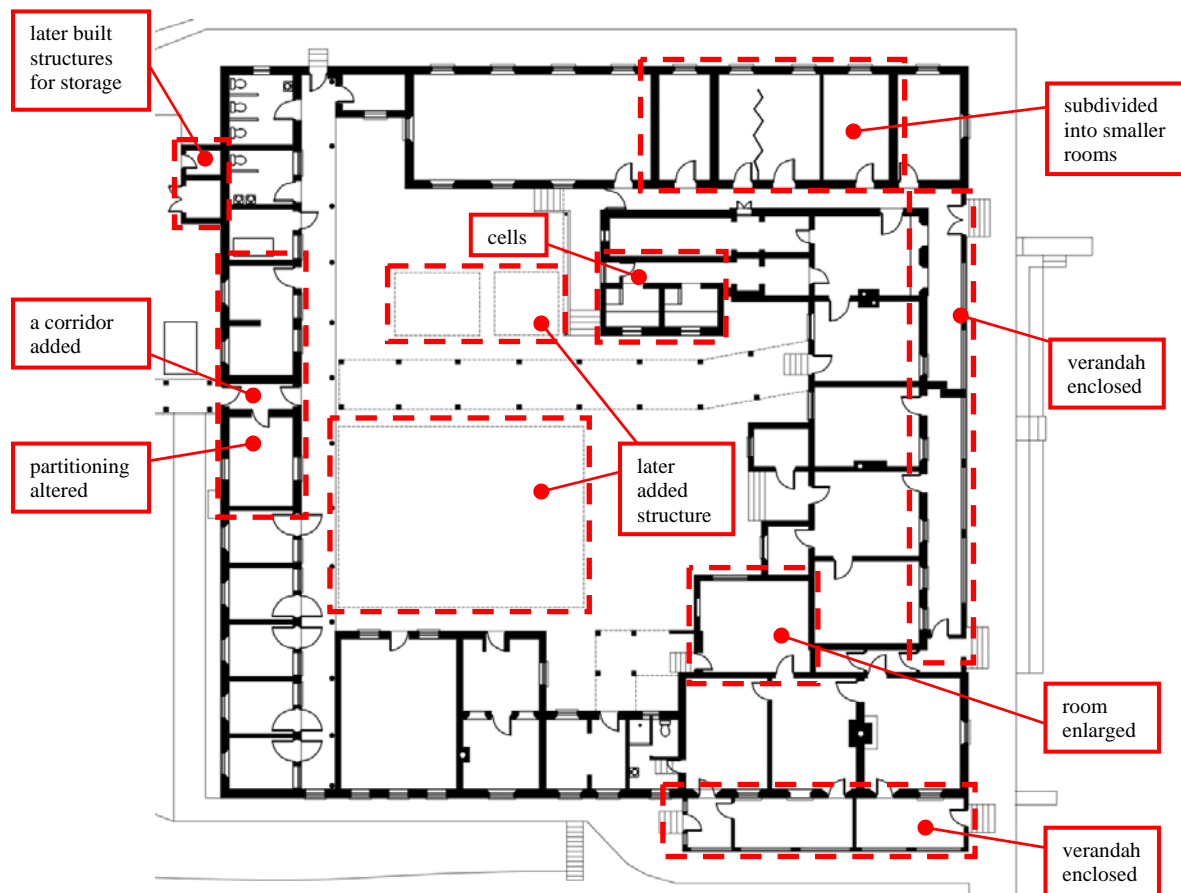
Fig. 43. Ground floor plan of Main Building in 2011.

Location	1958	2011
main building	No window on the rear elevation	Two openings are located for the installation of the air conditioners
Servant's rooms	Two small rooms were used as servants' rooms	The servants' rooms are converted into toilets
	No window on the rear elevation	Windows are found on the rear elevation

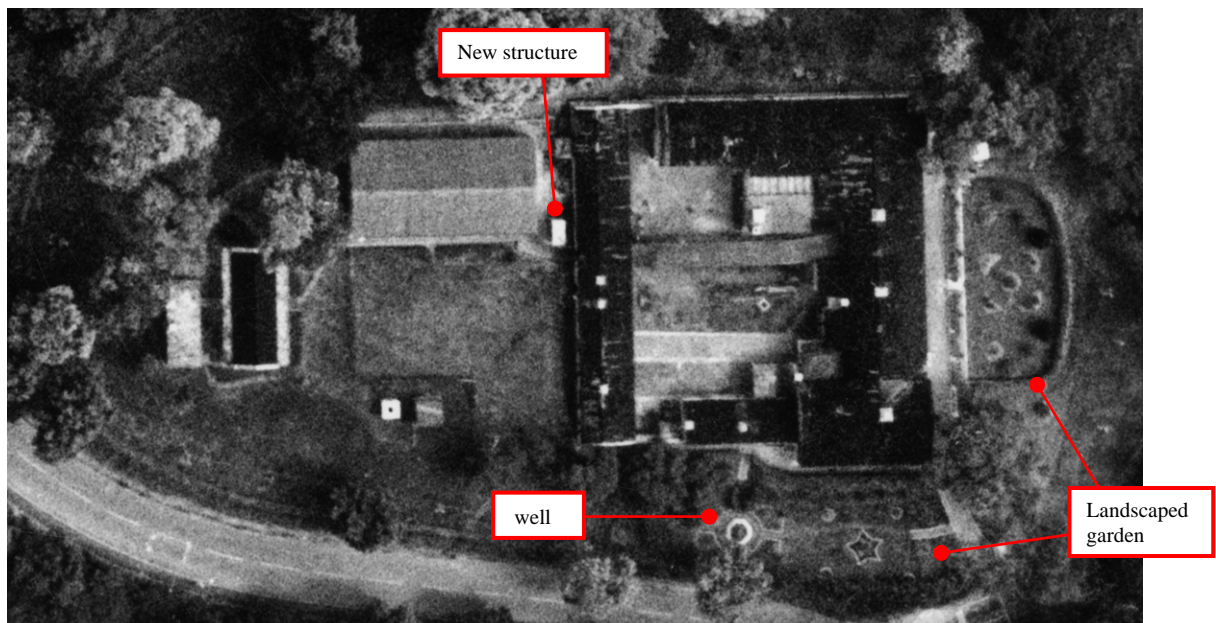
Fig. 48. Aerial photo in 1967.

Besides, an additional structure that might be the water tank found nowadays was shown at the rear of the west wing (Fig. 48). And, it is also recorded that the Staff Quarters was occupied as barrack accommodation by Women Police in 1960.⁵⁶

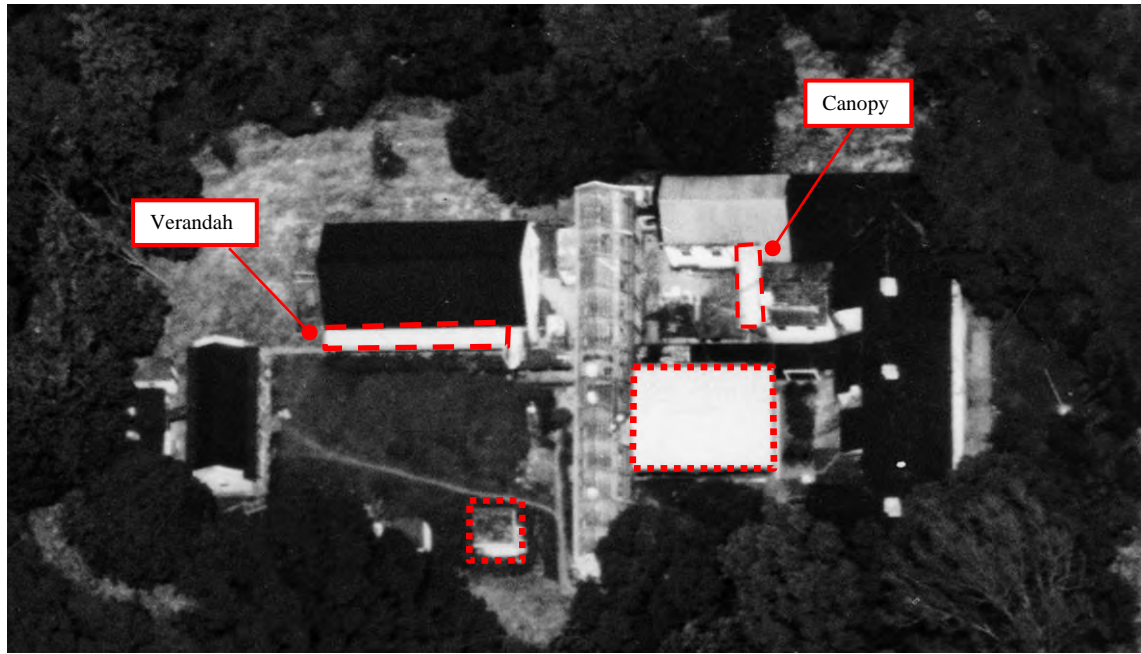
Fig. 51. Aerial photo in 1993.

It is shown in the aerial photo of 1993 that a large individual structure was erected at the internal courtyard of the Main Building, and a canopy was added adjacent to the cells and armoury. Moreover, a verandah was built in front of the Canteen Block while an additional structure, probably the dangerous goods store nowadays, was found at the south of the open lawn. (Fig. 51).

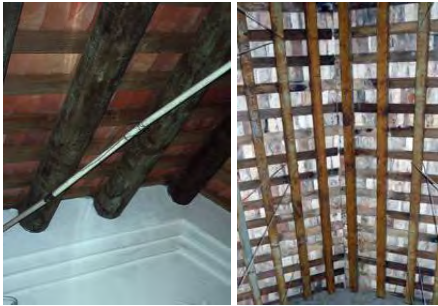
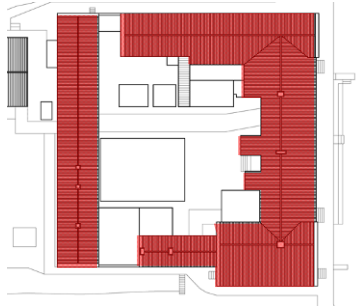
M-14	Timber roof structure, with some replaced by steel purlins

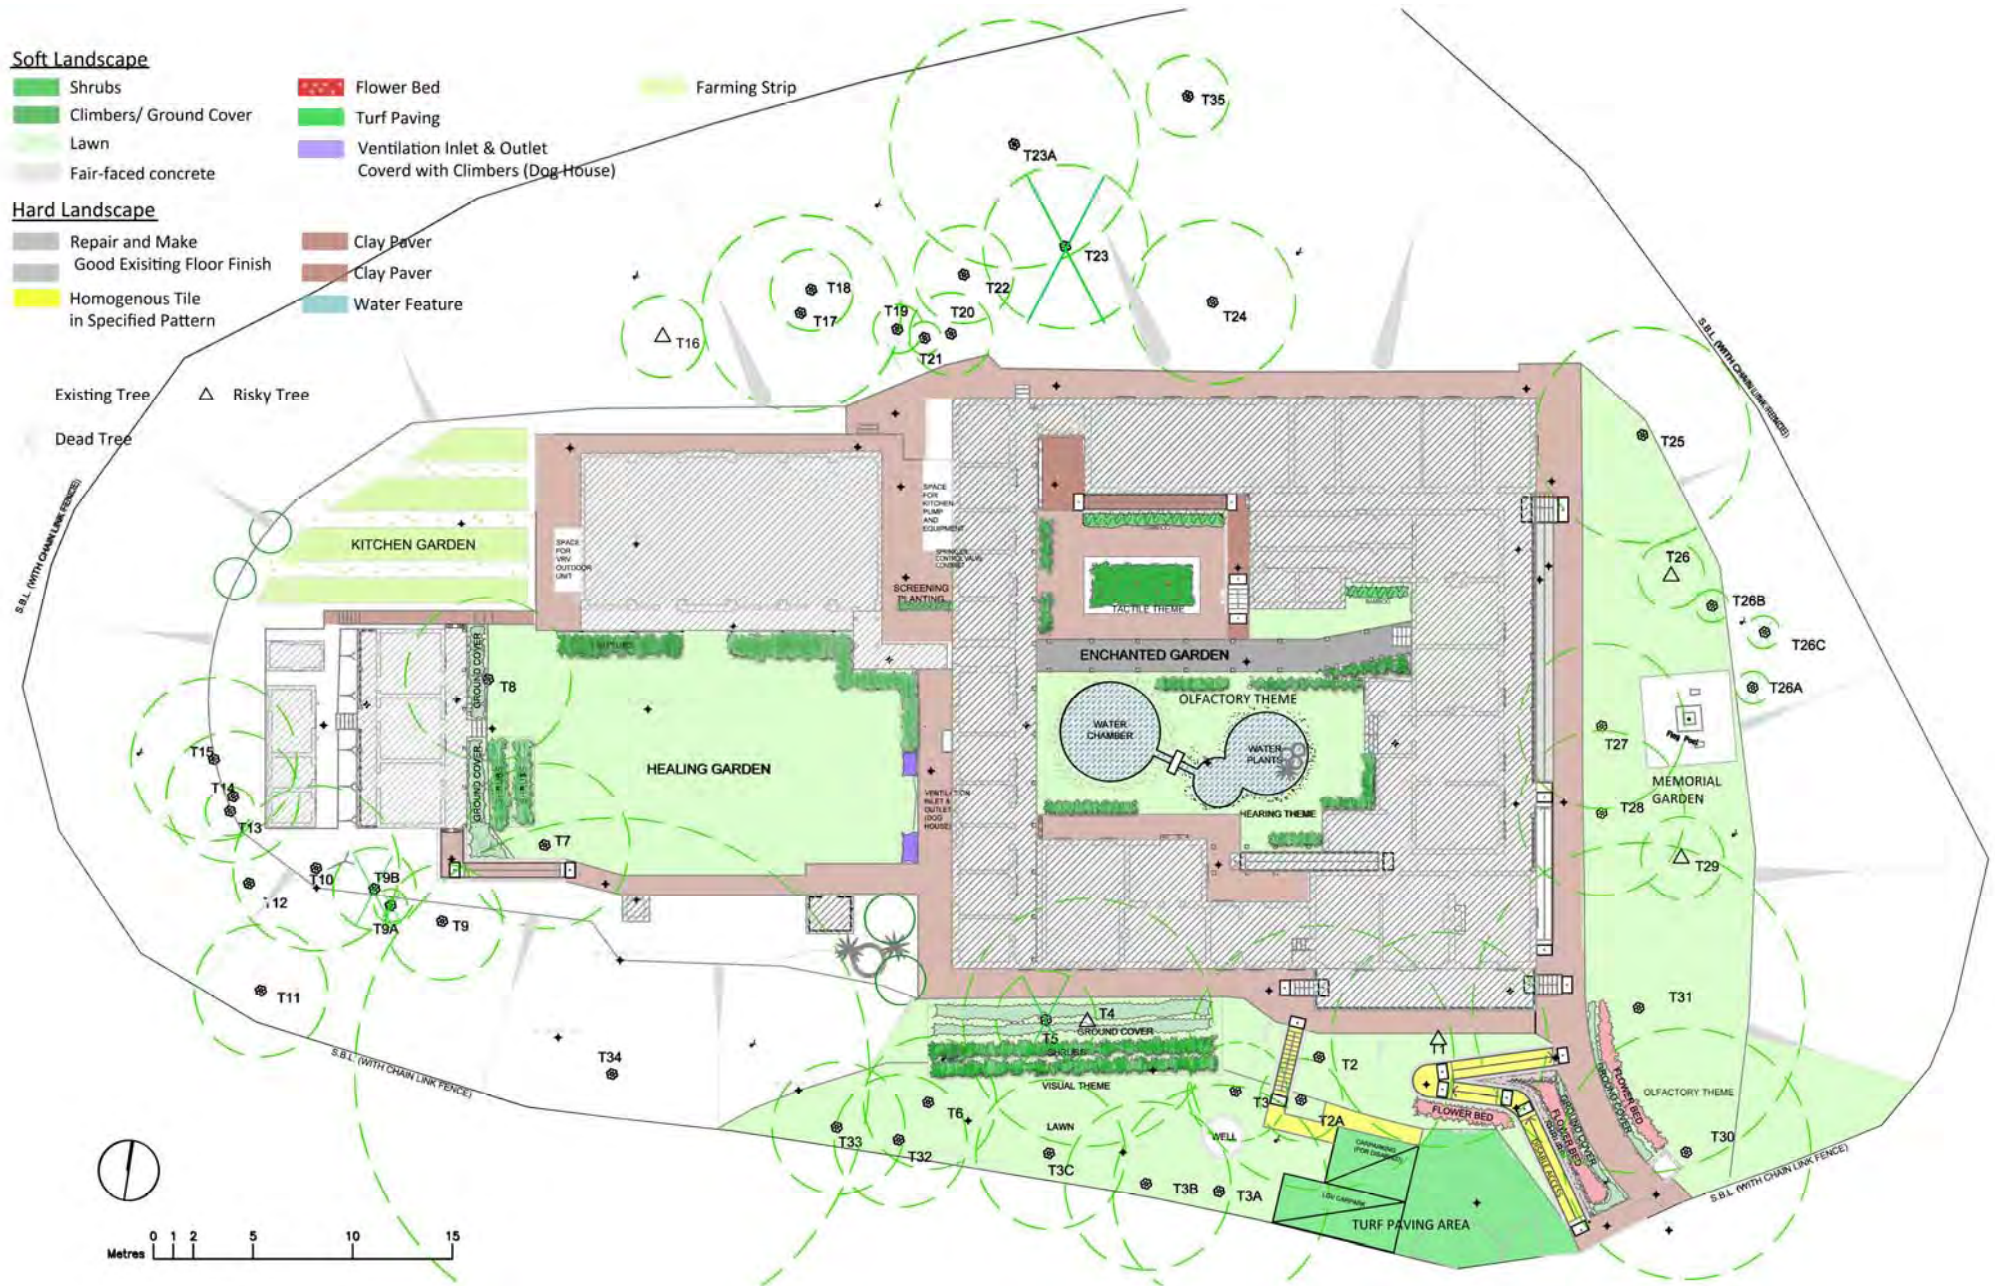
Fig. 55. Proposed Landscape Plan
