Consultancy for Heritage Impact Assessment for
Transformation of the Former Police Married Quarters Site
on Hollywood Road
into a Creative Industries Landmark

Volume II - Archaeological Impact Assessment
March 2011

Transformation of the Former
Police Married Quarters Site on
Hollywood Road into a Creative
Industries Landmark:
*Heritage Impact Assessment –
Volume 2 - Archaeological Impact
Assessment*

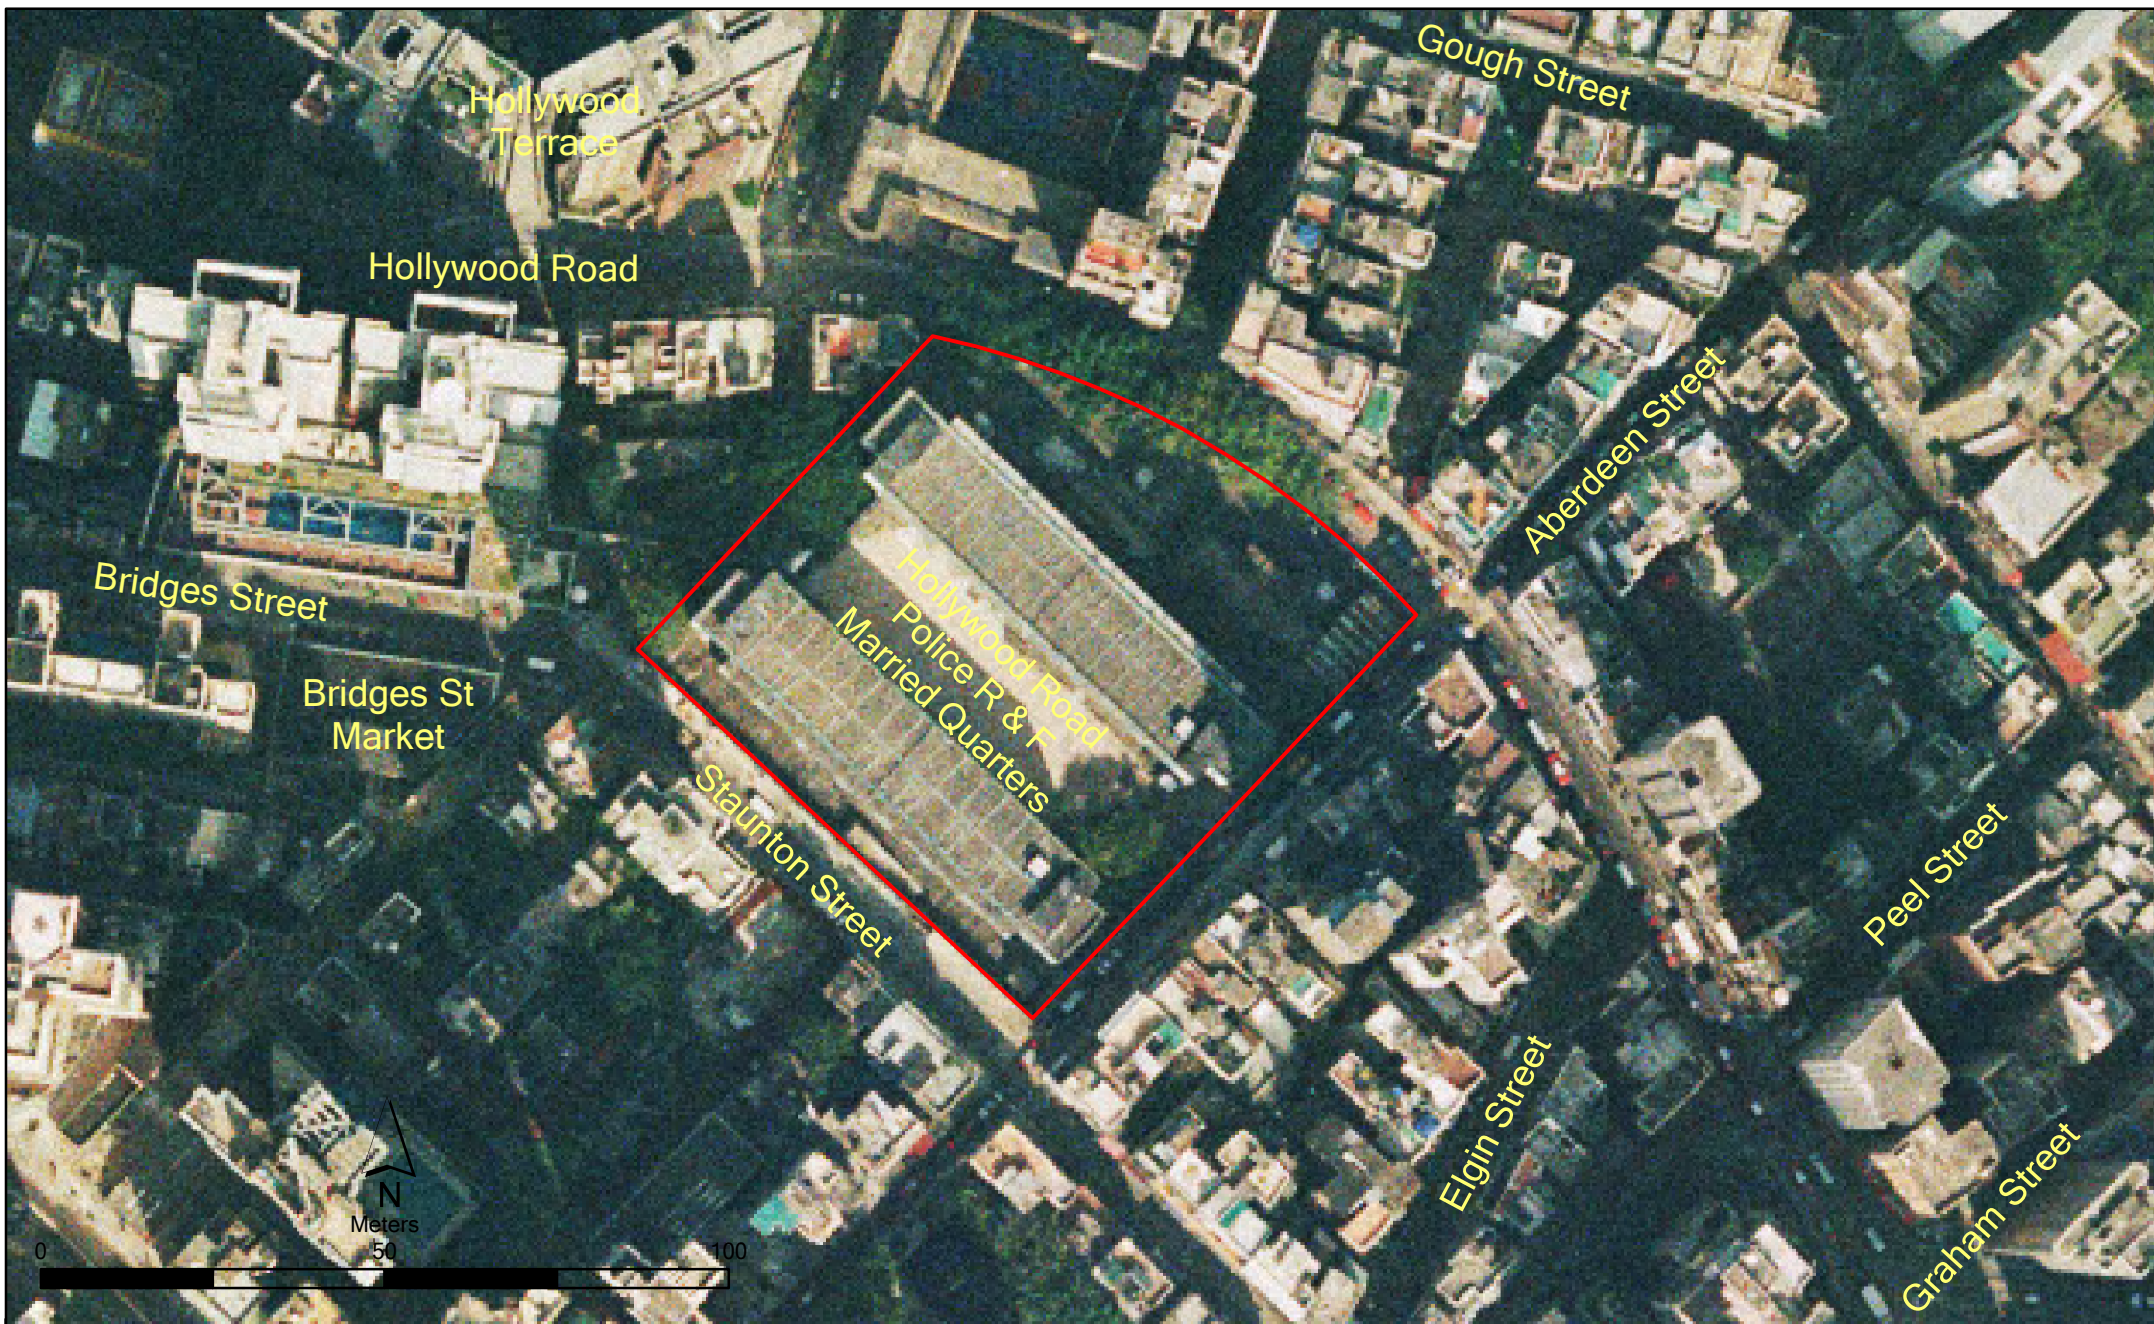
Figure 3.3

Aerial Photo of the Site in 2007

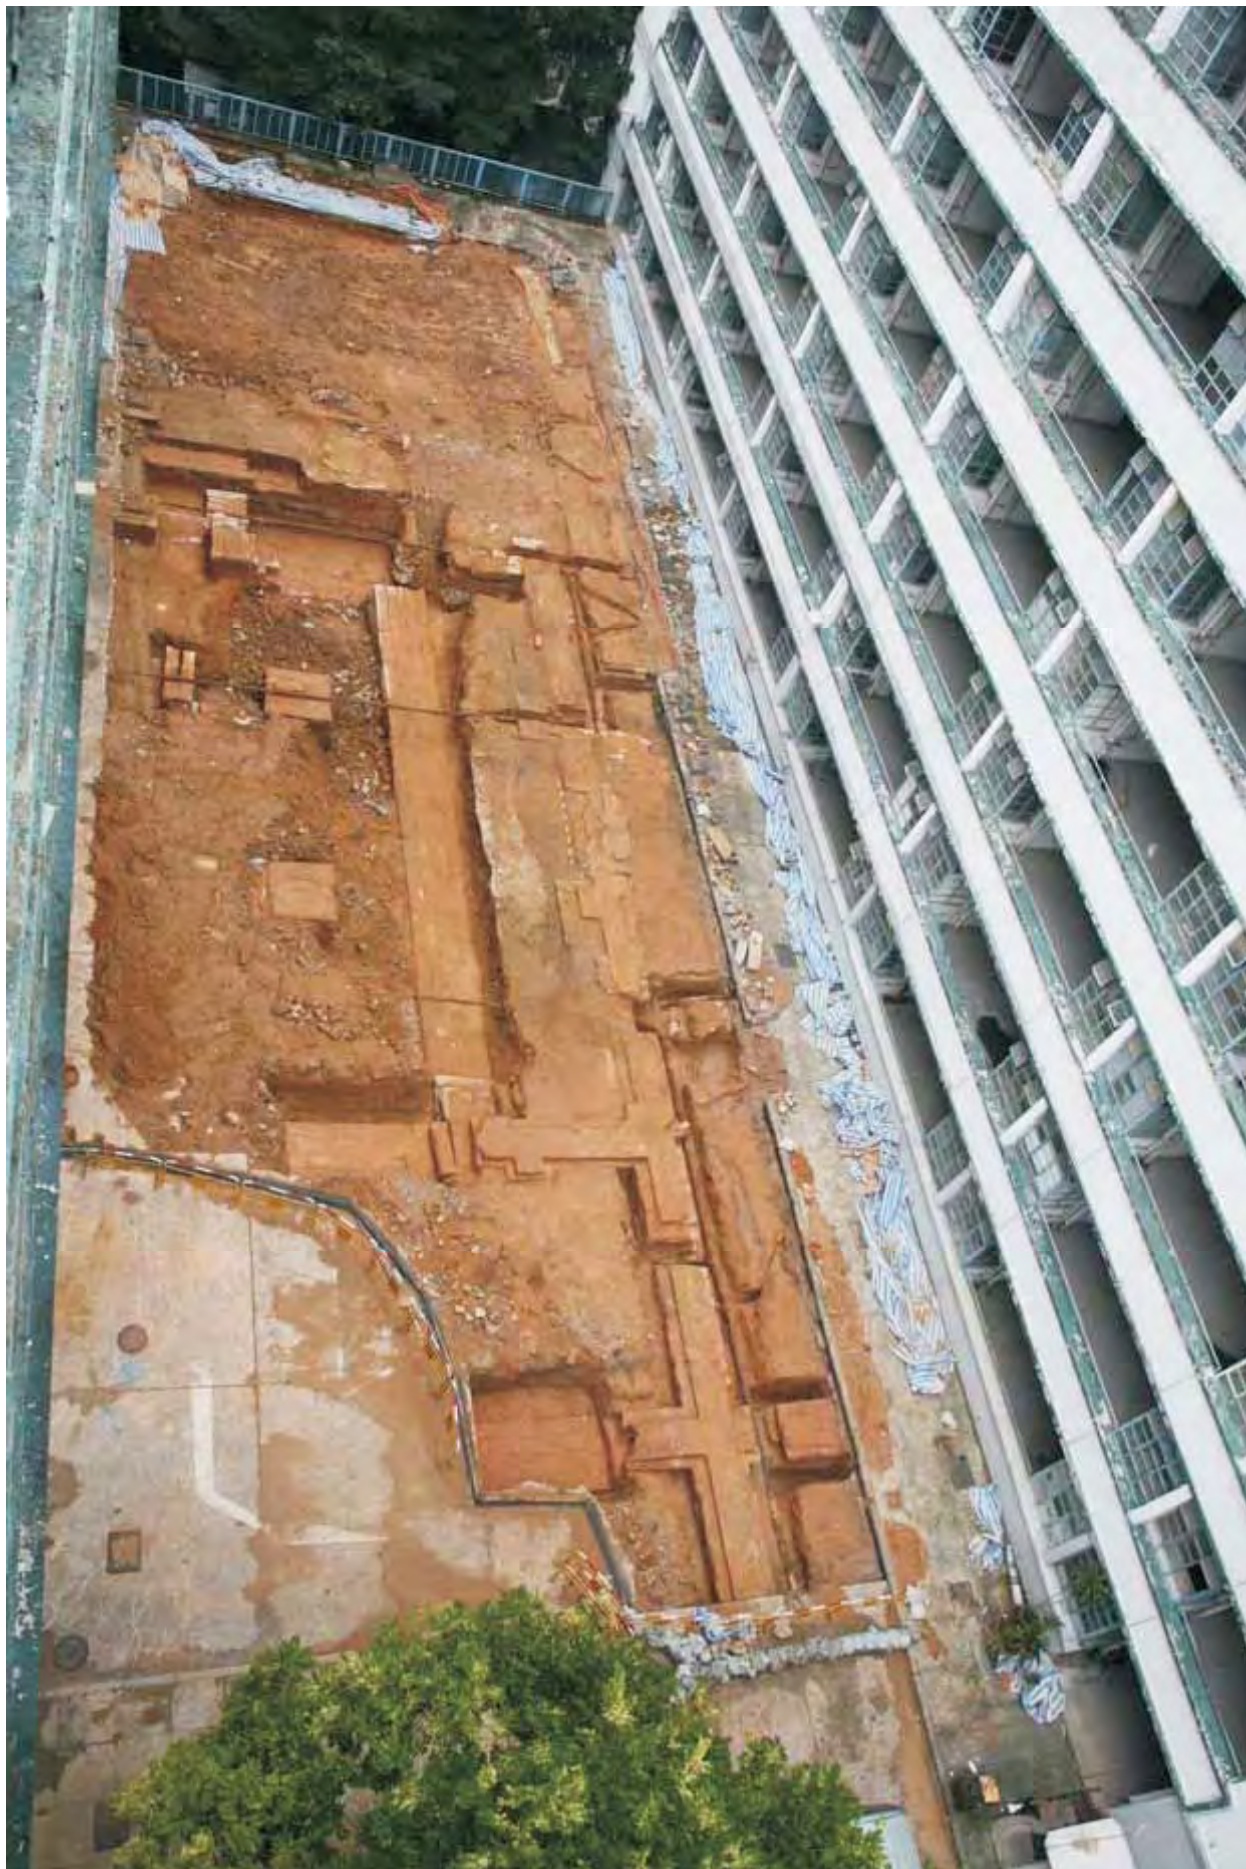
Figure 3.8 Bird View Photo Showing the Exposed Features at the 2nd Plateau in the 2007 Site Investigation

At the 2nd Plateau, features identified included: fragments of cement flooring; layer of hard-core; underground drainages; foundation walls; mortar wall and white mortar floor; inked marks on granite blocks; and remains of mud walls. A feature plan illustrating the locations of major features and a plan showing the corresponding Trial Trench system at the 2nd Plateau has been cited from the report (see *Figures 3.6* and *3.7* respectively). *Figure 3.8* is a bird view photo showing the exposed features at the 2nd Plateau in the 2007 Site Investigation.

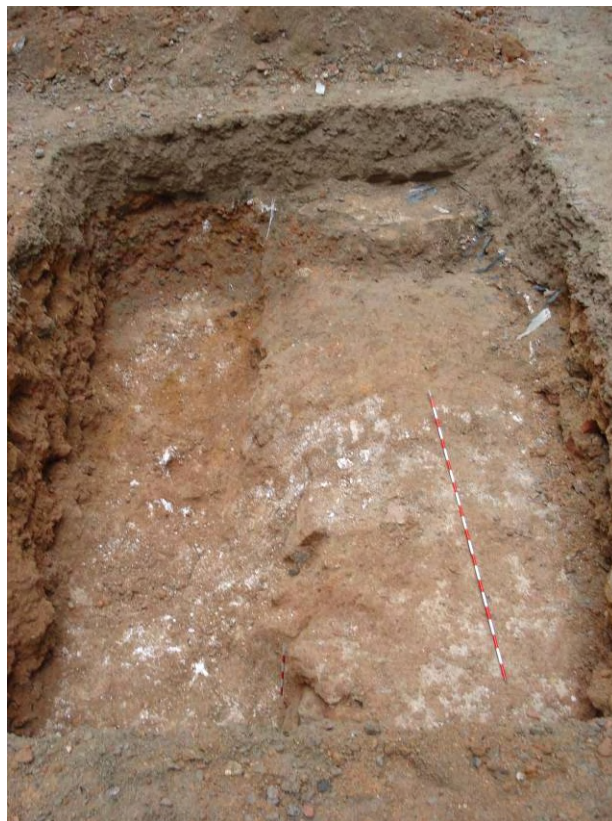
Two white mortar hard surfaces were identified in TTC1 (see *Figure 3.10*). They were step-like hard surfaces with a thin layer of lime (approximately 1cm in thickness) in white colour on top, and were aligned in parallel in the north-south orientation. The alignment of the surfaces is found consistent with the general landform of the Site (i.e. hill slope descending from south to north). Part of the white mortar surface at the higher level in the southern corner of the pit (approximately 30cm x 60cm in size) was identified to be the white hard mortar floor unearthed in the 2007 Site Investigation. It was situated at a level approximately 0.7m below existing ground level. The white mortar surface at the lower level in the northwest is approximately 1m below existing ground level.

Figure 3.10 *White Mortar Hard Surfaces in TTC1 (From Northwest to Southeast)*

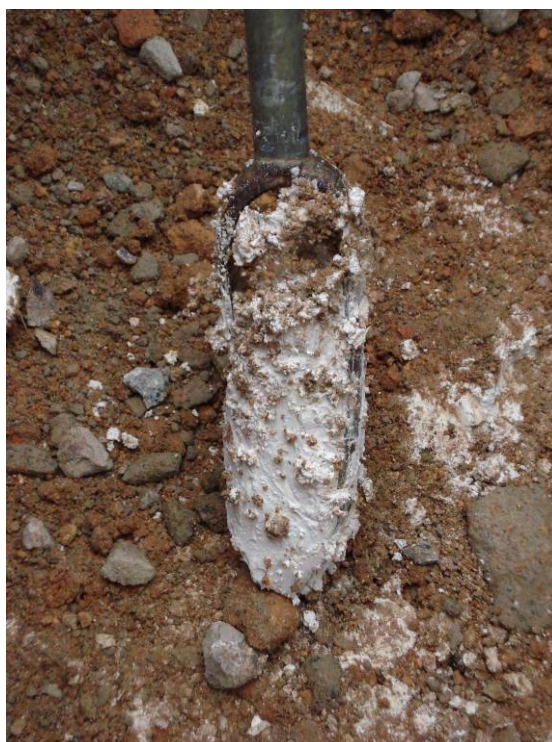
To ascertain the existence of any more archaeological remains underneath the white mortar hard surface in TTC1 while preserving them in-situ as much as possible, an attempt was made to drill an auger hole in the trial pit. However, the auger hole was only able to drill approximately 10cm from the surface of the exposed white mortar due to the hardness of the white mortar (see Figure 3.11).

Figure 3.11 *White Mortar Drilled by Auger Hole in TTC1*

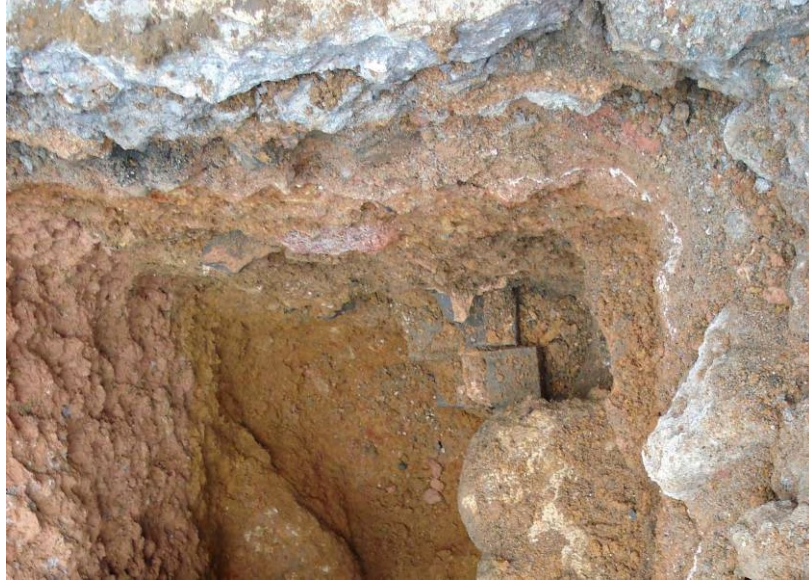
Some grey bricks were found accumulated layer by layer (in 5 nos. of layers) at the western corner of TTC3 (see *Figure 3.12*). The usage of the grey bricks is unknown. The grey brick structure is considered a feature not associated with the Former Central School and is probably an *in-situ* structure prior to the construction of the Former Central School.

Figure 3.12 *In-Situ Grey Bricks at the western corner of TTC3 (View from Above; From Northeast to Southwest)*

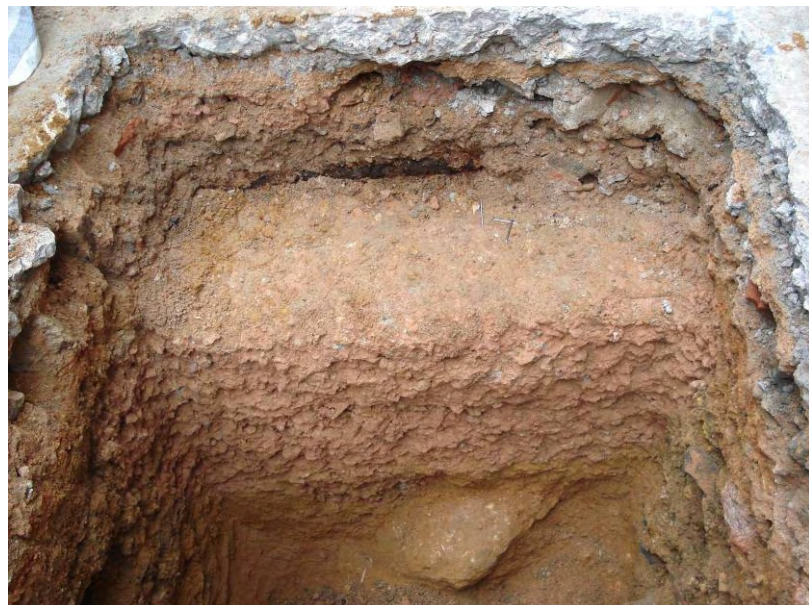
Modern intrusion of a pipeline trench was identified at the eastern wall of the trial pit. The trench was overlaid with a pipeline which may still be in use (see *Figure 3.13*). Besides, the trench was regarded as a modern intrusion compacted with pinkish clayey sand and stone fragments extending to the sterile layer beneath. Therefore, it was considered unnecessary to excavate the trench and better to preserve it *in-situ*.

Figure 3.13 *Pipeline Trench at the Eastern Wall of TTC3 (From Northwest to Southeast)*

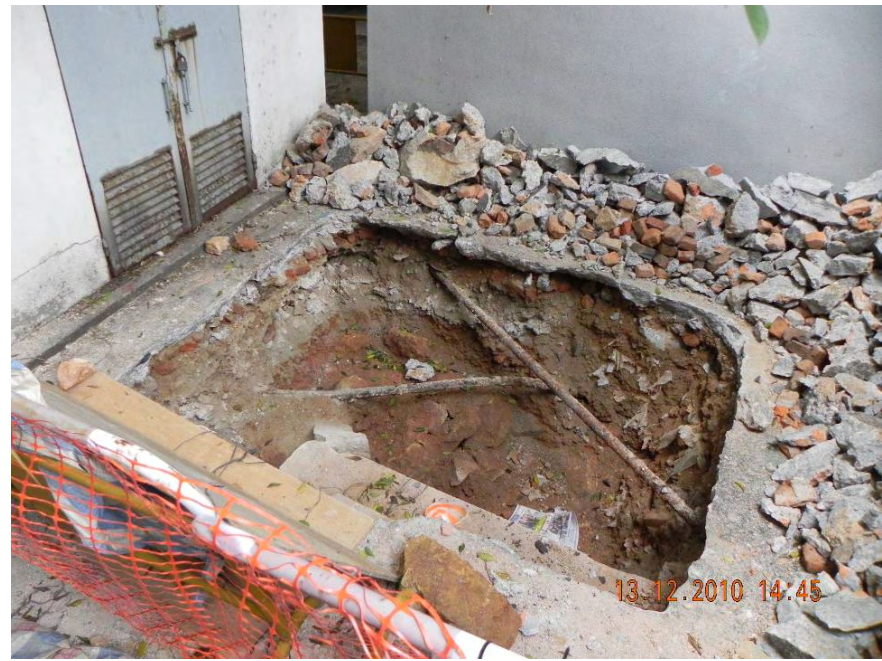
TTA4 with granite slab by the southwest wall

In TTA4 (as shown in *Figure B* in *Annex B*), part of a granite slab feature was identified on the 3rd Plateau adjacent to the existing retaining wall and balustrade separating the 2nd and 3rd Plateaux. However, whether the revealed part of the granite slab feature was associated with the Former Central School Site is unknown as according to the plan of the Former Central School as presented in *Figure 4.1*, TTA4 falls outside the foundation plan of the Former Central School.

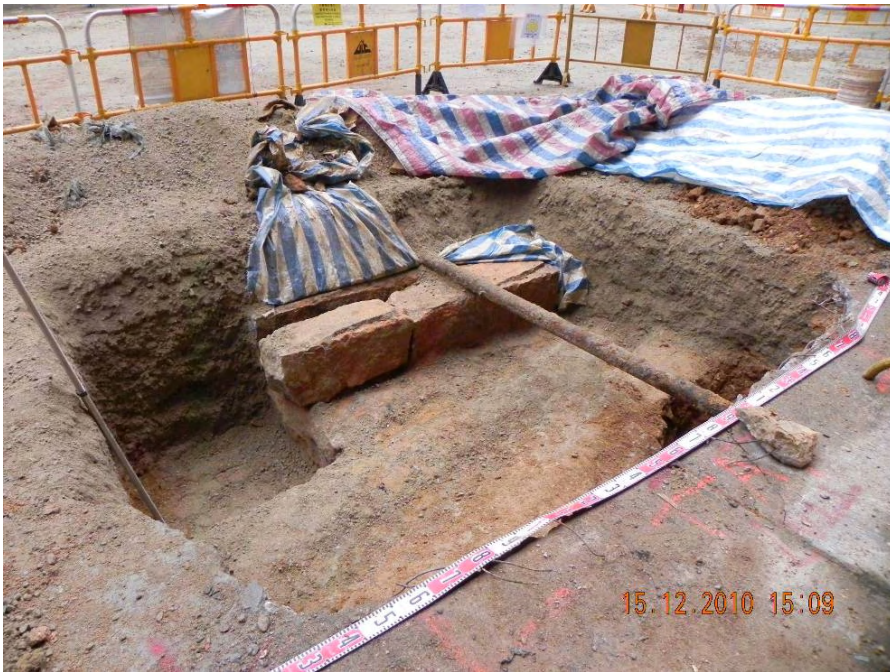
TTA7 exposed the foundation remains identified by AMO in 2007

During the GI works, it was attempted that TTA7 be opened outside the archaeological deposits area. However, due to some discrepancy, part of TTA7 reached the archaeological deposits area where some granite slabs of the Foundation 12 discovered by the AMO in 2007 was found.

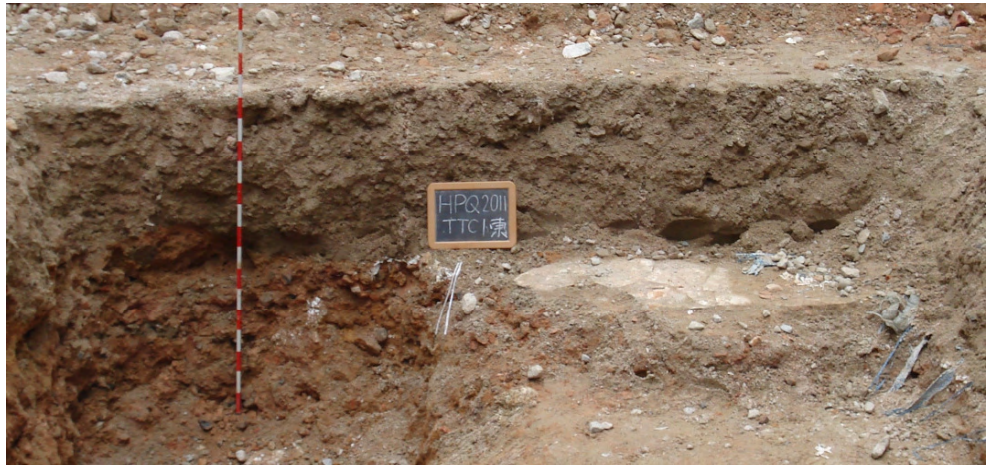
Eastern
Section

Photography of TTC1
