Contract No. DC/2012/05

**Sewerage at Yuen Long Kau Hui and Shap Pat Heung
(Sewerage Works at Portion B – Tai Tong Tsuen)**

Archaeological Watching Brief
Final Report

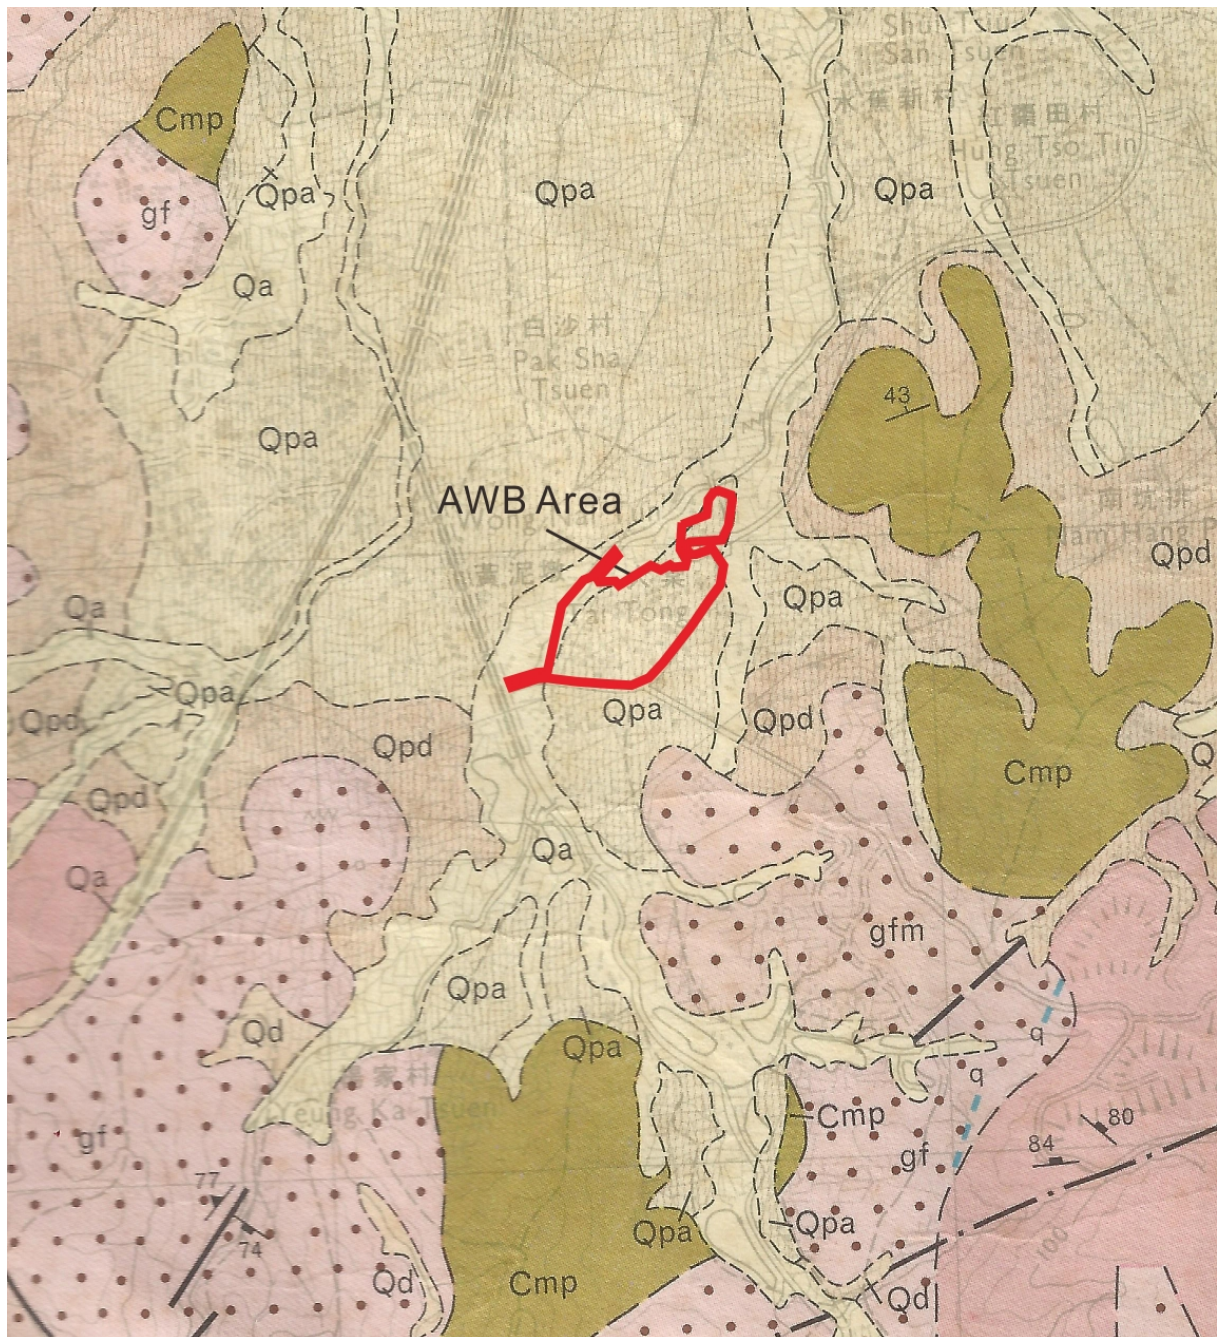
Figure 2 Geological Map of Tai Tong District

- 2.1.3 Geologically, the solid base of this area is composed of two major rock types. One is fine-to-medium-grained granite formed during the Jurassic-Cretaceous period of the Mesozoic; the other is metasiltstone and metasandstone formed during the Carboniferous period of the Palaeozoic (**Figure 2**).

- 2.1.4 The surface deposit of the Tai Tong Tsuen area is primarily terraced alluvial soil formed during the Pleistocene period, characterized by gravelly or sandy clay and silt. In the lower areas along the river courses, the surface is covered with Holocene alluvial deposit composed of well-sorted or semi-sorted clay and silt ⁽¹⁾.

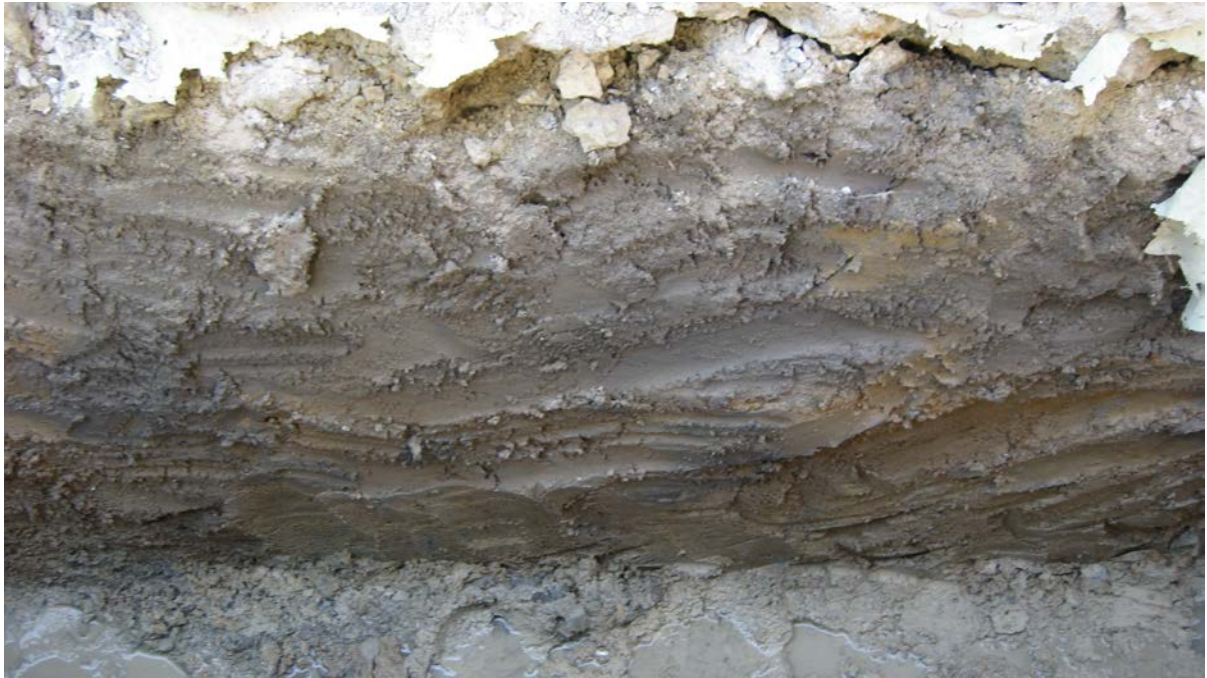
1, TTT0102 (Facing SE)

- 4.2.1 **TTT0102:** Four layers can be observed in this trench of about 1.2-metre deep. Under the concrete path surface is a blackish modern layer; further downward are two layers of sandy sludge soaked in water (**Plate 1.1**).

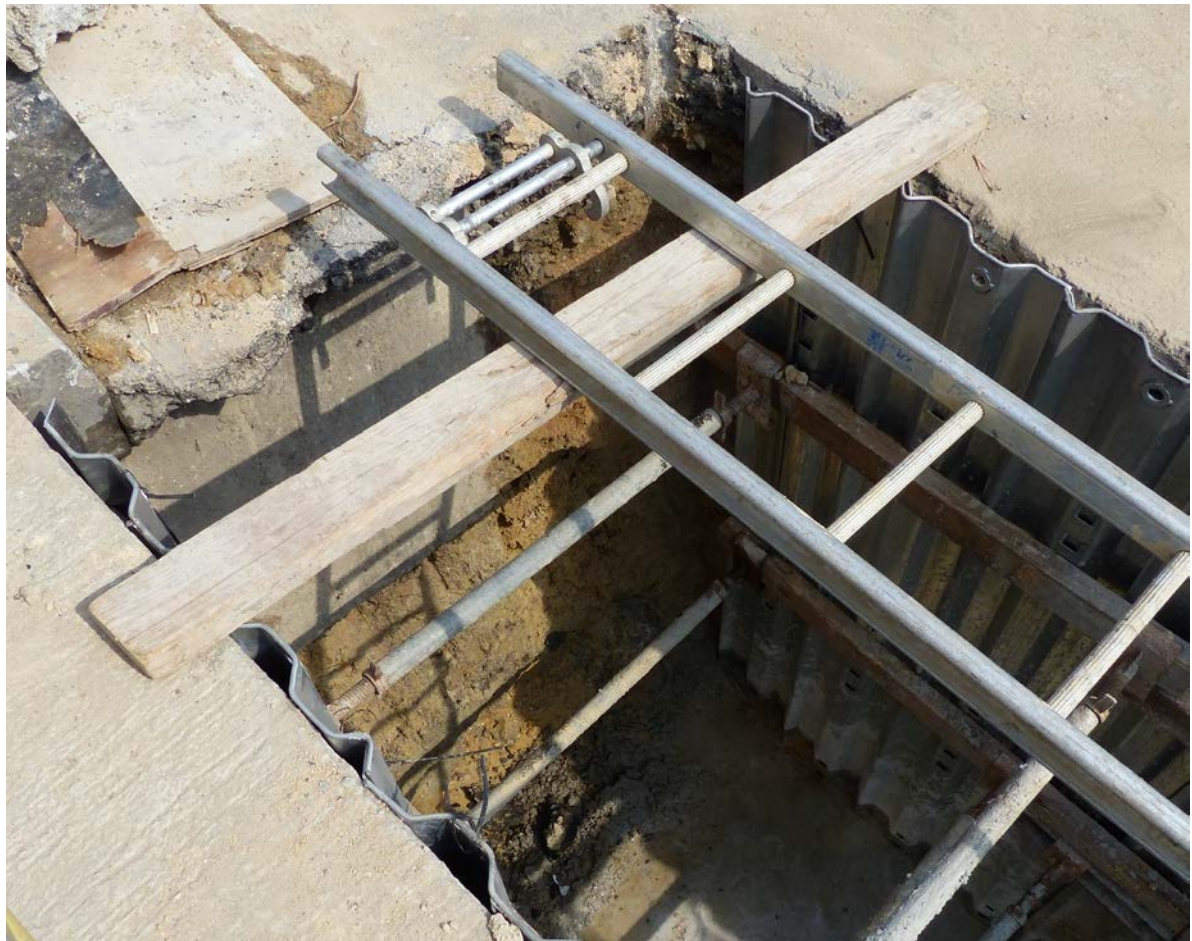
2. TTT0110 (Facing SE)

- 4.2.2 **TTT0110:** This trench is about 2.50 m in depth and reveals two layers. The first layer is the concrete path with a bitumen base; the second layer is modern fill with soil of mixed colors (**Plate 1.2**).

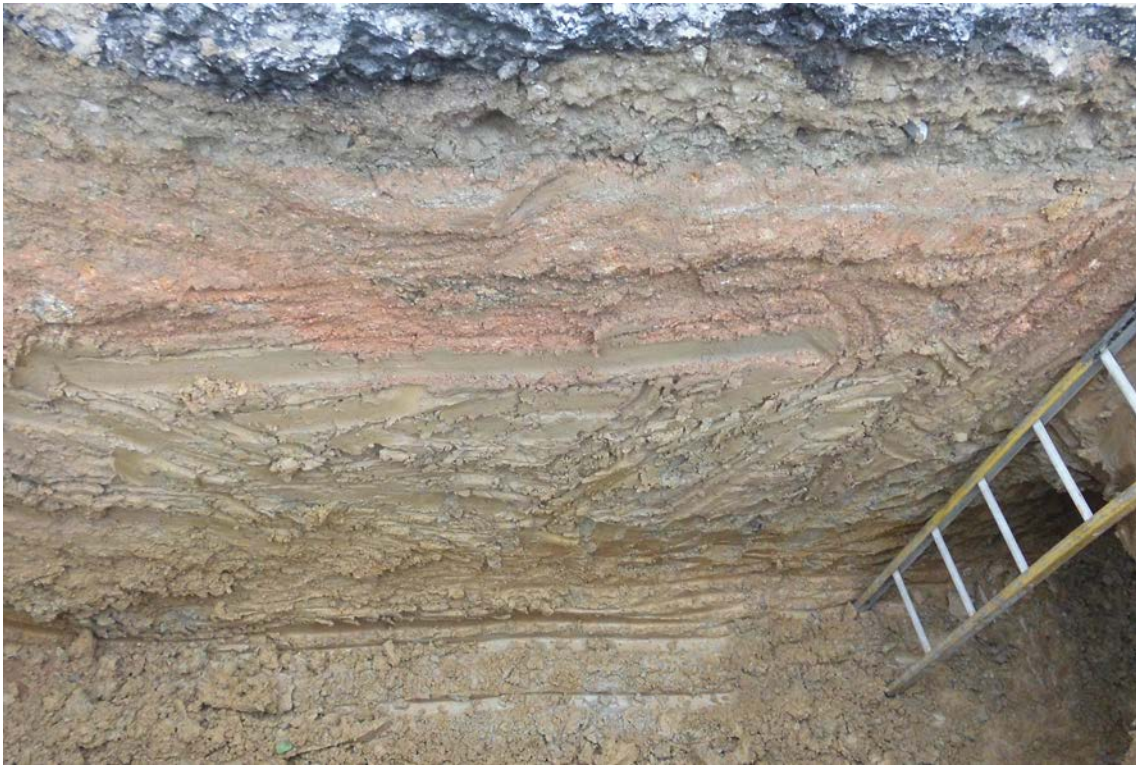
1. TTT0112 (Facing S)

- 4.2.3 **TTT0112:** This trench is about 2.80 m in depth and reveals two layers. The first layer is the concrete path with a bitumen base; the second layer is modern fill with soil of mixed colors (**Plate 2.1**).

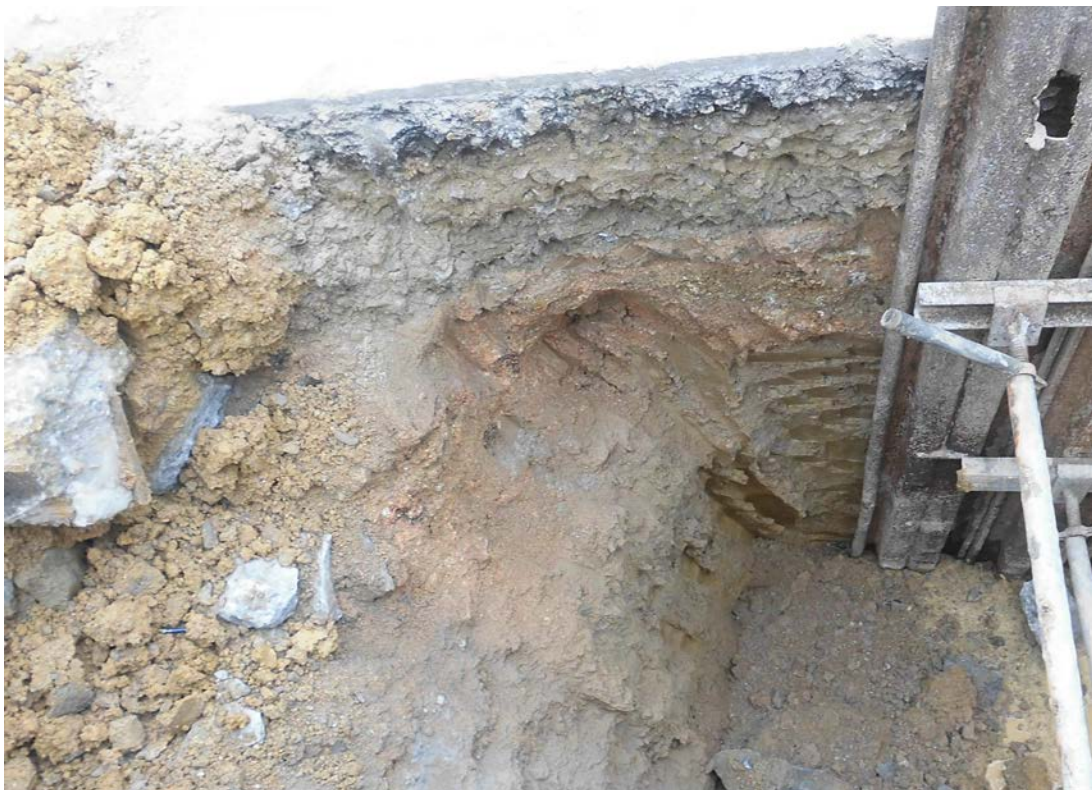
2. TTT0113 (Facing S)

- 4.2.4 **TTT0113:** This trench is about 2.20 m in depth and reveals two layers. The first layer is the concrete cover with a bitumen base; the second layer is modern fill with soil of mixed colors (**Plate 2.2**).

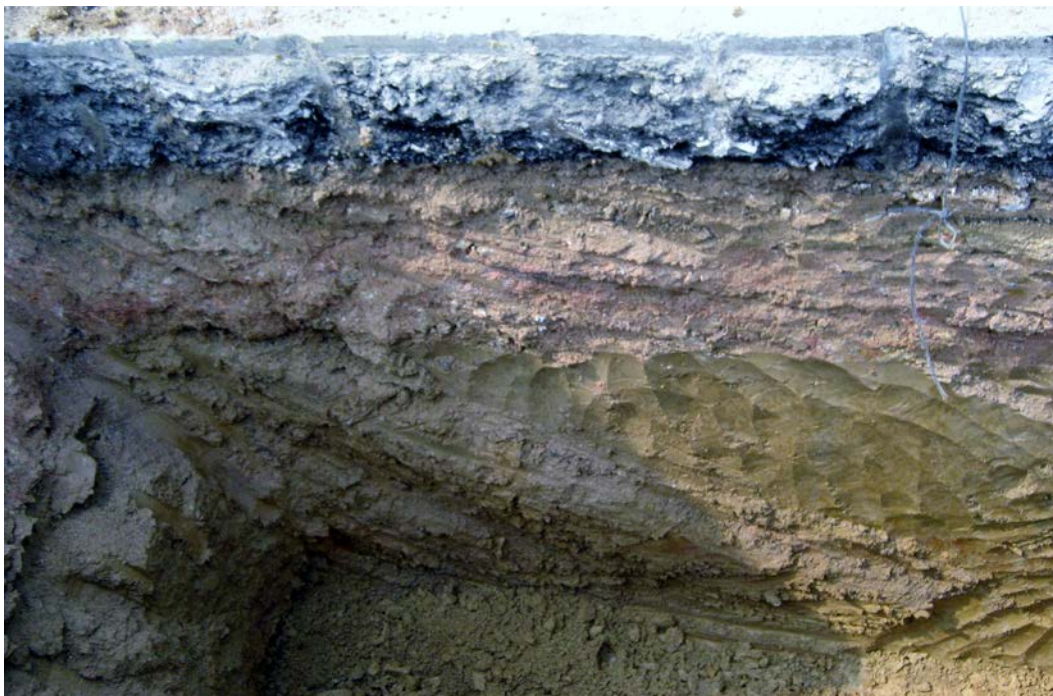
1. TTT0115 (Facing S)

- 4.2.5 **TTT0115:** This trench is about 2.60 m in depth and reveals three layers. The first layer is the concrete path with a bitumen base; the second layer is modern fill with soil of mixed colors; the bottom layer is a pure deposit of yellowish brown clay, probably a regolith deposit (**Plate 3.1**).

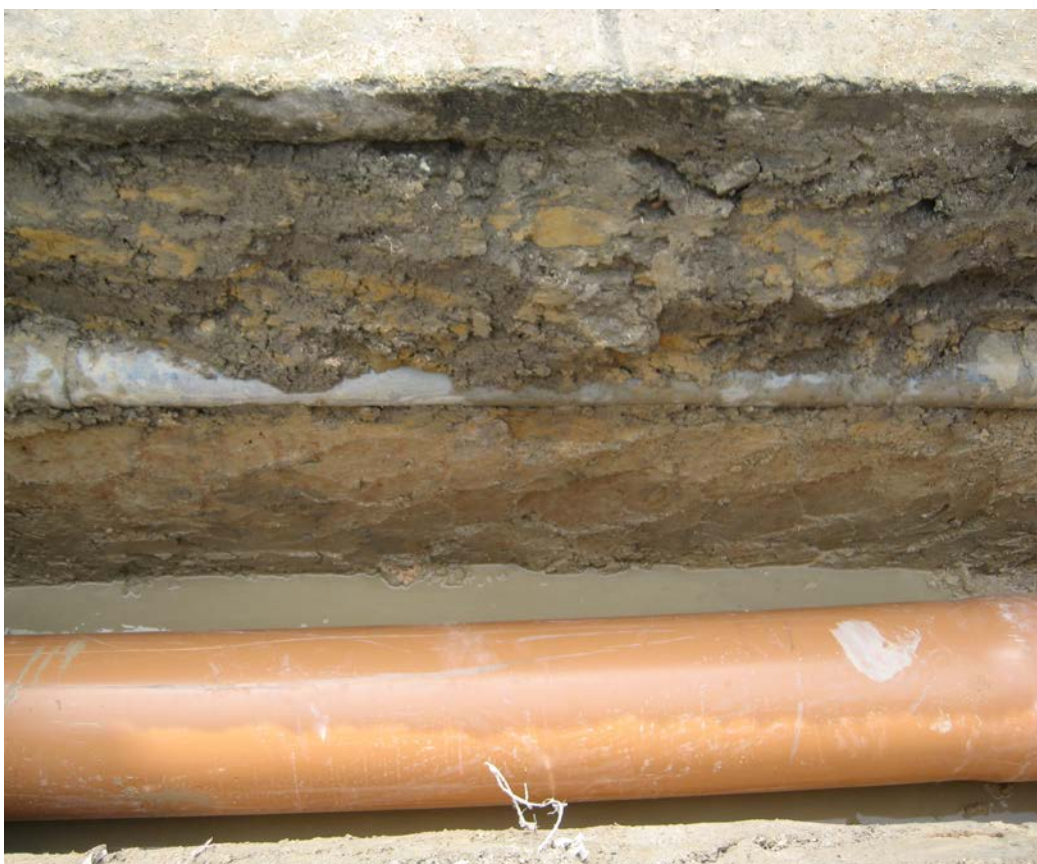
2. TTT0204 (Facing W)

- 4.2.6 **TTT0204:** This trench is about 1.20 m in depth and reveals three layers. The first layer is the concrete path cover; the second layer is modern fill with a rubber cable and a steel pipe running through this layer; the bottom layer in water is a regolith deposit composed of yellowish red clay (**Plate 3.2**).

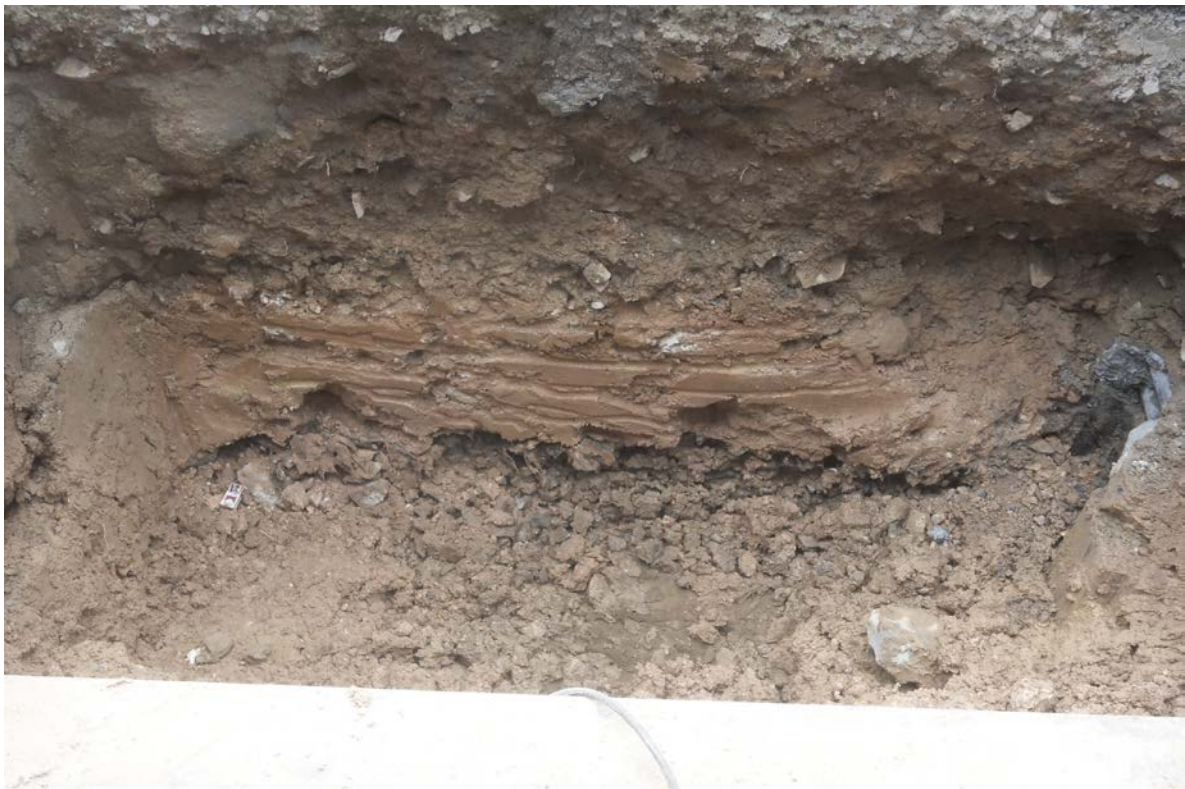
TTT0209 (Facing W)

- 4.2.7 **TTT0209:** This trench is about 1.20 m in depth and reveals three layers. The first layer is the concrete path cover; the second layer is blackish modern fill; the bottom layer is a regolith deposit composed of yellowish red clay (**Plate 4.1**).

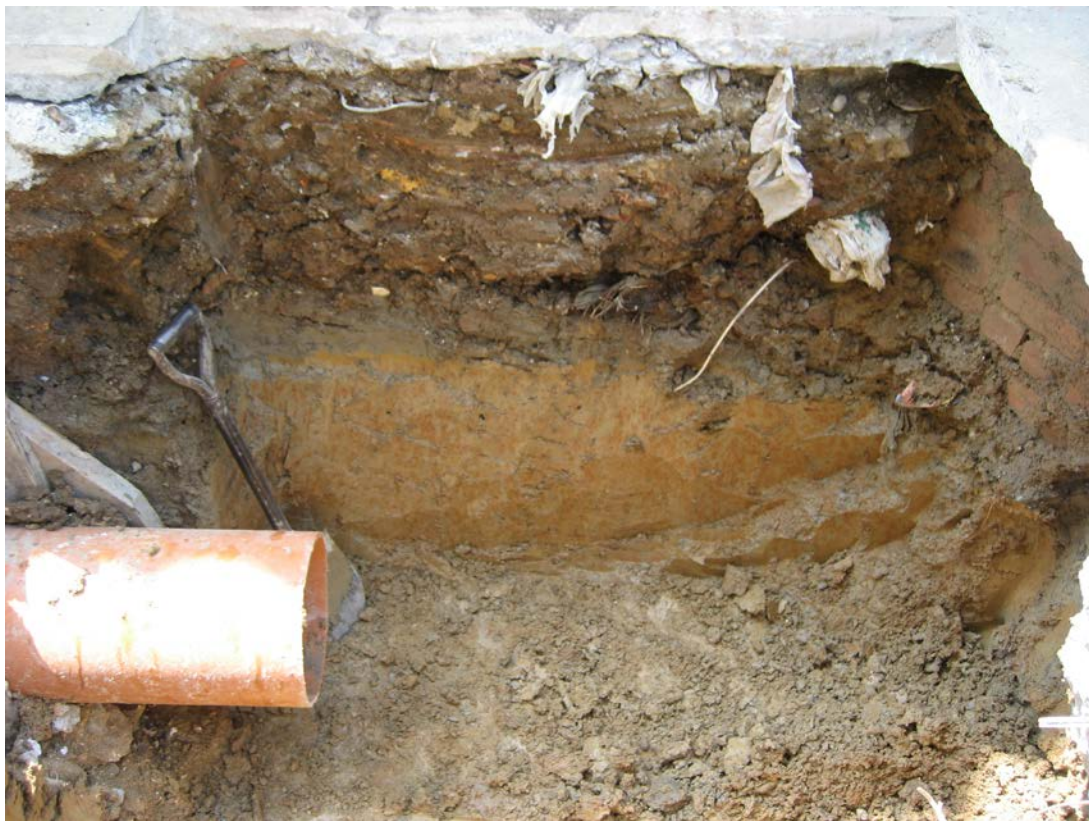
TTT0810 (Facing S)

- 4.2.8 **TTT0810:** This trench is about 1.40 m deep and its strata are the same as in TTT0209, with a blackish modern fill layer under concrete path and with regolith clay deposit further downward (**Plate 4.2**).

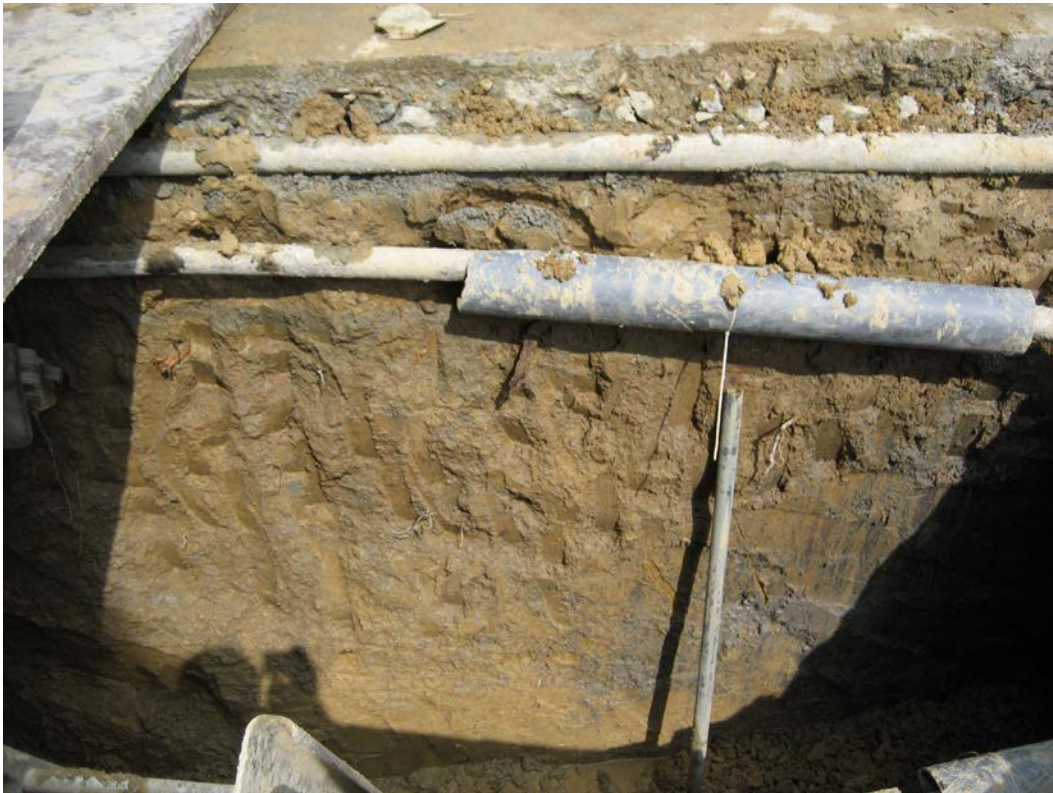
1. TTT0813 (Facing E)

- 4.2.9 **TTT0813:** This trench is approximately 1.90 m deep and reveals three layers. The first layer is the concrete path; the second layer is modern fill of mixed colors with a pipe running through; the bottom layer is a deposit of brownish yellow clay (**Plate 5.1**).

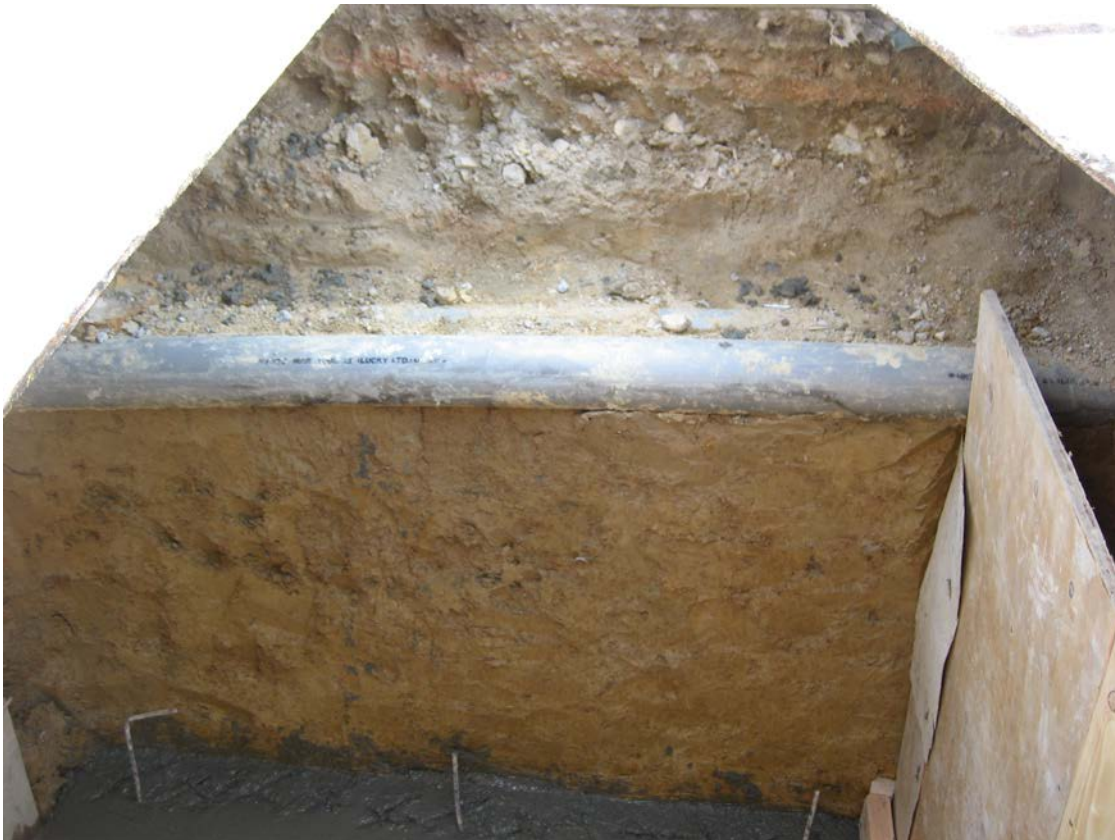
TTT0816 (Facing E)

- 4.2.10 **TTT0816:** This trench is about 1.30 m in depth and reveals three layers. The first layer is the crushed concrete path; the second layer is modern fill of mixed color with a pipe running through; the third and bottom layer is a deposit composed of brownish yellowish clay (**Plate 5.2**).

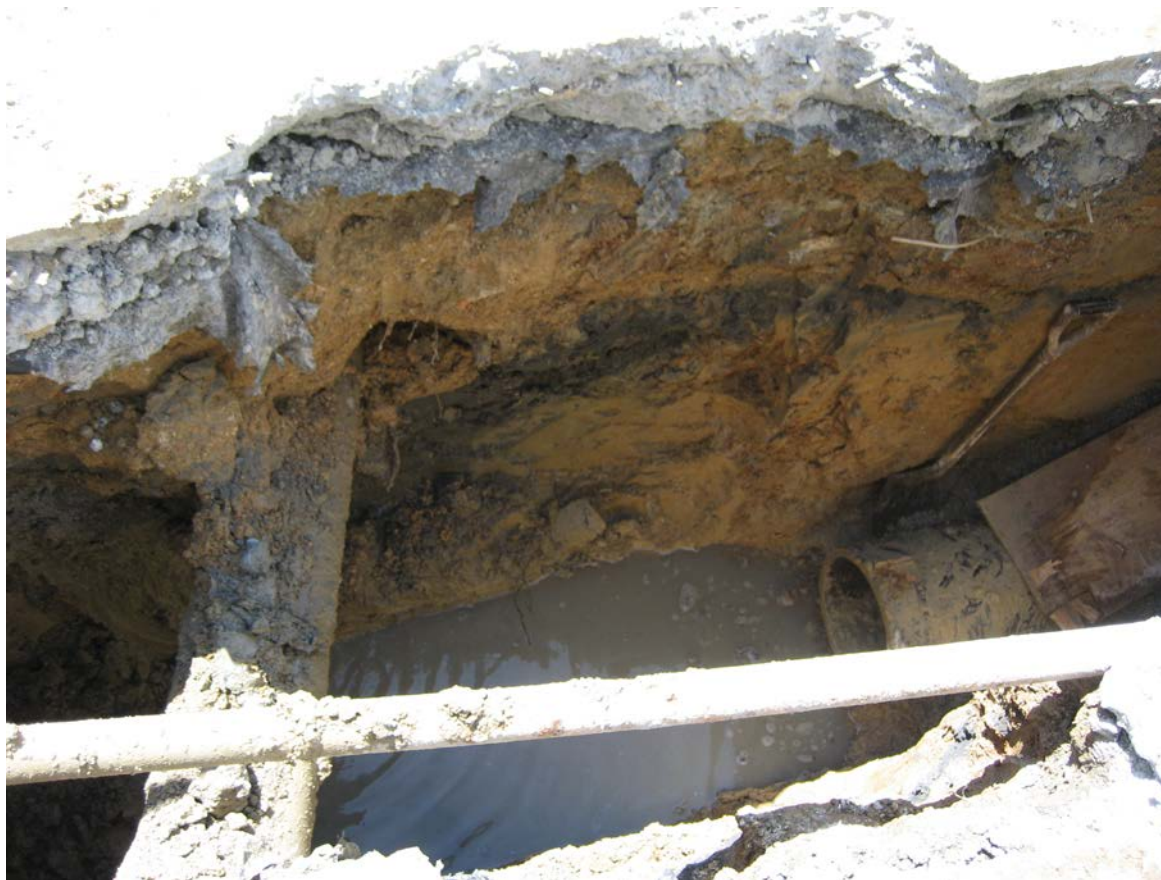
1. TTT0903 (Facing E)

- 4.2.11 **TTT0903:** This trench is about 1.60 m in depth and reveals four layers. The first layer is the concrete path over a bitumen base; the second layer is reddish brown modern fill with cable and iron bar; underneath the fill is a layer of blackish sludge, and the bottom layer is soft yellowish silty clay soaked in water (**Plate 6.1**).

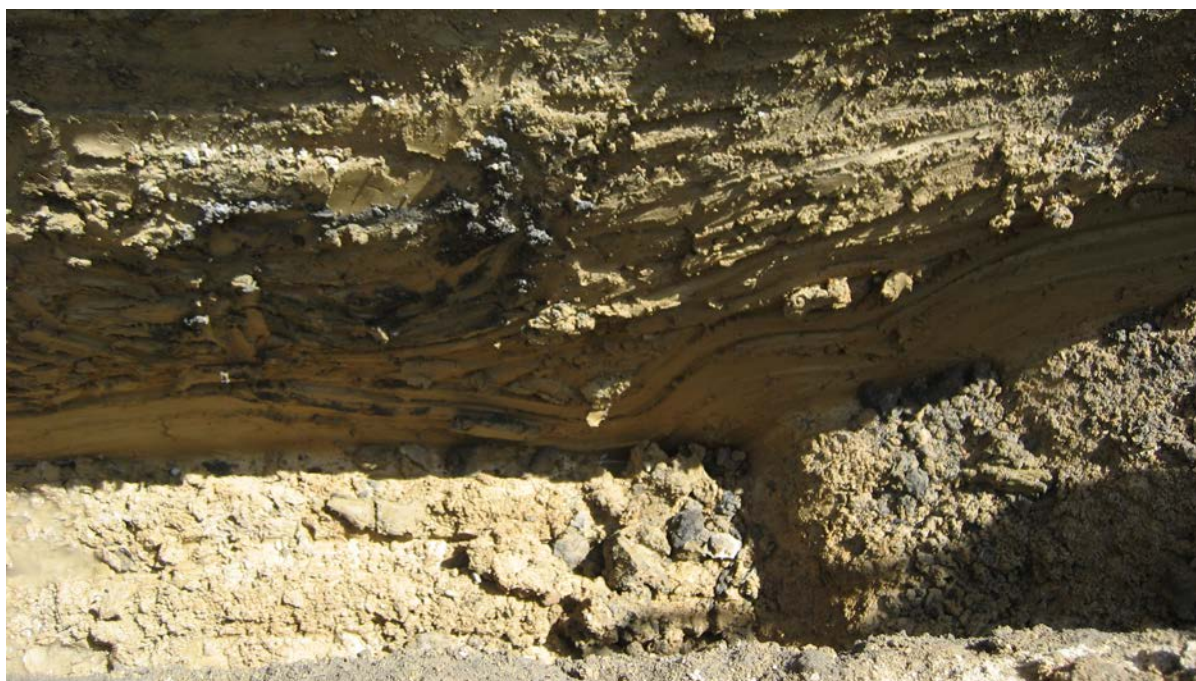
2. TTT1001 (Facing N)

- 4.2.12 **TTT1001:** Three layers are observed in this trench of about 1 metre deep. Under the yellow surface soil is a layer of black modern soil, which is on top of soft yellowish red clay deposit soaked in water (**Plate 6.2**).

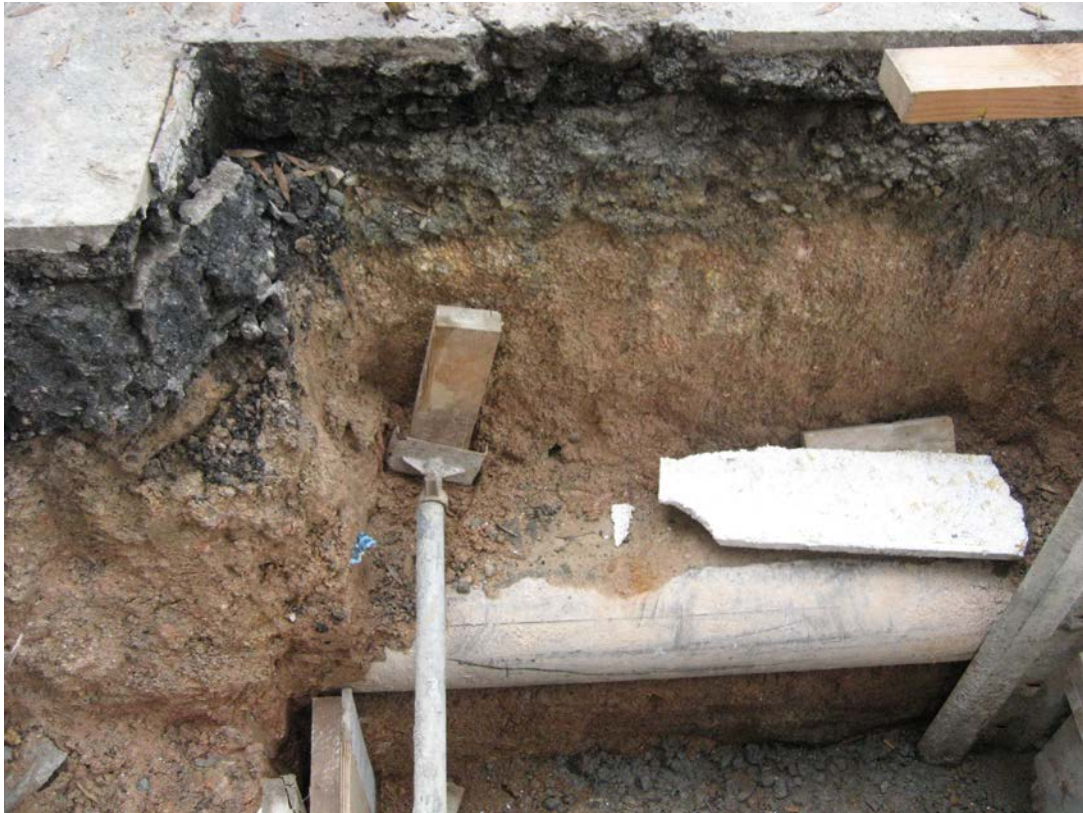
1. TTT2001 (Facing SE)

- 4.2.13 **TTT2001:** This trench is about 1.60 m in depth and reveals two layers. The first layer is the concrete cover with a bitumen base; the second layer is modern fill with a section of steel pipe (**Plate 7.1**).

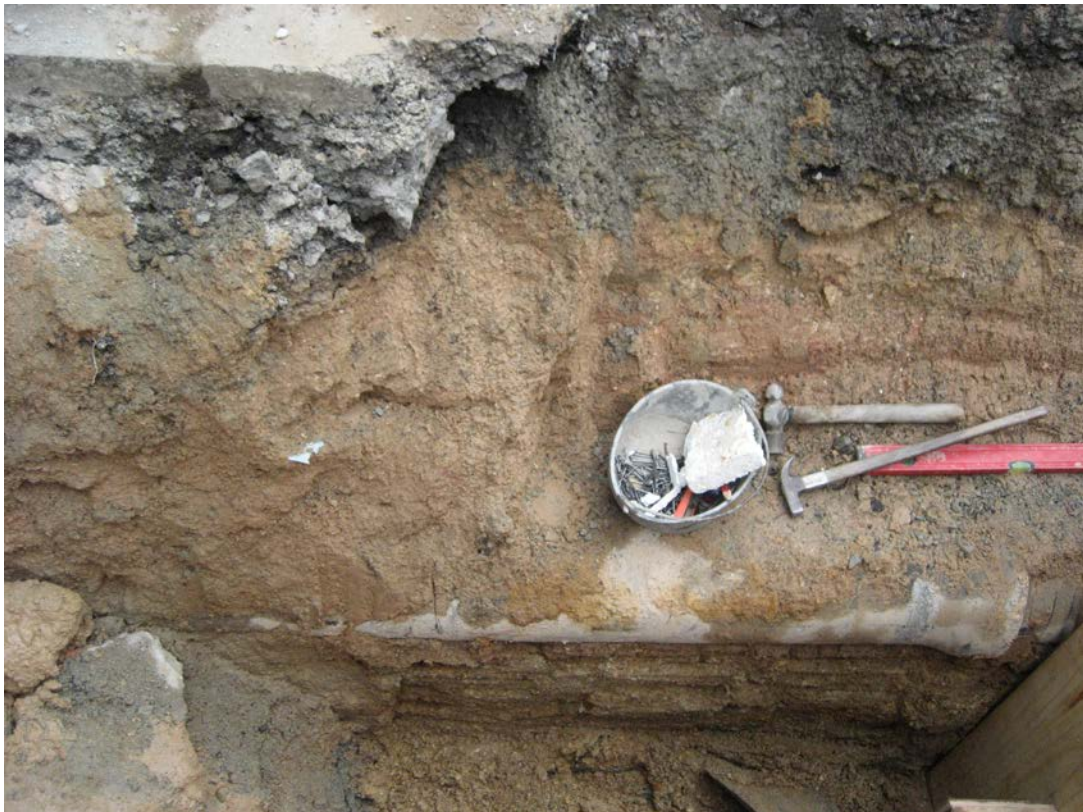
2. TTT2002 (Facing SE)

- 4.2.14 **TTT2002:** This trench is about 1.60 m in depth and reveals two layers. The first layer is the concrete cover with a bitumen base; the second layer is modern fill with a section of steel pipe (**Plate 7.2**).

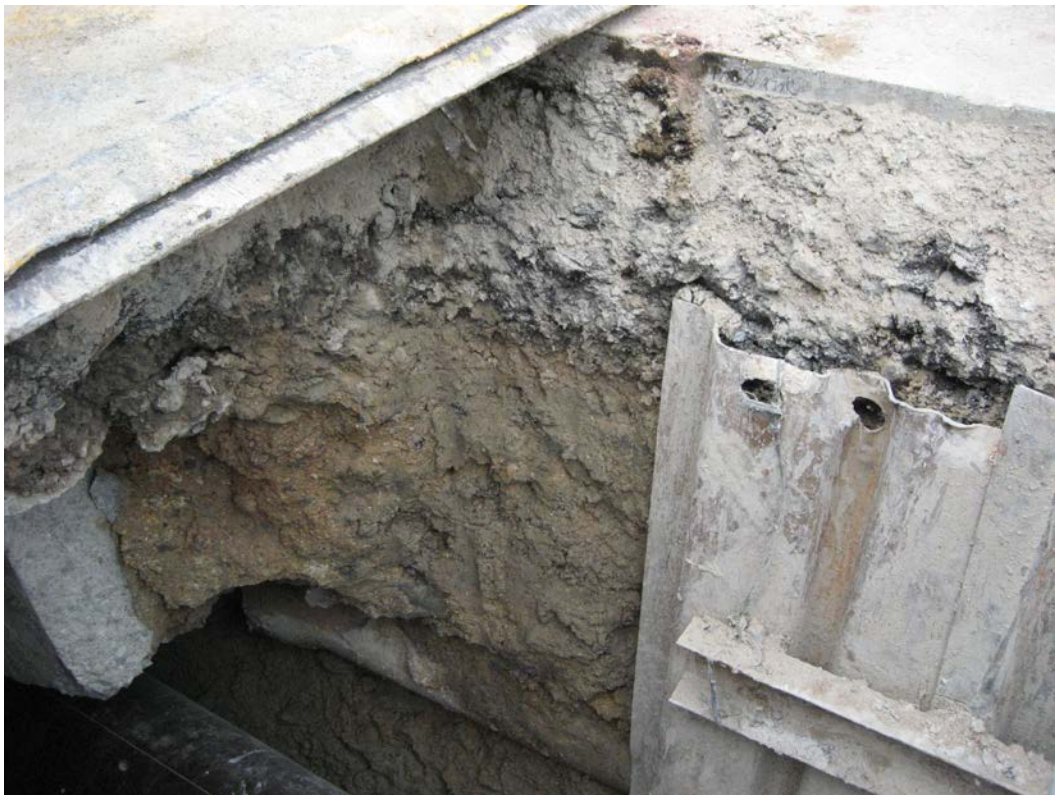
1. TTT2005 (Facing E)

- 4.2.15 **TTT2005:** This trench is about 1.35 m in depth and reveals two layers. The first layer is the concrete path over a bitumen base; the second layer is grayish yellow modern fill with steel pipes and concrete chunks (**Plate 8.1**).

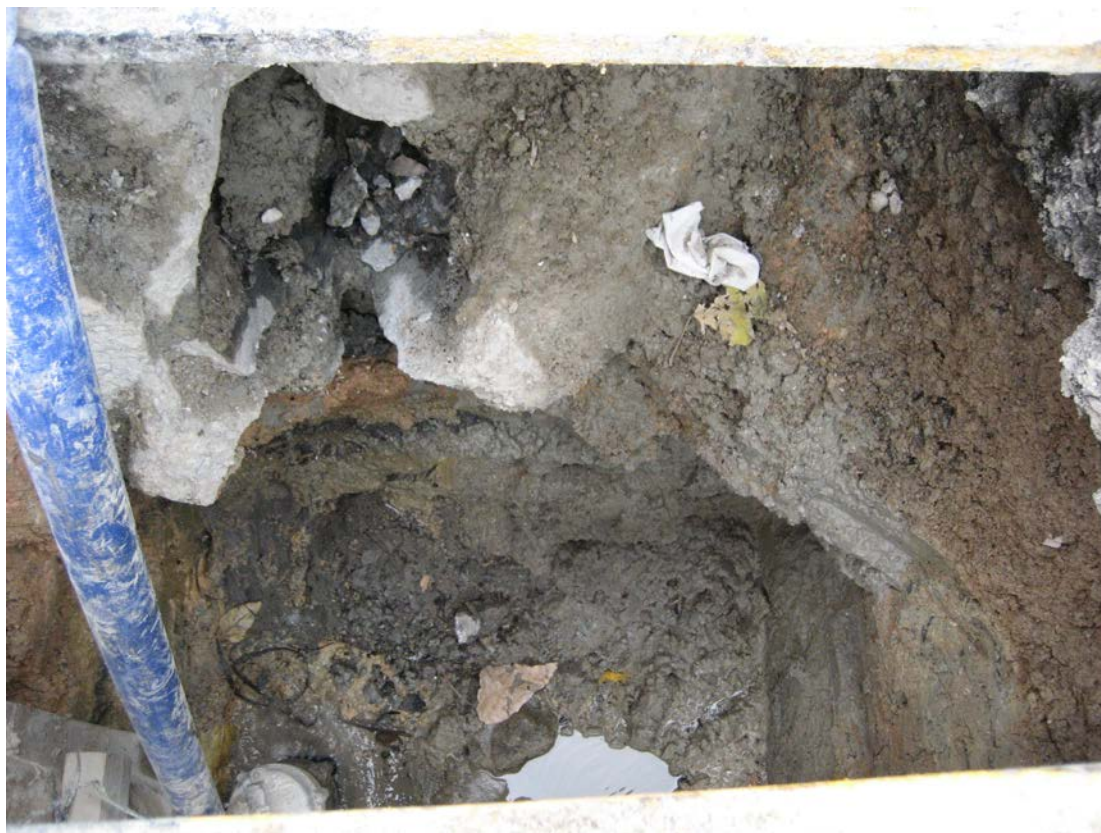
2. TTT2006 (Facing SE)

- 4.2.16 **TTT2006:** This trench is about 1.40 m deep and reveals three layers. The first layer is the concrete path over a bitumen base; the second layer is modern fill of mixed colors with concrete chunks; the third and bottom layer is grayish mud soaked in water (**Plate 8.2**).

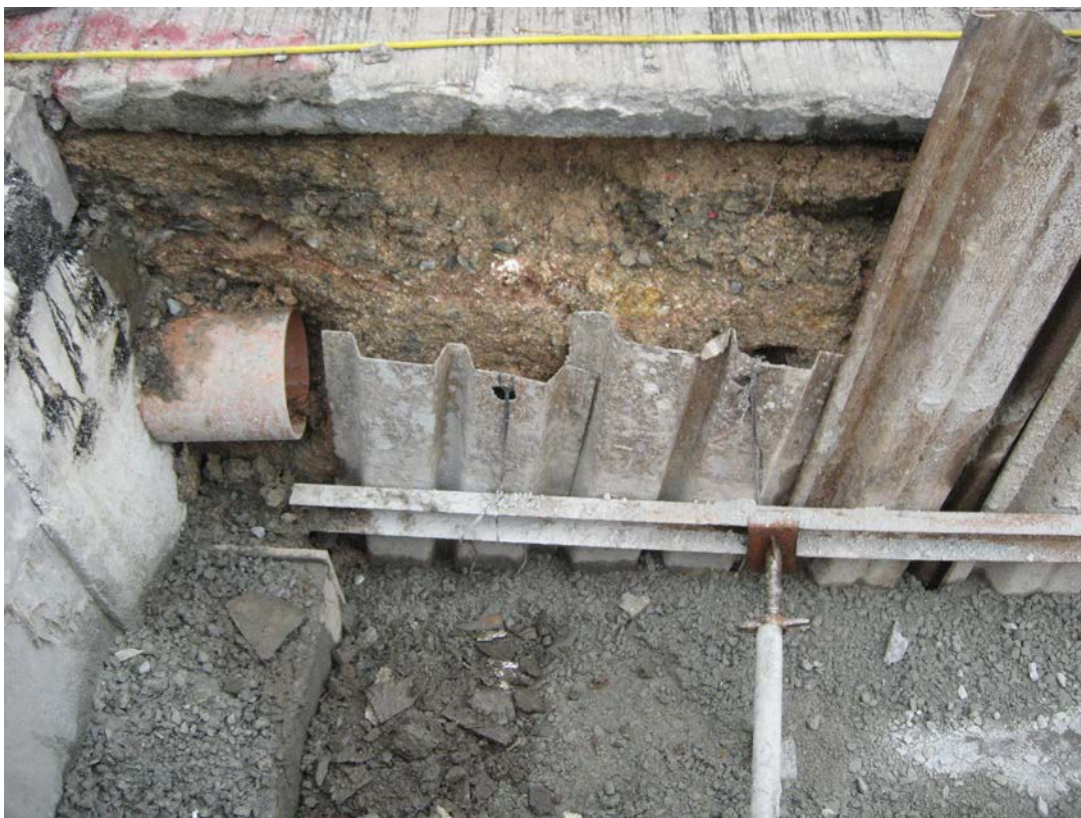
1. TTT2008 (Facing SE)

- 4.2.17 **TTT2008:** This trench on Kiu Hing Road is about 1.80 m in depth and reveals two layers. The first layer is the concrete road cover and the second layer is modern fill of mixed colors (**Plate 9.1**).

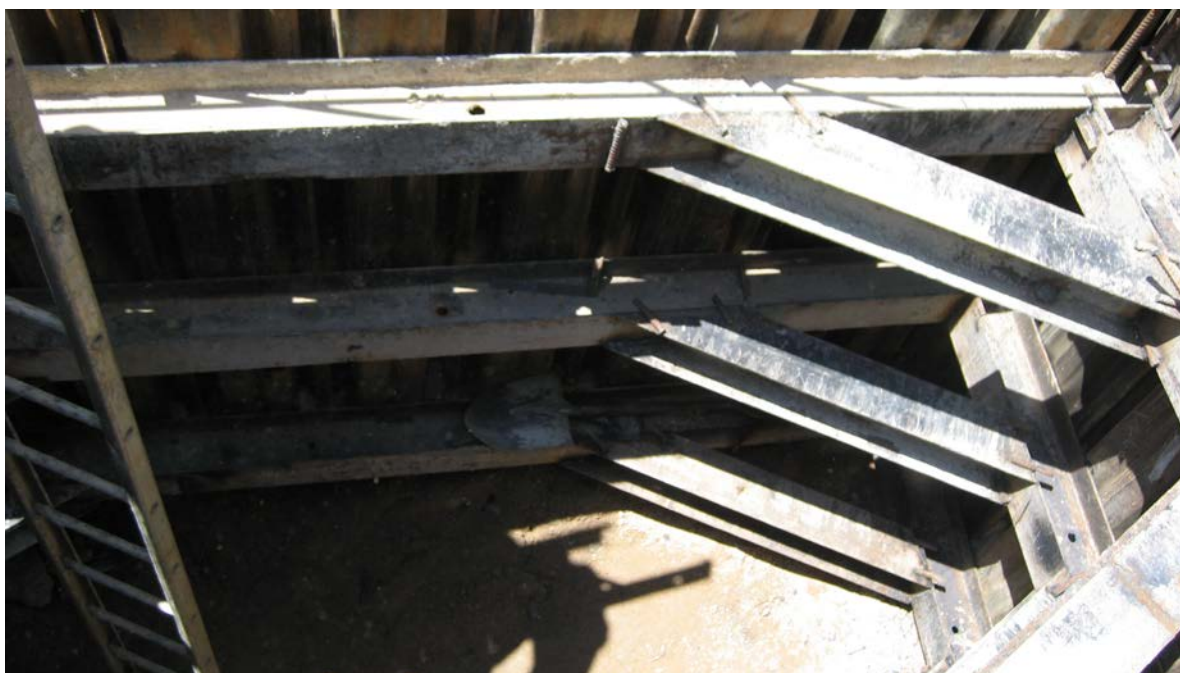
2. TTT2009 (Facing SE)

- 4.2.18 **TTT2009:** Two layers can be observed in this trench of about 1.20 m deep on Kiu Hing Road. The first layer is the concrete road cover over a bitumen base, and the second layer is modern fill mixed with rock fragments (**Plate 9.2**).

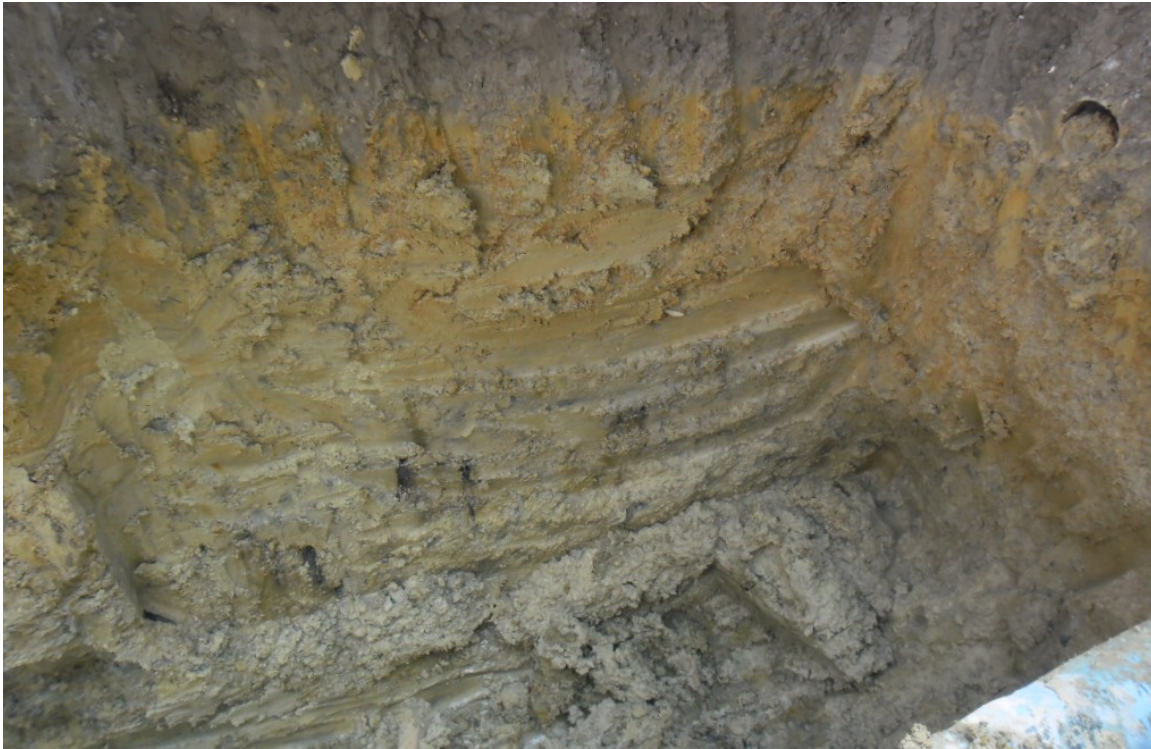
1. TTT2014 (Facing E)

- 4.2.19 **TTT2014:** Four layers can be observed in this trench of about 1.10 m deep. Under the concrete path surface is a blackish modern deposit with a cable; further downward is a sandy deposit which is on top of blackish sludge (**Plate 10.1**).

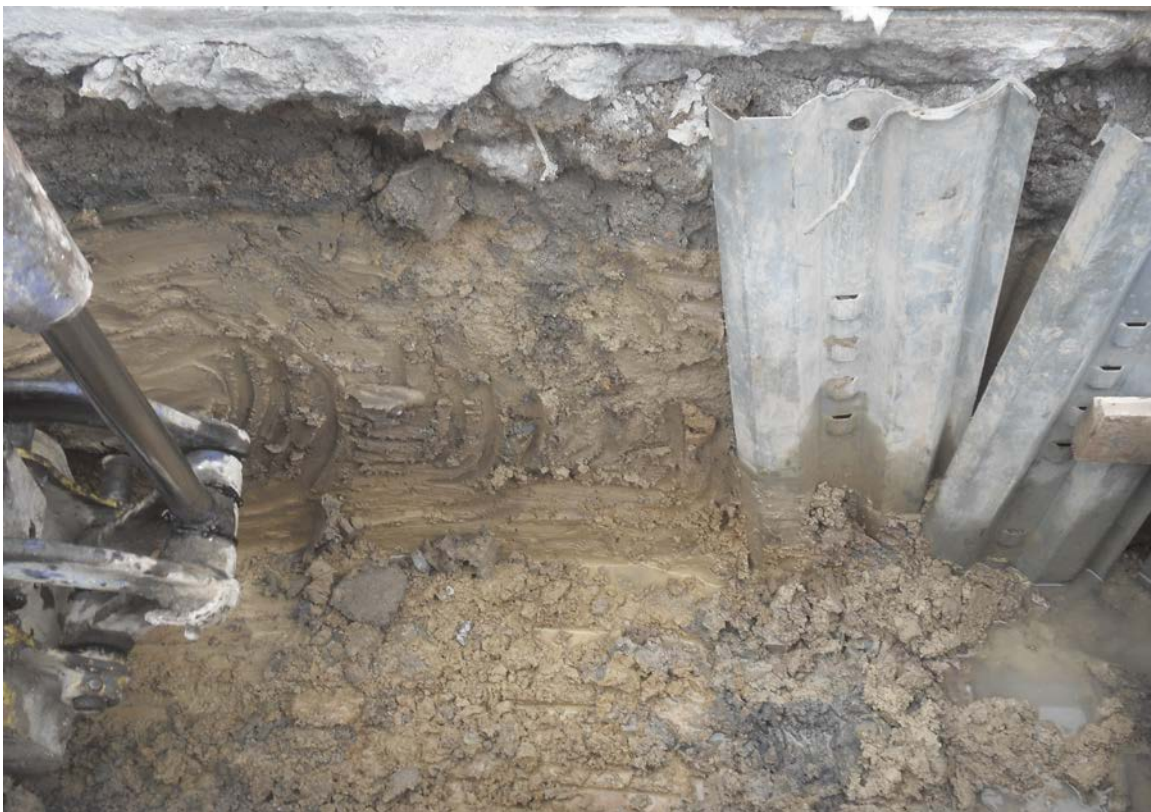
2. TTT2019 (Facing S)

- 4.2.20 **TTT2019:** Two layers can be observed in this trench of about 1.30 m deep. The first layer is light black surface soil with concrete path cover and the second layer is light brown sandy silt soaked in water (**Plate 10.2**).

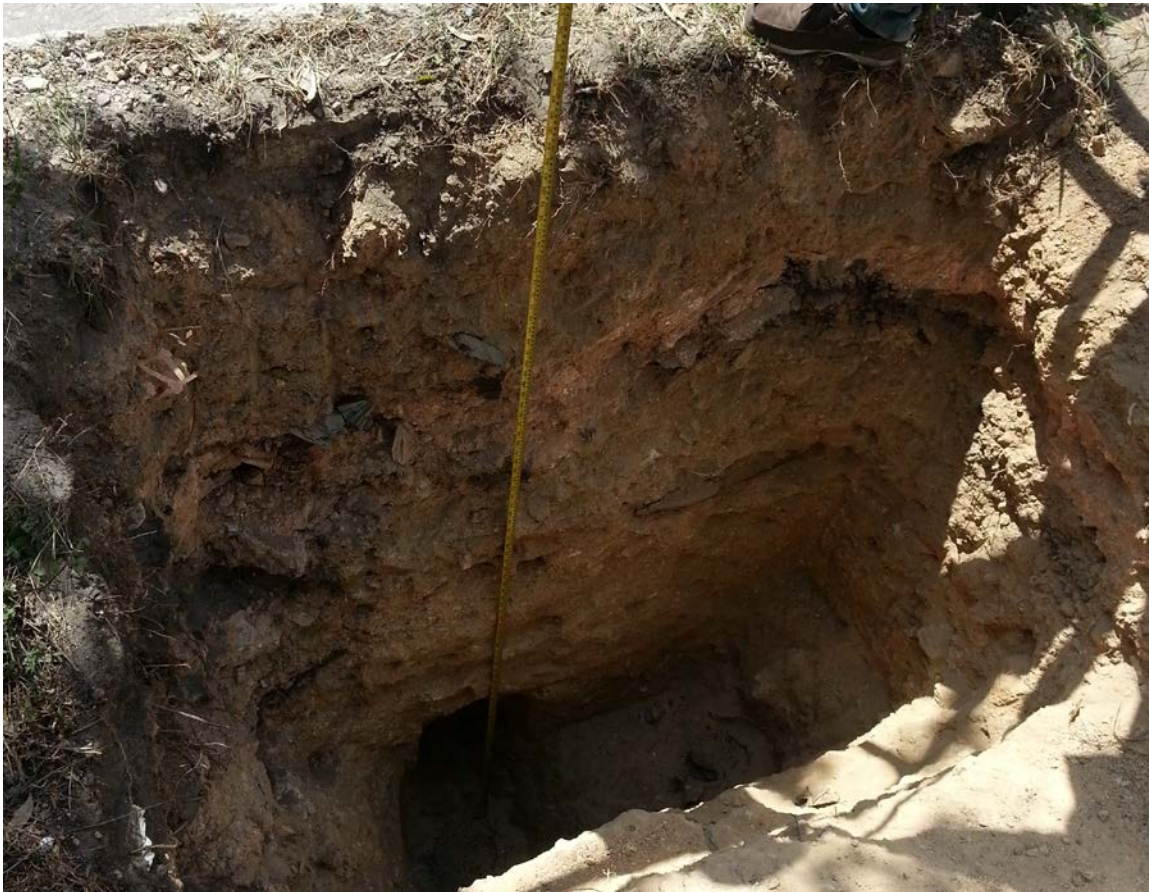
1. TTT2028 (Facing S)

- 4.2.21 **TTT2028:** This trench is dug about 2.40 metre deep from the surface. Under the black surface soil is a slope deposit of modern fill, which cuts into the bottom layer of reddish regolith clay (**Plate 11.1**).

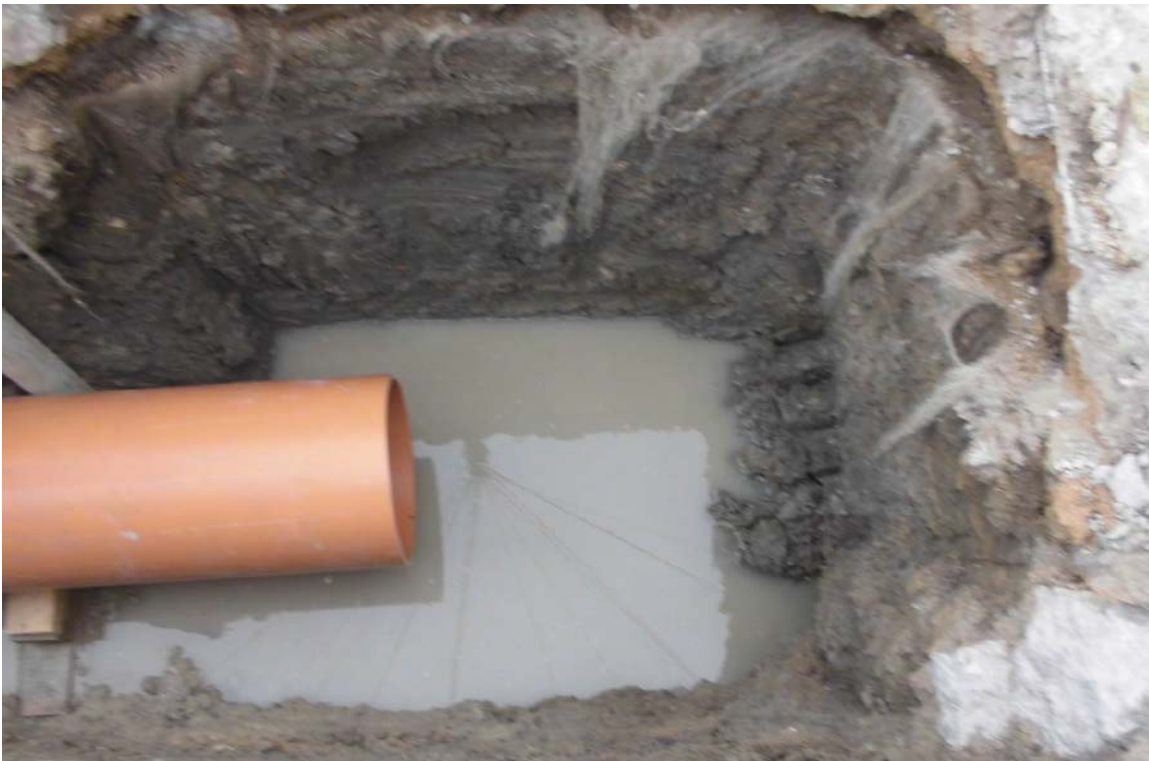
2. TTT2031 (Facing E)

- 4.2.22 **TTT2031:** Two layers can be observed in this trench of about 1 metre deep. The first layer is surface soil with concrete path cover and the second layer is black sludge deposit soaked in water (**Plate 11.2**).
