Contract No. DC/2012/05

**Sewerage at Yuen Long Kau Hui and Shap Pat Heung
(Sewerage Works at Portion B – Tai Tong Tsuen)**

Archaeological Watching Brief
Final Report

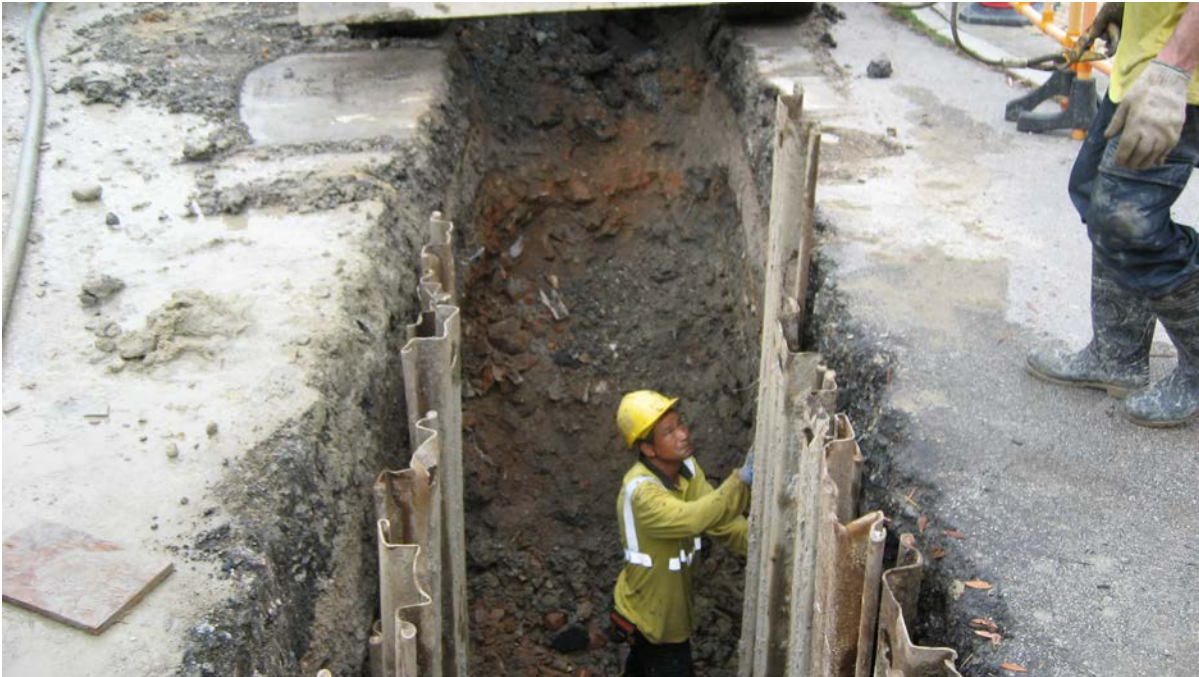
1. TTT2034 (Facing NE)

- 4.2.23 **TTT2034:** This trench is dug about 2.50 m deep from the surface. Under the concrete road cover is all fill from road construction with bricks and boulders (**Plate 12.1**).

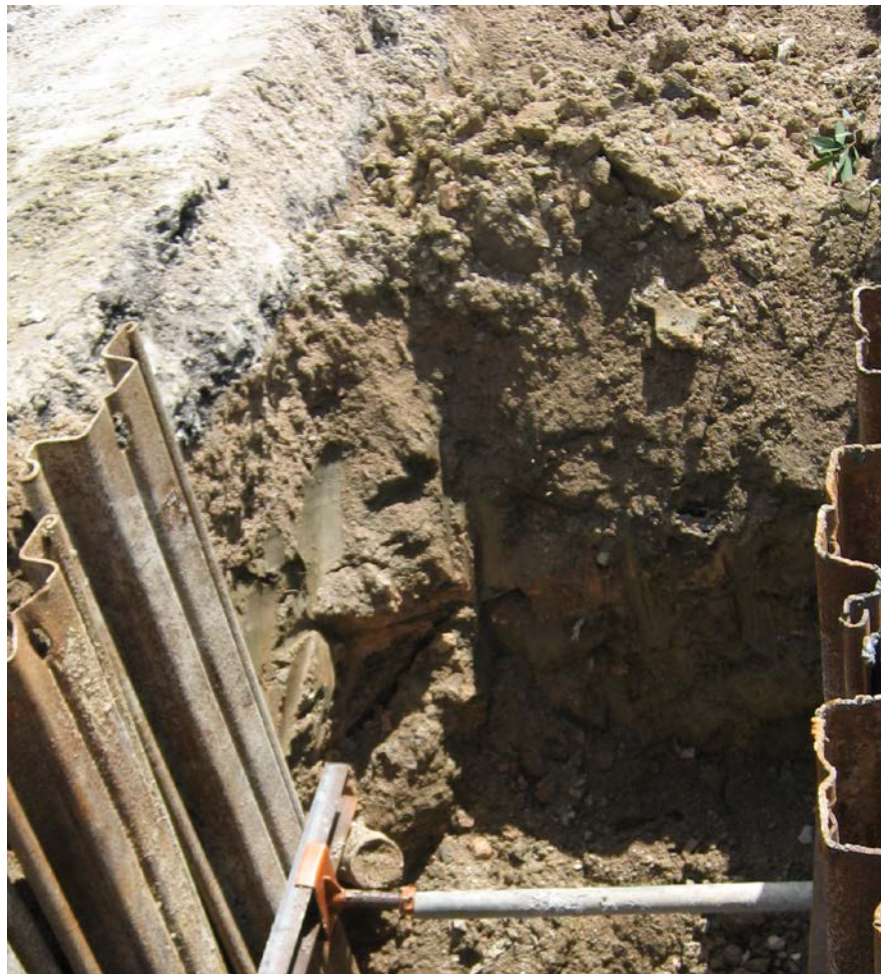
2. TTT2036 (Facing NE)

- 4.2.24 **TTT2036:** Two layers can be observed in this trench of about 1.50 m deep on Shui Tsiu San Tsuen Road. The first layer is concrete path cover over a bitumen base; the second layer is modern fill mixed with broken bricks and rocks (**Plate 12.2**).

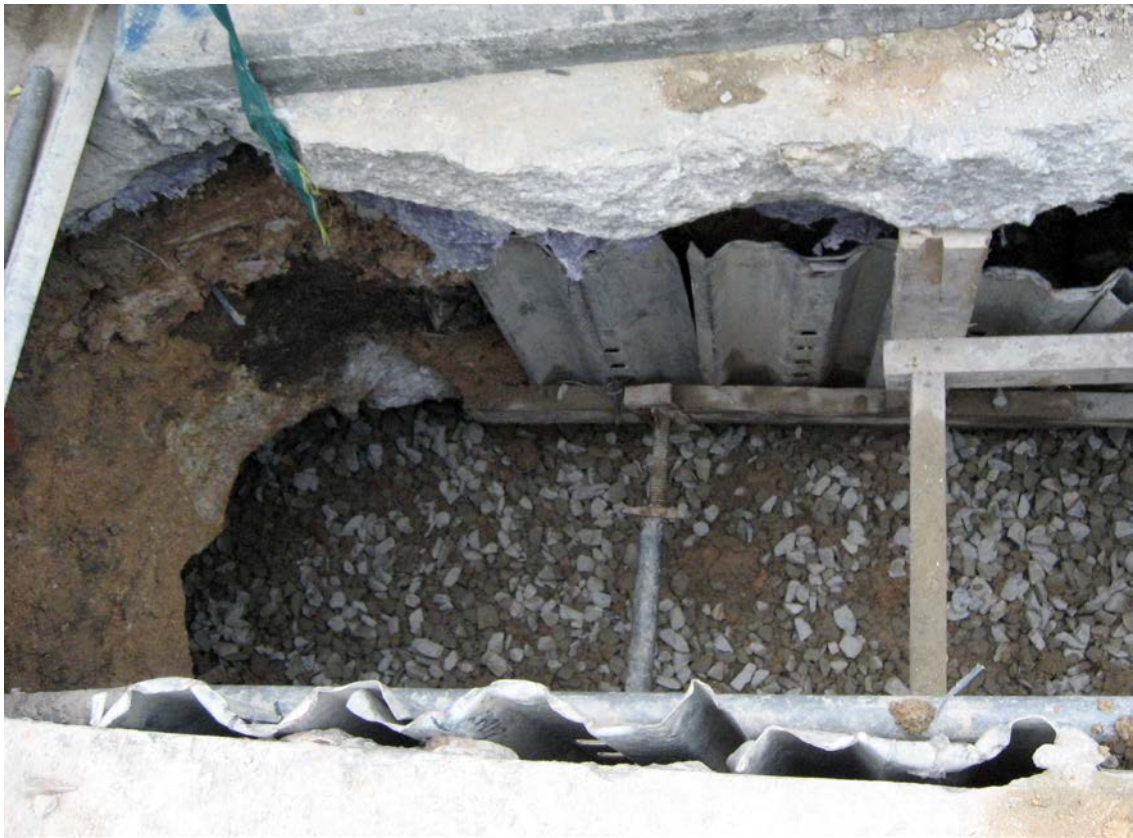
1. TTT2708 (Facing E)

- 4.2.25 **TTT2708:** This trench is adjusted its location from the original alignment across the street. This trench is about 1.50 m in depth and reveals two layers. The first layer is the concrete road surface and the second layer is modern fill (**Plate 13.1**).

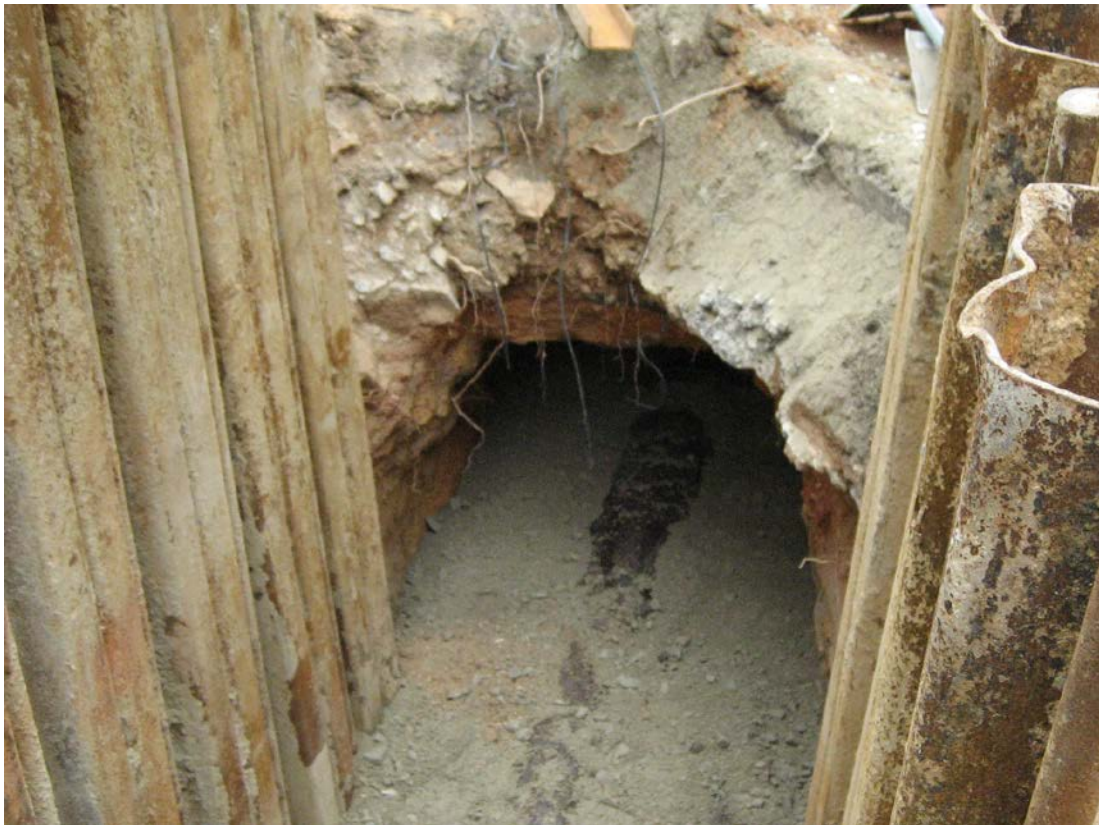
2. TTT2712 (Facing NE)

- 4.2.26 **TTT2712:** This trench is about 1.20 m in depth and reveals three layers. The first layer is the concrete path over a bitumen base, the second layer is the modern fill with broken rocks, and the bottom layer is a regolith deposit composed of reddish clay (**Plate 13.2**).

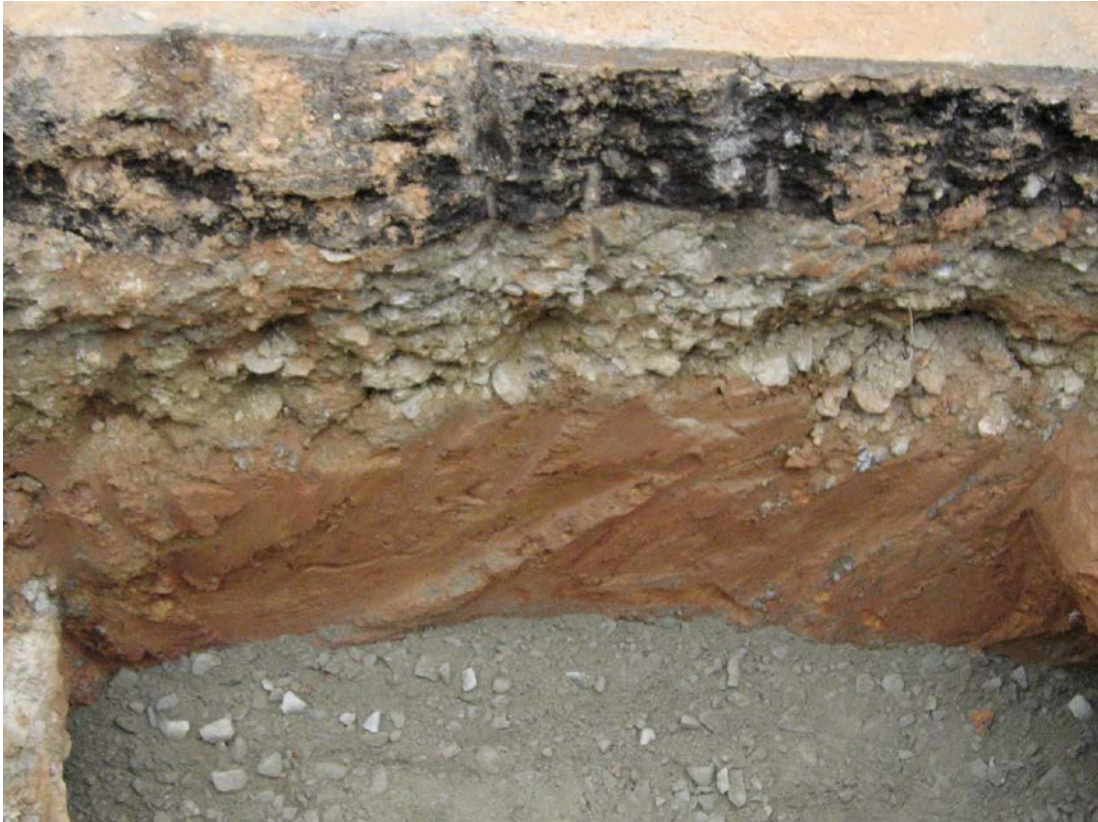
1. TTT3302 (Facing N)

- 4.2.27 **TTT3302:** This trench is about 1.10 m in depth and reveals three layers. The first layer is the concrete path over a bitumen base; the second layer is the modern fill with broken boulders; the bottom layer is a regolith deposit composed of reddish clay (**Plate 14.1**).

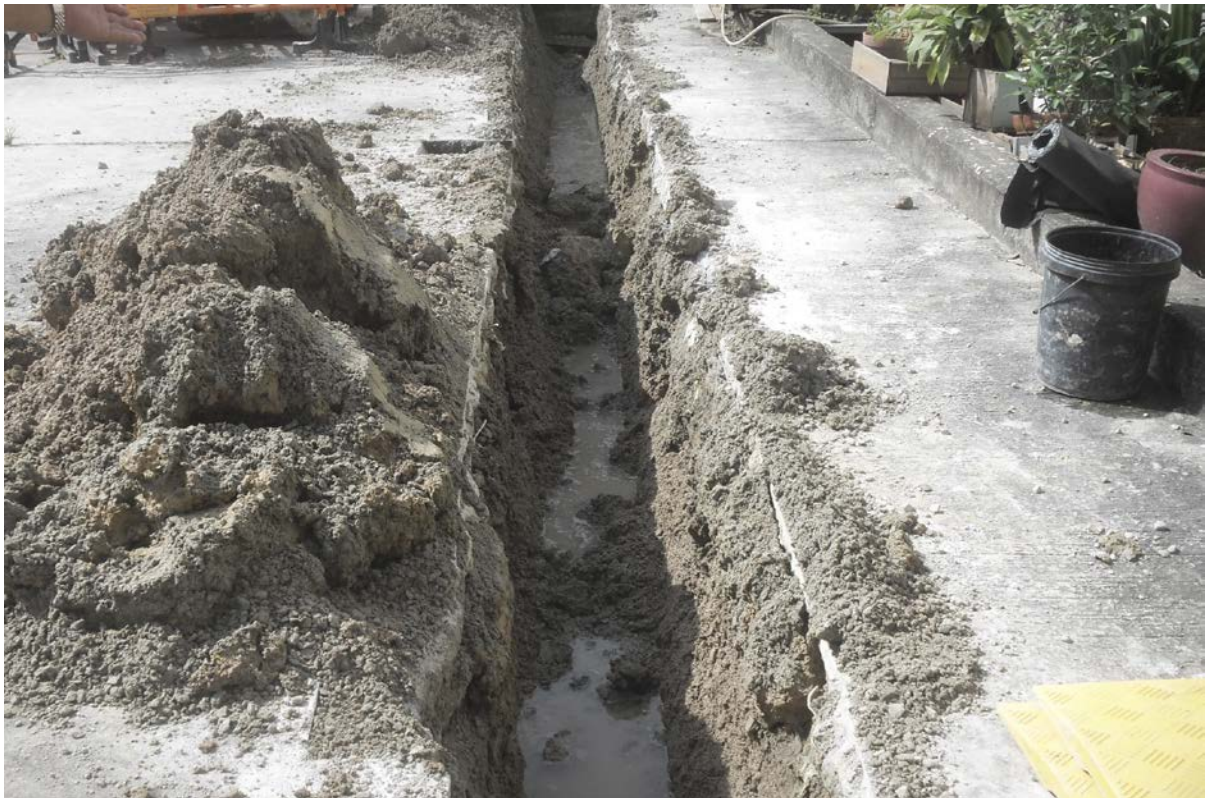
2. TTT3802 (Facing NW)

- 4.2.28 **TTT3802:** Two layers are observed in this trench of about 0.80 m deep. Under the surface layer is a silty deposit of modern fill (**Plate 14.2**).

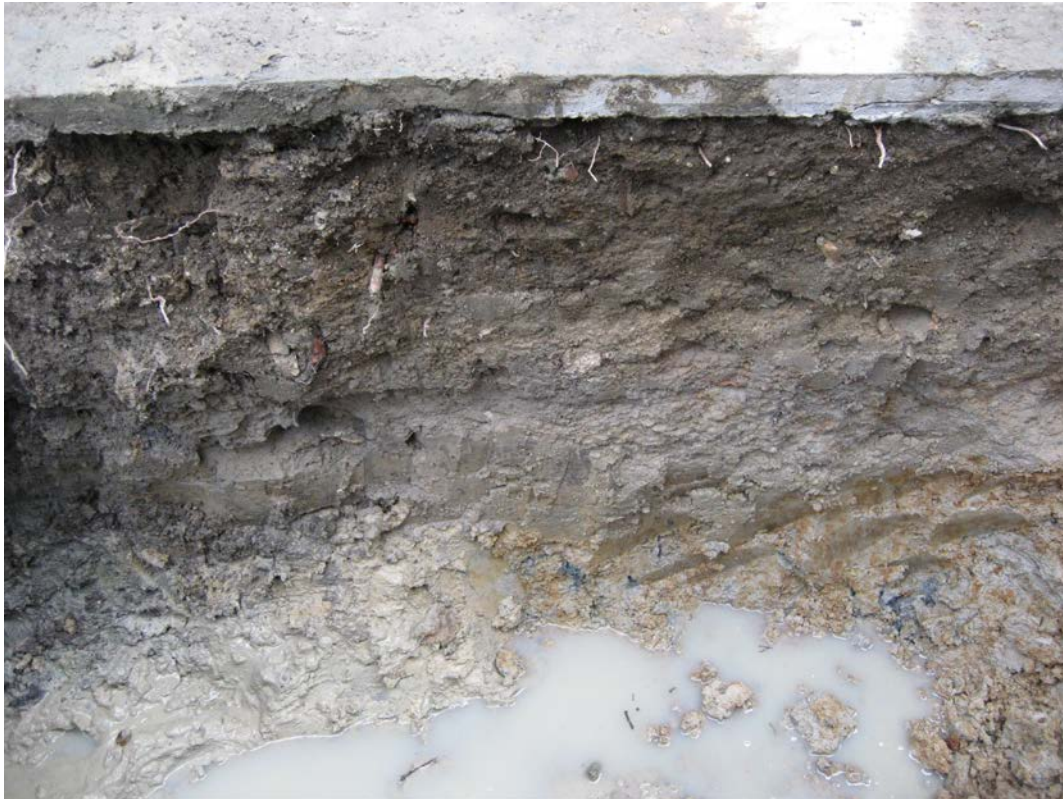
1. TTT4511 (Facing NW)

- 4.2.29 **TTT4511:** This trench is about 1.10 m deep and reveals three layers. The first layer is the concrete path over a blackish base; the second layer is a fill deposit of soft clay; the bottom layer is a deposit of grayish yellow sludge soaked in water (**Plate 15.1**).

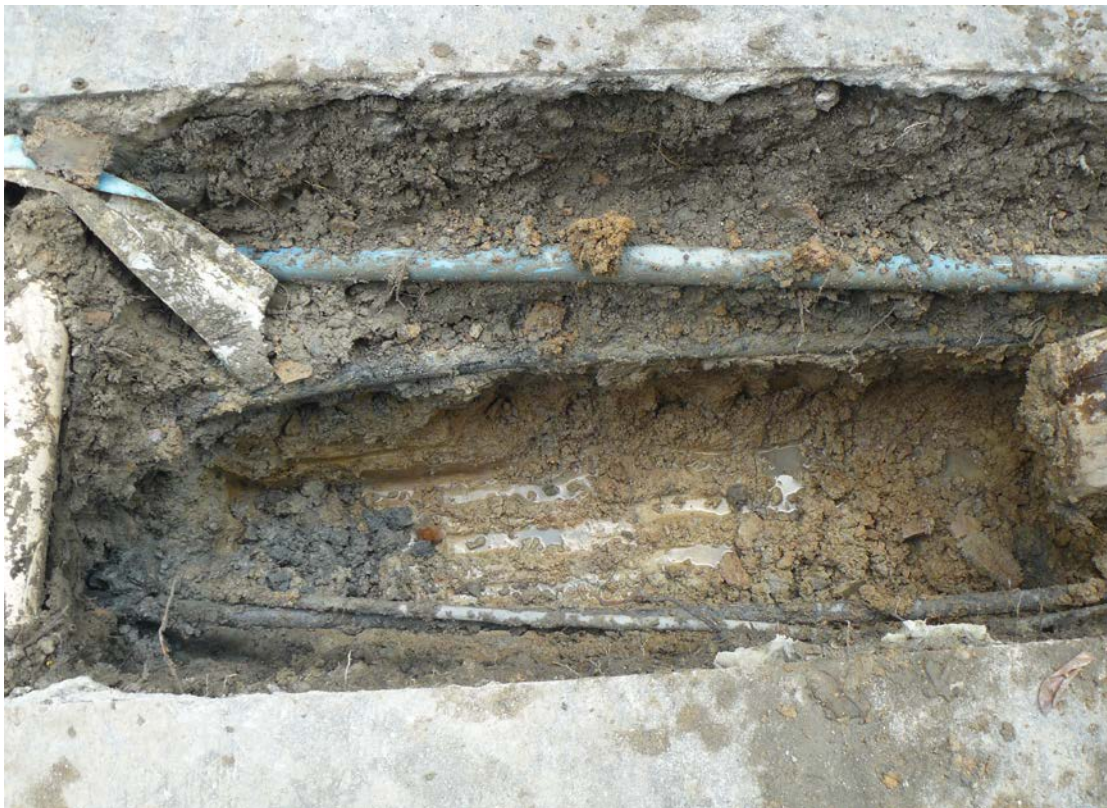
2. TTT4512 (Facing SE)

- 4.2.30 **TTT4512:** Three layers are observed in this trench of about 1 metre deep. Under the surface layer is a modern deposit of gray sludge, with pipes and cables running through the deposit. At the bottom is a deposit characterized by yellow silt mixed with red clay flecks (**Plate 15.2**).

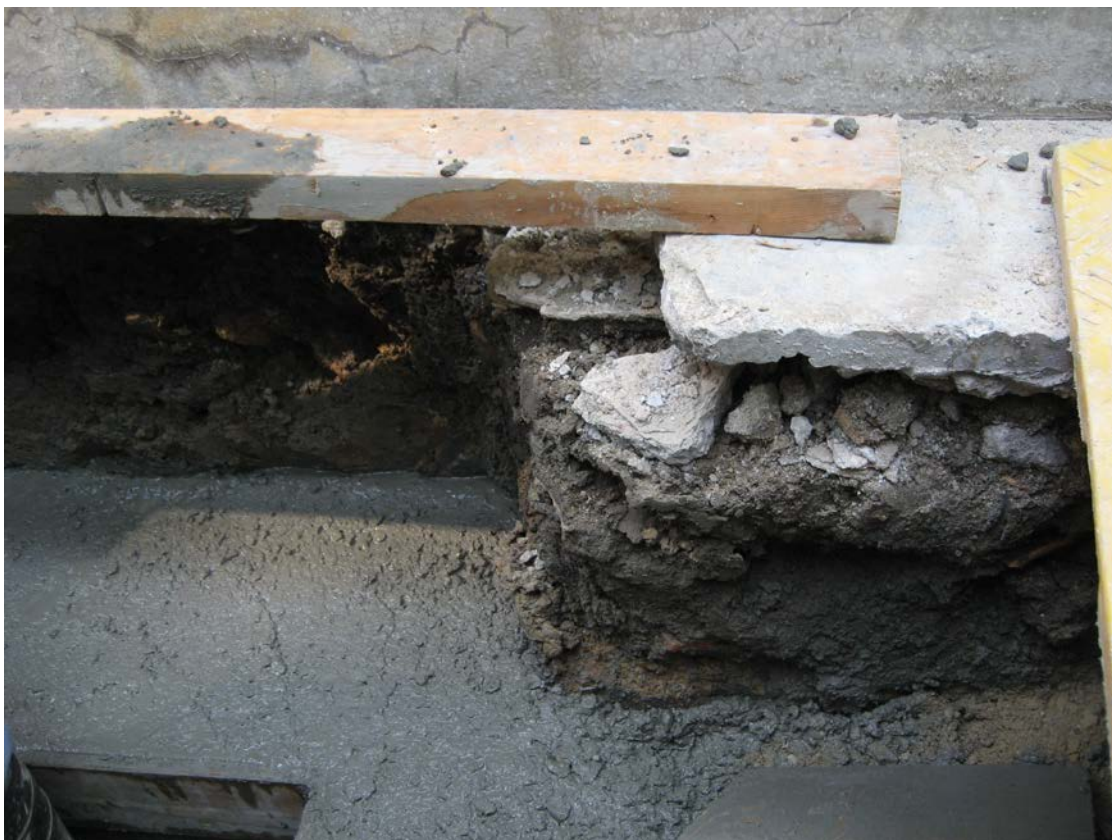
1. TTT4516 (Facing SE)

- 4.2.31 **TTT4516:** This trench is about 1.00 m deep and reveals two layers. The first layer is the concrete path; underneath the path is a blackish deposit of modern fill, which is being molded with a concrete platform at the bottom (**Plate 16.1**).

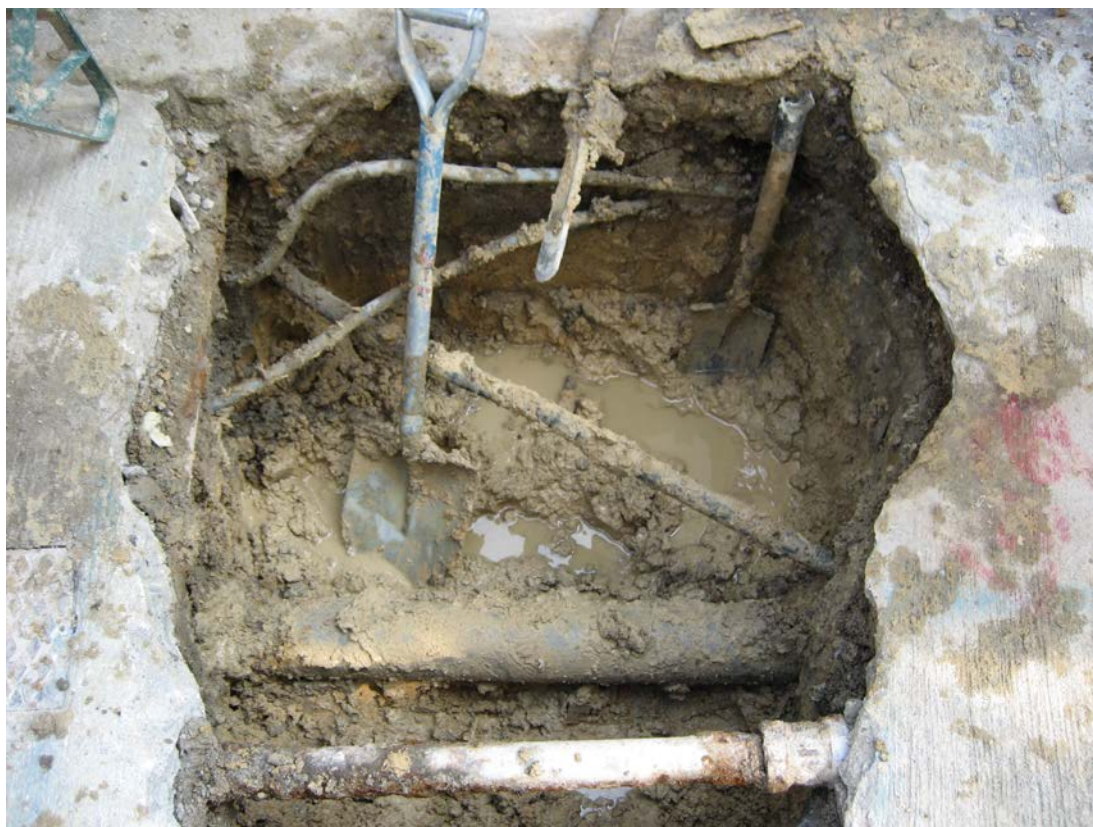
2. TTT4518 (Facing SE)

- 4.2.32 **TTT4518:** This trench is about 1.00 m deep and reveals three layers. The first layer is the concrete path; the second layer is a blackish deposit of modern fill with cable and metal pipe; the bottom layer is a light brownish deposit of sludge with steel pipe soaked in water (**Plate 16.2**).

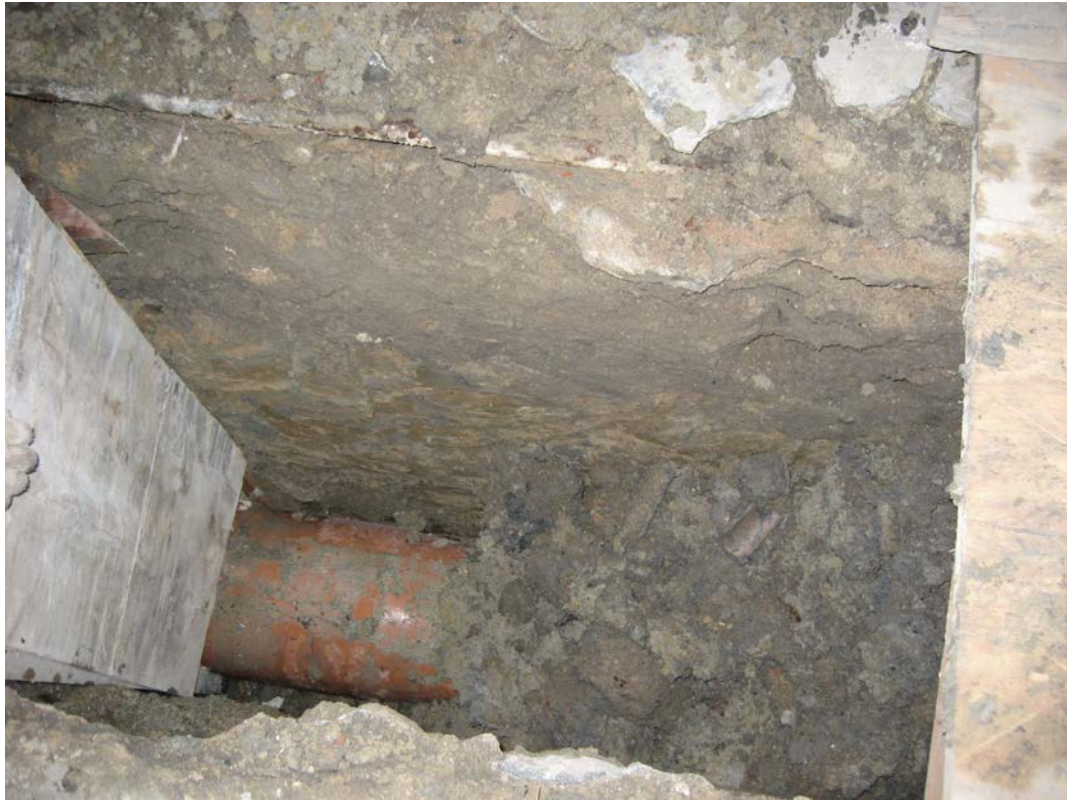
1. TTT4527 (Facing NW)

- 4.2.33 **TTT4527:** This trench is about 1.70 m deep and reveals three layers. The first layer is the concrete path over blackish fill with a metal pipe at the bottom; the second layer is a thick fill deposit of soft clay; the third and bottom layer is a deposit of grayish yellow sludge (**Plate 17.1**).

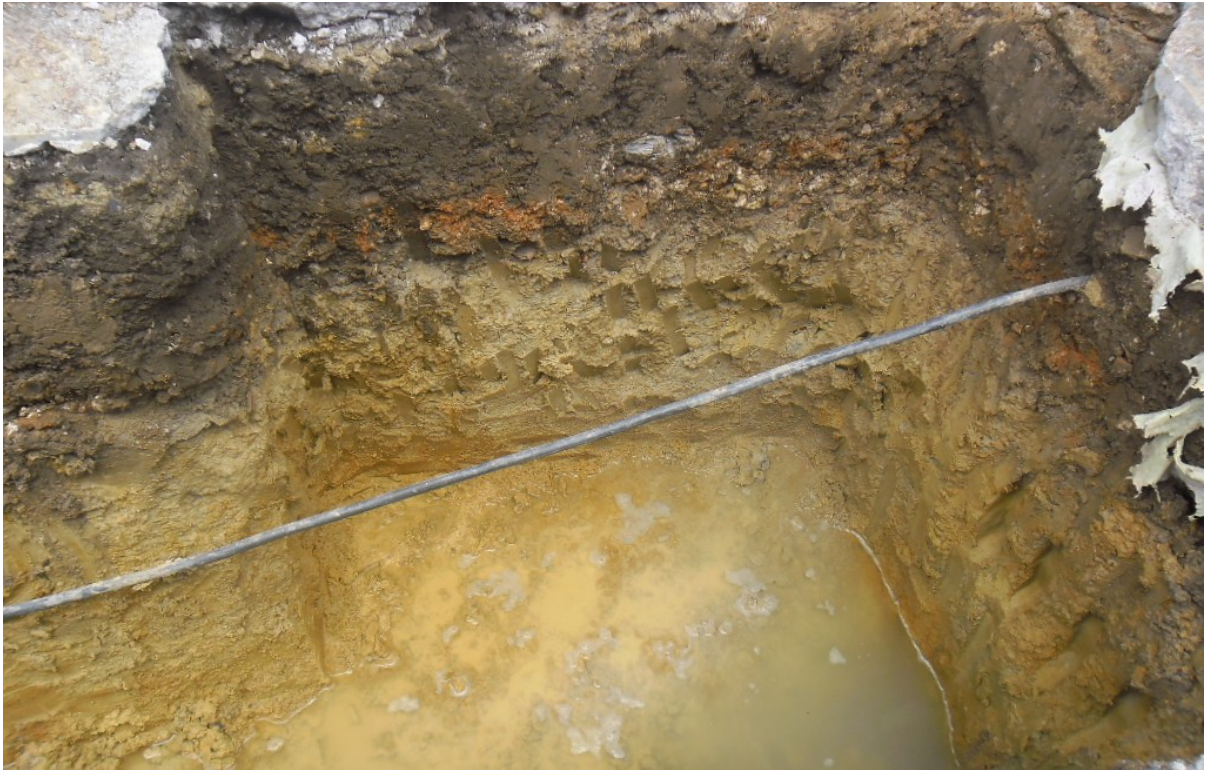
2. TTT4532 (Facing S)

- 4.2.34 **TTT4532:** Three layers are observed in this trench of about 1.50 m deep. Under the surface concrete cover is a modern deposit with a section of cable, and the modern deposit overlaps a layer of soft yellow clay deposit soaked in water (**Plate 17.2**).

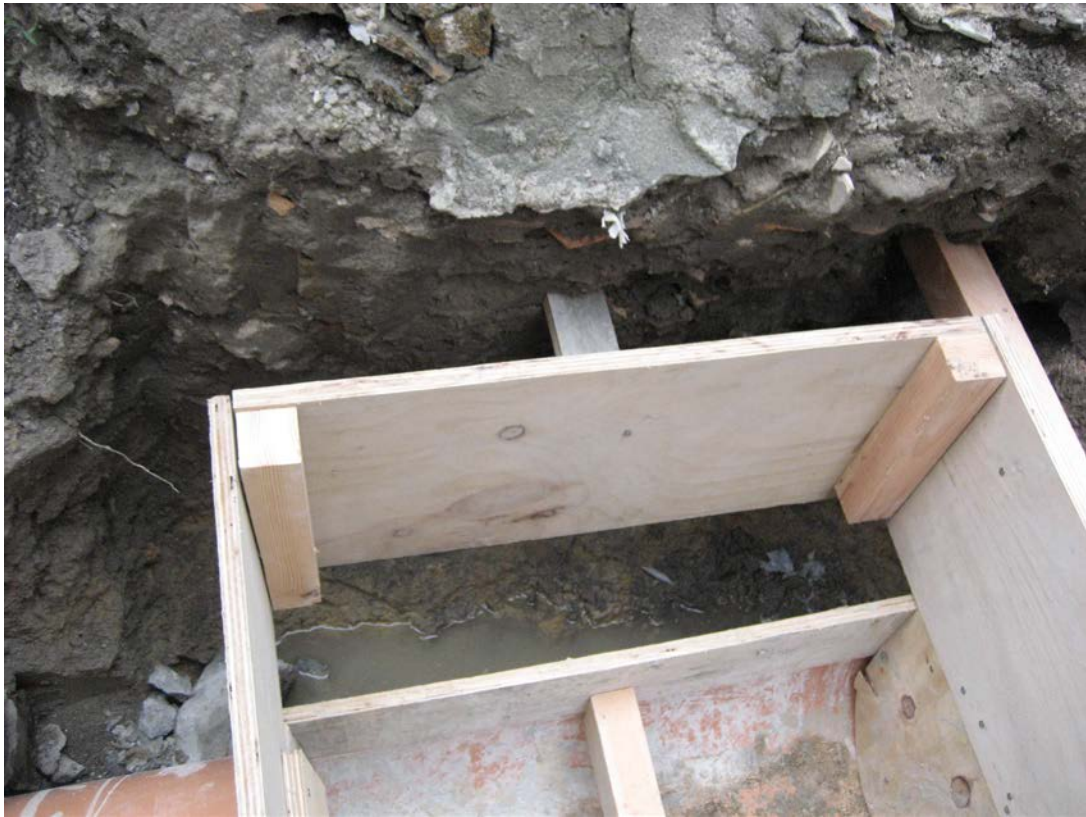
1. TTT4601 (Facing N)

- 4.2.35 **TTT4601:** This trench is about 1.10 m deep and reveals three layers. The first layer is the concrete path over blackish fill; the second layer is a fill deposit with rocks and bricks; the bottom layer is a deposit of grayish yellow sludge soaked in water (**Plate 18.1**).

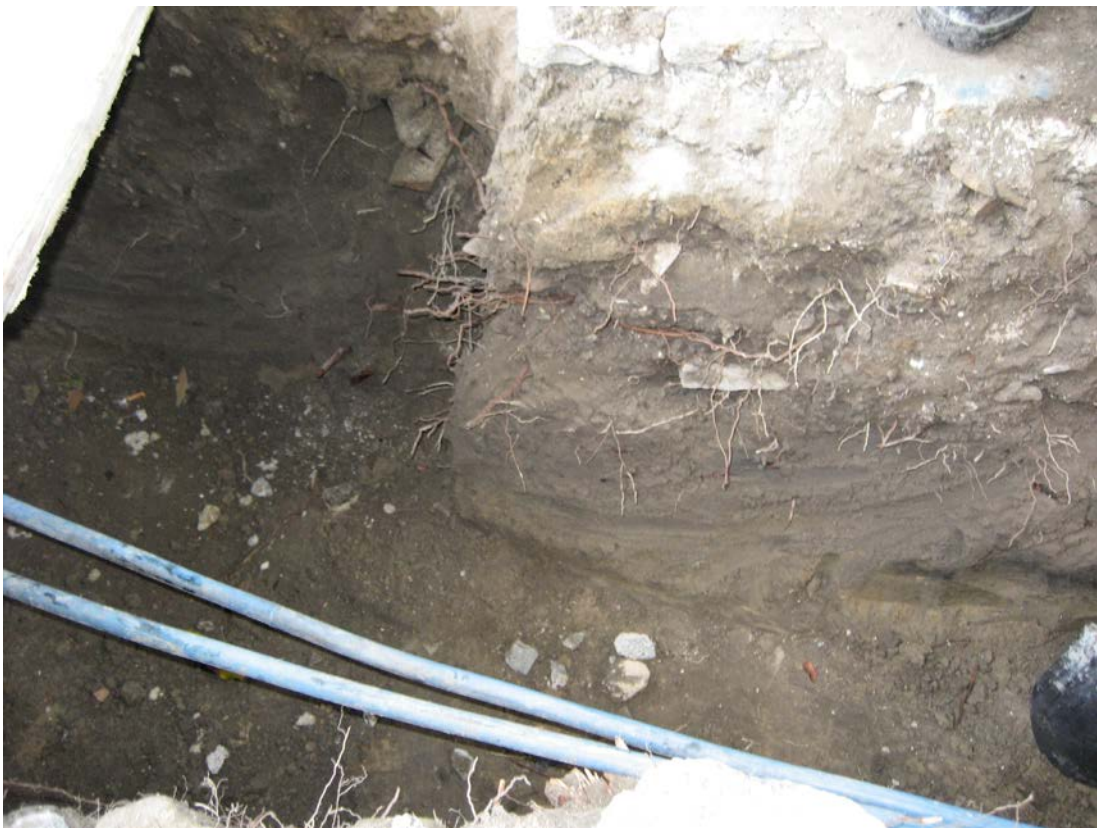
2. TTT4903 (Facing N)

- 4.2.36 **TTT4903:** This trench is about 1.00 m deep and reveals three layers. The first layer is the concrete path; the second layer is a light blackish deposit of modern fill with plant roots; the third and bottom layer is also a modern fill mixed with modern rubbish (**Plate 18.2**).

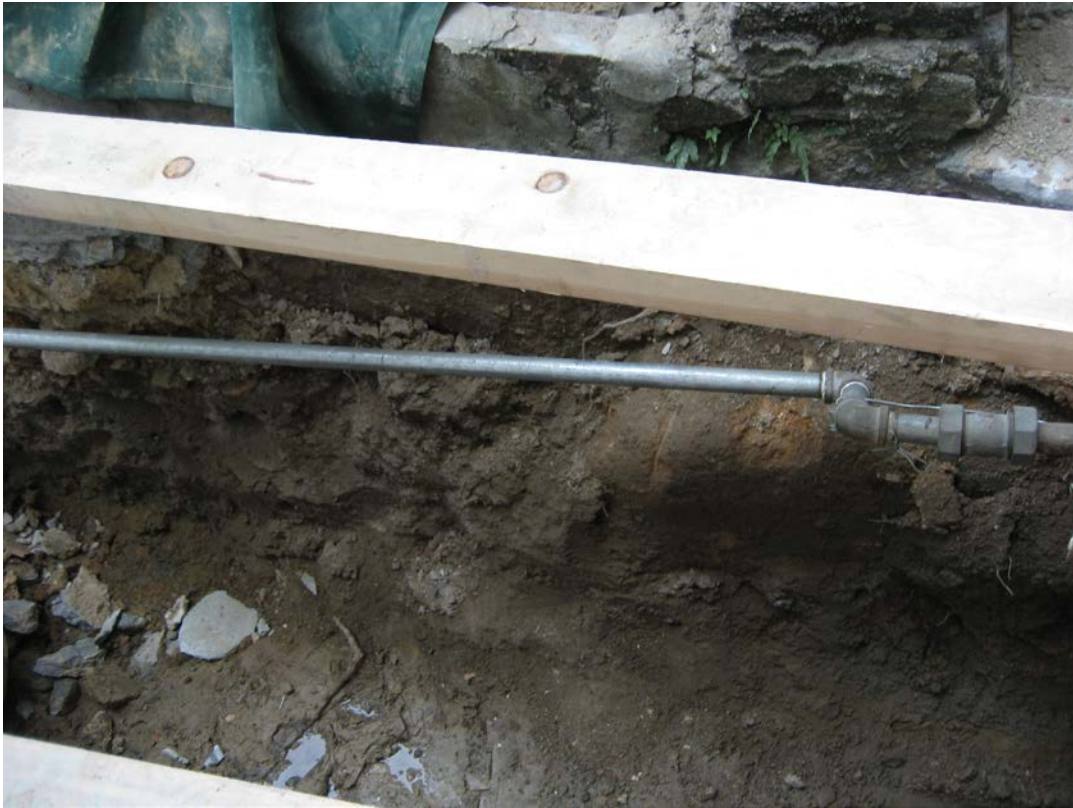
1. TTT5202 (Facing SE)

- 4.2.37 **TTT5202:** This trench is about 1.00 m in depth and reveals three layers. The first layer is the concrete path over light black surface soil; the second layer is grayish black modern fill with a water pipe running through, and the bottom layer is dark grayish sludge (**Plate 19.1**).

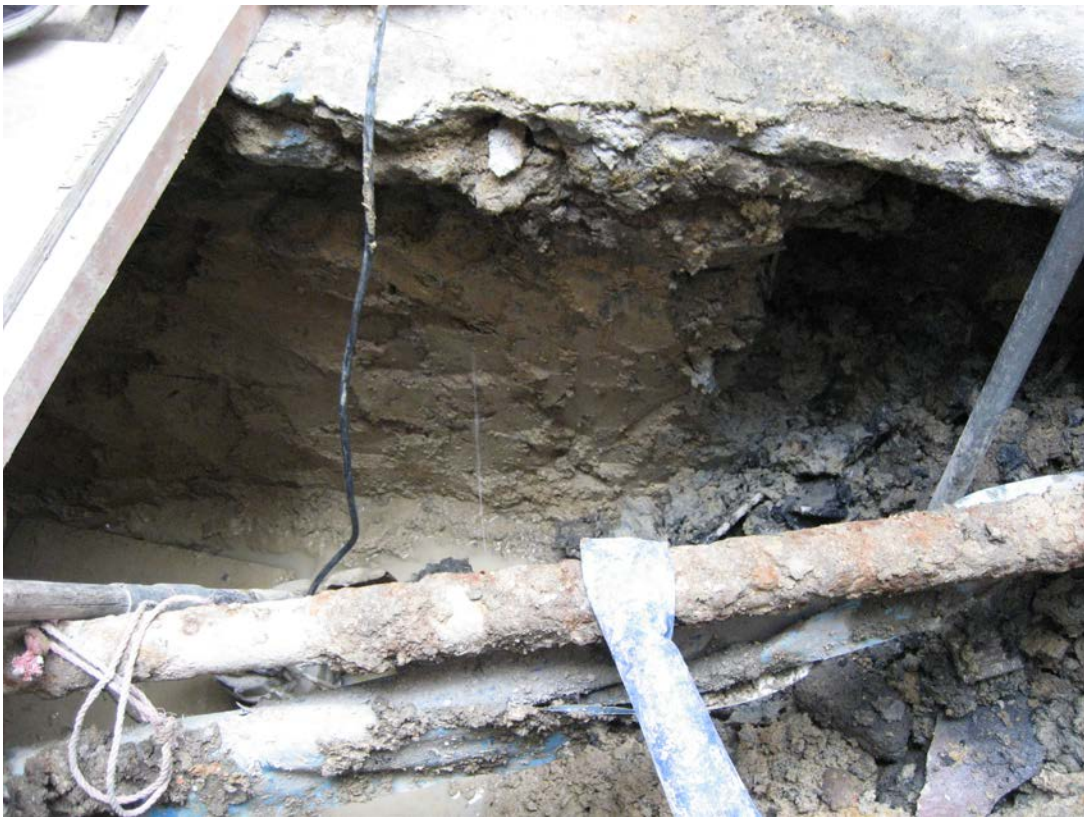
2. TTT5701 (Facing SW)

- 4.2.38 **TTT5701:** This trench is about 1.10 m deep and reveals three layers. The first layer is the concrete path over blackish fill, the second layer is a fill deposit of soft clay; the bottom layer is a deposit of grayish yellow sludge soaked in water (**Plate 19.2**).

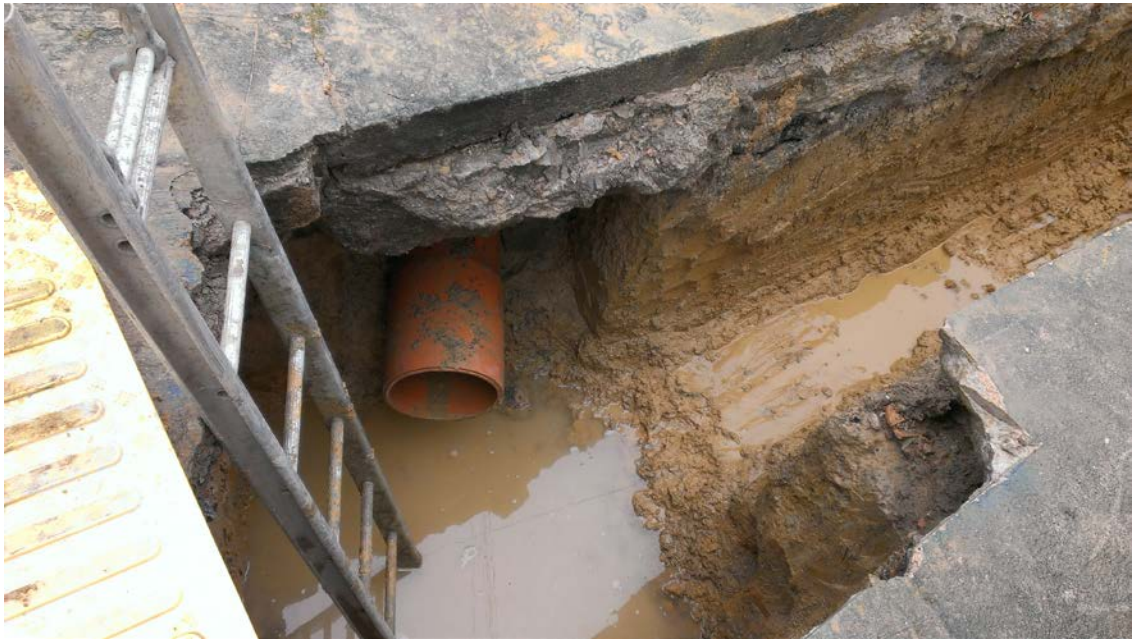
1. TTT5803 (Facing SE)

- 4.2.39 **TTT5803:** Two layers can be observed in this trench of about 1 metre deep. The first layer is concrete path cover over a bitumen base; the second layer is modern fill

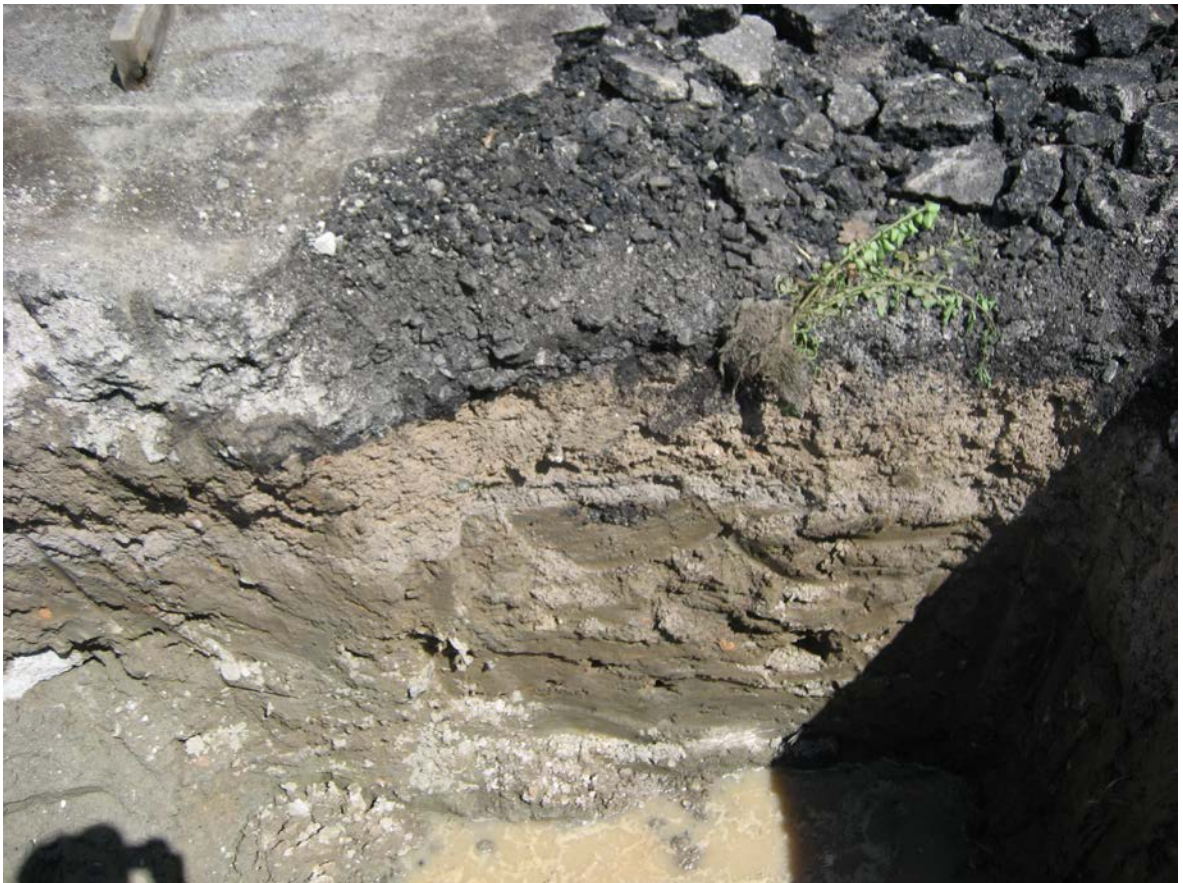
2. TTT6001 (Facing NW)

- 4.2.40 **TTT6001:** Four layers can be observed in this trench of about 1.40 m deep on Shui Tsiu San Tsuen Road. The first layer is concrete path cover over a bitumen base; underneath are three layers of modern slope deposits, comprising light brown fill, light black fill and dark gray sludge soaked in water (**Plate 20.2**).
