Heritage Impact Assessment for Revitalization of the Stone Houses at Junction Road, Kowloon City into Stone Houses Family Garden

June 2011

CONSULTANCY FOR HERITAGE IMPACT ASSESSMENT FOR REVITALIZATION OF THE STONE HOUSES AT JUNCTION ROAD, KOWLOON CITY INTO STONE HOUSES FAMILY GARDEN

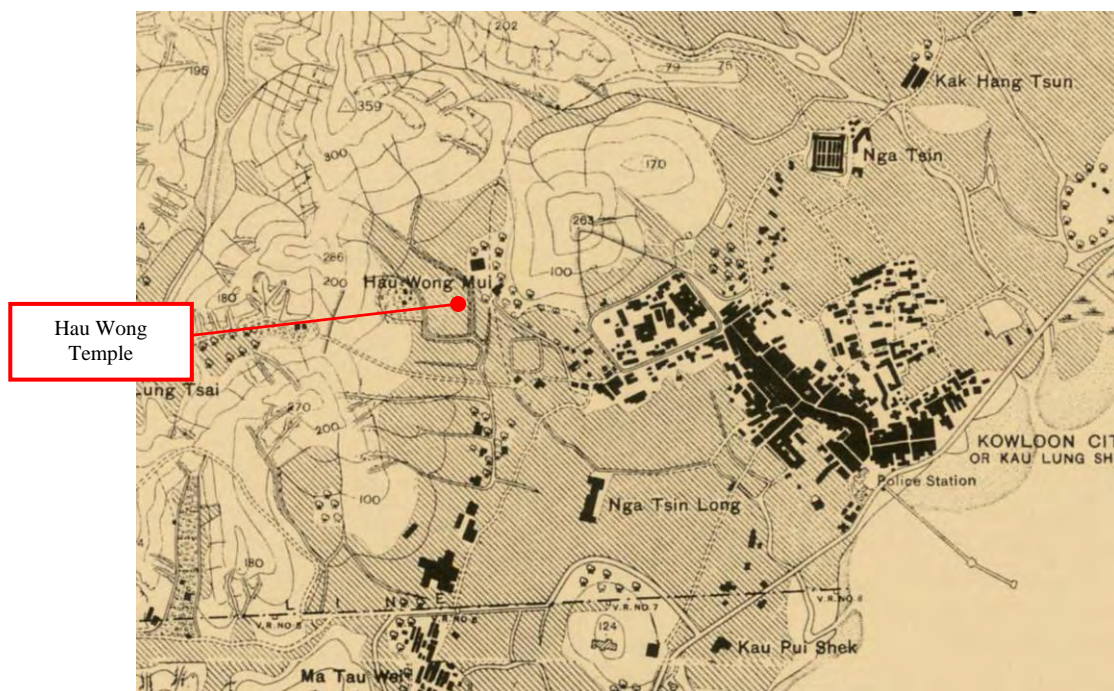
Fig. 9. An old map of 1902-03 showing the building structure located to the northwest of Hau Wong Temple.
(from Empson, Hal, *Mapping Hong Kong: a Historical Atlas*, Hong Kong, Government Information Services, 1992, p. 180.)

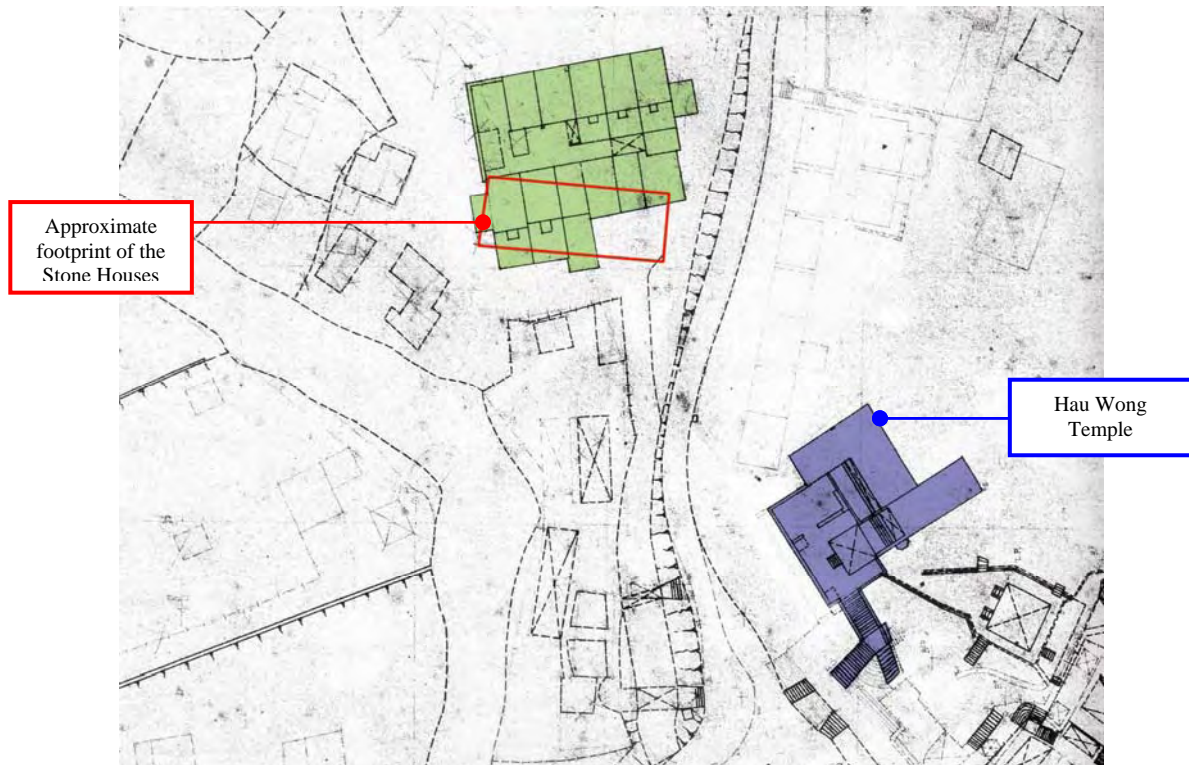
Fig. 10. An old map of 1922-1935 showing the layout of building located to the northwest of Hau Wong Temple.
 (Courtesy of Survey and Mapping Office, Lands Department, Hong Kong SAR Government, survey sheet no.: CXXXVII-NE-6.)

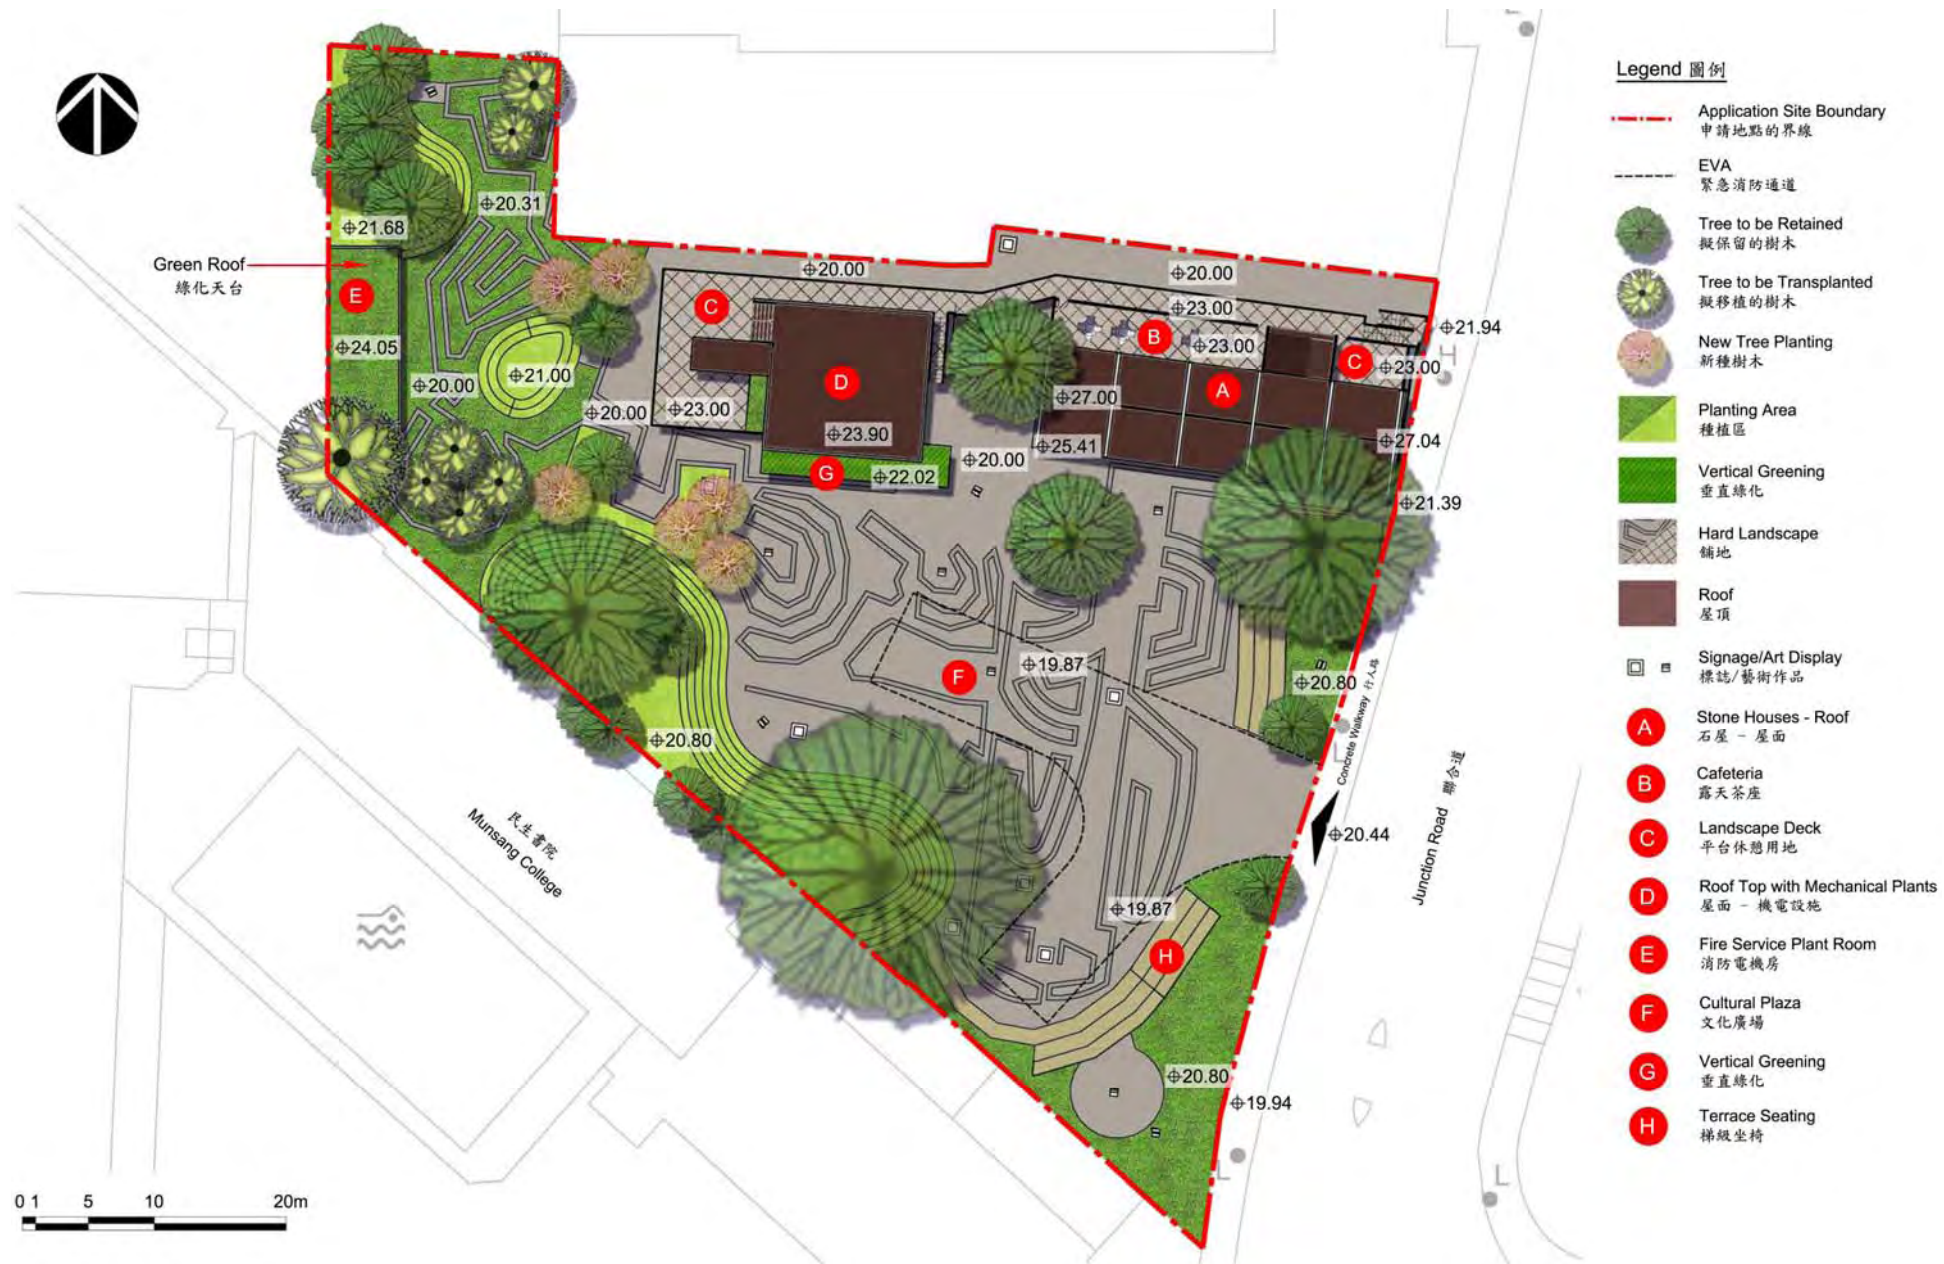
Fig. 36. Proposed Landscape Plan

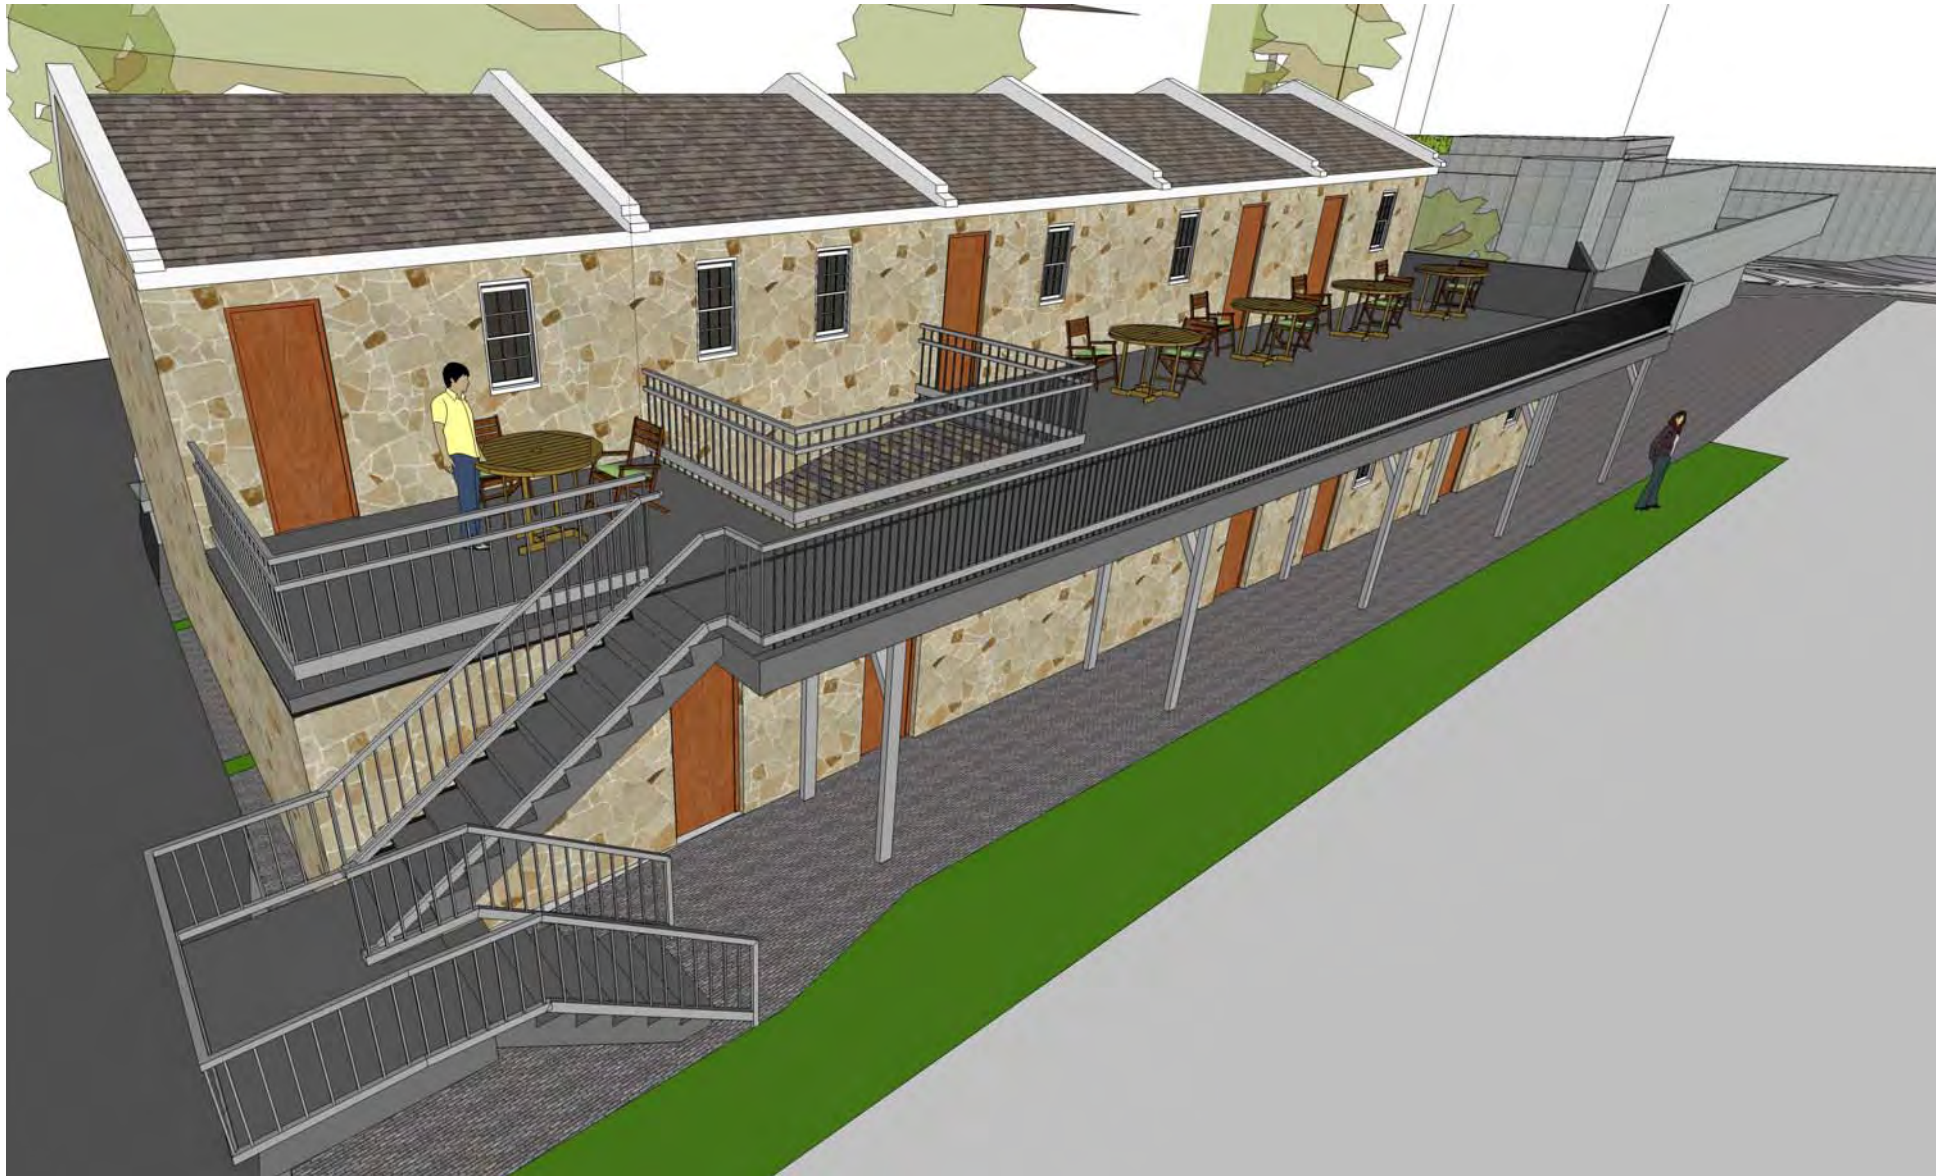
Fig. 40. Proposed walkway at the rear of the historic building.

C-8	Addition of a new walkway and connecting platform at the rear of the historic building for barrier free access	Original building form	moderate	high	<ul style="list-style-type: none"> Such new walkway is acceptable providing it is of compatible design, in term of suitable material, colour and texture. Such addition should be reversible without causing permanent damage to the historic fabric. The new structure should be discernible from the original historic fabric and be understated in character. It should be structurally independent and will not disturb to the historic fabrics. The rear annex at Unit 32 will be preserved in-situ and restored to include in the “Stone Houses Interpretation Area”. A viewing well shall be left on the outdoor walkway for public appreciation.
C-9	Existing trees (5 nos.) at the rear and immediate front of the historic buildings will be transplanted	trees	low	low	<ul style="list-style-type: none"> The transplantation shall be carried out with adequate guidance from tree specialist.

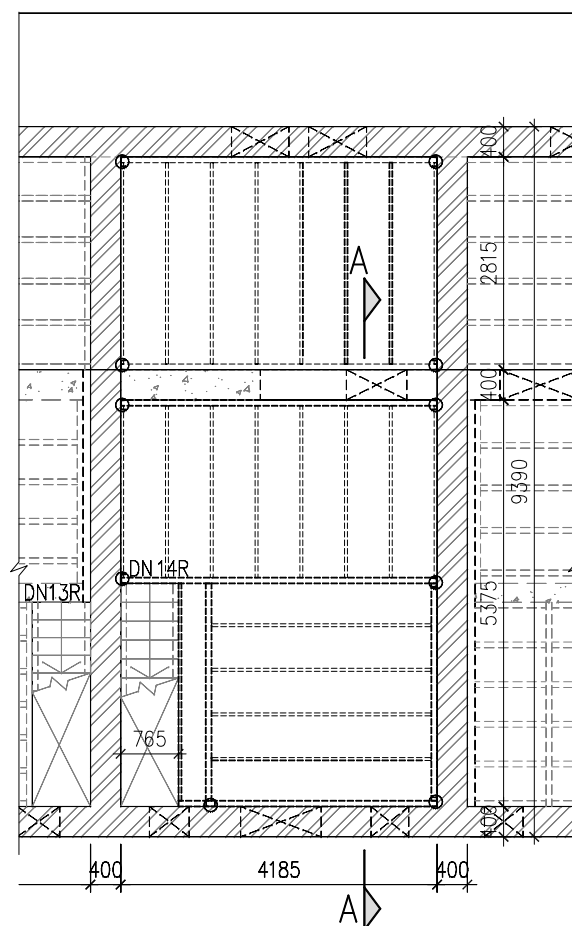
ADDITION WORKS AT 1/F FRAMING PLAN
(FOR HOUSE NO. 31 & 33~35)
31及33至35號屋一樓改造大樣圖
1 : 100

D-4	Convert the timber flooring of inadequate structural integrity at No. 31, 33, 34 and 35 into metal decking for functionality (see Appendix II)	Timber joists and planking	high	high	<ul style="list-style-type: none"> New structures shall be minimized in size without overwhelming the interior and shall be in compatible design to the historic ambience of the historic buildings. The existing timber planks shall be inspected and salvaged as much as possible for reuse on the new metal decking to form the new flooring of the 1/F. Disturbance to historic fabrics shall be minimized. Documentation should be prepared during the course of such alteration works.

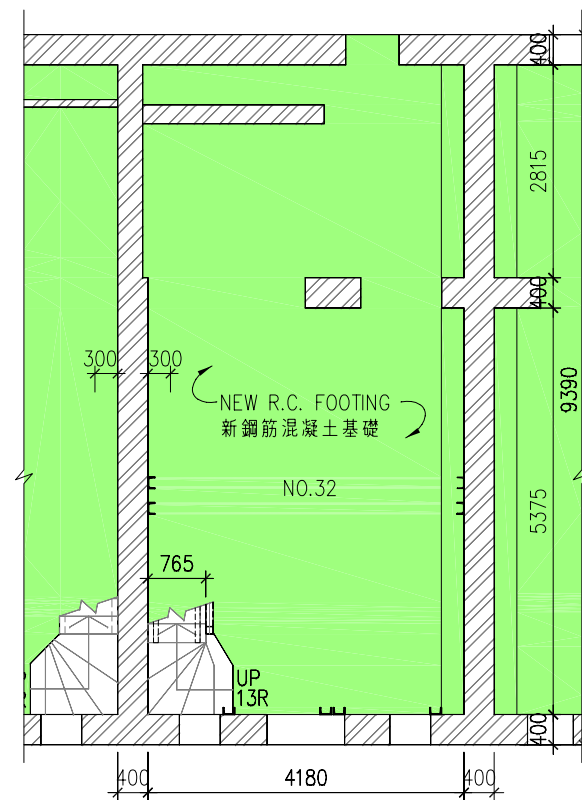
ADDITION WORKS AT G/F FRAMING PLAN
(FOR HOUSE NO. 32)
32號屋地下改造大樣圖
1 : 100

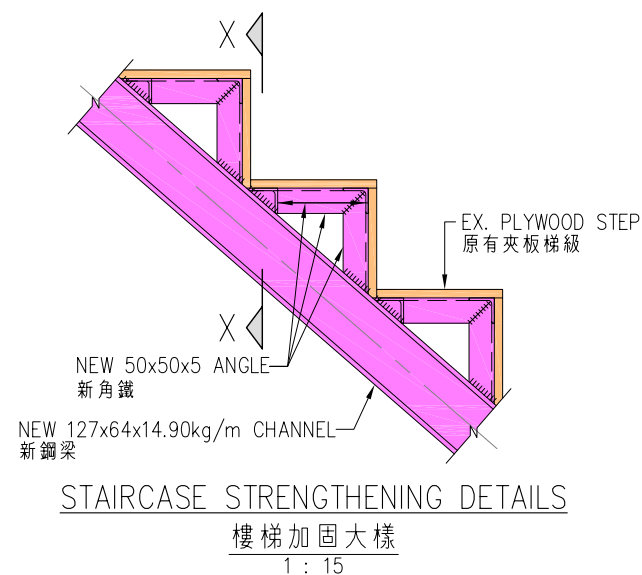
STAIRCASE STRENGTHENING DETAILS
樓梯加固大樣
1 : 15

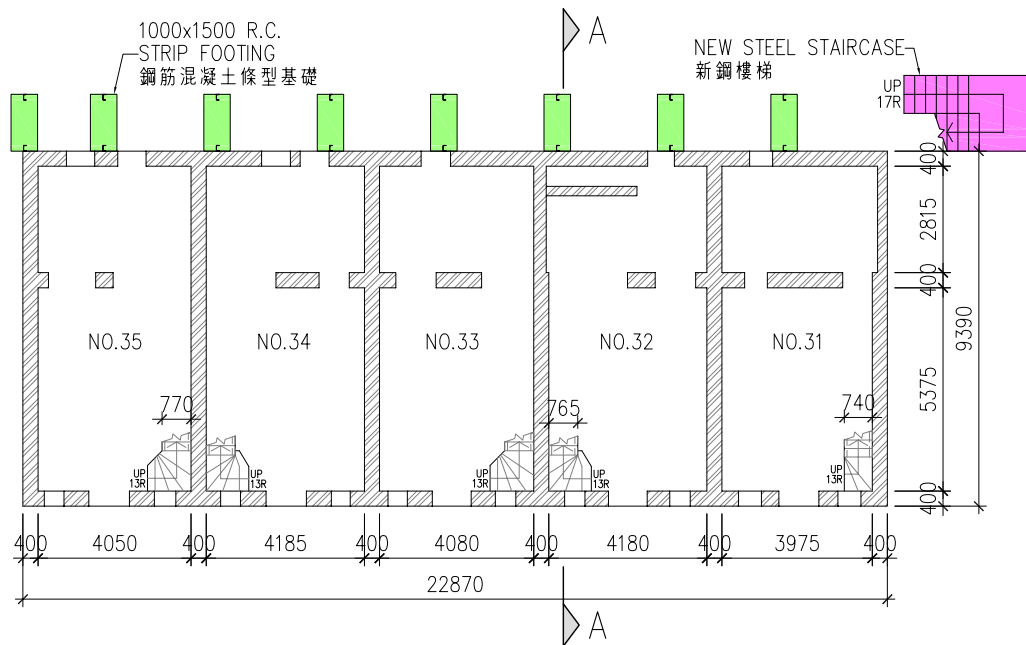
G/F FRAMING PLAN 1 : 200
地下結構平面圖

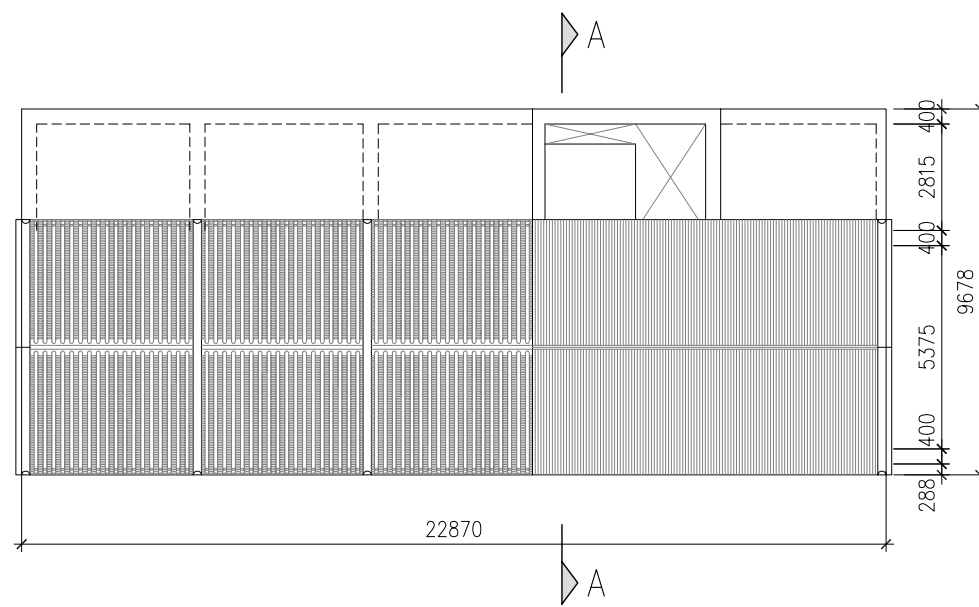
ROOF FRAMING PLAN 1 : 200
屋頂層結構平面圖

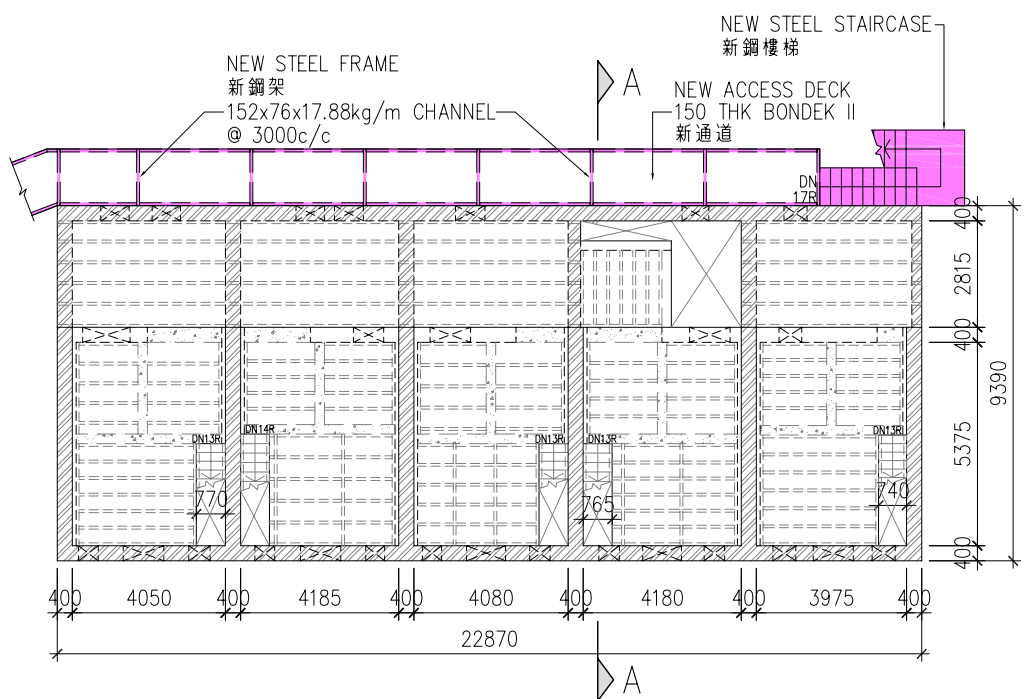
1/F FRAMING PLAN 1 : 200
首層結構平面圖
