圖版 1-3	前總督山頂別墅及工人宿舍遺址
Plate 1-3	Site of Former Mountain Lodge and Servant Quarters
圖版 4-5	石牆基外部
Plate 4-5	Exterior of stone wall foundation
圖版 6	遺址發掘前情況
Plate 6	Site before excavation
圖版 7-11	工人宿舍區內的探溝 TD - TG (AI 區)
Plate 7-11	Test Trenches TD - TG in area of servant quarters (Area AI)
圖版 12-13	工人宿舍區內的範圍探溝 TH (AII 區)
Plate 12-13	Test Trench TH in area of servant quarters (Area AII)
圖版 14	探坑 T2 (2007 年考古調查)
Plate 14	Trial Pit T2 (2007 Archaeological Investigation)
圖版 15-16	探坑 T4 (2007 年考古調查)
Plate 15-16	Trial Pit T4 (2007 Archaeological Investigation)
圖版 17	探溝 T5 (2007 年考古調查)
Plate 17	Test Trench T5 (2007 Archaeological Investigation)
圖版 18	探溝 T7 (2007 年考古調查)
Plate 18	Test Trench T7 (2007 Archaeological Investigation)
圖版 19	探溝 T8 (2007 年考古調查)
Plate 19	Test Trench T8 (2007 Archaeological Investigation)
圖版 20-23	發掘後的出入口及門廊上的地磚(2007 年考古調查)
Plate 20-23	Main entrance after the excavation and the floor tiles of the porch (2007 Archaeological Investigation)

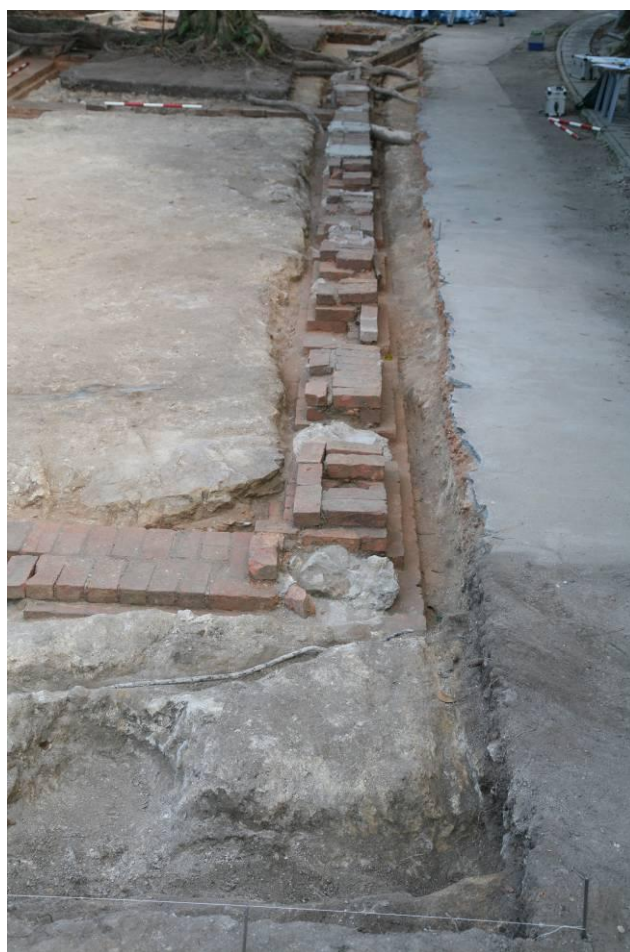
1. 探溝 TD 的磚牆基(南向北)
Brick wall foundation of TD (South to North)

2. 探溝 TD 的磚牆基及渠 D1(東南向西北)
Brick wall foundation and drainage D1 of TD
(Southeast to Northwest)

3. 探溝 TD 內的磚牆基及渠 D1(西向東)
Brick wall foundation and D1 of TD (West to East)

4. 探溝 TD 內的磚牆基(西向東)
Brick wall foundation of TD (West to East)

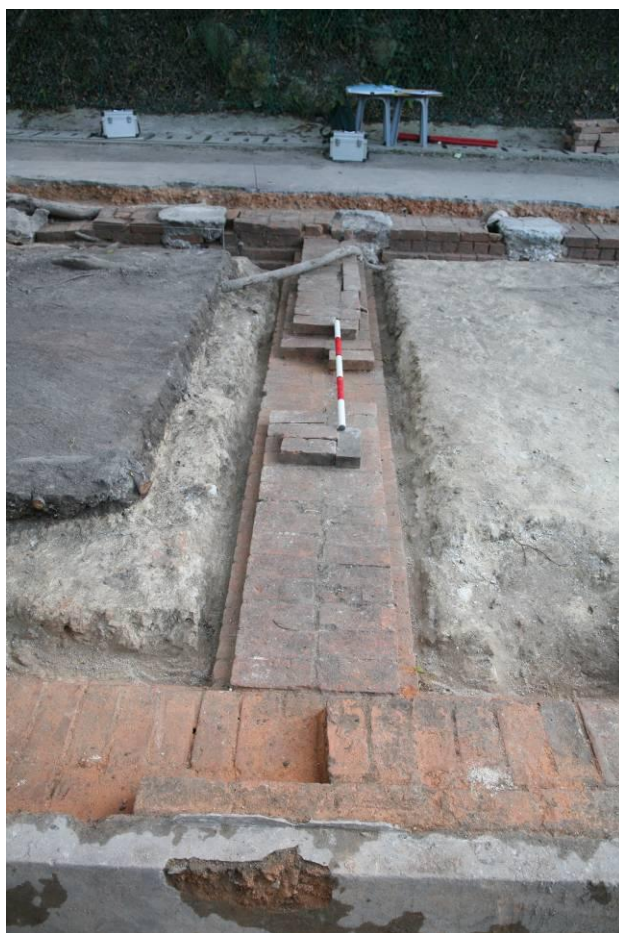
1. 探溝 TD、TF、TG 的磚牆基(西南向東北)
Brick wall foundations of TD, TF and TG
(Southwest to Northeast)

2. 探溝 TF 及 TD 的磚牆基(北向南)
Brick wall foundations of TF and TD (North to South)

3. 探溝 TD、TF 的磚牆基及渠 D1(西向東)
Brick wall foundations of TD and TF and D1
(West to East)

4. 探溝 TD、TF、TG 之間的磚牆基(北向南)
Intersection between brick wall foundations TD,
TF and TG (North to South)

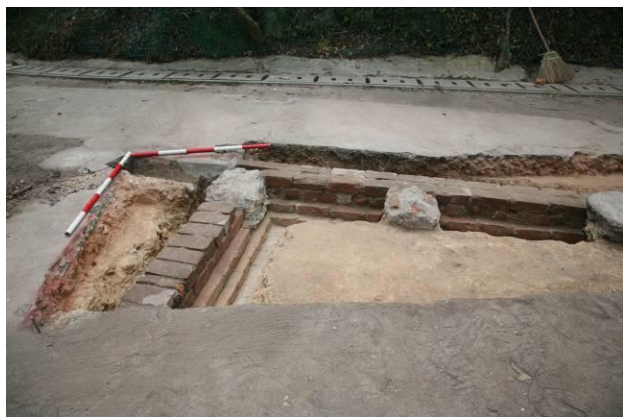
1. 探溝 TG (北向南)
TG (North to South)

2. 探溝 TG (南向北)
TG (South to North)

3. 探溝 TG (東向西)
TG (East to West)

4. 探溝 TG (西向東)
TG (West to East)

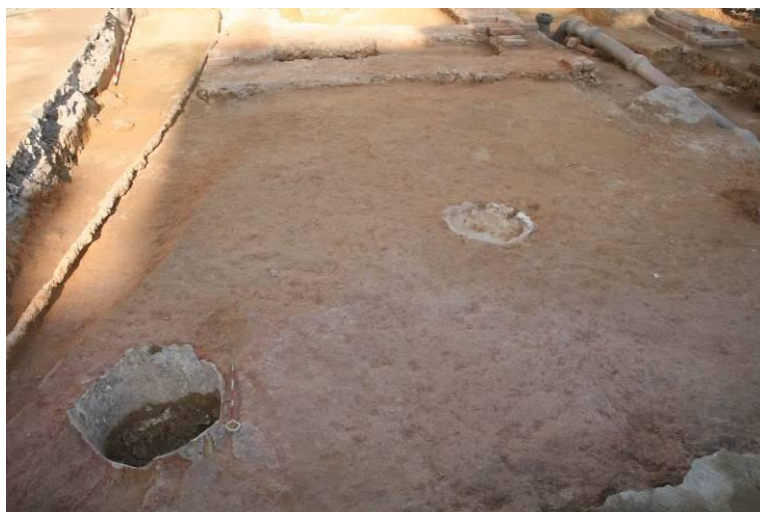
1. 探溝 TH 內所發現的兩個石灰坑 Two lime pits discovered in TH	2-3. 石灰坑 Lime pits
4. 探溝 TH 內的沙井 (東向西) Manhole in TH (East to West)	5. 探溝 TH 內的沙井及陶水管(南向北) Manhole and ceramic pipe of TH (South to North)

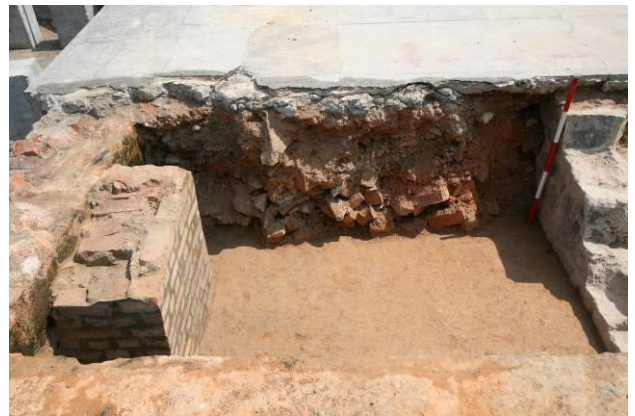
1. 探溝 T5 北壁及磚牆 B4 North profile of Test Trench 5 and brick wall foundation B4	2. 探溝 T5 西壁 West profile of Test Trench 5	3. 探溝 T5 磚牆 B4 的頂部 Top view of B4 in Test Trench 5
4. 探溝 T5 北壁 North profile of Test Trench 5	5. 探溝 T5 東壁 East profile of Test Trench 5

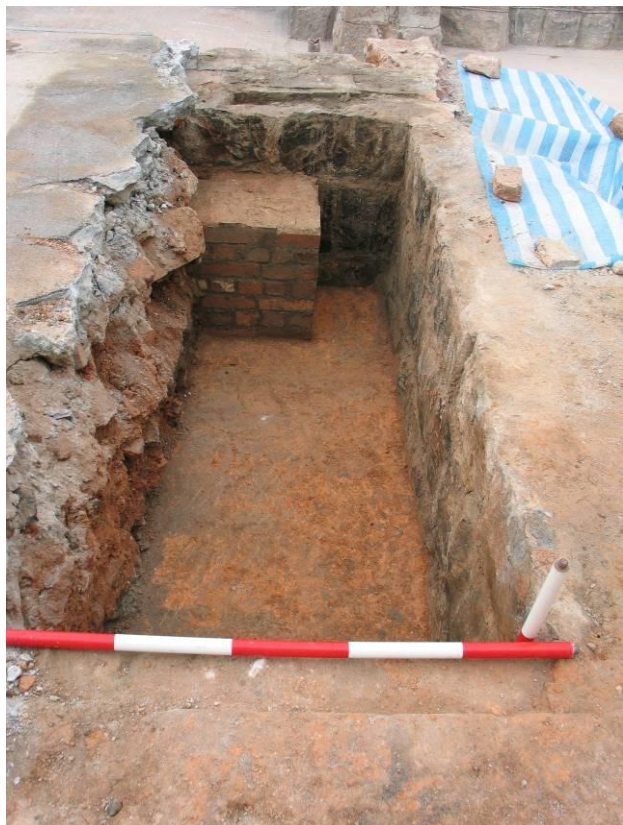
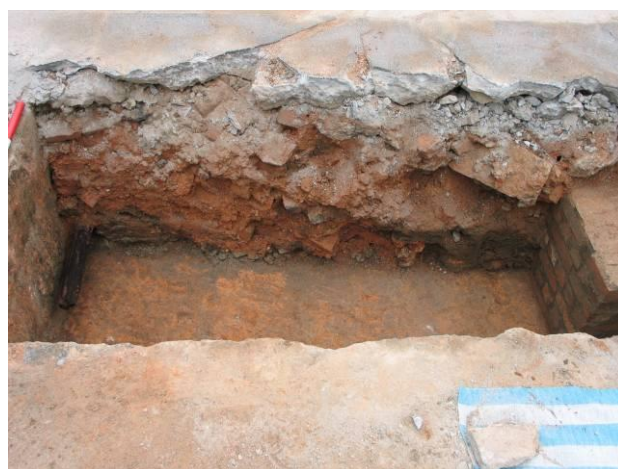
1. 探溝 T7 北壁及磚牆 B6
North profile of Test Trench 7 and brick wall
foundation B6

2. 探溝 T7 南壁
South profile of Test Trench 7

3. 探溝 T7 東壁
East profile of Test Trench 7.

4. 探溝 T7 西壁
West profile of Test Trench 7

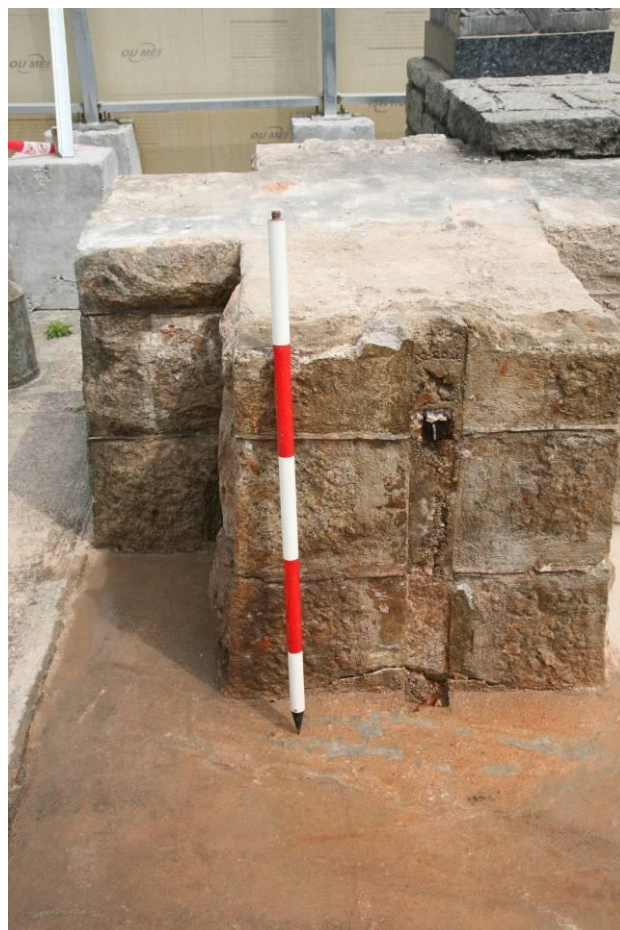
1. 正門出入口的石牆
Stone wall foundation of the Main Entrance

2. 正門出入口外的鐵排水管 (西南角)
Iron drainage pipes on the Main Entrance
(Southwest corner)

3. 正門出入口的門框痕跡(西北角)
Trace of door frame of the Main Entrance
(Northwest corner)

4. 門框及門銷孔痕跡 (正門出入口西南角)
Trace of door frame (Southwest corner of the
Main Entrance)

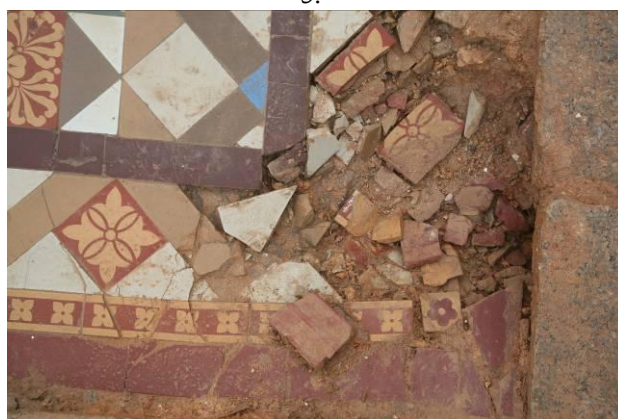
1-2. 地磚的邊框與主題 Design of the border and field	3. 地磚 (北向南) Floor tiles
4. 地磚 (西向東) Floor tiles (From West to East)	5. 地磚 (北向南) Floor tiles
6. 西南角的殘破部份 The broken part at the southwest corner

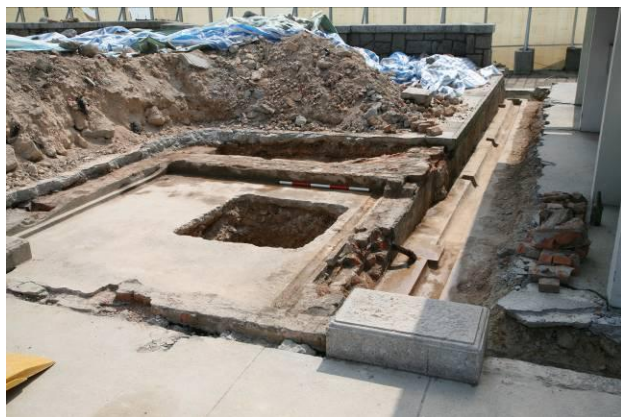
1. 探溝 T9 (西北向東南)
Test Trench 9 (Northwest to Southeast)

2. 探溝 T9 的陶水管 (南向北)
A ceramic pipe of Test Trench 9 (South to North)

3. 探溝 T9 內的雨水渠及管水管 (東向西)
Rainwater drain and ceramic pipe in Test Trench 9 (East to West)

4. 探溝 T9 的石牆基 (西向東)
Stone wall foundation in Test Trench 9 (West to East)

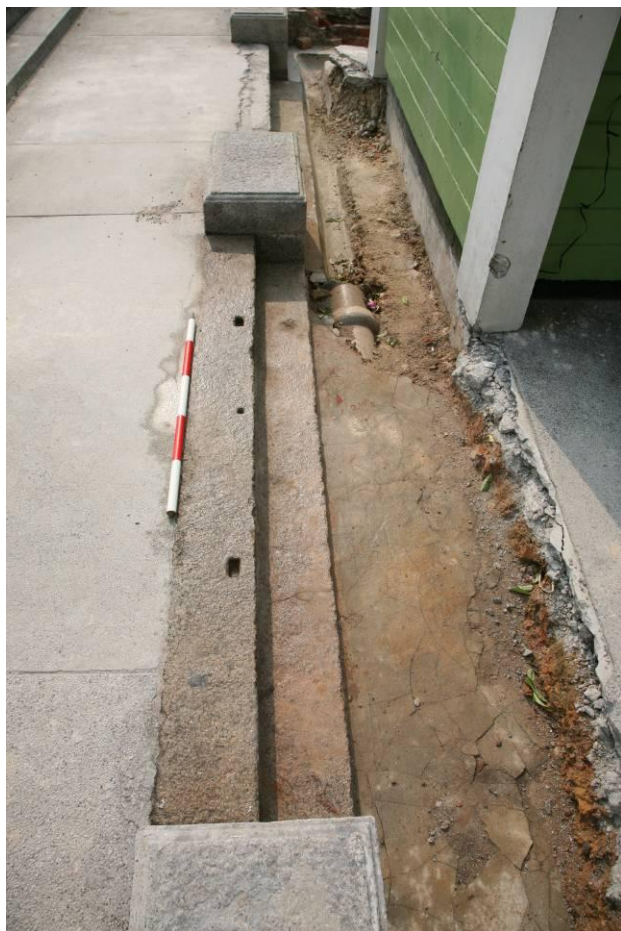
1. 近小食亭石梯階上的孔(西向東)
Holes on stone steps near kiosk (West to East)

2. 近遺址西北角石梯階上的孔(北向南)
Holes on stone steps near northwest corner
of Former Mountain Lodge (North to South)

3. 近小食亭石梯階上的孔(北向南)
Holes on stone steps near kiosk (North to
South)

4. 近遺址西北角石梯階上的孔(東向西)
Holes on stone steps near northwest corner
of Former Mountain Lodge(East to West)

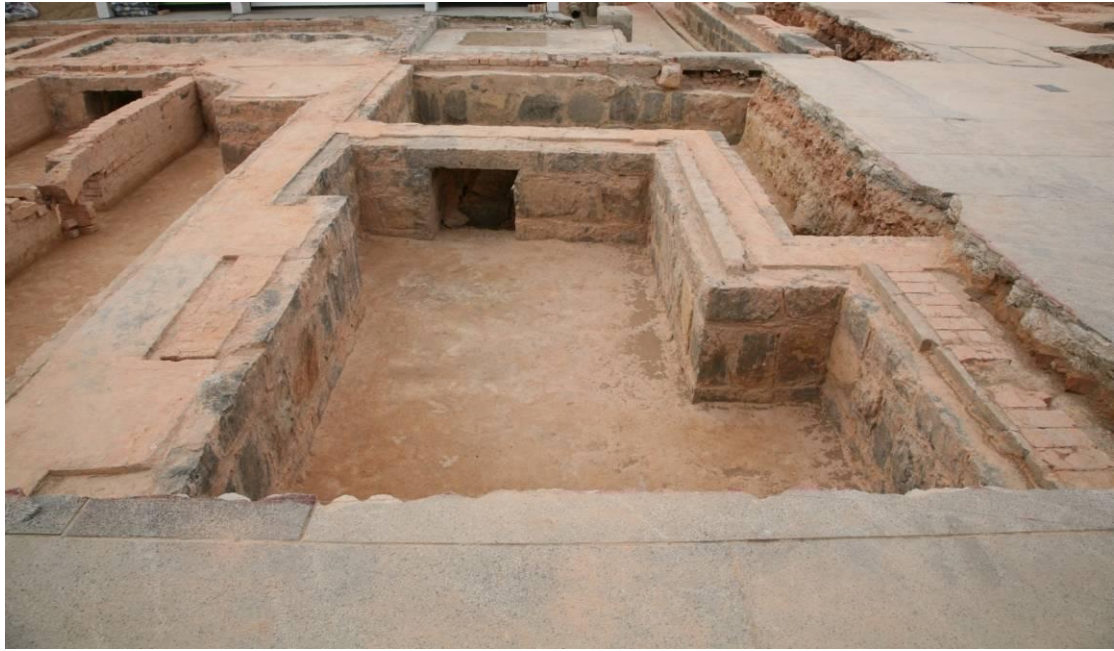
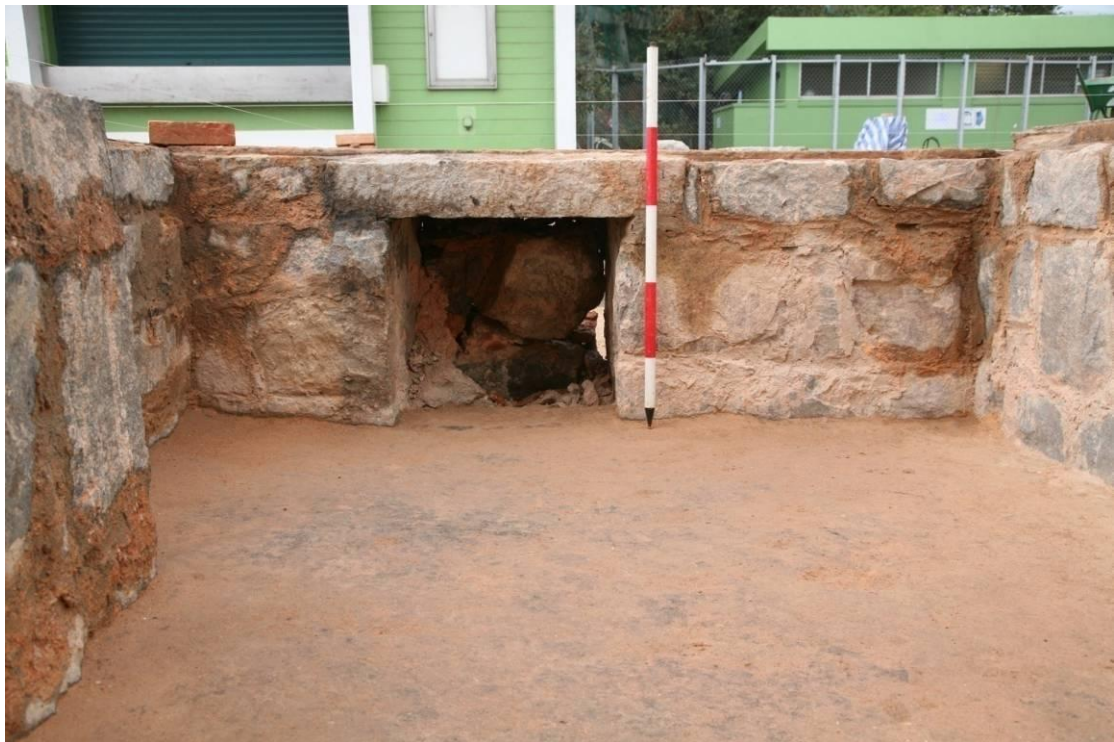
-
1. 石牆基 S5 及 S6(東向西)
Stone wall foundations S5 and S6 (East to West)
 2. 位於石牆基 S5 的通風口 V32(東向西)
Vent V32 located at stone wall foundation S5 (East to West)

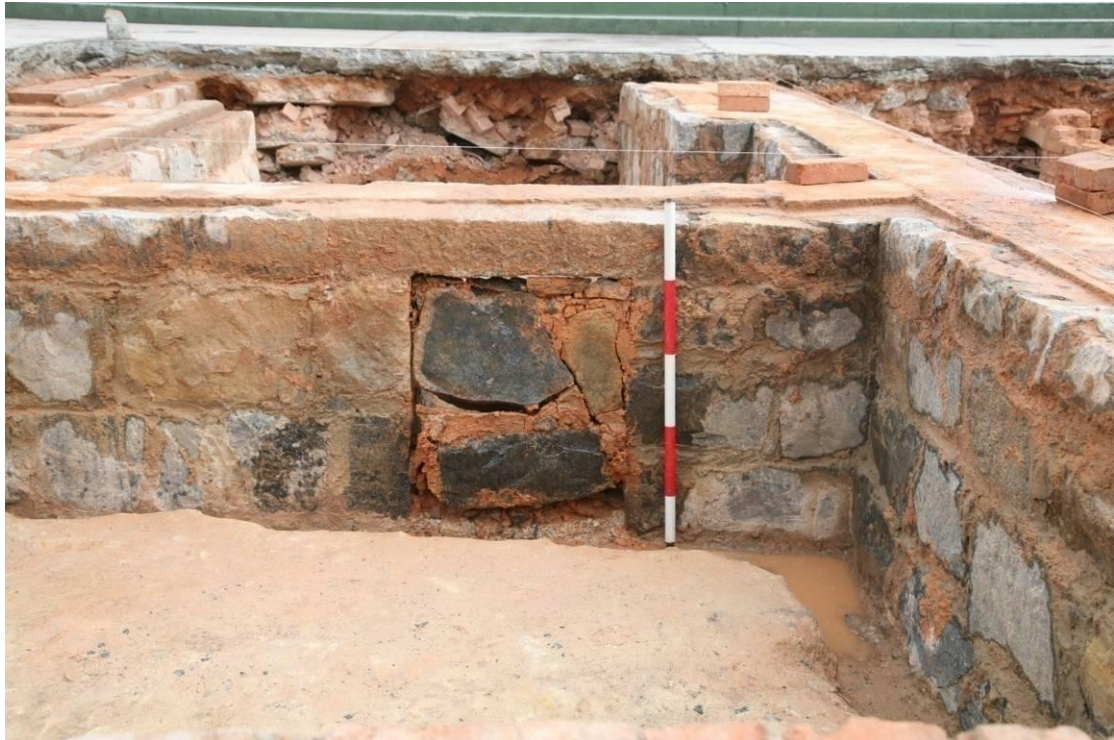
-
1. 通風口 V32 的另一面(西向東)

Other side of vent V32 (West to East)

2. 經發掘後，探溝 T10 內的石牆基基槽及生土面（北向南）

Ditch of stone wall foundations in T10 and sterile layer after excavation (North to South)

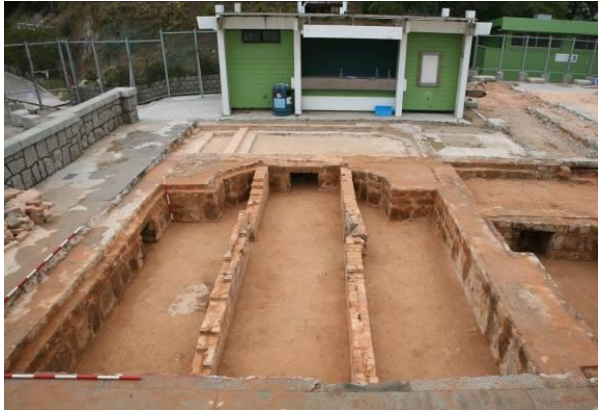
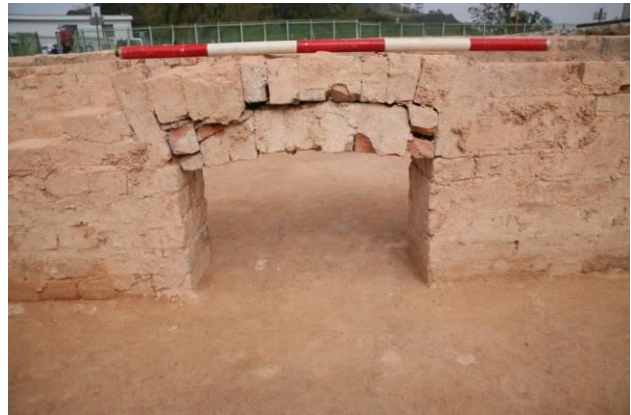
1. 磚牆 B1 及 B2(東向西) Brick wall foundations B1 and B2 (East to West)	2. 磚牆 B1 及 B2 (南向北) Brick wall foundations B1 and B2 (South to North)	3. 磚牆 B1 及 B2 (西向東) Brick wall foundations B1 and B2 (West to East)
4. 磚牆上的通風口 V36(前)及 V34(後) (南向北) Vents V36 (Front) and V34 (Back) of brick walls(South to North)	5. 通風口 V34(南向北) Vent V34 (South to North)	6. 通風口 V36(南向北) Vent V36 (South to North)

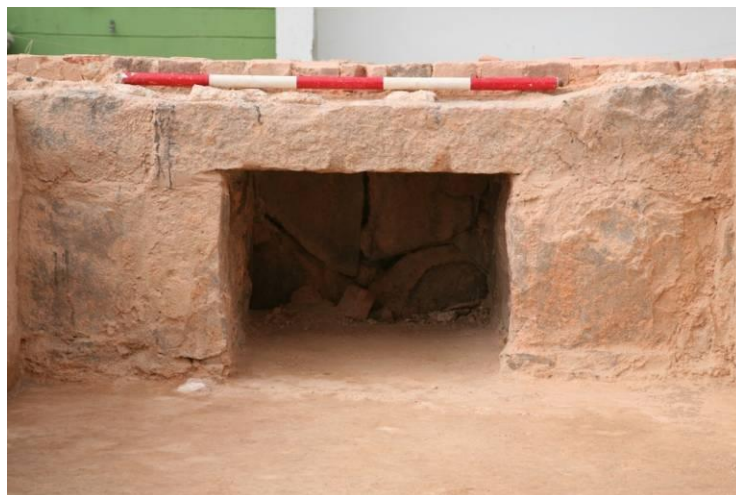
1. 通風口 V33(東向西)
Vent V33 (East to West)

2. 通風口 V39(北向南)
Vent V39 (North to South)

3. 通風口 V38(北向南)
Vent V38 (North to South)

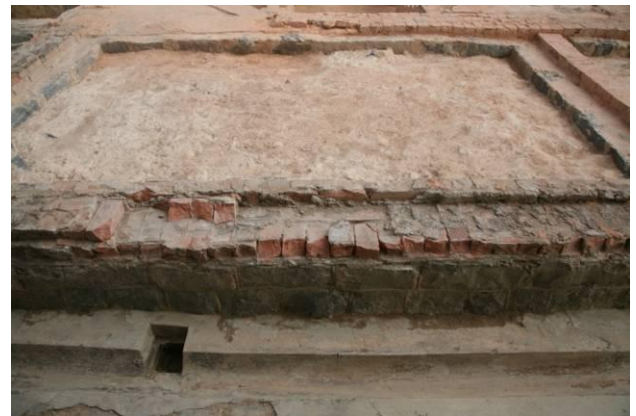
1. 石牆基 S13(北向南)
Stone wall foundation S13 (North to South)

3. 石牆基 S7, S8, S13 及 S14(南向北)
Stone wall foundations S7, S8, S13 and S14 (South to North)

2. 石牆基 S8(東向西)
Stone wall foundation S8 (East to West)

4. 石牆基 S14(西向東)
Stone wall foundation S14 (West to East)

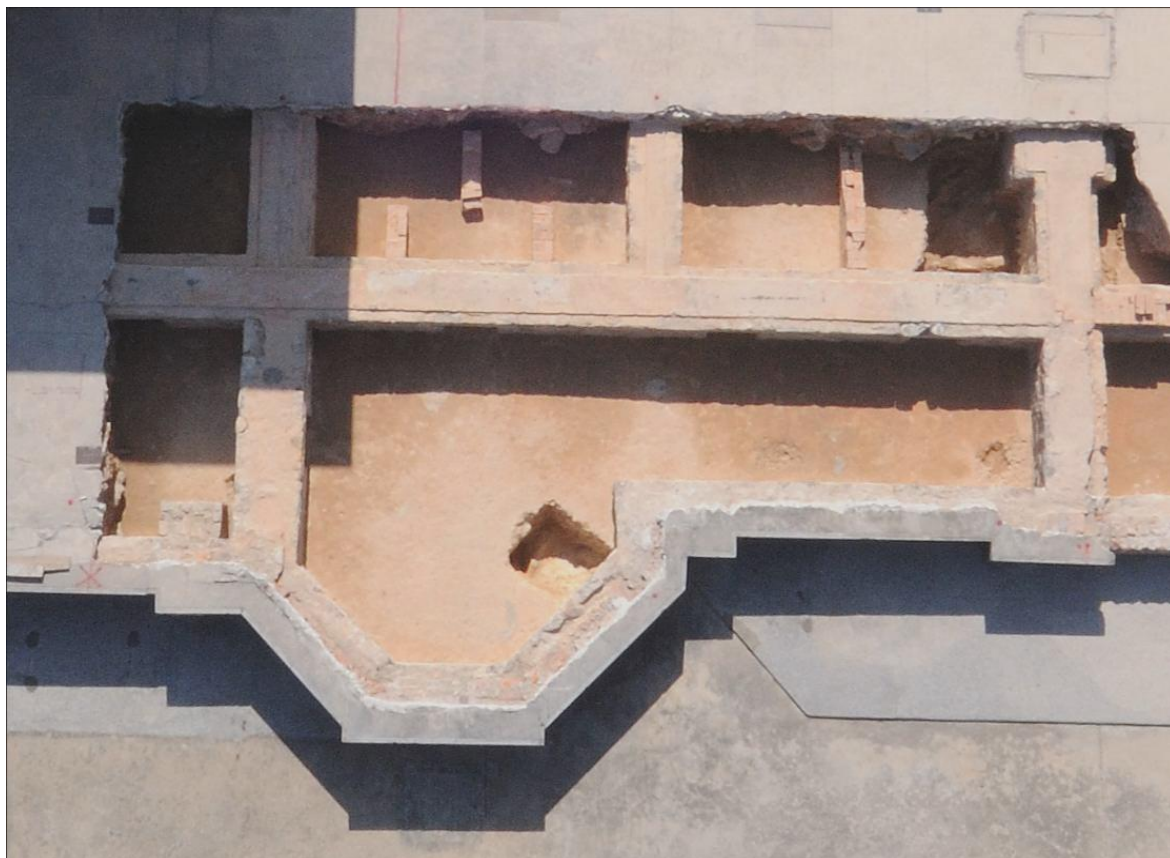
1. 探溝 T11
T11

2. 石牆基 S3(南向北)
Stone wall foundation S3 (South to
North)

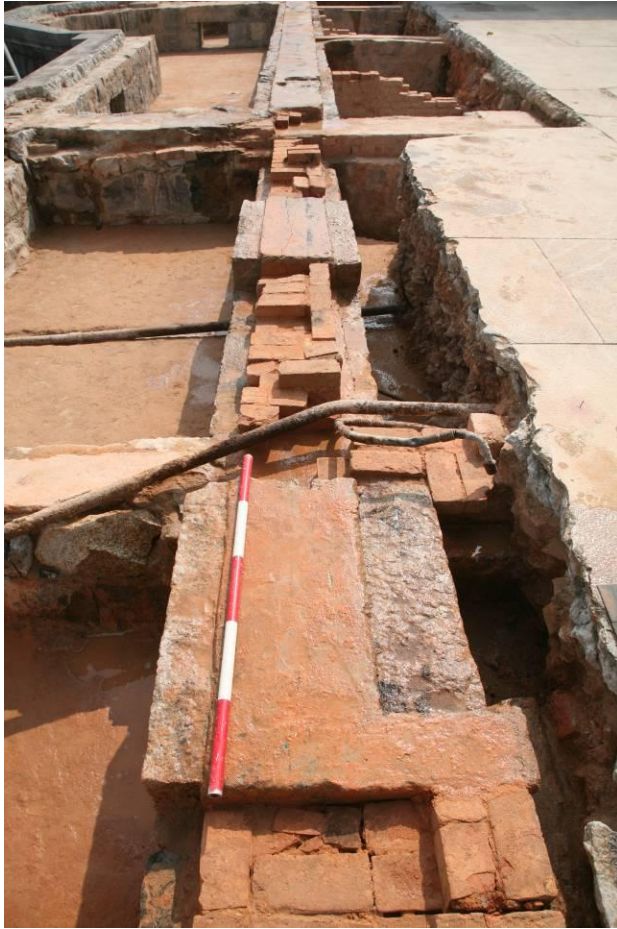
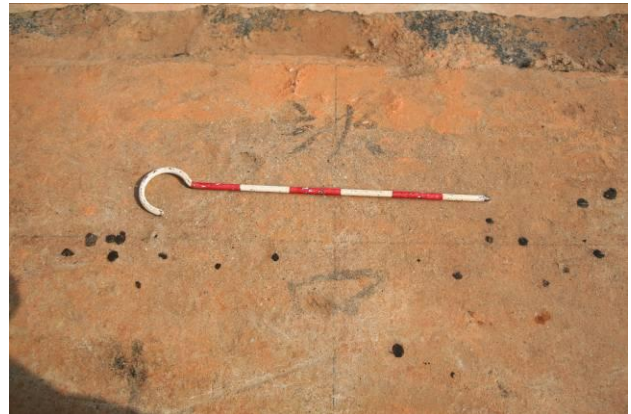
1. 石牆基 S3 (西向東) Stone wall foundation S3 (West to East)	2. 石牆基 S3 與 S11 的交接點 (東向西) Intersection between stone wall foundations S3 and S11 (East to West)
3. 石牆基 S3 的墨跡(南向北) Ink marking on S3 (South to North)	4. 磚牆基 B7 (南向北) Brick wall foundation B7 (South to North)
5. 石牆基 S3 的墨跡，飾有「三尺」及「中」字 (南向北) Ink marking on S3 with Chinese characters “三尺”(8 feet) and “中” (middle) (South to North)

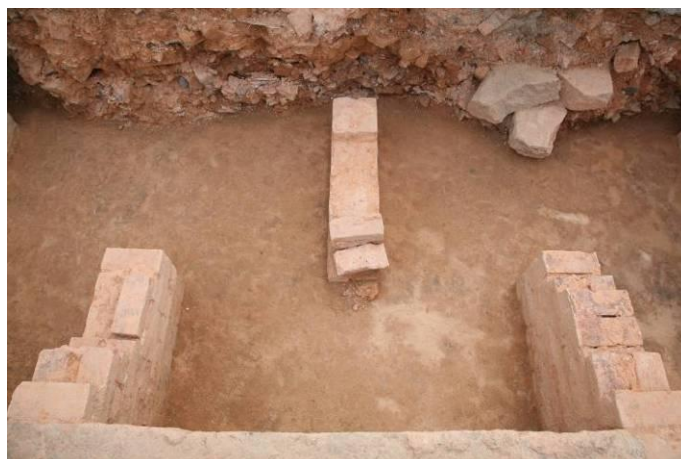
| 1. 磚牆基 B8(左)、B9(中)與 B10(右) (南向北)

Brick wall foundations B8 (Left), B9 (central) and B10(right) (South to North) | 2. 磚牆基 B10(上)、B9(中)與 B8(下) (東向西)
Brick wall foundations B10(upper), B9 (middle) and B8 (lower) (East to West) |

| 3. 磚牆基 B8(上)、B9(中)與 B10(下) (西向東)

Brick wall foundations B8(upper), B9I(middle) and B10(lower) (West to East) | |

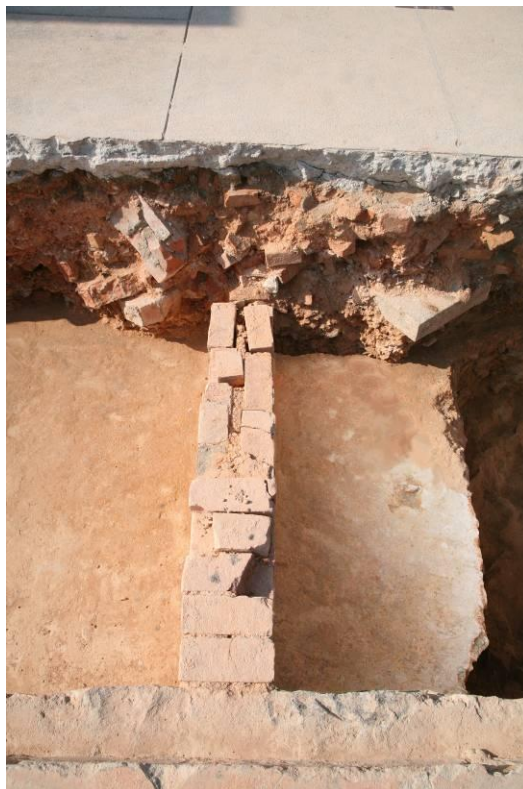
1. 磚牆基 B11 (北向南)

Brick wall foundation B11 (North to South)

2. 石牆基 S13 (北向南)

Stone wall foundation S13 (North to South)

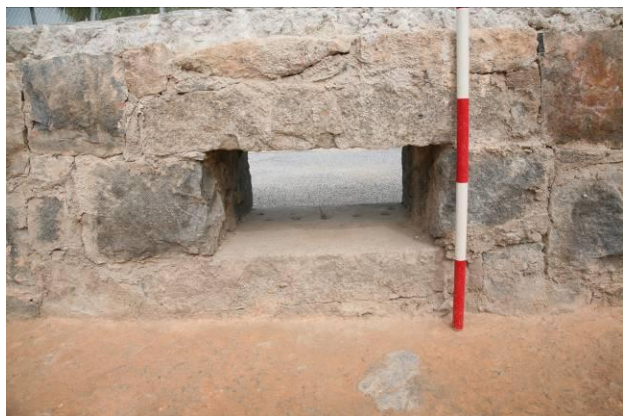
1. 通風口 V2 (南向北) Vent V2 (South to North)	2. 通風口 V2 (北向南) Vent V2 (North to South)
3. 通風口 V3 (南向北) Vent V3 (South to North)	4. 通風口 V3 (北向南) Vent V3 (North to South)
5. 通風口 V19 (西向東) Vent V19 (West to East)	6. 通風口 V19 (東向西) Vent V19 (East to West)

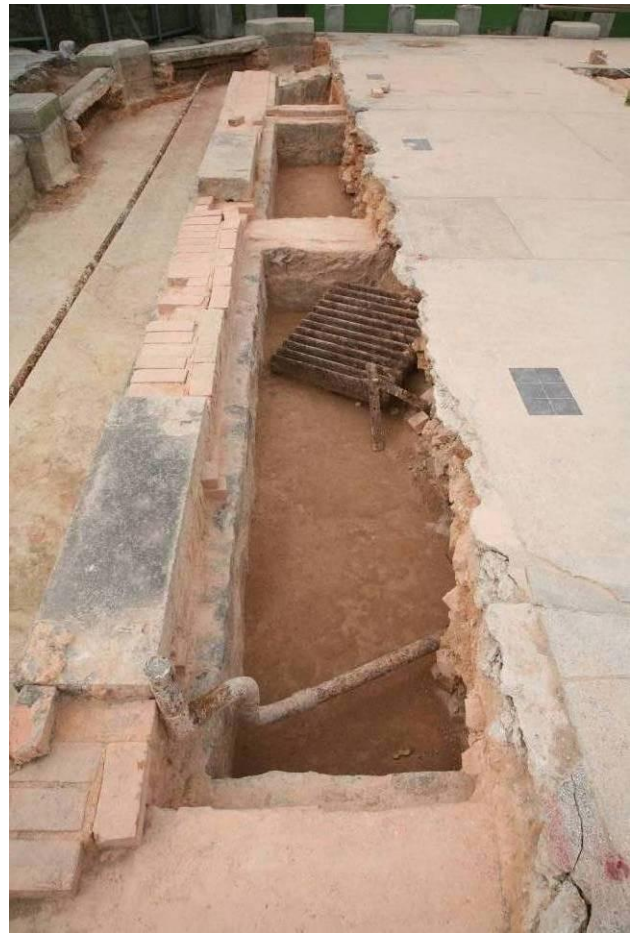
<p>1. 探溝 T12 東壁及石牆基 S13(西向東) East section of T12 and stone wall foundation S13 (West to East)</p>	<p>2. 探溝 T12 的陶水管(南向北) Ceramic pipe in T12 (South to North)</p>
<p>3. 探溝 T12 內的石牆基 S13 和 S4 的交接點(東向西) Intersection of stone wall foundations S13 and S4 of T12 (East to West)</p>	<p>4. 探溝 T12 內的石牆基 S4 及暖爐(東向西) Stone wall foundation S4 and heater in T12 (East to West)</p>

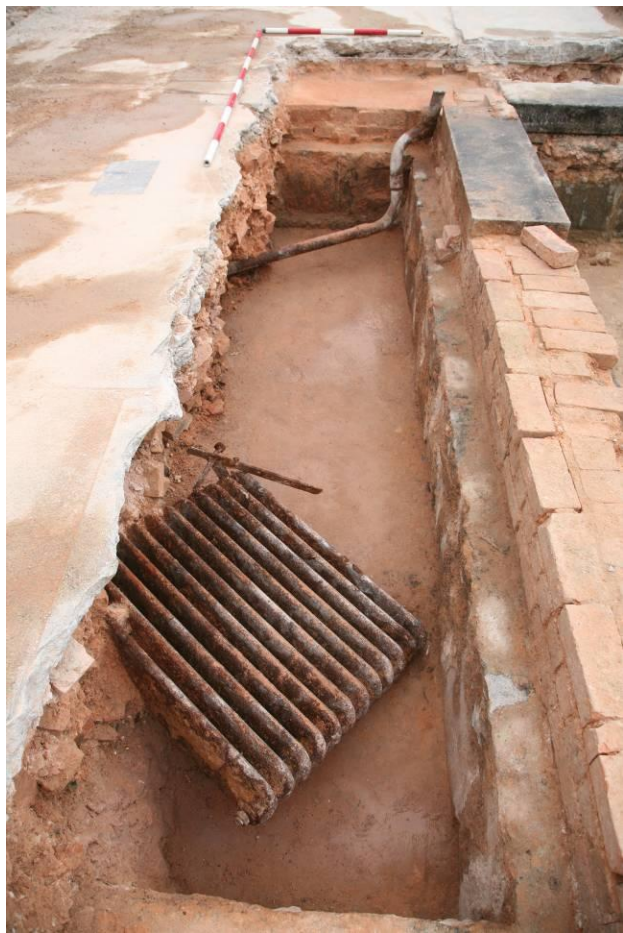
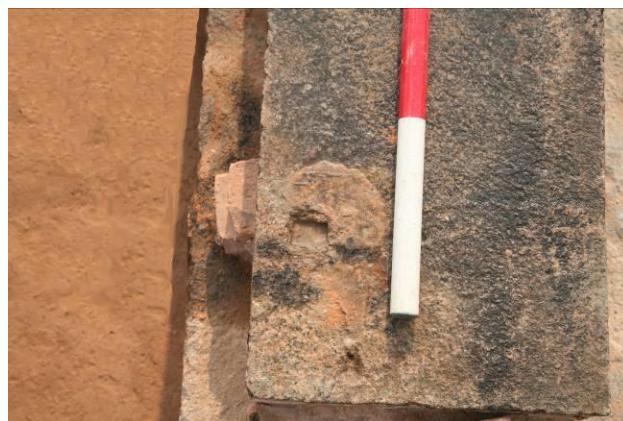
1. 探溝 T12 石牆基 S4 及暖爐(西向東)
Stone wall foundation S4 and heater in T12
(West to East)

2. 探溝 T12 內的暖爐(北向南)
Heater in T12 (North to South)

3. 石牆基 S13 的石梯階(南向北)
Stone step of stone wall foundation S13 (South
to North)

4. 石牆基 S13 的石梯階上的方孔(西向東)
Square hole on stone step of stone wall
foundation S13 (West to East)

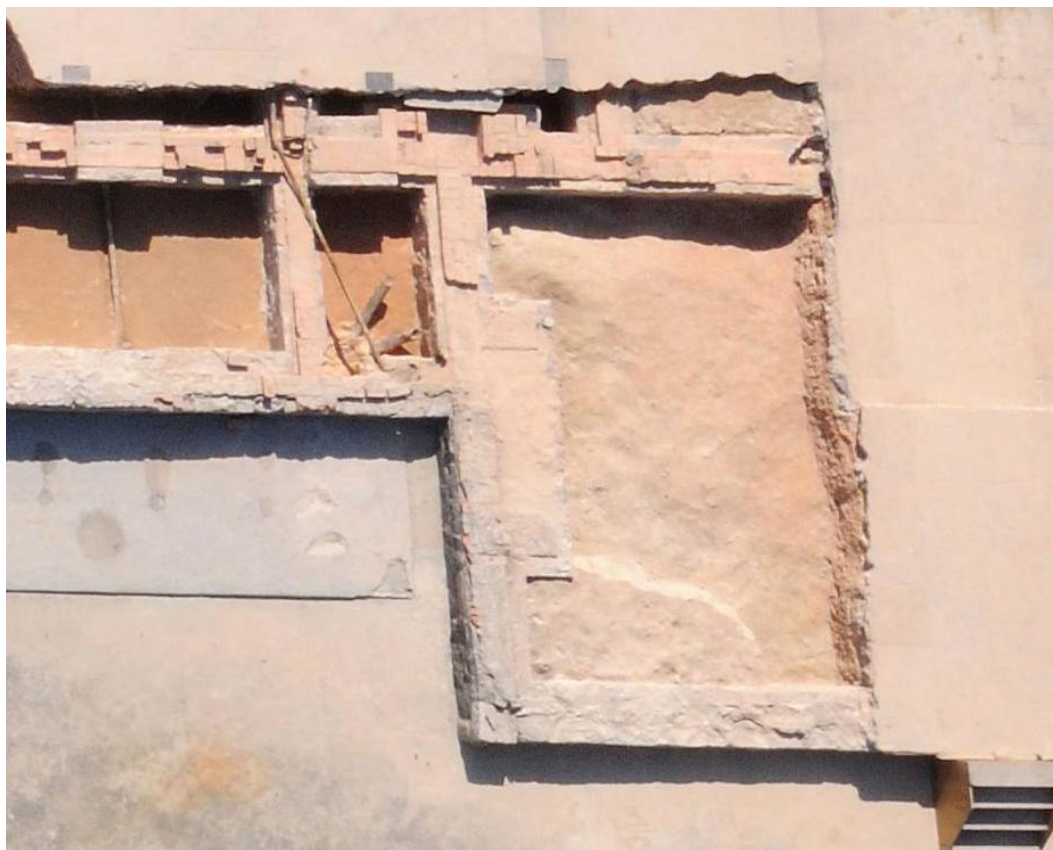
1. 探溝 T13

2. 探溝 T13，前總督山頂別墅的廚房(左)及浴室(右)位置(南向北)

T13, location of kitchen(left) and bathroom (right) of Former Mountain Lodge (South to North)

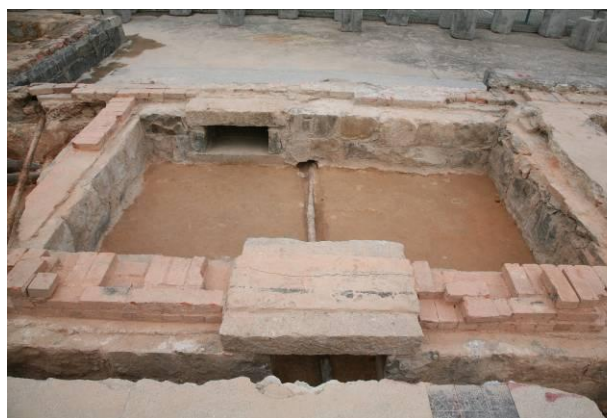
-
1. 石牆基 S15 與的 S3 接合點(南向北)
Intersection between stone wall foundations S15 and S3 (South to North)
 2. 原前總督山頂別墅的浴室位置(南向北)
Original bathroom of Former Mountain Lodge (South to North)
 3. 石牆基 S3 及鐵喉管(南向北)
Stone wall foundation S3 and iron pipe (South to North)

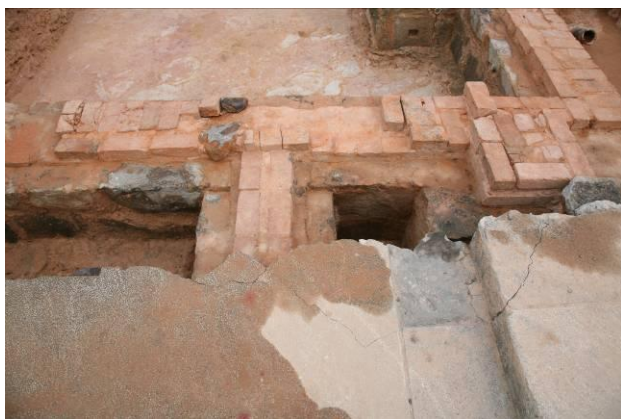
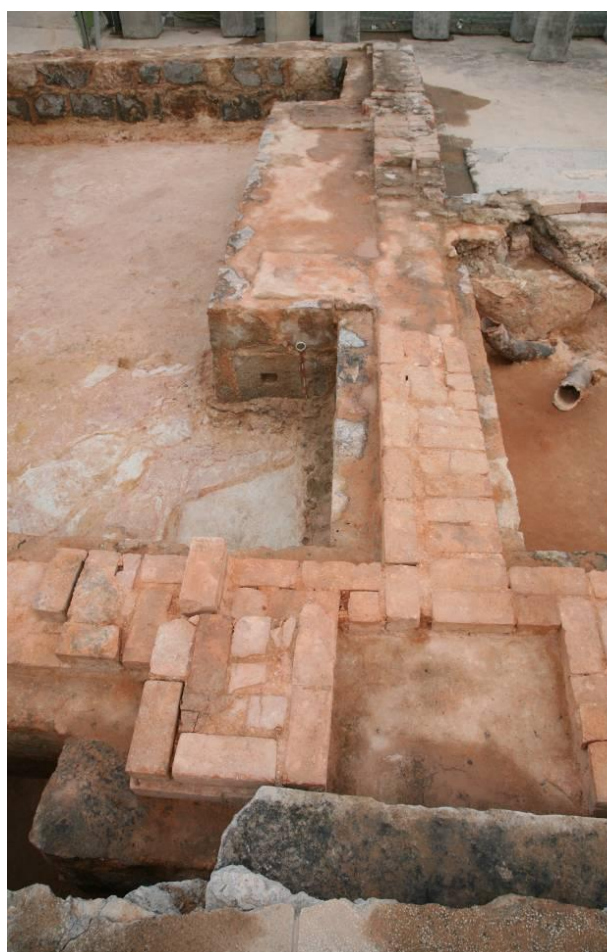
1. 石牆基 S17 (南向北)
Stone wall foundation S17 (South to North)

2. 石牆基 S16 的方形孔(南向北)
Square shaped hole in stone wall foundation
S16 (South to North)

3. 石牆基 S3 上的磚(東向西)
Bricks on stone wall foundation S3 (East to

4. 石牆基 S16 (南向北)
Stone wall foundation S16 (South to North)

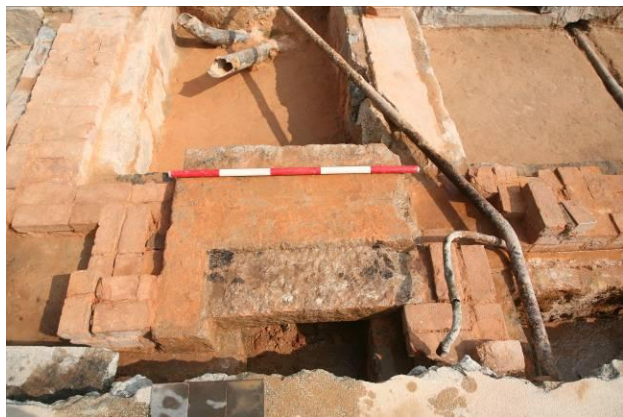
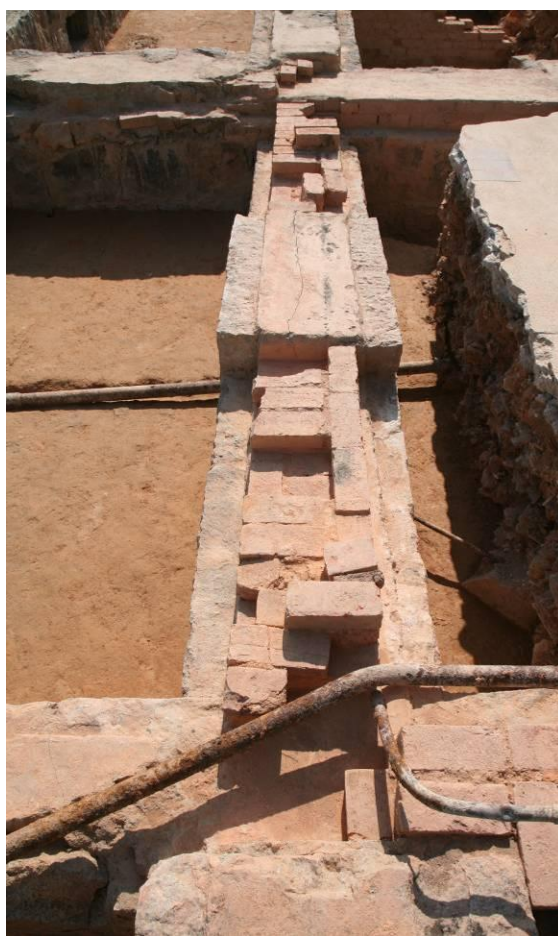
1. 石牆基 S3(南向北)
Stone wall foundation S3 (South to North)

3. 石牆基 S3(東向西)
Stone wall foundation S3 (East to West)

2. 石牆基 S3(南向北)
Stone wall foundation S3 (South to North)

4. 石牆基 S3(西向東)
Stone wall foundation S3 (West to East)

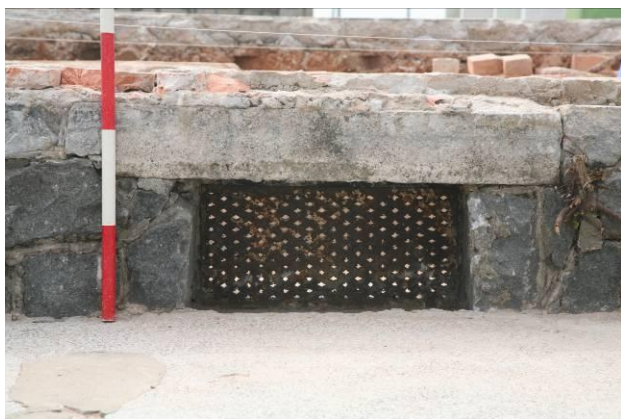
1. 通風口 V1(北向南) Vent V1 (North to South)	2. 通風口 V1(南向北) Vent WH1 (South to North)
3. 通風口 V21 及鐵喉管(北向南) Vent V21 and iron pipe (North to South)	4. 通風口 V20(北向南) Vent V20 (North to South)
5. 通風口 V1(下)及 V21(上)(北向南) Vent V1(lower) and V21(Upper) (North to South)

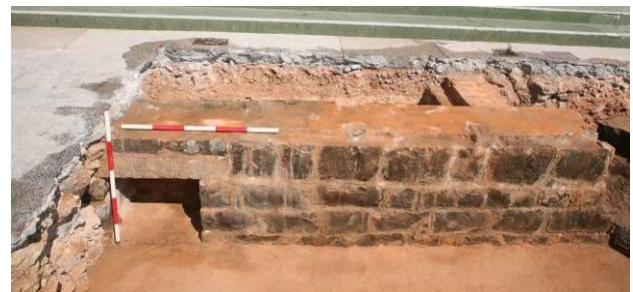
1. 石牆基 S7(西向東)
Stone wall foundation S7 (West to East)

2. 石牆基 S9 與 S7 的接合點(北向南)
Intersection of stone wall foundations S9 and S7
(North to South)

3. 鐵喉管打破石牆基 S7 的一段(南向北)
A iron pipe cut through stone wall foundation
S7 (South to North)

4. 石牆基 S7 及通風口 V40(南向北)
Stone wall foundation S7 and vent V40 (South
to North)

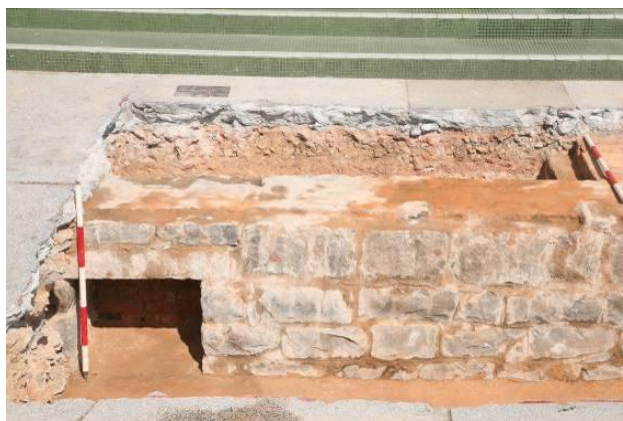
1. 通風口 V40(南向北) Vent V40 (South to North)	2. 通風口 V40 內部(南向北) Interior of vent V40 (South to North)
3. 通風口 V41(南向北) Vent V41 (South to North)	4. 通風口 V41 的另一面(北向南) Other side of vent V41 (North to South)

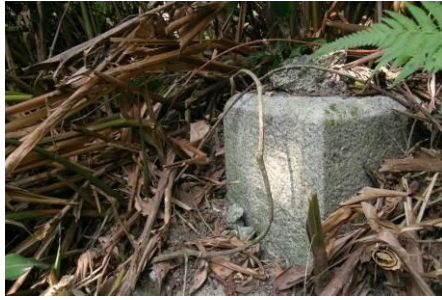
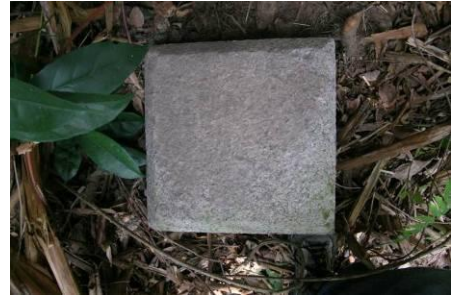
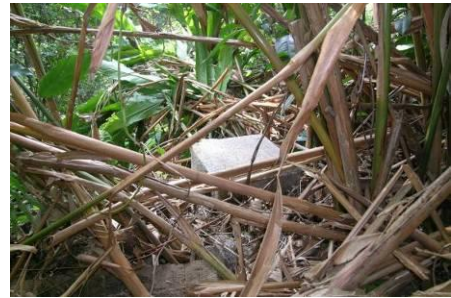
位置 Location B	於農場地段 57 號的分界，位於水泥路的西側，近護坡牆的東角 In the boundary of Farm Lot 57, located West of the concrete road and near east corner of the retaining wall		
現時狀況 Current Condition	大部份已被泥土淹埋，只露出 10 厘米，字面向路 Mostly buried, with 10cm exposed on top and inscription facing the road		
座向 Orientation	60°	長闊高 Dimension	L: 31 cm W: 31 cm H: 30 cm

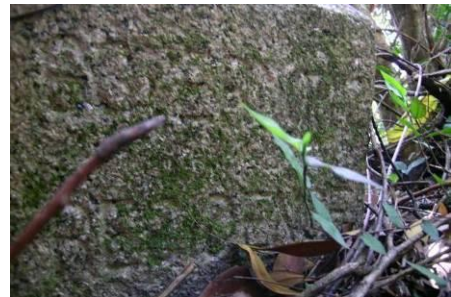
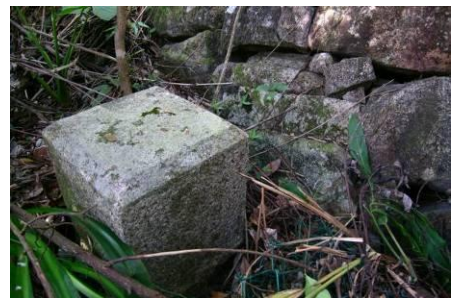
位置 Location C	在護坡牆的西南角下 On Southwest corner of the retaining wall		
現時狀況 Current Condition	界石向南傾斜，稍被移動，但相信仍在原位，字面向護坡牆 Facing South and being moved but mostly <i>in situ</i> with inscription facing the retaining wall		
座向 Orientation	25°	長闊高 Dimension	L: 29.5 cm W: 29.5 cm H: 41 cm

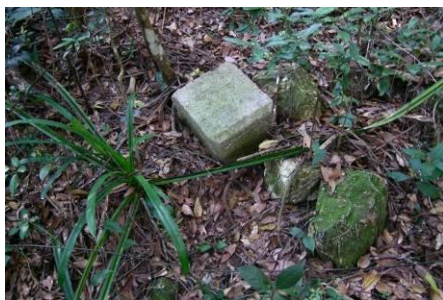
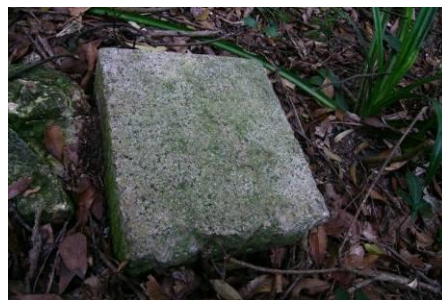
位置 Location E	在柯士甸山道，近電訊盈科發射站一段的南面山坡上 On Southern slope near PCCW radio station at Mount Austin Road		
現時狀況 Current Condition	已倒下，發現時字面向上；碑身較短，已折斷，現存於古物古蹟辦事處。附近有殘破建築構件堆積(傾倒場所 3) Collapsed with inscription facing up and probably damaged, which is currently stored in AMO. Building remains were being found (Dumping Area 3)		
座向 Orientation	Uncertain	長闊高 Dimension	L: 30 cm W: 30 cm H: 60 cm

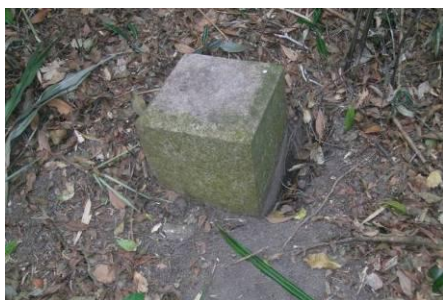
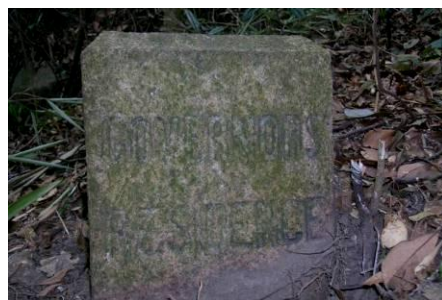
位置 Location H	在山坡近邊沿處 Near edge of the slope		
現時狀況 Current Condition	下半部被泥土淹埋，字面向山坡外 Lower part buried with inscription facing downslope		
座向 Orientation	295°	長闊高 Dimension	L: 28.5 cm W: 28.5 cm H: 30 cm

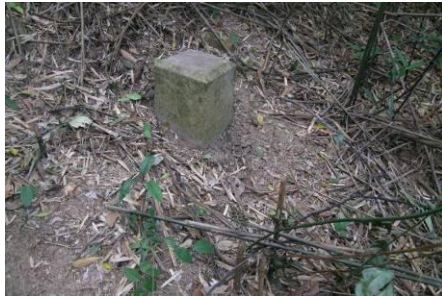
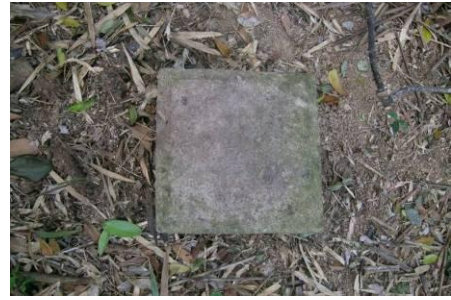
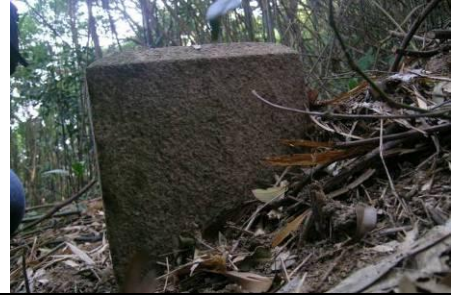
位置 Location I	山坡上 On the slope		
現時狀況 Current Condition	下半部份於泥土，字面向山坡外 Lower part buried with inscription facing downslope		
座向 Orientation	315°	長闊高 Dimension	L: 27.8 cm W: 27.8 cm H: 30 cm

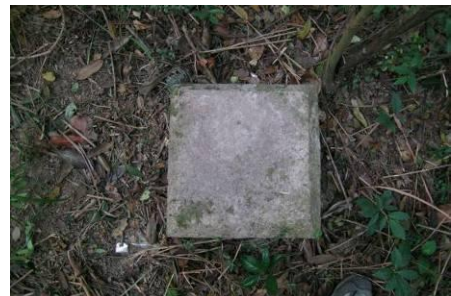
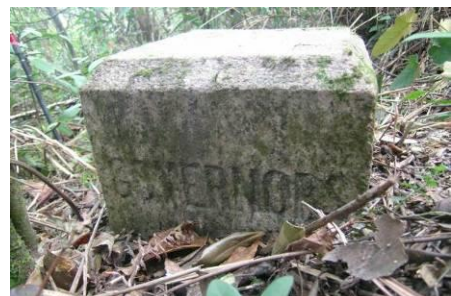
位置 Location J	在水泥路的北側，發現於 1982 年 North of concrete road and discovered in 1982		
現時狀況 Current Condition	下半部被泥土淹埋 Lower part buried		
座向 Orientation	295°	長闊高 Dimension	L: 29.5 cm W: 29 cm H: 23 cm

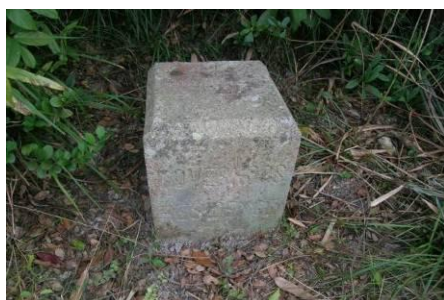
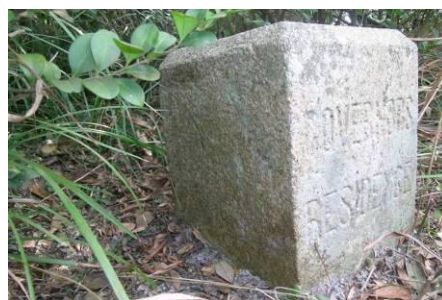
位置 Location K	在山頂大石側 Next to a huge rock on the Peak		
現時狀況 Current Condition	在雜草叢中，頂部似有一小片金屬殘留物 Concealed within bushes and a metal piece can be traced on top of the stone.		
座向 Orientation	263°	長闊高 Dimension	L: 29 cm W: 29 cm H: 32 cm

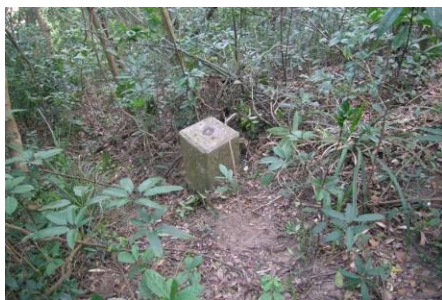
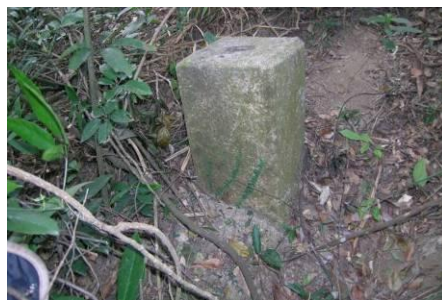
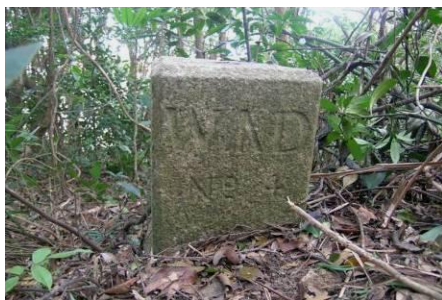
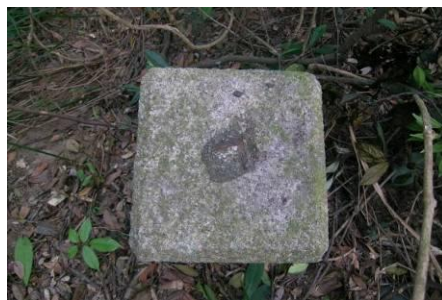
位置 軍部界石 4 Location WD No. 4	在夏力道號南面山坡上，J 界石北面不遠處 On the Southern slope of Harlech Road, northern side of boundary stone J		
現時狀況 Current Condition	在樹林中，頂上中央有金屬物殘存，字面向山坡內 Situating within forest and a piece of metal is on top with inscription facing upslope		
座向 Orientation	不詳 Unknown	長闊高 Dimension	L: 30.5 cm W: 30 cm H: 42 cm

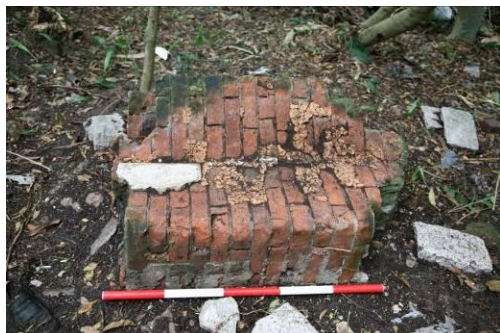
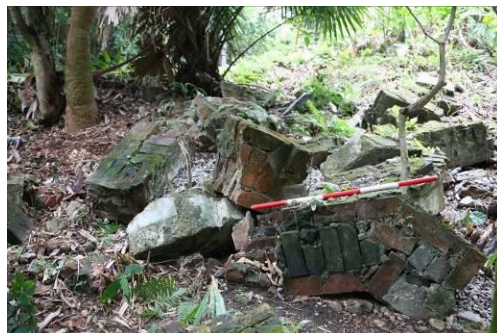
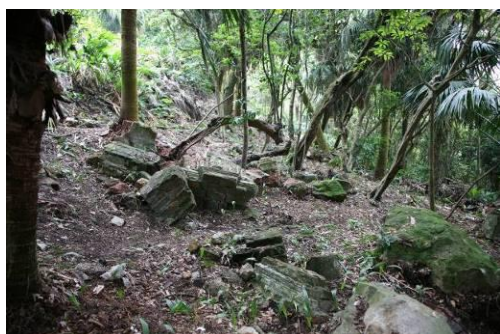
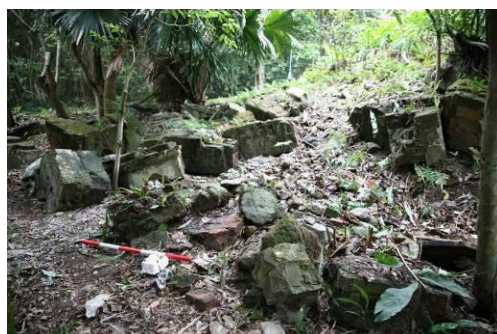
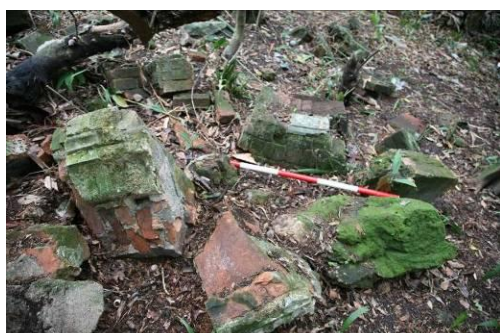
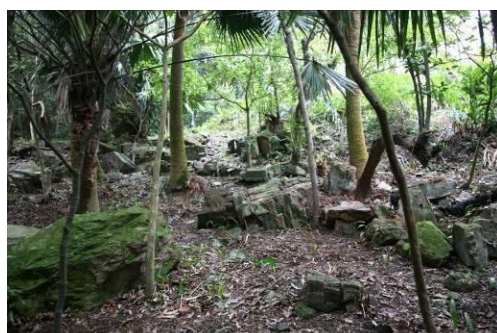
位置 傾倒場所 1 Location Dumping Area 1	前總督山頂別墅南面的叢林中 Bushes located at South part of the Mountain Lodge
備註 Remarks	發現有柱，卷拱、及欄桿的殘件，應為前總督山頂別墅的建築殘件 Ruined building materials such as columns, arches and iron cast rail of Former Mountain Lodge are discovered.

位置 傾倒場所 1 Location Dumping Area 1	前總督山頂別墅南面的叢林中 In bushes south of Former Mountain Lodge
備註 Remarks	發現有柱、卷拱、及欄桿的殘件，應為前總督山頂別墅的建築殘件 Ruined building materials such as columns, arches and iron cast rail of Former Mountain Lodge are discovered

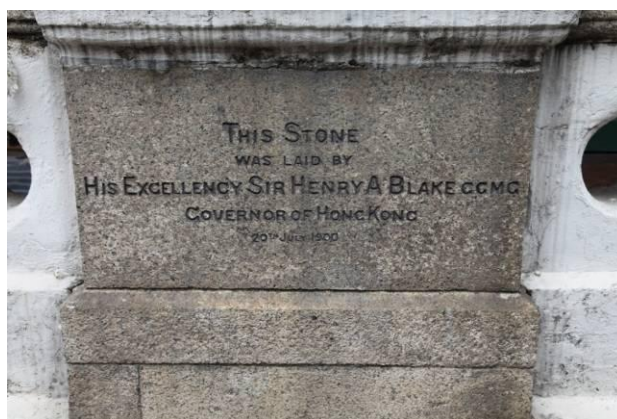
- 1-2. 位於尖沙咀彌敦道 136 號的前九龍英童學校，現為古物古蹟辦事處附屬建築物的磚牆結構(紅方框示)
The brick wall foundation in the Former Kowloon British School at No. 136 Nathan Road, Tsim Sha Stui, which is now an affiliated structure of the Antiquities and Monuments Office
(Indicated by red frame)
3. 與前總督山頂別墅相似的通風口(紅方框示)
Vent similar to Former Mountain Lodge (Indicated by red frame)
4. 前九龍英童學校(現古物古蹟辦事處)的奠基石，由前港督卜力於 1900 年主禮
Foundation stone of the Kowloon British School (Now the Antiquities and Monuments Office), laid by the former Governor of Hong Kong, Henry A. Blake in 1900
