**MTR Corporation Limited**

Express Rail Link (XRL)  
 Consultancy Agreement No.: C8016

**Shek Kong Stabling Sidings (SSS) –  
 Further Archaeological Investigation Report**

May 2011

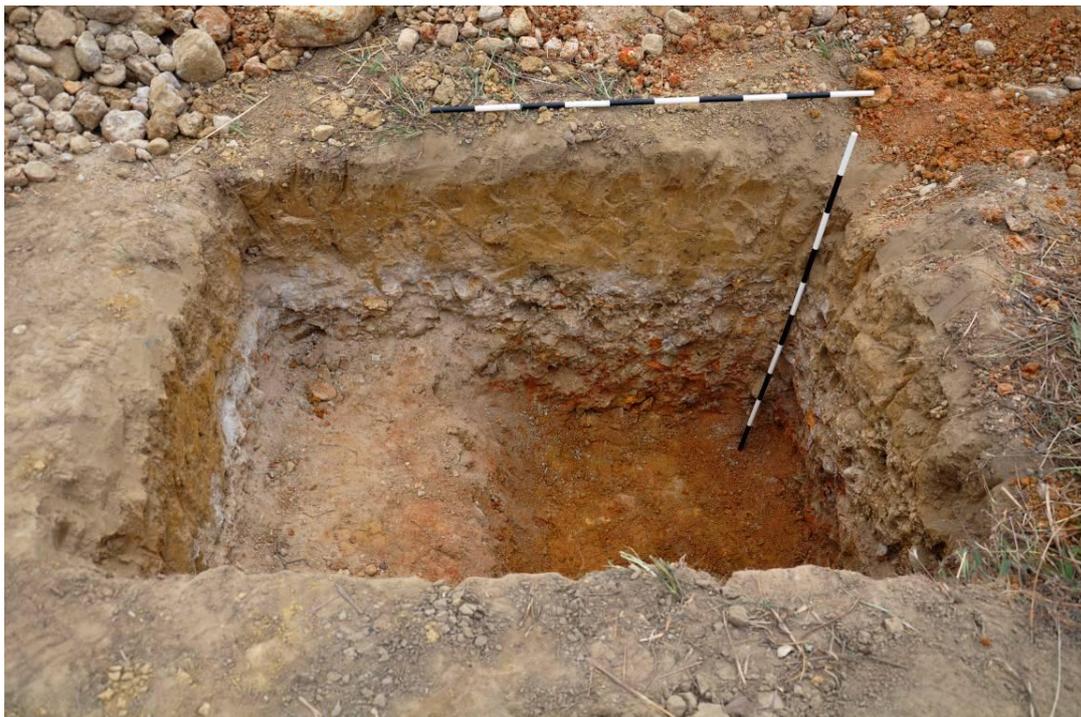
**SP 5 Eastern Profile**

Layer	Soil Texture	Soil Colour	Finds	Chronology
L1	Sandy Silt	Light Gray	Nil	Modern
L2	Silt	Yellowish Brown	Nil	N/A
L3	Cobbles with Coarse Sand	Light Gray	Nil	N/A
L4	Weathered Cobbles with Silt	Reddish Brown	Nil	N/A

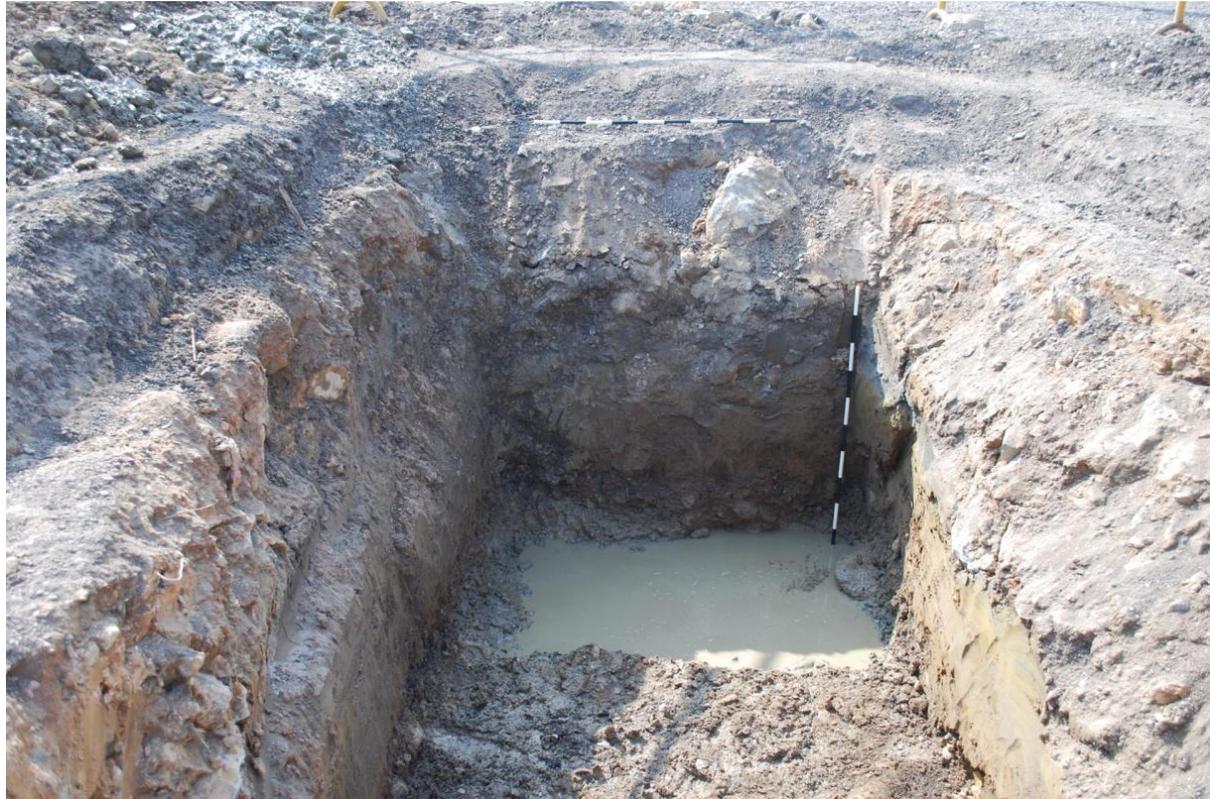
**SP9 Southern Profile**

Layer	Soil Texture	Soil Colour	Finds	Chronology
L1	Bitumen Paving	Black	Nil	Modern Ground Paving
L2	Clay with Boulders	Yellowish Brown	Nil	Modern Fill Soil
L3	Sandy Clay	Gray	Nil	N/A
L4	Clay	Light Olive Brown	Nil	N/A
L5	Clayey Sand	Olive Brown	Nil	N/A
L6	Clay with Boulders	Dark Gray	Nil	N/A

6.2.12 Similar to Area I, in SP9 and SH30 (see records in **Appendix A**), certain lower layers of these pits and holes contain organic-rich clay. It displayed perhaps the natural phenomena of fluvial actions, temporary seasonal lakes, or a result of an abandonment of river channel. This area is continually affected and reshaped by running water since Late Pleistocene into early Holocene and such condition would render it unsuitable for human settlements. It is therefore suggested that Area II East has no archaeological potential.

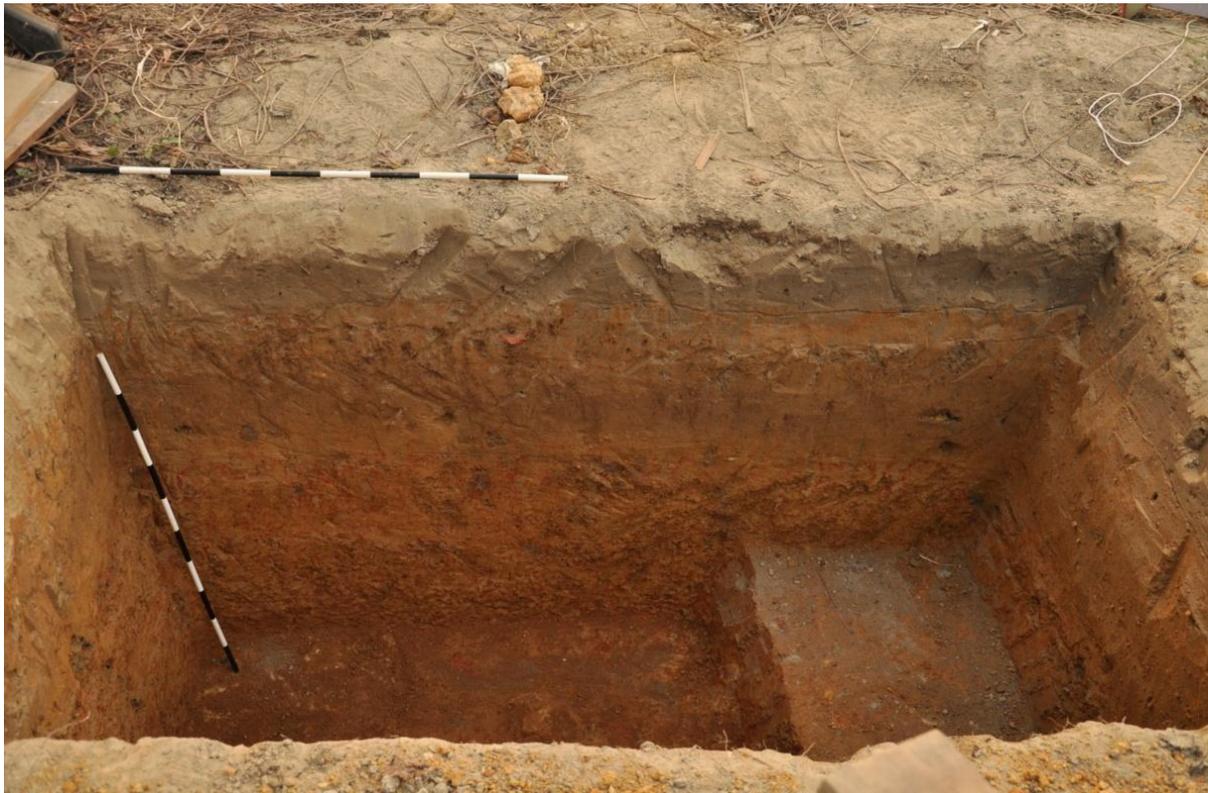
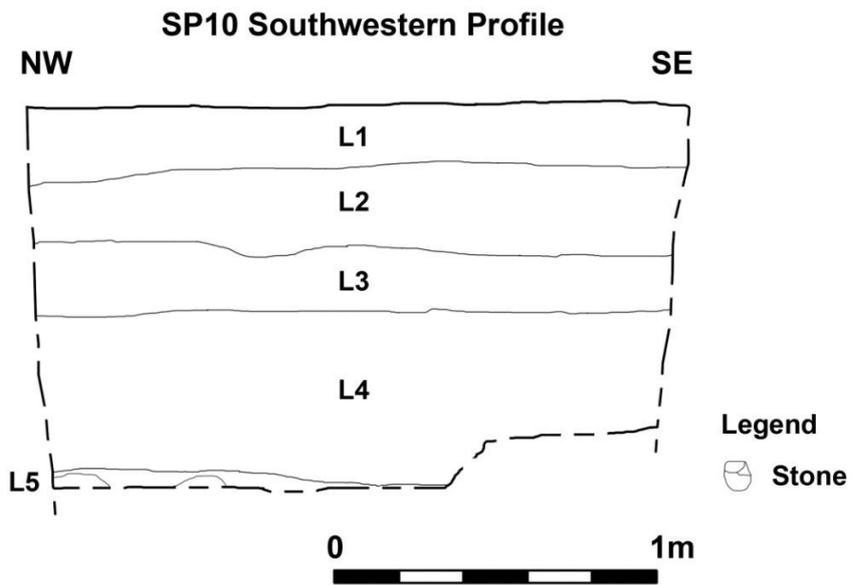
**SP10 Southwestern Profile**

- 5.3.5 Five layers were identified in SP10, numbered as L1 to L5 following excavation sequence (see record of SP10 in **Appendix A**). No feature was observed in the test pit.

Layer	Soil Texture	Soil Colour	Finds	Chronology
L1	Silty Sand	Dark Gray	Celadon and Porcelain shards	Modern (disturbed)
L2	Silty Sand	Brownish Yellow	A few tiles with pot shards	Song-Yuen dynasties
L3	Sandy Clay	Yellowish Brown	Nil	N/A
L4	Silty Clay with Course Sand	Olive Yellow + Red	Nil	N/A
L5	Silty Clay with Pebbles	Olive Yellow + Red	Nil	N/A

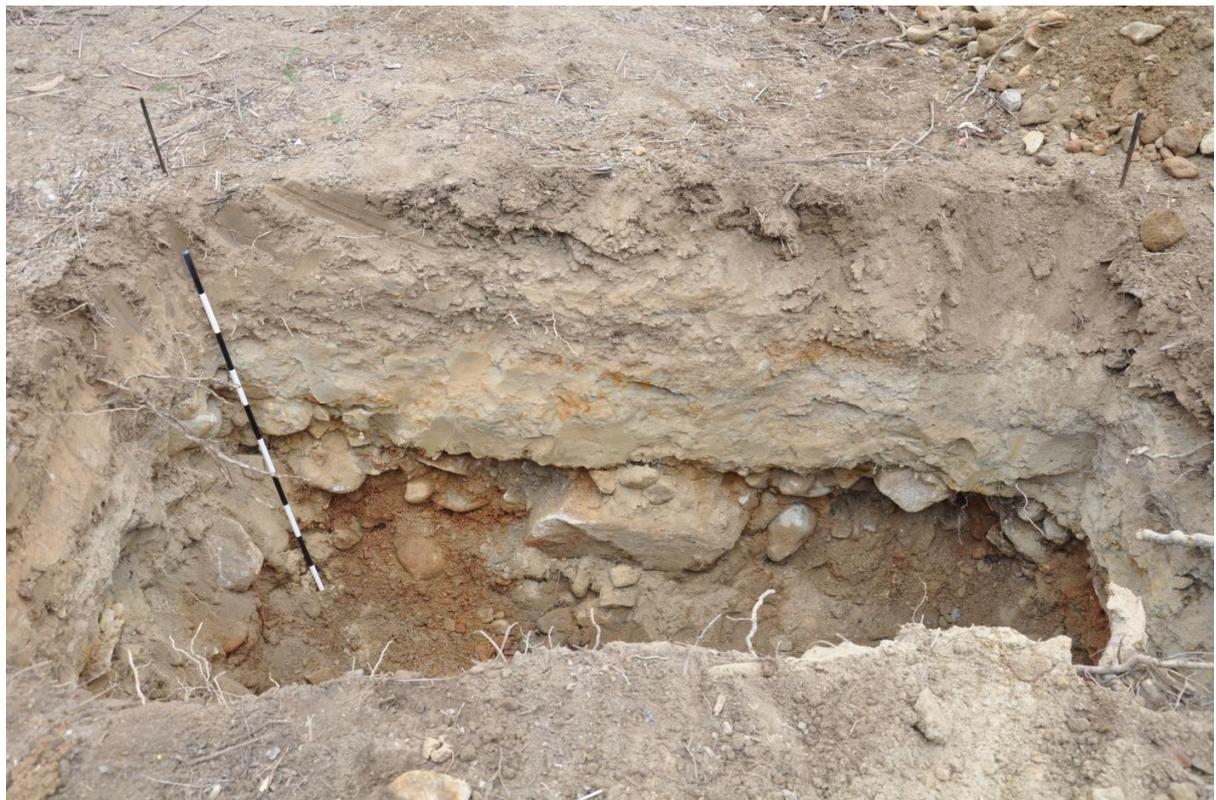
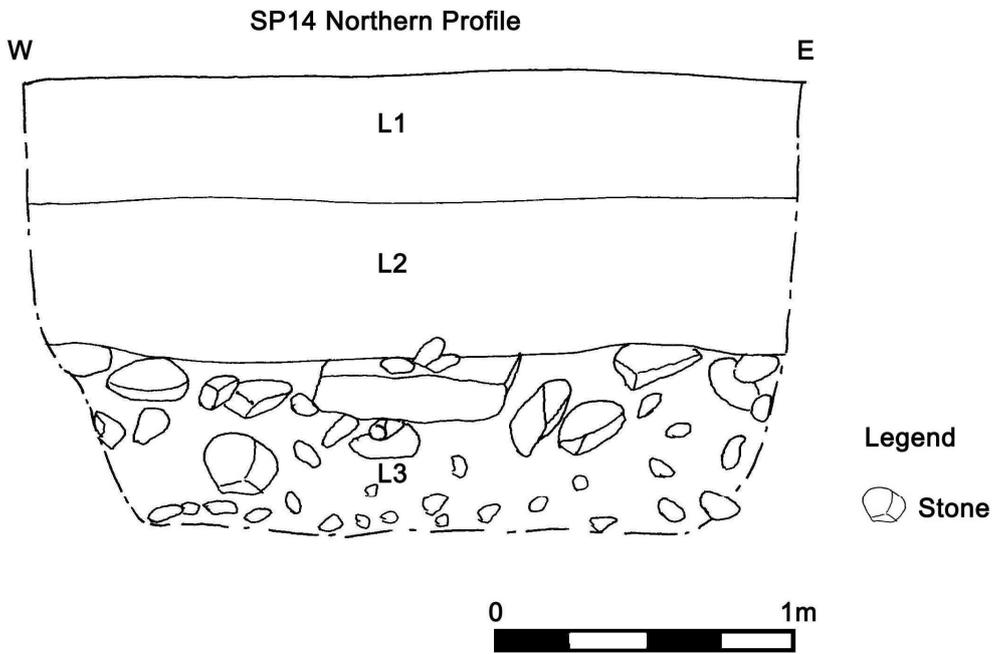
**SP14 Northern Profile**

5.3.11 Three layers were identified in SP14, numbered as L1 to L3 following excavation sequence (see record of SP14 in **Appendix A**). No feature was observed in the test pit.

<b>Layer</b>	<b>Soil Texture</b>	<b>Soil Colour</b>	<b>Finds</b>	<b>Chronology</b>
L1	Silt	Gray	Nil	Modern
L2	Silty sand	Very pale brown	Nil	N/A
L3	Boulders with pebbles and coarse sand	Red	Tiles with textile imprint	N/A

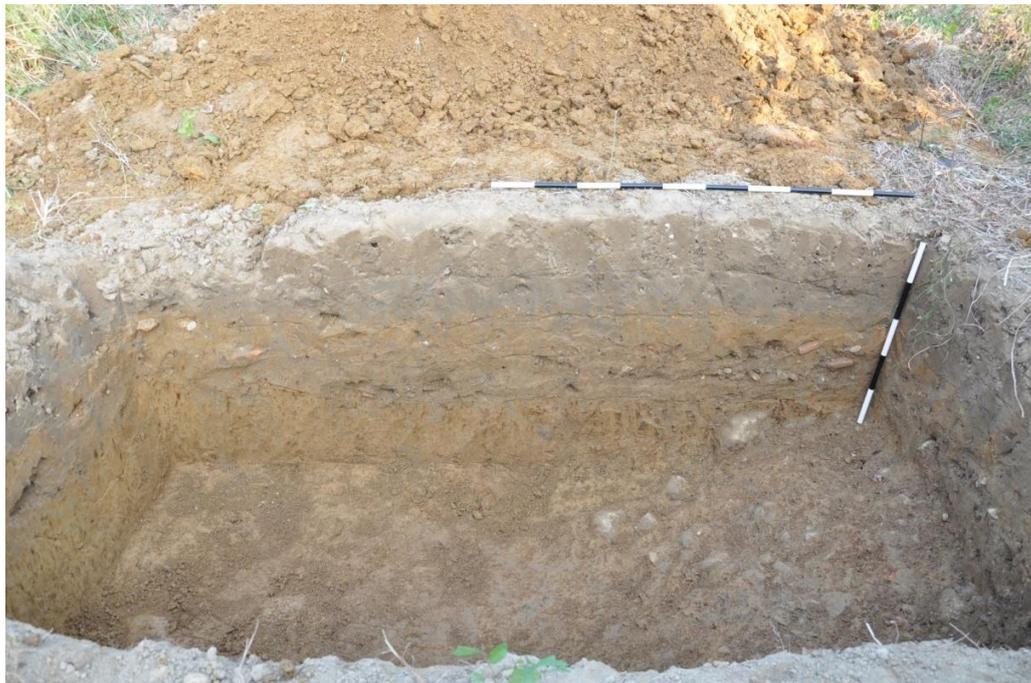
**SP16 Eastern Profile**

5.3.18 Six layers were identified in SP16, numbered as L1 to L6 following excavation sequence (see record of SP16 in **Appendix A**). No feature was observed during the course of excavation.

Layer	Soil Texture	Soil Colour	Finds	Chronology
L1	Silt	Olive Brown		Modern Topsoil
L2	Silt	Grayish Brown	Tiles, Porcelain, Pottery	Late Qing
L3	Silty Sand	Dark yellowish Brown	Tiles, B&W, Tiles	Ming-Qing
L4	Silty Sand	Olive Brown	Tiles, Celadon	Song-Yuan
L5	Clayey Silt	Light Olive Brown	Nil	N/A
L6	Clay with Pebbles	Light Olive Brown	Nil	N/A

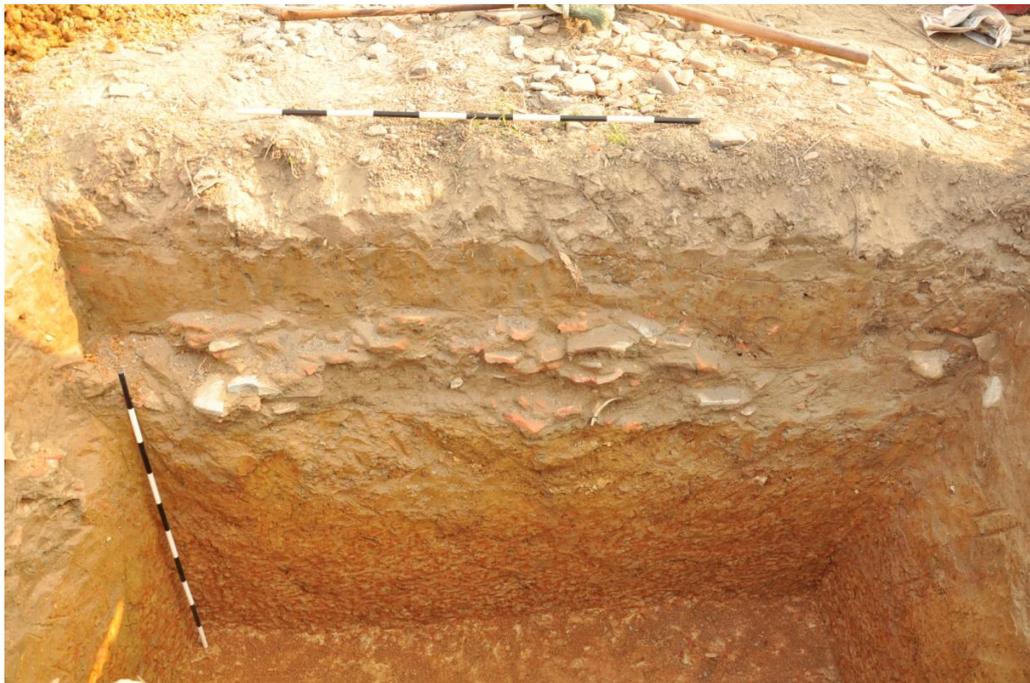
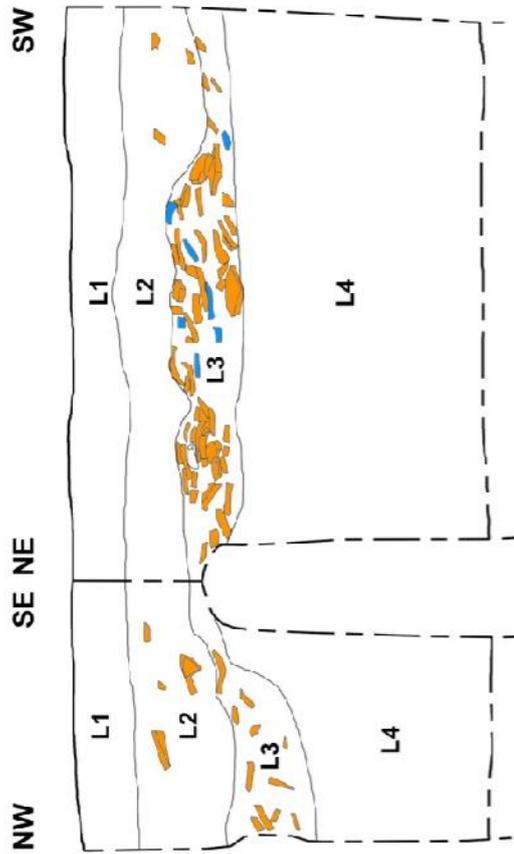
**SP20 Southeastern Profile**

5.3.26 Four layers were identified in SP20, numbered as L1 to L4 following excavation sequence (see record of **SP20** in **Appendix A**). No feature was observed in this test pit.

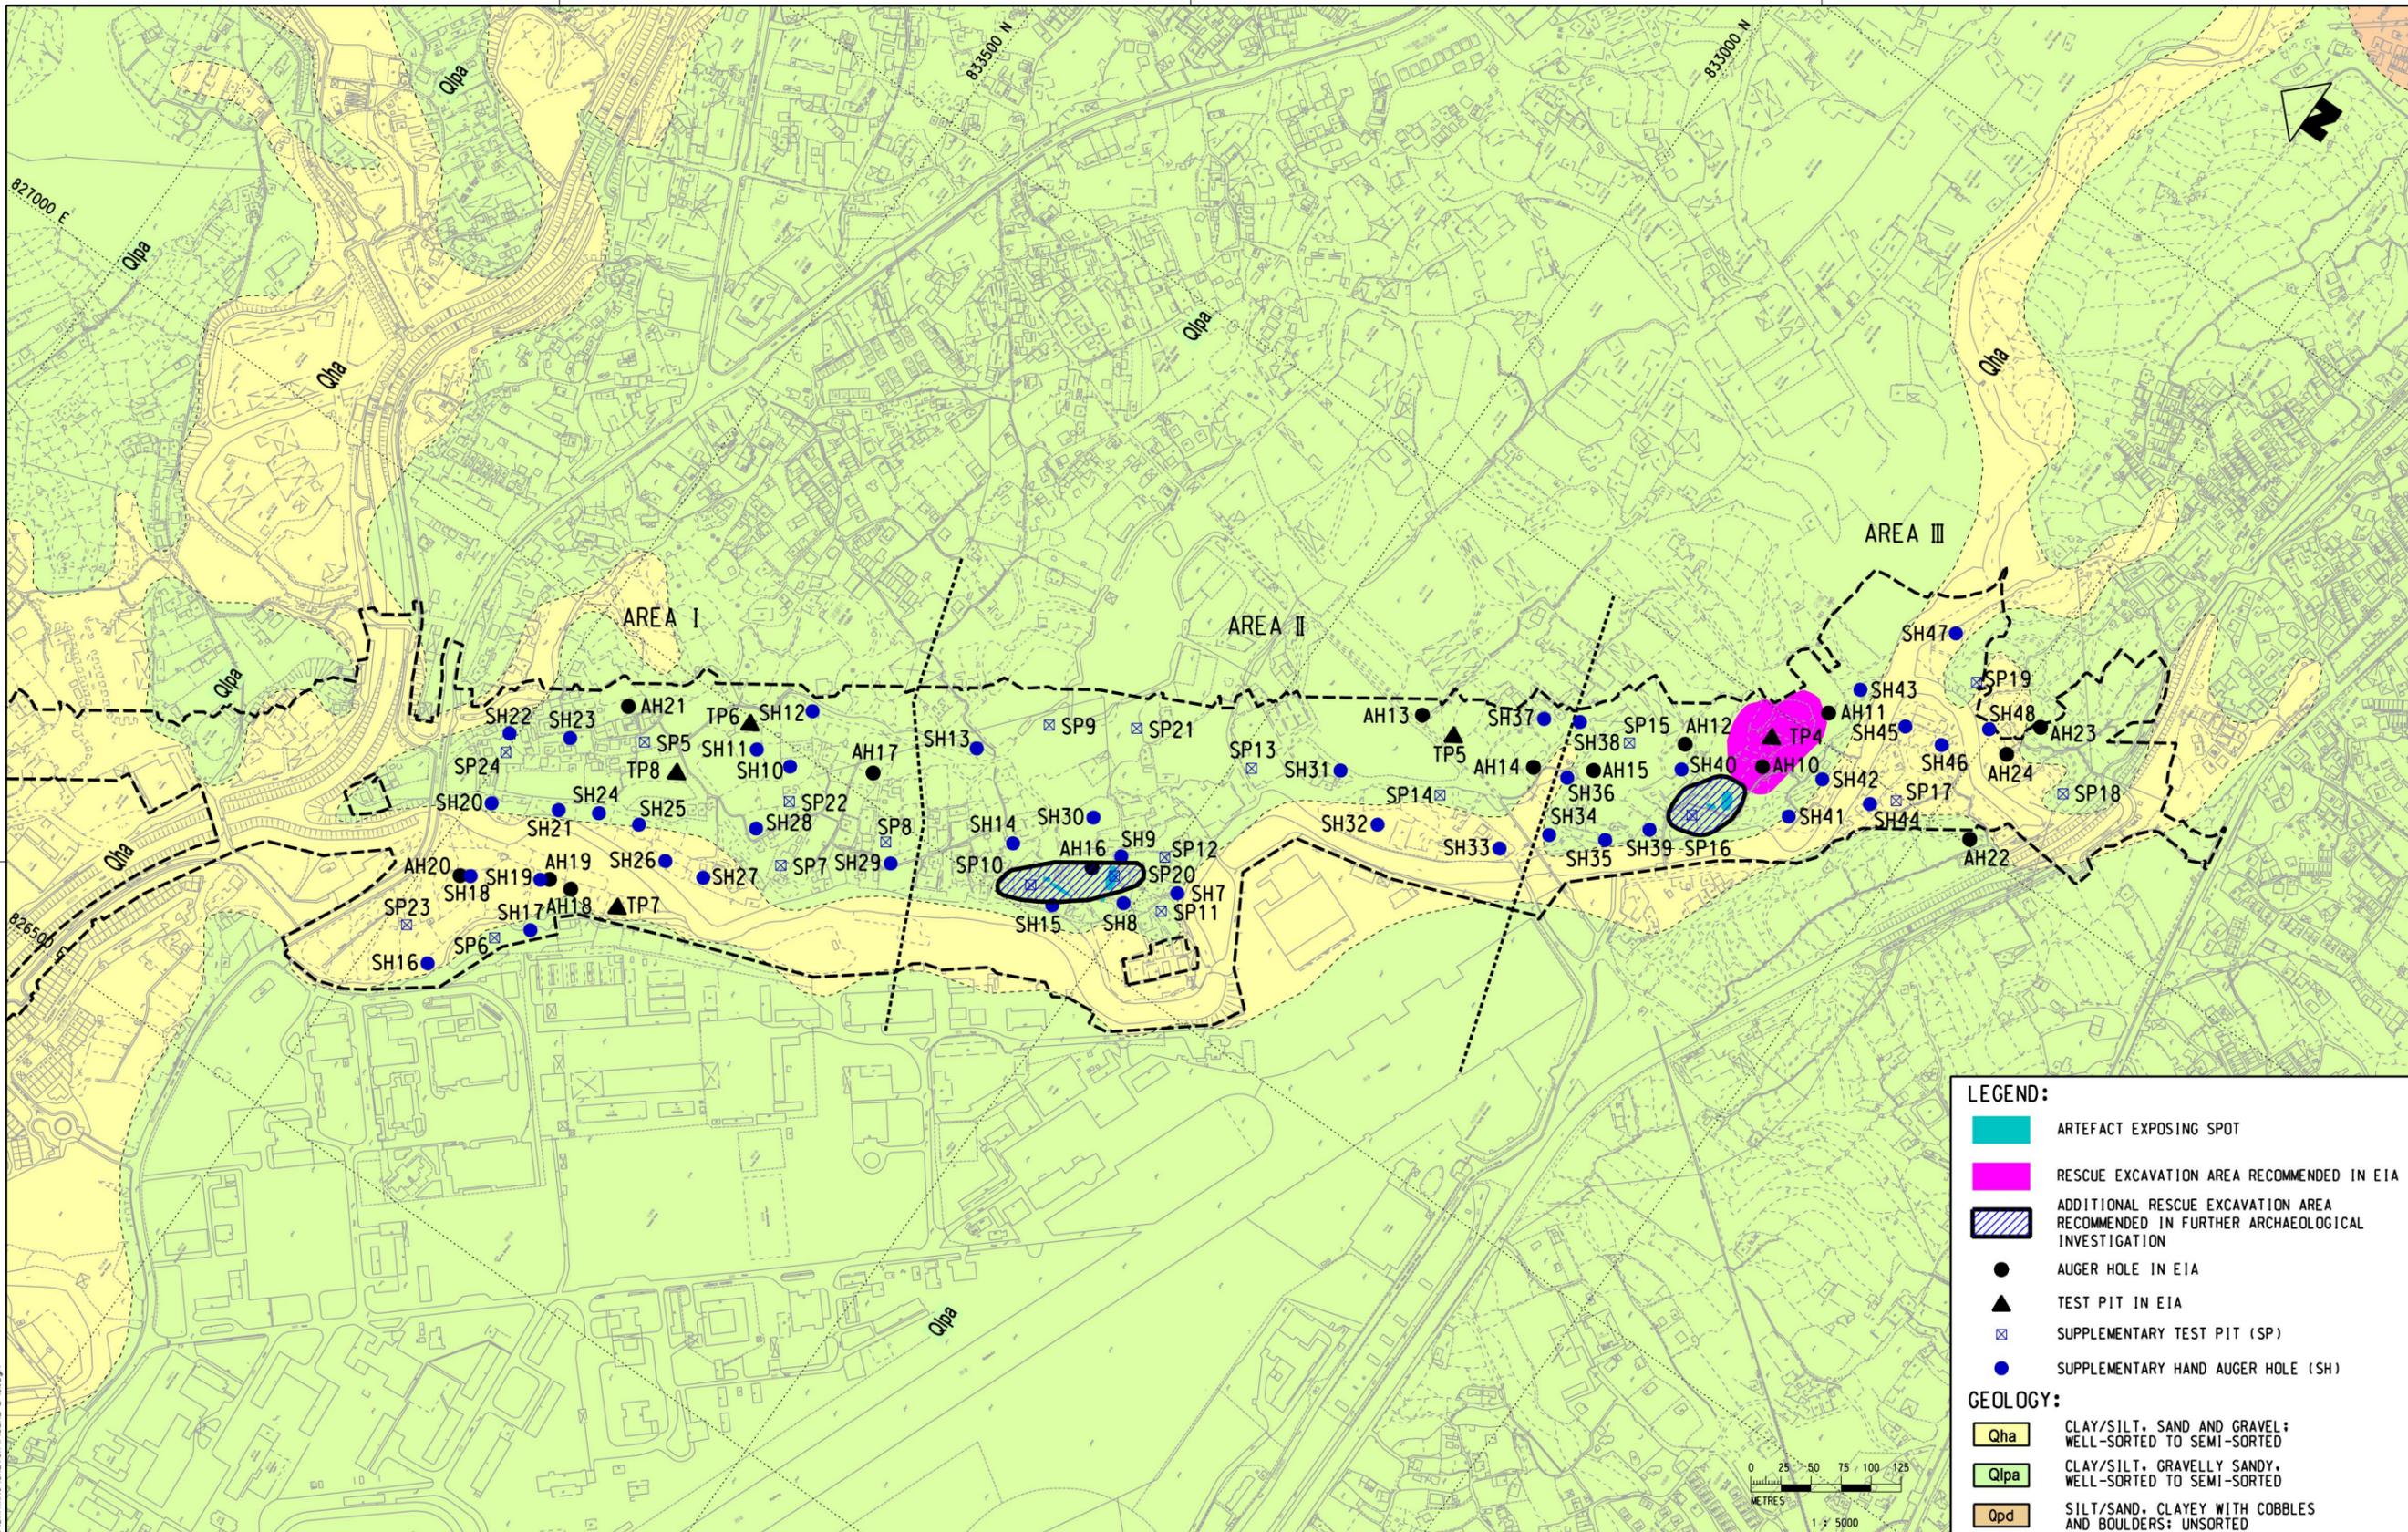
TITLE	<b>C8016</b> <b>ENVIRONMENTAL TERM CONSULTANCY FOR XRL</b> <b>LOCATION OF TEST PITS AND AUGER HOLES</b> <b>WITH GEOLOGY IN SHEK KONG</b>	
SCALE	1 : 5000 (A3)	FIGURE NO.
		FIGURE B-1
		REV. B

3.1.6 Hand augering were conducted at locations with consideration of site condition during the investigation period. The location of each drilled auger hole has been marked on a map with appropriate scale (see **Figure No. C8016/C/XRL/ENS/M55/009**).

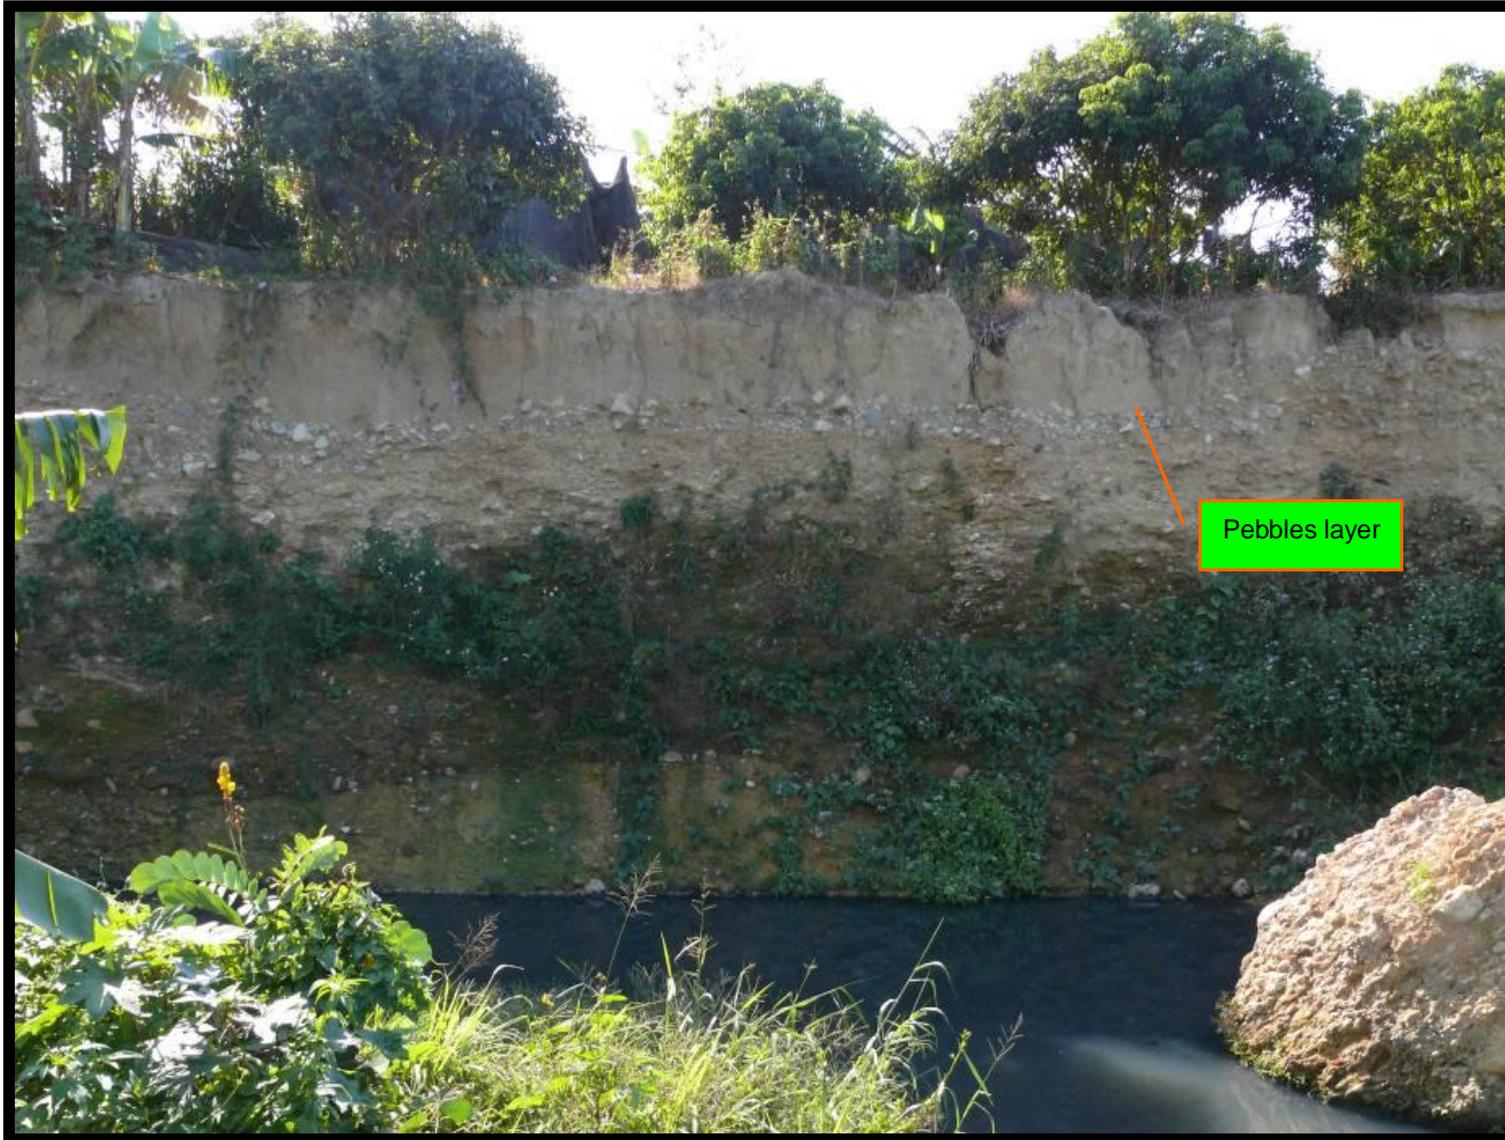
Figure B-5b Geological Profile of Pleistocene Alluvium (Chek Lap Kok Formation) Overlain by Holocene Alluvium in SSS Area III

6.2.20 Similar to Area I, this area is continually affected and reshaped by running water since Late Pleistocene into early Holocene and such condition would render it unsuitable for human settlements. The lacking of archaeological evidence and the reference from geological perspective suggested that Area III South has no archaeological remains.

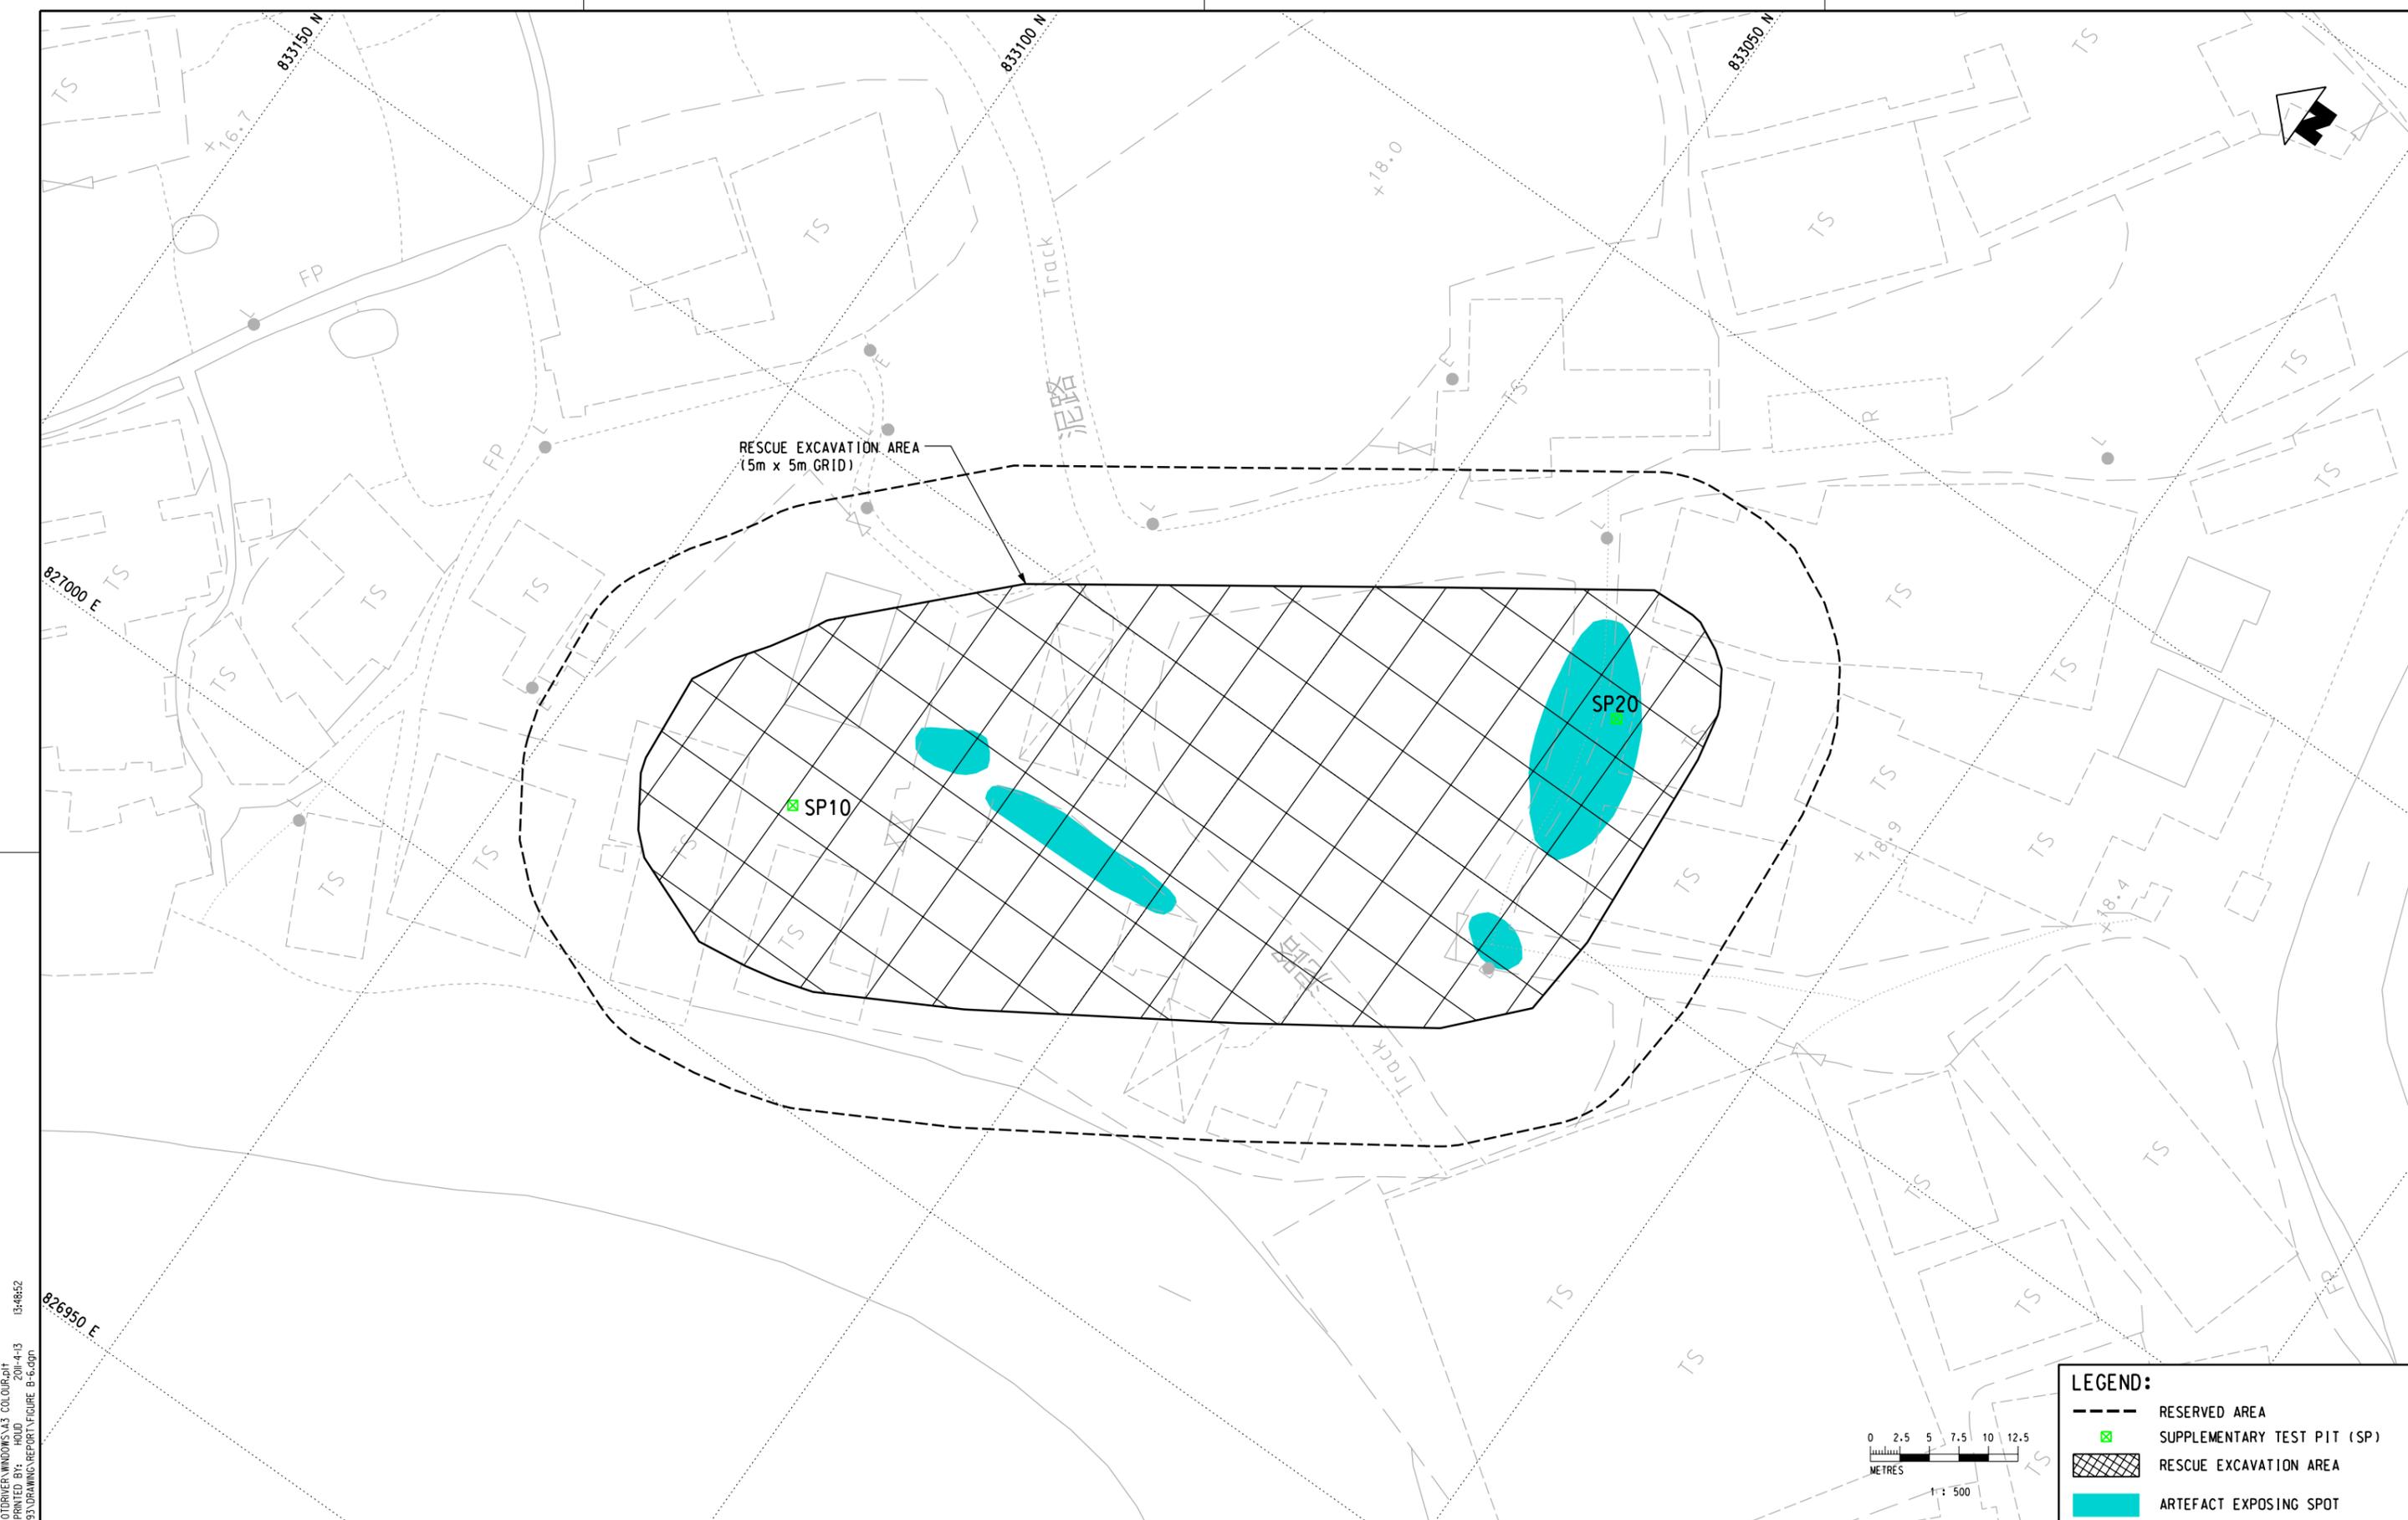
TITLE	<b>C8016 ENVIRONMENTAL TERM CONSULTANCY FOR XRL PROPOSED GRID SYSTEM AND RESERVED AREA OF ADDITIONAL RESCUE ARCHAEOLOGICAL EXCAVATION ON SP10 AND SP20</b>		
SCALE	1 : 500 (A3)	FIGURE NO.	<b>FIGURE B-6</b>
REV.	A

- 5.2.1 Field scanning was conducted in the resumed areas and some roof tiles, celadon and blue-and-white porcelain shreds were observed on the surface at the area at Area II West (between SP10 and SP20) and Area III North (near SP16). According to the datable characters, these shreds are dated to Song-Yuan and Qing Dynasties.
- 5.2.2 The findings of field scanning demarcated the extent of archaeological deposits at the areas of SP16 and between SP10 and 20 (see **Figures B-6 and B-7 in Appendix B**)

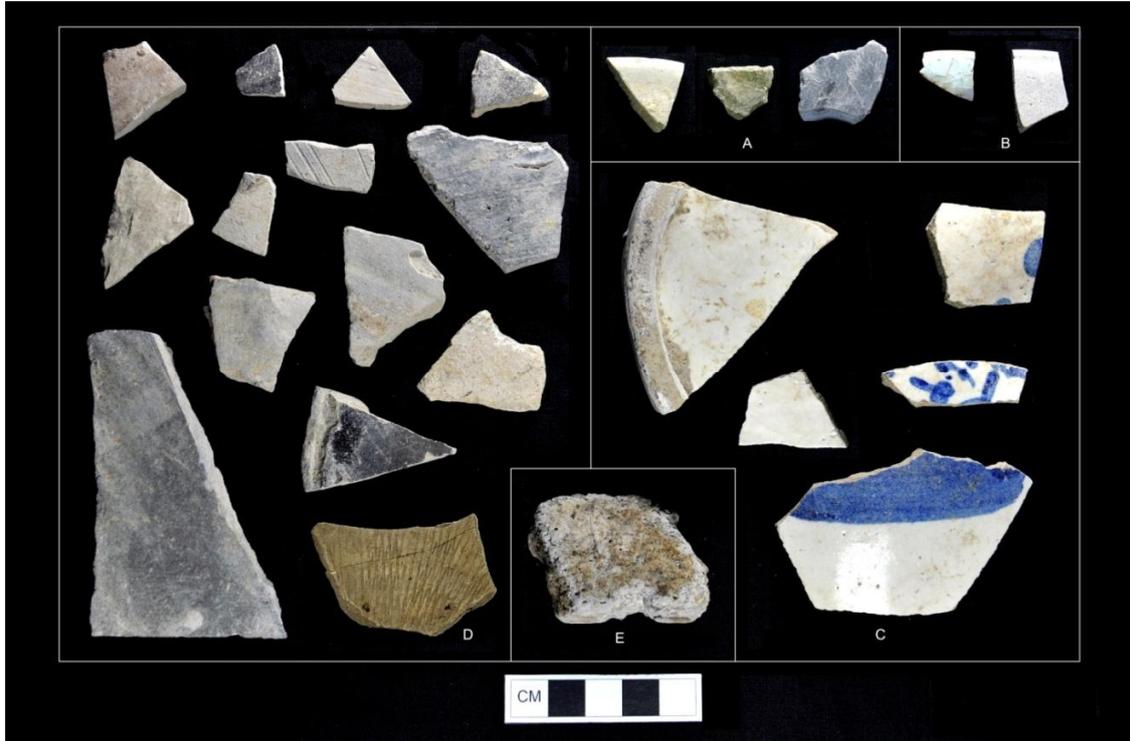
Figure C-1 Celadon (A), Undiagnosed Porcelain (B), Modern Porcelain Shreds (C), Pot shreds(D), Roof tiles (E) from SP10 L1

- Celadon, including 1 rim shred and 2 body shreds, were recovered (see **Figure C-1 (A)** of **Appendix C**). The rim shred has a thin layer of greyish blue translucent glaze with crackle. Glaze covers both interior and exterior except for the mouth rim, called as unglazed rim. Such glazing technique was adopted so that the vessel could be fired with its mouth rim faced up-side-down, and its foot rim or base could be fully glazed. The 2 body shreds have relatively thick (0.5mm) glaze in comparison to the rim shred, and both with crackle. Their glaze colours range from olive green to bluish green. These celadon shreds are too fragmentary to inform morphology, however, the glazing method and the characteristics of glaze (thickness, crackle, and colour) can be compared with Song to Yuan celadon shreds unearthed from rescue excavation undertaken at the Former Kai Tak Airport in 2009<sup>11</sup>.

- Undiagnosed porcelain, including 5 modern porcelain shreds (see **Figure C-1 (C)** of **Appendix C**), possibly broken fragments from the same flowerpot, and 2 other undiagnosed shreds (see **Figure C-1 (B)** of **Appendix C**), were found.

- CBM unearthed from L1 refers to an unknown object made of gray sandy fabric (see **Figure C-1 (E)** of **Appendix C**), which is similar to that of roof tiles, and thus the object is classified as CBM. It has four flat surfaces forming a blade-like cross section and both ends are broken.

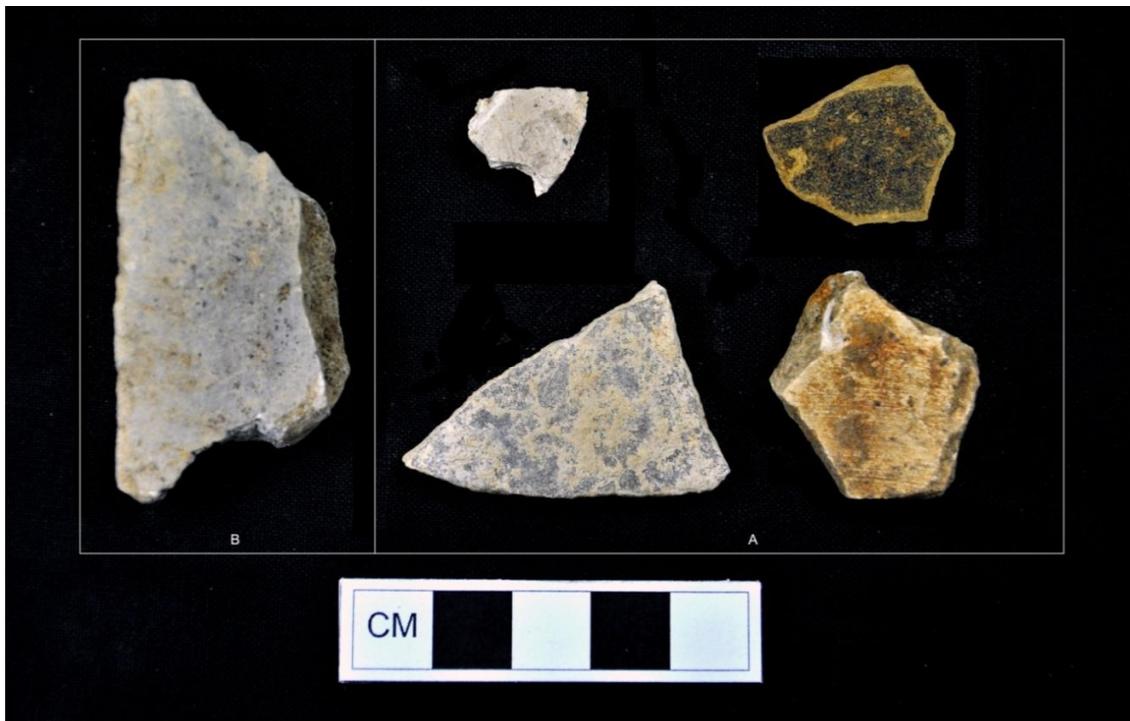
FigureC-2 Potshreds (A) and sample of Roof tiles (B) from SP10 L2

- Pottery shreds from L2 are mainly with black glaze (see **Figure C-2 (A)** of **Appendix C**). However, they are also too fragmentary to inform morphology and dating.
- CBM uncovered are mainly tile fragments in two individual piles lying in the middle of both the southwest and northeast sides of the test pit (see **Figure C-3** of **Appendix C**). Each pile has only a few tile fragments. The tiles have orangish red clay fabric and black slip and textile imprint on their surface. Their body form appears to be slightly curve in the middle. Similar tiles were found in excavation at Mong Tseng Wai at Tin Shui Wai and Siu Hang Tsuen at Tuen Mun<sup>12</sup>. Another piece of CBM fragment found in this layer is probably tile in

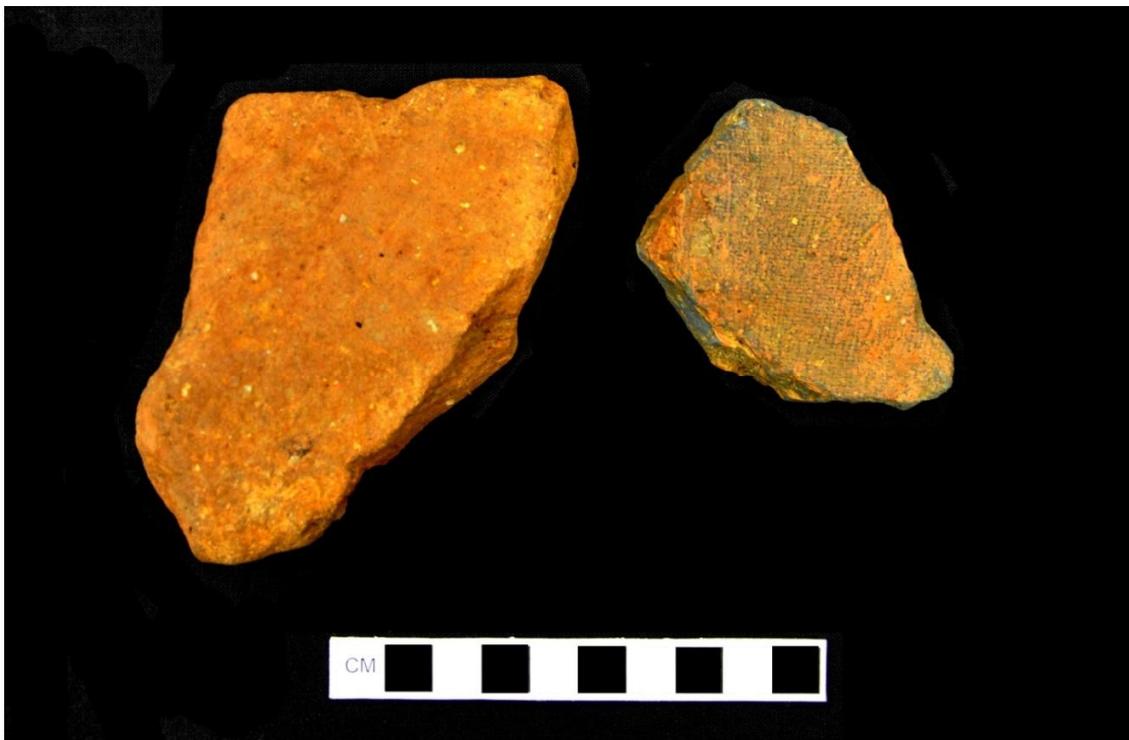
Figure C-4 Tiles from SP14 L3

- **CBM** (see **Figure C-4 of Appendix C**) uncovered are 2 thick tile fragments. They are of red fabric and both bear textile imprint on their surface. Their body form appears to be slightly curve in the middle. Their edges are shattered, indicating long time exposure to natural agencies such as water or heat. Considering their thickness, colour of fabric and characteristic on surface, they are very similar to tiles found in SP 10 and SP 20. Thus they possibly can be dated to Song-Yuan to Qing periods. However, since they were unearthed in a consistent pebble layer, which indicates the location was once a river rift. It is therefore considered that the tiles fragments may be moved away by either natural or artificial agency from their original position and deposited along with the pebbles at river side.

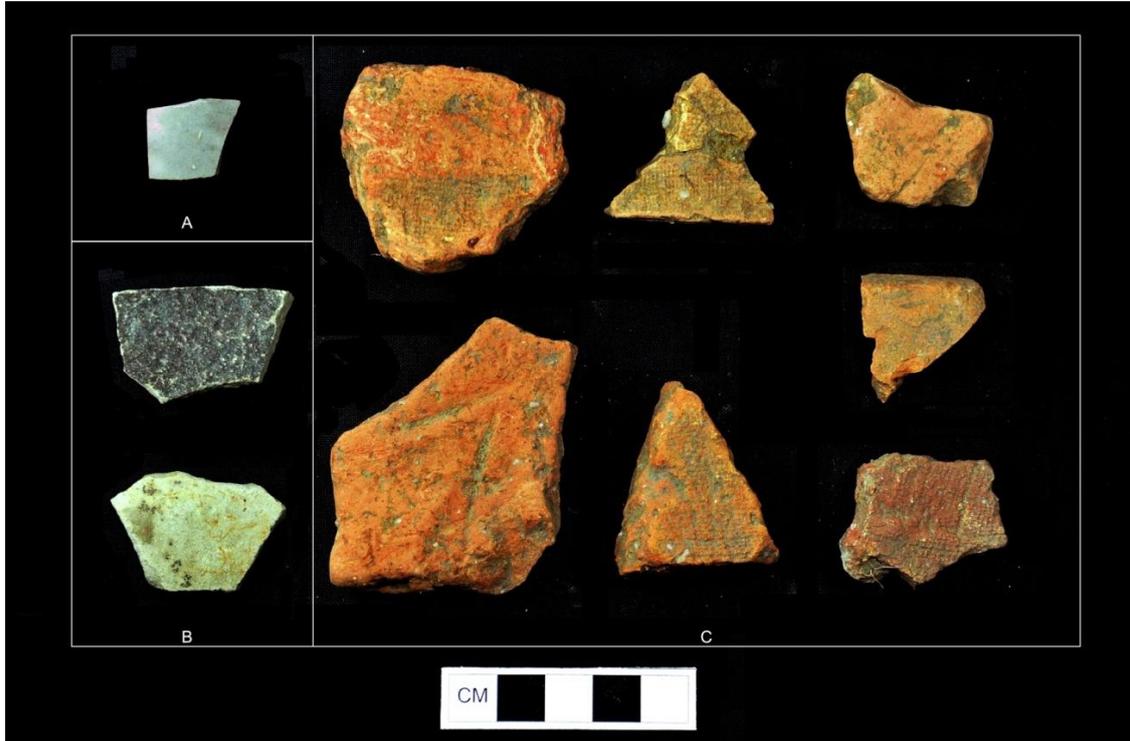
Figure C-5 Glazed Porcelain shred (A), Pot shreds (B) and Roof Tiles (C) from SP16 L1

- The undiagnosed porcelain recovered is a body shred with a grayish green even glaze on both interior and exterior (see **Figure C-5 (A) of Appendix C**). It could be a fragment of late Qing blue and white. However, the piece is too fragmentary and bears no blue glaze on it.
- Pottery found in this layer includes 2 body shreds with one of them applied with dark brown glaze (see **Figure C-5 (B) of Appendix C**). There are no sufficient characteristics to inform dating.
- CBM found in this layer are tiles fragments made of orangish red fabric, and with shattered edges (see **Figure C-5 (C) of Appendix C**). Textile imprint could be observed on some tile fragments.

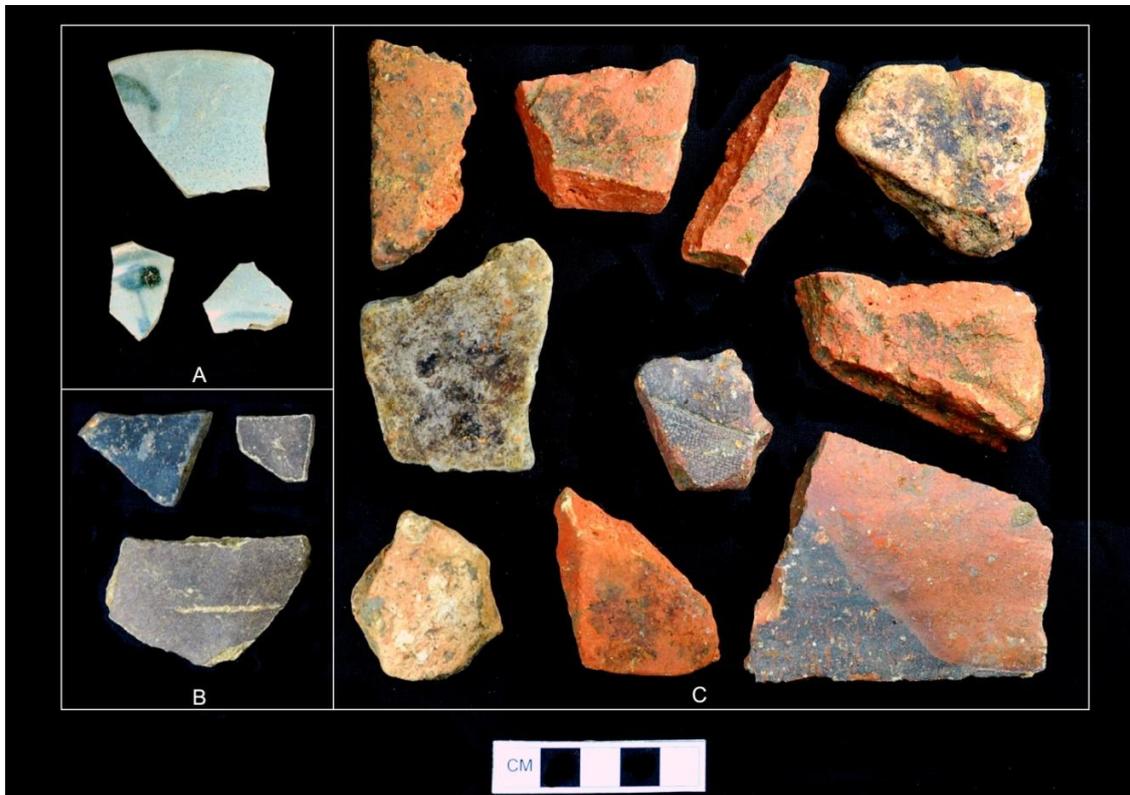
Figure C-6 Blue-and- White Porcelian Shreds (A), Glazed Pot shreds (B), and Roof Tiles (C) from SP16 L2

- Blue and white porcelain recovered from L2 includes 2 rim shreds and 1 body shred (see **Figure C-6 (A) of Appendix C**). The background glaze of them appears to be in grey tone, and the blue paint appears to be in dull tone. These shreds share similar characteristics with those in a Late Qing dating excavated from Wun Yiu Archaeological Site.
- Pottery found in L2 consists of body shreds with brown and black glaze (see **Figure C-6 (B) of Appendix C**) and they lack characteristics for dating.
- CBM found in this layer are tiles fragments (see **Figure C-6 (C) of Appendix C**). Fabric of most tile fragments is in orangish red colour while one fragment is in light grey. Black slip and
