**MTR Corporation Limited**

Express Rail Link (XRL)  
 Consultancy Agreement No.: C8016

**Shek Kong Stabling Sidings (SSS) –  
 Further Archaeological Investigation Report**

May 2011

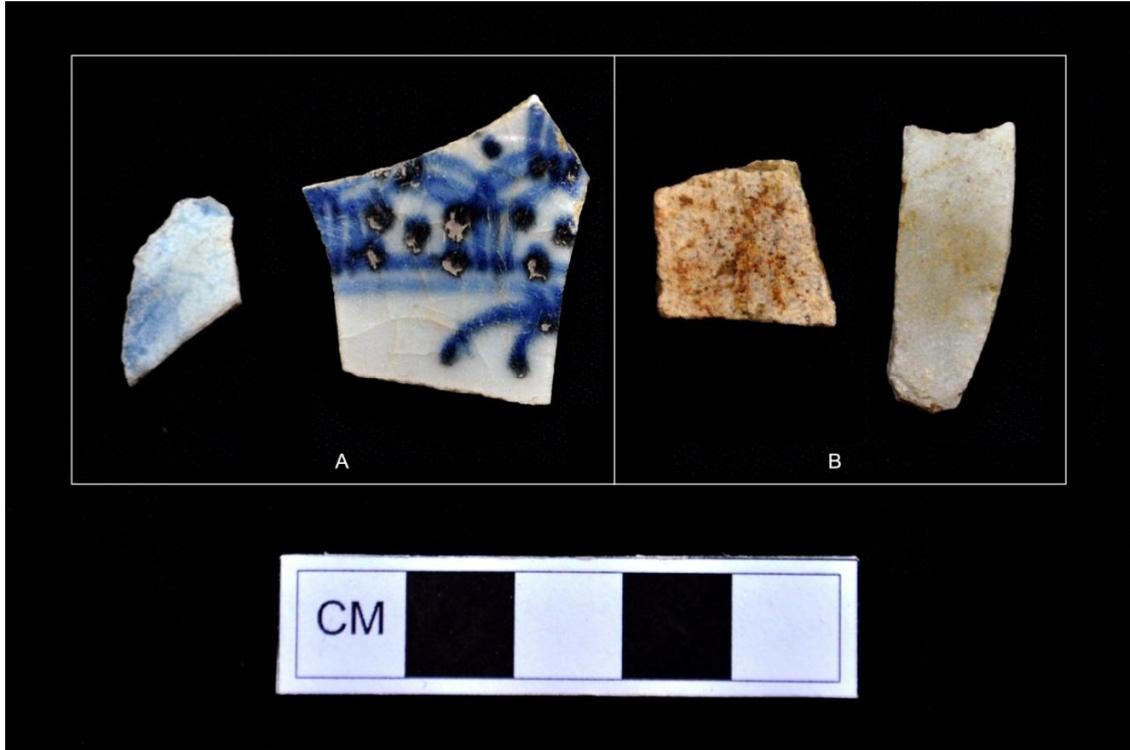
Figure C-7 Blue-and-White Porcelain Sherds (A) and Undiagnosed Porcelain Shreds (B) from SP16 L3

- Undiagnosed porcelain recovered from L3 includes 2 body shreds (see **Figure C-7 (B) of Appendix C**).
- CBM unearthed from L3 are tile fragments (see **Figure C-8 of Appendix C**). Most of them are with shattered edges and textile imprint. In general, these tiles have red fabric, while occasional grey fabric ones were also found. Considering their form and fabric, they can be compared with tiles found in SP10 and SP20 and those unearthed in Siu Hang Tsuen excavation.

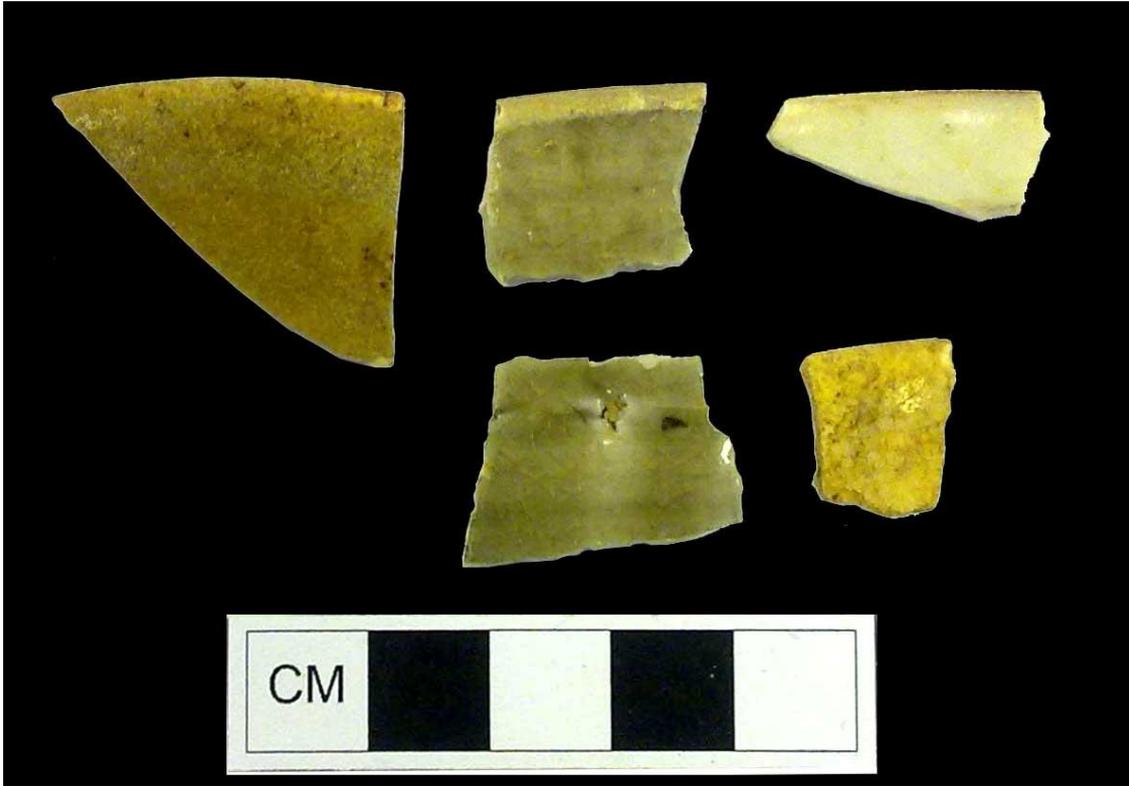
Figure C-9 Celadon rim sherds from SP16 L4

- Celadon shreds found in L4 are too fragmentary to inform morphology and manufactory technique (see **Figure C-9 of Appendix C**). However, they are considered prevalent porcelain type during Song to Yuan period.
- CBM unearthed from L4 are tile fragments (see **Figure C-10 of Appendix C**). Most of them are with shattered edges and textile imprint. In general, these tiles have red fabric, while occasional grey fabric ones were also found. Considering their form and fabric, they can be compared with tiles found in SP10 and SP20 and those unearthed in Siu Hang Tsuen excavation.

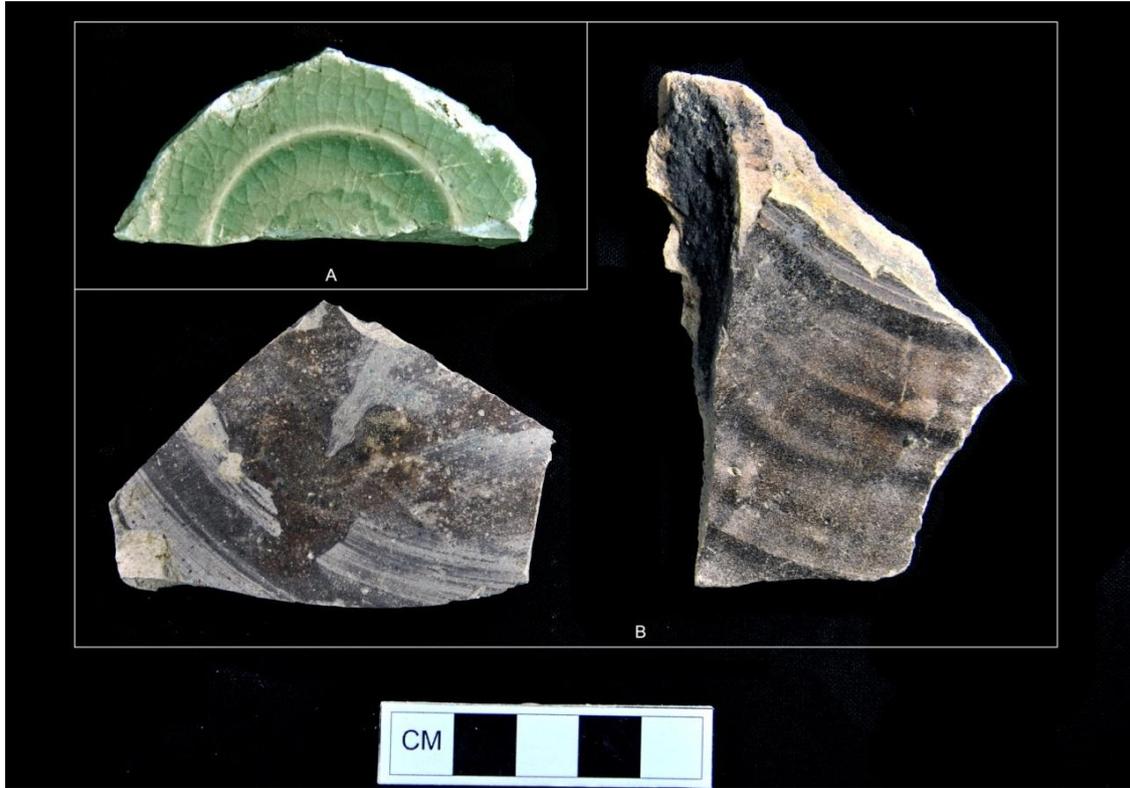
Figure C-11 Celadon Bowl Base (A) and Pot Shreds (B) from SP20 L1

- Celadon recovered from L1 is a broken bowl base (see **Figure C-11 (A)** of **Appendix C**). It has a translucent thick glaze (0.7 to 1.5mm) in green colour and a light grey clay fabric. Apparent crackle can be observed all over the glaze layer. Glaze is applied to inner bowl base and the foot ring, and that the bottom of the base is left unglazed. At the inner base is a circle pattern with a smaller wave-shape circle incised in the centre. Such celadon shred can be compared with those recovered at Kai Tak Rescue Excavation of 2009<sup>14</sup>. It is believed that celadon wares were prevalent during Song to Yuan period.

- Pottery found at L1 includes 2 body shreds with brown glaze (see **Figure C-11 (B)** of **Appendix C**). However, they do not bear distinctive characteristics which can inform dating.

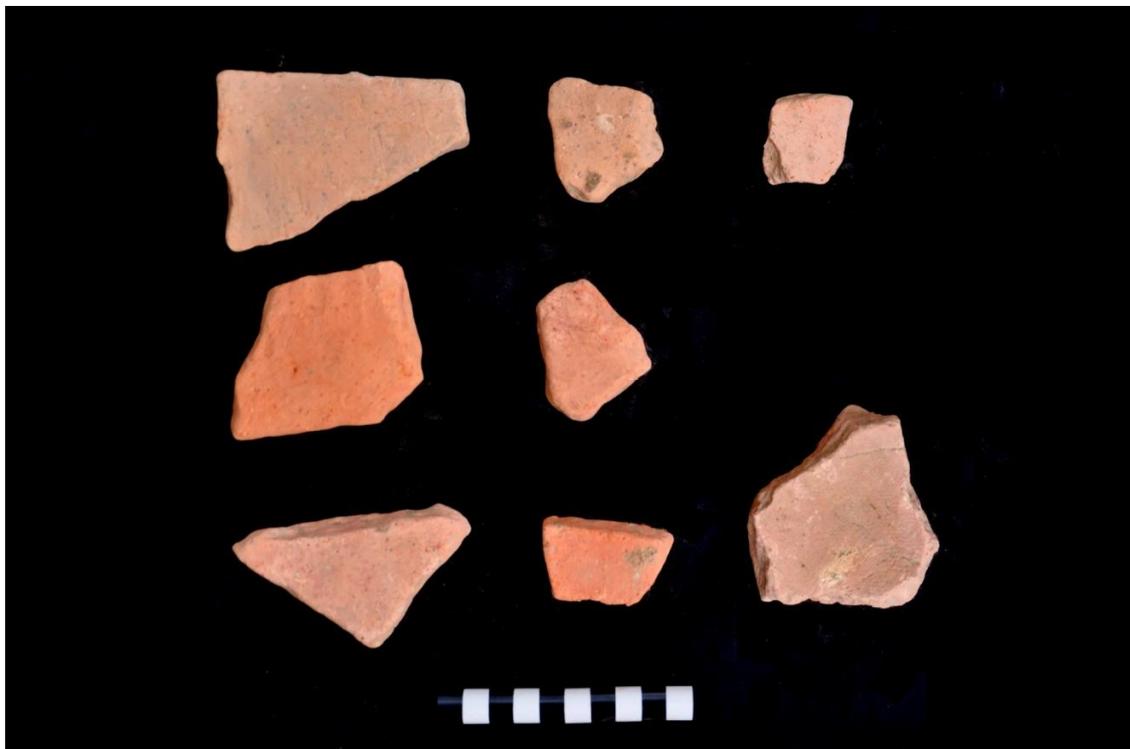
Figure C-12 Samples of Tiles from SP20 L1

- CBM found in this layer are tiles fragments made of orangish red fabric, and with shattered edges (see **Figure C-12** of **Appendix C**). Textile imprint could be observed on some tile fragments.

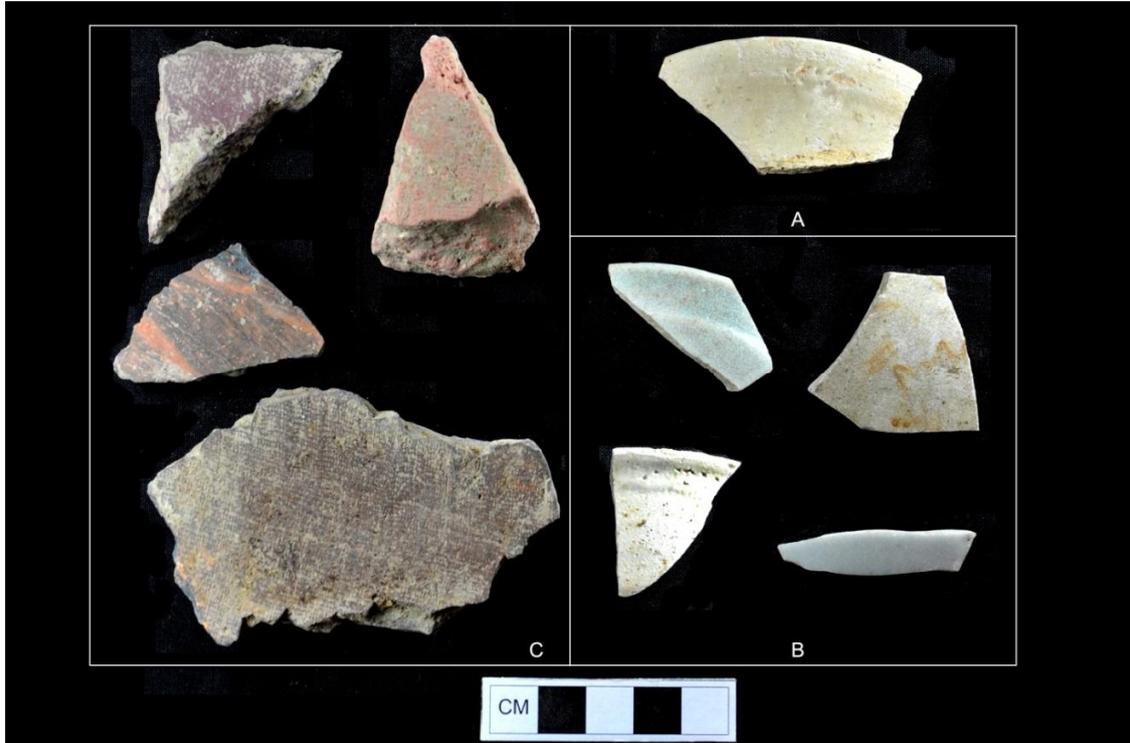
Figure C-13 Celedon Shreds (A), Undiagnosed Porcelain Sherds (B), and Roof Tiles (C) from SP20 L2

- Celadon unearthed from L2 is a celadon rim shred (see **Figure C-13 (A)** of **Appendix C**). It has a thin and fragile transparent pale green glaze with fine crackle. The remaining rim shred has a diameter of 12cm, and its mouth form is open.

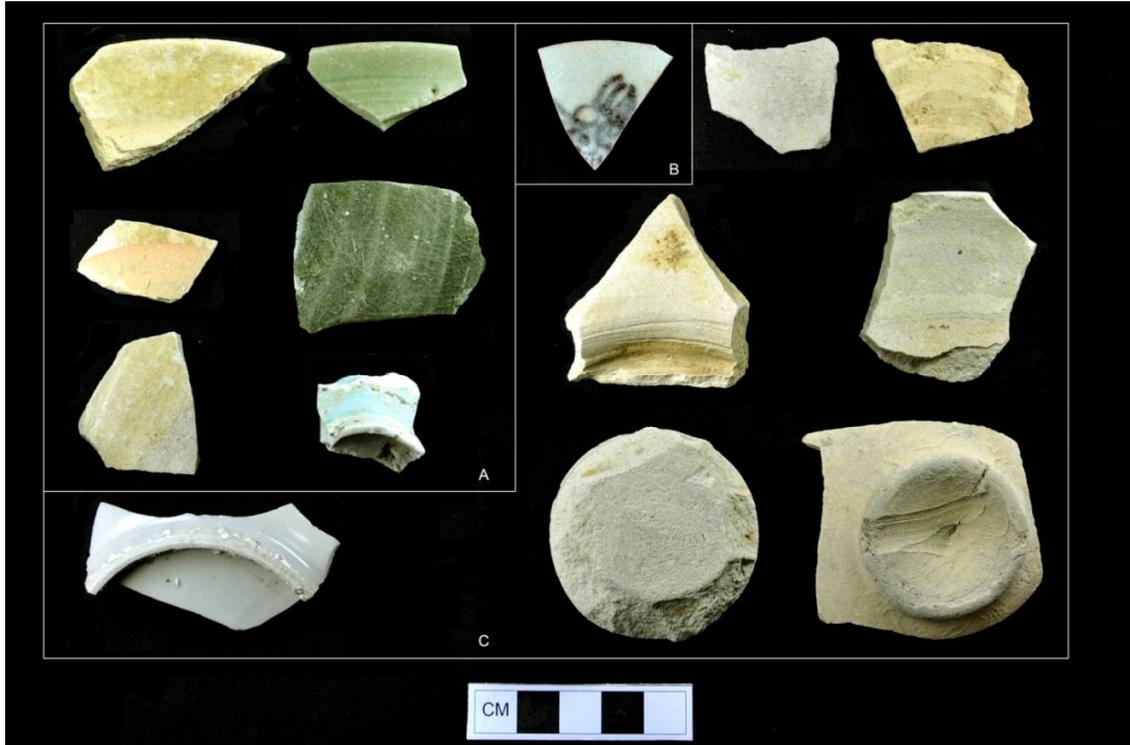
Figure C-15 Celadon Shreds (A) and Blue-and-White Porcelain Shreds (B) and Undiagnosed Porcelain (C) from SP20 L3

- Celadon unearthed from L3 includes 2 rim shreds, 3 body shreds and 1 base shred (see **Figure C-15 (A) of Appendix C**). One of the rim shreds has a light green glaze, grey fabric and incised circles on the exterior near the mouth. It can be dated to Southern Song period in comparison with the finds unearthed in Kai Tak Rescue Excavation<sup>15</sup>. One of the body shreds has a glass-like dark green glaze with crackle. It has a measured thickness ranging 4 – 8 mm, relatively thicker than those dated to Song to period. It was probably made during Ming to Qing periods. The other 3 shreds have thin and fragile light green glaze. They can be compared with celadon wares produced in Guangdong region during Yuan to Ming periods.

- Undiagnosed Porcelain includes 1 rim shred, 2 body shred, and 4 base shreds (see **Figure C-15 (C) of Appendix C**). A reused bowl base with a conical bottom can be compared with similar ones found in Kai Tak Rescue Excavation in 2009, which were dated to Song to Yuan periods.

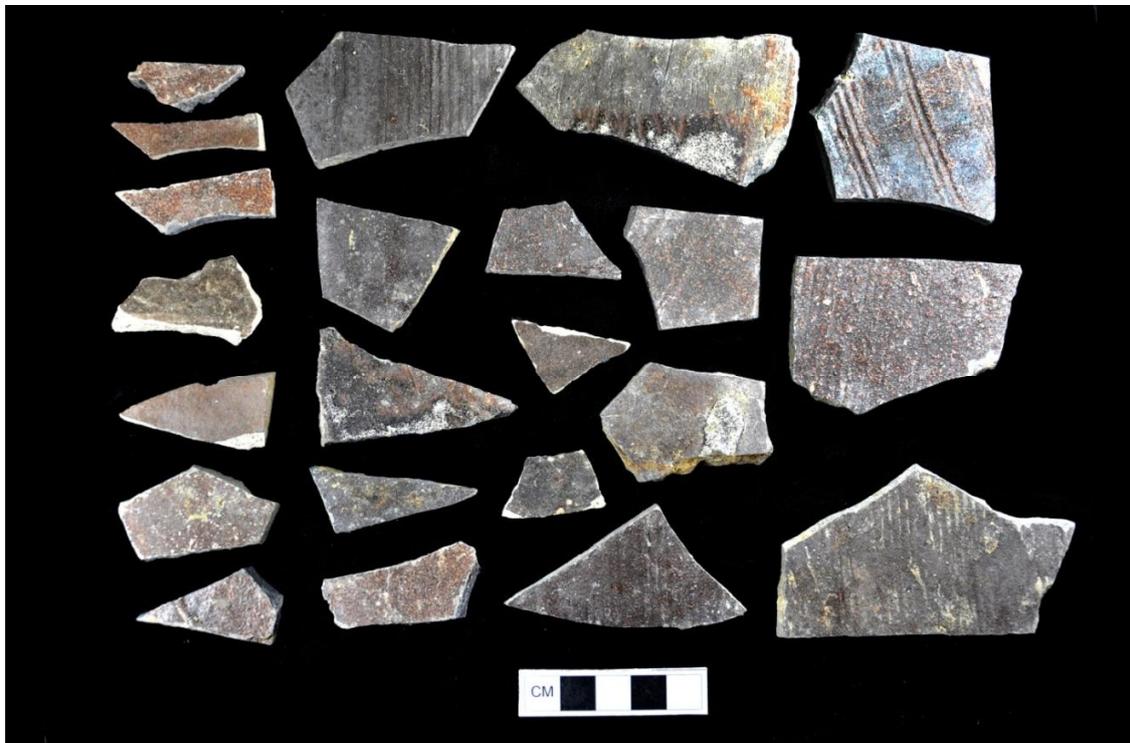
Figure C-16 Potshreds from SP20 L3

- Pottery shreds found in L3 are composed of rim shreds and body shreds (see **Figures C-16 to C18 of Appendix C**). In general, surface decoration can be divided into two main categories, namely with glaze and with slip. Glaze colour ranges from mid brown to black. Slip colour includes black and pinkish red. Nonetheless, these shreds are too fragmentary to inform dating.

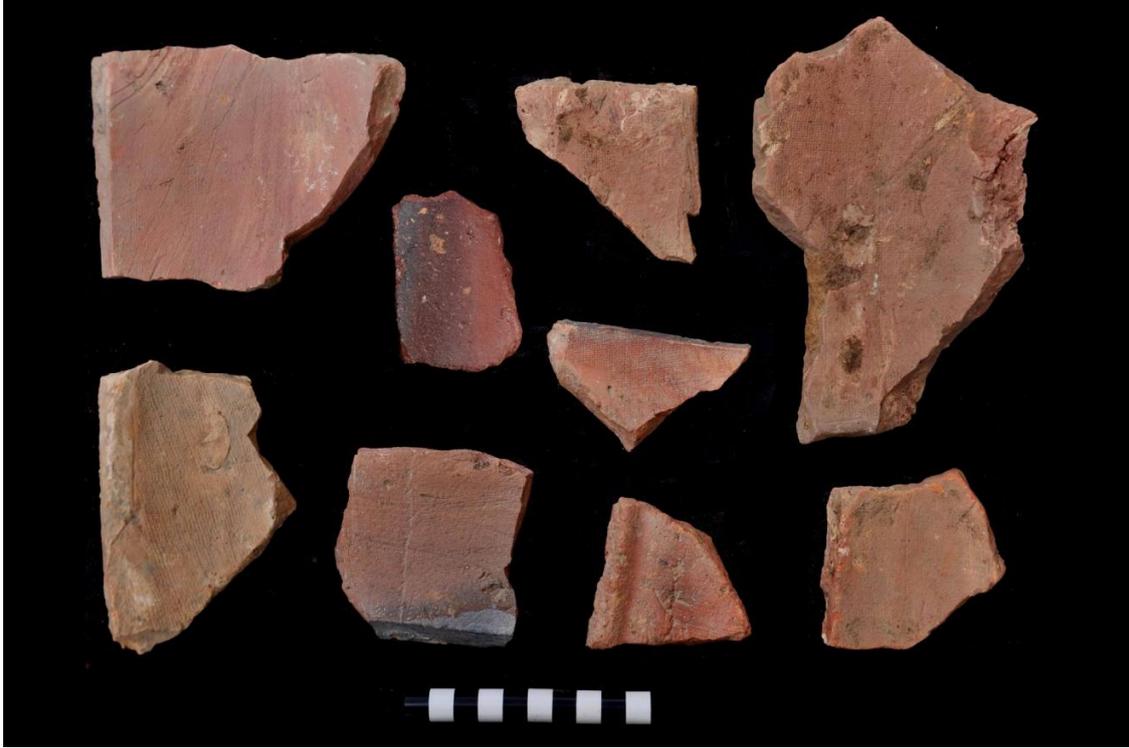
Figure C-19 Samples of Tiles from SP20 L3

- CBM unearthed from L3 are tile fragments (see **Figures C-19 of Appendix C**). Most of them are with shattered edges and textile imprint. In general, these tiles have red fabric, while occasional grey fabric ones were also found. Considering their form and fabric, they can be compared with tiles found in SP10 and those unearthed in Siu Hang Tsuen excavation<sup>16</sup>.
