Interim report on the Archaeological Watching Brief Findings in Harcourt Garden for South Island Line (East)

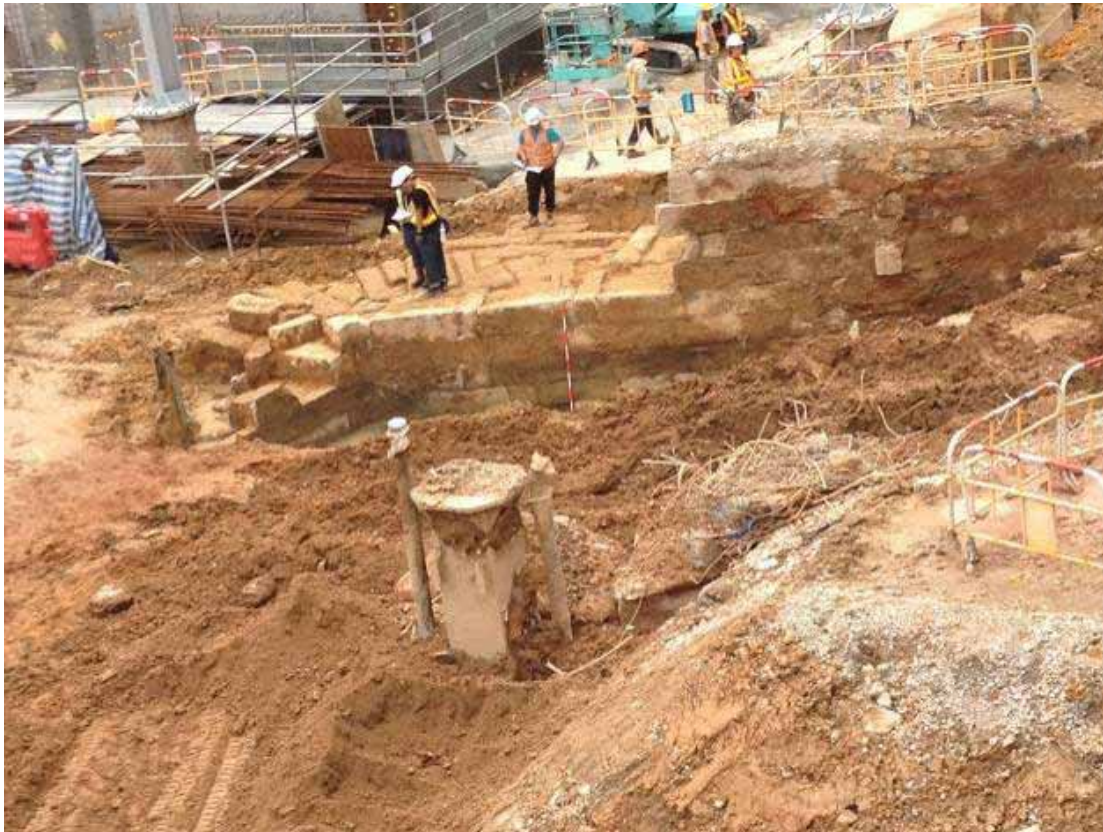
PLATE 2.b Bird eye view of east section of seawall

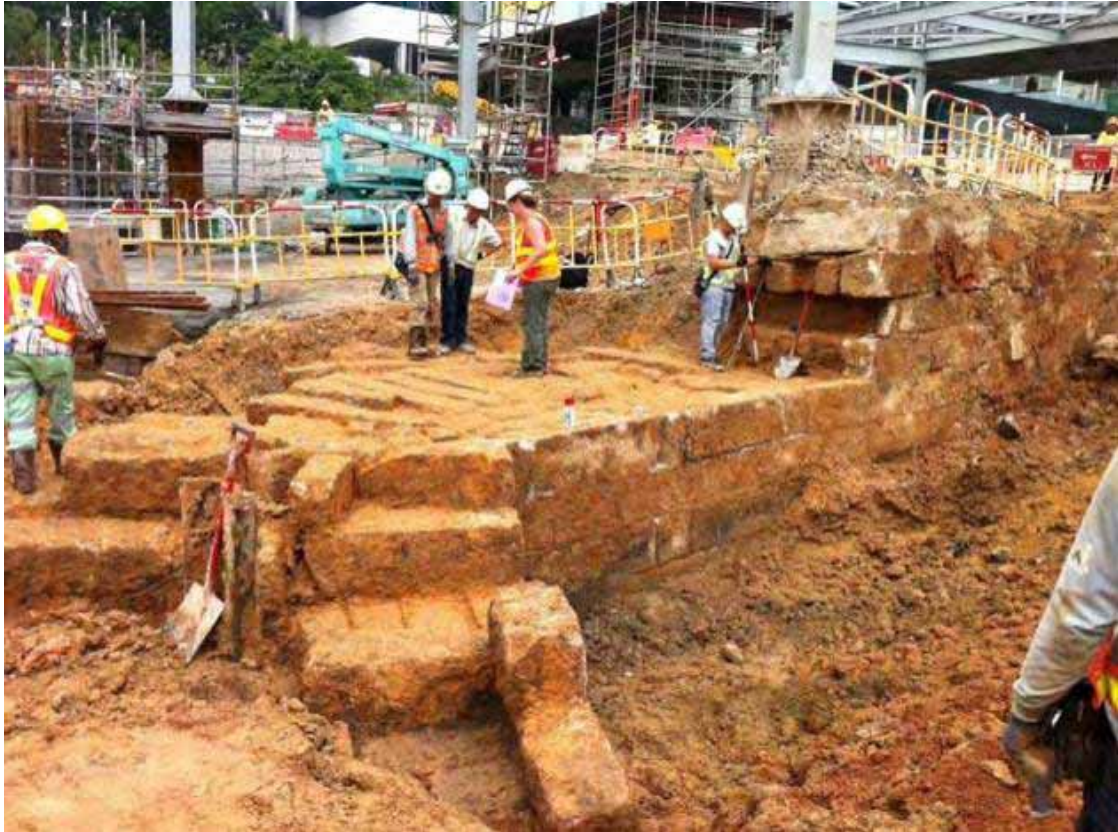
PLATE 2.c View of east section of seawall looking to southwest

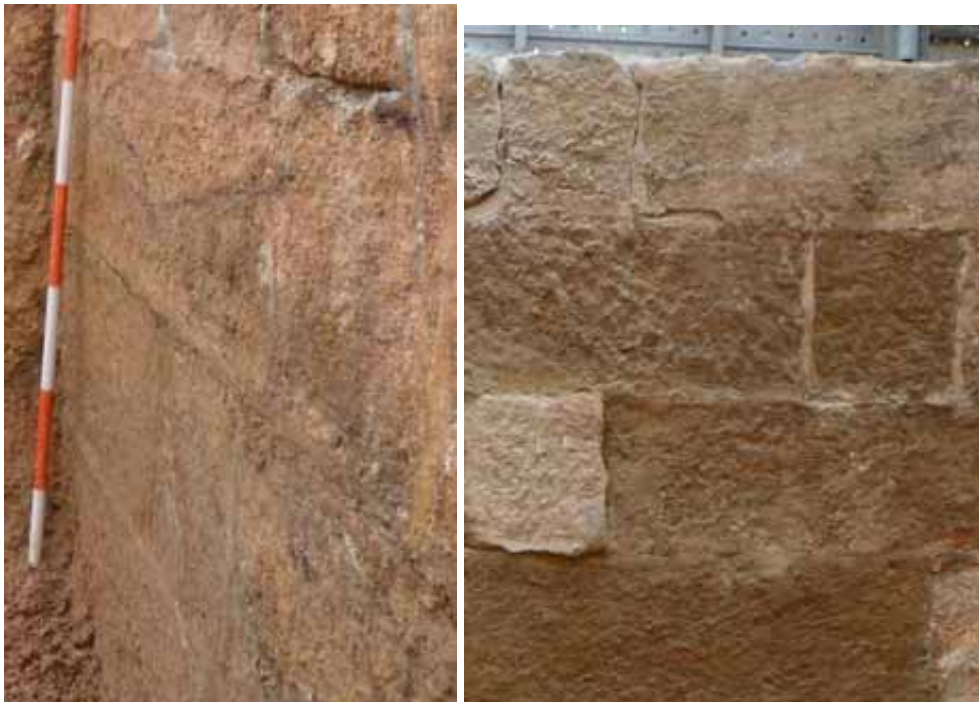
The seawall fragment was entirely constructed with cut granite ashlar (PLATE 2) of which only the exposed north façade was dressed finely (PLATE 3). The granite blocks besides being sourced locally have a durable quality which is suited for seawalls. The cracks between the ashlar had been sealed with a concrete mortar to form a watertight barrier (PLATE 4).

PLATE 4 Granite ashlar joints sealed with concrete mortar

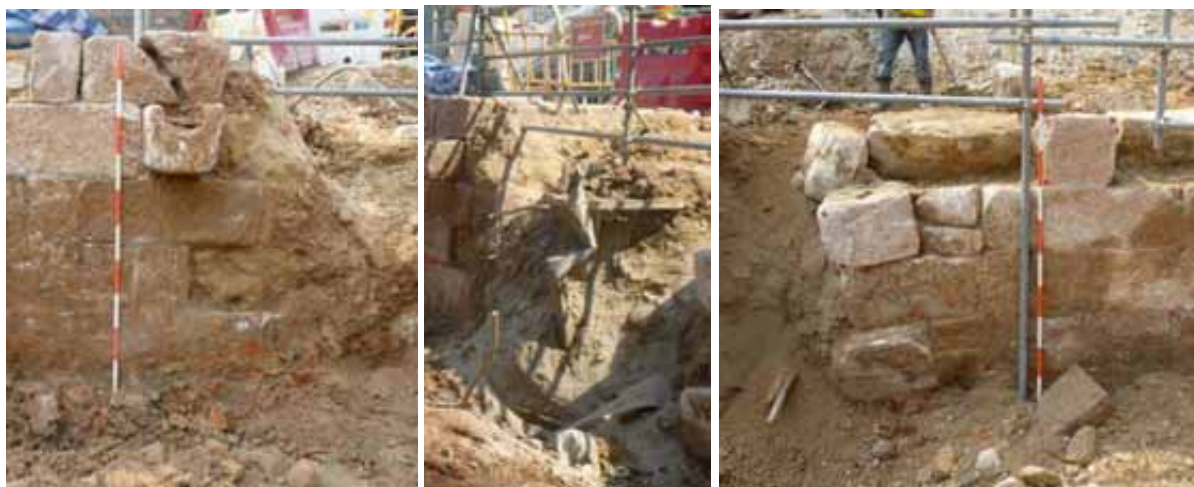
PLATE 13 a Plunge column sunk from surface level prior to excavations has dissected the seawall fragment and affected the condition of seawall; left and right shows seawall fragment on either side of the plunge column (centre photo)

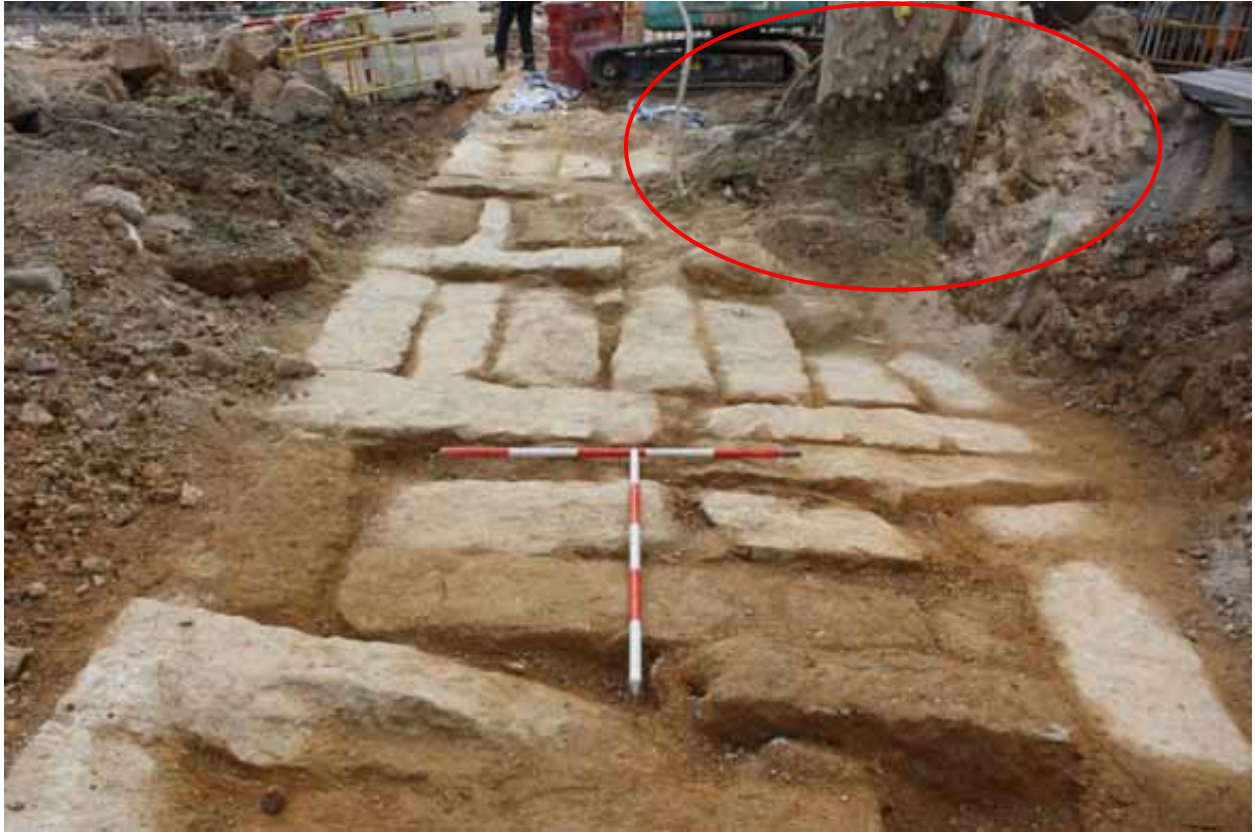
PLATE 13 b Plunge column sunk from surface level prior to excavations damaged the rear of the seawall fragment

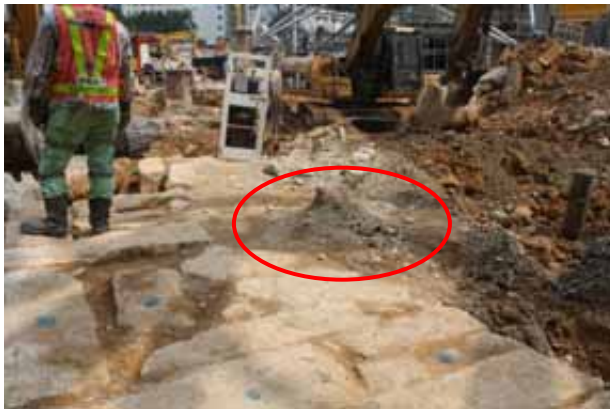
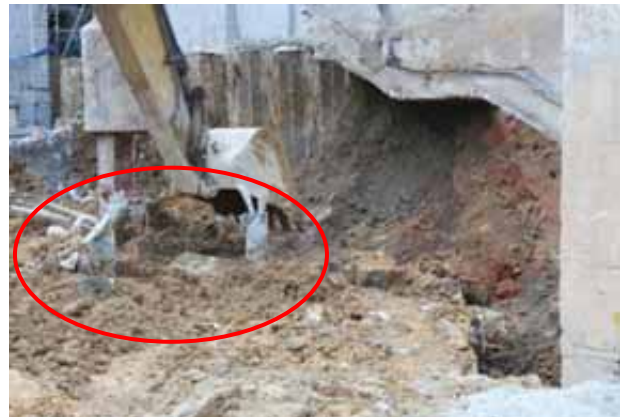
PLATE 13 c Thick rebar foundations part of previous MTRC Entrance/Exit 'E' construction damaged the rear of the seawall fragment

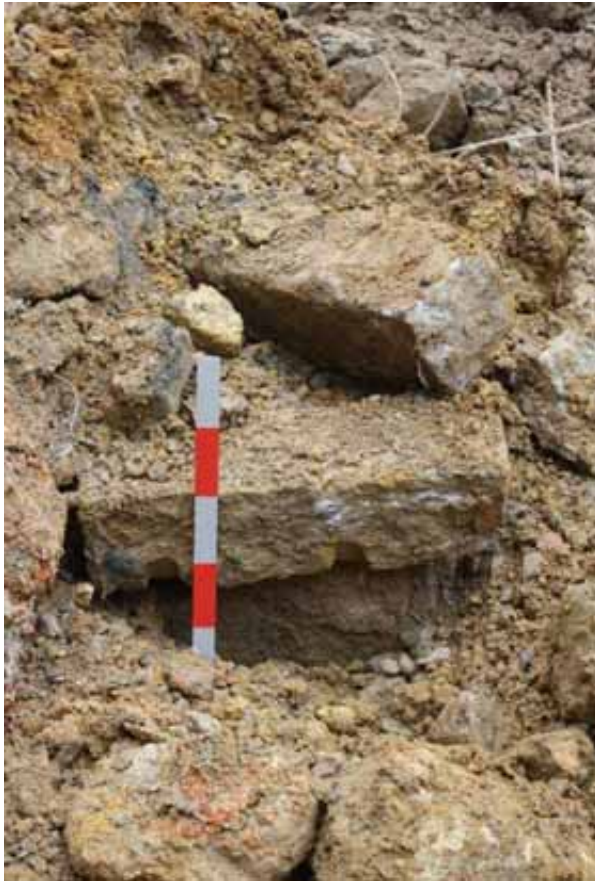
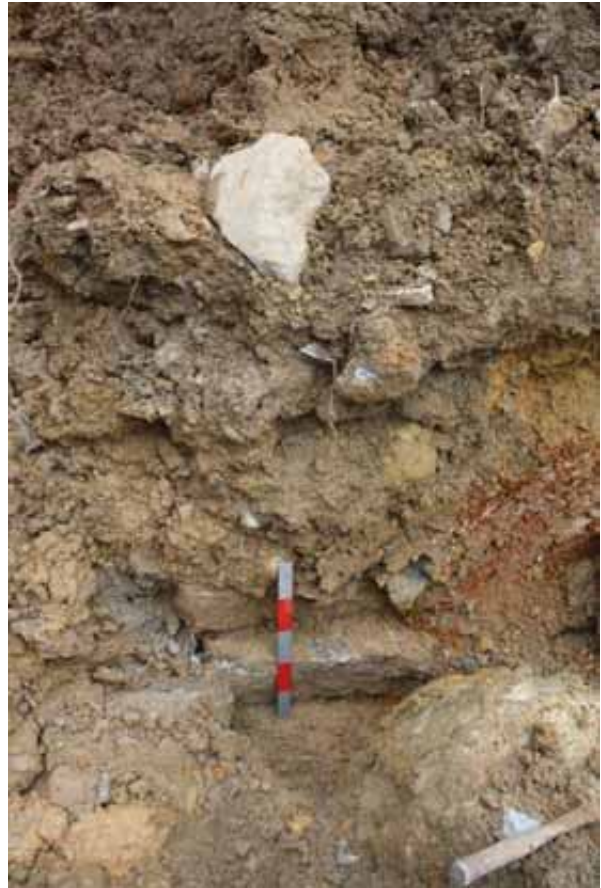
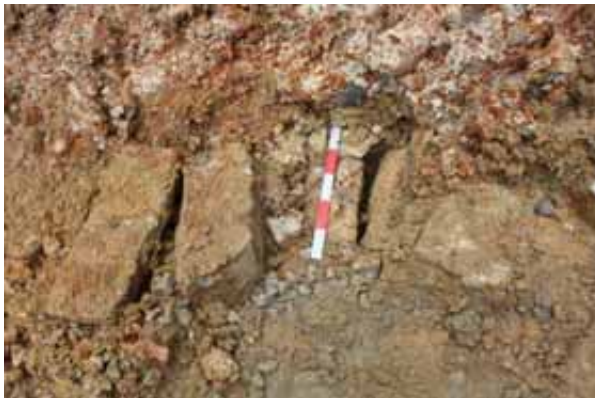
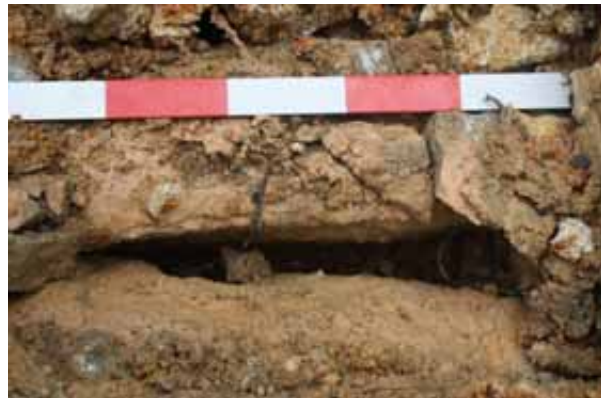
During a regular Archaeological Watching Brief visit granite blocks were noticed during excavations in the SEE shaft. The granite blocks were found in an irregular pattern and in loose manner (PLATE 14), no associated archaeological material was found. The blocks appeared arranged around a concrete pile (PLATE 15) which confused the interpretations. After the central concrete pile stopped and was removed it became clear that the feature was part of a well.

PLATE 14 Early stage of uncovering the well remnant: granite blocks in an irregular pattern and loose manner which hampered early interpretation

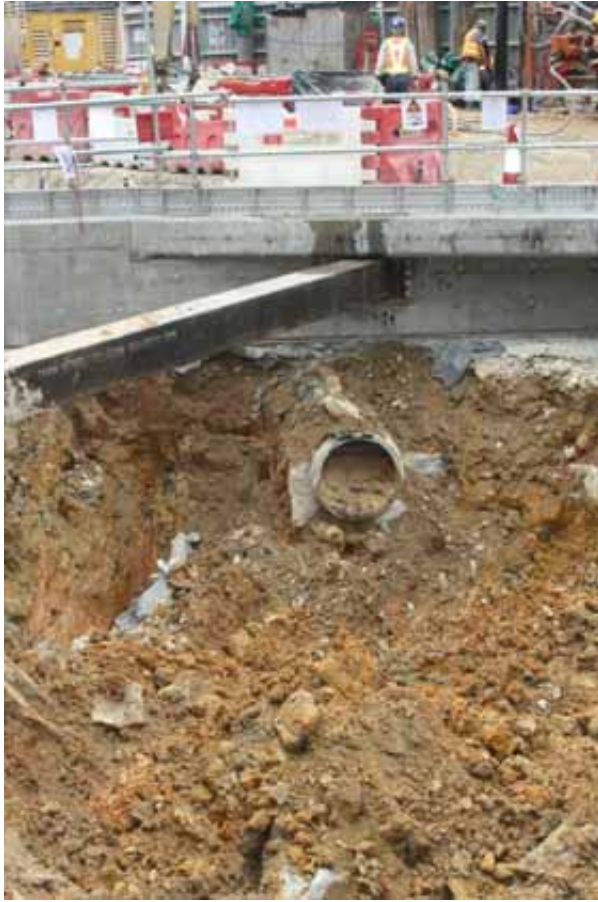
The well remnant was recorded between 3.10mPD and -0.10mPD. The top of the well had been cut by the concrete casing of a large ceramic pipe (PLATE 19) and the top of the well would have been at a height of more than 4 or 5mPD. The well had not been in use for a very long time and was found filled with a 1959 rubble fill and concrete to below the concrete pipe casing which had cut the well.

PLATE 19 Concrete casing and pipe from a previous development which cut the top of the well and leaves shaft and bottom on well
