Agreement No. CE30/2008 (CE)

Kai Tak Development - Infrastructure at Former Runway and  
Remaining Areas of North Apron and Improvement of Adjacent  
Waterways: Design and Construction

Phase 1 Archaeological Field Investigation Report

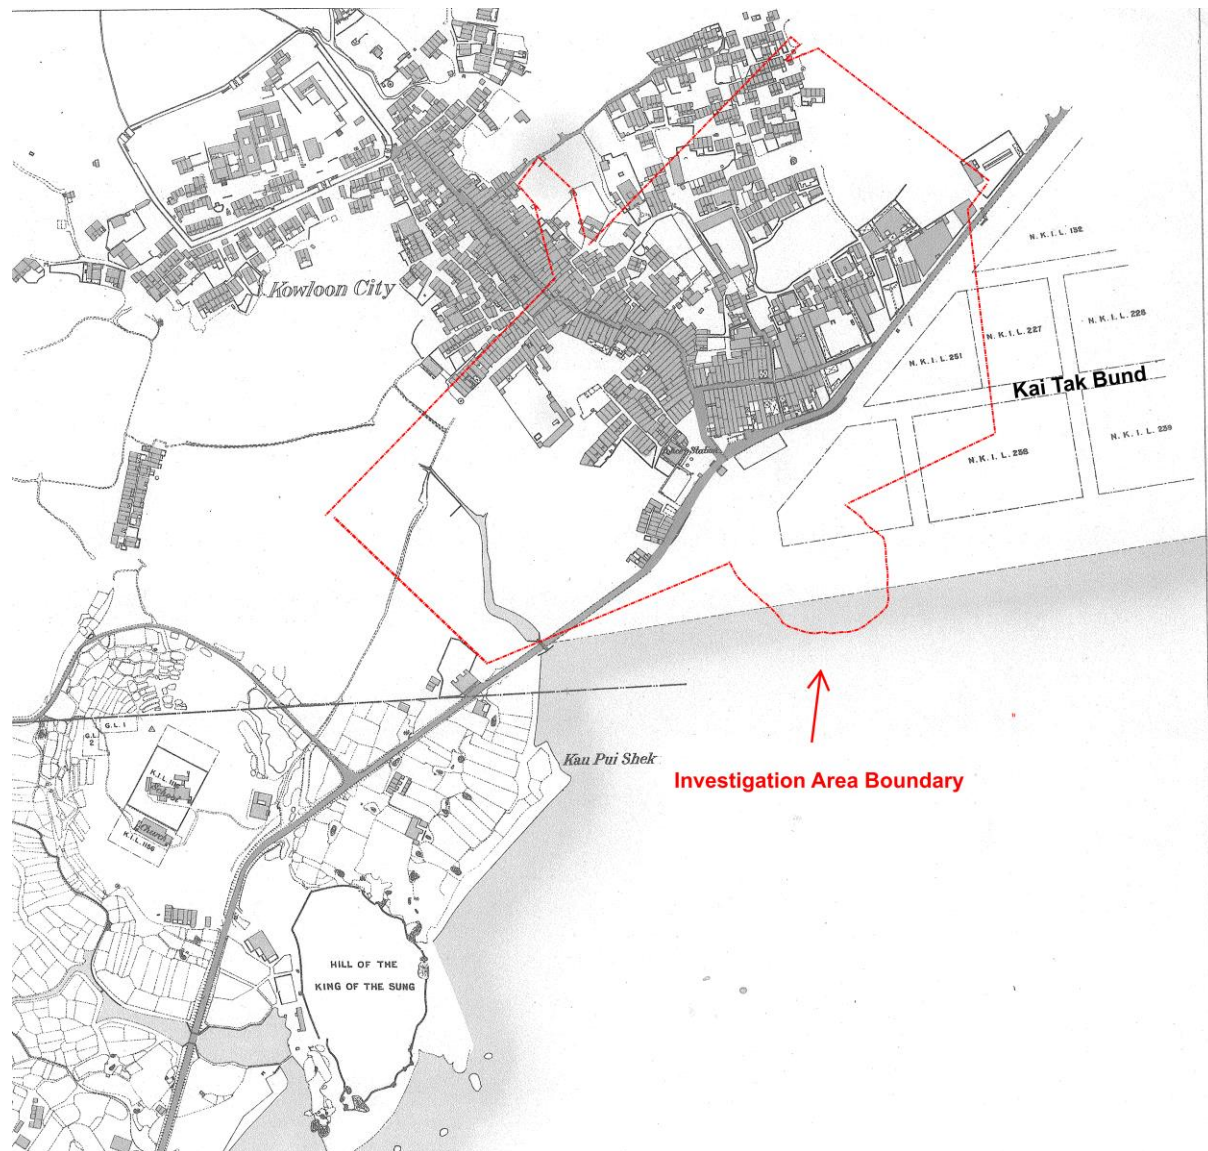
**Figure 3.5 Historical Features, Study Area and Investigation Area (Indicative)**  
(Source: Lands Department, 1924 Kowloon Peninsula Sheet 2 (HG1-2))

- 3.2.17 The First Reclamation of Kowloon Bay coastal area was carried out between 1916 and the early 1920s, which was known as the Kai Tak Bund. Chinese businessmen Sir Ho Kai (何啟) and Mr. Au Tack (區德) established Kai Tak Land Investment Company in the early of 20<sup>th</sup> century. This company bought the rights to reclaim the northern part of Kowloon Bay, including the Investigation Area, for residential development. The reclamation of Kai Tak Bund was planned to be conducted in three stages. Stage one started in 1916 and finished by 1924, but the later stages did not proceed as the Company went bankrupt. About 170m of landward portion of LTSB was buried and the northern part of LTSB was disturbed during the reclamation works<sup>24</sup> (**Figures 3.4, 3.5**).

- 3.2.18 The Kai Tak Bund reclamation was completed in 1924. LTSB was shortened with only a concrete pavement of causeway linking up the seawall and the landing platform of the LTSB by 1933. In order to maintain the function of the LTSB, a 60m concrete pier was built to connect with the southern end of the LTSB between 1936 and 1937 and the pier was later renamed as Kowloon City Pier (**Figures 3.4, 3.5**).

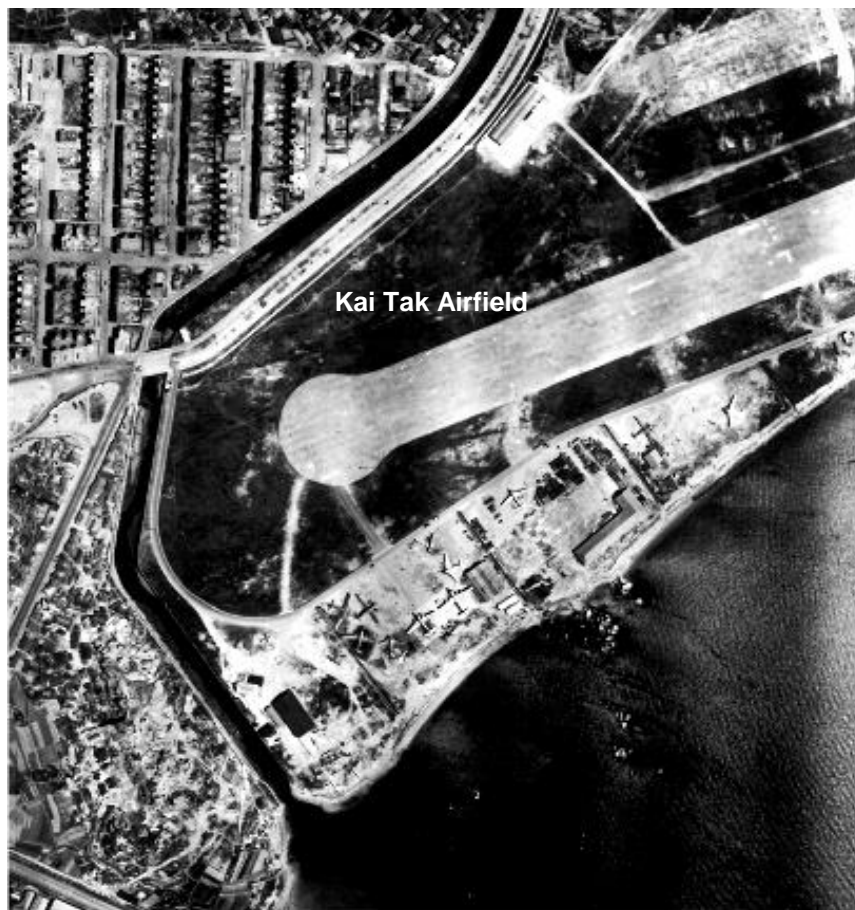
**Figure 3.6 Aerial Photo of Kai Tak Airfield, 1949**  
(Source: Lands Department)

- 3.2.20 The Second Reclamation took place during the Japanese occupation between Dec.1941 and Aug.1945. The Japanese Government expanded Kai Tak Airfield to cater for their military needs. The Japanese troops began the extension works of the two new runways of Kai Tak Airfield in 1942. The extension works involved the demolition of houses in Kai Tak Bund and villages in Kowloon Bay, as well as further reclamation. The granite blocks forming the wall of Kowloon Walled City were also demolished by Japanese troops for the construction of the Kai Tak Nullah in 1942 (hereafter referred to as 1942 Nullah)<sup>26</sup>. Likewise, the remaining structure of the Kowloon City Pier was buried in the reclamation. Half of the Sacred Hill was also leveled for reclamation<sup>27</sup>. The extension works of Kai Tak Airfield were completed in 1943 (**Figures 3.6 and 3.7**).

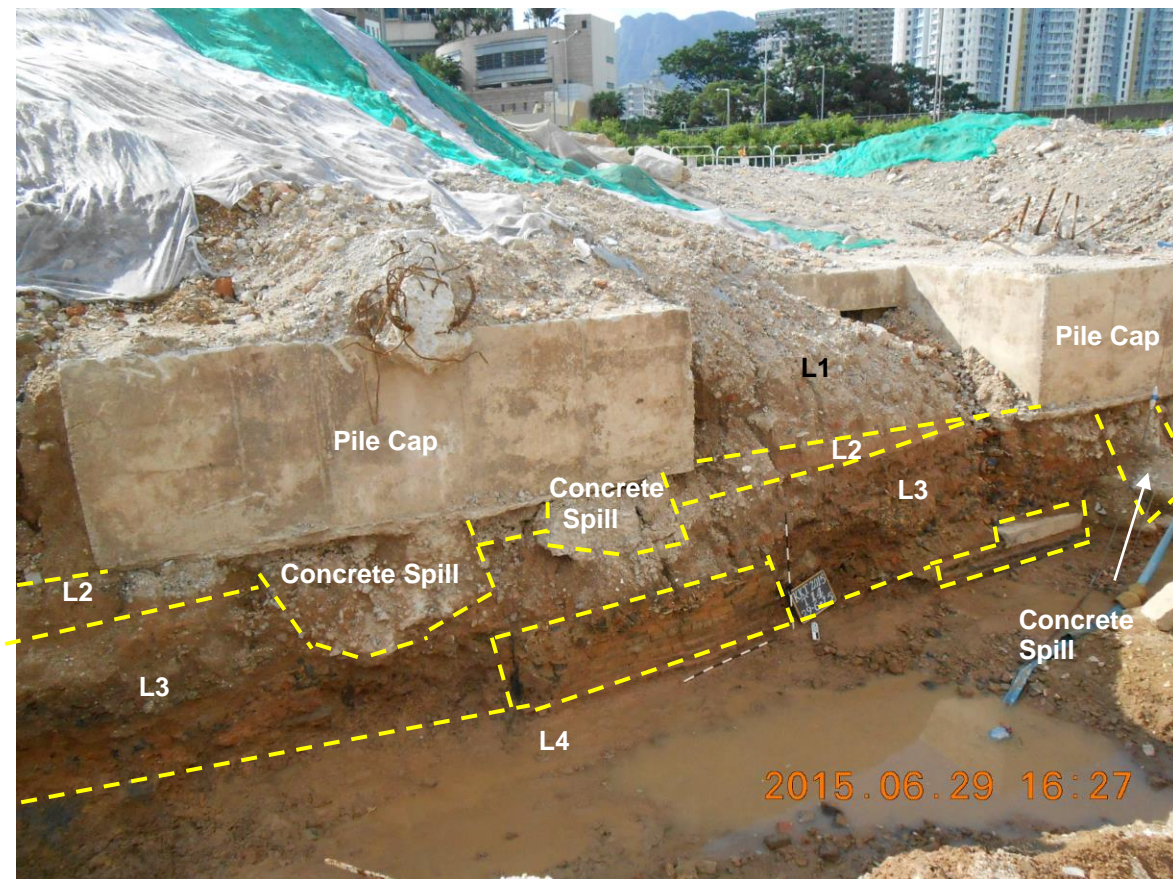
**Figure 4.1 Photographic Record of T14, Northwest profile**

**4.1.3** The stratigraphy in each test square and trench is presented in **Table 4.2**. For more details, please refer to **Appendix A**. T14 was selected as the example to illustrate the stratigraphy. (**Figures 4.1 and 4.2**)

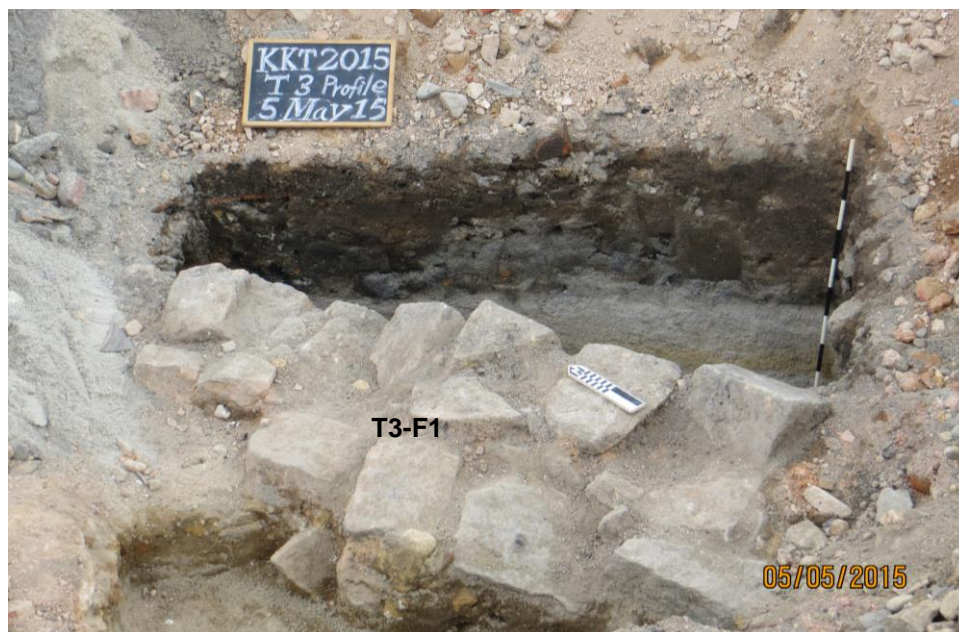
Figure 4.3 Granite Block Alignment (T3-F1) in T3 (facing east)

- 4.2.2 A row of dressed granite blocks in two tiers (T3-F1) was aligned in bearing 335° at an elevation of +3.05mPD on top of L4. Ten granite blocks were exposed in T3, each of which has an average size of about 44cm x 30cm x 20cm. The length of the exposed alignment is 220cm, and its width 80cm (see **Figure 4.3**).
- 4.2.3 The linear alignment and the configuration of these granite blocks suggested that it was a conscious planning to demark some sort of boundary (such as fence or house wall). However, there is no other archaeological evidence and record to prove its exact function. Stratigraphic evidence suggested that it has been disturbed by the later Kai Tak Airfield reclamation that formed L2.

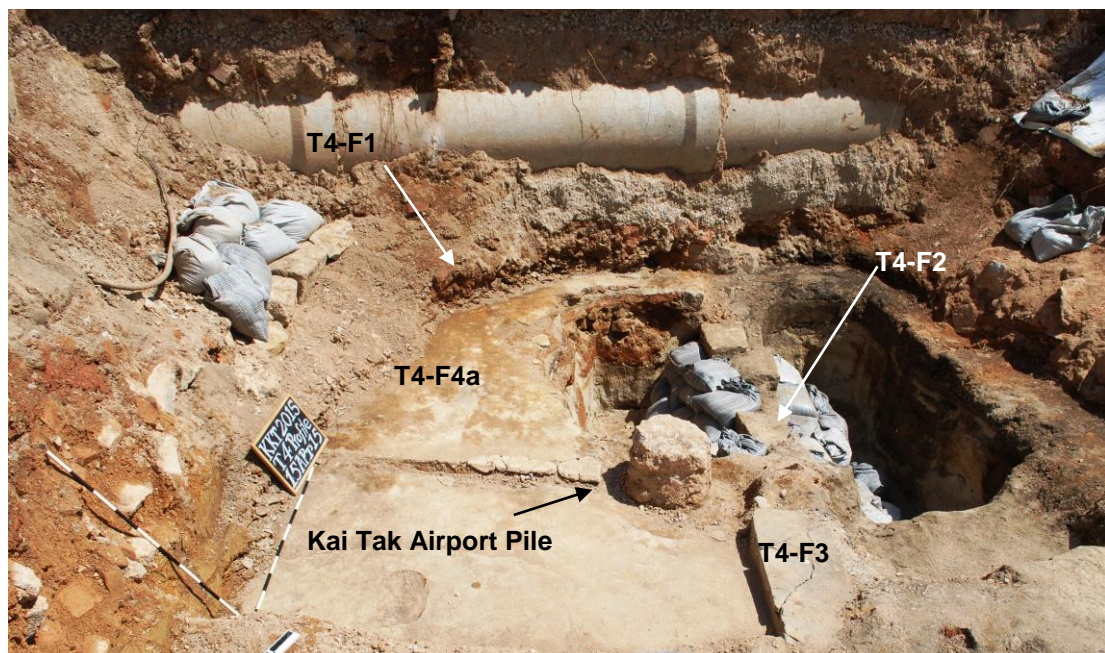
**Figure 4.4 House Remains in T4 (facing southeast)**

- 4.2.4 The features discovered in T4 were more complicated compared to the single granite block alignment in T3 (**Table 4.3** refers). A row of dressed granite wall foundation (T4-F2) which marked a house's external wall was aligned in

338° at +2.96mPD. A cement paved floor (T4-F4a) and rammed earth (T4-F4b to e) were identified next to the granite wall foundation. A layer of roof tile (T4-F1) covering the cement floor was also observed (see **Figures 4.4 to 4.8**). The features were remains of a house disturbed by the Kai Tak Airfield reclamation that formed L2.

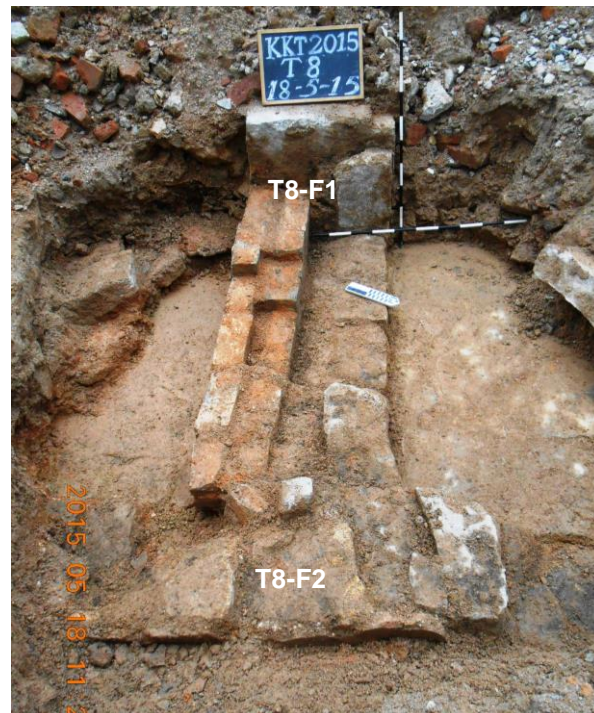
Figure 4.9 House Remains in T8 (1 of 2)

4.2.5 A row of combined brick and granite block structure (T8-F1) and a row of dressed granite blocks in two tiers (T8-F2), as well as a cement paved tile floor (T8-F3a) were identified in T8 on top of L4. Rammed earth (T8-F3b to 3d) was found beneath the cement paved tile floor. The granite block walls mark a house boundary. It is believed to be house remains, which was disturbed by Kai Tak Airfield reclamation (L2) (see **Figure 4.9**). The remains contain the following contents (**Table 4.4**):

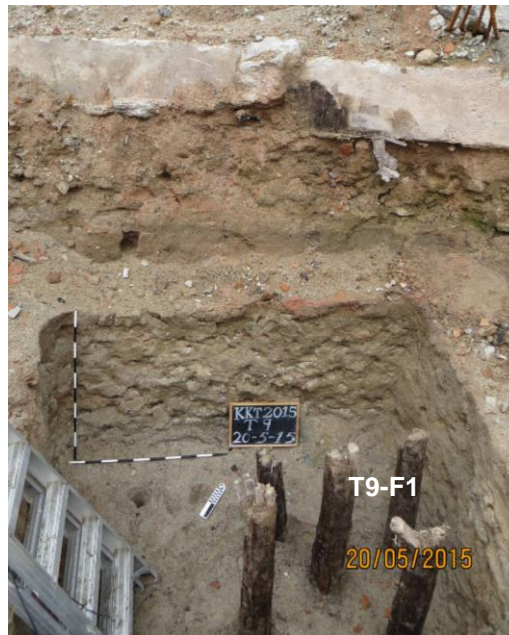
Figure 4.11 Wooden Piles in T9 (facing northwest)

- 4.2.6 Five wooden piles (T9-F1) at an elevation of c.a. +2.9mPD were found in the eastern part of T9. Each wooden pile diameter measured average in 20cm. The length of the exposed part is 120cm.

4.2.7 The location of these piles and drainage pipes indicated that they were underground facilities and foundation structures. Hence, it is believed that they were infrastructures of Kai Tak Bund (see **Figure 4.11**). Stratigraphic evidence suggested that it has been destroyed by the later Kai Tak Airfield reclamation (L2).

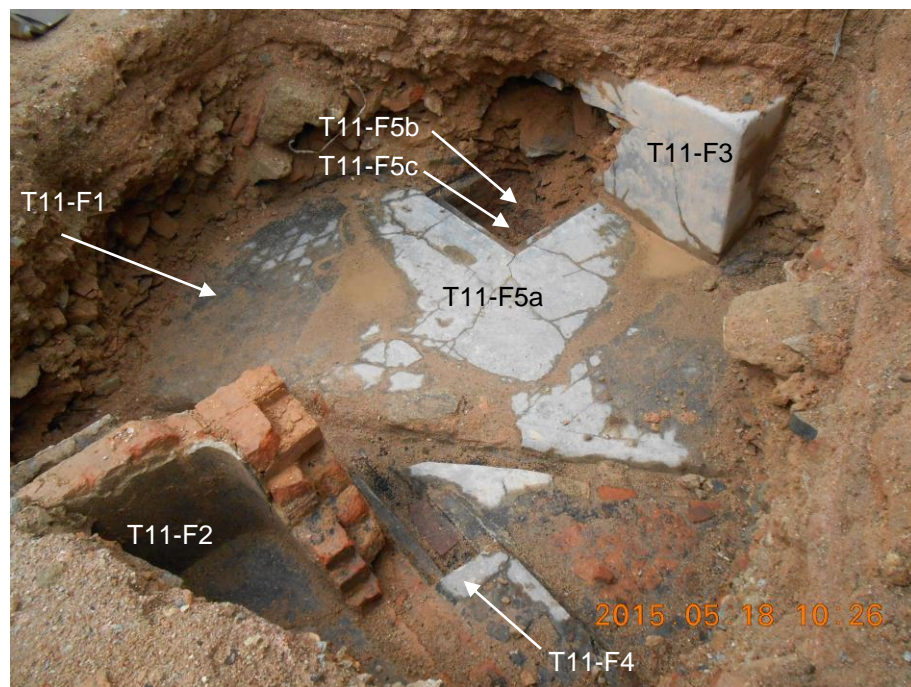
Figure 4.12 House Remains in T11

4.2.8 A layer of broken roof tile (T11-F1), granite block (T11-F4), two brick structures (T11-F2 and 3), and a cement floor with rhombic pattern (T11-F5a) were identified in T11 on top of L4. With reference to the top elevation of these features, it is believed that they are house remains of the early 20<sup>th</sup> century, which was disturbed by Kai Tak Airfield reclamation (L2) (see **Figure 4.12**). The remains contain the following contents (**Table 4.5**):

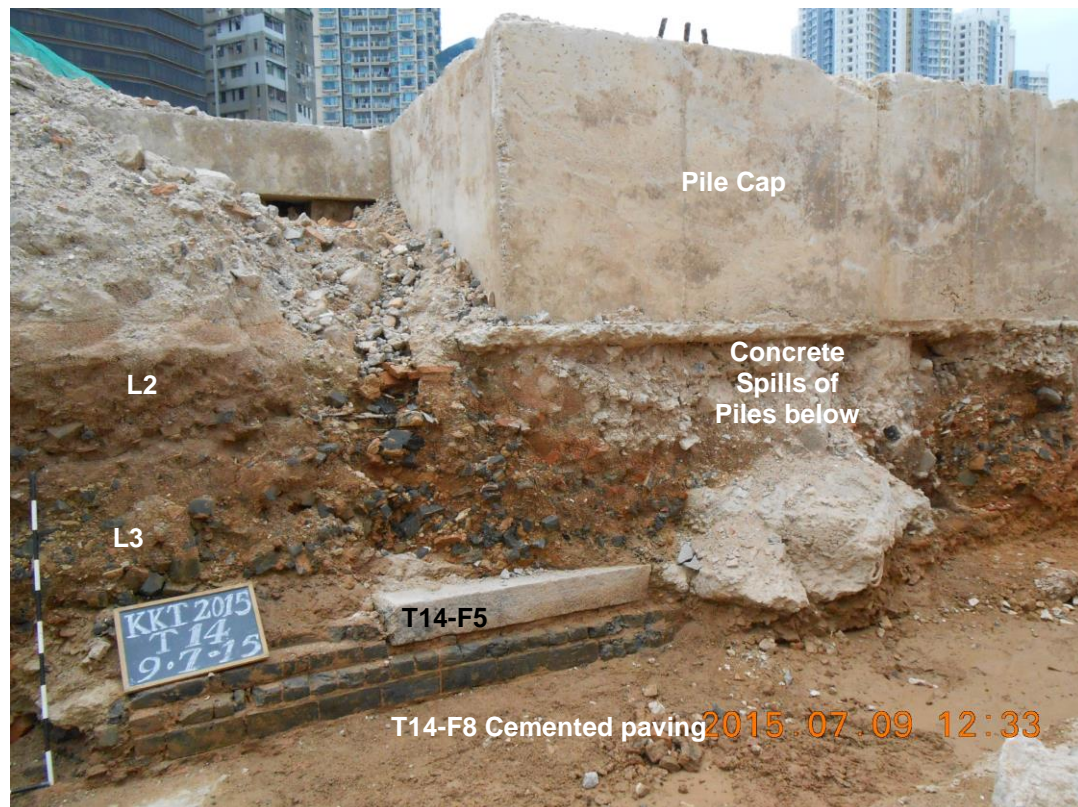
Figure 4.13 House Remains in T14,NE profile (1 of 7)

4.2.9 A linear alignment of green brick wall foundation with granite blocks (T14-F4) marked a house boundary was identified in T14 on top of L4 at +2.83mPD. A red brick wall with cement finishing (T14-F7) was identified inside the house boundary. Two green brick walls (T14-F5 and F6) run along house boundary toward further south. Cement footing (T14-F9) is found outside the house walls. It is believed to be house remains, which was disturbed by Kai Tak Bund and Kowloon City reclamation (L3) (see **Figures 4.13 to 4.19**).

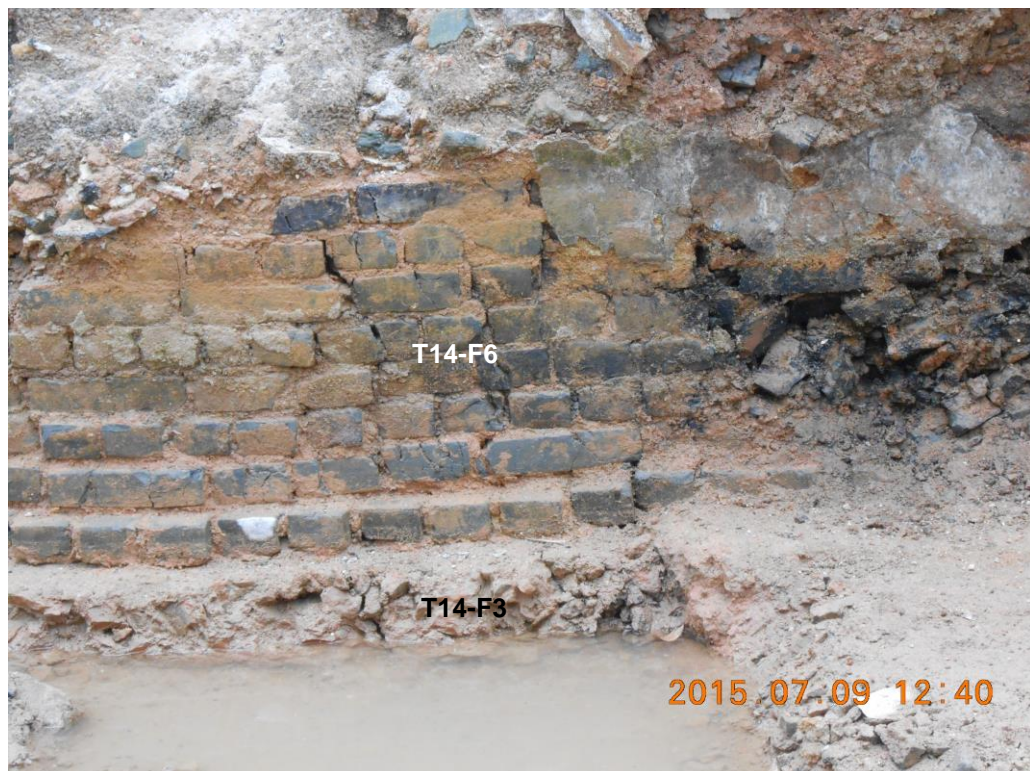
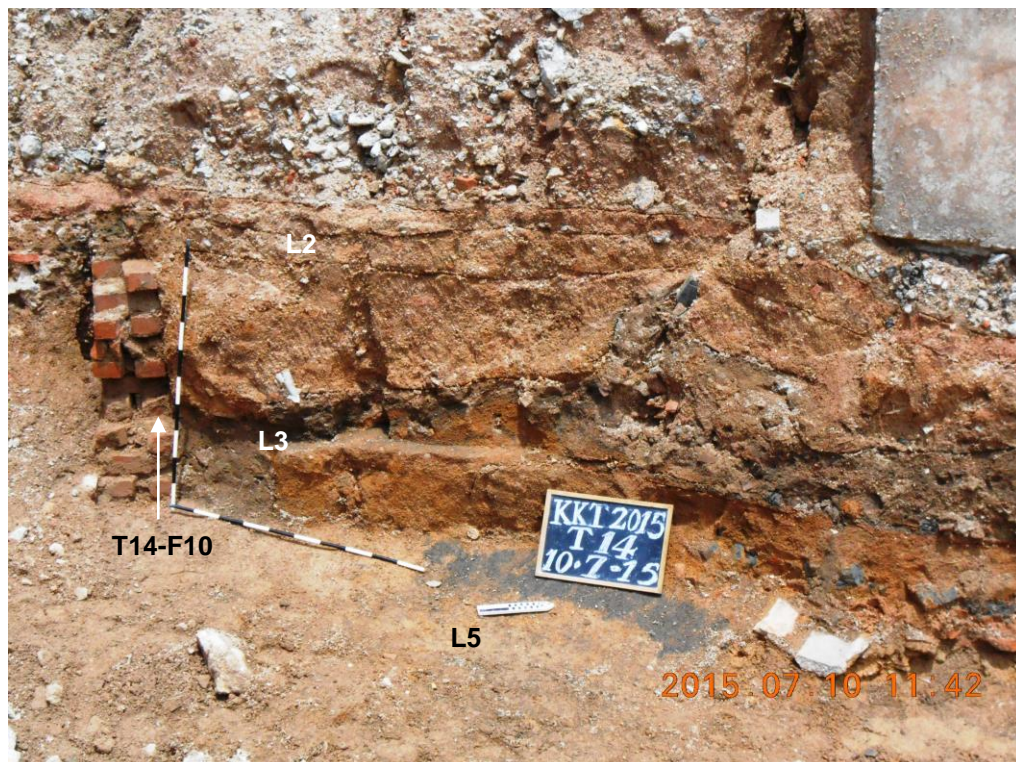
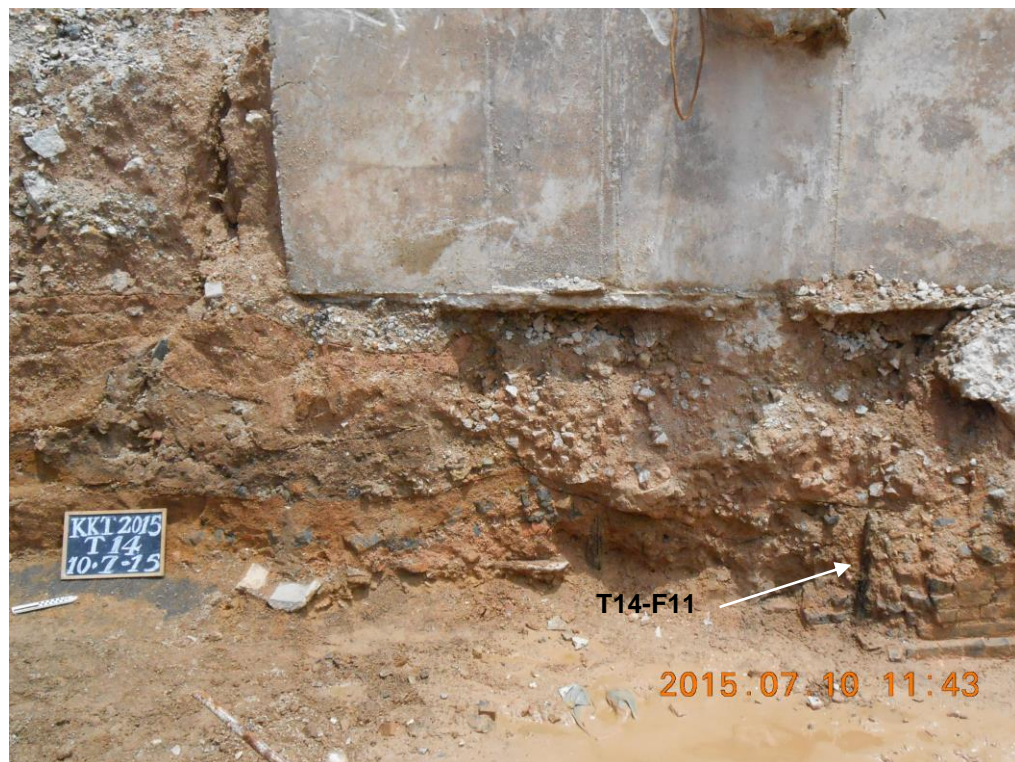
Figure 4.17 House Remains in T14 (5 of 7)

Figure 4.18 House Remains in T14 (6 of 7)

Figure 4.19 House Remains in T14 (7 of 7)

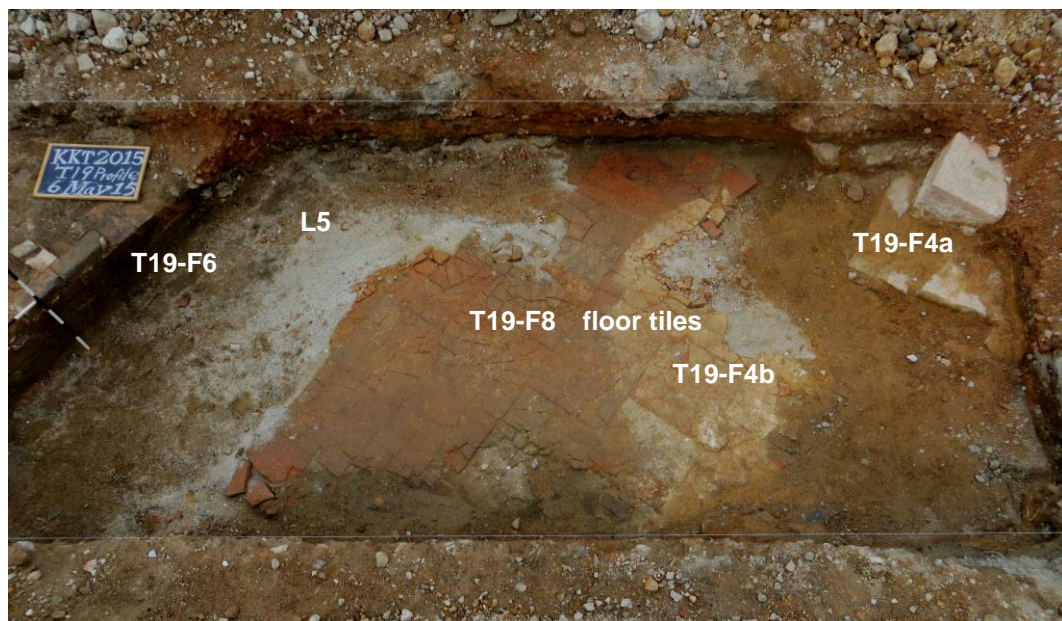
Figure 4.23 House Remains in T19 (1 of 2)

<ul style="list-style-type: none"> <li>Size of granite block in first row: 44×20×20cm<sup>3</sup></li> </ul>		
T19-F6	Green brick structure	<ul style="list-style-type: none"> <li>length exposed: 152cm</li> <li>Width: 56cm</li> <li>Bearing: 357°</li> <li>Number of tiers count from base: 3</li> <li>Average size of each brick: 26×10×6cm<sup>3</sup></li> </ul>	+3.08	Wall foundation
T19-F7	Red brick structure	<ul style="list-style-type: none"> <li>Length exposed: 200cm</li> <li>Width: 30cm</li> <li>Bearing: 352°</li> <li>Number of tiers count from base: 1</li> <li>Average size of each brick: 28×12×6cm<sup>3</sup></li> </ul>	+3.05	Wall foundation
T19-F8a	Area of floor tile	<ul style="list-style-type: none"> <li>Length: 310cm</li> <li>Width exposed: 200cm</li> <li>Average size of each floor tile: 38×38×4cm<sup>3</sup></li> </ul>	+2.83	Floor
T19-F8b	Layer of sand	<ul style="list-style-type: none"> <li>Thickness: 9cm</li> </ul>	+2.79	Layer of rammed earth foundation

T19-F9a	Area of floor tile	<ul style="list-style-type: none"> <li>Length exposed: 158cm</li> <li>Width exposed: 60cm</li> <li>Average size of each floor tile: 38×38×4cm<sup>3</sup></li> </ul>	+2.92	Floor
T19-F9b	Layer of sandy clay	<ul style="list-style-type: none"> <li>Thickness: 8cm</li> </ul>	+2.88	Layer of rammed earth foundation

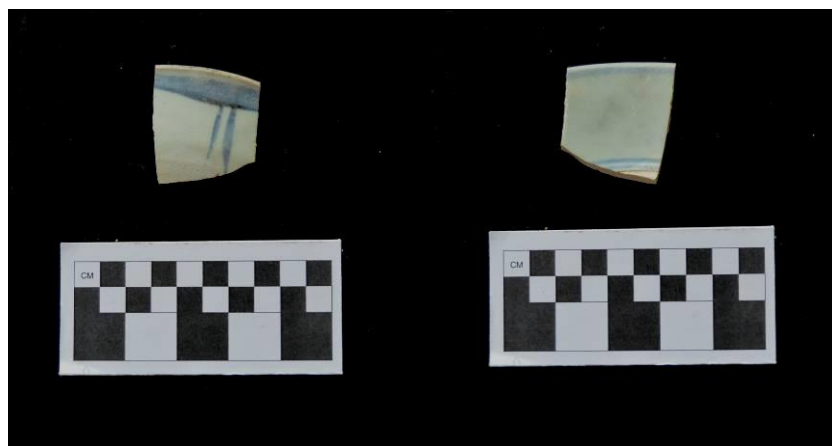
Figure 4.31

- 4.3.12 Selected Finds No. T1 L2:1 (see **Figure 4.31**) is a blue and white rim sherd of bowl with hard and greyish white body. The surface is smooth and without crackle. The cobalt is greyish blue with pattern of floral on the exterior and double circle at the interior base. Its length is 4.5cm and width is 4cm. According to its glaze, body and morphological style and pattern, it can be dated to the Late Qing dynasty to the early 20<sup>th</sup> century.

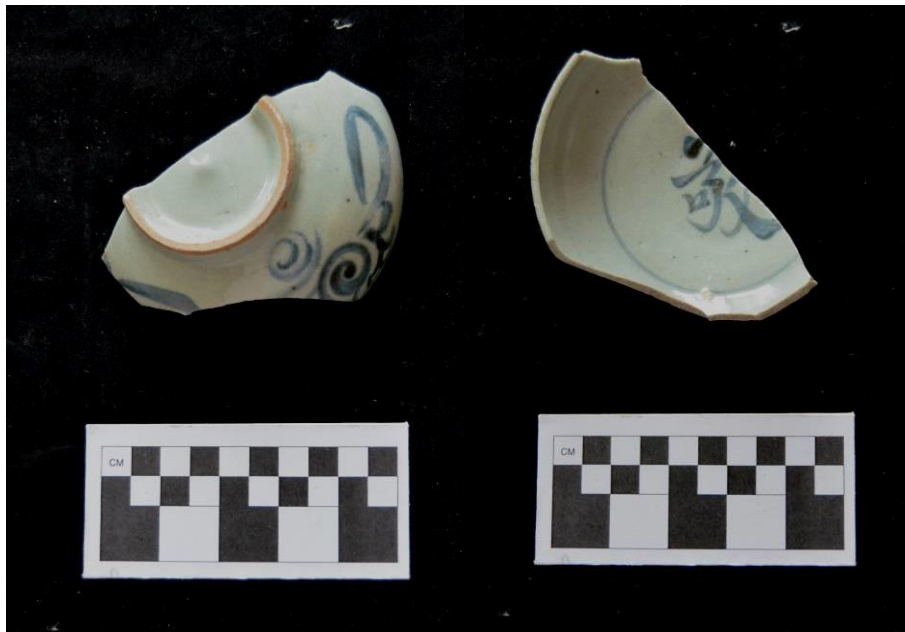
Figure 4.32

4.3.13 Selected Finds No. *T3 L4:1* (see **Figure 4.32**) is a blue and white bowl sherd with hard and greyish white body. The surface is smooth and without crackle. The cobalt is greyish blue with pattern of chrysanthemum on the exterior and Chinese character “敬” (respect) at the interior base. Its height is 4.3cm and foot ring diameter is 5.8cm. According to its glaze, body and morphological style and pattern, it can be dated to the Late Qing Dynasty to the early 20<sup>th</sup> century.

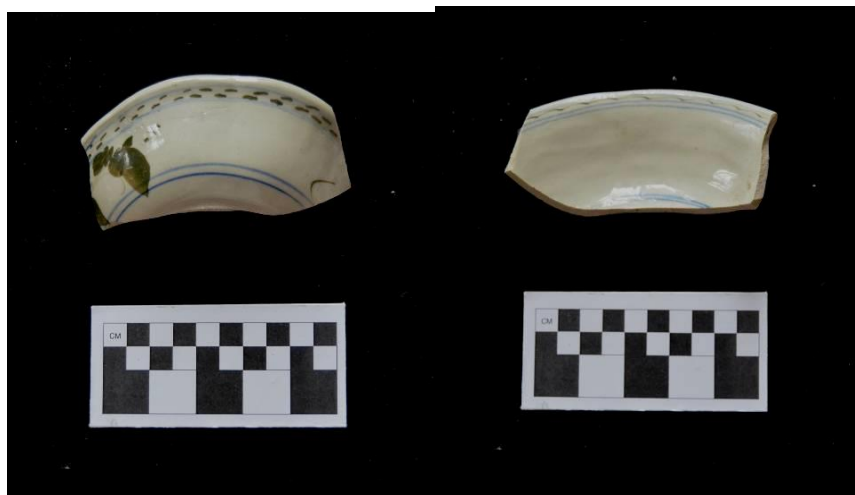
Figure 4.33

4.3.14 Selected Finds No. *T3 L4:2* (see **Figure 4.33**) is a polychrome porcelain body sherd of bowl with hard and greyish white body. Covered by greyish white glaze on both sides, the surface is smooth and without crackle. The cobalt is blue with pattern of double circle on rim and base of both sides. Green colour of dotted pattern and leaf pattern painted on the exterior. Its length is 11cm and width is 5cm. According to its glaze, body and morphological style and pattern, it can be dated to the Late Qing dynasty to the early 20<sup>th</sup> century.

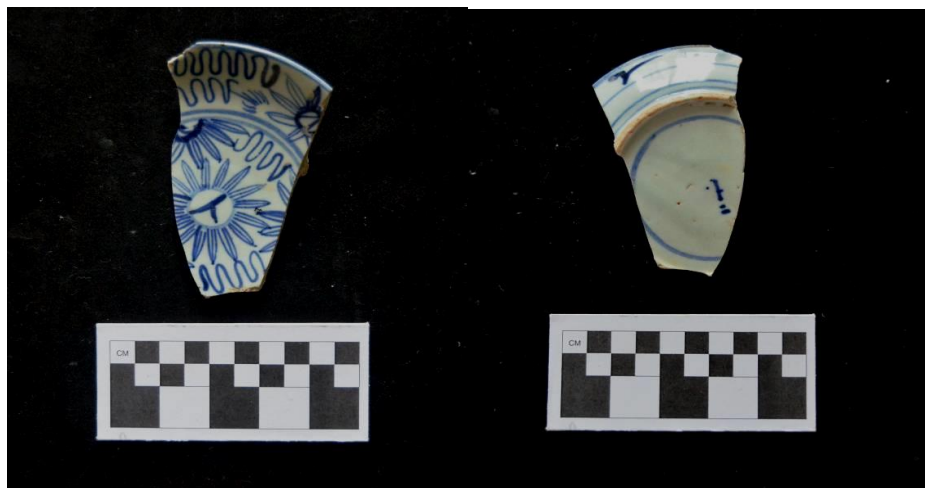
**Figure 4.35**

4.3.16 Selected Finds No. *T4 L4:1* (see **Figure 4.35**) is a blue and white plate sherd with hard and white body. Covered by white glaze on both sides, the surface is smooth and without crackle. The cobalt is blue with pattern of chrysanthemum and ribbon on the interior body and base. Moreover, a cobalt line is on the rim and a small floral pattern is on the exterior body bounded by lines. Foot ring diameter 8cm and height is 2.5cm. According to its glaze, body and morphological style and pattern, it can be dated to the early 20<sup>th</sup> century.

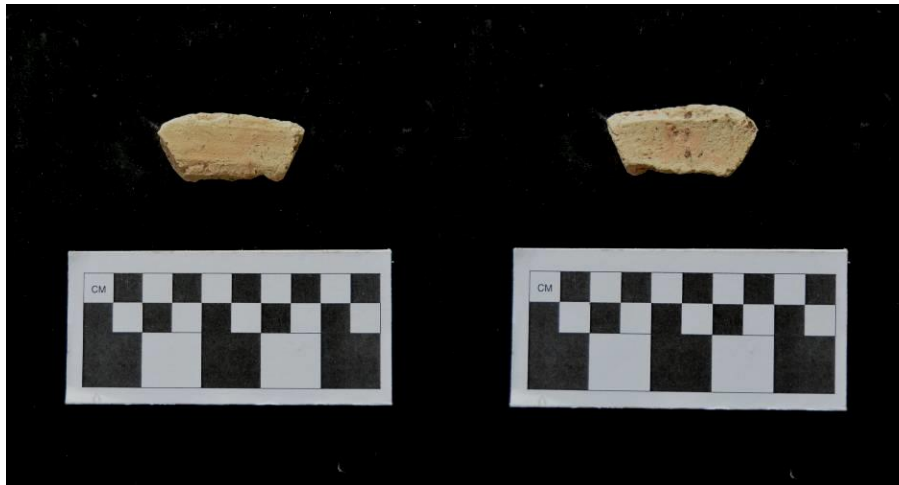
Figure 4.36

4.3.17 Selected Finds No. *T6 L5:1* (see **Figure 4.36**) is a roof tile sherd with hard and reddish orange body. Its length is 5cm and width is 2cm. The sub-angular shape of the broken edge of the tile indicated that it is a secondary deposit. According to body, it can be dated to the early 20<sup>th</sup> century.

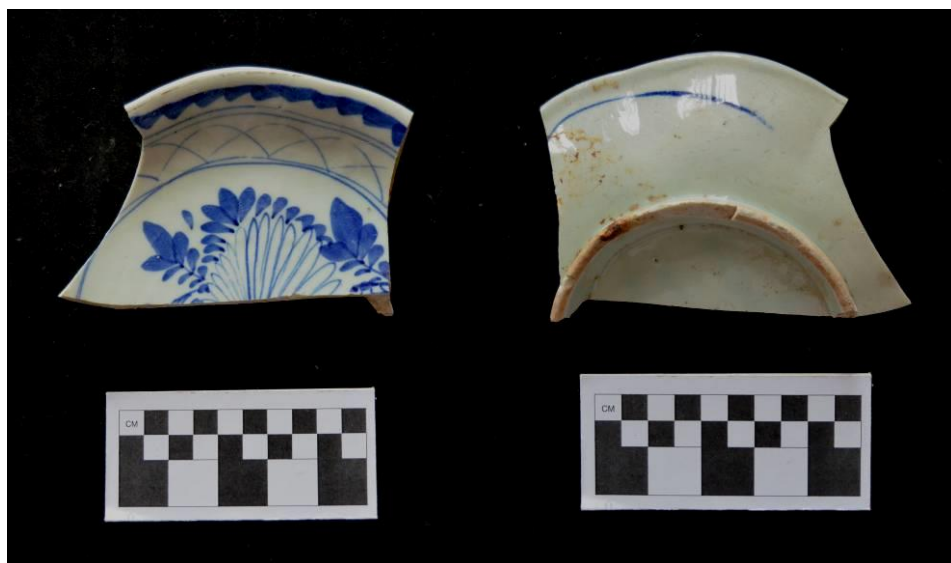
Figure 4.37

4.3.18 Selected Finds No. *T7 L2:1* (see **Figure 4.37**) is a blue and white plate sherd with hard and white body. The rim is in floral shape and it covered by white glaze on both sides, the surface is smooth and without crackle. The cobalt is blue with pattern of fence on the interior body and chrysanthemum at the base. A line of cobalt is on the exterior body. Foot ring diameter 11cm and height is 4cm. According to its glaze, body and morphological style and pattern, it can be dated to the early 20<sup>th</sup> century.

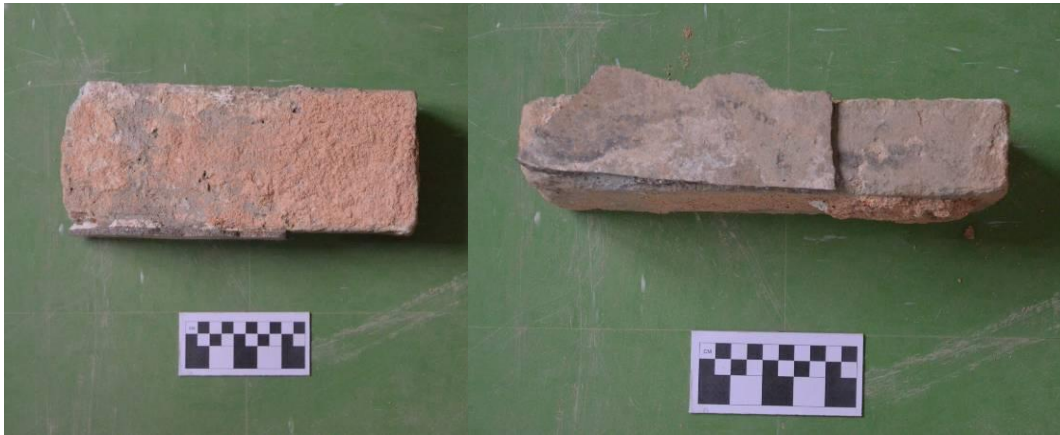
Figure 4.38

4.3.19 Selected Finds No. *T8 F1:1* (see **Figure 4.38**) is a brick with hard and reddish orange body. Cement finishing with 0.7cm is paved on the exterior of the brick.

Its length is 28cm, width is 11.5cm and height is 6cm. According to its body and morphological style, it can be dated to the early 20<sup>th</sup> century.

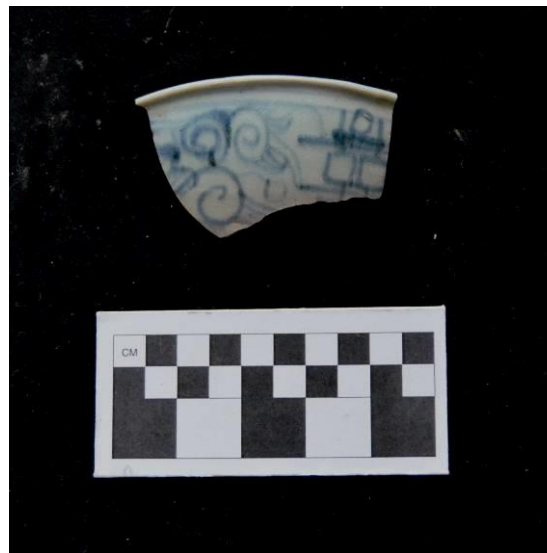
Figure 4.39

4.3.20 Selected Finds No. T9 L2:1 (see **Figure 4.39**) is a blue and white rim sherd of bowl with hard and greyish white body. Covered by greyish white glaze on both sides, the surface is smooth and without crackle. The cobalt is greyish blue with pattern of Chinese character “喜喜” (double happiness) on the exterior body. Its length is 8cm and width is 5cm. According to its glaze, body and morphological style and pattern, it can be dated to the early 20<sup>th</sup> century.

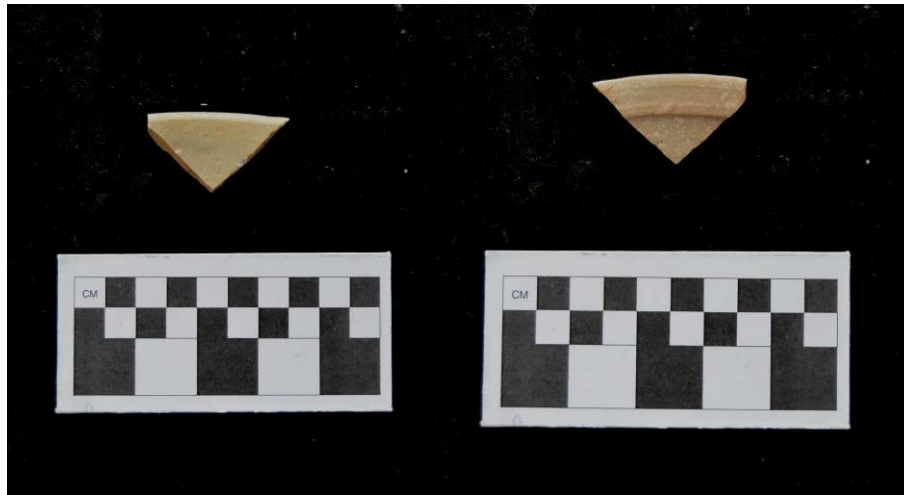
Figure 4.40

4.3.21 Selected Finds No. T11 L2:1 (see **Figure 4.40**) is a celadon rim sherd of bowl with hard and greyish white body. Covered by yellowish green glaze on both sides, the surface is smooth and without pattern and crackle. Its length is 4.5cm and width is 3cm. According to its glaze, body and morphological style, it can be dated to the Song Dynasty. However, it is found in the filled soil of Kai Tak Airfield reclamation (L2) and hence considered a secondary deposit.

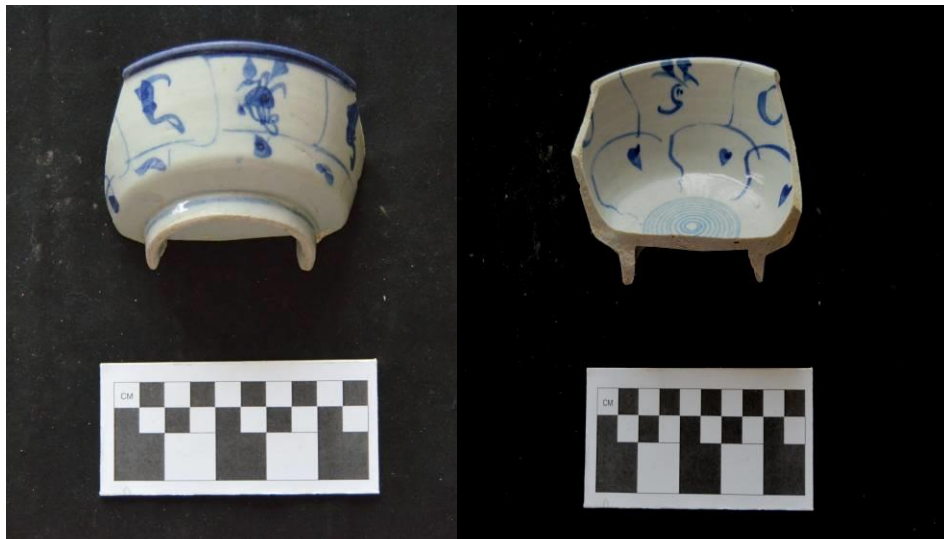
Figure 4.41

4.3.22 Selected Finds No. *T14 L3:1* (see **Figure 4.41**) is a blue and white bowl sherd with hard and greyish white body. Covered by greyish white glaze on both sides, the surface is smooth and without crackle. The cobalt is blue with pattern of floral inside panels on the exterior and interior body. The rim covered by cobalt line and a spiral is at the interior base. Rim diameter is 11.4cm, foot ring diameter is 6.4cm and height is 5.5cm. According to its glaze, body and morphological style and pattern, it can be dated to the early 20<sup>th</sup> century.

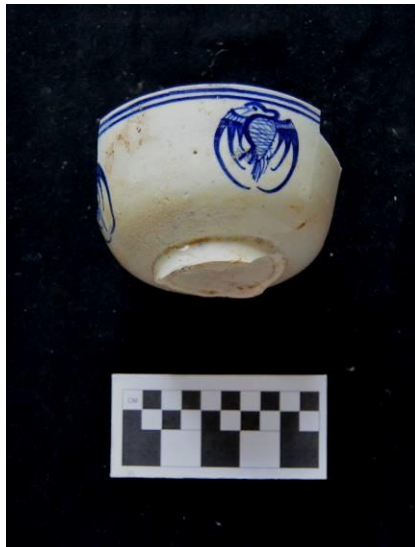
4.3.23 Selected Finds No. *T19 L3:1* (see **Figure 4.42**) is a blue and white bowl sherd with hard and white body. Covered by white glaze on both sides, the surface is covered with crackle. The cobalt is blue with pattern of double circle under the rim and pattern of cranes on the exterior body. The Rim diameter is 13cm, foot ring diameter is 6 cm and height is 7.5cm. According to its glaze, body and morphological style and pattern, it can be dated to the early 20<sup>th</sup> century.

**Figure 4.42      Small Finds No. T19 L3:1**

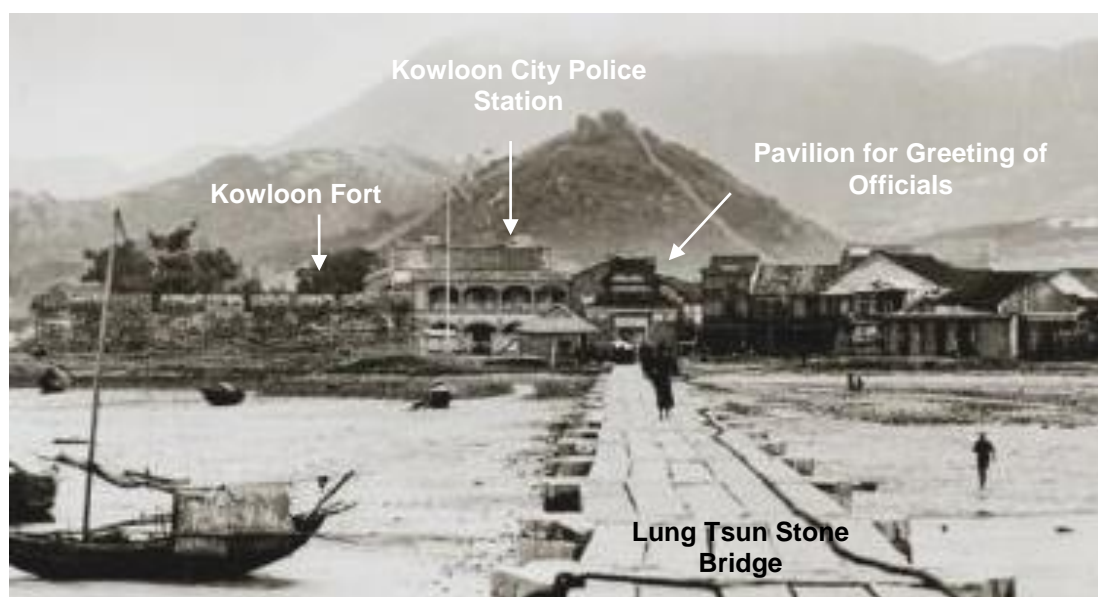
**Figure 5.2 Lung Tsun Stone Bridge & Kowloon Fort, the 1900s**  
(Source: <http://gwulo.com>)

5.1.4 From the 1898 and the 1900s historical photo (**Figures 3.1b** and **5.2**), it is known that the Kowloon Fort had a battery using large quantities of dressed granite slabs on its exterior (which possibly wrapped the rammed earth or other fill materials inside). In light of this, finding of groups of granite slabs at its original location could imply the presence of this battery of the Fort at T14. However, this field investigation did not find any granite slabs in such condition. In fact, as presented in **Table 4.2** and Sections 4.2.9 to 4.2.12 and 4.2.15 and 4.2.17, the lack of any granite slabs (and potential fill materials of the battery) identified suggested that the Kowloon Fort has been demolished entirely, as late as the construction of the Kai Tak Bund in the 1930s where no sign of the Fort was observed on the 1930s' survey map (**Figure 5.3**).

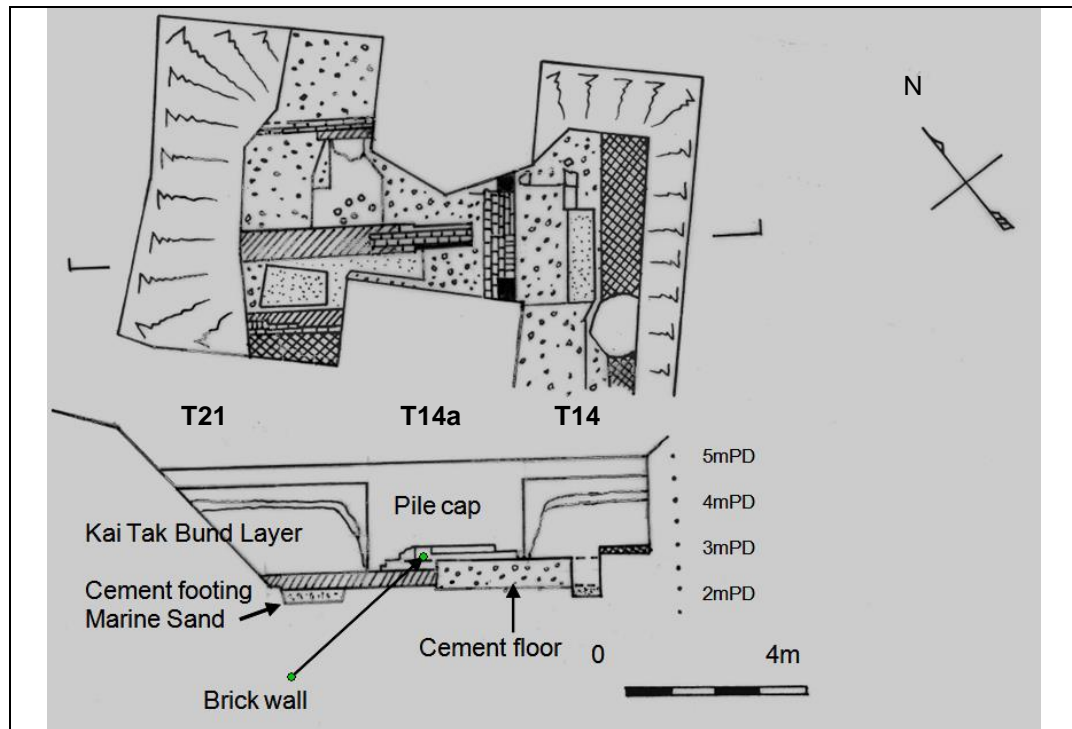
**Figure 5.4b** Cross Section of T14, T14a and T21

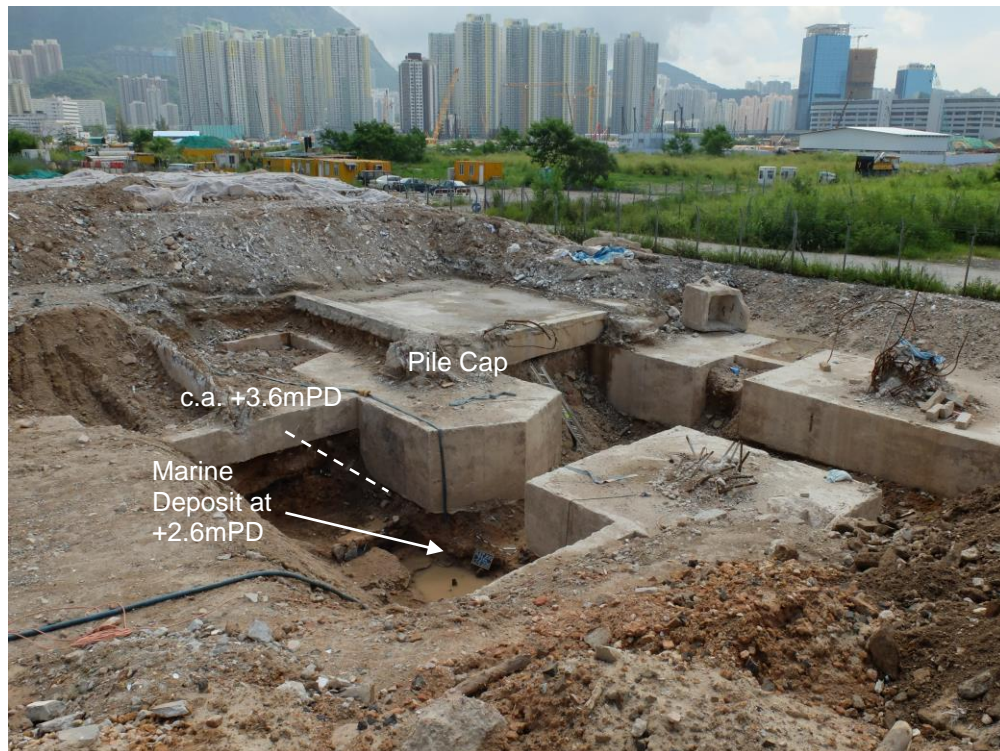
Figure 5.6 Pile Caps and Ground Beams at T14, T14a and T21.
