Express Rail Link (XRL)
Consultancy Agreement No.: C8016

Environmental Term Consultancy for XRL**Tai Kong Po Emergency Assess Point –
Further Archaeological Investigation
Report**

January 2011

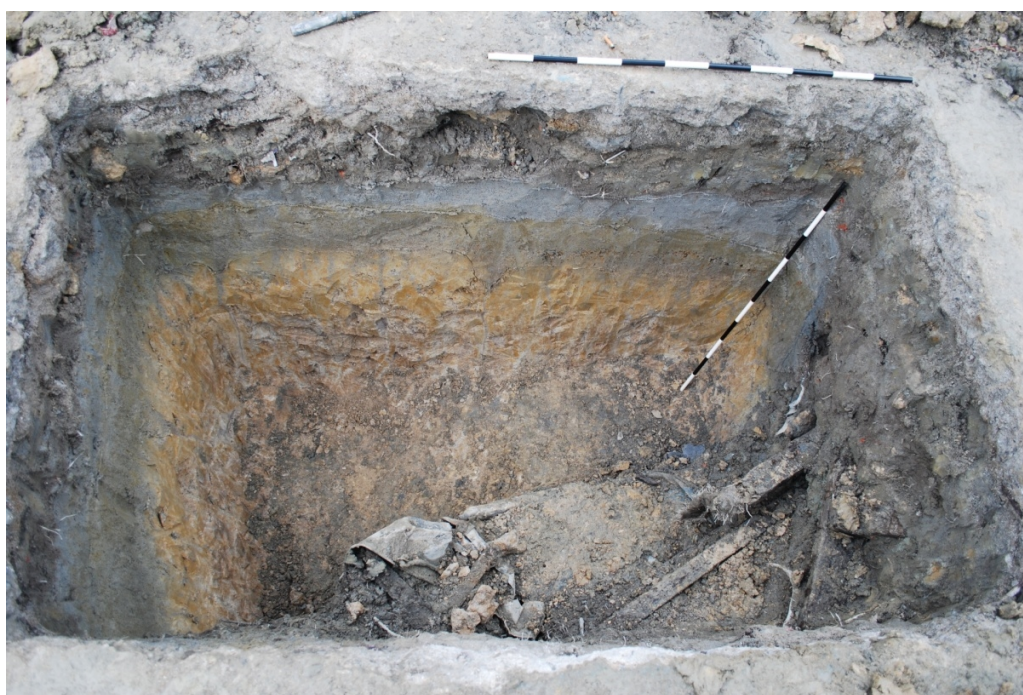
SP1 Northern Profile

- 5.3.2 SP1 is situated on concreted paved ground between two abandoned chicken sheds and is on a gentle slope backed by Kai Kung Leng to the northeast. A test pit of 2m x 1.2m was excavated up to a depth of 150cm from the ground surface by hand, and then an auger hole was drilled to extend the depth to 280cm from the ground surface, when underground water emerged which prevent soils extraction by hand augering.
- 5.3.3 Six strata were defined in SP1, none of which contained archaeological finds. Details on the stratigraphy are presented in **Table 5.1** and **Appendix A**.

Layer	Soil Texture	Soil Colour	Finds	Chronology / Remarks
L1	Concrete Paving		Nil	Modern
L2	Sand	Grayish Red	Nil	Modern Fill Soil
L3	Sand	Gray	Nil	
L4	Sandy Loam	Bright Reddish Brown	Nil	
L5	Clay	Bright Yellowish Brown	Nil	
L6	Sandy Clay	Bright Yellowish Brown	Nil	Sterile Regolith, underground water at 270cm deep

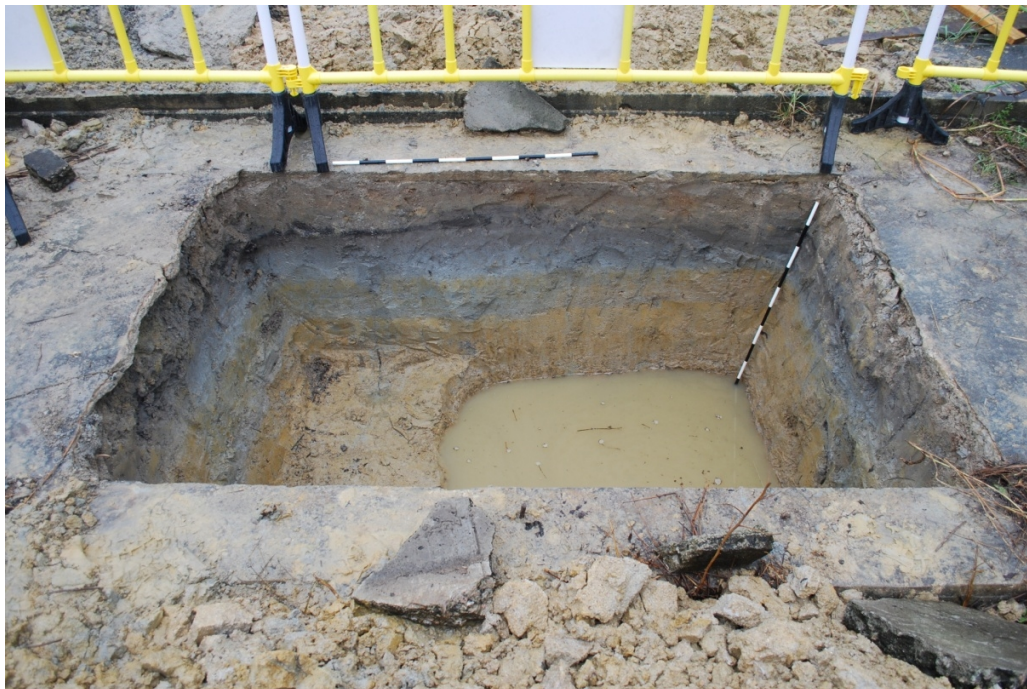
SP2 Northern Profile

- 5.3.4 SP2 is situated on concrete paved ground beside an abandoned and levelled pig shed. It is on a river terrace and is backed by Kai Kung Leng to the north. A test pit of 2.3m x 1.45m was excavated up to a depth of 112cm from the ground surface by hand, and then an auger hole was drilled to extend the depth to 210cm from the ground surface, when the soil is too muddy to be extracted by hand augering. Underground water emerged at a depth of 100cm from the ground surface.

- 5.3.5 Seven strata were defined in SP2. A sherd of dark brown glazed pottery was found in stratum L4, which is an orange firm sandy loam. The sherd was found in isolation from any archaeological materials, as well as the lack of distinctive diagnostic features on the sherd, the glazing resembled those pots seen from the 19th century to Modern Age. Details on the stratigraphy are presented in **Table 5.1** and **Appendix A**.

Layer	Soil Texture	Soil Colour	Finds	Chronology / Remarks
L1	Concrete Paving		Nil	Modern
L2	Sandy Soil	Dull Yellowish Brown	Nil	
L3	Coarse Sand	Grayish Red	Nil	
L4	Sandy Loam	Orange	a Modern brown glazed pottery sherd	19 th century to Modern
L5	Sand	Dull Orange	Nil	Underground water reached at 100cm
L6	Sand	Bright Yellowish Brown	Nil	Alluvium
L7	Clay	Light Yellow	Nil	Sterile Regolith

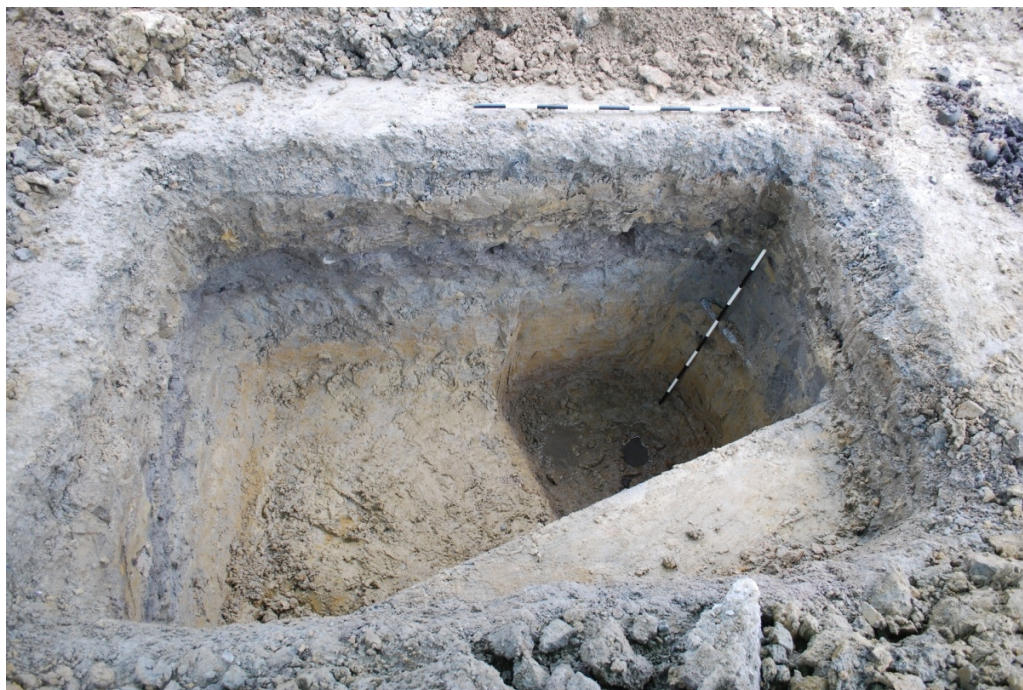
SP3 Southeastern Profile

- 5.3.6 SP3 is situated on concrete paved ground beside an abandoned and levelled pig shed and an abandoned iron tower for feed storage. It is on a flat river terrace and is backed by Kai Kung Leng to the north. A test pit of 2.3m × 1.2m was excavated up to a depth of 140cm from the ground surface by hand, and then an auger hole was drilled to extend the depth to 230cm from the ground surface, when the soil is too muddy to be extracted by hand augering. Underground water emerged at a depth of 145cm from the ground surface.
- 5.3.7 Six strata were defined in SP3, none of which contained archaeological finds. Details on the stratigraphy are presented in **Table 5.1** and **Appendix A**.

Layer	Soil Texture	Soil Colour	Finds	Chronology / Remarks
L1	Concrete Paving		Nil	Modern
L2	Clayey Silt	Dull Yellow Orange	Nil	Modern Fill Soil
L3	Clay	Brownish Gray	Nil	Modern with Concrete Slab and Plastic Tubes
L4	Sandy Clay	Gray	Nil	Modern, with Plastic Tubes
L5	Clayey Sand	Bright Yellowish Brown	Nil	Alluvial, Underground water reached at 145cm
L6	Clay	Olive Black	Nil	Sterile Regolith

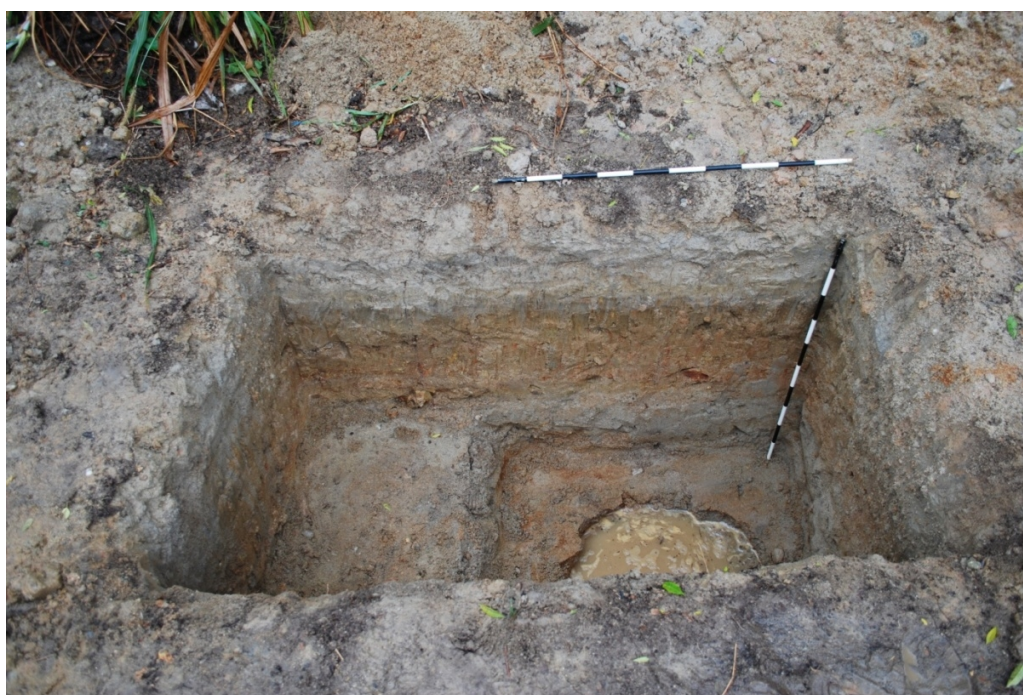
SP4 Northern Profile

- 5.3.8 SP4 is situated on a vacant land with olive brown sand as topsoil. There are concrete rubbles discarded on this small vacant lot, which might have caused recent disturbance to the soil near to the surface. It is on a flat river terrace and is backed by Kai Kung Leng to the north. A test pit of 1.8m × 1.0m was excavated up to a depth of 120cm from the ground surface by hand, and then an auger hole was drilled to extend the depth to 130cm from the ground surface, when underground water emerged at 95cm which prevent soils extraction by hand augering.
- 5.3.9 Five strata were defined in SP4, none of which contained archaeological finds. Details on the stratigraphy are presented in **Table 5.1** and **Appendix A**.

Layer	Soil Texture	Soil Colour	Finds	Chronology / Remarks
L1	Sand with Pebbles	Olive Brown	Nil	Modern
L2	Silty Sand	Dull Yellowish Brown	Nil	
L3	Sand with Pebbles	Bright Brown	Nil	
L4	Sand	Dull Yellow Orange	Nil	Alluvium, Underground water reached at 95cm
L5	Sand	Brown	Nil

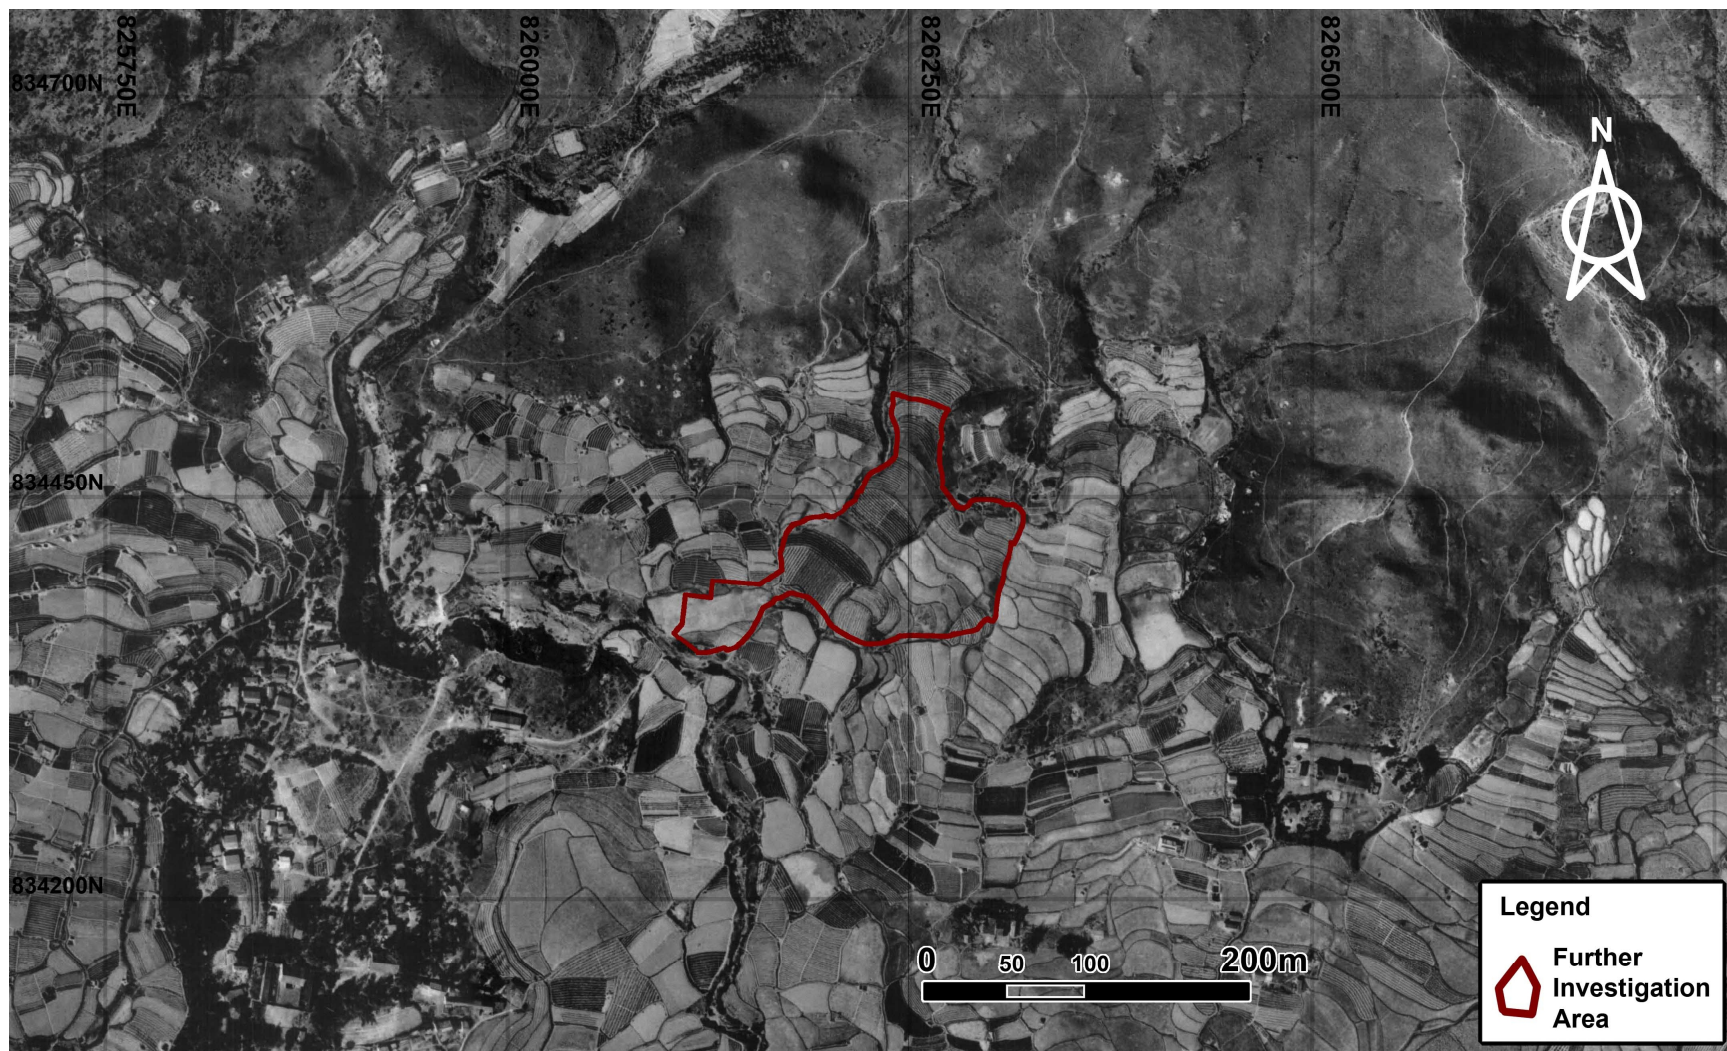
Figure B2 Further Investigation Area of TPP on an 1963 Aerial Photograph
(Source: Survey and Mapping Office of Lands Department 1963 Aerial Photo)

- 2.2.2 Locations of further archaeological investigation are shown in **Figures B1 to B3 of Appendix B and Figure No. C8016/C/XRL/ENS/M55/005**. In order to demarcate the boundary of archaeological deposit and search of archaeological potential, field walking, four test pits and six auger holes are carried out in these areas.

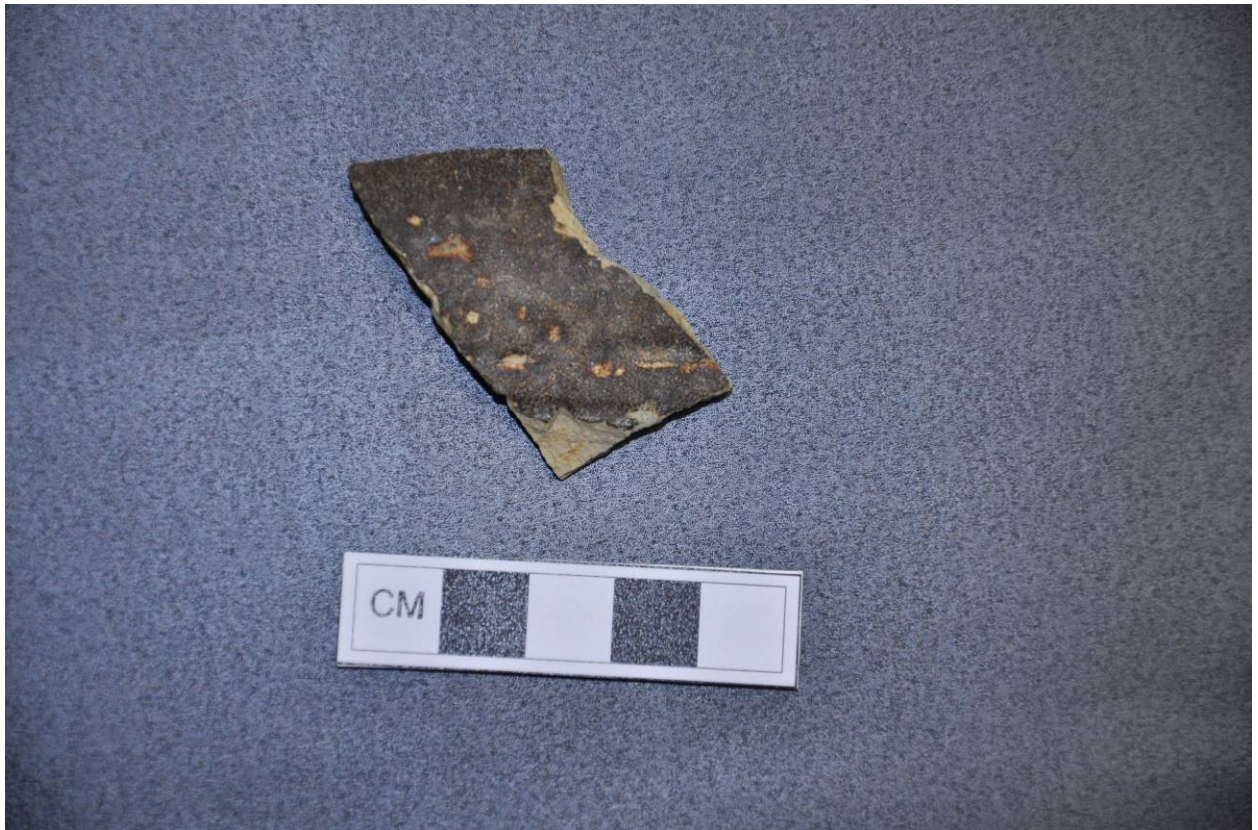
Figure B4 Dark Brown Glazed Pottery in L4 of SP2
(Source: AECOM Asia Co. Ltd. 2010)
