- 1.3.1 The structure of the AIA Report is set out below:
- Section 2 describes the relevant legislation and guidelines;
 - Section 3 sets out the objectives and methodology;
 - Section 4 presents the related geological, historic and archaeological background to the Project, and findings of desktop review;
 - Section 5 presents the result of archaeological investigation;
 - Section 6 presents the potential impact on archaeology and recommends mitigation measures according to Antiquities and Monument Office (AMO) guidelines;
 - Section 7 presents a summary of the conclusions of the AIA; and
 - Section 8 presents bibliography.

TITLE
NOL / ERL -300
ENVIRONMENTAL IMPACT ASSESSMENT
OVERALL VIEW OF ALIGNMENT

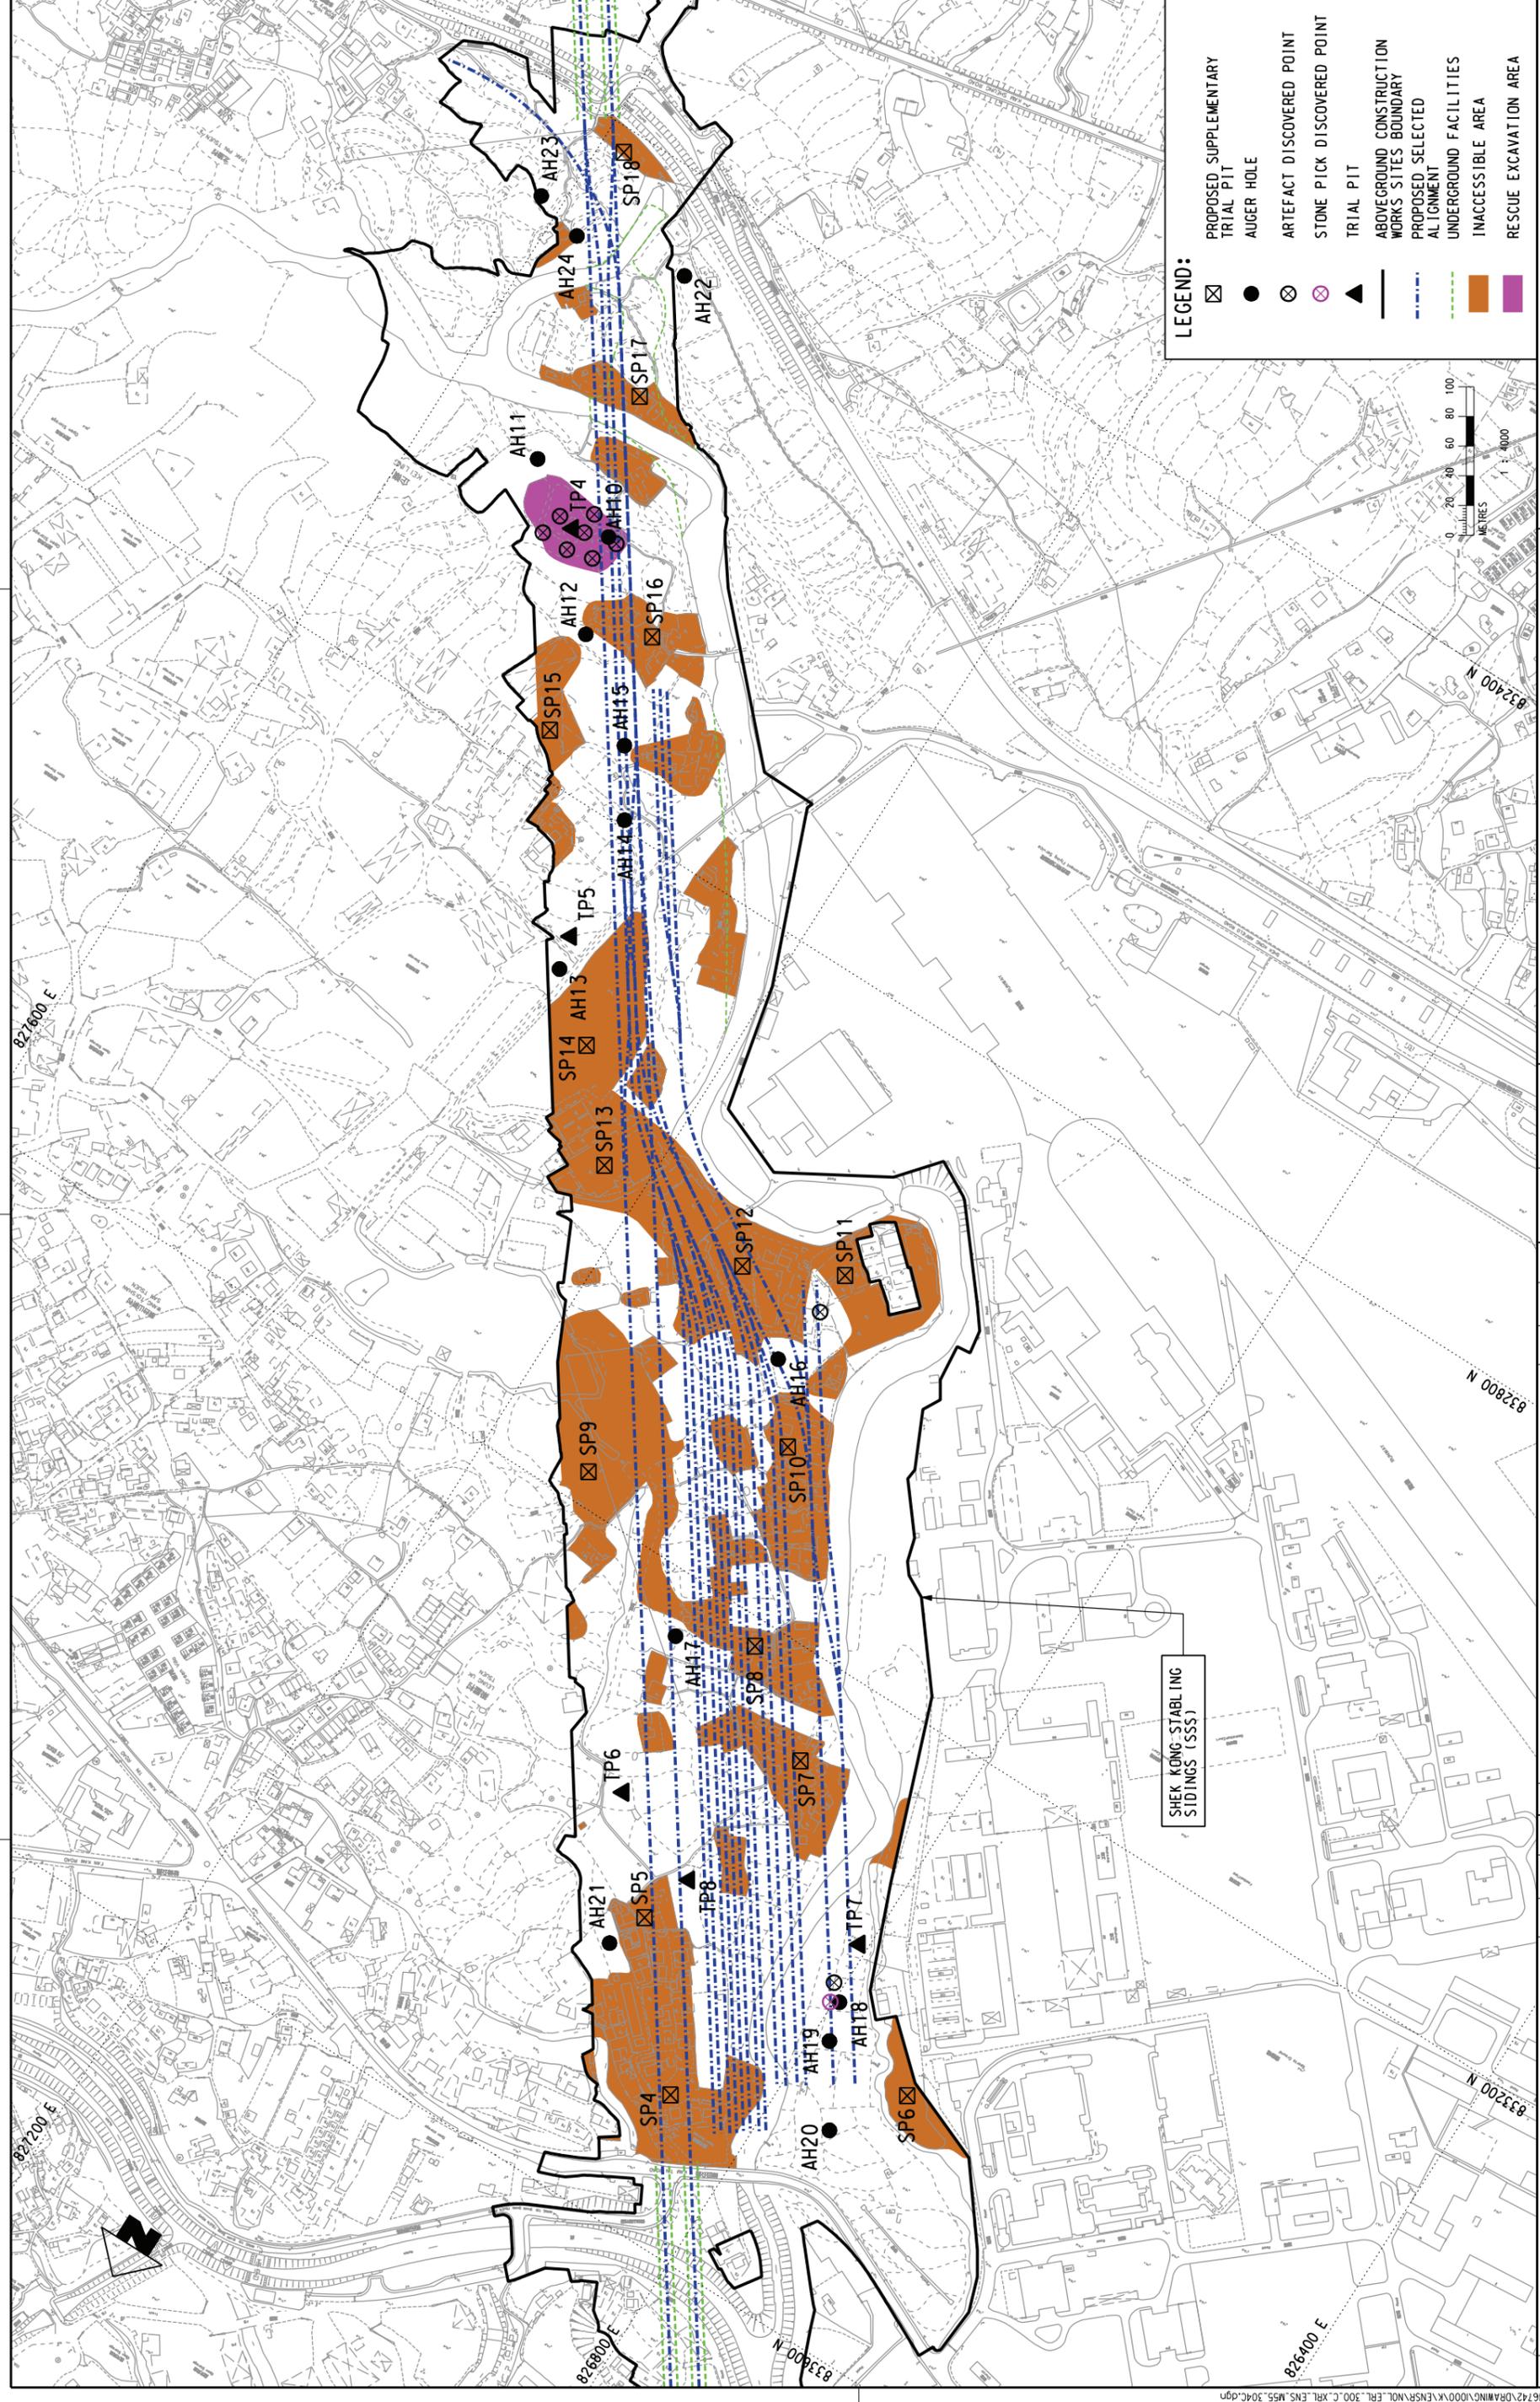
SHEK KONG STABILING SIDINGS (SSS)

- ☒ PROPOSED SUPPLEMENTARY TRIAL PIT
- AUGER HOLE
- ⊗ ARTEFACT DISCOVERED POINT
- ⊗ STONE PICK DISCOVERED POINT
- ▲ TRIAL PIT
- ABOVEGROUND CONSTRUCTION WORKS SITES BOUNDARY
- ALIGNMENT SELECTED
- UNDERGROUND FACILITIES
- INACCESSIBLE AREA
- RESCUE EXCAVATION AREA

6.3.6 A cultural layer was identified in southern SSS in which artefacts dated to Song and Ming dynasties were unearthed. A rescue excavation is therefore recommended so as to preserve the archaeological remains by detailed records. Proposed rescue excavation area is shown in **Figure No. NOL/ERL/300/C/XRL/ENS/M55/304**.

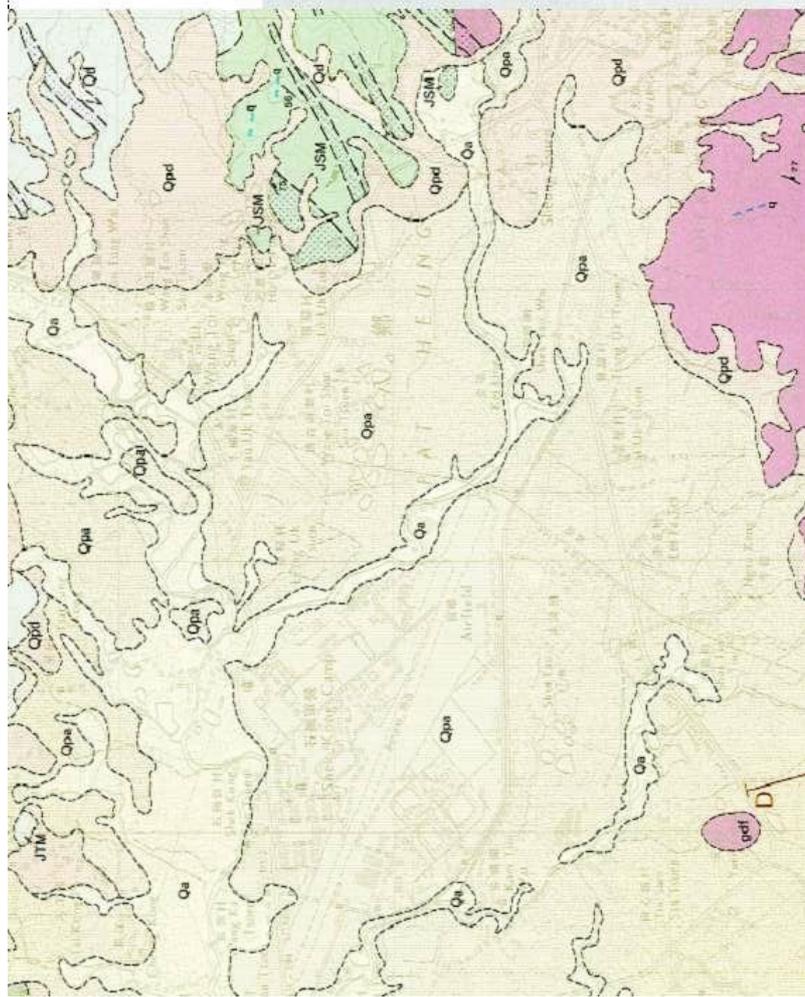
Figure A4 Superficial Geological Map of Kam Tin (1:20,000)

GENETIC CLASSIFICATION 成因類型		PRINCIPAL MATERIALS	
Fill 填土	填土	填土	Natural earth and waste
Alluvium 沖積物	沖積物	Qa	Clay/silt, sand and gravel; well-sorted to semi-sorted
Beach deposits 海灘沉積物	海灘沉積物	Qb	Sand
Raised beach deposits 隆起海灘沉積物	隆起海灘沉積物	Qjb	Sand
Marine sand 海洋砂	海洋砂	OrH	Undivided, mainly dark grey marine mud
		ms	Sand, part silty
HANG HAU FORMATION 荳白圍			
DEBRIS FLOW DEPOSITS 碎屑-泥流沉積物		Qd	Unsorted sand, gravel, cobbles and boulders; clay/silt matrix
Talus (rockfall) deposits 岩屑-塊石沉積物		Qt	Gravel, cobbles and boulders
CHEK LAP KOK FORMATION 赤立角			
Terraced alluvium 階地沖積物		Qpa	Clay/silt, gravelly sandy, well-sorted to semi-sorted
Debris flow deposits 碎屑-泥流沉積物		Qpd	Silt/clay, gravelly, clayey with cobbles and boulders; unsorted
		Qck	Undivided; red, yellow, and grey clay, silt, sand and gravel

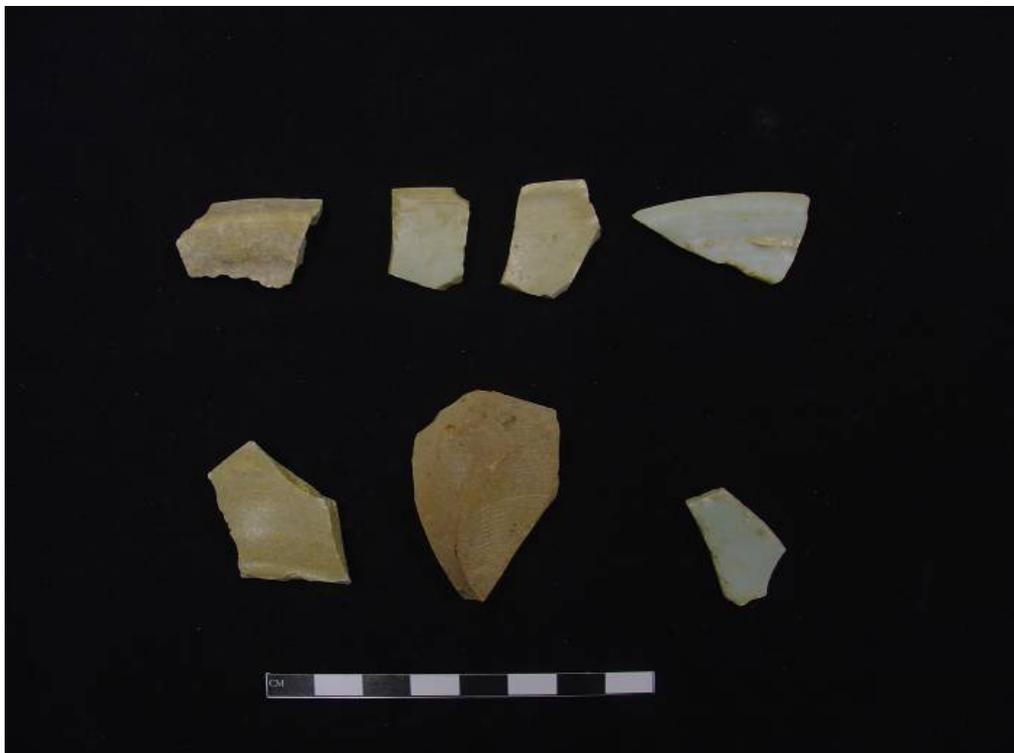
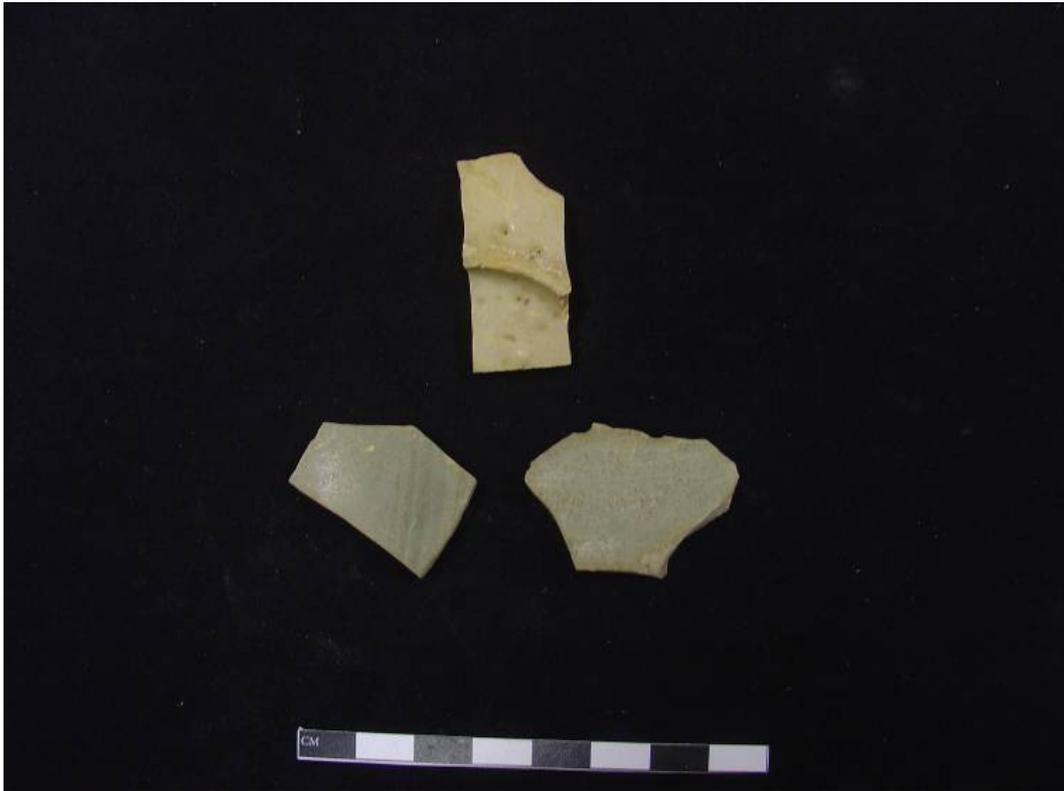
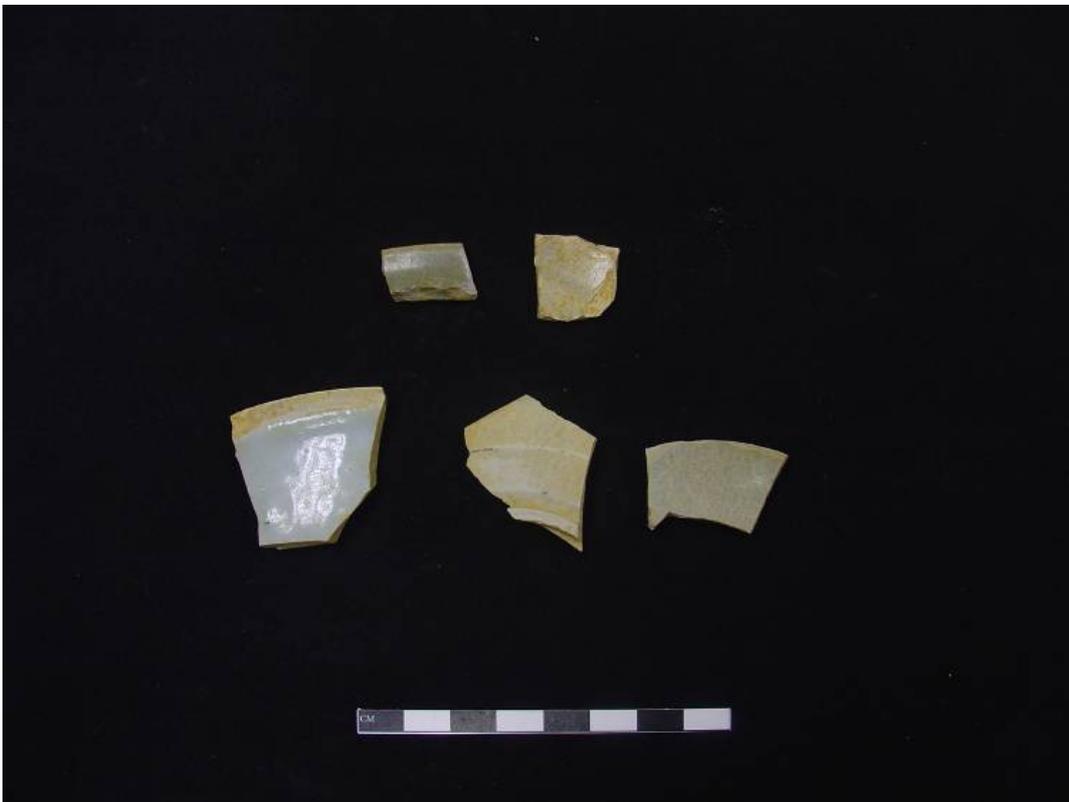
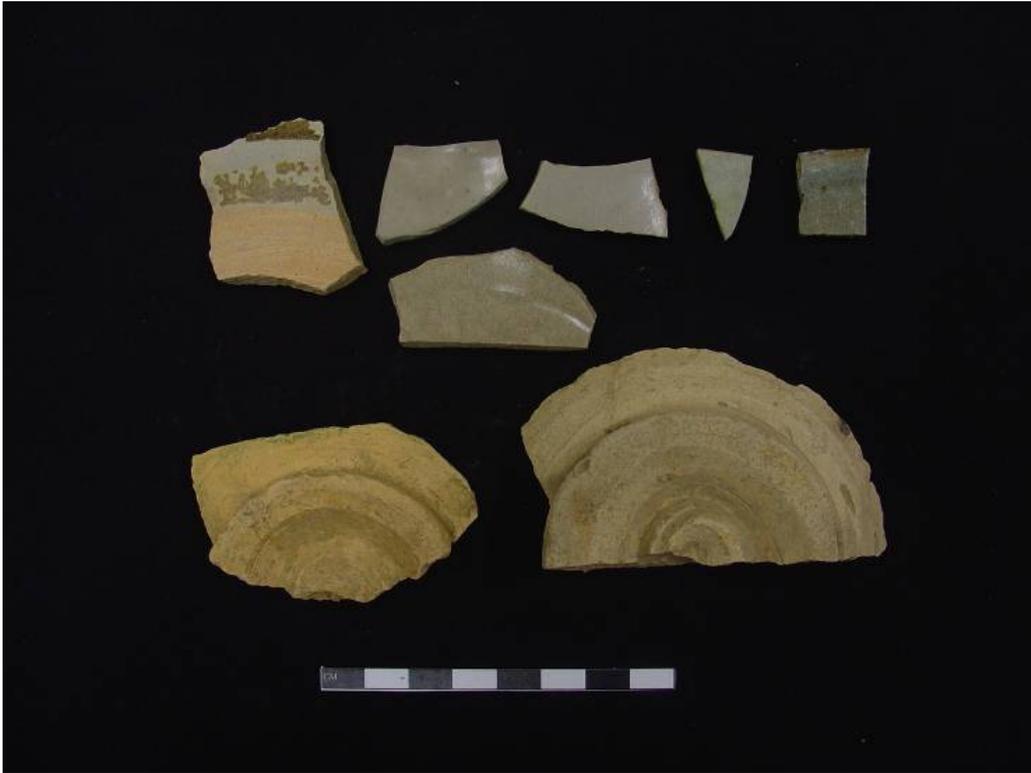
Figure B7 Song Celadon Collected From Ground Surface in Tsat Sing Kong Archaeological Site

Figure B8 Song Celadon Collected From SSS

Figure B9 Song Celadon Collected in Ground Surface Surrounding of TP4

Figure B10 Song Celadon Collected in Ground Surface Surrounding of TP4

- Song dynasty celadon: these shards were collected and unearthed in Tsat Sing Kong Archaeological Site, TUW and SSS. Most of the glazes are brown in colour and peeled off. The cracked light green glazed broken bowl unearthed from L2 of TP4, this kind of cracked light green glaze is one of the characters of products from Guangdong coastal kilns in southern Song dynasty (1127-1279). (**Figures B7 to B10**).

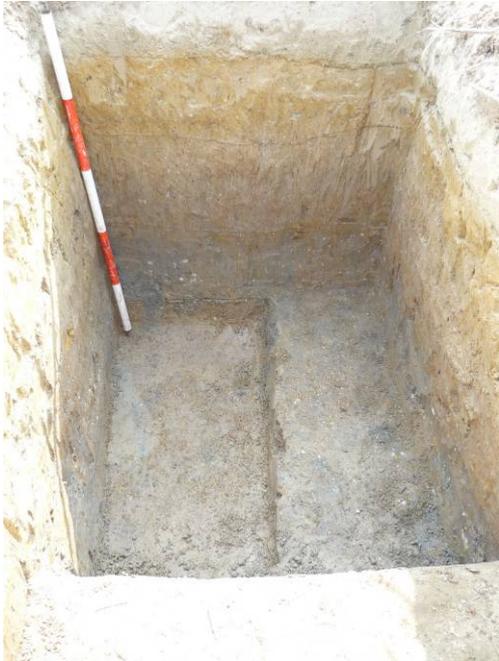
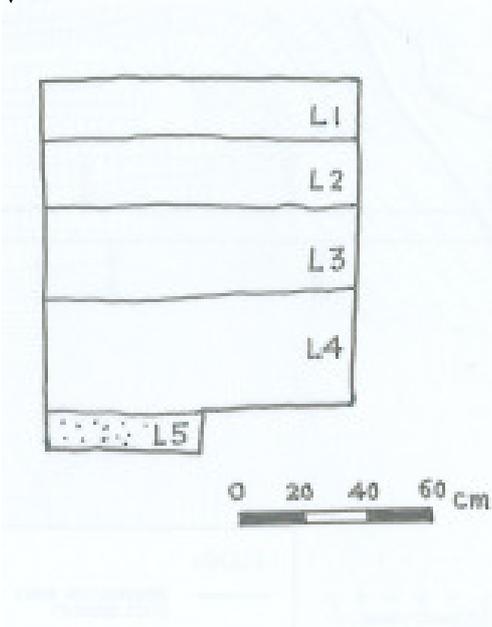
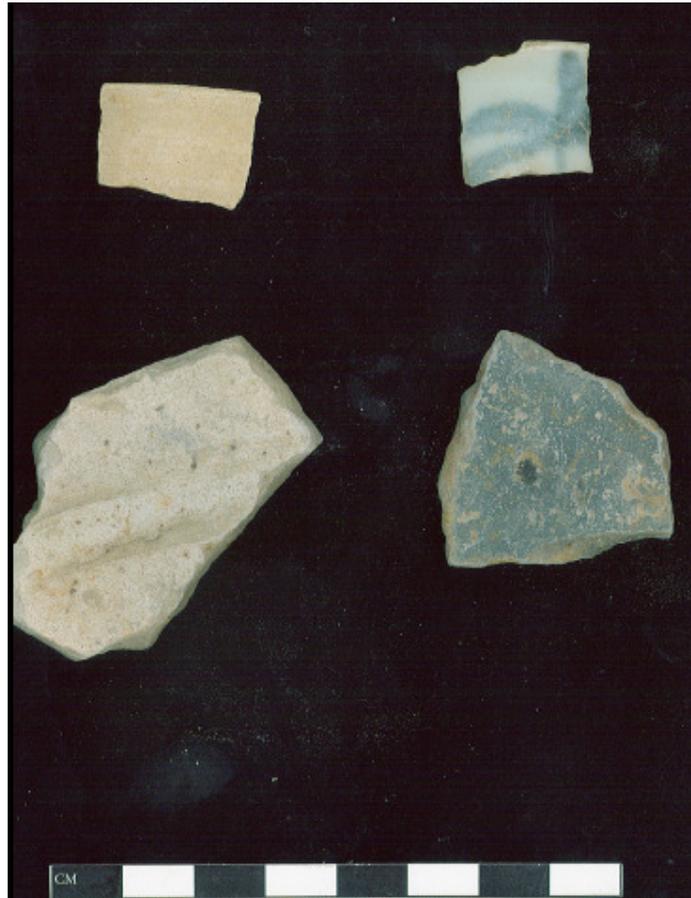
Location	TUW	Site Code	----	Test Pit No.	TP 2
Test Pit Coordinate	832051.497 Northing	827837.711 Easting	Test Pit Measurement	1.5 m x 1 m	
Digging Method	Machine & Hand Digging		Ground Level	31.300 mPD (SW corner)	
Stratigraphy and Finds					
Layer	Soil Texture	Soil Colour	Finds	Chronology	
L1	Sandy soil	2.5YR 8/4 pale yellow	Blue-and White porcelain bowl fragment	Modern	
L2	Loamy soil	2.5YR 7/4 light yellow	Bowl rim	Modern	
L3	Loamy soil with iron stains	2.5YR 6/3 dark yellow	Brown glazed pot shards	Modern	
L4	Loamy soil	2.5YR 5/1 yellowish gray	Brown glazed pot shards, blue-and-white bowl shards and a piece of Song celadon bowl shard (reversed stratification)	Modern	
L5	Gravelly soil	2.5YR 6/1 yellowish gray	N/A	----	
Test Pit Wall Photography			Test Pit Wall Drawing		
Southern Wall Section			Southern Wall Section

Artefacts form L4

5.3.6 A total of 5 pieces of pot, blue-and-white porcelain bowl fragment and celadon bowl fragment were unearthed in L4 of TP2 at TUW. The reversed stratification was identified in TP2 in TUW, modern pot shards and blue-and-white porcelain bowl fragment was found with a piece of Song celadon bowl in this layer.

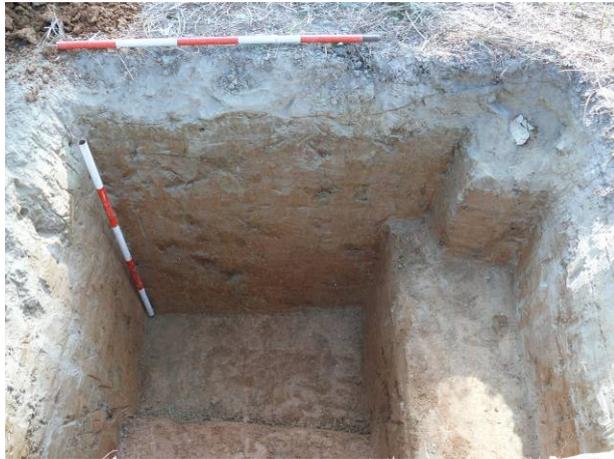
Close-up of Song celadon bowl discovered in L2

- 7.1.3 Some prehistoric and historic artefacts were collected on the ground surface at some areas within the SSS. A cultural layer of Song to Ming dynasty was discovered in test pit TP4 at the southern portion of SSS, indicating that there were human activities in SSS at ancient periods. The indicative extent of an archaeological deposit area with a cultural layer at southern SSS was defined, and rescue excavation is recommended at this area, in which the archaeological remains would be preserved by detailed records.

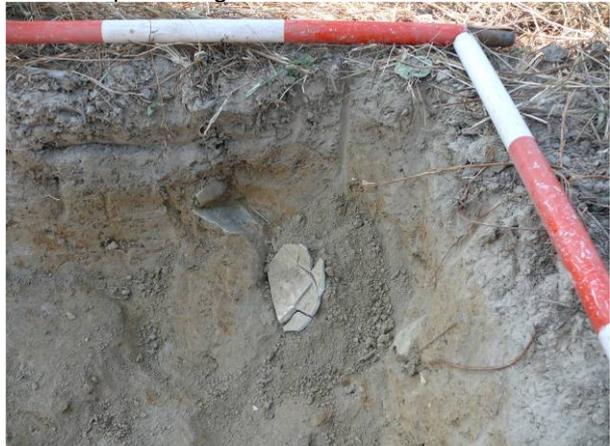
Close-up of basin shard discovered in L2

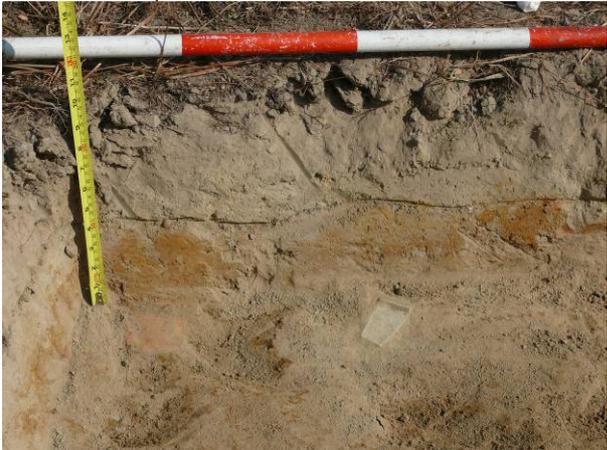
Glazed pot shoulder with an ear from L2

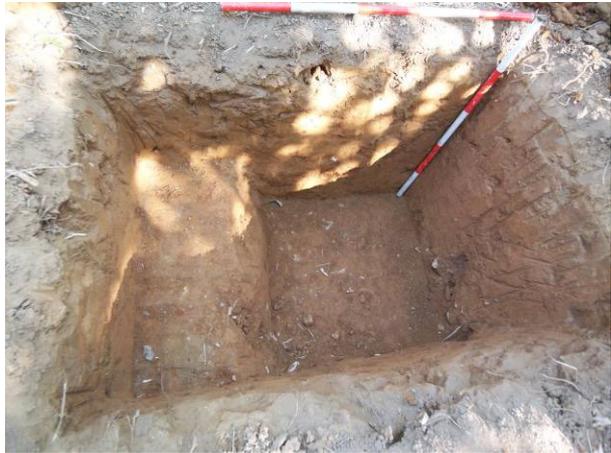
Location	SSS	Site Code	----	Test Pit No.	TP 5
Test Pit Coordinate	832878.899 Northing	827344.745 Easting	Test Pit Measurement	1.3 m x 1.5 m	
Digging Method	Machine & Hand Digging		Ground Level	21.630 mPD (SW corner)	
Stratigraphy and Finds					
Layer	Soil Texture	Soil Colour	Finds	Chronology	
L1	Silty soil	7.5YR 8/3 light yellow orange	None	----	
L2	Silty soil	7.5YR 8/6 light yellow orange	None	-----	
L3	Loam soil	7.5YR 5/6 bright brown	None	-----	
L4	Clay	7.5YR 6/8 orange	None	-----	
L5	Clay	7.5YR 5/6 bright brown	None	-----	
Test Pit Wall Photography			Test Pit Wall Drawing		
Eastern Wall Section			Eastern Wall Section

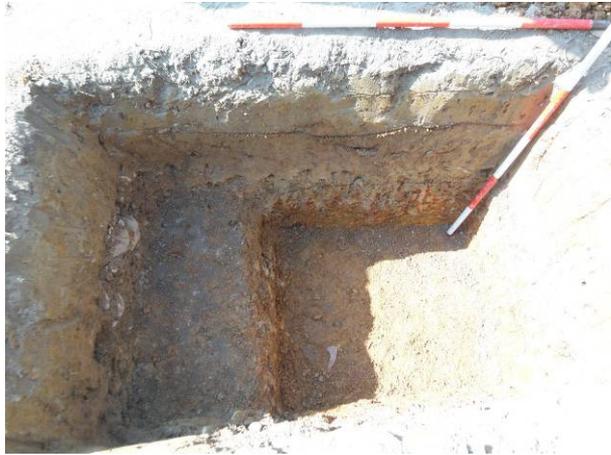
Location	SSS	Site Code	-	Test Pit No.	TP 6
Test Pit Coordinate	833343.228 Northing	826985.441 Easting	Test Pit Measurement	1 m x 1.5 m	
Digging Method	Hand Digging		Ground Level	15.398 mPD (SW corner)	
Stratigraphy and Finds					
Layer	Soil Texture	Soil Colour	Finds	Chronology	
L1	Sandy soil	10YR 7/1 light grey	None	----	
L2	Loamy soil	10YR 7/4 dull yellow orange	None	----	
L3	Sandy soil	10YR 7/6 bright yellow brown	None	-----	
L4	Loamy soil with few pebbles	10YR 6/6 bright yellowish brown	None	-----	
L5	Sandy soil	7.5YR 6/8 orange	None	-----	
Test Pit Wall Photography			Test Pit Wall Drawing		
Southern Wall Section			Southern Wall Section

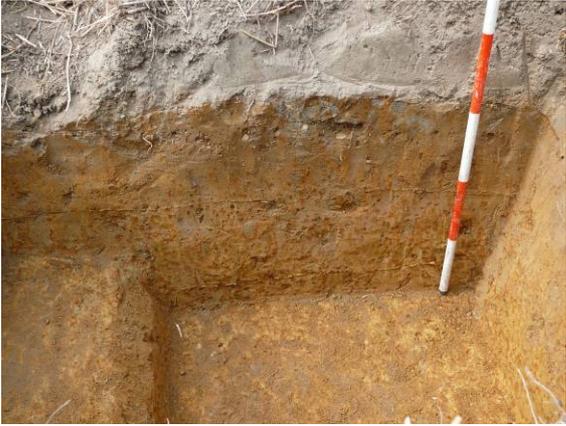
Location	SSS	Site Code	-	Test Pit No.	TP 7
Test Pit Coordinate	833351.101 Northing	826801.791 Easting	Test Pit Measurement	1.2 m x 1.8 m	
Digging Method	Hand Digging		Ground Level	13.269 mPD (SW corner)	
Stratigraphy and Finds					
Layer	Soil Texture	Soil Colour	Finds	Chronology	
L1	Sandy soil	7.5YR 7/3 dull orange	None	----	
L2	Loamy soil	7.5YR 7/6 orange	None	-----	
L3	Loamy soil	7.5YR 6/6 orange	None	-----	
L4	Sandy soil	7.5YR 6/8 orange	None	-----	
Test Pit Wall Photography			Test Pit Wall Drawing		
Eastern Wall Section			Eastern Wall Section

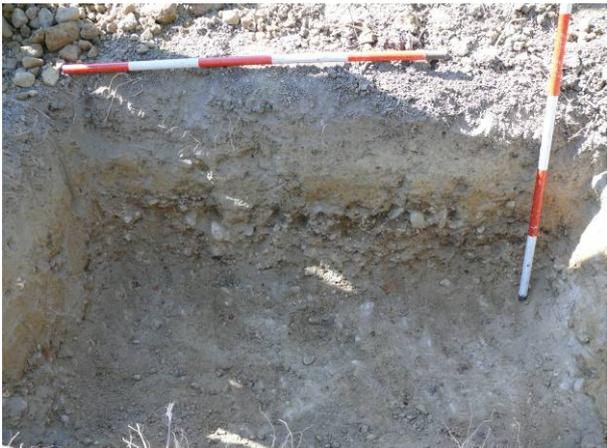
Location	SSS	Site Code	-	Test Pit No.	TP 8
Test Pit Coordinate	833378.811 Northing	826937.190 Easting	Test Pit Measurement	1.2 m x 1.8 m	
Digging Method	Machine & Hand Digging		Ground Level	14.899 mPD (SW corner)	
Stratigraphy and Finds					
Layer	Soil Texture	Soil Colour	Finds	Chronology	
L1	Sandy soil	10YR 7/2 yellow orange	None	----	
L2	Loamy soil	10YR 7/6 yellow orange	None	-----	
L3	Pebble in coarse sandy soil matrix	10YR 7/6 bright yellow	None	-----	
Test Pit Wall Photography			Test Pit Wall Drawing		
Northern Wall Section			Northern Wall Section
