**Brief on the Progress of the Archaeological Watching Brief at the  
To Kwa Wan Station Area of the  
Shatin to Central Link – Tai Wai to Hung Hom Section**

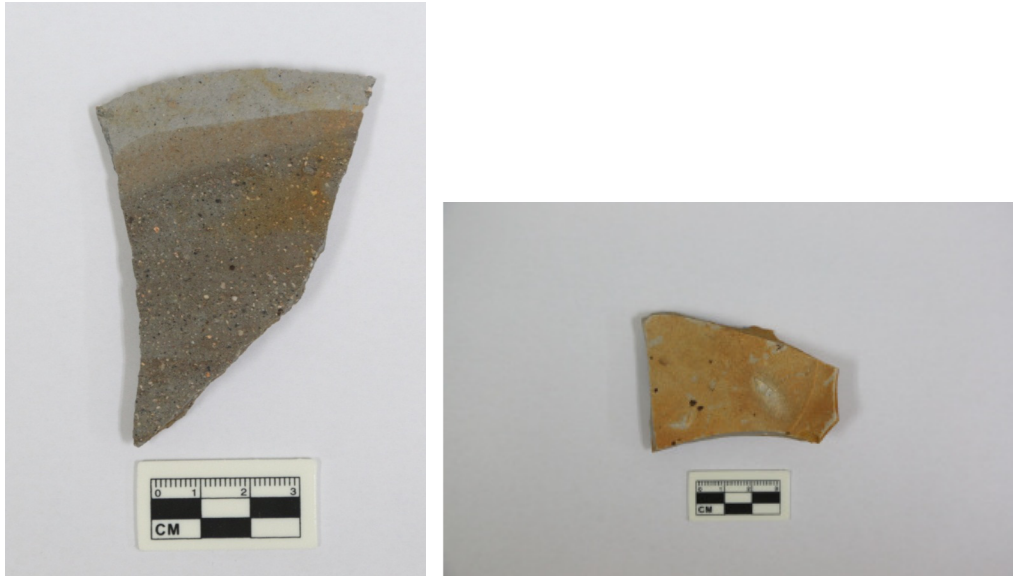
Photo 1: Pottery sherd (left) and celadon sherd (right) found in the fill layer of well J2 are similar to those of Song-Yuan period unearthed from the T1 area.

2. Further fieldwork and assessment of the well structure were conducted. During the detailed study of the ceramic sherds of Song-Yuan period from the T1 area, it was found that some of them share a number of similarities in typology with those found in the fill layer of Well J2 (Photo 1). Further excavation outside Well J2 was conducted with a view to understanding the construction sequence by exposing a full elevation. The findings indicate that Well J2 may be originally a Song-Yuan structure but adaptively reused in the 20<sup>th</sup> century since the majority portion of the well was constructed at the same time while the top southwest portion was truncated by a pit containing decomposed granite stones (Photo 2), which was connected to a water channel built in the 20<sup>th</sup> century with granite and cement. At the moment, the use of the water channel and how the water collected was diverted still remain unknown.

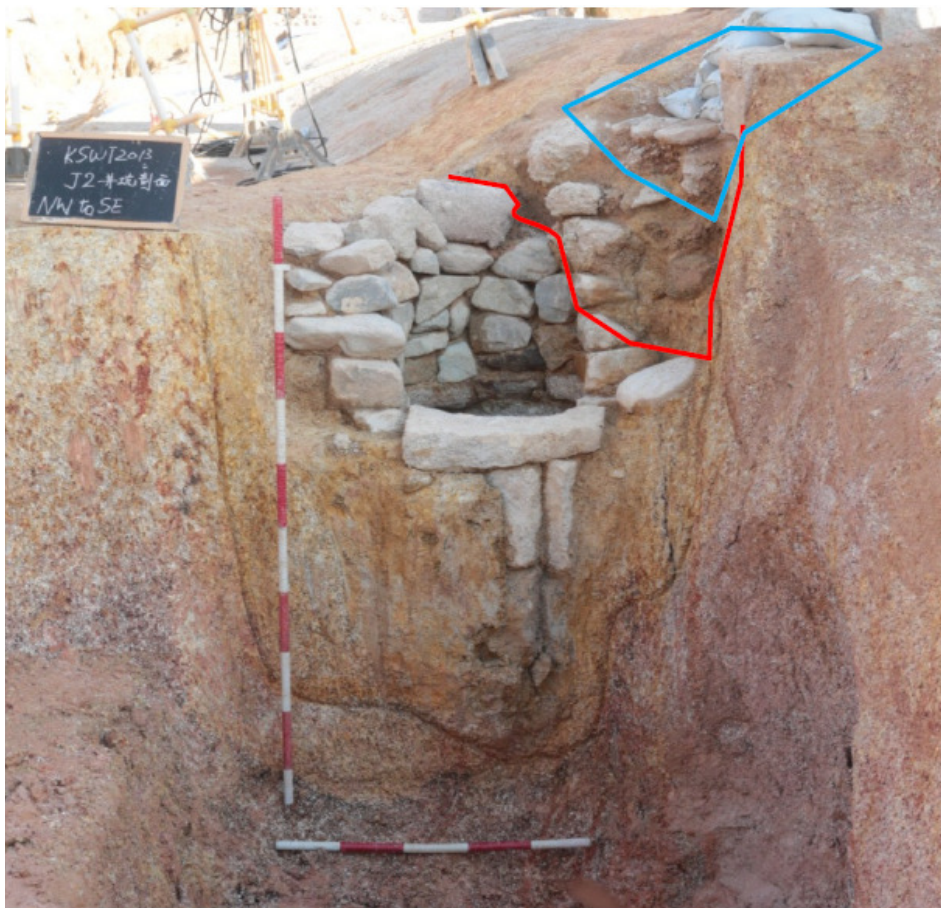
Photo 2: The top southwest portion of well J2 was truncated by a pit containing decomposed granite stones.

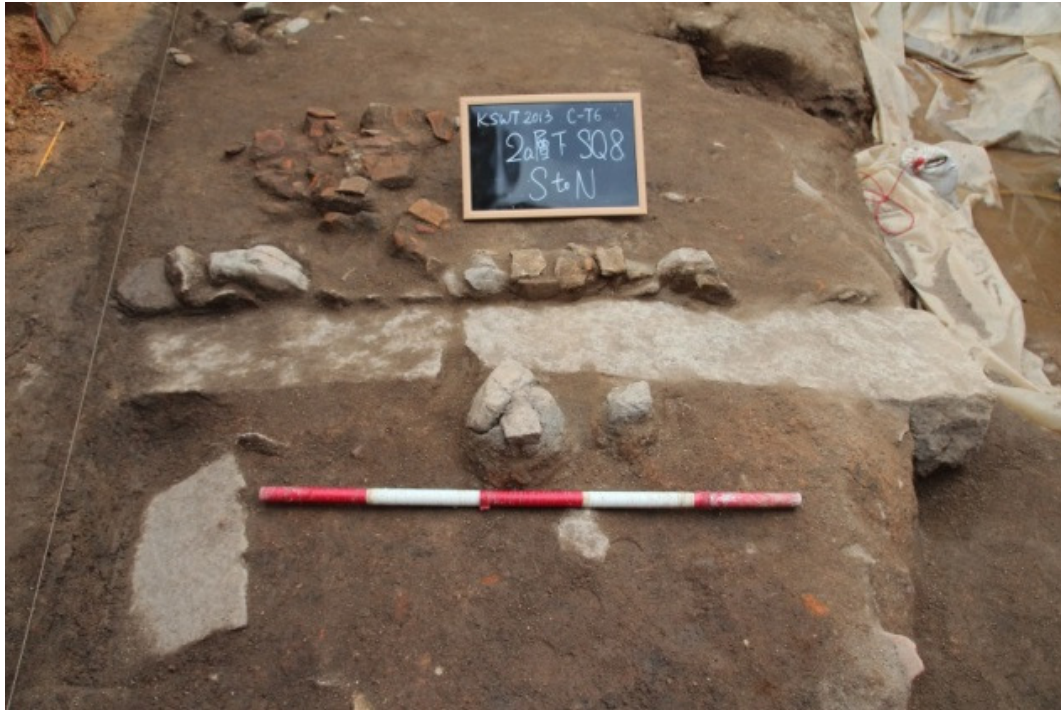
Photo 3: Stone foundations and compact surfaces of building structures of Song-Yuan structures were found at Adit C area.

3. Excavation continued in the southern end of Adit C which is at the riverbank of the former Ma Tau Chung. Stone foundations and compact surfaces of building structures of Song-Yuan period were found (Photo 3). Excavation is in progress.

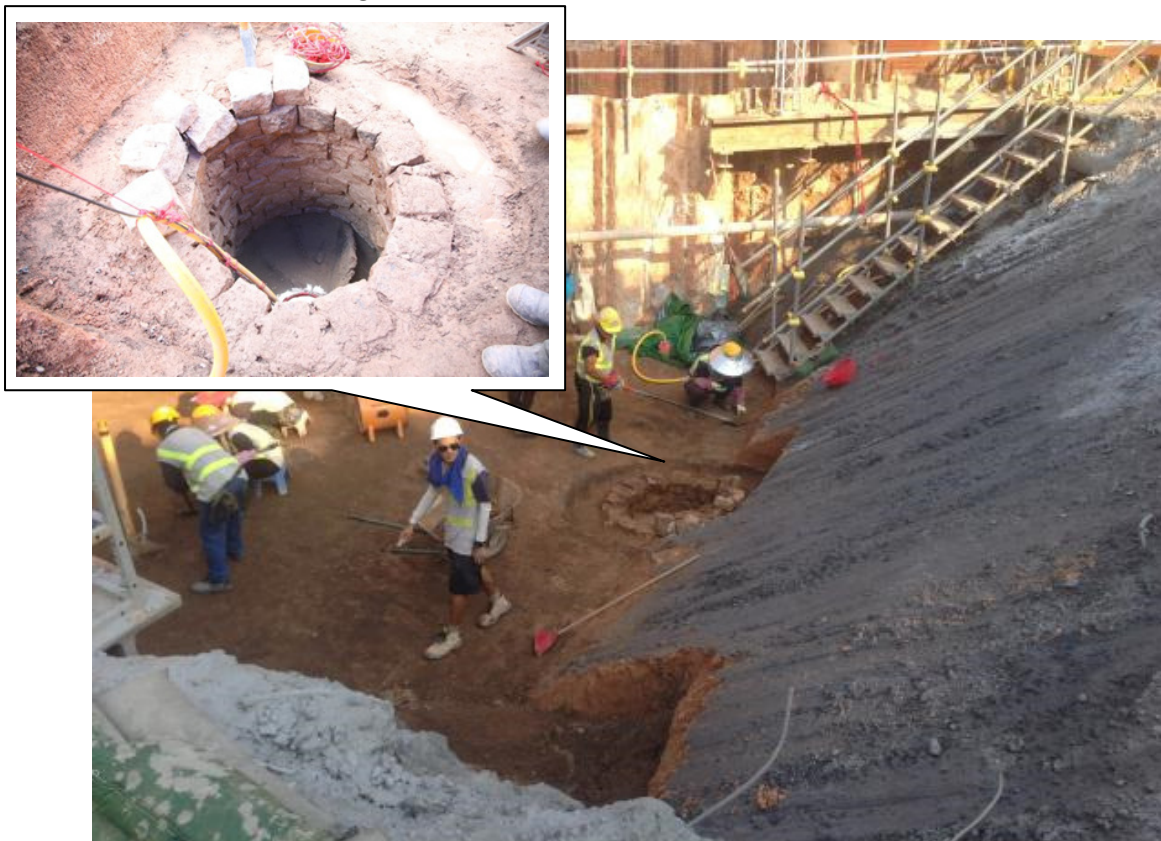
Photo 4: A well of Qing to Republican periods was discovered in the area between Ventilation Shaft and Adit C (Zone D).

4. Besides the Song-Yuan layer with cultural remains associated with those found in the Ventilation Shaft and Adit C, a well of Qing to Republican periods was discovered (Photo 4). Excavation is underway.

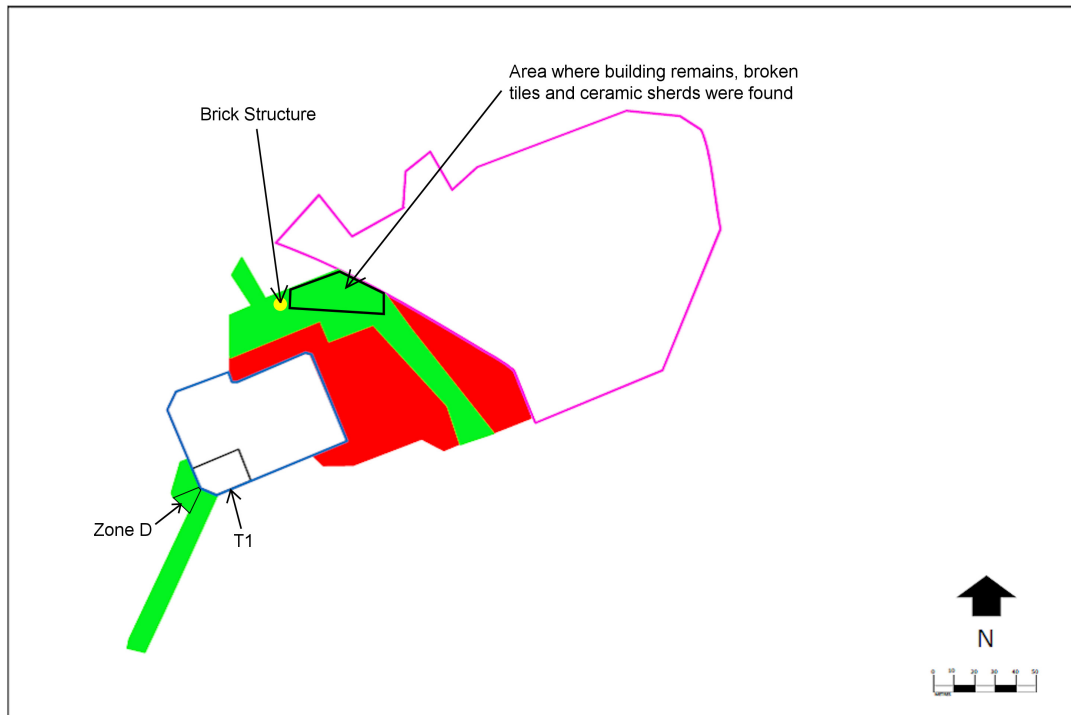
Figure A: Approximate location of stone foundation of building structures and broken tiles and ceramic sherds

5. Building remains and more broken tiles and ceramic sherds were unearthed in the Song-Yuan layer (Figure A and Photo 5). During the excavation of the baulk of TP23, a pit with wooden structure was found (Photo 6), and archaeological work is still on-going to find out more details. The Central Conservation Office of the Leisure and Cultural Services Department has examined the wooden structure and will provide technical advice on its conservation.

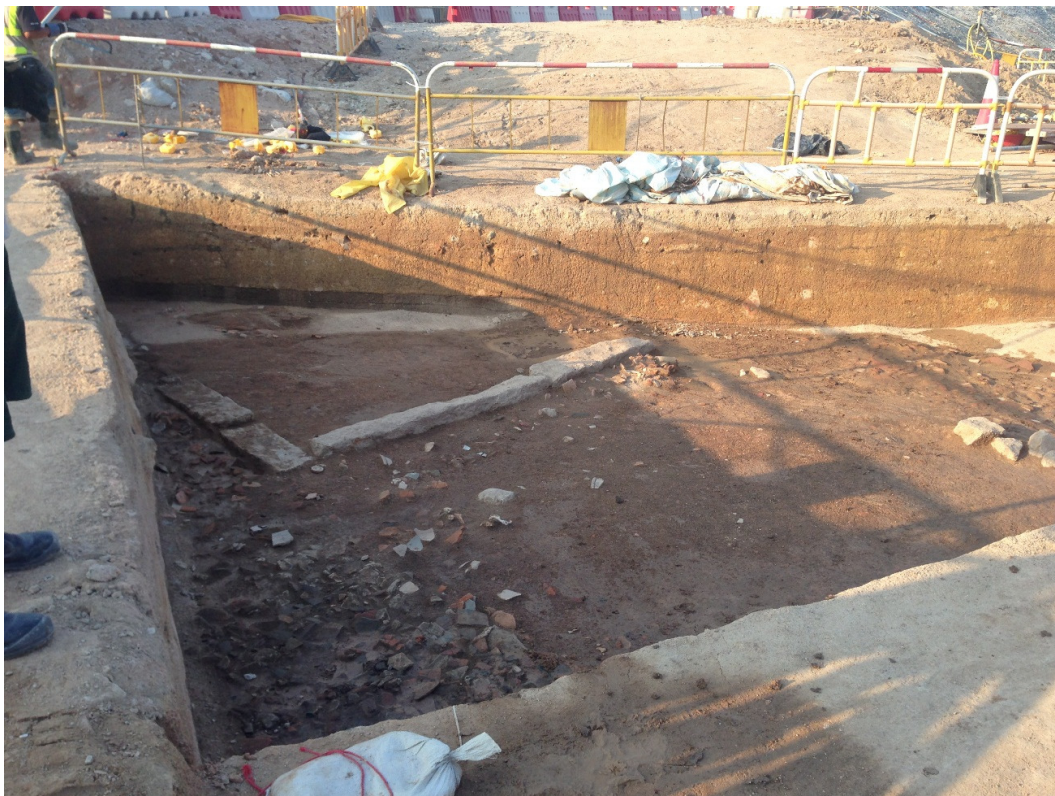
Photo 5: Building remains and more broken tiles and ceramics sherds were unearthed in the Song-Yuan layer

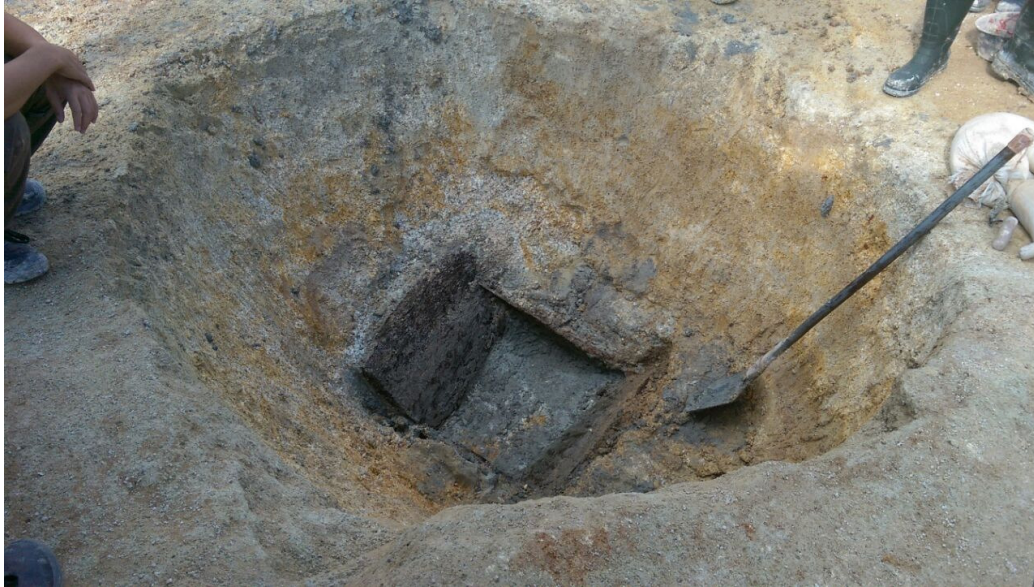
Photo 6: A pit with wooden structure was discovered in the baulk of TP23.

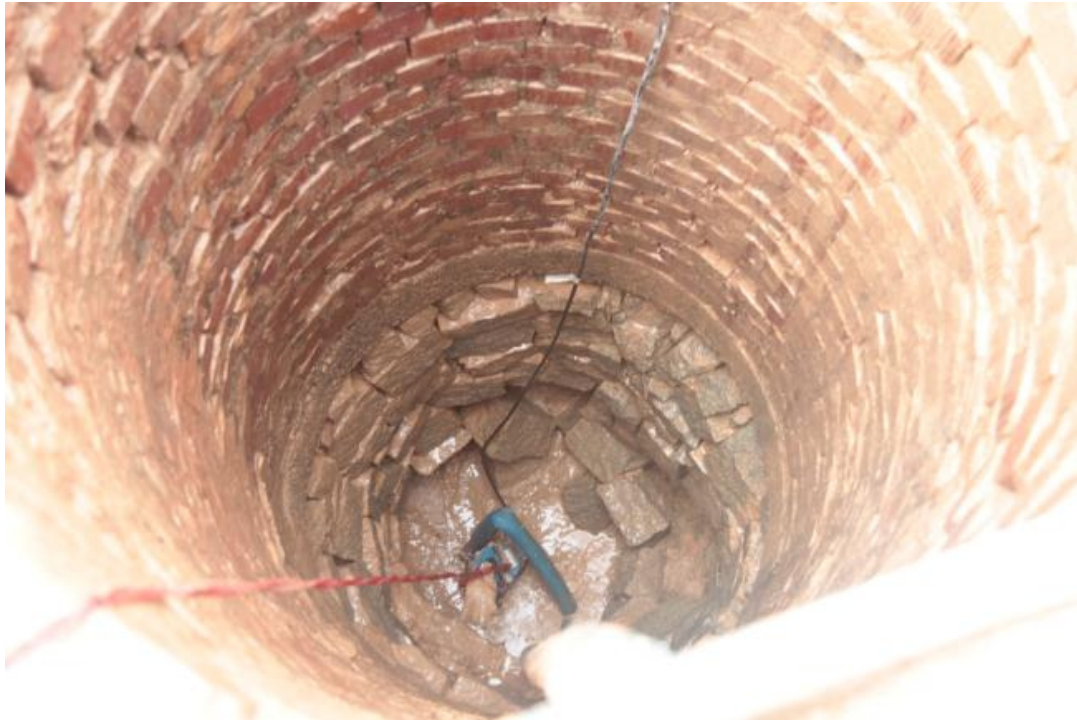
Photo 7: Base of the brick structure.

6. Regarding the round-shaped brick structure discovered, detailed examination reveals that the structure is divided into three sub-sections. The upper section was constructed with grooved red bricks with cement as bonding agent. The middle part was constructed with mixture of small rocks and cement. The lower part was built with granite blocks with no mortar in between. The evidence suggests that the brick structure is a modern well (Photo 7).

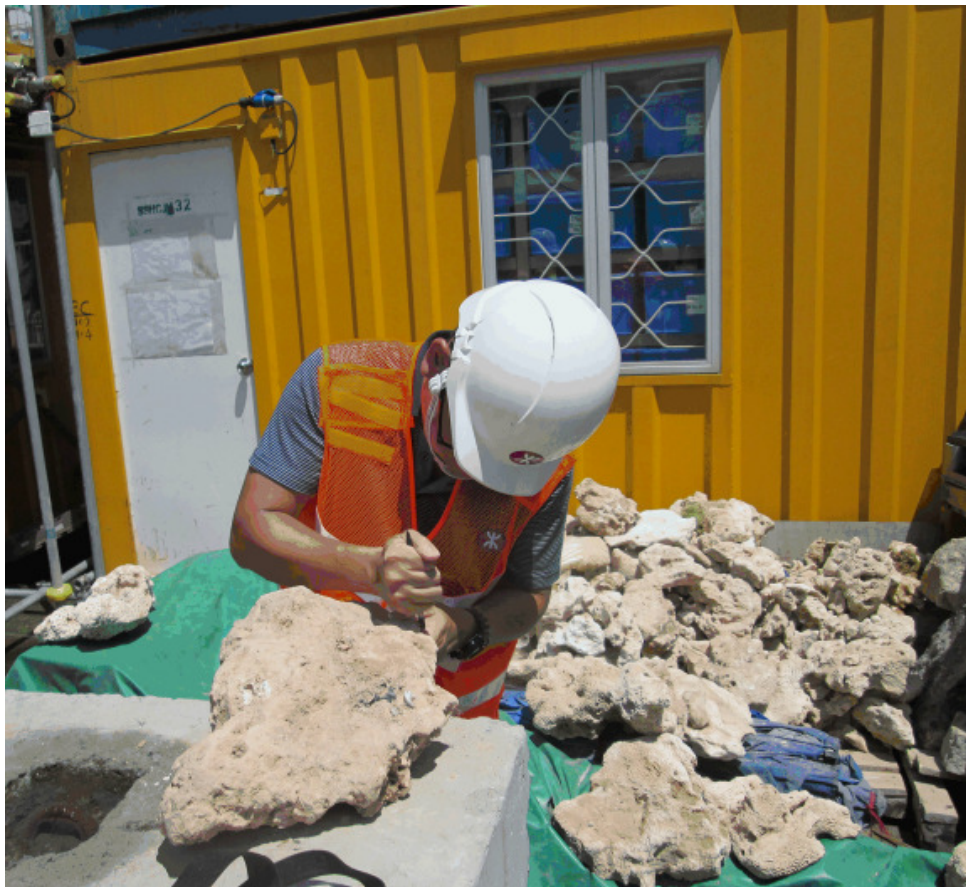
Photo 8: The coral remains found in the Song-Yuan features were examined by the specialists of the Agriculture, Fisheries and Conservation Department.

8. The coral remains found in the Song-Yuan features were examined by the specialists of the Agriculture, Fisheries and Conservation Department (Photo 8). The examination reveals that the coral remains generally belong to the genera that have massive growth form and are common in shallow waters of Hong Kong. No remains of red coral were identified.
