**Centennial Campus Project, The University of Hong Kong  
Heritage Impact Assessment Report**

**Workmen's Quarters, Senior Staff Quarters and Treatment Works  
Building of the Former Elliot Pumping Station and Fliters  
in Pokfulam**

**The University of Hong Kong**

**March, 2012**

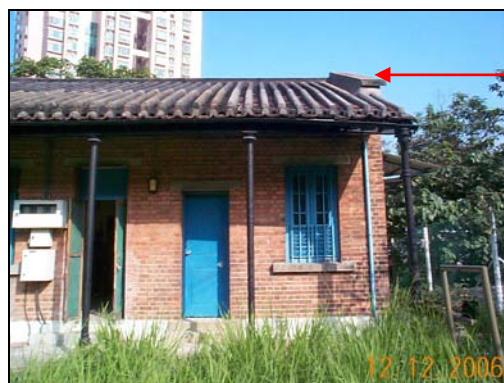
Granite coping on top of east gable wall

- From the condition survey, there are leakages on the roof.
- The “double layer pan and double layer roll” (雙筒雙瓦) Chinese tile roof shall be replaced with similar construction.
- The granite coping on top of both side of gable wall shall be preserved (not to be taken down) and protected during replacement of the roof tiling.
- The granite coping shall be cleaned, and the defective pointing to be removed and the joint re-point with 1:3 lime sand mortar.

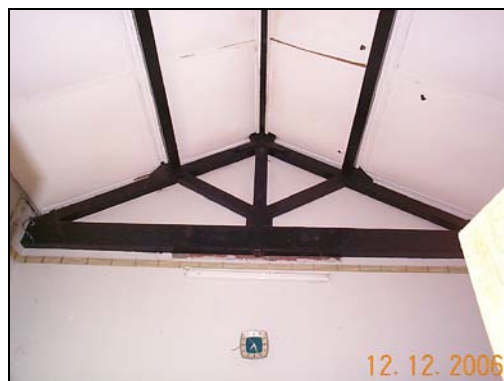
- The soffit of the roof is covered either by timber panels fixed at the soffit of the tiling or suspended false ceiling, and after taking down part of the covering it is found that the timber roof members have been infested by termite.
- The timber roof structure including the timber roof trusses, purlins and battens shall be replaced, if found to be defective. Such replacement work may have difficult in satisfying the statutory requirements, early consultation with Building Authority is recommended. (Paragraph 1.4 in the *Practical Guidebook*).
- The replacement shall follow the existing construction, i.e. the size, spacing, and details of the joints, etc.

Exposed timber roof truss at the west end room

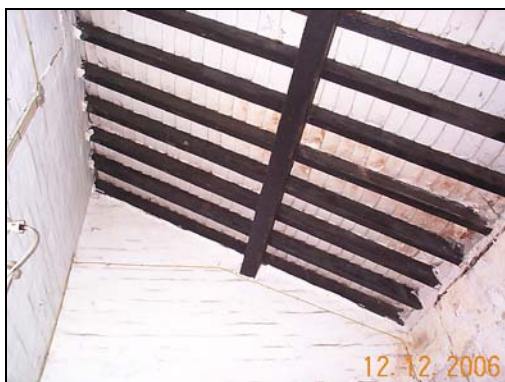
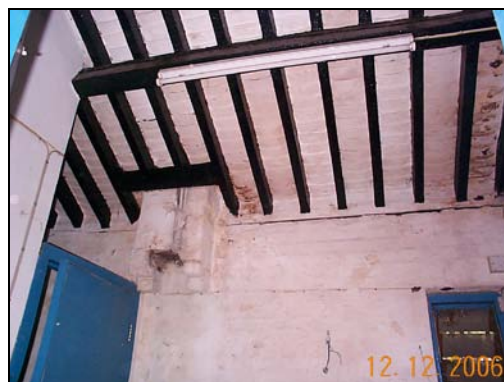
Timber purlin supporting the battens at the rear service room

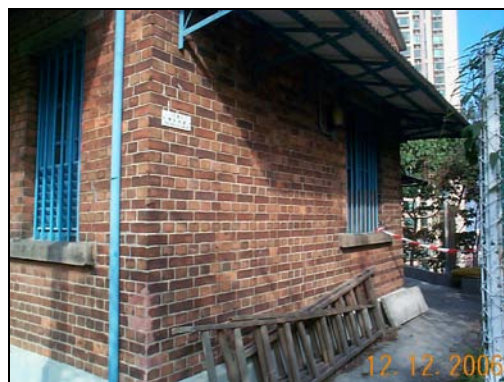
Later added canopy at east elevation

- Canopies have been added surrounding the building except at the verandah (façade), these later added canopies shall be carefully removed without creating additional damages to the red facing brickwork.
- The holes shall be carefully fill up with repair mortar. The repair mortar is recommended to be 1:3 lime / red brick fines mortar, and mock ups shall be prepared before the final decision for the mix and the type of red brick fines and other aggregates for the repair mortar.
- After the removal of the canopies, it may be necessary to added eaves gutter to the rear pitch of the roof. The size, shape and material of the eaves gutter and rainwater downpipe shall follow the existing at the verandah.

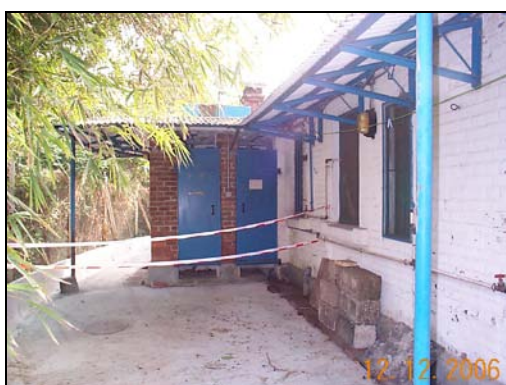
Later added canopy at rear elevation,  
west side

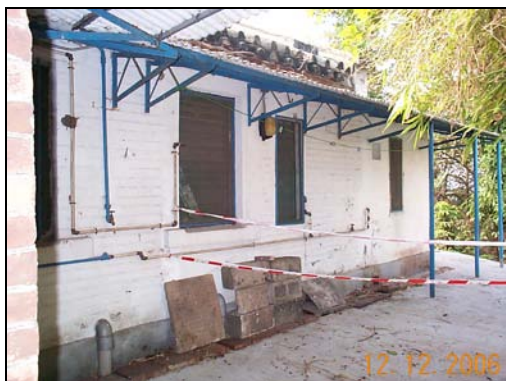
- Part of the red facing brickwall at the rear (west side) has been painted white. The white paint shall be removed and the damaged bricks and pointing (if any) to be restored.

West part of rear elevation painted white,  
view from east side

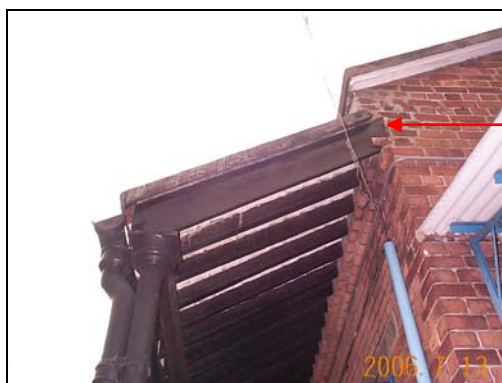
The batten at the east end

Upper end  
of batten  
“tongued”  
into bricks

- The upper end of the batten at both end are “tongued” into the red facing brickwork and this details shall be recorded and replicated (not to be changed) in the replacement.

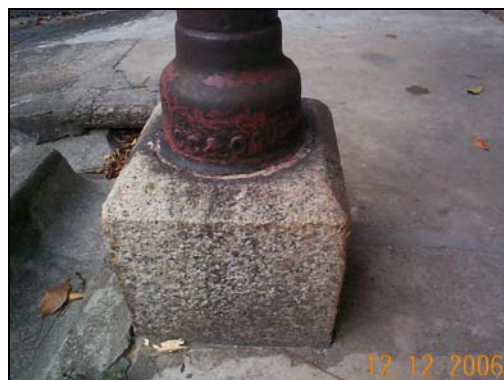
Granite pillar base

- The paint on the cast iron pillars shall be removed, and the pillars properly primed and re-painted.
- The granite pillar base shall be cleaned and it is not necessary to repair the minor damages and irregularities, i.e. wear and tear, and chipped corners.

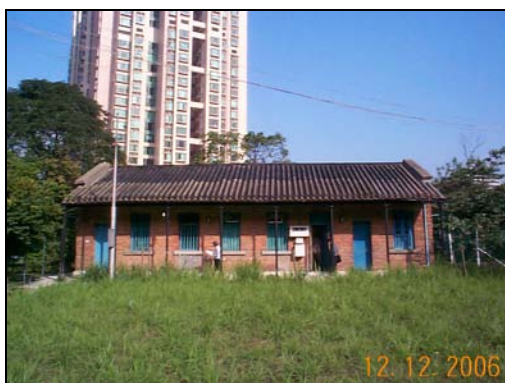
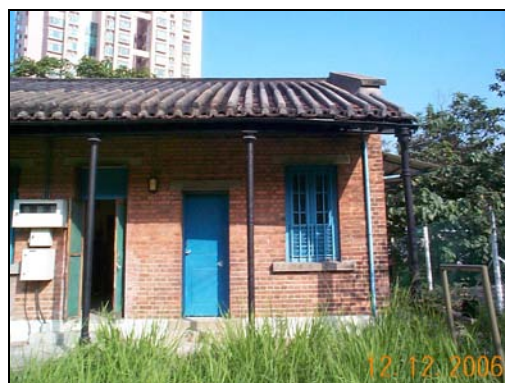
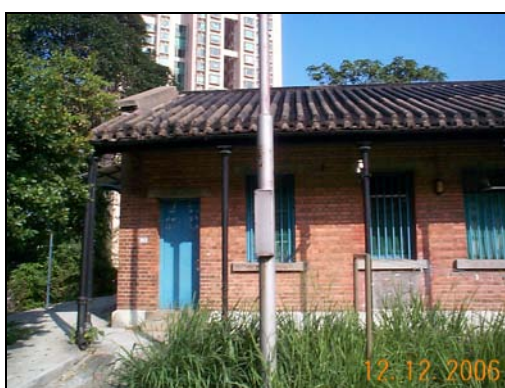
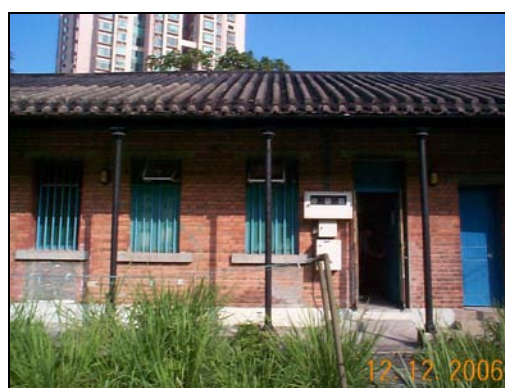
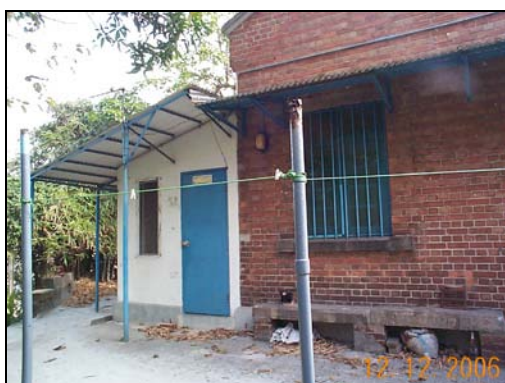
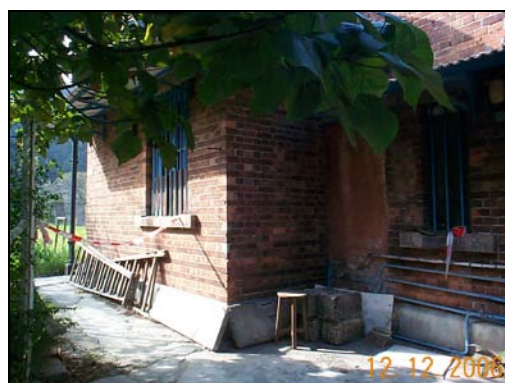
- From site inspection, the condition of the windows and frames are in a very poor condition and beyond repair, and the upper part of two of the windows at the facade have been modified for installation of window type air-conditioning unit, they are to be replaced.
- Care shall be taken when taking down the window frame and installation of new window frame in order to avoid any damages to the brick window jambs.
- The window at the west end of the façade has not been modified (for installation of window type air-conditioning unit), thus it is recommended to take this window as the prototype (size, detailing and construction) for replication.
- The colour of the window can be changed.
- The vertical iron anti-burglar bars can be removed to match the new usage.

Windows at facade

Windows at facade, east part

Windows at facade, west part

Windows at facade, central part

Window at west elevation

Windows at east elevation

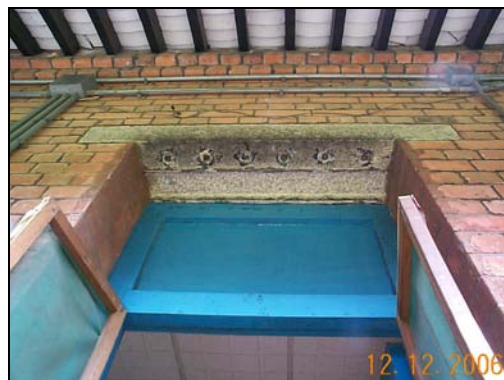
Original window changed to door shown by the holes in the granite lintol after removal of the iron vertical security bars

- The granite lintols, thresholds and step shall be cleaned and it is not necessary to repair the minor damages, i.e. chipped corners.
- The damaged granite lintol due to the removal of the iron vertical security bars shall be properly repair, by carefully removal of any left in iron, and fill up the holes with 1 : 3 lime / granite fine mortar.

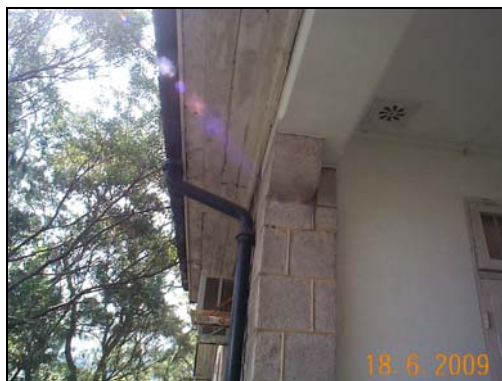
- The roof eave is projected above 500 mm beyond the external wall and the soffit is covered with timber panel.
- From visual inspection, the panel and side fascia board are defective and may have been infested by termite.
- The panel and fascia board shall be replaced with similar construction.
- It is recommended to keep the white colour, unless a more appropriate colour to match the external appearance of the building is identified.

The soffit panel of the projecting roof eaves and fascia board at rear elevation

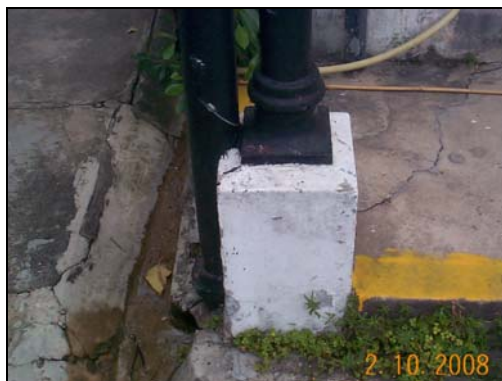
The shoe of the cast iron downpipe

- The eaves gutter including the brackets shall be repair, and to be replaced if beyond repair.
- The paint on the rainwater downpipes and brackets shall be removed, and these components properly primed and re-painted.
- The rainwater hoppers which are not properly fixed, shall be taken down and properly fix with appropriate brackets and fixing details.

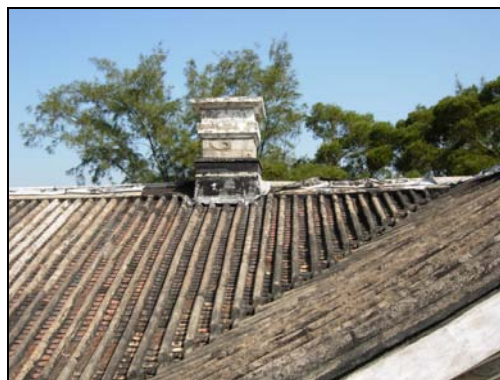
Chimney stack

- The granite chimney stacks shall be cleaned.
- The defective pointing shall be removed and the joints re-pointed with 1 : 3 lime sand mortar.
- Copper wire mesh shall be added at the internal side of the chimney stack to prevent birds building nest inside the chimney.

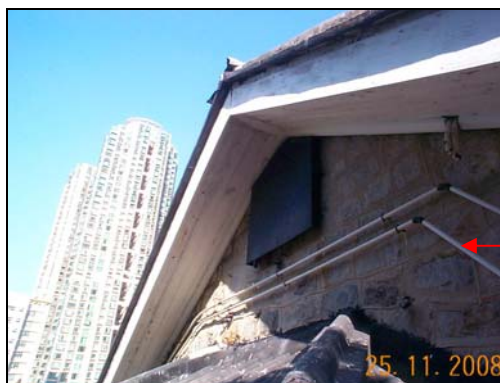
Water pipes fixed on the facade

- All conduits, light fittings and water pipes fixed on the wall shall be carefully removed without creating additional damages to the granite blocks.
- The holes shall be carefully fill up with repair mortar. The repair mortar is recommended to be 1:3 lime / granite fines mortar, and mock ups shall be prepared before the final decision for the mix and other aggregates of the repair mortar.

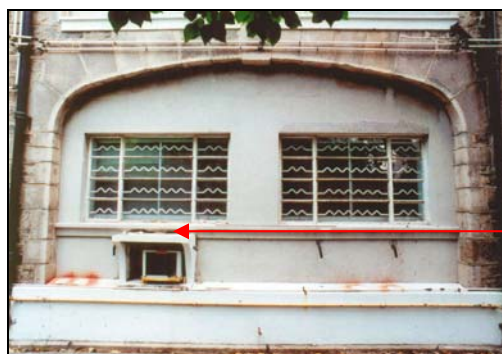
Opening  
blocked up

The verandah at the ground floor verandah has been filled up with blockwork/brickwork with two steel windows

- Openings are recommended to be opened on this part of the external wall.

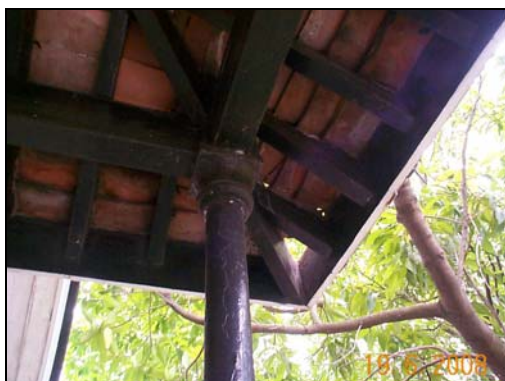
The capital of the cast iron pillar

- The paint on the cast iron pillars shall be removed, and the pillars properly primed and re-painted.

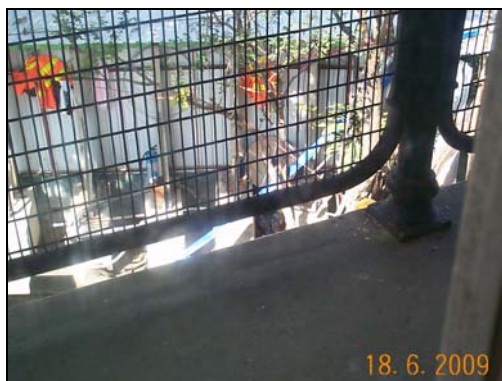
The base of the cast iron pillar

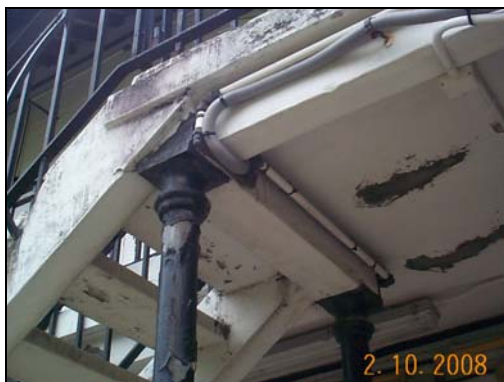
The capital of the cast iron pillar

- The paint on the cast iron pillars shall be removed, and the pillars properly primed and re-painted.
- The plastered pillar base shall be touch-up and re-paint.

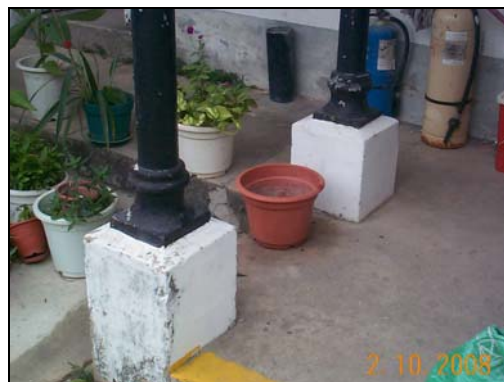
Pillar base

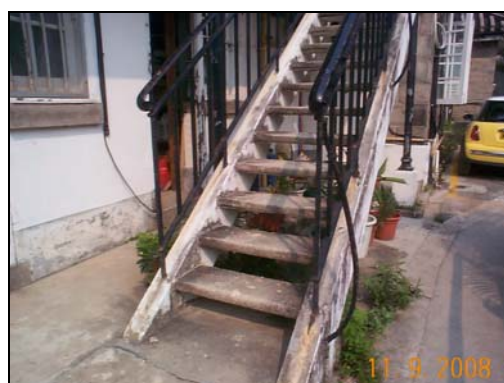
A special curve is added to the lowest vertical rail

- The paint on the metal balustrade shall be removed, and the members handrail, vertical and horizontal railing properly primed and re-painted.
- Although this balustrade cannot satisfy the statutory requirements, e.g. height, spacing between vertical railing and lateral load capacity, it should not be replaced.
- A new set of balustrade is recommended to be added at the internal side of the balustrade.

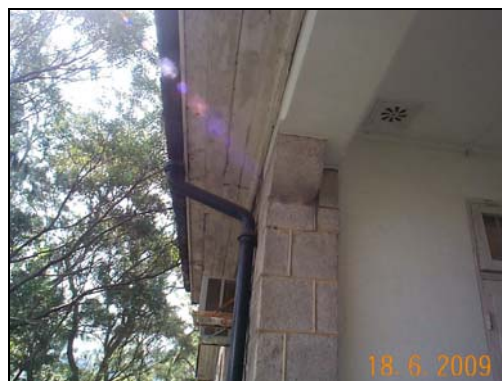
The pattern grille at one of the corners at ceiling of first floor verandah

- The soffit of the roof is covered by suspended timber false ceiling, and on accessing to the attic part from the access panel it is found that the timber false ceiling have been infested by termite, the timber false ceiling shall be replaced with similar construction.
- The pattern grille at the four corners shall be preserved if possible, if they are beyond repair, they shall be re-constructed.
- It is recommended to keep the white colour, unless a more appropriate colour to match the external appearance of the building is identified.

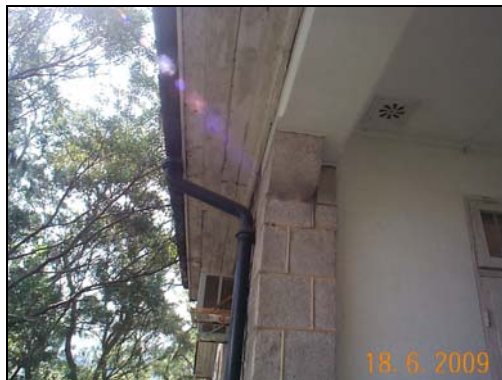
The granite corbel at the capital of the pillar

- Clean the granite block pillar and corbels.
- The defective pointing shall be removed and the joints re-pointed with 1 : 3 lime sand mortar.

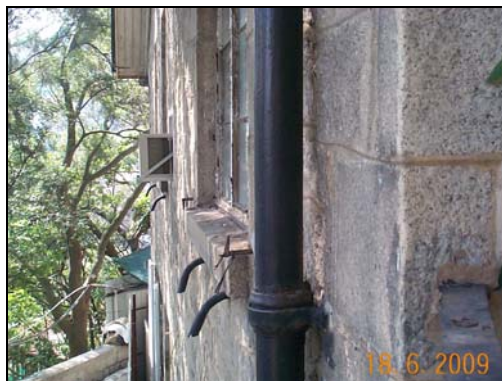
- The existing balustrade is not the original balustrade, because the pocket for the fish-tail of the original handrail of the balustrade is still visible.
- This balustrade cannot satisfy the statutory requirements for protective barrier, e.g. lateral load capacity. They shall be replaced with design to match the architectural style of the building. The replacement may have difficulty in satisfying the statutory requirements, early consultation with Building Authority is recommended. (Paragraph 1.4 in the *Practical Guidebook*).
- Any damages to the granite work should be filled with repair mortar as recommended in the repair of the granite external wall.

The pocket at the granite wall the granite was the groove for the original handrail if the balustrade

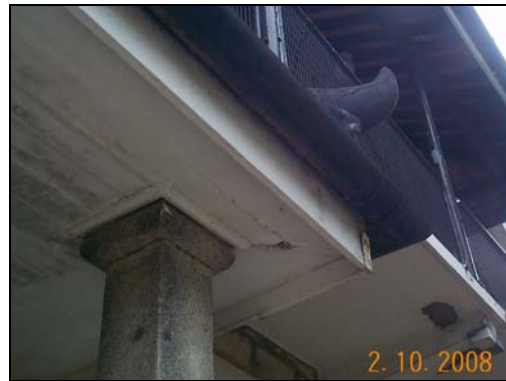
- The soffit of the roof is covered by suspended timber false ceiling, and may have been infested by termite as in other timber building components.
- If it has been infested, the timber false ceiling shall be replaced with similar construction.
- The pattern grille at the four corners shall be preserved if possible, if they are beyond repair, they shall be re-constructed.
- It is recommended to keep the white colour, unless a more appropriate colour to match the external appearance of the building is identified.

Edge of the timber false ceiling at ground floor entrance porch

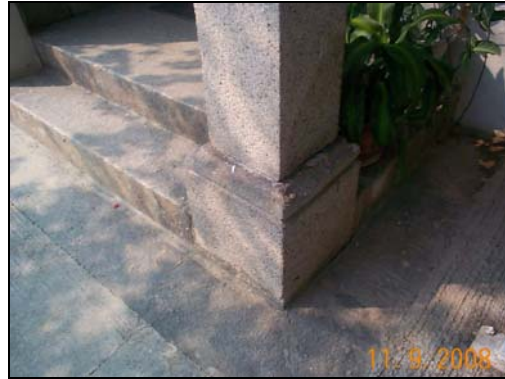
The granite pillar base

- The granite pillar with base and capital shall be cleaned.
- The defective pointing shall be removed and the joints re-pointed with 1 : 3 lime sand mortar.

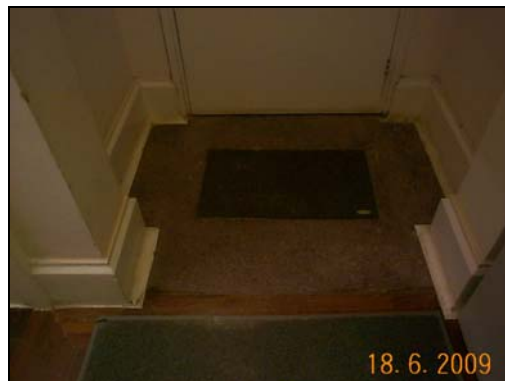
The floor mat well at the rear side of the ground floor quarter entrance

- The granite floor paving shall be cleaned.
- The defective pointing shall be removed and the joints re-pointed with 1 : 3 lime sand mortar.
- The floor mat well at both the exterior and the interior shall be preserved.

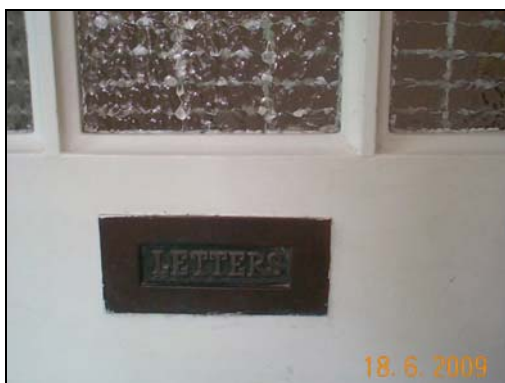
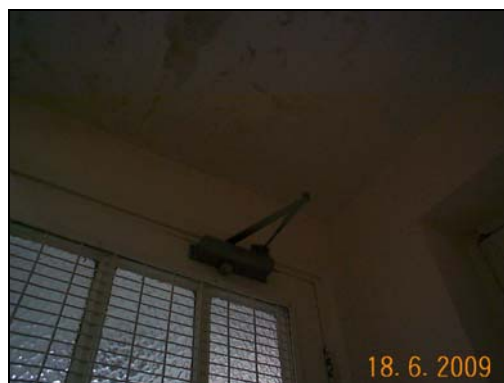
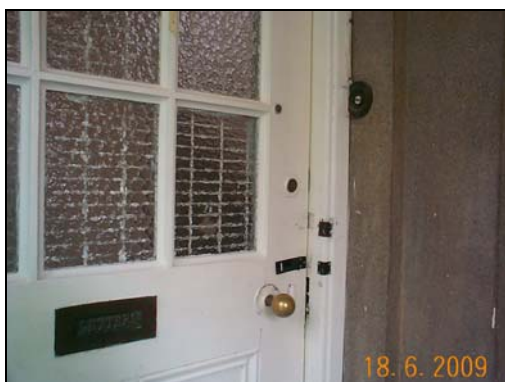
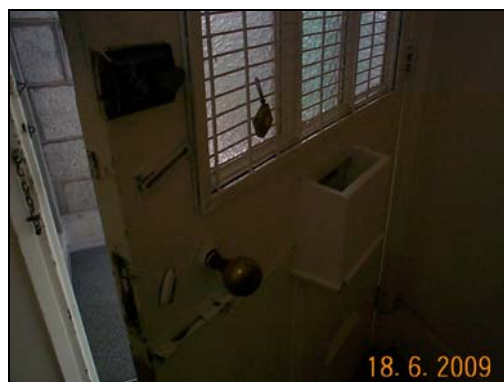
Ground floor quarter entrance door – the brass letter box fascia plate

Ground floor quarter entrance door – the surface mount door closer

Ground floor quarter entrance door, the ironmongeries are brass letter box fascia plate, brass knob cylindrical door lock, cylindrical rim of the rim night latch, lock plate for the pad lock and peep eye

Ground floor quarter entrance door, the ironmongeries are brass knob cylindrical door lock, rim night latch, horizontal bolt, security chain and peep eye

- The ironmongeries which are considered to be the original building components shall be preserved.
- The ironmongeries that are considered to be the original building components in the first floor quarter entrance door at the brass knob cylindrical door lock, the brass letter box fascia plate and the horizontal bolt.
- The later replaced or added ironmongeries shall be replaced with ironmongeries compatible with the architectural style of the building.

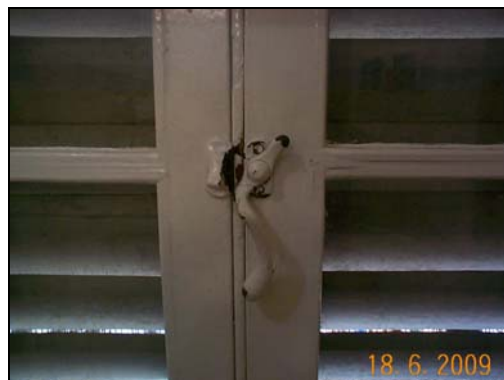
Lever handle lock to French window at first floor façade balcony

- The later replacement ironmongeries which are not compatible with those used in the period when the building was constructed shall be replaced with compatible ones.
- The ironmongeries can be replaced with brass ironmongeries.

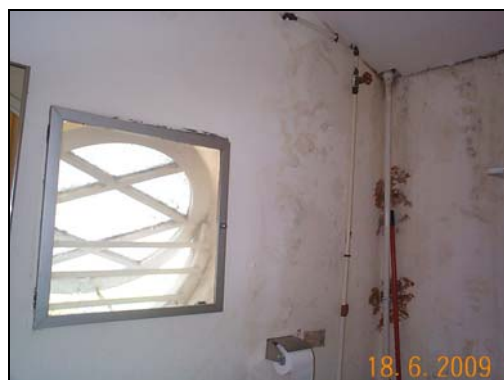
Internal view of the window

- From site inspection, the painting to the window and frame is very thick, it is recommended to remove the paint to examine the condition of the window.
- The defective part of the window and frame shall be repair.
- The centre-pivoted mechanism shall be touched up for easy opening and closing of the window.
- It is recommended to keep the white colour, unless a more appropriate colour to match the external appearance of the building is identified.
- The mosquito screen and the three horizontal security bars shall be removed.
- Glazing panel can be added at the rear side of the window of necessary.
- The brass window stay shall be preserved and polished.

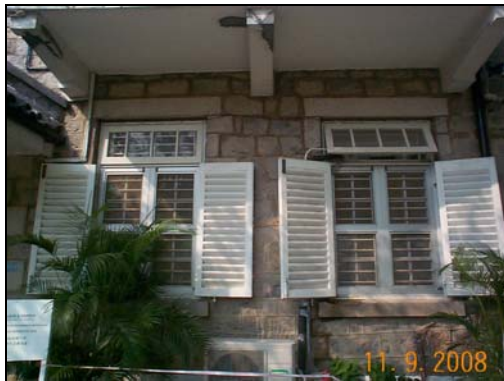
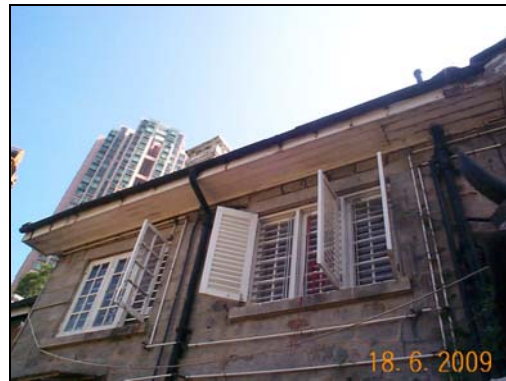
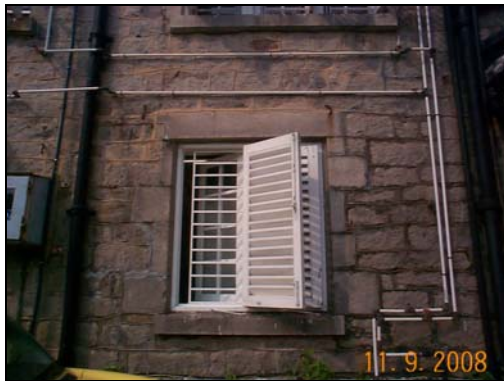
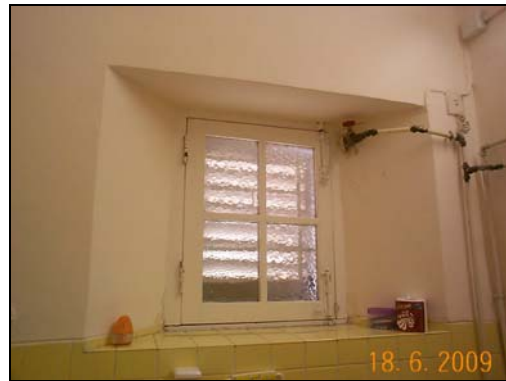
- From site inspection, the painting to the window and frame, and jalousies are very thick and because of the thick painting layer, some of the windows cannot close properly. It is recommended to remove all the paint to examine the conditions of the window and framer.

External view of windows on ground floor

External view of windows on first floor – window on the right side open inwards and the left one open outwards

External view of window on ground floor (toilet window)

Internal view of window on ground floor (bathroom window)

- The defective part of the window and frame, and jalousies shall be repair.
- Defective window and frame, and jslousies which are beyond repair should be replaced.

- The replacement shall follow the existing construction, i.e. the size, spacing, and details of the joints, etc.
- The window which opens inwards has inherent difficulty in water-tightness. It is recommended to add a gasket at the window frame to improve water-tightness.

- It is recommended to keep the white colour, unless a more appropriate colour to match the external appearance of the building is identified.
- The mosquito screen and the security grille panel shall be removed.

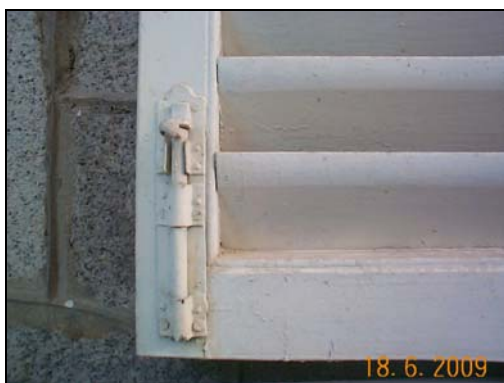
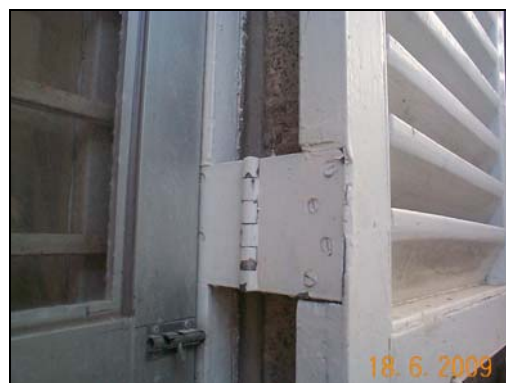
Vertical bottom bolt at jalousies

Hinge at jalousies

- It is recommended to carry out an ironmongery survey to identify those ironmongeries which are original.
- The later replacement ironmongeries which are not compatible with the period when the building was constructed shall be replaced with compatible ones.
- The ironmongeries can be replaced with brass ironmongeries.

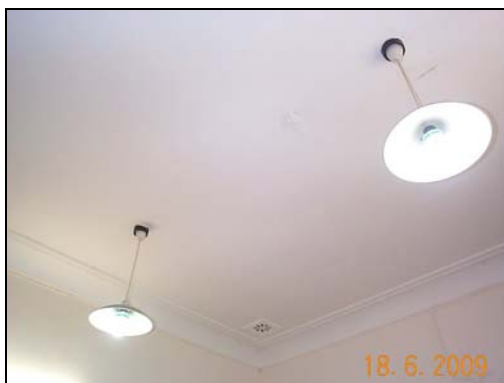
The false ceiling

- The false ceiling can be taken down for the fixing of building services installation to the soffit of the floor slab.
- In restoring the defective/missing original false ceiling, the original details of the existing false ceiling, i.e. the cove ceiling border, cornices and the pattern grill at the corners, shall be replicated.

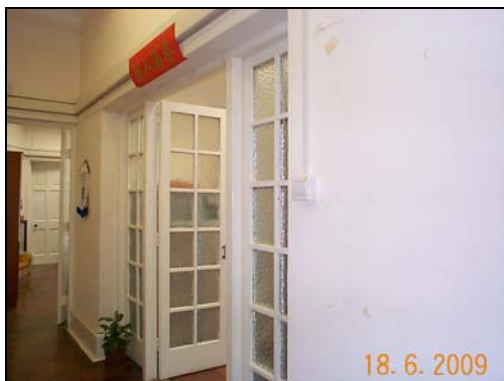
- There are two sets of glazed partition with door, one at each floor.
- From site inspection, the painting to the partition frame and door are very thick, it is recommended to remove the paint to examine the condition of the partition frame and door.
- The defective part of the frame shall be repair.
- The broken glass pane shall be repair the texture glass to match existing.
- It is recommended to carry out an ironmongery survey to these two sets of door and the non-compatible ones replaced.

The glazed partition with door at ground floor

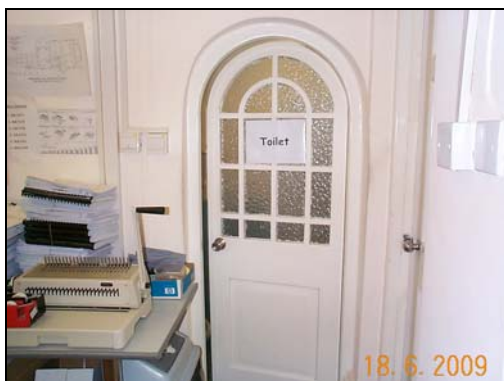
- From site inspection, it is observed that there are two types of doors – those which may be the original building components and the later replacements.
- The original doors are usually those with glazed panels and a bottom panel.
- The later replacements are usually plain surface hollow core door. It is not recommended to replace these doors.
- From site inspection, the painting to the door window and frame is very thick, it is recommended to remove the paint to examine the condition of the door window and frame.
- The defective part of the door and frame shall be repaired.
- It is recommended to carry out an ironmongery survey to identify those ironmongeries which are original.
- The later replacement ironmongeries which are not compatible with those used in the period when the building was constructed shall be replaced with compatible ones.

The toilet door at ground floor, this may be one of the original door

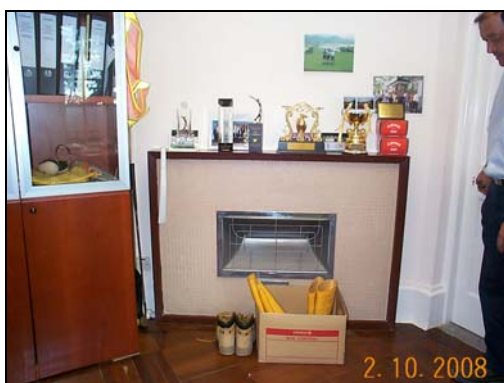
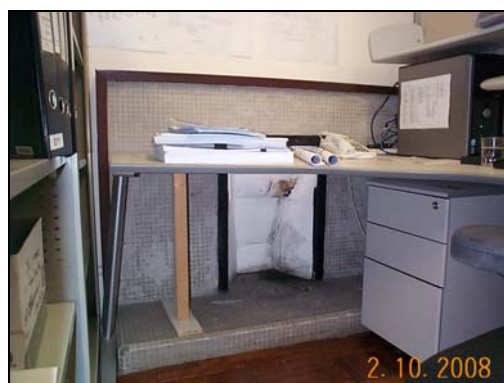
- All fireplaces shall be preserved.
- The fireplaces shall be restored to original appearance.
- One of the fireplaces at ground floor has been blocked up to change to accommodate an electrical heater, it is recommended to restore this fireplace.

Fireplace at ground floor

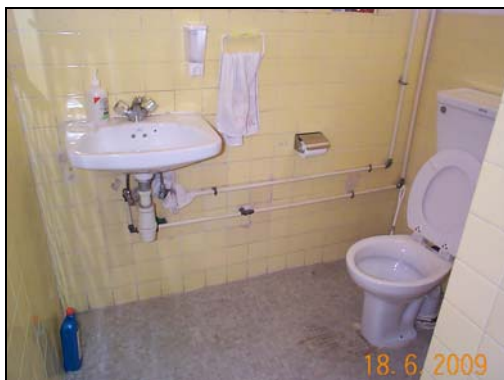
- The sanitary fittings are later replacements.
- There is one corner type wash basin in the toilet at first floor corridor which may be the original building component, and this basin should be preserved.

The ground floor bathroom

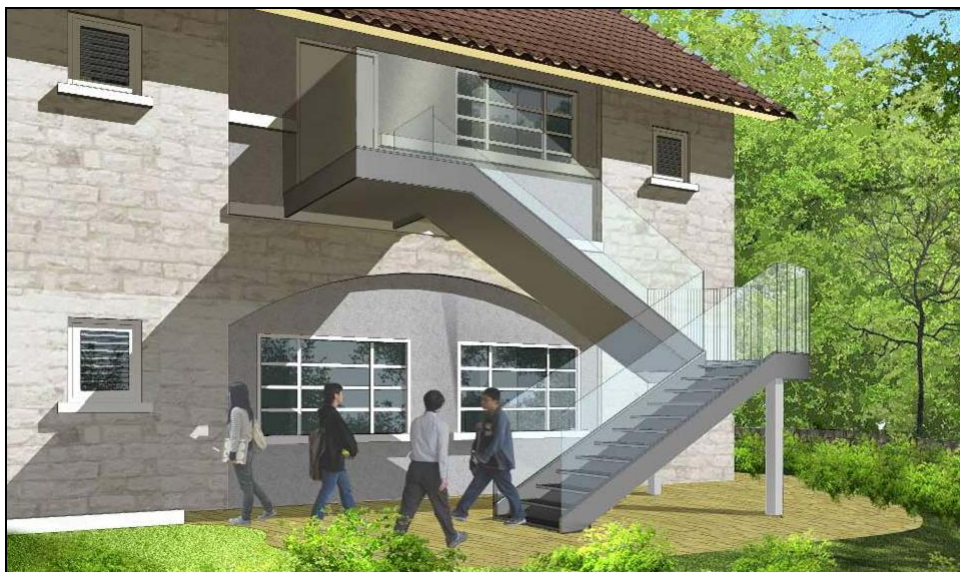
View of external staircase at east elevation with trees removed

- Forming of the opening at first floor of east elevation, impact – low because the position of the opening is a later in-fill wall to enclose the open verandah.
- Visual impact – low because the surrounding will be landscape with trees.

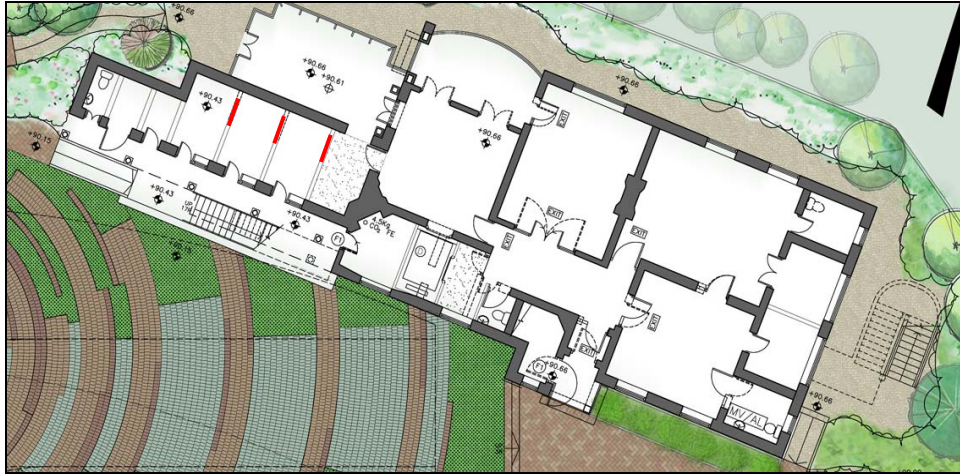
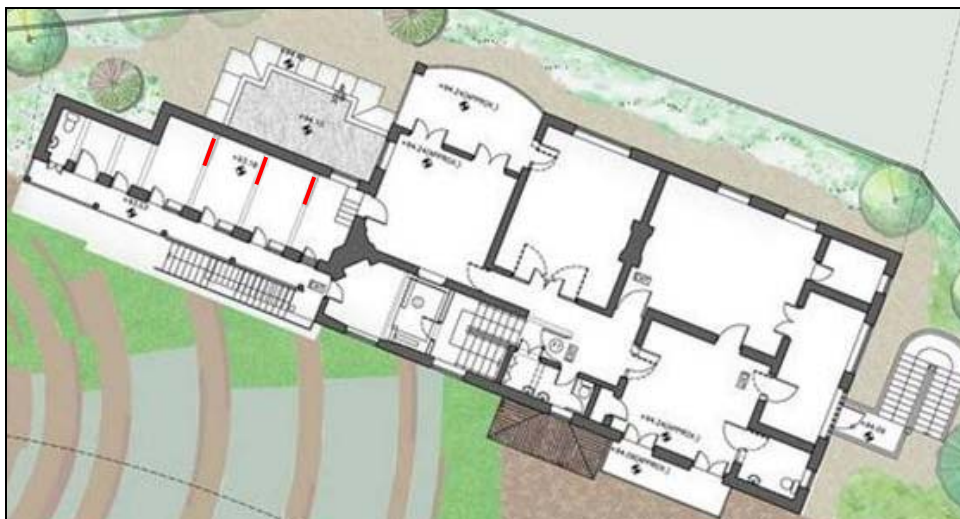
Ground floor – new internal layout with new opening to be formed marked in red

First floor – new internal layout with new opening to be formed marked in red

- New openings have to be formed on the partitions for the adaptive re-use scheme.
  - The strengthening proposal for the formation of the opening on the partitions has been prepared by the Structural Engineer.
- (e) Impact assessment –
- New openings to partitions – medium impact to the building structure since structural strengthening will be needed, and the original room layout changed.

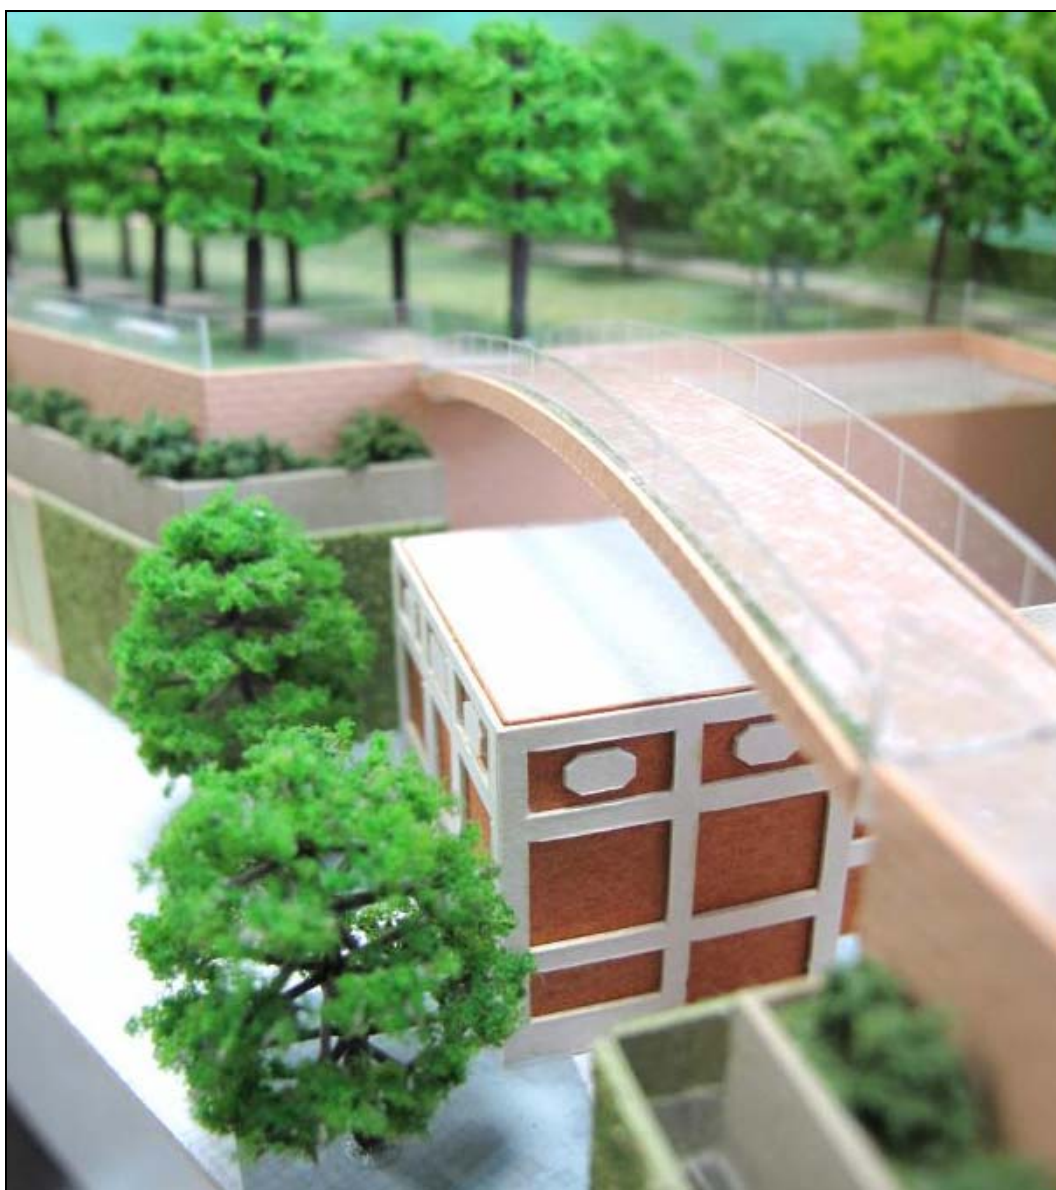
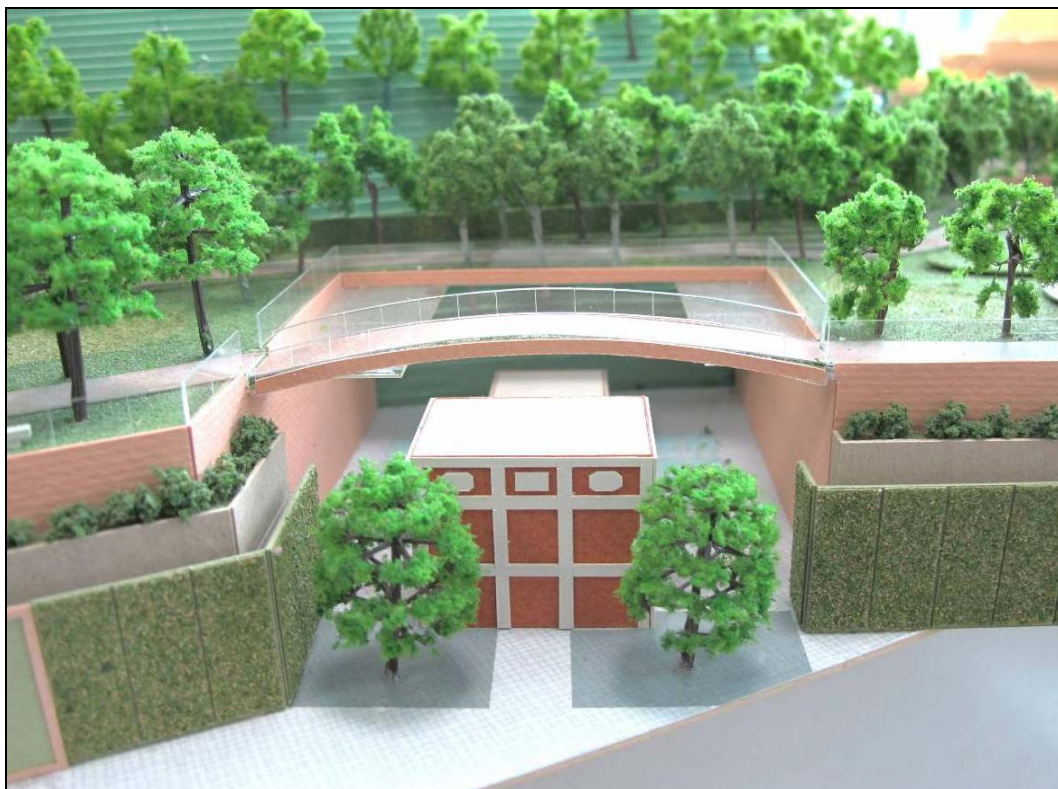
View of Treatment Woks Building with the bridge spanning at the façade

View of Treatment Woks Building with the two bridges

- (b) Impact assessment – low because the setting of the historic building (including the filters beds at both sides) are not disturbed and the two bridges are designed to be built at a level higher than the roof of the front four level “tower”.
- (c) Mitigation measures recommended –
- Photographic record of the elevations of the historic building taken before the work.
  - Close site supervision to ensure that the historic building is not affected during the construction of the two bridges.

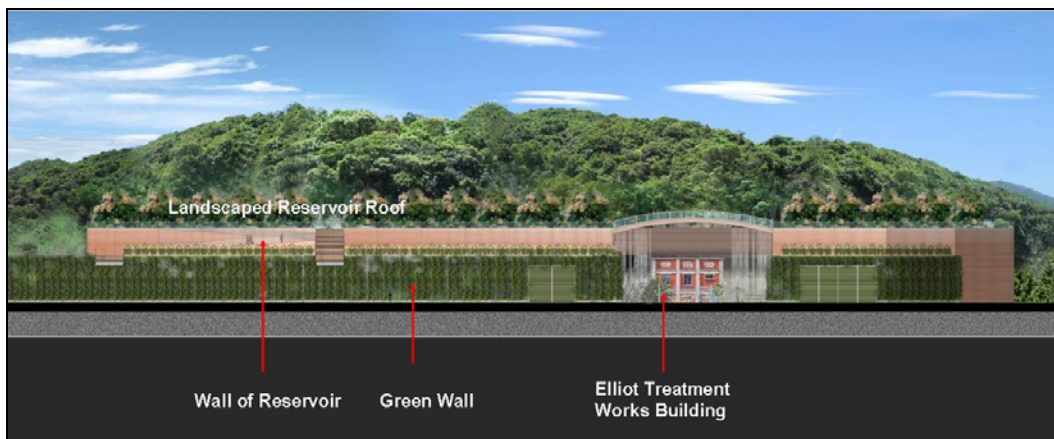
Treatment Works Building façade with the “arch bridge” spanning on top

- (b) Impact assessment – low because the visual impact is minimal when one is looking at the historic building on the ground.
- (c) Mitigation measures recommended –
- The materials for the construction of the bridge should be differentiable from the historic building.
  - Interpretation panels to be installed at the façade of the historic building and on the bridge.
