Revitalisation Scheme – Conversion of Lui Seng Chun into Hong Kong Baptist University Chinese Medicine and Healthcare Centre

**HERITAGE IMPACT ASSESSMENT
CONSERVATION MANAGEMENT PLAN**

April 2010

Heritage Consultant: AGC Design Ltd.

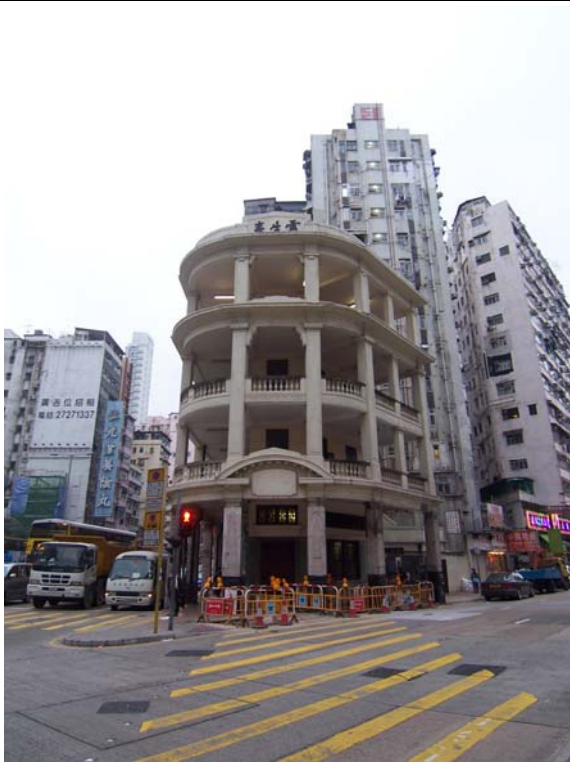
(Ref: No. 1.1)	Exceptional

Item No	Elements / Materials	Photo and Reference	Level of Significance
1.1	Main façade The whole of the concrete frame structure including beams, slabs and columns with decorative capitals and cornices in granolithic cement finish, with the urn-shaped balustrades at verandah

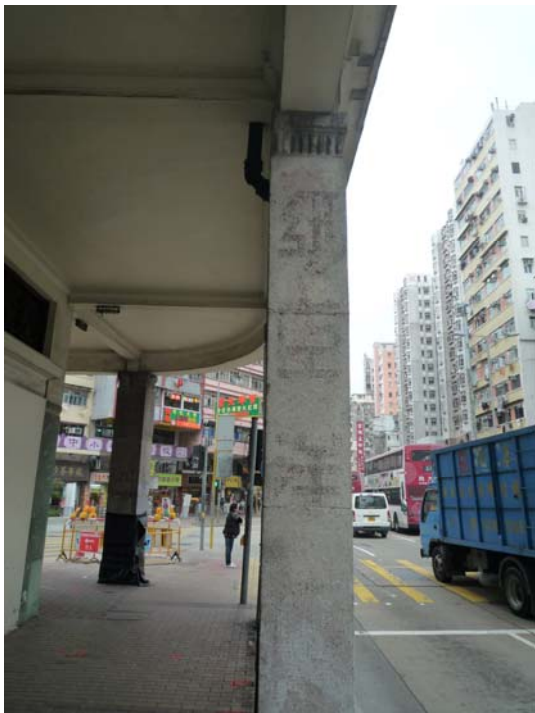
<p>(Ref: No. 1.2)</p>	Exceptional
1.3	<p>Granite columns with decorative capitals, plinths and groove joints at G/F</p> <p>The granite columns have remains of painted commercial letterings</p>

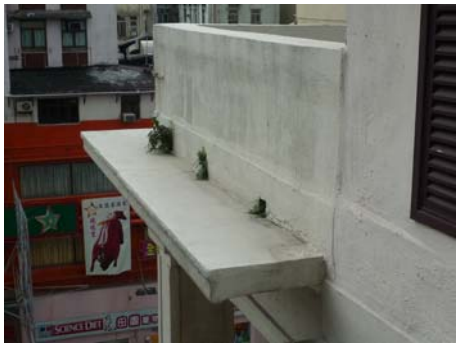
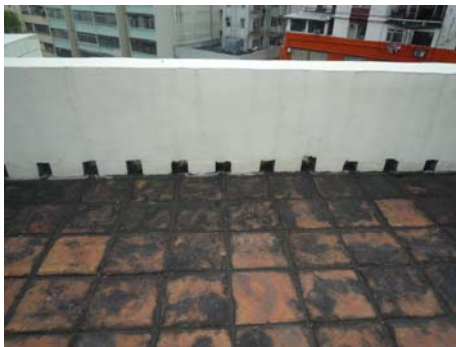
<p>1.8</p>	<p>Drain points at parapet wall at 3/F and Roof</p> <p>Vegetation is found at certain location of the drain points</p>	<div data-bbox="604 192 1062 521">

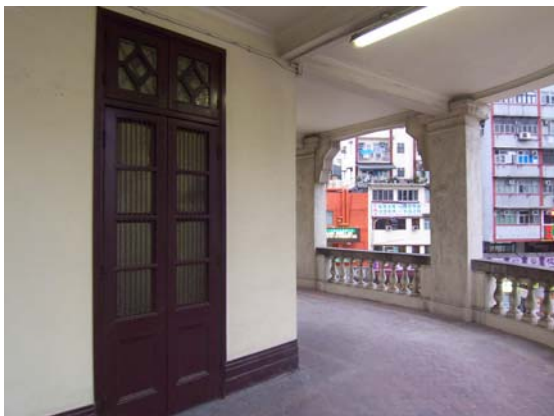
1.10.2	Timber doors at the verandahs are with openable glass panels and fanlights with iron grilles and frosted/obscured glass.

All timber doors and door frames with openable glass panels and fanlights with iron grilles and frosted/ obscured glass (items 1.10.1 to 10.5, 1.11 in Section 3.1), decorative timber surrounds to display window facing street at G/F,(item 1.10.6 in abovementioned section), ironmongery with locking devices to all timber doors and windows (item 1.10.7 in abovementioned section) should be repaired as existing or if beyond repair, replaced by new materials matching the existing style.

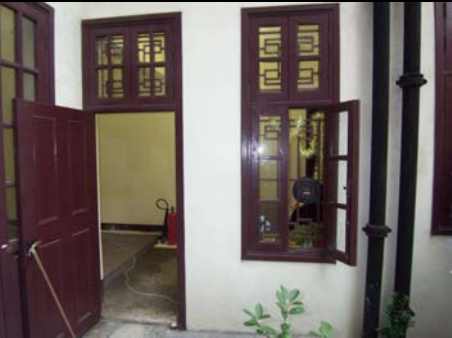
<p>1.11</p>	<p>Decorative iron grilles to windows and fanlights</p> <p>Doors and fan lights are new replacement in traditional style.</p>

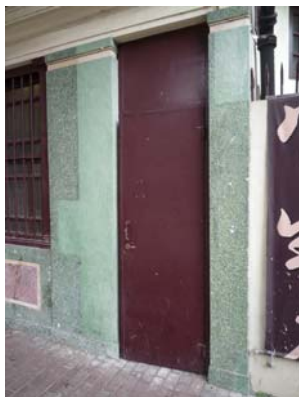
(Ref: No. 3.1)	Intrusive

Item No	Elements / Materials	Photo and Reference	Level of Significance
3.1	Exit door for staircase at G/F The steel exit door is new addition. The style does not match with the existing architectural style

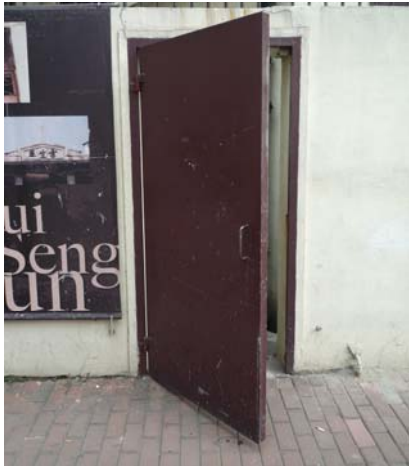
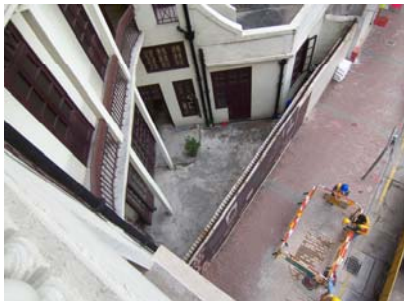
<p>3.2</p>	<p>Fence Wall and Steel Door at G/F</p> <p>The Street door is later addition with no architectural merit.</p> <p>The fence wall is a solid wall with paint finished and no architectural merit.</p>

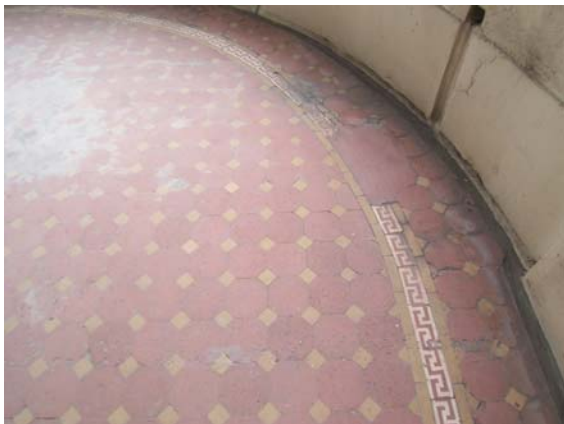
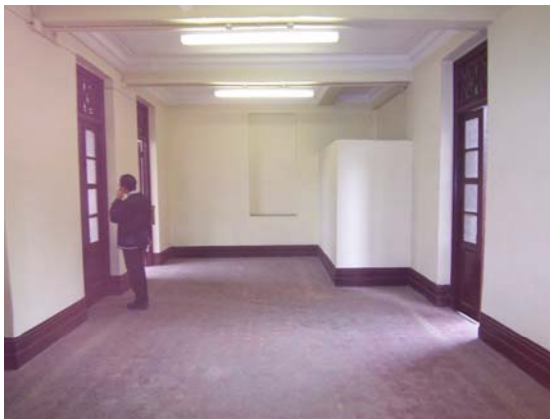
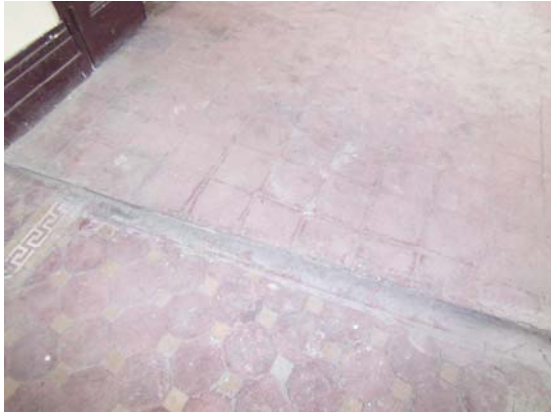
<p>(Ref: No. 5.1)</p>	Moderate
5.2	Floor tiles patterned for verandahs and internal area at all floors

The existing patterned and coloured ceramic tiles should be exposed for appreciation. In case of operational need or protection reason, the existing floor can be allowed to cover up on temporary basis, e.g. carpet can be provided during heavy goods / furniture logistics; light weight & removable floor decking can be provided at new herbs brewing room at 1/F. Additional floor finishes should be removable without causing damage to the existing floor tiles such as carpet. If a more permanent floor finishes is being used, protective material such as plywood or plastic sheet can be applied for separation.

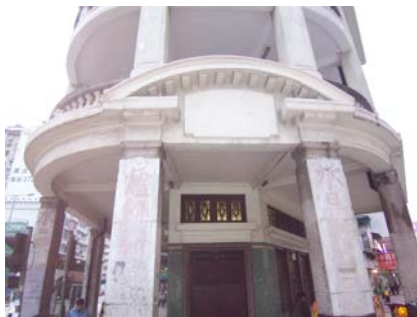
<p>(Ref: No. 1.2)</p>	Exceptional	<ul style="list-style-type: none"> - Preserve in-situ - Repair and clean existing surface - Existing painted surfaces to be repainted in cream lime wash colour scheme 	Low

<p>existing skeleton</p> <ul style="list-style-type: none"> - New addition or alteration works directly on the external facade should be avoided 	
1.2	Cornice and pediment

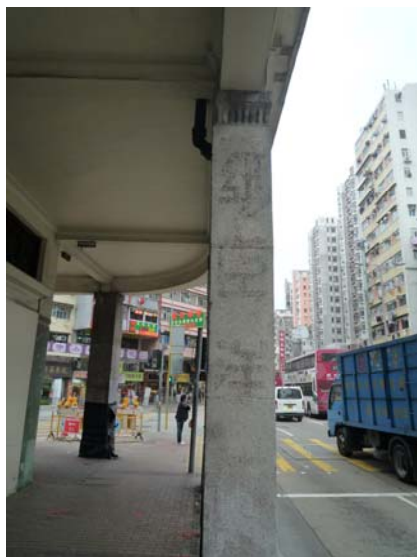
1.3	<p>Granite columns with decorative capitals, plinths and groove joints at G/F</p> <p>The granite columns have remains of painted commercial letterings</p>

<p>(Ref: No. 1.3)</p>	Exceptional	<ul style="list-style-type: none"> - Preserve in-situ - Repair and clean, brush off & remove stains from the surface of stone - Keep the granite unpainted - The painted commercial letterings to be remained to reflect the past commercial activities of the building 	Low
1.4	<p>Shanghai plastered coloured walls with plastered cornice and moldings at G/F</p> <p>The shanghai rendering have been badly repaired in different colour</p>

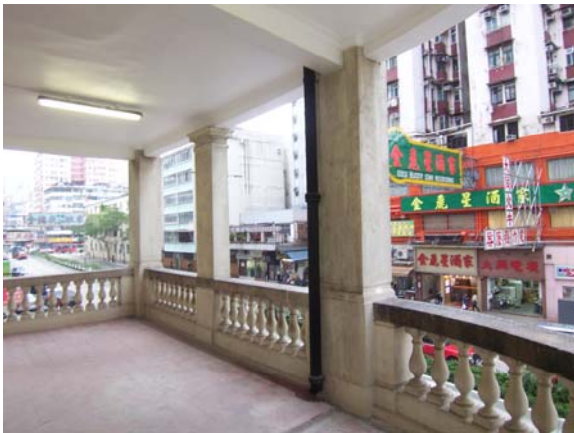
1.6	<p>Plastered columns with paint finish at 1,2 & 3/F</p> <p>The columns as a major element on the façade are in good condition</p>

<p>(Ref: No. 1.6)</p>	Exceptional	<ul style="list-style-type: none"> - Preserve in-situ - Repair, clean and repaint the columns to match the existing colour 	Low
1.7	<p>Verandahs with urn-shaped balustrades at 1 & 2/F and plain parapets topped with granite at 3/F</p> <p>The verandahs will be enclosed by glass due to functional need</p>

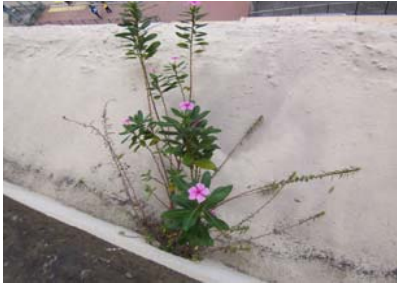
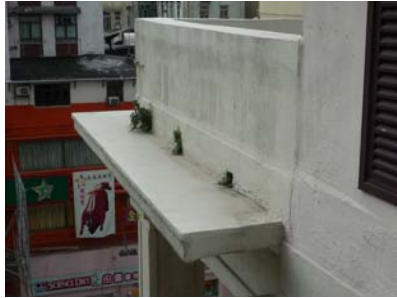
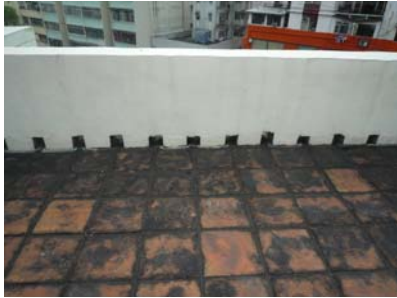
1.8	<p>Drain points at parapet wall at 3/F and Roof</p> <p>Vegetation is found at certain location of the drain points</p>

<p>(Ref: No. 1.8c)</p>	Moderate	<ul style="list-style-type: none"> - Preserve in-situ - Remove all vegetation on the building - Keep the drain points unblocked 	Low
-----	---	--	----------	--	-----

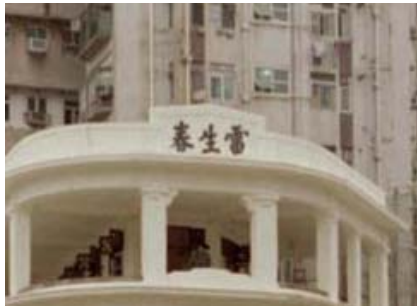
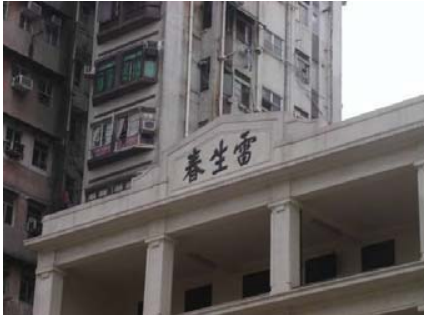
1.9	<p>Profiled Stone Plaques at Roof</p> <p>There are 2 nos. of profiled stone plaques inscribed “<i>Lui Seng Chun</i>” at roof level</p>

<p>(Ref: No. 1.9b)</p>	Exceptional	<ul style="list-style-type: none"> - Preserve in-situ - Repair and repaint to match existing colour 	Low
-----	---	---	-------------	---	-----

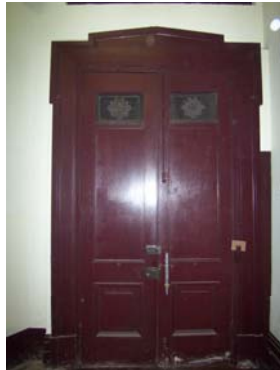
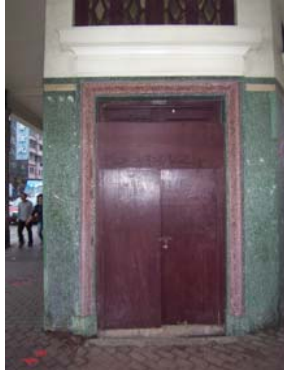
(Ref: No. 1.10.1a)

1.10	Doors and Windows There are different types of doors and windows in the building, some are old and some new replacements in traditional style.					
1.10.1	Main entrance door Main timber exit door in the boundary wall with period style ironmongery

(Ref: No. 1.10.1b)	Exceptional	<ul style="list-style-type: none">- Preserve in-situ- Repair and repaint to match existing colour	Low
1.10.2	Timber doors at the verandahs are with openable glass panels and fanlights with iron grilles and frosted/obscured glass.

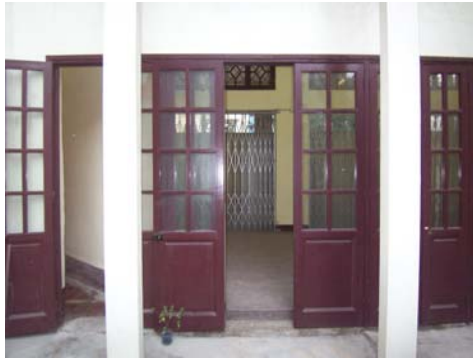
glass panels as far as possible.	
1.10.3	<p>Timber door with clear glass panels at the G/F facing courtyard</p> <p>They are new replacements in traditional style</p>

<p>(Ref: No. 1.10.3)</p>	Moderate	<ul style="list-style-type: none"> - Preserve in-situ - Repair and repaint to match existing colour 	Low
1.10.4	<p>Double leaves solid timber doors for the staircase</p> <p>The doors at 3/F & 1/F are new replacements in traditional style</p>

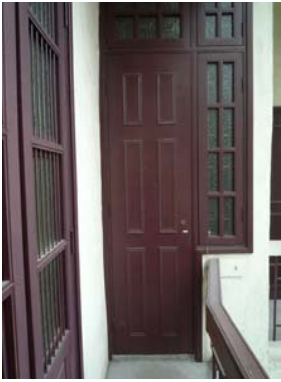
repair works or restored to original situation.	
1.10.5 a	Solid timber doors from balcony facing rear courtyard to existing kitchen These doors are new replacements in traditional style

(Ref: No. 1.10.5a)	Low	- These doors will be retained and kept locked and exposed to view as part of the interior of the new toilet	Low
1.10.5 b	Solid timber doors for the kitchens and toilet cubicles These doors are new replacements in traditional style

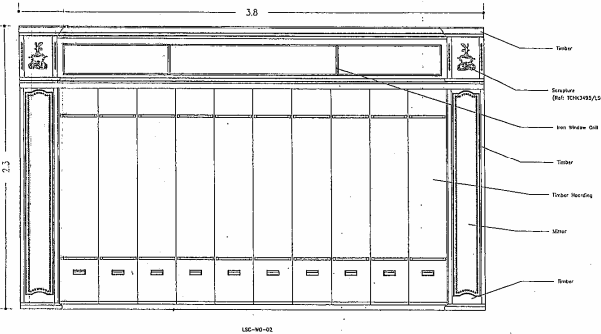
1.10.6	Decorative timber surrounds to display window facing street at G/F

<p>Extracted from Measured Drawings from ArchSD Plan no.TCHK3495/LSC/22 by Ted Chan & Associated Jan 2001</p> <p>(Photos pending removal of existing timber board)</p>	High	<ul style="list-style-type: none"> - Preserve in-situ - Repair and repaint to match existing colour 	Neutral
1.10.7	Ironmongery with locking devices to all timber doors and windows

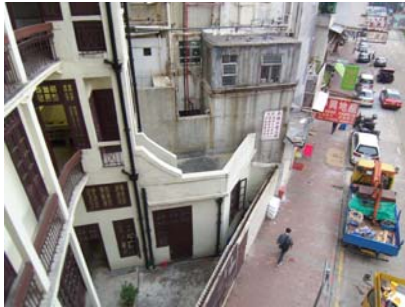
differentiate the building with the pavement. (refer to courtyard and new gate design in Appendix B)	
3.3	<p>Servant annex at G/F</p> <p>It is an attachment to the existing building with little architectural merit, but shows authentic planning of the building in its time.</p>

<p>(Ref: No. 3.3)</p>	Moderate	<ul style="list-style-type: none"> - Preserve in-situ - The service annex will be removed for the new escape staircase to comply the current building regulation - The existing doors and windows should be salvaged for re-use on site for future repair works. 	Low

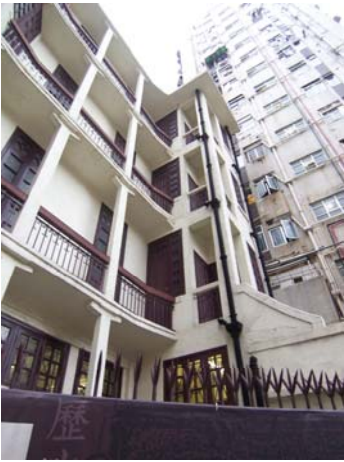
3.4	<p>Service Annex at 1, 2&3/F</p> <p>Original kitchen and toilet cubicle are located inside this annex.</p>

<p>(Ref: No. 3.4)</p>	High	<ul style="list-style-type: none"> - Preserve in-situ - The internal partition of the service annex will be removed for the new toilets to comply the current building regulations. - The existing doors and windows facing the balcony should be kept intact and expose to view in the interior of the new toilet design. - The doors from kitchen to the open area and to the toilet cubicle to be removed and salvaged for future repair works. - The balconies will be enclosed by blockwall with compatible design yet distinguishable from the existing fabric. 	Neutral
-----	---	--	------	--	---------

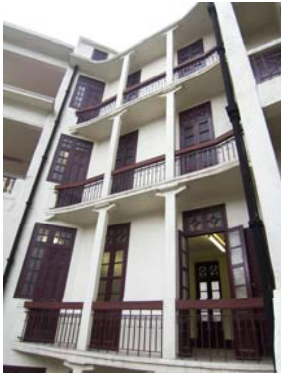
3.5	Rear Verandah with concrete slab and profiled column at 1,2 & 3/F

<p>(Ref: No. 3.5)</p>	Exceptional	<ul style="list-style-type: none"> - Preserve in-situ - Profile columns are new addition during previous restoration works and to be preserved to maintained structural stability. - Repair and repaint to match existing colour 	Low
3.6	Iron railing with timber top rails at rear verandahs These items are new replacements in traditional style

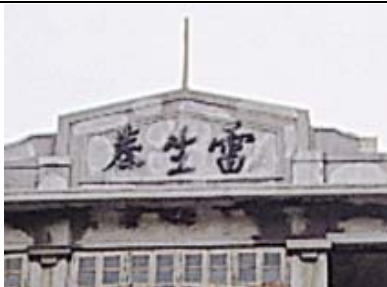
<p>(Ref: No. 4.4a)</p>

4.4	<p>Flag posts</p> <p>R.C. flag poles (2 nos.) above of each of the stone plaques at roof level, but found missing on site</p>

<p>(Ref: No. 4.4b)</p>	High	Reinstate missing flag poles by a replica to same design as original	Low
-----	--	---	------	--	-----

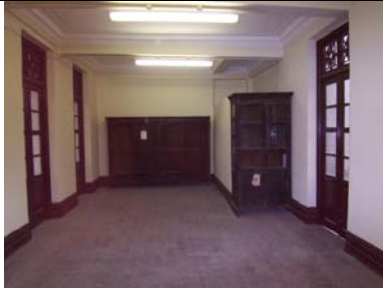
Item No	Elements / Materials	Photo and Reference	Level of Significance	Recommended Treatment / Justification / Mitigation Measures	Impact Level
5.1	Open plan for internal space Original open plan of internal space

(Ref: No. 5.1)	Moderate	<ul style="list-style-type: none"> - The internal space will be partitioned for the operation need of medical consultation and ancillary facilities. The subdivision will be kept as minimum as possible. - Align new partitions with the new strengthening at ceiling above as far as possible to minimize intrusion to building fabric. 	Neutral

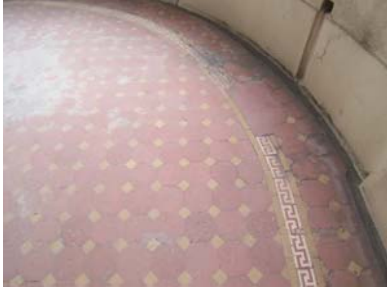
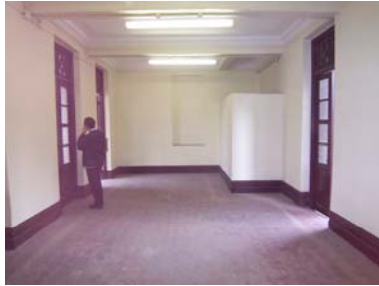
5.2	Floor tiles patterned for verandahs and internal area at all floors

<p>(Ref: No. 5.2c)</p>	High	<ul style="list-style-type: none"> - Preserve in-situ - Floor tiles were added at later stage on top of the original floor tiles at the verandah on 1/F facing Tong Mei Road. It should be removed to expose the origin tiles as far as possible. Should the condition of the original tiles after removal is not sound, new floor tiles of compatible, but being distinguishable from existing tiles should be applied. - Remove raised wooden temporary floor from ground shop area. - No corrosive cleaning detergent is permitted. - In case the condition of the original tiles is so poor to repair, reconstruct with matching design and colour - Original tiles to be removed 	Moderate
-----	---	--	------	---	----------

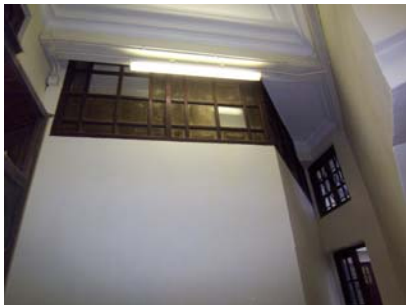
5.5	<p>Internal wall with high windows at G/F</p> <p>The design of high windows has no architectural merit</p>

<p>(Ref: No. 5.5)</p>	Low	<p>Part of the wall will be removed to fit the operation need.</p> <p>The glass screens at top to be retained as far as possible to reflect the use of space in the past.</p>	Low

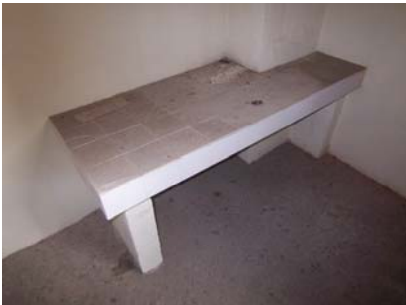
5.6	<p>Kitchens & Toilet cubicles at Service Annex</p> <p>The existing kitchens and toilet cubicles has no architectural merit.</p> <p>5.6a – New bench</p> <p>5.6b – Chimney Hood</p> <p>5.6c – Stove at 1/F</p>

<p>(Ref: No. 5.6a)</p>	<p>5.6a - Low</p> <p>5.6b - Moderate</p> <p>5.6c - Moderate</p> <p>5.6d - Low</p>	<ul style="list-style-type: none"> - The original kitchens & toilet cubicles will be demolished for the new toilets to comply with the current Building Regulations - The existing chimney hood should be preserved as far as possible. - The benches in the kitchen have no architectural merit - The stove in the kitchen at 1/F has certain level of historic value. It should be detailly recorded. Small fixtures from 	Low

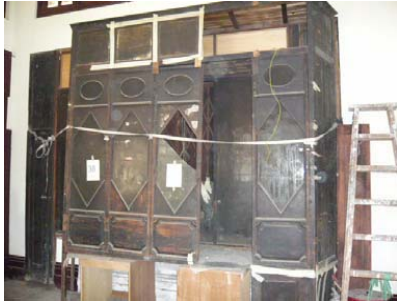
5.9	Old furniture including glazed display cabinets

<p>(Ref: No. 5.9)</p>	High	<ul style="list-style-type: none"> - Repair and re-use of the old furniture in the building are recommended. - Temporary relocate off site during works if required. - To make good and repaint any damaged wall surface after removal of the old furniture. 	Low
-----	--	--	------	---	-----

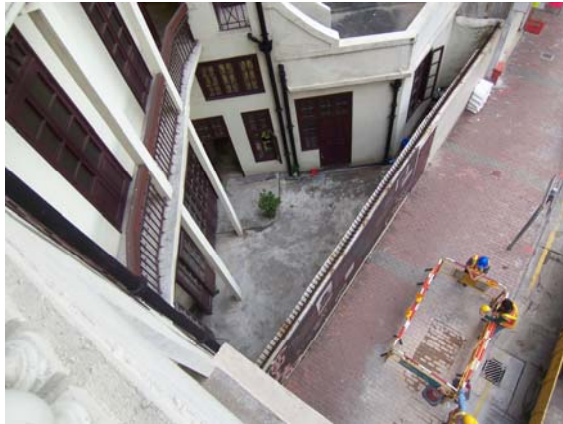
Item No	Elements / Materials	Photo and Reference	Level of Significance	Recommended Treatment / Justification / Mitigation Measures	Impact Level
6.1	The existing courtyard was separated from the public pavement by a fence wall. It was served as a service courtyard with concrete floor finish in the original design

<p>(Ref: No. 6.1)</p>	Moderate	<ul style="list-style-type: none"> - The open courtyard should be retained in its existing uncovered condition, to show its original function as a ventilated light-well to the building. It will open up for the public enjoyment with upgraded landscape design. - New escape staircase and building services provisions to comply current building regulations will be located at the side of the courtyard 	Neutral
