Heritage Impact Assessment for Conversion of
the Former Clubhouse of Royal Hong Kong Yacht Club
at 12 Oil Street, North Point
into a Community and Public Art Centre - Artspace @ Oil Street

Volume II - Heritage Impact Assessment
September 2011

**HERITAGE IMPACT ASSESSMENT
FOR THE FORMER CLUBHOUSE OF ROYAL HONG KONG YACHT
CLUB AT 12, OIL STREET, NORTH POINT, INTO A COMMUNITY
AND PUBLIC ART CENTRE – ARTSPACE @ OIL STREET
VOL. II – HERITAGE IMPACT ASSESSMENT**

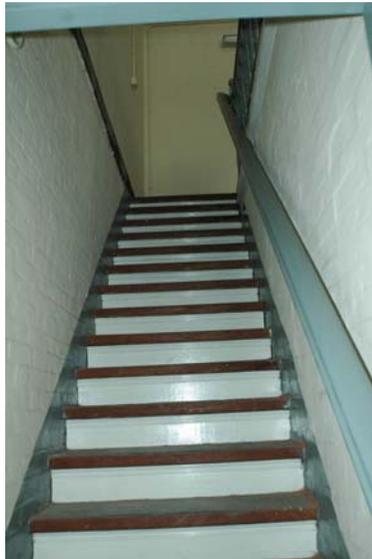
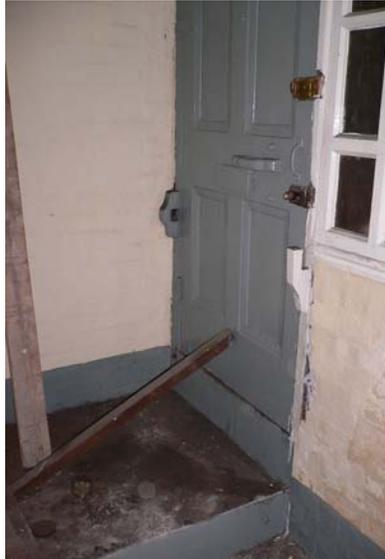
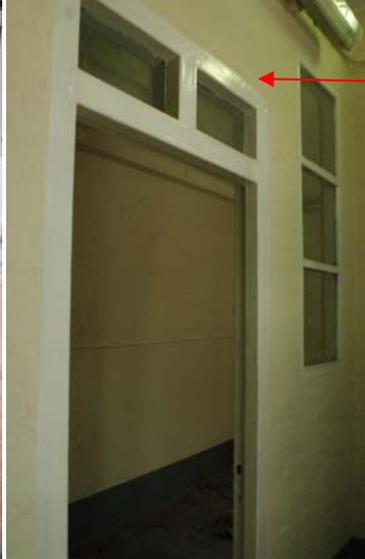
D-01

These internal windows and door on G/F of ST-2 are later alteration and addition which can be removed or blocked up

External windows shall be kept intact as far as practicable.

Existing windows beside ST-2 can be protected by adding fire rated board at the rear.

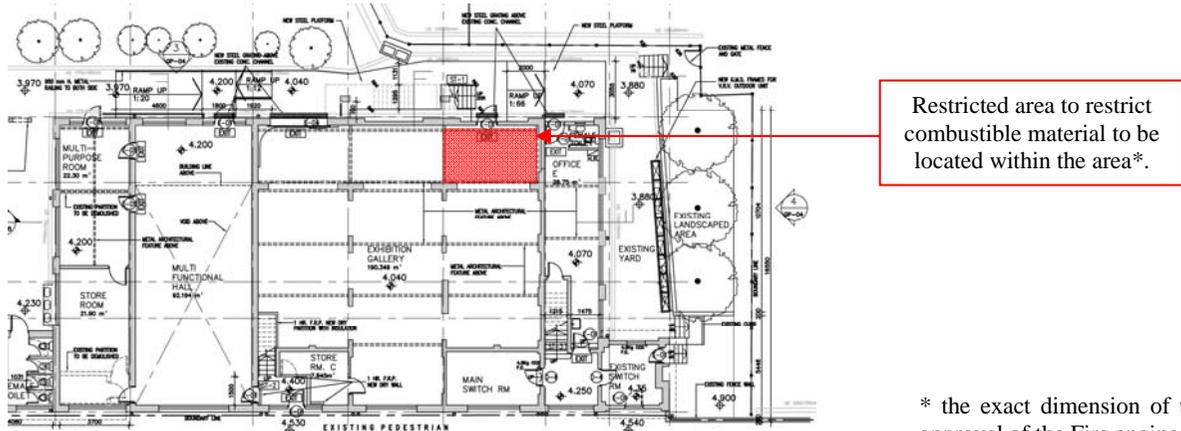
D Fire safety upgrading for means of escape						
Item	Assessment items / Proposed Works	Fabric affected	Level of Significance	Reasons for changes/ Deficiency	Mitigation measures	Overall Adverse Impact Level
D-02	<p>Restricted area in the exhibition gallery of the Main Building</p> <p>The area in the exhibition gallery of the Main Building which is close to the proposed escape stair (the concrete stair) will be dedicated as “restricted area” to restrict combustible materials to be located within the area. The management staff shall keep special attention to restrict any accumulation of combustible materials.</p>	G/F of the Main Building	High	Unprotected opening which is close to the proposed means of escape, the existing concrete stair	<ul style="list-style-type: none"> Special training and briefing shall be provided to the frontline management staff to pay special attention to the restriction area to avoid the accumulation of combustible materials. 	Low

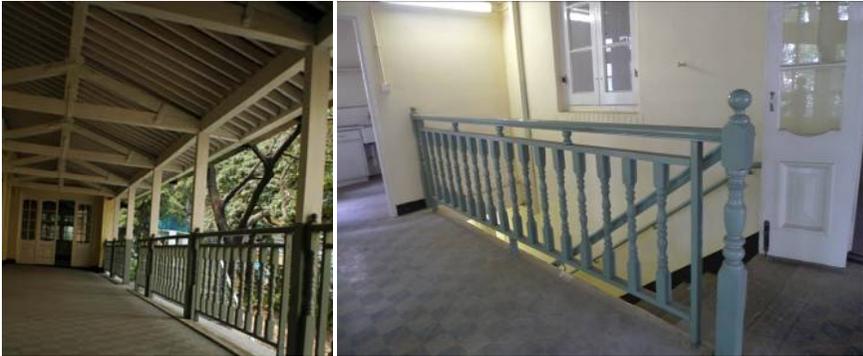
E Others upgrading works for statutory requirements						
Item	Assessment items / Proposed Works	Fabric affected	Level of Significance	Reasons for changes/ Deficiency	Mitigation measures	Overall Adverse Impact Level
Main Building						
E-01	<p>Provide Protective Barrier in front of existing balustrades along 1/F verandah and the timber stair (ST-3)</p> <ul style="list-style-type: none"> To adopt management control to prevent people from leaning on existing balustrades by putting portable plants or other measures in front of existing balustrades. 	Existing balustrades along verandah with cement floor tiles	High	Existing balustrades do not comply with the design requirements, such as <1100mm High, >100mm spacing, without 150mm solid base, and cannot resist the required horizontal imposed load for barrier	<ul style="list-style-type: none"> As 1/F will be used as office and only staff can be accessed, subject to the approval by authorities, management control shall be implemented by putting portable plants or other measures in front of the existing balustrades along 1/F verandah and stair which are considered not fully compliance with current safety requirements to prevent people from leaning on them. The portable plants placed in front of the existing balustrades along 1/F verandah and stair shall not obstruct the passage and the effective width of the mean of escape. 	Low

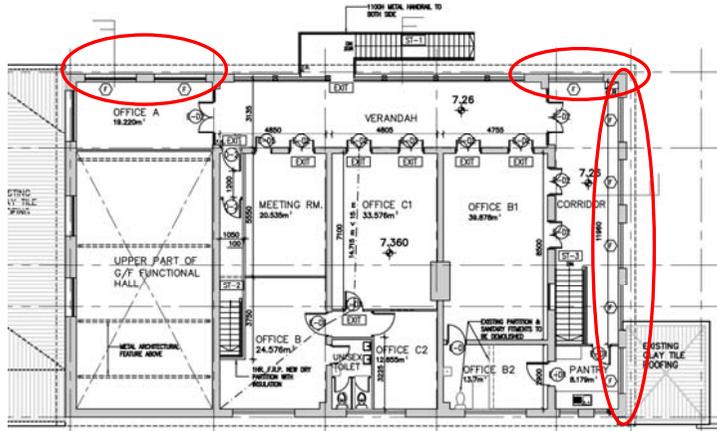
E Others upgrading works for statutory requirements (Cont'd)						
Item	Assessment items / Proposed Works	Fabric affected	Level of Significance	Reasons for changes/ Deficiency	Mitigation measures	Overall Adverse Impact Level
Main Building						
E-02	<p>Provide Protective Barrier - windows</p> <ul style="list-style-type: none"> Along 1/F enclosed verandah at the Main Building – the timber windows To lock existing timber windows with the sill lower than the required safety height in most of the time. 	Existing windows along enclosed verandah	High	Existing openable windows are less than 1100mm above floor level	<ul style="list-style-type: none"> As 1/F will be used as office and only staff can be accessed, and in most of the time the windows would be closed/locked for air-conditioning, subject to the approval by authorities, management approach shall be adopted to lock the timber windows with the sill lower than the required safety height in most of the time, and close supervision shall be provided if opening the windows is necessary for maintenance. The lock of the timber windows shall be made reversible and can be removed in the future. 	Low

<p>Windows along enclosed verandah at Main Building can be locked and closed at all time.</p>

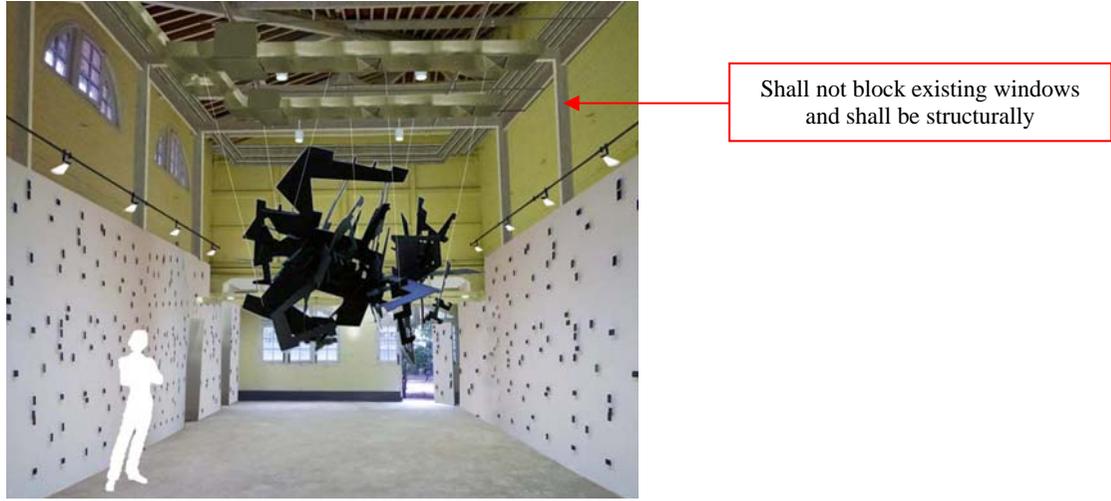
F Others alteration and addition works for new uses						
Item	Assessment items / Proposed Works	Fabric affected	Level of Significance	Reasons for changes	Mitigation measures	Overall Adverse Impact Level
Main Building						
F-01	Construction of new steel structures for display use At Multi-functional Hall Independent steel structure with wallboard finish	Existing brick wall and floor	High	For exhibition display and building services installation	<ul style="list-style-type: none"> The new steel structures shall be structurally independent which shall not affect the structural stability of the existing building and the brick wall. This can be removed or altered in the future without causing great damage to the historic building fabric. The new steel structures shall be located away from existing windows without blocking them, so that natural lighting to the interior will not be affected. The new steel structures shall be minimized in size without overwhelming the interior space. 	Low

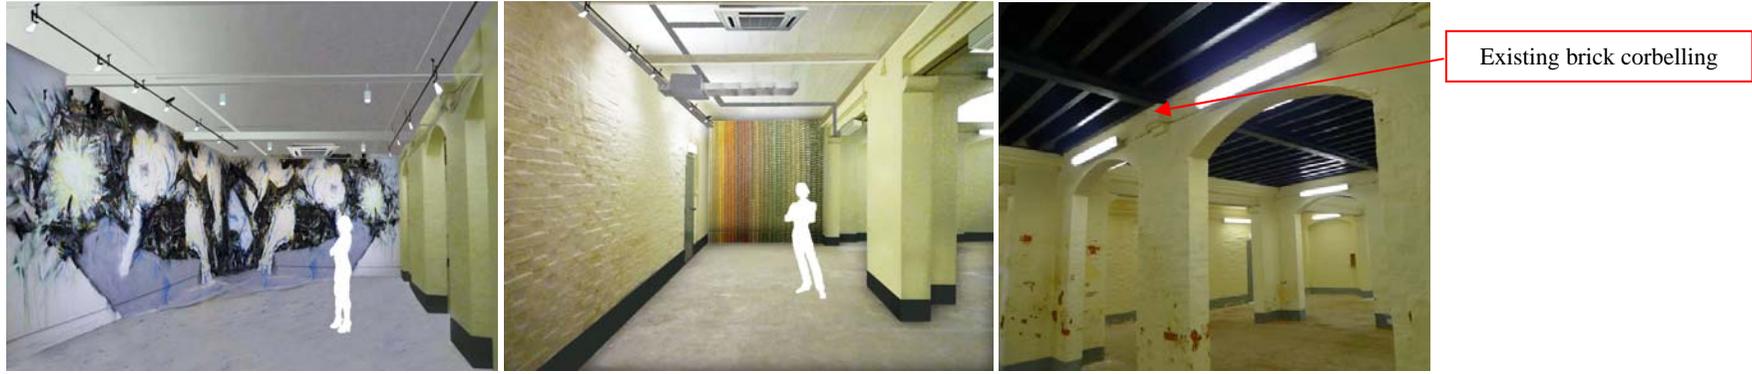
F Others alteration and addition works for new uses (Cont'd)						
Item	Assessment items / Proposed Works	Fabric affected	Level of Significance	Reasons for changes	Mitigation measures	Overall Adverse Impact Level
F-02	<p>Construction of new steel structures for display use At Exhibition Gallery</p> <p>Steel structure with wallboard finish to be fixed on existing brick wall</p>	Existing brick wall	High	For exhibition display and building services installation	<ul style="list-style-type: none"> Carry out survey on existing condition of brick wall, which are found deteriorated due to covering up by non-breathable layer of paint finish before any works. Carry out necessary brick repair work prior to the installation of the new steel structure. Installation of the steel structures shall be fixed by removing whole pieces of brick one by one rather than coring on the brick wall in order to minimize the damage on individual bricks. The historic bricks shall be salvaged and stored properly for future restoration. The size of the fixing shall be minimized in size in order to minimize the disturbance. Such fixing shall not disturb existing brick corbelling or brick arch Detail photographic and cartographic survey on the brick wall shall be properly carried out prior to the commencement of any works. 	Medium

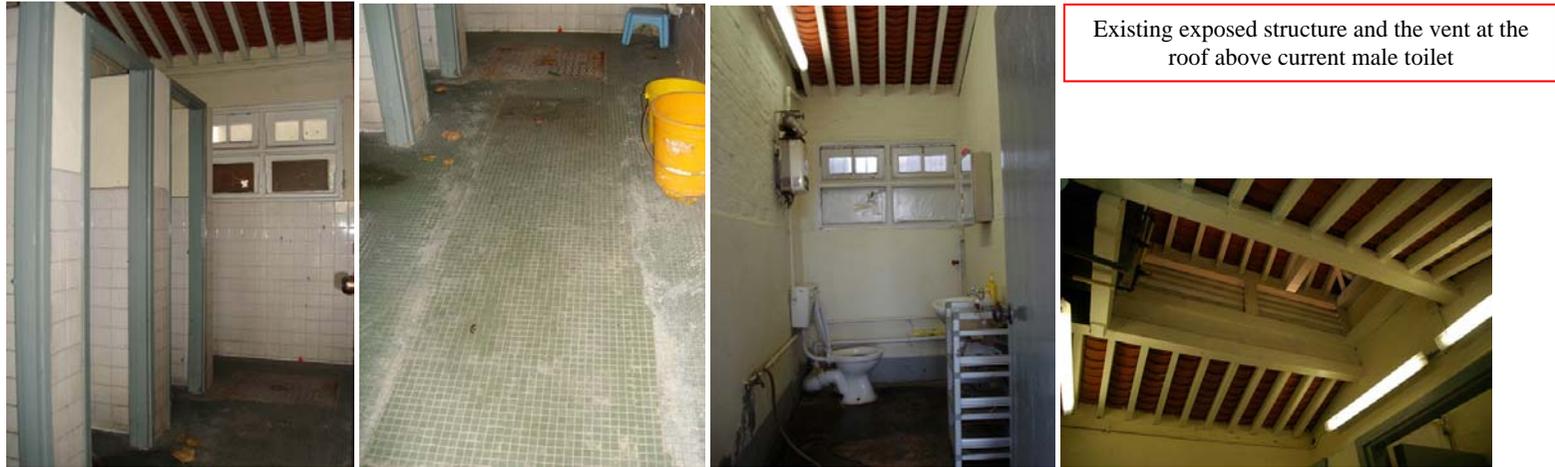
F Others alteration and addition works for new uses (Cont'd)						
Item	Assessment items / Proposed Works	Fabric affected	Level of Significance	Reasons for changes	Mitigation measures	Overall Adverse Impact Level
F-04	Renovate the existing toilets beside existing kitchen (G/F)	Existing toilets	Low	Upgrading toilet provision for new uses	<ul style="list-style-type: none"> Existing toilet partitions, wall and floor tiles, toilet fittings are modern alteration and addition, shall be removed in a way to minimize the damage on existing brick wall. Existing exposed structure of the vent at the roof shall be remained intact. Existing vent at the roof can be made used for future ventilation of the toilet. 	Low

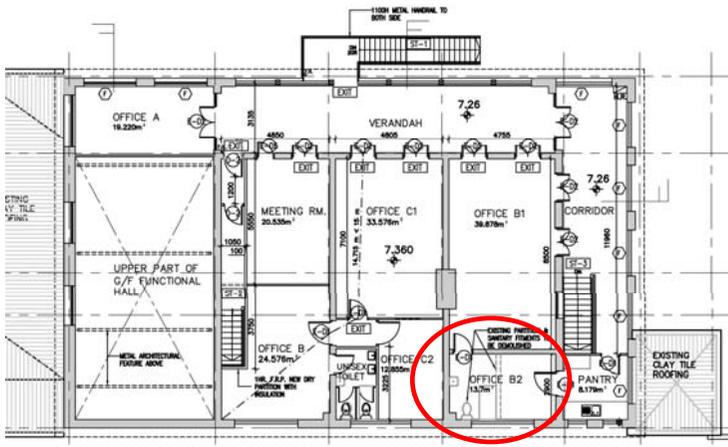
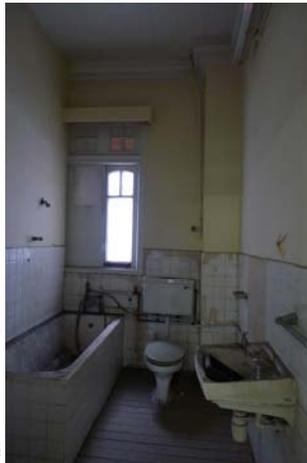
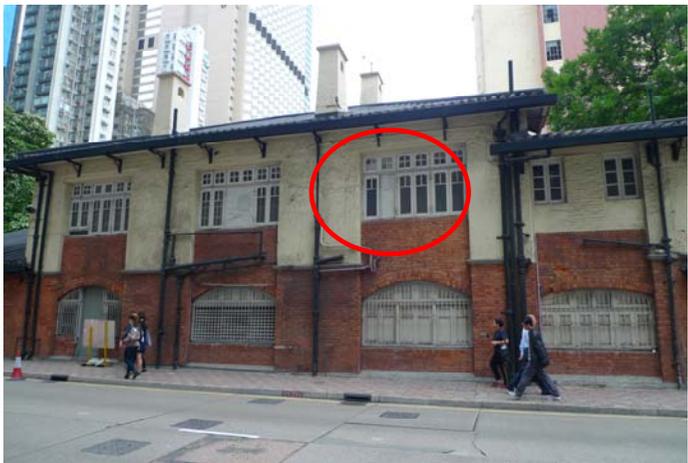
F Others alteration and addition works for new uses (Cont'd)						
Item	Assessment items / Proposed Works	Fabric affected	Level of Significance	Reasons for changes	Mitigation measures	Overall Adverse Impact Level
F-05	Change existing toilet at 1/F Main Building to Office (B2)	Internal layout	Low	For new uses	<ul style="list-style-type: none"> Existing toilet was later alteration and addition that the proposed removal of the wall partition and toilet fittings is acceptable. Instead of removal of the existing wall tiles, new wall panels for new office use can be added on top of wall tiles, which could be removed or altered in the future without causing great damage to existing brick walls. The existing blocked window facing Electric Road will be restored with the appearance making reference to adjoining windows. 	Low

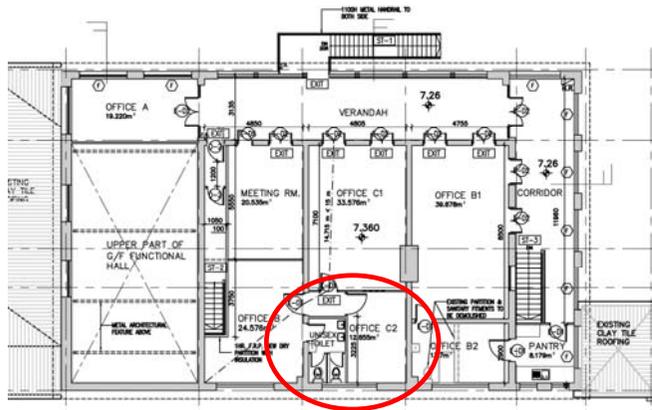
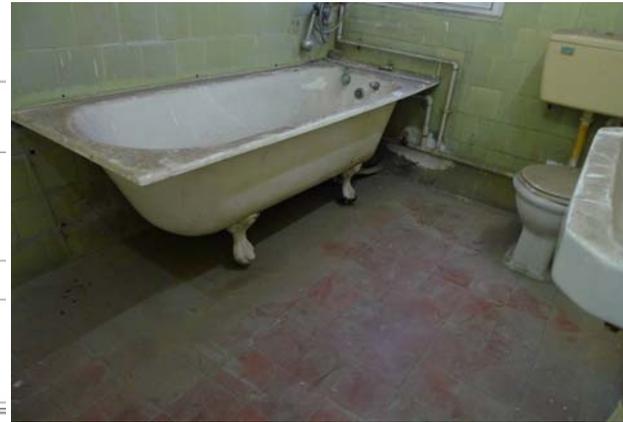
F Others alteration and addition works for new uses (Cont'd)						
Item	Assessment items / Proposed Works	Fabric affected	Level of Significance	Reasons for changes	Mitigation measures	Overall Adverse Impact Level
F-06	Renovate existing toilet at 1/F Main Building	Existing toilet fittings	Low	For new uses	<ul style="list-style-type: none"> Existing brick wall and timber windows shall be made good after toilet renovation works. 	Low

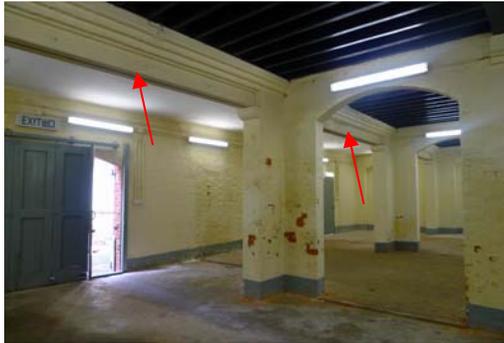
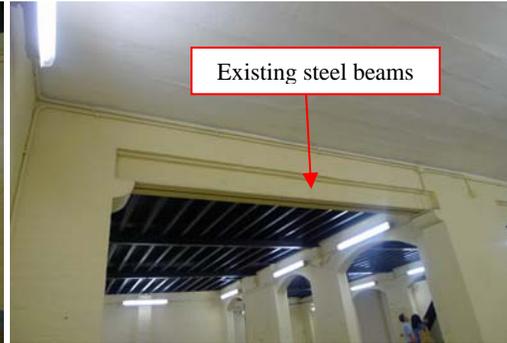
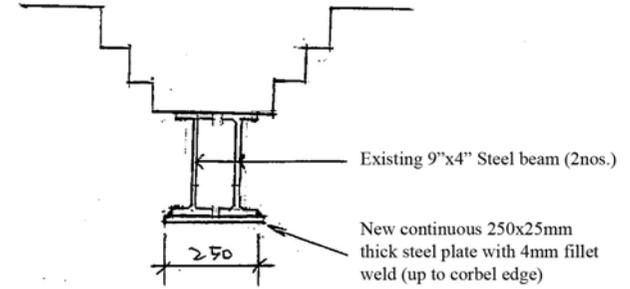
Strengthening of Steel Beam under the verandah

2.	Steel beams underneath 1/F verandah (3 nos.) (for Main Building)	Structurally inadequate	Structural strengthening works are required by welding new steel plate underneath the existing twin steel beams up to the edge of the brick corbel.

G Structural strengthening works						
Item	Assessment items / Proposed Works	Fabric affected	Level of Significance	Reasons for changes	Mitigation measures	Overall Adverse Impact Level
All historic buildings						
G-01	Limit 1/F for storage with design imposed load not exceeding 5KPa No strengthening work is required	Timber floor structure	High	To minimize strengthening works	<ul style="list-style-type: none"> Heavy equipment, heavy exhibits or other items with design imposed load exceeding 5 KPa shall not be placed at 1/F store room. Special training and briefing shall be provided to the frontline management staff to pay special attention to avoid unregulated loading. 	Low
Main Building						
G-02	Strengthen the existing 3 bays steel beams underneath 1/F verandah of the Main Building (along the edge between the concrete slab and the timber floor structure of the Exhibition Gallery)	Steel beams	High	Structurally inadequate	<ul style="list-style-type: none"> The strengthening to the existing 3 bays steel beams of the timber floors shall not damage the adjoining brick structures. This can be achieved by welding additional steel plates underneath the existing beams in lieu of replacing or removing them. The strengthening steel plates shall not cover the brand name of the existing steel "GLENARNOCK STEEL" which signified the steel beams were supplied from UK. 	Low

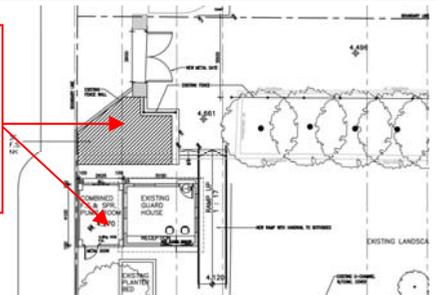
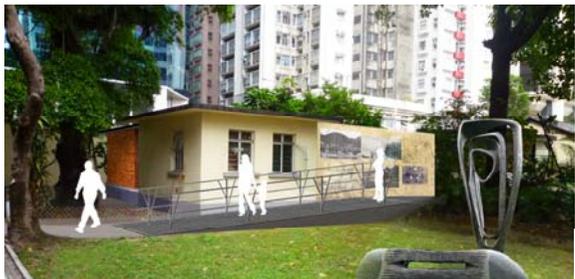
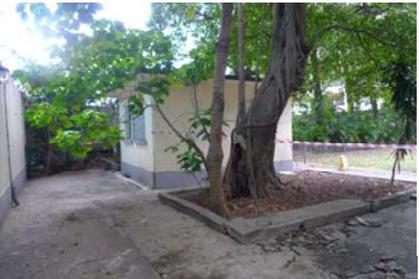
H Building services upgrading works (Cont'd)						
Item	Assessment items / Proposed Works	Fabric affected	Level of Significance	Reasons for changes	Mitigation measures	Overall Adverse Impact Level
Fire services Installation						
H-03	Construction of a combined fire service and sprinkler pump room and a combined fire services and sprinkler tank beside existing guard house	Existing guard house	Low	Upgrade fire safety for new uses	<ul style="list-style-type: none"> The construction of the combined fire services, and sprinkler pump room and the corresponding water tanks at the rear and adjacent to the guard house shall allow sufficient maintenance space for external wall. The proposed combined water tank which is subject to the approval of the authorities shall be kept to the minimum size and shall be screened off by decorated panels in order to mitigate the visual impact. Interpretation panels telling the cultural significance of the site can be used for screening off the proposed combined water tank. Alternatively and also subject to the approval of the authorities, the feasibility of further omitting the water tank by obtaining direct feed from the town main water supply shall be explored in order to further mitigate the visual impact. 	Low

<div style="display: flex; align-items: flex-start;"> <div style="border: 1px solid red; padding: 5px; margin-right: 10px;"> <p>Proposed location for combined F.S. and Sprinkler Tank as well as the combined pump room</p> </div>
