CONSULTANCY STUDY ON THE PRESERVATION OF ANCIENT ROCK CARVINGS OF HONG KONG

12-18 January 2010

Richard A. Engelhardt, UNESCO Senior Advisor for Culture
Consultant

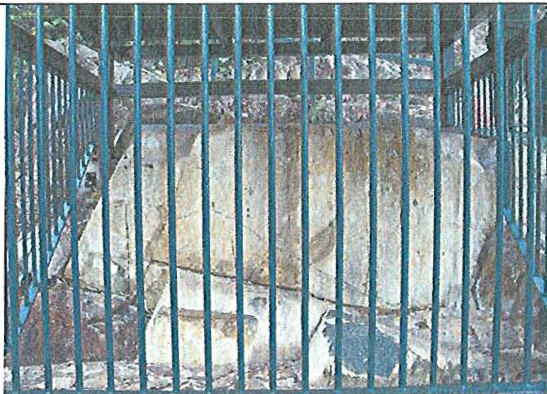
5. Photo Reference

4. Present Condition and Past Treatment	<p><u>Present Condition</u></p> <ul style="list-style-type: none"> Overall condition of rock carving was stable. <p><u>Past Treatment in 2008</u></p> <ul style="list-style-type: none"> Cleaned with soft bristle brush for removing dust and loose vegetation. The surface was cleaned with biodegradable and non-ionic surfactant (Decon@90) and then rinsed thoroughly with water.

<ul style="list-style-type: none"> approx. 2.0 m (W) 1.1 m (H)

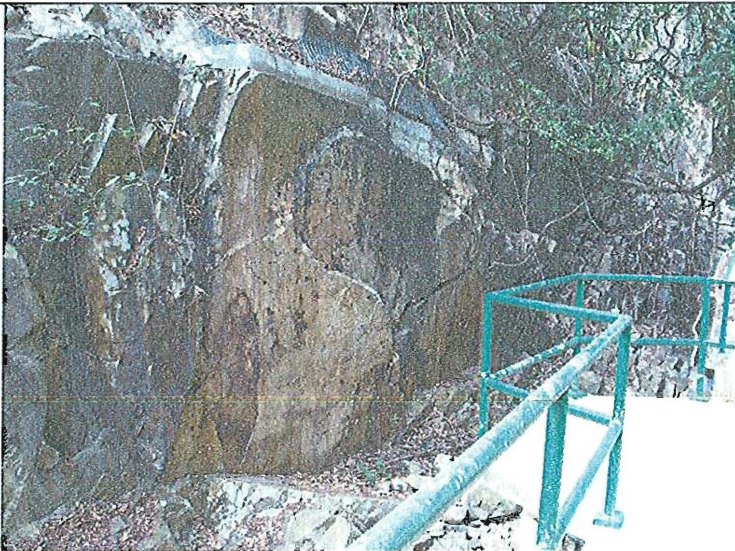
5. Photo Reference

4. Present Condition and Past Treatment	<p><u>Present Condition</u></p> <ul style="list-style-type: none"> Overall condition of rock carving was stable <p><u>Past Treatment in 2006</u></p> <ul style="list-style-type: none"> Green moss on the rock carving was removed by soft bristle brush with water. The surface was cleaned with biodegradable and non-ionic surfactant (Decon@90) and then rinsed thoroughly with water. Applied aqueous solution of isothiazolinon (Remmer BFA) to prevent further vegetation growth; Applied siloxane based hydrophobic agent (Remmer SNL) to act as water-repelling layer to avoid air pollutants deposition and pest infestation.

<ul style="list-style-type: none"> approx. 2 m (W) 3 m (H)

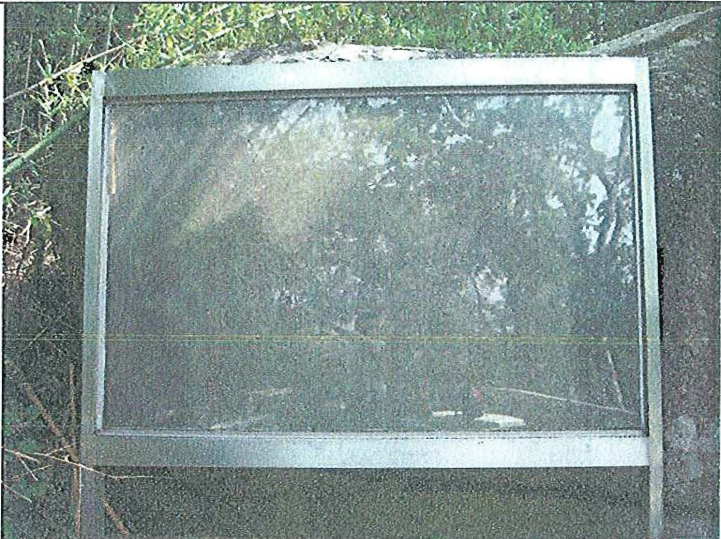
5. Photo Reference

4. Present Condition and Past Treatment	<p><u>Present Condition.</u></p> <ul style="list-style-type: none"> Overall condition of rock carving was stable. <p><u>Past Treatment in 2004</u></p> <ul style="list-style-type: none"> Cleaned with soft bristle brush for removing dust and loose vegetation. <p><u>Past Treatment in 2006</u></p> <ul style="list-style-type: none"> Cleaned with soft bristle brush for removing dust and loose vegetation. The surface was cleaned with biodegradable and non-ionic surfactant (Decon@90) and then rinsed thoroughly with water. Applied aqueous solution of isothiazolinon (Remmer BFA) to prevent further vegetation growth; Applied siloxane based hydrophobic agent (Remmer SNL) to act as water-repelling layer to avoid air pollutants deposition and pest infestation.

<ul style="list-style-type: none"> approx. 1.5 m (W) x 1.2 m (H)

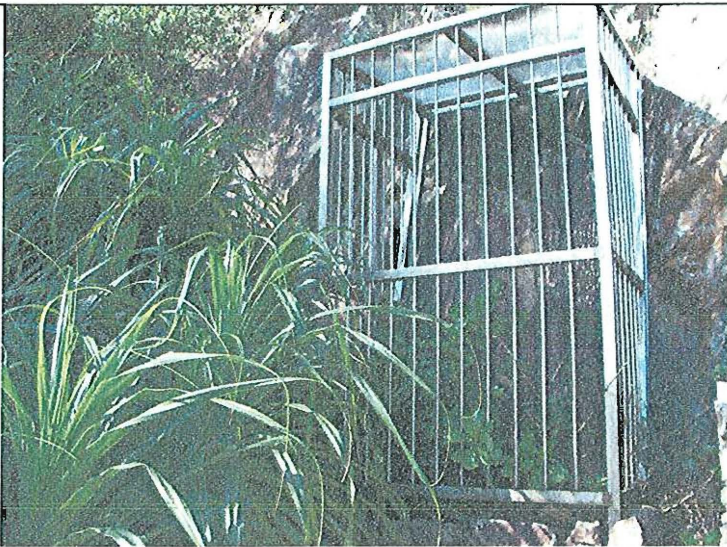
5. Photo Reference

4. Present Condition and Past Treatment	<p><u>Present Condition.</u></p> <ul style="list-style-type: none"> • Overall condition of rock carving was stable. • Prosperous plant growth was found in front of protect cover.

<ul style="list-style-type: none"> • approx. 80 cm (W) x 100 cm (H)

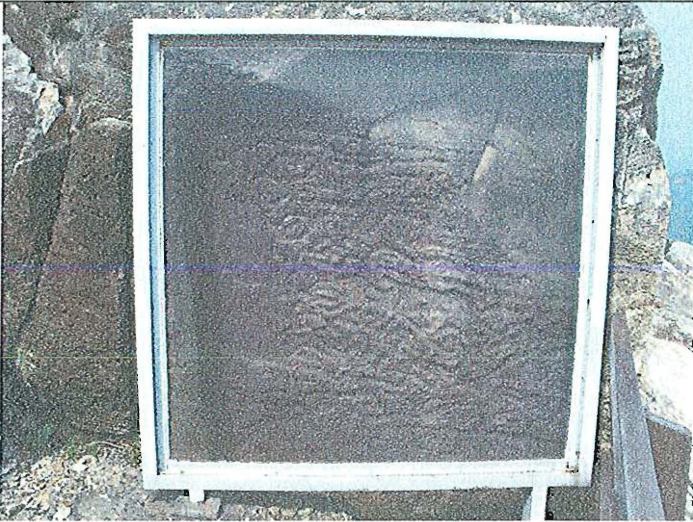
5. Photo Reference

4. Present Condition and Past Treatment	<p><u>Present Condition.</u></p> <ul style="list-style-type: none"> Overall condition of rock carving was stable. <p><u>Past Treatment in 2006</u></p> <ul style="list-style-type: none"> Cleaned with soft bristle brush for removing dust and loose vegetation. Applied silicic acid ethyl ester based stone strengthener (Remmer 300) to consolidate the rock carving. Applied siloxane based hydrophobic agent (Remmer SNL) to act as water-repelling layer to avoid air pollutants deposition and pest infestation.

<ul style="list-style-type: none"> approx. 1.4 m (W) x 1.4 m (H)

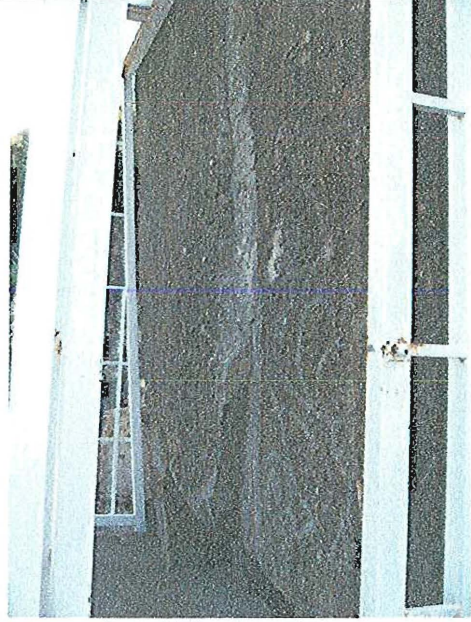
5. Photo Reference

4. Present Condition and Past Treatment	<p><u>Present Condition.</u></p> <ul style="list-style-type: none"> • Overall condition of rock carving was stable. <p><u>Past Treatment in 2006</u></p> <ul style="list-style-type: none"> • Cleaned with soft bristle brush for removing dust and loose vegetation. • The surface was cleaned with biodegradable and non-ionic surfactant (Decon@90) and then rinsed thoroughly with water.

<ul style="list-style-type: none"> • approx. 3 m (W) x 2 m (H)

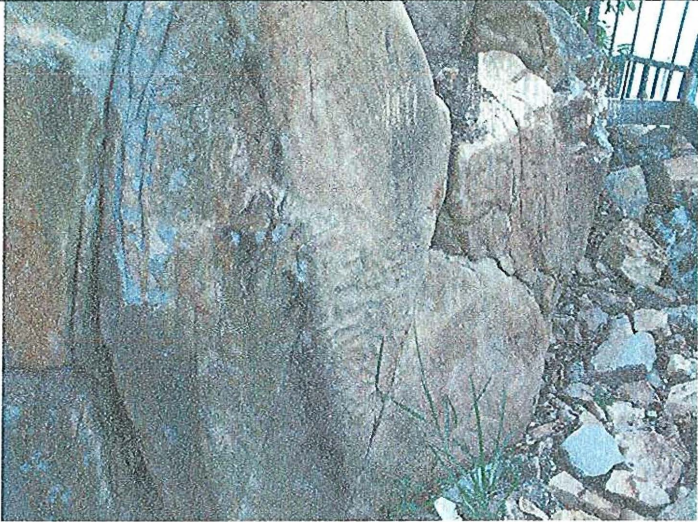
5. Photo Reference

4. Present Condition and Past Treatment	<p><u>Present Condition.</u></p> <ul style="list-style-type: none"> Overall condition of rock carving was stable. Stains of microbiological growth were found on the surface.

<ul style="list-style-type: none"> approx. 0.3m (W) x 0.4m (H);

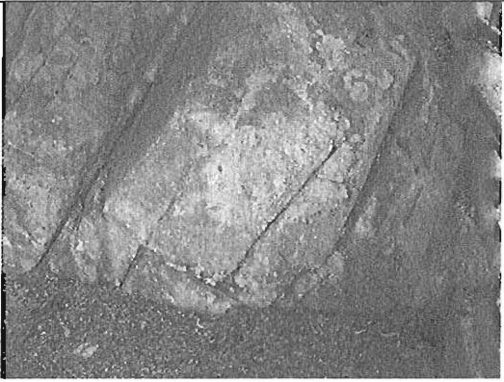
5. Photo Reference

4. Present Condition and Past Treatment	<p><u>Present Condition</u></p> <ul style="list-style-type: none"> Overall condition of rock carving was stable. <p><u>Past Treatment in 2005</u></p> <ul style="list-style-type: none"> Cleaned with soft bristle brush for removing dust and loose vegetation. The surface was cleaned with biodegradable and non-ionic surfactant (<u>Decon@90</u>) and then rinsed thoroughly with water.

<ul style="list-style-type: none"> approx. 0.3 m (W) x 0.8 m (H)
