Study project on the preservation of nine rock art carvings in Hong Kong

Consultancy Agreement Report

Valérie Magar

Rome, 10 July 2010

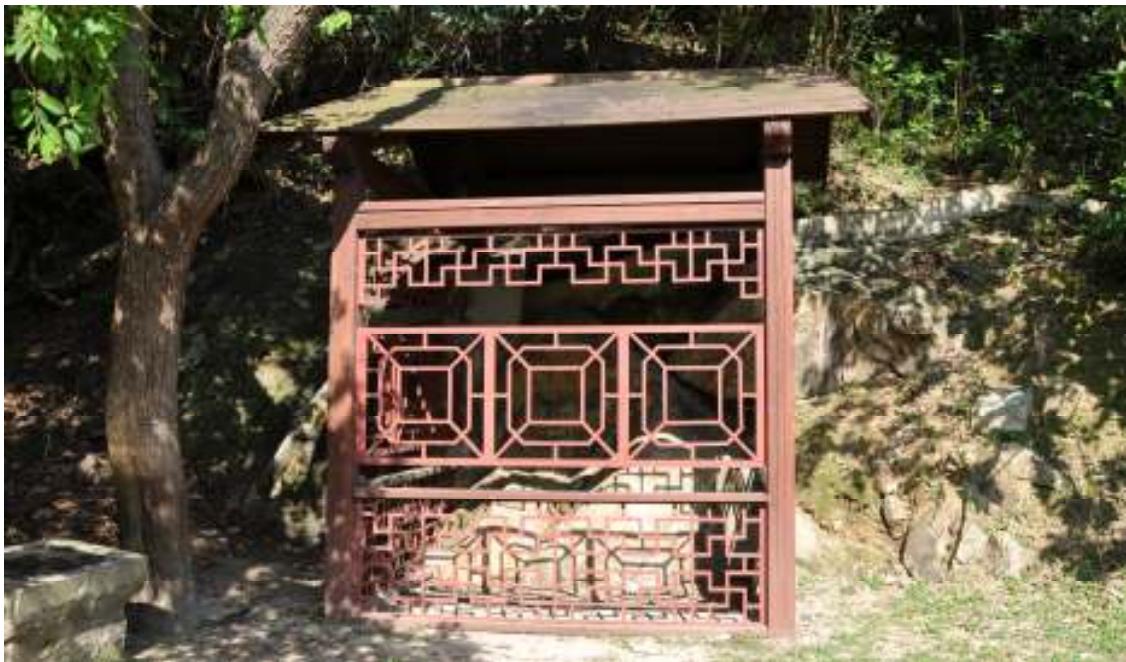
The outcrop is currently protected by a shelter, and surrounded by a metal fence dating from 2005. Although the fence is quite massive, by using a traditional design it allows a clear visibility of the two engraved areas: there are window-like openings for adults, and a horizontal opening for children. There is sufficient distance to allow for photographs of both engraved areas to be taken by visitors.

Figure 5. View of the fence and shelter at Shek Pik

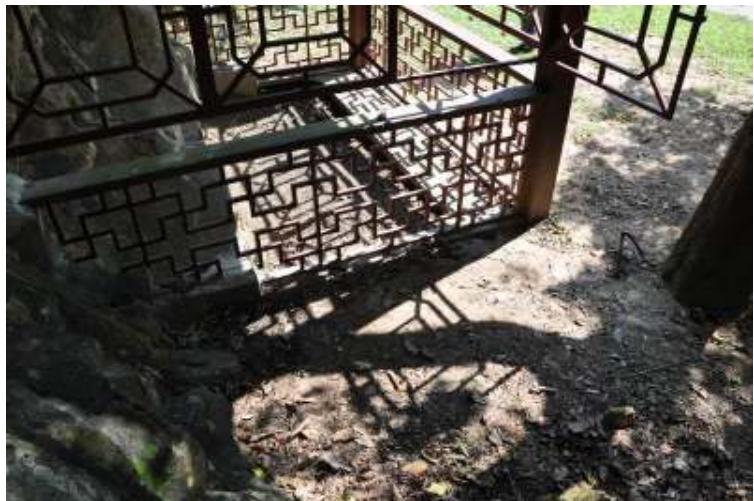
A long cement barrier was placed in 1985 above the outcrop, with the aim of channelling the water coming from the terrain above the site. The water is directed towards the northern side, taking advantage of the shape of the outcrop. However, the slope at the ground level seems to go towards the shelter, and the soil level is lower under the shelter. Possible water accumulation inside the shelter should be monitored in the future.

Figure 7. View of the area north of the shelter, where water is channelled. Note the higher level of the ground in this area, in comparison to ground level inside of the shelter.

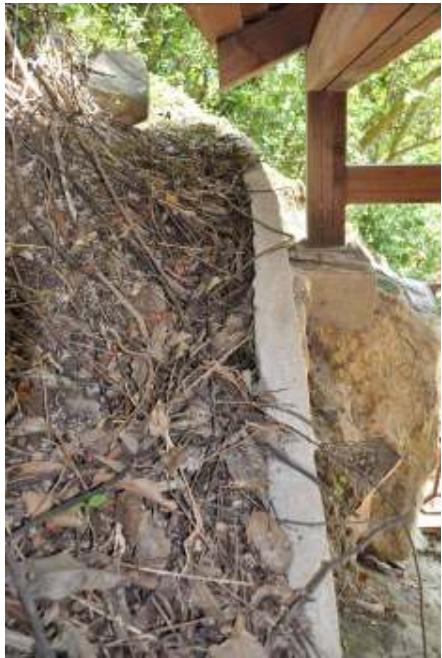
Figure 8. Accumulation of earth and leaves on the channel

Above the cement barrier, the channel is filled with large amounts of vegetation (leaves, branches, soil...). Some water may be overflowing towards the engraved areas, rendering the barrier ineffective.

A possible solution would be to change the channel for a new one. Cement is not an adequate material for a series of reasons. On one hand, it is a material which releases soluble or partially soluble salts (essentially sulphates) which can be harmful to the rock (causing whitish veils which can obscure a surface, or favouring exfoliation and disintegration of the rock through the wetting and drying of the soluble salts). Cement is also inadequate as it will never form a perfect bond with the rock: they have different physical reactions to changes in temperature and humidity, and there are therefore often hairline cracks (or larger visible ones) between cement and stones, allowing for water to penetrate and seep. A new channel could be built using smaller stones from the locality, with a lime-based mortar (using preferably a natural hydraulic lime). On the channel side, the barrier could be covered with a layer of clay (such as bentonite). The clay layer will swell in the presence of humidity, creating a water-proof barrier. This has been successfully used in various heritage sites, including for example the Domus Aura in Rome (GIAVARINI, 2001: 217-228).

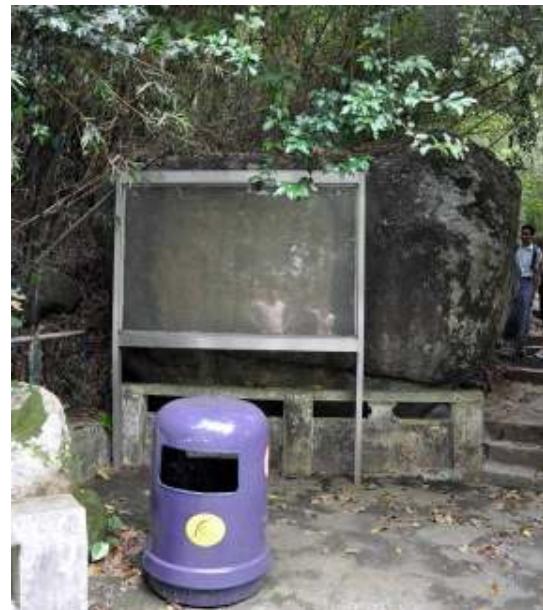
Waste bins have been placed on the path, including one that is currently located in front of inscription.

Figure 14. View of the inscription at Joss House Bay. Note the waste bin located in front of the inscription.

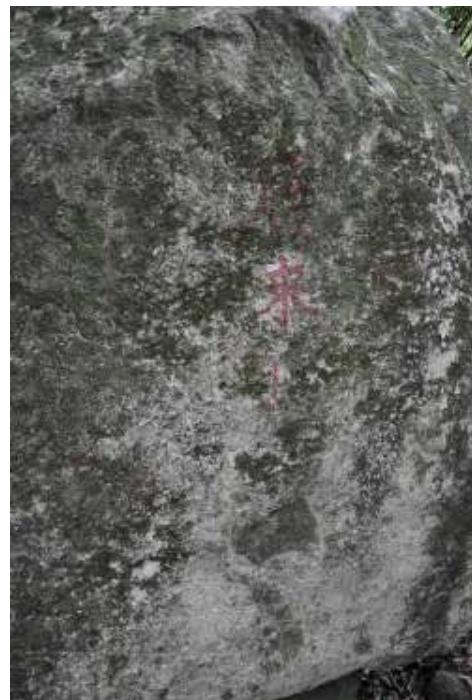
There is a graffiti painted on the side of the boulder containing the engraving. It is always good policy to remove graffiti as soon as possible when they are detected in the vicinity of rock art sites, as there is always a risk for other persons to copy the idea. Although there are not many graffiti visible along the path, I would still recommend cleaning this one in the near future.

Figure 22. Graffiti on the side of the boulder

When doing the cleaning, it will be important to also clean a slightly larger area, in order to avoid having a 'clean' window that would attract attention.

For the cleaning of the graffiti, as it is standard in all cleaning processes, it will be important to test various materials and techniques, starting from the less aggressive ones.

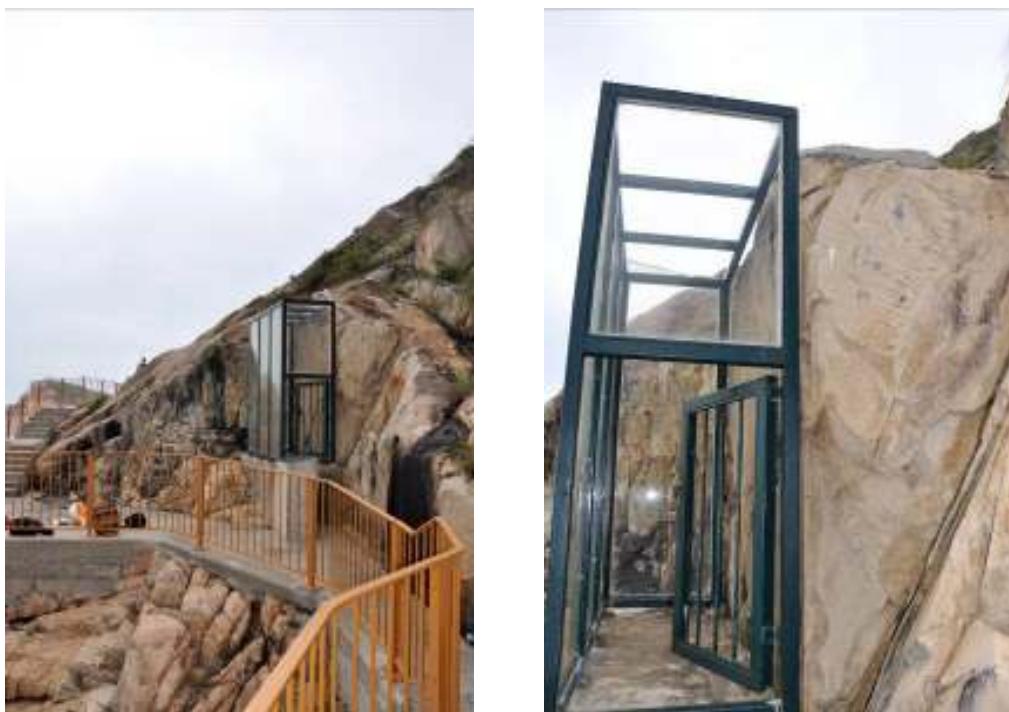
The engraved panel is currently protected by glass panels and a metal structure. There are three front panels, one more on the left lateral side, and half a panel on the right lateral side. The upper panels are either broken or entirely missing, and they may have been broken when a strong typhoon hit Hong Kong in 2008. The lower right side only has metal bars and an access door, which closes with a chain and lock.

Figures 30 and 31. General view of the protective structure for group 1

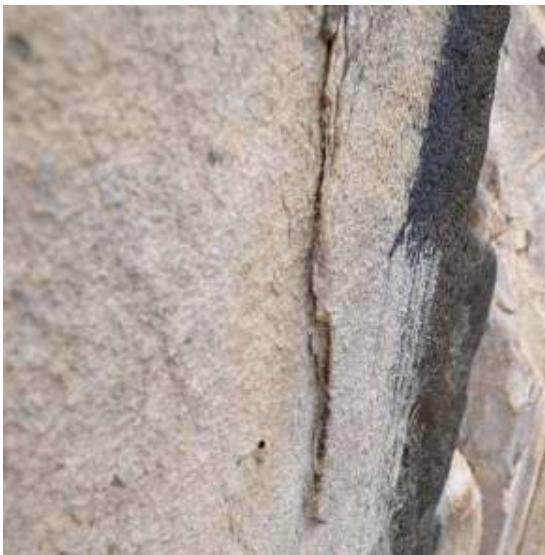
The surface of the granite is stable, but there are some areas which could tend to delamination, and should therefore be monitored.

Figure 44. Detail of areas that should be monitored, to detect any possible risk of delamination

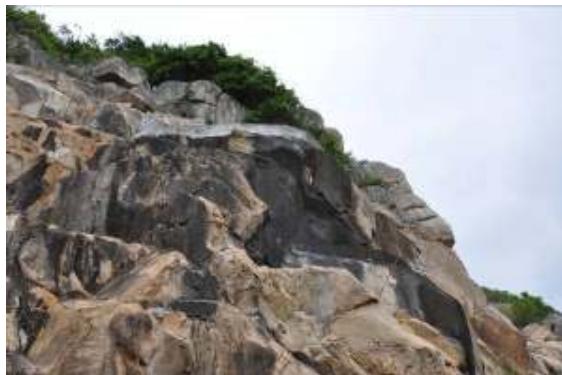
The other one, higher up is not useful: as in other sites, there is a poor contact between the cement and the granite, with clearly visible cracks between them. Water seepage was confirmed by pouring water above the channel during our visit, and within a short time, water was easily passing under the barrier.

Figure 45. View of the upper cement barrier

For group 2, given the number of areas of water seepage above and around the engraved panel, it would be desirable to remove the cement barrier, and replace it with a new one, built with small granite stones and a lime-sand mortar. This new barrier could, as suggested for the site of Shek Pik, be "sealed" above with clay (e.g. bentonite). Its behaviour should be monitored, and periodic maintenance of the barrier would need to be devised.

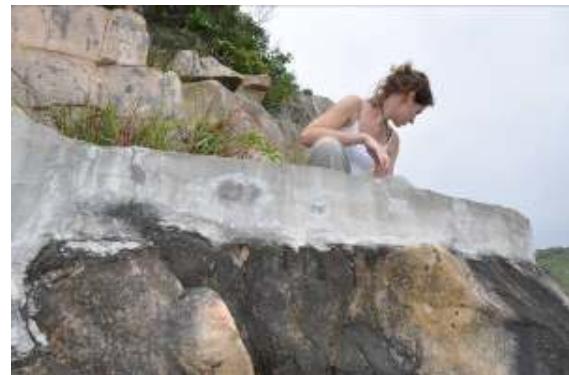
Figure 46. Detail of the cement barrier

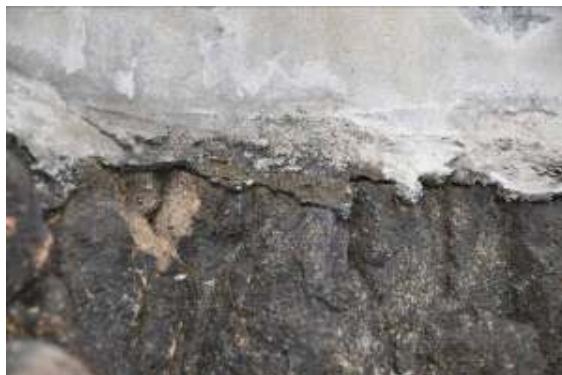
Figure 47. Detail of the poor contact between the cement and the granite

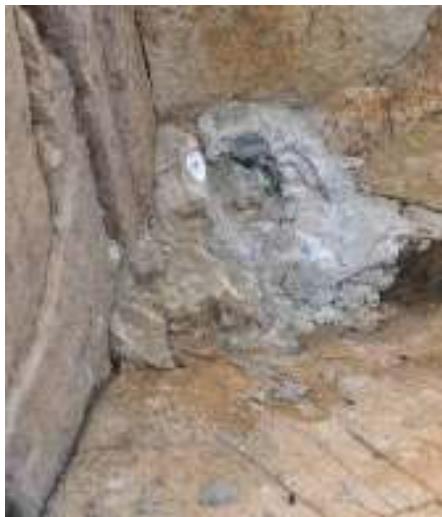
Figure 51. Detail of remains of cement from an older protective structure

Another desired action would be the removal of all remains of cement from ancient protective structures at the site, to make sure the site offer a well cared for image to visitors.

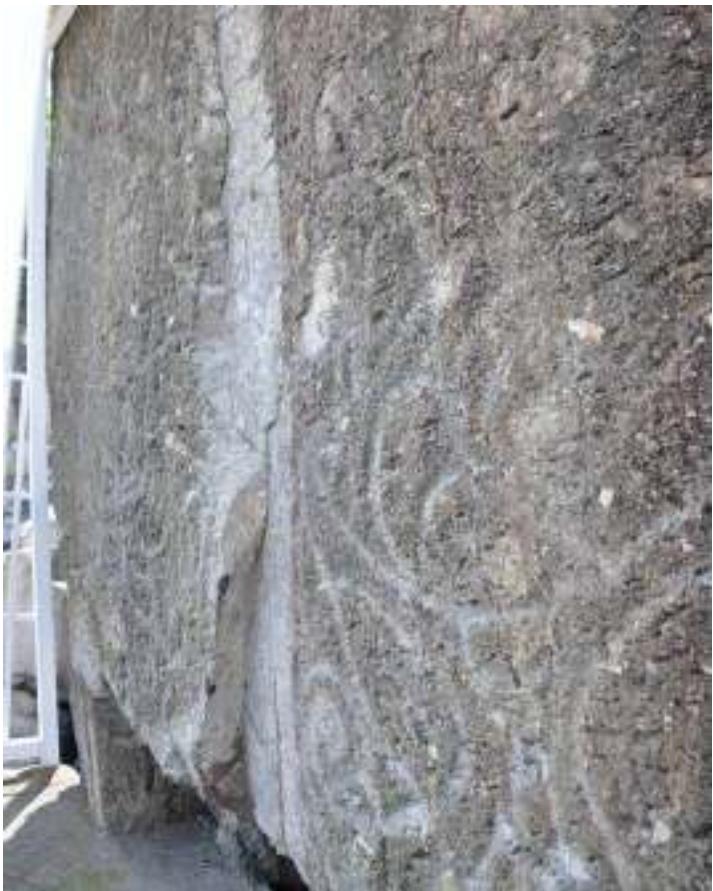
Figure 55. Detail of the engraving

The rock seems stable, but there is a large missing fragment (spalled) in the central part of the panel, corresponding to a fracture in the material (see Figure 55).

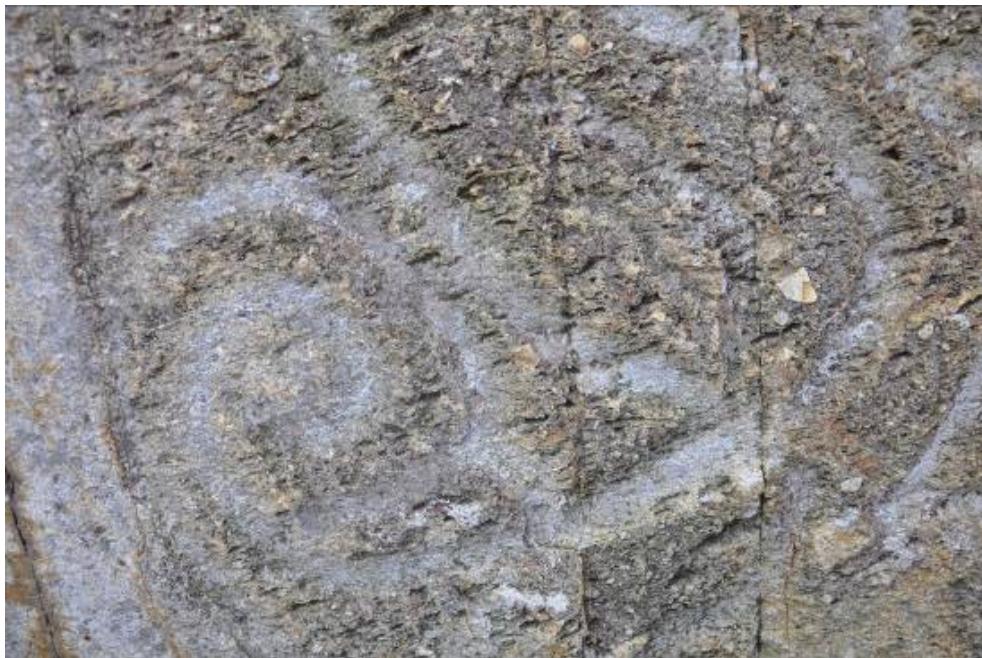
Figure 60. Detail of the engraving and the rock support

The engraving was made on a large block, in one of its vertical surfaces, facing northwest to the sea. The large rock fragment is loose and overhangs under the engraving. The engraving is relatively deep (3-4 mm) on an irregular and weathered surface. The rock is composed by an "euxtatic lapillic lithic and coarse ash crystal bearing fine ash vitric tuff" (Ho and Ho, 2010: 72).

The lower part of the panel has a series of cracked blocks.

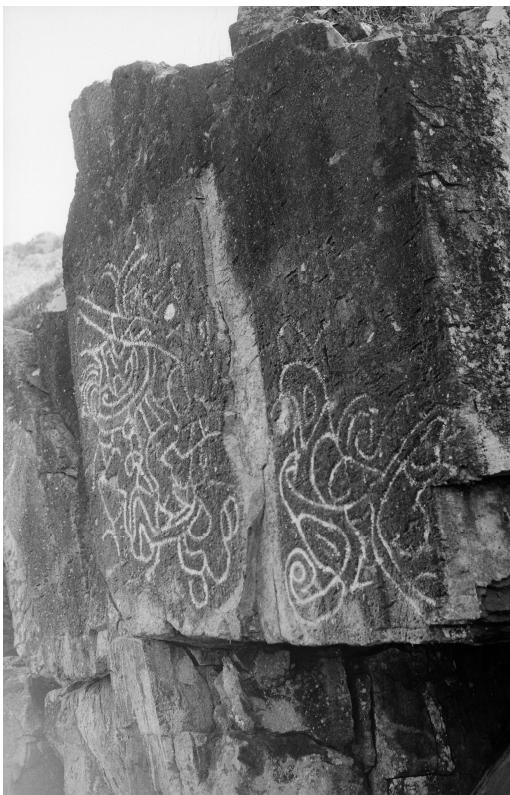
Figure 61. Ancient image of Tung Lung, dating from 1977 (courtesy Government of the Hong Kong Special Administrative Region)

There are visible remains of a greyish material on the engraved areas, on top of which microorganisms have grown. While discussing with the colleagues present during the visit, they mentioned that a cast was made in the past, and this greyish material are remains from the materials used on that occasion. Older photographs also show evidence of enhancement of the engravings with a light materials (possibly chalk) (see Figure 61).

More direct conservation treatments could include cleaning to tests to see the feasibility of removing the material present on the engravings (which could be the remains of a material used during cases made to the engravings, or it could be chalk or gypsum remains, from an ancient enhancement of the shapes).

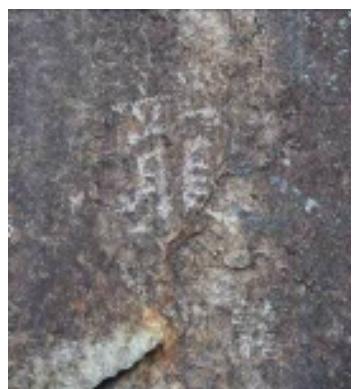
Figure 64. Detail of a crack at the base of the rock, on the left hand side.

A thorough monitoring system should be devised, to control both the condition of the surface of the rock where the engravings are located, as well as the cracks present at the base of the rock overhang, visible both on the front facade and on the left-hand side.

For the surface, the same techniques already proposed for previous sites could be devised. For the cracks on the lateral side, movement sensors could be applied, to verify any movement or widening of the crack.

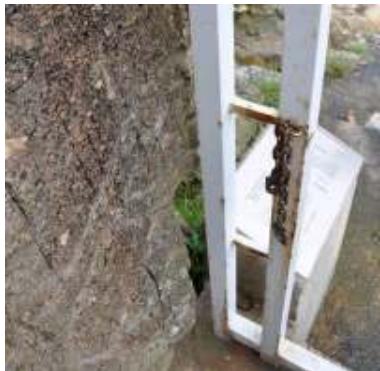
Figure 66. Chain to be removed as soon as possible

The door on the protective structure currently closes with a lock, but there is still a chain from a previous closing system. This loose chain should be removed as soon as possible, as it is long enough to scratch the rock surface, especially in case of high winds.

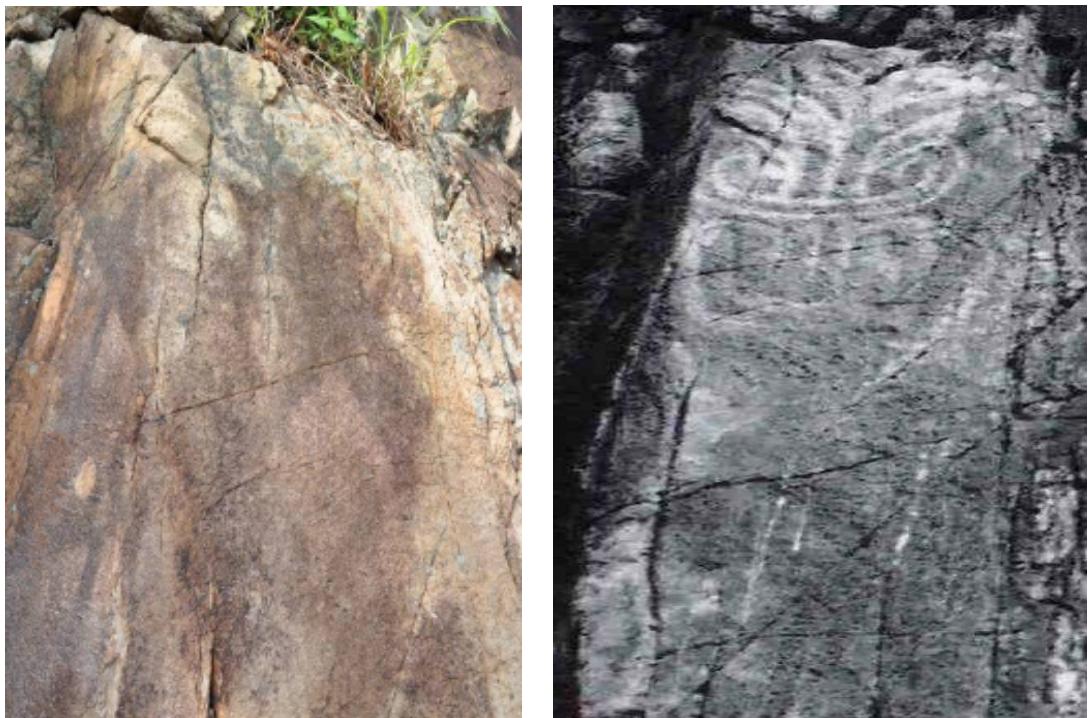
The engraving is not very easily visible, and the lower part seems to have been more weathered. According to the descriptions, it represents a zoomorphic motif. There is a striking difference when comparing the visibility of the engraving nowadays with an image dating from 1977. Is it decay or just less visibility due to a more homogeneous surface colour?

Figures 71 and 72. View of the engraving nowadays (left) and view from a different angle in an ancient image dating from 1977 (courtesy Government of the Hong Kong Special Administrative Region)

This is the site which seems to have suffered most from weathering and decay of the engravings, and although the surface seems stable, a thorough monitoring system should be devised. This will allow a better control and will help indicate whether any active decay is still taking place.

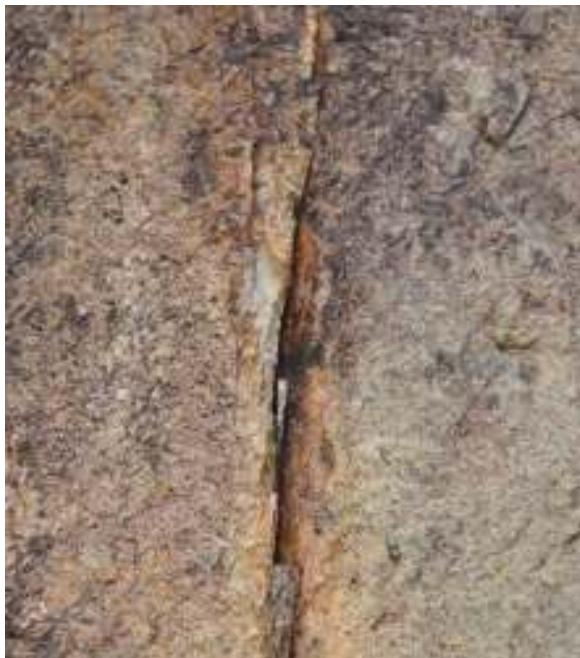
Figure 73. Detail of small scales on a vertical crack

Although the rock seems stable at the moment, there are small vertical scales along some of the vertical and diagonal cracks, which should be monitored. And given the difference between the images shown above, a thorough monitoring of the entire panel would be desirable.

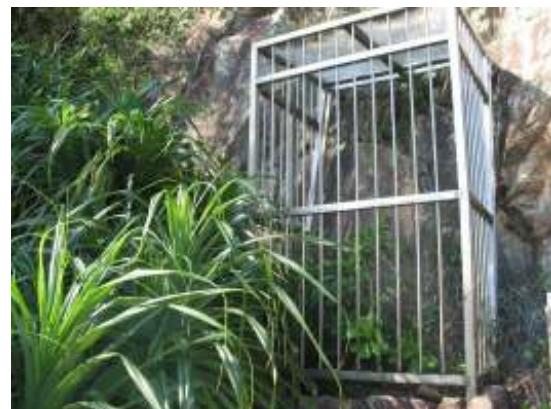
There are various plants growing around the site, notably to the left side, at the ground level, and above the engraving, which need periodic maintenance. Evidence of that maintenance is already taking place is visible in Figure 74, which shows an abundant vegetation growth around the site.

Figure 74. View of the site with overgrown vegetation (courtesy Government of the Hong Kong Special Administrative Region)

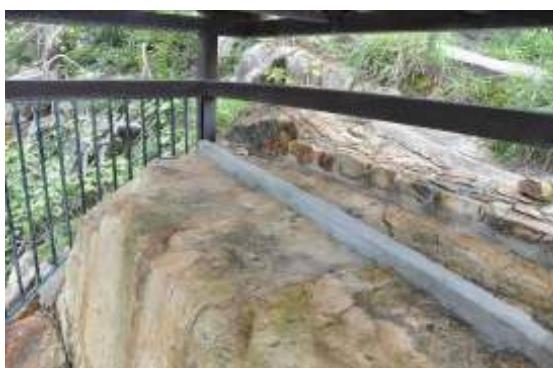
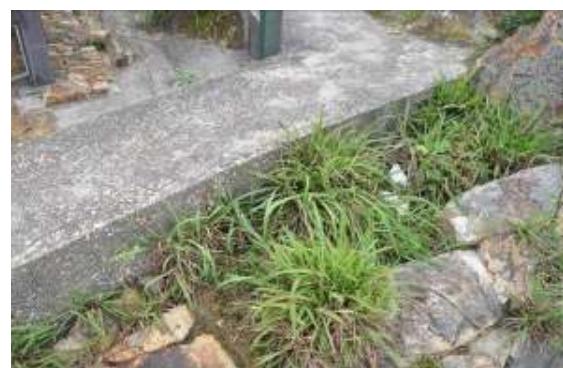
A cement barrier was built in the slope above the engraved area to deviate water. An additional cement barrier was built on a ledge above the engravings. There are numerous areas of water seepage in the immediate vicinity. The barrier around the site has accumulated soil and grass, and will need to be cleaned.

Figures 82 and 83. Details of the cement barrier above the engravings, and the vegetation growth on the channels removing water around the site.

The area in front of the cement barrier above the engraved area has a whitish veil on the surface, which may be composed of soluble salts leaching from the cement. Samples of this veil should be analyzed, and if leaching products from cement are verified to be present, the cement barrier should be immediately removed.

Maintenance should also include the periodic cleaning of the water channels around the site, particularly prior and during rainy seasons.

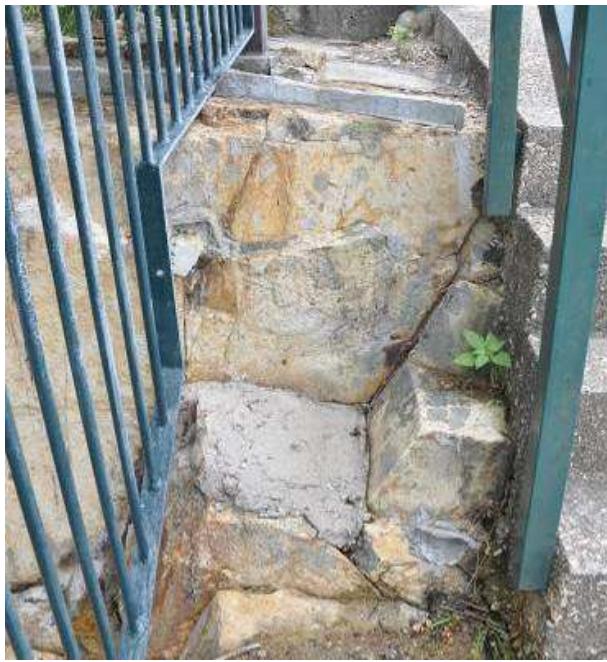
Figure 84. Detail of cement remains at the site, which should be removed.

There are also various areas with cement patches from previous protective structures and signage, and these should also be removed as quickly as possible. On one hand, because of the bad impression they cause on the site, and on the other hand, because they may also be slowly leaching soluble salts which are damaging to the tuff.

Cement and any other evidence from previous protective structures or signage around the site should also be removed, to keep the site as clean as possible.

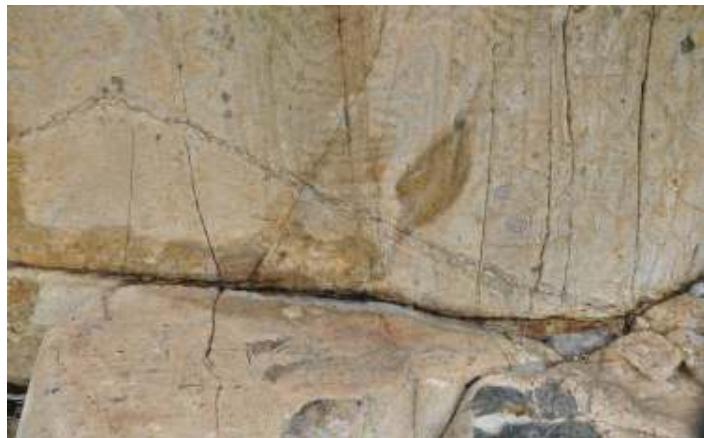
Figure 85. Detail of the lower area of the engravings, with water seepage along the cracks, and cement in the lower area

The overall aspect of the surface seems stable, even if there are various areas of water seepage, keeping the rock surface wet along some of the vertical and horizontal cracks.

There are cement remains at the base of the engravings, and tests should be undertaken to determine the feasibility of their possible removal.

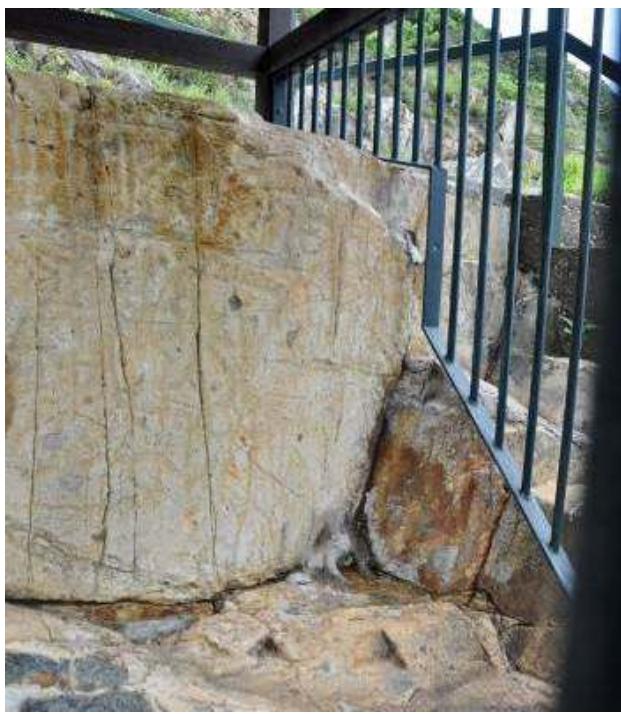
Figure 86. Detail of the right side of the site, with water seeping along a series of cracks

There is also a zone of water seepage on the right-hand side of the engraving. Small plants are growing in this area, which should be removed periodically, to avoid the development of larger plants with roots which could be damaging for the site. There are also some roots on the cracks (possibly from plants which were removed in the past), and these should also be monitored (see Figure 86).

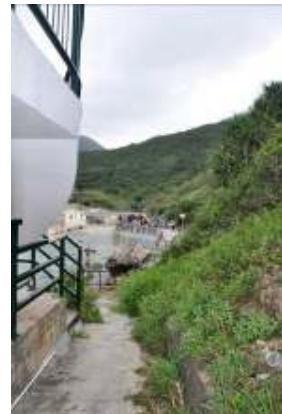
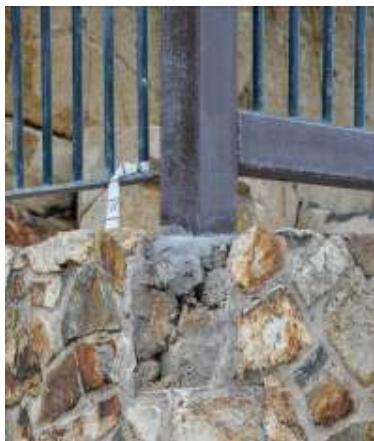
Figure 90. Detail of the corner of the viewing platform, with a missing stone.

A specific repair should also be undertaken as soon as possible, to replace a missing stone on corner of the platform (the could produce a weakness of the structure in case of typhoon).

Another important action is the repair of the missing stone in one of the corners of the viewing platform, to prevent possible further damages.

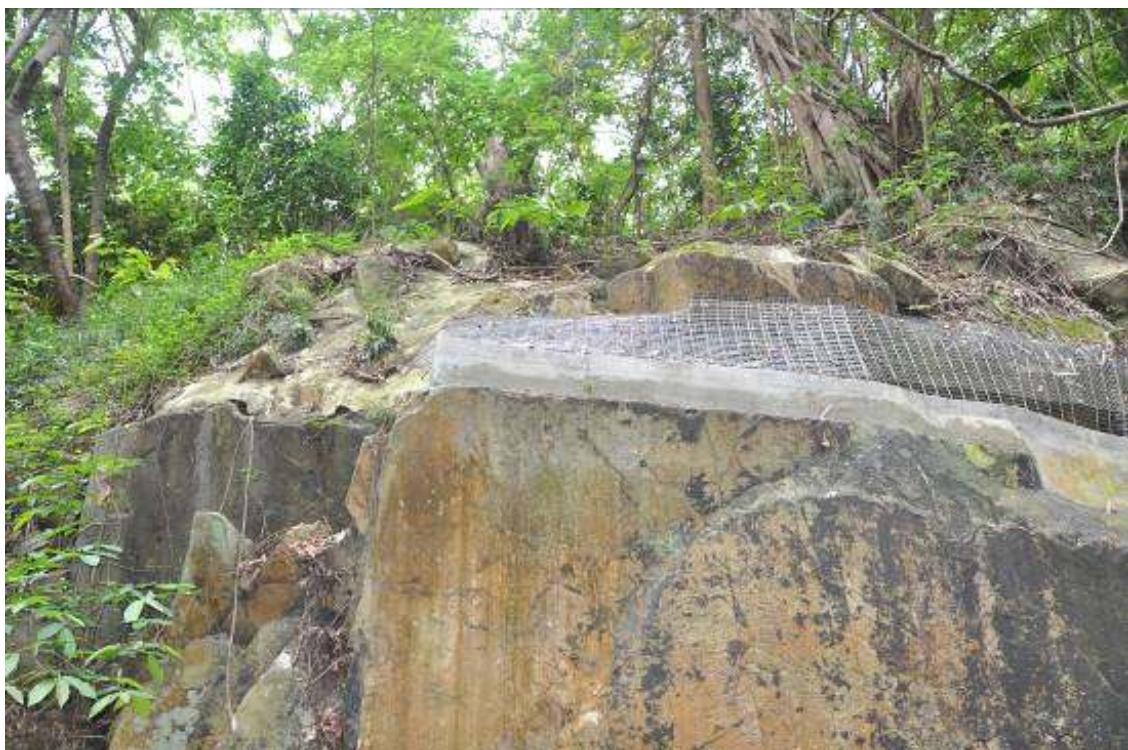
A cement barrier and mesh were placed above the engravings (no date provided) to avoid diminish water runoff on the engraved surface and also to avoid soil and debris getting onto the surface. Although the solution is not very aesthetically appealing, it does seem to be effective.

There is also a capping (possibly cement, but no close observation was done) on both sides of the upper parts of the stream. This capping may have been placed to stabilise the soil in these areas, where settlements used to exist in the past.

Figure 96. View of the cement barrier and mesh place above the engravings, and of the capping covering the upper parts of the stream walls.

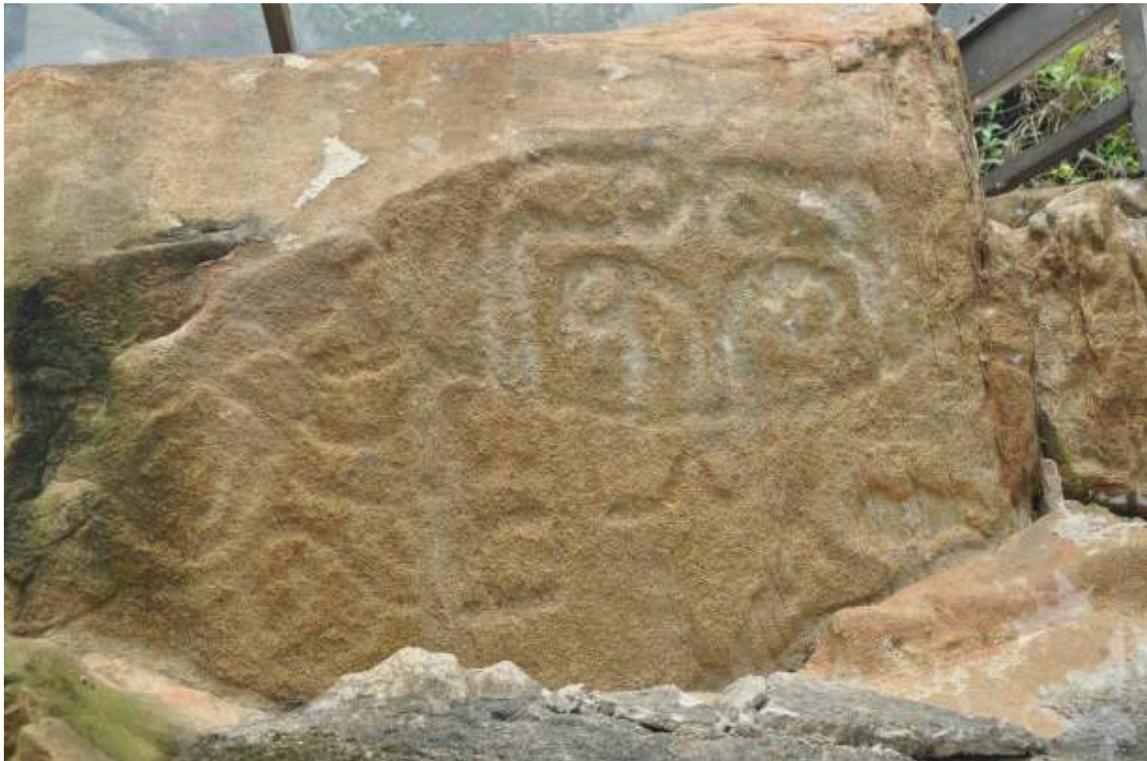
The engravings, located on a vertical surface, consist of two groups of similar design with several carved lines surrounding small depressions. They are clearly visible, and seem well preserved.

Figure 100. Engravings from Cheung Chau

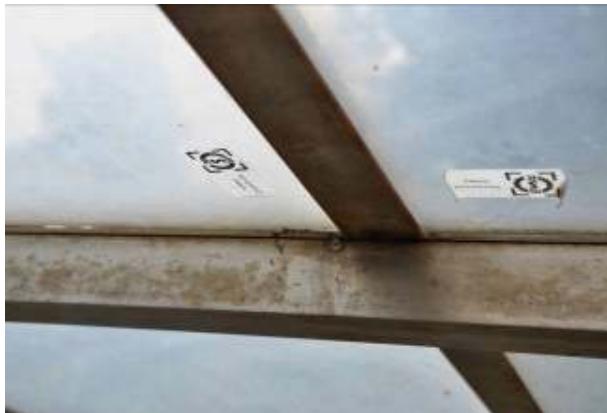
A close inspection of the roof of the shelter also gave evidence of some water going into the site along the large joints. The evidence is provided both by small debris visible on the inner part of the metal structure, and by very clear stripes of microorganisms growth exactly under each roof joint.

Figures 103 and 104. Detail of water seeping from the roof structure (left) and evidence of microorganisms growth under the roof railings

The third action should focus on the roof of the shelter to make sure no more leaks occur. This could either be by sealing the existing joints (for example using a translucent silicone paste) or entirely replacing the Perspex panels. This will require periodic maintenance, to ensure the joints are always tightly sealed, and special inspections prior to, or at the beginning of the raining season.

Solving the problem of water leaking from the roof of the shelter should also be an immediate concern, before the main raining season evolves.

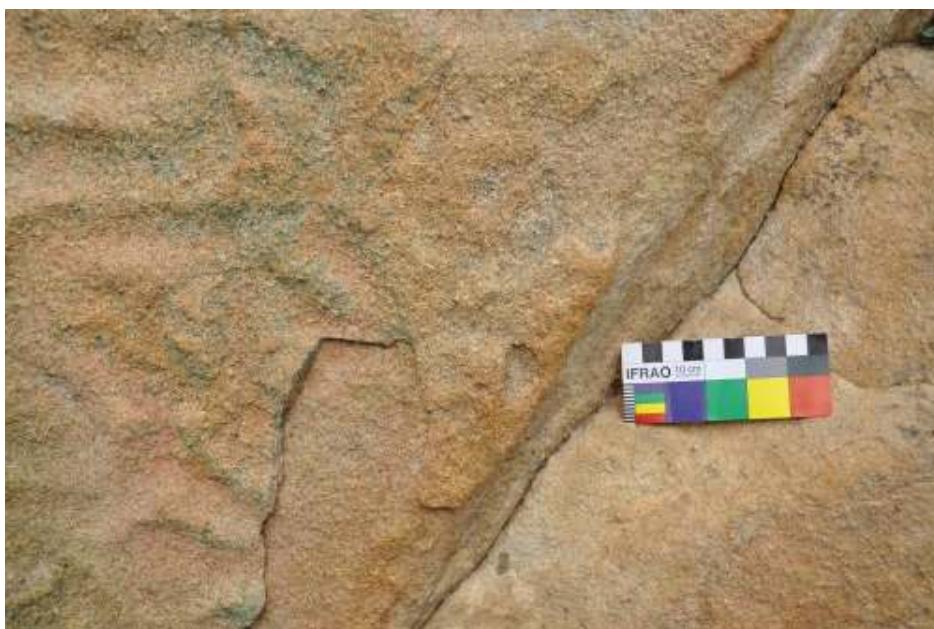
There are small remains of green paint on the stone surface, in the vicinity of the engravings, but it does not seem to be posing a problem, and will probably fall alone with time.

Figure 105. Detail of an area with remains of green paint (especially on the left-hand side)

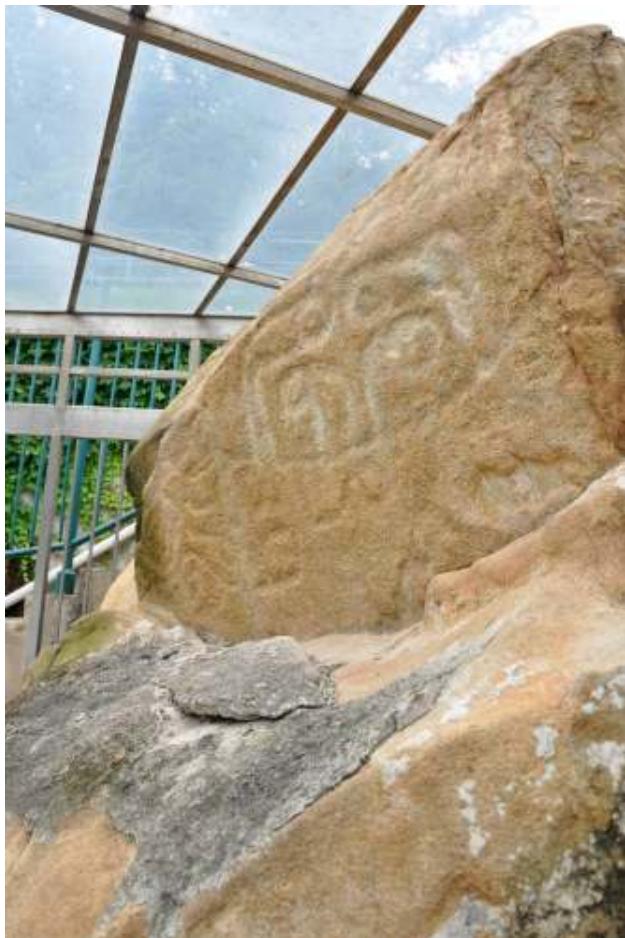
There are some cement remains in the close vicinity of the engravings, which should be removed as soon as possible. This should be a relatively easy task, as the cement is already partially detached from the rock surface.

Figure 106. View of cement at the base of the engravings. A large block is already detached, and other areas sound loose when gently tapping over them.

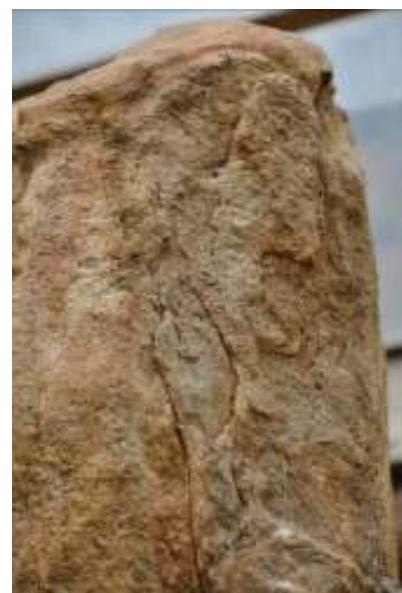
Figure 107. Detail of area to be monitored, on the lower left-hand side of the engraved panel

A periodic monitoring of the surface of the stone should be planned, in a similar manner to what was proposed for Shek Pik. In this case, special focus should be placed on the lower left hand side, where some risk of spalling was detected.

The second action should set in motion the monitoring of the condition of the surface, especially the area where potential spalling has been detected.
