Condition Survey of Nine Rock Carvings

A study of the condition, management and treatments of nine sites within the Hong Kong autonomous boundaries.

Prepared for the
Leisure and Cultural Services Department

December 2009

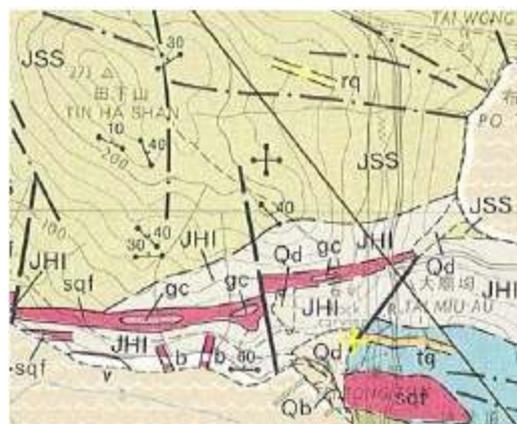
Figure 5 Detail of the geology surrounding the engraved panel at Joss House Bay.

What is clear however is that visual inspection by a non specialist is not very informative and that there is a need to have the rocks accurately classified. The type of rock influences its ability to absorb consolidants and water proofing treatments, and better explains some surface alterations. It would be most beneficial to have a geologist identify the rocks type at each site and prepare fully interpreted thin sections to be kept in the site files.

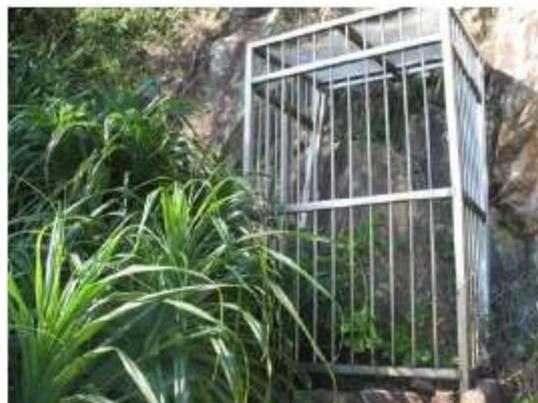
Weeds No weeds encroach into the site however plants growing at the base need to be controlled to avoid abrasion when bigger. Earlier photographs held by client indicate substantial vegetation around engraved panel in previous years.

Biological activity Some of the surface staining is no doubt biological.

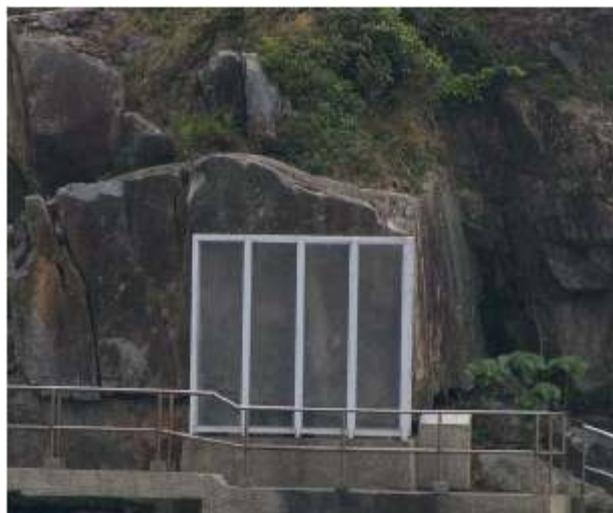
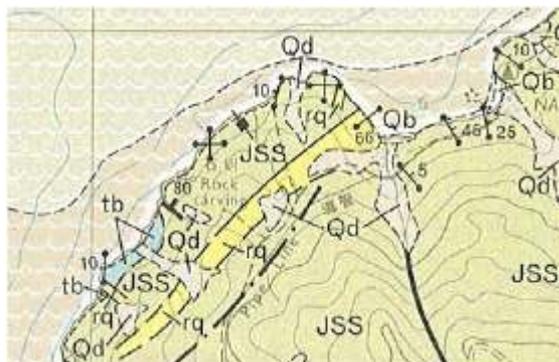
Flat vertical surface facing NW on exposed durable metamorphosed lava or breccia.

Moisture survey No measurements taken but no immediate evidence of water flowing through the stone. Minimal wash over upper edge.

Water wash damage Minimal water flows into the carved area from the outer rim due to the shape of the block that slopes away from the carved face.

Ground erosion No evidence of erosion from the ground. A horizontal fissure below isolates the carved panel from lower ground water influences.

The infrastructure at this site overwhelms the site and its setting. It is recommended that the presentation of this site be reviewed and that this be used as the first site, or perhaps after Po Toi, to implement low impact and low visibility infrastructure. It has been argued that the screen provides some but not substantial protection from the elements and that there are better ways of separating the panels from visitors. In fact this is the perfect site to create separation due to the severe drop between the panel and surrounding rocks.

The adjacent photograph presents the site as it stands. A blue line indicates how the viewing level could be separated by lowering it by a metre and separating the platform from the rock by at least 1.5 metres. Ideally this could be more but is limited by the need to secure the platform to rock ledges below. By lowering and moving the viewing area away from the rock face the severe drop between will prevent touching and visitors cannot approach from below due to the height and angularity of the natural rock. Under this recommendation the screen should be removed and all the concrete steps going further to the right.

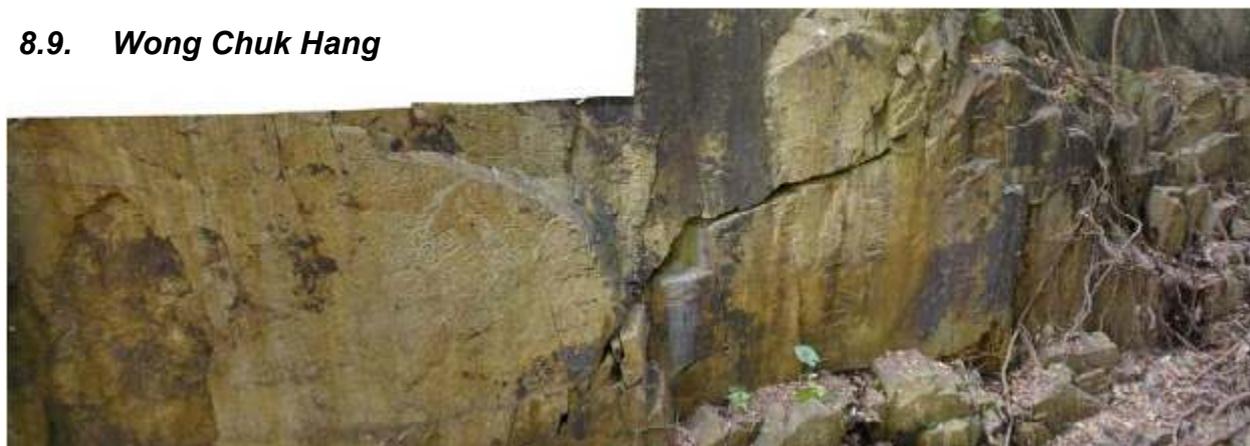
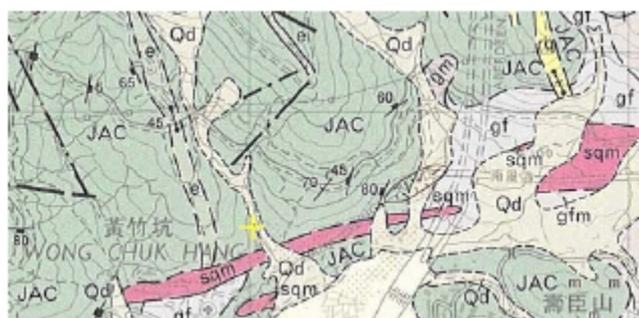
8.9. Wong Chuk Hang

Morphology Vertical cliff wall.
Description, brief Engraved geometric forms on vertical cliff face.
Visit dates 07 11 2009, 04:21
Survey team Andrew Thorn, Eddy,

Moisture survey No measurements taken but evidence of water wash down the south end of the rock away from engravings. Dam above appears to deflect most water from hill but is clearly leaking in the southern section.

Water wash damage Water washes down from the 8 metre vegetated slope above. The current dam intercepts most of this.

Rock stability Rock appears moderately stable but there is some degree of friability in the outer altered surface. There is no urgent need to consider consolidation of this surface but its condition needs to be monitored.

Biological activity Strong biological staining in some places but less apparent in engraved areas. These have received water repellent. Surface had stronger presence of green algae before treatment.
