BUILDING

3.1 Architectural evolution

3.1.1 The former Royal Hong Kong Yacht Club (1908-1938)

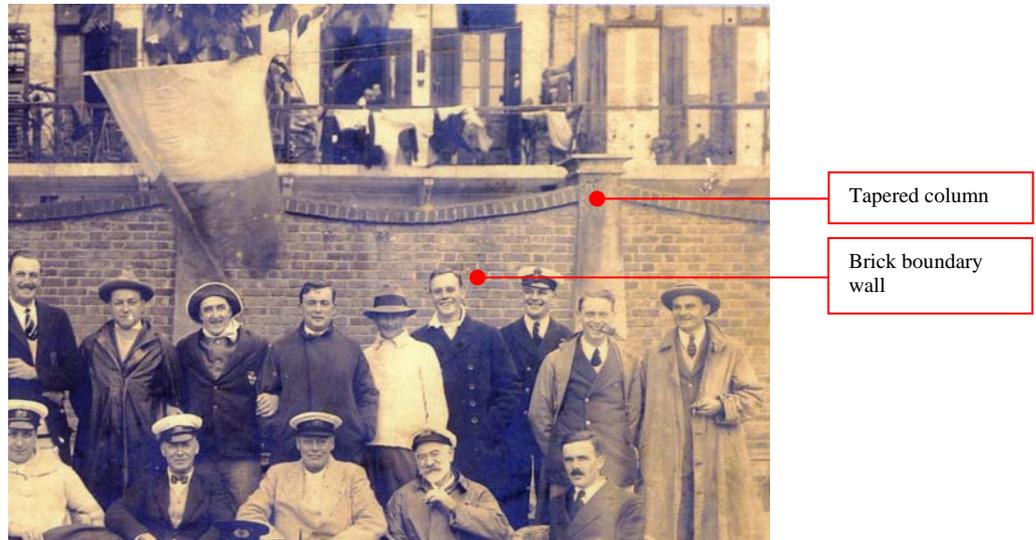
Fig. 81. Brick boundary wall of the former clubhouse.
(from Gillian Chambers, *Eastern Waters, Eastern Winds, A History of the Royal Hong Kong Yacht Club*, p. 49.)

Another old photo with the boundary wall as background showed clearly the composition of the boundary wall (Fig. 81). It was a wall with tapered columns at intervals. Between the columns were brick walls with the edge slightly curved downwards. Those columns appeared to be of the same style as the columns found at the former entrance porch of the clubhouse and the former entrance gate at Annex A nowadays (Fig. 82).

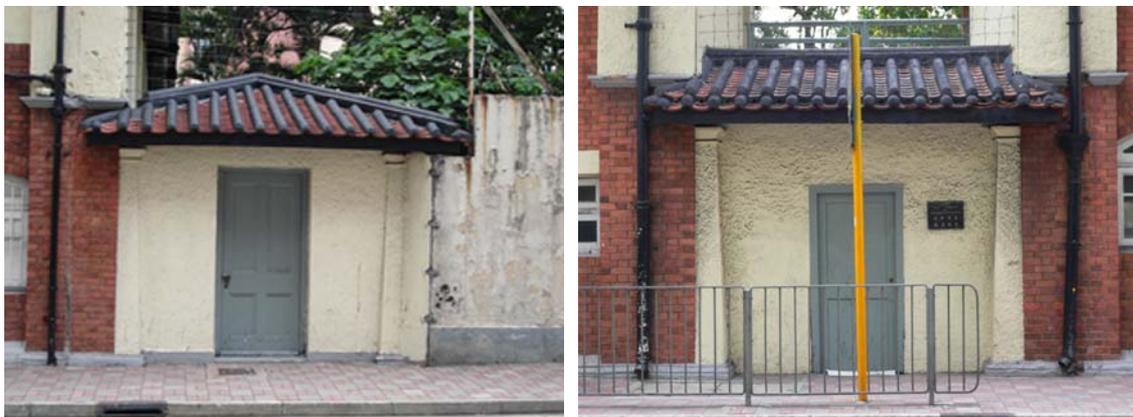
Fig. 82. The former entrance porch of the clubhouse (left) and the former entrance gate at Annex A (right) in 2008.

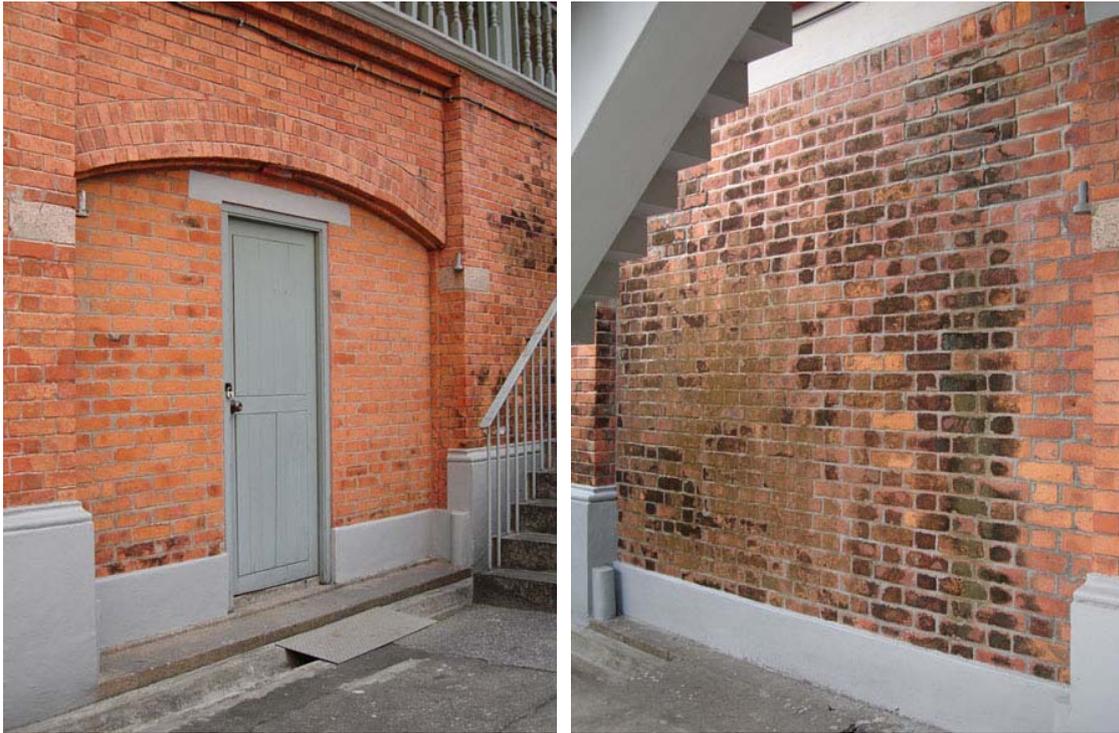
Fig. 93. Blind-arch with later added door (left) and infilled doorway (right) at RM 4 of the main building.

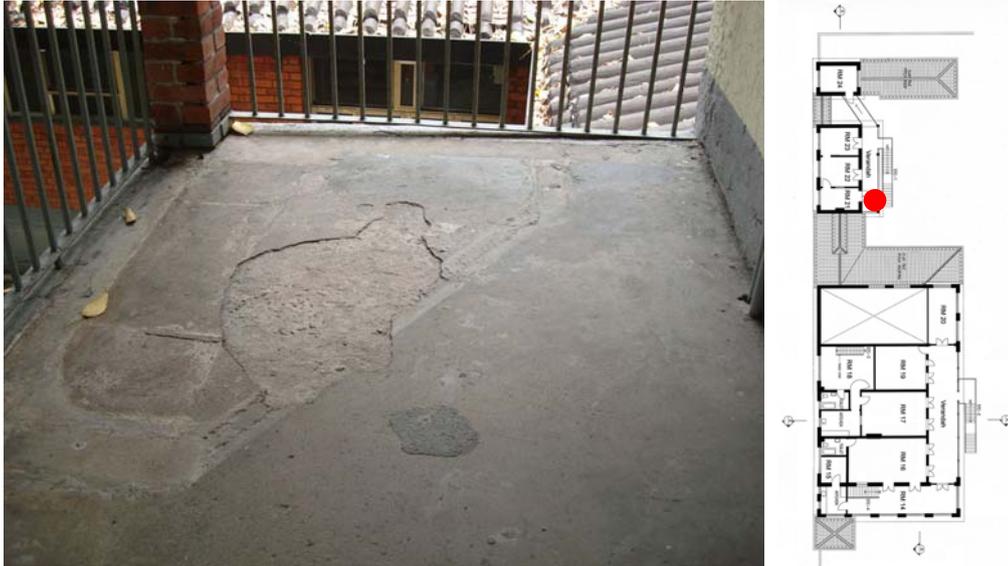
Fig. 98. Traces on the floor of the verandah on the first floor of Annex A giving evidence of the kitchen once located here.

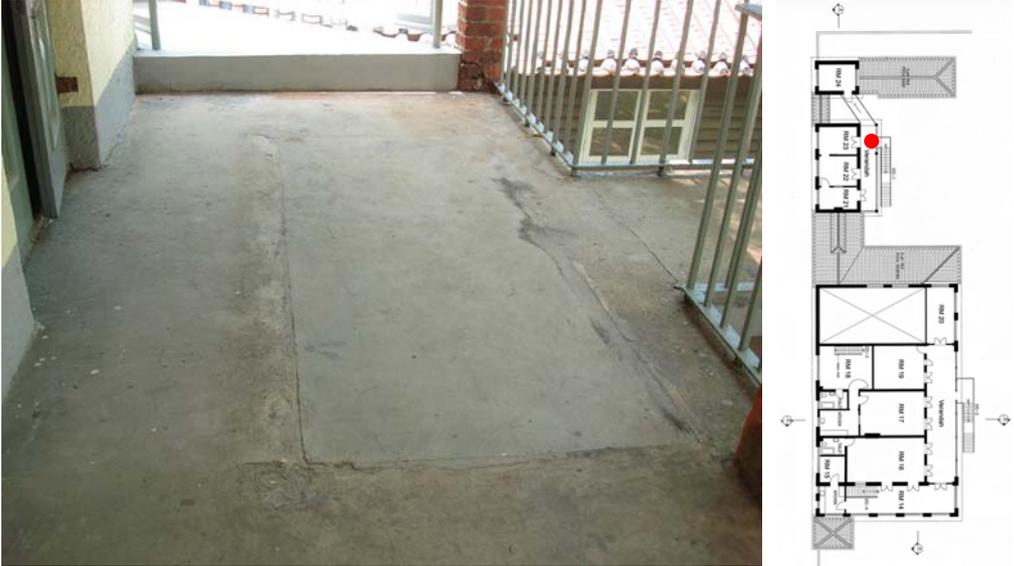
Fig. 100. Traces showing the location of the existing concrete staircase at the verandah on the first floor of Annex A.

The existing stair well shown in the drawing also reflected that there was a staircase located at the verandah in 1975, instead of outside as it is nowadays (Fig. 97). Traces can be found at the floor of the verandah and the ceiling of the arcade below (Fig. 100 - Fig. 101).

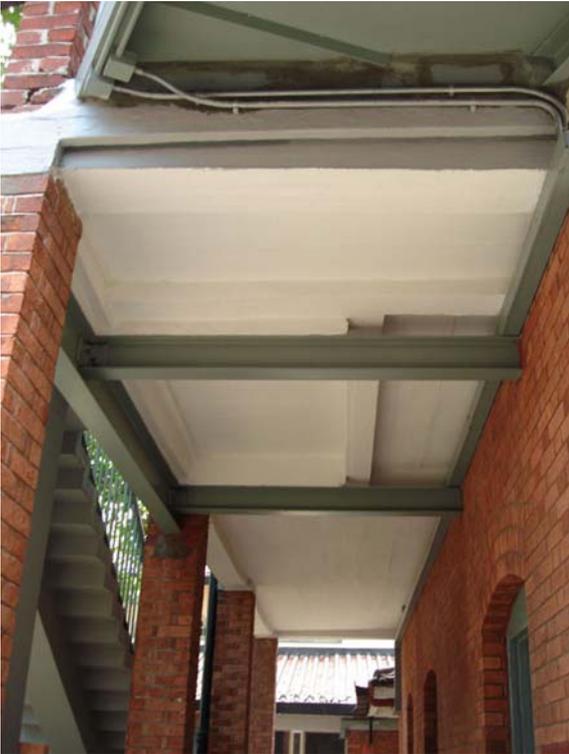
Fig. 101. Traces of the stair well from the ceiling of the arcade below.

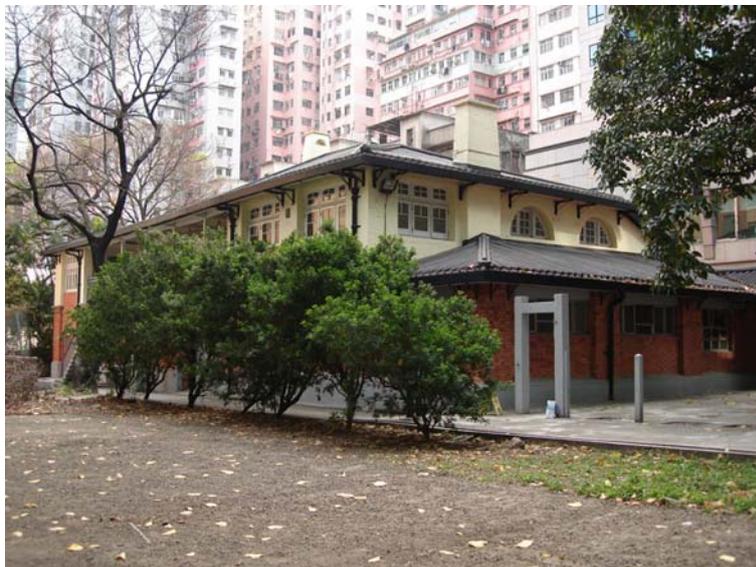
The former clubhouse was used as the store for the Antiquities and Monuments Office before it is now vacated (Fig. 112). The brickwork of the main building is restored to its natural colour, while the downpipes are restored back to the original black colour, with the renovation date unknown. The verandah is re-opened up with the windows removed.

Fig. 112. The main building in 2008.

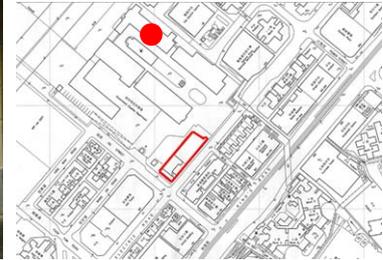
The block built in 1939

Fig. 114. Government stores.

Today, some parts of the government stores dated back to 1939 still remained at the site (Fig. 114). The former clubhouse is further surrounded by highrises (Fig. 113). To the northeast, the Electric Road Municipal Services Building was built probably in 1993 with a footbridge across

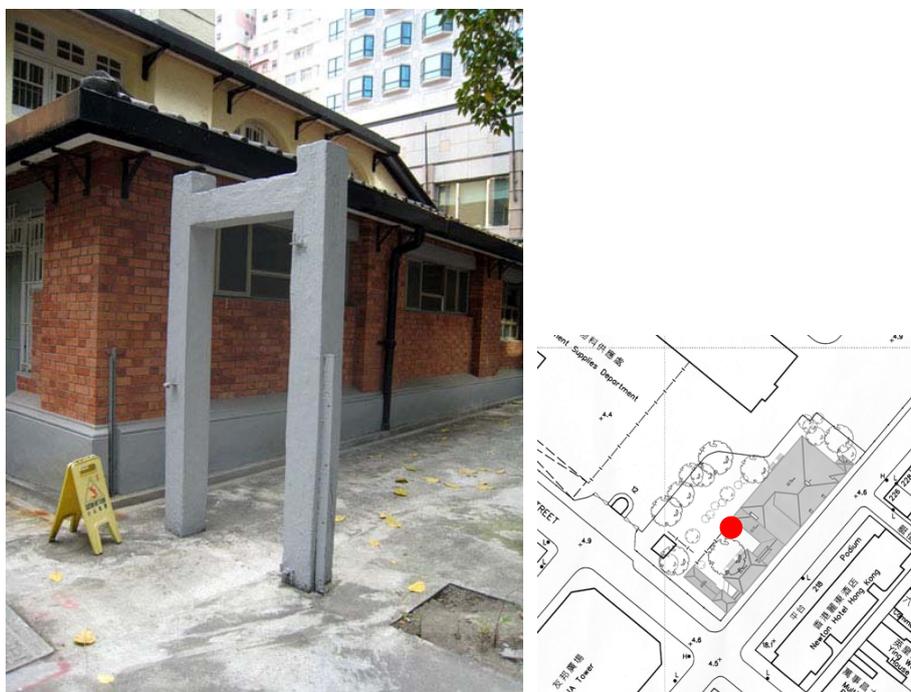
Fig. 127. Gate to the court.

The court at the rear of Annex A is roughly a rectangular court surrounded by the main building, Annex A and Annex B (Fig. 126). It was once enclosed by fence at the rear of the court, where the concrete gate and posts for the enclosure are still remained nowadays (Fig. 127). There is a row of 9 tree pits, with only one tree left (Fig. 128). There is an octagonal planter at the centre of the court with a tree planted in it (Fig. 129).

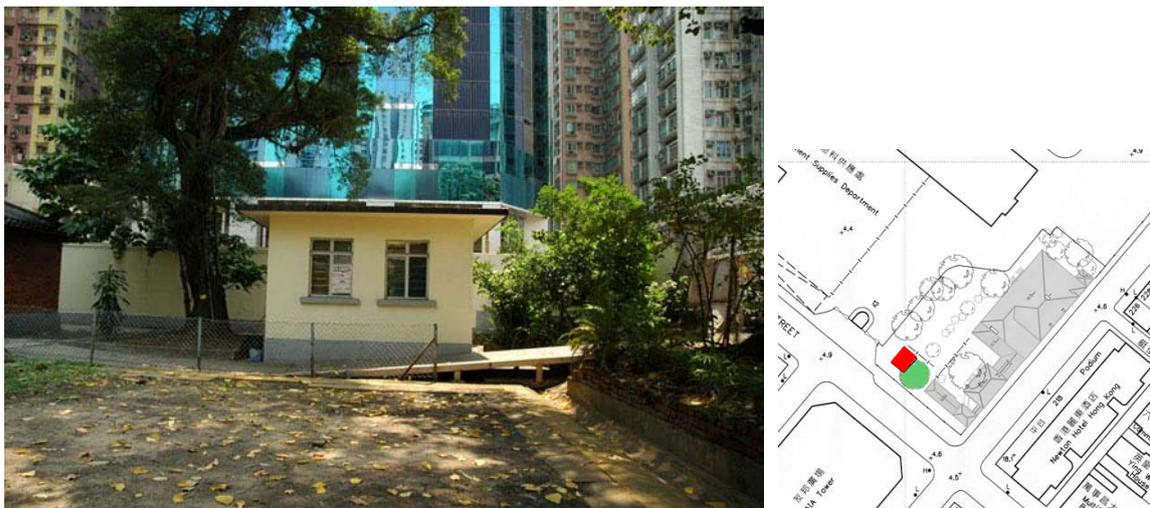
Fig. 137. General view of the square guard house.

The square guard house is located at the south west of the site facing towards the lawn (Fig. 137). It is a square block built of concrete with a flat overhanging roof, which appears to be a modern addition to the site at an unknown date probably after 1950s.¹⁵⁶ There is an old tree adjacent to the square guard house. It is an old *Ficus microcarpa* 細葉榕 (Chinese Banyan or Small-Leaved Banyan) which is considered as a potential valuable tree subject to LCSD's future evaluation.

¹⁵⁶ From the old survey map of 1956, the square guard house is still absent. See Fig. 85.

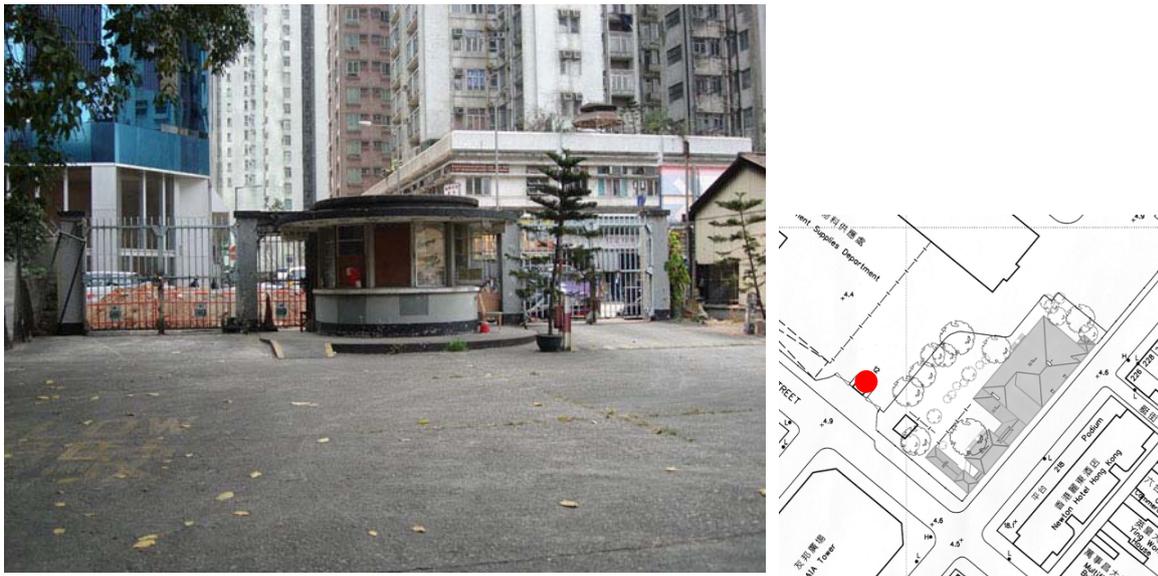
Fig. 138. The semi-circular guard house at the entrance of the site.

The semi-circular guard house is located at the north west of the site which is at the entrance to the site (Fig. 138). It is flanked by two metal entrance gates. The guard house faces towards the Government Supplies Department which used to be the guard house of the department probably built in the late 1950s. It is built in the modern International style features a semi-circular plan, built of concrete with the curved façades enclosed by metal-framed windows, and with a flat roof with deep overhanging eaves. The rear of the guard house is a wall with the inscription of the Government Supplies Department in both Chinese and English (Fig. 139).

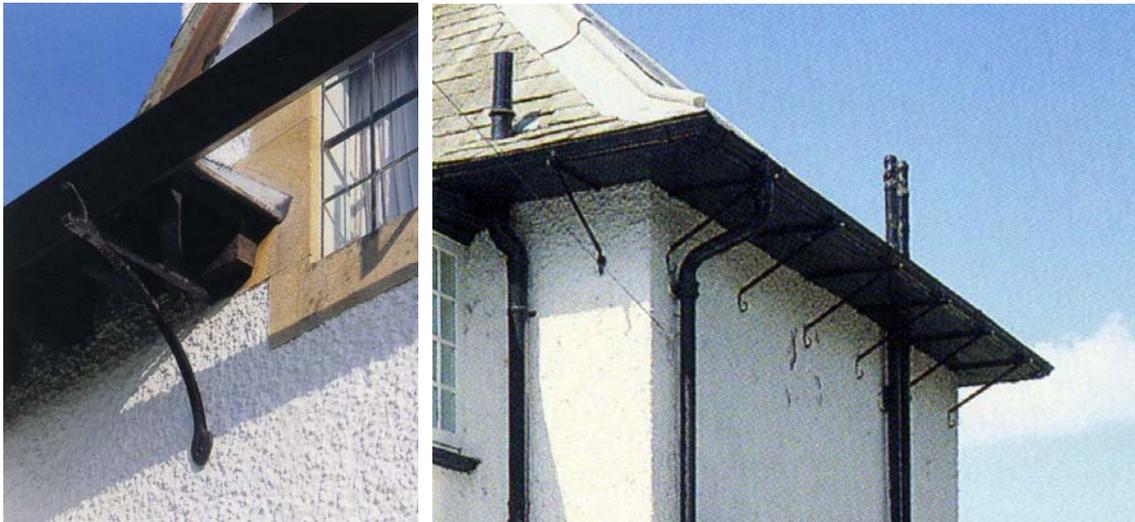
Fig. 147. Close up of the brackets at the Homestead (left) and Perrycroft (right).
(from Hitchmough, Wendy, *CFA Voysey*, 1992, pp. 77, 168.)

Another influential figure of the time was C.F.A. Voysey (1857-1941), an English architect who received great influence from William Morris. His design mostly adopted roughcast wall (Fig. 144 - Fig. 146), with brackets supporting the eaves of the roofs or gutters along the eaves (Fig. 147), and the black-painted water downpipes (Fig. 148). Some of his works also showed tapered chimneys (Fig. 145 - Fig. 146). In particular, the kind of design which combined windows and glazed doors were popular in the Arts and Crafts Movements, which could be reflected in the interior design of Voysey (Fig. 149).

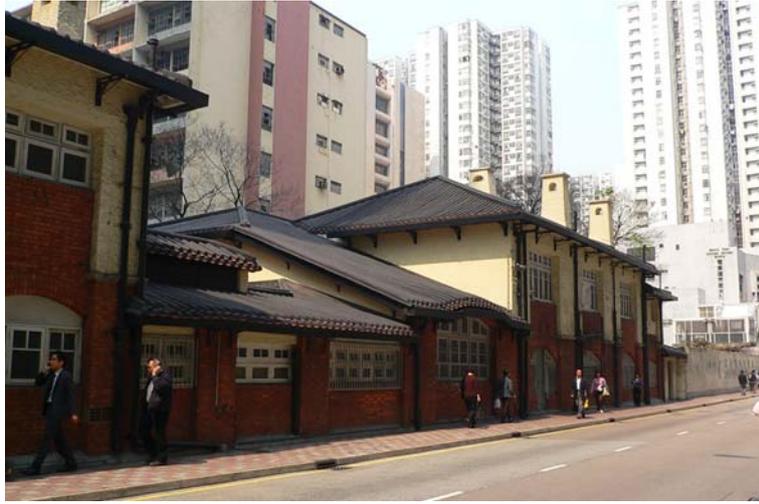
Fig. 152. The multiple roof forms of the former clubhouse at No. 12 Oil Street.

Arranged in a linear manner, the multiple roof forms of the main building and the annexes constituted a very interesting elevation to the building compound (Fig. 152). The roofs are mainly hipped roofs, with pitched roof, pyramidal roof and other irregular roof forms are adopted. One particular interesting roof form is the roof above RM 6, which curved near the eaves following the segmental arch curvature of the window below (Fig. 153). Iron brackets are found all along the eaves of the roofs (Fig. 154).

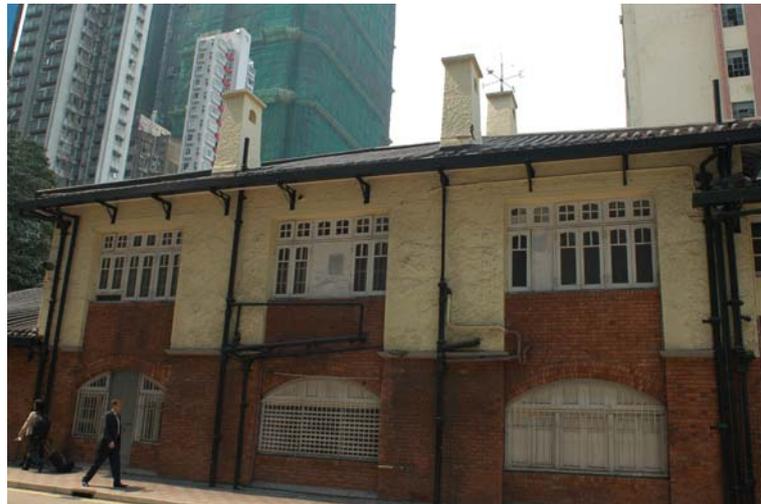
Fig. 155. Front façade of the former clubhouse at No. 12 Oil Street.

The most eye-catching part of the former clubhouse is the red brickworks contrasting to the roughcast wall, separated by stringcourses (Fig. 155). This seems to be a combination of the two most favourite wall surface treatments during the movement. The craftsmanship of the brickwork is further emphasized at the columns of the arcade at Annex A, which are not covered by plaster (Fig. 156).

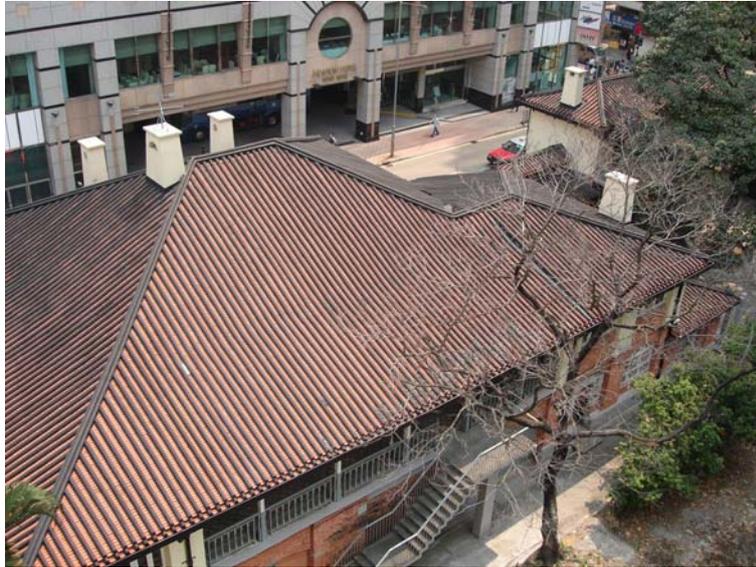
Fig. 157. Hipped roof of the main building.

The roofs are constructed with double-layered Chinese pan and roll tiles, which showed an adoption of the local traditional materials and building technique (Fig. 157 - Fig. 158).

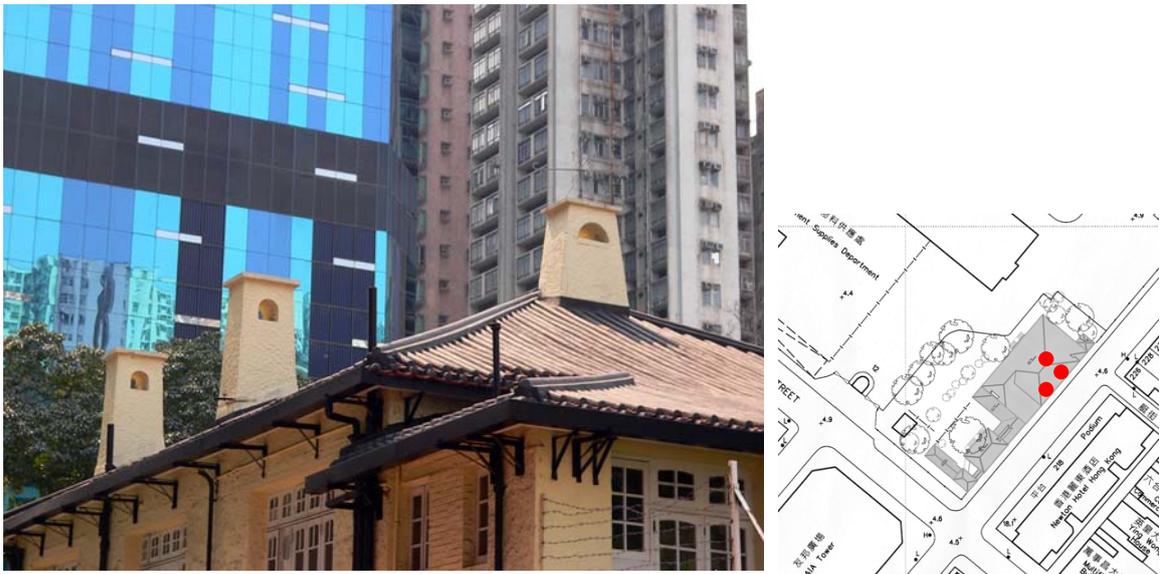
Fig. 159. Chimneys at the main building.

Prominent chimneys are found at both the main building and Annex A. There are four chimneys at the main building, with one of which's opening blocked (Fig. 159 - Fig. 160). The chimneys are of different size, with different form of openings and tapered with different gradient, which intended to avoid regularity in their design. Semi-circular and semi-circular arched openings are adopted with brick surrounds. There is only one chimney at Annex A, slightly tapered, but with simpler rectangular openings (Fig. 161). The tapered design might have referenced to the design by C.F.A. Voysey.

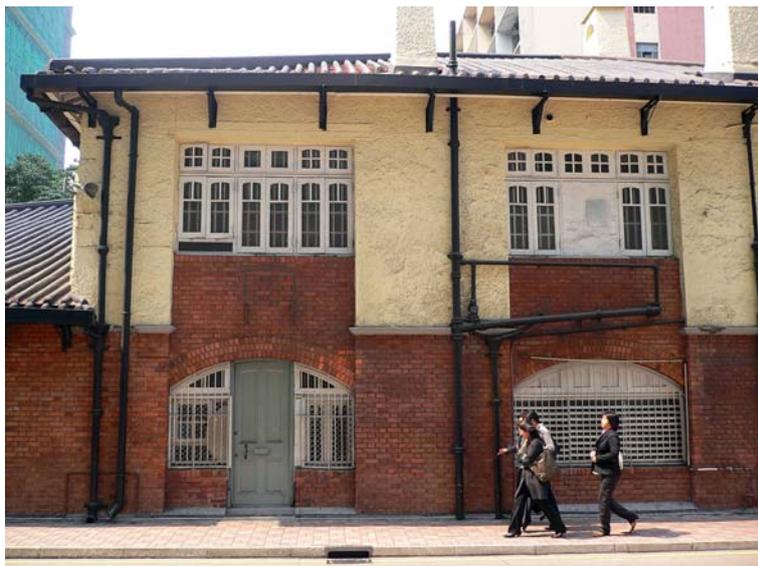
Fig. 162. Black-painted downpipes on the front façade of main building.

There is a number of downpipes on the wall surfaces of the building compound, with a considerable amount of the iron downpipes of earlier dates retained (Fig. 162). Those possess hopper heads and pipe brackets with fine details (Fig. 163). There is no concrete evidence of the exact period those downpipes were belonged, but believed to be from a much earlier period either the time when it was used as the clubhouse or when it was converted into a staff quarters during 1930s.

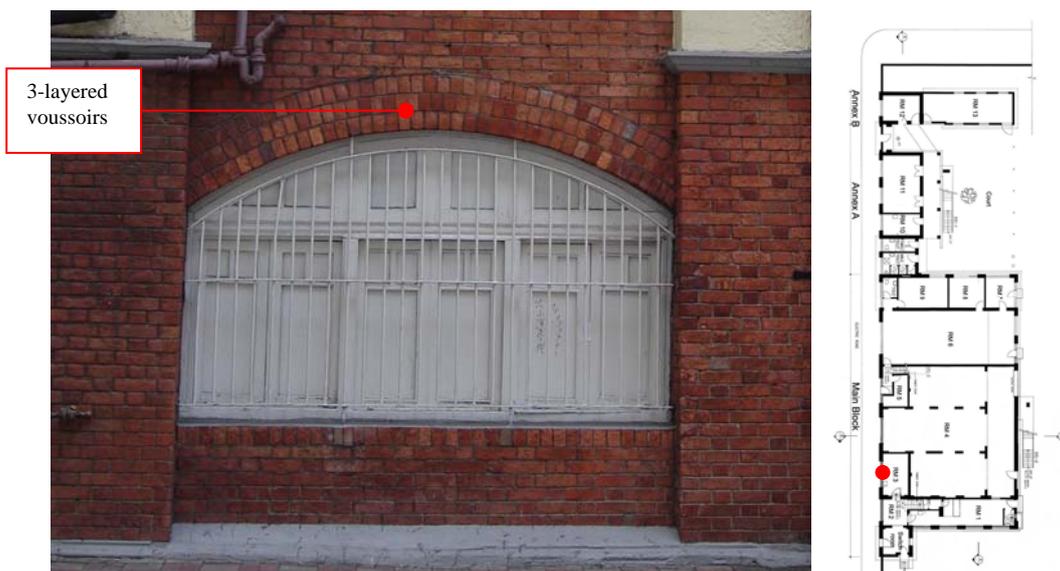
Fig. 164. Segmental-headed windows on the front façade on the ground floor of the main building.

The segmental-headed windows and doors are other important features to the buildings, which echoed with those widely used by Philip Webb. The details around the windows are emphasized with the three-layered voussoirs (Fig. 164). Apart from the doors and windows, segmental archways are also found at RM 4 on the ground floor (Fig. 165). Even the timber window glazings are segmental-headed (Fig. 166).

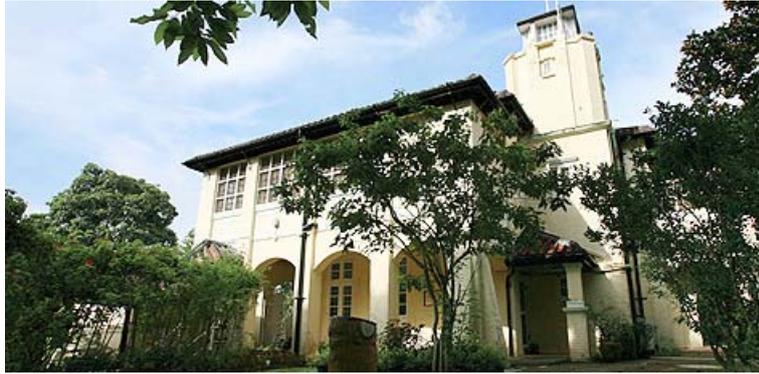
Fig. 169. Island House.

Island House has a much simpler form with a 2-storey building with a tower (Fig. 169). The wall is plastered, with mouldings on the first floor, which is more decorative comparing to the roughcast wall and the red brickworks of the former clubhouse (Fig. 170). There are buttresses supporting at the piers of the archways at the verandah on the ground floor, which may be influenced from the design of C.F.A. Voysey which is not present in the former clubhouse.. Mainly built of Arts and Crafts style, the building also shows some influence from Art Deco at the owner, whereas no other significant style can be found at the former clubhouse.

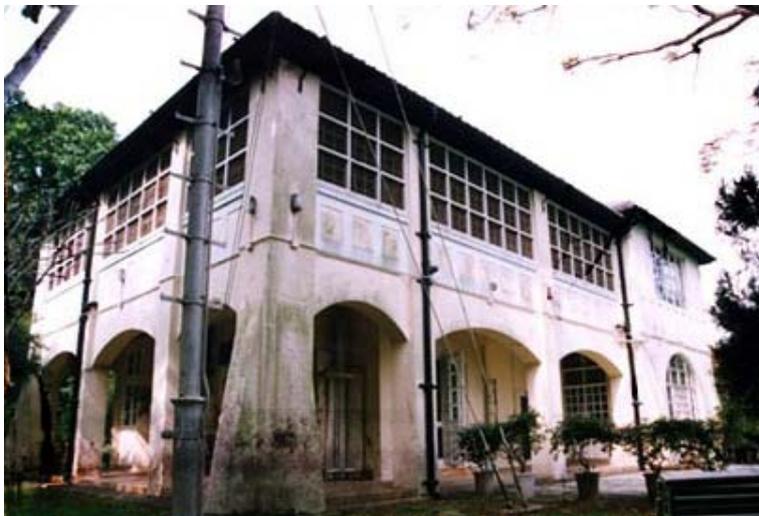
Fig. 170. Overview of Island House.

Same as the former clubhouse, the roof at Island House is covered with Chinese traditional pan and roll tiles, with the eaves supported on brackets. Segmental and semi-circular arches are found with layers of voussoirs (Fig. 170). Prominent downpipes painted in black are found on the building façades

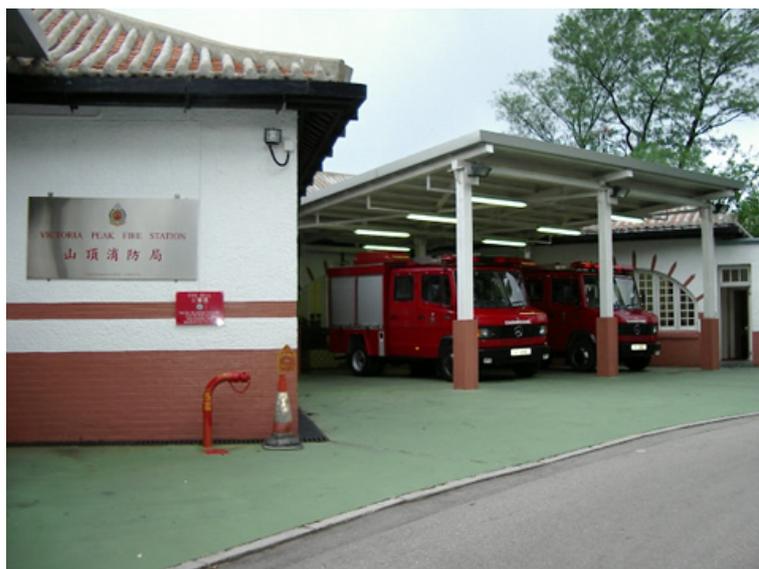
Fig. 171. The Victoria Peak Fire Station.
(From Fire Services Department, The Government of the Hong Kong Special Administrative Region, website:
http://www.hkfsd.gov.hk/home/images/station_photo/hk/vp.html.)

Similar to the former clubhouse, the hipped roofs at the fire station are traditional Chinese pan and roll tiles, with the eaves supported on brackets (Fig. 171). The wall surface is mainly roughcast in white with brickworks exposed at the lower portion. The semi-circular arches at the windows and doors are found with voussoirs highlighted at intervals (Fig. 172).

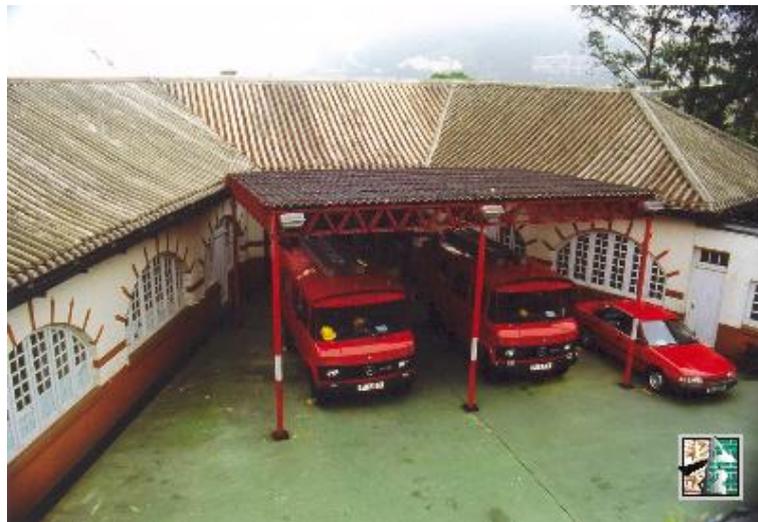
Fig. 173. An overview of the Victoria Peak Fire Station.
(From Antiquities and Monuments Office, *Former Peak School [AM90-0453]*,
website: http://www5.lcsd.gov.hk/gishinter/html/viewer_en.htm.)

The fire station is of 1-storey high with a U-shaped plan. Unlike the former clubhouse, it is not breakdown into several buildings but comprises one volume (Fig. 173).

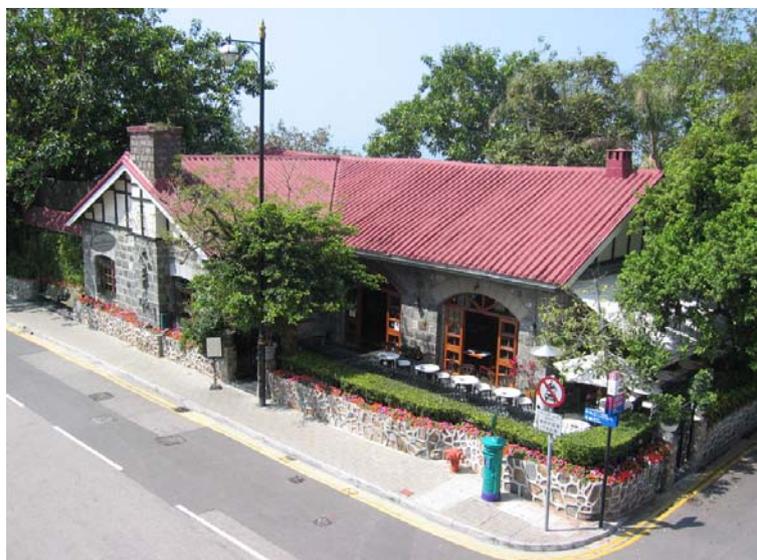
Fig. 174. Overview of Old Peak Café.

Unlike the former clubhouse, it is a single-storey building with an L-shaped plan which does not breakdown into several buildings (Fig. 174). Stone is used as the building materials instead of brick, and the rustication of stone masonry is demonstrated on the wall surfaces. The surfaces of the gables are roughcast with stripes reminiscent of the half-timber structure in England (Fig. 175).

Similar to the former clubhouse, the roof is covered with traditional Chinese pan and roll tiles with eaves supported on brackets (Fig. 174 - Fig. 175). Prominent chimney is found on the main façade, with the shaft observed at the interior of the café. Segmental arches with voussoirs are found as window and door openings all around the building. In the interior, the roof structures are exposed (Fig. 176).

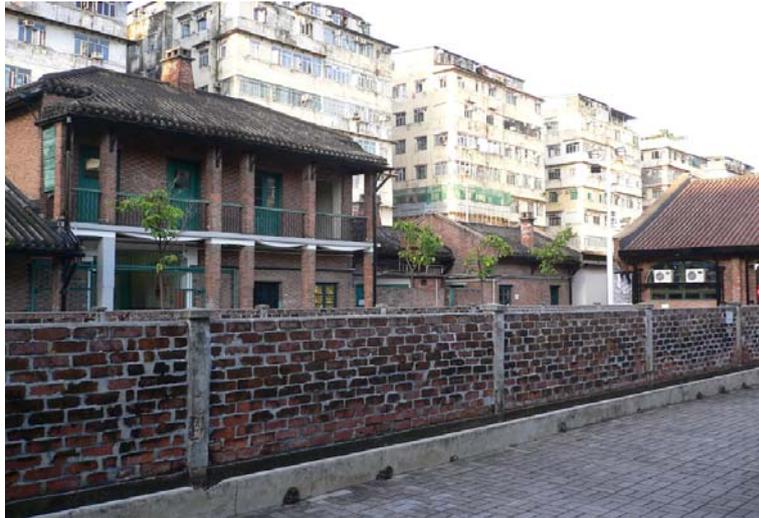
Fig. 177. Overview of the Ex-Ma Tau Kok Animal Quarantine Depot.

The depot is a very much alike compound as the former clubhouse. The depot comprises a several individual structures on a long and narrow site, which are of one to two-storey high (Fig. 177). They are all red brick buildings with traditional Chinese roof with pan and roll tiles. The red brickworks are shown even at the columns of the verandahs similar to Annex A of the former clubhouse (Fig. 178). Different roof forms are found, namely hipped roof, pitched roof, and vault of different scales. Brackets are found along the eaves. Chimneys are found with tapered profile. Prominent downpipes could also be found painted in black. Segmental-arched openings are widely adopted at the buildings.

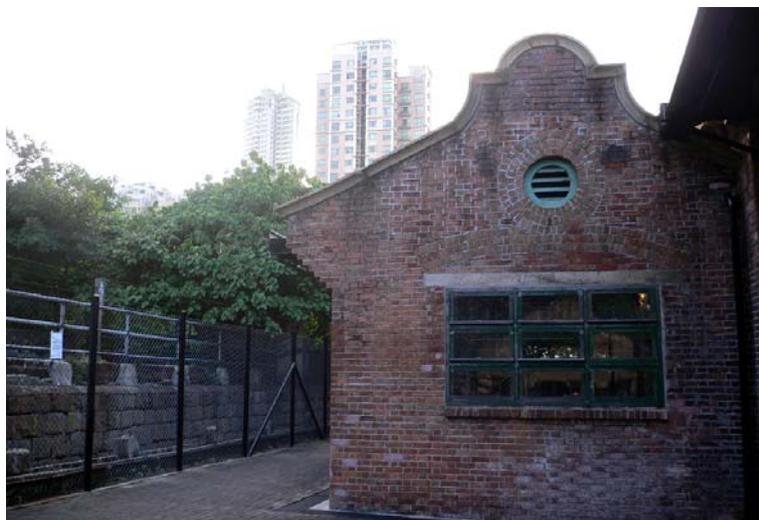
Fig. 179. Stylized gable at the Ex-Ma Tau Kok Animal Quarantine Depot.

As a depot, the buildings are rather functional with simple, unadorned appearance. Little decoration can be found such as the stylized gable (Fig. 179). The plinth and roughcast wall found in the former clubhouse are absent here.

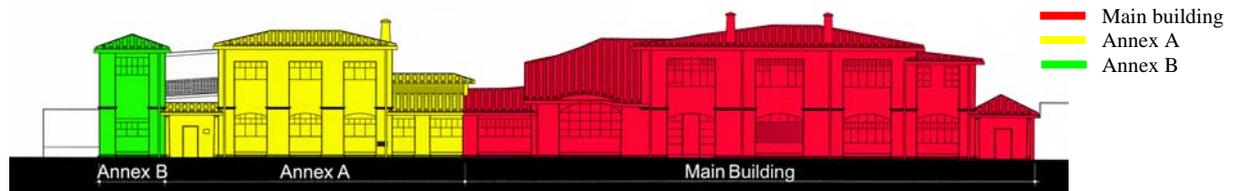
Fig. 180. Existing front elevation of the former clubhouse at No. 12 Oil Street, North Point (1:400).

The three blocks (main building, Annex A and Annex B) are mainly of 2-storey high and rectangular in plan. The main building mainly comprises a 1-storey former entrance porch, a 2-storey part at the middle, a room with changing headroom from 1-storey to 2-storey (RM 6), and a 1-storey part (RM 7-RM 9). Annex A comprises two 1-storey toilets in the northeast, a 2-storey part with verandah running along the rear façade for both storeys, and a wall with a door opened to Electric Road in the southwest which appears to be a former entrance gate. Annex B comprises a 2-storey front block with a 1-storey block at the rear (Fig. 180).

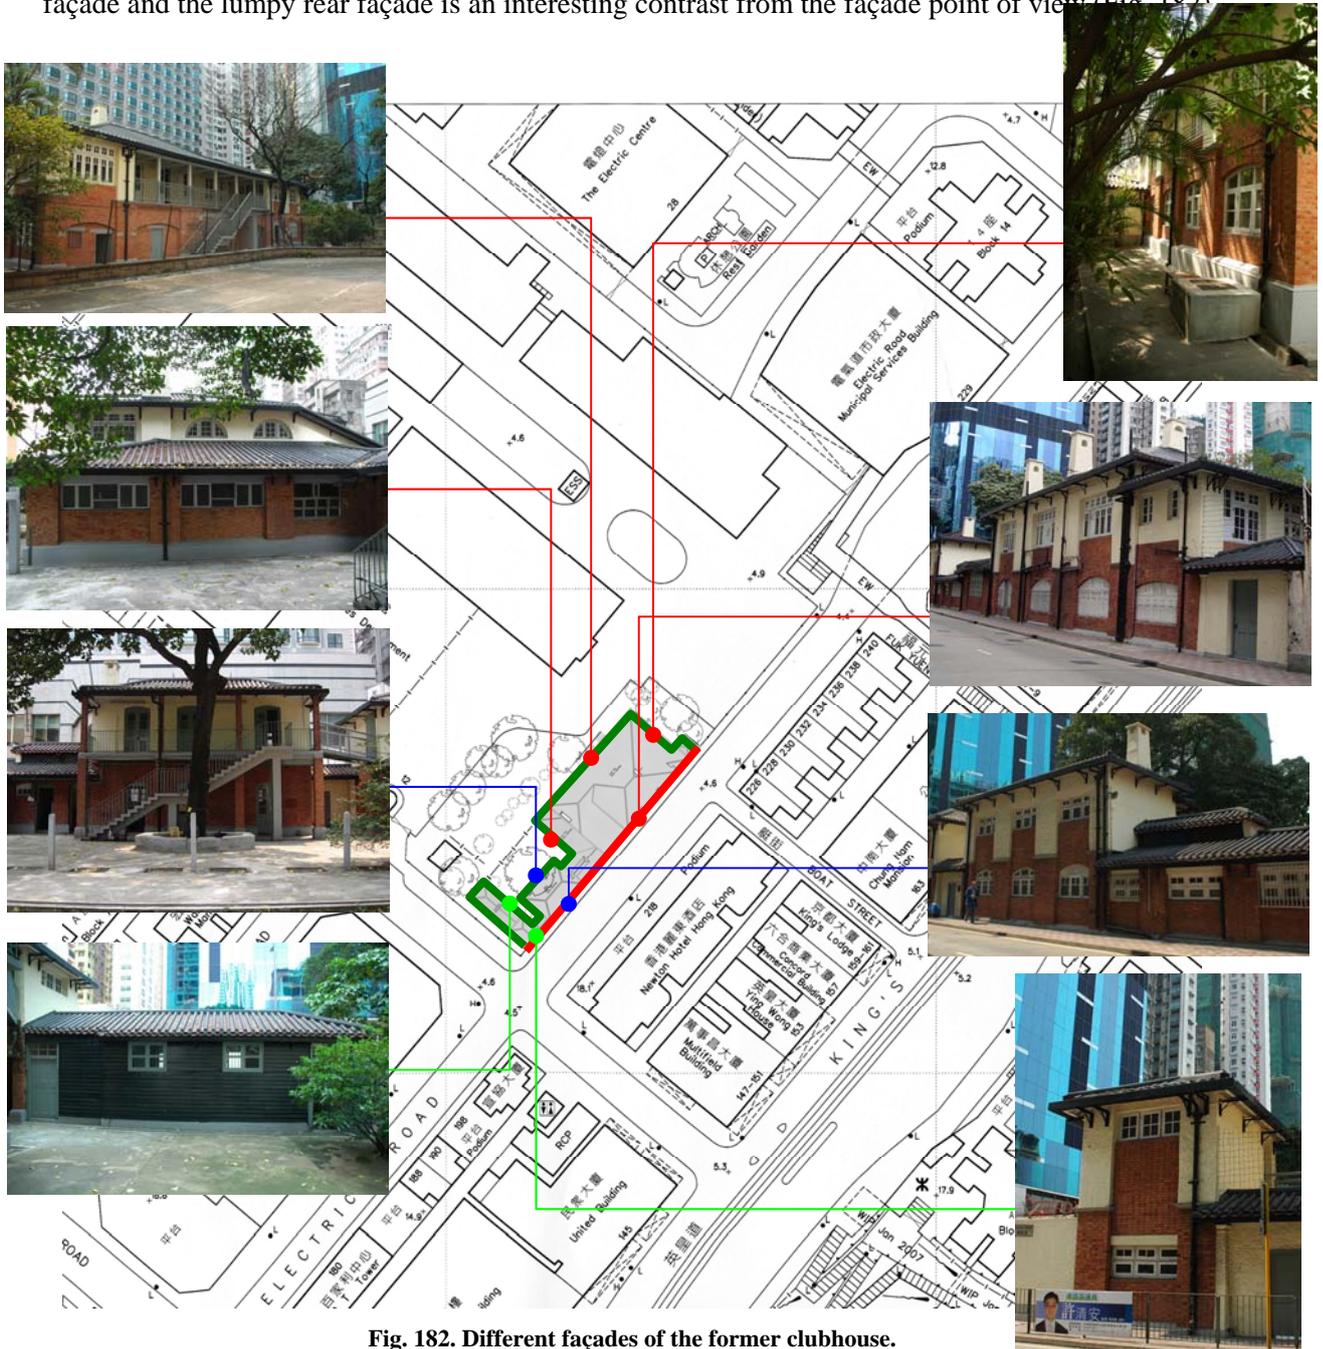
Fig. 182. Different façades of the former clubhouse.

Due to its irregularity in plan and the breaking down of building masses, the former clubhouse has many façades which much increased the visual interest of the viewer. The one continuous front façade and the lumpy rear façade is an interesting contrast from the façade point of view (Fig. 182)

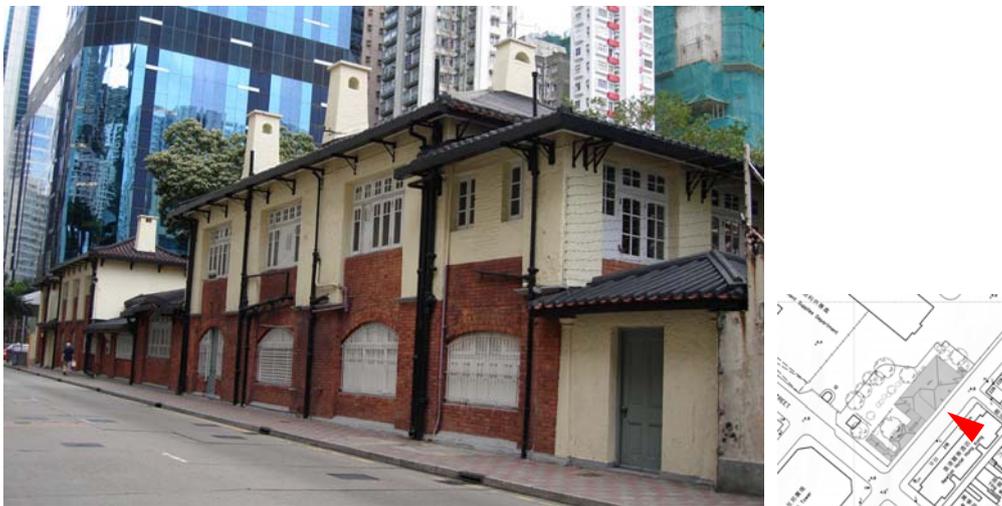
Fig. 184. Front façade facing Electric Road of the main building.

Brackets are found supporting the eaves or gutters except the former entrance porch and former entrance gate. Downpipes are almost found at regular intervals between each bay (Fig. 184). The plinth is almost hidden below the pedestrian level, which reflects that the original ground level of the clubhouse was lower than the ground level nowadays (Fig. 185).

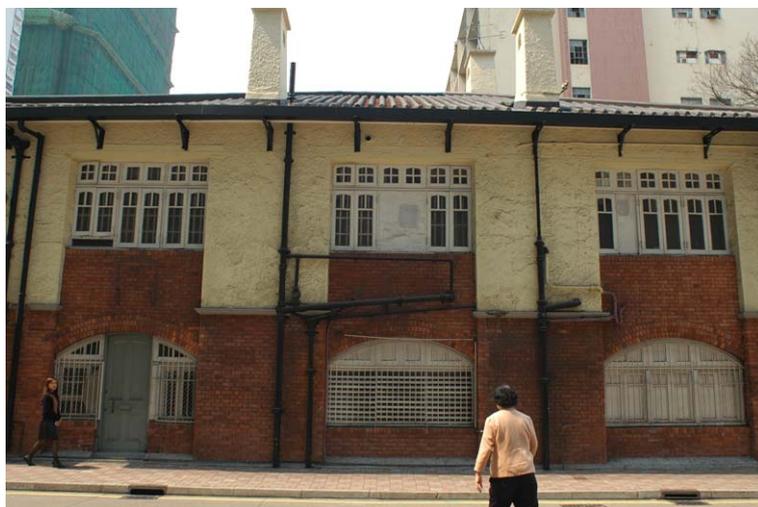
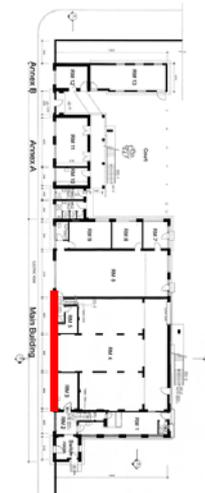
Fig. 186. The three middle bay of the main building.

The three middle bays of the main building and Annex A are of 2-storey high with a very similar façade design (Fig. 186 - Fig. 187). Both have segmental arched window openings on the ground floor, while rectangular window openings are used on the first floor. The main difference between the two is the narrower bay width of Annex A. On the other hand, the front façade of Annex B is also similar, but with only 1 bay's width. Rectangular window opening is used on the ground floor instead (Fig. 189).

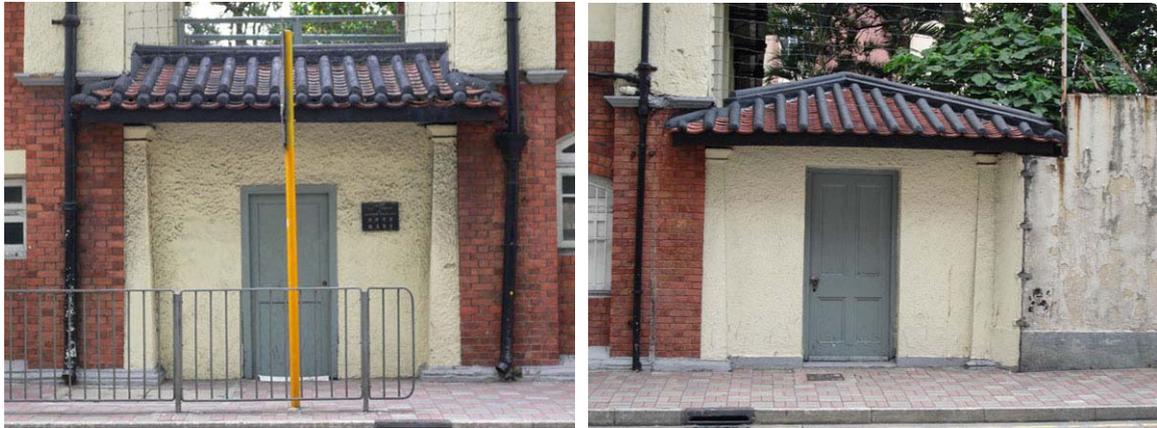
Fig. 189. The former entrance gate (left) and the former entrance porch (right) of the main building.

Another two parts with similar façade design are the former entrance porch and former entrance gate (Fig. 189). They are very prominent on this façade with the roughcast wall contrasting to the red brickworks of other wall surfaces on the ground floor. Both structures have their roof supported on tapered columns but without any bracket, revealing that the wall between columns to be a later addition. The main difference is the roof form.

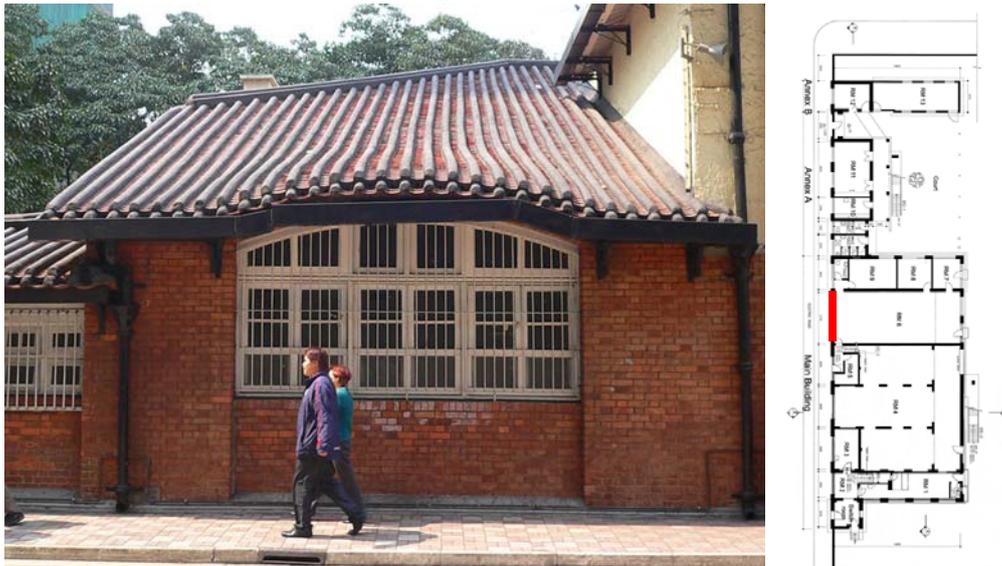
Fig. 190. Front façade of RM 6 of the main building.

The front façade of RM 6 at the main building is of 1-storey high purely in red brickworks (Fig. 190). The window is at a higher position comparing to other windows on the ground floor. This bay also appears to be under another roof but actually the same with the three middle bays. The most interesting part of the roof is the deep pitched roof with the edge curved following the curvature of the segmental-headed window.

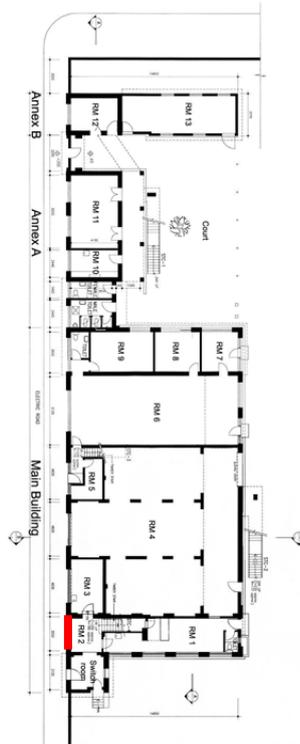
Fig. 192. Front façade of the RM 2 and the kitchen of RM 14 of the main building.

The bay of RM 2 and the kitchen of RM 14 at the main building is of 2-storey high which appears to be lower in height than the three middle bays (Fig. 192). However, this part of the main building is actually under the same roof of the three middle bays, with this portion of eaves designed to be at a lower position on this façade. This may be intended to distinguish a difference in the function of the interior space. The extent of the brickworks and the curvature of the segmental arch are also lower than the three middle bays as a result. On the first floor, between the two windows is a portion of brickworks without being roughcasted, giving extra interest to this façade. There is a lintel above the windows, which can be also found in other rectangular openings on this façade.

Lintel

Brickworks

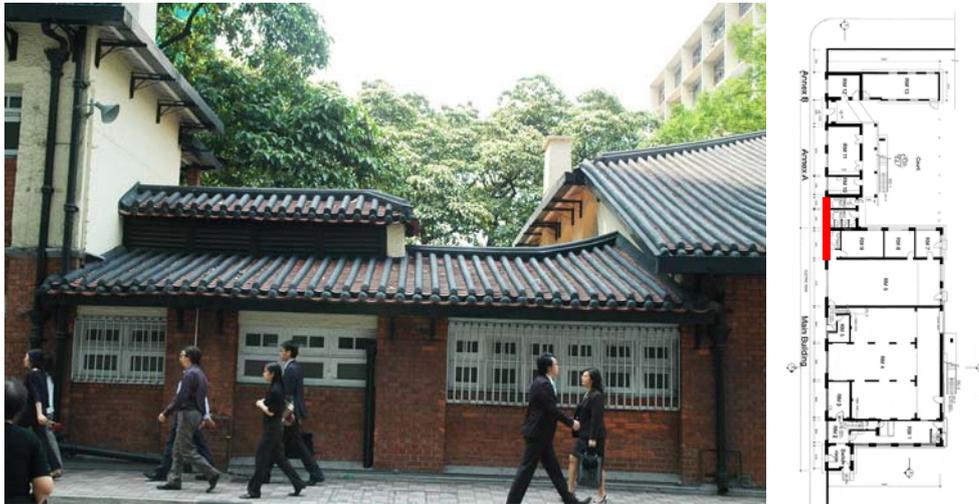
Fig. 193. Front façade of the toilet adjacent to RM 6 at the main building.

The front façade of the toilets adjacent to RM 6 is of 1-storey high, also purely in red brickworks (Fig. 193). Rectangular window opening is used instead of segmental arched one. Its height is almost the lowest amongst the other bays on the front façade, and with the minimal articulation of this façade, this implies that its function is to be of the lowest significance.

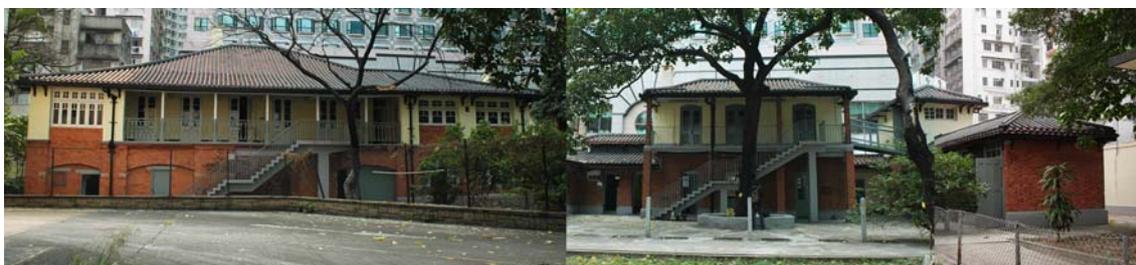
Fig. 196. A photo montage of the rear façade.

The rear façade is the façade originally facing towards the Victoria Harbour when it was built. Nowadays, it faces a piece of lawn with the reclaimed land further beyond (Fig. 196 - Fig. 197). Contrary to the front façade, the rear façade is not continuous, with a more distinguishable building façade for each block (main building Annex A and Annex B) due to their difference in volume. The façade treatment is similar to that of the front façade, mainly with red brickworks on the ground floor and roughcast wall above. The plinth which is hidden at the front façade can be seen from this façade with a lower ground level. They appear to be very tall and thick plinth (Fig. 198). Brackets are found supporting below the eaves and gutters, while downpipes are also found on most façades.

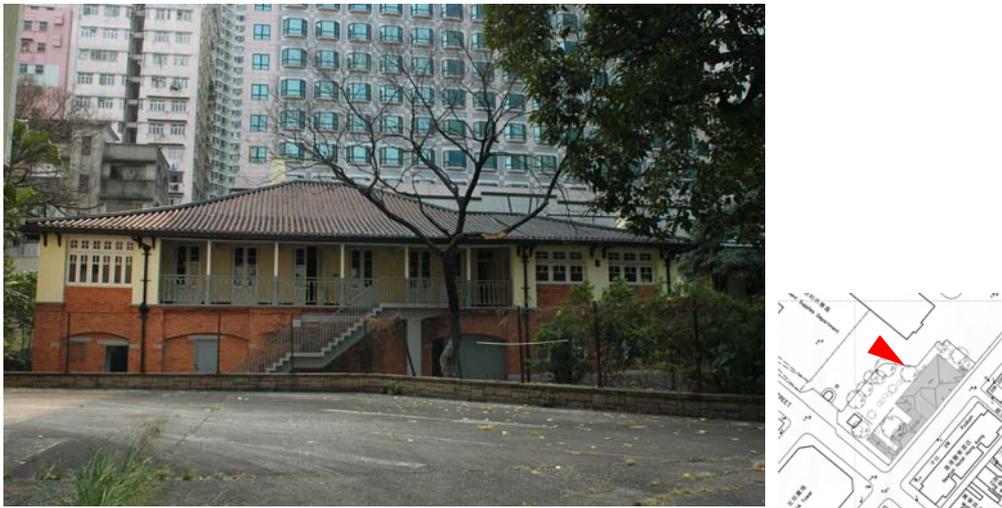
Fig. 200. An overview of the rear façade of the main building.

Similar to the case at the front, the rear façades of 3 middle bays of the main building and Annex A are of similar design (Fig. 200 - Fig. 201). Both of them have red brickworks on the ground floor with segmental arched door openings, and a verandah on the first floor. Even the later addition of the concrete staircase to each of this façade is similar in design. The rear façades of the two blocks are more open comparing to the front façades with the semi-open verandahs. On the other hand, the rear façade of Annex B is different from that of the other two blocks without a verandah or balcony.

The major differences are that from the rear façade, it is clearly revealed that the 6 middle bays of the main building are actually under the same roof instead of the middle 3, and the verandah columns of Annex A are structural elements which continue down to the ground floor forming an arcade.
