BUILDING

3.1 Architectural evolution

3.1.1 The former Royal Hong Kong Yacht Club (1908-1938)

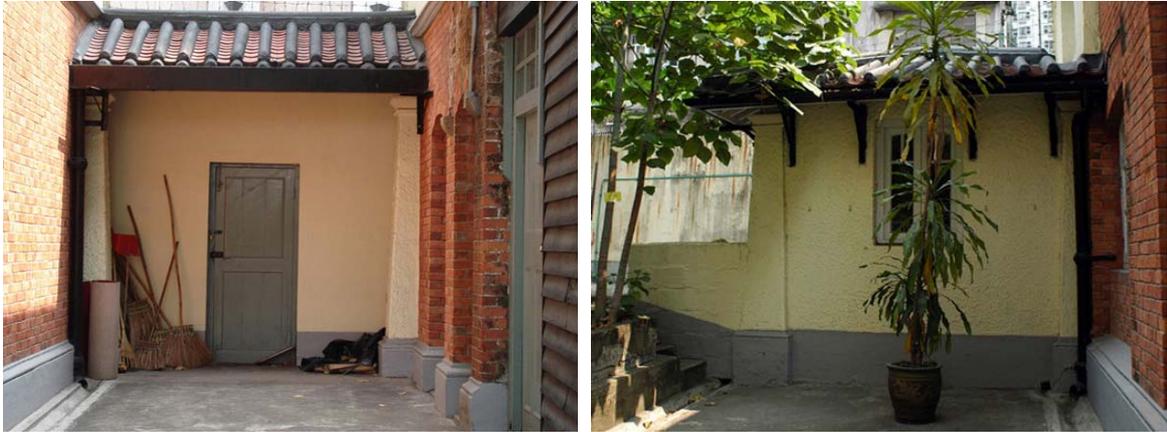
Fig. 203. Rear façade of the former entrance gate (left) and the former entrance porch (right).

The rear façades of the former entrance porch and former entrance gate are more or less the same as their front (Fig. 203). A window is opened on the rear wall of the former entrance porch with segmental-headed glazings which is of the original window design. This implies that the façade is retained as it was built.

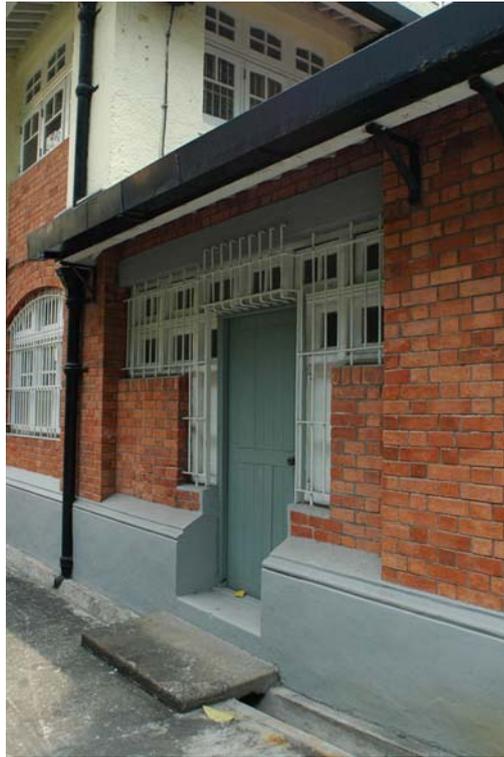
Fig. 204. Rear façade of RM 7.

The rear façade of RM 7 is of 1-storey high (Fig. 204). A door was opened at the centre to the original rectangular window opening which makes this design similar to those popular in the Arts and Crafts Movement, with the date of alteration unknown. It is the only bay with rectangular window openings on the ground floor, which may implies a difference in the function or with its function of relatively lower significance.

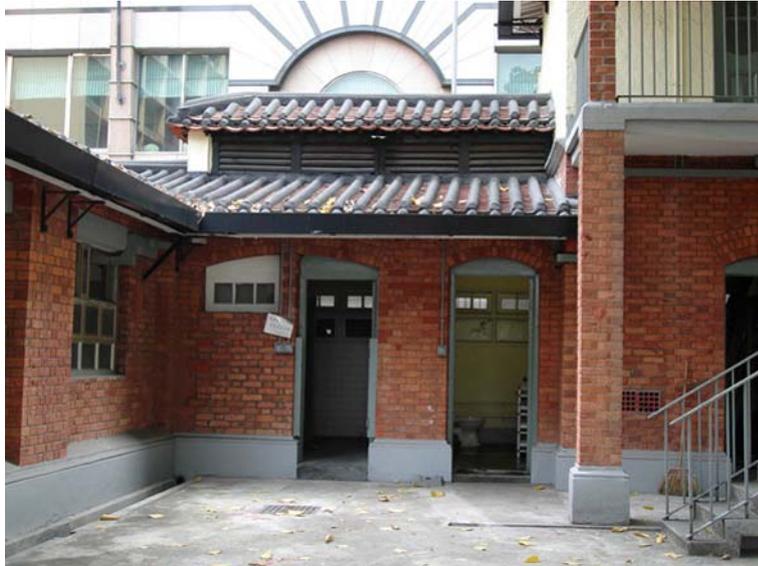
Fig. 205. Rear façade of the male and female toilets of Annex A.

The rear façade of the male and female toilets is mainly comprises of the doorways to the two toilets respectively. Traces on the wall of the male toilet indicate that there used to be a segmental-headed archway, which was later partially blocked and converted into openings for a window and a door. It is believed that the conversion was made during the conversion into the staff quarters in the 1930s. The entrance to the female toilet is also a segmental-headed doorway (Fig. 205).

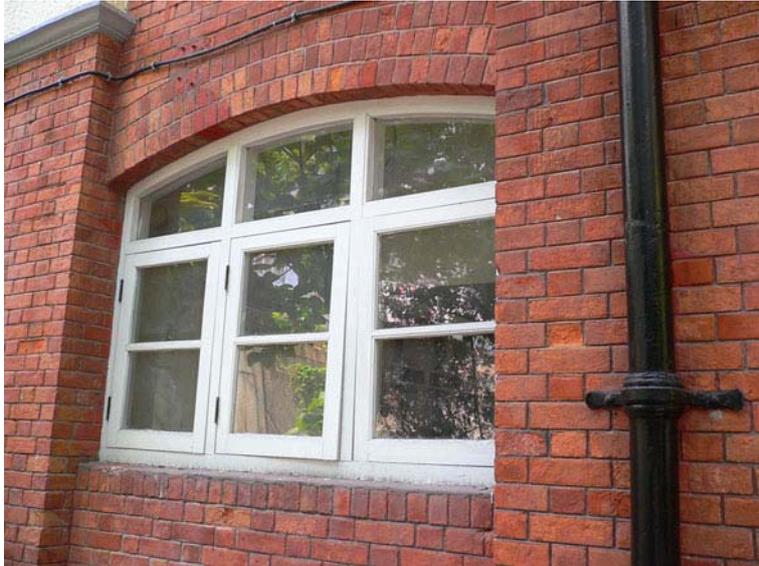
Fig. 208. Later added timber-framed window at RM 1 on the ground floor.

The side façade facing northeast can be divided into five bays, mainly of 2-storey high (Fig. 206). One of the bays also includes the side façade of the former entrance porch, while the rest of the bays have similar design to the three middle bays on the front façade with identical façade design (Fig. 207). Brackets are present under the eaves. High plinth can be found. Four downpipes could be found on this façade. The windows on the ground floor appear to be later addition with the newer timber window frames.

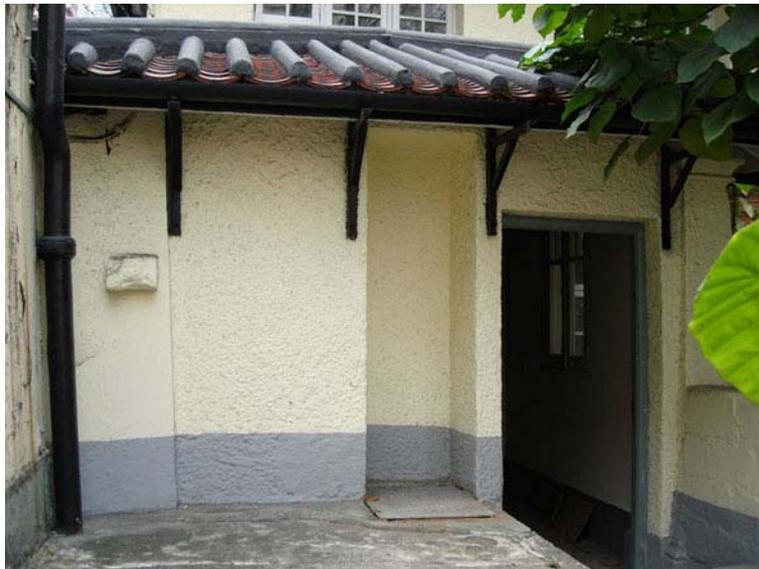
Fig. 209. Northeast façade of the former entrance porch.

The side façade of the entrance porch mainly comprises a tapered column and a wall with door and a recess (Fig. 209). Brackets are found under the eaves.

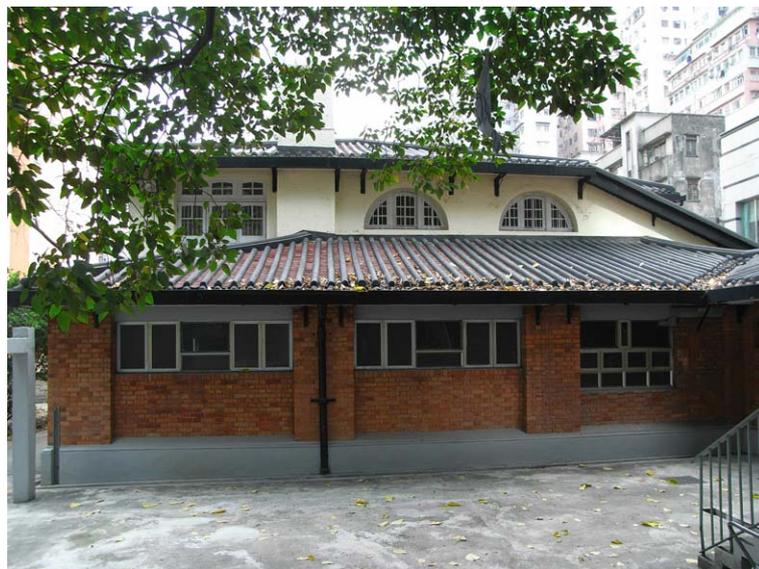
The side façade on the ground floor is of red brickworks with the window portion slightly recessed into the wall. The windows of RM 7 and RM 8 are opened at the same level, while that of RM 9 is larger in size opened at a lower position (Fig. 211). According to the old photo, the windows of this façade on the ground floor were used to be opened at the same height, and that of RM 9 appears to be enlarged in a later renovation (Fig. 212). All the windows nowadays are aluminium windows instead of the original timber-framed windows.

Fig. 211. Side façade of the main building facing southwest.

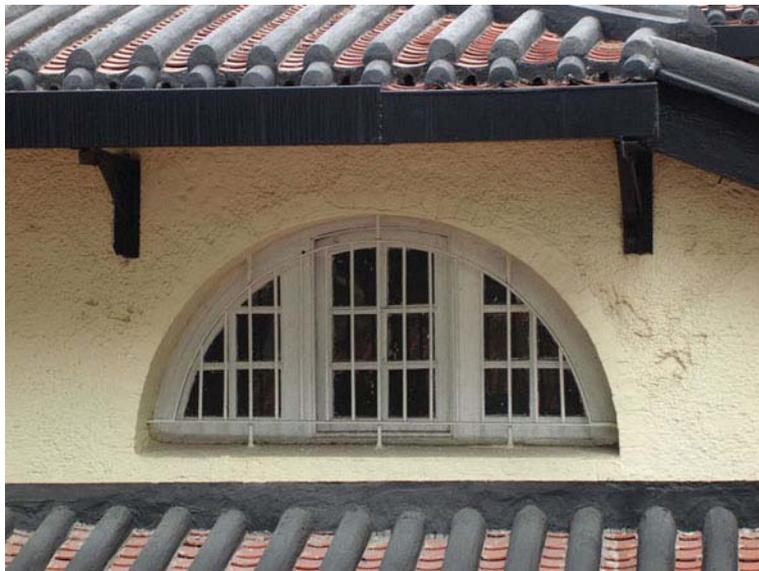
The side façade on the first floor is rendered with roughcast wall surface. A prominent chimney could be found on this façade with its stack protruding from the wall surface, which is a typical chimney design during the Arts and Crafts Movement. Rectangular window opening is used at RM 20, while two semi-circular window openings are used at the upper level of RM 6, implying the difference in the function of the interior space. A layer of brick voussoirs could be found surrounding the semi-circular windows (Fig. 213).

Fig. 213. Semi-circular window with brick voussoirs.

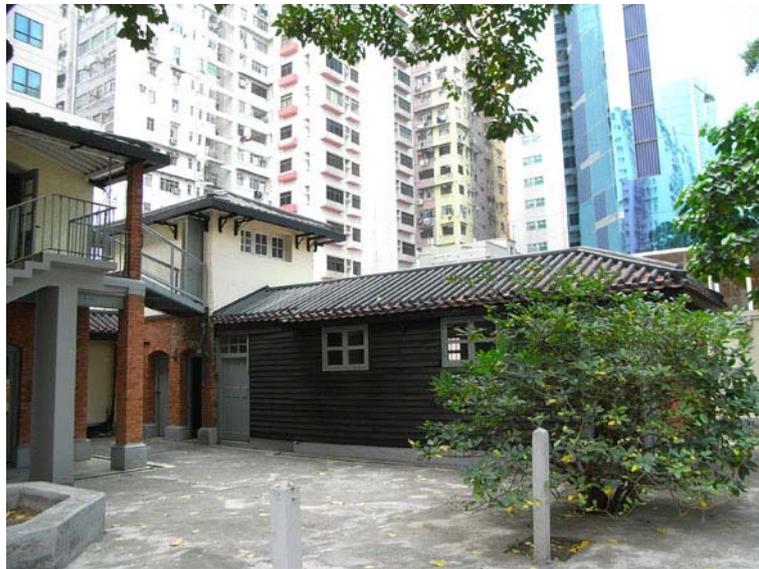
The façade of the front block is finished with red brickworks with plinths on the ground floor, while the first floor is finished with roughcast wall (Fig. 215). Segmental-headed doorways are found on the ground floor, while rectangular doorway is adopted on the first floor. The façade of the rear block is finished with timber planks, which is a totally different façade treatment in this site and make a strong contrast to any other parts of the site. Rectangular windows and doors are used on this façade. Brackets are found under the eaves.

Fig. 215. Northeast façade of Annex B on the ground floor.

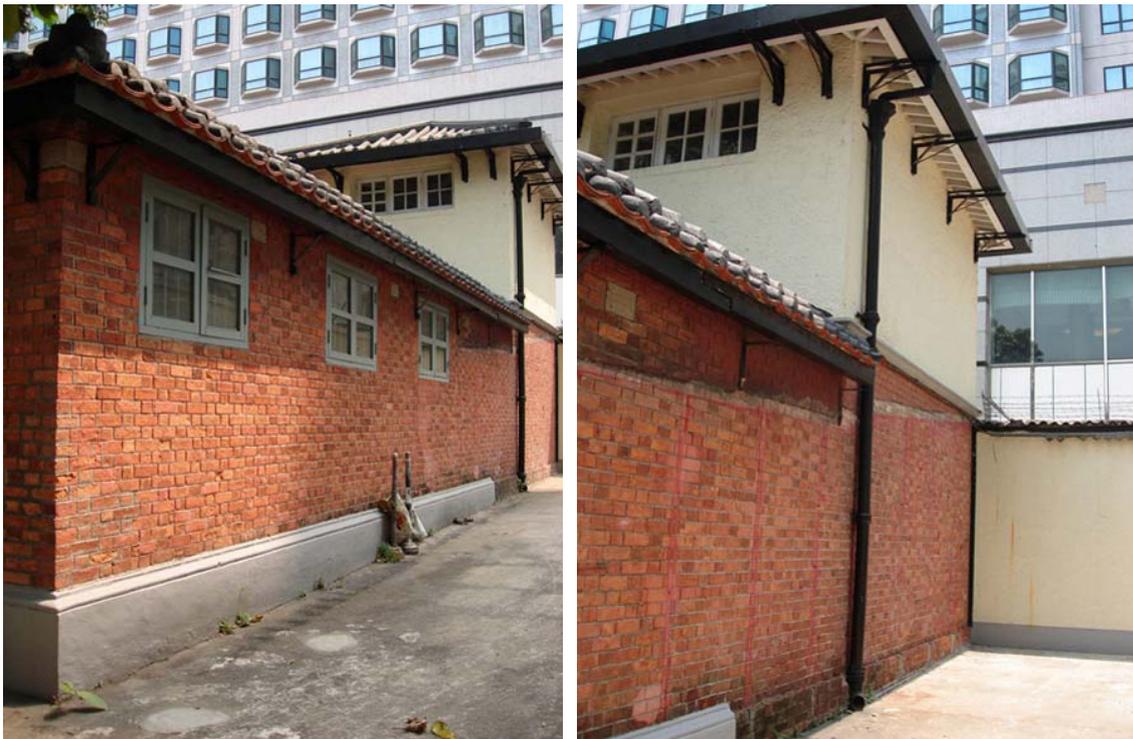
The southwest façade of Annex B is similar to that of the northeast façade, with red brickworks with plinth below on the ground floor, while the first floor is finished with roughcast wall (Fig. 217). Brackets are found under the eaves. Half of the plaster at the plinth is gone, where the brickworks of the plinth is clearly shown (Fig. 218).

Fig. 217. Southwest façade of Annex B.

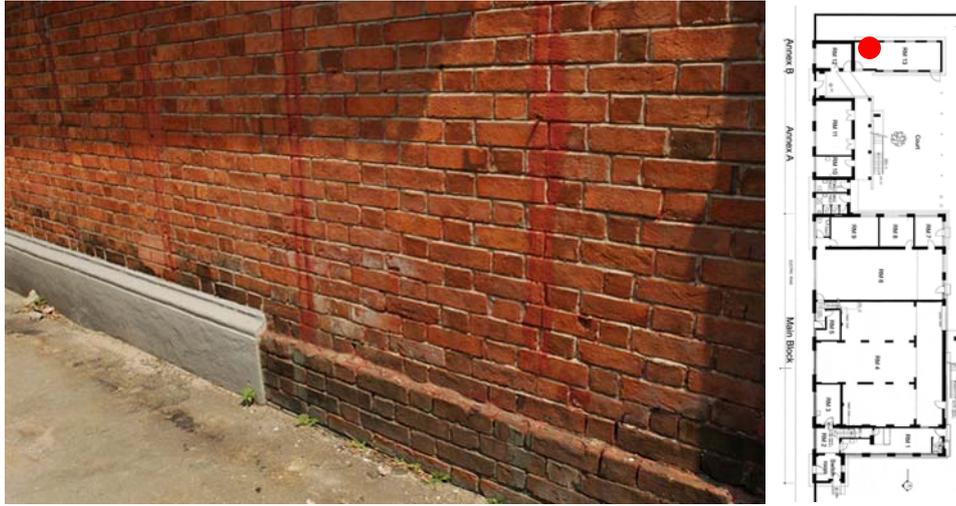
Fig. 218. The plinth on the southwest façade of Annex B.

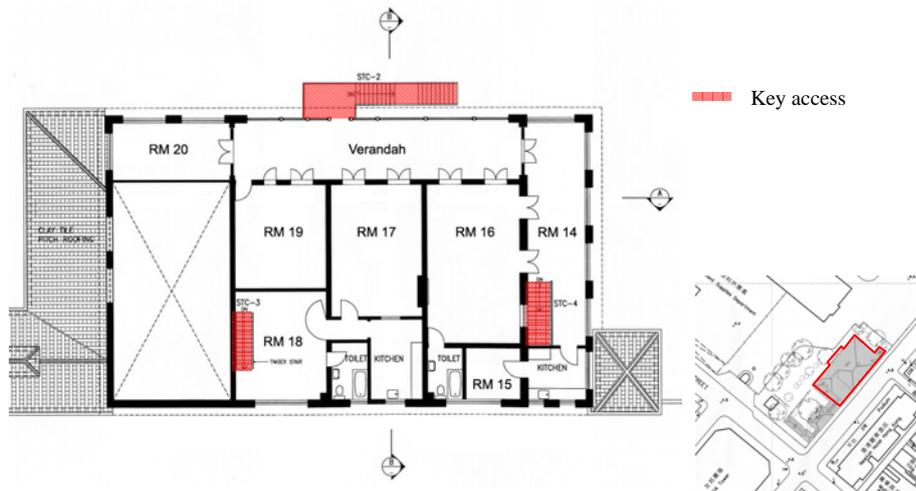
The circulation of the first floor is mainly gained through the verandah which gives access to all the rooms (Fig. 220). The interior of the first floor is mainly divided into five main rooms. The northeast room (RM 14) is also accessible through the timber staircase from RM 1 below. This room includes a kitchen which is further opened to another small room (RM 15). It is also opened to the adjacent room, RM 16. RM 16 is also provided with a toilet. The middle room (RM 17) includes a kitchen, which is further opened to a suite room (RM 18). RM 18 is also accessible through another timber staircase from RM 5 below. RM 19 is a single room without opening to any other room. The southwest room (RM 20) is accessible at the end of the verandah, in which it was once opened to the double-ceiling room (RM 6) below.

There are two internal timber staircases constructed at the time it was built or in early days. One is located at the northeast room (RM 1), while the other one is located at the central room (RM

4). An external concrete staircase is located at the rear façade leading up to the verandah on the first floor, which is a later addition in 1969.

Fig. 220. Existing first floor plan of the main building at No. 12 Oil Street, North Point (1:400).

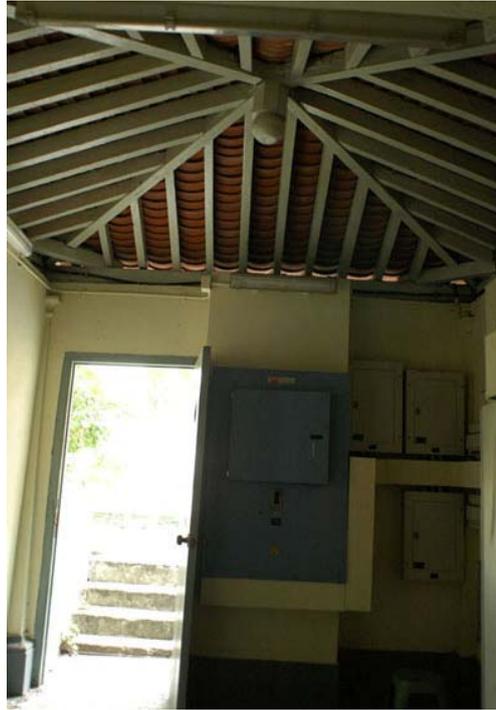
Fig. 226. Interior of the former entrance porch.

The former entrance porch is at the northeastern corner of the main building which can be accessed from three sides: from the door opened to Electric Road, another door opened to the northeast façade and a doorway from RM 2 (Fig. 225- Fig. 227). The window opened on the rear façade is a pair of casement windows with segmental-headed glazings (Fig. 228).

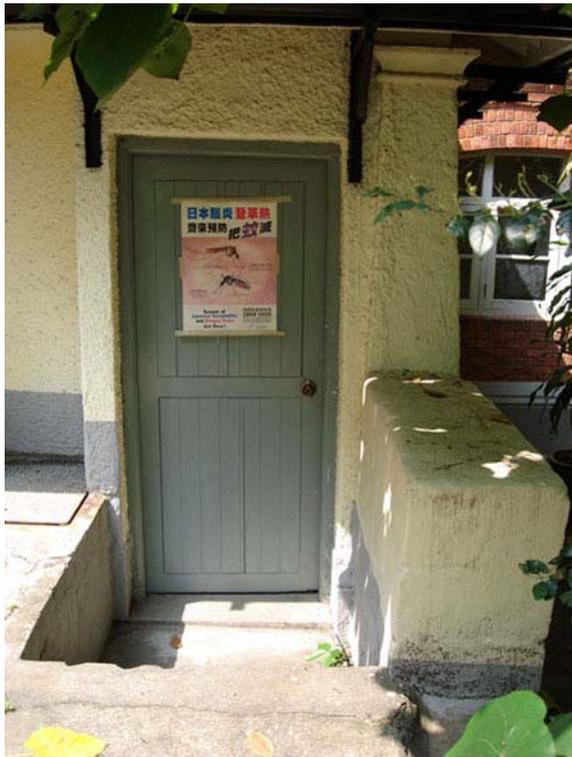
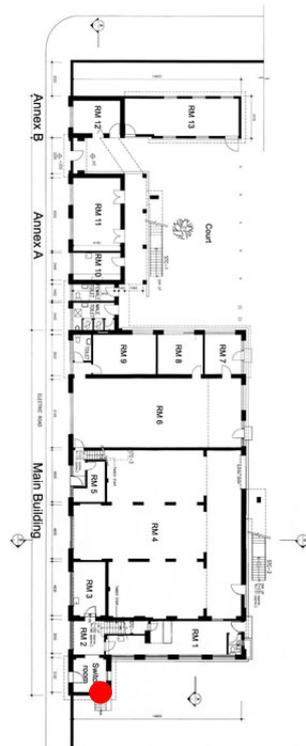
Fig. 227. Side entrance on the northeast of the former entrance porch.

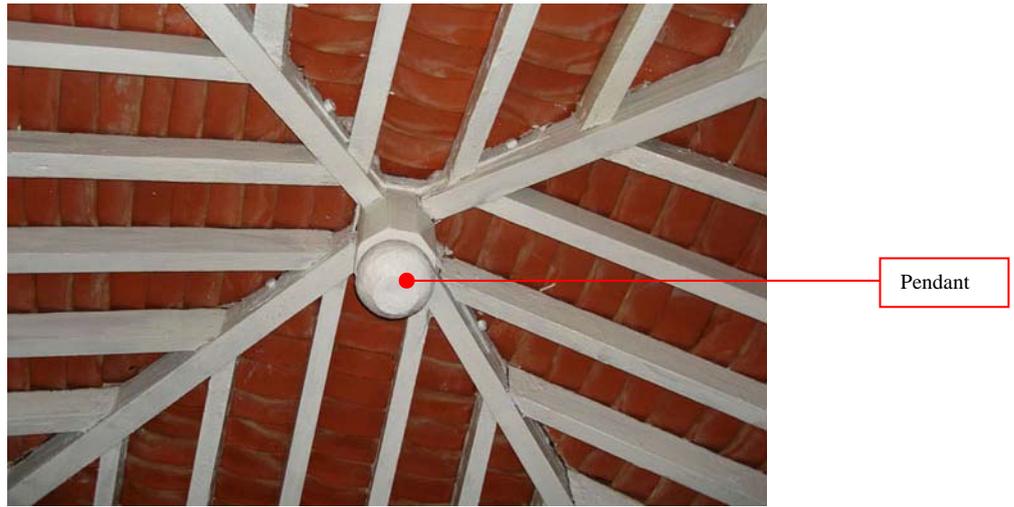
Fig. 231. Ceiling of the former entrance porch.

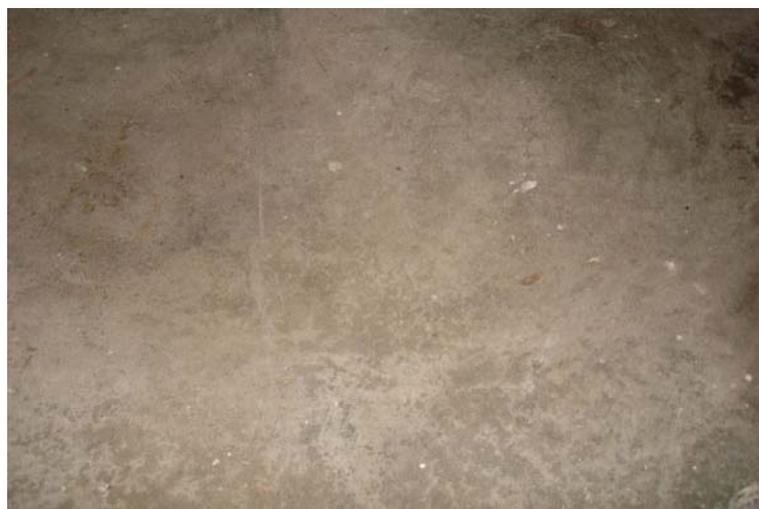
Fig. 233. Cement sand flooring of the former entrance porch.

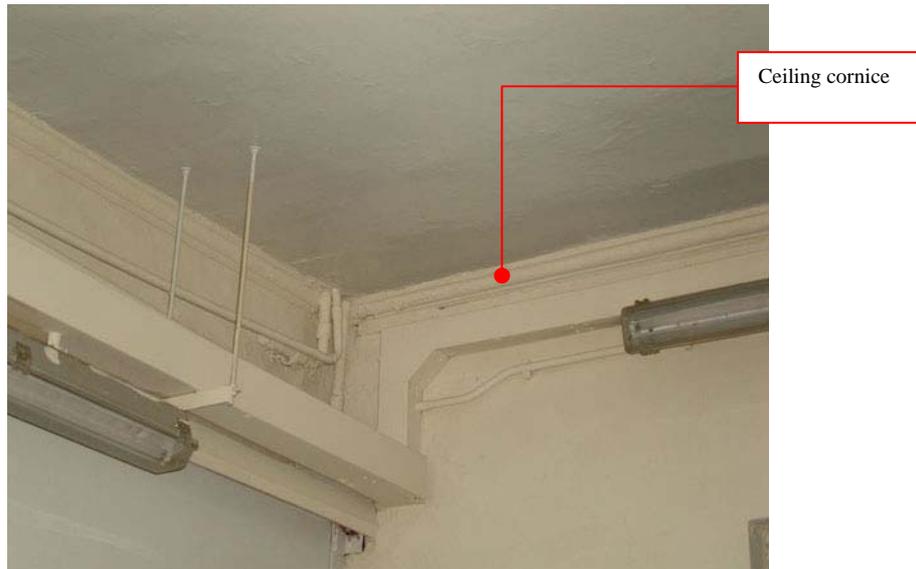
The room has a segmental-headed window opening which is now covered by a metal panel (Fig. 235). White glazed ceramic tiles are found at the lower part of some of the wall surfaces, which is believed to be a later addition. It has a concrete ceiling with cornice along the edges (Fig. 236). Encaustic tiles of black and white checkered pattern with borders are used as floor finishes (Fig. 237).

Fig. 236. Ceiling of RM 2.

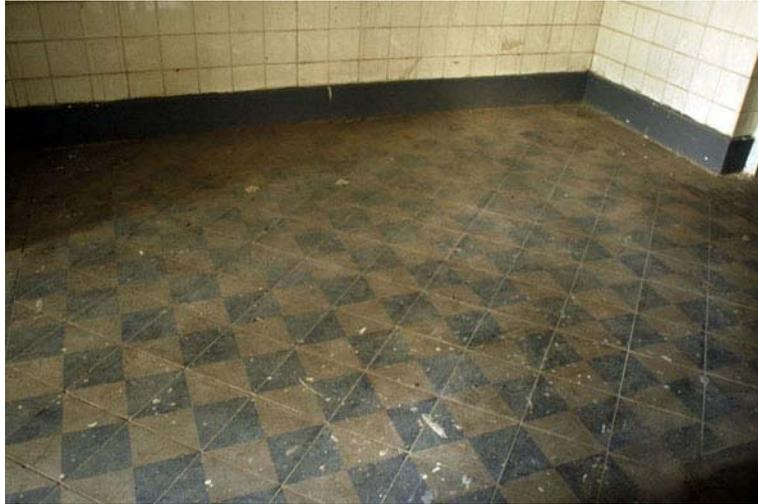
Fig. 237. Encaustic flooring tiles of RM 2.

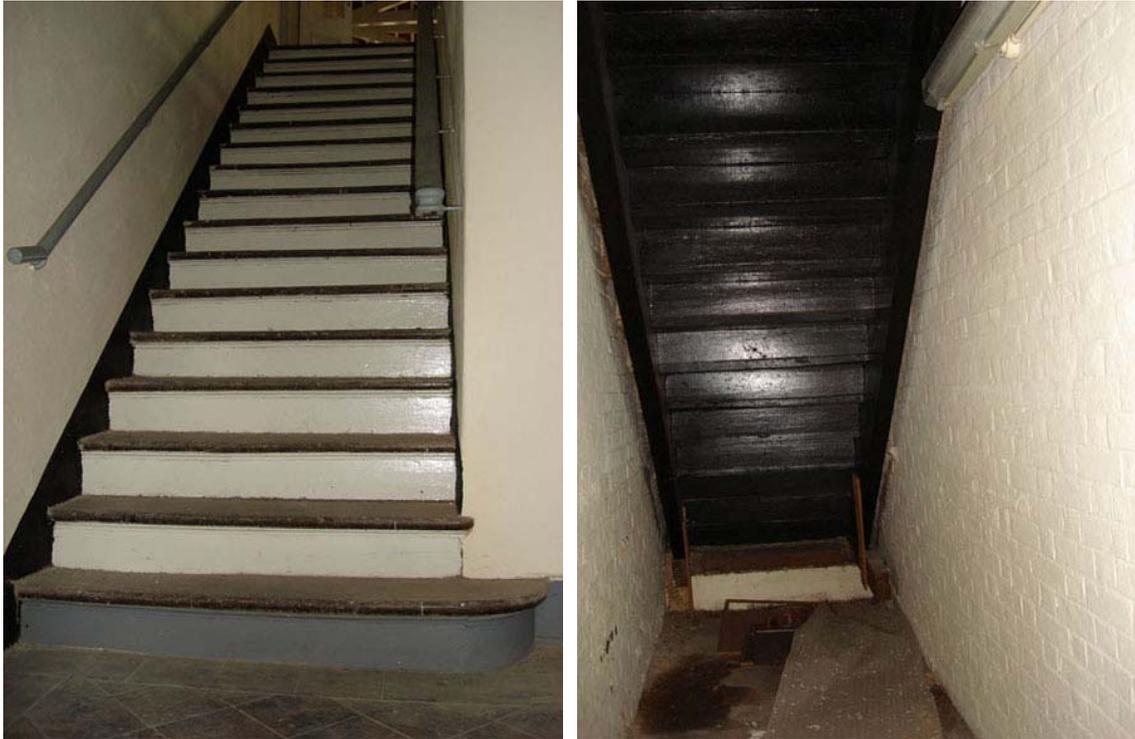
The timber staircase (STC – 4) is located at RM 2, the former entrance lobby of the main building leading up to RM 14 on the first floor (Fig. 238). The first step is rounded (Fig. 239). Timber handrail is found on one side of the staircase (Fig. 240). Balustrade with turned balusters is found on the first floor (Fig. 241). Treads are found with nosings (Fig. 242).

Fig. 239. Overview (left) and the underside (right) of the timber staircase (STC – 4) at the main building.

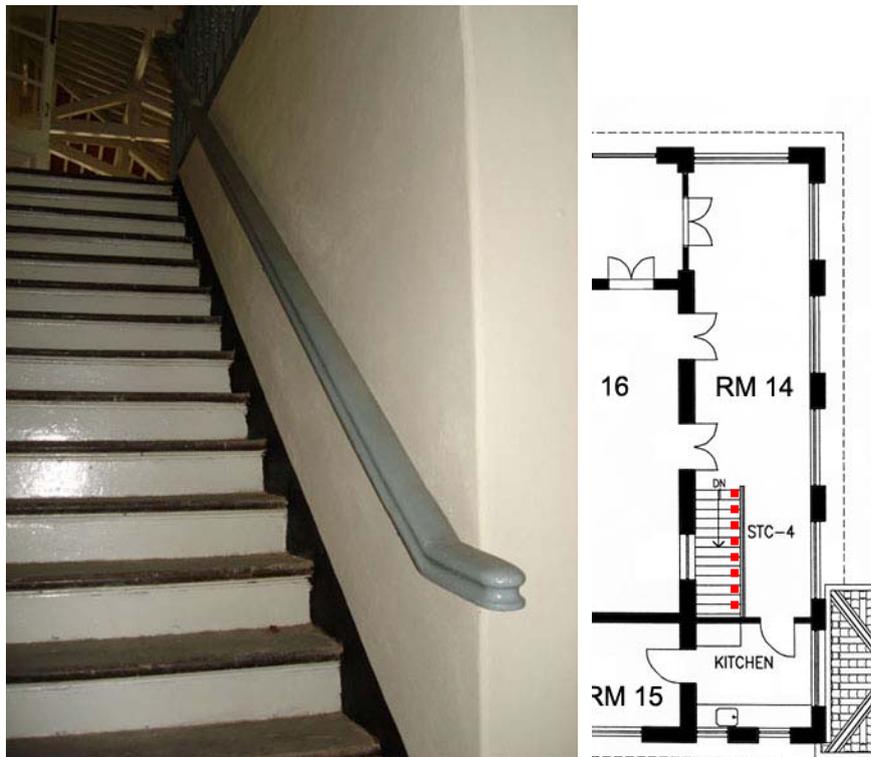
Fig. 240. The handrail of the timber staircase (STC – 4) at the main building.

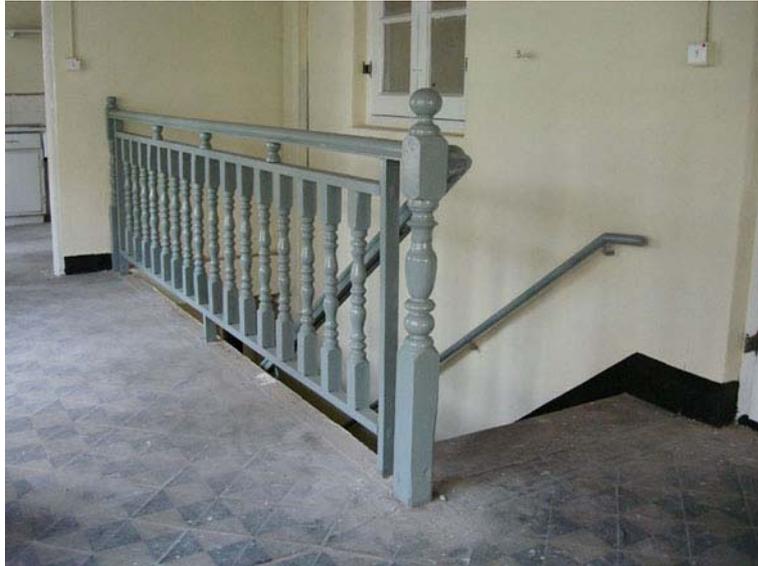
Fig. 241. Timber balustrade of the timber staircase (STC – 4) on the first floor of the main building.

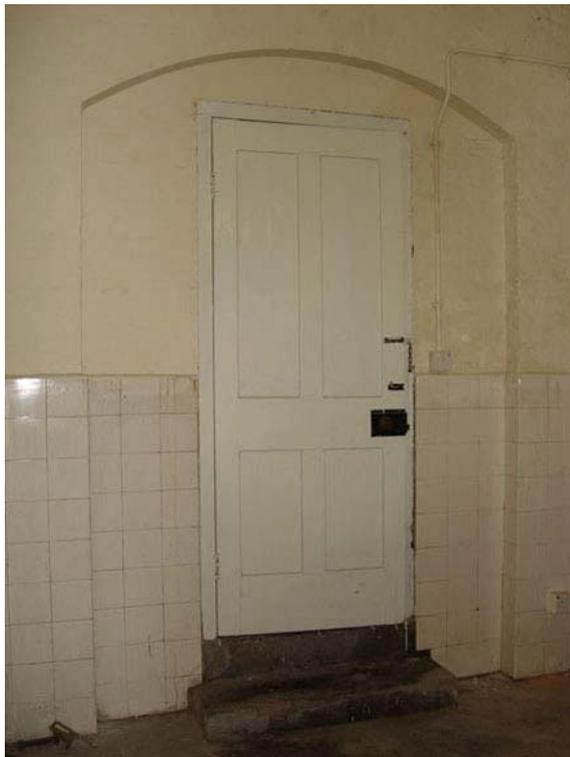
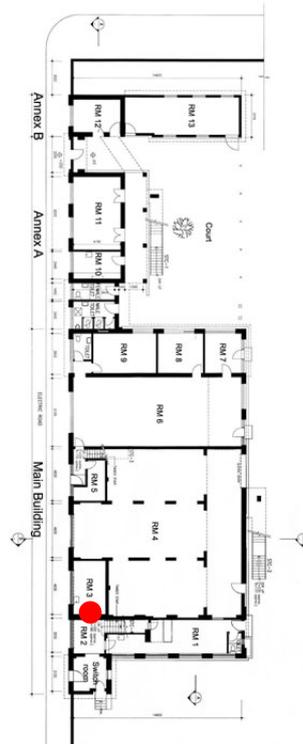
RM 3 is accessible from RM 2, the former entrance lobby (Fig. 243). It appears to be a later addition as implies from the blind arch of the walls viewed from RM 2 and RM 3, with the alteration date unknown (Fig. 244 - Fig. 245).

Fig. 244. The entrance of RM 3 within a blind arch on the wall at RM 3.

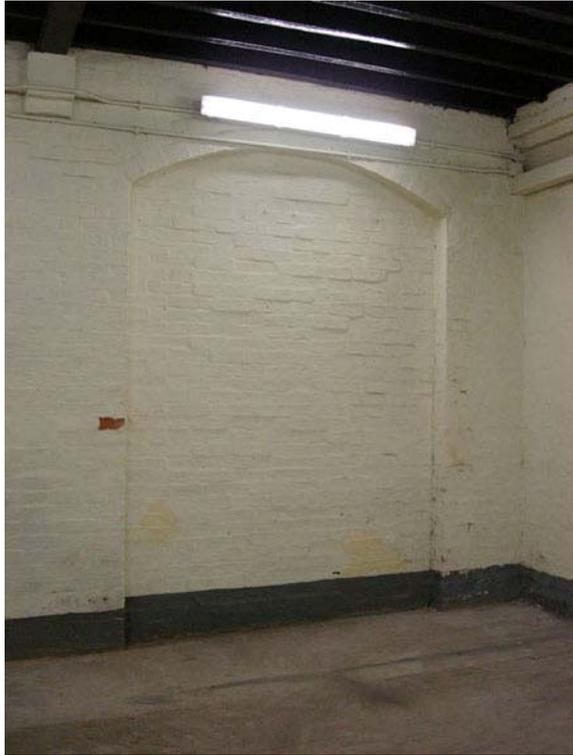
Fig. 245. The blind arch viewed from RM 4.

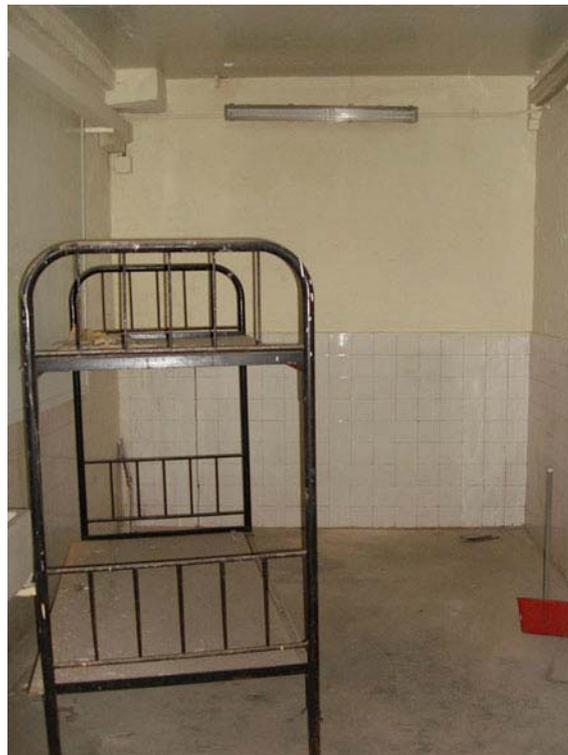
Fig. 246. Interior of RM 3 at the main building.

The room has a segmental-headed window opening which is now covered by a metal panel. White glazed ceramic tiles are found at the lower part of some of the wall surfaces, which is believed to be a later addition (Fig. 246). It has a concrete ceiling and cement sand floor finishes (Fig. 247 - Fig. 248). At the corner of the room, a blocked smoke flue is found (Fig. 249).

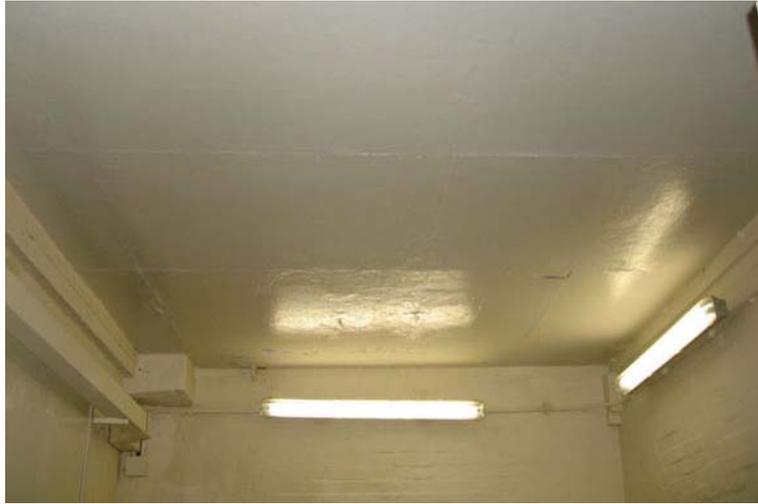
Fig. 247. Ceiling of RM 3.

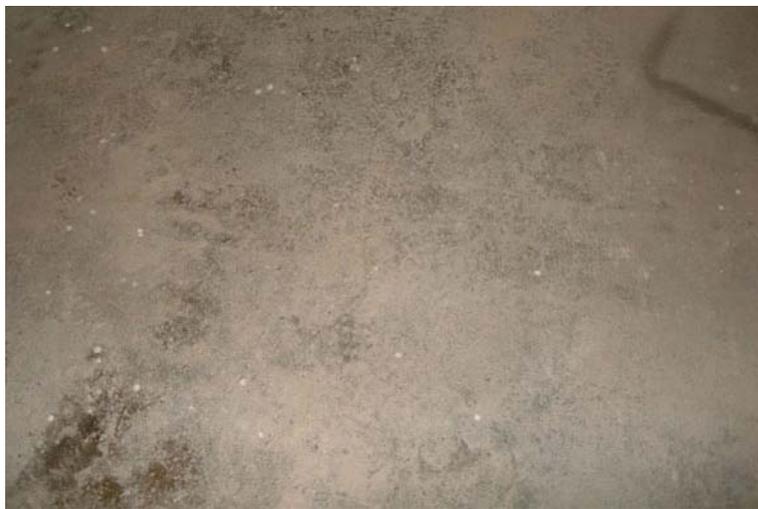
Fig. 248. Cement sand flooring of RM 3.

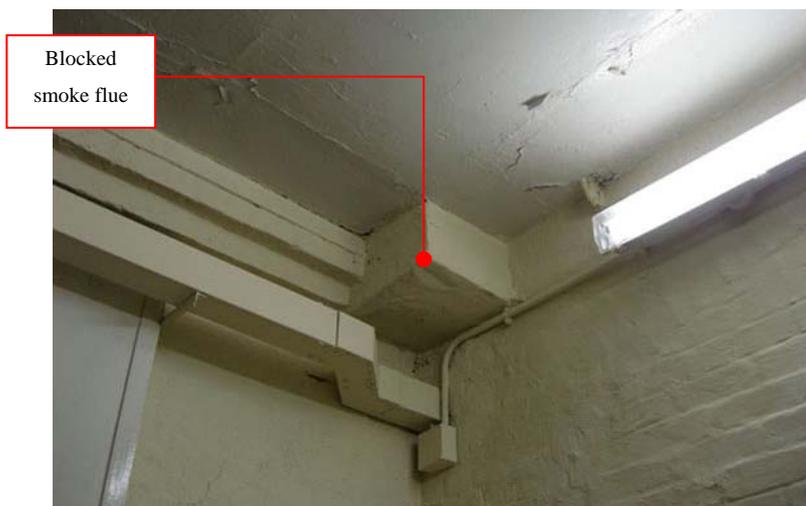
Fig. 249. The blocked smoke flue at RM 3.

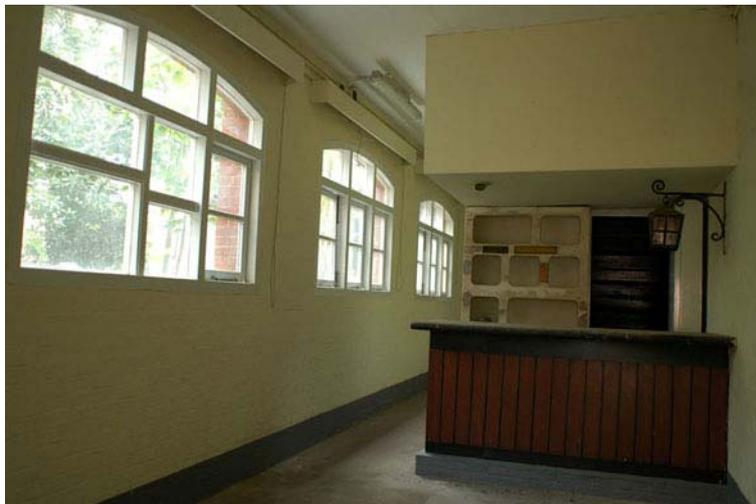
Fig. 251. Interior of RM 1.

RM 1 is accessible from RM 2 and from the door opened on the rear façade (Fig. 250 - Fig. 251). It is believed to be originally opened to RM 4 as implies from the blind arches viewed from RM 4 (Fig. 252). Traces of the original archways could also be found on the wall at RM 1 (Fig. 253). From the bar counter, it is believed that this space was used for bar facilities before it is vacated. It has a concrete ceiling and a red cement tile floor finishes (Fig. 254 - Fig. 255). The toilet at the rear appears to be a later addition, probably after the clubhouse was converted into a staff quarters (Fig. 256).

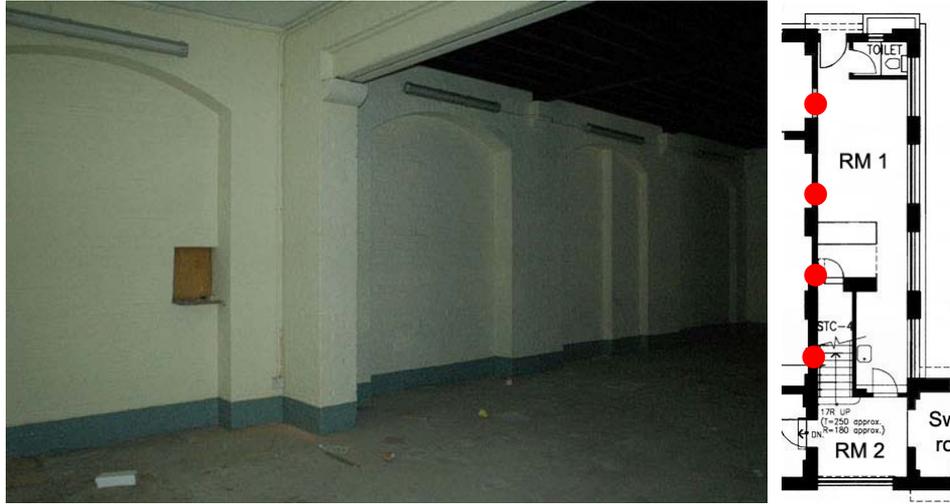
Fig. 252. Blind arches to RM 1 viewed from RM 4.

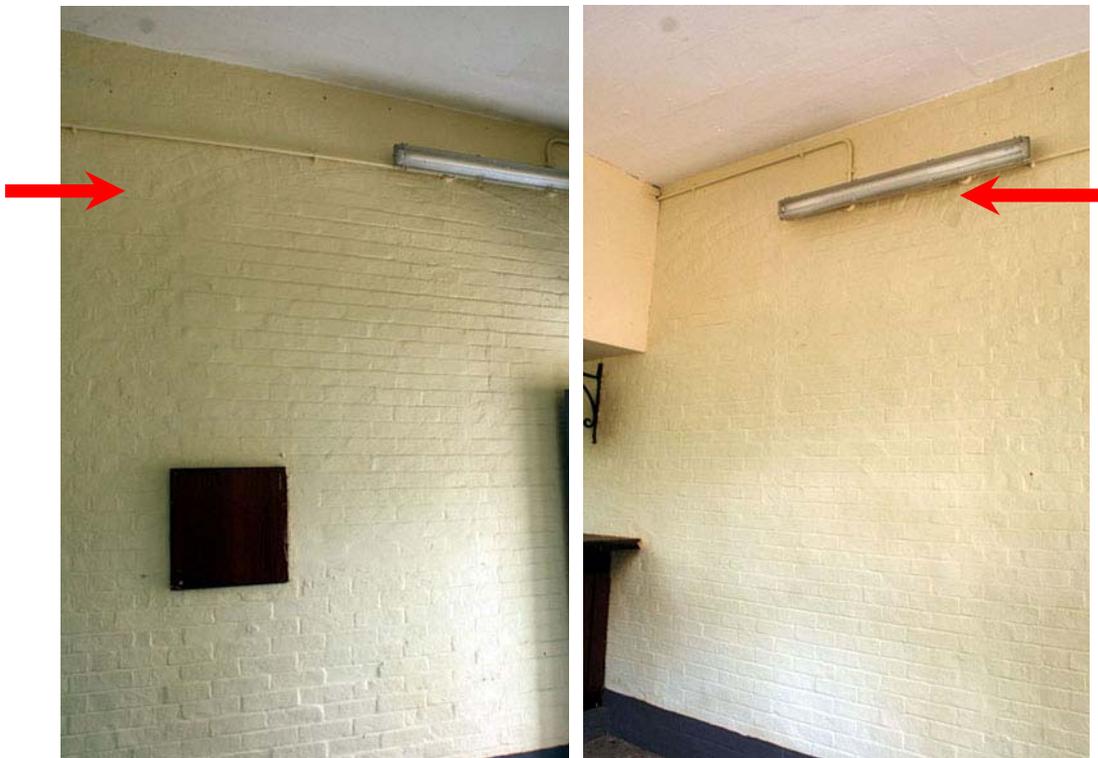
Fig. 253. Traces of the original archways on the wall at RM 1.

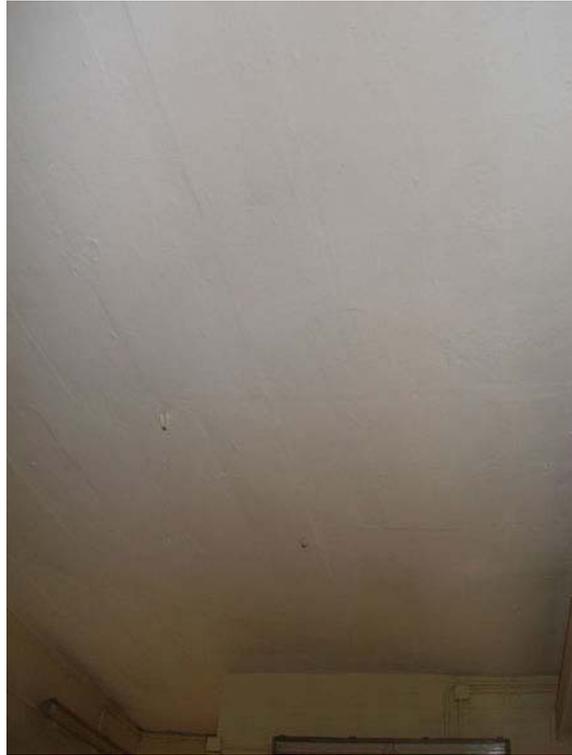
Fig. 254. Ceiling of RM 1.

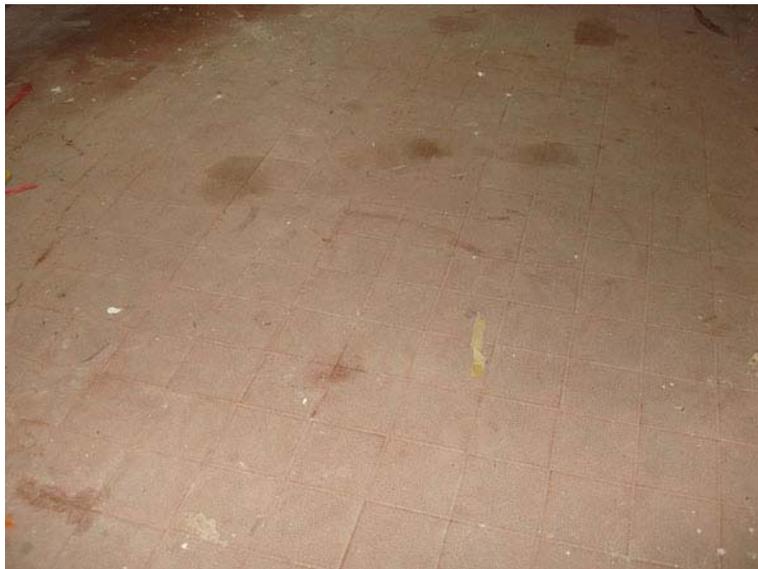
Fig. 255. Red cement flooring tiles at RM 1.

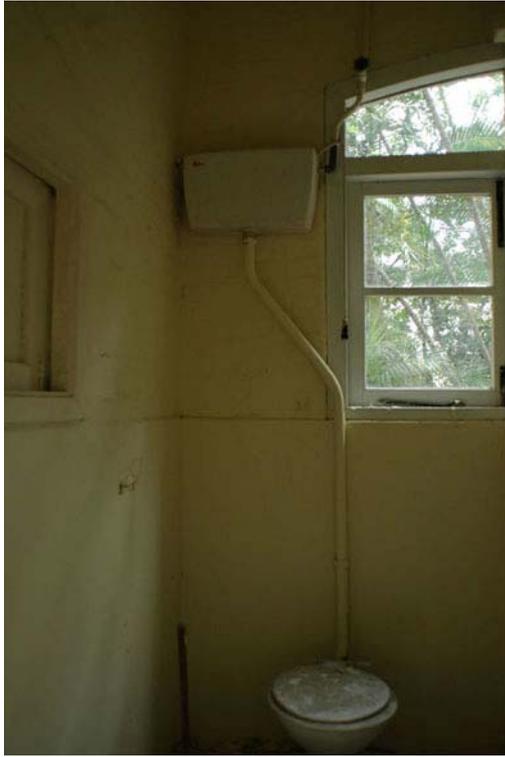
Fig. 256. Interior of the toilet at RM 1.

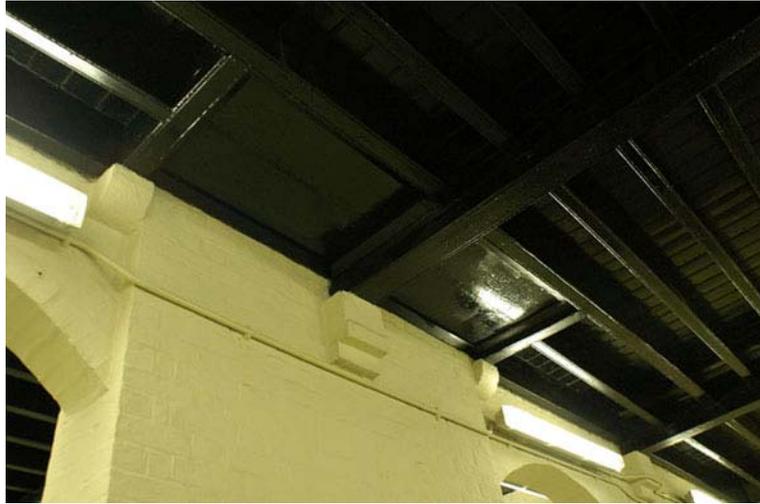
Fig. 258. Exposed timber floor of the first floor at RM 4 of the main building.

There are two ceiling types at RM 4, the exposed timber beams and planking of the floor system and the concrete ceiling revealing the concrete floor slab of the verandah on the first floor. These two ceiling types are supported by two structural systems: rows of segmental arches for the timber structures and piers with steel beams for the concrete floor above (Fig. 258 and Fig. 260). The arches mainly support the timber floor system above, with brackets on the piers supporting the timber beams (Fig. 259). The piers have brackets holding steel beams at the junction between the concrete floor and the timber floor (Fig. 261 - Fig. 262). The floor of RM 4 is finished with cement sand (Fig. 263). The original segmental-headed window opened to Electric Road is now blocked (Fig. 264).

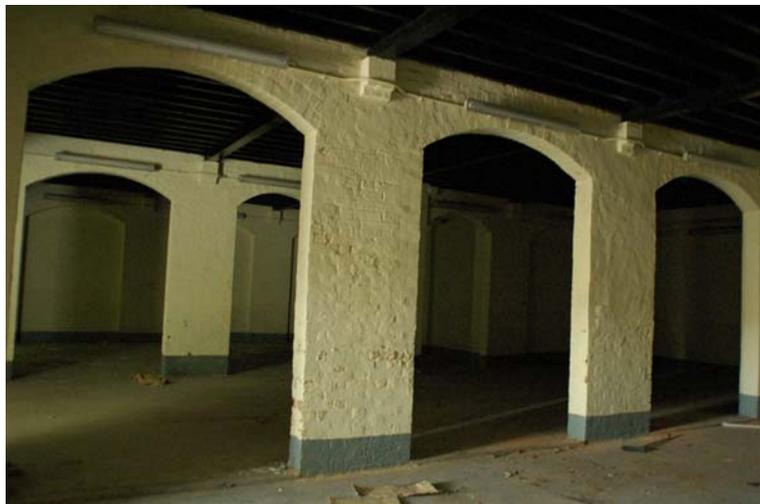
Fig. 259. Segmental archways at RM 4 of the main building.

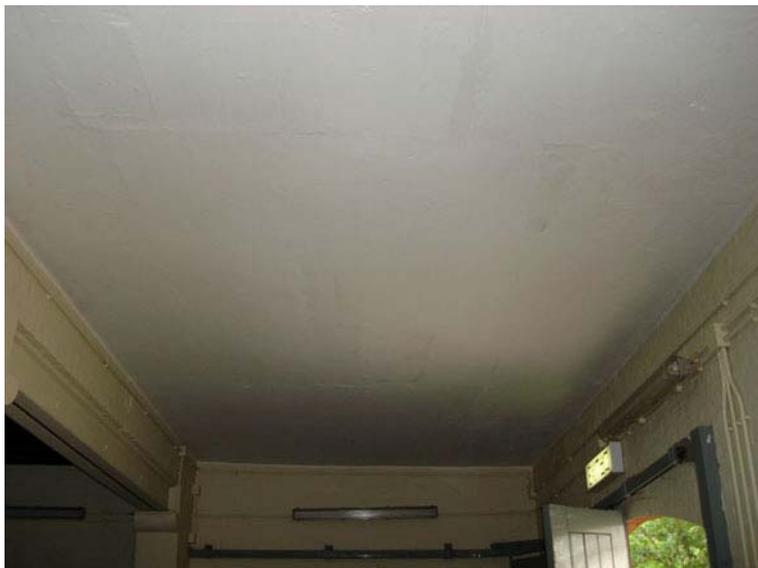
Fig. 260. Concrete ceiling at RM 4 of the main building.

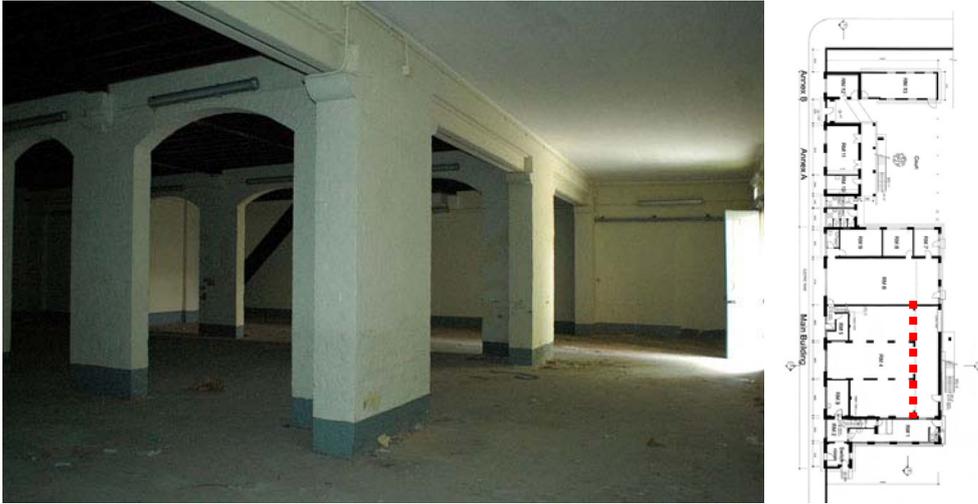
Fig. 261. Piers with brackets holding steel beams at RM 4 at the main building.

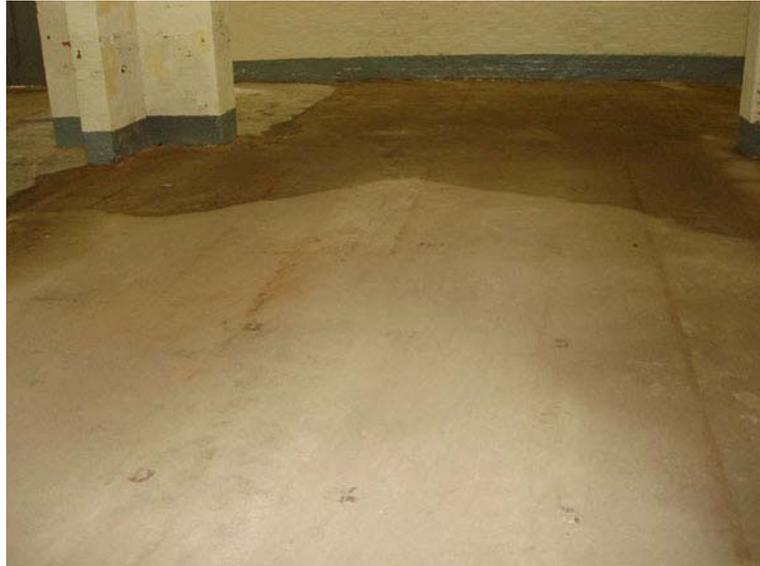
Fig. 263. Cement sand flooring of RM 4.

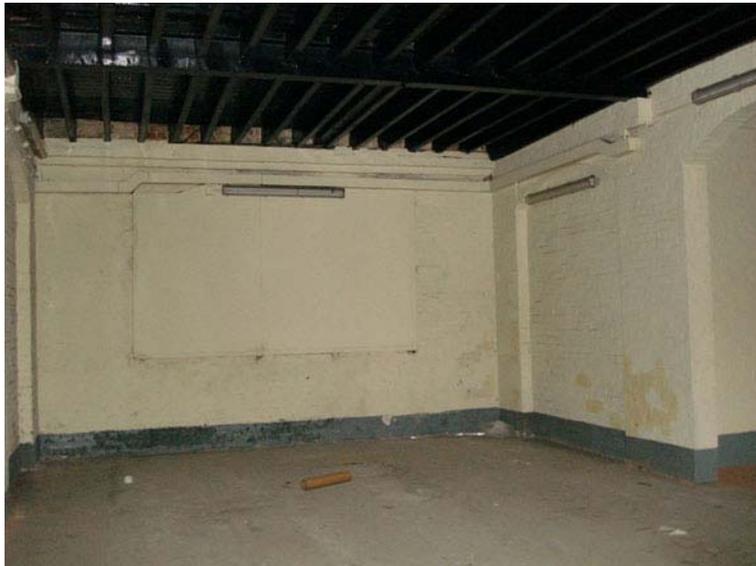
Fig. 264. Original segmental arched windows blocked at RM 4 of the main building.

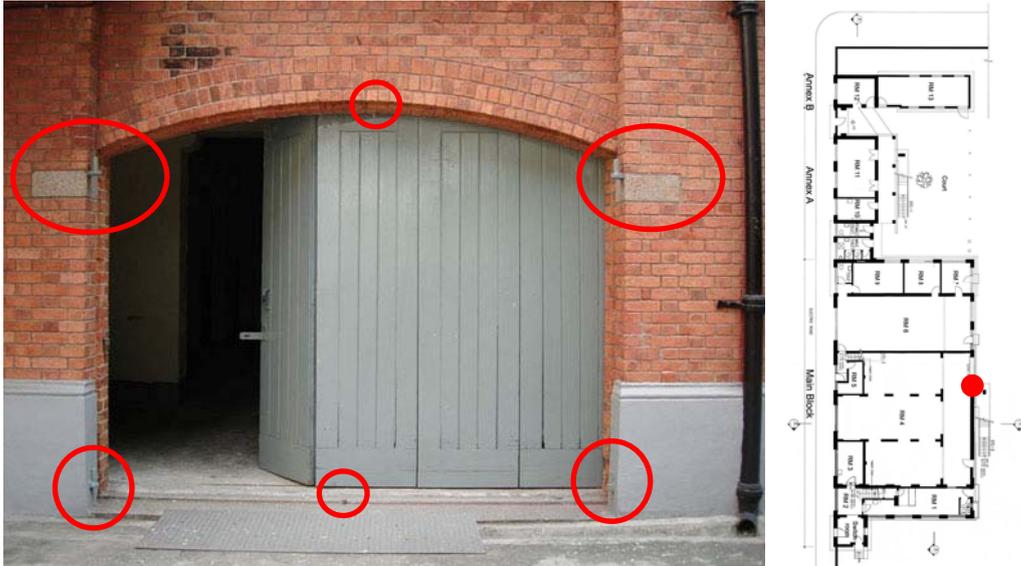
Fig. 265. Original door pintles and sockets at the rear façade of the main building.

Original iron pintles set in granite and sockets can be found at the segmental-headed door openings (Fig. 265), giving hints to the original door design when it was built (Fig. 266).

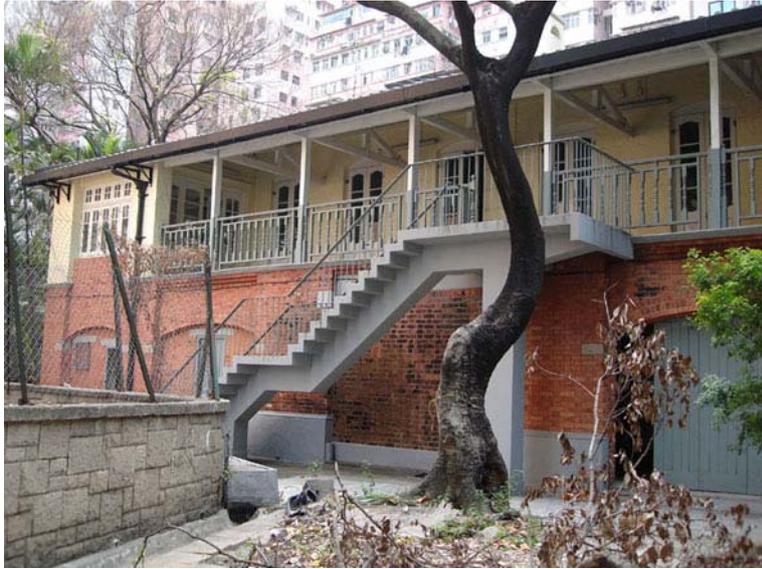
Fig. 269. The concrete staircase (STC – 2) at the main building.

The concrete staircase (STC – 2) is located at the rear of the main building (Fig. 267). It was added in 1969 when the first floor of the main building was converted into a staff quarters of three flats, which gave individual access to the flats (Fig. 268). The concrete staircase is supported on two concrete columns and surrounded by modern metal balustrade (Fig. 269).

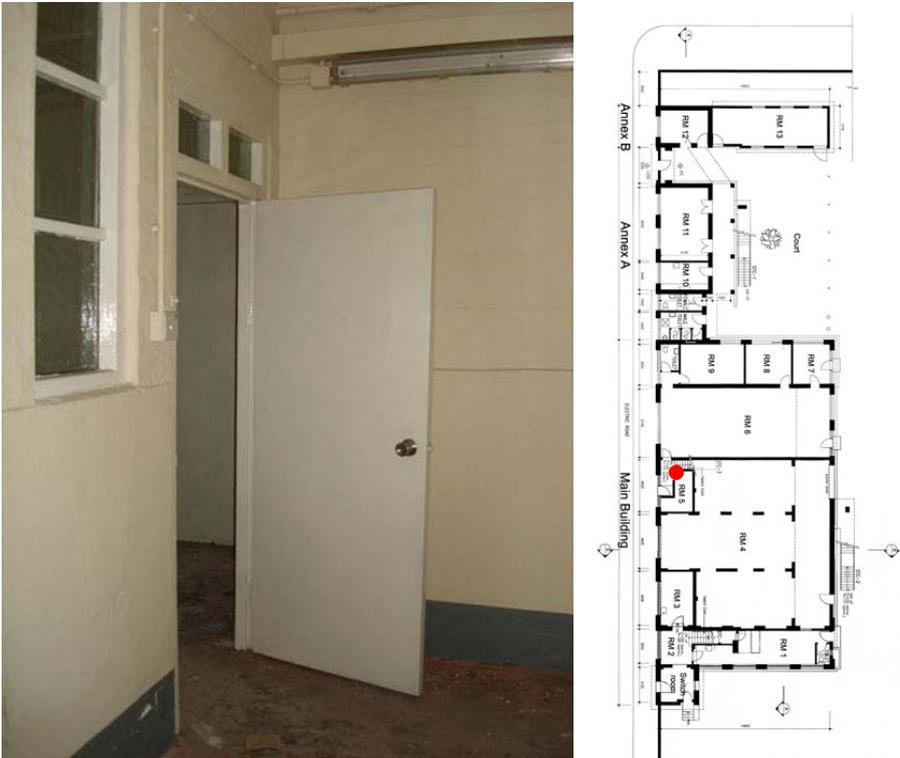
Fig. 272. The entrance to RM 5 from the stair lobby.

The room is in an L-shaped plan. The entrance is a timber door with a two-light fanlight above (Fig. 272). There is another window adjacent to the door. The window is half of the original segmental-headed window opened to Electric Road (Fig. 273). It has a concrete ceiling and cement
