BUILDING

3.1 Architectural evolution

3.1.1 The former Royal Hong Kong Yacht Club (1908-1938)

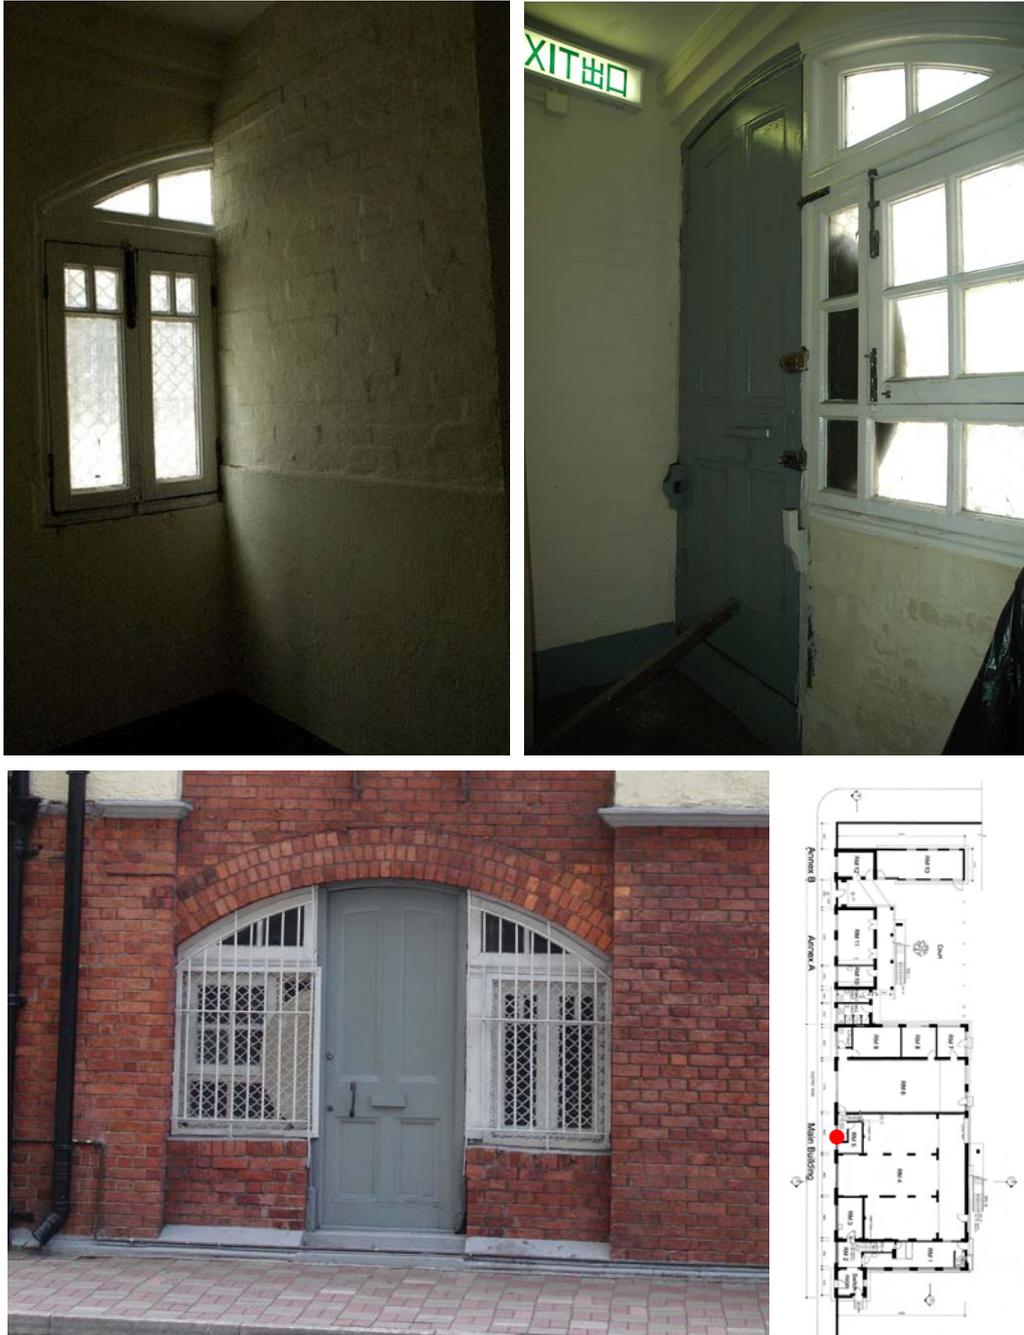
Fig. 273. The original segmental-headed window with door at the middle at RM 5 from the interior (above) and from the exterior (below) of the main building.

The room is in an L-shaped plan. The entrance is a timber door with a two-light fanlight above (Fig. 272). There is another window adjacent to the door. The window is half of the original segmental-headed window opened to Electric Road (Fig. 273). It has a concrete ceiling and cement

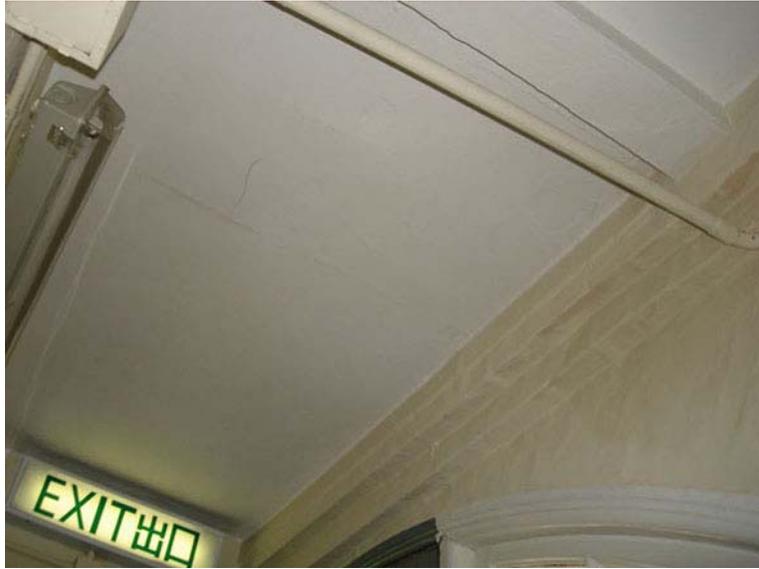
Fig. 274. Ceiling of RM 5.

sand floor finishes (Fig. 274 - Fig. 275). Corbels can be found along the ceiling implying that the original ceiling of this room could be timber structure. At the corner of the room, a blocked smoke flue is found (Fig. 276).

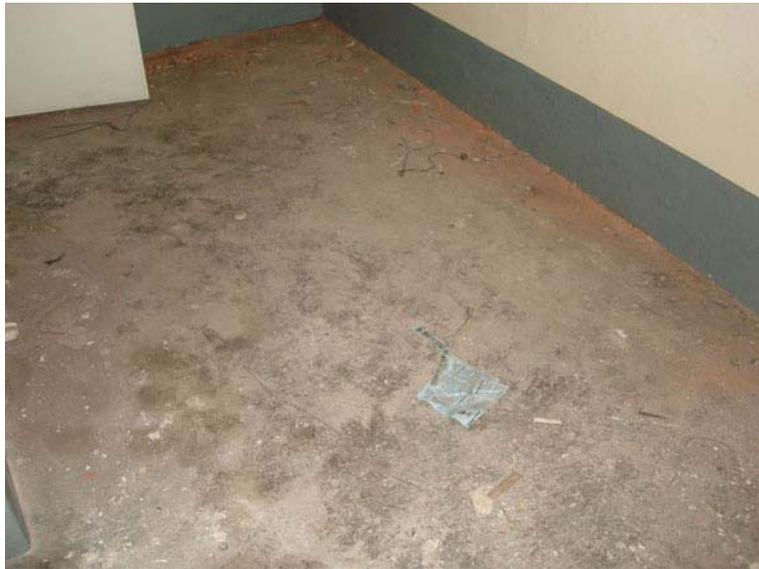
Fig. 275. Cement sand flooring of RM 5.

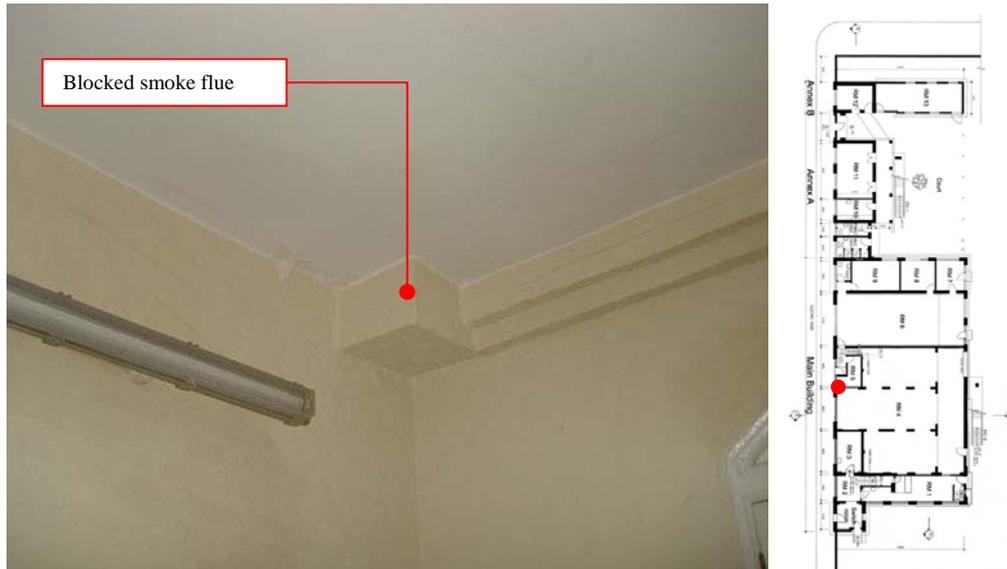
Fig. 276. Blocked smoke flue found in RM 5.

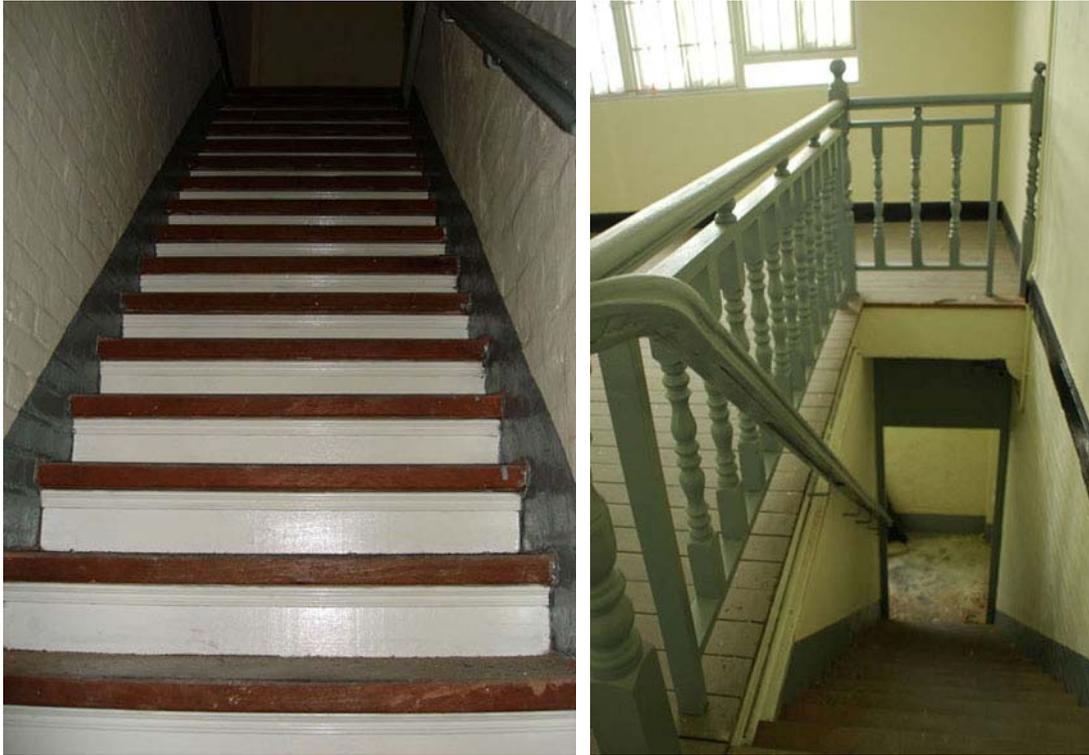
Fig. 278. Overview of the timber staircase (STC – 3) at the main building.

The timber staircase (STC – 3) is located adjacent to RM 5 (Fig. 277). The staircase is accessible from a door opened to Electric Road, which appears to be a side entrance of lower significance (Fig. 278). The first step is not rounded, which reflects its lower significance comparing to the staircase STC – 4 at the former entrance lobby. Timber handrails are found on both sides of the staircase (Fig. 279). Balustrade with turned balusters is found on the first floor (Fig. 280). Treads are found with nosings.

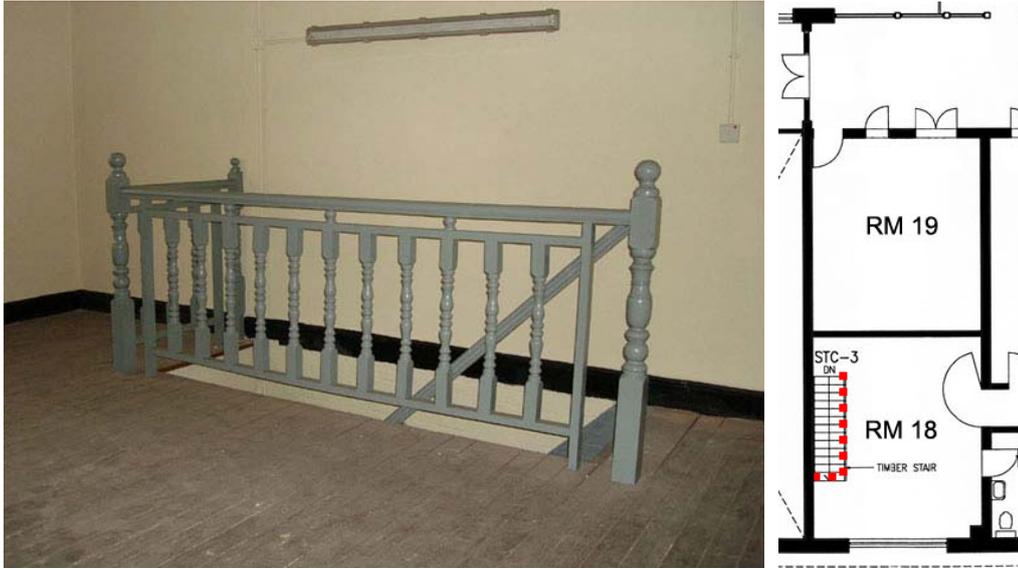
Fig. 280. Timber balustrade of the timber staircase (STC – 3) at the main building.

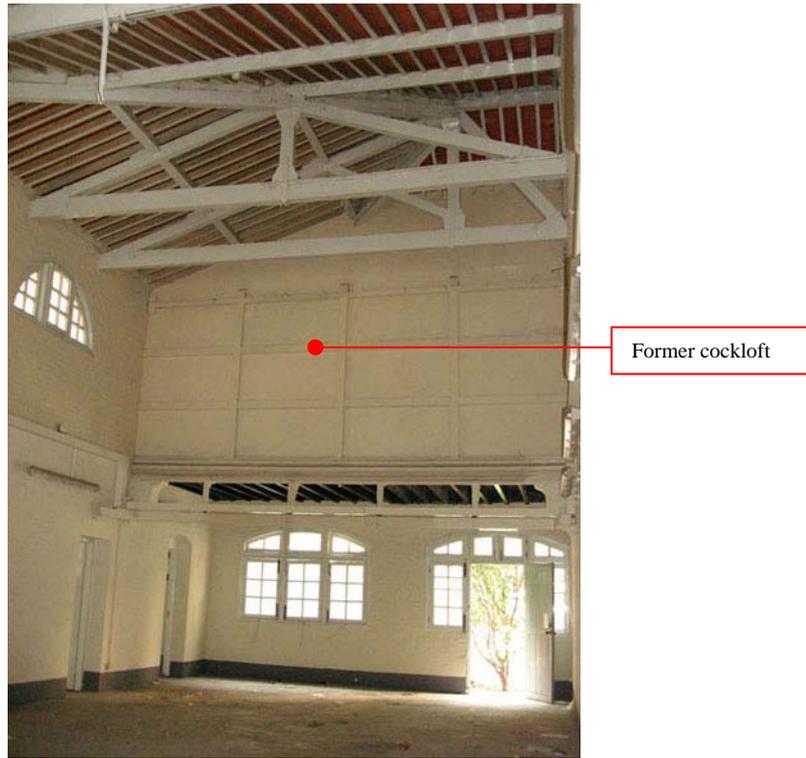
Fig. 282. Interior of RM 6.

The spatial quality of RM 6 is very interesting, with its double ceiling height, where the roof descends towards the front façade facing Electric Road (Fig. 282). The higher part is a cockloft where RM 20 is located, which is believed to be opened when it was built and enhance the cross ventilation within the double ceiling space. Together with the hooks on the walls on both sides of the room, RM 6 is believed to be the sail drying room when it was used as the clubhouse.

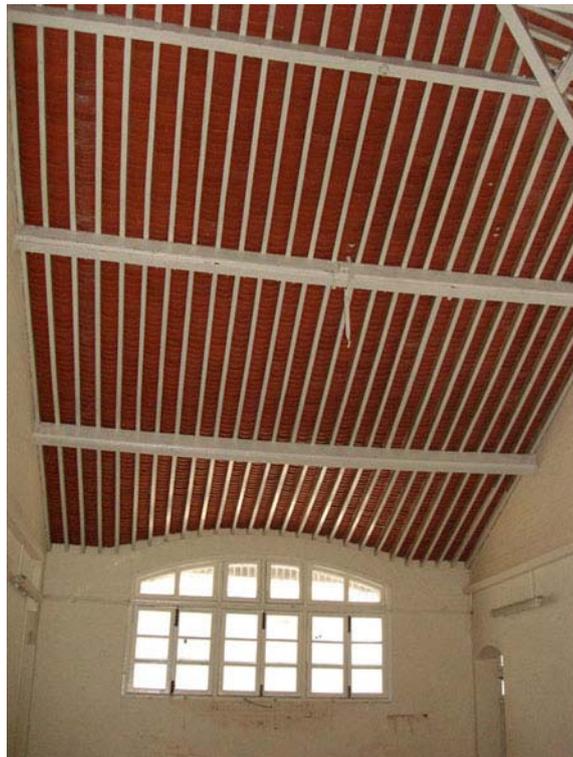
Fig. 283. The descending roof at RM 6.

The structural system of the roof is exposed, where the tiles, joists, beams and trusses could be clearly seen (Fig. 283 - Fig. 284). Cement sand is used as the flooring material (Fig. 285). The floor of the cockloft is supported on the wall and a steel section which is rest on the brick brackets (Fig. 286).

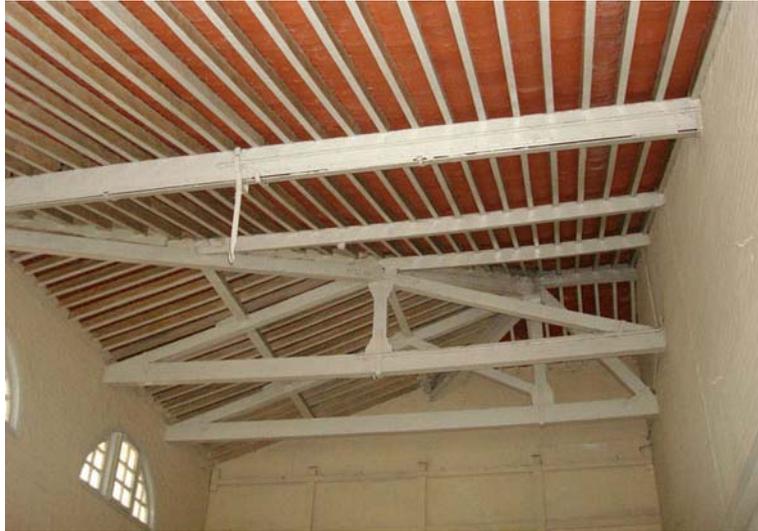
Fig. 284. The exposed roof system of RM 6 at the main building.

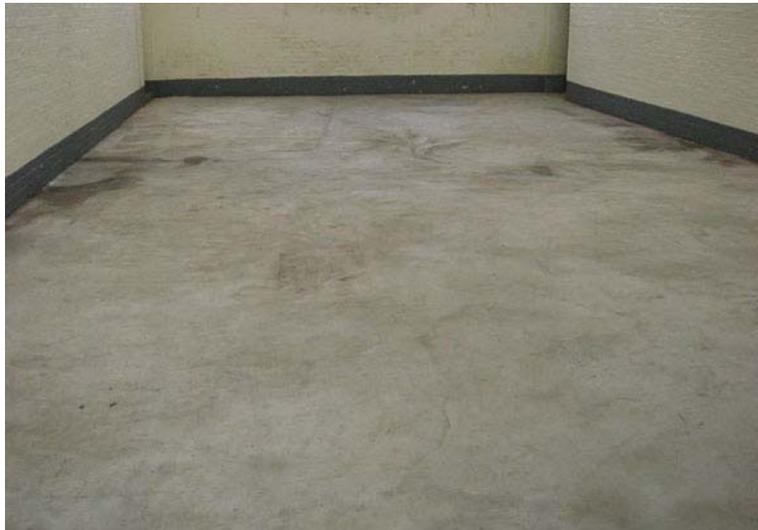
Fig. 285. Cement sand flooring of RM 6.

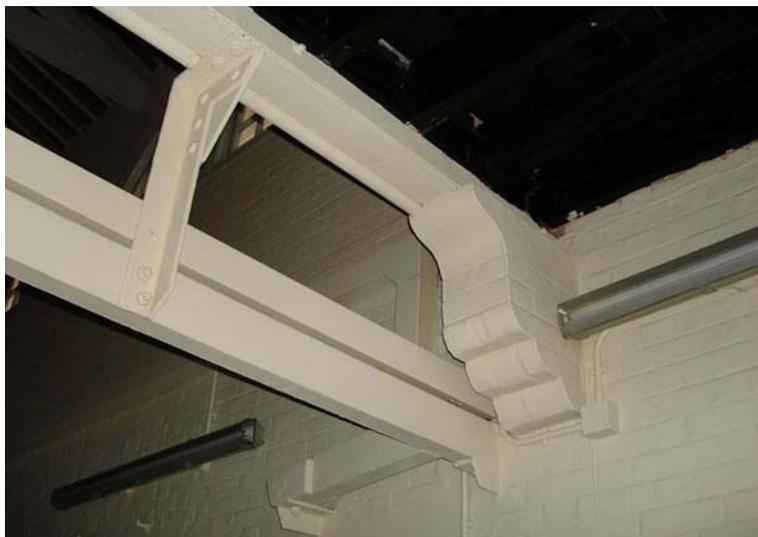
Fig. 286. Steel section supported on bracket at RM 6 of the main room.

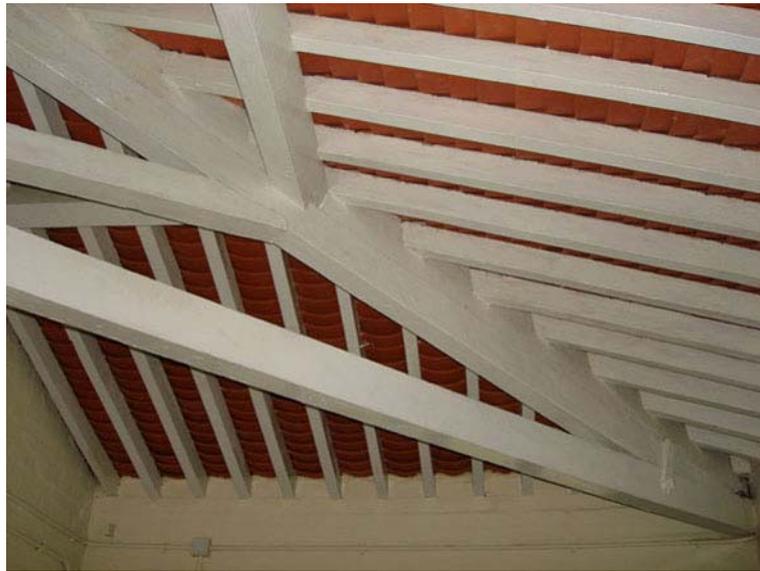
Fig. 291. Exposed roof structure at RM 7.

Together with RM 8, RM 9 and the toilet, it is under a separate roof from the hipped roof of the main body of the main building (Fig. 290). The roof structure is exposed in RM 7 (Fig. 291). The door from RM 6 is a segmental-headed door (Fig. 292). The original smoke flue can be found at northeast corner of the room, with the opening currently blocked (Fig. 293). Cement sand is used as the flooring material (Fig. 294). From the plaque of the entrance, it was used as an office before it was vacated.

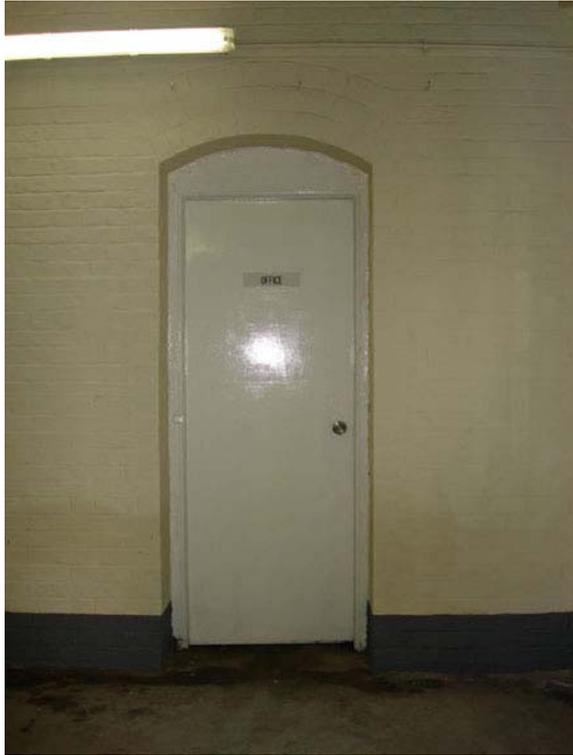
Fig. 292. Segmental-headed entrance to RM 7 from RM 6.

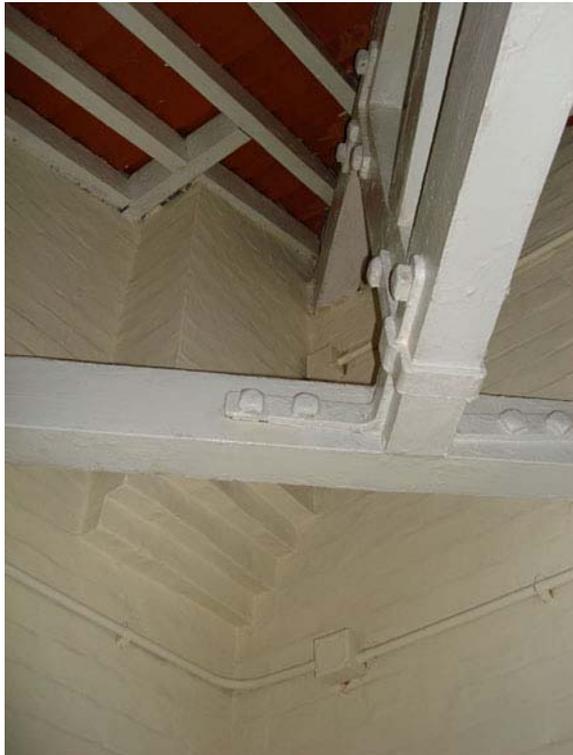
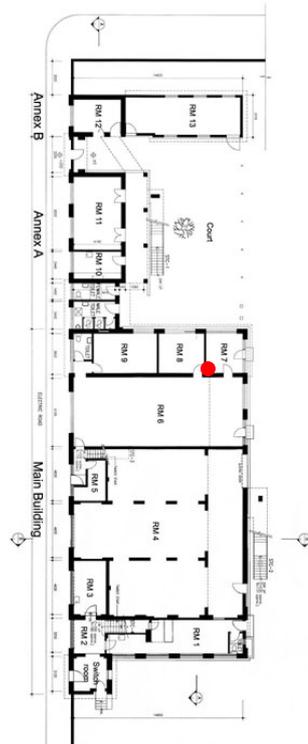
Fig. 293. Close up of the original smoke flue at RM 7 of the main building.

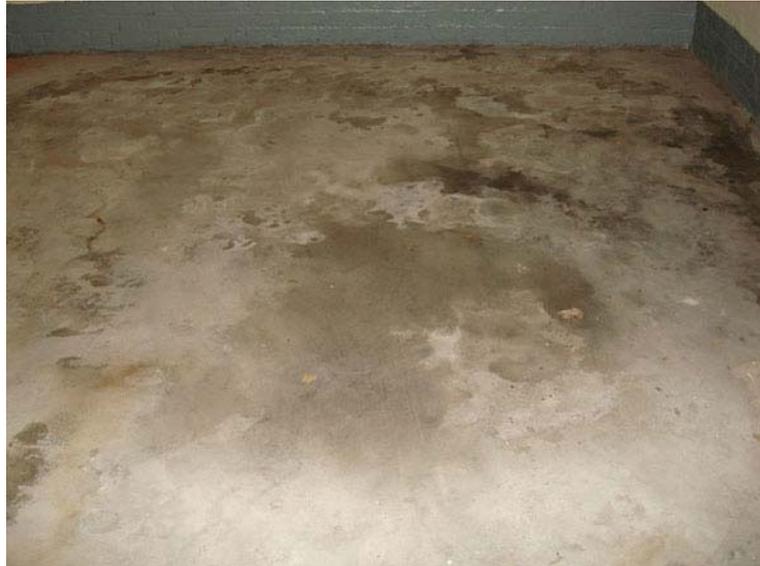
Fig. 294. Cement sand flooring of RM 7.

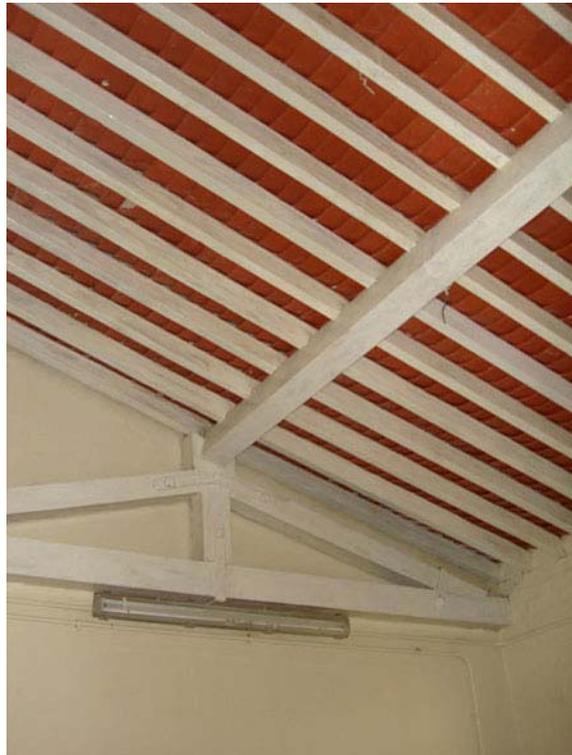
Fig. 297. Exposed roof structure at RM 8.

RM 8 is accessible from RM 6 (Fig. 295). Together with RM 7, RM 9 and the toilet, it is under a separate roof from the hipped roof of the main body of the main building (Fig. 296). The roof structure is exposed, while the floor is finished with cement sand (Fig. 297 - Fig. 298). It is believed that the door from RM 6 was originally a segmental-headed door, which was converted into a rectangular door during a renovation of an unknown date (Fig. 299). Rectangular window opening is found on the façade to the court facing Annex B. The aluminium windows are later addition of an unknown date. From the plaque of the entrance, it was used as a karaoke room before it was vacated.

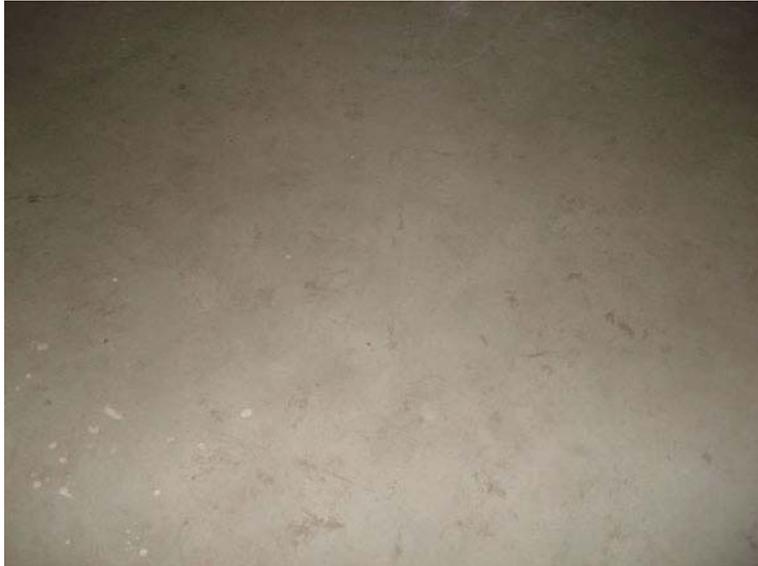
Fig. 298. Cement sand flooring at RM 8.

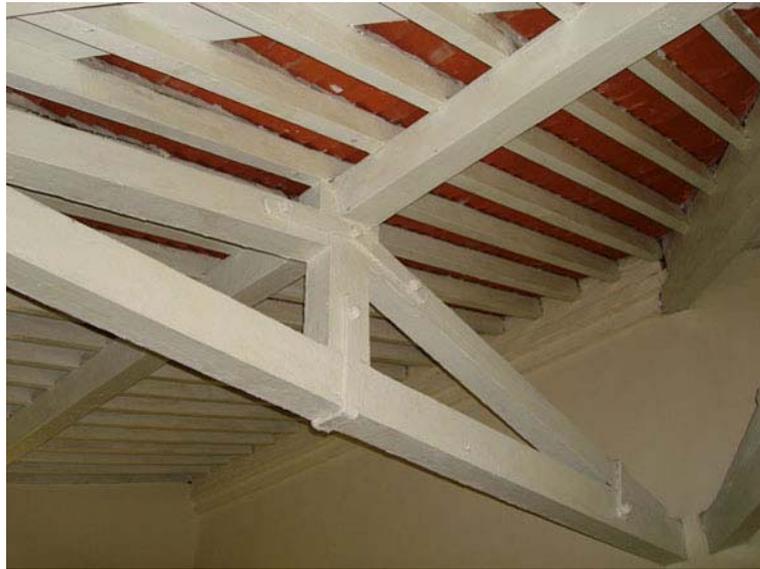
Fig. 303. Exposed roof structure of RM 9.

RM 9 is accessible from RM 6 through a segmental-headed doorway (Fig. 300 - Fig. 301). Together with RM 7, RM 8 and the toilet, it is under a separate roof from the hipped roof of the main body of the main building (Fig. 302). The roof structure is exposed, while the floor is finished with cement sand (Fig. 303). Rectangular window opening is found on the façade to the court facing Annex B. This opening was originally of a smaller size, which is now enlarged. The aluminium windows are later addition of an unknown date. From the plaque on the entrance door, this room was used as a conference room before it was vacated.

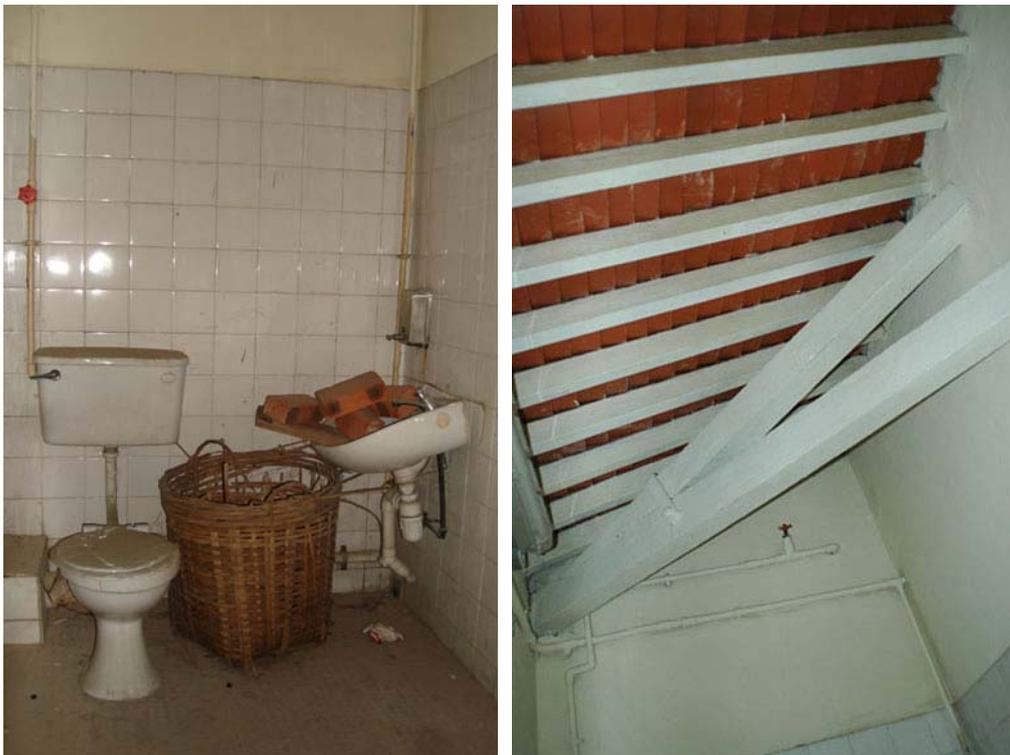
Fig. 305. Interior (left) and the exposed roof structure (right) of the toilet to RM 6 .

The toilet of RM 6 is accessible from RM 6 (Fig. 304). Together with RM 7, RM 8 and RM 9, it is under a separate roof from the hipped roof of the main body of the main building (Fig. 305). The roof structure is exposed, while the floor is finished with homogenous tiles (Fig. 306). Rectangular window opening is found on the front façade facing Electric Road, which extends to the corridor to RM 9 (Fig. 307). This reflects that the toilet is a later addition probably when the building was converted into a staff quarters.

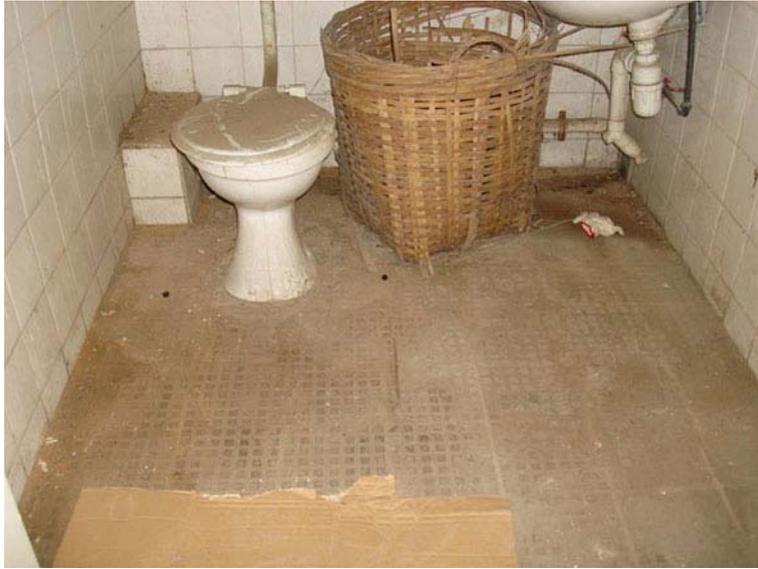
Fig. 306. Homogenous tile flooring of the toilet to RM 6.

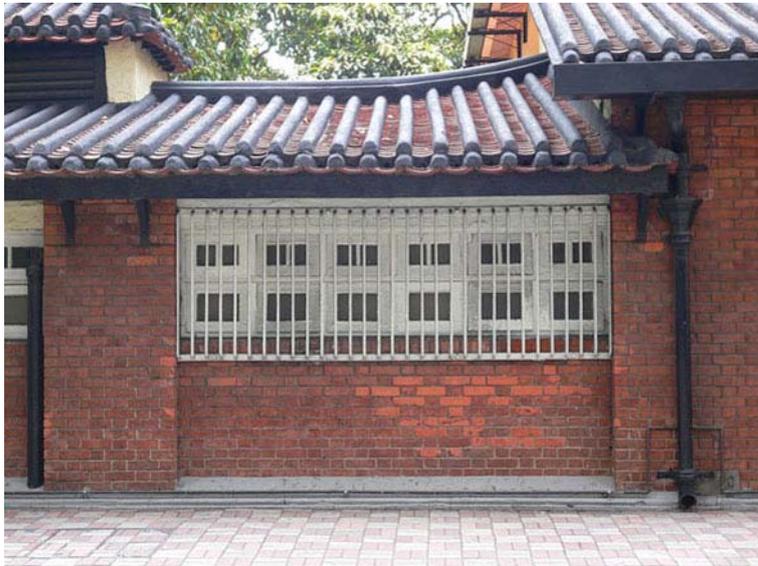
Fig. 307. Timber-framed windows of the toilet to RM 6 on the front façade.

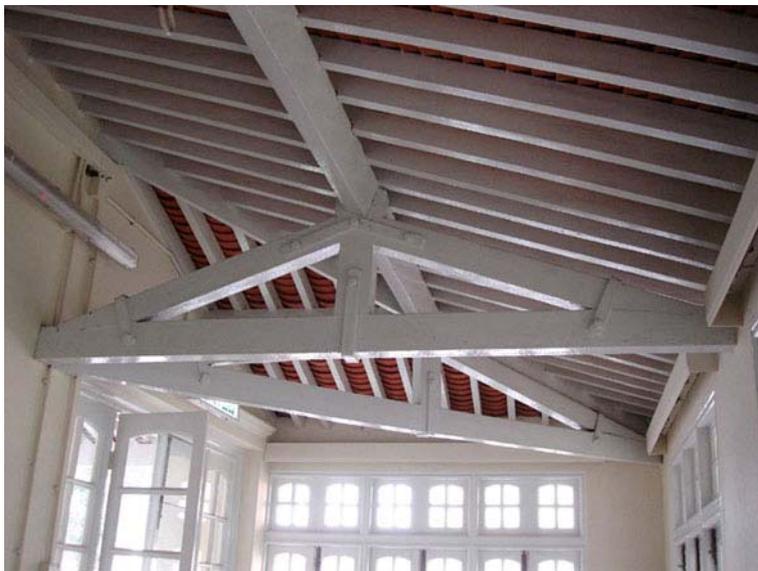
Fig. 311. Exposed roof structure of RM 14 at the main building.

The roof structure is exposed, where triangular trusses could be clearly seen (Fig. 311). The floor is finished with encaustic tiles with border, which is the same floor finishes as the verandah and the former entrance lobby on the ground floor (Fig. 312). This implies that this area could be used as a major public access or a space of high significance. There is a drain along the wall of the room, which might also implies that it was once a semi-outdoor area without window when it was built.

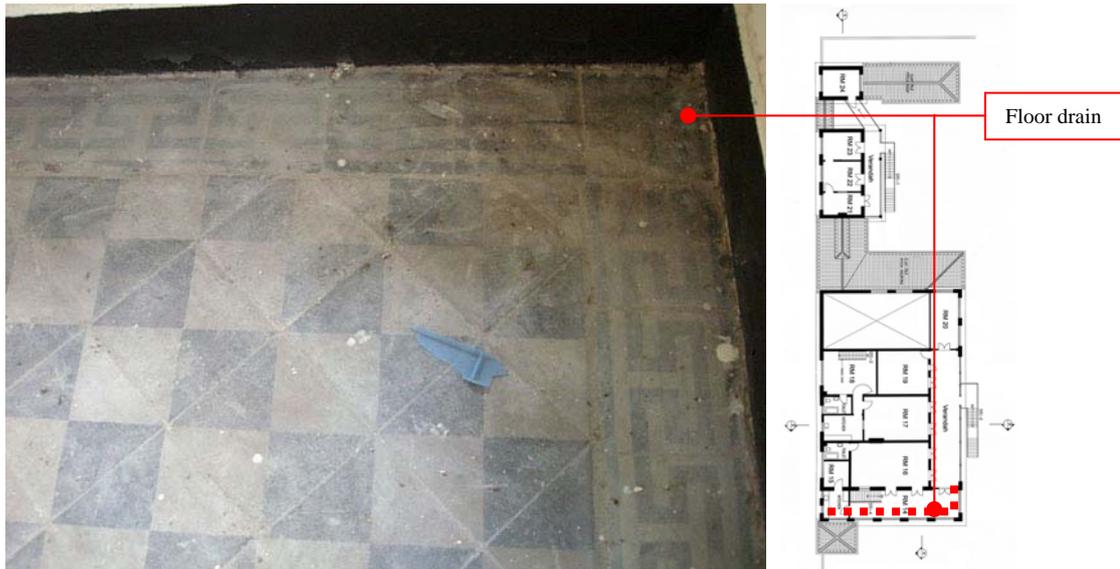
Fig. 312. Encaustic flooring tiles with border of RM 14 at the main building.

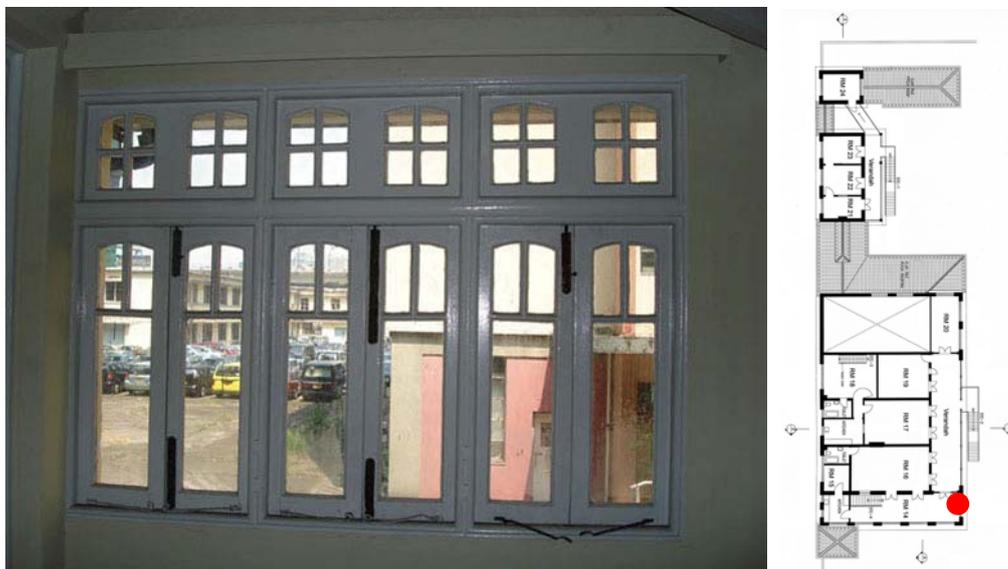
Fig. 313. Glazed timber windows at RM 14 of the main building.

Glazed timber casement windows are found all along the outer walls of this room, all with segmental-headed window glazings (Fig. 313). Some of them have scrolled window stays, which are believed to be of earlier days (Fig. 314). Glazed timber French door is found to the verandah, franked by two fixed glazed timber door panels (Fig. 315). All the door panels are found with segmental-headed glazings and a square panel at the bottom. There is a moulding along the top of the door opening facing the verandah.

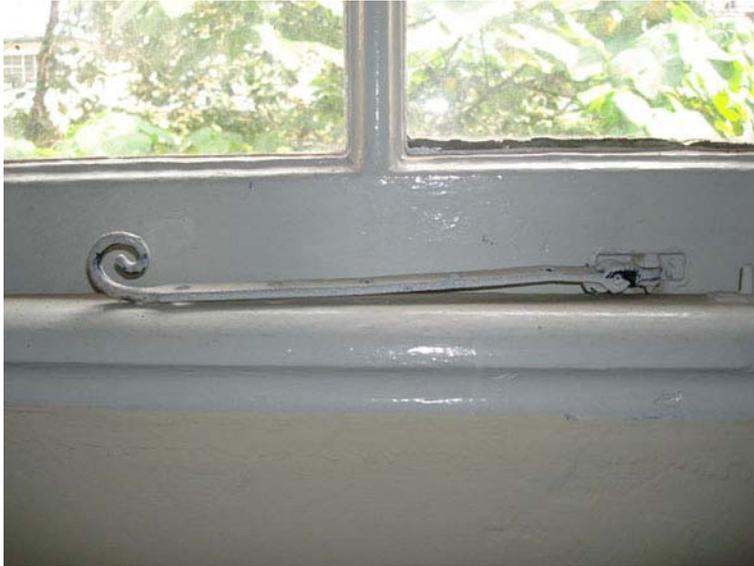
Fig. 314. Scrolled iron window stay at RM 14 of the main building.

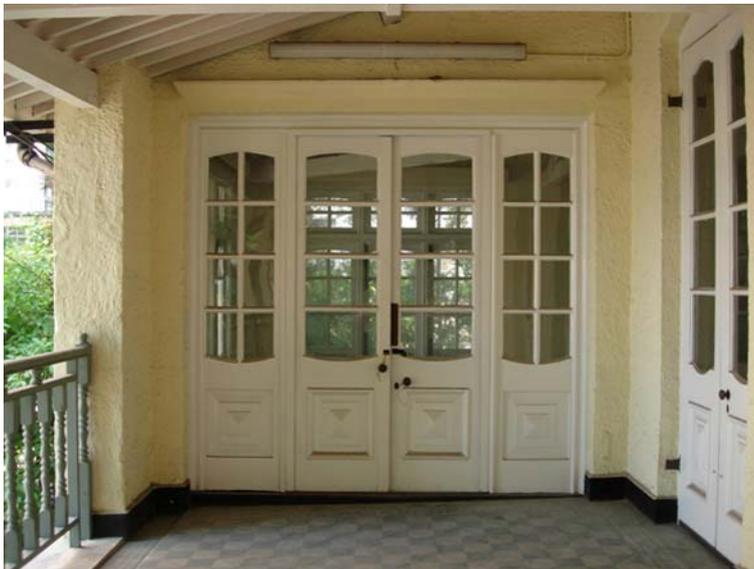
Fig. 315. Glazed timber French doors from RM 14 to the verandah at the main building.

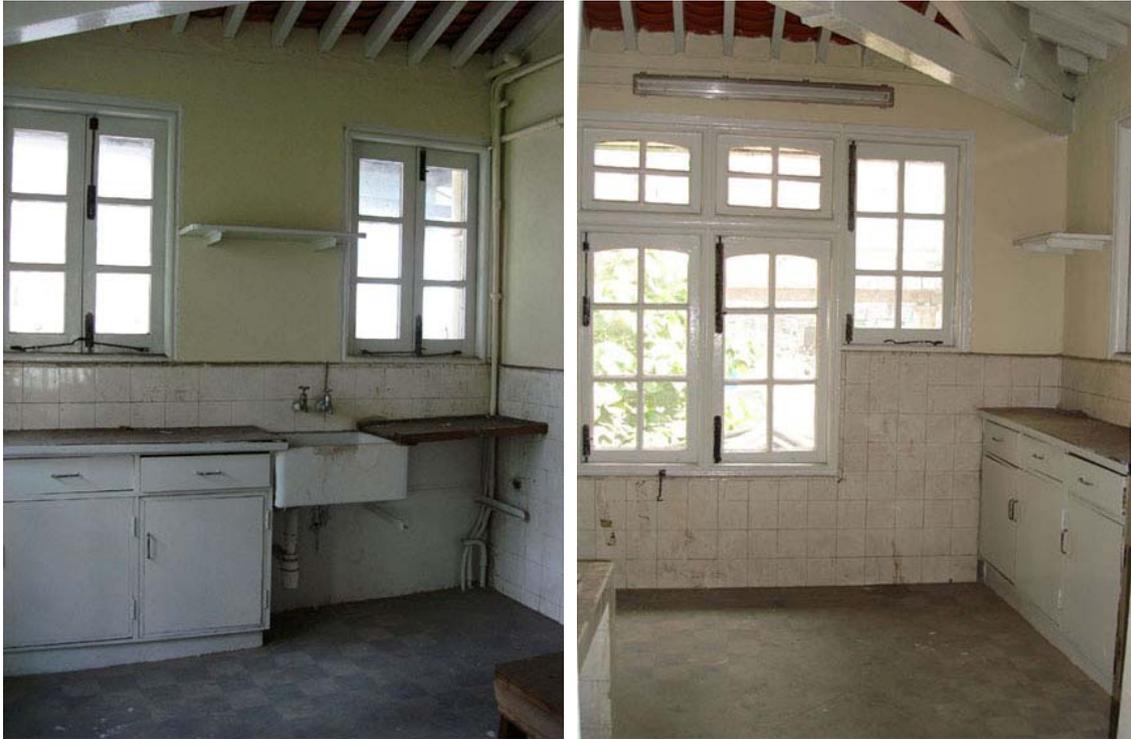
Fig. 316. Interior of the kitchen of RM 14 at the main building.

The kitchen of RM 14 is opened to another smaller room, RM 15 (Fig. 316). The roof structure is also exposed at the kitchen, with the same encaustic flooring tiles. The drain continues to this space, which might implies the original semi-outdoor area extended to this space (Fig. 317). The kitchen was a later addition probably when it was converted into a staff quarters in the 1930s. Windows are found on both the front façade and the northeast façade.

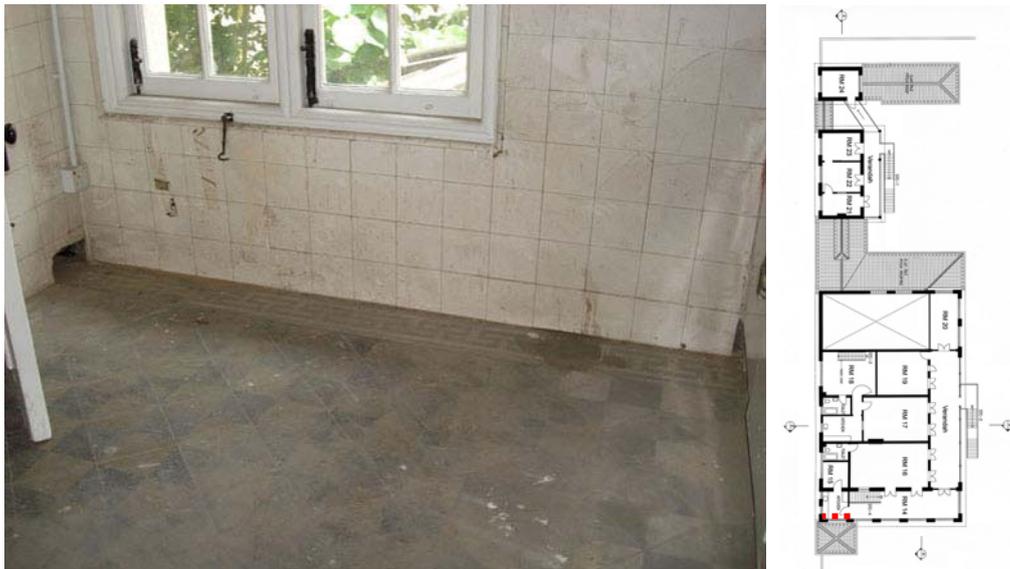
Fig. 317. The drain continued from RM 14 to the kitchen.

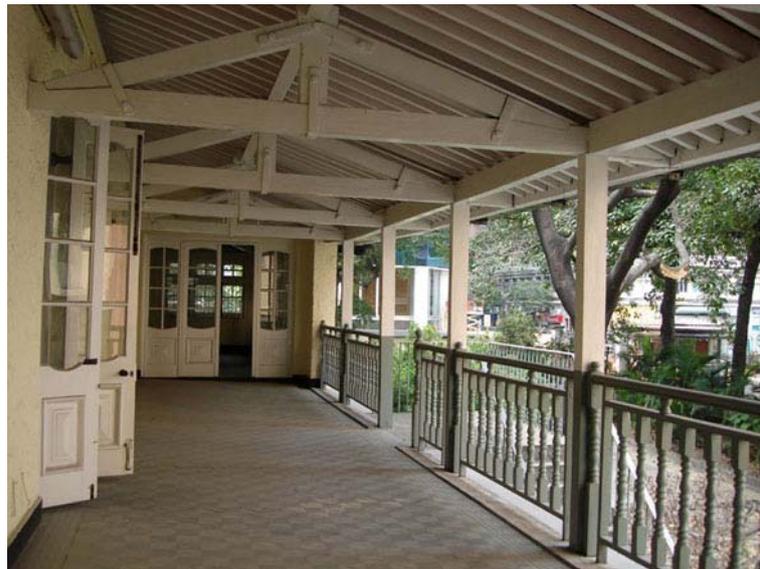
Fig. 319. Interior of the verandah at the main building.

Originally only accessible from the timber staircase at RM 14 (STC – 4), the verandah facing towards the sea served as a cozy area of the clubhouse. It is later accessible through the concrete staircase (STC – 2) which was added in 1969, and became the main circulation area on the first floor (Fig. 318). It is a long and narrow space with access to almost all the rooms on the first floor (Fig. 319 - Fig. 320).

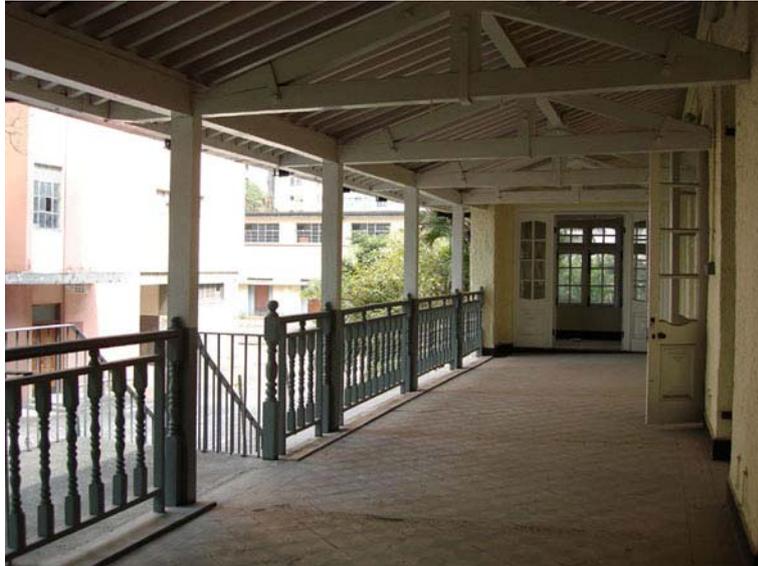
Fig. 320. Interior of the verandah of the main building.

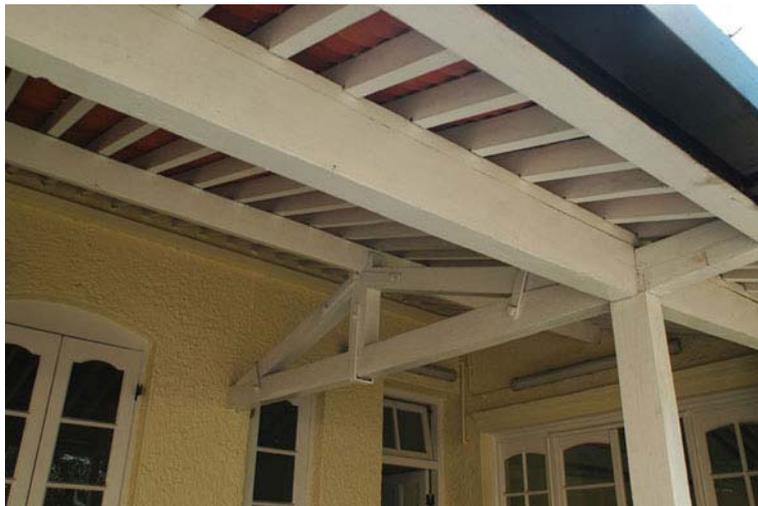
Fig. 321. Exposed roof trusses of the verandah at the main building.

The roof structure is exposed (Fig. 321). The floor is finished with encaustic tiles with border, the same floor finishes as the former entrance lobby (Fig. 322). The floor shows a slight fall towards the rear with a drain along the outer edge for water drainage.

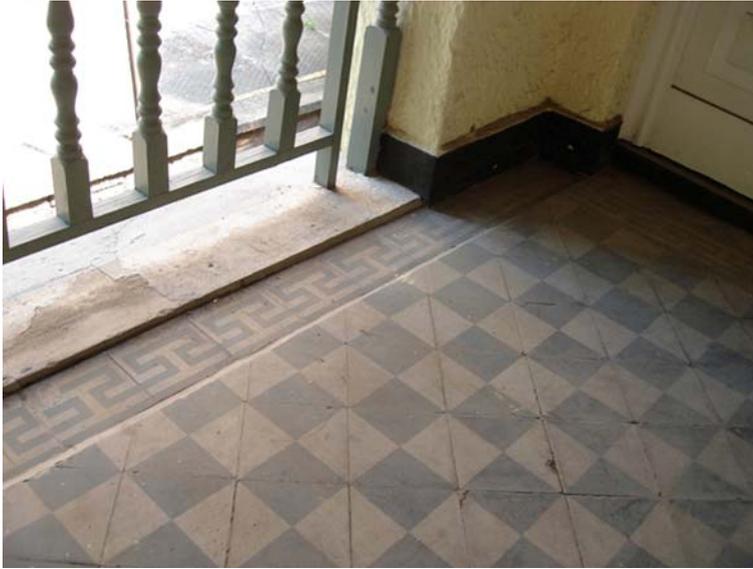
Fig. 322. Encaustic tiles with border and floor drain at the verandah of the main building.

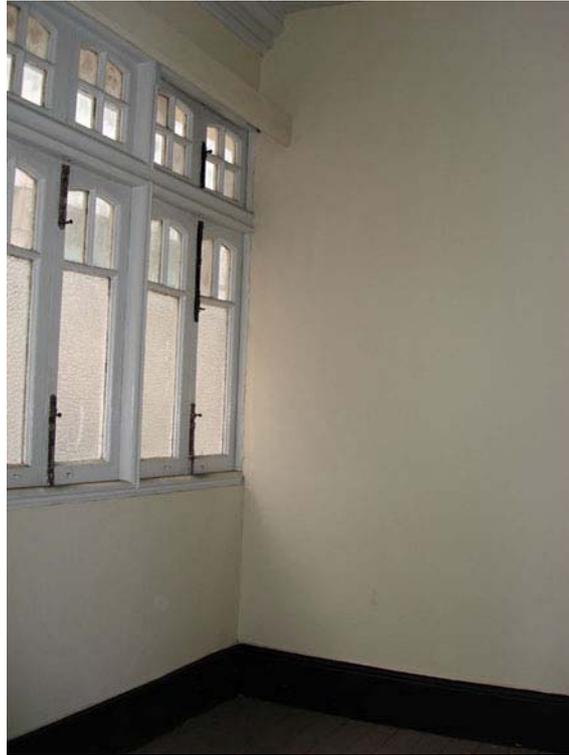
Fig. 325. Interior of RM 15 at the main building.

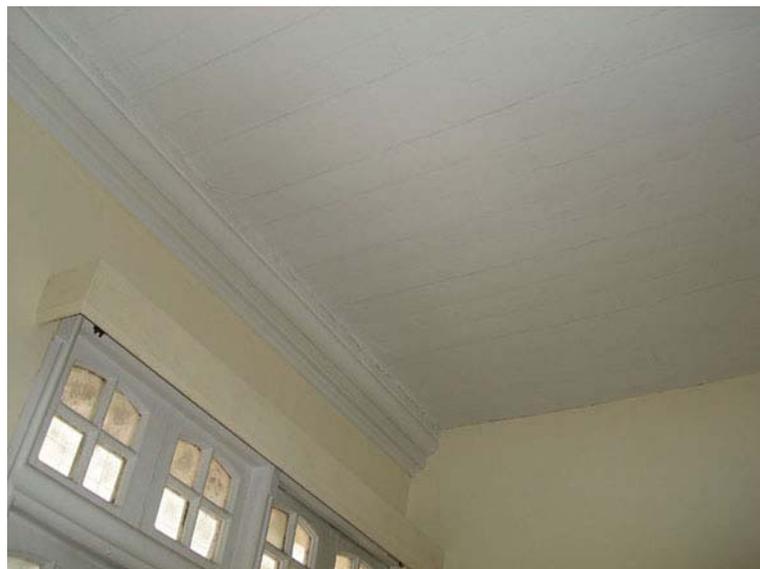
Fig. 326. Ceiling with cornice at RM 15 of the main building.

It has a timber planks false ceiling with cornice (Fig. 326). The cornice ends at the wall between RM 15 and the bathroom of RM 16, which may implies that RM 15 and the bathroom of RM 16 could be one single room which was sub-divided into two rooms. Two glazed timber casement windows are found on the front façade, which appears to be part of the original three casement windows that further give evidence of being one room with the bathroom of RM 16 at the time when it was built (Fig. 327). Segmental-headed window glazings were used. The floor is finished with timber planks with skirting around the room (Fig. 328).

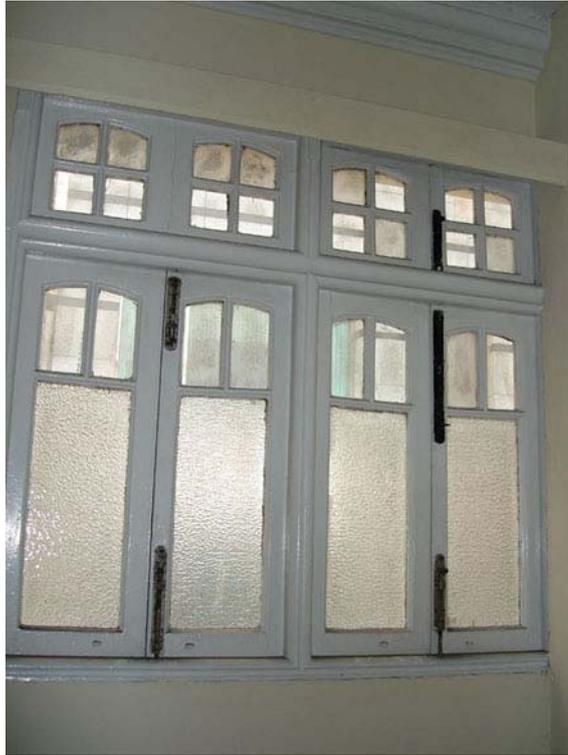
Fig. 327. Glazed timber casement windows at RM 15 of the main building.

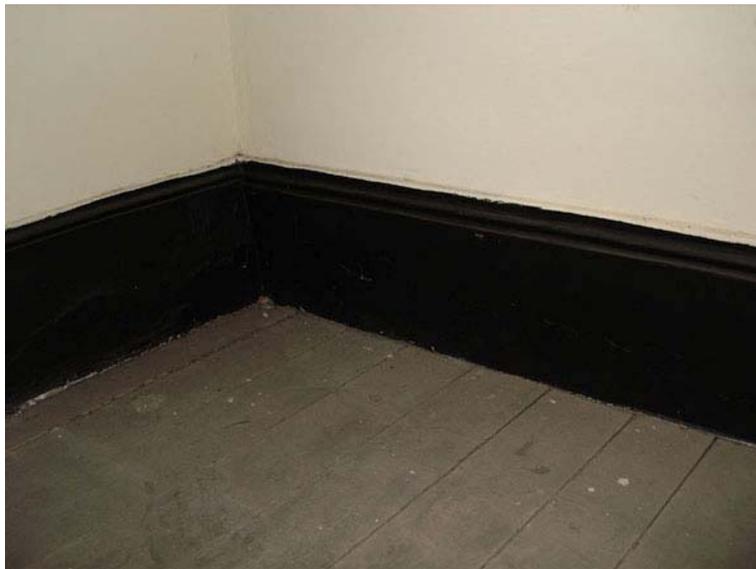
Fig. 328. Flooring with timber planks and skirting at RM 15 of the main building.

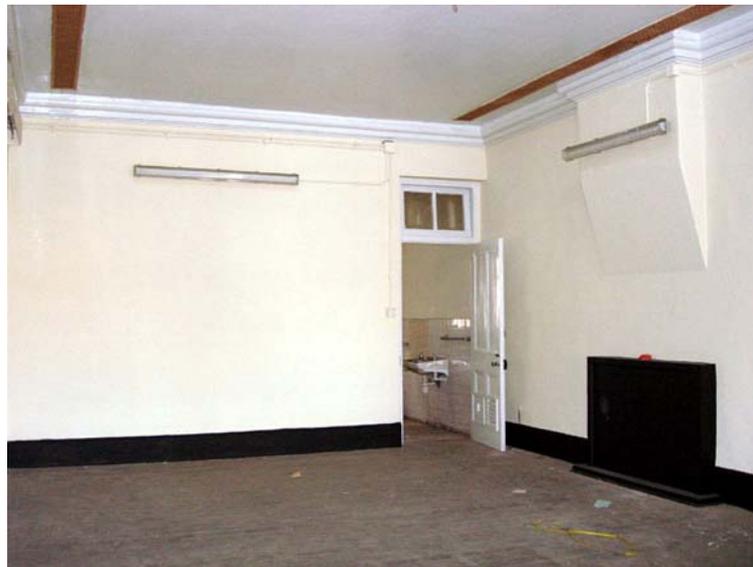
Fig. 330. Interior of RM 16 at the main building.

RM 16 can be accessible through the verandah and RM 14 adjacent to it. It is a rectangular room which also includes a bathroom (Fig. 329 and Fig. 330).

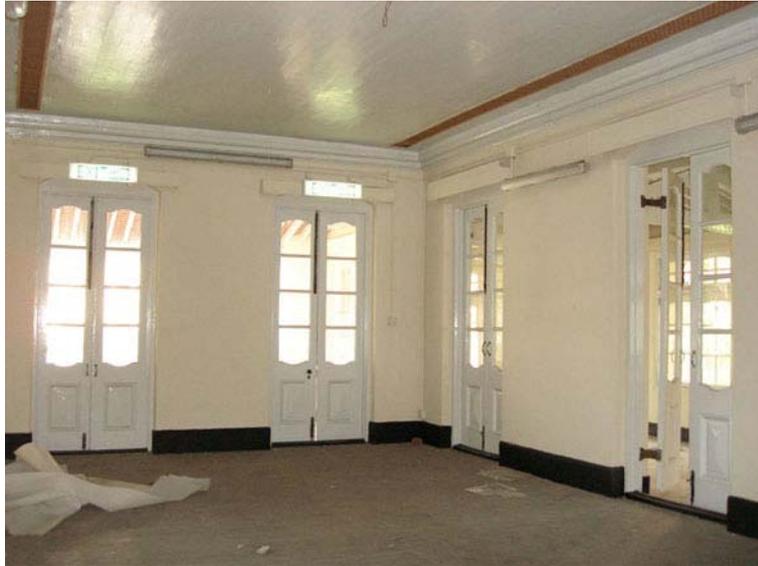
Fig. 331. Interior of RM 16 at the main building.

There are glazed timber French doors opened on two walls of the room (Fig. 331 and Fig. 332). A glazed timber casement window is also found on the northeast wall opened to RM 14. This may further implies that RM 14 was once a major circulation area. Timber planks false ceiling is used (Fig. 334). Cornice is also found along the ceiling of the room. The floor is finished with timber planks with skirtings. A fireplace that is now blocked is found with the chimney breast still present on the wall (Fig. 335).

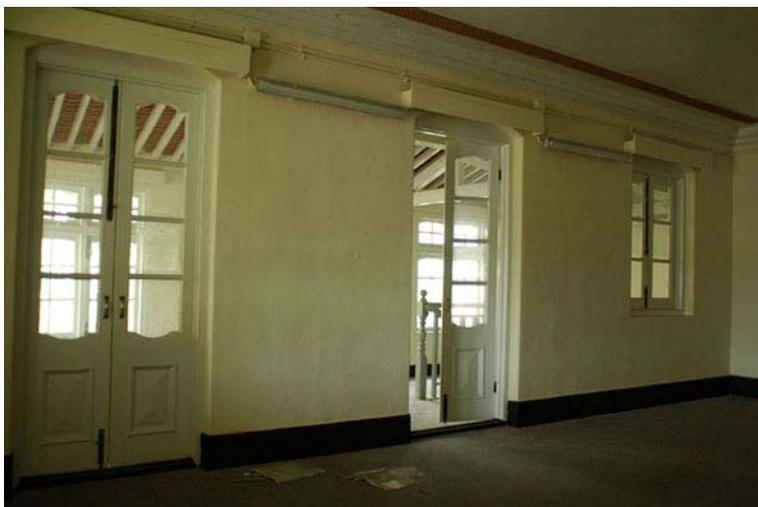
Fig. 332. Glazed timber French doors and casement windows at RM 16 of the main building.
