BUILDING

3.1 Architectural evolution

3.1.1 The former Royal Hong Kong Yacht Club (1908-1938)

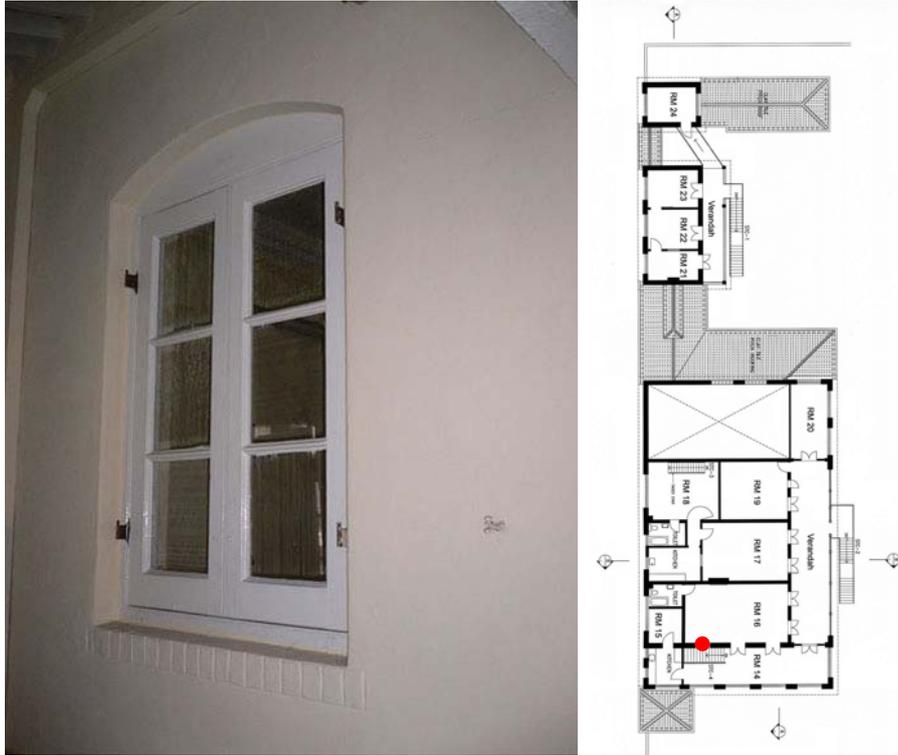
Fig. 333. Casement window opened to RM 14 at RM 16.

There are glazed timber French doors opened on two walls of the room (Fig. 331 and Fig. 332). A glazed timber casement window is also found on the northeast wall opened to RM 14. This may further implies that RM 14 was once a major circulation area. Timber planks false ceiling is used (Fig. 334). Cornice is also found along the ceiling of the room. The floor is finished with timber planks with skirtings. A fireplace that is now blocked is found with the chimney breast still present on the wall (Fig. 335).

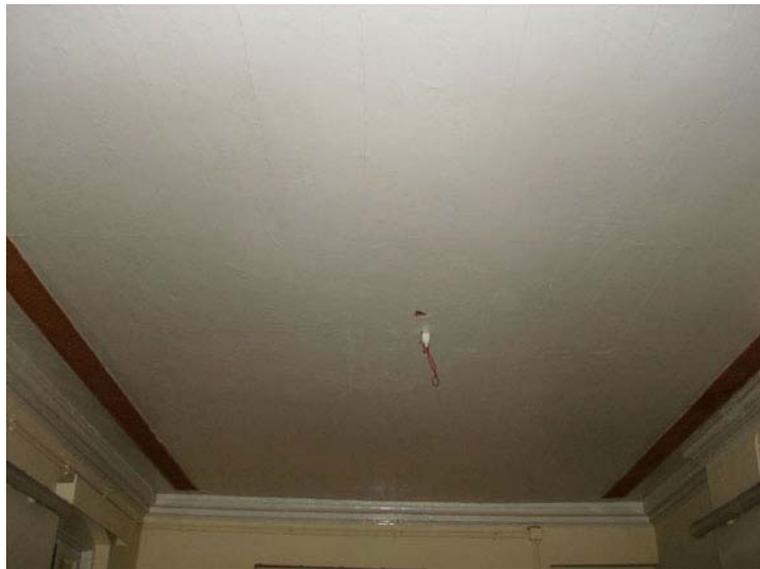
Fig. 334. Ceiling with cornice at RM 16 of the main building.

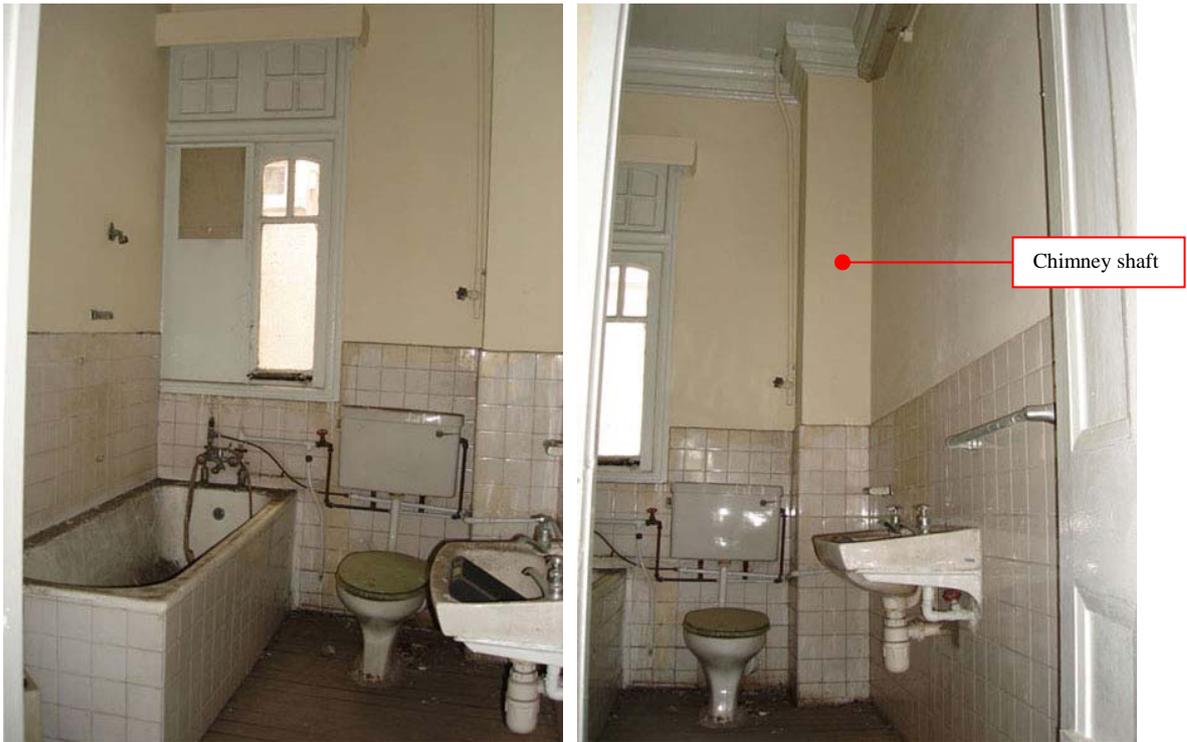
Fig. 336. Interior of the bathroom of RM 16 at the main building (left) and the chimney shaft at the corner of the bathroom (right).

The bathroom of RM 16 has a timber planks false ceiling with cornice along the ceiling, which ends at the wall between this room and RM 15 (Fig. 336). This further proves the later addition of RM 15 by adding the partition wall between the bathroom and RM 15 in the conversion in 1969. The floor is finished with timber planks. White glazed ceramic tiles are used as wall finishes up to half the height of the walls as dado (Fig. 337). A chimney shaft is found at the corner of the bathroom, which is the corresponding shaft for the smoke flue at RM 3 on the ground floor (Fig. 336).

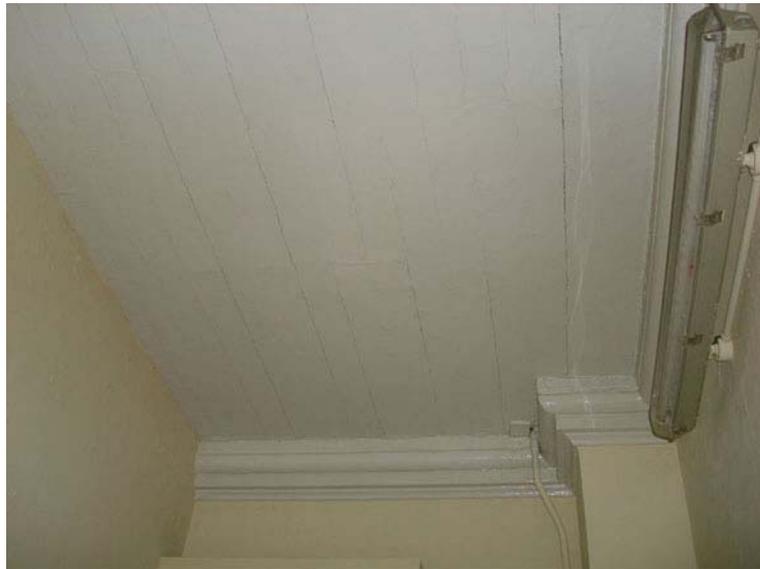
Fig. 337. Ceiling with cornice of the bathroom at RM 16 of the main building.

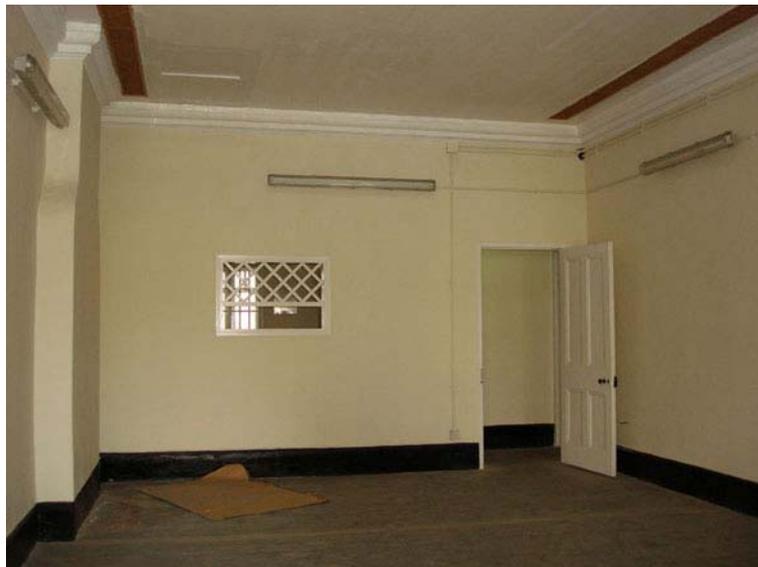
Fig. 339. Interior of RM 17 at the main building.

RM 17 is accessible from the verandah. It is opened to a kitchen and a suite room, RM 18 which includes a bathroom (Fig. 338 - Fig. 339).

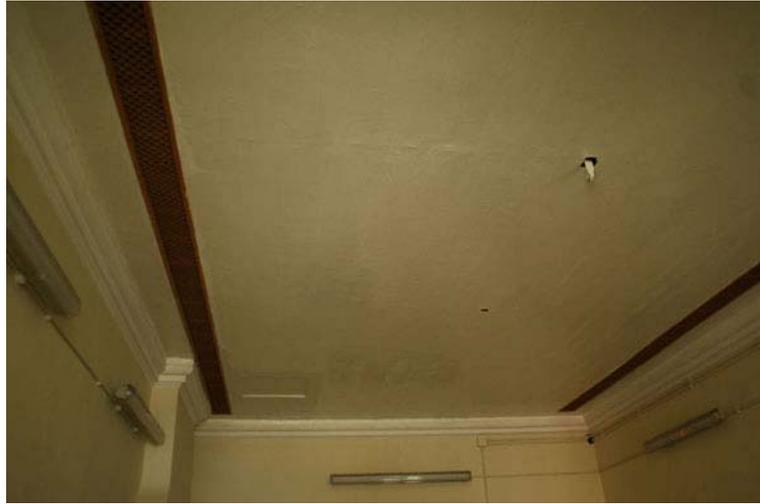
Fig. 340. False ceiling of RM 17 at the main building.

RM 17 has a timber planks false ceiling (Fig. 340). Cornice are found running along the ceiling. The floor is finished with timber planks, with skirting running along the bottom of the walls (Fig. 341).

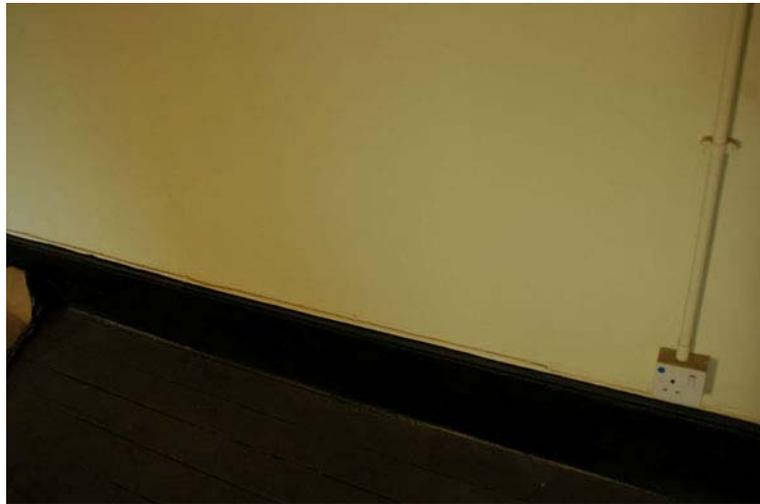
Fig. 341. Timber planks flooring with skirting of RM 17 at the main building.

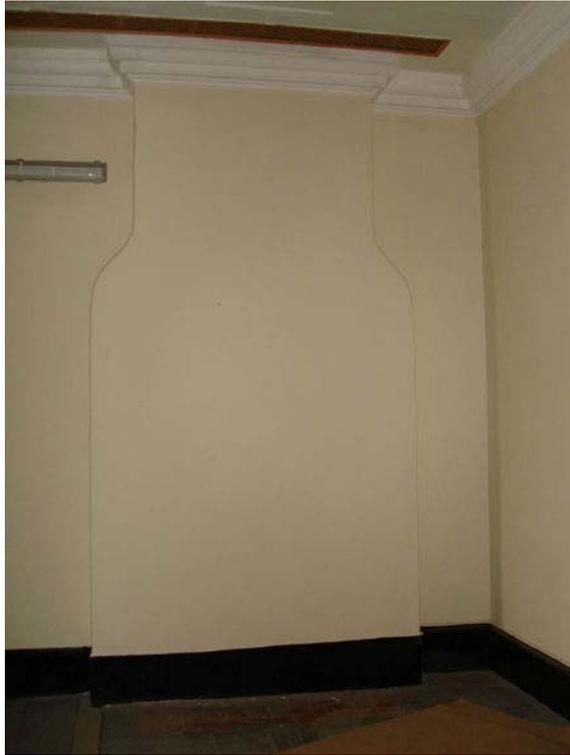
Fig. 343. Chimney breast of RM 17 at the main building.

A fireplace was originally present in this room as reflected from the old plan for the conversion to staff quarters in 1969 (Fig. 342). The fireplace was now blocked. The chimney breast with the lower portion wider than above (Fig. 343), and tiles for the hearth of the fireplace on the floor further proved the presence of the fireplace (Fig. 344). The old plan also indicated that an existing door originally opened to RM 16 was blocked. Glazed timber French doors are found opened to the verandah, while a window is opened to the kitchen which is believed to be a later addition (Fig. 345).

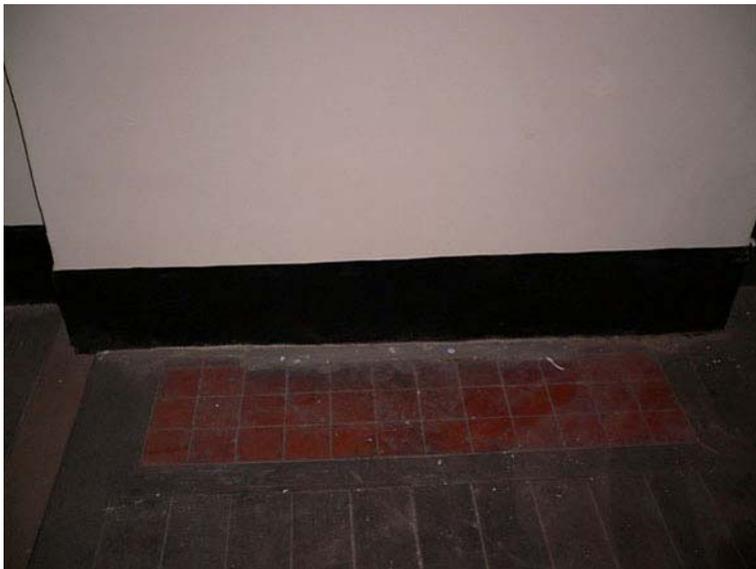
Fig. 344. Tiles for the hearth of the fireplace at RM 17.

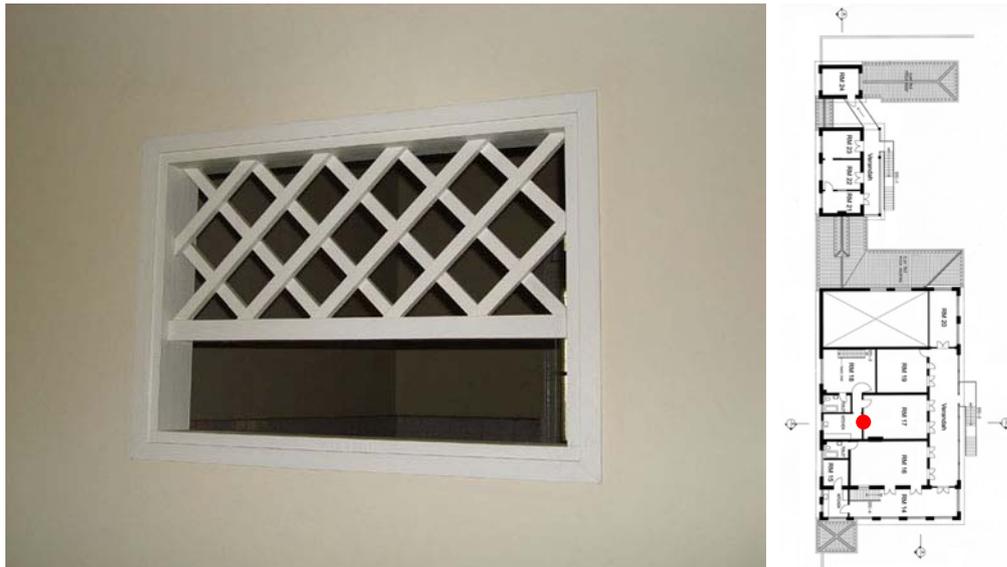
Fig. 345. Window opened to the kitchen at RM 17 of the main building.

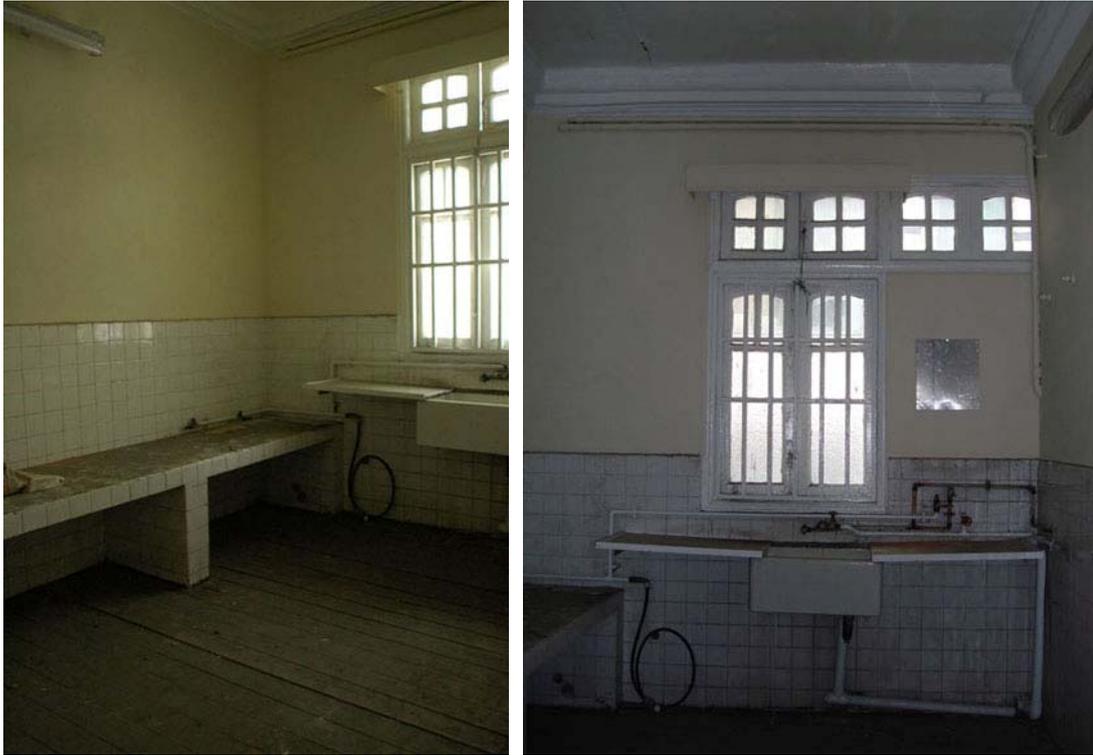
Fig. 346. Interior of the kitchen of RM 17 at the main building (left) and the casement window (right).

The kitchen has a timber planks false ceiling with cornice along the ceiling. The floor is finished with timber planks (Fig. 346). White glazed ceramic tiles are used as wall finishes up to half the height of the walls as dado. Two glazed timber casement windows are found, which appears to be part of the original three casement windows on the front façade that may imply the kitchen to be one room with the bathroom of RM 18 at the time when it was built (Fig. 347). From the old plan in 1969, it indicates that there was originally a door opened to the bathroom of RM 16 which is now blocked (Fig. 342). This implies that the room where the kitchen is located now may have shared amongst RM 16 and RM 17 once.

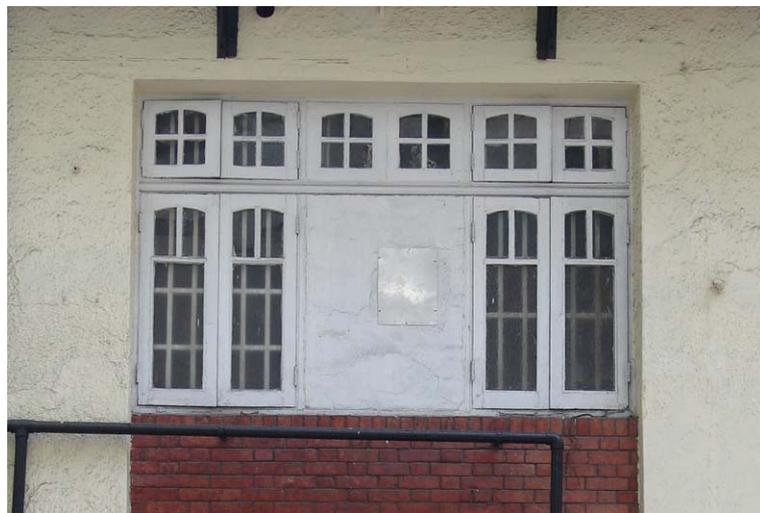
Fig. 347. Casement windows viewed from the front façade.

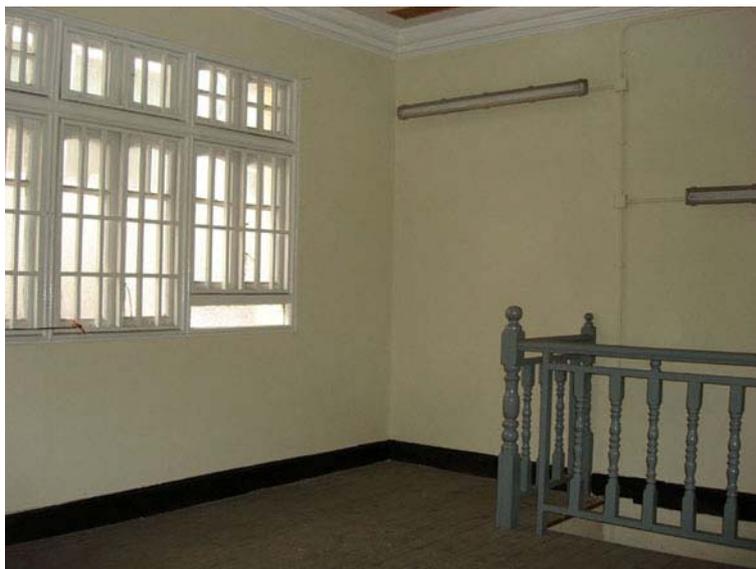
Fig. 349. Interior of RM 18 at the main building.

RM 18 is accessible from RM 17 and the timber staircase adjacent to RM 5 (STC – 3) on the ground floor (Fig. 348 -Fig. 349). It is also accessible to the kitchen of RM 17, and it includes a bathroom.

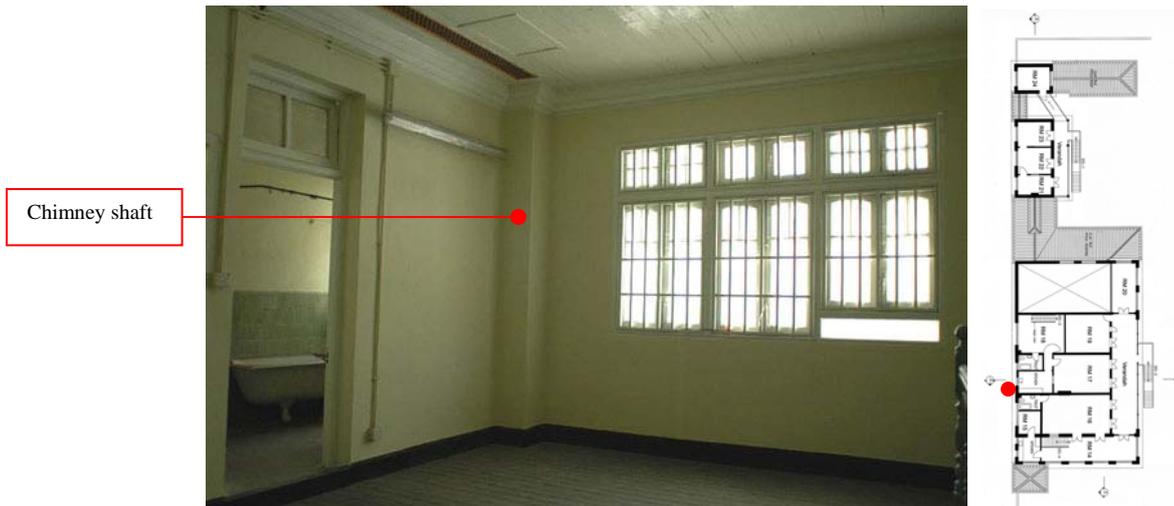
RM 18 has a timber planks false ceiling (Fig. 351). Cornice is found running along the ceiling. The floor is finished with timber planks with skirting along the bottom of the walls. A chimney shaft is found at the corner of the room (Fig. 350). Three glazed timber casement windows with segmental-headed glazings are found.

Fig. 350. Chimney shaft at RM 18.

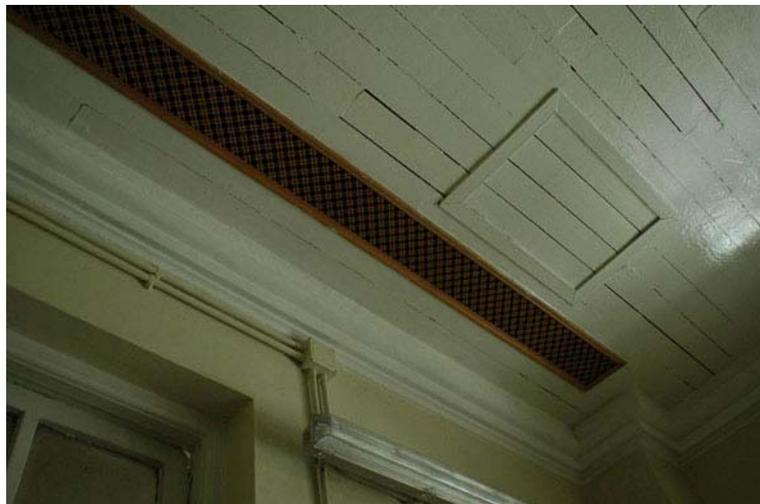
Fig. 351. False ceiling of RM 18 at the main building.

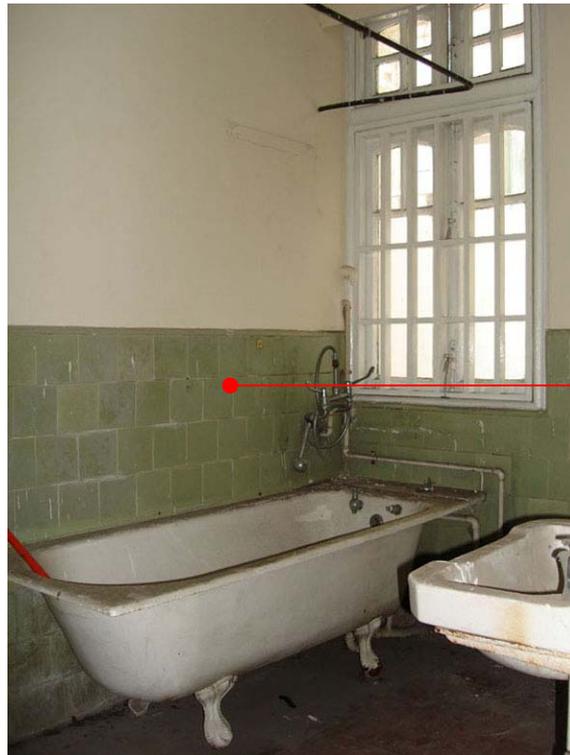
The bathroom has a timber planks false ceiling with cornice along the ceiling (Fig. 352 - Fig. 353). Green glazed ceramic tiles are used as wall finishes up to half the height of the walls as dado. The floor is finished with red quarry tiles which is believed to be a later addition of an unknown date (Fig. 354). A pair of glazed timber casement window is found.

Green glazed
ceramic tiles

Fig. 352. Interior of the bathroom at RM 18 of the main building.

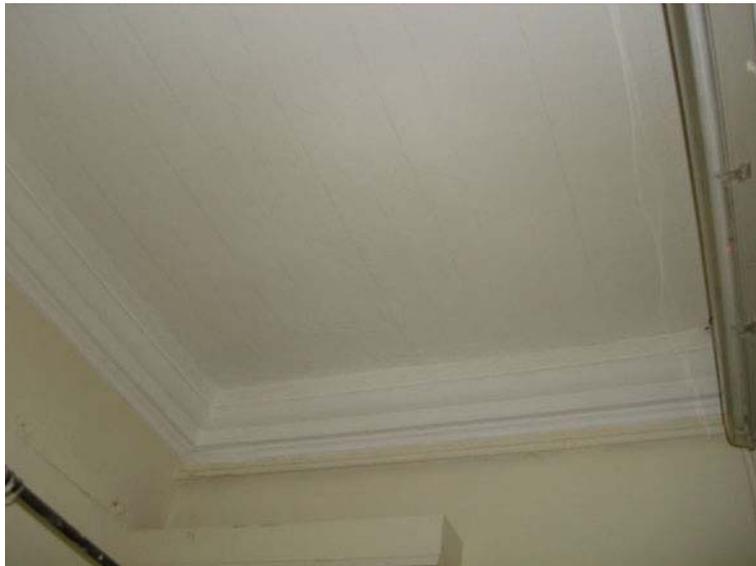
Fig. 353. False ceiling of the bathroom at RM 18 of the main building.

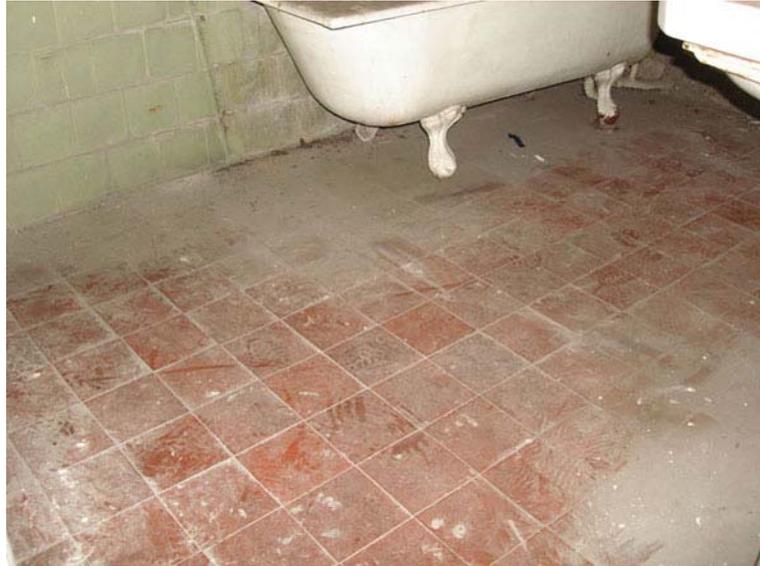
Fig. 354. Red quarry floor tiles at the bathroom of RM 18.

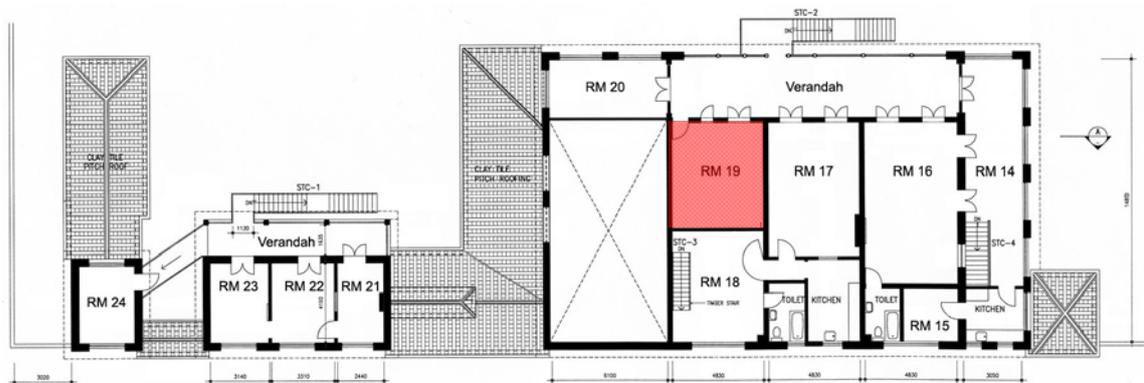
Fig. 355. Location of RM 19 on the first floor at the former clubhouse (1:400).

RM 19 is accessible from the verandah (Fig. 355). From the old plan in 1969, there was a corridor connecting from the verandah through RM 19 to the staircase at Rm 18, where the partition of this corridor was removed nowadays (Fig. 356).

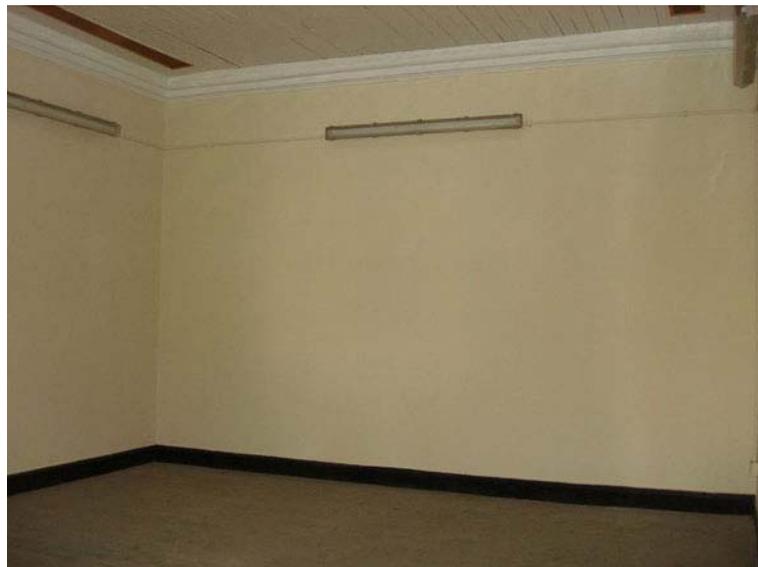
RM 19 has a timber planks false ceiling with cornice running along the ceiling (Fig. 357 - Fig. 358). The floor is finished with timber planks, with skirting running along the bottom of the walls (Fig. 359). There are three doors opened to the verandah, a pair of glazed timber French door, a glazed timber door and a panelled door with fanlight above (Fig. 360). The door with fanlight also gives a hint of the original corridor where it led.

Fig. 357. Interior of RM 19 at the main building.

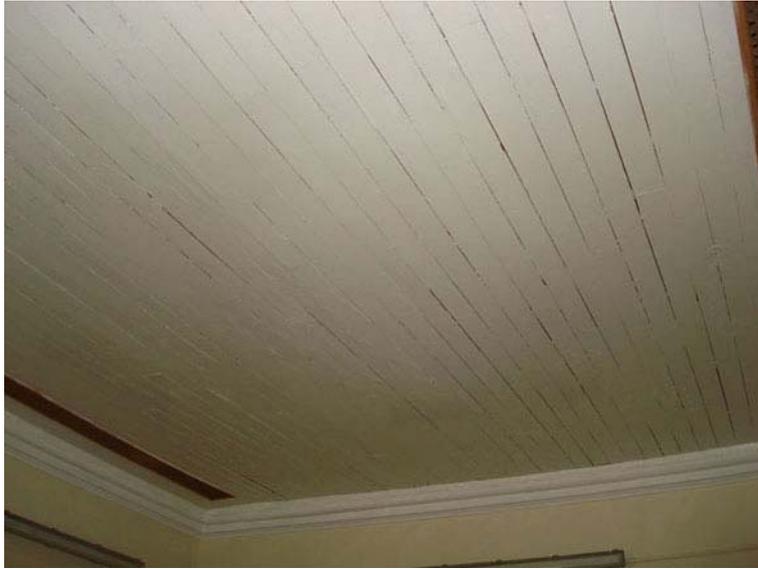
Fig. 358. Timber planks false ceiling at RM 19.

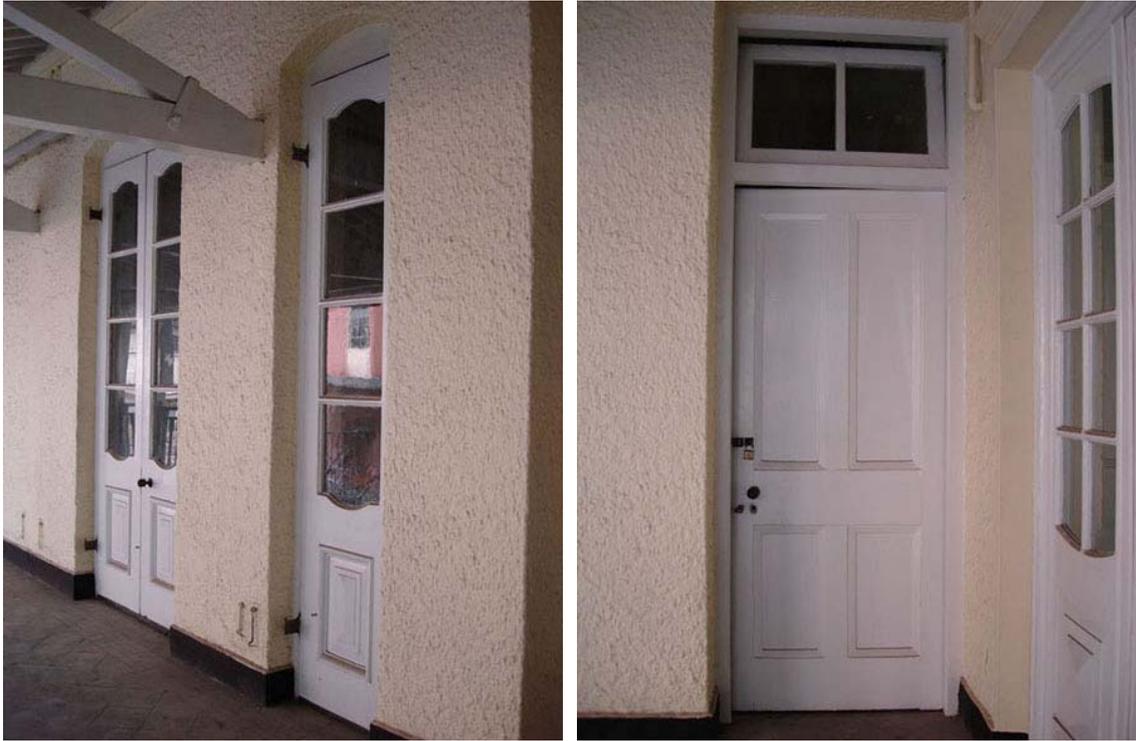
Fig. 360. Glazed timber doors (left) and panelled door with fanlight (right) at RM 19 of the main building.

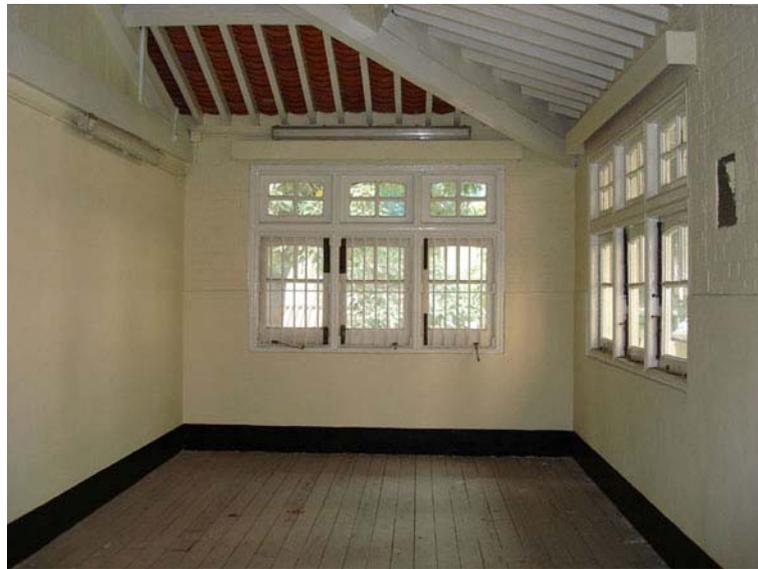
The roof structure is exposed at this room (Fig. 364). The floor is finished with timber planks, with skirting found along the bottom of the walls.

Fig. 364. Interior of RM 20 at the main building.

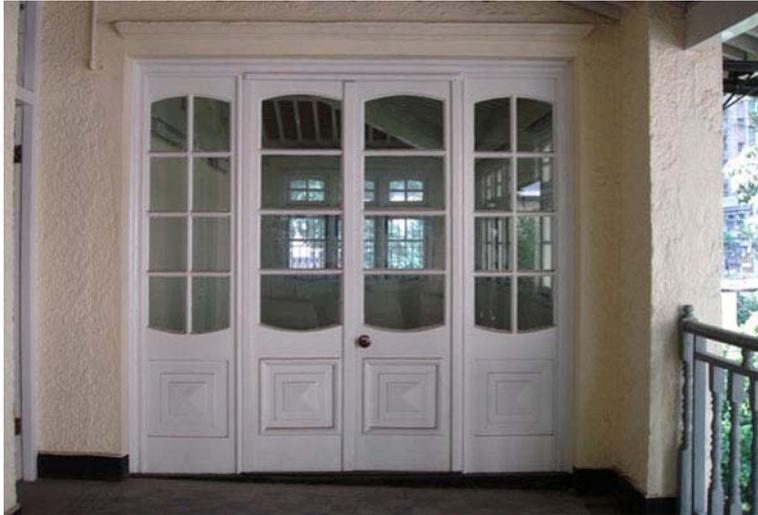
A pair of glazed timber French door is found flanked with two glazed panels on both sides (Fig. 365). Window openings are found on the rear façade and southwest façade respectively, each provided with three glazed timber windows with segmental-headed glazings (Fig. 366). Scrolled window stays can also be found here (Fig. 367).

Fig. 365. Glazed timber French door to RM 20 at the main building.

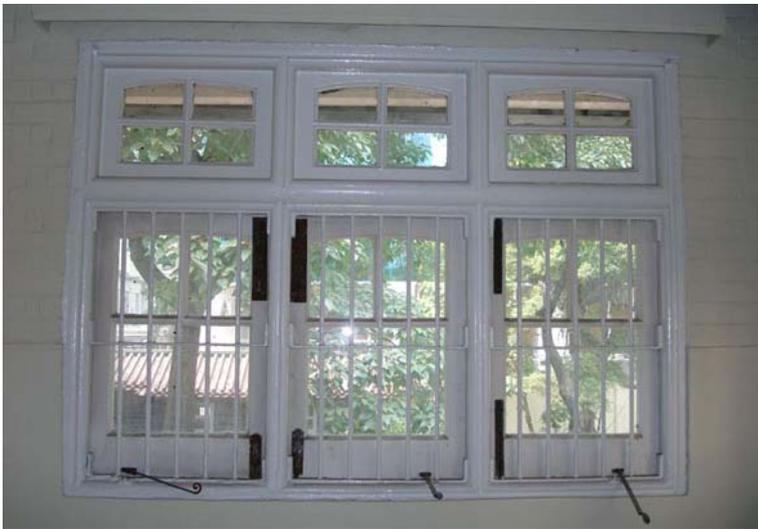
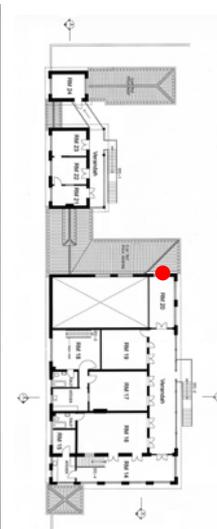
Fig. 366. Glazed timber windows at RM 20 of the main building.

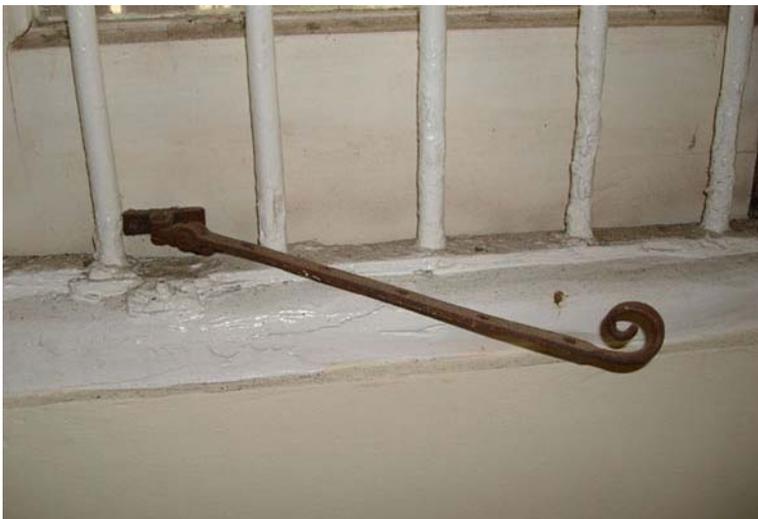
Fig. 367. Scrolled window stay of the window at RM 20 of the main building.

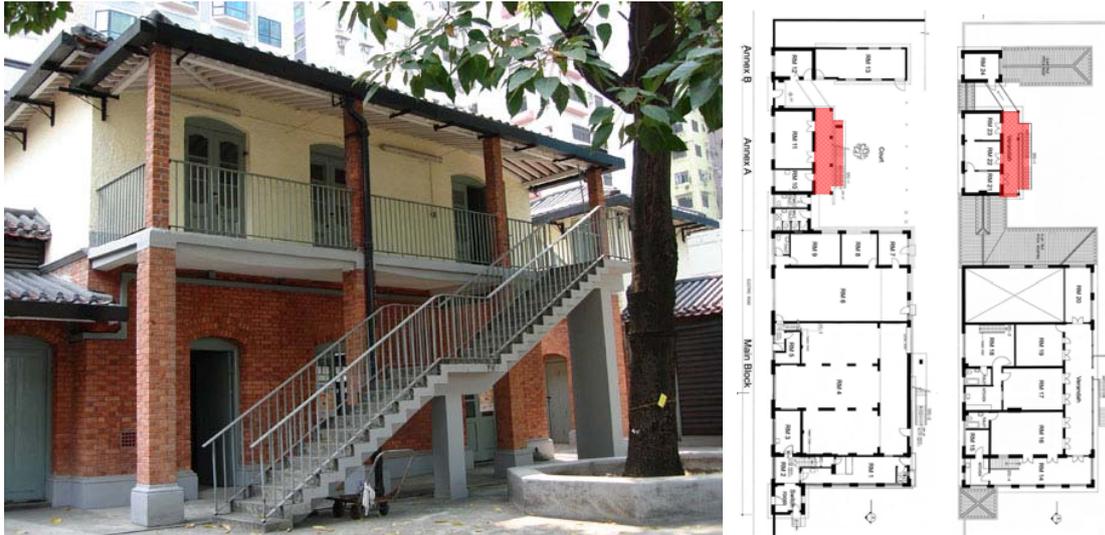
The colonnaded arcade and the verandah above are located at the rear of the 3-middle bays of Annex A (Fig. 368). They are the main feature of Annex A at the rear, and also the main access area to the building (Fig. 369). They provide shelters to the entrances of the rooms on both floors. The verandah is accessible by the concrete staircase (STC – 1). It also gives access to the first floor of Annex B through the bridge.

Fig. 368. Overview of the colonnaded arcade and verandah at the rear of Annex A.

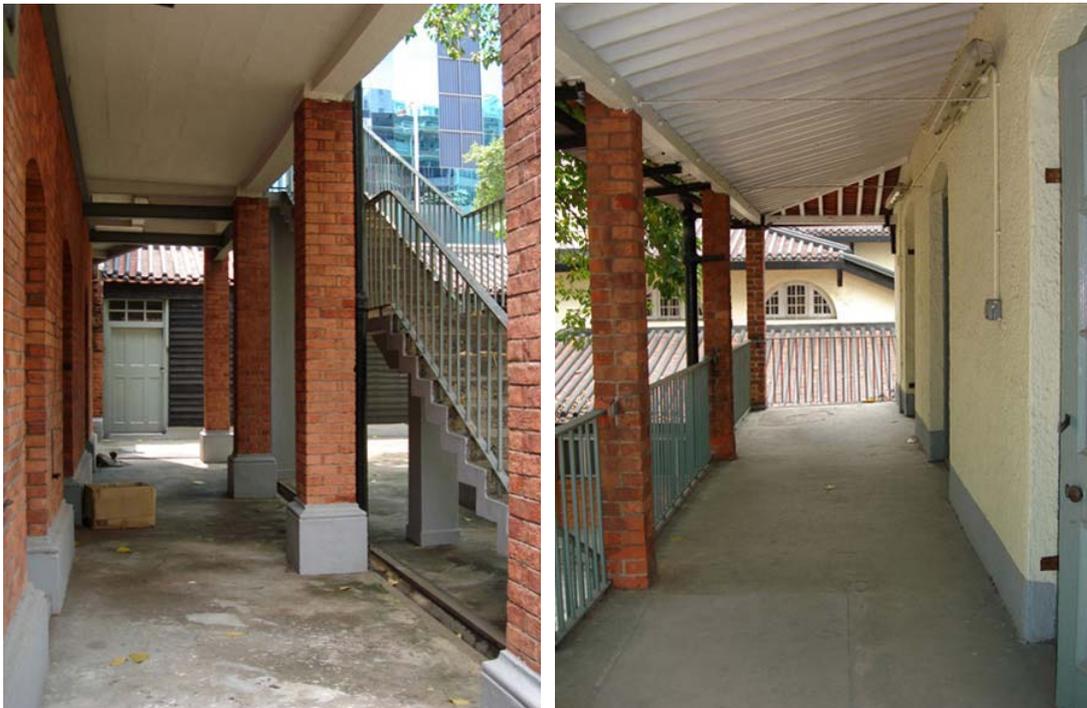
Fig. 369. General view of the arcade (left) and verandah (right) at Annex A.

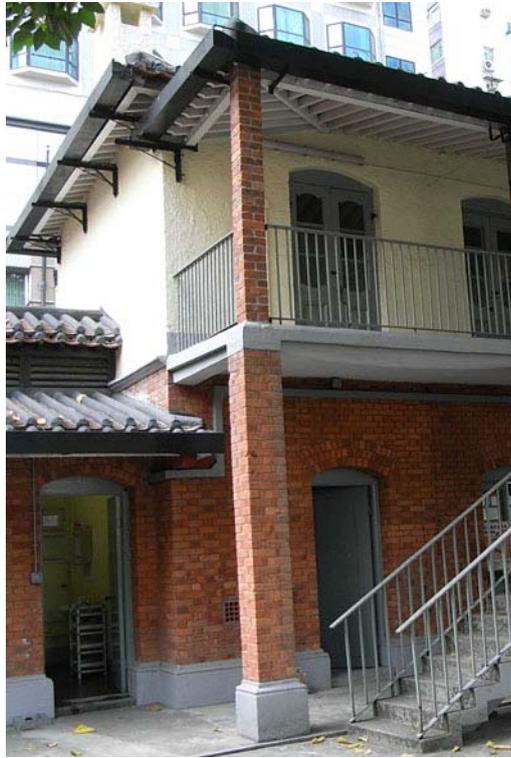
Both areas are formed by a row of 4 columns on each floor. The rectangular columns are constructed of red bricks with tall plinth as the column bases on the ground floor, whereas the columns at the verandah on the first floor are slimmer (Fig. 370).

Fig. 370. The brick columns at Annex A.

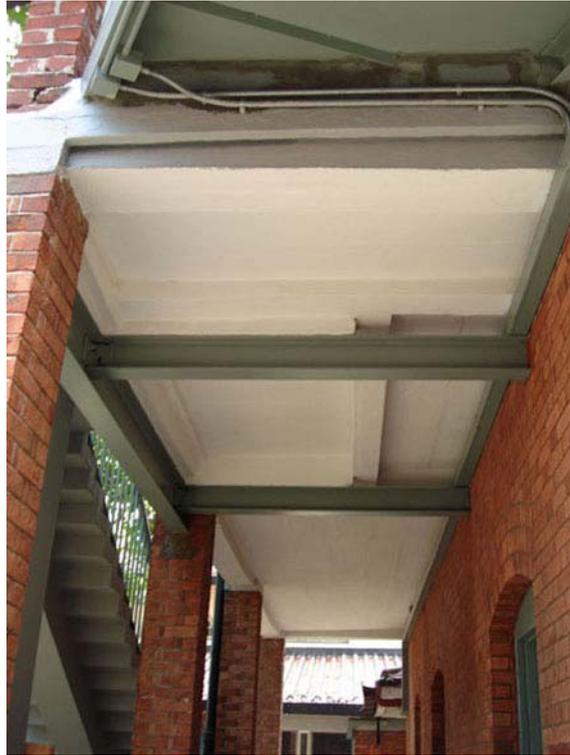
The concrete floor slab of the verandah is supported by concrete beams below, with reinforcement at the former stair well (Fig. 371 - Fig. 372). At the rear facing to the small court, there are curved beams which add visual interest to this elevation.

Fig. 372. Ceiling of the colonnaded arcade at Annex A.

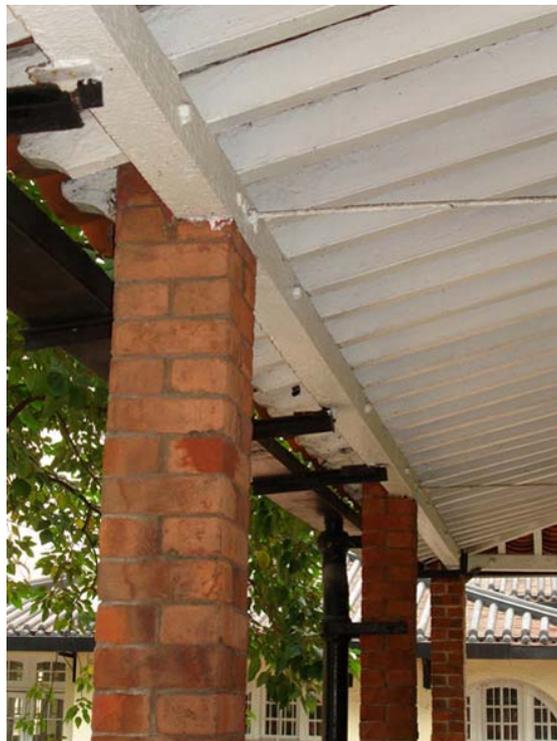
The roof of the 3-middle bays extended to the verandah, where the timber structures are exposed (Fig. 373). The verandah is surrounded by modern balustrades believed to be installed when the concrete staircase was built.

Fig. 373. Roof structure supported on brick columns at the verandah of Annex A.

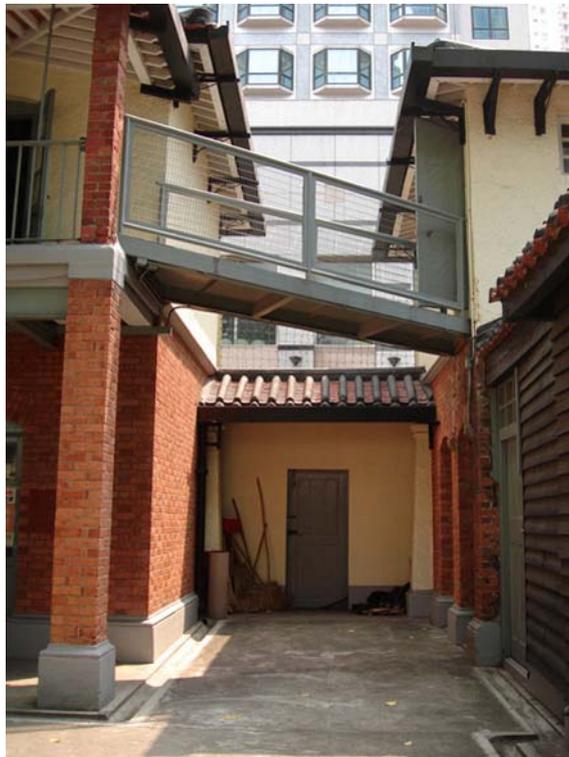
The bridge connects the first floor of the 3-middle bays of Annex A and RM 12 of Annex B (Fig. 374 - Fig. 375).

Fig. 375. The bridge connecting Annex A and Annex B on the first floor.

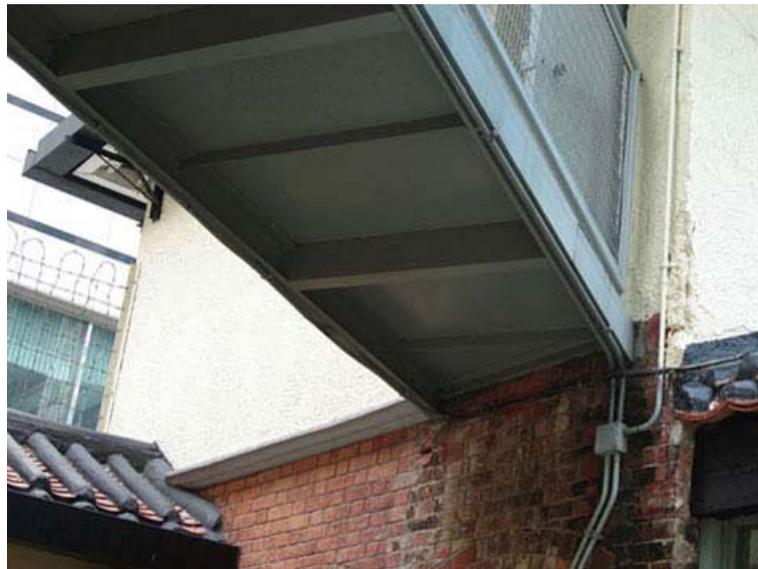
The bridge is built of modern steel structure with steel balustrades (Fig. 376 - Fig. 377). The only trace of the old bridge is a pair of granite support on the façade of Annex B (Fig. 378).

Fig. 377. The underside of the bridge at Annex A.

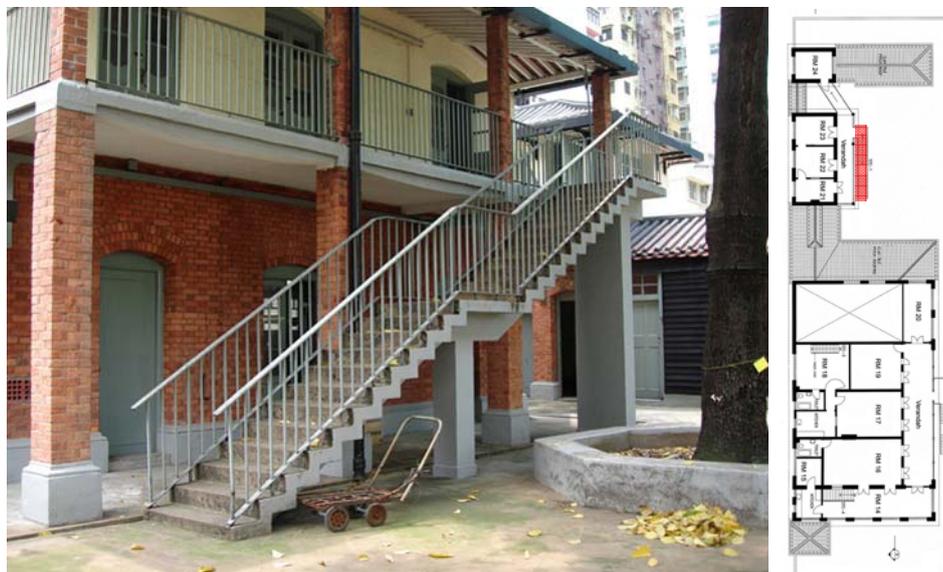
The concrete staircase (STC – 1) is located at the rear of the Annex A. This staircase is believed to be built either in 1975 or after. It is built in a similar design to the concrete staircase at the rear of the main building, which is supported on two concrete columns and surrounded by modern metal balustrades (Fig. 379).

Fig. 379. Concrete staircase (STC – 1) at the rear of Annex A.

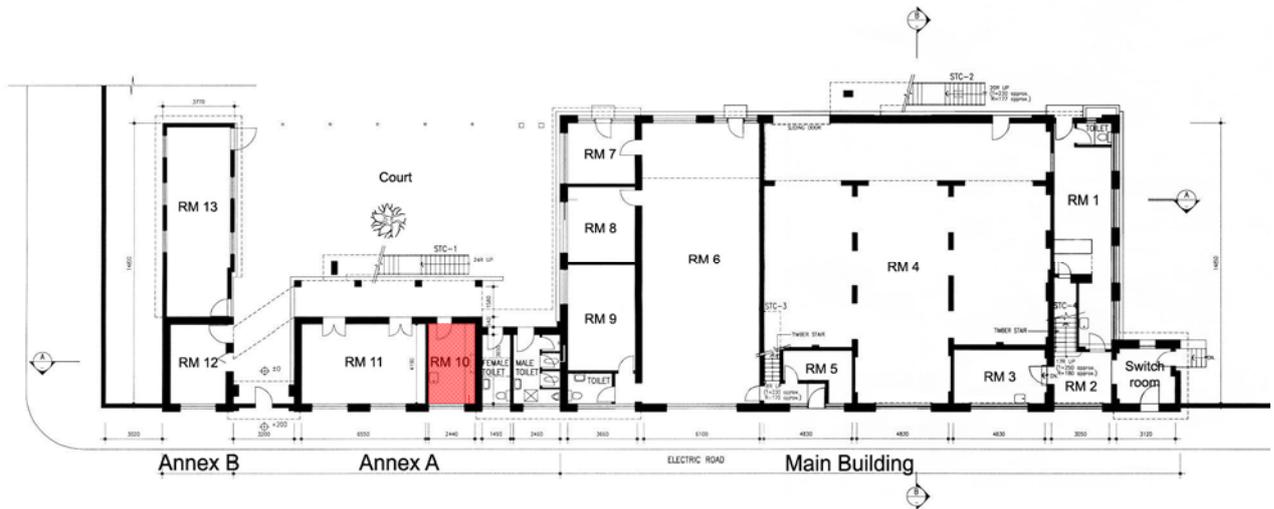
RM 10 used to be a kitchen since the building was built as indicated from the smoke flue. It is part of the 3-middle bays of Annex A, with this room one bay in width. It is accessible from the colonnaded arcade of the 3-middle bays (Fig. 380).

Fig. 380. Location of RM 10 on the ground floor at the former clubhouse (1:400).

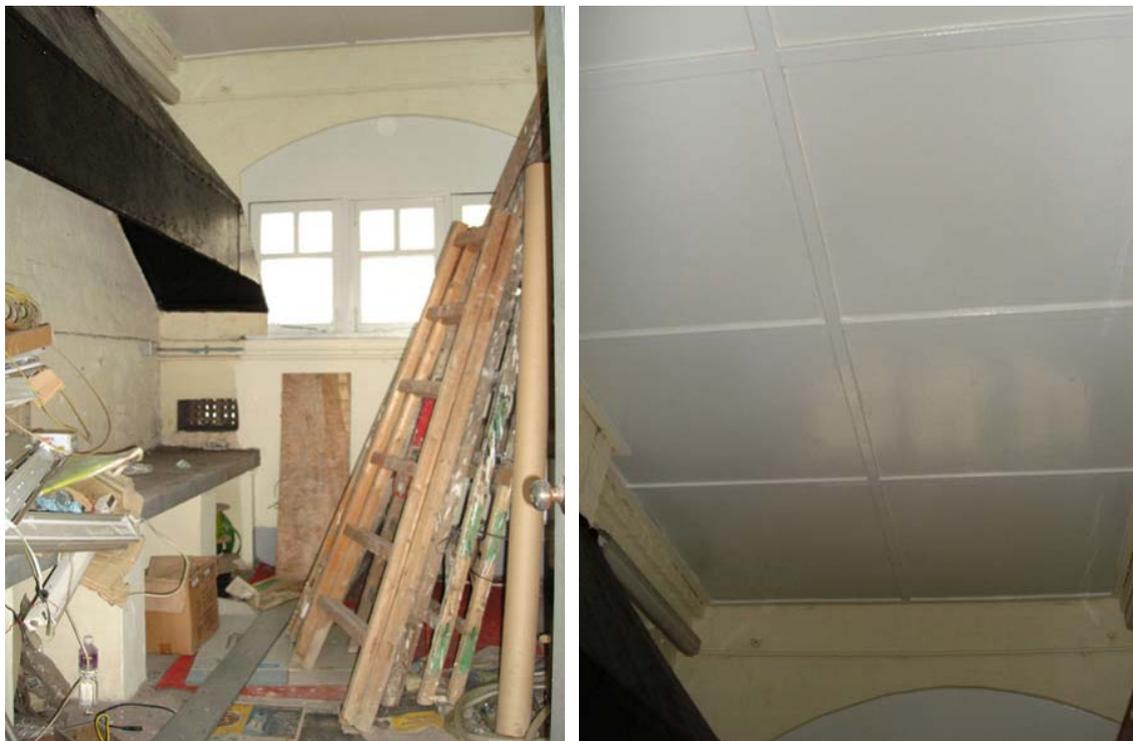
The lower part of the wall is plastered, while the upper part is finished with paint on the brickworks (Fig. 381). It has a metal false ceiling, believed to be a later addition of an unknown date. The floor is finished with cement sand (Fig. 382).

Fig. 381. Interior (left) and the metal false ceiling of RM 10 at Annex A (right).

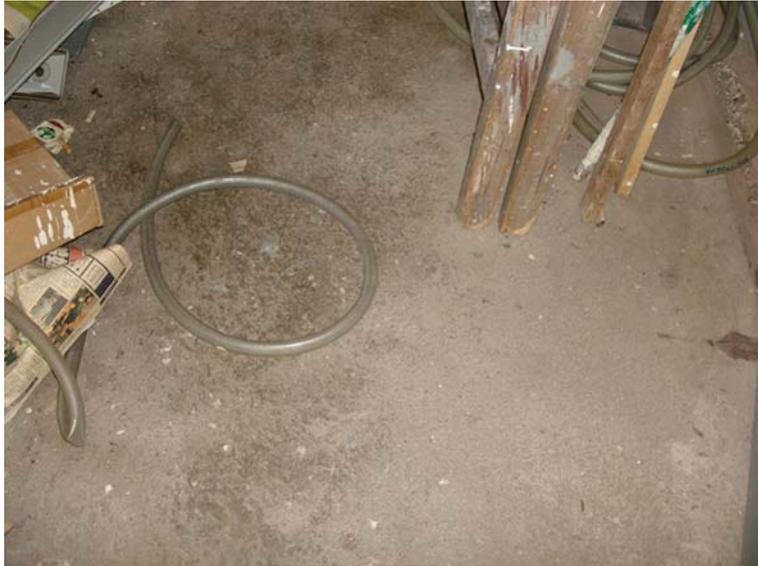
Fig. 382. Cement sand flooring of RM 10 at Annex A.

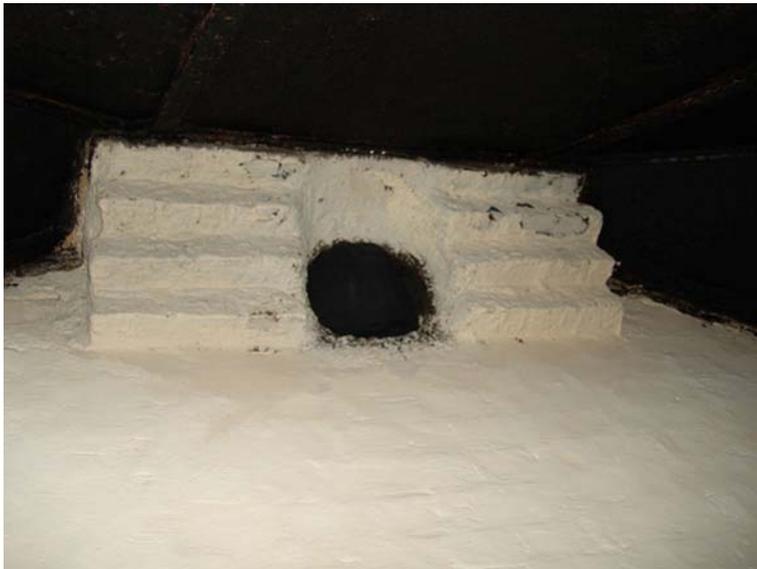
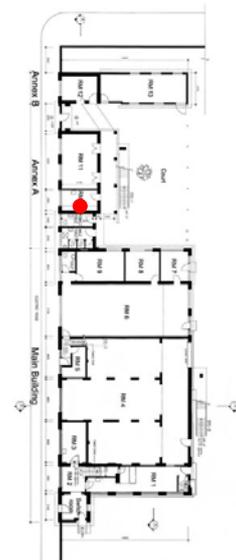
There is a smoke flue in RM 10 (Fig. 383). Together with the built-in bench and the ventilation grilles found on both the front and rear façades, these all give evidence that this room used to be a kitchen since it was built (Fig. 384). Granite threshold is found at the segmental-headed door to this room (Fig. 385).

Fig. 383. Smoke flue at RM 10 at Annex A.

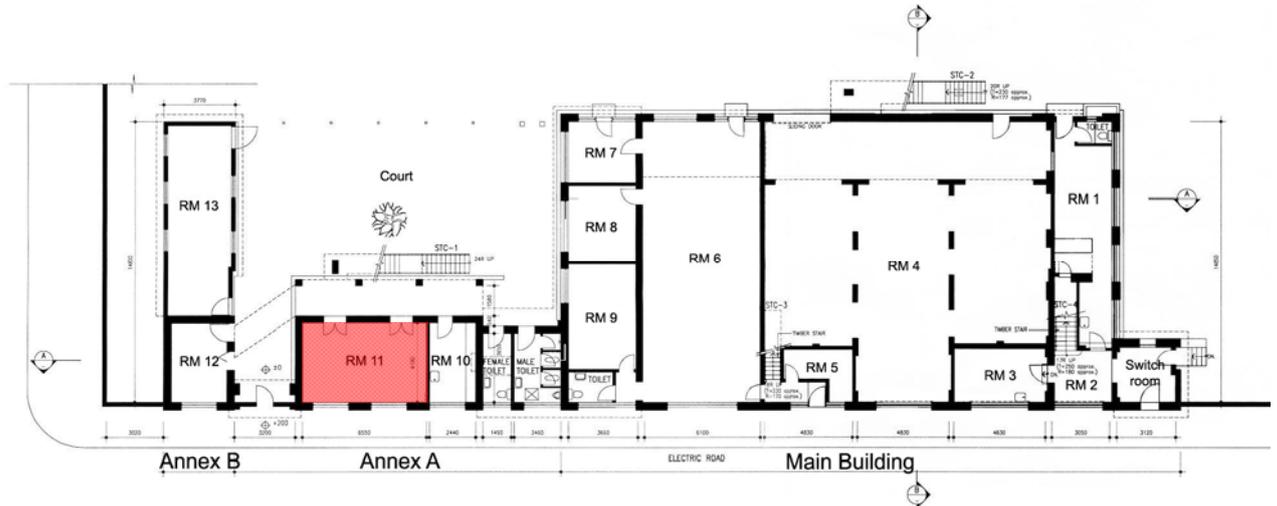
Fig. 386. Location of RM 11 on the ground floor at the former clubhouse (1:400).

RM 11 is a simple rectangular room as part of the 3-middle bays at Annex A. It is 2-bay in width. It is accessible from the colonnaded arcade with two entrances (Fig. 386).
