BUILDING

3.1 Architectural evolution

3.1.1 The former Royal Hong Kong Yacht Club (1908-1938)

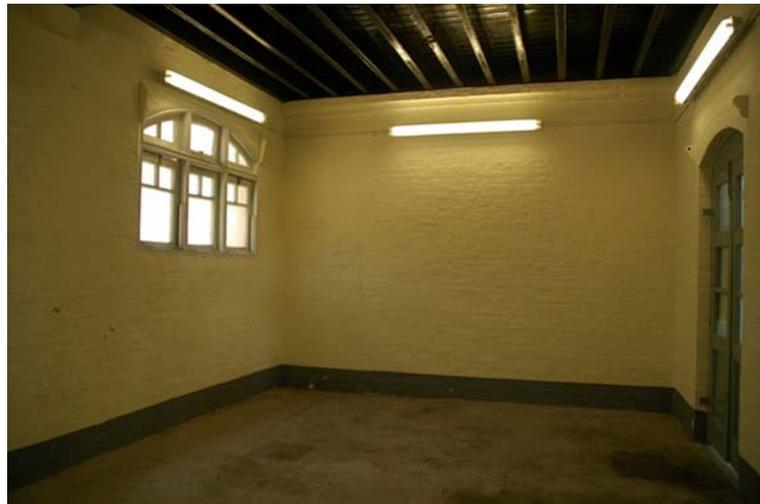
Fig. 387. Interior of RM 11 at Annex A.

The interior of RM 11 is finished with paint on the brickworks (Fig. 387). The ceiling structures are exposed, with the timber joists resting on corbels and further supported on a major beam at the centre of the room (Fig. 388). The floor is finished with cement sand (Fig. 389). The entrance doorways are found to be segmental-headed with granite threshold (Fig. 390).

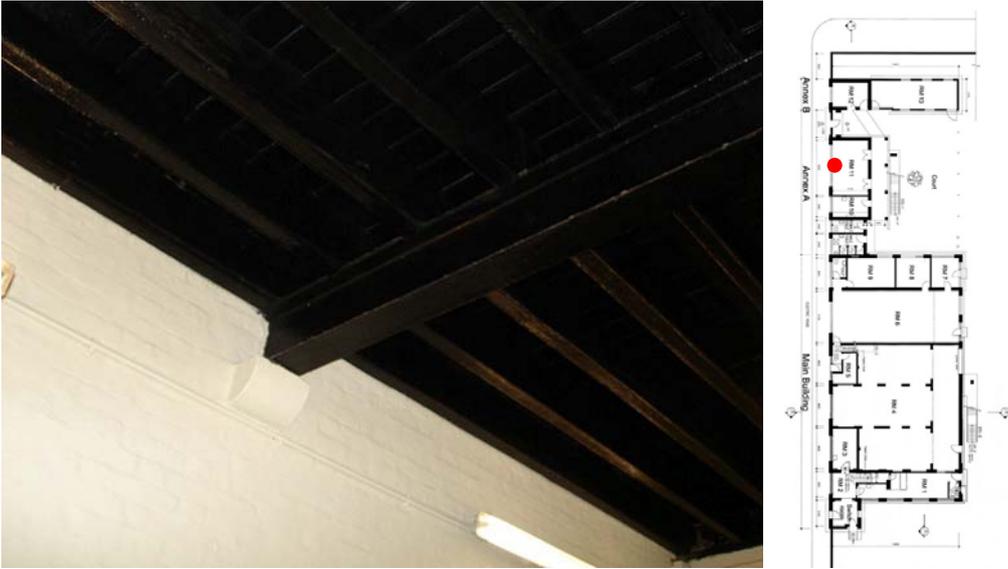
Fig. 388. Exposed ceiling structure of RM 11 at Annex A.

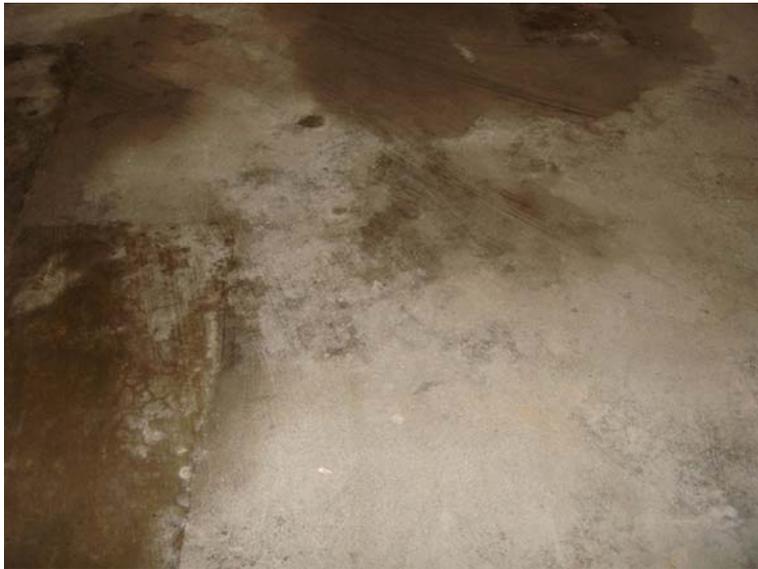
Fig. 389. Cement sand flooring of RM 11 at Annex A.

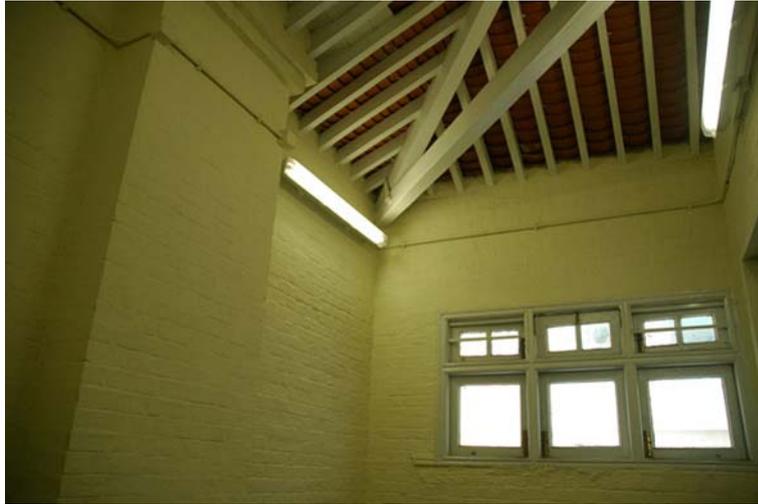
Fig. 392. Interior of RM 21 on the first floor of Annex A.

RM 21 is a rectangular room finished with paint on the brickworks (Fig. 392). The roof structure is exposed (Fig. 393). The floor is finished with timber planks (Fig. 394).

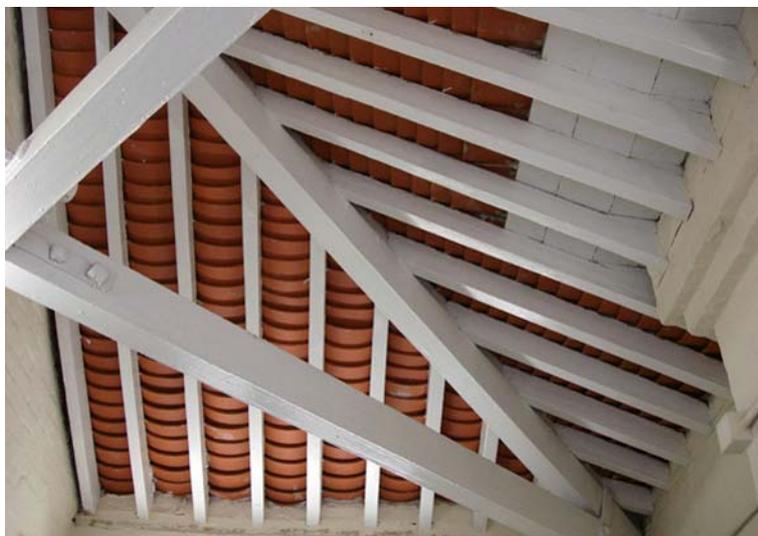
Fig. 393. Exposed roof structure at RM 21 of Annex A.

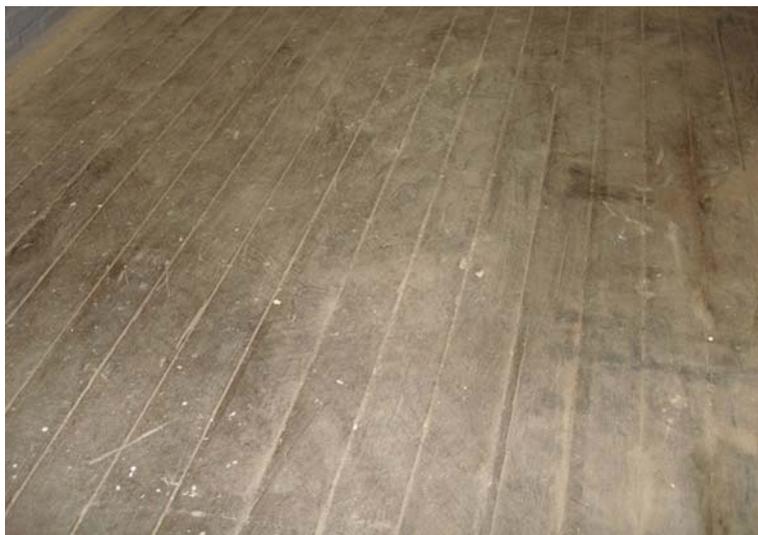
Fig. 394. Timber planks flooring of RM 21 at Annex A.

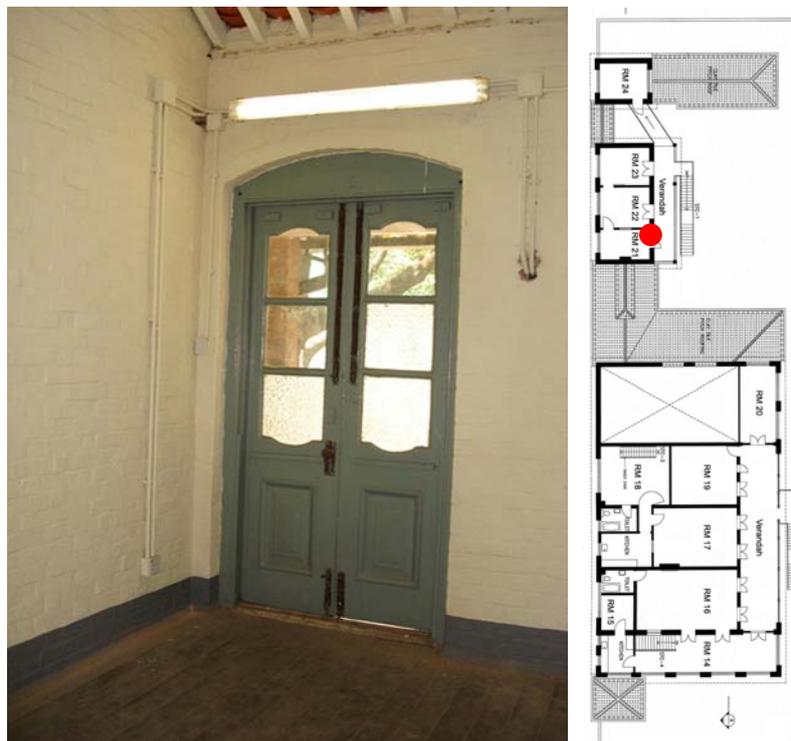
Fig. 396. Glazed timber French door at RM 21 of Annex A.

There is a chimney shaft at the middle of a wall which is the corresponding shaft for the smoke flue at RM 10 on the ground floor (Fig. 395). The entrance to RM 21 is a segmental-headed doorway with glazed timber French door (Fig. 396). Rectangular window opening is found with timber-framed glazed windows (Fig. 397).

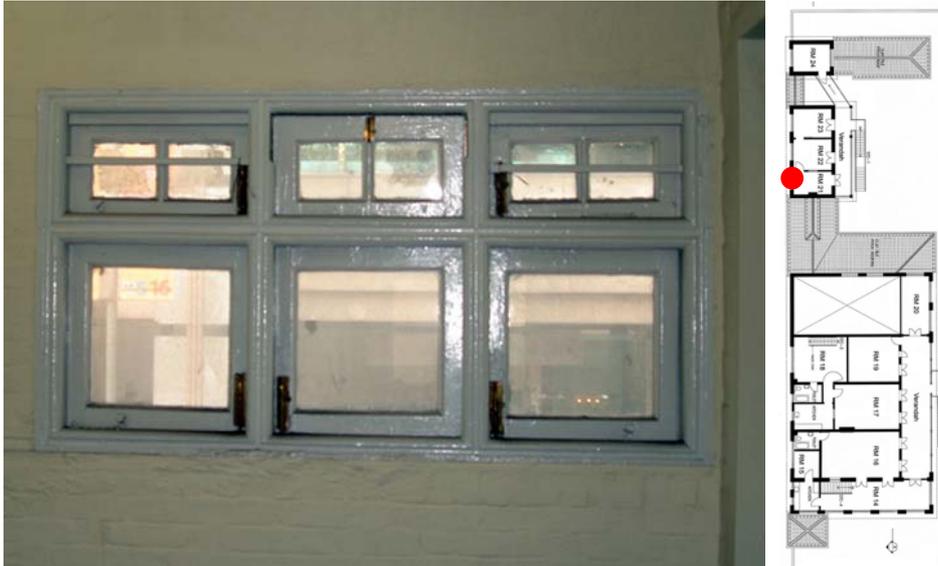
Fig. 397. Timber framed windows at RM 21 of Annex A.

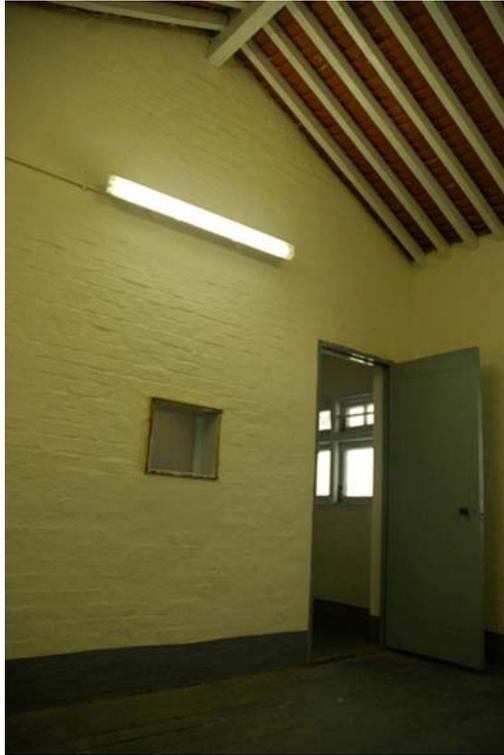
Fig. 399. Interior of RM 22 at Annex A.

RM 22 is a rectangular room finished with paint on the brickworks (Fig. 399). The roof structure is exposed. The floor is finished with timber planks (Fig. 400).

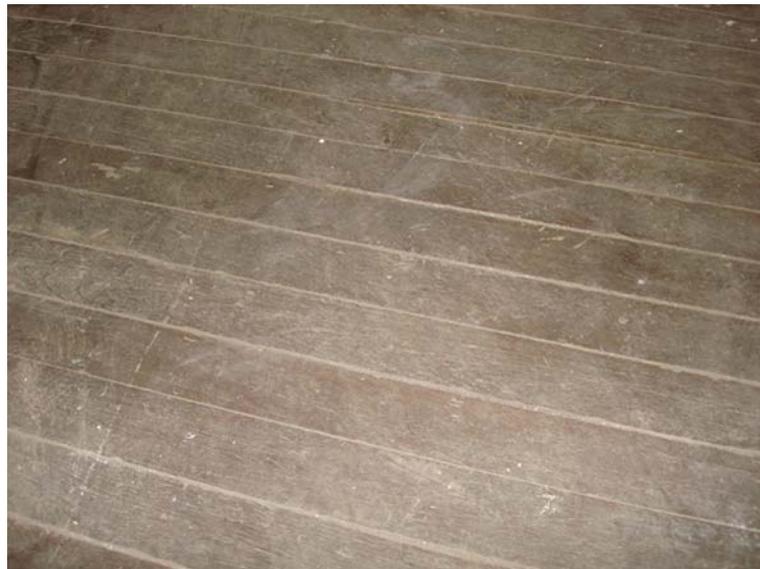
Fig. 400. Timber planks floor of RM 22 at Annex A.

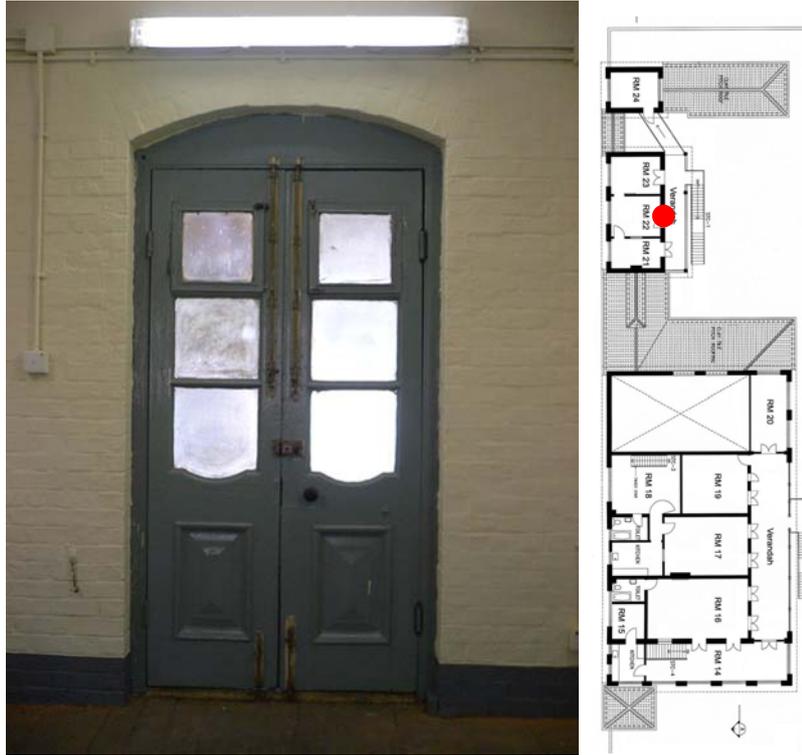
Fig. 401. Glazed timber French door at RM 22 of Annex A.

The entrance to RM 22 is a segmental-headed doorway with glazed timber French door (Fig. 401). Rectangular window opening is found with timber-framed glazed windows (Fig. 402).

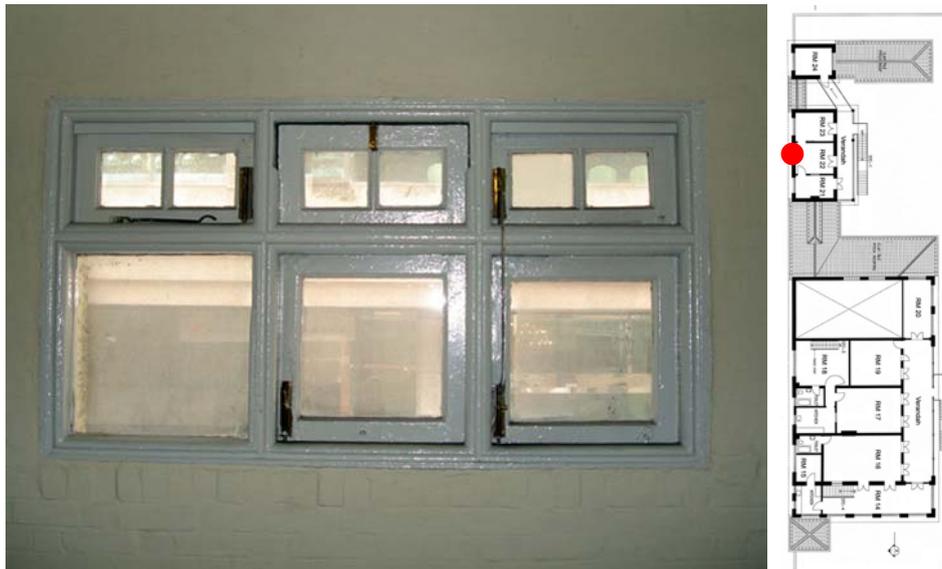
Fig. 402. Timber-framed windows at RM 22 of Annex A.

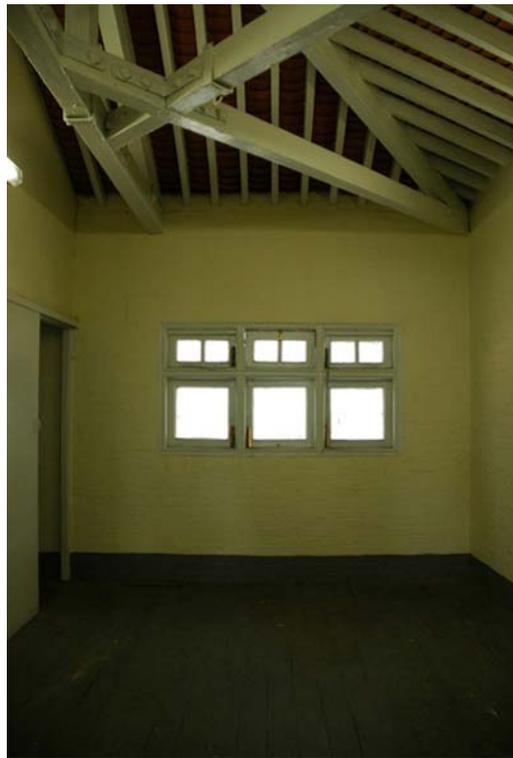
Fig. 404. Interior of RM 23 at Annex A.

The interior of RM 23 is finished with paint on the brickworks (Fig. 404). The roof structure is exposed (Fig. 405). The floor is finished with timber planks (Fig. 406).

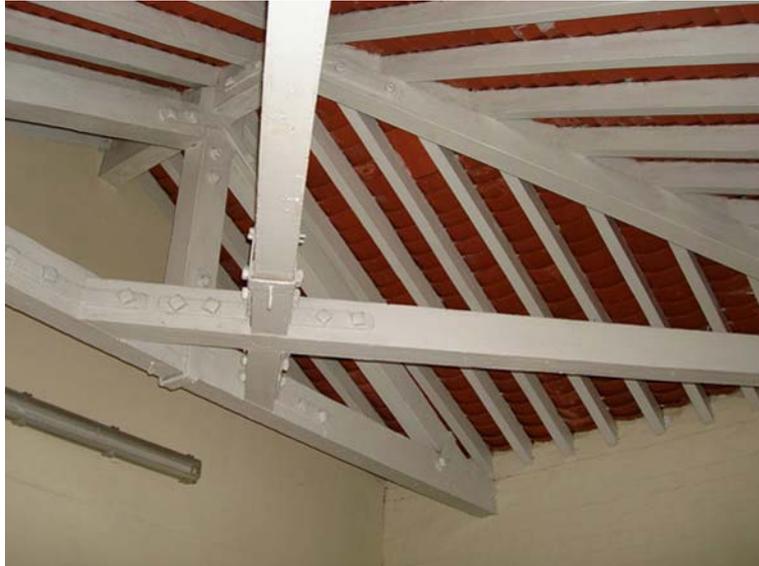
Fig. 405. Roof structure exposed at RM 23

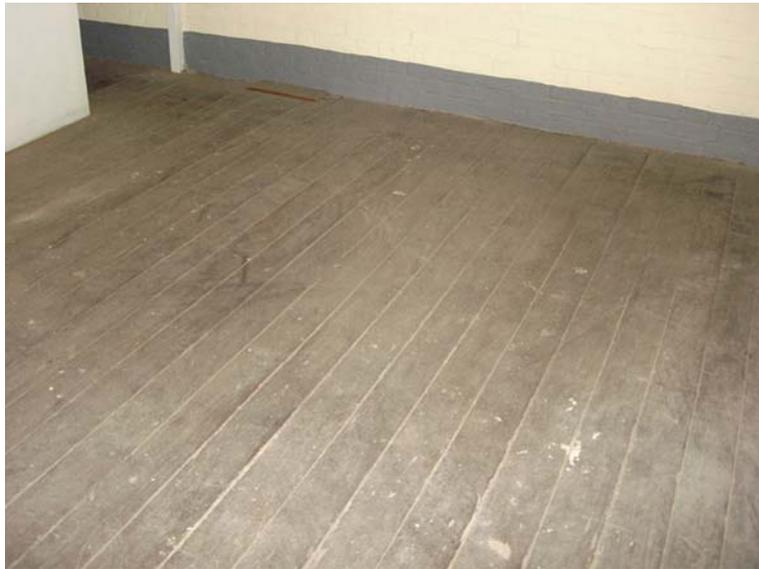
Fig. 406. Timber planks flooring at RM 23 of Annex A.

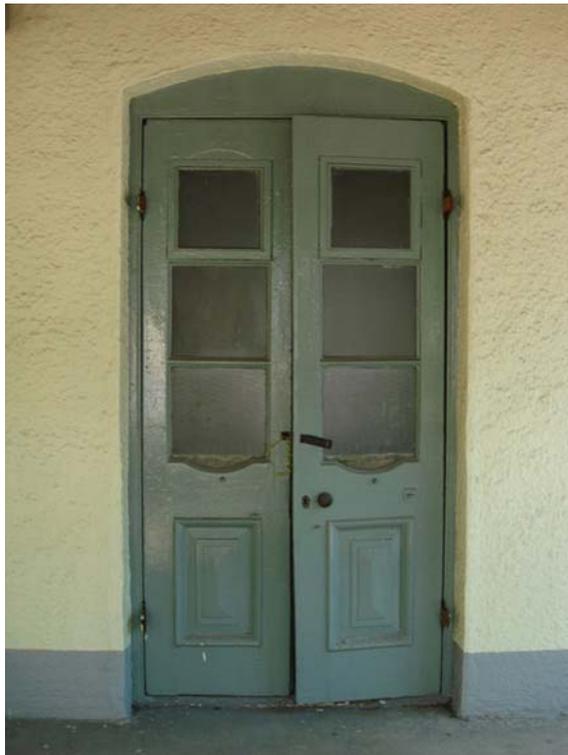
Fig. 407. Glazed timber French door at RM 23 of Annex A.

The entrance to RM 23 is a segmental-headed doorway with glazed timber French door (Fig. 407). Rectangular window opening is found with timber-framed glazed windows and scrolled window stays (Fig. 408).

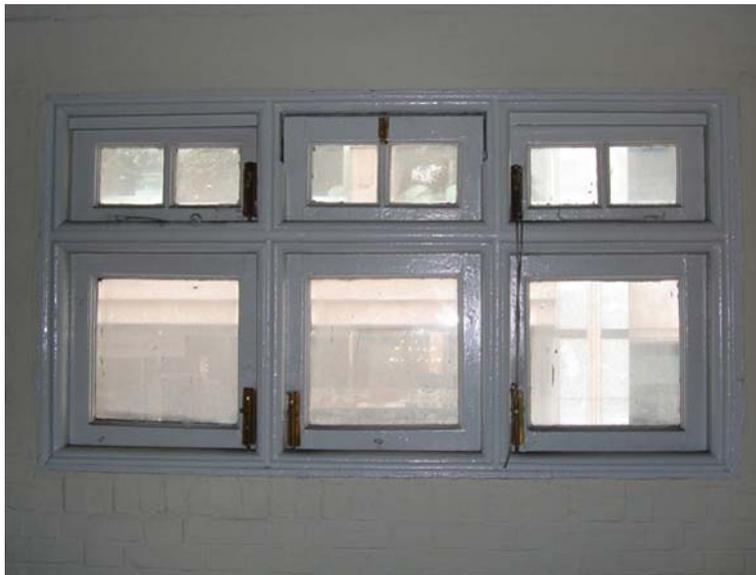
Fig. 408. Timber framed windows at RM 23 of Annex A.

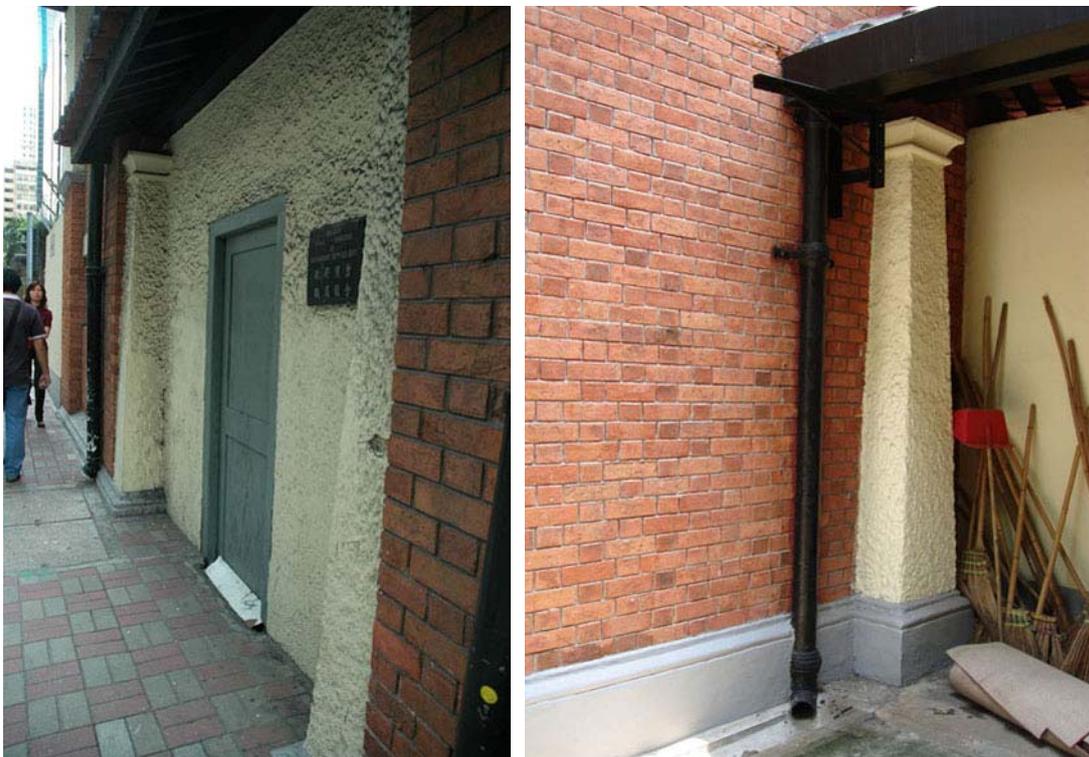
Fig. 410. Tapered columns at the front (left) and rear (right) of the former entrance gate at Annex A.

The former entrance gate is a simple structure with actually four columns and a pitched roof (Fig. 409). As a wall was constructed between the two columns facing Electric Road, only two columns could be detected from either side (Fig. 410). The roof is mainly supported on by the adjacent walls.

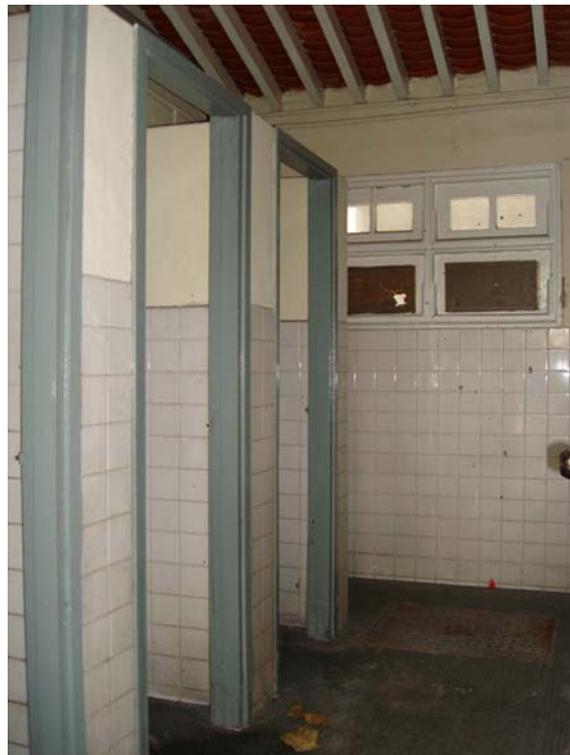
Fig. 412. Interior of the male toilet at Annex A.

The interior of the male toilet is divided into cubicles (Fig. 412). The ceiling of the male toilet is exposed with the vent clearly seen (Fig. 413). White glazed ceramic tiles are found at the lower part of the wall surfaces which is believed to be a later addition of an unknown date, while the upper part of the wall is plastered. The floor is finished with mosaic tiles (Fig. 414).

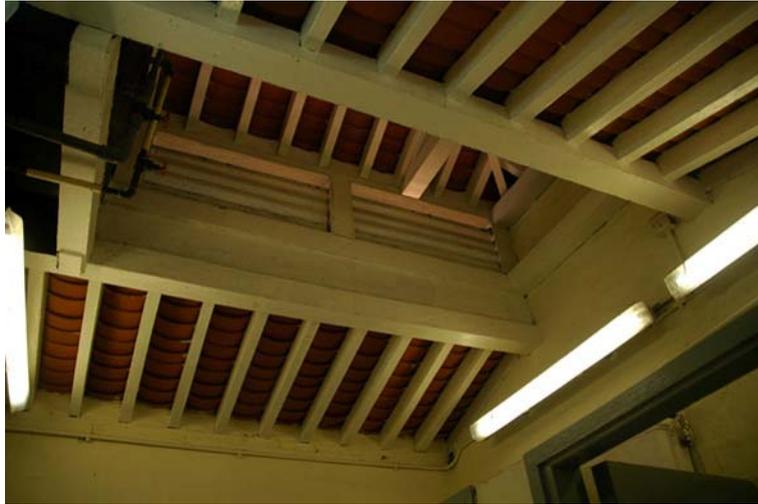
Fig. 413. The exposed structure of the vent at the male toilet of Annex A.

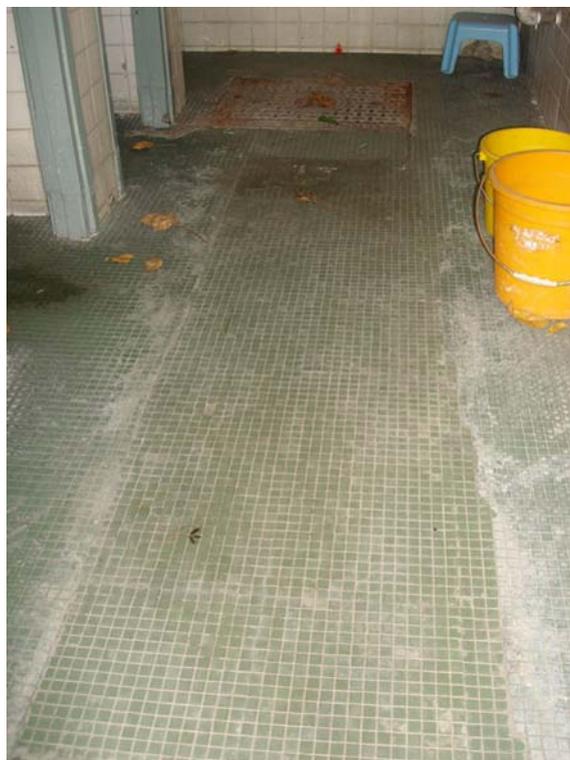
Fig. 414. Mosaic flooring of the male toilet at Annex A.

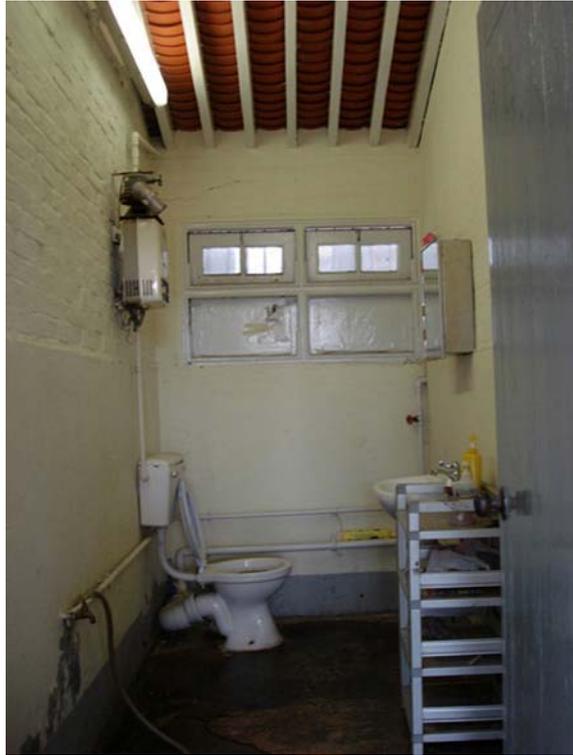
Fig. 415. Interior of female toilet at Annex A.

The female toilet is a single rectangular space (Fig. 415). The ceiling structure is exposed with the opening to the vent blocked (Fig. 416). The lower part of the wall is plastered, while the upper part is finished with paint on the brickworks. The floor is finished with cement sand. Granite threshold is found at the entrance doorway (Fig. 417).

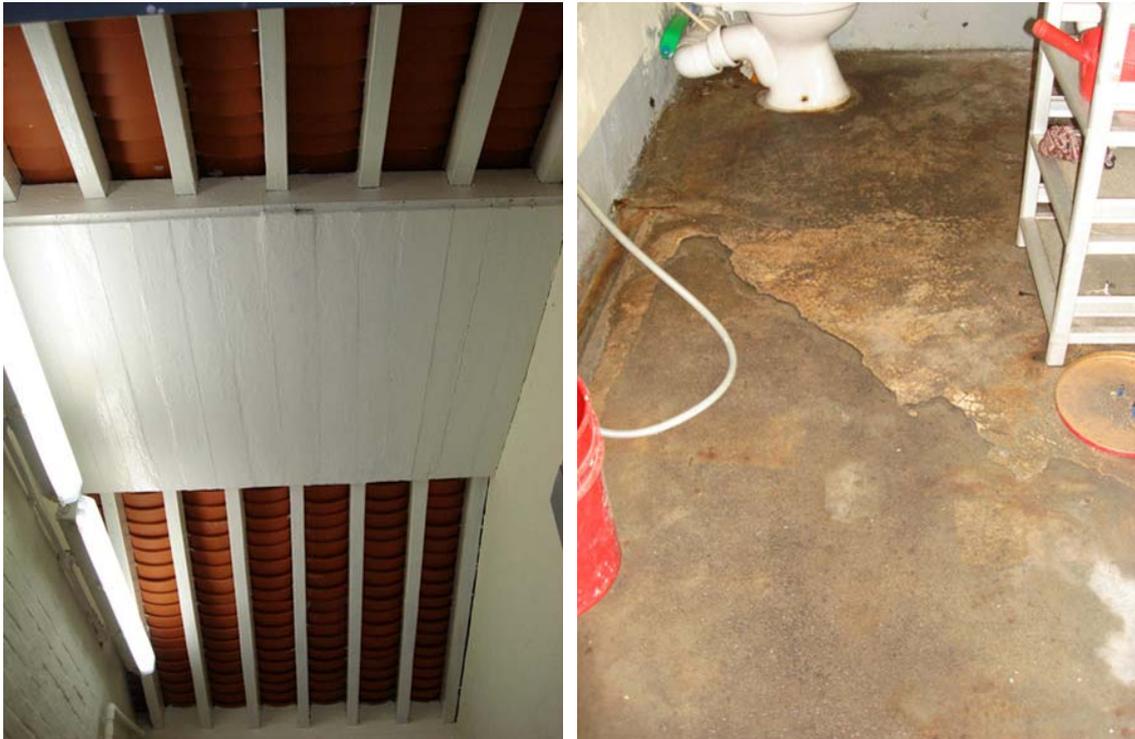
Fig. 416. Ceiling (left) and cement sand flooring (right) of the female toilet at Annex A.

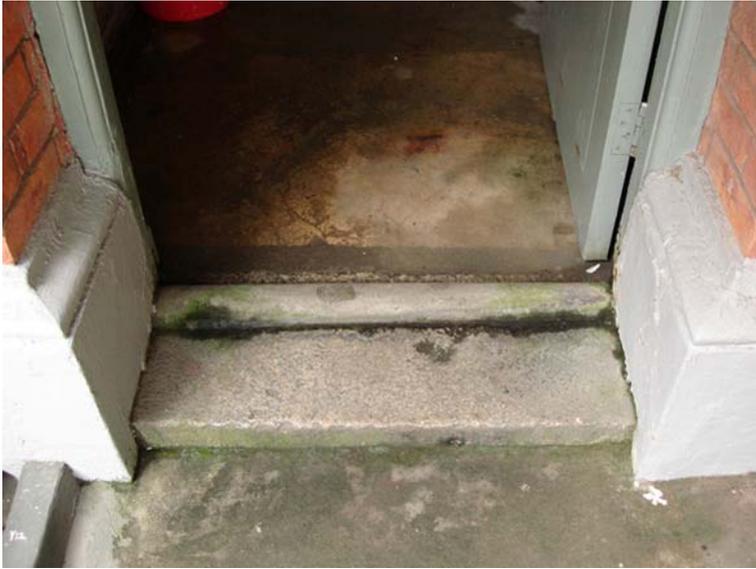
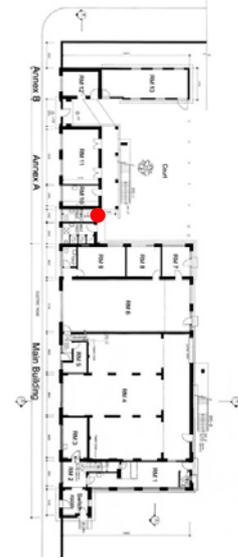
Fig. 417. Granite threshold at the doorway of the female toilet at Annex A.

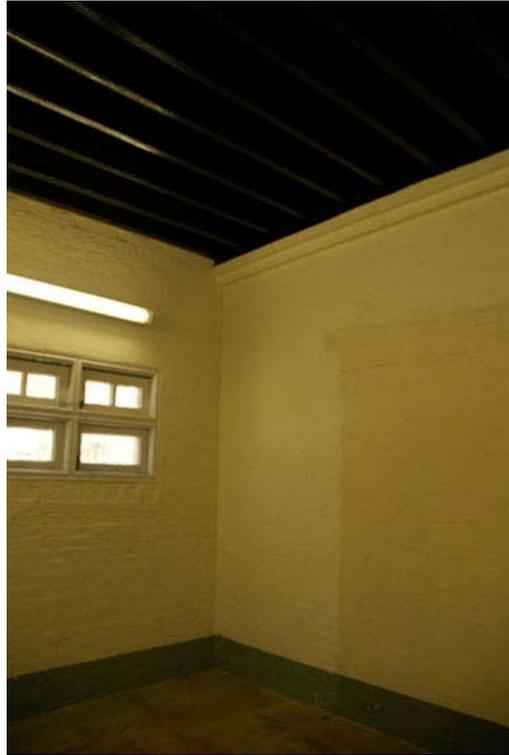
Fig. 419. Interior of RM 12 at Annex B.

The interior of RM 12 is finished with paint on the brickworks (Fig. 419). The timber structure of the floor slab on the first floor is exposed, with the joists resting on the corbels (Fig. 420). The floor is finished with cement sand. From the two entrances and the trace on the floor, it is believed that originally RM 12 was divided into two rooms, with the removal of the partition at an unknown date (Fig. 421).

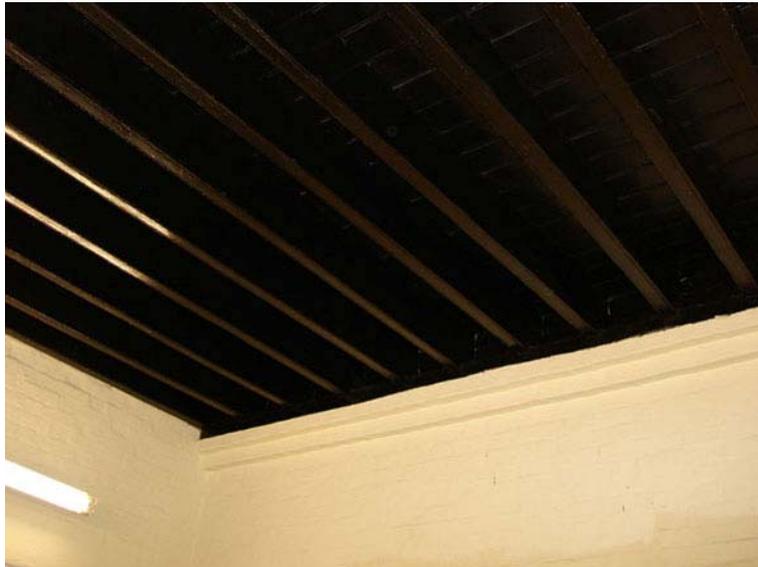
Fig. 420. Exposed timber structure of the ceiling at RM 12 of Annex B.

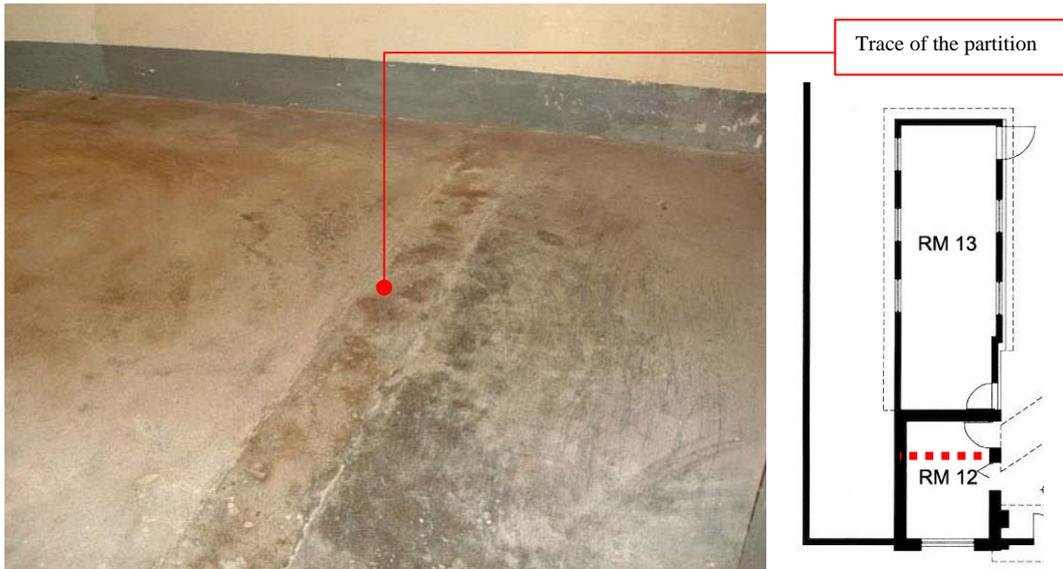
Fig. 421. Cement sand flooring of RM 12 at Annex B.

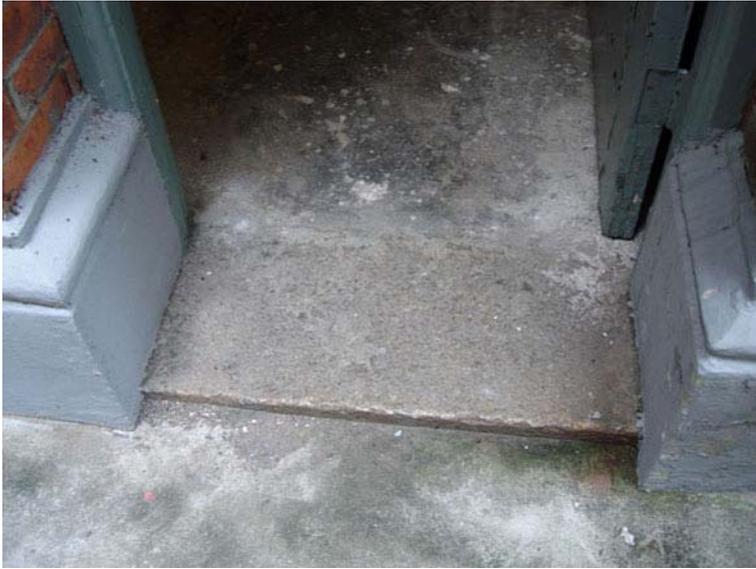
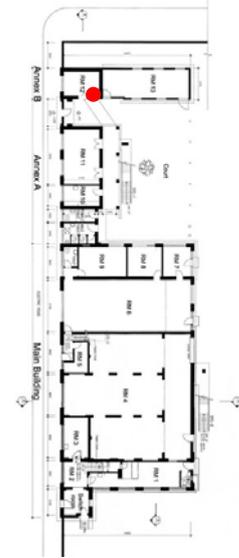
Fig. 423. Granite threshold at the entrances of RM 12 of Annex B.

As mentioned, there are two entrances to this room. Both are of the same design with segmental-headed doorway, granite threshold and a framed, ledged and braced battened door (Fig. 422 - Fig. 423). There is a rectangular window opening at the front façade with timber-framed windows (Fig. 424).

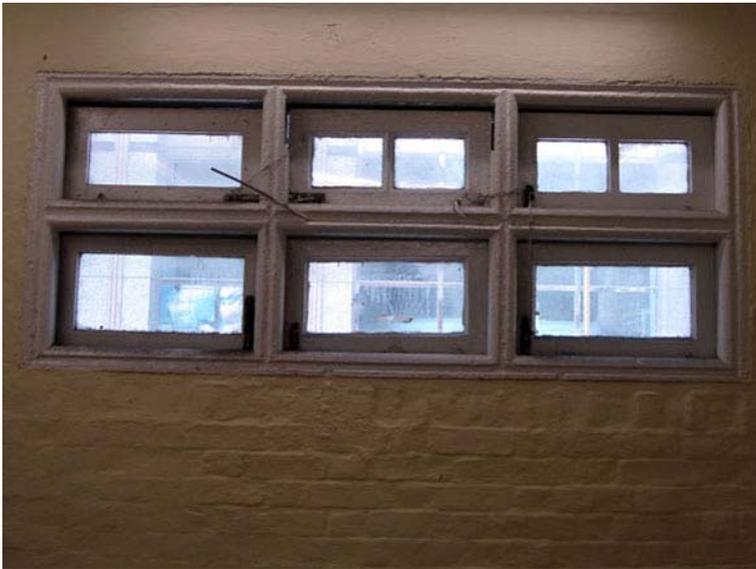
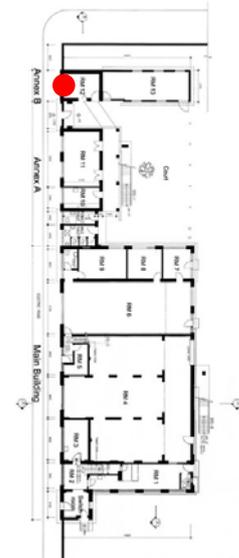
Fig. 424. Timber-framed windows at RM 12 of Annex B.

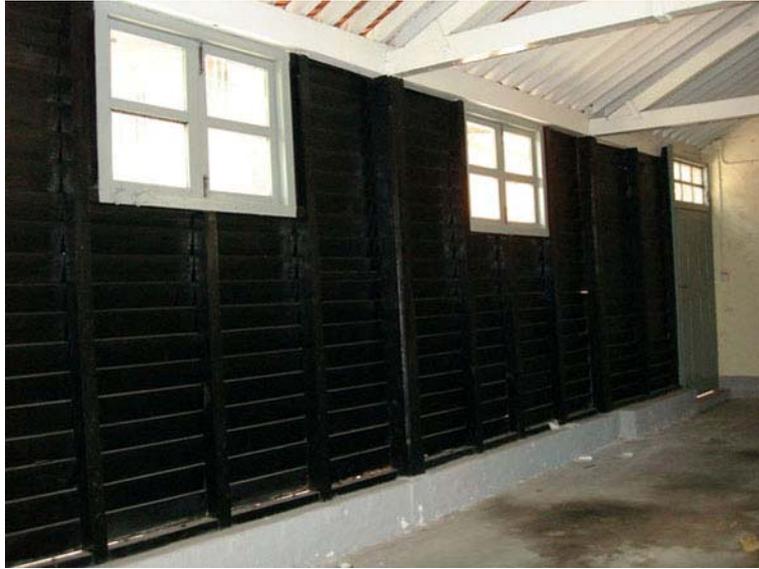
Fig. 427. Wall constructed with timber planks at RM 13 of Annex B.

RM 13 is finished with paint on brickworks on three sides, while the wall built of timber planks is also painted same as its external façade (Fig. 426 - Fig. 427). The roof structure is exposed, with the trusses rest on granite blocks at the brick wall on one side and timber columns at the timber planks wall on the other side (Fig. 427 - Fig. 429). The floor is finished with cement sand (Fig. 430).

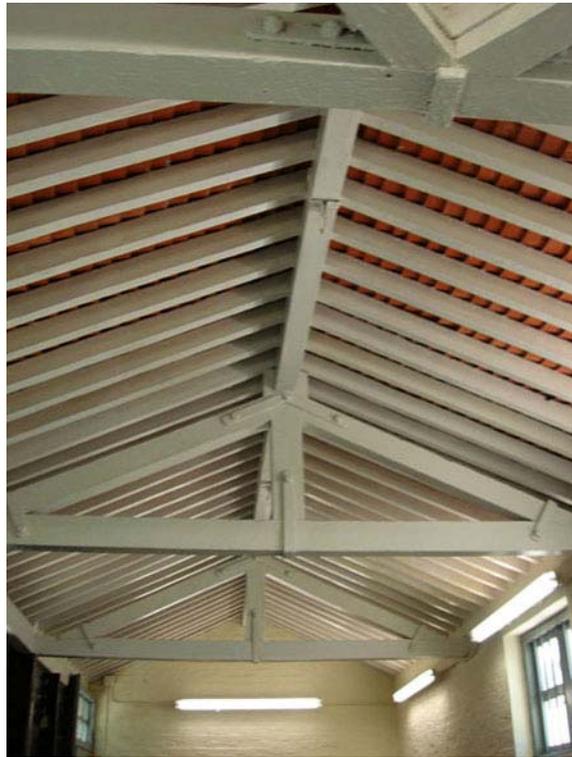
Fig. 428. Exposed roof structure at RM 13 of Annex B.

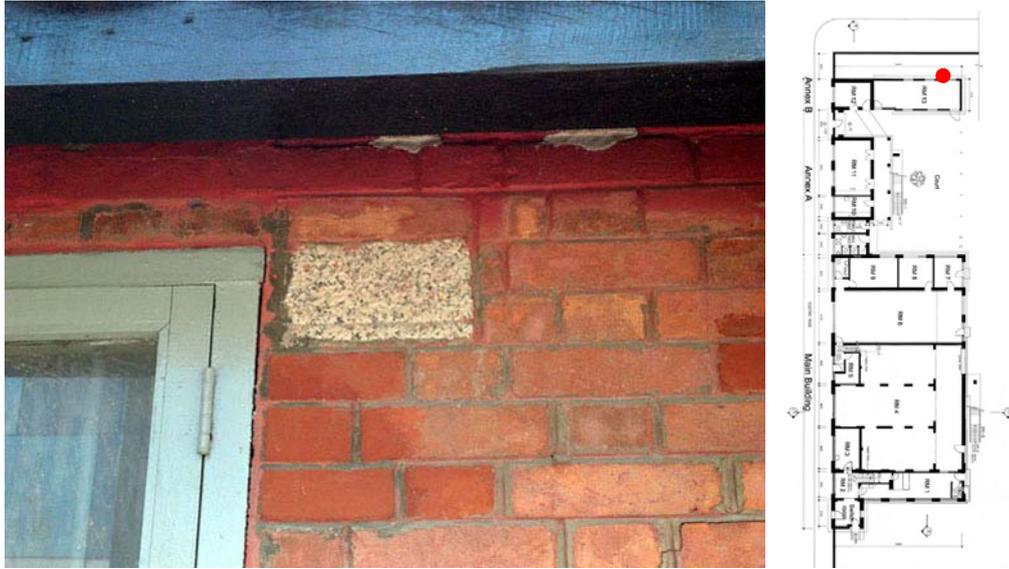
Fig. 429. Granite block for the support of timber roof truss at RM 13 of Annex B.

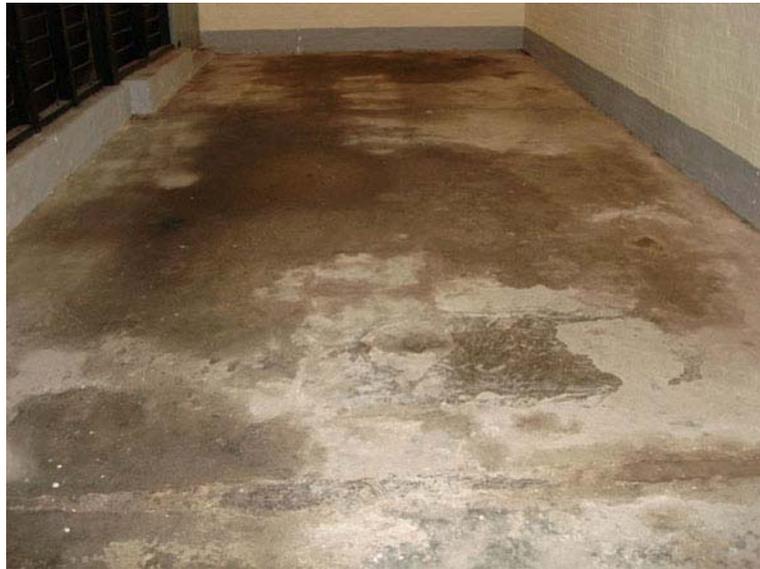
Fig. 430. Cement sand flooring at RM 13 of Annex B.

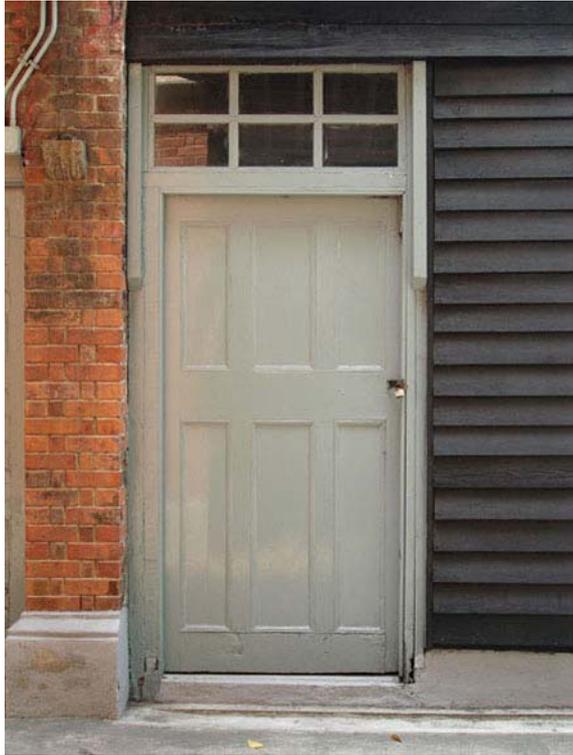
Fig. 431. Timber panelled door at the entrance of RM 13 of Annex B.

The two entrances to RM 13 are rectangular door openings, each with a timber-panelled door with a fanlight above (Fig. 431). There are timber-framed windows on both sides of the room (Fig. 432).

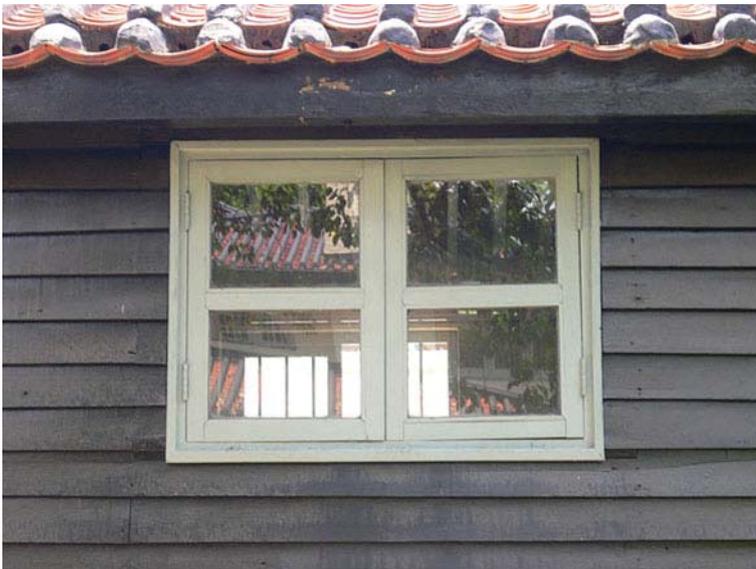
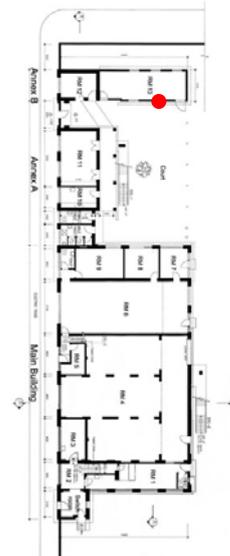
Fig. 432. Timber-framed window at RM 13 of Annex B.

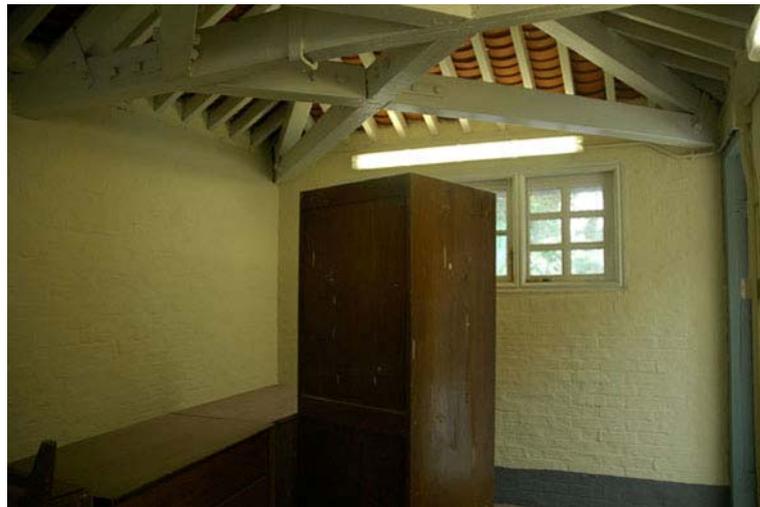
Fig. 434. Interior of RM 24 on the first floor of Annex B.

The interior of RM 24 is finished with paint on the brickworks (Fig. 434). The roof structure is exposed, with the roof trusses clearly seen (Fig. 435). The floor is finished with timber planks (Fig. 436).

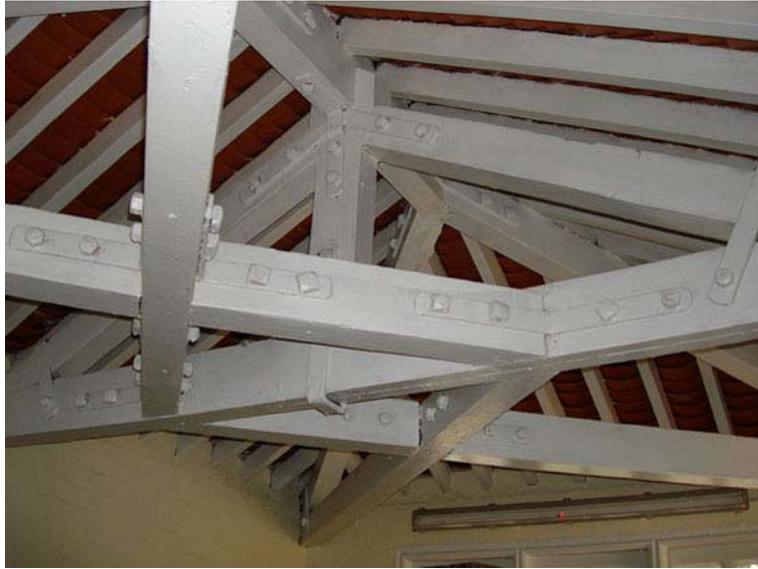
Fig. 435. Exposed roof structure of RM 24 at Annex B.

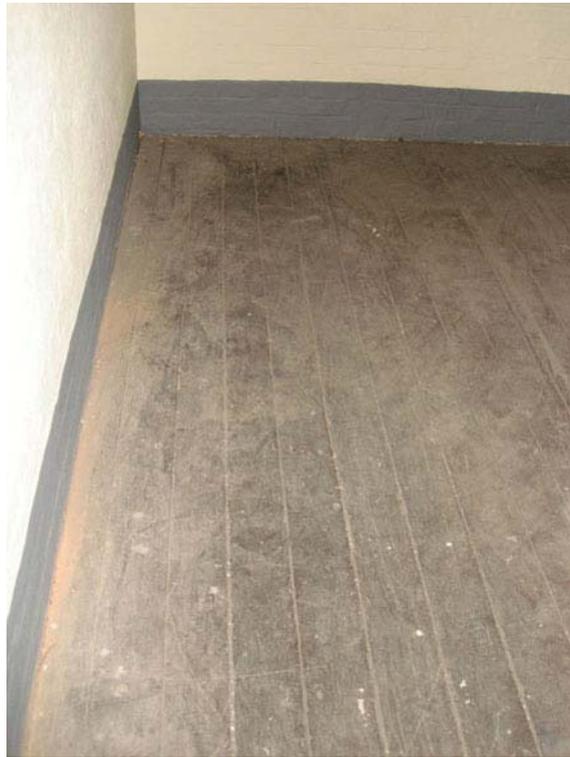
Fig. 436. Timber planks flooring at RM 24 of Annex B.

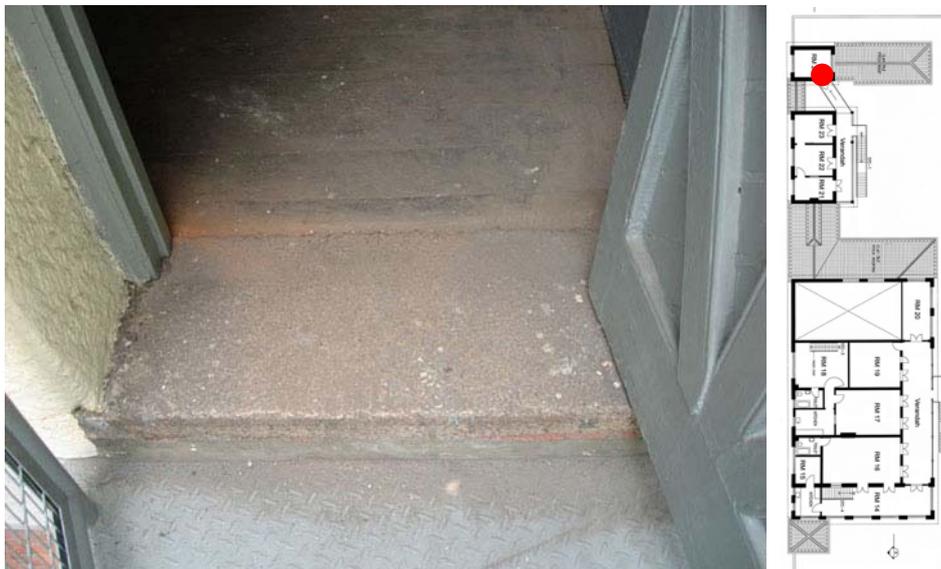
Fig. 438. Granite threshold at the entrance of RM 24 at Annex B.

The entrance is a rectangular opening with a framed, ledged and braced battened door and a granite threshold (Fig. 437 - Fig. 438). There are windows on both sides of the room (Fig. 439 - Fig. 440).

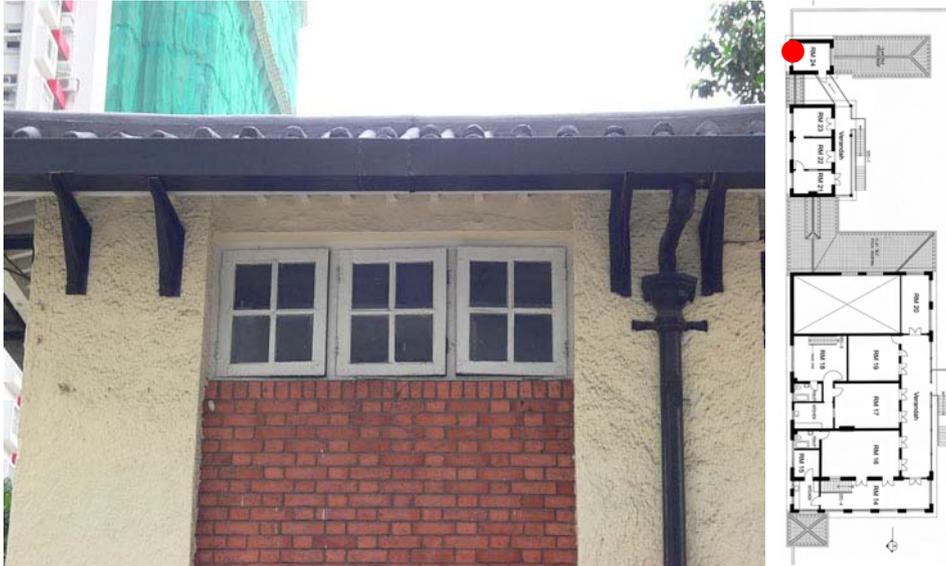
Fig. 439. Timber-framed windows on the front façade at RM 24 of Annex B.

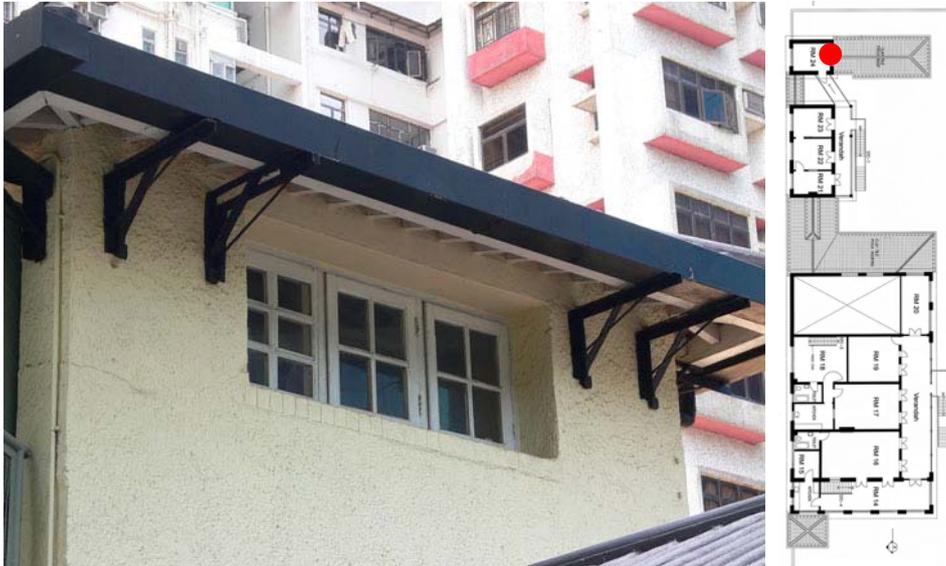
Fig. 440. Timber-framed windows on the rear façade at RM 24 of Annex B.
